# Levee Inspection Report

Name of System: Gary  
 Name of Segment: Gary North  
 NLD System ID: 2605000003 NLD Segment ID: 2604000003

Segment Type: USACE Constructed, Public sponsor O&M  
 Levee Sponsor (Name and Organization): Little Calumet River Basin Development Commission, Little Calumet River Basin Development Commission  
 Inspection Report Prepared by: \_\_\_\_\_ Date(s) of Inspection: 05/11/2020 - 05/13/2020

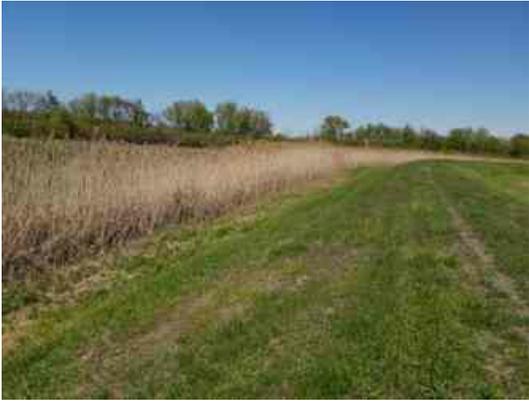
<p><b>Inspect ID:</b> 2020-0005 <b>Title:</b> 2604000003_CELRC_2020_A_0005_1_20200511T200355.jpg <b>Rated Item:</b> 1. Unwanted Vegetation Growth <b>Caption:</b> Minimally Acceptable - Small trees close to riverside toe.</p>

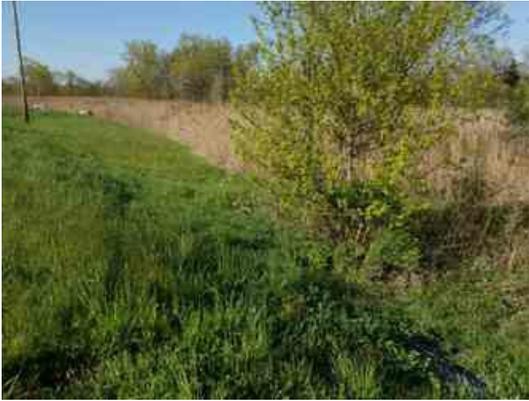
<p><b>Inspect ID:</b> 2020-0027 <b>Title:</b> 2604000003_CELRC_2020_A_0027_1_20200512T131329.jpg <b>Rated Item:</b> 1. Unwanted Vegetation Growth <b>Caption:</b> Minimally Acceptable - Tree on riverside toe.</p>

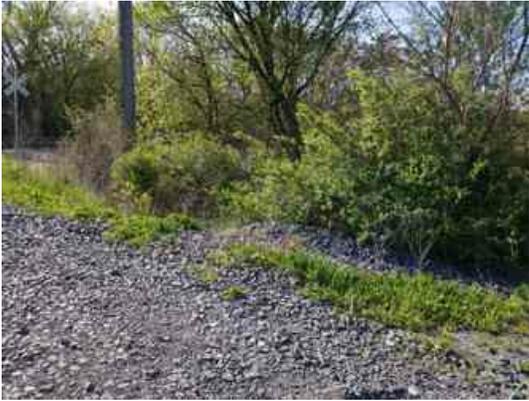
<p><b>Inspect ID:</b> 2020-0039 <b>Title:</b> 2604000003_CELRC_2020_A_0039_1_20200512T131901.jpg <b>Rated Item:</b> 1. Unwanted Vegetation Growth <b>Caption:</b> Minimally Acceptable - Trees on riverside slope.</p>

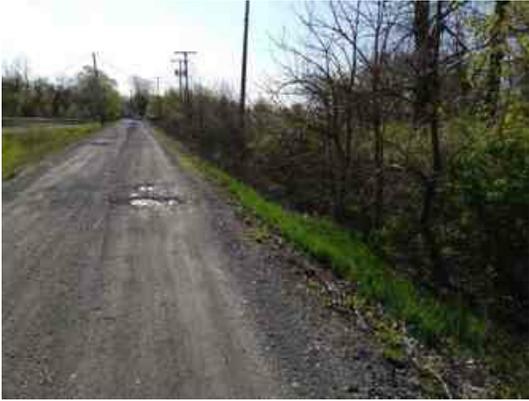
<p><b>Inspect ID:</b> 2020-0041 <b>Title:</b> 2604000003_CELRC_2020_A_0041_1_20200512T131958.jpg <b>Rated Item:</b> 1. Unwanted Vegetation Growth <b>Caption:</b> Minimally Acceptable - Trees on riverside toe and slope.</p>

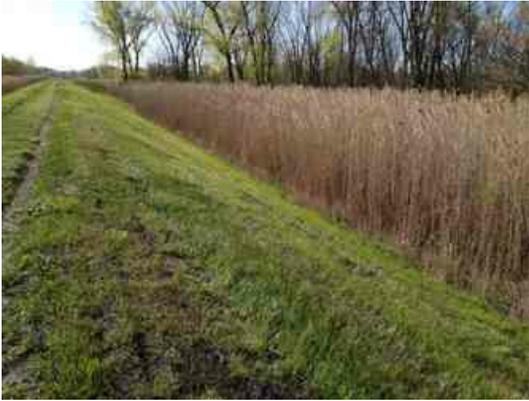
<p><b>Inspect ID:</b> 2020-0051 <b>Title:</b> 2604000003_CELRC_2020_A_0051_1_20200512T132429.jpg <b>Rated Item:</b> 1. Unwanted Vegetation Growth <b>Caption:</b> Minimally Acceptable - Small trees along riverside toe.</p>

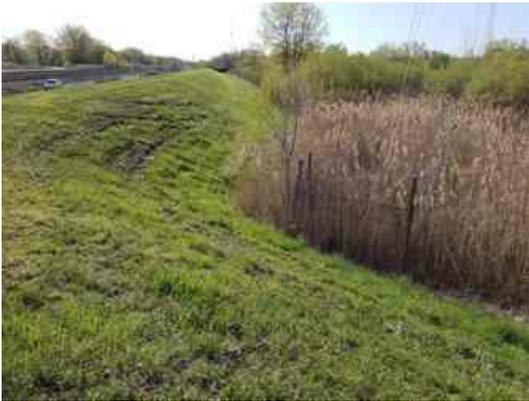
<p><b>Inspect ID:</b> 2020-0073 <b>Title:</b> 2604000003_CELRC_2020_A_0073_1_20200512T134055.jpg <b>Rated Item:</b> 1. Unwanted Vegetation Growth <b>Caption:</b> Minimally Acceptable - Small tree on the riverside toe.</p>

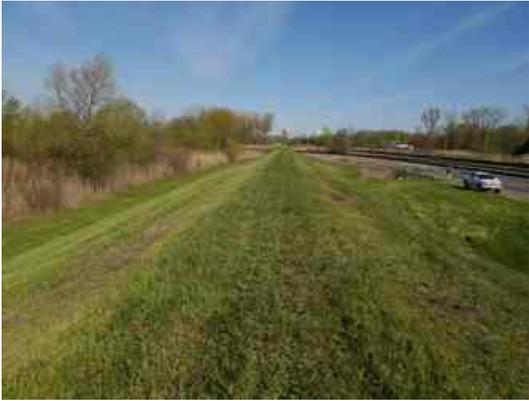
<p><b>Inspect ID:</b> 2020-0077 <b>Title:</b> 2604000003_CELRC_2020_A_0077_1_20200512T134405.jpg <b>Rated Item:</b> 1. Unwanted Vegetation Growth <b>Caption:</b> Acceptable - Good vegetation clearing on both sides.</p>

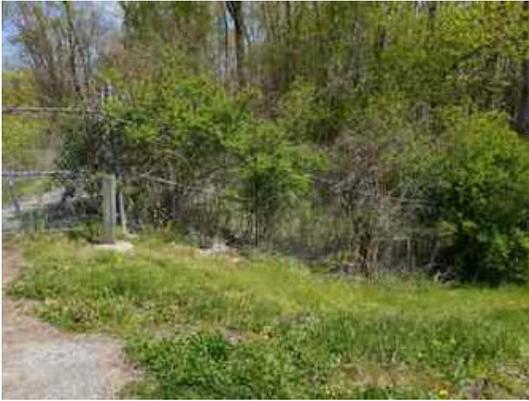
<p><b>Inspect ID:</b> 2020-0183 <b>Title:</b> 2604000003_CELRC_2020_A_0183_1_20200512T152615.jpg <b>Rated Item:</b> 1. Unwanted Vegetation Growth <b>Caption:</b> Minimally Acceptable - Trees along fence on landside slope.</p>

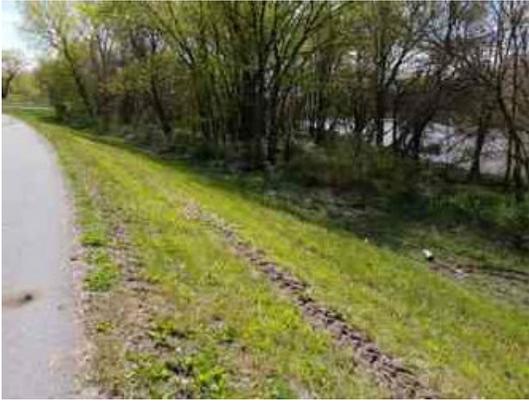
<p><b>Inspect ID:</b> 2020-0189 <b>Title:</b> 2604000003_CELRC_2020_A_0189_1_20200512T153007.jpg <b>Rated Item:</b> 1. Unwanted Vegetation Growth <b>Caption:</b> Minimally Acceptable - Trees near riverside toe.</p>

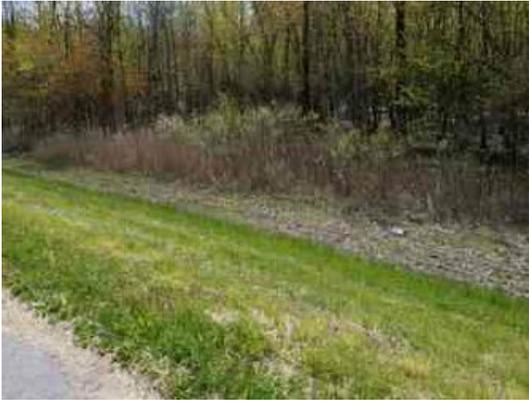
<p><b>Inspect ID:</b> 2020-0227 <b>Title:</b> 2604000003_CELRC_2020_A_0227_1_20200512T160828.jpg <b>Rated Item:</b> 1. Unwanted Vegetation Growth <b>Caption:</b> Minimally Acceptable - Small trees near riverside toe.</p>

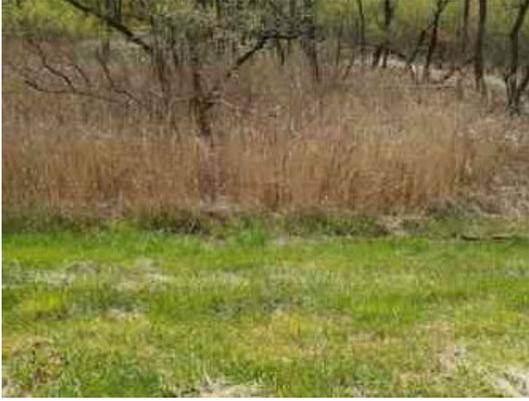
<p><b>Inspect ID:</b> 2020-0235 <b>Title:</b> 2604000003_CELRC_2020_A_0235_1_20200512T161816.jpg <b>Rated Item:</b> 1. Unwanted Vegetation Growth <b>Caption:</b> Minimally Acceptable - Small trees on riverside toe.</p>

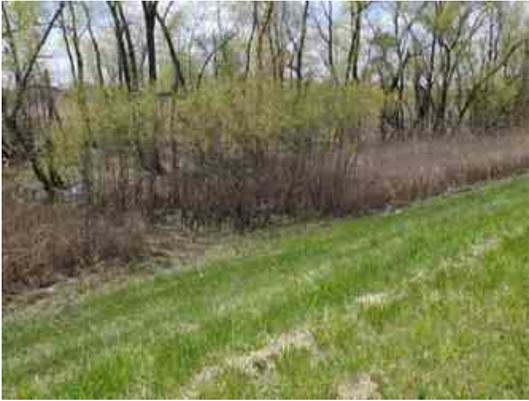
<p><b>Inspect ID:</b> 2020-0273 <b>Title:</b> 2604000003_CELRC_2020_A_0273_1_20200512T170305.jpg <b>Rated Item:</b> 1. Unwanted Vegetation Growth <b>Caption:</b> Minimally Acceptable - Small trees on riverside toe.</p>

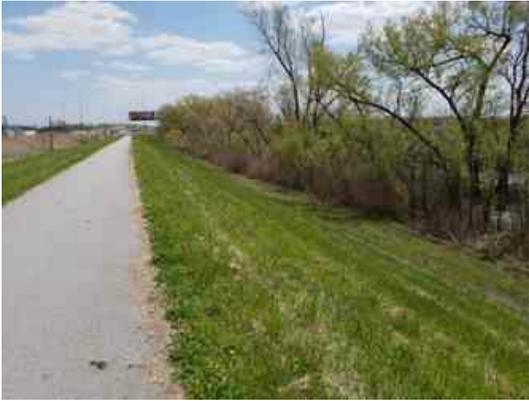
<p><b>Inspect ID:</b> 2020-0279 <b>Title:</b> 2604000003_CELRC_2020_A_0279_1_20200512T170859.jpg <b>Rated Item:</b> 1. Unwanted Vegetation Growth <b>Caption:</b> Minimally Acceptable - Small trees near riverside toe.</p>

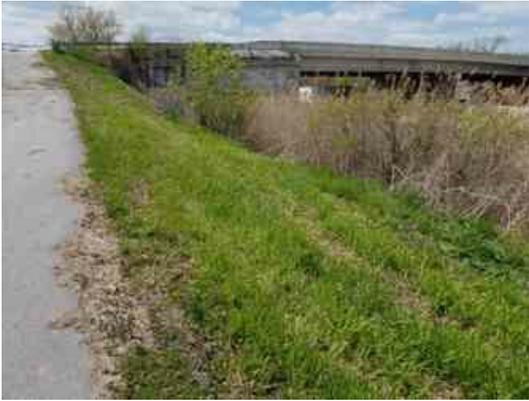
<p><b>Inspect ID:</b> 2020-0327 <b>Title:</b> 2604000003_CELRC_2020_A_0327_1_20200512T183333.jpg <b>Rated Item:</b> 1. Unwanted Vegetation Growth <b>Caption:</b> Minimally Acceptable - Trees on landside toe.</p>

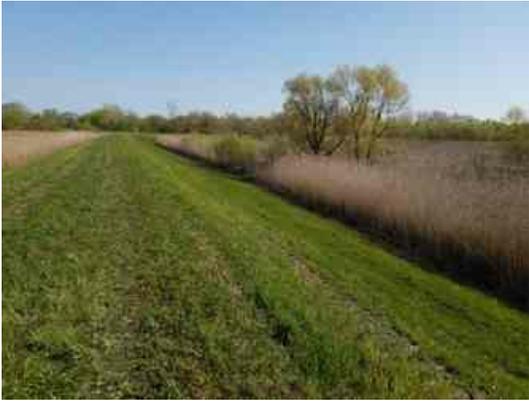
<p><b>Inspect ID:</b> 2020-0421 <b>Title:</b> 2604000003_CELRC_2020_A_0421_1_20200513T135510.jpg <b>Rated Item:</b> 1. Unwanted Vegetation Growth <b>Caption:</b> Minimally Acceptable - Small trees near landside toe.</p>

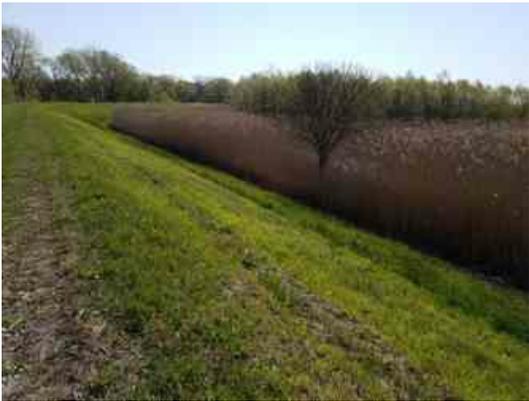
<p><b>Inspect ID:</b> 2020-0425 <b>Title:</b> 2604000003_CELRC_2020_A_0425_1_20200513T135953.jpg <b>Rated Item:</b> 1. Unwanted Vegetation Growth <b>Caption:</b> Minimally Acceptable - Trees on riverside toe.</p>

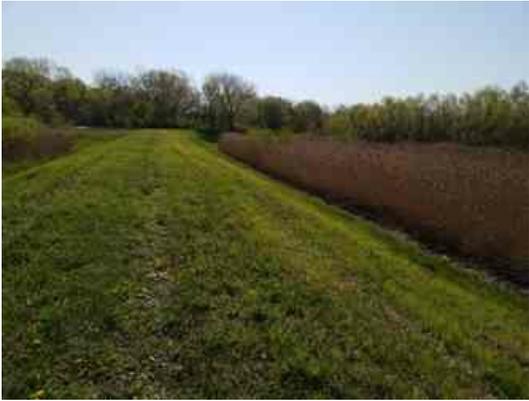
<p><b>Inspect ID:</b> 2020-0433 <b>Title:</b> 2604000003_CELRC_2020_A_0433_1_20200513T140540.jpg <b>Rated Item:</b> 1. Unwanted Vegetation Growth <b>Caption:</b> Minimally Acceptable - Small trees on riverside toe.</p>

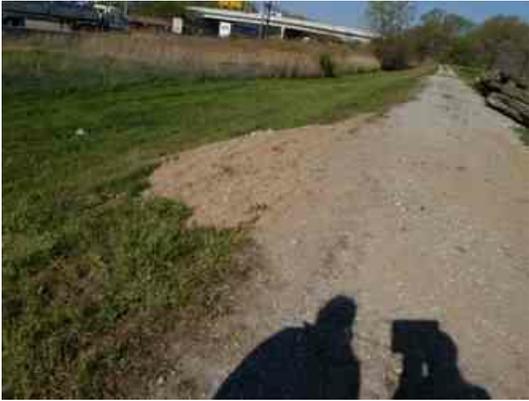
<p><b>Inspect ID:</b> 2020-0395 <b>Title:</b> 2604000003_CELRC_2020_A_0395_1_20200513T134059.jpg <b>Rated Item:</b> 2. Sod Cover <b>Caption:</b> Minimally Acceptable - Poor sod cover on landside slope due to sand on slope.</p>

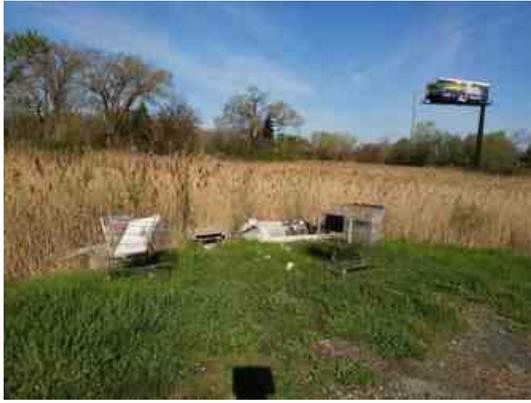
<p><b>Inspect ID:</b> 2020-0031 <b>Title:</b> 2604000003_CELRC_2020_A_0031_1_20200512T131549.jpg <b>Rated Item:</b> 3. Encroachments <b>Caption:</b> Minimally Acceptable - Debris on riverside slope at turnaround.</p>

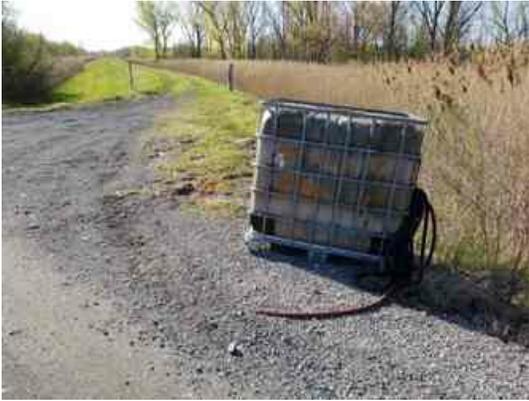
<p><b>Inspect ID:</b> 2020-0047 <b>Title:</b> 2604000003_CELRC_2020_A_0047_1_20200512T132313.jpg <b>Rated Item:</b> 3. Encroachments <b>Caption:</b> Minimally Acceptable - Container on crest on riverside.</p>

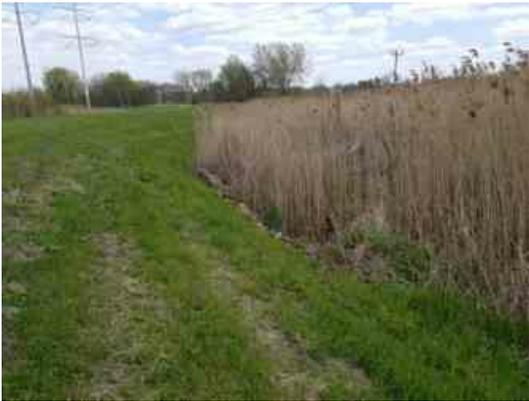
<p><b>Inspect ID:</b> 2020-0337 <b>Title:</b> 2604000003_CELRC_2020_A_0337_1_20200512T184426.jpg <b>Rated Item:</b> 3. Encroachments <b>Caption:</b> Minimally Acceptable - Downed tree at riverside toe.</p>

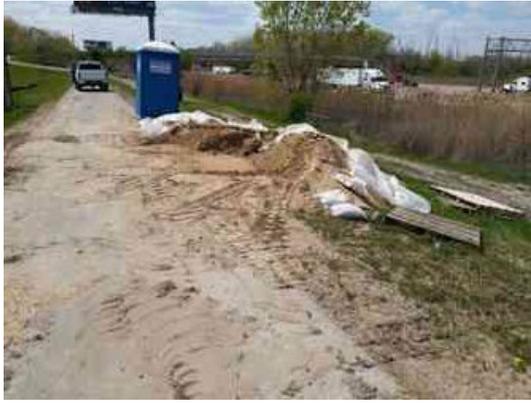
<p><b>Inspect ID:</b> 2020-0385 <b>Title:</b> 2604000003_CELRC_2020_A_0385_1_20200512T193309.jpg <b>Rated Item:</b> 3. Encroachments <b>Caption:</b> Minimally Acceptable - Sand from ongoing work on the crest.</p>

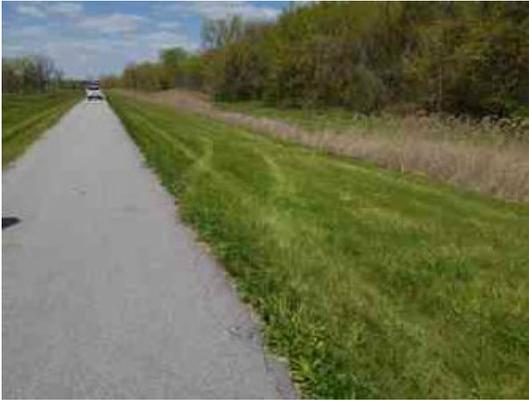
<p><b>Inspect ID:</b> 2020-0217 <b>Title:</b> 2604000003_CELRC_2020_A_0217_1_20200512T160133.jpg <b>Rated Item:</b> 5. Slope Stability <b>Caption:</b> Minimally Acceptable - Irregular landside slope with minor cracking of asphalt,</p>

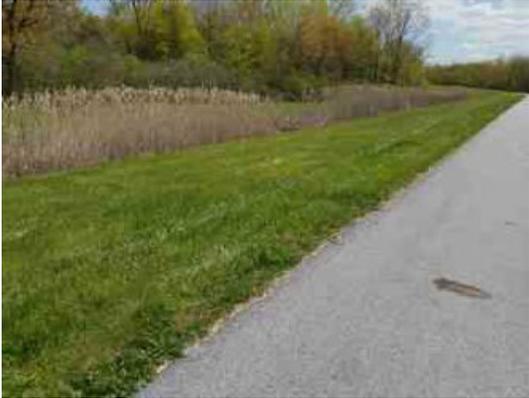
<p><b>Inspect ID:</b> 2020-0221 <b>Title:</b> 2604000003_CELRC_2020_A_0221_1_20200512T160349.jpg <b>Rated Item:</b> 5. Slope Stability <b>Caption:</b> Minimally Acceptable - Irregular landside slope with minor cracking of asphalt.</p>

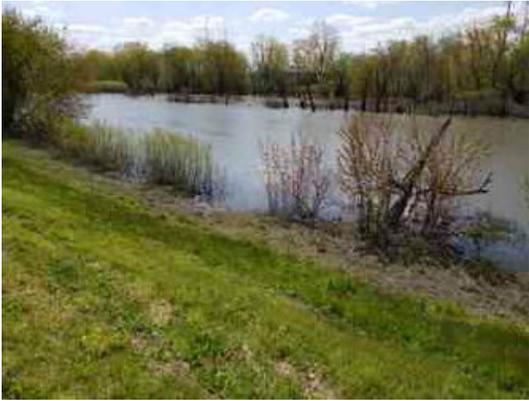
<p><b>Inspect ID:</b> 2020-0175 <b>Title:</b> 2604000003_CELRC_2020_A_0175_1_20200512T151958.jpg <b>Rated Item:</b> 6. Erosion/ Bank Caving <b>Caption:</b> Minimally Acceptable - Erosion on riverside toe.</p>

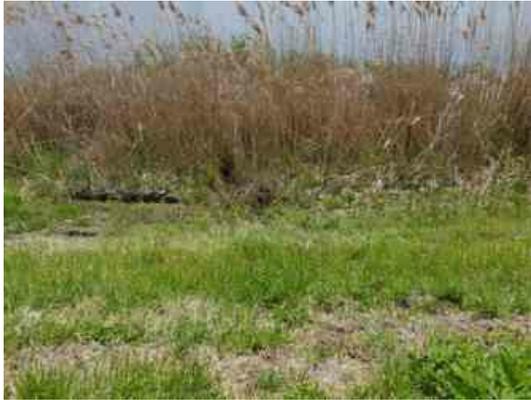
<p><b>Inspect ID:</b> 2020-0331 <b>Title:</b> 2604000003_CELRC_2020_A_0331_1_20200512T183745.jpg <b>Rated Item:</b> 6. Erosion/ Bank Caving <b>Caption:</b> Minimally Acceptable - Gully on riverside toe.</p>

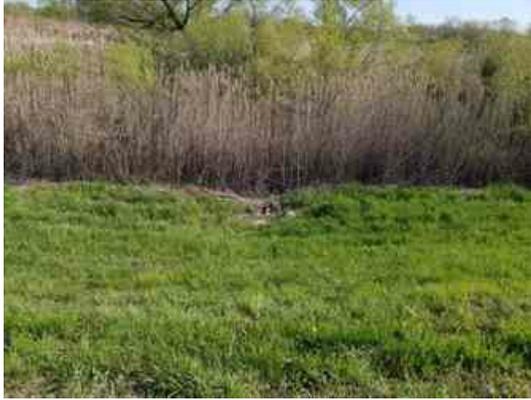
<p><b>Inspect ID:</b> 2020-0391 <b>Title:</b> 2604000003_CELRC_2020_A_0391_1_20200513T133922.jpg <b>Rated Item:</b> 6. Erosion/ Bank Caving <b>Caption:</b> Minimally Acceptable - Erosion on riverside toe.</p>

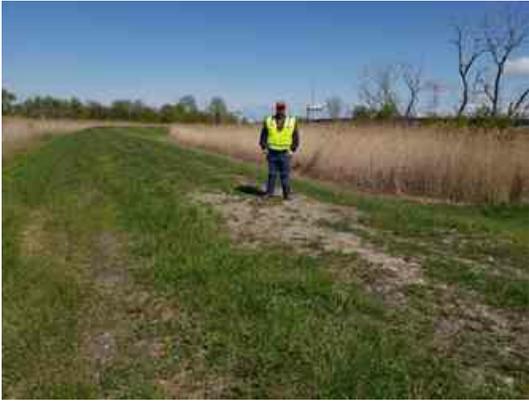
<p><b>Inspect ID:</b> 2020-0003 <b>Title:</b> 2604000003_CELRC_2020_A_0003_1_20200511T200146.jpg <b>Rated Item:</b> 8. Depressions/ Rutting <b>Caption:</b> Minimally Acceptable - Depression on crest.</p>

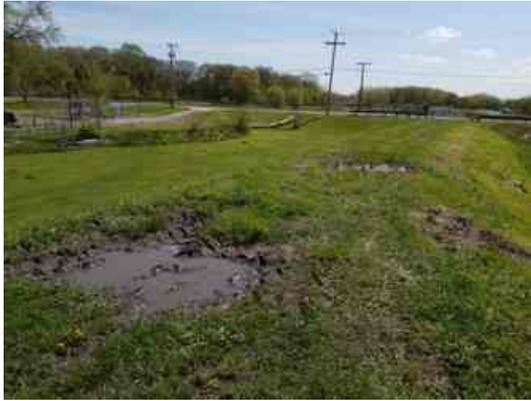
<p><b>Inspect ID:</b> 2020-0167 <b>Title:</b> 2604000003_CELRC_2020_A_0167_1_20200512T150946.jpg <b>Rated Item:</b> 8. Depressions/ Rutting <b>Caption:</b> Minimally Acceptable - Pondered water in ruts on crest, 3-4 inches deep.</p>

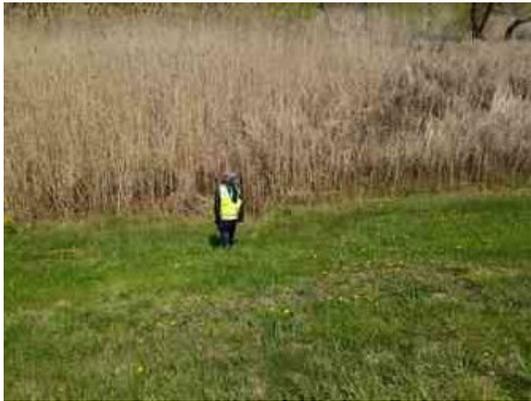
<p><b>Inspect ID:</b> 2020-0233 <b>Title:</b> 2604000003_CELRC_2020_A_0233_1_20200512T161556.jpg <b>Rated Item:</b> 8. Depressions/ Rutting <b>Caption:</b> Minimally Acceptable - Depression on landside slope, 2 ft deep.</p>

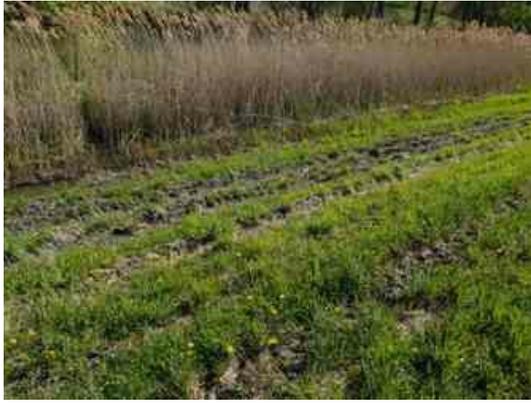
<p><b>Inspect ID:</b> 2020-0431 <b>Title:</b> 2604000003_CELRC_2020_A_0431_1_20200513T140435.jpg <b>Rated Item:</b> 8. Depressions/ Rutting <b>Caption:</b> Minimally Acceptable - Deep ruts on landside toe and slope.</p>

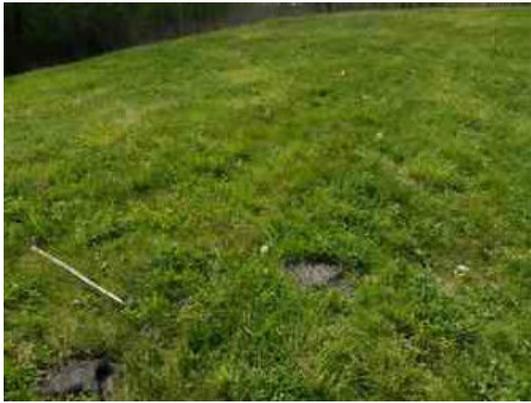
<p><b>Inspect ID:</b> 2020-0201 <b>Title:</b> 2604000003_CELRC_2020_A_0201_1_20200512T153829.jpg <b>Rated Item:</b> 10. Animal Control <b>Caption:</b> Minimally Acceptable - Animal mounds on landside slope and crest.</p>

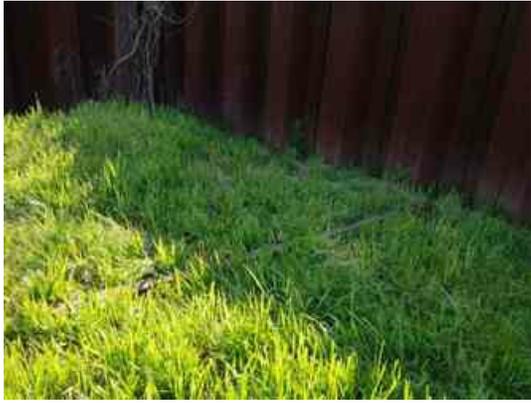
<p><b>Inspect ID:</b> 2020-0089 <b>Title:</b> 2604000003_CELRC_2020_A_0089_1_20200512T135404.jpg <b>Rated Item:</b> 2. Encroachments <b>Caption:</b> Minimally Acceptable - Debris on landside.</p>

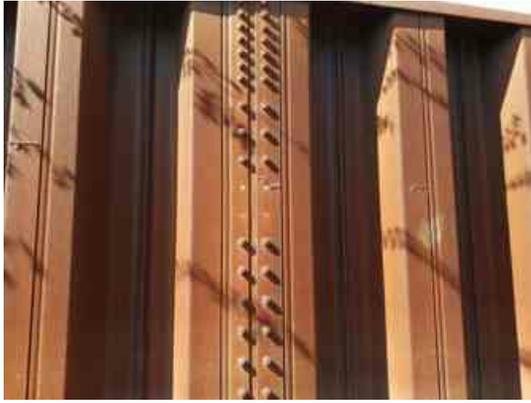
<p><b>Inspect ID:</b> 2020-0113 <b>Title:</b> 2604000003_CELRC_2020_A_0113_1_20200512T141632.jpg <b>Rated Item:</b> 4. Concrete Surfaces <b>Caption:</b> Minimally Acceptable - 4 missing bolts on the landside.</p>

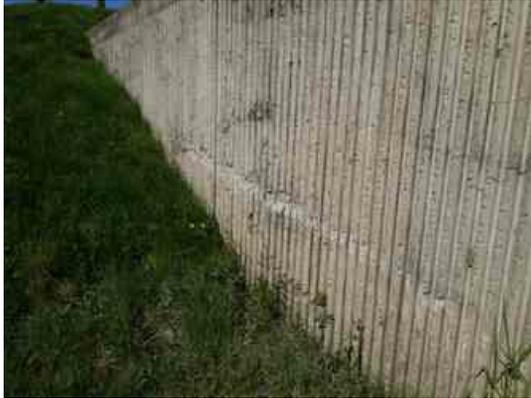
<p><b>Inspect ID:</b> 2020-0153 <b>Title:</b> 2604000003_CELRC_2020_A_0153_1_20200512T145250.jpg <b>Rated Item:</b> 4. Concrete Surfaces <b>Caption:</b> Minimally Acceptable - Damage from mower on the riverside.</p>

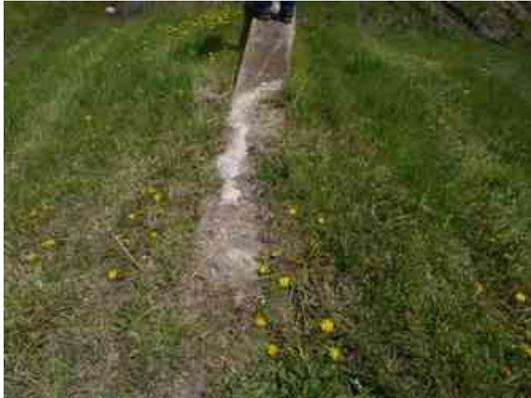
<p><b>Inspect ID:</b> 2020-0343 <b>Title:</b> 2604000003_CELRC_2020_A_0343_1_20200512T184830.jpg <b>Rated Item:</b> 4. Concrete Surfaces <b>Caption:</b> Minimally Acceptable - Damage to concrete from mower on the top.</p>

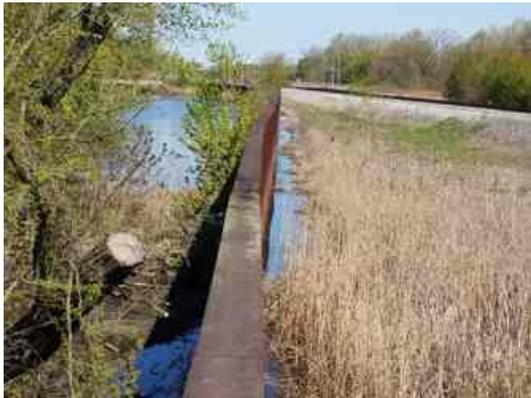
<p><b>Inspect ID:</b> 2020-0123 <b>Title:</b> 2604000003_CELRC_2020_A_0123_1_20200512T142431.jpg <b>Rated Item:</b> 5. Tilting, Sliding or Settlement of Concrete Structures <b>Caption:</b> Minimally Acceptable - Alignment issues.</p>

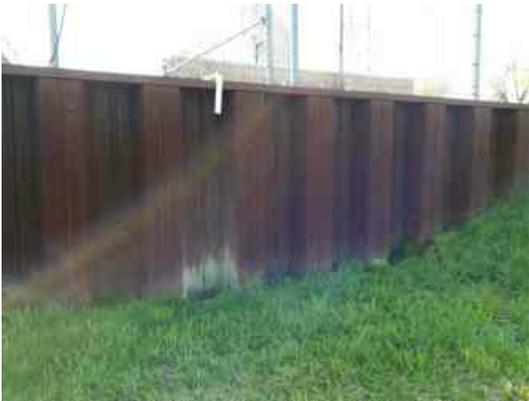
6. Foundation of Concrete Structures <sup>1</sup>	M	A	No active erosion, scouring, or bank caving that might endanger the structure's stability.	2020-0087 : Sump pump eroding foundation next to radio tower. (M)
		M	There are areas where the ground is eroding towards the base of the structure. Efforts need to be taken to slow and repair this erosion, but it is not judged to be close enough to the structure or to be progressing rapidly enough to affect structural stability before the next inspection. For the purposes of inspection, the erosion or scour is not closer to the riverside face of the wall than twice the floodwall's underground base width if the wall is of L-wall or T-wall construction; or if the wall is of sheetpile or I-wall construction, the erosion is not closer than twice the wall's visible height. Additionally, rate of erosion is such that the wall is expected to remain stable until the next inspection.

<p><b>Inspect ID:</b> 2020-0087 <b>Title:</b> 2604000003_CELRC_2020_A_0087_1_20200512T135307.jpg <b>Rated Item:</b> 6. Foundation of Concrete Structures <b>Caption:</b> Minimally Acceptable - Sump pump eroding foundation next to radio tower.</p>

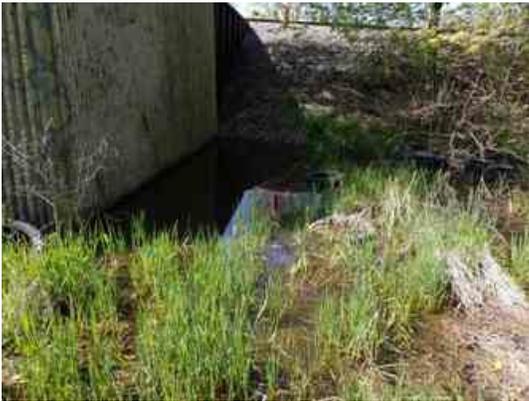
<p><b>Inspect ID:</b> 2020-0159 <b>Title:</b> 2604000003_CELRC_2020_A_0159_1_20200512T150449.jpg <b>Rated Item:</b> 9. Seepage <b>Caption:</b> Minimally Acceptable - Water in ditch on landside.</p>

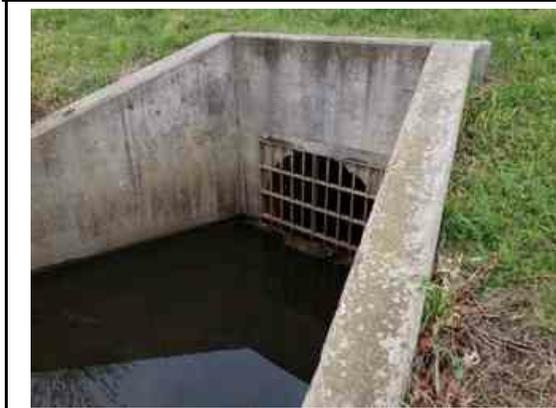
**Inspect ID:** 2020-0438 **Title:** 2604000003\_CELRC\_2020\_A\_0438\_1\_20200523T221745.jpg **Rated Item:** 1. Vegetation and Obstructions **Caption:** Acceptable - GN-3: Inlet clear.

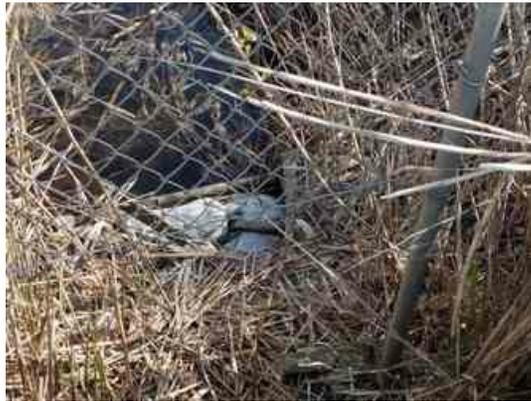
**Inspect ID:** 2020-0018 **Title:** 2604000003\_CELRC\_2020\_A\_0018\_1\_20200512T134901.jpg **Rated Item:** 2. Encroachments **Caption:** Minimally Acceptable - GN-15: Inlet has debris.

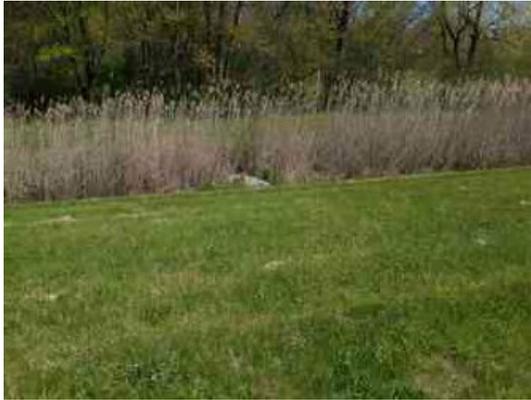
<p><b>Inspect ID:</b> 2020-0213 <b>Title:</b> 2604000003_CELRC_2020_A_0213_1_20200512T155222.jpg <b>Rated Item:</b> 2. Encroachments <b>Caption:</b> Minimally Acceptable - Debris in ditch.</p>

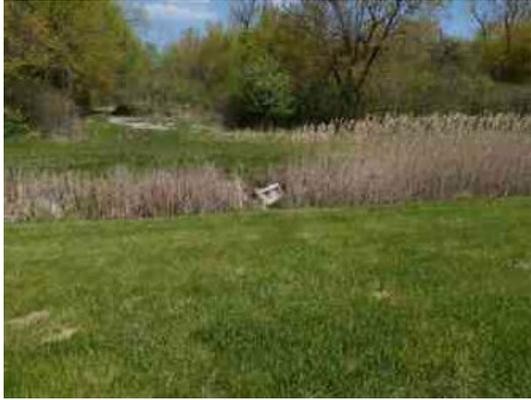
<p><b>Inspect ID:</b> 2020-0219 <b>Title:</b> 2604000003_CELRC_2020_A_0219_1_20200512T160252.jpg <b>Rated Item:</b> 2. Encroachments <b>Caption:</b> Minimally Acceptable - Debris in ditch.</p>

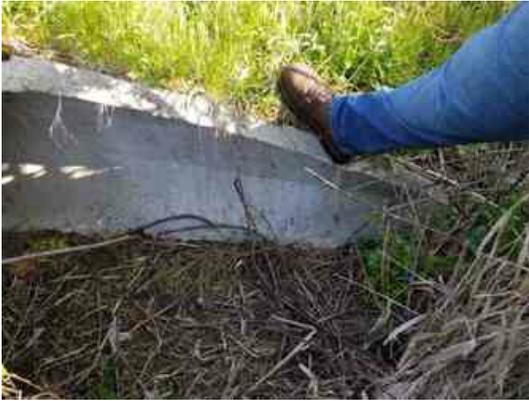
<p><b>Inspect ID:</b> 2020-0021 <b>Title:</b> 2604000003_CELRC_2020_A_0021_1_20200512T131034.jpg <b>Rated Item:</b> 5. Concrete Surfaces (Such as gate wells, outfalls, intakes, or culverts) <b>Caption:</b> Minimally Acceptable - GN-1: Minor cracking on inlet wing.</p>

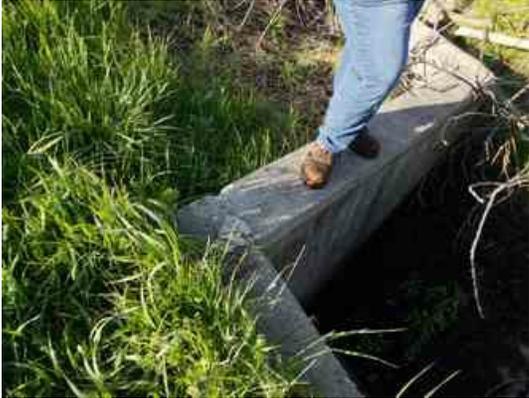
<p><b>Inspect ID:</b> 2020-0025 <b>Title:</b> 2604000003_CELRC_2020_A_0025_1_20200512T131245.jpg <b>Rated Item:</b> 5. Concrete Surfaces (Such as gate wells, outfalls, intakes, or culverts) <b>Caption:</b> Minimally Acceptable - GN-1: Minor spelling on outlet headwall.</p>

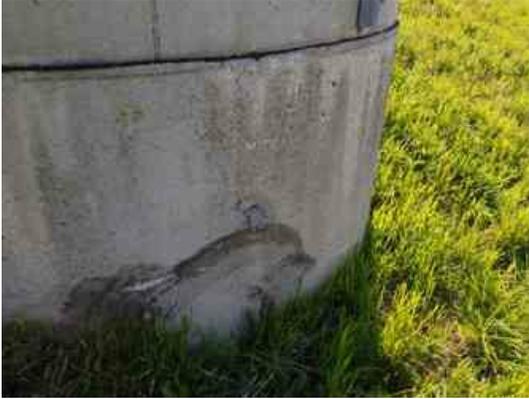
<p><b>Inspect ID:</b> 2020-0057 <b>Title:</b> 2604000003_CELRC_2020_A_0057_1_20200512T133033.jpg <b>Rated Item:</b> 5. Concrete Surfaces (Such as gate wells, outfalls, intakes, or culverts) <b>Caption:</b> Minimally Acceptable - GN-2: Manhole hole patch is loose and minor spalling on other side.</p>

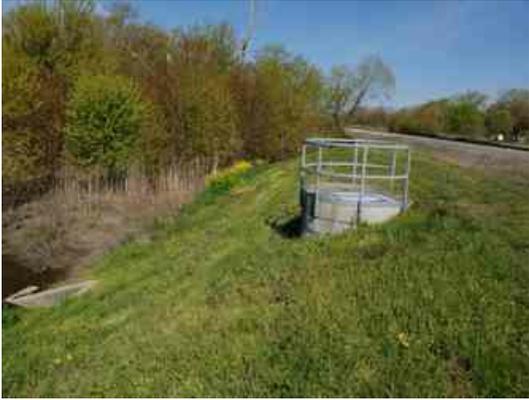
<p><b>Inspect ID:</b> 2020-0131 <b>Title:</b> 2604000003_CELRC_2020_A_0131_1_20200512T143424.jpg <b>Rated Item:</b> 5. Concrete Surfaces (Such as gate wells, outfalls, intakes, or culverts) <b>Caption:</b> Minimally Acceptable - GN-4: Outlet in good condition.</p>

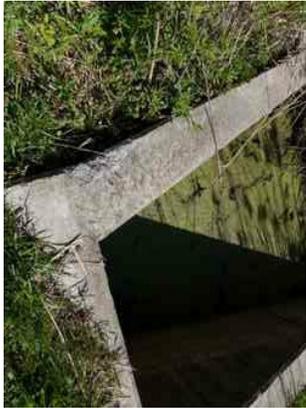
A photograph showing a concrete structure, likely an inlet or culvert, with some vegetation growing around it. The structure is made of light-colored concrete and has a rectangular opening.	<p><b>Inspect ID:</b> 2020-0145 <b>Title:</b> 2604000003_CELRC_2020_A_0145_1_20200512T144800.jpg <b>Rated Item:</b> 5. Concrete Surfaces (Such as gate wells, outfalls, intakes, or culverts) <b>Caption:</b> Minimally Acceptable - GN-5: Minor spalling at inlet.</p>

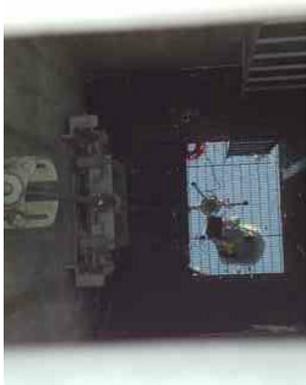
A photograph showing a sluice gate or slide gate, which is a large metal structure used to control water flow. The gate is closed, and the water level is visible behind it.	<p><b>Inspect ID:</b> 2020-0010 <b>Title:</b> 2604000003_CELRC_2020_A_0010_1_20200512T134118.jpg <b>Rated Item:</b> 10. Sluice/ Slide Gates <b>Caption:</b> Acceptable - GN-13: Sluice gate closed completely.</p>

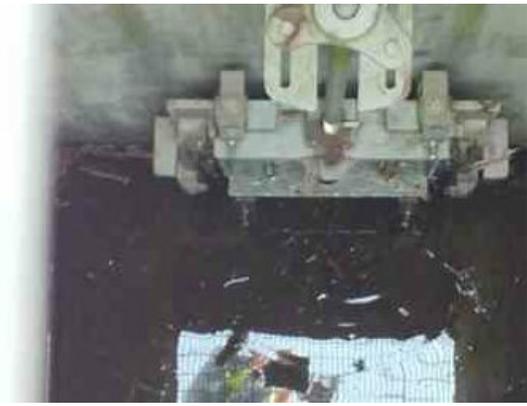
<p><b>Inspect ID:</b> 2020-0014 <b>Title:</b> 2604000003_CELRC_2020_A_0014_1_20200512T134427.jpg <b>Rated Item:</b> 10. Sluice/ Slide Gates <b>Caption:</b> Acceptable - GN-13: Sluice gate open completely.</p>

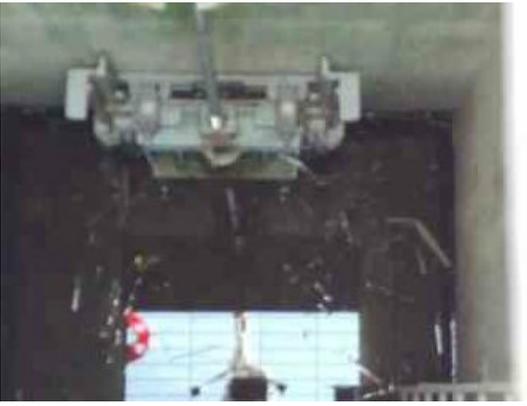
<p><b>Inspect ID:</b> 2020-0016 <b>Title:</b> 2604000003_CELRC_2020_A_0016_1_20200512T134542.jpg <b>Rated Item:</b> 10. Sluice/ Slide Gates <b>Caption:</b> Acceptable - GN-15: Sluice gate closed and opened completely.</p>
