# Levee Inspection Report

Name of System: Gary  
 Name of Segment: Gary South  
 NLD System ID: 2605000003 NLD Segment ID: 2604000004

Segment Type: USACE Constructed, Public sponsor O&M  
 Levee Sponsor (Name and Organization): Little Calumet River Basin Development Commission  
 Inspection Report Prepared by: \_\_\_\_\_ Date(s) of Inspection: 05/11/2020 - 05/11/2020

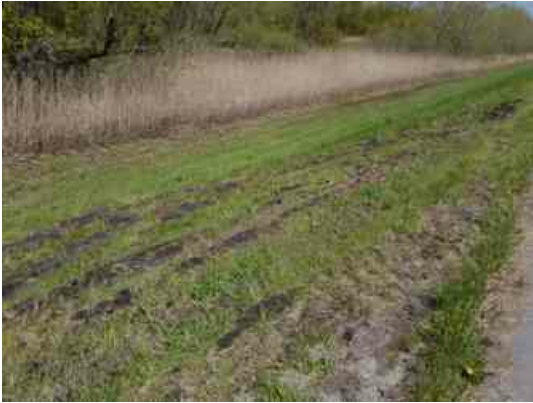
<p><b>Inspect ID:</b> 2020-0137 <b>Title:</b> 2604000004_CELRC_2020_A_0137_1_20200511T191803.jpg <b>Rated Item:</b> 2. Sod Cover <b>Caption:</b> Minimally Acceptable - Poor sod cover on riverside slope due to rutting.</p>

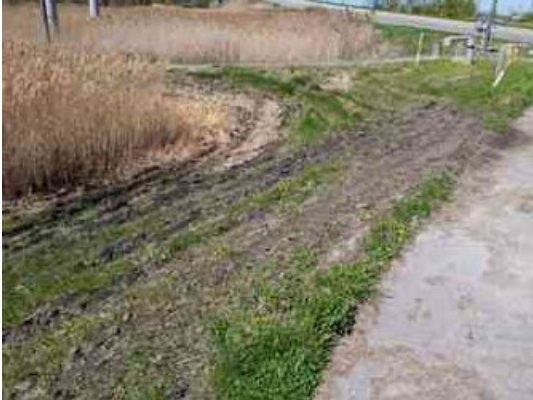
2. Sod Cover	M	A	There is good coverage of sod over the levee.	2020-0017 : Good sod cover on landside and riverside slopes. (A)
		M	Approximately 25% of the sod cover is missing or damaged over a significant portion or over significant portions of the levee embankment. This may be the result of over-grazing or feeding on the levee, unauthorized vehicular traffic, chemical or insect problems, or burning during inappropriate seasons.	2020-0021 : Poor sod cover on on riverside slope due to rutting. (M) 2020-0107 : Poor sod cover on riverside slope and crest caused by rutting. (M)
		U	Over 50% of the sod cover is missing or damaged over a significant portion or portions of the levee embankment.	2020-0137 : Poor sod cover on riverside slope due to rutting. (M)
		N/A	Surface protection is provided by other means.	2020-0169 : Poor sod cover on riverside slope due to rutting. (M)

<p><b>Inspect ID:</b> 2020-0169 <b>Title:</b> 2604000004_CELRC_2020_A_0169_1_20200511T195610.jpg <b>Rated Item:</b> 2. Sod Cover <b>Caption:</b> Minimally Acceptable - Poor sod cover on riverside slope due to rutting.</p>

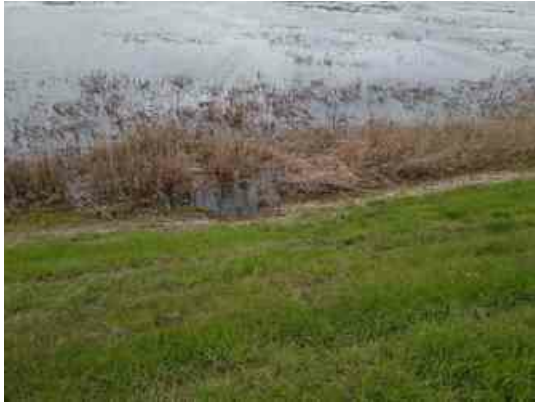
<p><b>Inspect ID:</b> 2020-0031 <b>Title:</b> 2604000004_CELRC_2020_A_0031_1_20200511T163145.jpg <b>Rated Item:</b> 6. Erosion/ Bank Caving <b>Caption:</b> Minimally Acceptable - Erosion on riverside toe.</p>

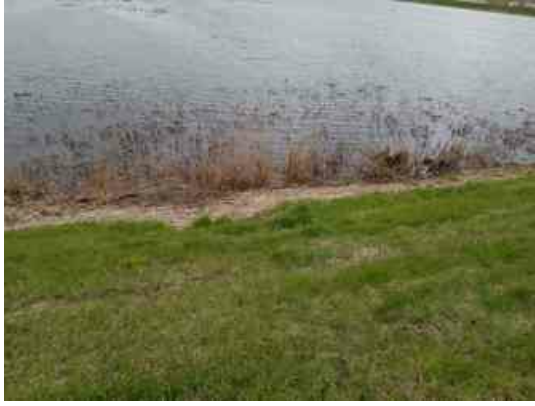
<p><b>Inspect ID:</b> 2020-0037 <b>Title:</b> 2604000004_CELRC_2020_A_0037_1_20200511T163643.jpg <b>Rated Item:</b> 6. Erosion/ Bank Caving <b>Caption:</b> Minimally Acceptable - Erosion on riverside toe.</p>

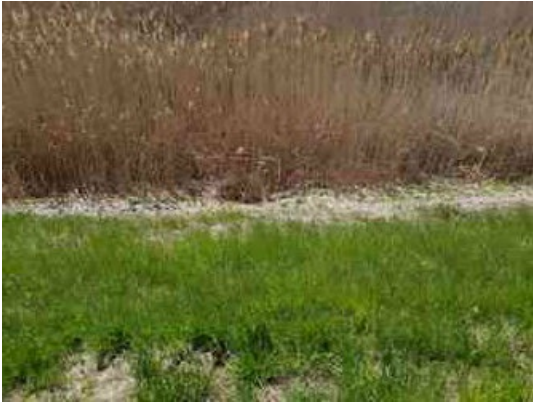
<p><b>Inspect ID:</b> 2020-0163 <b>Title:</b> 2604000004_CELRC_2020_A_0163_1_20200511T195227.jpg <b>Rated Item:</b> 6. Erosion/ Bank Caving <b>Caption:</b> Minimally Acceptable - Erosion of riverside toe.</p>
 	<p><b>Inspect ID:</b> 2020-0165 <b>Title:</b> 2604000004_CELRC_2020_A_0165_1_20200511T195337.jpg <b>Rated Item:</b> 6. Erosion/ Bank Caving <b>Caption:</b> Minimally Acceptable - Erosion of riverside toe.</p>

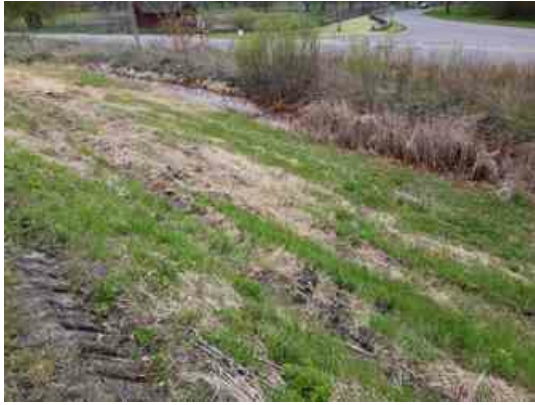
<p><b>Inspect ID:</b> 2020-0093 <b>Title:</b> 2604000004_CELRC_2020_A_0093_1_20200511T182128.jpg <b>Rated Item:</b> 8. Depressions/ Rutting <b>Caption:</b> Minimally Acceptable - Rutting on landside slope.</p>

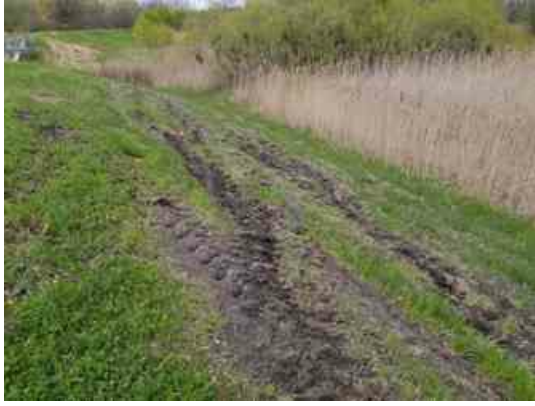
<p><b>Inspect ID:</b> 2020-0095 <b>Title:</b> 2604000004_CELRC_2020_A_0095_1_20200511T182806.jpg <b>Rated Item:</b> 8. Depressions/ Rutting <b>Caption:</b> Minimally Acceptable - Rutting on riverside slope.</p>

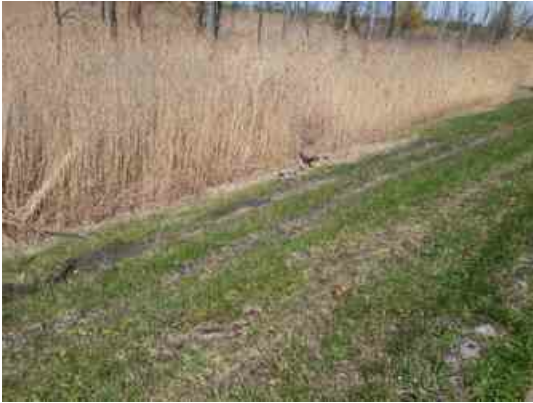
<p><b>Inspect ID:</b> 2020-0145 <b>Title:</b> 2604000004_CELRC_2020_A_0145_1_20200511T193203.jpg <b>Rated Item:</b> 8. Depressions/ Rutting <b>Caption:</b> Minimally Acceptable - Rutting on riverside slope.</p>

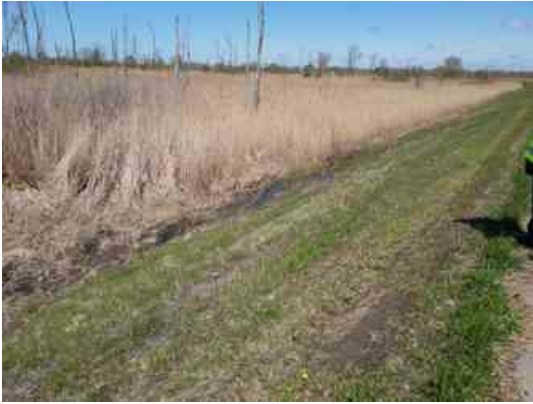
<p><b>Inspect ID:</b> 2020-0149 <b>Title:</b> 2604000004_CELRC_2020_A_0149_1_20200511T193636.jpg <b>Rated Item:</b> 8. Depressions/ Rutting <b>Caption:</b> Minimally Acceptable - Rutting on riverside toe.</p>

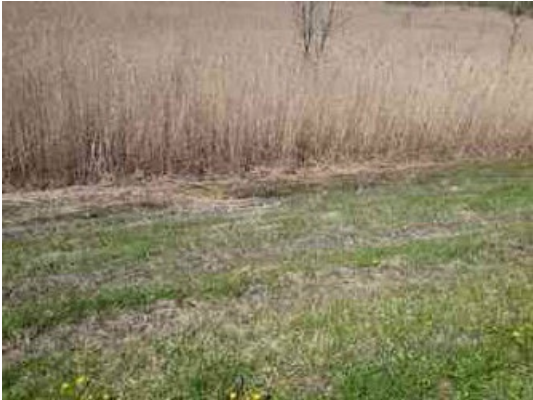
<p><b>Inspect ID:</b> 2020-0151 <b>Title:</b> 2604000004_CELRC_2020_A_0151_1_20200511T193827.jpg <b>Rated Item:</b> 8. Depressions/ Rutting <b>Caption:</b> Minimally Acceptable - Rutting on riverside toe.</p>

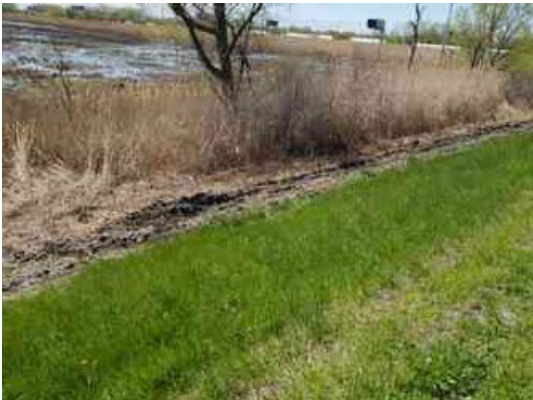
<p><b>Inspect ID:</b> 2020-0167 <b>Title:</b> 2604000004_CELRC_2020_A_0167_1_20200511T195421.jpg <b>Rated Item:</b> 8. Depressions/ Rutting <b>Caption:</b> Minimally Acceptable - Rutting on riverside toe.</p>

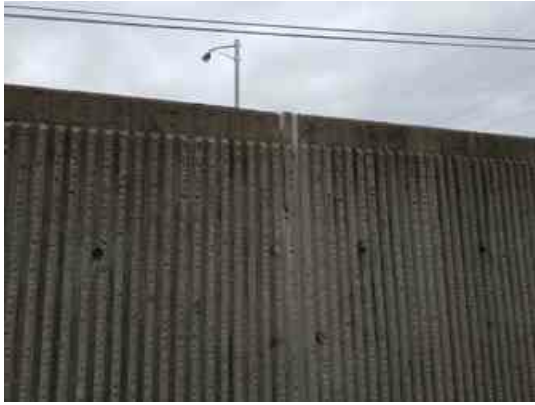
<p><b>Inspect ID:</b> 2020-0069 <b>Title:</b> 2604000004_CELRC_2020_A_0069_1_20200511T171122.jpg <b>Rated Item:</b> 4. Concrete Surfaces <b>Caption:</b> Minimally Acceptable - Previously sealed crack reopened on riverside.</p>

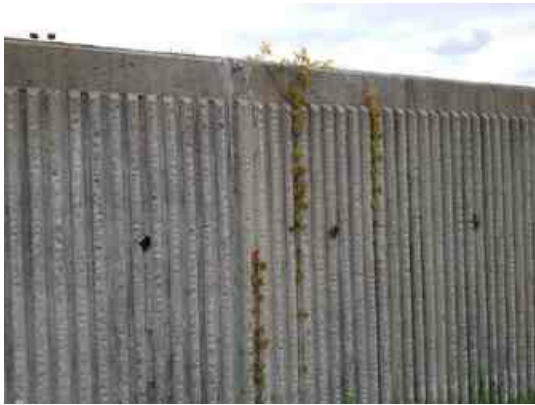
<p><b>Inspect ID:</b> 2020-0075 <b>Title:</b> 2604000004_CELRC_2020_A_0075_1_20200511T171506.jpg <b>Rated Item:</b> 4. Concrete Surfaces <b>Caption:</b> Minimally Acceptable - Crack on landside.</p>

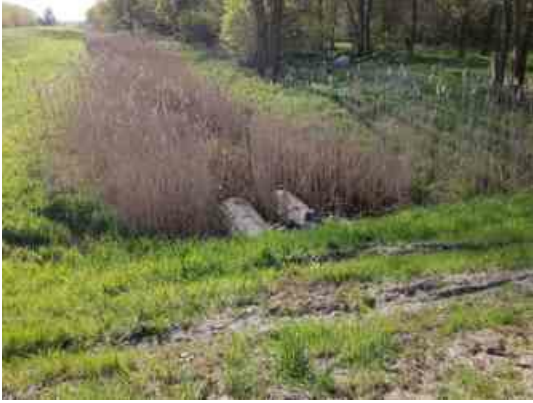
<p><b>Inspect ID:</b> 2020-0064 <b>Title:</b> 2604000004_CELRC_2020_A_0064_2_20200512T125652.jpg <b>Rated Item:</b> 1. Vegetation and Obstructions <b>Caption:</b> Minimally Acceptable - GS-14: Vegetation in inlet.</p>

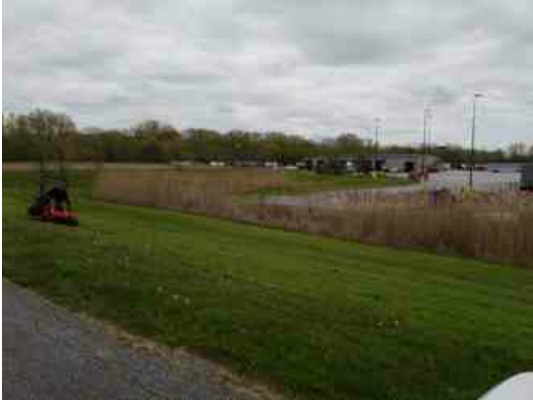
<p><b>Inspect ID:</b> 2020-0079 <b>Title:</b> 2604000004_CELRC_2020_A_0079_1_20200511T175156.jpg <b>Rated Item:</b> 1. Vegetation and Obstructions <b>Caption:</b> Minimally Acceptable - Small trees in ditch.</p>

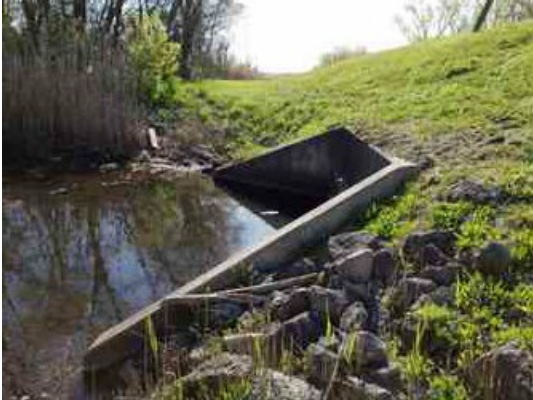
<p><b>Inspect ID:</b> 2020-0084 <b>Title:</b> 2604000004_CELRC_2020_A_0084_1_20200512T132452.jpg <b>Rated Item:</b> 1. Vegetation and Obstructions <b>Caption:</b> Acceptable - GS-15: Outlet clear.</p>

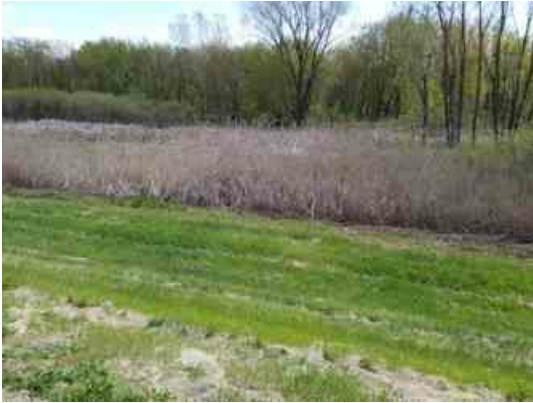
<p><b>Inspect ID:</b> 2020-0127 <b>Title:</b> 2604000004_CELRC_2020_A_0127_1_20200511T190956.jpg <b>Rated Item:</b> 1. Vegetation and Obstructions <b>Caption:</b> Minimally Acceptable - Small trees in ditch.</p>

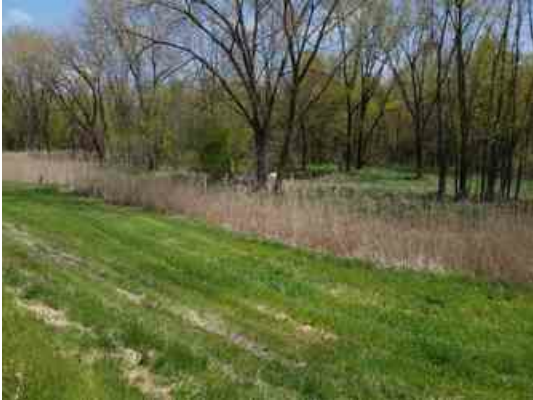
<p><b>Inspect ID:</b> 2020-0129 <b>Title:</b> 2604000004_CELRC_2020_A_0129_1_20200511T191248.jpg <b>Rated Item:</b> 1. Vegetation and Obstructions <b>Caption:</b> Minimally Acceptable - Small trees in ditch.</p>

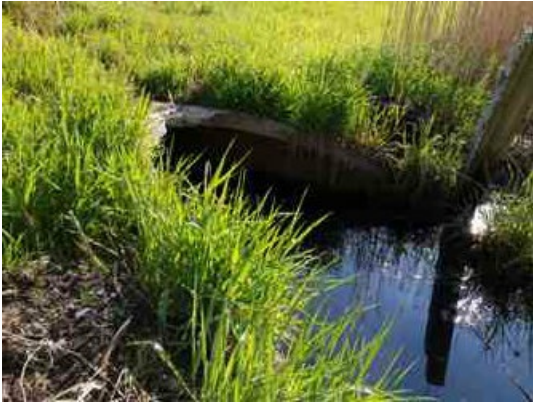
<p><b>Inspect ID:</b> 2020-0072 <b>Title:</b> 2604000004_CELRC_2020_A_0072_1_20200512T131200.jpg <b>Rated Item:</b> 2. Encroachments <b>Caption:</b> Acceptable - GS-15: Inlet is clean.</p>

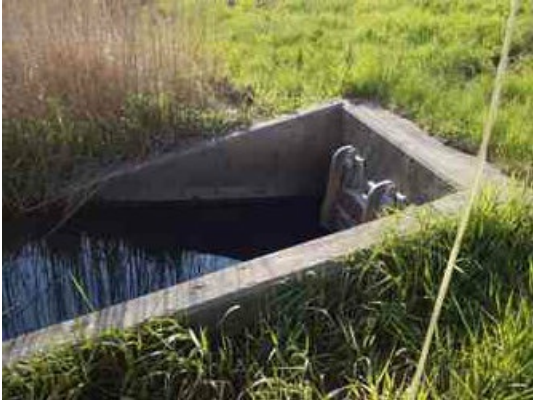
<p><b>Inspect ID:</b> 2020-0074 <b>Title:</b> 2604000004_CELRC_2020_A_0074_1_20200512T131400.jpg <b>Rated Item:</b> 2. Encroachments <b>Caption:</b> Acceptable - GS-15: Outlet has no debris.</p>

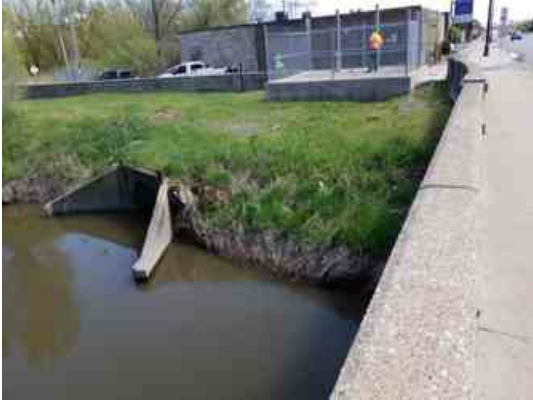
<p><b>Inspect ID:</b> 2020-0038 <b>Title:</b> 2604000004_CELRC_2020_A_0038_1_20200511T193549.jpg <b>Rated Item:</b> 7. Foundation of Concrete Structures (Such as culverts, inlet and discharge structures, or gatewells.) <b>Caption:</b> Minimally Acceptable - GS-11a, b: Ground appears to be eroding behind outlet wingwalls.</p>

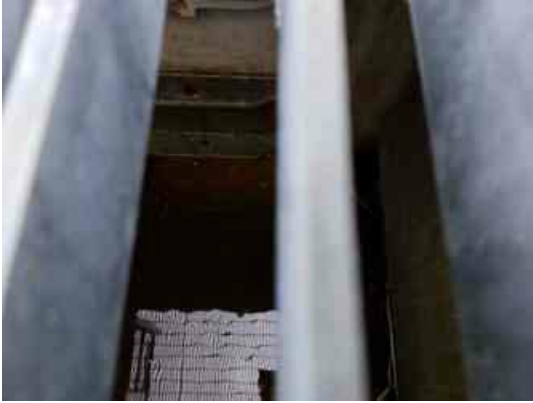
<p><b>Inspect ID:</b> 2020-0010 <b>Title:</b> 2604000004_CELRC_2020_A_0010_1_20200511T175237.jpg <b>Rated Item:</b> 10. Sluice/ Slide Gates <b>Caption:</b> Acceptable - GS-3: Sluice gate closed completely.</p>

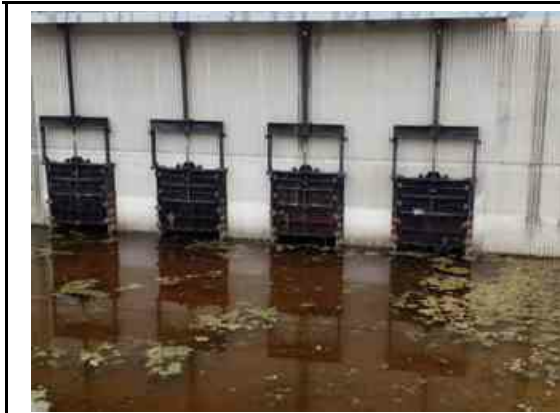
**Inspect ID:** 2020-0016 **Title:** 2604000004\_CELRC\_2020\_A\_0016\_4\_20200511T175543.jpg **Rated Item:** 10. Sluice/ Slide Gates **Caption:** Acceptable - GS-2a-d: All sluice gates operated and closed completely

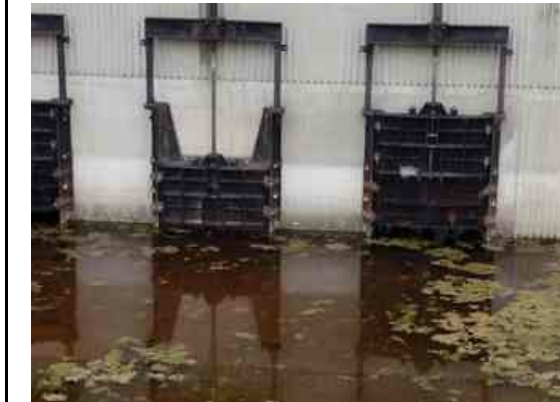
**Inspect ID:** 2020-0016 **Title:** 2604000004\_CELRC\_2020\_A\_0016\_6\_20200511T175725.jpg **Rated Item:** 10. Sluice/ Slide Gates **Caption:** Acceptable - GS-2a-d: All sluice gates operated and closed completely

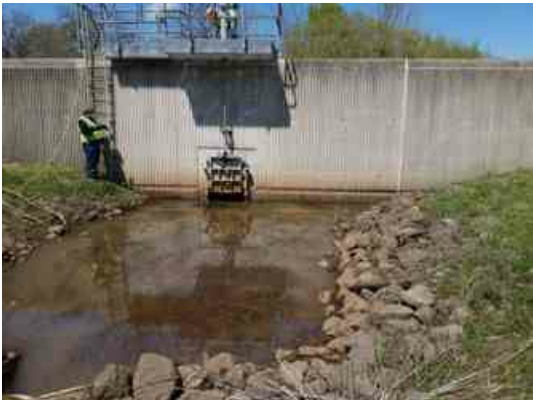
A second photograph of the same sluice gate, showing the same sediment buildup and the worker on the platform.	<p><b>Inspect ID:</b> 2020-0036 <b>Title:</b> 2604000004_CELRC_2020_A_0036_2_20200511T192446.jpg <b>Rated Item:</b> 10. Sluice/ Slide Gates <b>Caption:</b> Minimally Acceptable - GS-10: Sediment preventing it from closing.</p>

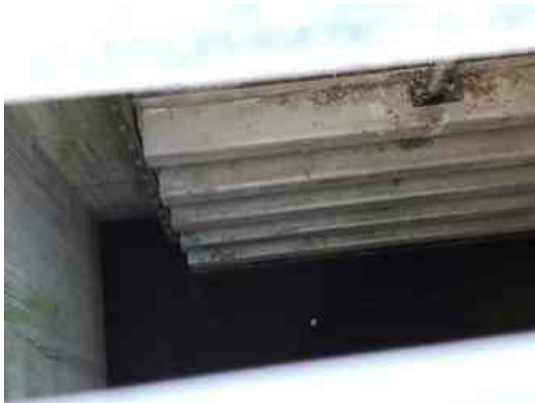
<p><b>Inspect ID:</b> 2020-0068 <b>Title:</b> 2604000004_CELRC_2020_A_0068_1_20200512T130008.jpg <b>Rated Item:</b> 10. Sluice/ Slide Gates <b>Caption:</b> Acceptable - GS-14: Sluice gate closed completely.</p>

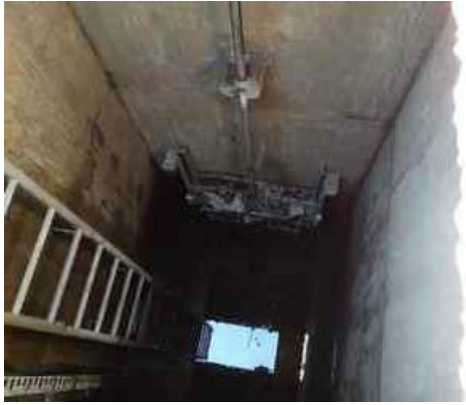
<p><b>Inspect ID:</b> 2020-0076 <b>Title:</b> 2604000004_CELRC_2020_A_0076_1_20200512T131445.jpg <b>Rated Item:</b> 10. Sluice/ Slide Gates <b>Caption:</b> Acceptable - GS-15: Closed completely.</p>

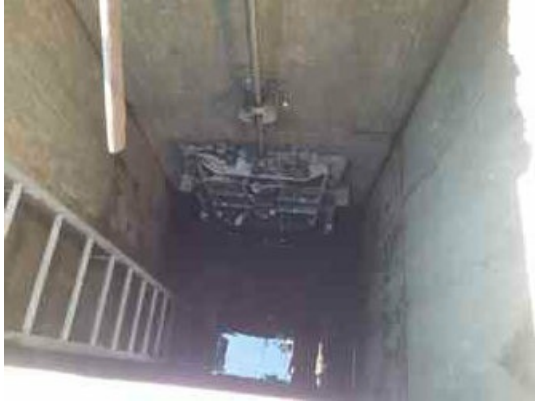
<p><b>Inspect ID:</b> 2020-0080 <b>Title:</b> 2604000004_CELRC_2020_A_0080_1_20200512T131756.jpg <b>Rated Item:</b> 10. Sluice/ Slide Gates <b>Caption:</b> Acceptable - GS-15: Sluice gate opened completely.</p>

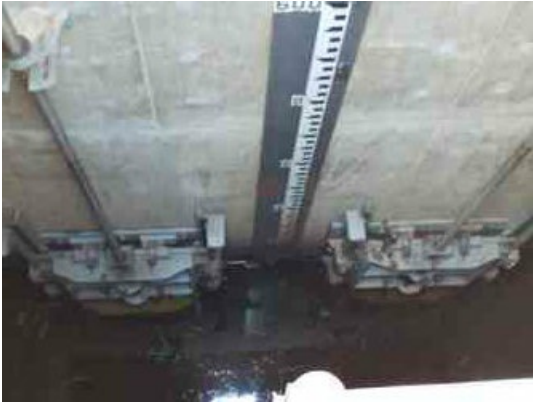
<p><b>Inspect ID:</b> 2020-0086 <b>Title:</b> 2604000004_CELRC_2020_A_0086_1_20200512T132550.jpg <b>Rated Item:</b> 10. Sluice/ Slide Gates <b>Caption:</b> Acceptable - GS-16a and GS-16b: Closed completely.</p>

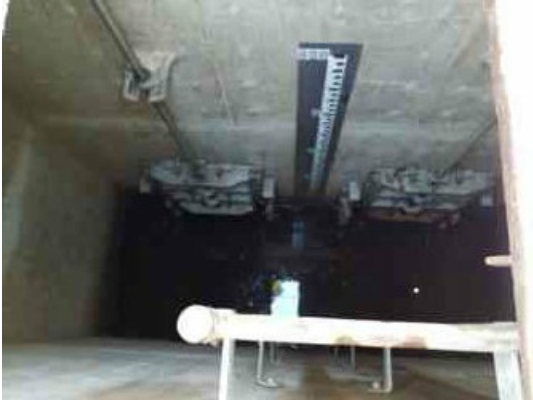
<p><b>Inspect ID:</b> 2020-0088 <b>Title:</b> 2604000004_CELRC_2020_A_0088_1_20200512T132948.jpg <b>Rated Item:</b> 10. Sluice/ Slide Gates <b>Caption:</b> Acceptable - GS-16a and GS-16b: Sluice gate opened.</p>

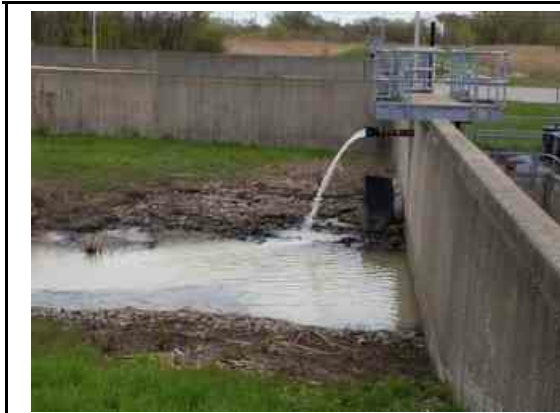
**Inspect ID:** 2020-0055 **Title:** 2604000004\_CELRC\_2020\_A\_0055\_1\_20200511T165939.jpg **Rated Item:** 15. Revetments other than Riprap **Caption:** Minimally Acceptable - Eroded grouted riprap on riverside of PS-GW.

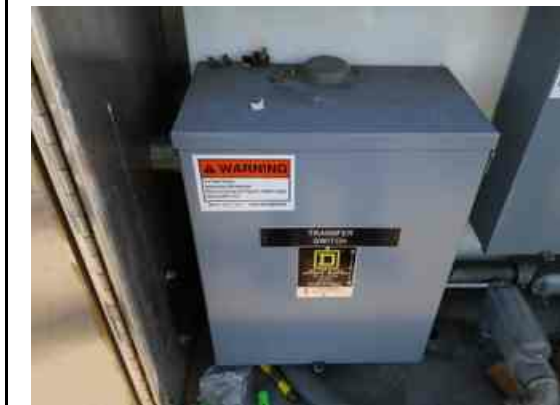
**Inspect ID:** 2020-0094 **Title:** 2604000004\_CELRC\_2020\_A\_0094\_1\_20200513T132159.jpg **Rated Item:** 3. Safety Compliance **Caption:** Acceptable - PS-GE: Arc flash warning label added.

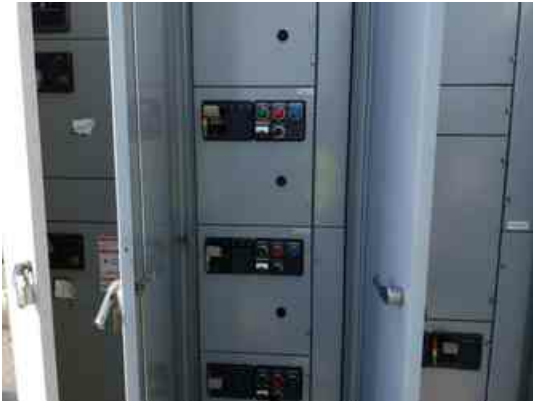
<p><b>Inspect ID:</b> 2020-0100 <b>Title:</b> 2604000004_CELRC_2020_A_0100_1_20200513T133628.jpg <b>Rated Item:</b> 3. Safety Compliance <b>Caption:</b> Minimally Acceptable - PS-GW: Still no Arc-flash warning labels.</p>

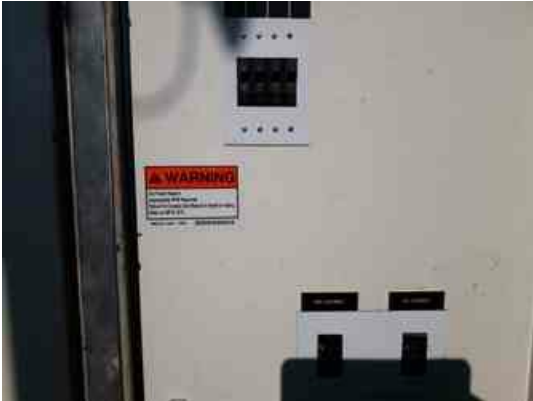
<p><b>Inspect ID:</b> 2020-0106 <b>Title:</b> 2604000004_CELRC_2020_A_0106_1_20200513T134719.jpg <b>Rated Item:</b> 3. Safety Compliance <b>Caption:</b> Acceptable - PS-CL: New Arc-flash warning labels have been added.</p>

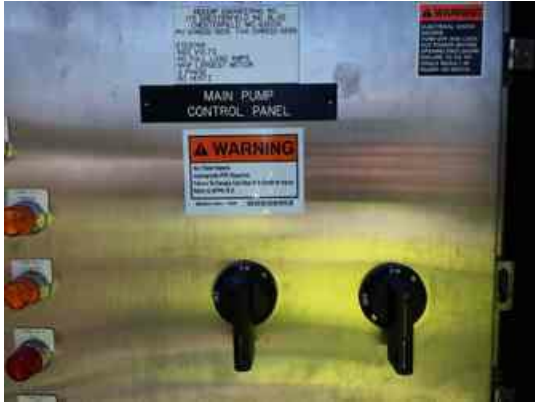
<p>A photograph of an electrical control panel for a main pump. The panel is yellow and features two large black rotary switches in the center. Above the switches, there is a black label that reads "MAIN PUMP CONTROL PANEL". To the left of the switches, there are three smaller rotary switches with red, orange, and yellow indicators. A prominent "WARNING" label with a red triangle and exclamation mark is positioned above the main switches. The background is a plain, light-colored wall.</p>	<p><b>Inspect ID:</b> 2020-0173 <b>Title:</b> 2604000004_CELRC_2020_A_0173_1_20200524T175745.jpg <b>Rated Item:</b> 3. Safety Compliance <b>Caption:</b> Acceptable - PS-BW: Arc-flash labels present.</p>

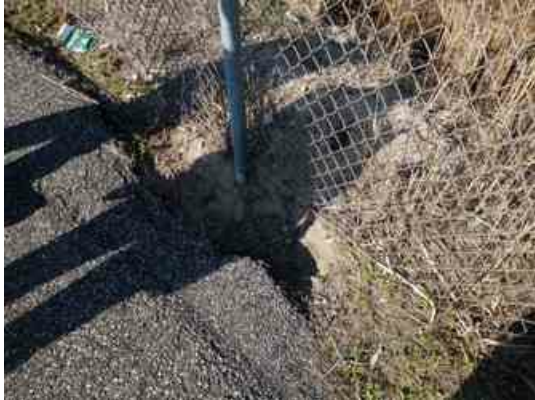
<p>A photograph showing a close-up of a metal fence post. The post is set in a concrete pad. To the right of the pad, there is a hole in the ground, which is an animal burrow. The surrounding area is covered with dry, brown grass and some gravel.</p>	<p><b>Inspect ID:</b> 2020-0104 <b>Title:</b> 2604000004_CELRC_2020_A_0104_1_20200513T134022.jpg <b>Rated Item:</b> 5. Plant Building <b>Caption:</b> Minimally Acceptable - PS-GW: Animal burrow under pad of pump station.</p>

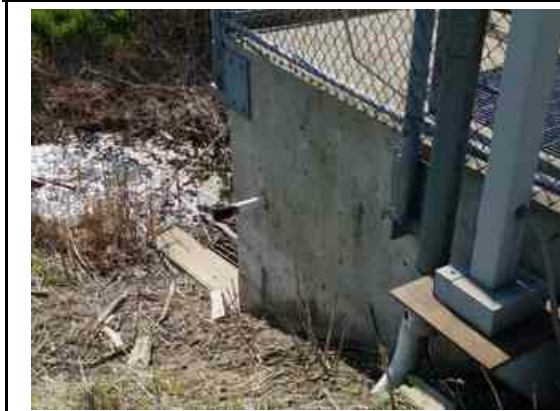
**Inspect ID:** 2020-0108 **Title:** 2604000004\_CELRC\_2020\_A\_0108\_1\_20200513T135015.jpg **Rated Item:** 9. Sumps/ Wet well **Caption:** Minimally Acceptable - PS-CL: Sump pump discharges back to intake.

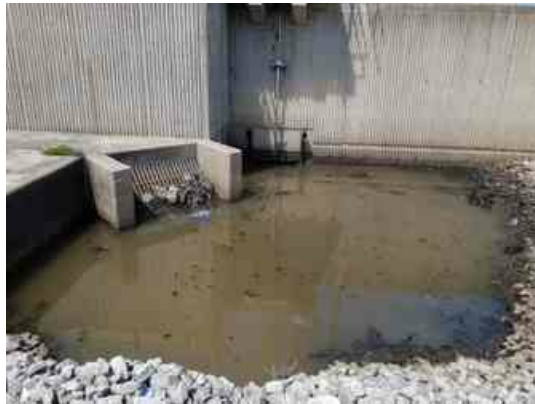
**Inspect ID:** 2020-0024 **Title:** 2604000004\_CELRC\_2020\_A\_0024\_1\_20200511T184955.jpg **Rated Item:** 11. Non-Mechanical Trash Racks **Caption:** Minimally Acceptable - PS-GE, GS-8: Garbage in inlet.

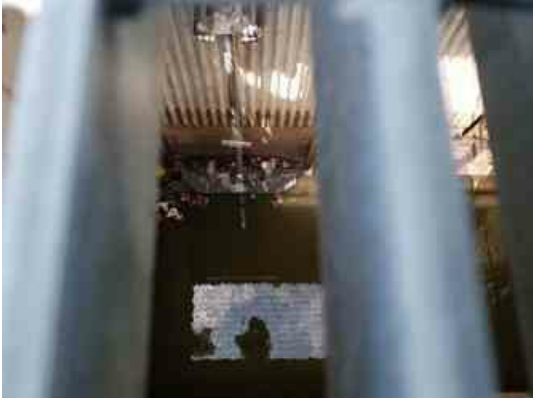
<p><b>Inspect ID:</b> 2020-0028 <b>Title:</b> 2604000004_CELRC_2020_A_0028_1_20200511T185729.jpg <b>Rated Item:</b> 18. Sluice/ Slide Gates <b>Caption:</b> Minimally Acceptable - PS-GE, GS-8a: High water and lots of garbage make it hard to tell if it closed.</p>

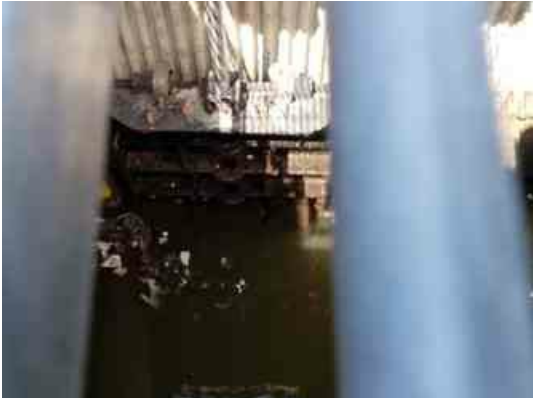
<p><b>Inspect ID:</b> 2020-0028 <b>Title:</b> 2604000004_CELRC_2020_A_2020-0028_2_20200511T185942.jpg <b>Rated Item:</b> 18. Sluice/ Slide Gates <b>Caption:</b> Minimally Acceptable - PS-GE, GS-8a: High water and lots of garbage make it hard to tell if it closed.</p>

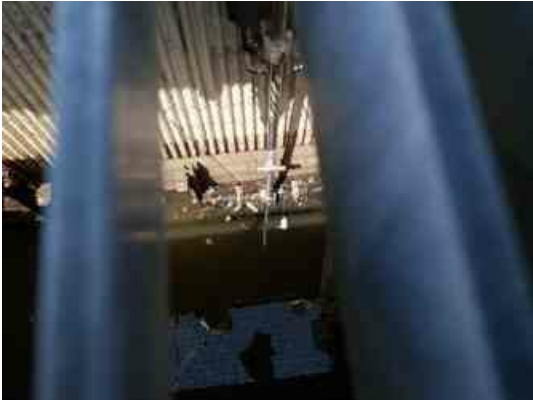
<p><b>Inspect ID:</b> 2020-0030 <b>Title:</b> 2604000004_CELRC_2020_A_0030_1_20200511T190210.jpg <b>Rated Item:</b> 18. Sluice/ Slide Gates <b>Caption:</b> Minimally Acceptable - PS-CL, GS-8b: Lots of garbage on top of sluice gate makes it hard to tell if it closed.</p>

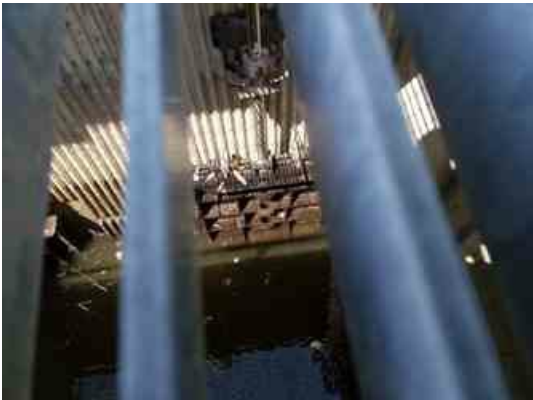
<p><b>Inspect ID:</b> 2020-0030 <b>Title:</b> 2604000004_CELRC_2020_A_2020-0030_2_20200511T190433.jpg <b>Rated Item:</b> 18. Sluice/ Slide Gates <b>Caption:</b> Minimally Acceptable - PS-CL, GS-8b: Lots of garbage on top of sluice gate makes it hard to tell if it closed.</p>

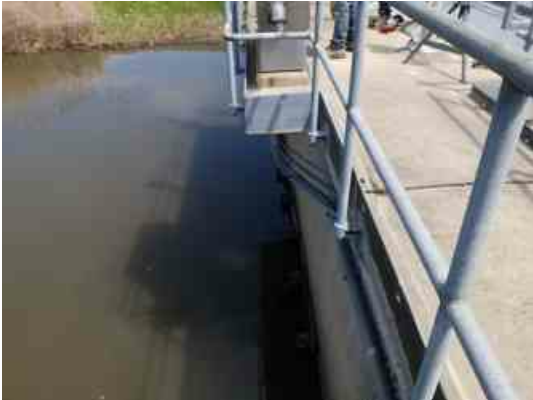
<p><b>Inspect ID:</b> 2020-0026 <b>Title:</b> 2604000004_CELRC_2020_A_0026_1_20200511T185158.jpg <b>Rated Item:</b> 19. Flap Gates/ Flap Valves/ Pinch Valves <b>Caption:</b> Acceptable - PS-GE, GS-8: Flap gates underwater.</p>

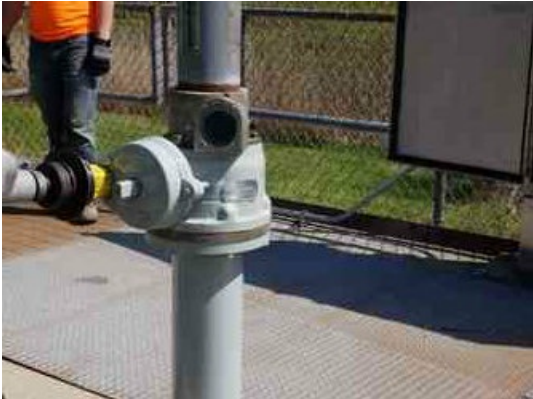
<p><b>Inspect ID:</b> 2020-0048 <b>Title:</b> 2604000004_CELRC_2020_A_0048_1_20200511T200552.jpg <b>Rated Item:</b> 21. Other Metallic Items (Equipment, Ladders, Platform Anchors, etc) <b>Caption:</b> Minimally Acceptable - PS-BW, GS-12a: Missing gage on sluice gate.</p>

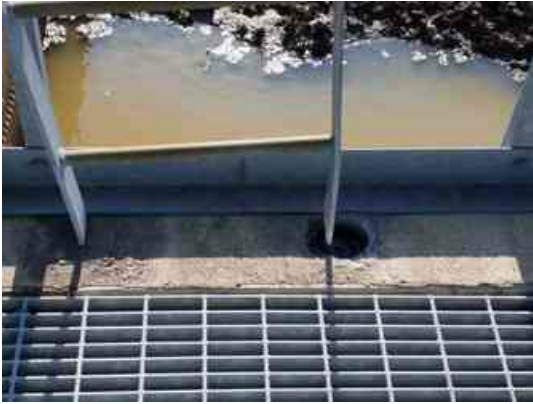
<p><b>Inspect ID:</b> 2020-0096 <b>Title:</b> 2604000004_CELRC_2020_A_0096_1_20200513T132311.jpg <b>Rated Item:</b> 21. Other Metallic Items (Equipment, Ladders, Platform Anchors, etc) <b>Caption:</b> Minimally Acceptable - PS-GE: Ladder need to be secured.</p>
---	---
