**US Army Corps
of Engineers ®**

Site Visit Summary

Name of System: Hammond Forest Ave

Date of Site Visit: 06/05/2023 - 06/06/2023

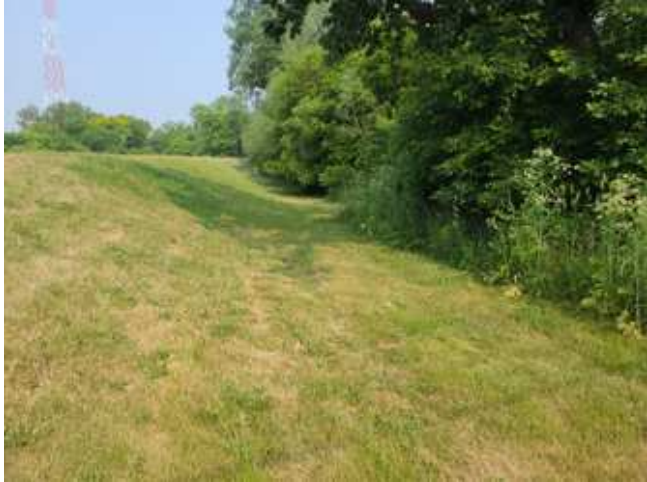
Category:	Levee Embankments	Item:	Unwanted Vegetation
Observation ID:	2023-0003		
Description:	Vegetation along riverside slope		
Caption:	0003 - No User Rating (Site Visit) - Vegetation along riverside slope		
Lat/Long:	41.57769/-87.52266

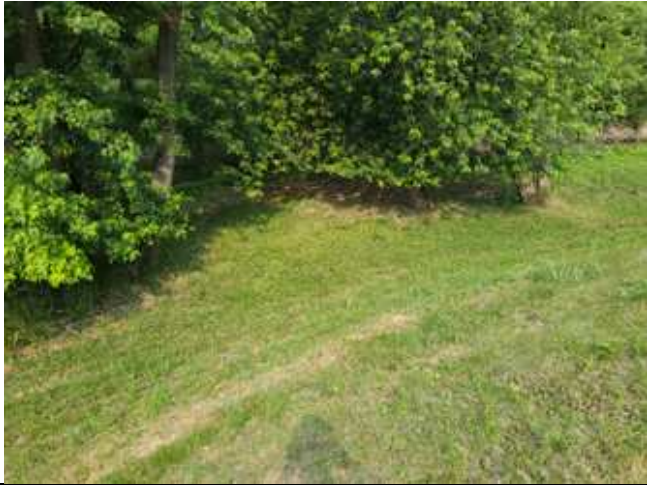
Category:	Levee Embankments	Item:	Unwanted Vegetation
Observation ID:	2023-0007		
Description:	Typical vegetation along landside toe		
Caption:	0007 - No User Rating (Site Visit) - Typical vegetation along landside toe		
Lat/Long:	41.57799/-87.52301

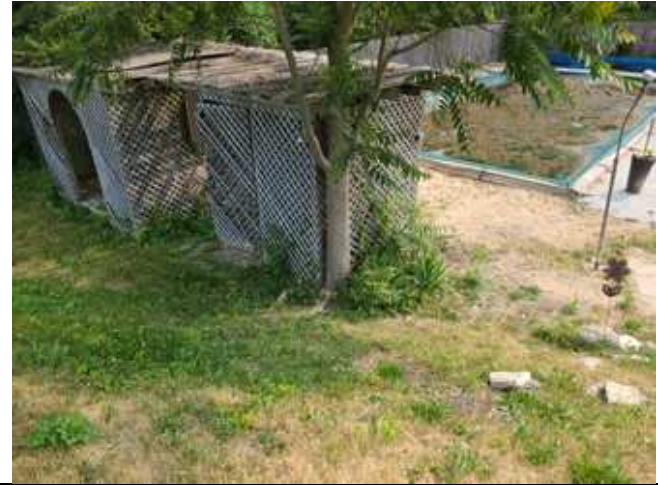
Category:	Levee Embankments	Item:	Unwanted Vegetation
Observation ID:	2023-0027		
Description:	Trees along riverside toe		
Caption:	0027 - No User Rating (Site Visit) - Trees along riverside toe		
Lat/Long:	41.57840/-87.52477

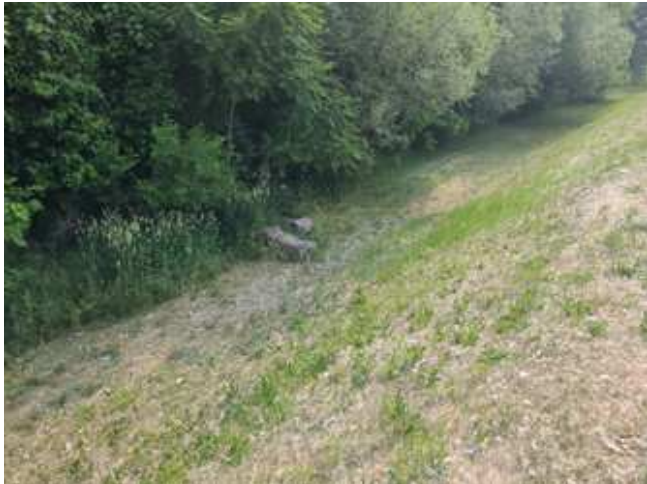
Category:	Levee Embankments	Item:	Unwanted Vegetation
Observation ID:	2023-0183		
Description:	Vegetation on slope and vegetation/tree along toe on landside levee embankment		
Caption:	0183 - No User Rating (Site Visit) - Vegetation on slope and vegetation/tree along toe on landside levee embankment		
Lat/Long:	41.58120/-87.52429

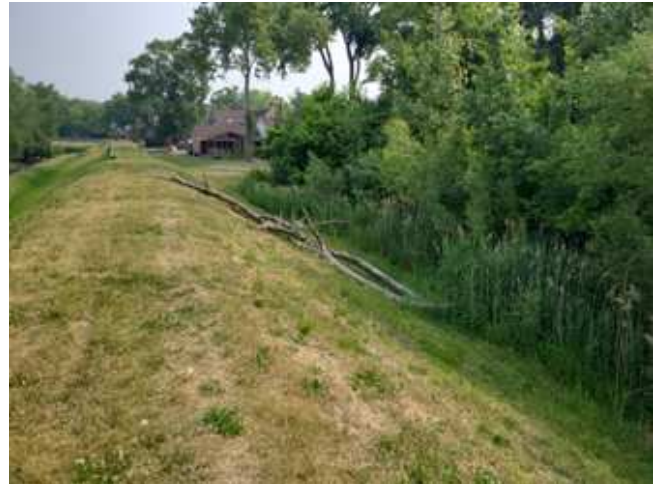
Category:	Levee Embankments	Item:	Encroachments
Observation ID:	2023-0015		
Description:	Log on landside toe		
Caption:	0015 - No User Rating (Site Visit) - Log on landside toe		
Lat/Long:	41.57816/-87.52407

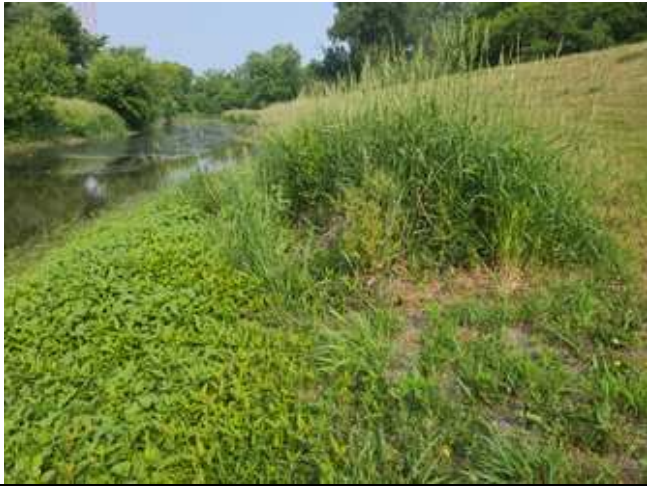
Category:	Levee Embankments	Item:	Slope Stability
Observation ID:	2023-0115		
Description:	Wall is tilted on the riverside toe		
Caption:	0115 - No User Rating (Site Visit) - Wall is tilted on the riverside toe		
Lat/Long:	41.58110/-87.52426

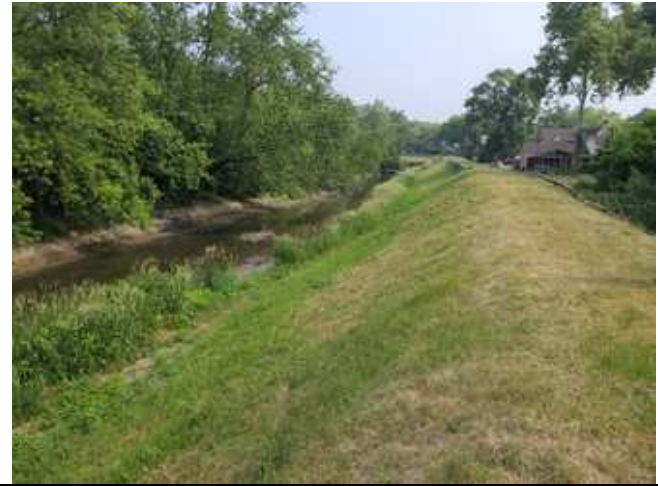
Category:	Levee Embankments	Item:	Erosion/ Bank Caving
Observation ID:	2023-0011		
Description:	Bank caving on the riverside toe		
Caption:	0011 - No User Rating (Site Visit) - Bank caving on the riverside toe		
Lat/Long:	41.57777/-87.52310

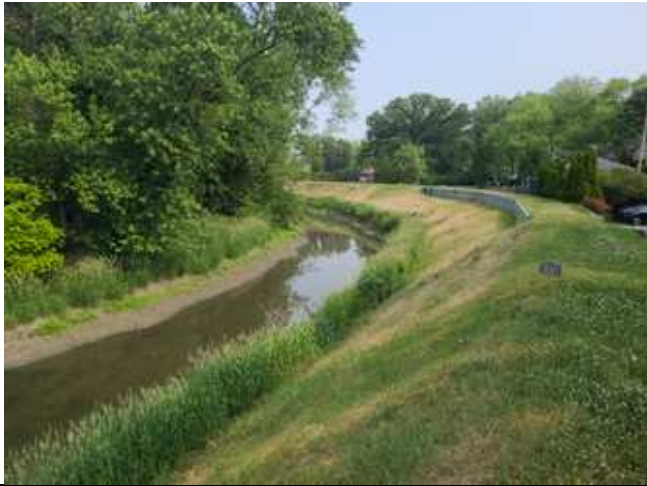
Category:	Levee Embankments	Item:	Erosion/ Bank Caving
Observation ID:	2023-0039		
Description:	Bank caving along riverside toe in phragmites		
Caption:	0039 - No User Rating (Site Visit) - Bank caving along riverside toe in phragmites		
Lat/Long:	41.57905/-87.52468

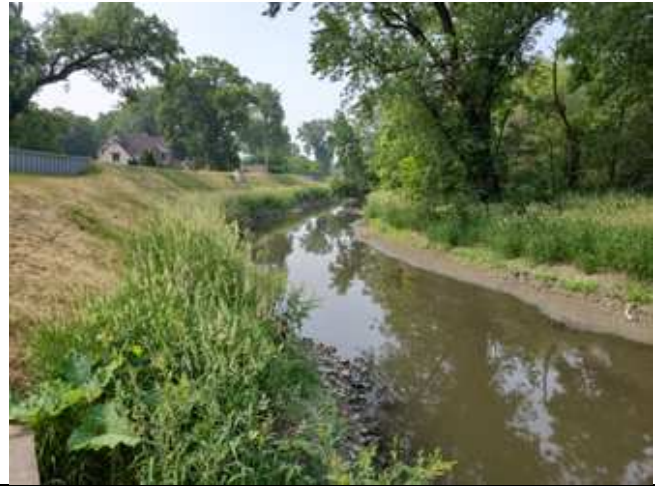
Category:	Levee Embankments	Item:	Erosion/ Bank Caving
Observation ID:	2023-0075		
Description:	Typical erosion along riverside slope		
Caption:	0075 - No User Rating (Site Visit) - Typical erosion along riverside slope		
Lat/Long:	41.58053/-87.52416

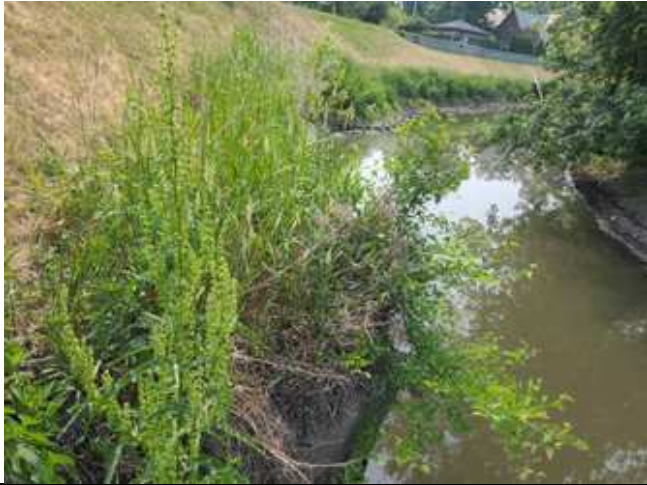
Category:	Levee Embankments	Item:	Erosion/ Bank Caving
Observation ID:	2023-0099		
Description:	Typical riverside bank erosion - north of gate FA-03		
Caption:	0099 - No User Rating (Site Visit) - Typical riverside bank erosion - north of gate FA-03		
Lat/Long:	41.58098/-87.52430

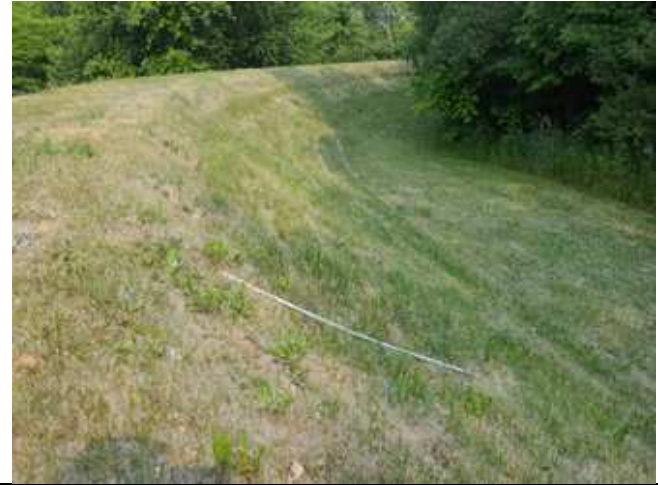
Category:	Levee Embankments	Item:	Erosion/ Bank Caving
Observation ID:	2023-0135		
Description:	Riverside slope scour - downstream of retaining wall		
Caption:	0135 - No User Rating (Site Visit) - Riverside slope scour - downstream of retaining wall		
Lat/Long:	41.58139/-87.52485

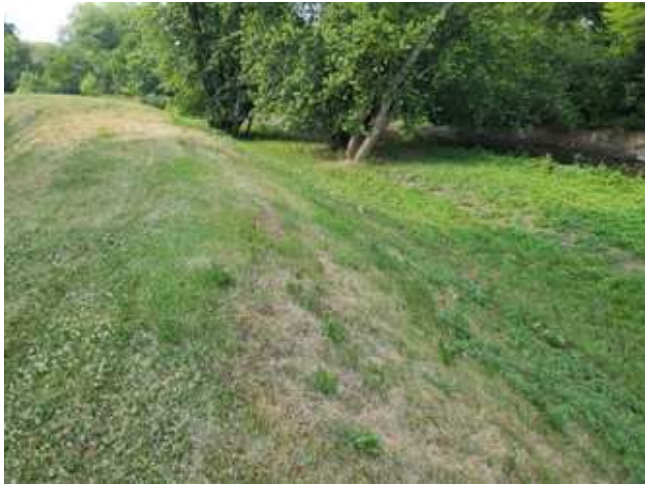
Category:	Levee Embankments	Item:	Depressions/ Rutting
Observation ID:	2023-0019		
Description:	Depression and rutting on landside slope		
Caption:	0019 - No User Rating (Site Visit) - Depression and rutting on landside slope		
Lat/Long:	41.57822/-87.52433

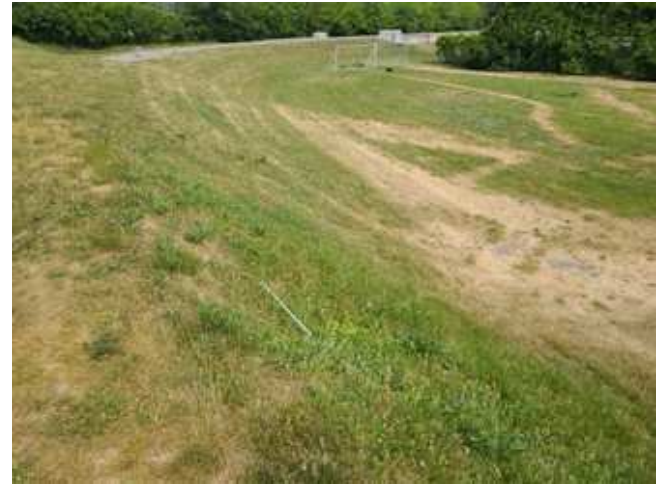
Category:	Levee Embankments	Item:	Depressions/ Rutting
Observation ID:	2023-0035		
Description:	Rutting and depressions on riverside slope		
Caption:	0035 - No User Rating (Site Visit) - Rutting and depressions on riverside slope		
Lat/Long:	41.57861/-87.52481

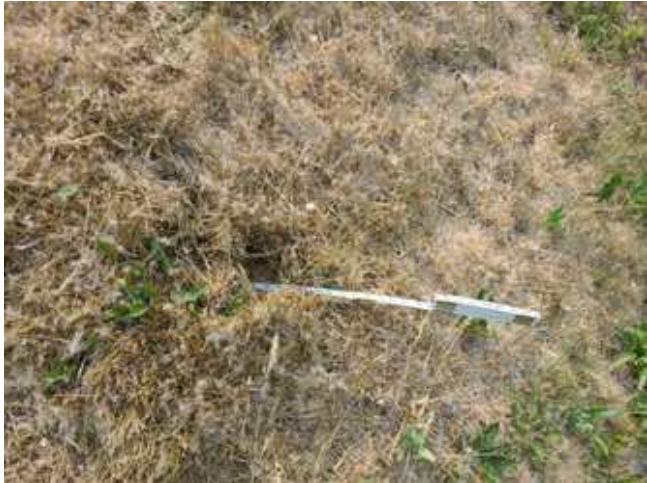
Category:	Levee Embankments	Item:	Depressions/ Rutting
Observation ID:	2023-0143		
Description:	Depressions on landside slope		
Caption:	0143 - No User Rating (Site Visit) - Depressions on landside slope		
Lat/Long:	41.58144/-87.52488

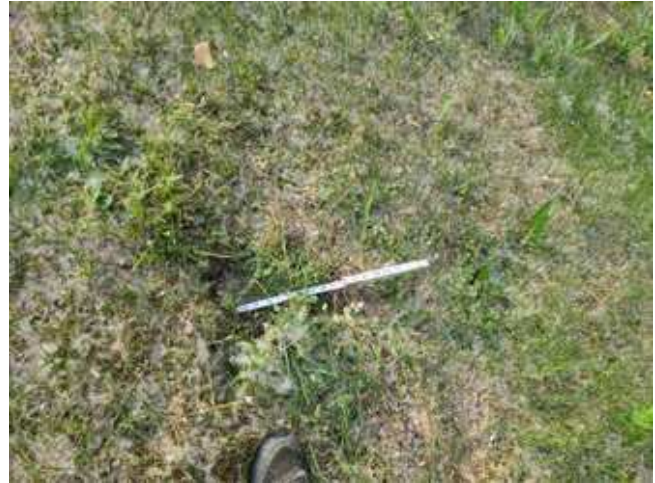
Category:	Levee Embankments	Item:	Animal Control
Observation ID:	2023-0023		
Description:	10 in. deep animal burrow on riverside crown		
Caption:	No User Rating (Site Visit) - 10 in. deep animal burrow on waterside crown		
Lat/Long:	41.57827/-87.52466

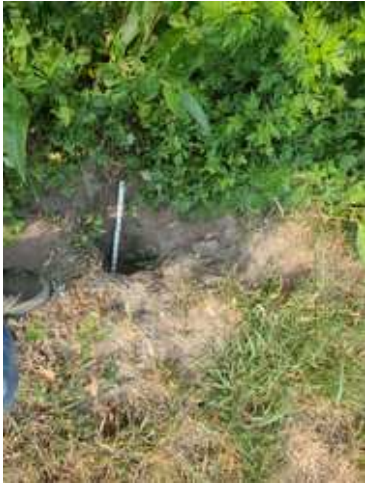
Category:	Levee Embankments	Item:	Animal Control
Observation ID:	2023-0031		
Description:	8 in. deep animal burrow on riverside crest		
Caption:	0031 - No User Rating (Site Visit) - 8 in. deep animal burrow on riverside crest		
Lat/Long:	41.57839/-87.52478

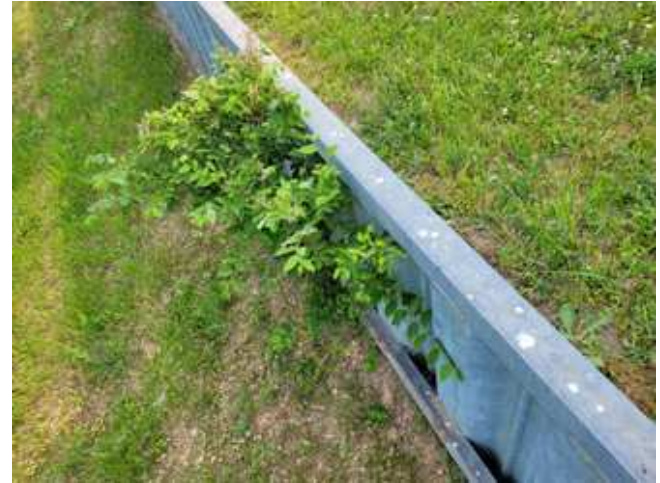
Category:	Levee Embankments	Item:	Animal Control
Observation ID:	2023-0139		
Description:	1 ft wide by 6 ft deep animal burrow on the riverside toe		
Caption:	0139 - No User Rating (Site Visit) - 1 ft wide by 6 ft deep animal burrow on the riverside toe		
Lat/Long:	41.58141/-87.52484

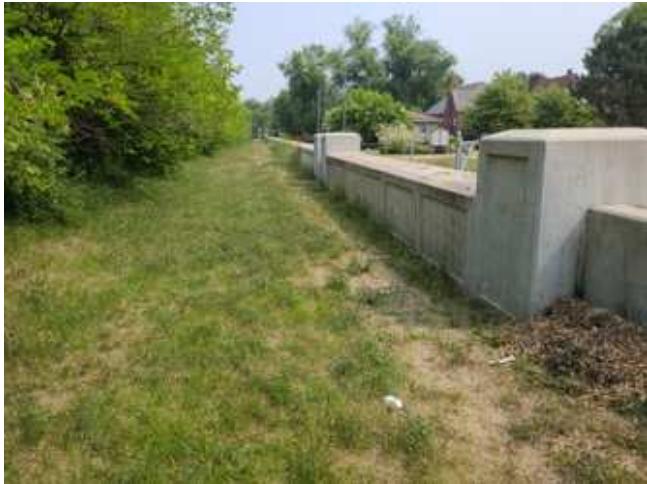
Category:	Floodwalls	Item:	Unwanted Vegetation
Observation ID:	2023-0055		
Description:	Trees growing along riverside sheetpile		
Caption:	0055 - No User Rating (Site Visit) - Trees growing along riverside sheetpile		
Lat/Long:	41.57970/-87.52450

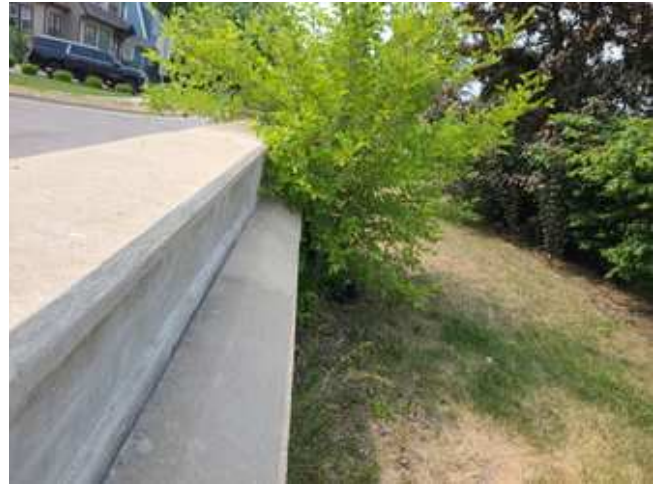
Category:	Floodwalls	Item:	Unwanted Vegetation
Observation ID:	2023-0155		
Description:	Typical vegetation along riverside wall		
Caption:	0155 - No User Rating (Site Visit) - Typical vegetation along riverside wall		
Lat/Long:	41.58162/-87.52537

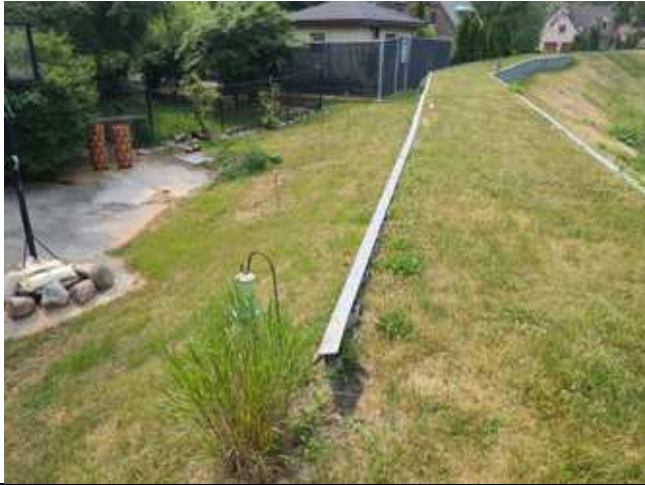
Category:	Floodwalls	Item:	Encroachments
Observation ID:	2023-0083		
Description:	Landscape trees along landside of wall		
Caption:	0083 - No User Rating (Site Visit) - Landscape trees along landside of wall		
Lat/Long:	41.58065/-87.52414

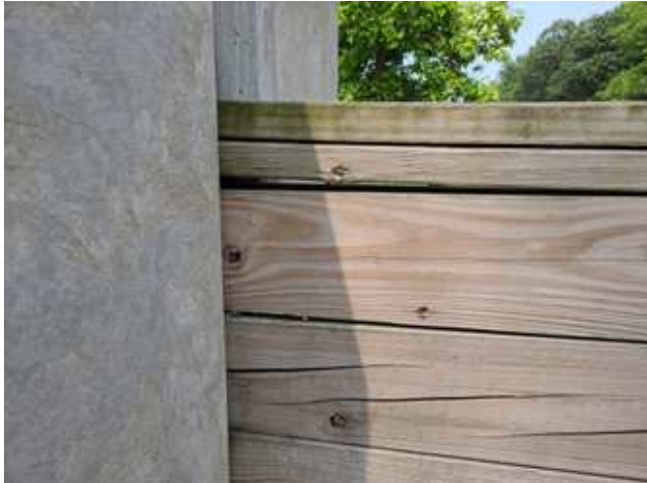
Category:	Floodwalls	Item:	Closure Structures (
Observation ID:	2023-0163		
Description:	Horizontal gap between wooden boards in south closure		
Caption:	0163 - No User Rating (Site Visit) - Horizontal gap between wooden boards in south closure		
Lat/Long:	41.58195/-87.52532

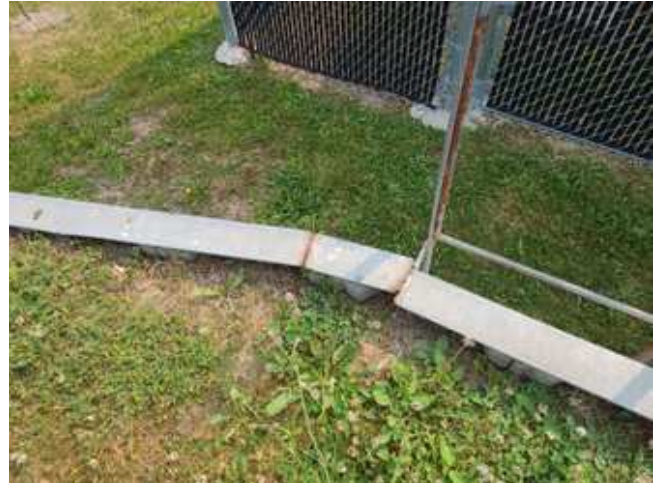
Category:	Floodwalls	Item:	Closure Structures (
Observation ID:	2023-0171		
Description:	Board warping in north closure		
Caption:	0171 - No User Rating (Site Visit) - Board warping in north closure		
Lat/Long:	41.58305/-87.52527

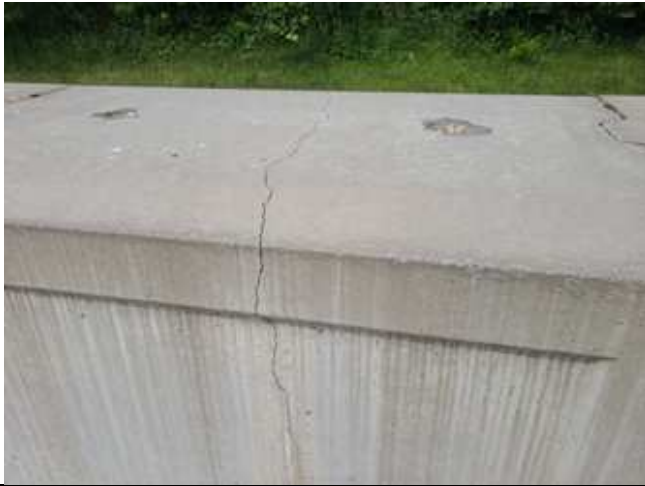
Category:	Floodwalls	Item:	Concrete Surfaces
Observation ID:	2023-0111		
Description:	Failed joints on landside sheetpile		
Caption:	0111 - No User Rating (Site Visit) - Failed joints on landside sheetpile		
Lat/Long:	41.58096/-87.52419

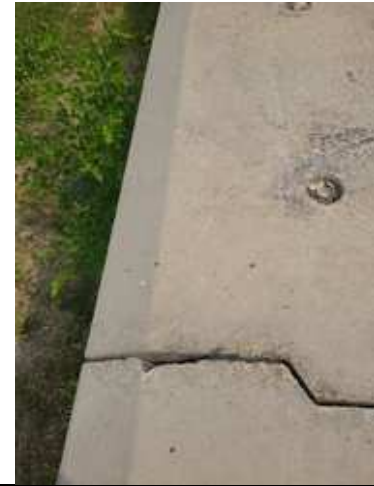
Category:	Floodwalls	Item:	Concrete Surfaces
Observation ID:	2023-0159		
Description:	Typical cracks through concrete surface with some weeping		
Caption:	0159 - No User Rating (Site Visit) - Typical cracks through concrete surface with some weeping		
Lat/Long:	41.58254/-87.52531

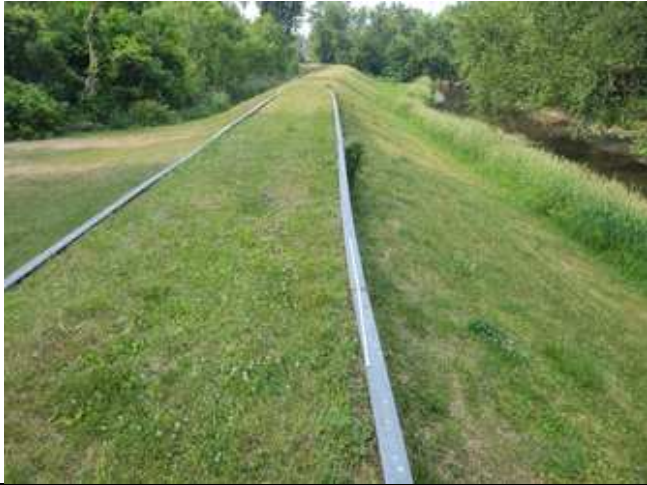
Category:	Floodwalls	Item:	Concrete Surfaces
Observation ID:	2023-0167		
Description:	Minor spalling at concrete joint on riverside		
Caption:	0167 - No User Rating (Site Visit) - Minor spalling at concrete joint on riverside		
Lat/Long:	41.58287/-87.52533

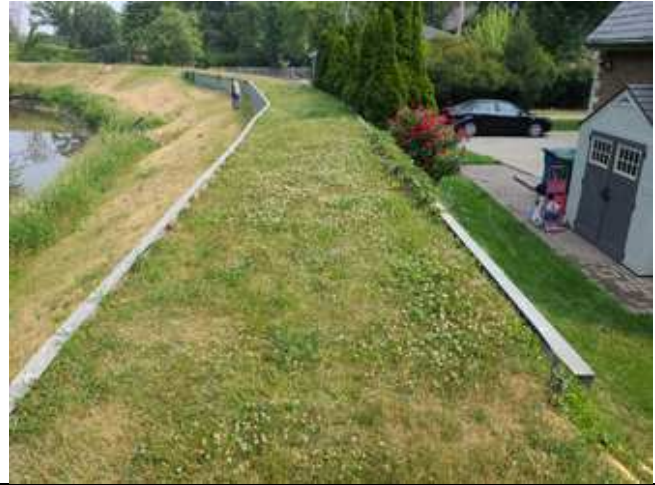
Category:	Floodwalls	Item:	Tilting, Sliding or
Observation ID:	2023-0059		
Description:	Bent box wall sheetpile alignment		
Caption:	0059 - No User Rating (Site Visit) - Bent box wall sheetpile alignment		
Lat/Long:	41.57967/-87.52446

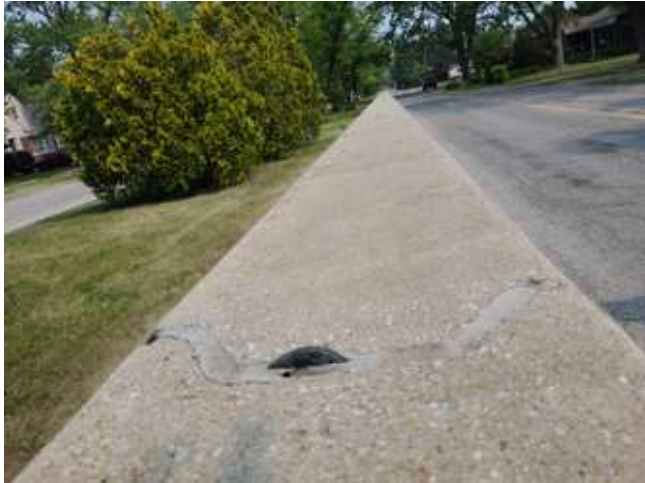
Category:	Floodwalls	Item:	Foundation of Concre
Observation ID:	2023-0087		
Description:	Settlement of box wall soil - evidenced by exposed sheetpile wall		
Caption:	0087 - No User Rating (Site Visit) - Settlement of box wall soil - evidenced by exposed sheetpile wall		
Lat/Long:	41.58070/-87.52417

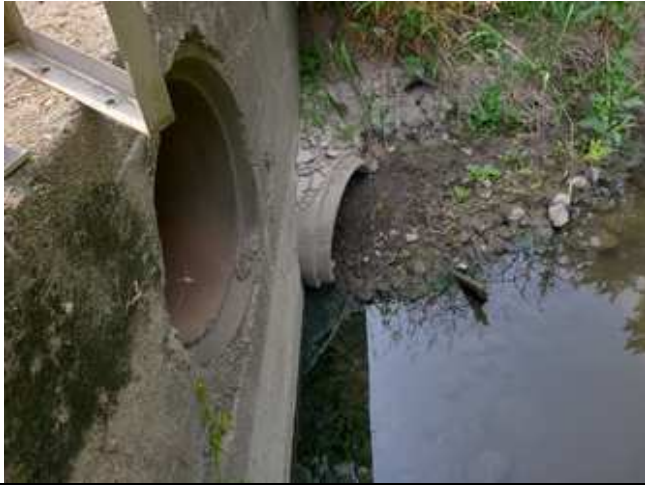
Category:	Interior Drainage System	Item:	Vegetation and Obstr
Observation ID:	2023-0071		
Description:	FA-04: Vegetation in outlet structure - preventing inspection of duckbill valve		
Caption:	0071 - No User Rating (Site Visit) - FA-04: Vegetation in outlet structure - preventing inspection of duckbill valve		
Lat/Long:	41.58038/-87.52422

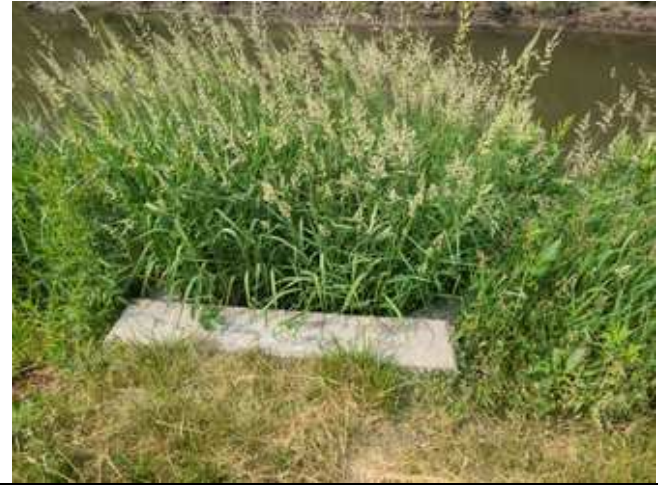
Category:	Interior Drainage System	Item:	Vegetation and Obstr
Observation ID:	2023-0095		
Description:	FA-03: Sediment in outlet pipe obstructing flow. Lower pipe is completely filled		
Caption:	0095 - No User Rating (Site Visit) - FA-03: Sediment in outlet pipe obstructing flow. Lower pipe is completely filled		
Lat/Long:	41.58096/-87.52429

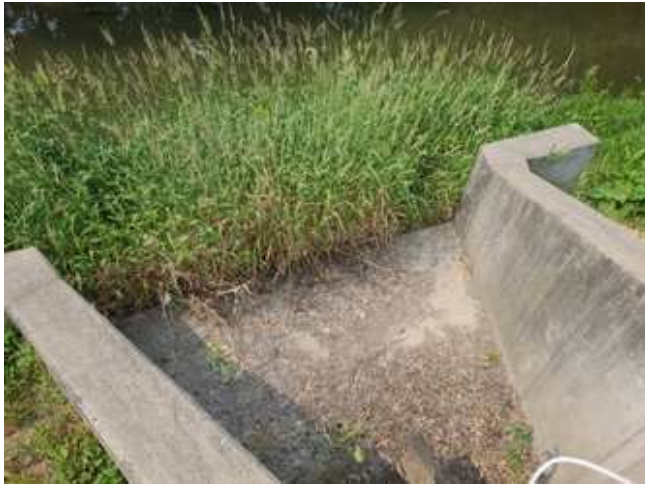
Category:	Interior Drainage System	Item:	Vegetation and Obstr
Observation ID:	2023-0131		
Description:	FA-02: Vegetation in outlet		
Caption:	0131 - No User Rating (Site Visit) - FA-02: Vegetation in outlet		
Lat/Long:	41.58132/-87.52457

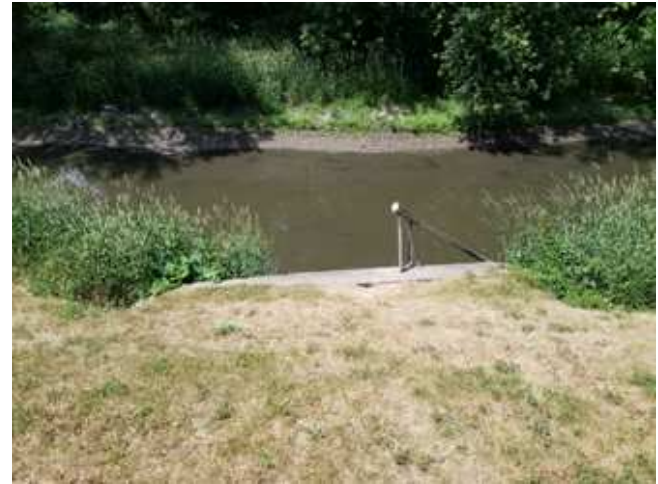
Category:	Interior Drainage System	Item:	Vegetation and Obstr
Observation ID:	2023-0147		
Description:	FA-01: Vegetation against outlet spillway		
Caption:	0147 - No User Rating (Site Visit) - FA-01: Vegetation against outlet spillway		
Lat/Long:	41.58150/-87.52534

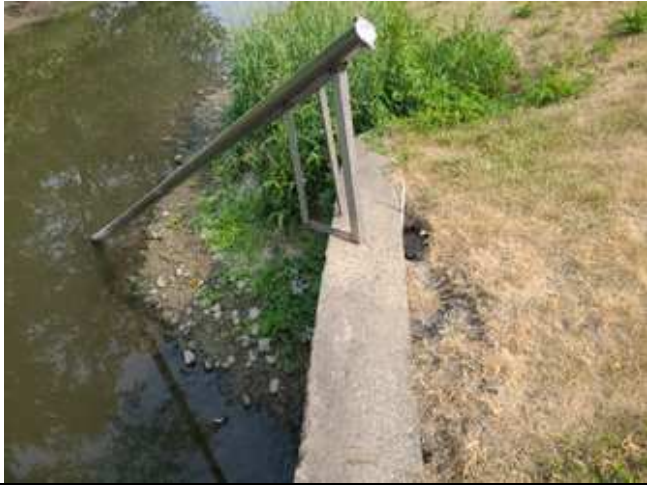
Category:	Interior Drainage System	Item:	Foundation of Concre
Observation ID:	2023-0061		
Description:	FA-03: Erosion around outlet headwall		
Caption:	No User Rating (Site Visit) - FA-03: Erosion around outlet headwall		
Lat/Long:	41.58096/-87.52420

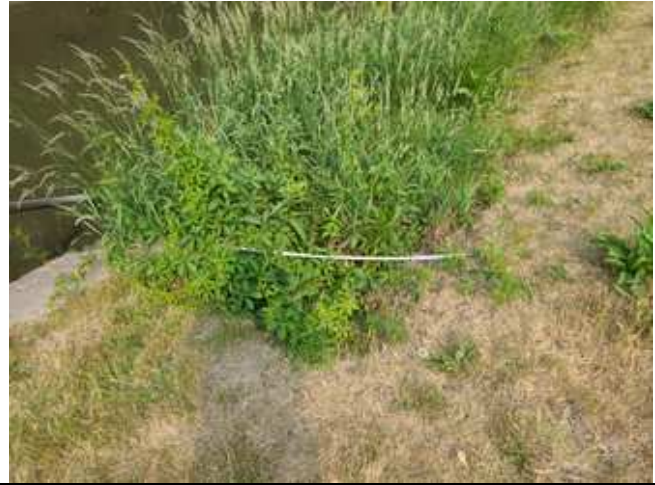
Category:	Interior Drainage System	Item:	Foundation of Concre
Observation ID:	2023-0091		
Description:	FA-01: 3 ft deep hole behind headwall		
Caption:	0091 - No User Rating (Site Visit) - FA-01: 3 ft deep hole behind headwall		
Lat/Long:	41.58096/-87.52429

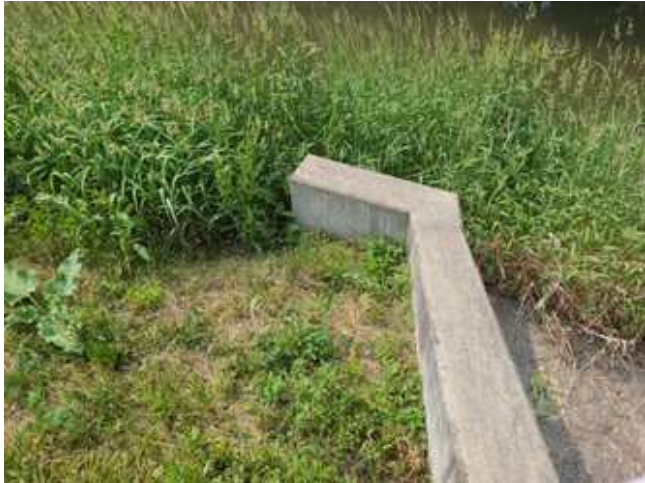
Category:	Interior Drainage System	Item:	Foundation of Concre
Observation ID:	2023-0103		
Description:	FA-03: 70-inch erosion cuts behind wing walls		
Caption:	0103 - No User Rating (Site Visit) - FA-03: 70-inch erosion cuts behind wing walls		
Lat/Long:	41.58099/-87.52429

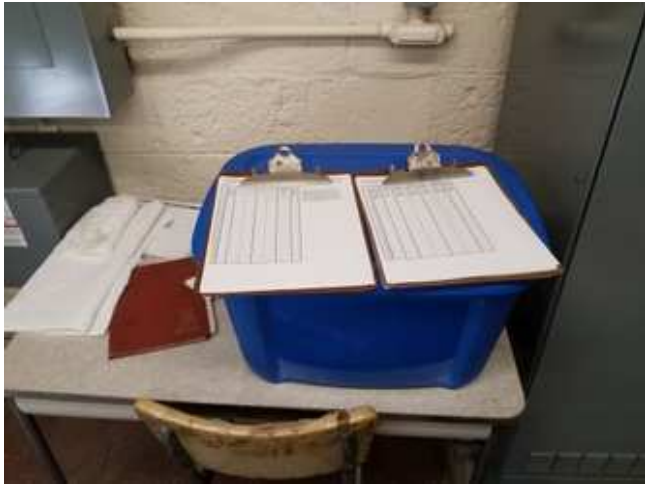
Category:	Pump Stations	Item:	Pump Station Operati
Observation ID:	2023-0005		
Description:	PS-SH: Operations manuals present onsite		
Caption:	0005 - No User Rating (Site Visit) - PS-SH: Operations manuals present onsite		
Lat/Long:	41.57792/-87.52277

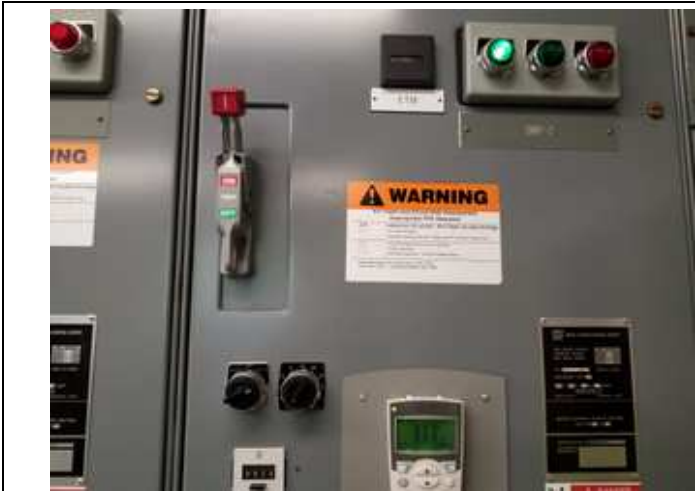
Category:	Pump Stations	Item:	Safety Compliance
Observation ID:	2023-0009		
Description:	PS-SH: Outdated arc flash labels		
Caption:	0009 - No User Rating (Site Visit) - PS-SH: Outdated arc flash labels		
Lat/Long:	41.57792/-87.52277

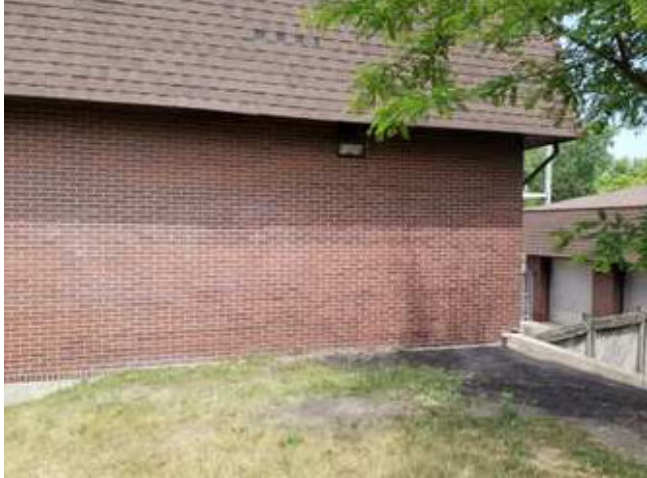
Category:	Pump Stations	Item:	Plant Building
Observation ID:	2023-0021		
Description:	PS-SH: Erosion near building/sluiceway		
Caption:	0021 - No User Rating (Site Visit) - PS-SH: Erosion near building/sluiceway		
Lat/Long:	41.57786/-87.52285
