## Site Visit Summary

Name of System: Hammond

Name of Segment: Hammond

Date of Site Visit: 06/05/2023 - 06/09/2023

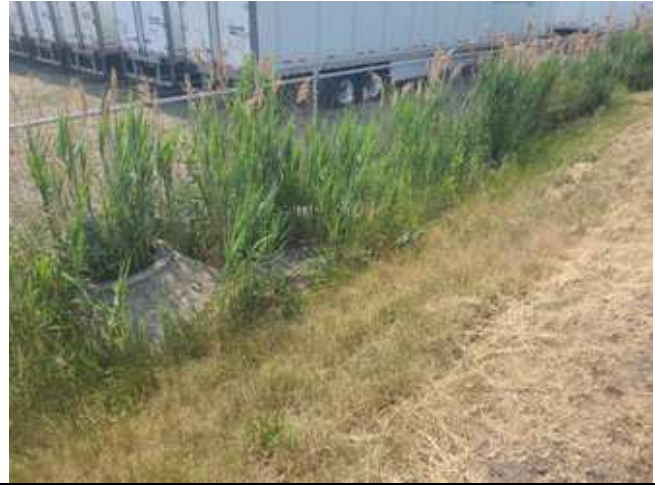
Category:	Levee Embankments	Item:	Encroachments
Observation ID:	2023-0339		
Description:	Debris on landside toe		
Caption:	0339 - No User Rating (Site Visit) - Debris on landside toe		
Lat/Long:	41.57218/-87.44752

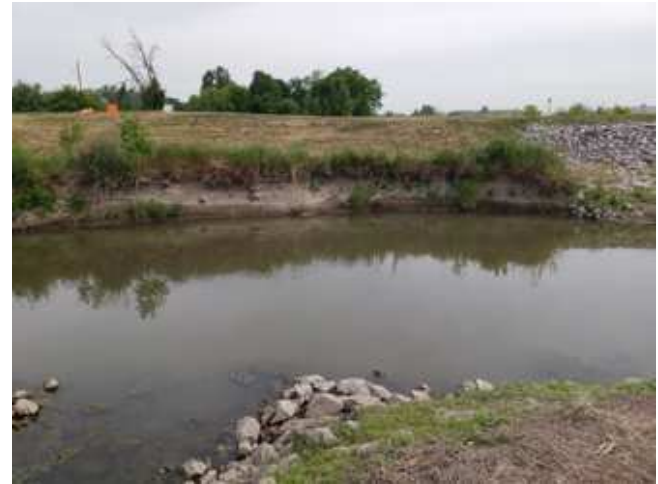
Category:	Levee Embankments	Item:	Animal Control
Observation ID:	2023-0002		
Description:	3 animal burrows in the eroded part of the riverside bank.		
Caption:	0002 - No User Rating (Site Visit) - 3 animal burrows in the eroded part of the riverside bank.		
Lat/Long:	41.56646/-87.48504

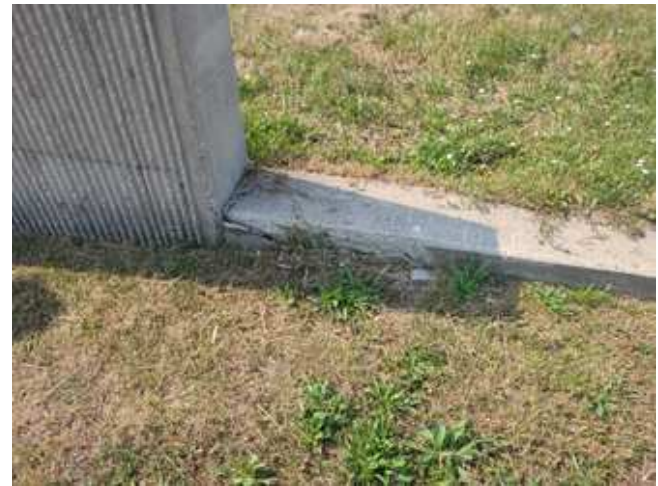
Category:	Floodwalls	Item:	Closure Structures (
Observation ID:	2023-0299		
Description:	Concrete spalling - closure structure at Kennedy		
Caption:	0299 - No User Rating (Site Visit) - Concrete spalling - closure structure at Kennedy		
Lat/Long:	41.56985/-87.46136

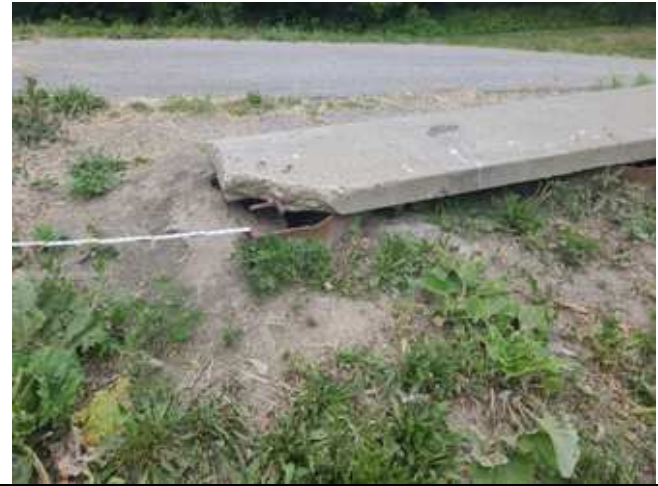
Category:	Floodwalls	Item:	Concrete Surfaces
Observation ID:	2023-0059		
Description:	Damaged concrete cap		
Caption:	0059 - No User Rating (Site Visit) - Damaged concrete cap		
Lat/Long:	41.57281/-87.51564

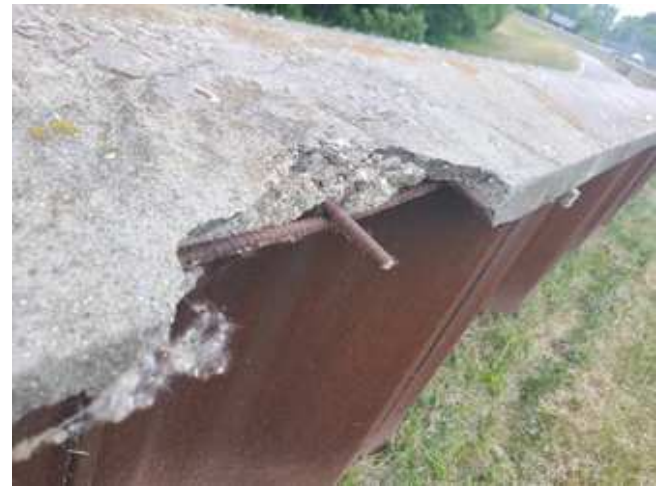
Category:	Floodwalls	Item:	Concrete Surfaces
Observation ID:	2023-0075		
Description:	Damaged concrete cap		
Caption:	0075 - No User Rating (Site Visit) - Damaged concrete cap		
Lat/Long:	41.57276/-87.51359

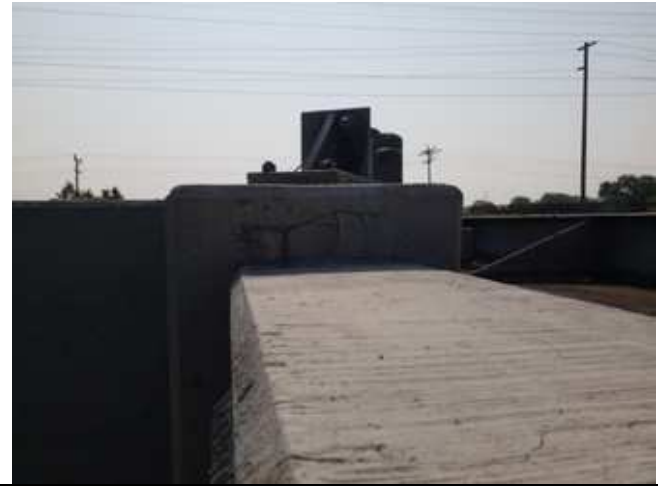
Category:	Floodwalls	Item:	Concrete Surfaces
Observation ID:	2023-0144		
Description:	Spalling on cap - near railroad gate		
Caption:	0144 - No User Rating (Site Visit) - Spalling on cap - near railroad gate		
Lat/Long:	41.57024/-87.46682

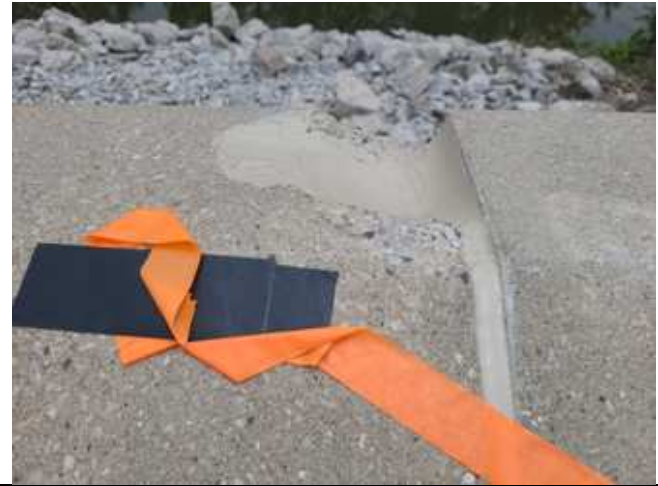
Category:	Floodwalls	Item:	Concrete Surfaces
Observation ID:	2023-0187		
Description:	Spalled surface on cap		
Caption:	0187 - No User Rating (Site Visit) - Spalled surface on cap		
Lat/Long:	41.57072/-87.49866

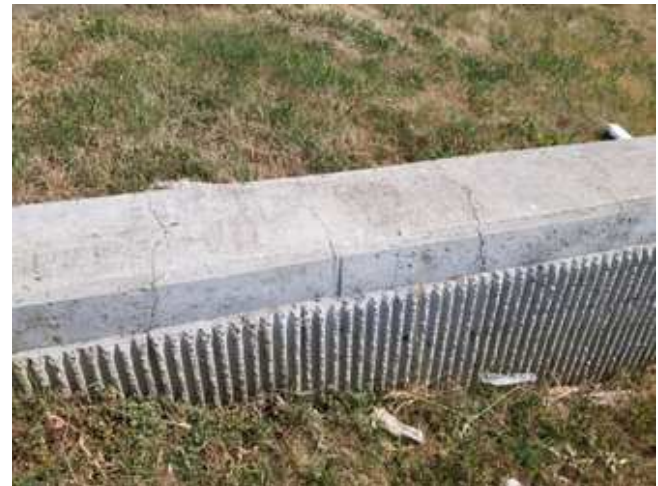
Category:	Floodwalls	Item:	Concrete Surfaces
Observation ID:	2023-0238		
Description:	Cracks on cap		
Caption:	0238 - No User Rating (Site Visit) - Cracks on cap		
Lat/Long:	41.56989/-87.46208

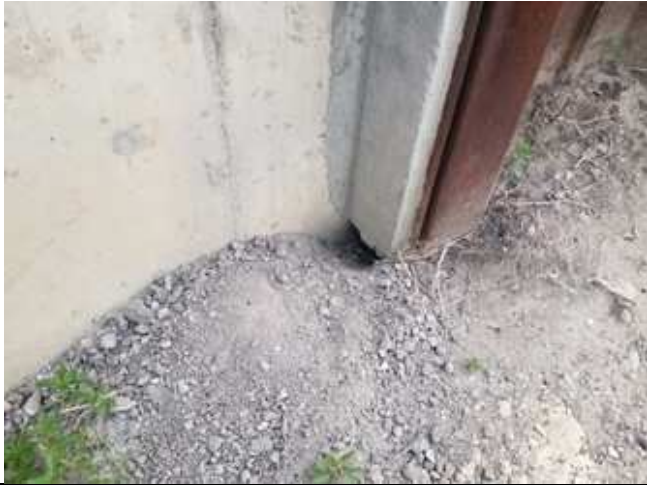
Category:	Floodwalls	Item:	Foundation of Concre
Observation ID:	2023-0006		
Description:	Animal burrow under concrete foundation on waterside of floodwall		
Caption:	0006 - No User Rating (Site Visit) - Animal burrow under concrete foundation on waterside of floodwall		
Lat/Long:	41.57315/-87.51780

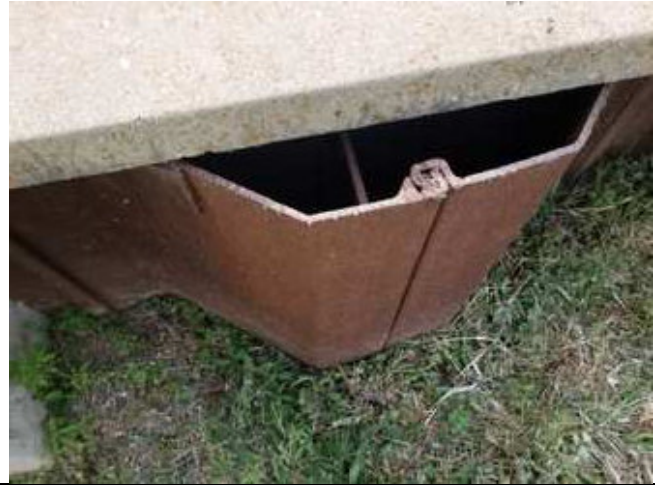
Category:	Floodwalls	Item:	Foundation of Concre
Observation ID:	2023-0054		
Description:	Gap between top of floodwall and sheetpile		
Caption:	0054 - No User Rating (Site Visit) - Gap between top of floodwall and sheetpile		
Lat/Long:	41.57231/-87.51352

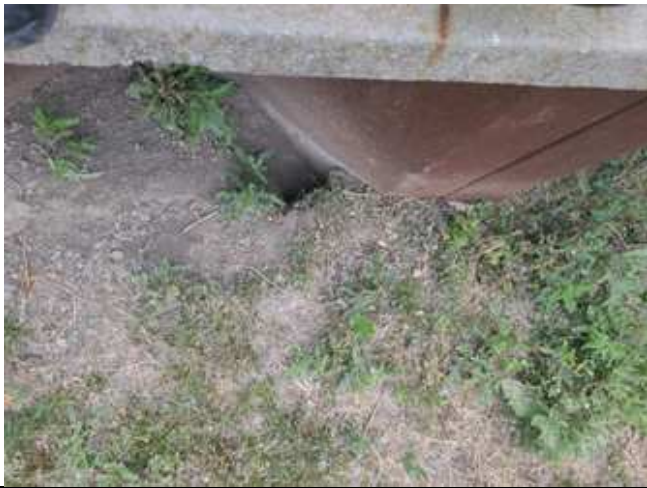
Category:	Floodwalls	Item:	Foundation of Concre
Observation ID:	2023-0079		
Description:	Animal burrow riverside - typical		
Caption:	0079 - No User Rating (Site Visit) - Animal burrow riverside - typical		
Lat/Long:	41.57246/-87.51362

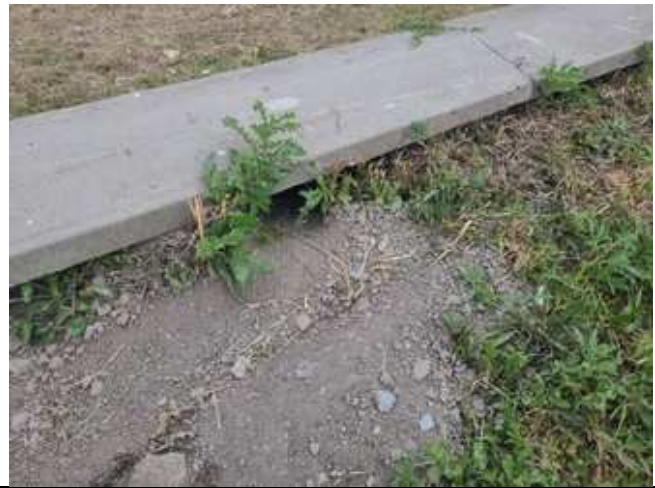
Category:	Floodwalls	Item:	Foundation of Concre
Observation ID:	2023-0115		
Description:	Animal burrow riverside		
Caption:	0115 - No User Rating (Site Visit) - Animal burrow riverside		
Lat/Long:	41.57155/-87.50870

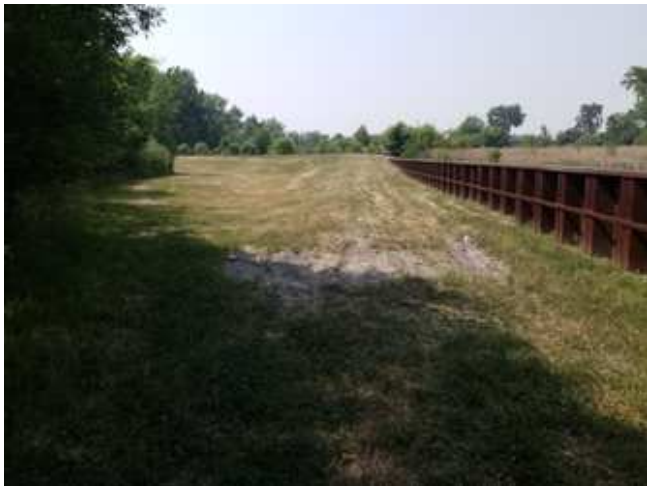
Category:	Floodwalls	Item:	Foundation of Concre
Observation ID:	2023-0180		
Description:	Rutting on landside of floodwall		
Caption:	0180 - No User Rating (Site Visit) - Rutting on landside of floodwall		
Lat/Long:	41.56952/-87.44134

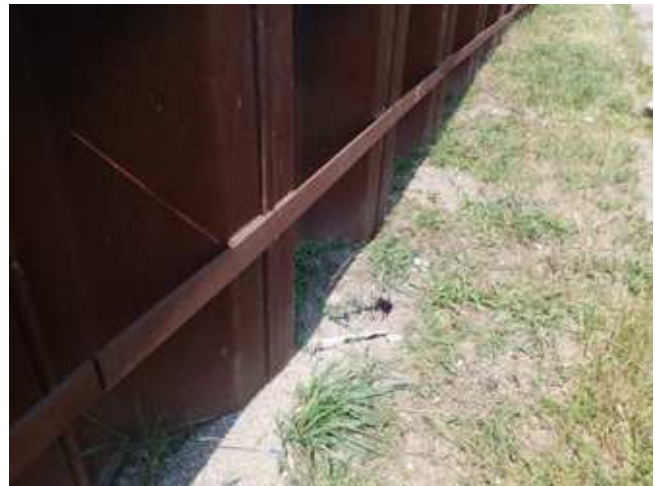
Category:	Floodwalls	Item:	Foundation of Concre
Observation ID:	2023-0266		
Description:	Two 2.5 ft deep burrows on landside of wall		
Caption:	0266 - No User Rating (Site Visit) - Two 2.5 ft deep burrows on landside of wall		
Lat/Long:	41.56782/-87.43360

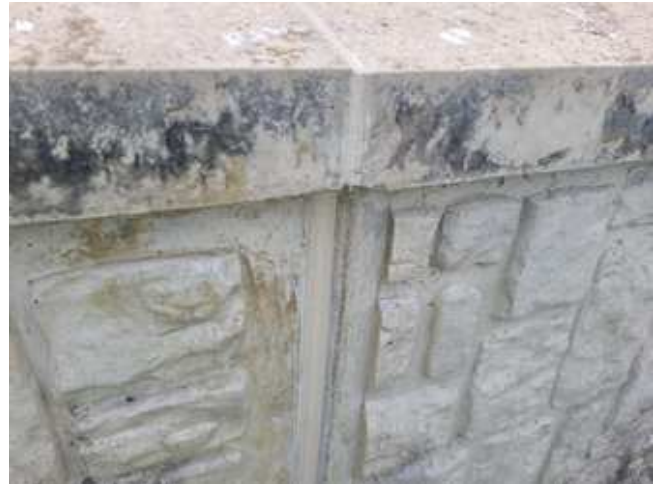
Category:	Floodwalls	Item:	Monolith Joints
Observation ID:	2023-0199		
Description:	Joint sealant repaired		
Caption:	0199 - No User Rating (Site Visit) - Joint sealant repaired		
Lat/Long:	41.56692/-87.48976

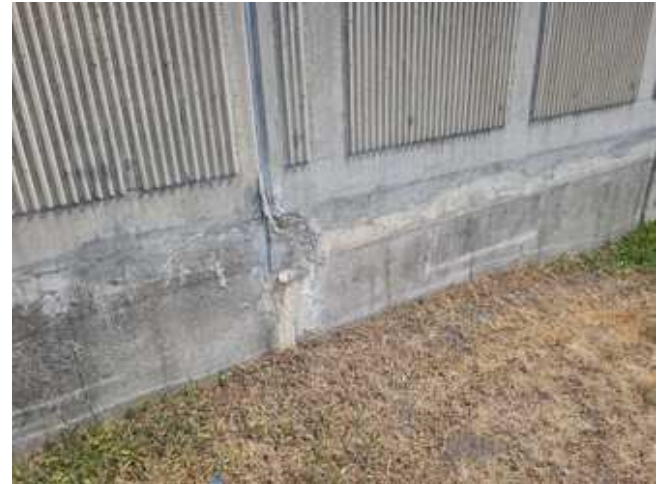
Category:	Floodwalls	Item:	Monolith Joints
Observation ID:	2023-0335		
Description:	Deteriorating riverside joint sealant		
Caption:	0335 - No User Rating (Site Visit) - Deteriorating riverside joint sealant		
Lat/Long:	41.57293/-87.44775

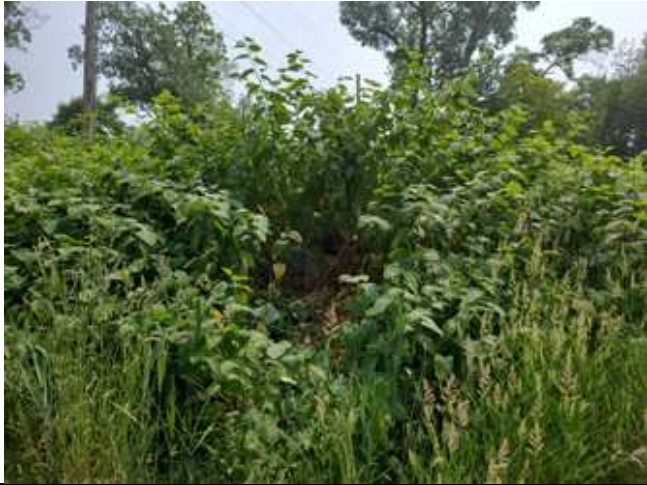
Category:	Interior Drainage System	Item:	Vegetation and Obstr
Observation ID:	2023-0011		
Description:	HA-01: Heavy vegetation around manhole. Also some spalling around manhole (not pictured)		
Caption:	0011 - No User Rating (Site Visit) - HA-01: Heavy vegetation around manhole. Also some spalling around manhole (not pictured)		
Lat/Long:	41.57625/-87.51932

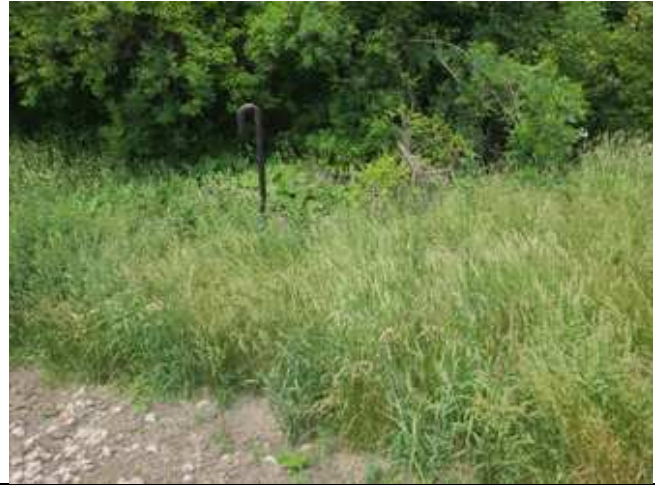
Category:	Interior Drainage System	Item:	Vegetation and Obstr
Observation ID:	2023-0015		
Description:	HA-02: Heavy vegetation around structure		
Caption:	0015 - No User Rating (Site Visit) - HA-02: Heavy vegetation around structure		
Lat/Long:	41.57460/-87.51866

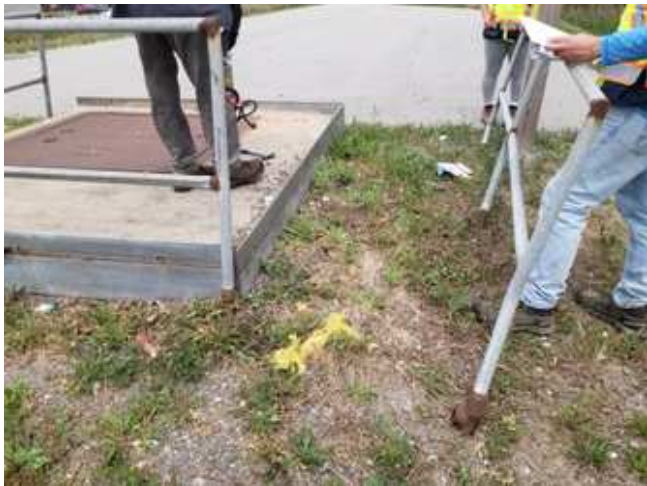
Category:	Interior Drainage System	Item:	Fencing and Gates
Observation ID:	2023-0182		
Description:	HA-20: Unstable and broken guardrails around manhole		
Caption:	0182 - No User Rating (Site Visit) - HA-20: Unstable and broken guardrails around manhole		
Lat/Long:	41.56884/-87.47490

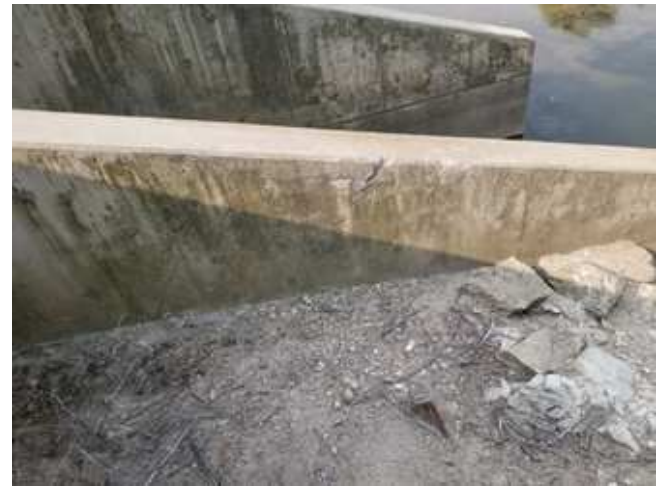
Category:	Interior Drainage System	Item:	Concrete Surfaces (S
Observation ID:	2023-0014		
Description:	HA-04: Spalling on west wingwall at outlet		
Caption:	0014 - No User Rating (Site Visit) - HA-04: Spalling on west wingwall at outlet		
Lat/Long:	41.57326/-87.51787

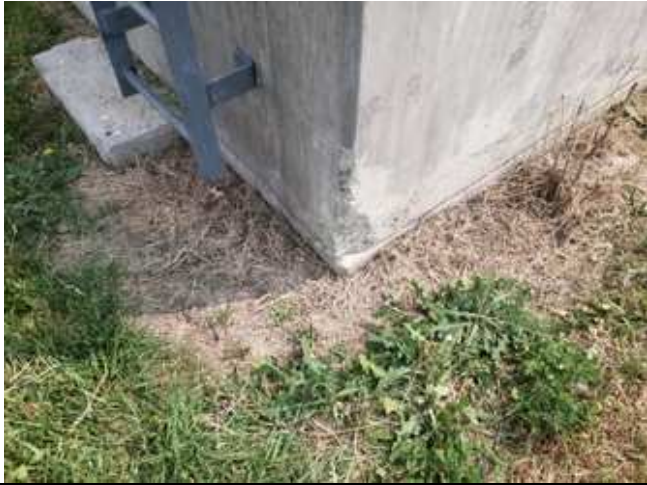
Category:	Interior Drainage System	Item:	Concrete Surfaces (S
Observation ID:	2023-0098		
Description:	HA-13: Spalling on corner of outlet structure		
Caption:	0098 - No User Rating (Site Visit) - HA-13: Spalling on corner of outlet structure		
Lat/Long:	41.56920/-87.50045

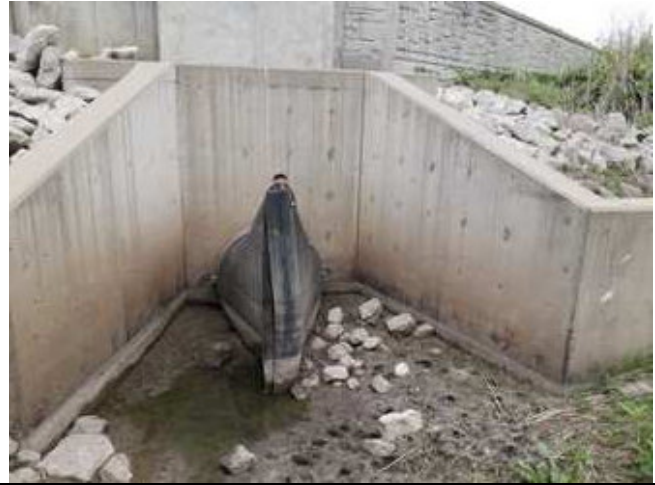
Category:	Interior Drainage System	Item:	Concrete Surfaces (S
Observation ID:	2023-0130		
Description:	HA-14: Spalling on corner of outlet structure		
Caption:	0130 - No User Rating (Site Visit) - HA-14: Spalling on corner of outlet structure		
Lat/Long:	41.56950/-87.50000

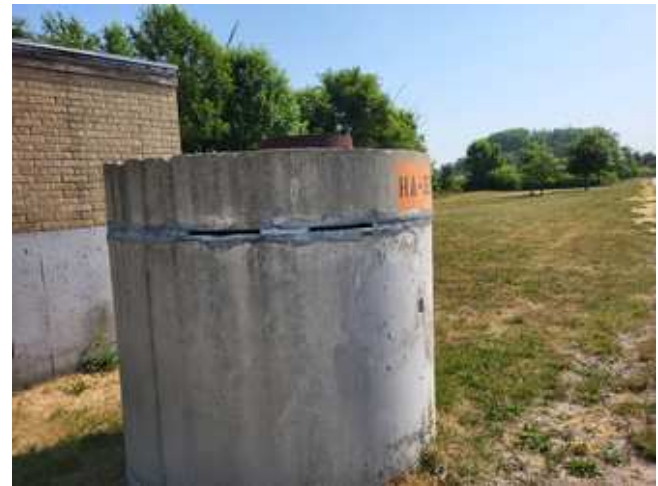
Category:	Interior Drainage System	Item:	Concrete Surfaces (S
Observation ID:	2023-0422		
Description:	HA-29: Deteriorating joint material		
Caption:	0422 - No User Rating (Site Visit) - HA-29: Deteriorating joint material		
Lat/Long:	41.57036/-87.45825

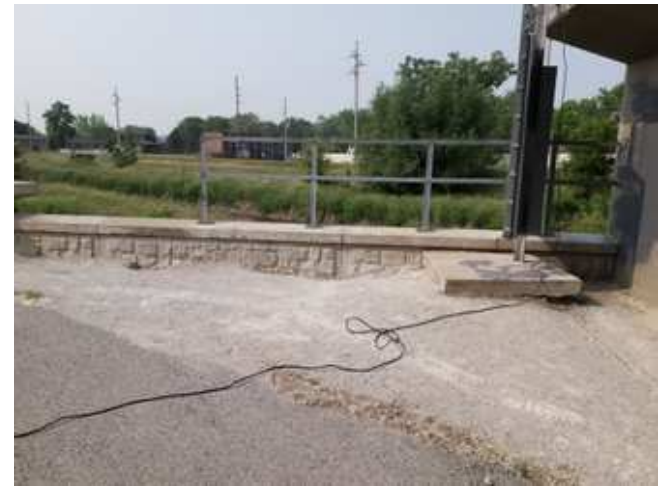
Category:	Interior Drainage System	Item:	Foundation of Concre
Observation ID:	2023-0018		
Description:	HA-04: Erosion around outlet structure		
Caption:	0018 - No User Rating (Site Visit) - HA-04: Erosion around outlet structure		
Lat/Long:	41.57330/-87.51783

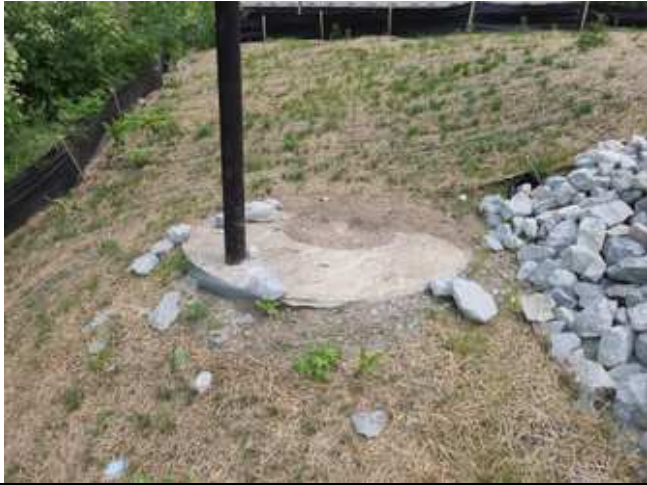
Category:	Interior Drainage System	Item:	Foundation of Concre
Observation ID:	2023-0019		
Description:	HA-03: Erosion around manhole		
Caption:	0019 - No User Rating (Site Visit) - HA-03: Erosion around manhole		
Lat/Long:	41.57427/-87.51862

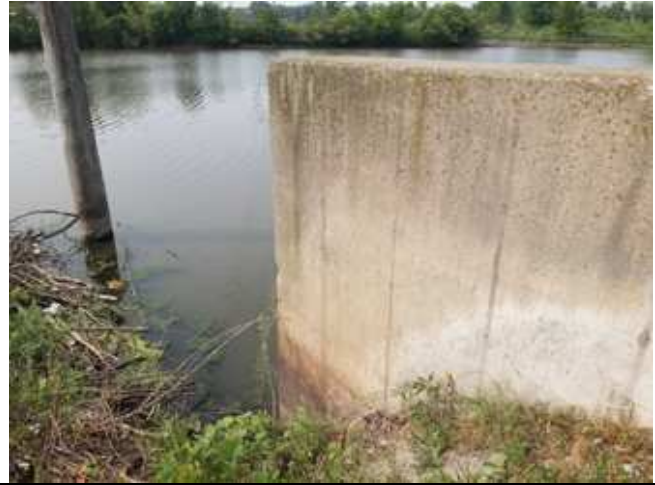
Category:	Interior Drainage System	Item:	Foundation of Concre
Observation ID:	2023-0024		
Description:	HA-33: Erosion along outlet wingwall		
Caption:	0024 - No User Rating (Site Visit) - HA-33: Erosion along outlet wingwall		
Lat/Long:	41.57058/-87.44766

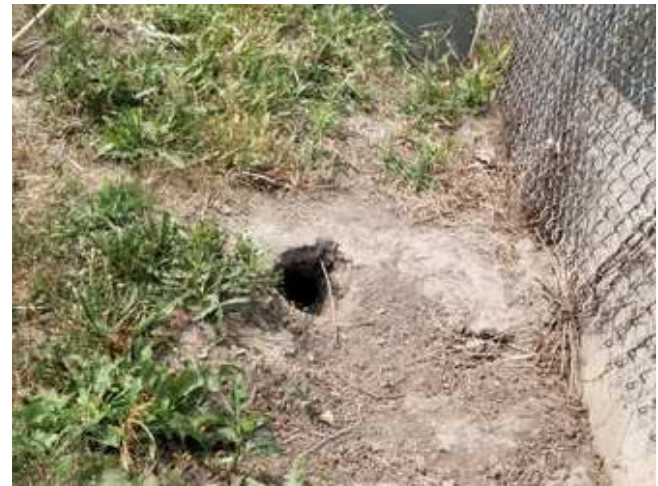
Category:	Interior Drainage System	Item:	Foundation of Concre
Observation ID:	2023-0090		
Description:	HA-13: Animal burrow near outlet structure		
Caption:	0090 - No User Rating (Site Visit) - HA-13: Animal burrow near outlet structure		
Lat/Long:	41.56919/-87.50039

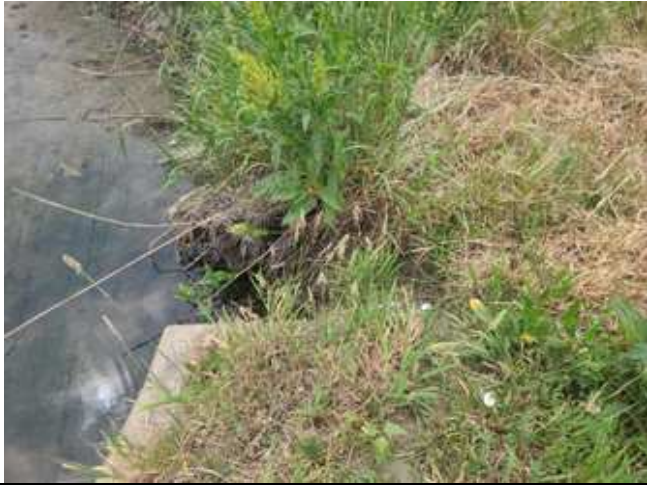
Category:	Interior Drainage System	Item:	Foundation of Concre
Observation ID:	2023-0111		
Description:	HA-08: Erosion around wingwalls at outlet		
Caption:	0111 - No User Rating (Site Visit) - HA-08: Erosion around wingwalls at outlet		
Lat/Long:	41.57140/-87.50937

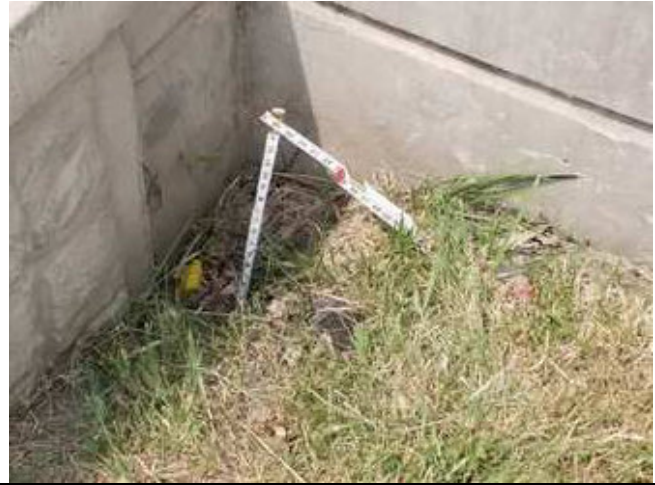
Category:	Interior Drainage System	Item:	Foundation of Concre
Observation ID:	2023-0114		
Description:	HA-13: Animal burrow near inlet structure		
Caption:	0114 - No User Rating (Site Visit) - HA-13: Animal burrow near inlet structure		
Lat/Long:	41.56940/-87.50043

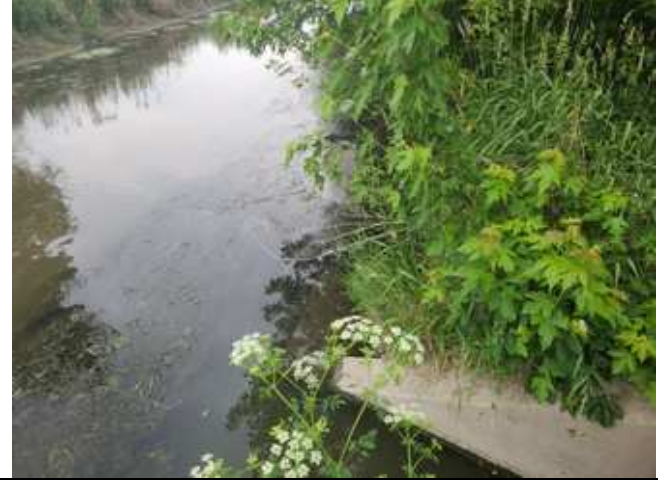
Category:	Interior Drainage System	Item:	Foundation of Concre
Observation ID:	2023-0131		
Description:	HA-09: Erosion around wingwalls at outlet		
Caption:	0131 - No User Rating (Site Visit) - HA-09: Erosion around wingwalls at outlet		
Lat/Long:	41.57118/-87.50694

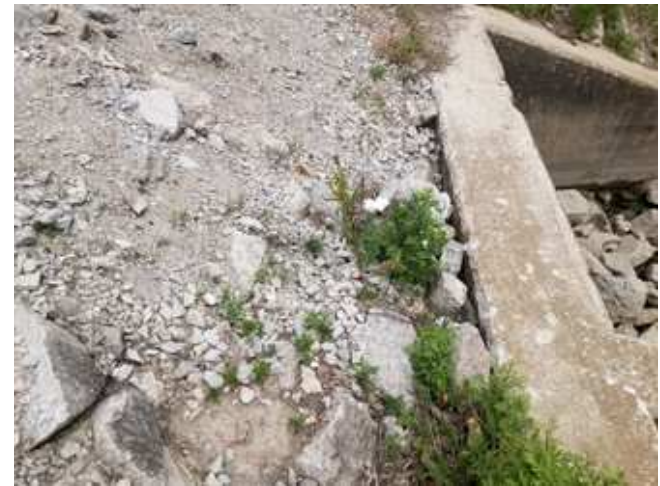
Category:	Interior Drainage System	Item:	Foundation of Concre
Observation ID:	2023-0178		
Description:	HA-17: Erosion around headwall at outlet		
Caption:	0178 - No User Rating (Site Visit) - HA-17: Erosion around headwall at outlet		
Lat/Long:	41.56860/-87.47560

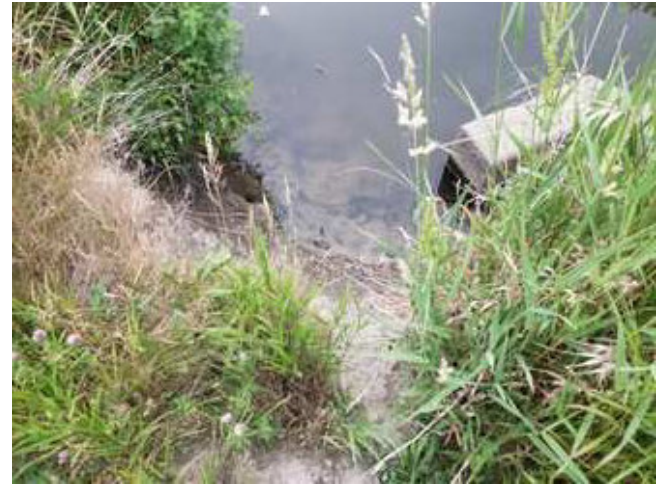
Category:	Interior Drainage System	Item:	Foundation of Concre
Observation ID:	2023-0202		
Description:	HA-21: Erosion on sides of outlet		
Caption:	0202 - No User Rating (Site Visit) - HA-21: Erosion on sides of outlet		
Lat/Long:	41.57009/-87.47258

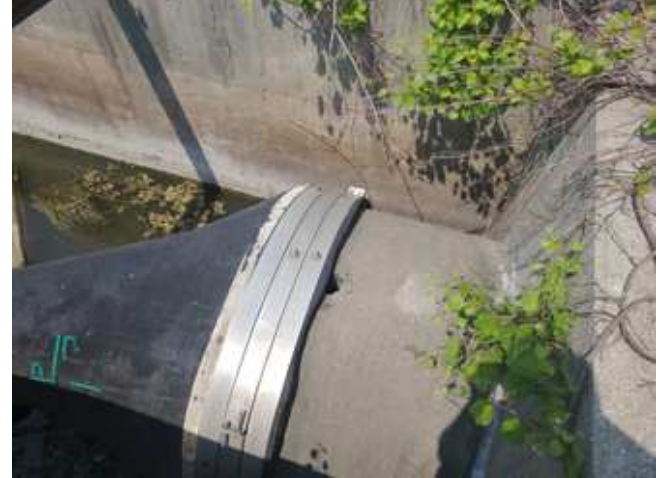
Category:	Interior Drainage System	Item:	Culverts/ Discharge
Observation ID:	2023-0387		
Description:	HA-38: Hole in RCP at duckbill connection		
Caption:	0387 - No User Rating (Site Visit) - HA-38: Hole in RCP at duckbill connection		
Lat/Long:	41.56687/-87.43162

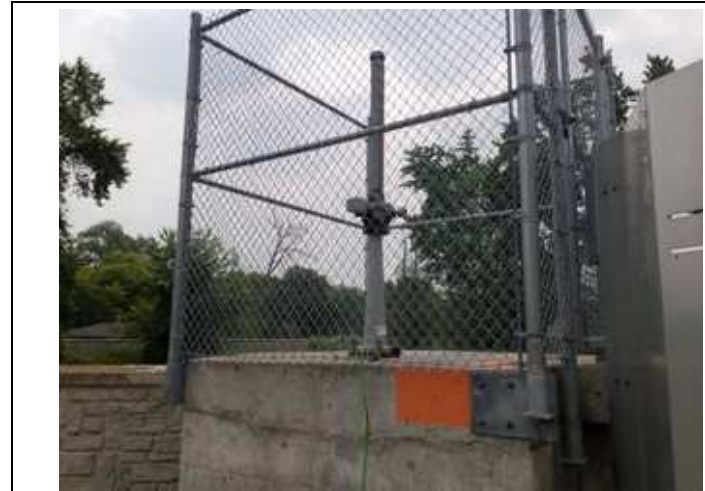
Category:	Interior Drainage System	Item:	Sluice / Slide Gates
Observation ID:	2023-0126		
Description:	HA-14: Rusting on gauge and column		
Caption:	0126 - No User Rating (Site Visit) - HA-14: Rusting on gauge and column		
Lat/Long:	41.56957/-87.50003

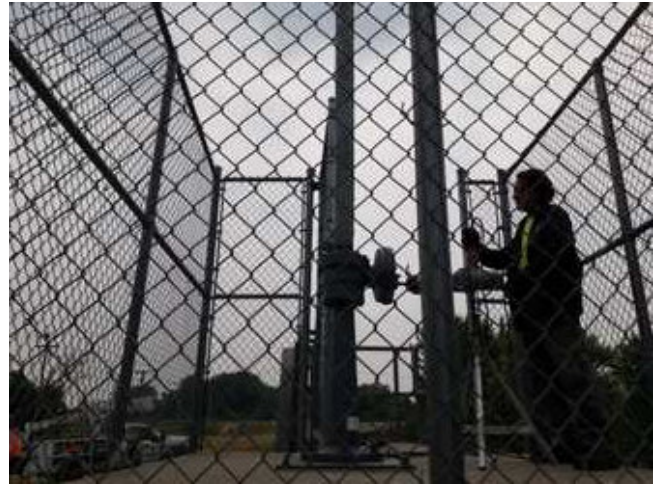
Category:	Interior Drainage System	Item:	Sluice / Slide Gates
Observation ID:	2023-0146		
Description:	HA-16: Sluice gate stem fixed from FY22 inspection		
Caption:	0146 - No User Rating (Site Visit) - HA-16: Sluice gate stem fixed from FY22 inspection		
Lat/Long:	41.56733/-87.48707

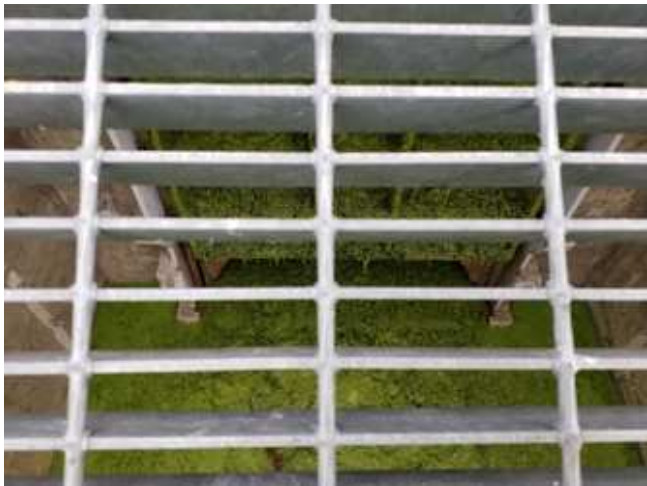
Category:	Interior Drainage System	Item:	Sluice / Slide Gates
Observation ID:	2023-0158		
Description:	HA-16: Gate to remain fully open. Some skipping while raising. Corrosion was noted on inside as well as some chipping.		
Caption:	0158 - No User Rating (Site Visit) - HA-16: Gate to remain fully open. Some skipping while raising. Corrosion was noted on inside as well as some chipping.		
Lat/Long:	41.56728/-87.48705

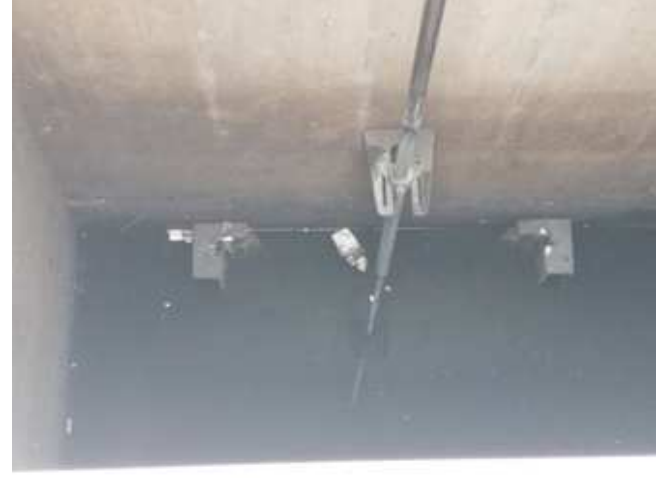
Category:	Interior Drainage System	Item:	Sluice / Slide Gates
Observation ID:	2023-0222		
Description:	HA-21C: Some debris in gatewell. Water dripping while opening during FY22 inspection - not noted during this inspection		
Caption:	0222 - No User Rating (Site Visit) - HA-21C: Some debris in gatewell. Water dripping while opening during FY22 inspection - not noted during this inspection		
Lat/Long:	41.57008/-87.47252

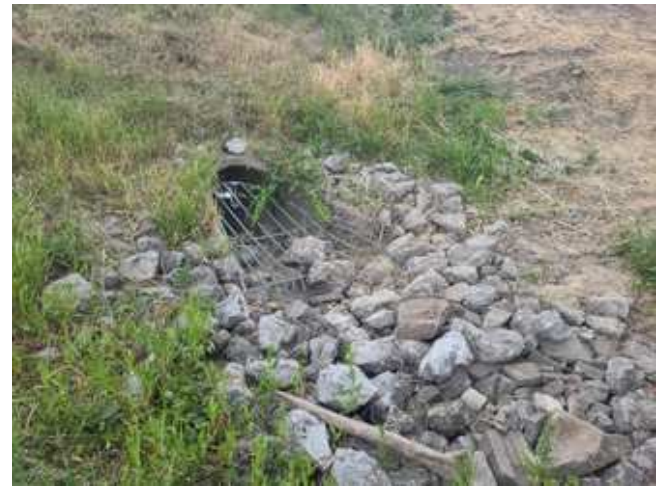
Category:	Interior Drainage System	Item:	Trash Racks (non-mec
Observation ID:		2023-0143	
Description:	HA-09: Damaged trash rack		
Caption:	0143 - No User Rating (Site Visit) - HA-09: Damaged trash rack		
Lat/Long:	41.57129/-87.50681

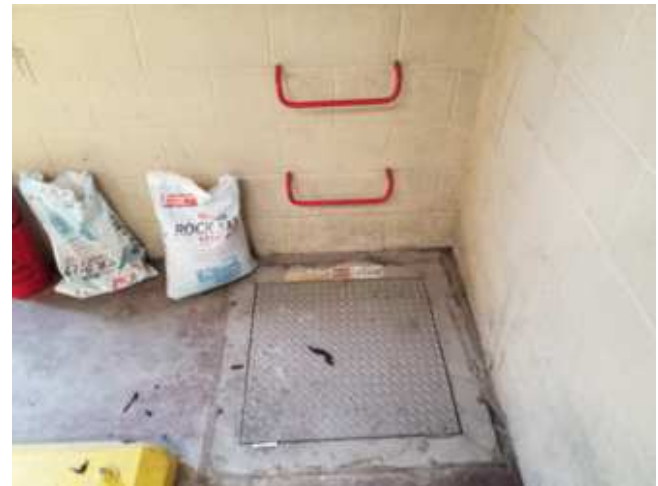
Category:	Pump Stations	Item:	Safety Compliance
Observation ID:	2023-0193		
Description:	PS-SK: Confined space label is missing		
Caption:	0193 - No User Rating (Site Visit) - PS-SK: Confined space label is missing		
Lat/Long:	41.57361/-87.46184

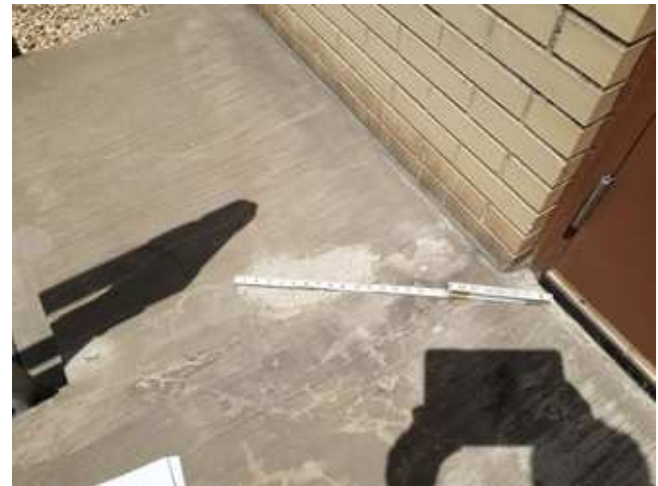
Category:	Pump Stations	Item:	Plant Building
Observation ID:	2023-0013		
Description:	PS-JA: Spalling on outside stair landing platform		
Caption:	0013 - No User Rating (Site Visit) - PS-JA: Spalling on outside stair landing platform		
Lat/Long:	41.57296/-87.51746

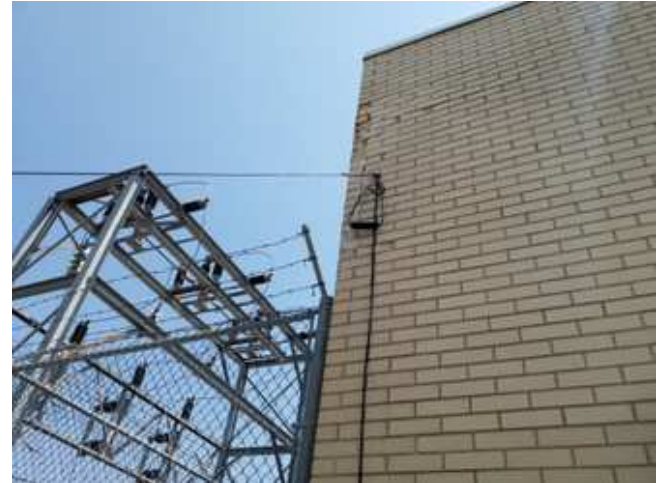
Category:	Pump Stations	Item:	Plant Building
Observation ID:	2023-0029		
Description:	PS-JA: Cracks on exterior brick surface of building		
Caption:	0029 - No User Rating (Site Visit) - PS-JA: Cracks on exterior brick surface of building		
Lat/Long:	41.57309/-87.51752

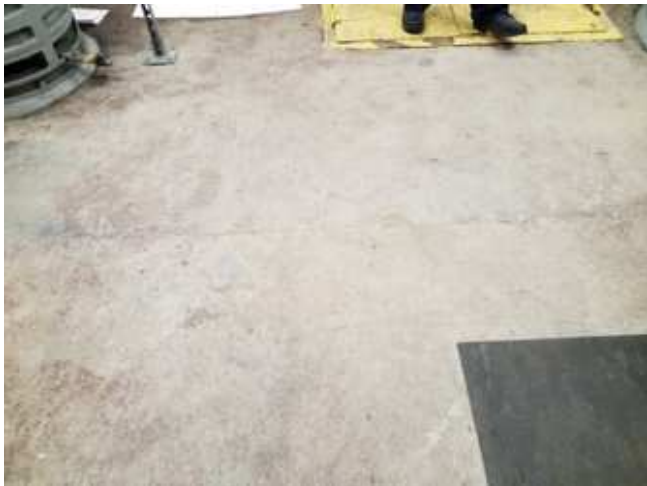
Category:	Pump Stations	Item:	Plant Building
Observation ID:	2023-0041		
Description:	PS-TA: Concrete floor crack along interior of building		
Caption:	0041 - No User Rating (Site Visit) - PS-TA: Concrete floor crack along interior of building		
Lat/Long:	41.57064/-87.50506

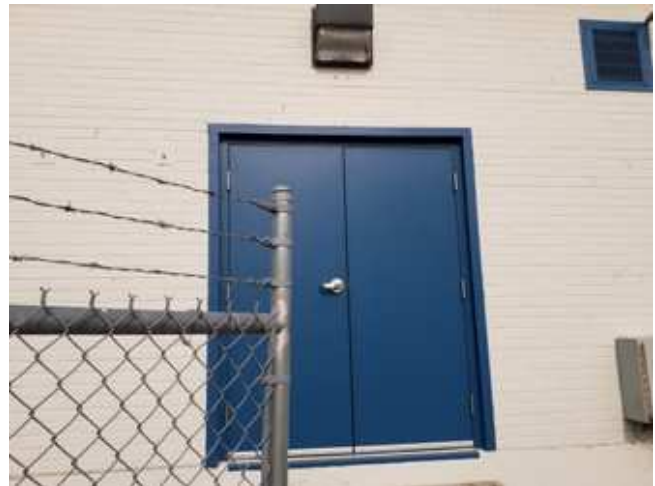
Category:	Pump Stations	Item:	Plant Building
Observation ID:	2023-0049		
Description:	PS-TA: New doors installed and exterior of building and louvers repainted		
Caption:	0049 - No User Rating (Site Visit) - PS-TA: New doors installed and exterior of building and louvers repainted		
Lat/Long:	41.57062/-87.50505

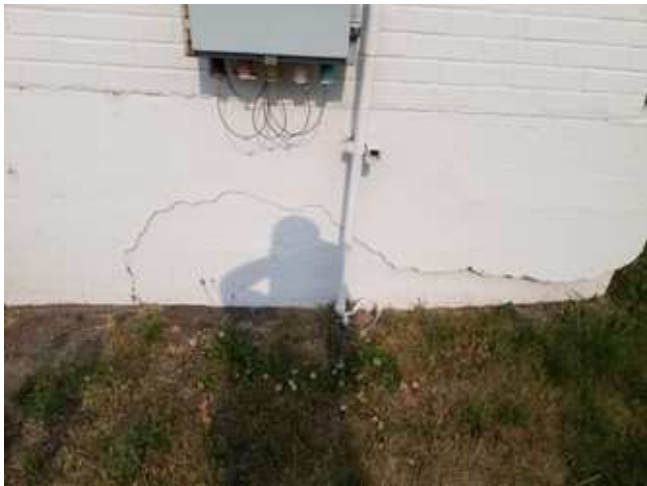
Category:	Pump Stations	Item:	Plant Building
Observation ID:	2023-0053		
Description:	PS-TA: Crack in foundation of building		
Caption:	0053 - No User Rating (Site Visit) - PS-TA: Crack in foundation of building		
Lat/Long:	41.57064/-87.50509

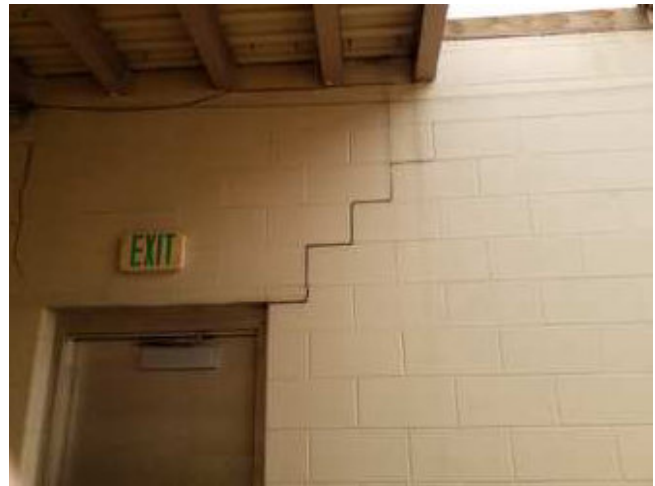
Category:	Pump Stations	Item:	Plant Building
Observation ID:	2023-0085		
Description:	PS-SS: Interior wall stairstep cracks		
Caption:	0085 - No User Rating (Site Visit) - PS-SS: Interior wall stairstep cracks		
Lat/Long:	41.57345/-87.50060

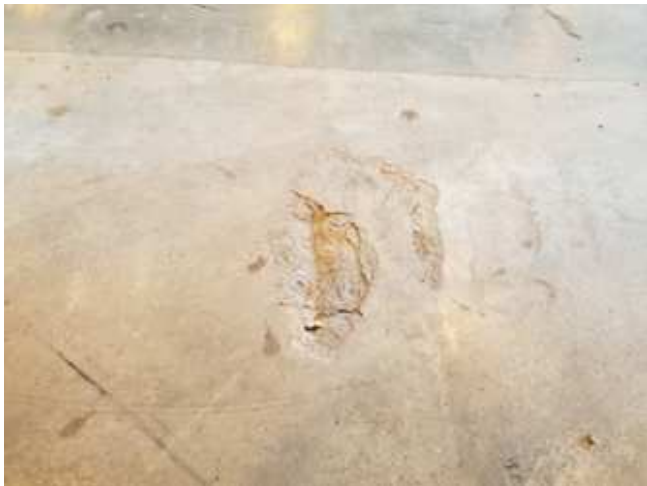
Category:	Pump Stations	Item:	Plant Building
Observation ID:	2023-0093		
Description:	PS-SS: Concrete spalling on interior building floor		
Caption:	0093 - No User Rating (Site Visit) - PS-SS: Concrete spalling on interior building floor		
Lat/Long:	41.57345/-87.50059

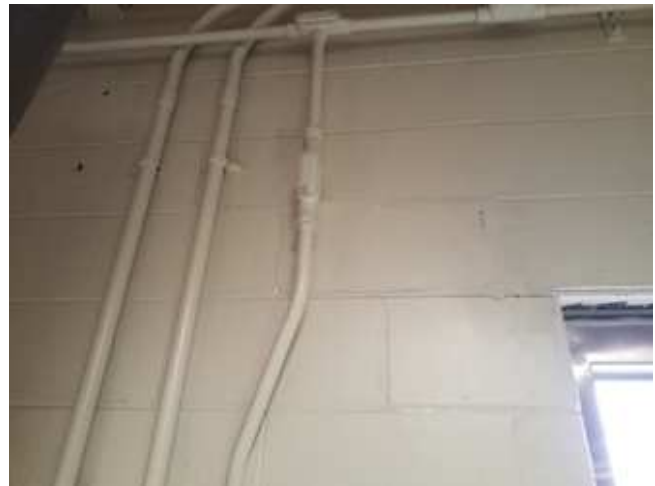
Category:	Pump Stations	Item:	Plant Building
Observation ID:	2023-0117		
Description:	PS-WA: Stairstep interior wall crack		
Caption:	0117 - No User Rating (Site Visit) - PS-WA: Stairstep interior wall crack		
Lat/Long:	41.56900/-87.49289

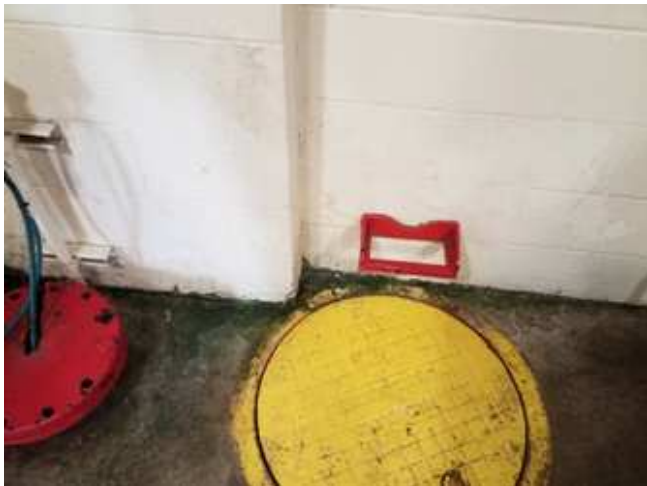
Category:	Pump Stations	Item:	Plant Building
Observation ID:	2023-0121		
Description:	PS-WA: Mold growth but no active leak evident		
Caption:	0121 - No User Rating (Site Visit) - PS-WA: Mold growth but no active leak evident		
Lat/Long:	41.56899/-87.49289

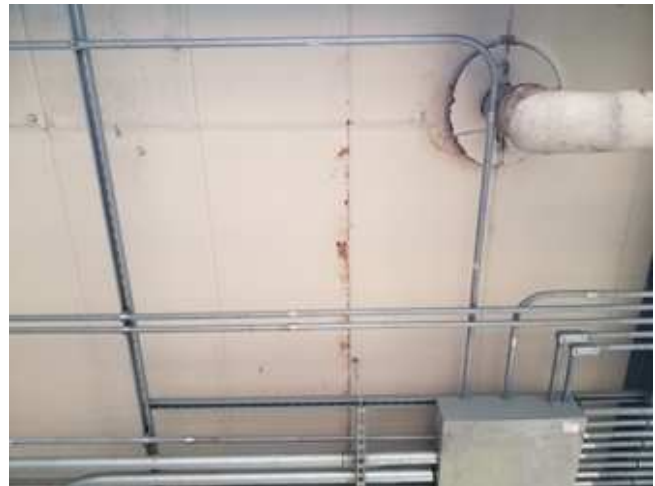
Category:	Pump Stations	Item:	Plant Building
Observation ID:	2023-0153		
Description:	PS-IN: Minor corrosion on ceiling		
Caption:	0153 - No User Rating (Site Visit) - PS-IN: Minor corrosion on ceiling		
Lat/Long:	41.57485/-87.47517

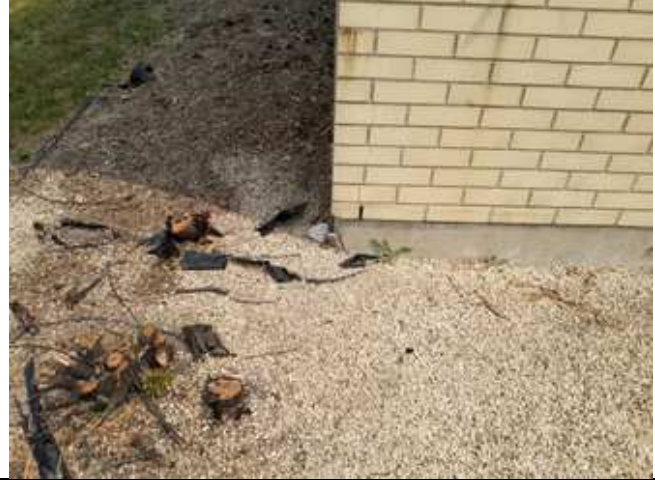
Category:	Pump Stations	Item:	Plant Building
Observation ID:	2023-0161		
Description:	PS-IN: Crack in corner of building foundation		
Caption:	0161 - No User Rating (Site Visit) - PS-IN: Crack in corner of building foundation		
Lat/Long:	41.57474/-87.47533

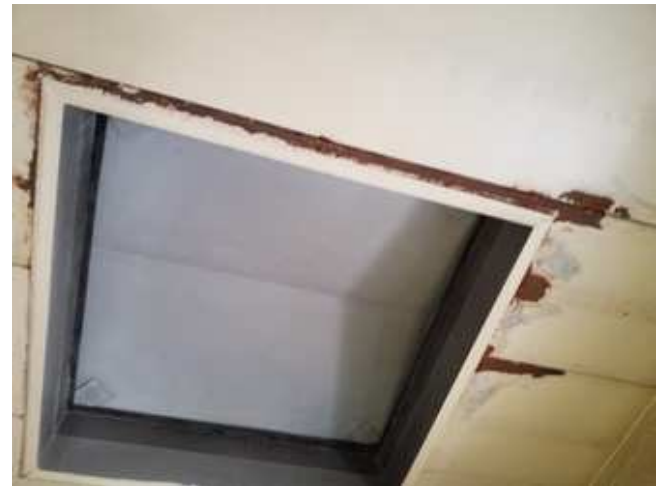
Category:	Pump Stations	Item:	Plant Building
Observation ID:	2023-0205		
Description:	PS-SK: Corrosion along ceiling		
Caption:	0205 - No User Rating (Site Visit) - PS-SK: Corrosion along ceiling		
Lat/Long:	41.57363/-87.46185

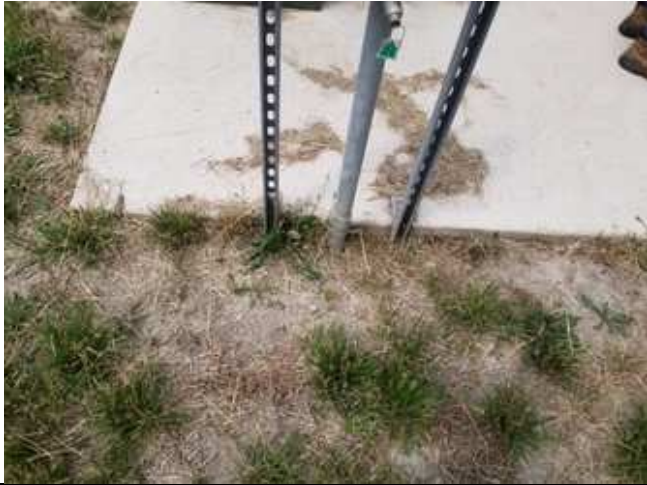
Category:	Pump Stations	Item:	Plant Building
Observation ID:	2023-0213		
Description:	PS-SK: Soil subsidence noted during FY22 inspection has been repaired		
Caption:	0213 - No User Rating (Site Visit) - PS-SK: Soil subsidence noted during FY22 inspection has been repaired		
Lat/Long:	41.57351/-87.46186

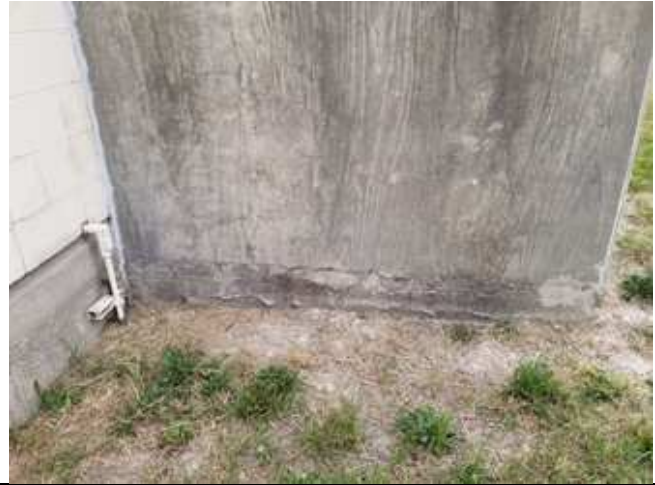
Category:	Pump Stations	Item:	Plant Building
Observation ID:	2023-0217		
Description:	PS-SK: Cracks near building foundation		
Caption:	0217 - No User Rating (Site Visit) - PS-SK: Cracks near building foundation		
Lat/Long:	41.57356/-87.46187

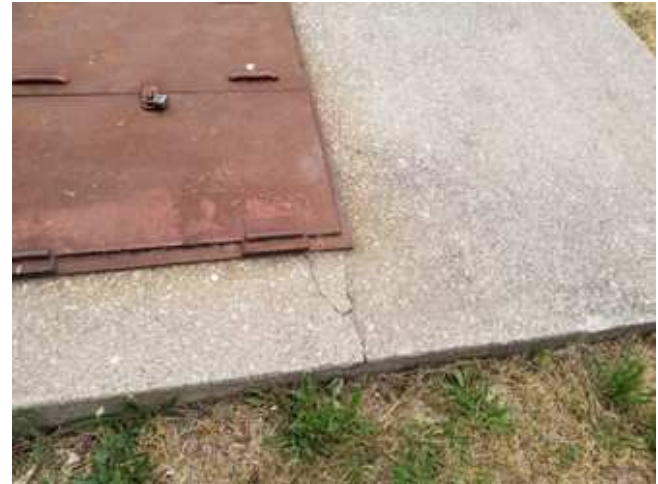
Category:	Pump Stations	Item:	Plant Building
Observation ID:	2023-0241		
Description:	PS-KA: Crack on concrete foundation pad		
Caption:	0241 - No User Rating (Site Visit) - PS-KA: Crack on concrete foundation pad		
Lat/Long:	41.57056/-87.45824

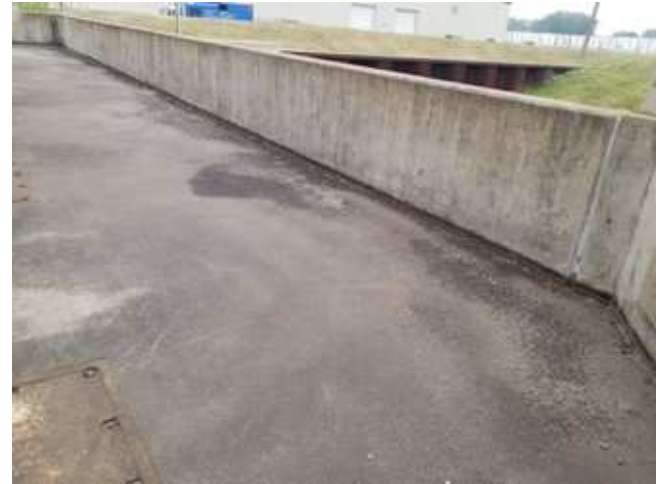
Category:	Pump Stations	Item:	Plant Building
Observation ID:	2023-0281		
Description:	PS-HV: Ponding water by the wall, noted during previous inspections, was not noted during current inspection		
Caption:	0281 - No User Rating (Site Visit) - PS-HV: Ponding water by the wall, noted during previous inspections, was not noted during current inspection		
Lat/Long:	41.57300/-87.44798

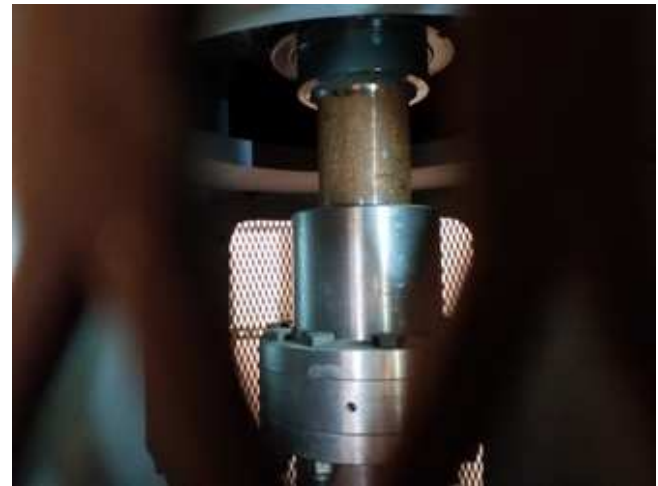
Category:	Pump Stations	Item:	Pumps
Observation ID:	2023-0073		
Description:	PS-SS: Upper exposed pump shaft for SWP-1 is corroded more than other pump shafts		
Caption:	0073 - No User Rating (Site Visit) - PS-SS: Upper exposed pump shaft for SWP-1 is corroded more than other pump shafts		
Lat/Long:	41.57343/-87.50046
