Name of System: Highland	Levee	Inspection Report	
US Army Corps of Engineers ® Name of Segment: Highland 2605000005		NLD Segment ID: 2604000007	
Segment Type: Locally Constructed, Locally Operated and Mainta Levee Sponsor (Name and Organization): Little Calumet River Bas Inspection Report Prepared by: Yuki Galisanao Inspection Report Prepared by: Chris Schaal	in Development Commission	Date(s) of Inspection: 06/08/2023 - 06/08/20	023
Segment Name N	Other LD Segment ID#	Segments Within This System Segment Type	Segment Inspection Rating
Contents of Levee Inspection Report: Levee Inspection Summary General Items	Type of Inspection:	Formal Inspection Special	Inspection (mark this if purpose is Initial Eligibility Inspection)
General Items Levee Embankment Floodwalls Interior Drainage System Pump Stations FRM Channels	Approval Signature:	John A Groboski	Date Approved:
Public Sponsor Pre-Inspection Form National Flood Insurance Program - 44 CFR 65.10 Subset Criteria Evaluation Levee Inspection Reference Guide Photos

No change in rating from Minimally Acceptable since the previous inspection. Minor issues with trees and tall vegetation, sod cover, debris, slope stability, bank erosion, ru

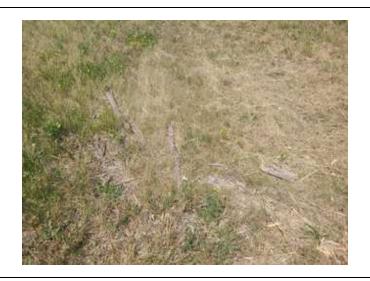
Rated Item: 3. Encroachments Caption: 0172 - Minimally Acceptable - Wooden bollard missing on levee crown

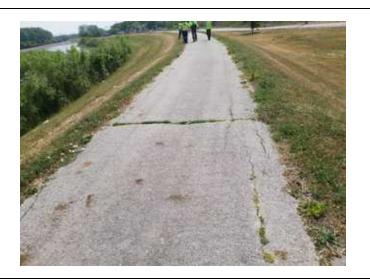
2604000007_CELRC_2023_A_2023-0096_1_1686238938092.jpg **Rated Item:** 9. Cracking **Caption:** 0096 - Minimally Acceptable - Crack in asphalt on crest

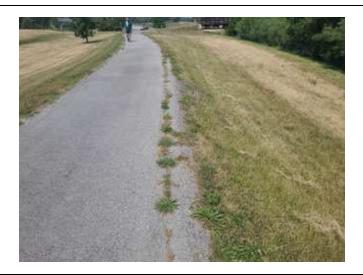
Rated Item: 9. Cracking Caption: 0100 - Minimally
Acceptable - Crack in asphalt with vegetation growing within

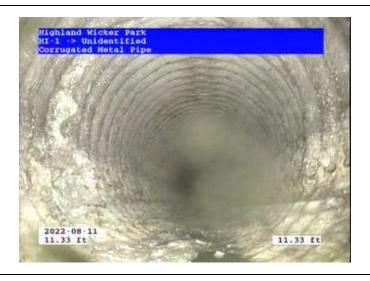
Rated Item: 11. Culverts/ Discharge Pipes (This item includes both concrete and corrugated metal pipes.) Caption: 0322 - Minimally Acceptable - small creasing failure about 6 feet from start of inspection (9 to 12 oclock. Small joint separation at 11.33 feet from access point

Rated Item	Rating	Rating Guidelines	Observation Locations with Descriptions and Resulting Item Rating Justification
11. Culverts / Discharge Pipes (This item includes both concrete and corrugated metal pipes.)	M	A There are no breaks, holes, cracks in the discharge pipes/ culverts that would result in significant water leakage. All joints appear to be closed and the soil tight. The interior condition of pipes has been verified using television camera videotaping or visual inspection methods within the frequency determined in accordance with Levee Inspections and Site Visits: Standard Operating Procedures. The exterior pipe conditions observed are in good condition. M There are some defects noted that should be monitored. The interior condition of pipes has been verified using television camera videotaping or visual inspection methods at the frequency determined in accordance with Levee Inspections and Site Visits: Standard Operating Procedures. The exterior pipe condition assessment. U One or more significant defects exist. The exterior pipe conditions observed indicate there may be a change in pipe condition since the last condition assessment. The interior condition of pipes has not been verified using television camera videotaping or visual inspection methods at the frequency determined in accordance with Levee Inspections and Site Visits: Standard Operating Procedures. NA There are no discharge pipes / culverts.	2023-0322: HI-1: sizeable settle silt deposits (25% full estimated), 4 to 8 oclock, about 5-10 feet long in concrete pipe section. Mild corrosion in corrugated metal pipe section, as well as small creasing failure about 6 feet from start of inspection (9 to 12 oclock. Small joint separation at 11.33 feet from access point, some soil infiltration. Elliptical deformation in corrugated metal pipe, 23.36 feet to 29.78 feet. Creasing at the end. (M) 2023-0323: HI-2: no issues observed (M) 2023-0324: HI-3: infiltration 10-11 oclock, dripper, just downstream of closed sluice gate. Minor leaks in seal around sluice gate. Minor cracks on joint near ditchline grates (M) 2023-0325: HI-7A: spalling of concrete in outfall structure. Missing vertical bar on grate. HI-7B: small joint offset at 22 feet from access point. No soil showing yet. (M) 2023-0326: HI-10A: no issues observed. HI-10B: no issues observed. HI-10C: large vegetation debris 18-20 feet into pipe. HI-10D: no issues observed. (M) 2023-0327: HI-11: large amount of vegetation in stagnant water, downstream of sluice gate. May need to be cleaned out. (M) 2023-0328: HI-9: silt in the first 5 feet of pipe (rover travelled slowly) (M) 2023-0329: HI-5: no issues observed. HI-6: minor cracks at 12 oclock position throughout pipeline. Minor rust on sluice gate cover. (M) Recommendation: Monitor HI-1 for seepage paths during high water events.

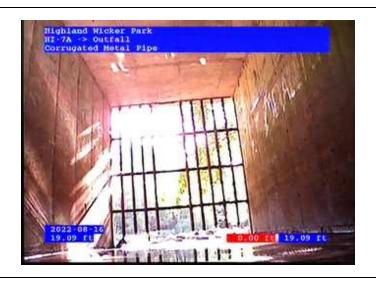
2604000007_2023_A_2023-0325_1_20230724T222011.jpg **Rated Item:** 11. Culverts/ Discharge Pipes (This item includes both concrete and corrugated metal pipes.) **Caption:** 0325 - Minimally Acceptable - HI-7A: spalling of concrete in outfall structure.

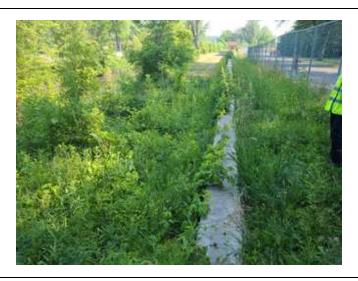
Rated Item: 15. Seepage Caption: 0330 - Minimally Acceptable - Area of previous minor seepage on landside toe.

No Seepage observed.

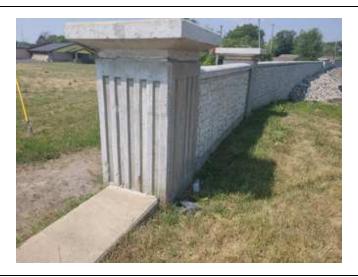
Rated Item: 3. Closure Structures (Stop Log Closures and Gates) (A or U only) Caption: Acceptable - Rubber gasket at

railroad closure missing

Rated Item	Rating		Rating Guidelines	Observation Locations with Descriptions and Resulting Item Rating Justification						
	3. Closure Structures (Stop Log Closures and Gates) (A or U only)	A	U	Closure structure in good repair. Placing equipment, stoplogs, and other materials are readily available at all times. Components are clearly marked and installation instructions/ procedures readily available. Trial erections have been accomplished in accordance with the O&M Manual. Any of the following issues is cause for this rating: Closure structure in poor condition. Parts missing or corroded. Placing equipment may not be available within the anticipated warning time. The storage vaults cannot be opened during the time of inspection. Components of closure are not clearly marked and installation instructions/ procedures are not readily available. Trial erections have not been accomplished in accordance with the O&M Manual.	2023-0099: Rubber gasket at railroad closure missing (A) 2023-0135: Closure structure in good condition in Kennedy (A) 2023-0319: Floodwall tieback, no issues noted (A) Recommendation: Replace rubber gasket on railroad closure.

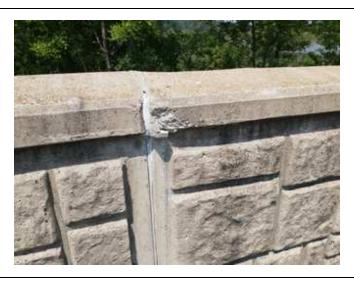
Rated Item: 4. Concrete Surfaces Caption: 0111 - Minimally Acceptable - Concrete spalling on tie in to levee embankment

Recommendation: Fill voids and cracks. Cut out damaged areas and patch with appropriate cement patch. cover hole in sheetpile. Replace missing bolt under sheetpile cap.

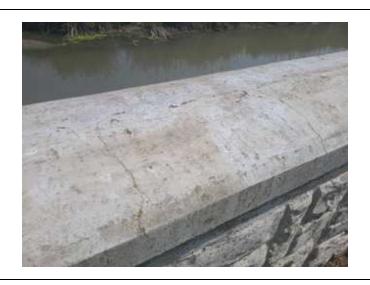
Rated Item: 4. Concrete Surfaces Caption: 0120 - Minimally

Acceptable - Spalling on landside face.

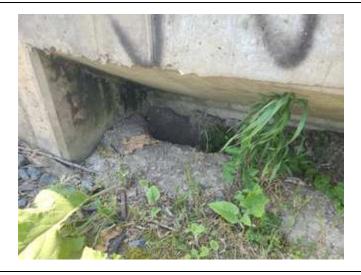
2604000007_CELRC_2023_A_2023-0088_1_1686238422879.jpg **Rated Item:** 6. Foundation of Concrete Structures **Caption:** 0088 - Minimally Acceptable - Depression on landside base

6.	Concrete	М	A	No active erosion, scouring, or bank caving that might endanger the structure's stability.	2023-0088 : Depression on landside base (M) 2023-0095 : Animal burrows under closure structure
	Structures		M	There are areas where the ground is eroding towards the base of the structure. Efforts need to be taken to slow and repair this erosion, but it is not judged to be close enough to the structure or to be progressing rapidly enough to affect structural stability before the next inspection. For the purposes of inspection, the erosion or scour is not closer to the riverside face of the wall than twice the floodwall's underground base width if the wall is of L-wall or T-wall construction; or if the wall is of sheetpile or I-wall construction, the erosion is not closer than twice the wall's visible height. Additionally, rate of erosion is such that the wall is expected to remain stable until the next inspection.	(M) 2023-0103: Burrow and vegetation on riverside (M) 2023-0167: Animal burrows near floodwall (M) 2023-0195: Scour around corner makes it hard to mow (M) Recommendation: Add fill to depressions and burrows next to landside wall.

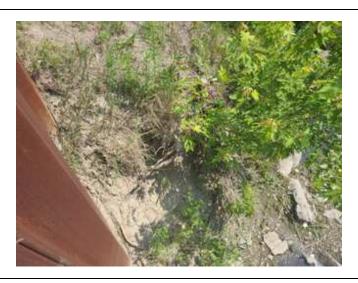
0103_1_1686237230243.jpg **Rated Item:** 6. Foundation of Concrete Structures **Caption:** 0103 - Minimally Acceptable - Burrow and vegetation on

riverside

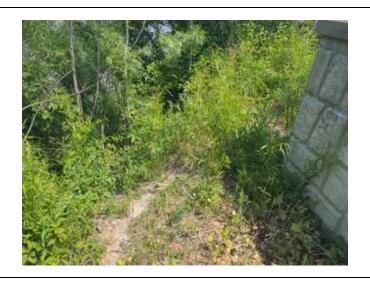
Rated Item: 6. Foundation of Concrete Structures Caption: 0167 - Minimally Acceptable - Animal burrows near floodwall

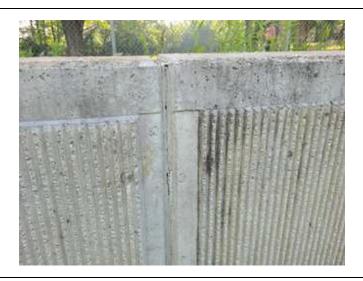
2604000007_CELRC_2023_A_2023-0195_1_1686241257208.jpg Rated Item: 6. Foundation of Concrete Structures Caption: 0195 - Minimally Acceptable - Scour around corner makes it

hard to mow

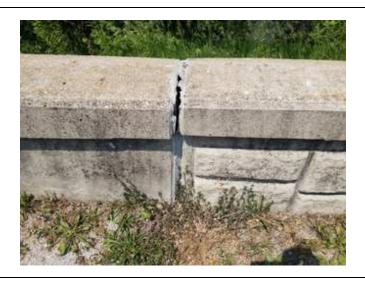
Rated Item: 7. Monolith Joints Caption: Minimally Acceptable - Broken caulking of monolith joints

Rated Item	Rating		Rating Guidelines	Observation Locations with Descriptions and Resulting Item Rating Justification
7.	Monolith Joints	M	A	The joint material is in good condition. The exterior joint sealant is intact and cracking/ desiccation is minimal. Joint filler material and/or waterstop is not visible at any point. The joint material has appreciable deterioration to the point where joint	2023-0011: Broken caulking of monolith joints (M) 2023-0116: Joint sealant deteriorated (M) 2023-0119: Typical cracking of sealant (M) 2023-0124 (M)
			M	filler material and/or waterstop is visible in some locations. This needs to be repaired or replaced to prevent spalling and cracking during freeze/ thaw cycles, and to ensure water tightness of the joint.	2023-0139: Typical monolith joint cracking of sealant riverside (M) 2023-0152: Missing caulk and filler material in joints (M)
			U	The joint material is severely deteriorated or the concrete adjacent to the monolith joints has spalled and cracked, damaging the waterstop; in either case damage has occurred to the point where it is apparent that the joint is no longer watertight and will not provide the intended level of protection during a flood.	2023-0156: Missing filler and caulk (M) 2023-0291: No sealant on joint (M) 2023-0299: Waterstop deteriorating landside (M) Recommendation: Replace sealant, waterstops, and

NA	There are no monolith joints in the floodwall.	joint materials where indicated with polyurethane grout.
8.	Underseepage Relief Wells/Toe Drain Systems	NA	A	Toe drainage systems and pressure relief wells necessary for maintaining levee segment / system stability during high water functioned properly during the last flood event and no sediment is observed in horizontal system (if applicable). Nothing is observed which would indicate that the drainage systems won't function properly during the next flood, and maintenance records indicate regular cleaning. Wells have been pumped tested within the past 5 years and documentation is provided.	
			M	Toe drainage systems or pressure relief wells are damaged and may become clogged if they are not repaired. Maintenance records are incomplete or indicate irregular cleaning and pump testing.	
			U	Toe drainage systems or pressure relief wells necessary for maintaining levee segment / system stability during flood events have fallen into disrepair or have become clogged. No maintenance records. No documentation of the required pump testing.

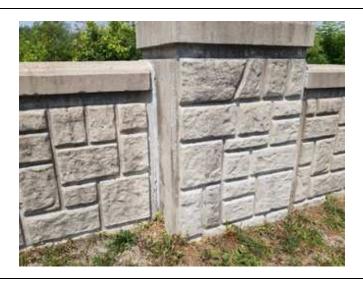
Rated Item: 7. Monolith Joints Caption: 0119 - Minimally
Acceptable - Typical cracking of sealant

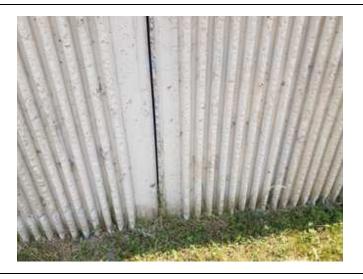
Rated Item: 7. Monolith Joints Caption: Minimally
Acceptable - Missing caulk and filler material in joints

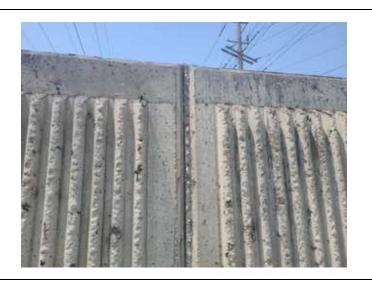
2604000007_CELRC_2023_A_2023-0156_1_1686245313779.jpg **Rated Item:** 7. Monolith Joints **Caption:** Minimally

Acceptable - Missing filler and caulk

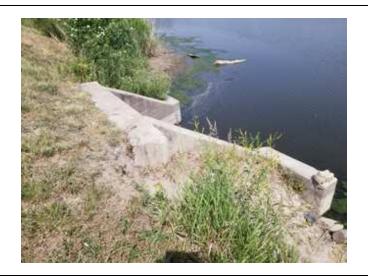
HI-7B: Spalling of surface

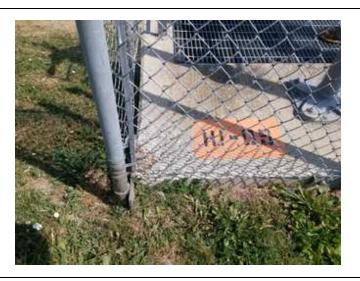
HI-09: Spalling of headwall

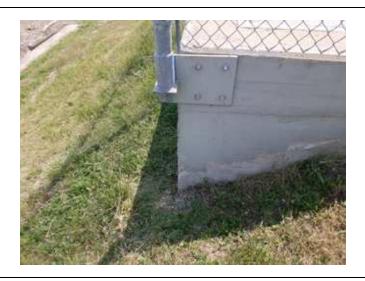
HI-09: Spalling of concrete near fencing

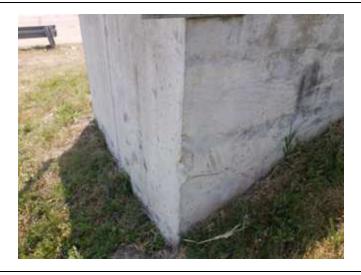
10ABCD: Minor spalling on gatewell concrete

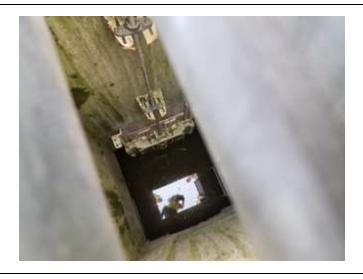
Rated Item: 10. Sluice / Slide Gates Caption: Minimally
Acceptable - HI-7A: Minor rust present on gate

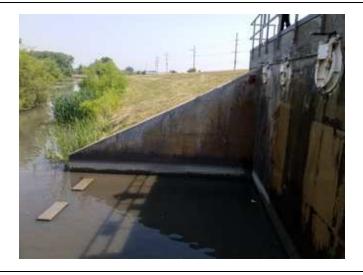
Rated Item: 5. Plant Building Caption: Minimally Acceptable
- PS-ND: South wing wall cracking. Repair is needed.
