**US Army Corps  
of Engineers ®**

## Site Visit Summary

Name of System: Munster

Date of Site Visit: 06/05/2023 - 06/05/2023

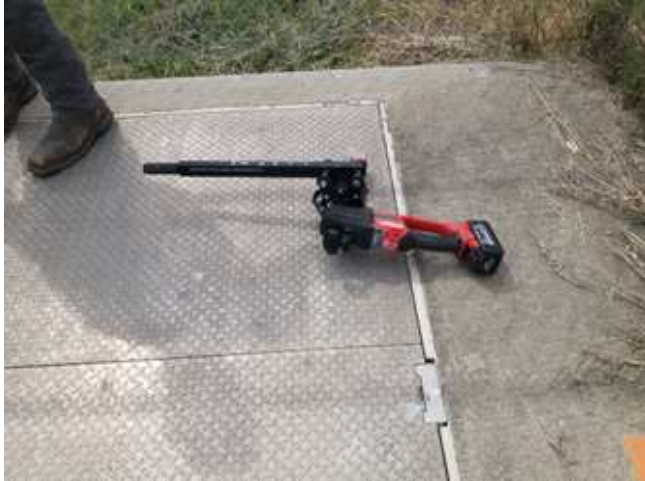
Category:	General Items	Item:	Emergency Supplies a
Observation ID:	2023-0054		
Description:	New battery powered drills to operate gates		
Caption:	0054 - No User Rating (Site Visit) - New battery powered drills to operate gates		
Lat/Long:	41.57296/-87.51828

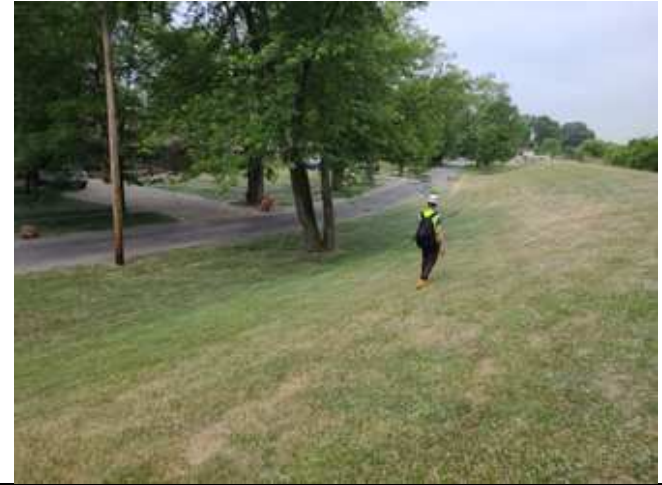
Category:	Levee Embankments	Item:	Unwanted Vegetation
Observation ID:	2023-0019		
Description:	Unwanted vegetation along riverside toe - typical		
Caption:	0019 - No User Rating (Site Visit) - Unwanted vegetation along riverside toe - typical		
Lat/Long:	41.56329/-87.48132

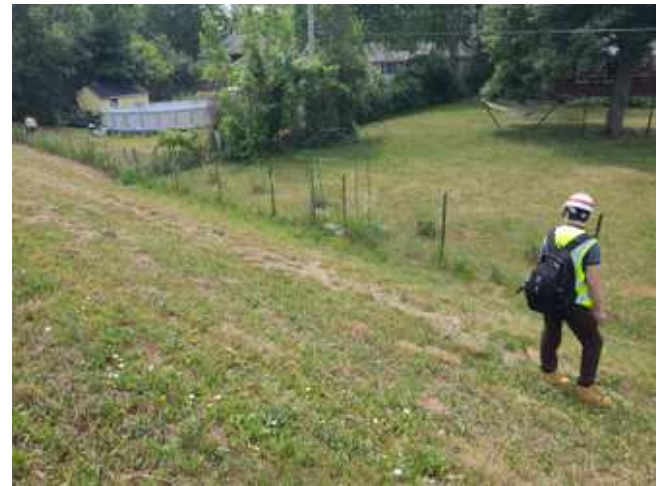
Category:	Levee Embankments	Item:	Unwanted Vegetation
Observation ID:	2023-0155		
Description:	Unwanted vegetation along riverside slope and toe		
Caption:	0155 - No User Rating (Site Visit) - Unwanted vegetation along riverside slope and toe		
Lat/Long:	41.57489/-87.51958

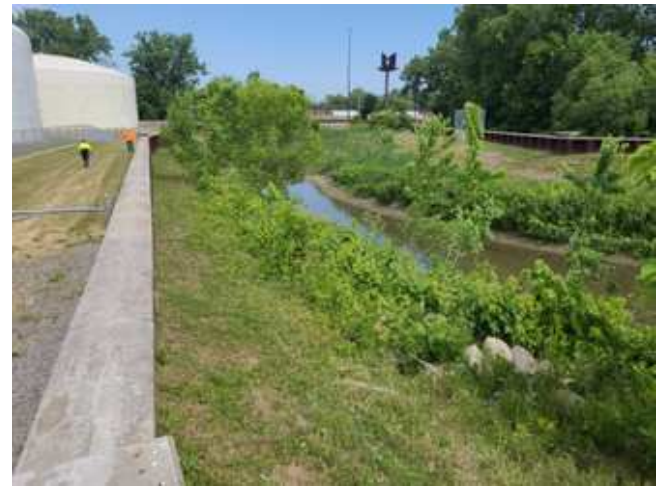
Category:	Floodwalls	Item:	Unwanted Vegetation
Observation ID:	2023-0055		
Description:	Six-foot vegetation free buffer on riverside floodwall - typical		
Caption:	0055 - No User Rating (Site Visit) - Six-foot vegetation free buffer on riverside floodwall - typical		
Lat/Long:	41.56638/-87.48981

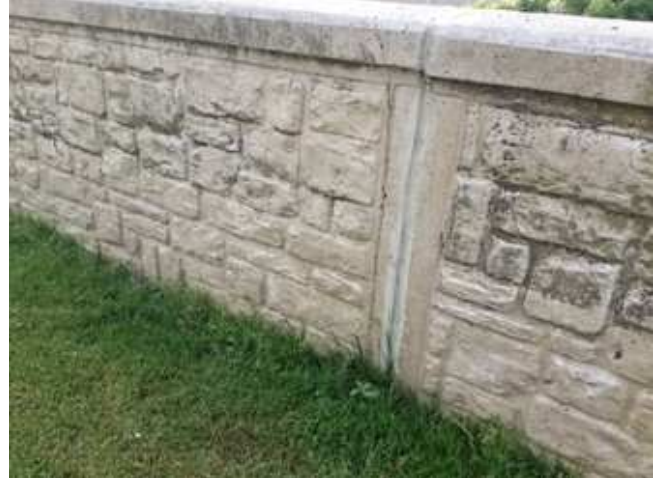
Category:	Floodwalls	Item:	Concrete Surfaces
Observation ID:	2023-0004		
Description:	Floodwall cracks on landside		
Caption:	0004 - No User Rating (Site Visit) - Floodwall cracks on landside		
Lat/Long:	41.56092/-87.48126

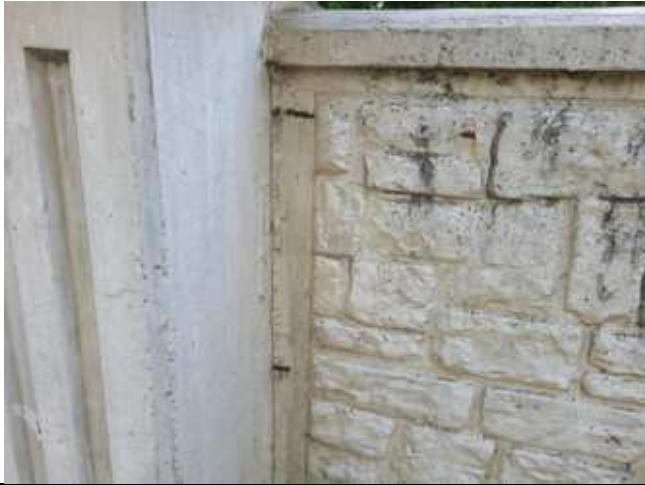
Category:	Floodwalls	Item:	Concrete Surfaces
Observation ID:	2023-0007		
Description:	Exposed rebar on landside floodwall		
Caption:	0007 - No User Rating (Site Visit) - Exposed rebar on landside floodwall		
Lat/Long:	41.56230/-87.48122

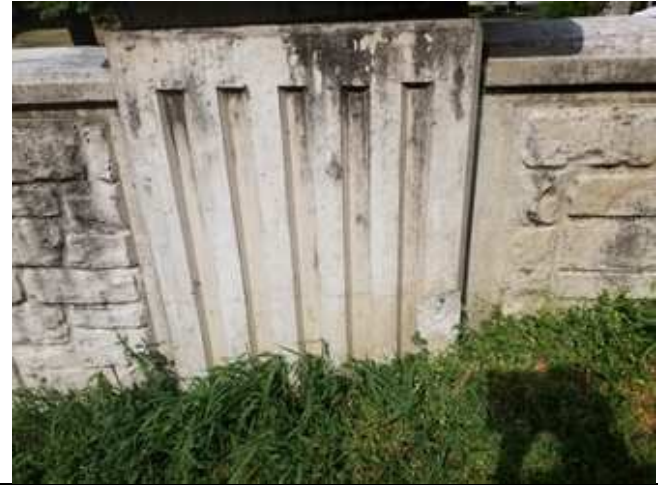
Category:	Floodwalls	Item:	Concrete Surfaces
Observation ID:	2023-0012		
Description:	Cracking and spalling on riverside floodwall		
Caption:	0012 - No User Rating (Site Visit) - Cracking and spalling on riverside floodwall		
Lat/Long:	41.56295/-87.48139

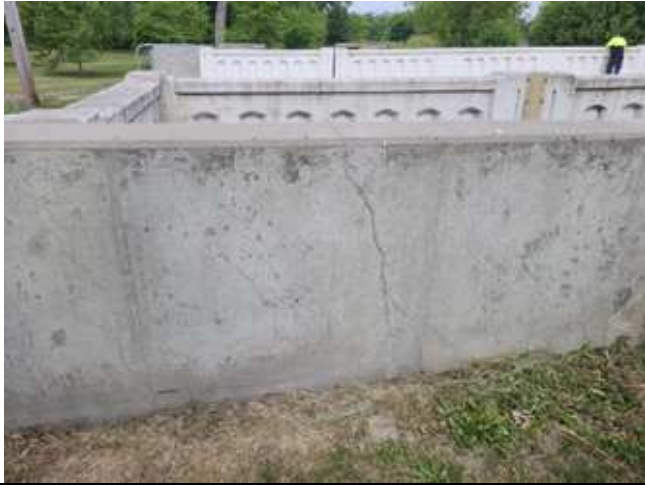
Category:	Floodwalls	Item:	Concrete Surfaces
Observation ID:	2023-0035		
Description:	Cracking of abutment on east side of Northcote Ave		
Caption:	0035 - No User Rating (Site Visit) - Cracking of abutment on east side of Northcote Ave		
Lat/Long:	41.56646/-87.48574

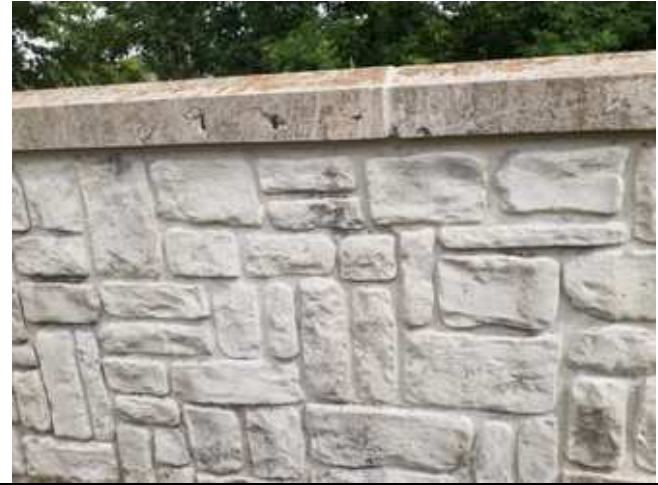
Category:	Floodwalls	Item:	Concrete Surfaces
Observation ID:	2023-0052		
Description:	Exposed rebar on landside cap		
Caption:	0052 - No User Rating (Site Visit) - Exposed rebar on landside cap		
Lat/Long:	41.56992/-87.49706

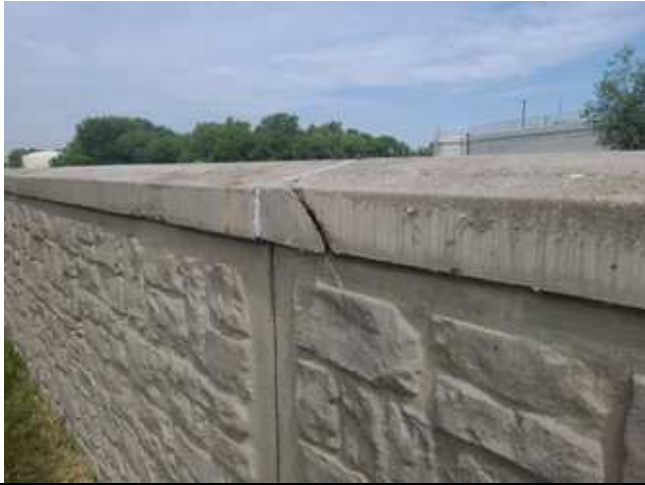
Category:	Floodwalls	Item:	Concrete Surfaces
Observation ID:	2023-0091		
Description:	Crack in landside cap near joint		
Caption:	0091 - No User Rating (Site Visit) - Crack in landside cap near joint		
Lat/Long:	41.57112/-87.50995

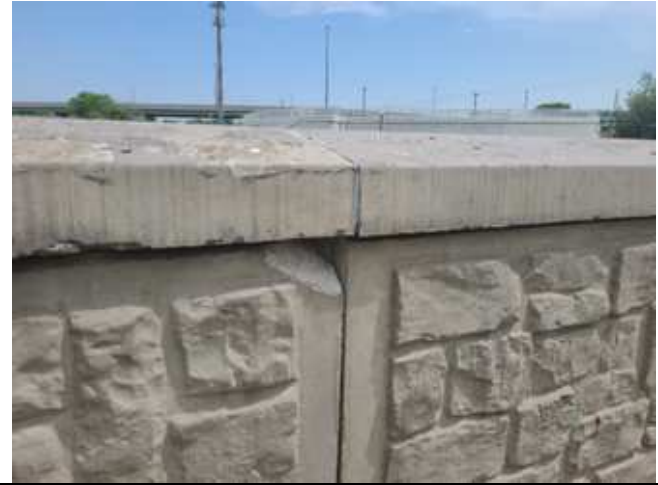
Category:	Floodwalls	Item:	Concrete Surfaces
Observation ID:	2023-0095		
Description:	Landside floodwall spalling/chipping		
Caption:	0095 - No User Rating (Site Visit) - Landside floodwall spalling/chipping		
Lat/Long:	41.57119/-87.51057

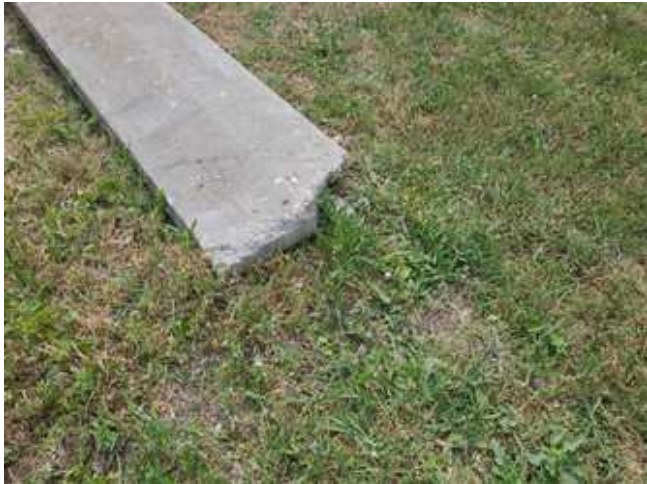
Category:	Floodwalls	Item:	Concrete Surfaces
Observation ID:	2023-0099		
Description:	Chipped cap		
Caption:	0099 - No User Rating (Site Visit) - Chipped cap		
Lat/Long:	41.57127/-87.51082

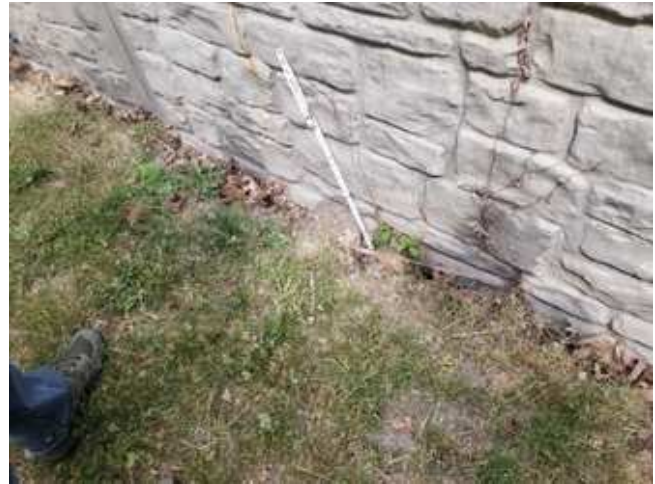
Category:	Floodwalls	Item:	Foundation of Concre
Observation ID:	2023-0056		
Description:	Depression along riverside floodwall foundation		
Caption:	0056 - No User Rating (Site Visit) - Depression along riverside floodwall foundation		
Lat/Long:	41.56859/-87.50081

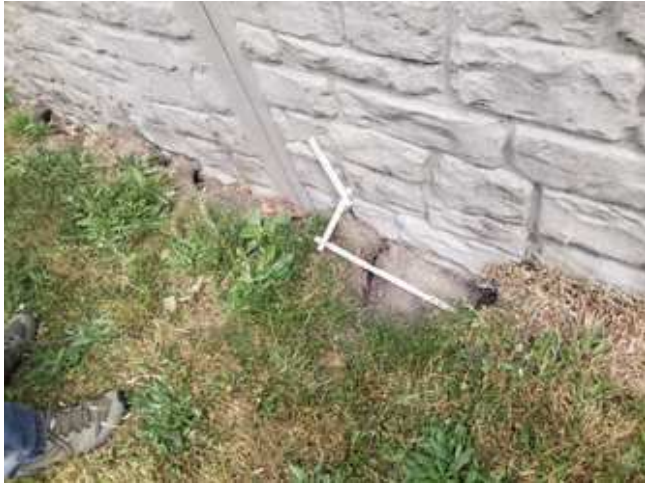
Category:	Floodwalls	Item:	Foundation of Concre
Observation ID:	2023-0060		
Description:	Two-ft deep animal burrows on landside floodwall foundation		
Caption:	0060 - No User Rating (Site Visit) - Two-ft deep animal burrows on landside floodwall foundation		
Lat/Long:	41.56848/-87.50139

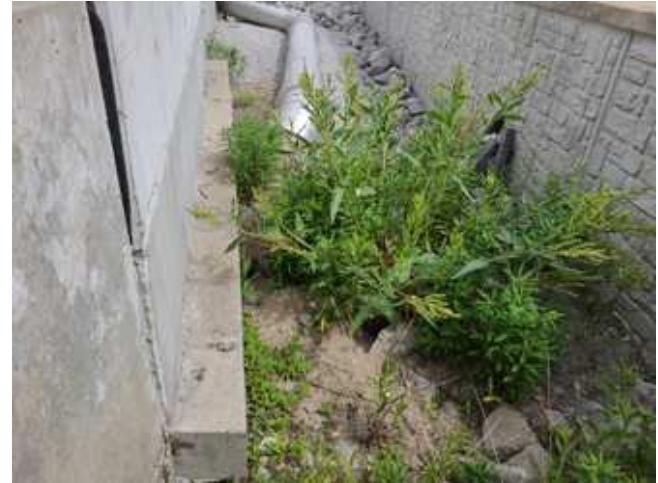
Category:	Floodwalls	Item:	Foundation of Concre
Observation ID:	2023-0067		
Description:	Animal burrow under abutment on east side of Columbia Ave		
Caption:	0067 - No User Rating (Site Visit) - Animal burrow under abutment on east side of Columbia Ave		
Lat/Long:	41.56886/-87.50009

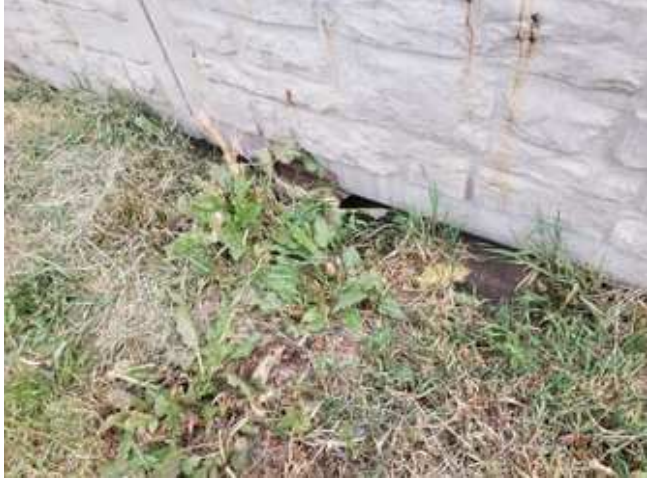
Category:	Floodwalls	Item:	Foundation of Concre
Observation ID:	2023-0068		
Description:	Depression under landside floodwall foundation - typical		
Caption:	0068 - No User Rating (Site Visit) - Depression under landside floodwall foundation - typical		
Lat/Long:	41.57074/-87.50625

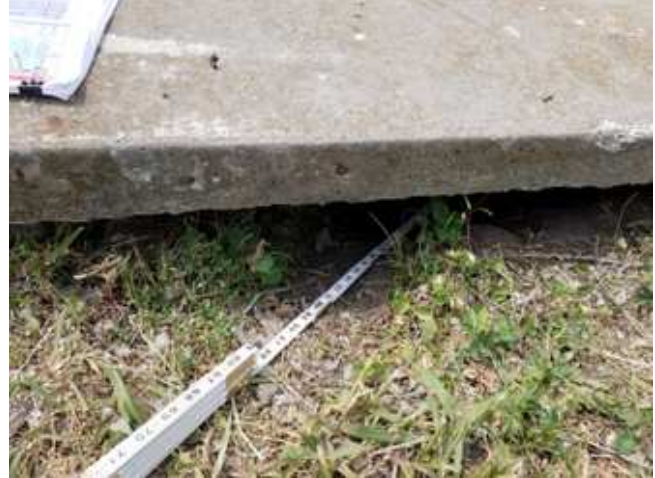
Category:	Floodwalls	Item:	Foundation of Concre
Observation ID:	2023-0076		
Description:	Erosion under floodwall cap on riverside		
Caption:	0076 - No User Rating (Site Visit) - Erosion under floodwall cap on riverside		
Lat/Long:	41.57130/-87.51083

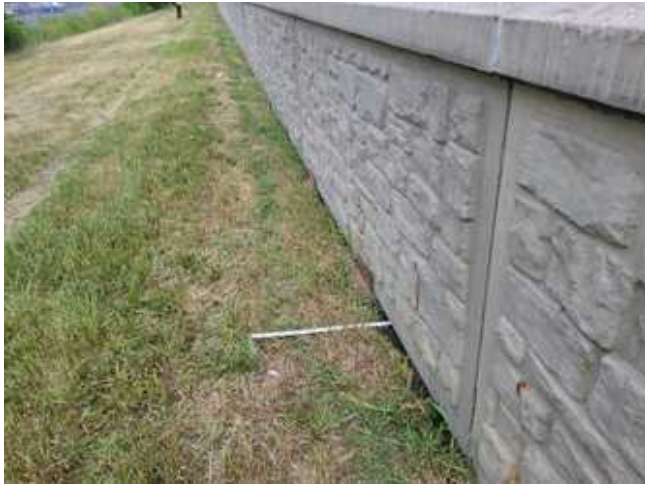
Category:	Floodwalls	Item:	Foundation of Concre
Observation ID:	2023-0079		
Description:	Erosion under landside floodwall facade - typical to Calumet Ave		
Caption:	0079 - No User Rating (Site Visit) - Erosion under landside floodwall facade - typical to Calumet Ave		
Lat/Long:	41.57066/-87.50617

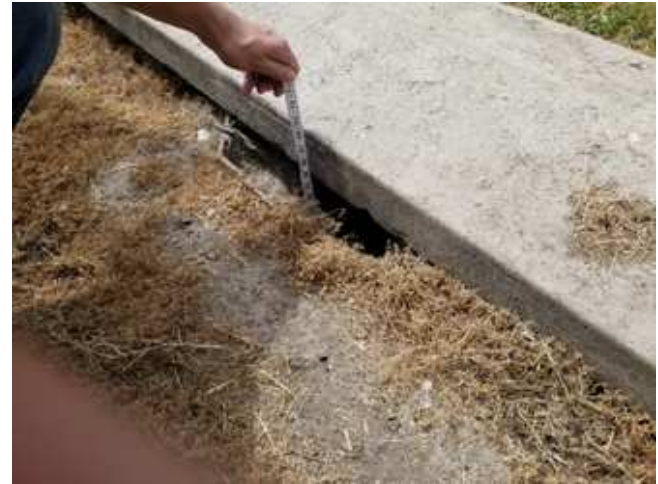
Category:	Floodwalls	Item:	Foundation of Concre
Observation ID:	2023-0084		
Description:	Erosion under landside floodwall cap		
Caption:	0084 - No User Rating (Site Visit) - Erosion under landside floodwall cap		
Lat/Long:	41.57234/-87.51390

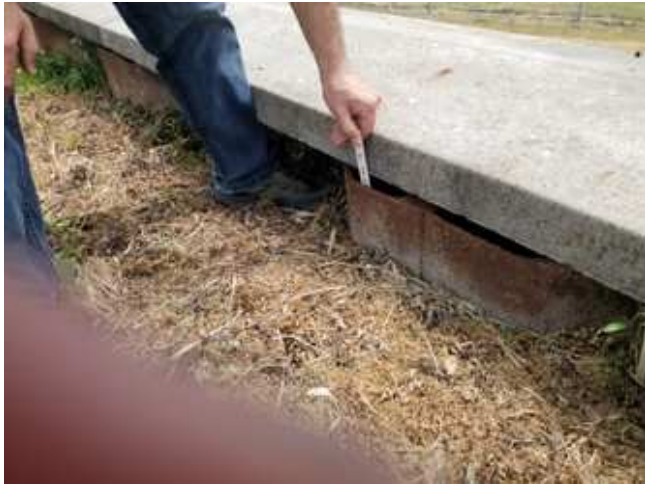
Category:	Floodwalls	Item:	Foundation of Concre
Observation ID:	2023-0092		
Description:	Landside floodwall cap misalignment over sheetpile		
Caption:	0092 - No User Rating (Site Visit) - Landside floodwall cap misalignment over sheetpile		
Lat/Long:	41.57287/-87.51458

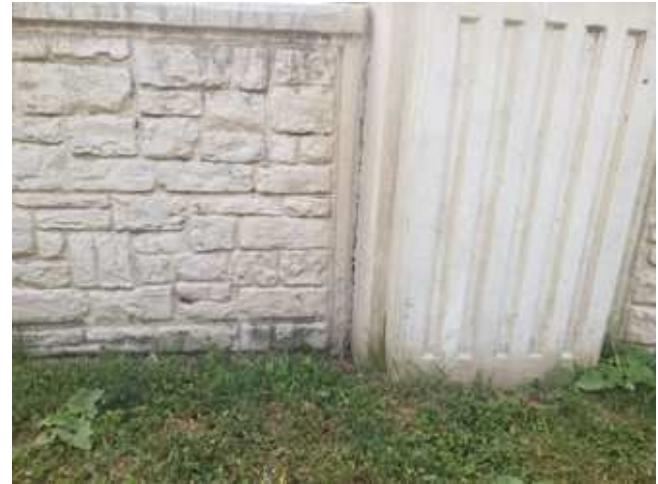
Category:	Floodwalls	Item:	Monolith Joints
Observation ID:	2023-0008		
Description:	Deteriorating joint sealant on landside floodwall		
Caption:	0008 - No User Rating (Site Visit) - Deteriorating joint sealant on landside floodwall		
Lat/Long:	41.56198/-87.48118

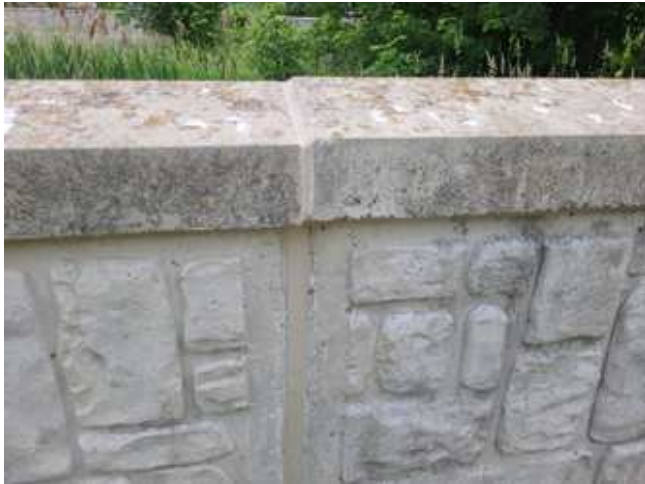
Category:	Floodwalls	Item:	Monolith Joints
Observation ID:	2023-0047		
Description:	Repaired joint caulking on landside floodwall		
Caption:	0047 - No User Rating (Site Visit) - Repaired joint caulking on landside floodwall		
Lat/Long:	41.56685/-87.48685

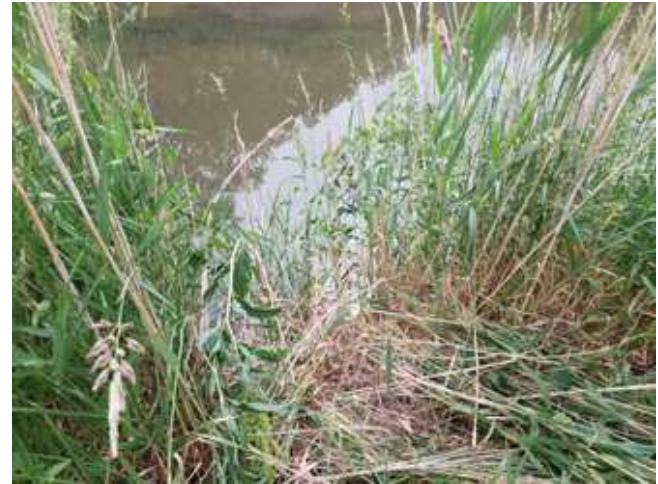
Category:	Interior Drainage System	Item:	Vegetation and Obstr
Observation ID:	2023-0022		
Description:	MU-08: Vegetation around outlet		
Caption:	0022 - No User Rating (Site Visit) - MU-08: Vegetation around outlet		
Lat/Long:	41.57243/-87.51392

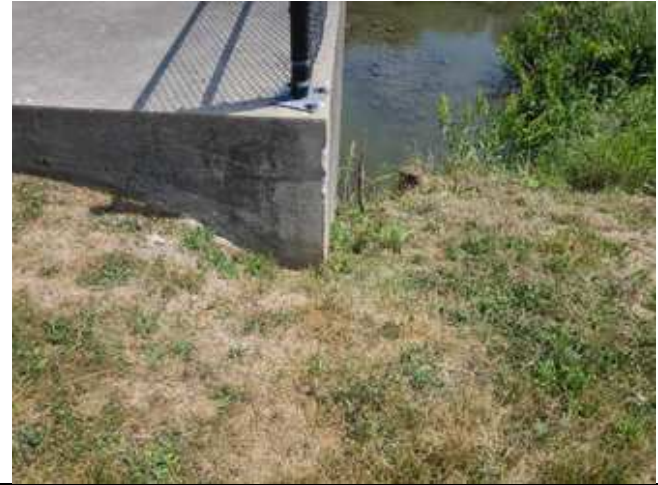
Category:	Interior Drainage System	Item:	Foundation of Concre
Observation ID:	2023-0143		
Description:	MU-07: Erosion at corners of gatewell		
Caption:	0143 - No User Rating (Site Visit) - MU-07: Erosion at corners of gatewell		
Lat/Long:	41.57200/-87.51771

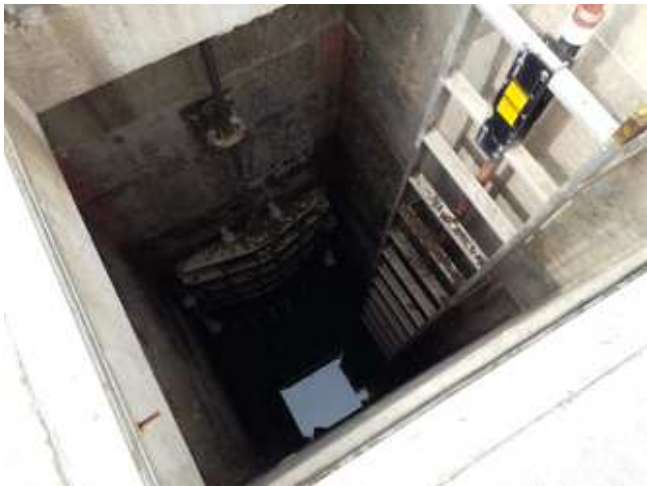
Category:	Interior Drainage System	Item:	Sluice / Slide Gates
Observation ID:	2023-0018		
Description:	MU-11: Sluice gate back in open position. No issues		
Caption:	0018 - No User Rating (Site Visit) - MU-11: Sluice gate back in open position. No issues		
Lat/Long:	41.56647/-87.48505

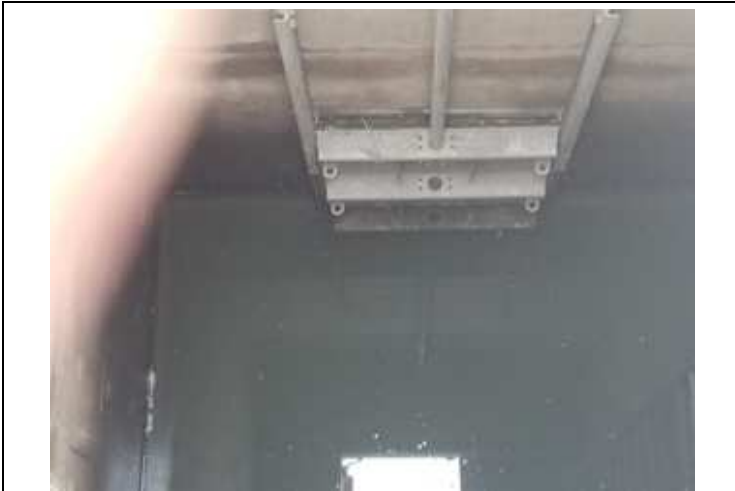
Category:	Interior Drainage System	Item:	Sluice / Slide Gates
Observation ID:	2023-0046		
Description:	MU-06: Sluice gate fully closed. No issues		
Caption:	0046 - No User Rating (Site Visit) - MU-06: Sluice gate fully closed. No issues		
Lat/Long:	41.57295/-87.51830

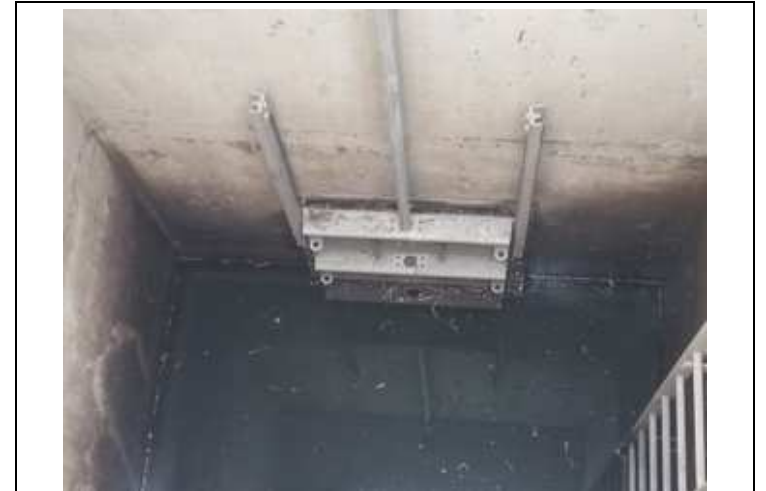
Category:	Interior Drainage System	Item:	Sluice / Slide Gates
Observation ID:	2023-0074		
Description:	MU-04: Sluice gate fully closed. No issues		
Caption:	0074 - No User Rating (Site Visit) - MU-04: Sluice gate fully closed. No issues		
Lat/Long:	41.57522/-87.51969

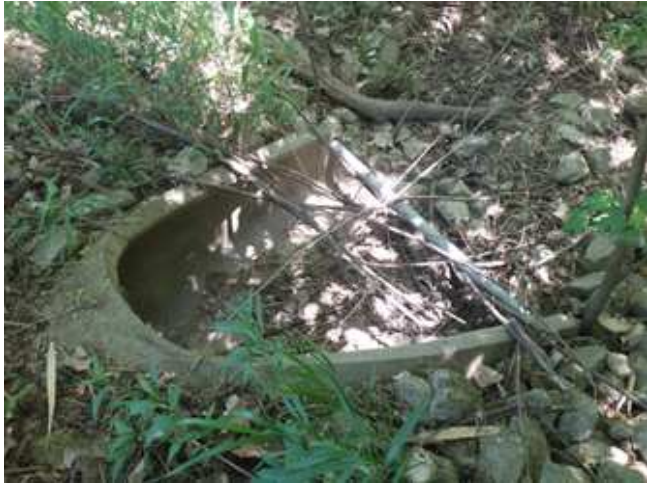
Category:	Interior Drainage System	Item:	Trash Racks (non-mec
Observation ID:		2023-0102	
Description:	MU-03: Missing trash rack		
Caption:	0102 - No User Rating (Site Visit) - MU-03: Missing trash rack		
Lat/Long:	41.57609/-87.52016

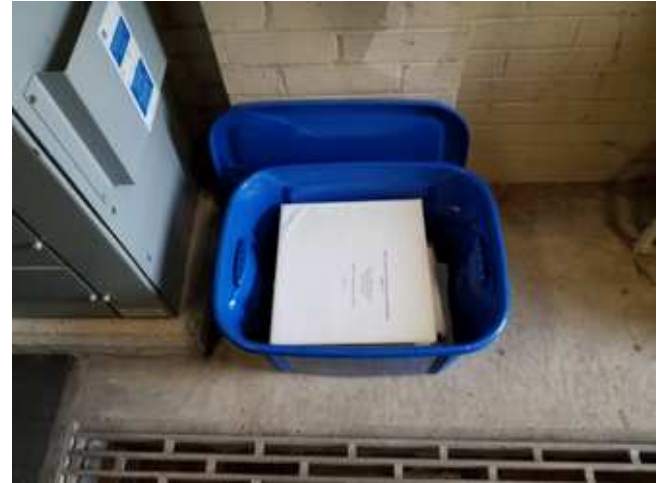
Category:	Pump Stations	Item:	Pump Station Operati
Observation ID:	2023-0001		
Description:	PS-BA: Operations manuals onsite		
Caption:	0001 - No User Rating (Site Visit) - PS-BA: Operations manuals onsite		
Lat/Long:	41.56638/-87.48510

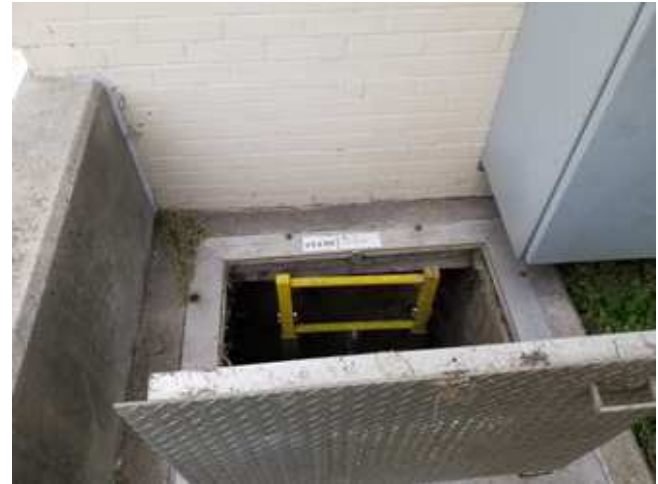
Category:	Pump Stations	Item:	Safety Compliance
Observation ID:	2023-0013		
Description:	PS-BA: Missing confined space entry label		
Caption:	0013 - No User Rating (Site Visit) - PS-BA: Missing confined space entry label		
Lat/Long:	41.56640/-87.48514

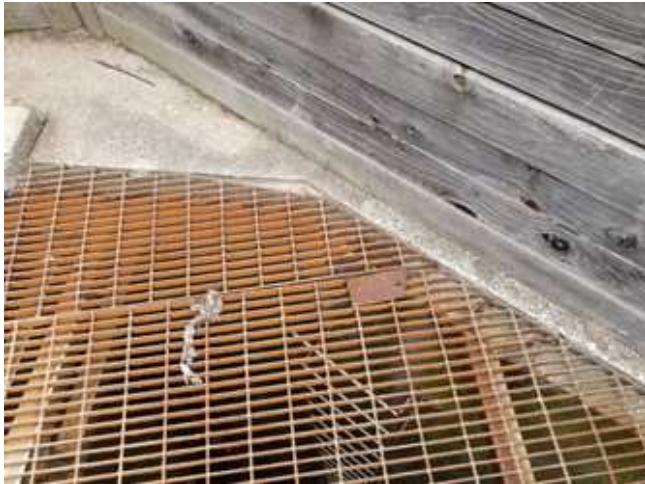
Category:	Pump Stations	Item:	Safety Compliance
Observation ID:	2023-0057		
Description:	PS-CA: Metal grate near intake of trash rake has no clips. Potential safety hazard.		
Caption:	0057 - No User Rating (Site Visit) - PS-CA: Metal grate near intake of trash rake has no clips. Potential safety hazard		
Lat/Long:	41.57082/-87.50775

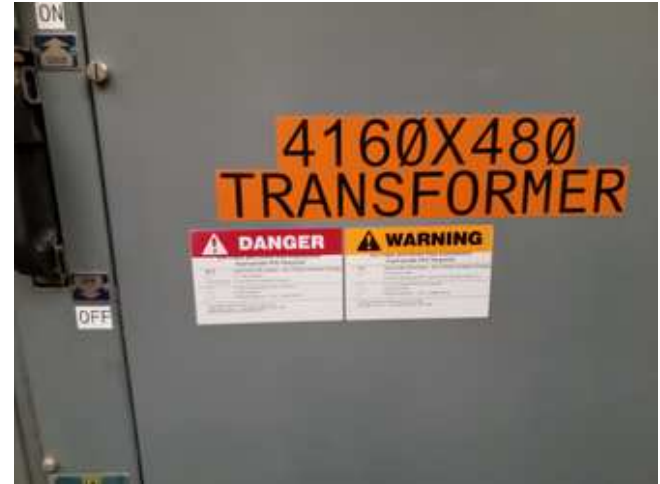
Category:	Pump Stations	Item:	Safety Compliance
Observation ID:	2023-0065		
Description:	PS-CA: Outdated arc flash labels		
Caption:	0065 - No User Rating (Site Visit) - PS-CA: Outdated arc flash labels		
Lat/Long:	41.57077/-87.50793

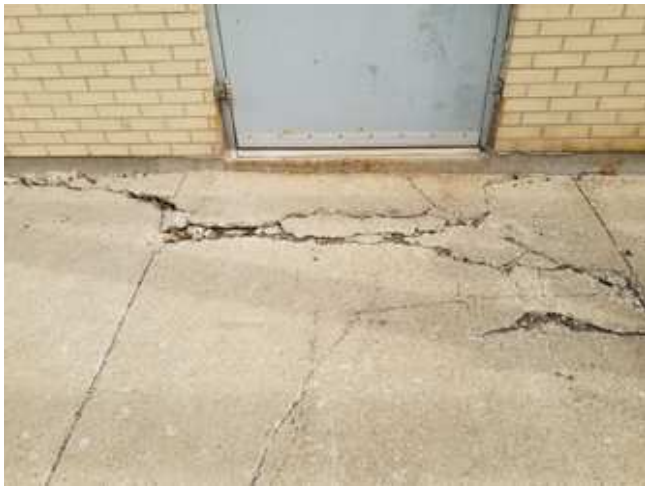
Category:	Pump Stations	Item:	Safety Compliance
Observation ID:	2023-0105		
Description:	PS-CA: Crack in concrete near front door to station. Potential trip hazard		
Caption:	0105 - No User Rating (Site Visit) - PS-CA: Crack in concrete near front door to station. Potential trip hazard		
Lat/Long:	41.57073/-87.50785

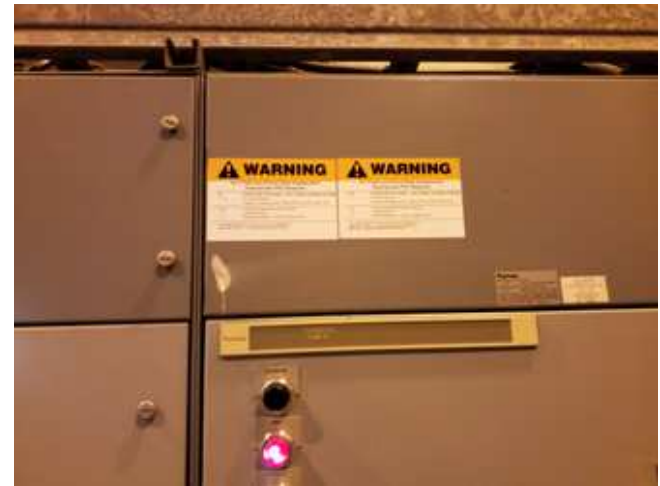
Category:	Pump Stations	Item:	Safety Compliance
Observation ID:	2023-0121		
Description:	PS-OA: Outdated arc flash labels		
Caption:	0121 - No User Rating (Site Visit) - PS-OA: Outdated arc flash labels		
Lat/Long:	41.57190/-87.51812

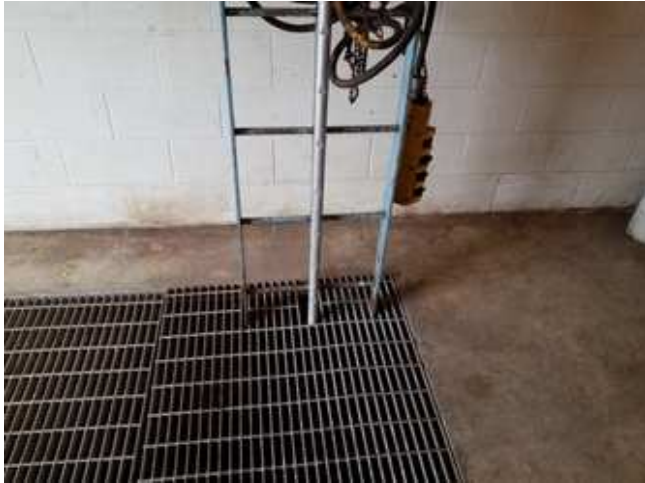
Category:	Pump Stations	Item:	Safety Compliance
Observation ID:	2023-0125		
Description:	PS-OA: Confined space labels missing throughout interior pump station. Typical shown		
Caption:	0125 - No User Rating (Site Visit) - PS-OA: Confined space labels missing throughout interior pump station. Typical shown		
Lat/Long:	41.57191/-87.51812

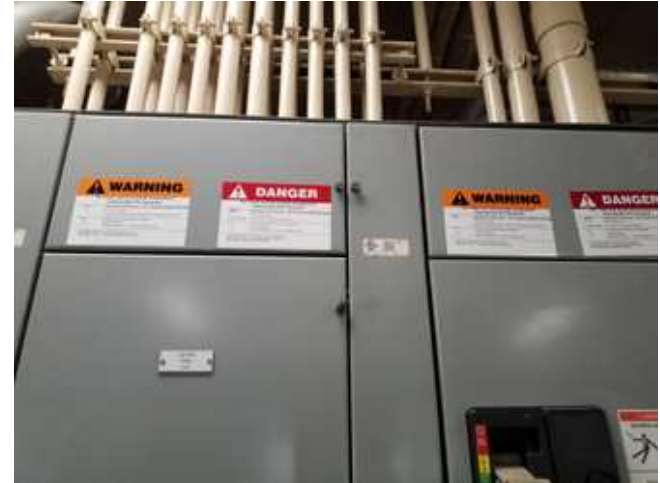
Category:	Pump Stations	Item:	Safety Compliance
Observation ID:	2023-0177		
Description:	PS-HM: Arc flash labels are outdated		
Caption:	0177 - No User Rating (Site Visit) - PS-HM: Arc flash labels are outdated		
Lat/Long:	41.57711/-87.52184

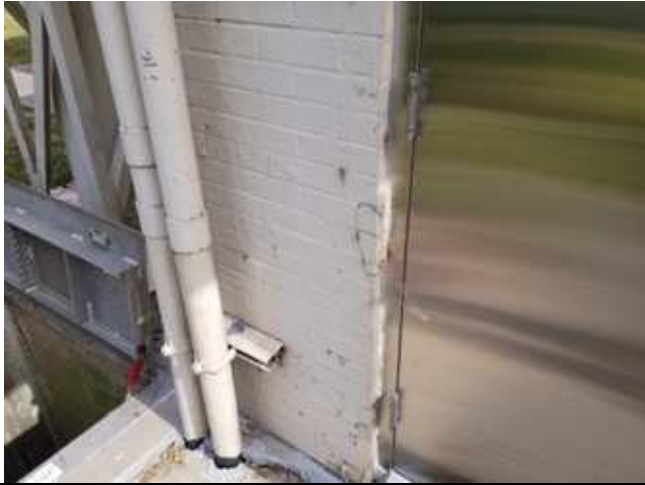
Category:	Pump Stations	Item:	Plant Building
Observation ID:	2023-0025		
Description:	PS-BA: Crack in building exterior wall		
Caption:	0025 - No User Rating (Site Visit) - PS-BA: Crack in building exterior wall		
Lat/Long:	41.56632/-87.48512

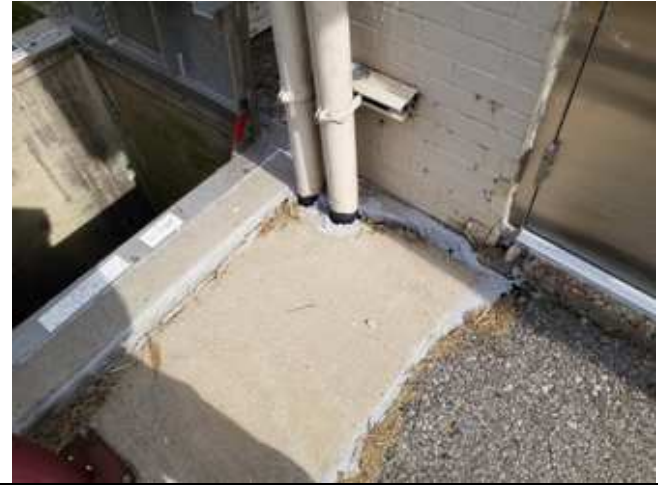
Category:	Pump Stations	Item:	Plant Building
Observation ID:	2023-0029		
Description:	PS-BA: Exterior wall cracks/spalling		
Caption:	0029 - No User Rating (Site Visit) - PS-BA: Exterior wall cracks/spalling		
Lat/Long:	41.56633/-87.48514

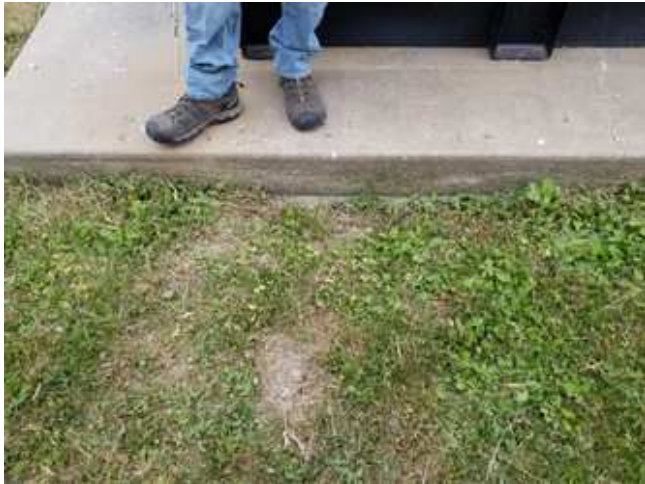
Category:	Pump Stations	Item:	Plant Building
Observation ID:	2023-0033		
Description:	PS-BA: Erosion around generator concrete pad		
Caption:	0033 - No User Rating (Site Visit) - PS-BA: Erosion around generator concrete pad		
Lat/Long:	41.56642/-87.48512

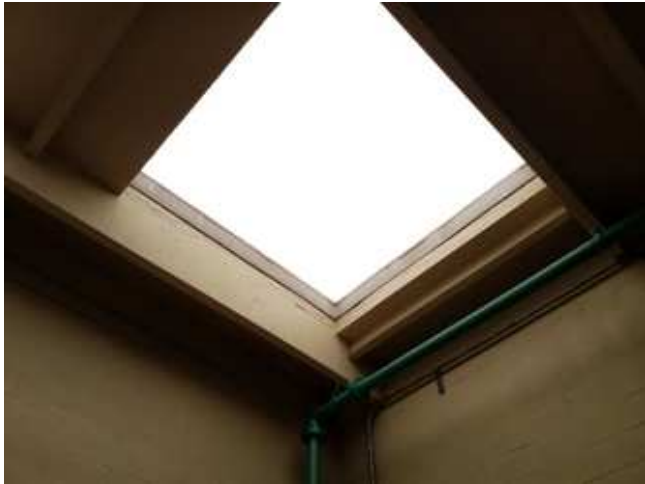
Category:	Pump Stations	Item:	Plant Building
Observation ID:	2023-0049		
Description:	PS-CA: Crack in skylight		
Caption:	0049 - No User Rating (Site Visit) - PS-CA: Crack in skylight		
Lat/Long:	41.57084/-87.50796

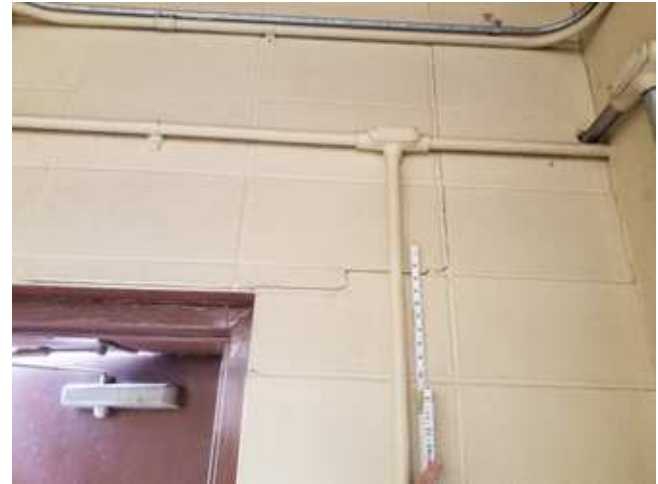
Category:	Pump Stations	Item:	Plant Building
Observation ID:	2023-0053		
Description:	PS-CA: Crack located next to back door. Typical of cracks found on masonry inside station		
Caption:	0053 - No User Rating (Site Visit) - PS-CA: Crack located next to back door. Typical of cracks found on masonry inside station		
Lat/Long:	41.57084/-87.50796

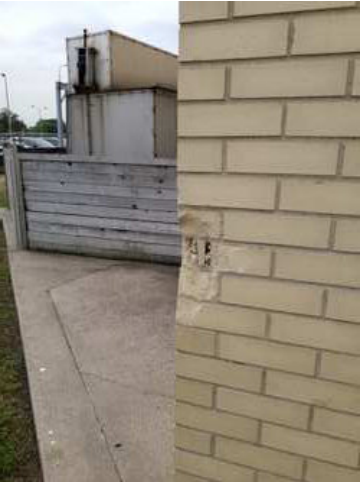
Category:	Pump Stations	Item:	Plant Building
Observation ID:	2023-0073		
Description:	PS-CA: Spalling on building exterior wall		
Caption:	0073 - No User Rating (Site Visit) - PS-CA: Spalling on building exterior wall		
Lat/Long:	41.57090/-87.50773

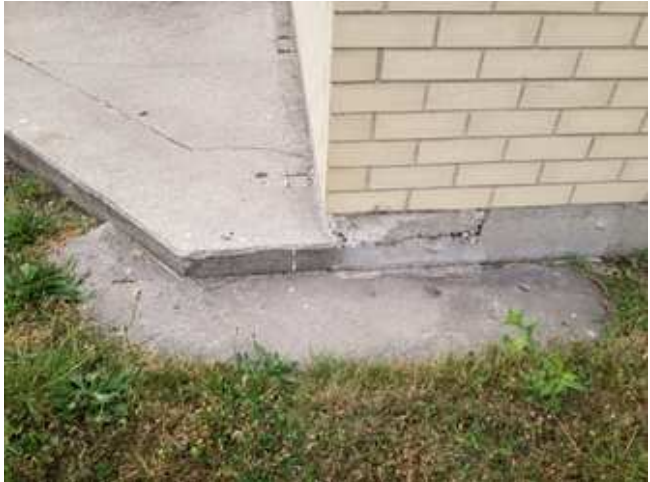
Category:	Pump Stations	Item:	Plant Building
Observation ID:	2023-0077		
Description:	PS-CA: Crack on foundation of building exterior		
Caption:	0077 - No User Rating (Site Visit) - PS-CA: Crack on foundation of building exterior		
Lat/Long:	41.57090/-87.50776

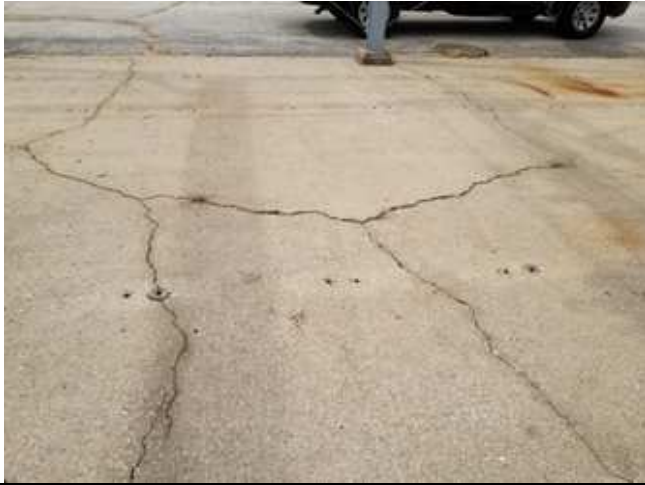
Category:	Pump Stations	Item:	Plant Building
Observation ID:	2023-0089		
Description:	PS-CA: Exterior concrete surface is cracked		
Caption:	0089 - No User Rating (Site Visit) - PS-CA: Exterior concrete surface is cracked		
Lat/Long:	41.57074/-87.50772

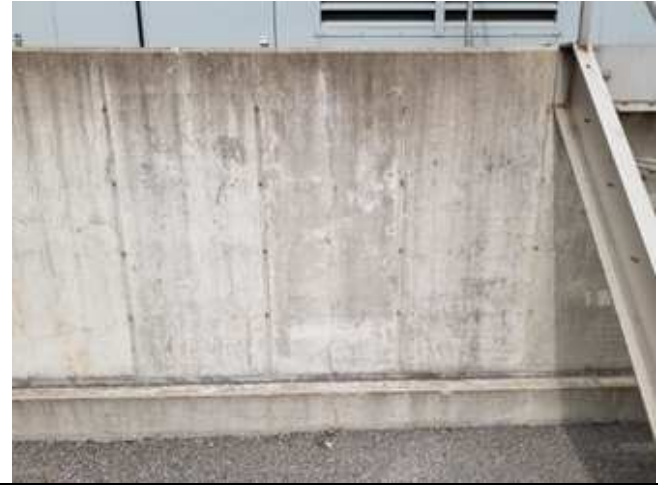
Category:	Pump Stations	Item:	Plant Building
Observation ID:	2023-0097		
Description:	PS-CA: Vertical crack on generator concrete pad		
Caption:	0097 - No User Rating (Site Visit) - PS-CA: Vertical crack on generator concrete pad		
Lat/Long:	41.57061/-87.50798

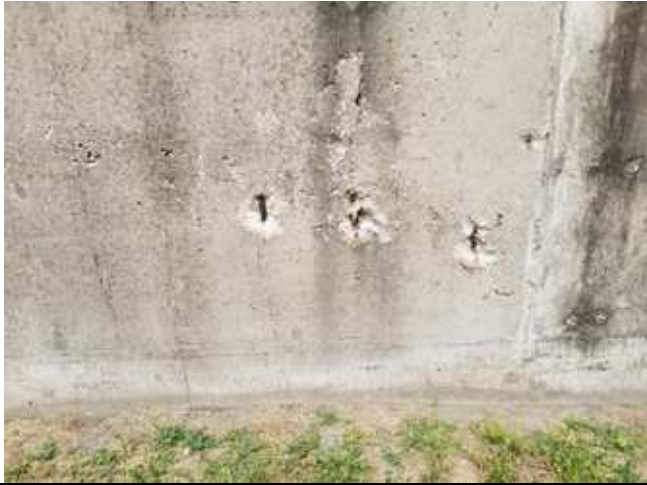
Category:	Pump Stations	Item:	Plant Building
Observation ID:	2023-0101		
Description:	PS-CA: Exposed rebar on exterior wall		
Caption:	0101 - No User Rating (Site Visit) - PS-CA: Exposed rebar on exterior wall		
Lat/Long:	41.57076/-87.50801

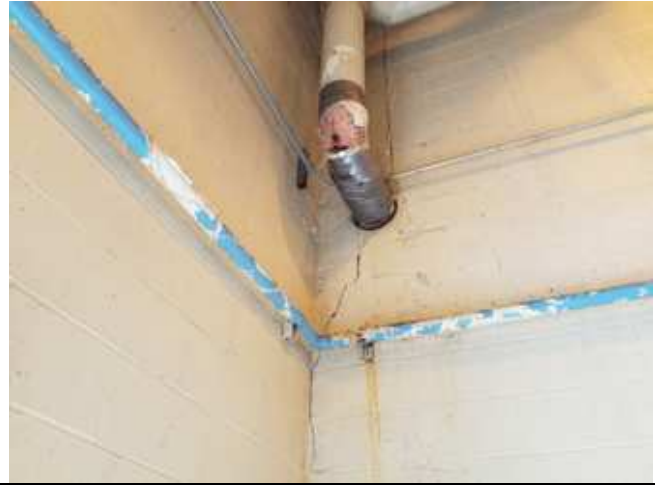
Category:	Pump Stations	Item:	Plant Building
Observation ID:	2023-0129		
Description:	PS-OA: Crack along interior building corner		
Caption:	0129 - No User Rating (Site Visit) - PS-OA: Crack along interior building corner		
Lat/Long:	41.57189/-87.51817

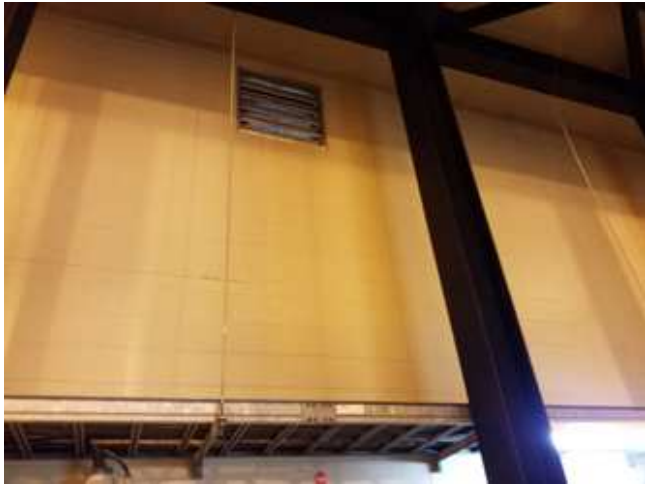
Category:	Pump Stations	Item:	Plant Building
Observation ID:	2023-0137		
Description:	PS-OA: Typical interior vertical cracks inside building. Some recently sealed		
Caption:	0137 - No User Rating (Site Visit) - PS-OA: Typical interior vertical cracks inside building. Some recently sealed		
Lat/Long:	41.57189/-87.51816

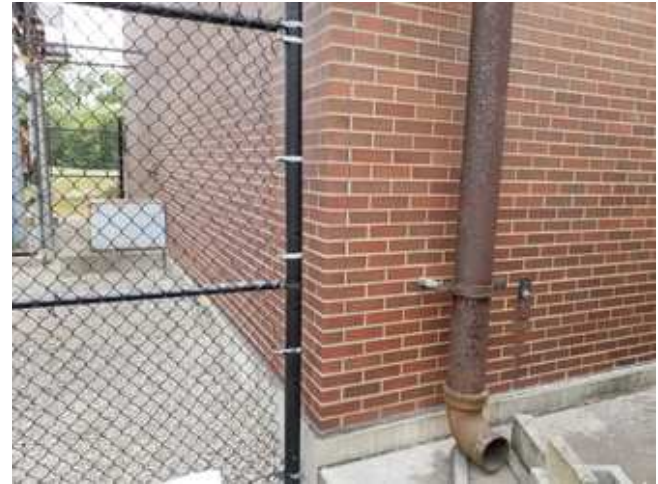
Category:	Pump Stations	Item:	Plant Building
Observation ID:	2023-0141		
Description:	PS-OA: Exterior masonry crack along length of building		
Caption:	0141 - No User Rating (Site Visit) - PS-OA: Exterior masonry crack along length of building		
Lat/Long:	41.57193/-87.51830

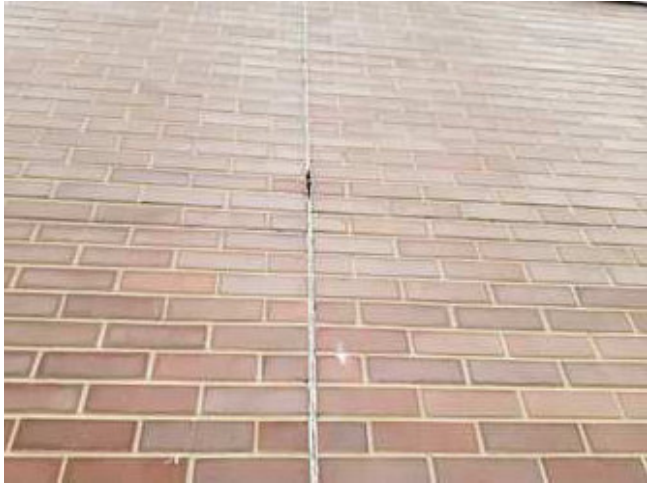
Category:	Pump Stations	Item:	Plant Building
Observation ID:	2023-0145		
Description:	PS-OA: Deteriorating joint sealant on exterior masonry		
Caption:	0145 - No User Rating (Site Visit) - PS-OA: Deteriorating joint sealant on exterior masonry		
Lat/Long:	41.57189/-87.51826

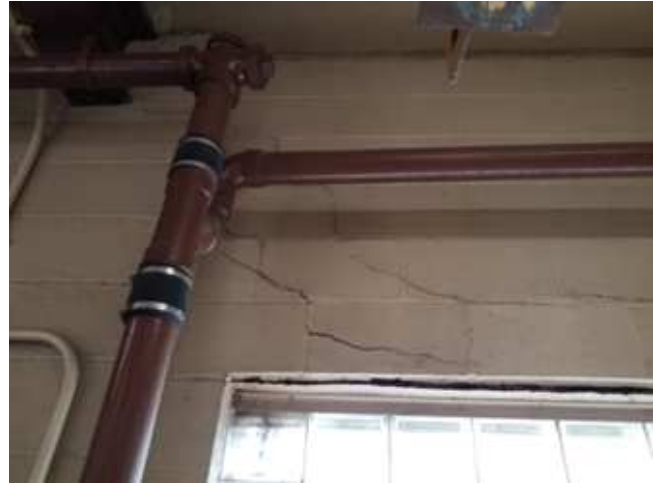
Category:	Pump Stations	Item:	Plant Building
Observation ID:	2023-0161		
Description:	PS-HM: Cracks in masonry above window		
Caption:	0161 - No User Rating (Site Visit) - PS-HM: Cracks in masonry above window		
Lat/Long:	41.57709/-87.52173

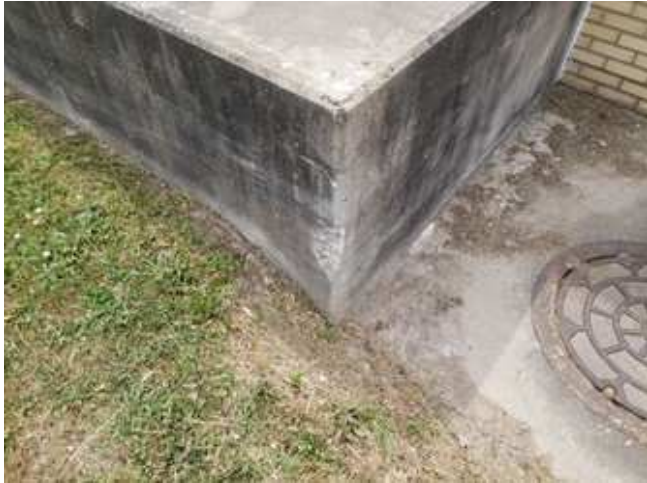
Category:	Pump Stations	Item:	Plant Building
Observation ID:	2023-0165		
Description:	PS-HM: Minor spalling on concrete corner on exterior of building		
Caption:	0165 - No User Rating (Site Visit) - PS-HM: Minor spalling on concrete corner on exterior of building		
Lat/Long:	41.57718/-87.52179

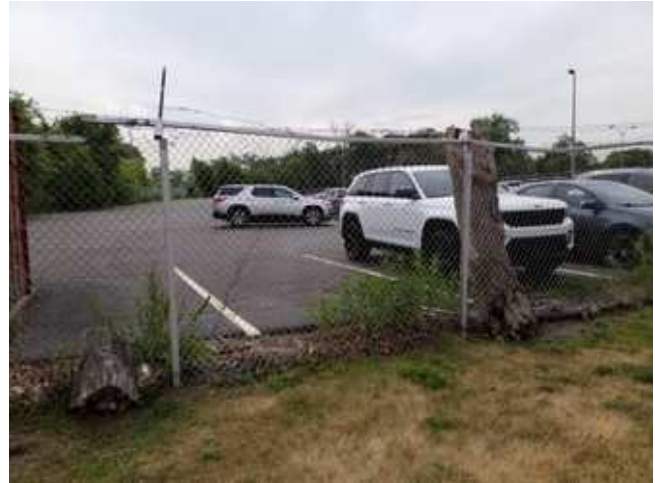
Category:	Pump Stations	Item:	Fencing and Gates
Observation ID:	2023-0085		
Description:	PS-CA: Damaged fence		
Caption:	0085 - No User Rating (Site Visit) - PS-CA: Damaged fence		
Lat/Long:	41.57077/-87.50769

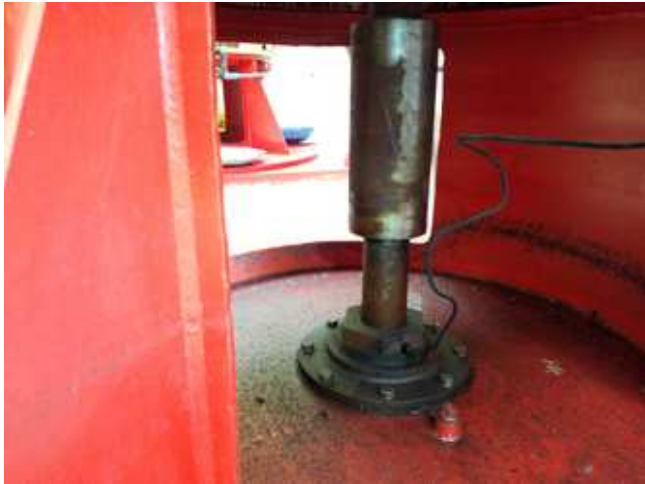
Category:	Pump Stations	Item:	Pumps
Observation ID:	2023-0045		
Description:	PS-CA: Exposed pump shaft on pump 2 looks to be more corroded than the other pumps		
Caption:	0045 - No User Rating (Site Visit) - PS-CA: Exposed pump shaft on pump 2 looks to be more corroded than the other pumps		
Lat/Long:	41.57084/-87.50796

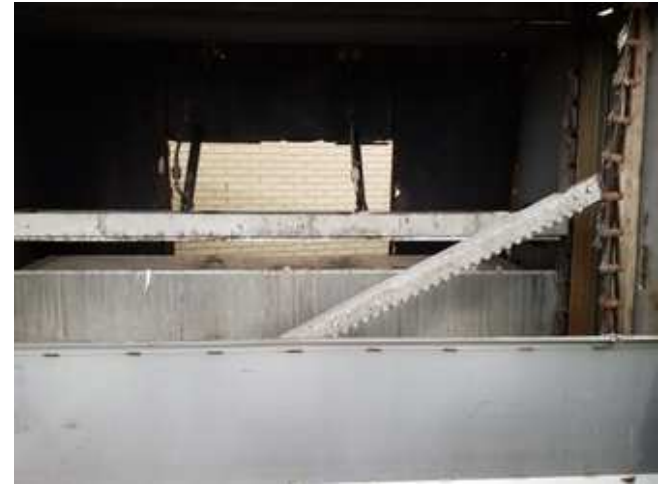
Category:	Pump Stations	Item:	Mechanical Operating
Observation ID:	2023-0041		
Description:	PS-CA: North mechanical trash rake out of service - parts ordered to repair		
Caption:	0041 - No User Rating (Site Visit) - PS-CA: North mechanical trash rake out of service - parts ordered to repair		
Lat/Long:	41.57080/-87.50768

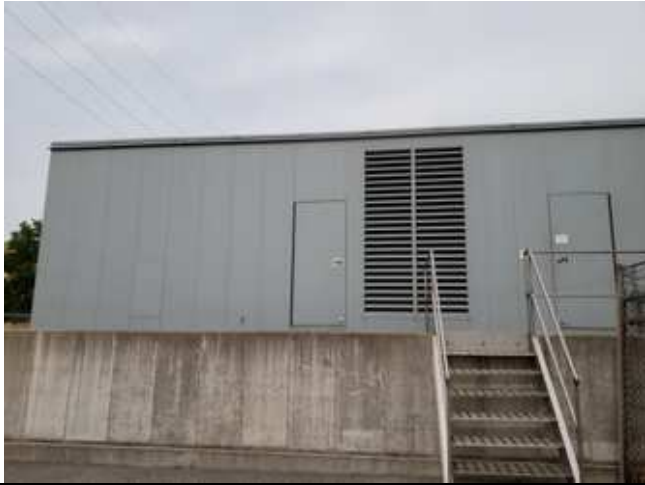
Category:	Pump Stations	Item:	Power Source
Observation ID:	2023-0093		
Description:	PS-CA: Generator in good condition. Has 398 runtime hours		
Caption:	0093 - No User Rating (Site Visit) - PS-CA: Generator in good condition. Has 398 runtime hours		
Lat/Long:	41.57067/-87.50797

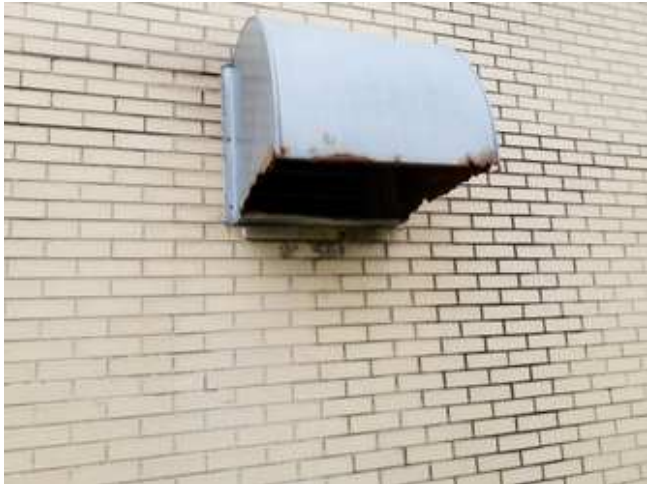
Category:	Pump Stations	Item:	Enclosures, Panels,
Observation ID:	2023-0081		
Description:	PS-CA: Corroded duct louver screen		
Caption:	0081 - No User Rating (Site Visit) - PS-CA: Corroded duct louver screen		
Lat/Long:	41.57091/-87.50788

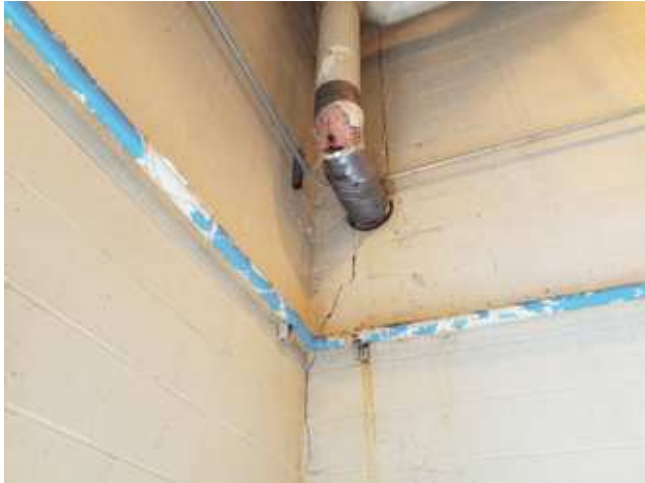
Category:	Pump Stations	Item:	Enclosures, Panels,
Observation ID:	2023-0133		
Description:	PS-OA: Corroded ceiling drainage pipe		
Caption:	0133 - No User Rating (Site Visit) - PS-OA: Corroded ceiling drainage pipe		
Lat/Long:	41.57189/-87.51816

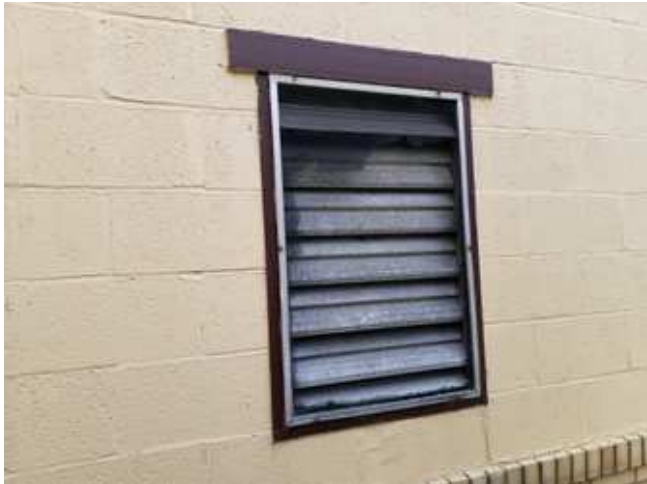
Category:	Pump Stations	Item:	Enclosures, Panels,
Observation ID:	2023-0169		
Description:	PS-HM: Broken louver screen		
Caption:	0169 - No User Rating (Site Visit) - PS-HM: Broken louver screen		
Lat/Long:	41.57703/-87.52171
