**US Army Corps  
of Engineers ®**

## Site Visit Summary

Name of System: Munster

Date of Site Visit: 06/05/2023 - 06/05/2023

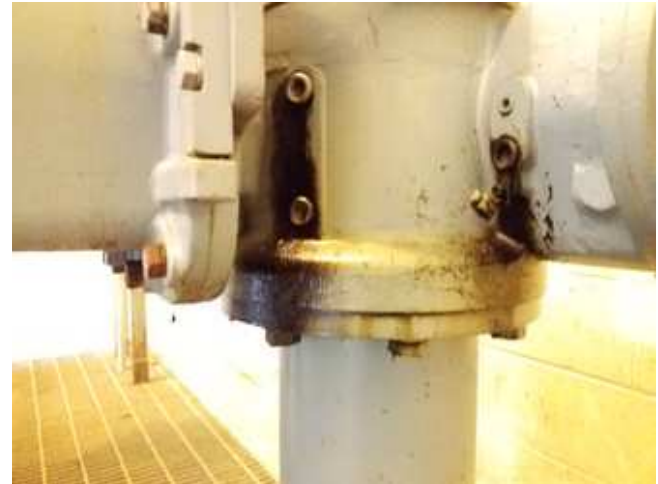
Category:	Pump Stations	Item:	Sluice/ Slide Gates
Observation ID:	2023-0113		
Description:	PS-OA: Sluice gate gear housing leaking		
Caption:	0113 - No User Rating (Site Visit) - PS-OA: Sluice gate gear housing leaking		
Lat/Long:	41.57197/-87.51816
