Site Visit Summary

Name of System: Burr Street

Name of Segment: Gary Burr St

Date of Site Visit: 04/10/2023 - 04/10/2023

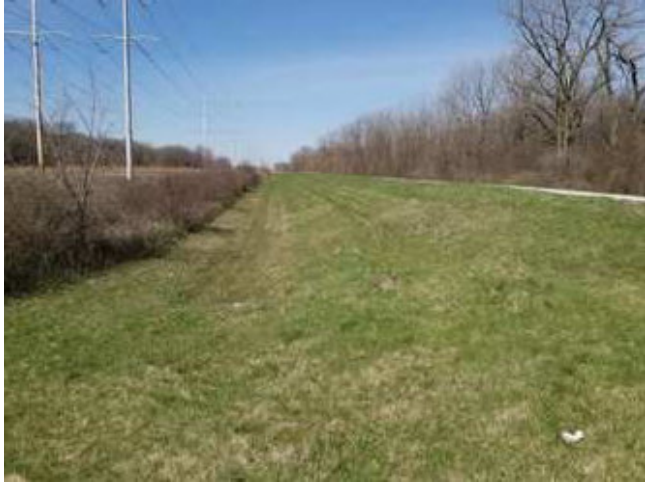
Category:	Levee Embankments	Item:	Unwanted Vegetation
Observation ID:	2023-0022		
Description:	Typical condition of landside slope facing west. Slopes adequately mowed prior to inspection		
Caption:	0022 - No User Rating (Site Visit) - Typical condition of landside slope facing west. Slopes adequately mowed prior to inspection		
Lat/Long:	41.55968/-87.40837

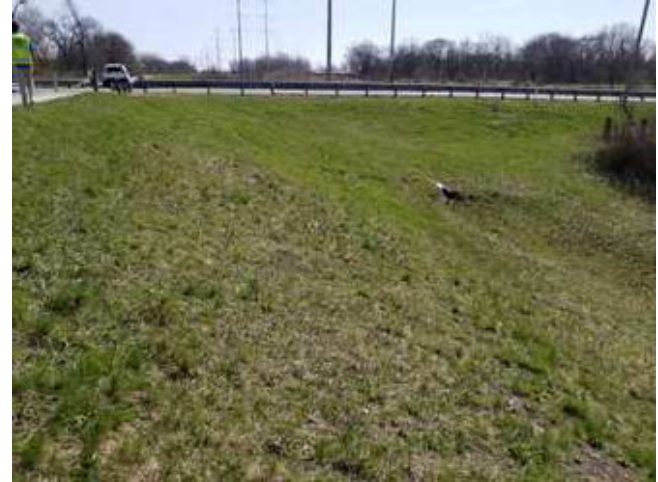
Category:	Levee Embankments	Item:	Sod Cover
Observation ID:	2023-0019		
Description:	Poor sod cover on landside slope		
Caption:	0019 - No User Rating (Site Visit) - Poor sod cover on landside slope		
Lat/Long:	41.55972/-87.40871

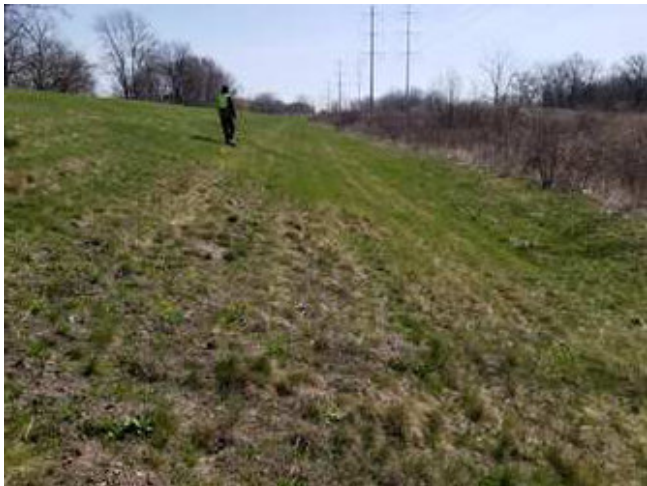
Category:	Levee Embankments	Item:	Sod Cover
Observation ID:	2023-0028		
Description:	Poor sod cover on landside slope		
Caption:	0028 - No User Rating (Site Visit) - Poor sod cover on landside slope		
Lat/Long:	41.55965/-87.40758

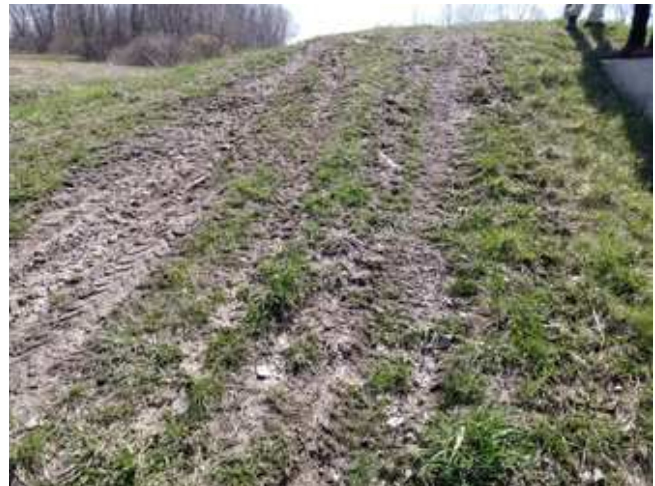
Category:	Levee Embankments	Item:	Sod Cover
Observation ID:	2023-0076		
Description:	Poor sod cover on riverside slope		
Caption:	0076 - No User Rating (Site Visit) - Poor sod cover on riverside slope		
Lat/Long:	41.55903/-87.40154

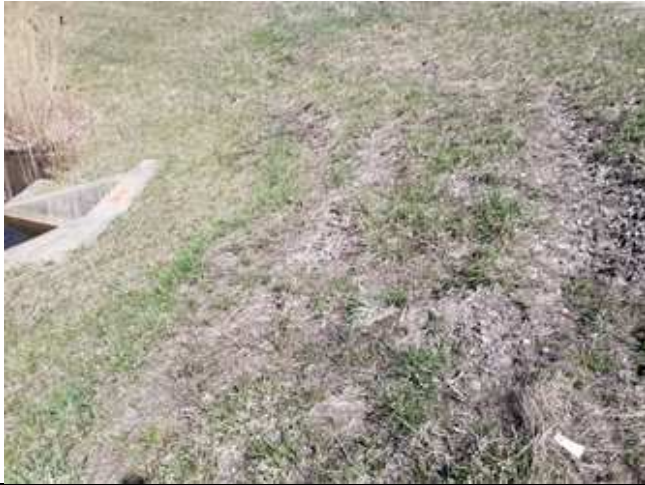
Category:	Levee Embankments	Item:	Sod Cover
Observation ID:	2023-0115		
Description:	Rutting and poor sod coverage at gate inlet GB-04		
Caption:	0115 - No User Rating (Site Visit) - Rutting and poor sod coverage at gate inlet GB-04		
Lat/Long:	41.55720/-87.39804

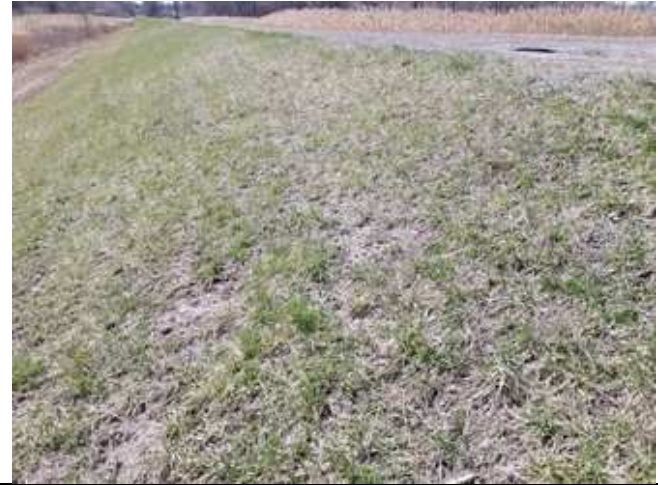
Category:	Levee Embankments	Item:	Sod Cover
Observation ID:	2023-0130		
Description:	Poor sod cover on riverside slope		
Caption:	0130 - No User Rating (Site Visit) - Poor sod cover on riverside slope		
Lat/Long:	41.55662/-87.39793

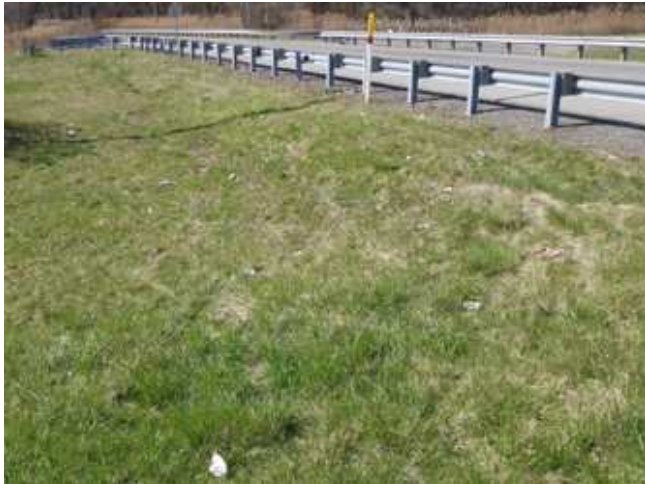
Category:	Levee Embankments	Item:	Encroachments
Observation ID:	2023-0001		
Description:	Trash/debris in the landside slope at Colfax Street crossing		
Caption:	0001 - No User Rating (Site Visit) - Trash/debris in the landside slope at Colfax Street crossing		
Lat/Long:	41.55971/-87.41290

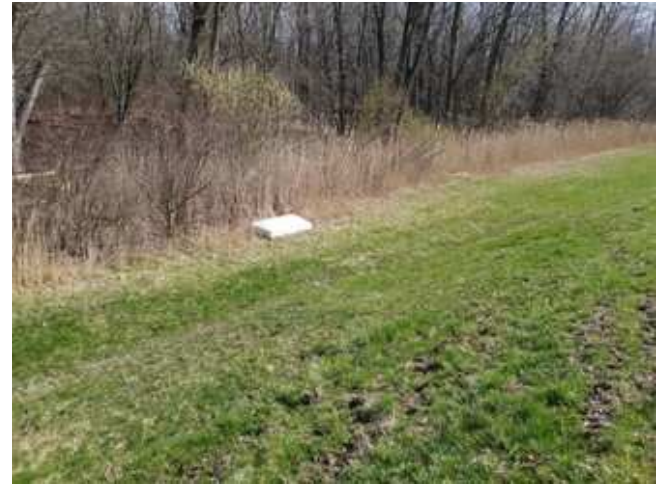
Category:	Levee Embankments	Item:	Encroachments
Observation ID:	2023-0007		
Description:	Debris at riverside toe near Colfax Avenue		
Caption:	0007 - No User Rating (Site Visit) - Debris at riverside toe near Colfax Avenue		
Lat/Long:	41.55975/-87.41231

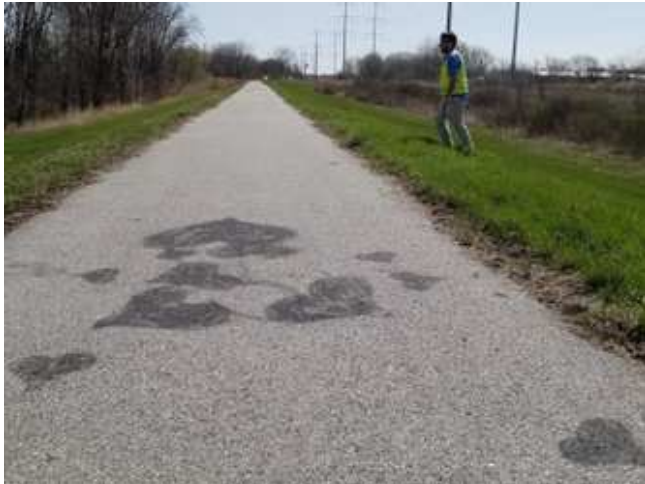
Category:	Levee Embankments	Item:	Encroachments
Observation ID:	2023-0034		
Description:	Graffiti at crest pathway		
Caption:	0034 - No User Rating (Site Visit) - Graffiti at crest pathway		
Lat/Long:	41.55976/-87.40647

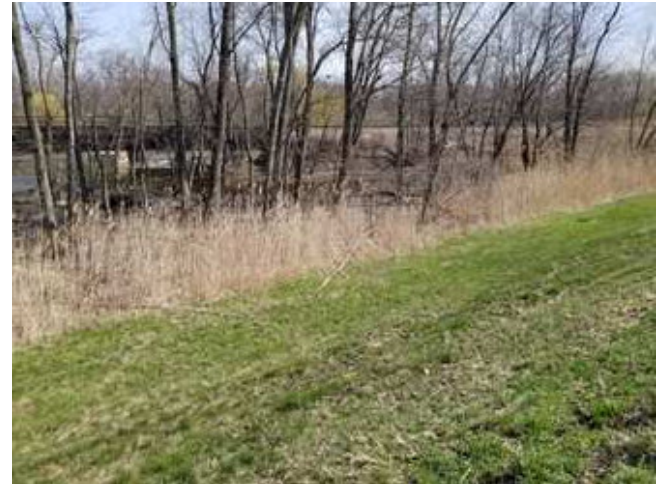
Category:	Levee Embankments	Item:	Encroachments
Observation ID:	2023-0040		
Description:	Wooden debris and logs encroaching on riverside toe		
Caption:	0040 - No User Rating (Site Visit) - Wooden debris and logs encroaching on riverside toe		
Lat/Long:	41.55982/-87.40499

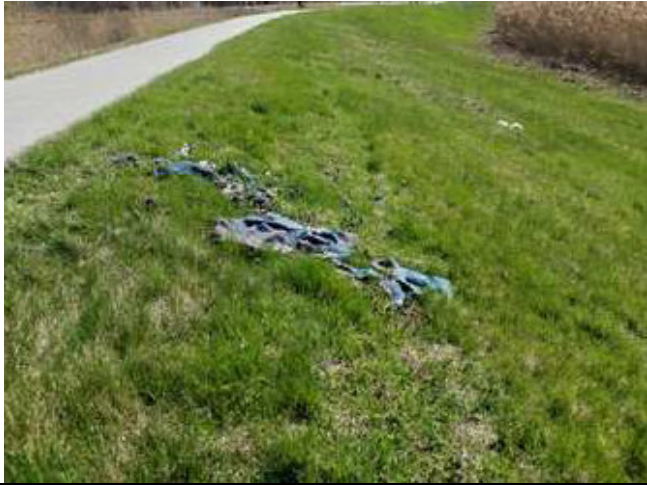
Category:	Levee Embankments	Item:	Encroachments
Observation ID:	2023-0043		
Description:	Debris on the riverside slope near railroad and Burr Street		
Caption:	0043 - No User Rating (Site Visit) - Debris on the riverside slope near railroad and Burr Street		
Lat/Long:	41.55977/-87.40473

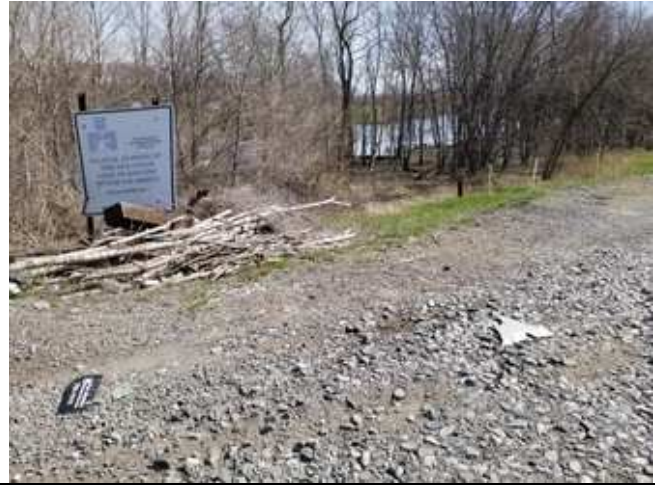
Category:	Levee Embankments	Item:	Encroachments
Observation ID:	2023-0052		
Description:	Debris on riverside crest		
Caption:	0052 - No User Rating (Site Visit) - Debris on riverside crest		
Lat/Long:	41.55989/-87.40335

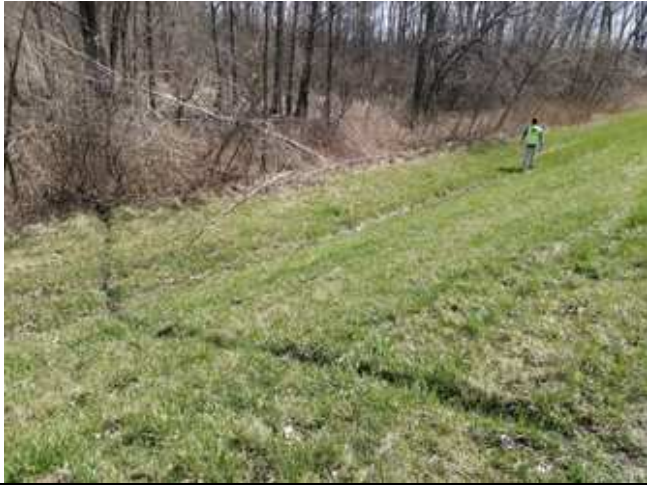
Category:	Levee Embankments	Item:	Encroachments
Observation ID:	2023-0094		
Description:	Downed tree on riverside toe		
Caption:	0094 - No User Rating (Site Visit) - Downed tree on riverside toe		
Lat/Long:	41.55820/-87.39959

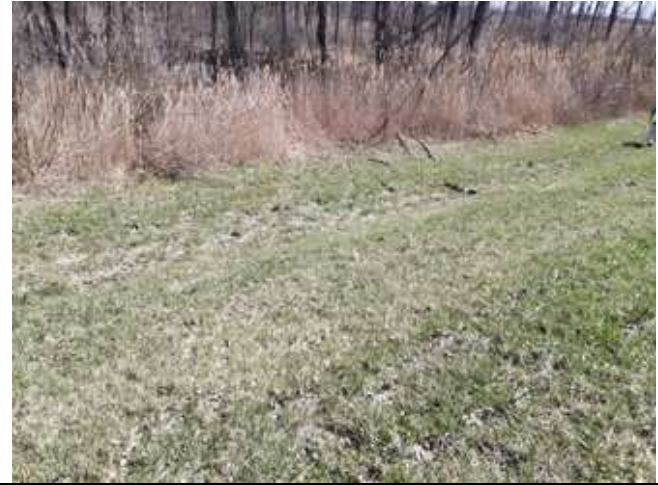
Category:	Levee Embankments	Item:	Encroachments
Observation ID:	2023-0100		
Description:	Wood debris encroaching on riverside toe		
Caption:	0100 - No User Rating (Site Visit) - Wood debris encroaching on riverside toe		
Lat/Long:	41.55786/-87.39894

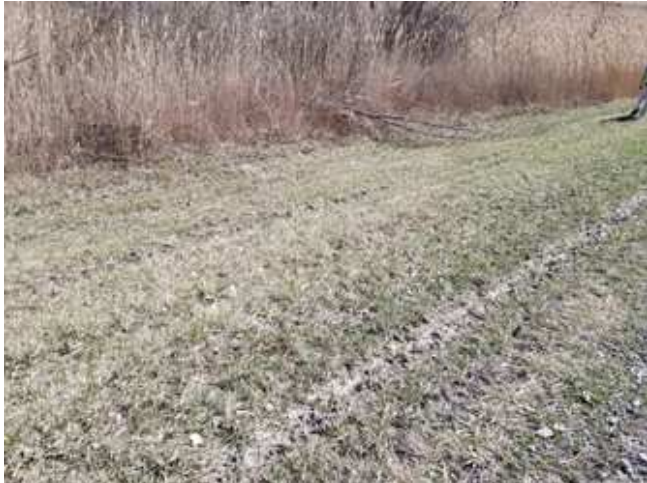
Category:	Levee Embankments	Item:	Encroachments
Observation ID:	2023-0103		
Description:	Downed tree encroaching on riverside toe		
Caption:	0103 - No User Rating (Site Visit) - Downed tree encroaching on riverside toe		
Lat/Long:	41.55765/-87.39852

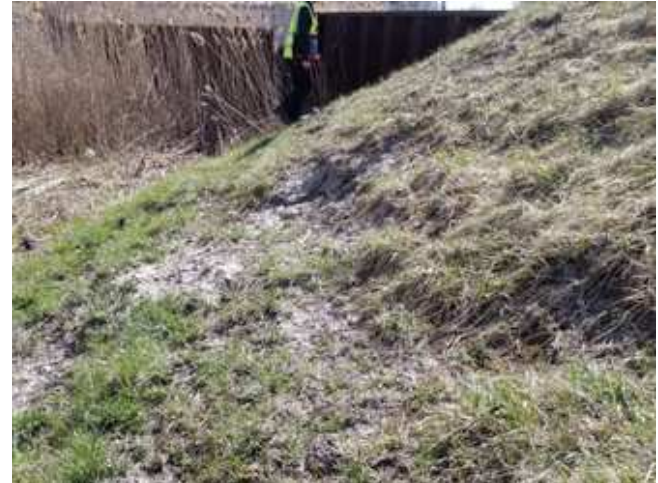
Category:	Levee Embankments	Item:	Erosion/ Bank Caving
Observation ID:	2023-0046		
Description:	Minor bank caving/erosion at riverside slope near railroad and Burr Street		
Caption:	0046 - No User Rating (Site Visit) - Minor bank caving/erosion at riverside slope near railroad and Burr Street		
Lat/Long:	41.55979/-87.40398

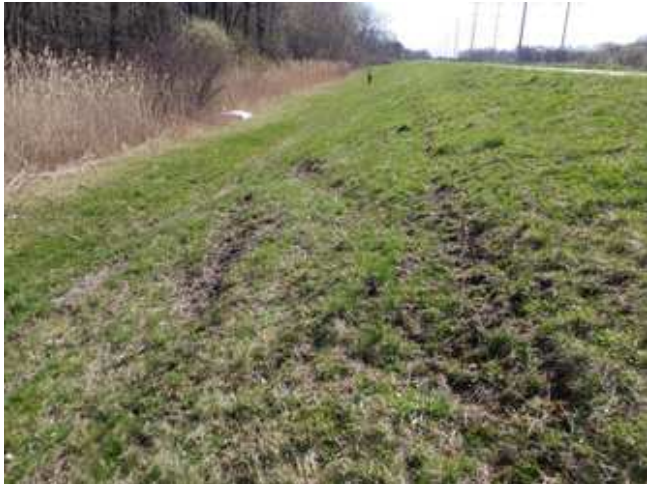
Category:	Levee Embankments	Item:	Depressions/ Rutting
Observation ID:	2023-0004		
Description:	Fresh rutting along riverside slope		
Caption:	0004 - No User Rating (Site Visit) - Fresh rutting along riverside slope.		
Lat/Long:	41.55976/-87.41255

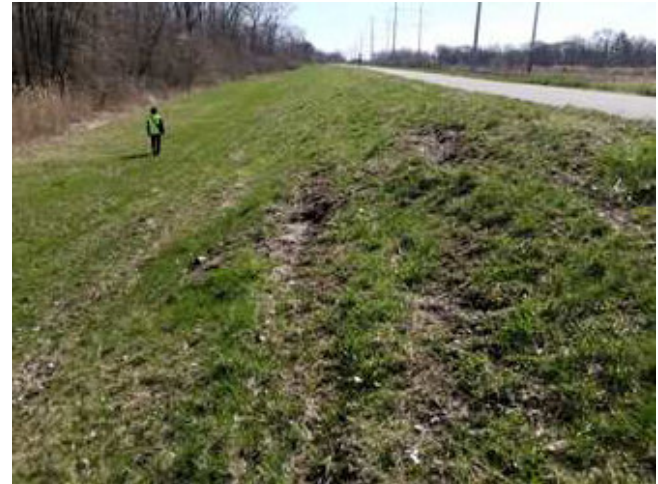
Category:	Levee Embankments	Item:	Depressions/ Rutting
Observation ID:	2023-0013		
Description:	Rutting or depression along riverside slope - 3 to 4-in deep		
Caption:	0013 - No User Rating (Site Visit) - Rutting or depression along riverside slope - 3 to 4-in deep		
Lat/Long:	41.55974/-87.41154

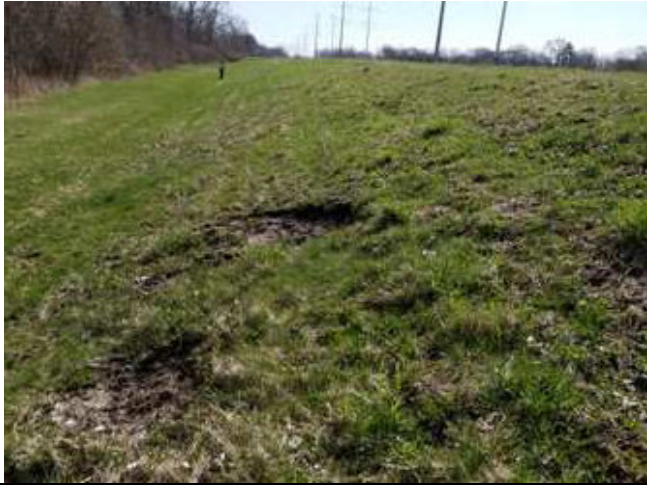
Category:	Levee Embankments	Item:	Depressions/ Rutting
Observation ID:	2023-0016		
Description:	Rutting along riverside slope - 3-in deep		
Caption:	0016 - No User Rating (Site Visit) - Rutting along the riverside slope - 3-in deep		
Lat/Long:	41.55978/-87.41133

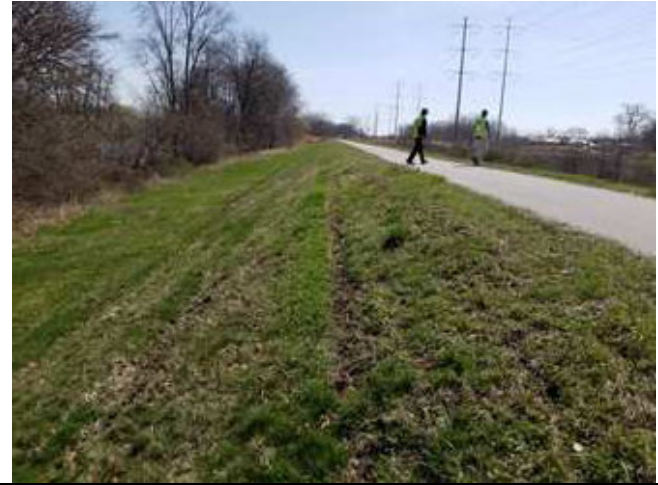
Category:	Levee Embankments	Item:	Depressions/ Rutting
Observation ID:	2023-0031		
Description:	Rutting on riverside slope - about 16-in deep max		
Caption:	0031 - No User Rating (Site Visit) - Rutting on riverside slope - about 16-in deep max		
Lat/Long:	41.55982/-87.40708

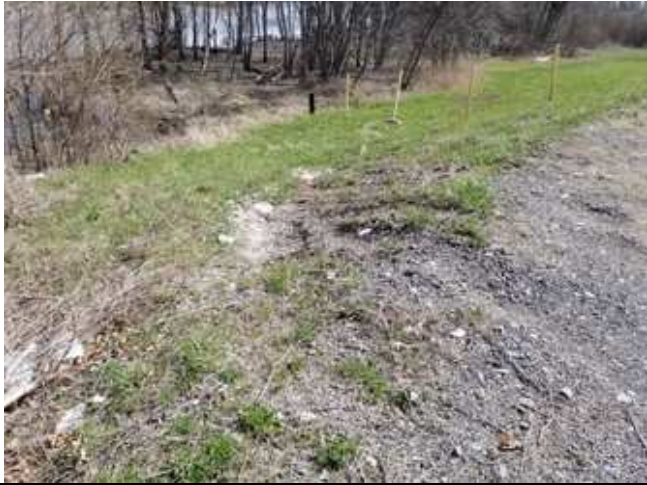
Category:	Levee Embankments	Item:	Depressions/ Rutting
Observation ID:	2023-0055		
Description:	Old rut on riverside slope near Burr Street crossing		
Caption:	0055 - No User Rating (Site Visit) - Old rut on riverside slope near Burr Street crossing		
Lat/Long:	41.55991/-87.40332

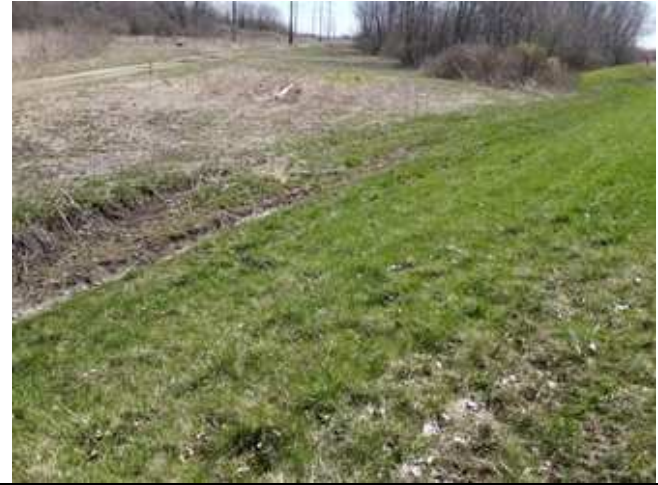
Category:	Levee Embankments	Item:	Depressions/ Rutting
Observation ID:	2023-0079		
Description:	Deep ruts on riverside toe		
Caption:	0079 - No User Rating (Site Visit) - Deep ruts on riverside toe		
Lat/Long:	41.55906/-87.40143

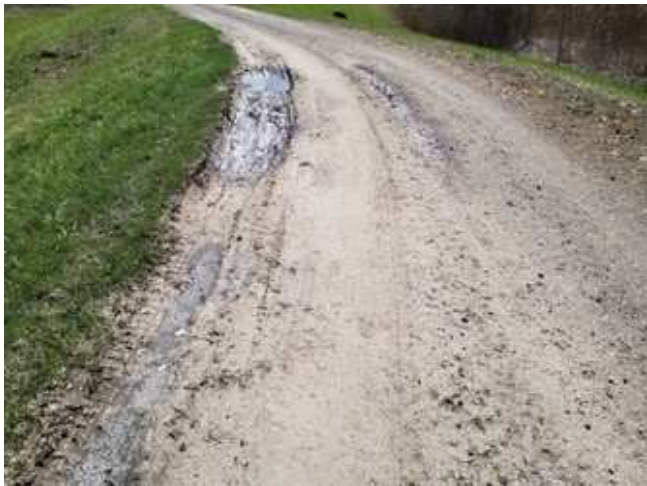
Category:	Levee Embankments	Item:	Depressions/ Rutting
Observation ID:	2023-0085		
Description:	Deep ruts on crest. Sponsor is repairing.		
Caption:	0085 - No User Rating (Site Visit) - Deep ruts on crest. Sponsor is repairing.		
Lat/Long:	41.55875/-87.40103

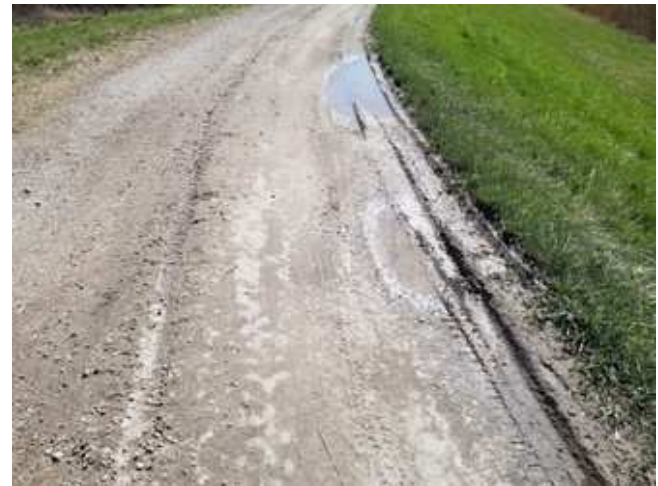
Category:	Levee Embankments	Item:	Depressions/ Rutting
Observation ID:	2023-0088		
Description:	Deep ruts on crest. Sponsor is repairing.		
Caption:	0088 - No User Rating (Site Visit) - Deep ruts on crest. Sponsor is repairing.		
Lat/Long:	41.55870/-87.40066

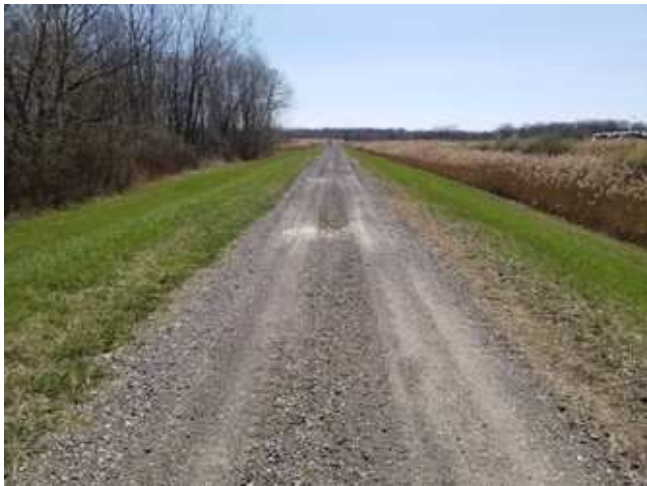
Category:	Levee Embankments	Item:	Depressions/ Rutting
Observation ID:	2023-0091		
Description:	Some small depressions on crest		
Caption:	0091 - No User Rating (Site Visit) - Some small depressions on crest		
Lat/Long:	41.55846/-87.40030

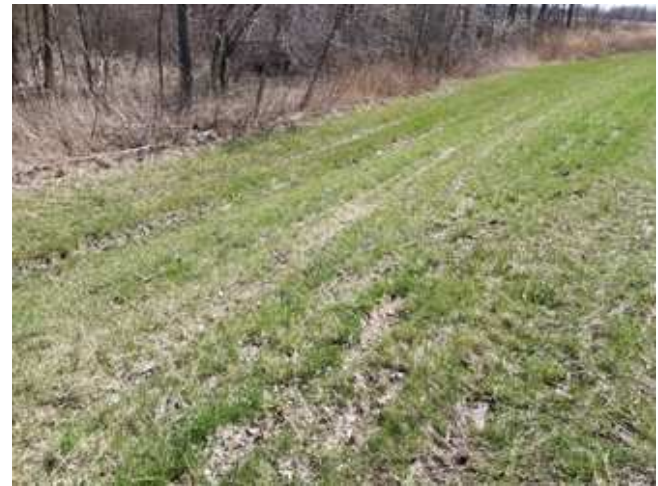
Category:	Levee Embankments	Item:	Depressions/ Rutting
Observation ID:	2023-0097		
Description:	Deep ruts on riverside toe		
Caption:	0097 - No User Rating (Site Visit) - Deep ruts on riverside toe		
Lat/Long:	41.55819/-87.39957

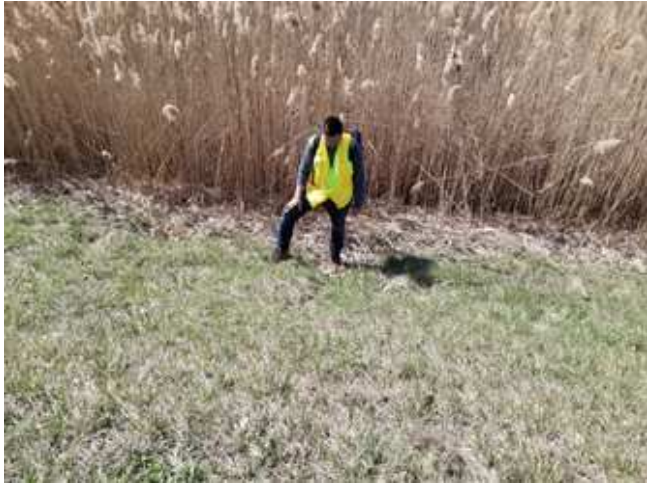
Category:	Levee Embankments	Item:	Depressions/ Rutting
Observation ID:	2023-0106		
Description:	Depression on landside toe		
Caption:	0106 - No User Rating (Site Visit) - Depression on landside toe		
Lat/Long:	41.55756/-87.39857

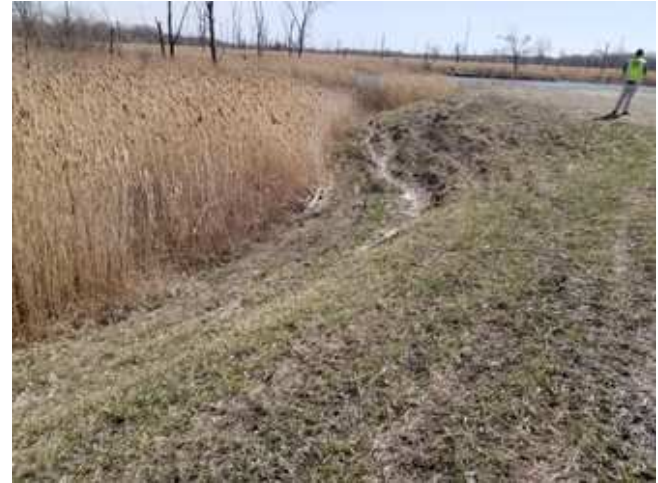
Category:	Levee Embankments	Item:	Depressions/ Rutting
Observation ID:	2023-0109		
Description:	Deep ruts on the riverside toe and slope		
Caption:	0109 - No User Rating (Site Visit) - Deep ruts on riverside toe and slope		
Lat/Long:	41.55746/-87.39815

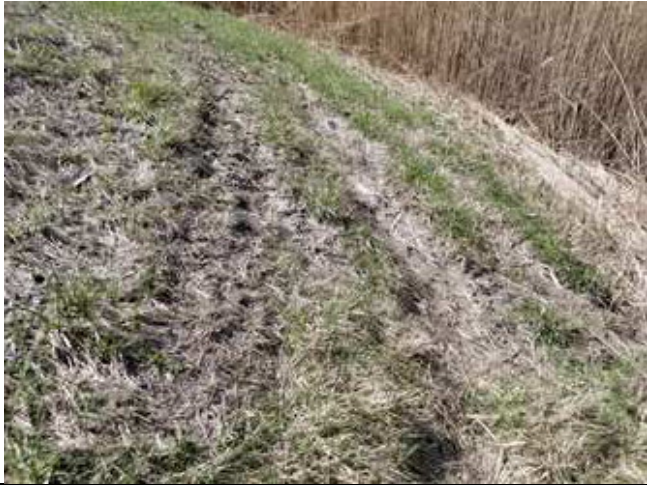
Category:	Levee Embankments	Item:	Depressions/ Rutting
Observation ID:	2023-0133		
Description:	Some rutting at the turnaround located about 1600 feet from Burr Street crossing		
Caption:	0133 - No User Rating (Site Visit) - Some rutting at the turnaround located about 1600 feet from Burr Street crossing		
Lat/Long:	41.55662/-87.39811

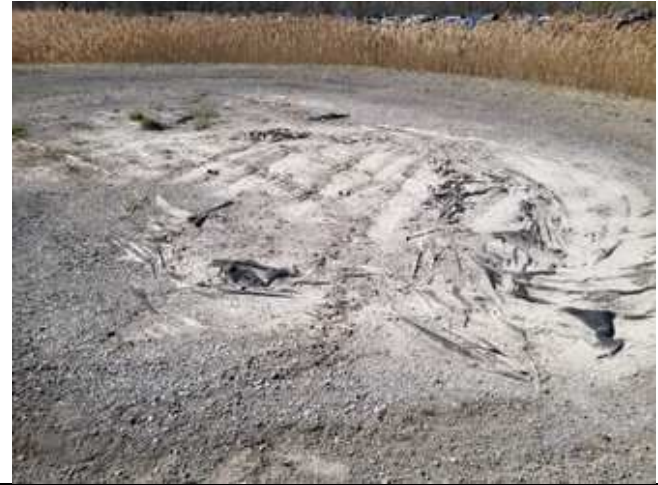
Category:	Levee Embankments	Item:	Depressions/ Rutting
Observation ID:	2023-0139		
Description:	Exposed geotextile at the turnaround located about 1600 feet SE from Burr Street.		
Caption:	0139 - No User Rating (Site Visit) - Exposed geotextile at the turnaround located about 1600 feet SE from Burr Street		
Lat/Long:	41.55496/-87.39794

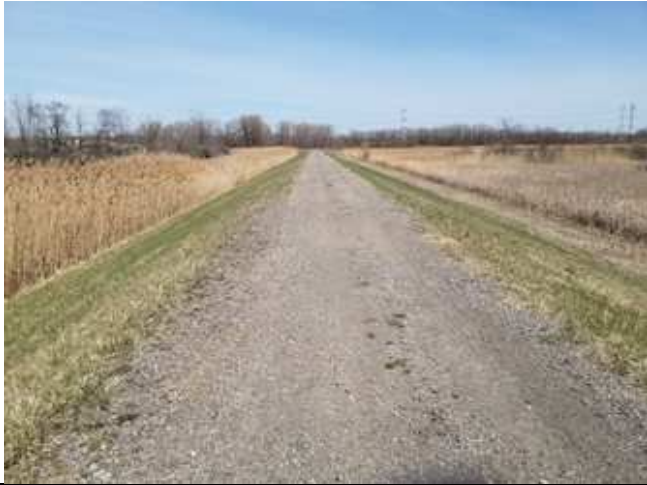
Category:	Levee Embankments	Item:	Depressions/ Rutting
Observation ID:	2023-0142		
Description:	Depressions along the entire crown starting at about 700 feet from Burr Street crossing to end of Gary Burr levee alignment		
Caption:	0142 - No User Rating (Site Visit) - Depressions along the entire crown starting at about 700 feet from Burr Street crossing to end of Gary Burr levee alignment		
Lat/Long:	41.55655/-87.39793

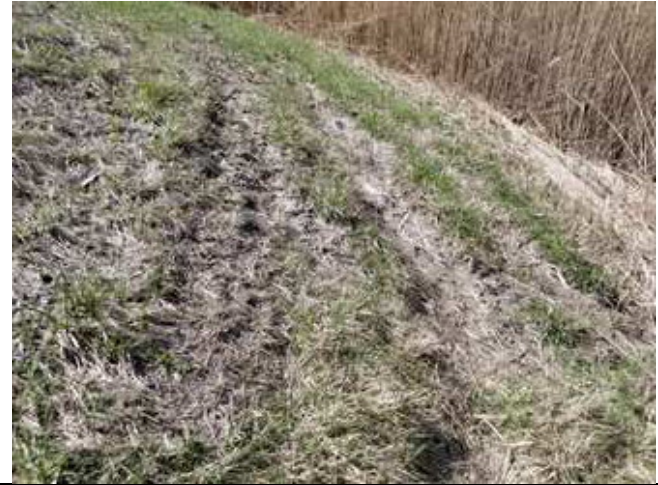
Category:	Levee Embankments	Item:	Depressions/ Rutting
Observation ID:	2023-0145		
Description:	Rutting along the landside slope starting at about 700 feet from Burr Street crossing to near end of Gary Burr levee alignment		
Caption:	0145 - No User Rating (Site Visit) - Rutting along the landside slope starting at about 700 feet from Burr Street crossing to near end of Gary Burr levee alignment		
Lat/Long:	41.55624/-87.39799

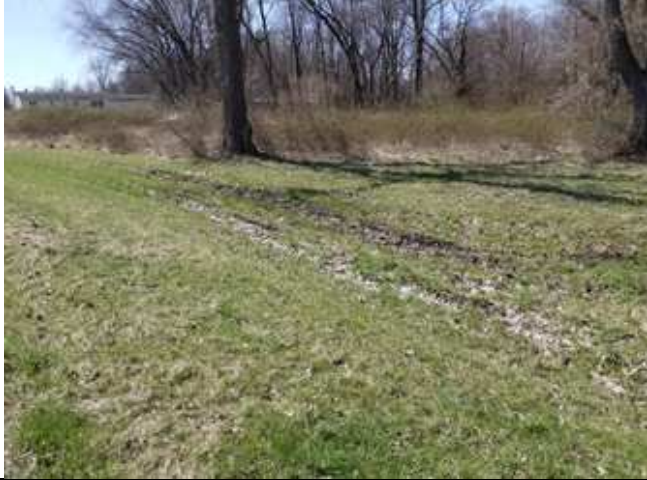
Category:	Levee Embankments	Item:	Depressions/ Rutting
Observation ID:	2023-0148		
Description:	Rutting along landside toe near the retaining wall tie-in at the end of Gary Burr levee alignment (east of Burr Street crossing)		
Caption:	0148 - No User Rating (Site Visit) - Rutting along landside toe near the retaining wall tie-in at the end of Gary Burr levee alignment (east of Burr Street crossing)		
Lat/Long:	41.55278/-87.39796

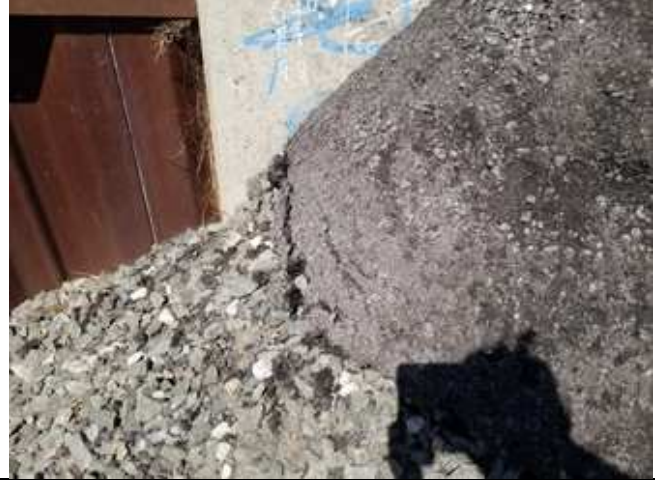
Category:	Levee Embankments	Item:	Cracking
Observation ID:	2023-0127		
Description:	Raveling of railroad asphalt cap		
Caption:	0127_1 - No User Rating (Site Visit) - Raveling of railroad asphalt cap		
Lat/Long:	41.55685/-87.39801

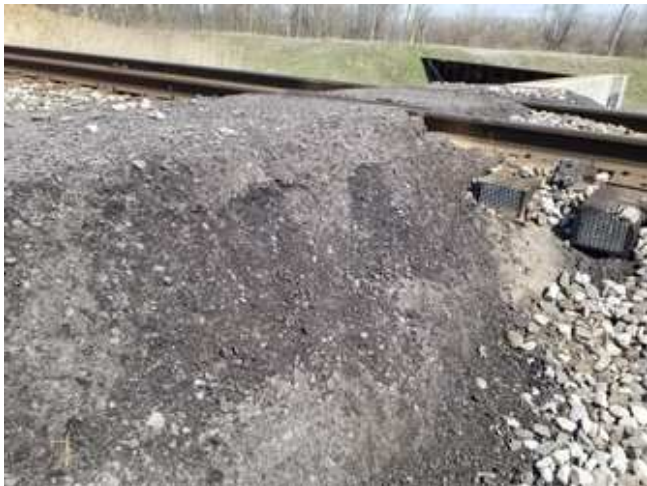
Category:	Levee Embankments	Item:	Cracking
Observation ID:	2023-0127		
Description:	Raveling of railroad asphalt cap		
Caption:	0127_2 - No User Rating (Site Visit) - Raveling of railroad asphalt cap		
Lat/Long:	41.55685/-87.39801

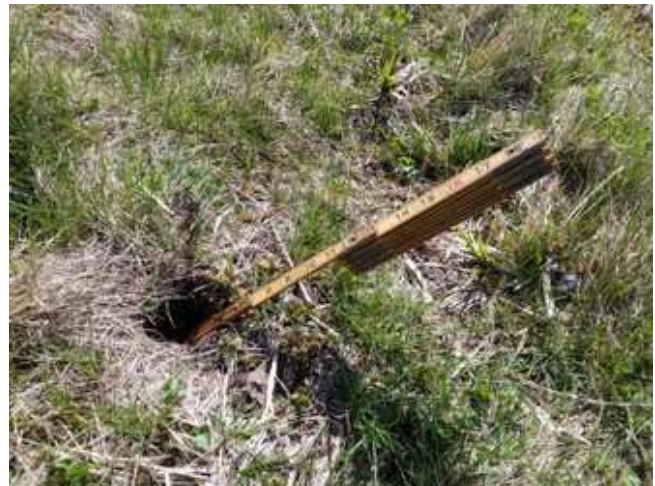
Category:	Levee Embankments	Item:	Animal Control
Observation ID:	2023-0010		
Description:	Animal burrow on landside (7-in deep)		
Caption:	0010 - No User Rating (Site Visit) - Animal burrow on landside (7-in deep)		
Lat/Long:	41.55964/-87.41165

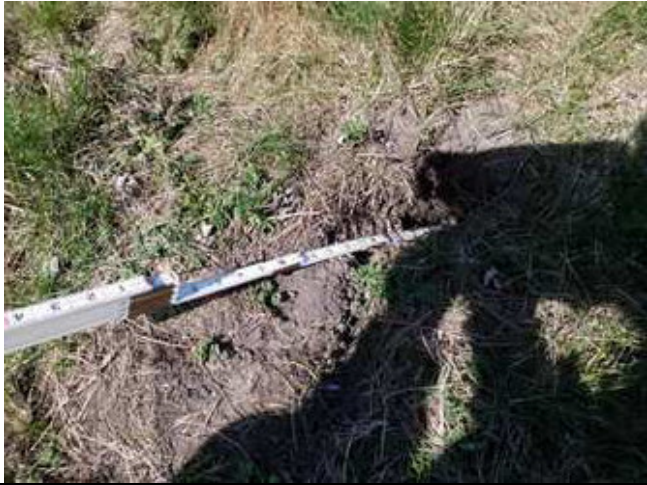
Category:	Levee Embankments	Item:	Animal Control
Observation ID:	2023-0037		
Description:	Animal burrow on landside (10-in deep)		
Caption:	0037 - No User Rating (Site Visit) - Animal burrow on landside (10-in deep)		
Lat/Long:	41.55974/-87.40636

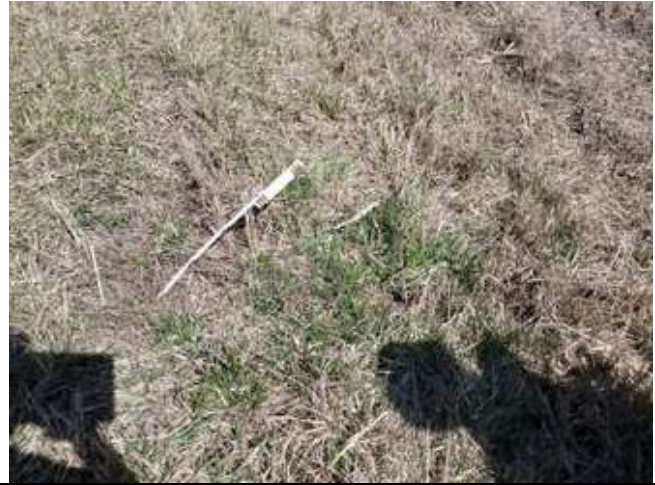
Category:	Levee Embankments	Item:	Animal Control
Observation ID:	2023-0136		
Description:	Animal burrows at riverside slope (8-in deep)		
Caption:	0136 - No User Rating (Site Visit) - Animal burrows at riverside slope (8-in deep)		
Lat/Long:	41.55624/-87.39786

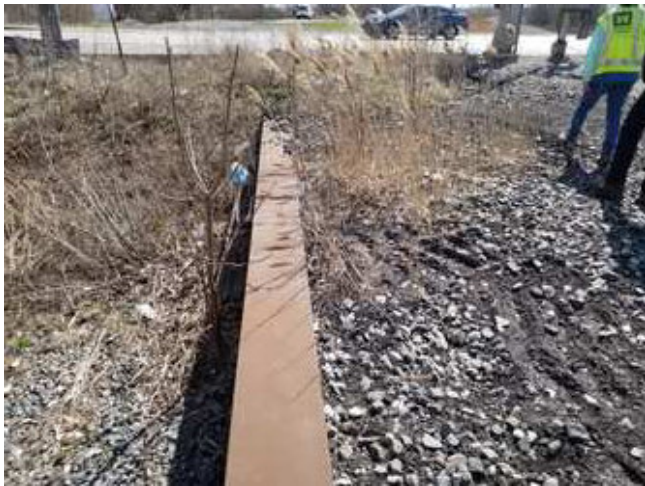
Category:	Floodwalls	Item:	Unwanted Vegetation
Observation ID:	2023-0049		
Description:	Small tree on the riverside face		
Caption:	0049 - No User Rating (Site Visit) - Small tree on the riverside face		
Lat/Long:	41.55992/-87.40373

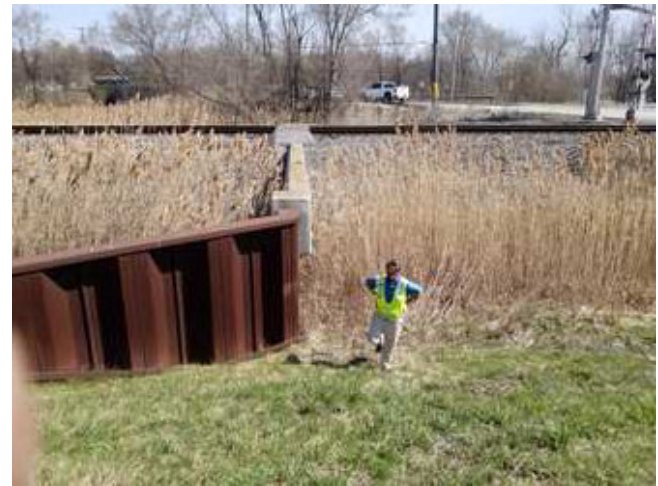
Category:	Floodwalls	Item:	Unwanted Vegetation
Observation ID:	2023-0157		
Description:	Vegetation along closure floodwall (both sides)		
Caption:	0157 - No User Rating (Site Visit) - Vegetation along closure floodwall (both sides)		
Lat/Long:	41.55992/-87.40373

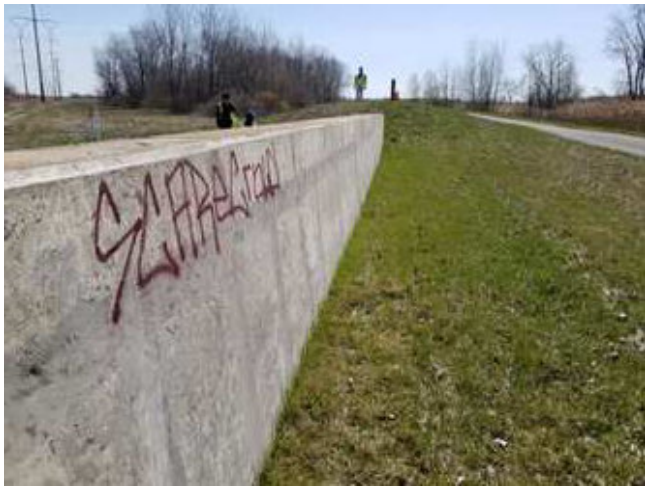
Category:	Floodwalls	Item:	Encroachments
Observation ID:	2023-0070		
Description:	Graffiti on landside face of floodwall		
Caption:	0070 - No User Rating (Site Visit) - Graffiti on landside face of floodwall		
Lat/Long:	41.55905/-87.40162

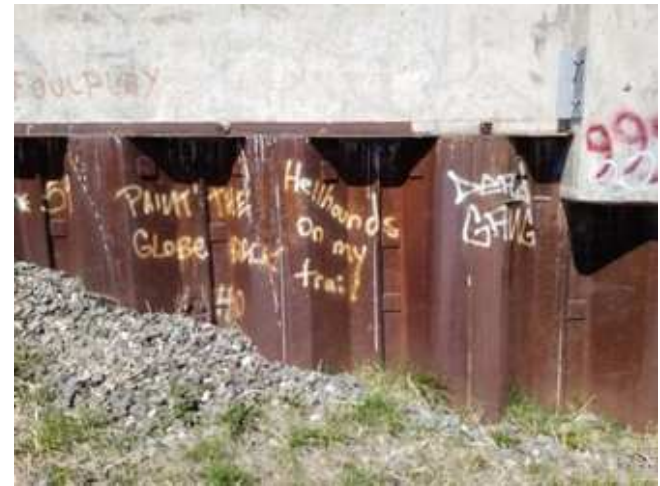
Category:	Floodwalls	Item:	Encroachments
Observation ID:	2023-0124		
Description:	Typical graffiti on riverside face of floodwall		
Caption:	0124 - No User Rating (Site Visit) - Typical graffiti on riverside face of floodwall		
Lat/Long:	41.55699/-87.39791

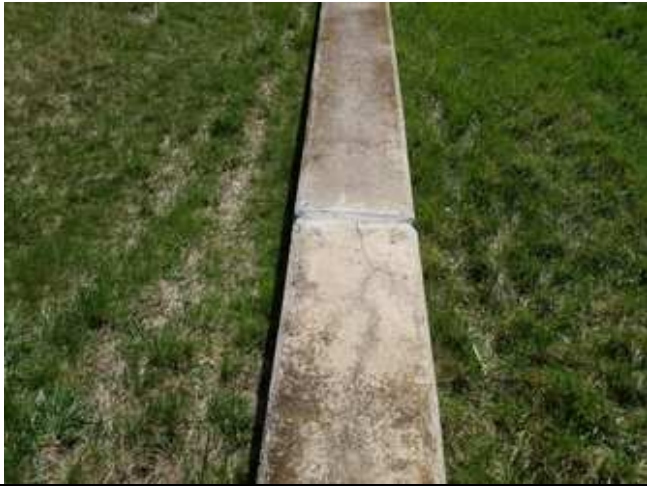
Category:	Floodwalls	Item:	Concrete Surfaces
Observation ID:	2023-0061		
Description:	Crack on top of floodwall		
Caption:	0061 - No User Rating (Site Visit) - Crack on top of floodwall		
Lat/Long:	41.55954/-87.40250

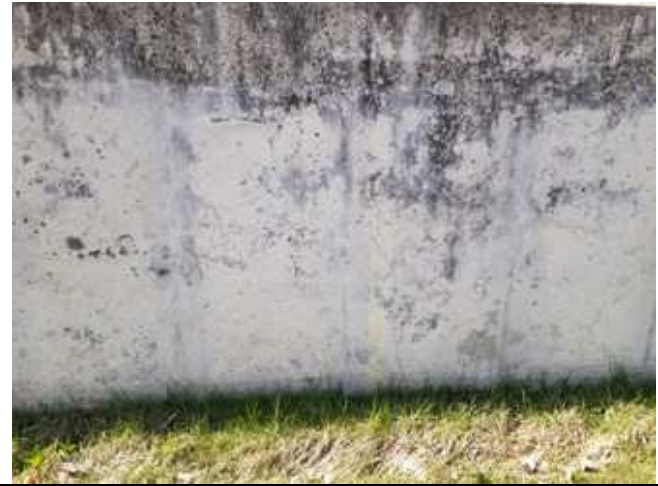
Category:	Floodwalls	Item:	Concrete Surfaces
Observation ID:	2023-0067		
Description:	Crack on riverside face of floodwall		
Caption:	0067 - No User Rating (Site Visit) - Crack on riverside face of floodwall		
Lat/Long:	41.55911/-87.40168

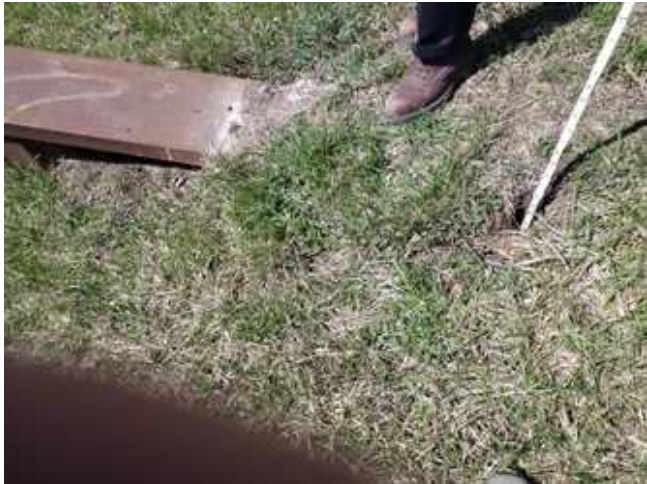
Category:	Floodwalls	Item:	Foundation of Concre
Observation ID:	2023-0118		
Description:	Animal burrow near levee embankment tie-in		
Caption:	0118 - No User Rating (Site Visit) - Animal burrow near levee embankment tie-in		
Lat/Long:	41.55715/-87.39796

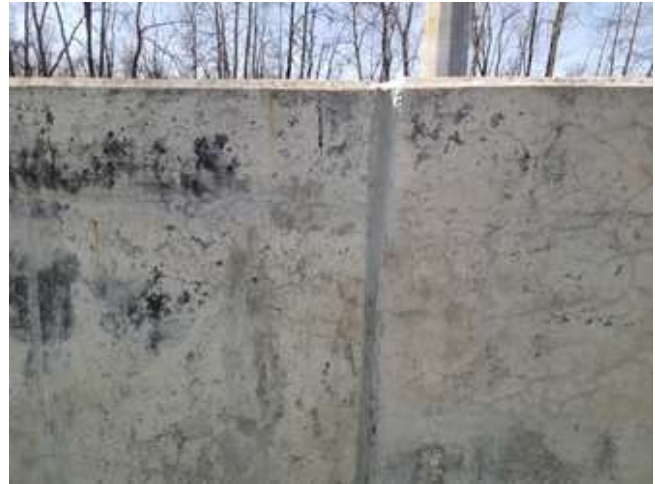
Category:	Floodwalls	Item:	Monolith Joints
Observation ID:	2023-0064		
Description:	Sealed joints of floodwall at riverside facing in good condition		
Caption:	0064 - No User Rating (Site Visit) - Sealed joints of floodwall at riverside facing in good condition		
Lat/Long:	41.55925/-87.40196

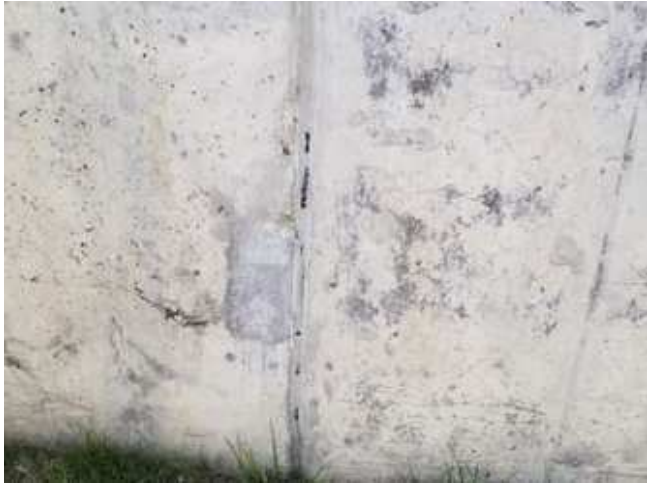
Category:	Floodwalls	Item:	Monolith Joints
Observation ID:	2023-0073		
Description:	Floodwall joints at riverside face have holes in sealant		
Caption:	0073 - No User Rating (Site Visit) - Floodwall joints at riverside face have holes in sealant		
Lat/Long:	41.55907/-87.40158

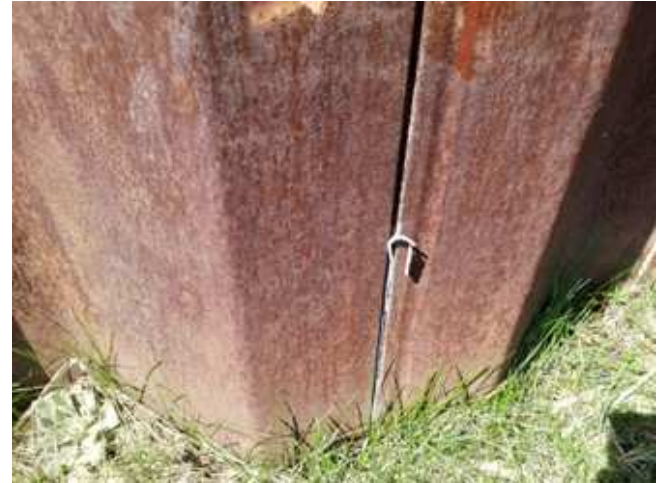
Category:	Floodwalls	Item:	Monolith Joints
Observation ID:	2023-0121		
Description:	Typical joint sealant peeling at riverside facing of floodwall		
Caption:	0121 - No User Rating (Site Visit) - Typical joint sealant peeling at riverside facing of floodwall		
Lat/Long:	41.55706/-87.39796

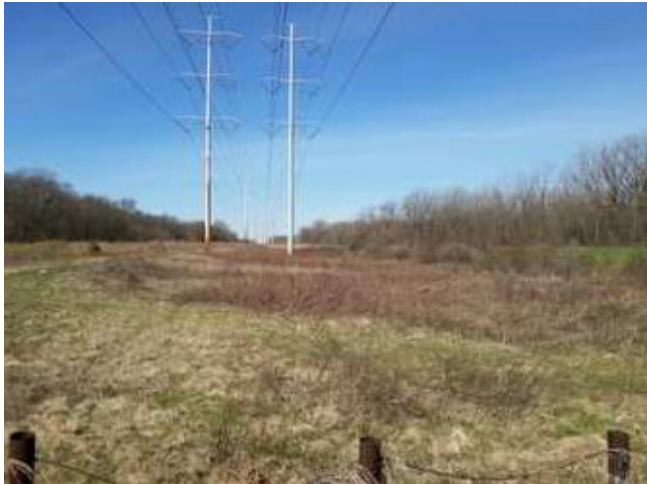
Category:	Interior Drainage System	Item:	Vegetation and Obstr
Observation ID:	2023-0025		
Description:	Typical condition of landside ditch - facing west		
Caption:	0025 - No User Rating (Site Visit) - Typical condition of landside ditch - facing west		
Lat/Long:	41.55930/-87.40838

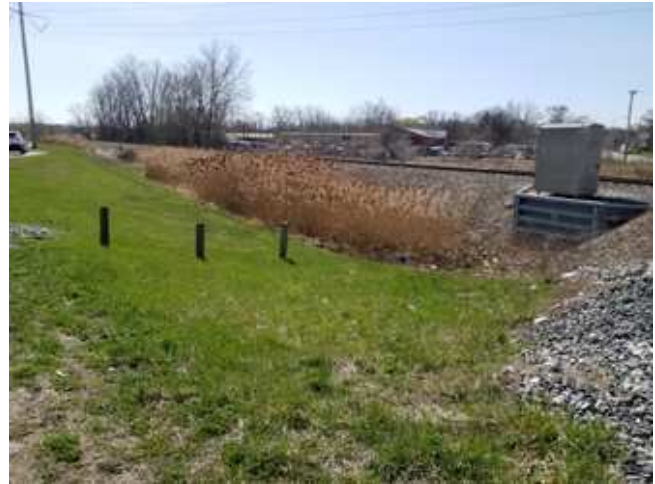
Category:	Interior Drainage System	Item:	Vegetation and Obstr
Observation ID:	2023-0058		
Description:	Tall vegetation in ditch		
Caption:	0058 - No User Rating (Site Visit) - Tall vegetation in ditch		
Lat/Long:	41.55981/-87.40298

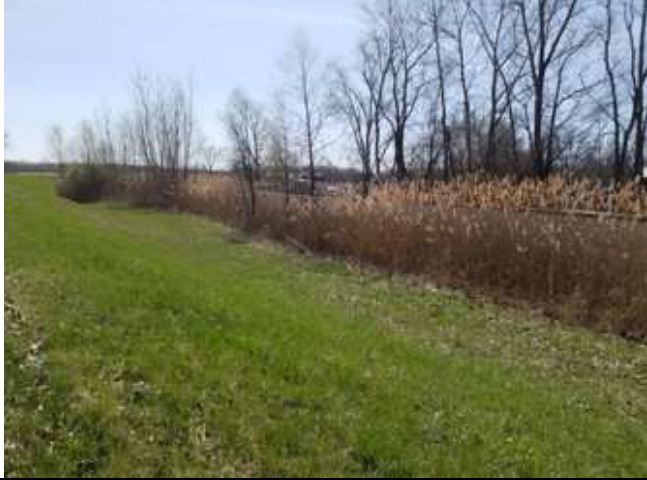
Category:	Interior Drainage System	Item:	Vegetation and Obstr
Observation ID:	2023-0082		
Description:	Trees and tall vegetation in ditch		
Caption:	0082 - No User Rating (Site Visit) - Trees and tall vegetation in ditch		
Lat/Long:	41.55884/-87.40119

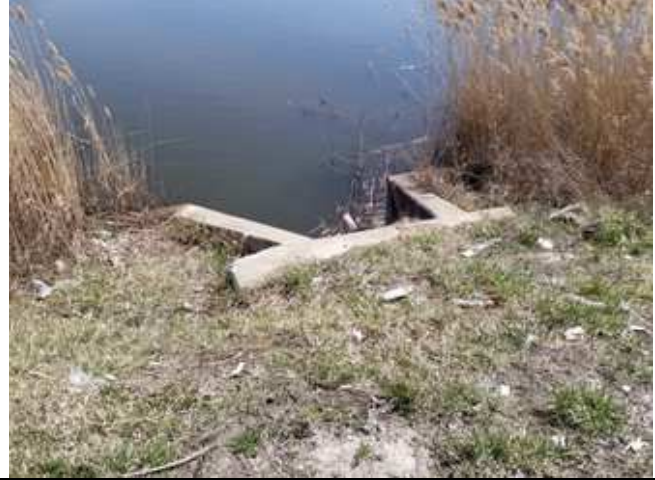
Category:	Interior Drainage System	Item:	Concrete Surfaces (S
Observation ID:	2023-0112		
Description:	GB-03: Spalling on outlet headwall		
Caption:	0112 - No User Rating (Site Visit) - GB-03: Spalling on outlet headwall		
Lat/Long:	41.55732/-87.39774

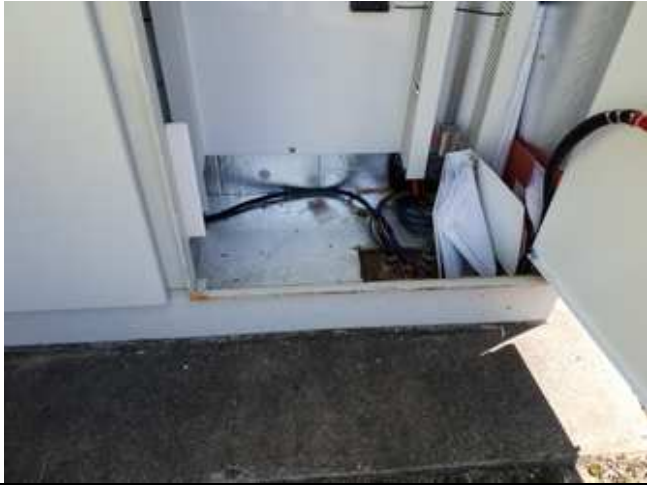
Category:	Pump Stations	Item:	Pump Station Operati
Observation ID:	2023-0150		
Description:	PS-BS: Operation manual present at pump station site. Records are updated		
Caption:	0150 - No User Rating (Site Visit) - PS-BS: Operation manual present at pump station site. Records are updated		
Lat/Long:	41.55893/-87.40295

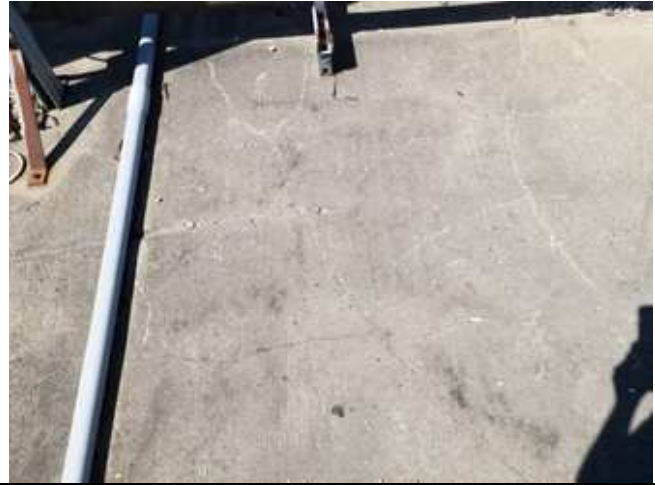
Category:	Pump Stations	Item:	Plant Building
Observation ID:	2023-0149		
Description:	PS-BS: Concrete crack observed in the pump foundation		
Caption:	0149 - No User Rating (Site Visit) - PS-BS: Concrete crack observed in pump foundation		
Lat/Long:	41.55896/-87.40303

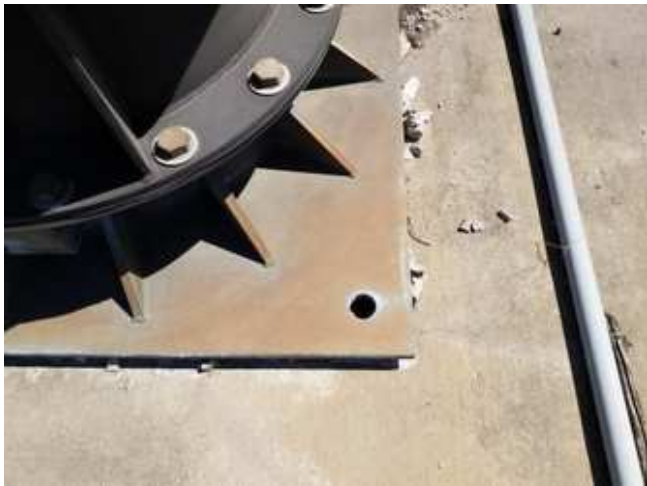
Category:	Pump Stations	Item:	Pumps
Observation ID:	2023-0151		
Description:	PS-BS: Missing nut and bolt on left corner of motor pump assembly		
Caption:	0151 - No User Rating (Site Visit) - PS-BS: Missing nut and bolt on left corner of motor pump assembly		
Lat/Long:	41.55898/-87.40306

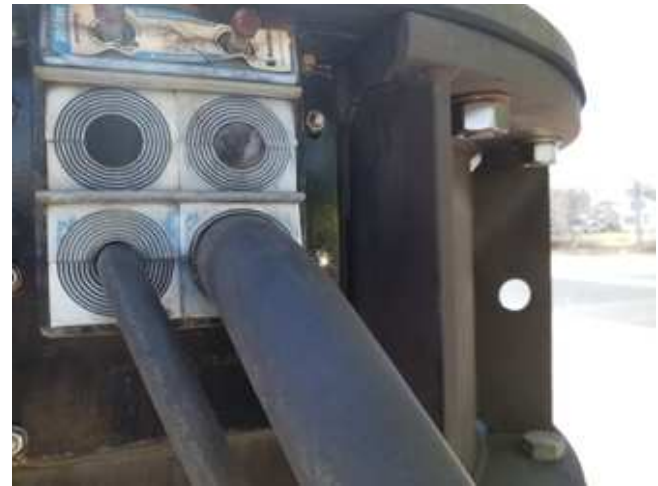
Category:	Pump Stations	Item:	Pumps
Observation ID:	2023-0154		
Description:	PS-BS: Loose gasket on motor pump assembly. Air can be heard when pump is running		
Caption:	0154 - No User Rating (Site Visit) - PS-BS: Loose gasket on motor pump assembly. Air can be heard when pump is running		
Lat/Long:	41.55897/-87.40308

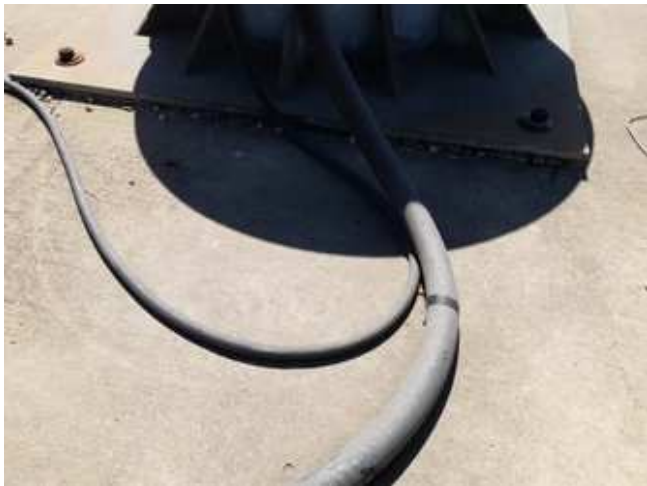
Category:	Pump Stations	Item:	Pumps
Observation ID:	2023-0155		
Description:	PS-BS: Cracked foundation in two motor pump assemblies		
Caption:	0155 - No User Rating (Site Visit) - PS-BS: Cracked foundation in two motor pump assemblies		
Lat/Long:	41.55899/-87.40311

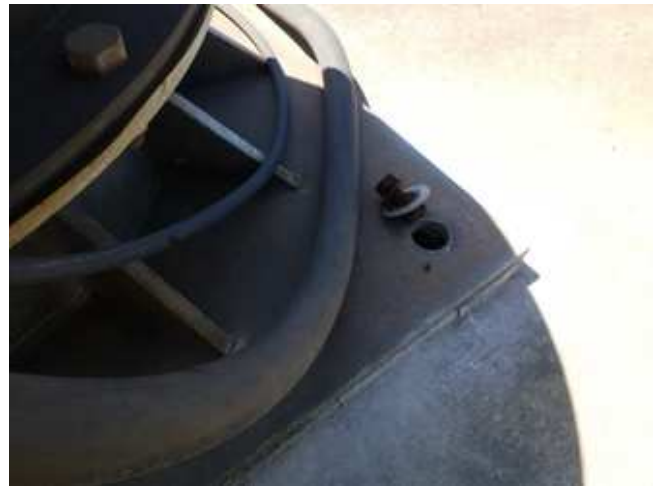
Category:	Pump Stations	Item:	Pumps
Observation ID:	2023-0156		
Description:	PS-BS: Bottom left bolt for Pump 2 has sheared off. Vibration of pump frame was observed during operation		
Caption:	0156 - No User Rating (Site Visit) - PS-BS: Bottom left bolt for Pump 2 has sheared off. Vibration of pump frame was observed during operation		
Lat/Long:	41.55890/-87.40311
