Site Visit Summary

Name of System: Burr Street

Name of Segment: Gary Burr St

Date of Site Visit: 04/10/2023 - 04/10/2023

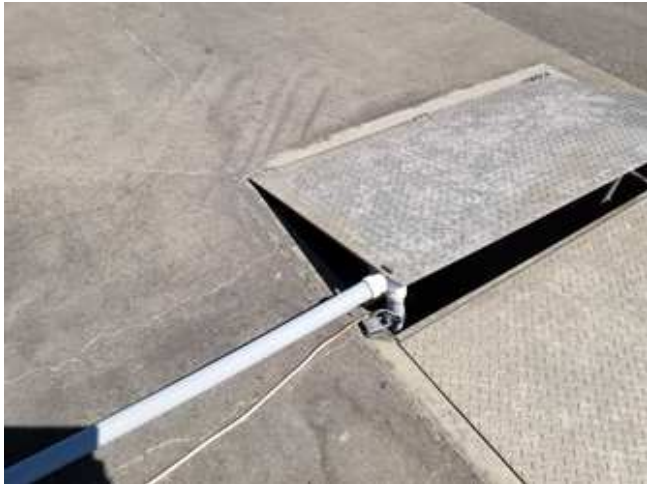
Category:	Pump Stations	Item:	Sumps / Wet Well
Observation ID:	2023-0153		
Description:	PS-BS: Temporary piping keeping grate cover open for ongoing work		
Caption:	0153 - No User Rating (Site Visit) - PS-BS: Temporary piping keeping open grate cover for interior of wet well		
Lat/Long:	41.55899/-87.40304

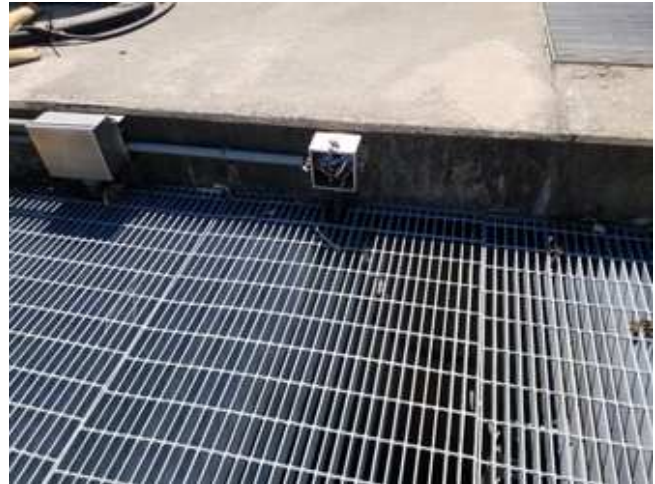
Category:	Pump Stations	Item:	Electrical Systems
Observation ID:	2023-0152		
Description:	PS-BS: Missing electrical box cover		
Caption:	0152 - No User Rating (Site Visit) - PS-BS: Missing electrical box cover		
Lat/Long:	41.55903/-87.40316
