**US Army Corps
of Engineers ®**

Site Visit Summary

Name of System: Gary

Name of Segment: Gary North

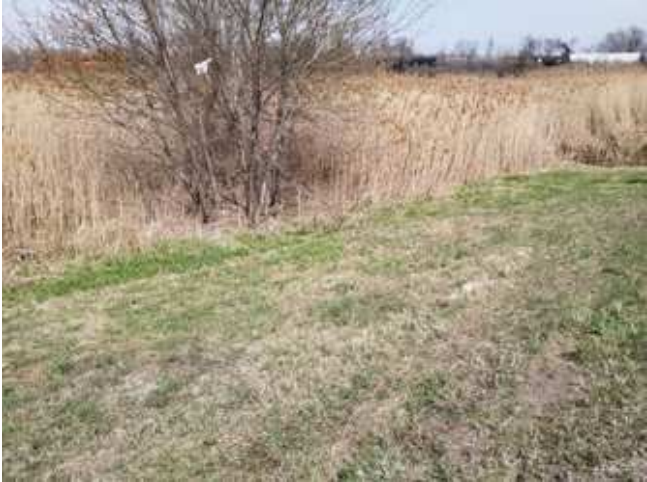
Category:	Levee Embankments	Item:	Unwanted Vegetation
Observation ID:	2023-0010		
Description:	Vegetation within 15 feet of riverside toe		
Caption:	0010 - No User Rating (Site Visit) - Vegetation within 15 feet of riverside toe		
Lat/Long:	41.56846/-87.31732

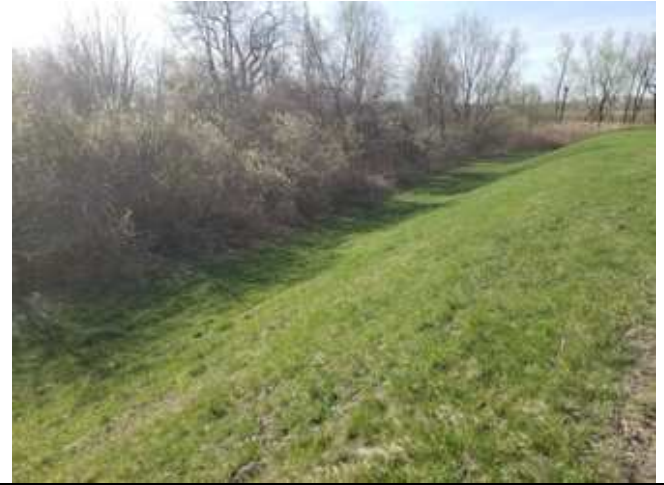
Category:	Levee Embankments	Item:	Unwanted Vegetation
Observation ID:	2023-0126		
Description:	Vegetation on riverside toe		
Caption:	0126 - No User Rating (Site Visit) - Vegetation on riverside toe		
Lat/Long:	41.56121/-87.39345

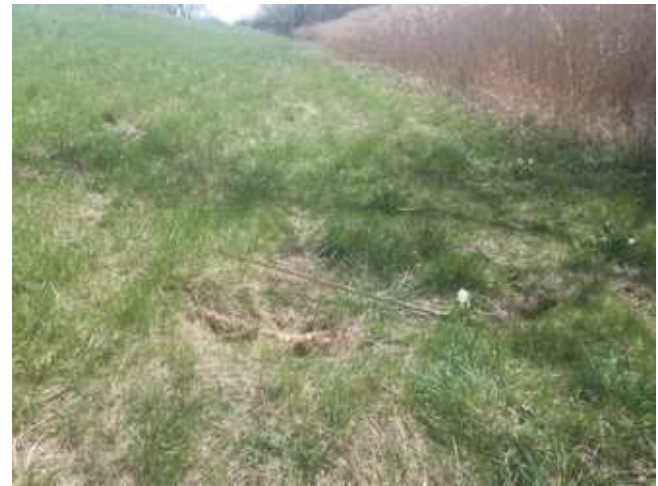
Category:	Levee Embankments	Item:	Unwanted Vegetation
Observation ID:	2023-0451		
Description:	Root extending into embankment/animal burrows on landside toe		
Caption:	0451 - No User Rating (Site Visit) - Root extending into embankment/animal burrows on landside toe		
Lat/Long:	41.56722/-87.34900

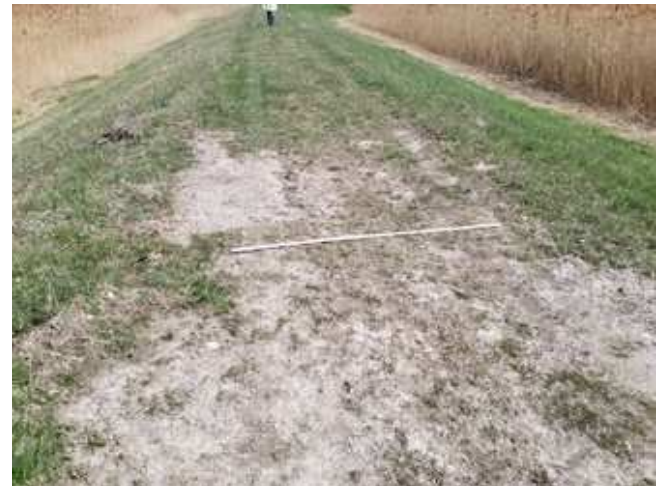
Category:	Levee Embankments	Item:	Sod Cover
Observation ID:	2023-0019		
Description:	Poor sod cover on crown		
Caption:	0019 - No User Rating (Site Visit) - Poor sod cover on crown		
Lat/Long:	41.56850/-87.31693

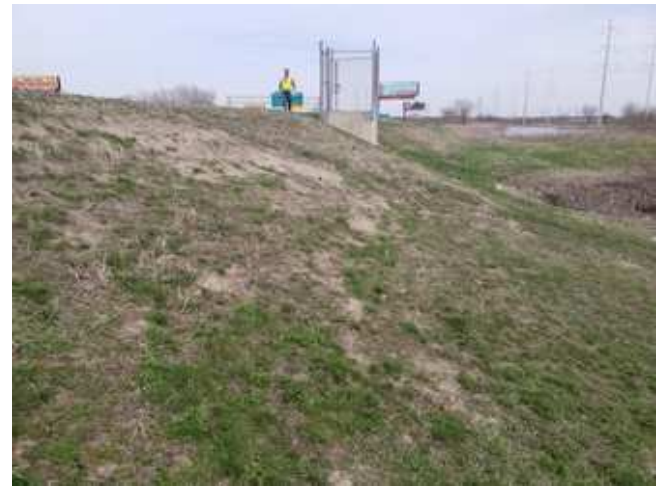
Category:	Levee Embankments	Item:	Sod Cover
Observation ID:	2023-0160		
Description:	Poor sod cover on riverside slope		
Caption:	0160 - No User Rating (Site Visit) - Poor sod cover on riverside slope		
Lat/Long:	41.56678/-87.32533

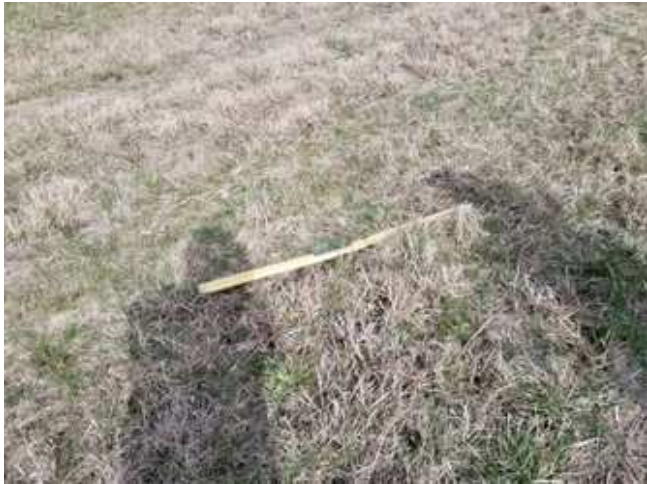
Category:	Levee Embankments	Item:	Encroachments
Observation ID:	2023-0055		
Description:	Broken tools on riverside slope		
Caption:	0055 - No User Rating (Site Visit) - Broken tools on riverside slope		
Lat/Long:	41.56795/-87.32347

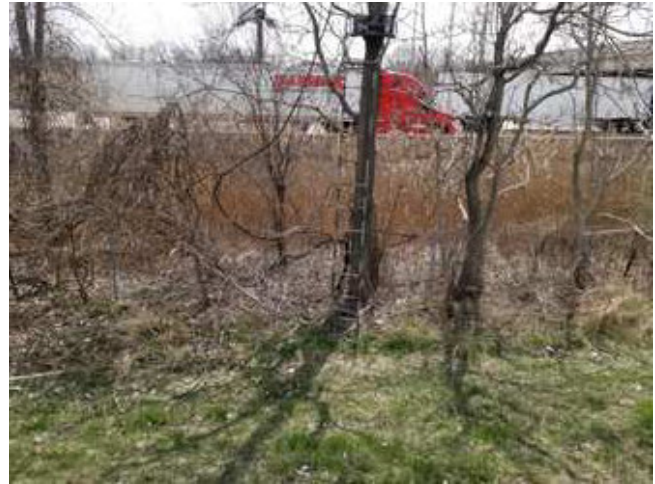
Category:	Levee Embankments	Item:	Encroachments
Observation ID:	2023-0076		
Description:	Hunters chair on landside toe		
Caption:	0076 - No User Rating (Site Visit) - Hunters chair on landside toe		
Lat/Long:	41.56789/-87.32637

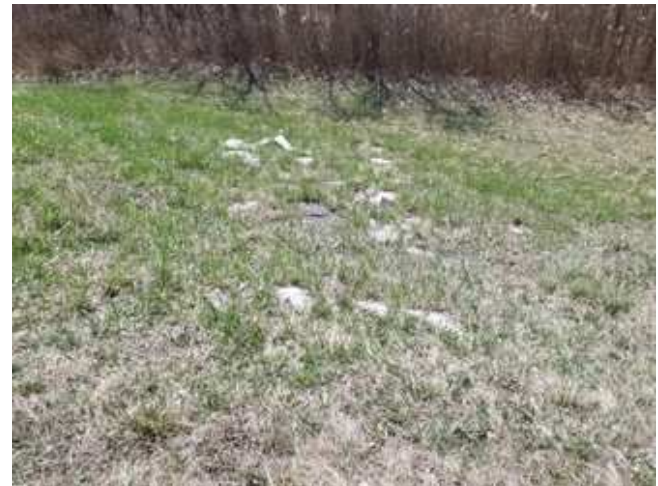
Category:	Levee Embankments	Item:	Encroachments
Observation ID:	2023-0247		
Description:	Debris on riverside slope		
Caption:	0247 - No User Rating (Site Visit) - Debris on riverside slope		
Lat/Long:	41.56707/-87.41936

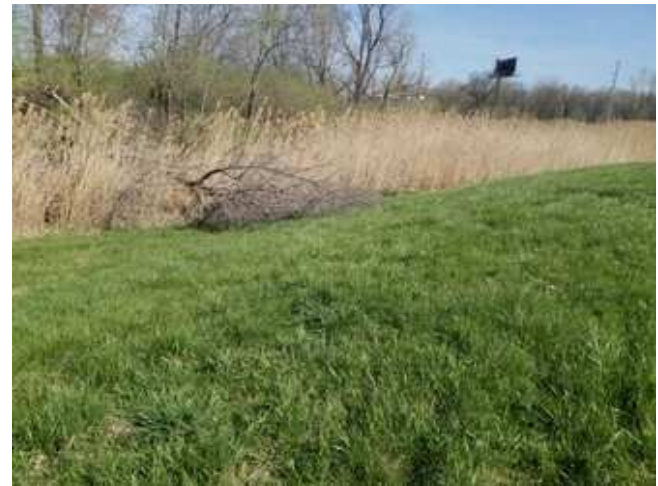
Category:	Levee Embankments	Item:	Encroachments
Observation ID:	2023-0430		
Description:	Downed tree on landside toe		
Caption:	0430 - No User Rating (Site Visit) - Downed tree on landside toe		
Lat/Long:	41.56779/-87.37471

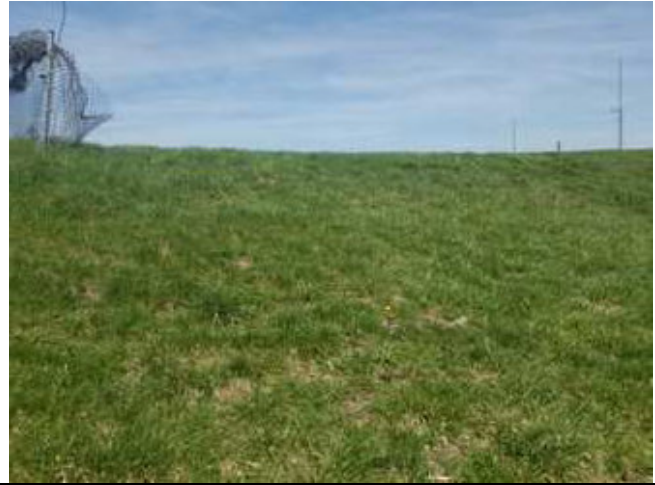
Category:	Levee Embankments	Item:	Encroachments
Observation ID:	2023-0484		
Description:	Broken fence/partially buried railing on riverside slope		
Caption:	0484 - No User Rating (Site Visit) - Broken fence/partially buried railing on riverside slope		
Lat/Long:	41.56550/-87.33812

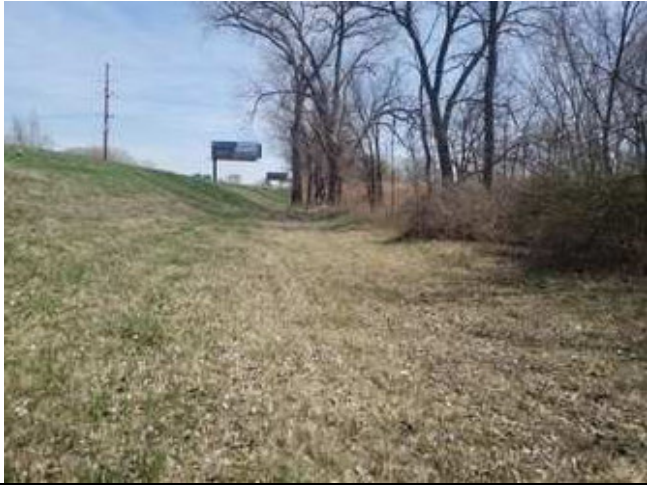
Category:	Levee Embankments	Item:	Encroachments
Observation ID:	2023-0493		
Description:	Downed tree on riverside toe		
Caption:	0493 - No User Rating (Site Visit) - Downed tree on riverside toe		
Lat/Long:	41.56677/-87.33284

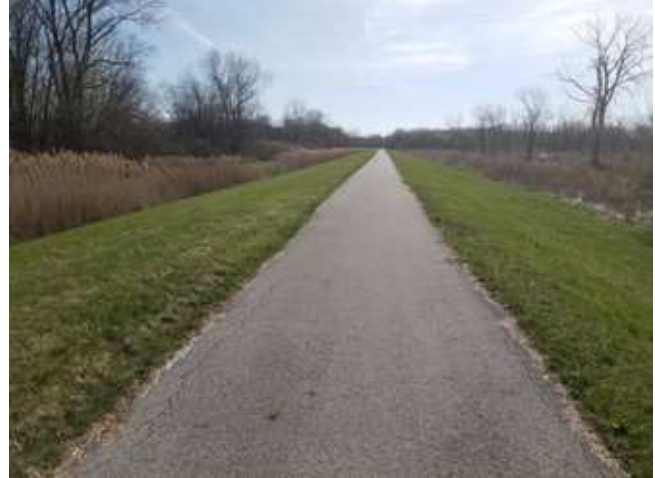
Category:	Levee Embankments	Item:	Settlement
Observation ID:	2023-0132		
Description:	Typical good condition of levee slopes and crest		
Caption:	0132 - No User Rating (Site Visit) - Typical good condition of levee slopes and crest		
Lat/Long:	41.56291/-87.39215

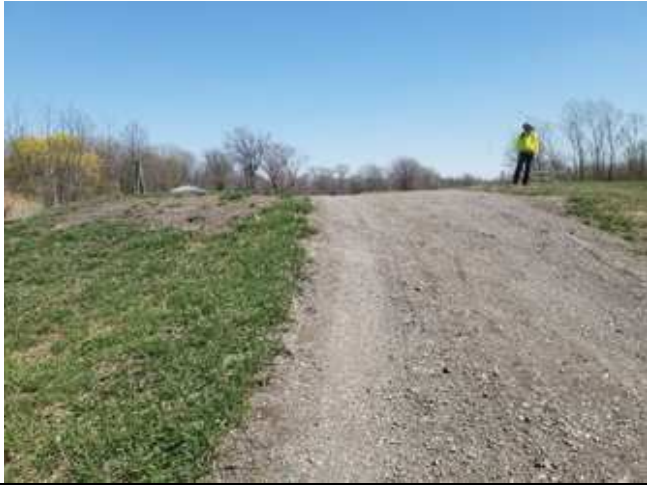
Category:	Levee Embankments	Item:	Settlement
Observation ID:	2023-0244		
Description:	Settlement of crown in road (towards left of photo)		
Caption:	0244 - No User Rating (Site Visit) - Settlement of crown in road (towards left of photo)		
Lat/Long:	41.56710/-87.41939

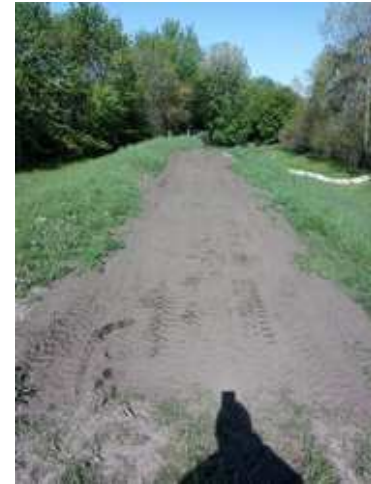
Minor issues with unwanted vegetation, encroachments/debris, rutting, sod cover, concrete cracking or spalling, holes or missing bolts in sheetpile, crooked alignment of floodwall cap, deteriorating joints, sluice and flap gates, and pump stations. There were significant issues with deep ruts in the crest west of Burr Street.

Category:	Levee Embankments	Item:	Depressions/ Rutting
Observation ID:	2023-0105		
Description:	Deep ruts along levee crest west of Burr St.		
Caption:	0105 - No User Rating (Site Visit) - Repaired ruts.		
Lat/Long:	41.56086/-87.40492

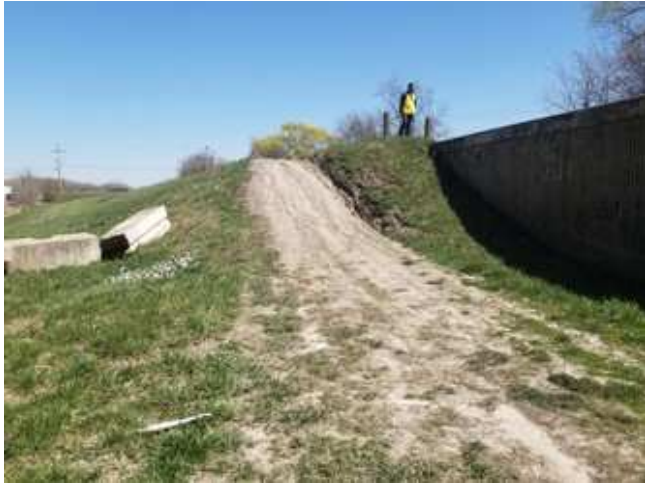
Category:	Levee Embankments	Item:	Depressions/ Rutting
Observation ID:	2023-0108		
Description:	Rutting along levee ramp		
Caption:	0108 - No User Rating (Site Visit) - Rutting along levee ramp		
Lat/Long:	41.56092/-87.40474

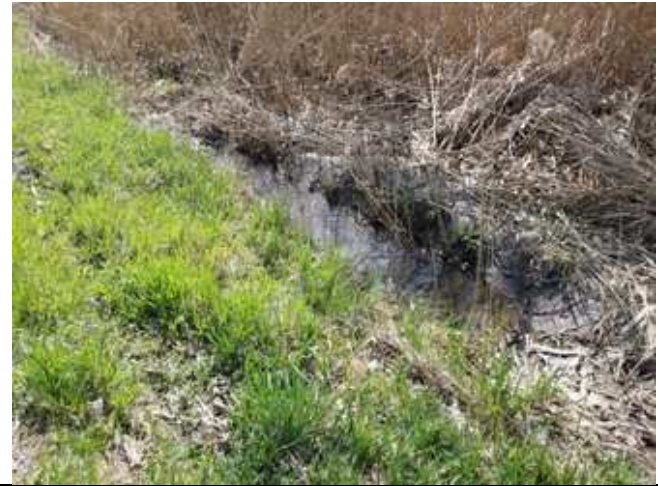
Category:	Levee Embankments	Item:	Depressions/ Rutting
Observation ID:	2023-0177		
Description:	Rutting and ponding on riverside toe		
Caption:	0177 - No User Rating (Site Visit) - Rutting and ponding on riverside toe		
Lat/Long:	41.56902/-87.36875

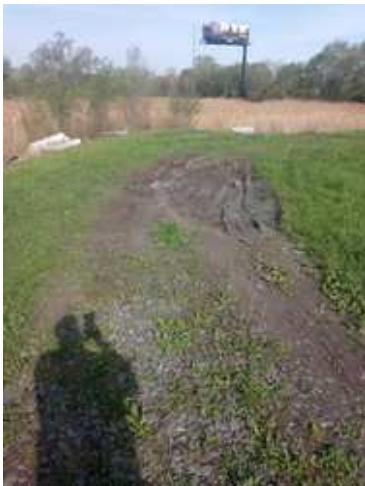
Category:	Levee Embankments	Item:	Depressions/ Rutting
Observation ID:	2023-0211		
Description:	Major rut in crown		
Caption:	0211 - No User Rating (Site Visit) - Repaired rut.		
Lat/Long:	41.56868/-87.42373

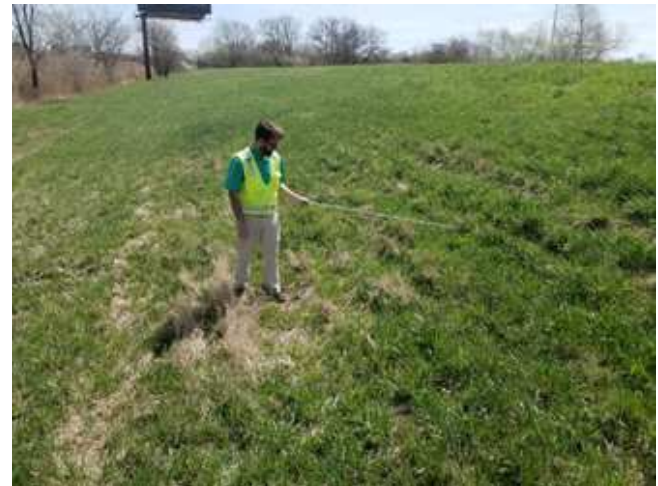
Category:	Levee Embankments	Item:	Depressions/ Rutting
Observation ID:	2023-0213		
Description:	Depression on landslide slope (12 foot wide 3 foot deep)		
Caption:	0213 - No User Rating (Site Visit) - Depression on landslide slope (12 foot wide 3 foot deep)		
Lat/Long:	41.56753/-87.35011

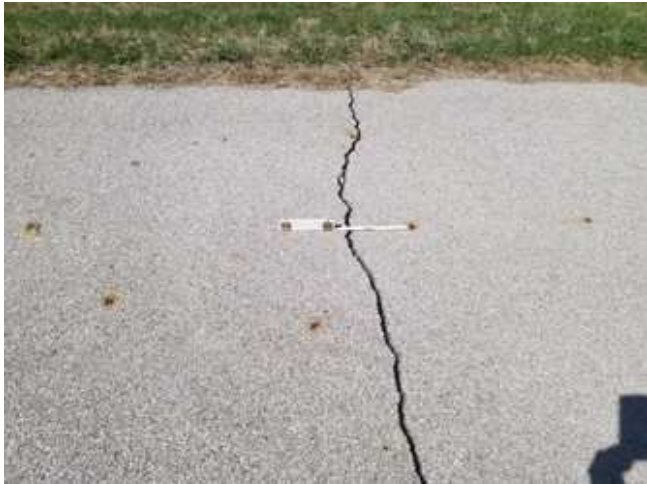
Category:	Levee Embankments	Item:	Cracking
Observation ID:	2023-0361		
Description:	Typical asphalt crack on crown		
Caption:	0361 - No User Rating (Site Visit) - Typical asphalt crack on crown		
Lat/Long:	41.56080/-87.40107

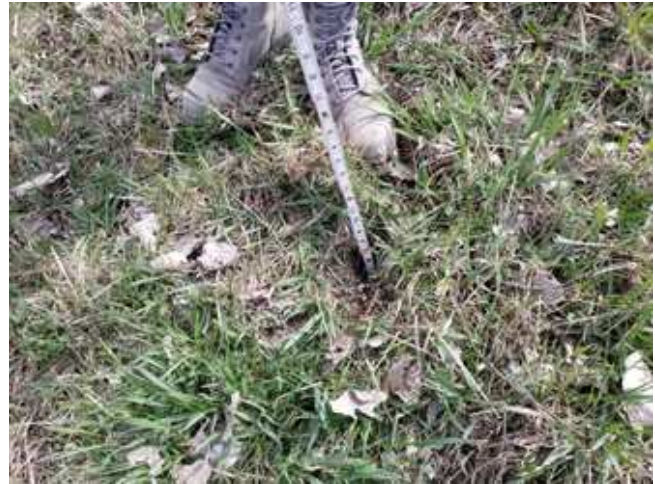
Category:	Levee Embankments	Item:	Animal Control
Observation ID:	2023-0052		
Description:	Six-inch burrow on riverside slope		
Caption:	0052 - No User Rating (Site Visit) - Six-inch burrow on riverside slope		
Lat/Long:	41.56800/-87.32187

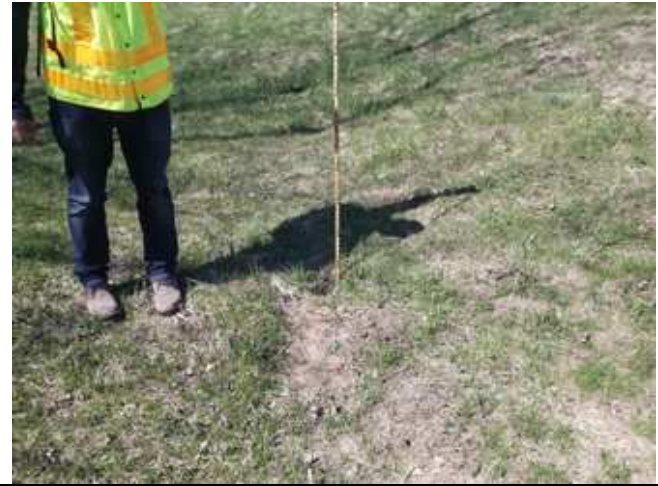
Category:	Levee Embankments	Item:	Animal Control
Observation ID:	2023-0373		
Description:	Animal burrow on riverside toe		
Caption:	0373 - No User Rating (Site Visit) - Animal burrow on riverside toe		
Lat/Long:	41.56085/-87.39740

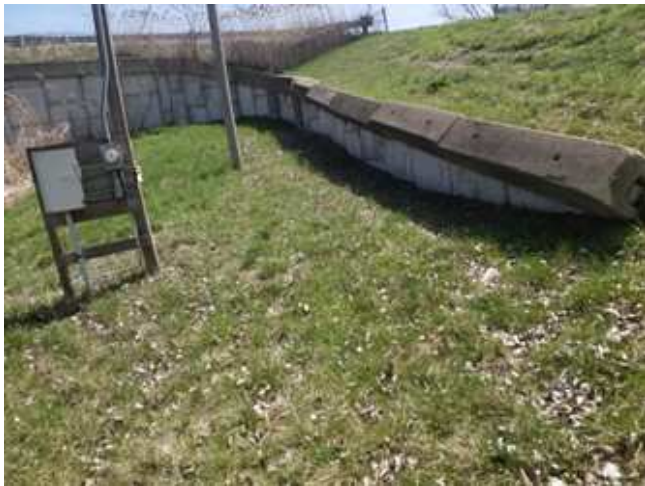
Category:	Levee Embankments	Item:	Revetments other tha
Observation ID:	2023-0228		
Description:	Revetment on landside toe is failing		
Caption:	0228 - No User Rating (Site Visit) - Revetment on landside toe is failing		
Lat/Long:	41.56718/-87.34677

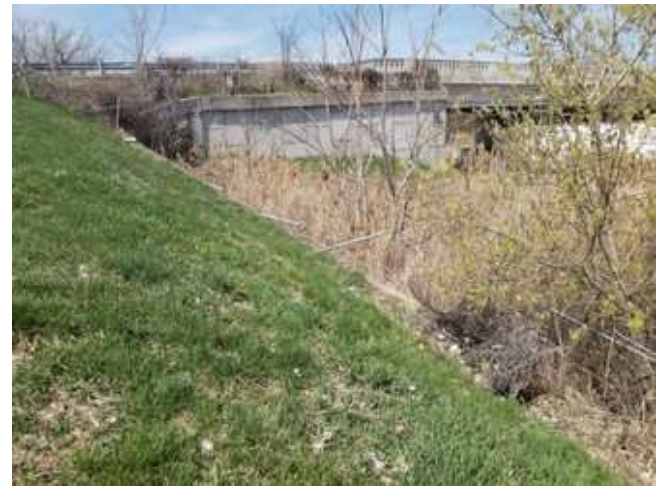
Category:	Levee Embankments	Item:	Revetments other tha
Observation ID:	2023-0234		
Description:	Revetment on other side of road from failed revetment		
Caption:	0234 - No User Rating (Site Visit) - Revetment on other side of road from failed revetment		
Lat/Long:	41.56712/-87.34599

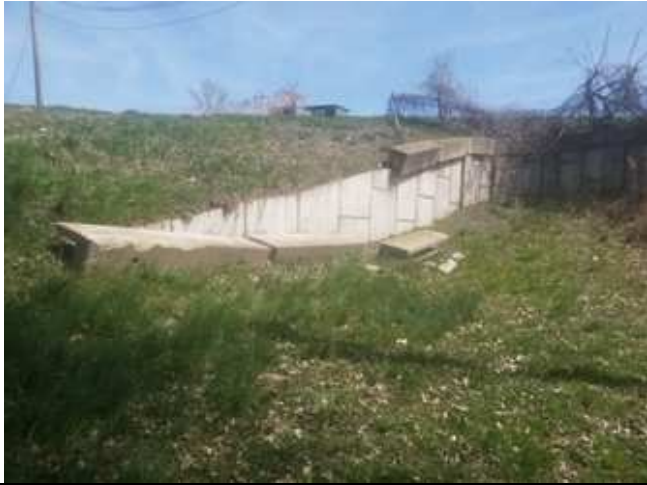
Category:	Levee Embankments	Item:	Revetments other tha
Observation ID:	2023-0457		
Description:	Failing/failed cap/wall (riverside)		
Caption:	0457 - No User Rating (Site Visit) - Failing/failed cap/wall (riverside)		
Lat/Long:	41.56699/-87.34679

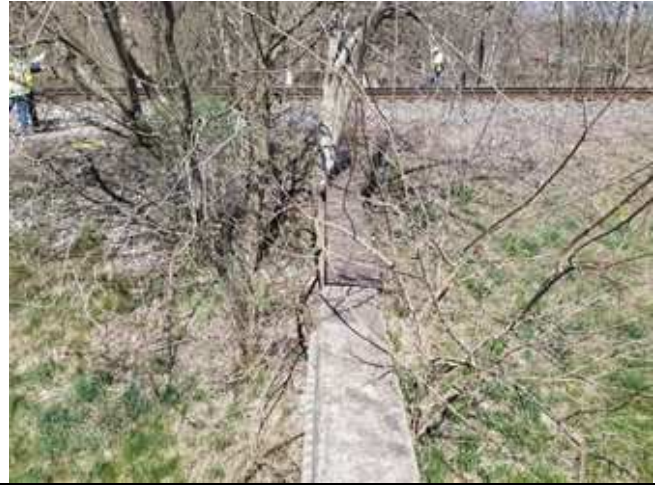
Category:	Floodwalls	Item:	Unwanted Vegetation
Observation ID:	2023-0093		
Description:	Large tree pushing floodwall on landside		
Caption:	0093 - No User Rating (Site Visit) - Large tree pushing floodwall on landside		
Lat/Long:	41.56070/-87.40589

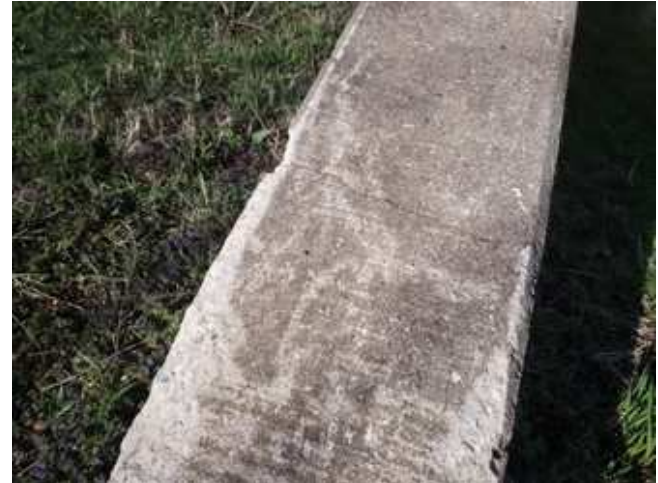
Category:	Floodwalls	Item:	Concrete Surfaces
Observation ID:	2023-0159		
Description:	Cracking and spalling on top of floodwall		
Caption:	0159 - No User Rating (Site Visit) - Cracking and spalling on top of floodwall		
Lat/Long:	41.56600/-87.37486

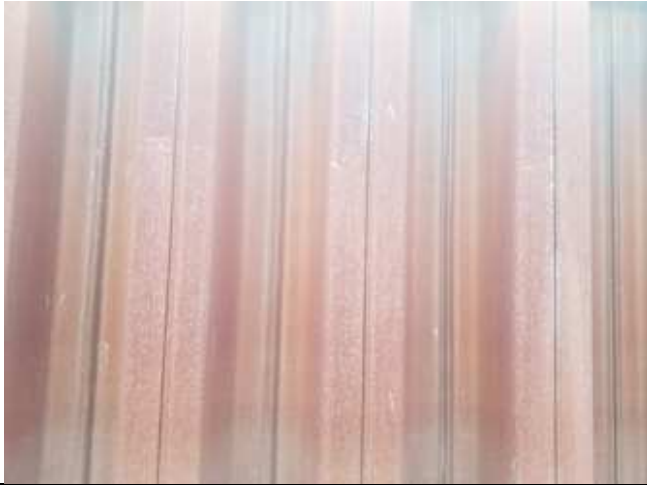
Category:	Floodwalls	Item:	Concrete Surfaces
Observation ID:	2023-0307		
Description:	Hole in sheetpile		
Caption:	0307 - No User Rating (Site Visit) - Hole in sheetpile		
Lat/Long:	41.56384/-87.41203

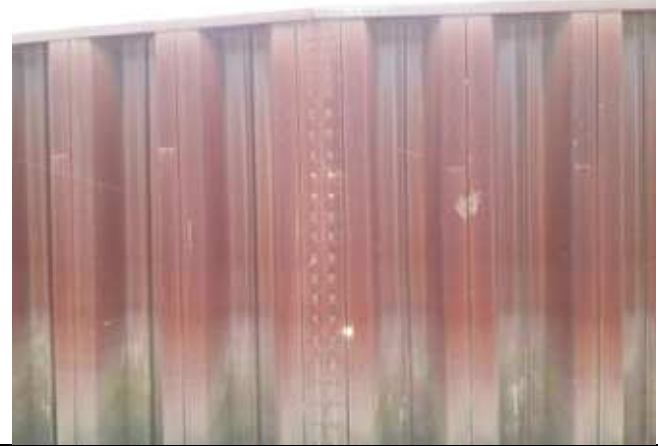
Category:	Floodwalls	Item:	Concrete Surfaces
Observation ID:	2023-0310		
Description:	4 missing bolts in sheetpile wall		
Caption:	0310 - No User Rating (Site Visit) - 4 missing bolts in sheetpile wall		
Lat/Long:	41.56369/-87.41161

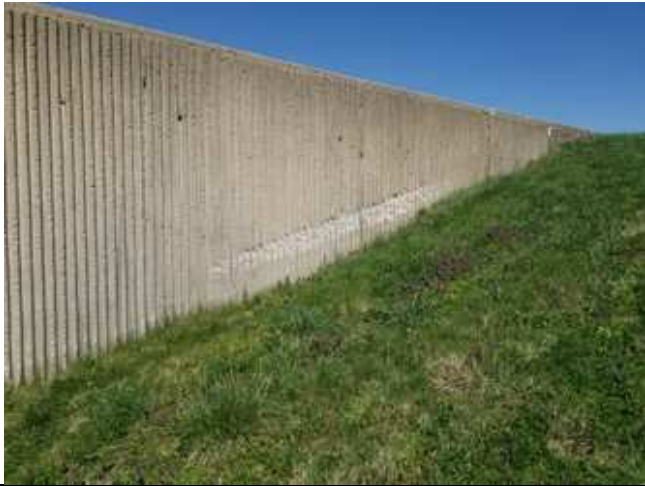
Category:	Floodwalls	Item:	Concrete Surfaces
Observation ID:	2023-0355		
Description:	Concrete scouring/spalling on riverside		
Caption:	0355 - No User Rating (Site Visit) - Concrete scouring/spalling on riverside		
Lat/Long:	41.56078/-87.40291

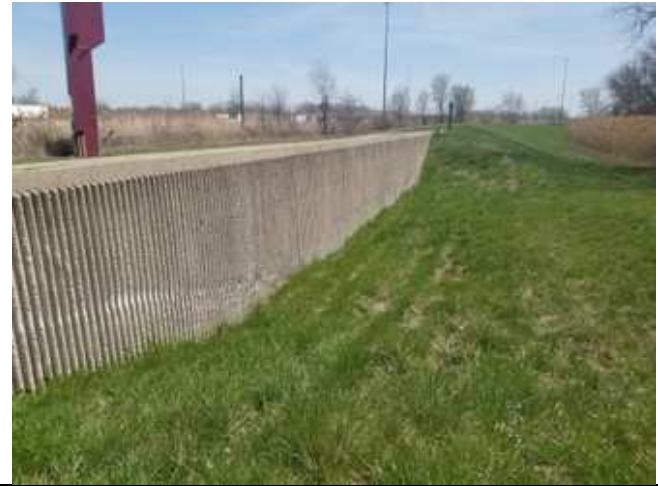
Category:	Floodwalls	Item:	Concrete Surfaces
Observation ID:	2023-0469		
Description:	Spalling/concrete erosion on riverside		
Caption:	0469 - No User Rating (Site Visit) - Spalling/concrete erosion on riverside		
Lat/Long:	41.56675/-87.34135

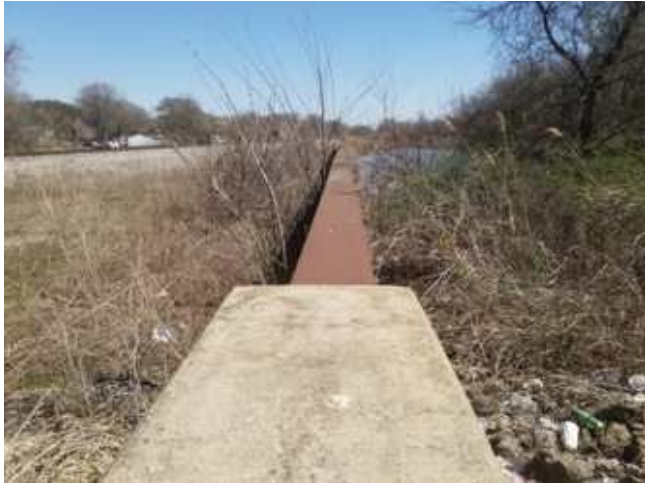
Category:	Floodwalls	Item:	Tilting, Sliding or
Observation ID:	2023-0301		
Description:	Alignment of cap is crooked by Colfax St.		
Caption:	0301 - No User Rating (Site Visit) - Alignment of cap is crooked by Colfax St.		
Lat/Long:	41.56415/-87.41283

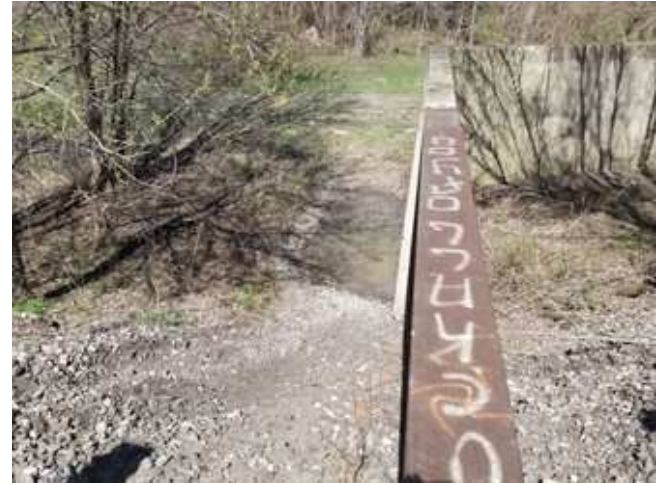
Category:	Floodwalls	Item:	Foundation of Concre
Observation ID:	2023-0096		
Description:	Ponding against landside floodwall foundation by the railroad west of Burr St.		
Caption:	0096 - No User Rating (Site Visit) - Ponding against landside floodwall foundation by the railroad west of Burr St.		
Lat/Long:	41.56086/-87.40567

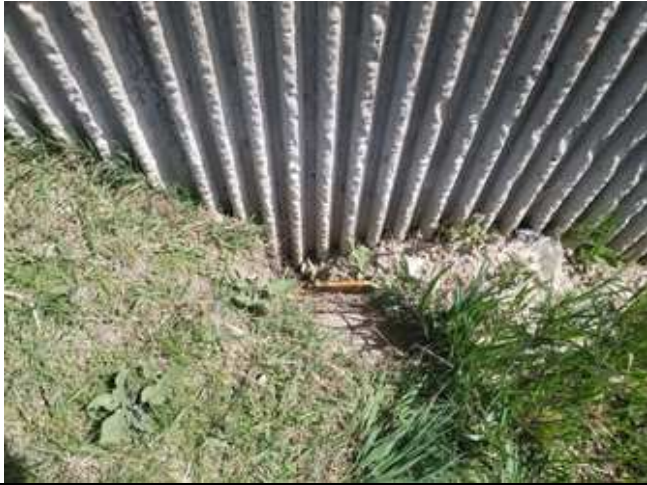
Category:	Floodwalls	Item:	Foundation of Concre
Observation ID:	2023-0439		
Description:	Animal burrow 22-in deep near riverside foundation		
Caption:	0439 - No User Rating (Site Visit) - Animal burrow 22-in deep near riverside foundation		
Lat/Long:	41.56710/-87.35472

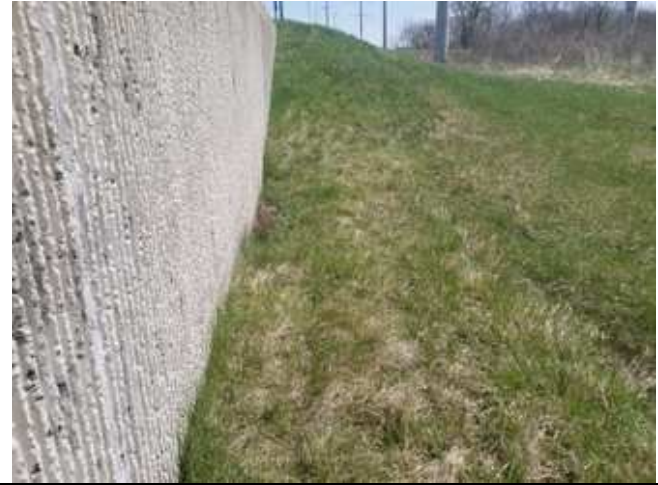
Category:	Floodwalls	Item:	Foundation of Concre
Observation ID:	2023-0490		
Description:	Erosion near base of riverside wall		
Caption:	0490 - No User Rating (Site Visit) - Erosion near base of riverside wall		
Lat/Long:	41.56564/-87.33780

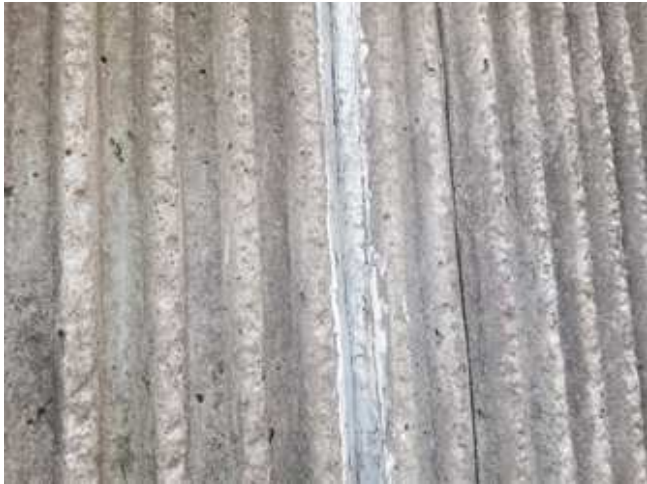
Category:	Floodwalls	Item:	Monolith Joints
Observation ID:	2023-0156		
Description:	Sealant cracking on landside joint		
Caption:	0156 - No User Rating (Site Visit) - Sealant cracking on landside joint		
Lat/Long:	41.56603/-87.37508

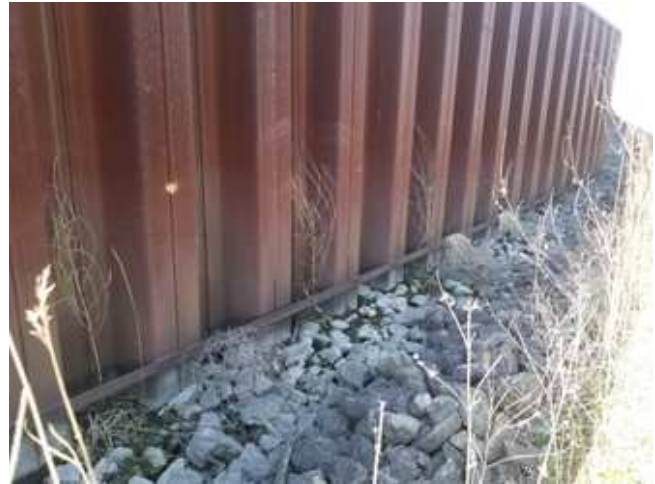
Category:	Floodwalls	Item:	Seepage
Observation ID:	2023-0313		
Description:	Area of prior seepage on landside sheetpile wall		
Caption:	0313 - No User Rating (Site Visit) - Area of prior seepage on landside sheetpile wall		
Lat/Long:	41.56362/-87.41148

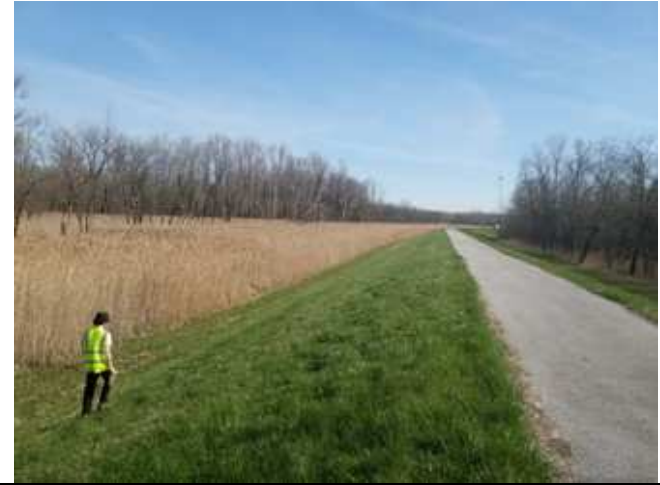
Category:	Interior Drainage System	Item:	Vegetation and Obstr
Observation ID:	2023-0406		
Description:	Vegetation in marsh area (ditch ends) close to the embankment toe		
Caption:	0406 - No User Rating (Site Visit) - Vegetation in marsh area (ditch ends) close to the embankment toe		
Lat/Long:	41.56383/-87.38232

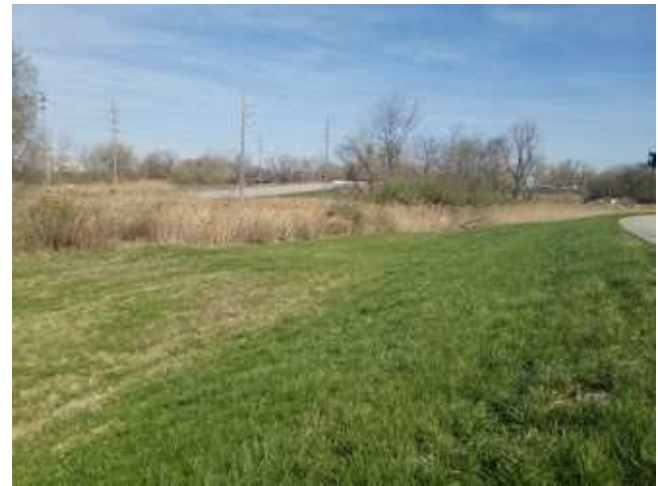
Category:	Interior Drainage System	Item:	Vegetation and Obstr
Observation ID:	2023-0427		
Description:	Small trees and tall vegetation in ditch		
Caption:	0427- No User Rating (Site Visit) - Small trees and tall vegetation in ditch		
Lat/Long:	41.56644/-87.37503

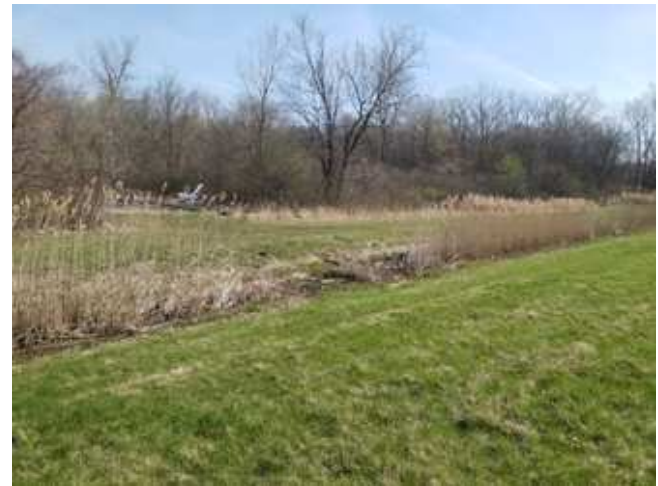
Category:	Interior Drainage System	Item:	Encroachments
Observation ID:	2023-0394		
Description:	Debris in ditch		
Caption:	0394 - No User Rating (Site Visit) - Debris in ditch		
Lat/Long:	41.56293/-87.38618

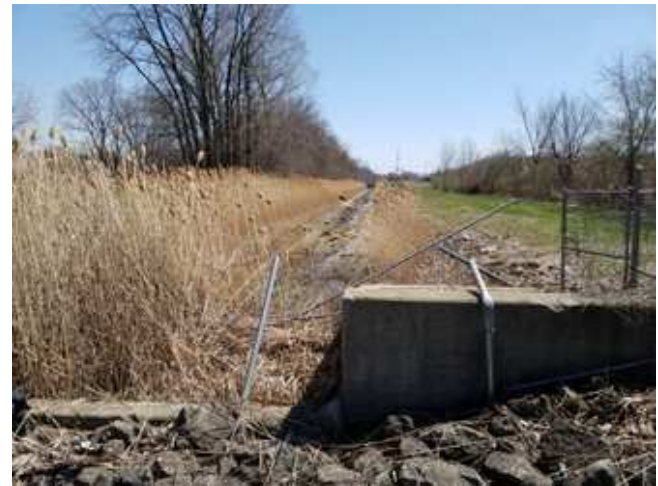
Category:	Interior Drainage System	Item:	Fencing and Gates
Observation ID:	2023-0187		
Description:	Fencing down near culvert near Black Oak Dr.		
Caption:	0187 - No User Rating (Site Visit) - Fencing down near culvert near Black Oak Dr.		
Lat/Long:	41.56635/-87.41589

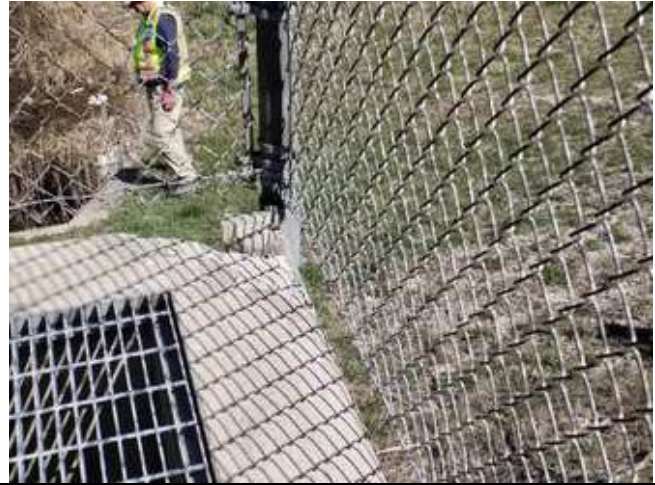
Category:	Interior Drainage System	Item:	Concrete Surfaces (S
Observation ID:	2023-0048		
Description:	GN-16: Spalling of corner		
Caption:	0048 - No User Rating (Site Visit) - GN-16: Spalling of corner		
Lat/Long:	41.56800/-87.32548

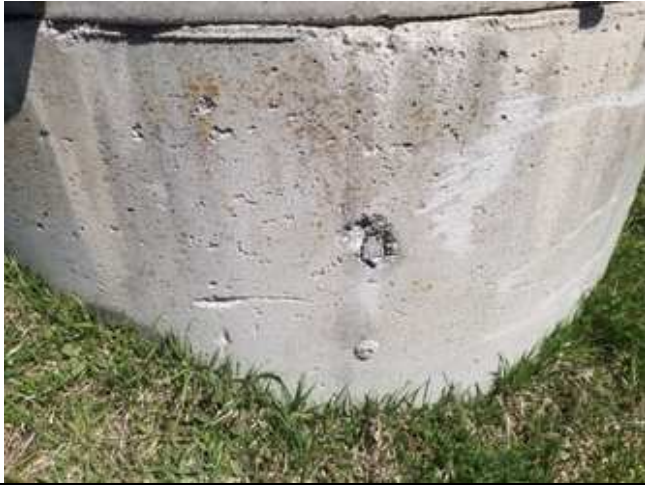
Category:	Interior Drainage System	Item:	Concrete Surfaces (S
Observation ID:	2023-0238		
Description:	GN-01: Spalling concrete on gate well structure		
Caption:	0238 - No User Rating (Site Visit) - GN-01: Spalling concrete on gate well structure		
Lat/Long:	41.56746/-87.41956

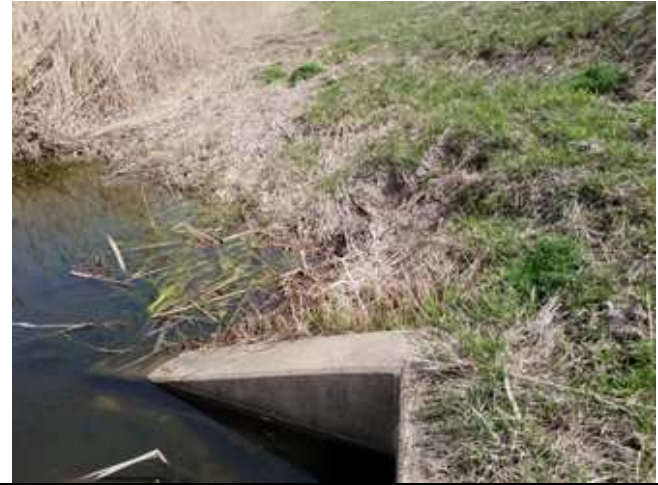
Category:	Interior Drainage System	Item:	Foundation of Concre
Observation ID:	2023-0013		
Description:	GN-1: Erosion at outfall		
Caption:	0013 - No User Rating (Site Visit) - GN-01: Erosion at outfall		
Lat/Long:	41.56853/-87.31709

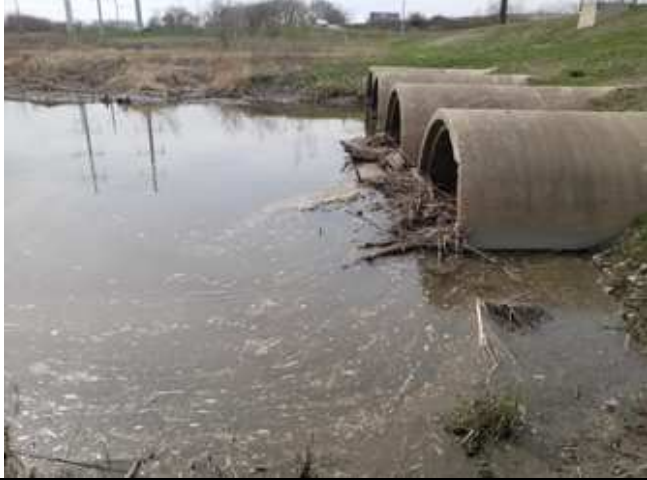
Category:	Interior Drainage System	Item:	Culverts/ Discharge
Observation ID:	2023-0163		
Description:	Debris near pipe inlet. Sponsor removed debris.		
Caption:	0163 - No User Rating (Site Visit) - Debris near pipe inlet		
Lat/Long:	41.56663/-87.32503

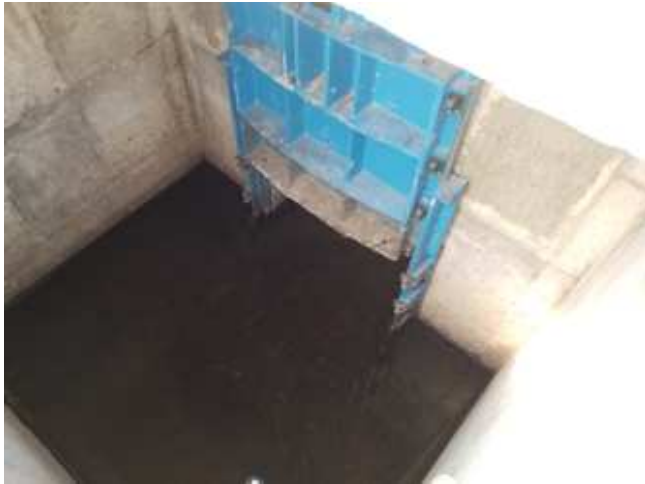
Category:	Interior Drainage System	Item:	Sluice / Slide Gates
Observation ID:	2023-0006		
Description:	Gate 950 open. Couldn't close gate (this was corrected later). Rust on screw for gate		
Caption:	0006 - No User Rating (Site Visit) - Gate 950 open. Couldn't close gate (this was corrected later). Rust on screw for gate		
Lat/Long:	41.56833/-87.31699

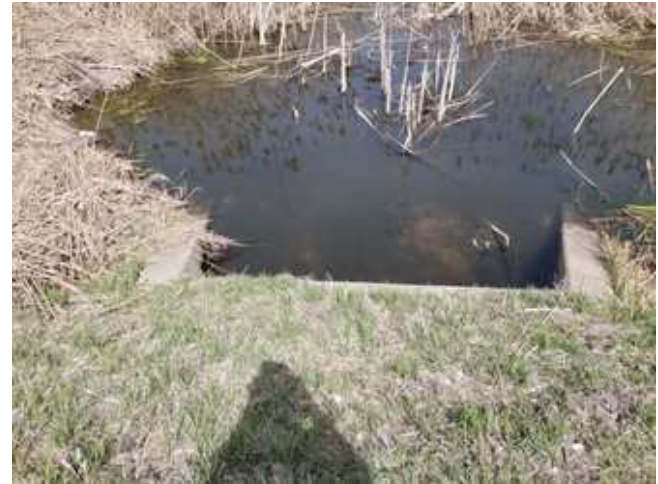
Category:	Interior Drainage System	Item:	Sluice / Slide Gates
Observation ID:	2023-0009		
Description:	GN-20: Outlet structure is clear of obstructions		
Caption:	0009 - No User Rating (Site Visit) - GN-20: Outlet structure is clear of obstructions		
Lat/Long:	41.56850/-87.31707

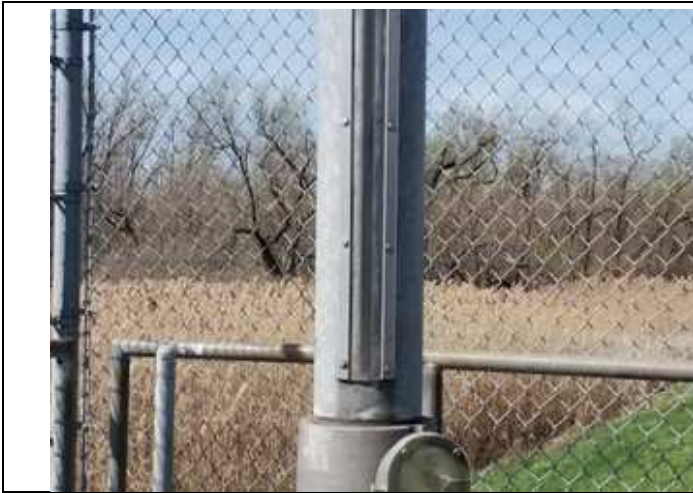
Category:	Interior Drainage System	Item:	Sluice / Slide Gates
Observation ID:	2023-0092		
Description:	GN-08C: Cannot see if gate is fully open but can assume based off shaft.		
Caption:	0092 - No User Rating (Site Visit) - GN-08C: Cannot see if gate is fully open but can assume based off shaft.		
Lat/Long:	41.56586/-87.37691

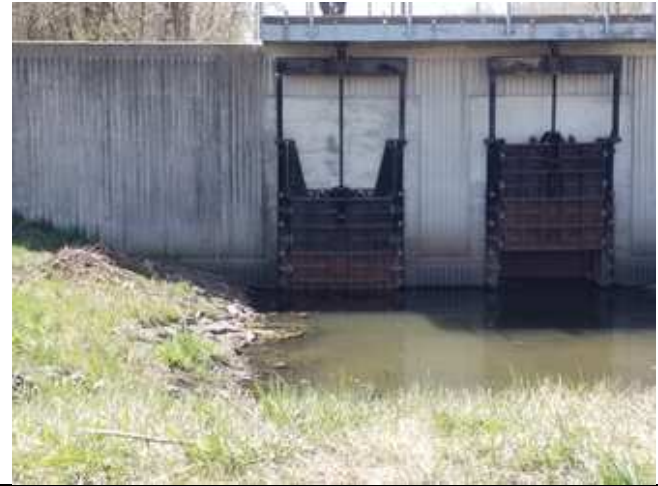
Category:	Interior Drainage System	Item:	Sluice / Slide Gates
Observation ID:	2023-0104		
Description:	GN-09B: Gate opened and closed		
Caption:	0104 - No User Rating (Site Visit) - GN-09B: Gate opened and closed		
Lat/Long:	41.56615/-87.37508

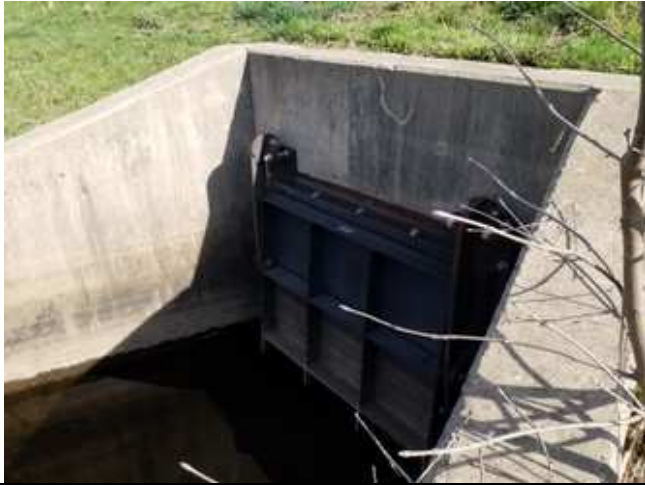
Category:	Interior Drainage System	Item:	Flap Gates/ Flap Val
Observation ID:	2023-0056		
Description:	GN-03: Flap gate in acceptable condition		
Caption:	0056 - No User Rating (Site Visit) - GN-03: Flap gate in acceptable condition		
Lat/Long:	41.56501/-87.41529

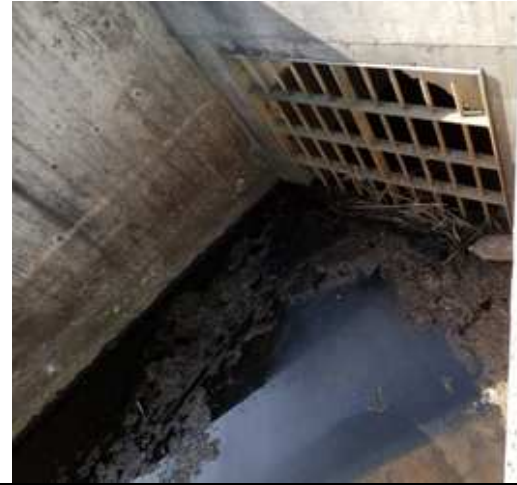
Category:	Interior Drainage System	Item:	Flap Gates/ Flap Val
Observation ID:	2023-0059		
Description:	GN-03: Inlet is in acceptable condition with minimal vegetation		
Caption:	0059 - No User Rating (Site Visit) - GN-03: Inlet is in acceptable condition with minimal vegetation		
Lat/Long:	41.56512/-87.41522

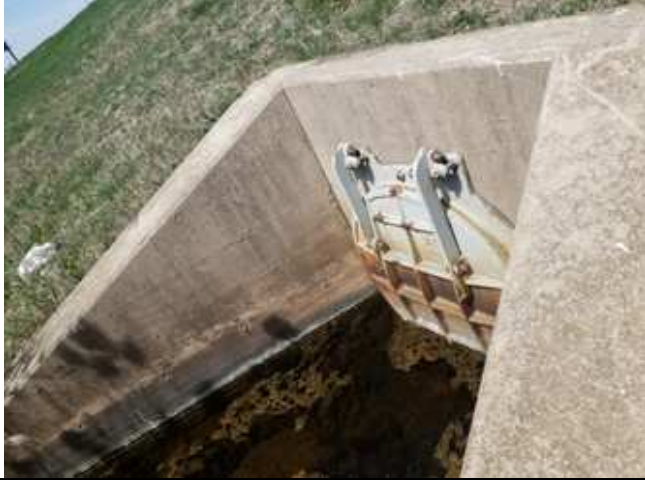
Category:	Interior Drainage System	Item:	Flap Gates/ Flap Val
Observation ID:	2023-0131		
Description:	GN-12: Flap gate in acceptable condition		
Caption:	0131 - No User Rating (Site Visit) - GN-12: Flap gate in acceptable condition		
Lat/Long:	41.56687/-87.32779

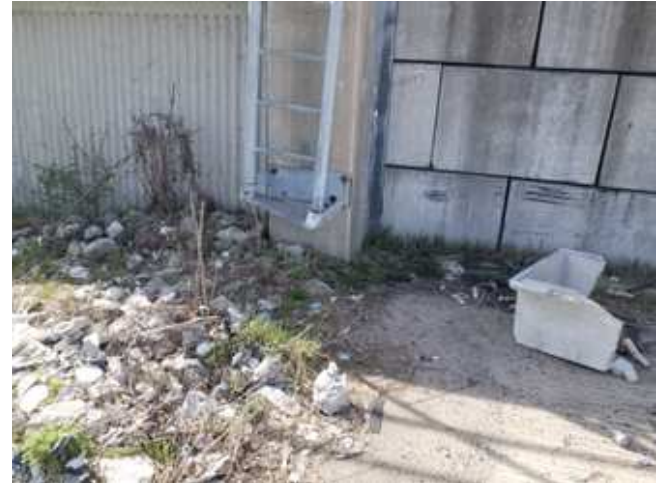
Category:	Interior Drainage System	Item:	Other Metallic Items
Observation ID:	2023-0153		
Description:	Broken ladder on landside face of floodwall		
Caption:	0153 - No User Rating (Site Visit) - Broken ladder on landside face of floodwall		
Lat/Long:	41.56610/-87.37527

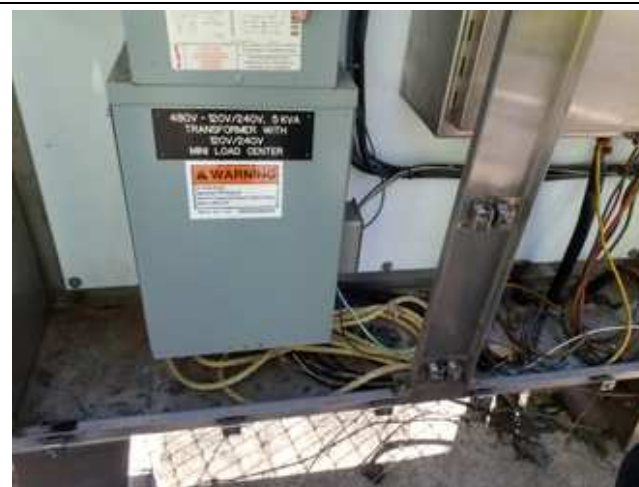
Category:	Pump Stations	Item:	Pump Station Operati
Observation ID:	2023-0008		
Description:	PS-IW: Operations manual not onsite. Found in office.		
Caption:	0008 - No User Rating (Site Visit) - PS-IW: Operations manual not onsite. Found in office.		
Lat/Long:	41.57300/-87.32151

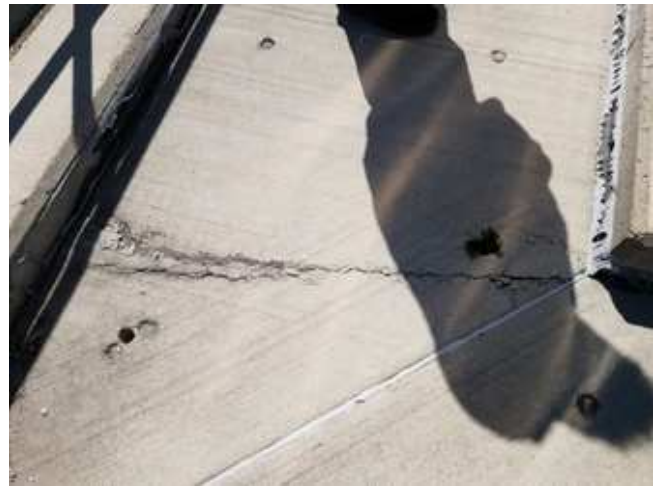
Category:	Pump Stations	Item:	Plant Building
Observation ID:	2023-0047		
Description:	PS-BR: Cracking in concrete.		
Caption:	0047 - No User Rating (Site Visit) - PS-BR: Cracking in concrete.		
Lat/Long:	41.56096/-87.40232

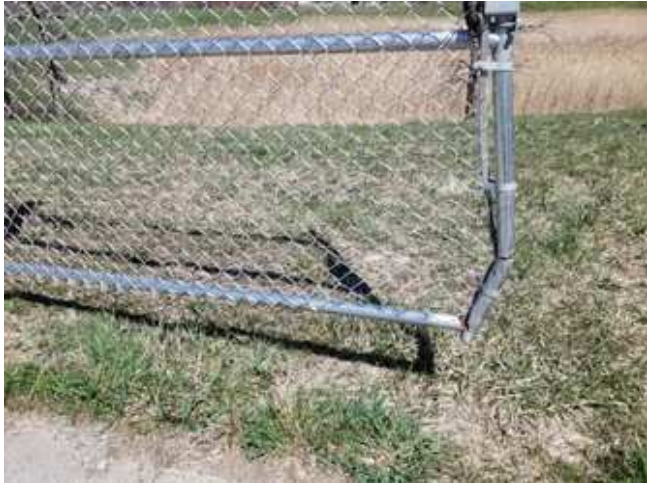
Category:	Pump Stations	Item:	Fencing and Gates
Observation ID:	2023-0053		
Description:	PS-BR: Fence damaged at entrance.		
Caption:	0053 - No User Rating (Site Visit) - PS-BR: Fence damaged at entrance.		
Lat/Long:	41.56088/-87.40290

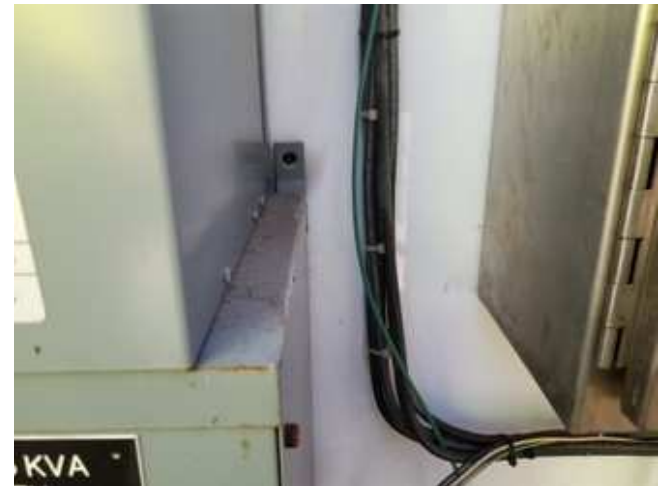
Category:	Pump Stations	Item:	Electrical Systems
Observation ID:	2023-0014		
Description:	PS-IW: Nut and bolt missing on transformer		
Caption:	0014 - No User Rating (Site Visit) - PS-IW: Nut and bolt missing on transformer		
Lat/Long:	41.57300/-87.32153

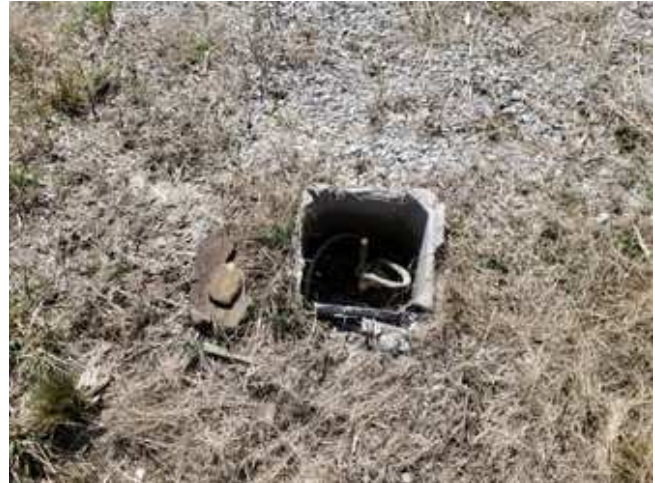
Category:	Pump Stations	Item:	Electrical Systems
Observation ID:	2023-0041		
Description:	PS-BR: Cover missing from ground well		
Caption:	0041 - No User Rating (Site Visit) - PS-BR: Cover missing from ground well		
Lat/Long:	41.56096/-87.40220
