## Site Visit Summary

Name of System: Gary

Name of Segment: Gary South

Date of Site Visit: 04/11/2023 - 04/12/2023

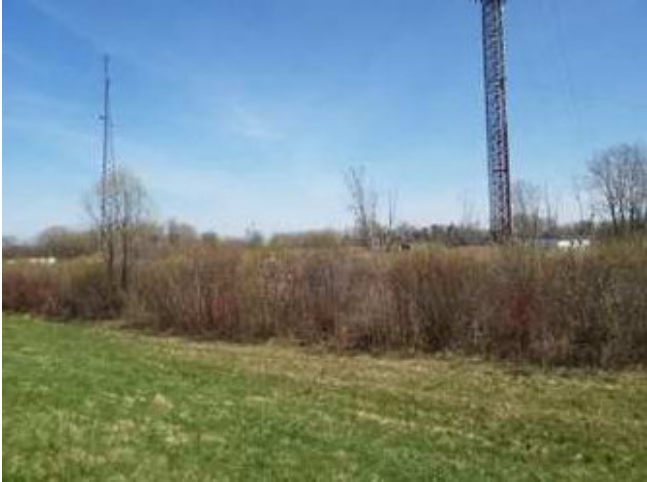
Category:	Levee Embankments	Item:	Unwanted Vegetation
Observation ID:	2023-0010		
Description:	Small trees in the ditch along the landside toe.		
Caption:	0010 - No User Rating (Site Visit) - Small trees in the ditch along the landside toe.		
Lat/Long:	41.55272/-87.37468

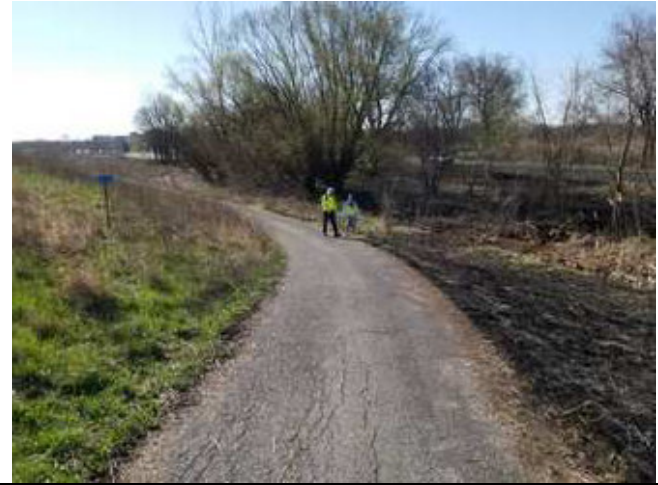
Category:	Levee Embankments	Item:	Unwanted Vegetation
Observation ID:	2023-0136		
Description:	Vegetation was not burned along the left side portion of the levee embankment located east of North Gleason Park.		
Caption:	0316 - No User Rating (Site Visit) - Vegetation was not burned along the left side portion of the levee embankment located east of North Gleason Park.		
Lat/Long:	41.56088/-87.34441

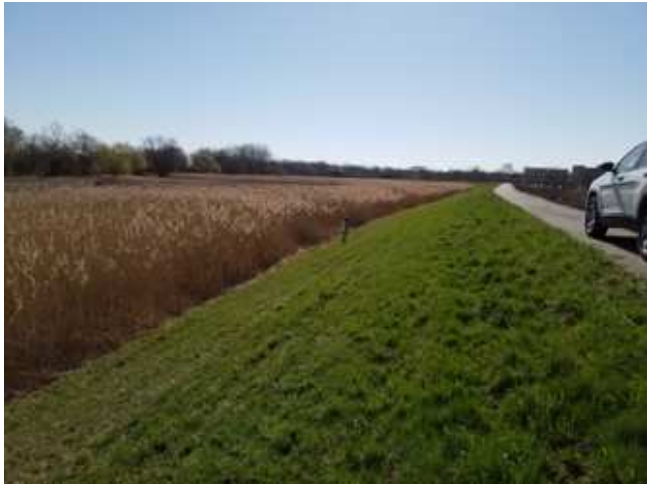
Category:	Levee Embankments	Item:	Unwanted Vegetation
Observation ID:	2023-0148		
Description:	Vegetation along the riverside toe.		
Caption:	0148 - No User Rating (Site Visit) - Vegetation along the riverside toe.		
Lat/Long:	41.56028/-87.34350

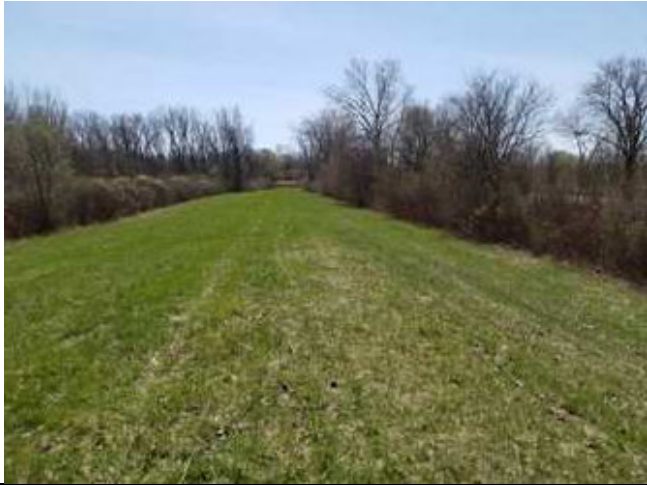
Category:	Levee Embankments	Item:	Sod Cover
Observation ID:	2023-0013		
Description:	Good sod cover noted.		
Caption:	0013 - No User Rating (Site Visit) - Good sod cover noted.		
Lat/Long:	41.55452/-87.37481

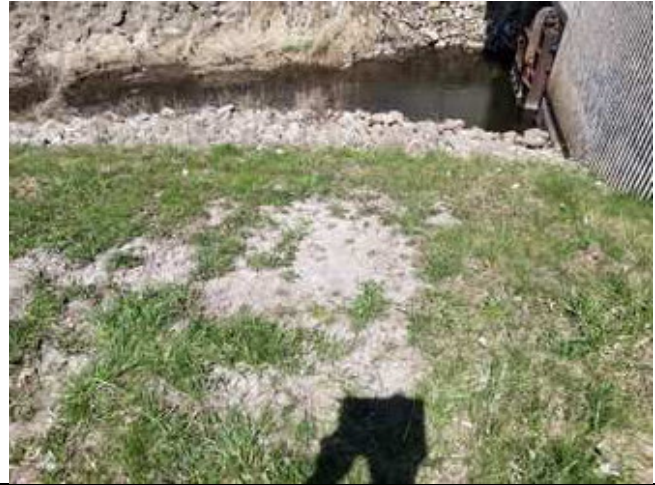
Category:	Levee Embankments	Item:	Sod Cover
Observation ID:	2023-0022		
Description:	Poor sod cover on the riverside slope.		
Caption:	0022 - No User Rating (Site Visit) - Poor sod cover on the riverside slope.		
Lat/Long:	41.55525/-87.37458

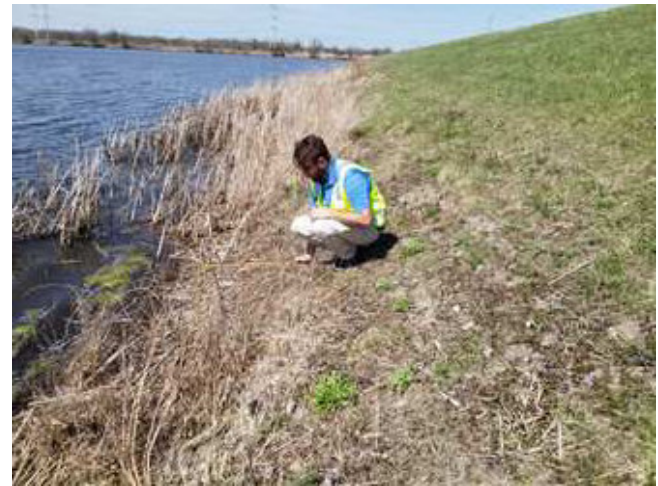
Category:	Levee Embankments	Item:	Erosion/ Bank Caving
Observation ID:	2023-0082		
Description:	Caving along the riverside toe located south of the Little Cal river (parallel to Grant Street).		
Caption:	0082 - No User Rating (Site Visit) - Caving along the riverside toe located south of the Little Cal river (parallel to Grant Street).		
Lat/Long:	41.56122/-87.35943

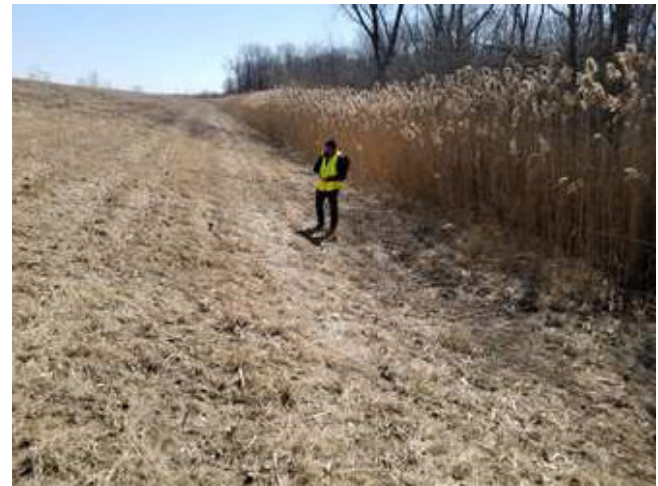
Category:	Levee Embankments	Item:	Erosion/ Bank Caving
Observation ID:	2023-0229		
Description:	Erosion of about 8-inch deep x 8-ft long x 5-ft wide located on the landside toe east of Georgia Street.		
Caption:	0229 - No User Rating (Site Visit) - Erosion of about 8-inch deep x 8-ft long x 5-ft wide located on the landside toe east of Georgia Street.		
Lat/Long:	41.56055/-87.32591

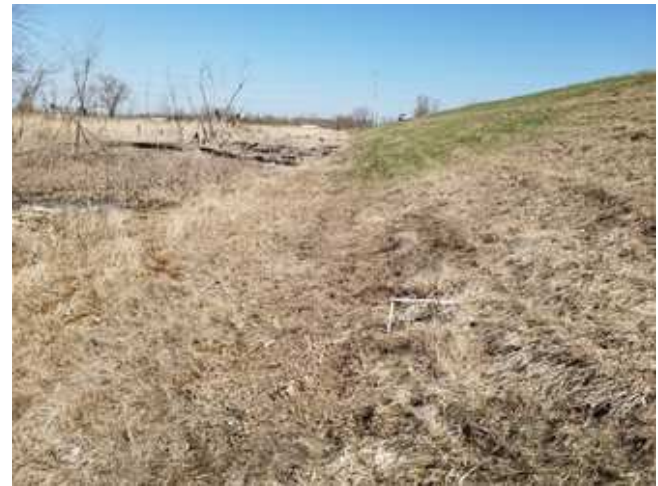
Category:	Levee Embankments	Item:	Erosion/ Bank Caving
Observation ID:	2023-0259		
Description:	Slope/bank erosion on the riverside slope west of Martin Luther King Drive.		
Caption:	0259 - No User Rating (Site Visit) - Slope/bank erosion on the riverside slope west of Martin Luther King Drive.		
Lat/Long:	41.56186/-87.31935

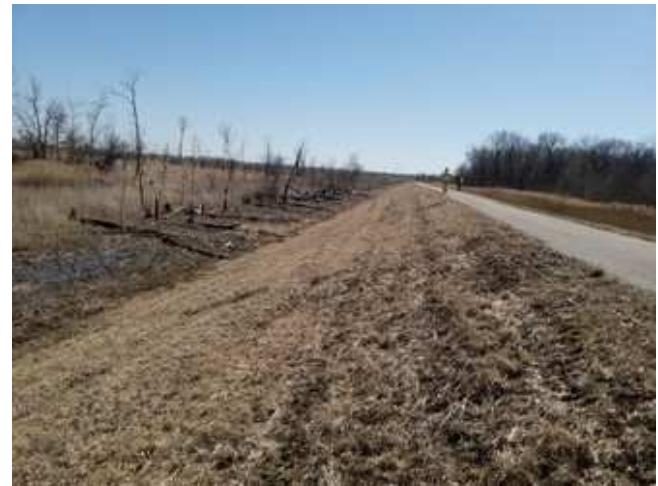
Category:	Levee Embankments	Item:	Depressions/ Rutting
Observation ID:	2023-0235		
Description:	Some ruts along the riverside slope located 500 feet east of Georgia Street.		
Caption:	0235 - No User Rating (Site Visit) - Some ruts along the riverside slope located 500 feet east of Georgia Street.		
Lat/Long:	41.56068/-87.32559

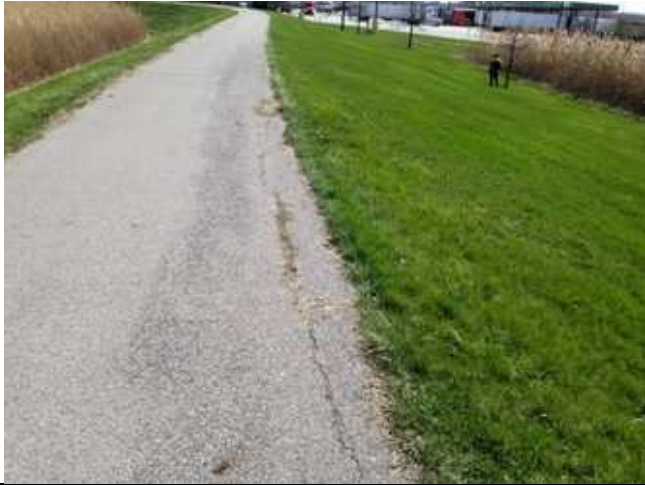
Category:	Levee Embankments	Item:	Cracking
Observation ID:	2023-0109		
Description:	Asphalt cracking on the levee crown located at SE of Little Cal river and Grant Street.		
Caption:	0109 - No User Rating (Site Visit) - Asphalt cracking on the levee crown located at SE of Little Cal river and Grant Street.		
Lat/Long:	41.56413/-87.35349

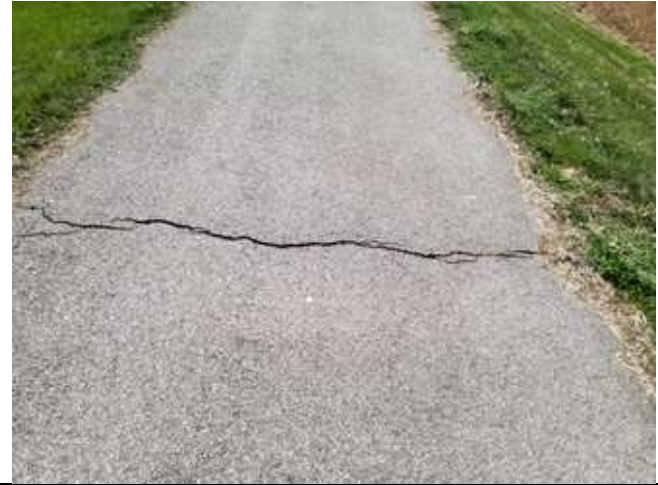
Category:	Levee Embankments	Item:	Cracking
Observation ID:	2023-0115		
Description:	Asphalt cracking on the levee crown located at SE of Little Cal river and Grant Street.		
Caption:	0115 - No User Rating (Site Visit) - Asphalt cracking on the levee crown located at SE of Little Cal river and Grant Street.		
Lat/Long:	41.56377/-87.35265

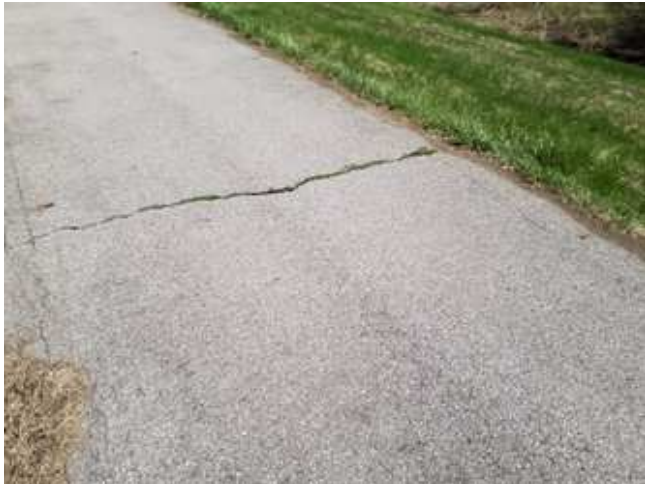
Category:	Levee Embankments	Item:	Cracking
Observation ID:	2023-0124		
Description:	Vegetation in the asphalt crack on the levee crown located about 600 feet west of Harrison Street and W. 30th Avenue.		
Caption:	0124 - No User Rating (Site Visit) - Vegetation in the asphalt crack on the levee crown located about 600 feet west of Harrison Street and W. 30th Avenue.		
Lat/Long:	41.56383/-87.34842

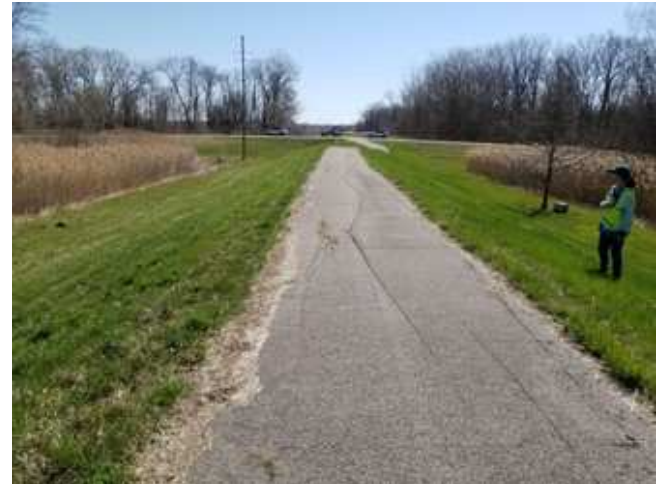
Category:	Levee Embankments	Item:	Cracking
Observation ID:	2023-0214		
Description:	Longitudinal cracking and depression on the levee crown located about 250 feet west of Georgia Street.		
Caption:	0214 - No User Rating (Site Visit) - Longitudinal cracking and depression on the levee crown located about 250 feet west of Georgia Street.		
Lat/Long:	41.56070/-87.32810

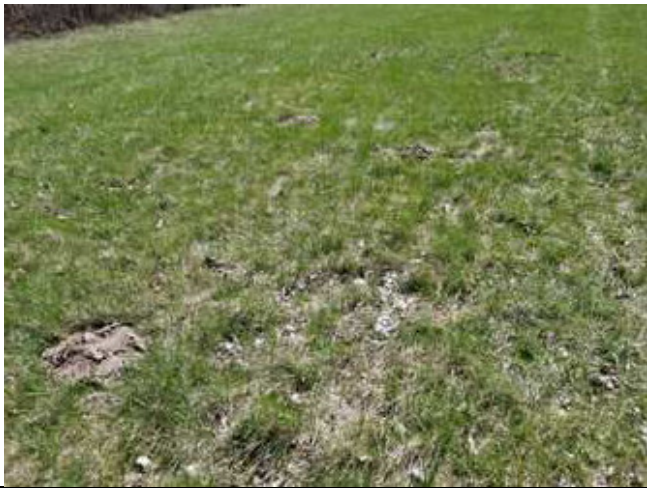
Category:	Levee Embankments	Item:	Animal Control
Observation ID:	2023-0016		
Description:	Animal burrow activity on the landside slope located SE of Chase Street and W. 35th Avenue.		
Caption:	0016 - No User Rating (Site Visit) - Animal burrow activity on the landside slope located SE of Chase Street and W. 35th Avenue.		
Lat/Long:	41.55469/-87.37475

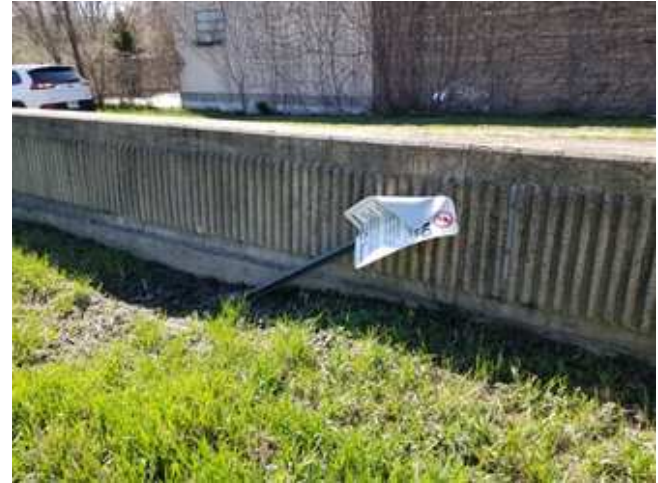
Category:	Floodwalls	Item:	Encroachments
Observation ID:	2023-0193		
Description:	Broken signage near Broadway encroaching on riverside of floodwall.		
Caption:	0193 - No User Rating (Site Visit) - Broken signage near Broadway encroaching on riverside of floodwall.		
Lat/Long:	41.56071/-87.33639

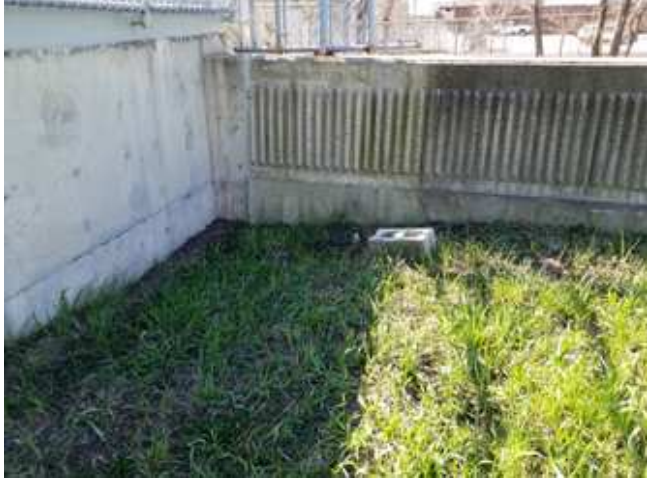
Category:	Floodwalls	Item:	Encroachments
Observation ID:	2023-0196		
Description:	Cinder block encroaching on riverside of floodwall near Broadway.		
Caption:	0196 - No User Rating (Site Visit) - Cinder block encroaching on riverside of floodwall near Broadway.		
Lat/Long:	41.56074/-87.33636

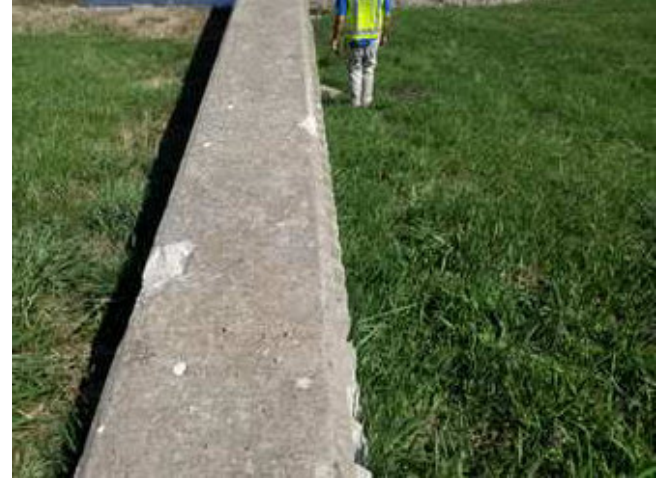
Category:	Floodwalls	Item:	Concrete Surfaces
Observation ID:	2023-0094		
Description:	Concrete spalling on top of floodwall near Grant Street.		
Caption:	0094 - No User Rating (Site Visit) - Concrete spalling on top of floodwall near Grant Street.		
Lat/Long:	41.56467/-87.35691

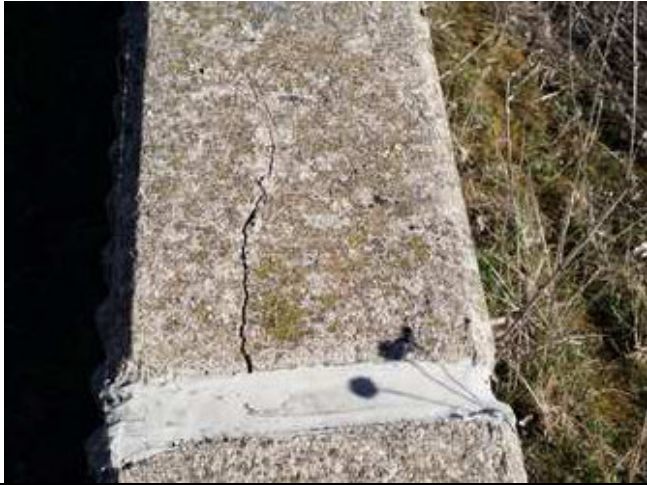
Category:	Floodwalls	Item:	Concrete Surfaces
Observation ID:	2023-0178		
Description:	Concrete crack on top of floodwall near Broadway.		
Caption:	0178 - No User Rating (Site Visit) - Concrete crack on top of floodwall near Broadway.		
Lat/Long:	41.56011/-87.33756

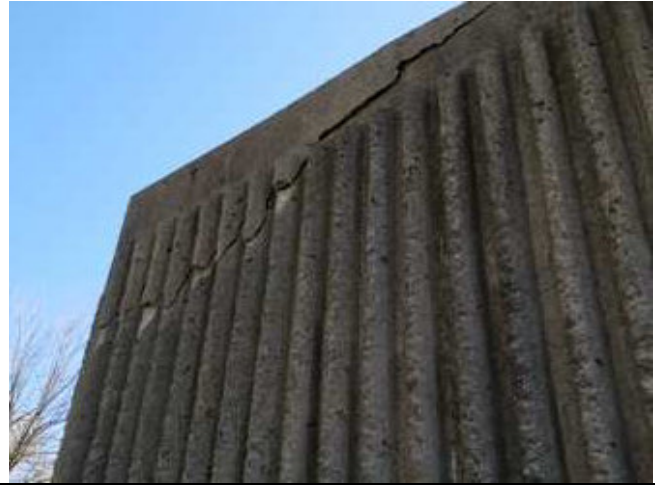
Category:	Floodwalls	Item:	Concrete Surfaces
Observation ID:	2023-0181		
Description:	Fascia spalling on floodwall facing near Broadway.		
Caption:	0181 - No User Rating (Site Visit) - Fascia spalling on floodwall facing near Broadway.		
Lat/Long:	41.56027/-87.33757

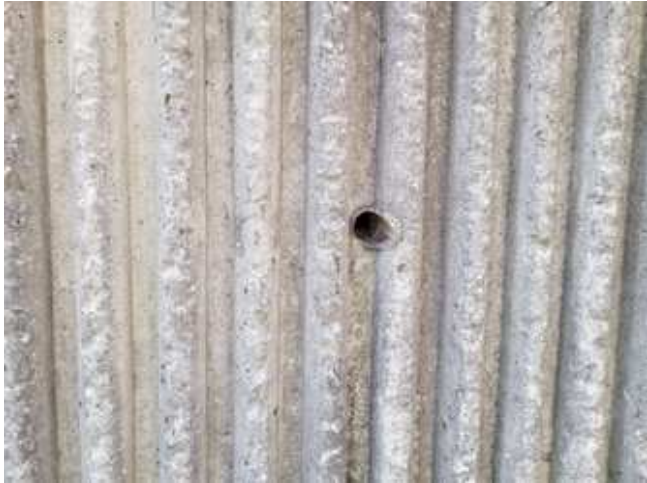
Category:	Floodwalls	Item:	Concrete Surfaces
Observation ID:	2023-0184		
Description:	Hole in the floodwall facing near Broadway about 4 inches deep by 2-inch diameter.		
Caption:	0184 - No User Rating (Site Visit) - Hole in the floodwall facing near Broadway about 4 inches deep by 2-inch diameter.		
Lat/Long:	41.56052/-87.33732

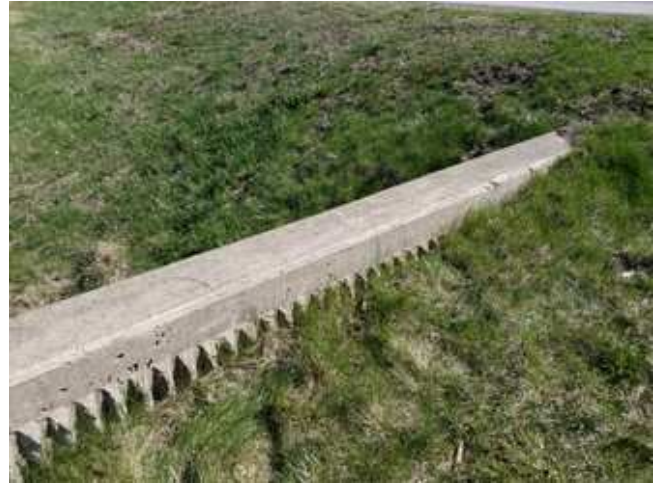
Category:	Floodwalls	Item:	Concrete Surfaces
Observation ID:	2023-0220		
Description:	Concrete crack on top of floodwall (facing the riverside) near Georgia Street.		
Caption:	0220 - No User Rating (Site Visit) - Concrete crack on top of floodwall (facing the riverside) near Georgia Street.		
Lat/Long:	41.56065/-87.32715

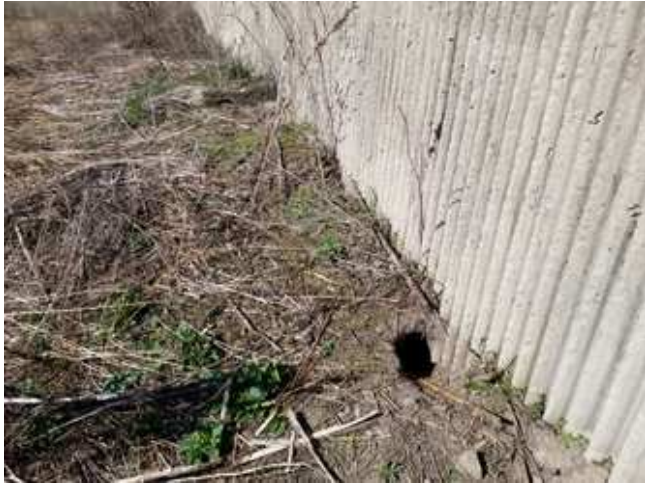
Category:	Floodwalls	Item:	Foundation of Concre
Observation ID:	2023-0190		
Description:	Animal burrow activity on the floodwall base near Broadway to about 8 feet long by 2 feet deep.		
Caption:	0190 - No User Rating (Site Visit) - Animal burrow activity on the floodwall base near Broadway to about 8 feet long by 2 feet deep.		
Lat/Long:	41.56043/-87.33721

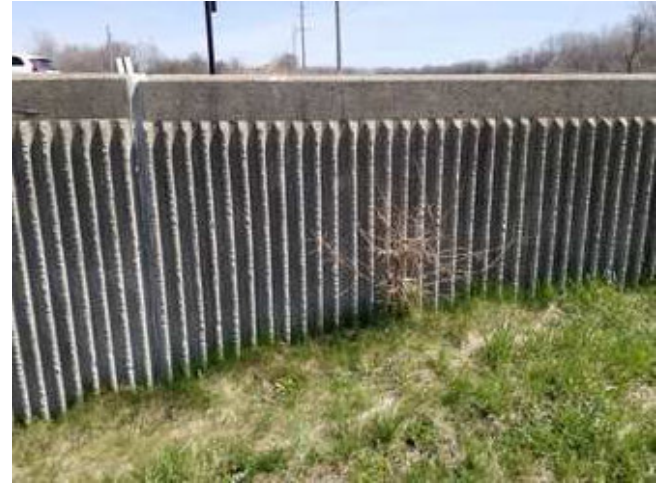
Category:	Floodwalls	Item:	Monolith Joints
Observation ID:	2023-0019		
Description:	Small tree in the wall joints and sealant wearing down/cracking near the intersection of W. 35th Avenue and Chase Street.		
Caption:	0019 - No User Rating (Site Visit) - Small tree in the wall joints and sealant wearing down/cracking near the intersection of W. 35th Avenue and Chase Street.		
Lat/Long:	41.55508/-87.37477

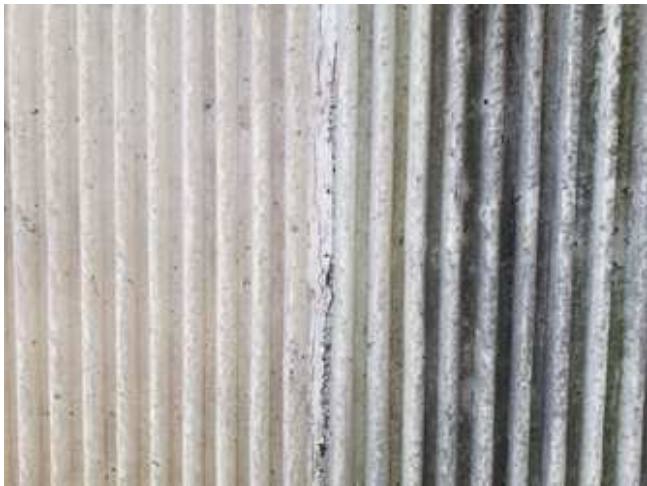
Category:	Floodwalls	Item:	Monolith Joints
Observation ID:	2023-0139		
Description:	Sealant not cured in the wall east of North Gleason Park.		
Caption:	0139 - No User Rating (Site Visit) - Sealant not cured in the wall east of North Gleason Park.		
Lat/Long:	41.56077/-87.34416

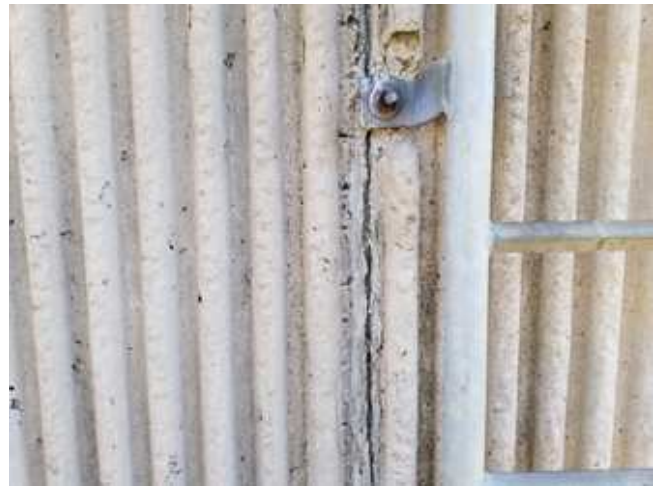
Category:	Floodwalls	Item:	Monolith Joints
Observation ID:	2023-0142		
Description:	Sealant cracks in the wall east of North Gleason Park.		
Caption:	0142 - No User Rating (Site Visit) - Sealant cracks in the wall east of North Gleason Park.		
Lat/Long:	41.56057/-87.34400

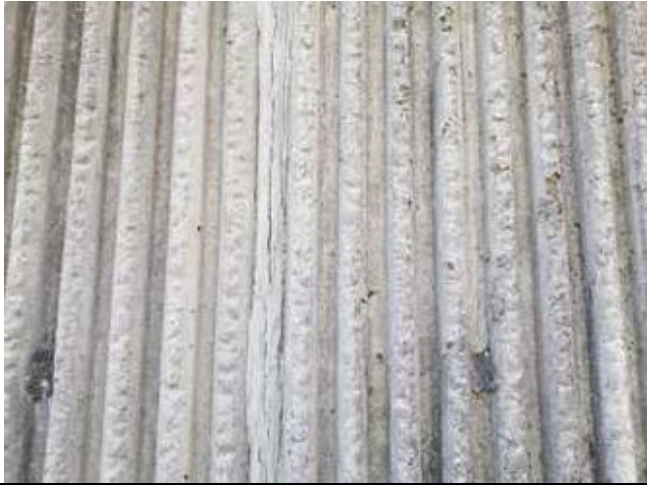
Category:	Floodwalls	Item:	Monolith Joints
Observation ID:	2023-0187		
Description:	Sealant cracks in the wall near Broadway.		
Caption:	0187 - No User Rating (Site Visit) - Sealant cracks in the wall near Broadway.		
Lat/Long:	41.56060/-87.33716

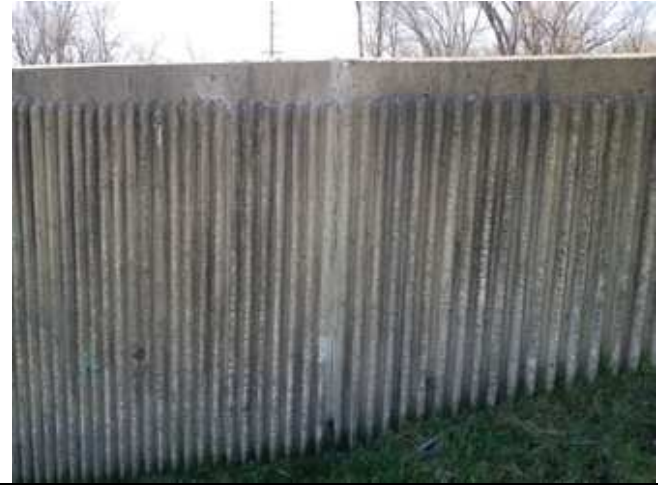
Category:	Floodwalls	Item:	Monolith Joints
Observation ID:	2023-0217		
Description:	Sealant cracking in the wall joints near Georgia Street.		
Caption:	0217 - No User Rating (Site Visit) - Sealant cracking in the wall joints near Georgia Street.		
Lat/Long:	41.56066/-87.32731

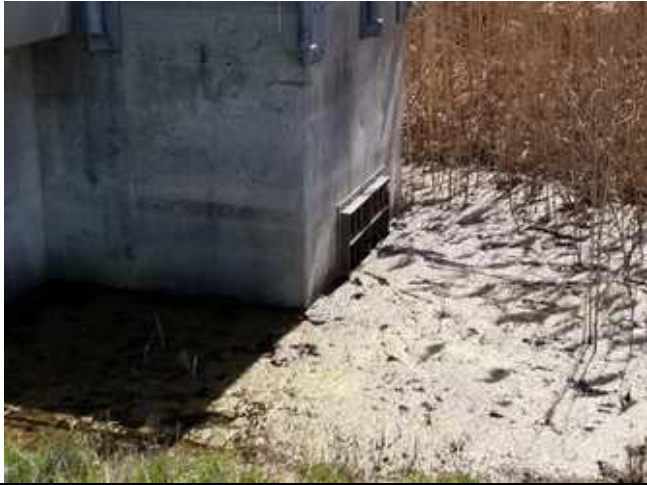
Category:	Interior Drainage System	Item:	Vegetation and Obstr
Observation ID:	2023-0033		
Description:	GS-3: Some debris at the SW gate in the ditch.		
Caption:	0033 - No User Rating (Site Visit) - GS-3: Some debris at the SW gate in the ditch.		
Lat/Long:	41.55883/-87.35925

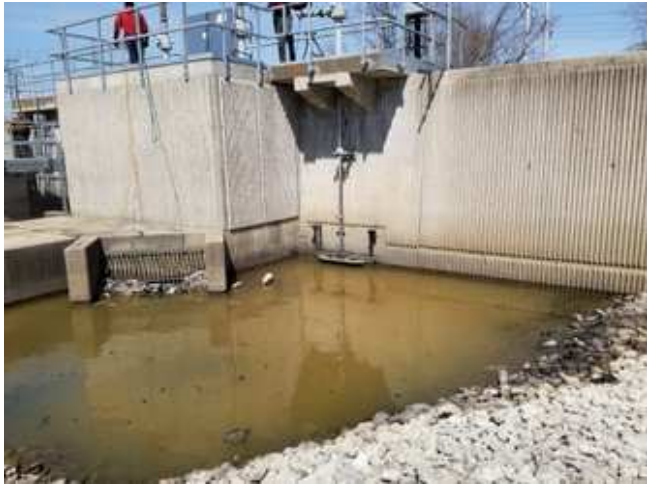
Category:	Interior Drainage System	Item:	Vegetation and Obstr
Observation ID:	2023-0057		
Description:	GS-6c: Some debris was noted when gate was opened and closed. Gate closed completely.		
Caption:	0057 - No User Rating (Site Visit) - GS-6c: Some debris was noted when gate was opened and closed. Gate closed completely.		
Lat/Long:	41.56458/-87.35518

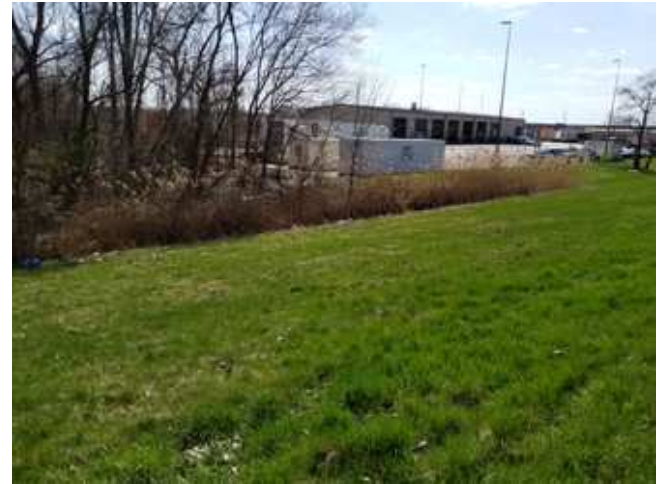
Category:	Interior Drainage System	Item:	Vegetation and Obstr
Observation ID:	2023-0118		
Description:	Vegetation in ditches located east of Grant Street.		
Caption:	0118 - No User Rating (Site Visit) - Vegetation in ditches located east of Grant Street.		
Lat/Long:	41.56375/-87.35264

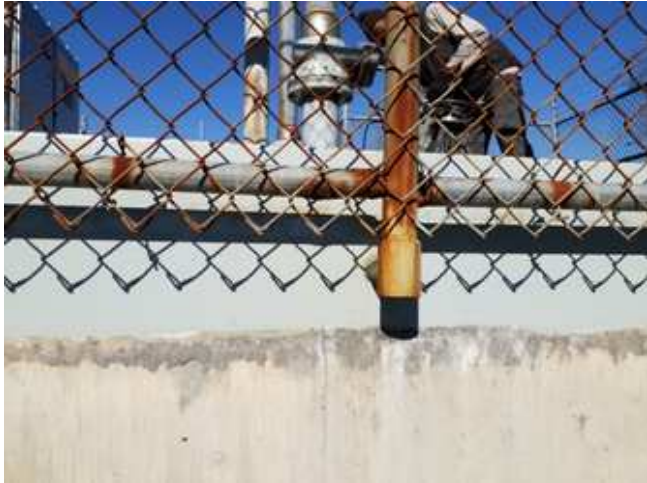
Category:	Interior Drainage System	Item:	Fencing and Gates
Observation ID:	2023-0096		
Description:	Corrosion of fence on GS-12 near Broadway.		
Caption:	0096 - No User Rating (Site Visit) - Corrosion of fence on GS-12 near Broadway.		
Lat/Long:	41.56073/-87.33595

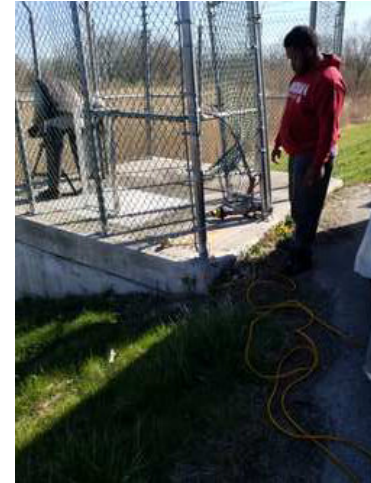
Category:	Interior Drainage System	Item:	Fencing and Gates
Observation ID:	2023-0105		
Description:	GS-14: fence and post broken.		
Caption:	0105 - No User Rating (Site Visit) - GS-14: fence and post broken.		
Lat/Long:	41.56066/-87.33364

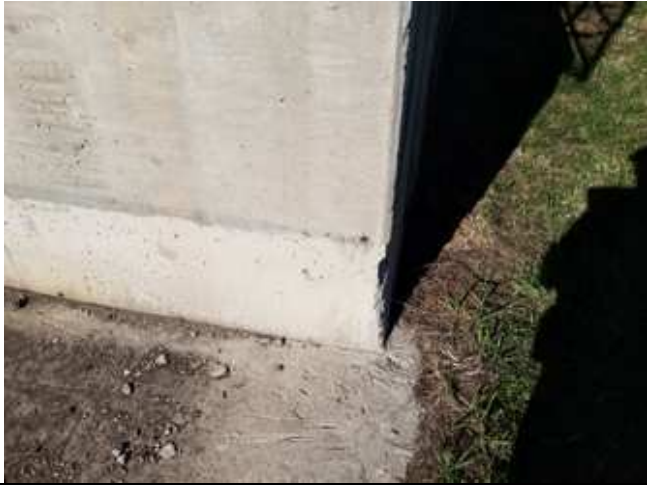
Category:	Interior Drainage System	Item:	Concrete Surfaces (S
Observation ID:	2023-0099		
Description:	Typical spalling of concrete at corners of GS-12 structure near Broadway.		
Caption:	0099 - No User Rating (Site Visit) - Typical spalling of concrete at corners of GS-12 structure near Broadway.		
Lat/Long:	41.56076/-87.33597

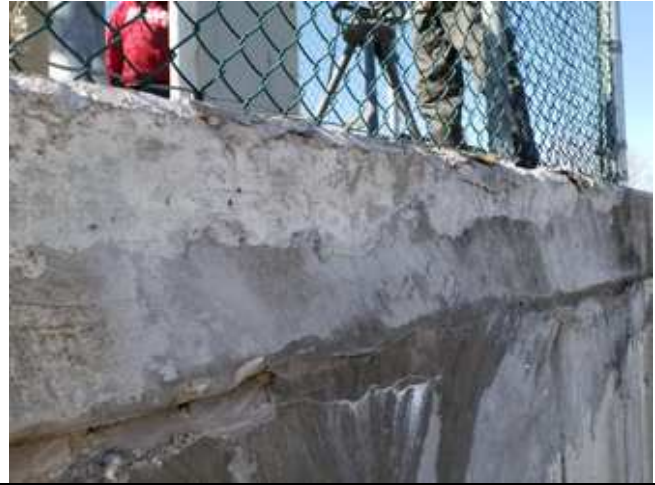
Category:	Interior Drainage System	Item:	Concrete Surfaces (S
Observation ID:	2023-0111		
Description:	Delamination and spalling in concrete at patch and corners at GS-14 near Broadway.		
Caption:	0111 - No User Rating (Site Visit) - Delamination and spalling in concrete at patch and corners at GS-14 near Broadway.		
Lat/Long:	41.56069/-87.33362

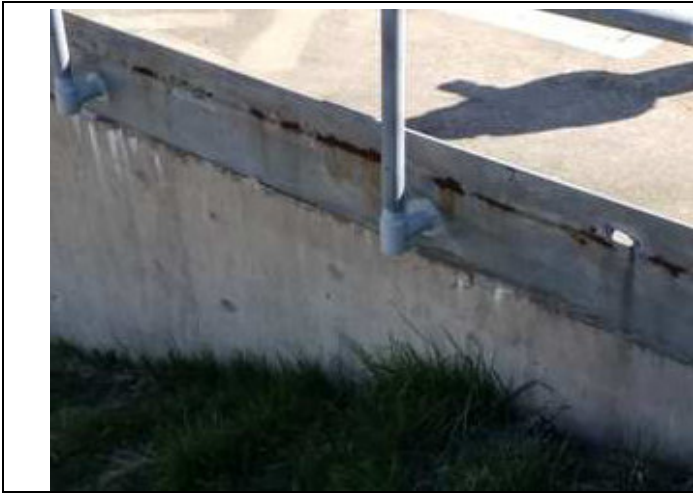
Category:	Interior Drainage System	Item:	Concrete Surfaces (S
Observation ID:	2023-0120		
Description:	Delamination and spalling in concrete at patch and corners at GS-15 near Broadway.		
Caption:	0120 - No User Rating (Site Visit) - Delamination and spalling in concrete at patch and corners at GS-15 near Broadway.		
Lat/Long:	41.56069/-87.33299

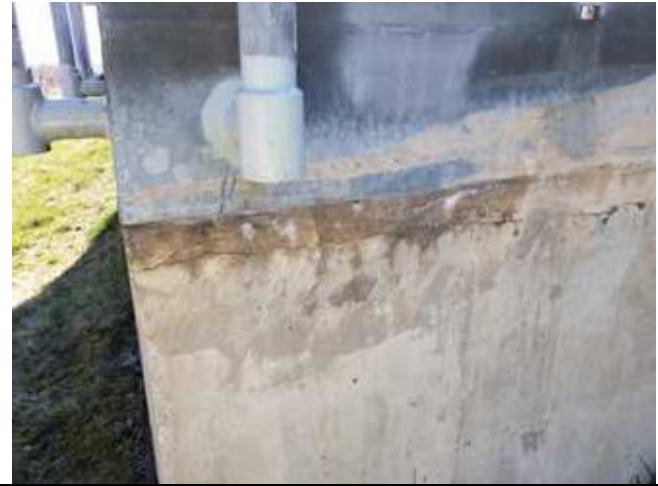
Category:	Interior Drainage System	Item:	Concrete Surfaces (S
Observation ID:	2023-0129		
Description:	Delamination and spalling in concrete at joints at GS-16 near Georgia Street.		
Caption:	0129 - No User Rating (Site Visit) - Delamination and spalling in concrete at joints at GS-16 near Georgia Street.		
Lat/Long:	41.56071/-87.32670

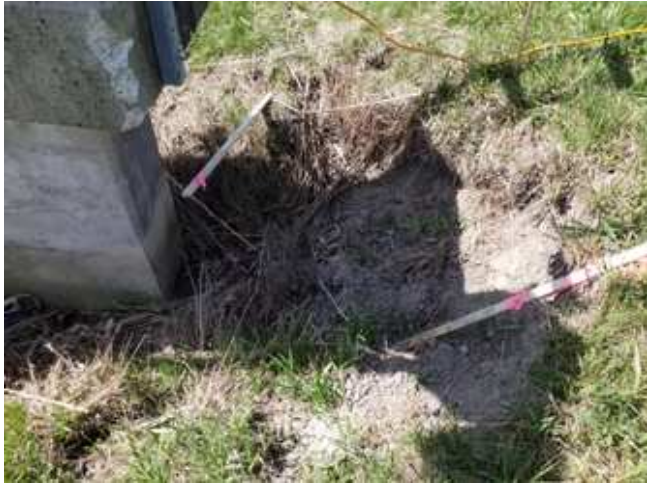
Category:	Interior Drainage System	Item:	Foundation of Concre
Observation ID:		2023-0039	
Description:	Erosion around GS-3 and access ramp structures near Grant Street.		
Caption:	0039 - No User Rating (Site Visit) - Erosion around GS-3 and access ramp structures near Grant Street.		
Lat/Long:	41.55886/-87.35949

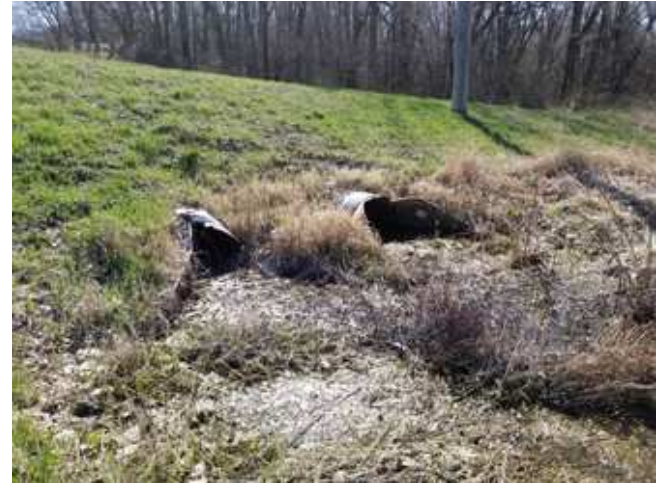
Category:	Interior Drainage System	Item:	Culverts/ Discharge
Observation ID:		2023-0208	
Description:	Debris and some damage were observed at the pipe invert near Delaware Street.		
Caption:	0208 - No User Rating (Site Visit) - Debris and some damage were observed at the pipe invert near Delaware Street.		
Lat/Long:	41.56049/-87.33207

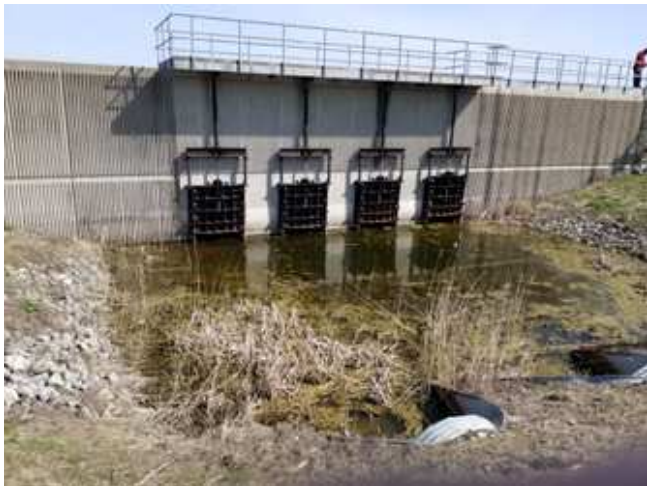
Category:	Interior Drainage System	Item:	Sluice / Slide Gates
Observation ID:	2023-0018		
Description:	GS-2a-d: Gates were partially open; acceptable conditions.		
Caption:	0018 - No User Rating (Site Visit) - GS-2a-d: Gates were partially open; acceptable conditions.		
Lat/Long:	41.55879/-87.36691

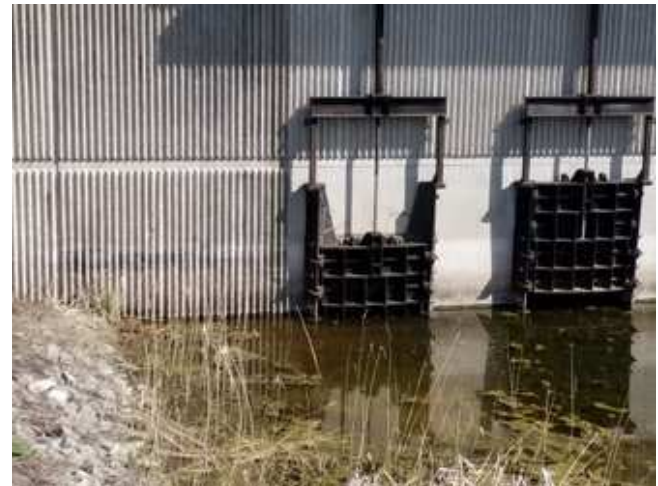
Category:	Interior Drainage System	Item:	Sluice / Slide Gates
Observation ID:	2023-0021		
Description:	GS-2a: gate closed completely.		
Caption:	0021 - No User Rating (Site Visit) - GS-2a: gate closed completely.		
Lat/Long:	41.55879/-87.36691

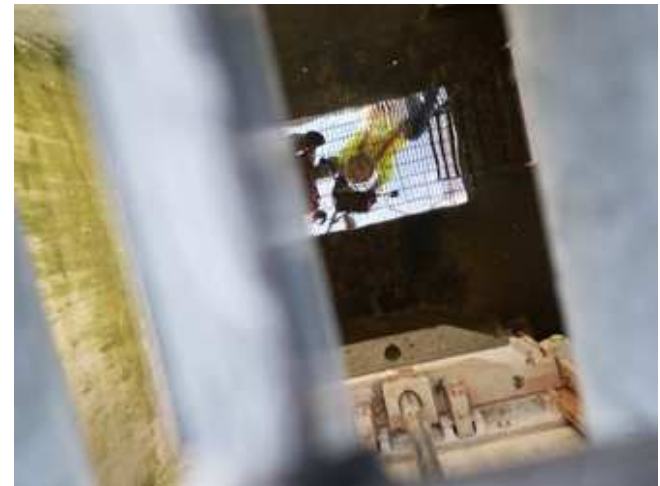
Category:	Interior Drainage System	Item:	Sluice / Slide Gates
Observation ID:	2023-0042		
Description:	GS-3: closed completely.		
Caption:	0042 - No User Rating (Site Visit) - GS-3: closed completely.		
Lat/Long:	41.55894/-87.35974

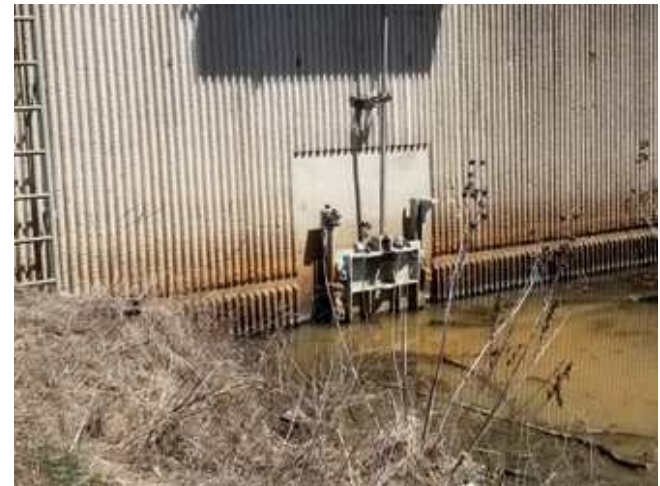
Category:	Interior Drainage System	Item:	Sluice / Slide Gates
Observation ID:	2023-0063		
Description:	GS-10: Gate opened and closed completely. No sediment noted.		
Caption:	0063 - No User Rating (Site Visit) - GS-10: Gate opened and closed completely. No sediment noted.		
Lat/Long:	41.56061/-87.34399

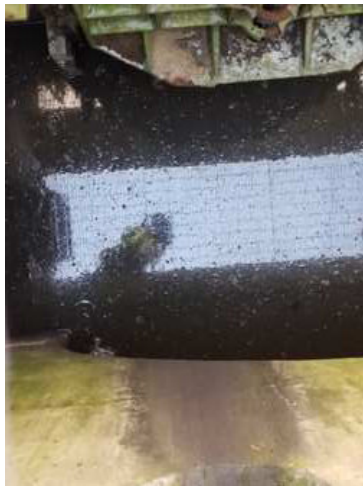
Category:	Interior Drainage System	Item:	Sluice / Slide Gates
Observation ID:	2023-0072		
Description:	GS-11a: gate was opened, no sediment noted.		
Caption:	0072 - User Rating (Site Visit) - GS-11a: gate was opened, no sediment noted.		
Lat/Long:	41.56077/-87.33638

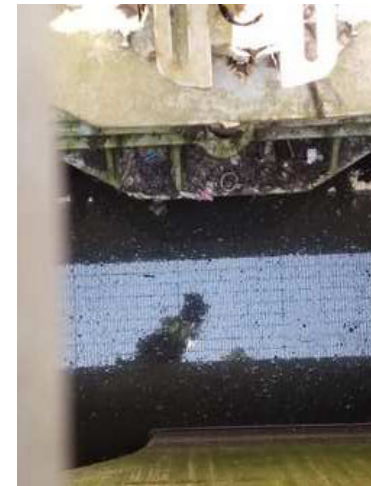
Category:	Interior Drainage System	Item:	Sluice / Slide Gates
Observation ID:	2023-0075		
Description:	GS-11b: gate opened.		
Caption:	0075 - No User Rating (Site Visit) - GS-11b: gate opened.		
Lat/Long:	41.56074/-87.33635

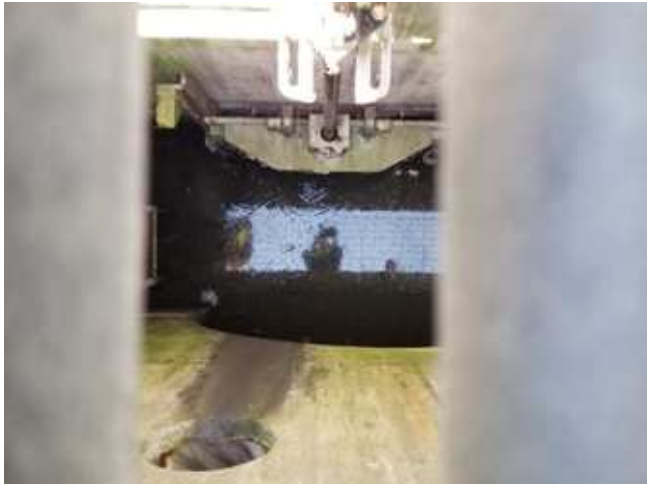
Category:	Interior Drainage System	Item:	Sluice / Slide Gates
Observation ID:	2023-0078		
Description:	GS-11a: gate partially closed. Sediment/silt obstruction was noted.		
Caption:	0078 - No User Rating (Site Visit) - GS-11a: gate partially closed. Sediment/silt obstruction was noted.		
Lat/Long:	41.56075/-87.33641

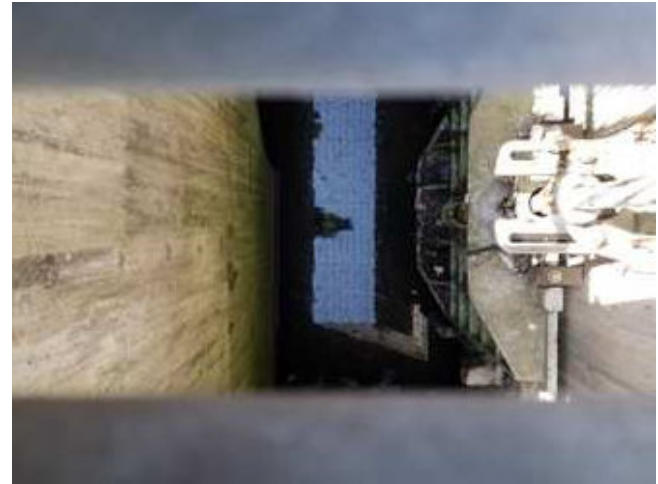
Category:	Interior Drainage System	Item:	Sluice / Slide Gates
Observation ID:	2023-0081		
Description:	GS-11b: gate partially closed. Sediment/silt obstruction was noted.		
Caption:	0081 - No User Rating (Site Visit) - GS-11b: gate partially closed. Sediment/silt obstruction was noted.		
Lat/Long:	41.56073/-87.33639

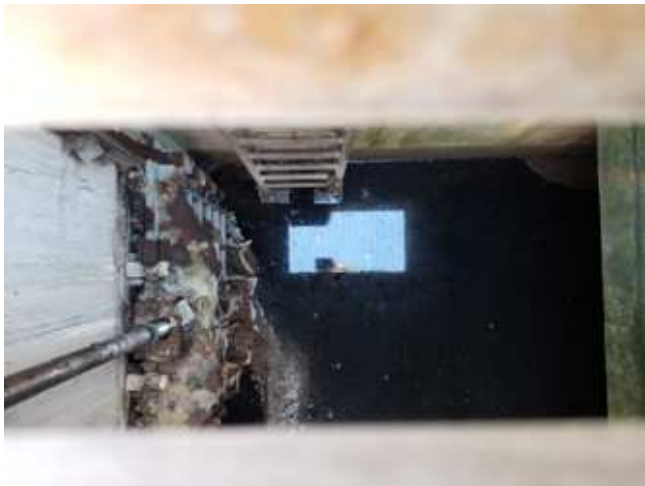
Category:	Interior Drainage System	Item:	Sluice / Slide Gates
Observation ID:	2023-0087		
Description:	GS-12a: Gate opened and closed completely.		
Caption:	0087 - No User Rating (Site Visit) - GS-12a: Gate opened and closed completely.		
Lat/Long:	41.56069/-87.33630

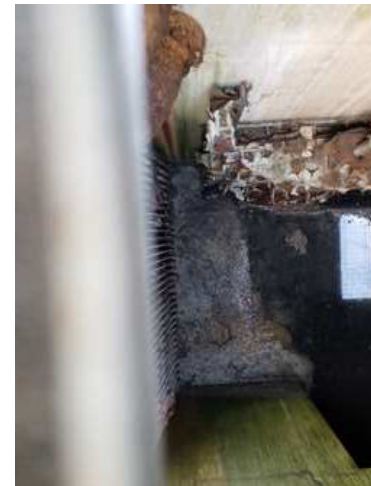
Category:	Interior Drainage System	Item:	Sluice / Slide Gates
Observation ID:	2023-0093		
Description:	GS-12b: Gate opened and closed. Leaking when closed.		
Caption:	0093 - No User Rating (Site Visit) - GS-12b: Gate opened and closed. Leaking when closed.		
Lat/Long:	41.56069/-87.33630

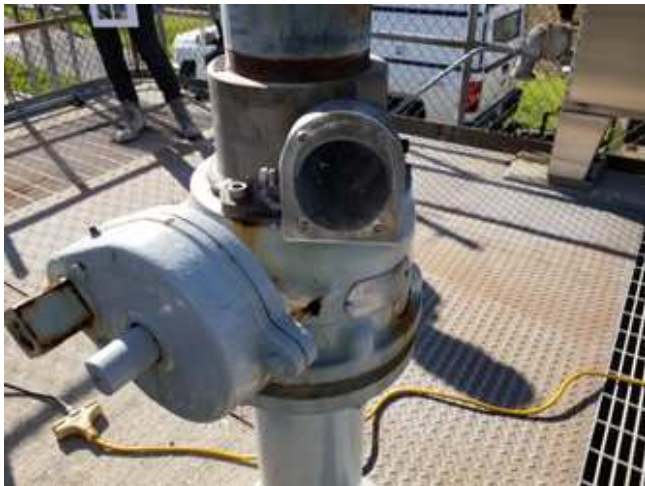
Category:	Interior Drainage System	Item:	Sluice / Slide Gates
Observation ID:	2023-0102		
Description:	GS-12b: upstream gate missing dial.		
Caption:	0102 - No User Rating (Site Visit) - GS-12b: upstream gate missing dial.		
Lat/Long:	41.56069/-87.33604

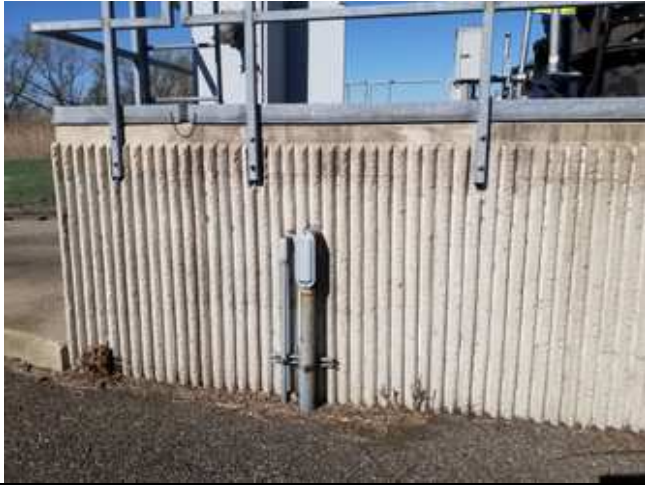
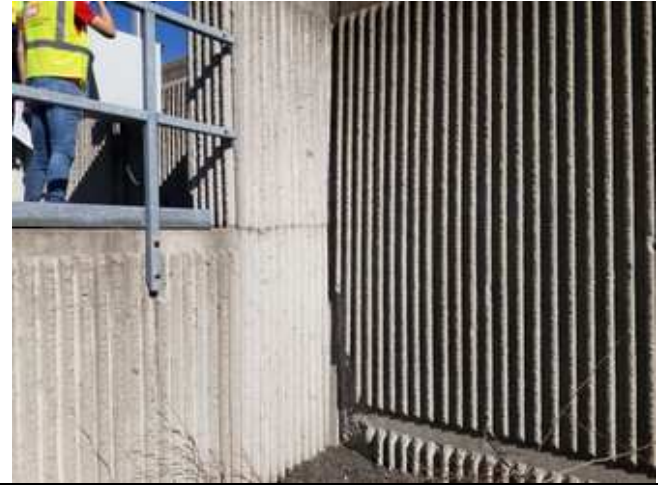
Category:	Pump Stations	Item:	Plant Building
Observation ID:	2023-0014		
Description:	PS-GW: Minimal cracks in concrete wall facing.		
Caption:	0014_1 - No User Rating (Site Visit) - PS-GW: Minimal cracks in concrete wall facing.		
Lat/Long:	41.56466/-87.35655

Category:	Pump Stations	Item:	Plant Building
Observation ID:	2023-0014		
Description:	PS-GW: Minimal cracks in concrete wall facing.		
Caption:	0014_2 - No User Rating (Site Visit) - PS-GW: Minimal cracks in concrete wall facing.		
Lat/Long:	41.56466/-87.35655

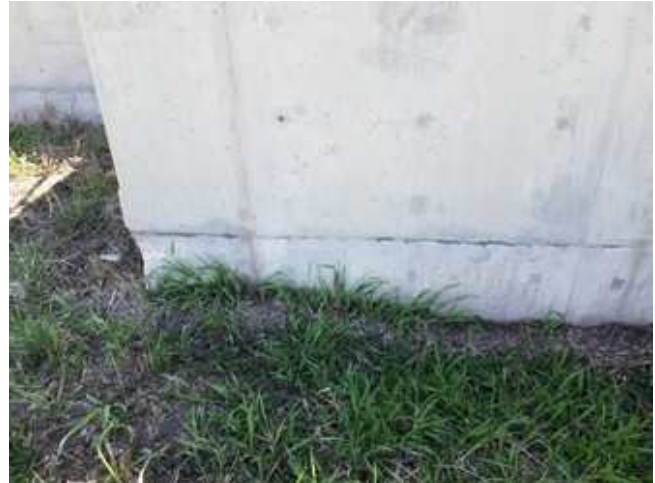
Category:	Pump Stations	Item:	Plant Building
Observation ID:	2023-0062		
Description:	PS-BW: Minimal cracking and chipping in the concrete base.		
Caption:	0062 - No User Rating (Site Visit) - PS-BW: Minimal cracking and chipping in the concrete base.		
Lat/Long:	41.56079/-87.33593

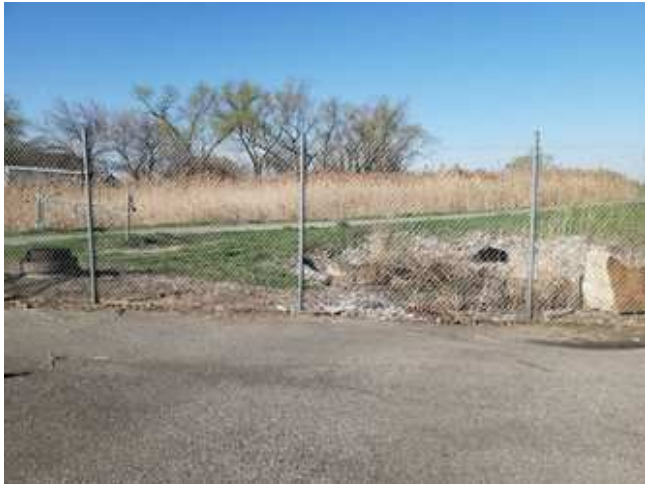
Category:	Pump Stations	Item:	Fencing and Gates
Observation ID:	2023-0008		
Description:	PS-GW: Fence post has been repaired/replaced.		
Caption:	0008 - No User Rating (Site Visit) - PS-GW: Fence post has been repaired/replaced.		
Lat/Long:	41.56449/-87.35656

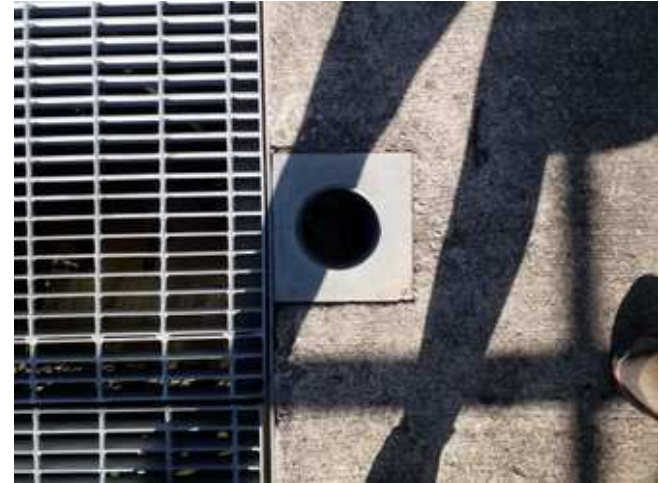
Category:	Pump Stations	Item:	Pumps
Observation ID:	2023-0005		
Description:	PS-GE: sump pump out of service. LCRBDC has a plan in place to replace pump.		
Caption:	0005 - No User Rating (Site Visit) - PS-GE: sump pump out of service. LCRBDC has a plan in place to replace pump.		
Lat/Long:	41.56466/-87.35520

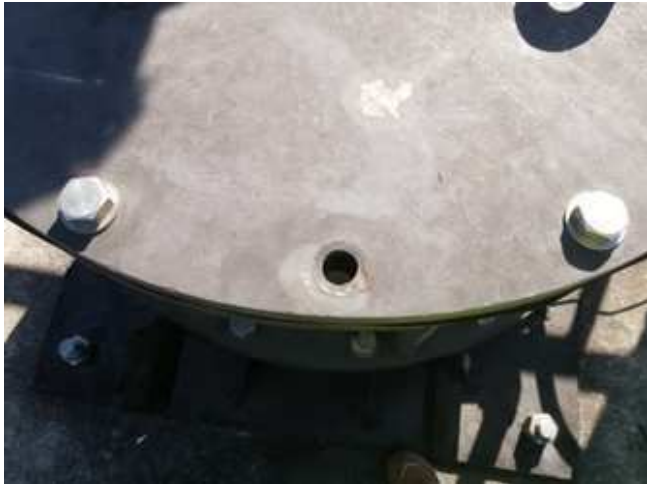
Category:	Pump Stations	Item:	Pumps
Observation ID:	2023-0017		
Description:	PS-GW: Missing nut and bolt on top of pump assembly.		
Caption:	0017 - No User Rating (Site Visit) - PS-GW: Missing nut and bolt on top of pump assembly.		
Lat/Long:	41.56466/-87.35650

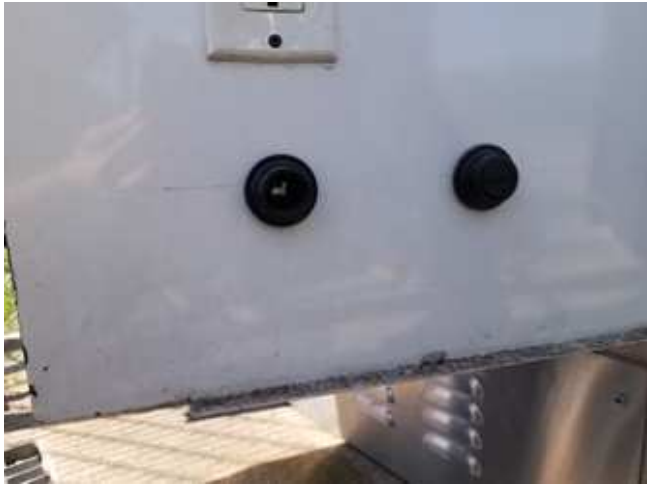
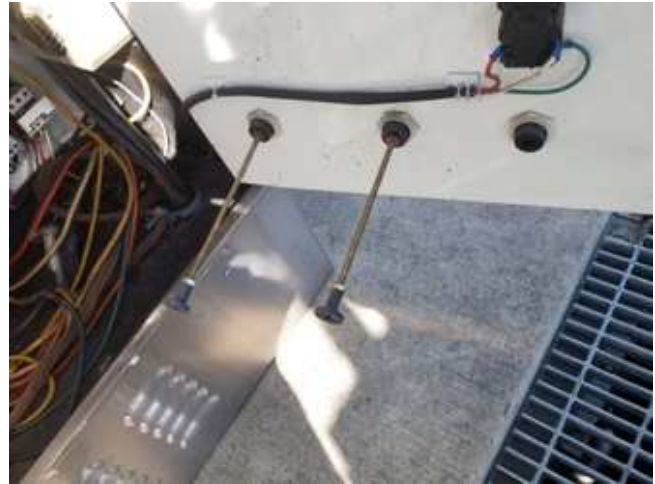
Category:	Pump Stations	Item:	Electrical Systems
Observation ID:	2023-0035		
Description:	PS-CL: Reset Button Missing		
Caption:	0035_1 - No User Rating (Site Visit) - PS-CL: Reset Button Missing		
Lat/Long:	41.56055/-87.35911

Category:	Pump Stations	Item:	Electrical Systems
Observation ID:	2023-0035		
Description:	PS-CL: Reset Button Missing		
Caption:	0035_2 - No User Rating (Site Visit) - PS-CL: Reset Button Missing		
Lat/Long:	41.56055/-87.35911

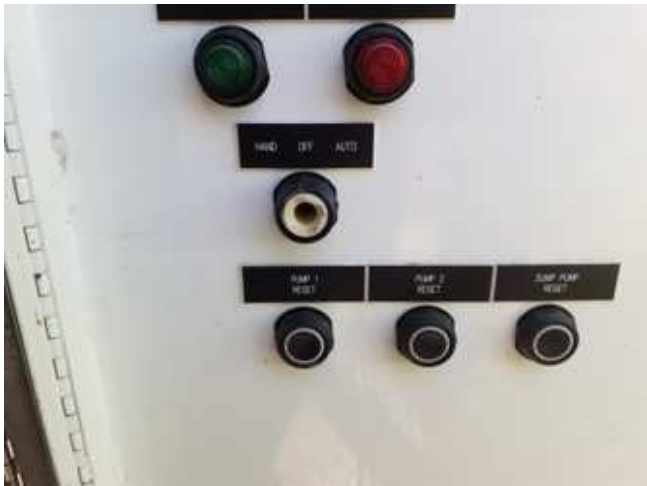
Category:	Pump Stations	Item:	Electrical Systems
Observation ID:	2023-0038		
Description:	PS-CL: Broken Button.		
Caption:	0038 - No User Rating (Site Visit) - PS-CL: Broken Button.		
Lat/Long:	41.56057/-87.35905
