## Site Visit Summary

Name of System: Gary

Name of Segment: Gary South

Date of Site Visit: 04/11/2023 - 04/12/2023

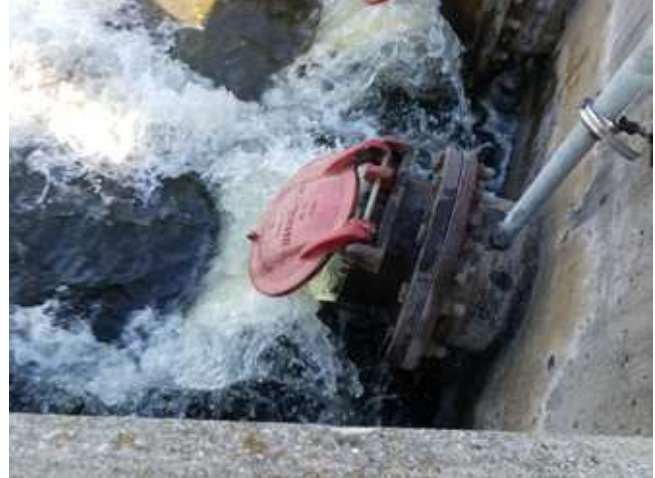
Category:	Pump Stations	Item:	Flap Gates/ Flap Val
Observation ID:	2023-0047		
Description:	PS-CL: Left flap gate has broken linkage assembly, and does not fully close.		
Caption:	0047 - No User Rating (Site Visit) - PS-CL: Left flap gate has broken linkage assembly, and does not fully close.		
Lat/Long:	41.56055/-87.35936
