ww			Site Visit S	ummary	
	Name of System:	Burr Street			
10. A	Name of Segment:	·			A () () () () () () () () () (
IS Army Corps of Engineers ®	NLD System ID:	2605000004		NLD Segment II): <u>2604000006</u>
	*	, turned over to public sponso	•		
Levee Sponsor (Name ar	nd Organization): Littl	le Calumet River Basin Deve	lopment Commission		
Field Trip Report Prepar	ed by: Chris Schaal			Date of Site	Visit: 04/11/2023 - 04/11/2023
			Other Segments With	hin This System	
Segment Name		NLD Segment ID#		Segment Type	
Griffith River Road Levee 2604000014		2604000014		Non-Federally Constructed, local O&M	
Gary Burr St			2604000005		USACE Constructed, Public sponsor O&M
	·

Summary of Site Visit: [Summarize pertinent discussions with sponsor regarding levee conditions, O&M activities, etc. and describe notable observations or changed conditions since the last site visit or inspection]
Minor issues with vegetation in the ditch, debris, concrete spalling, rutting, and animal activity. Minor issues with larger vegetation within the vegetation free zone.

Burr Street System (2605000004)/ Griffith Burr Segment (2604000005) Levee Sponsor Pre-Inspection Form

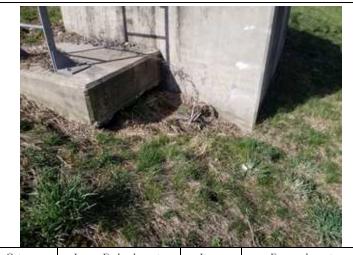
T	MATERIAL PROPERTY AND ADDRESS OF THE PARTY AND	THE RESERVE AND ADDRESS OF THE PERSON.	1 1 1 1 1 1 1 1 1 1 1 1 1 1 1 1 1 1 1	COLUMN TO SERVICE DE LA COLUMN TOUR PROPERTY OF THE PARTY	
Category:	Levee Embankments		Item:	Encroachments	
Observation ID:		2023-0025			
Description:	Debris at the riverside slope near the pump gate - about 0.3 miles east			p gate - about 0.3 miles east	
	of railroad				
Caption:	0025 - No User Rating (Site Visit) - Debris at the riverside slope near				
	the pump gate - about 0.3 miles east of railroad				
Lat/Long:	41.55986/-87.41798

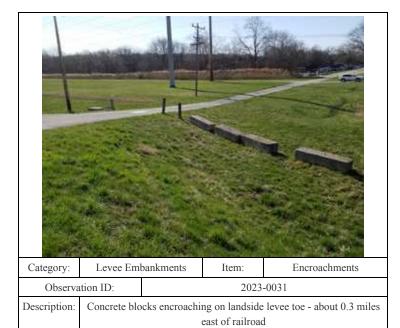
0031 - No User Rating (Site Visit) - Concrete blocks encroaching on landside levee toe - about 0.3 miles east of railroad
41.55972/-87.41779

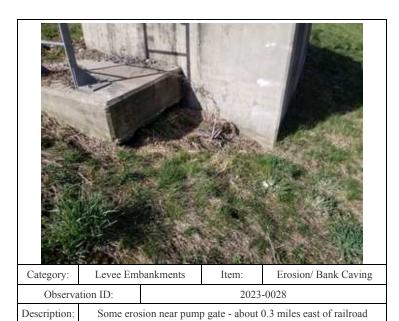
0028 - No User Rating (Site Visit) - Some erosion near pump gate -

about 0.3 miles east of railroad

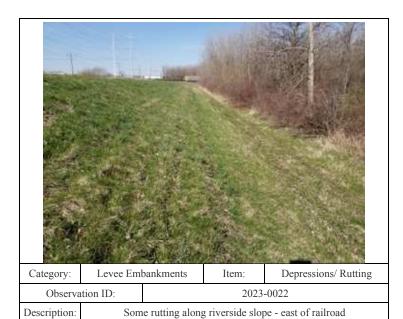
No User Rating (Site Visit) - Some rutting along riverside slope - east

of railroad

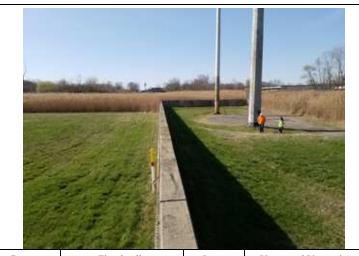
Category:	Floodwalls		Item:	Unwanted Vegetation	
Observation ID:		2023-0007			
Description:	Small veg	etation along t	he riverside floodwall - east of railroad		
Caption:	0007 - No	Ü (Site Visit) - Sr loodwall - east	mall vegetation along the of railroad	
Lat/Long:	41.55935/-87.42262			262

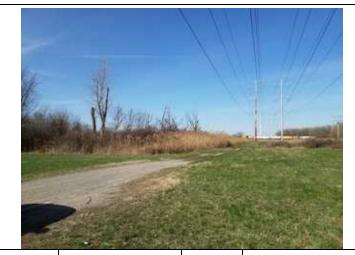
Category:	Interior Drainage System		Item:	Vegetation and Obstr	
Observa	ation ID:	2023-0034			
Description:	Т	all vegetation	n at ditch west of Arbogast Ave.		
Caption:	No User Ratio	ng (Site Visit)	- Tall vegetati	on at ditch west of Arbogast	
	Ave.				
Lat/Long:	41.55929/-87.41782

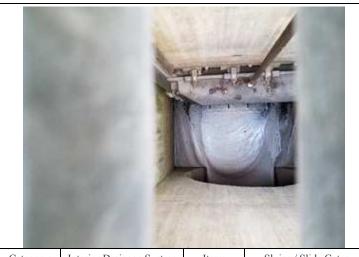
Category:	Interior Drainage System		Item:	Sluice / Slide Gates	
Observation ID:		2023-0003			
Description:	GR-02: Gate completely closed and working properly			nd working properly	
Caption:	0003 - No User Rating (Site Visit) - GR-02: Gate completely closed			02: Gate completely closed	
	and working properly				
Lat/Long:	41.55991/-87.41797

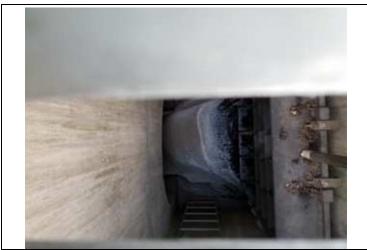
Category:	Interior Drainage System		Item:	Sluice / Slide Gates	
Observation ID:		2023-0009			
Description:		GR-	-02: Gate fully open		
Caption:	0009 - N	o User Rating	ng (Site Visit) - GR-02: Gate fully open		
Lat/Long:	41.55988/-87.41796

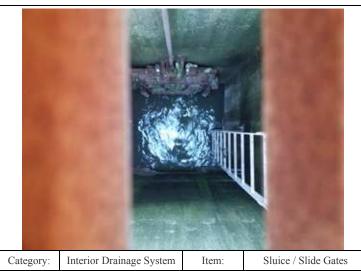
Category:	Interior Drainage System		Item:	Sluice / Slide Gates			
Observa	ation ID:		2023-0015				
Description:	_			cted to city combined sewer.			
	Griffith did not want to open completely, working properly						
Caption:	0015 - No User Rating (Site Visit) - GR-01: Gate partially open because connected to city combined sewer. Griffith did not want to open completely, working properly			er. Griffith did not want to			
Lat/Long:		41	.55898/-87.422	287
