SUBJECT: Little Calumet River - Inspection of I-Walls

Little Calumet River Flood Wall Inspection

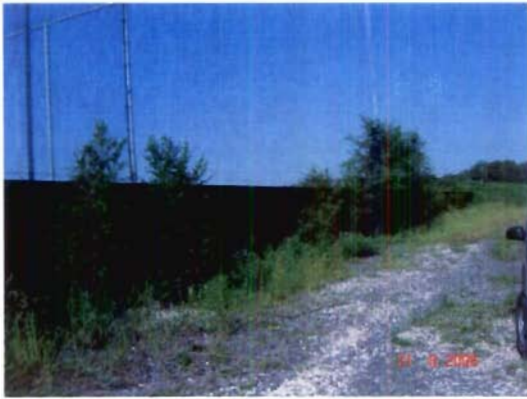
4. Location 1, approximately 1000 feet west of Colfax at the WIND radio transmitter. This is a steel sheet pile wall in good condition. There are some scrub trees beginning to grow along the landside of the wall (Photo 1). These need to be removed to comply with Corps regulations.

Photo 1. Scrub trees adjacent to wall west of Colfax north of river by WIND radio.

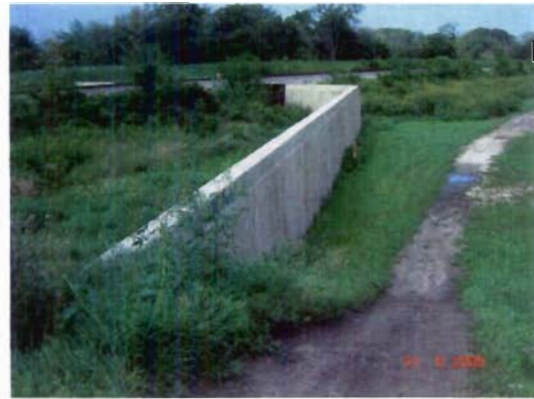
6. Location 3, west of Burr Street along the Norfolk and Southern railroad tracks. This wall transitions from concrete I-wall to steel sheet piling where it passes under the tracks and then back to concrete I-wall (Photo 4). The joints in this wall appear newly caulked and look very good. This location, however, has a few young trees near the railroad that should be removed and cracking in the fractured fin finish (Photo 5). Lifting holes are still visible in the steel sheets near the railroad (Photo 6). There is a crack in the concrete at the concrete/steel transition south of the racks (Photo 7). This crack will need to be evaluated and repaired. The crack could be caused by vibrations caused by the passing trains or due to a difference in rigidity between the steel and concrete section. This wall exhibits also some of the rust staining previously mentioned found on many of the concrete walls (Photo 8).

Photo 4. Floodwall west of Burr Street at NS railroad.

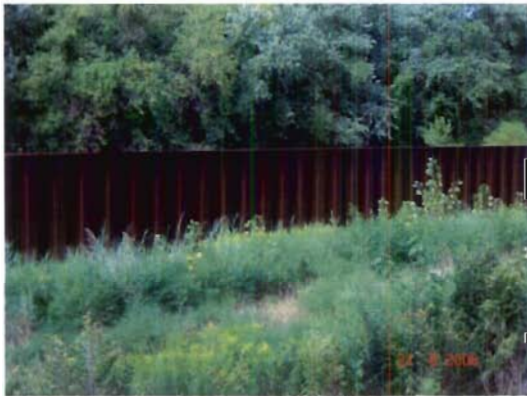
5. Location 2, east of Colfax along NS railroad. This is a steel sheet pile wall in good condition (Photo2). There are some seedlings and scrub brush beginning to grow along the riverside of the wall. These should be removed. The riverside of this wall is difficult to access and could not be inspected for its entire length. Aside from the brush, river water was virtually up to the wall. Limited access was gained by walking along a narrow ledge of riprap. This wall needs to be inspected either during low river levels or from a canoe. Near the bend in the wall alignment four (4) bolts are missing from a bolted connection about three (3) feet from the top of the wall (Photo 3).

Photo 2. Landward side of wall east of Colfax Ave and north of river.

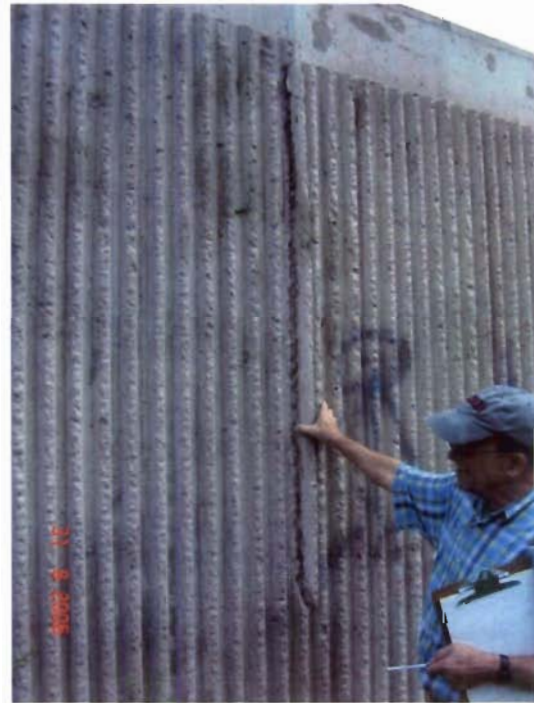
Photo 5. Cracking of the fractured fin finish (landside).

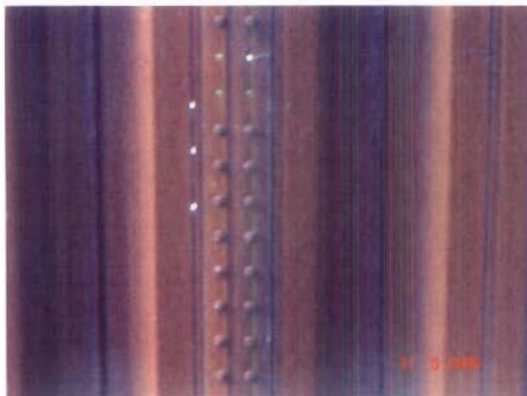
Photo 3. Missing bolts at connection east of Colfax Ave. and north of river.

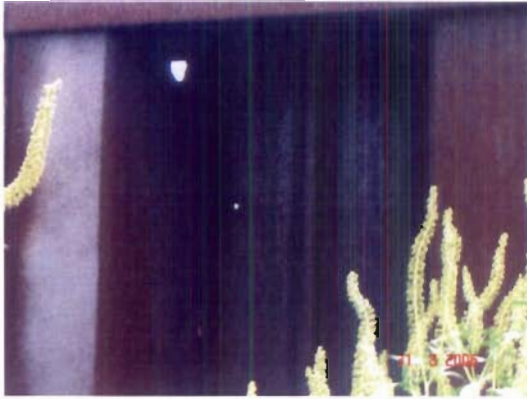
Photo 6. Lifting holes at top of steel sheets west of Burr Street at NS railroad.

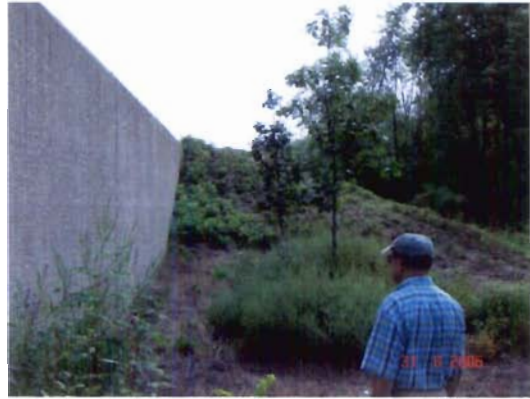
7. Location 4, east of Burr Street at retention pond. This is a 12-foot high concrete T-wall, the only T-wall constructed in the east reach of the Little Calumet project (Photo 9). T-walls are not specifically addressed in the HQ directive. The base of this wall is founded approximately 14.5 feet below existing grade and extends 7.5 feet riverward from the longitudinal centerline of the wall. This wall has a vertical crack that does not appear to coincide with a designed contraction joint (Photo 10). This crack should be repaired if it is determined that it does not contain a waterstop. Photo 9 also shows trees planted under a recent landscaping contract only 8 feet from the riverside of the wall. Corps regulations require that no vegetation be planted 12 feet from the face of the wall or, in the case of a T-wall, 8 feet from the toe or heel. These trees need to be relocated more than 15 feet from the wall face.

Photo 9. Concrete T-wall east of Burr Street.

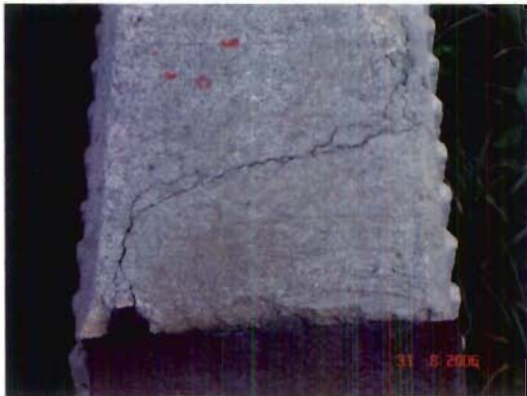
Photo 7. Hairline cracking at concrete to steel transition west of Burr south of RR.

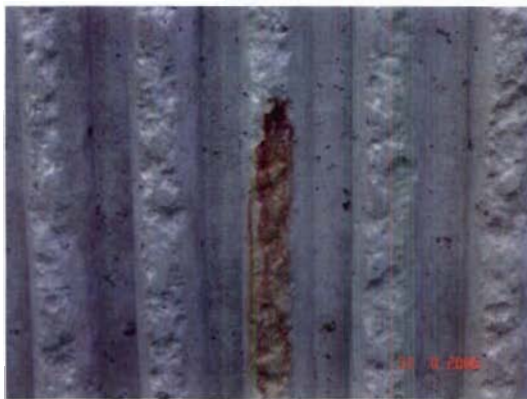
Photo 8. Typical rust staining on concrete.

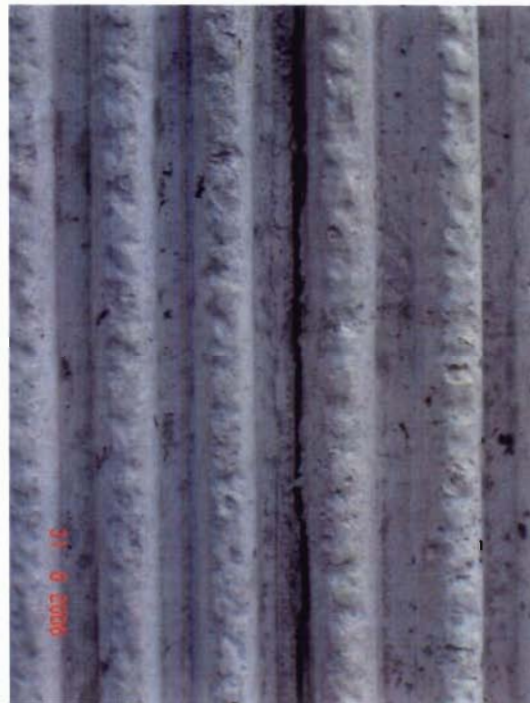
Photo 10. Vertical crack in T-wall at Burr Street.

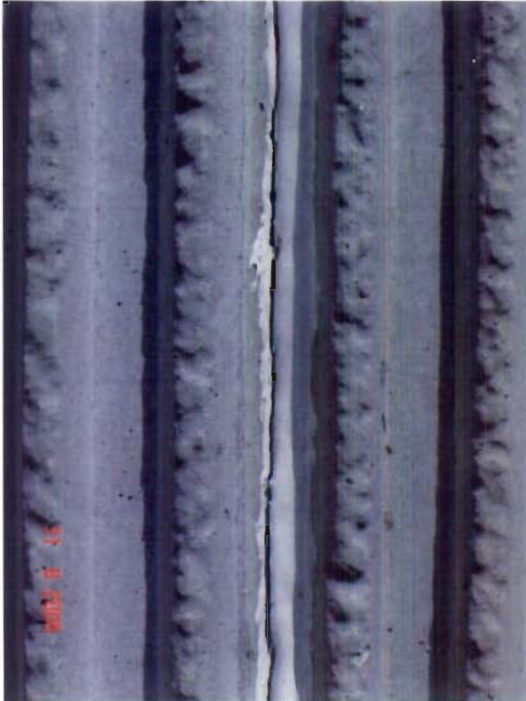
8. Location 5, Chase Street closure structure. This is a concrete I-wall. A small gap was observed in a previously caulked joint (Photo 11), but this wall is in overall good condition.

Photo 11. Caulked joint at Chase Street

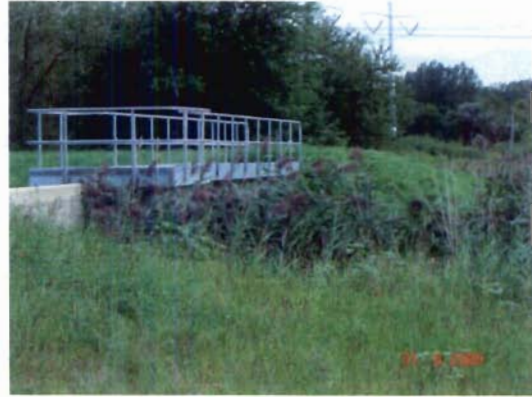
10. Location 7, east of Grant Street. The riverside of this wall was greatly obscured by high grass (Photo 14). The wall was in good alignment and no gaps could be seen from the top. This wall may be better inspected during the winter.

Photo 14. High grass obstruction east of Grant and north of river.

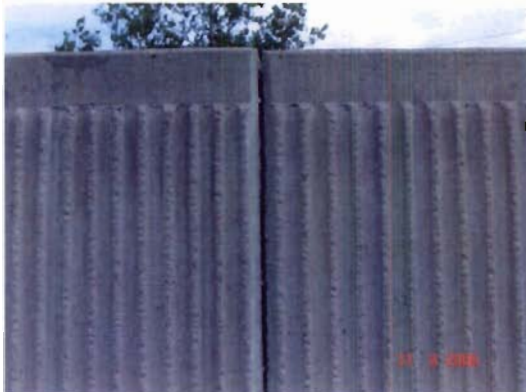
9. Location 6, west of Grant Street. This concrete I-wall was partially inaccessible due to water in the drainage ditch. This wall has a gap at an expansion joint (Photo 12). Expansion material appears in-place. This location should be watched during high water to insure that the waterstop is intact. Caulking may help protect the joint. Some spalling of the concrete was observed adjacent to the catwalk to the sluice gate controls (Photo 13).

Photo 12. Opening at control joint west of Grant Street and north of river.

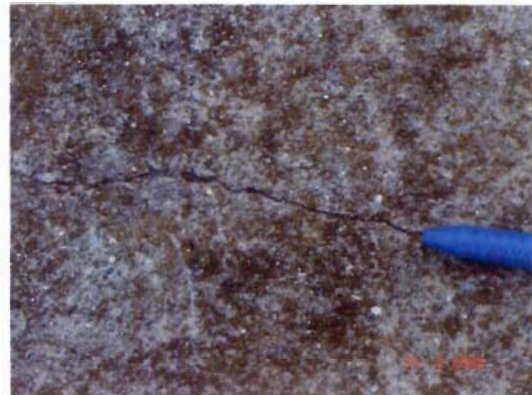
11. Location 8, utility crossing west of Broadway. This concrete wall is in overall good condition. A small hairline crack was noticed at the top near the west end of the wall (Photo 15).

Photo 15. Hairline crack at utility crossing west of Broadway.

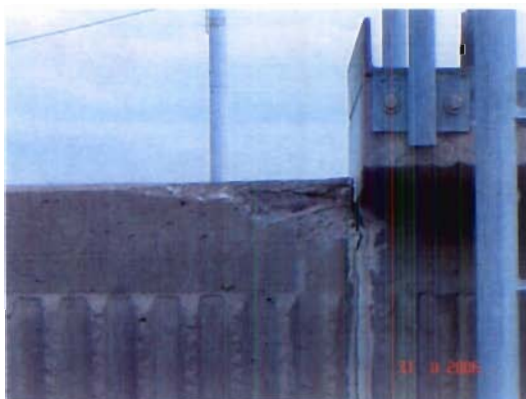
Photo 13. Spalling adjacent to catwalk .

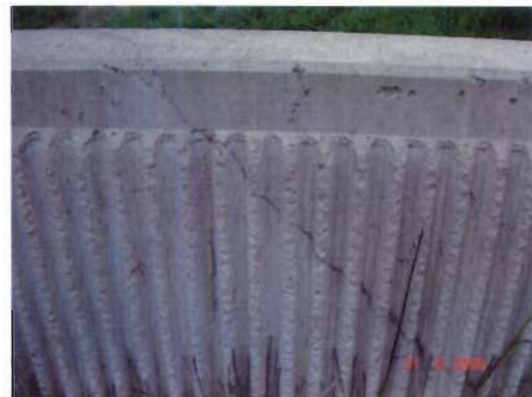
13. Location 10, west of Georgia Street. This concrete I-wall is also in good condition. A diagonal crack was noted on the landward side of the wall (Photo 16). This crack will need to be evaluated and repaired to prevent a larger problem in the future.

Photo 16. Hairline crack on landward side at Georgia Street south of river.

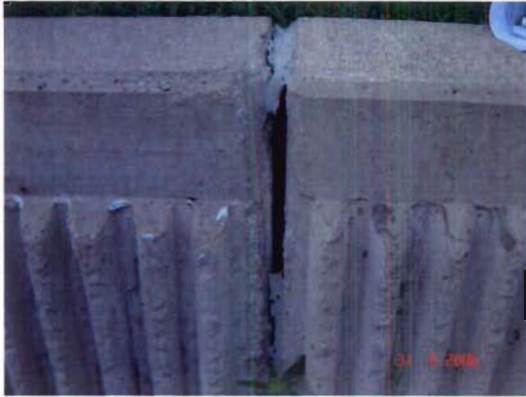
15. Location 12, east of Broadway. This concrete I-wall is not more than 6-feet high and is technically not part of the HQ directive. This wall has some caulk missing from the expansion joints (Photo 17).

Photo 17. Missing caulk south of river and east of Broadway.

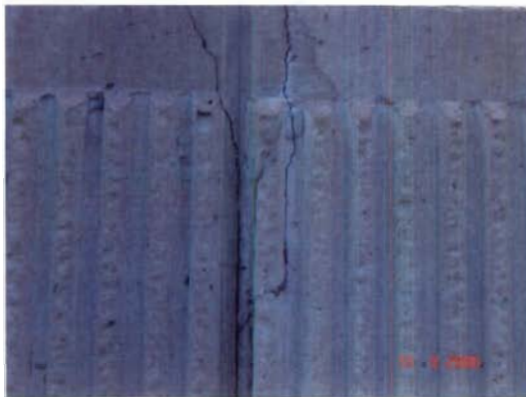
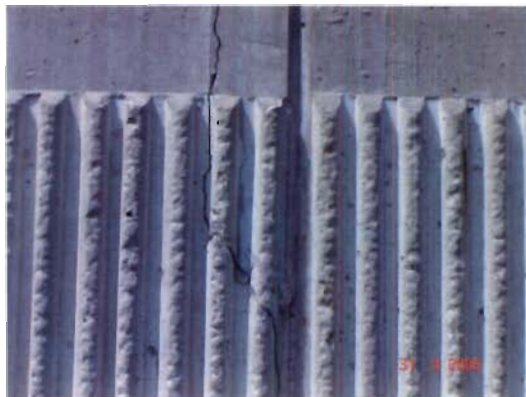
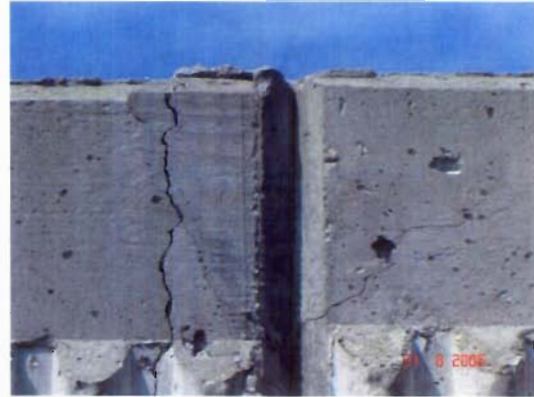
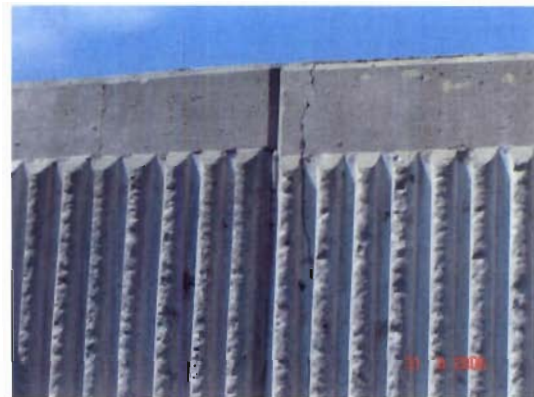
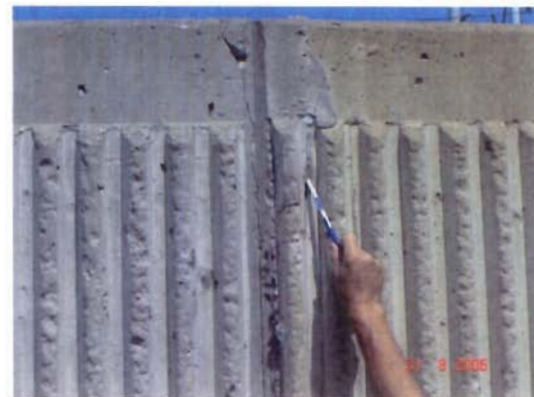
17. Location 14, east of Grant Street. There are no signs of tilting or gaps in this concrete I-wall, however all joints exhibit some cracking both riverside and landside (Photos 18-22). These cracks will need to be repaired. The north-south leg of this wall was constructed by InDOT as part of the Grant Street interchange construction. As-builts are not shown on Corps documents.

Photo 20. Hairline joint cracks east of Grant and south of river landside.

Photo 18. Hairline joint cracks east of Grant and south of river riverside.

Photo 21. Hairline joint cracks east of Grant and south of river landside.

Photo 19. Hairline joint cracks east of Grant and south of river riverside.

Photo 22. Hairline joint cracks east of Grant and south of river landside.

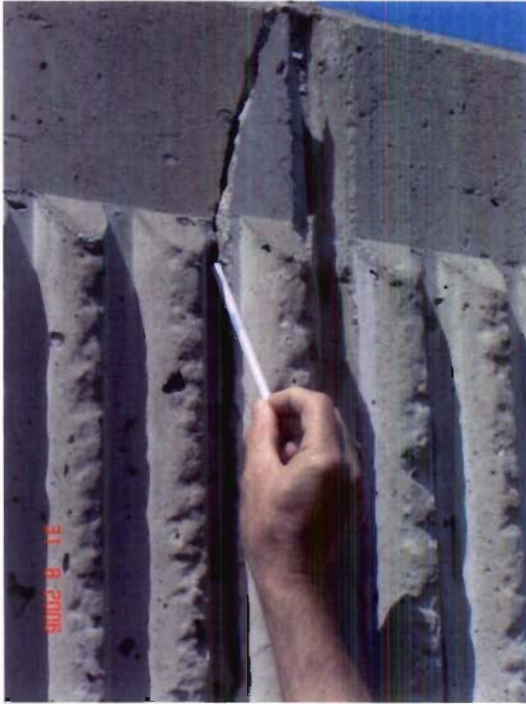
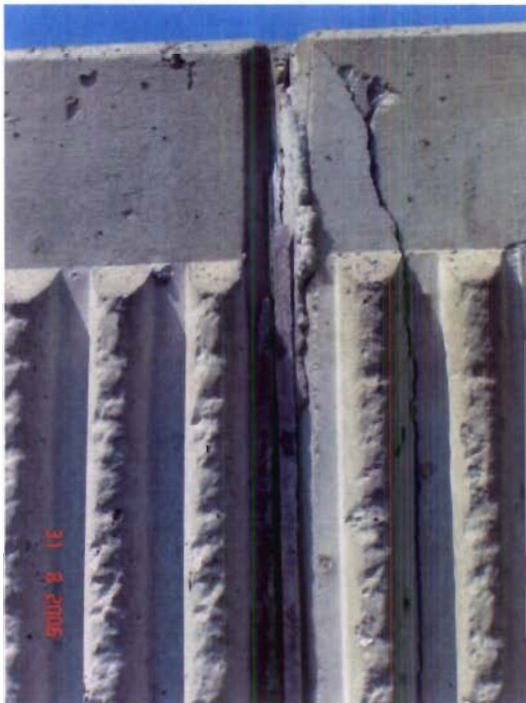
18. Location 15, west of Grant Street. This concrete I-wall shows cracking and signs of potential spalling on the landside (Photos 23 and 24). These are large cracks that have growth potential and will need to be evaluated and repaired as necessary. The north-south leg of this wall was constructed by InDOT as part of the Grant Street interchange construction. As-builts are not shown on Corps documents.

Photo 23. Cracking west of Grant and south of river landside.

Photo 24. Cracking west of Grant and south of river landside.

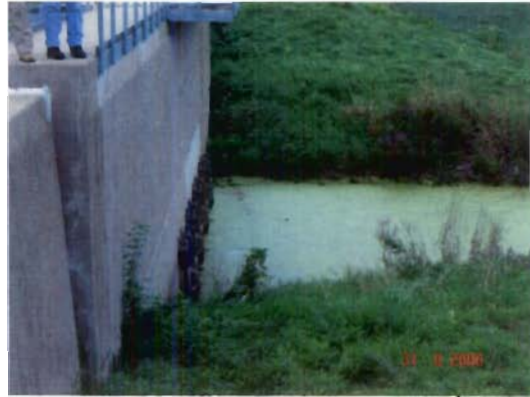
19. Location 16, 35th Street between Chase and Grant. This concrete I-wall was partially inaccessible due to water in the ditch (Photo 25). Some re-caulking is needed near the gatewell, but overall the wall is in good condition with no tilting or gaps. This is one wall that is constructed on box piles as opposed to single sheets.

Photo 25. Inaccessibility along 35th Street between Chase and Grant.

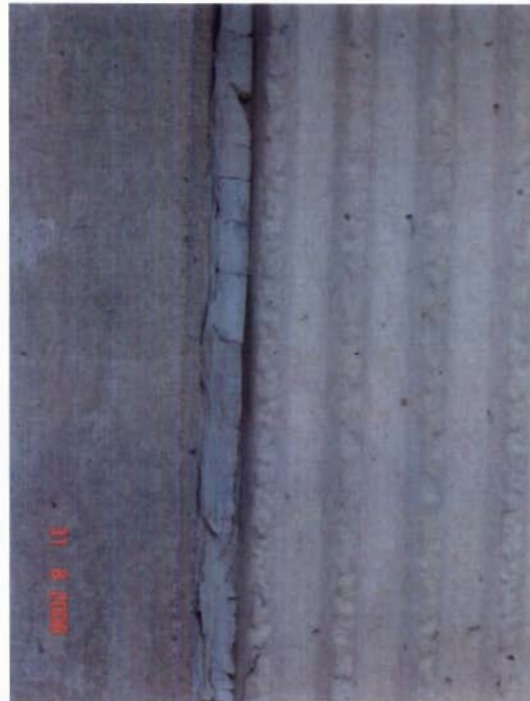
20. Location 17, 35th and Chase Street closure structure. This wall is partially inaccessible due to water in the ditch. There is a small gap at the joint on the south side of the street (Photo 26).

Photo 26. Gap at joint in closure structure at 35th and Chase Street.
