**US Army Corps
of Engineers®**

Levee Inspection Report

Name of System: Hammond Forest Ave

Date(s) of Inspection: 07/06/2020 - 07/08/2020

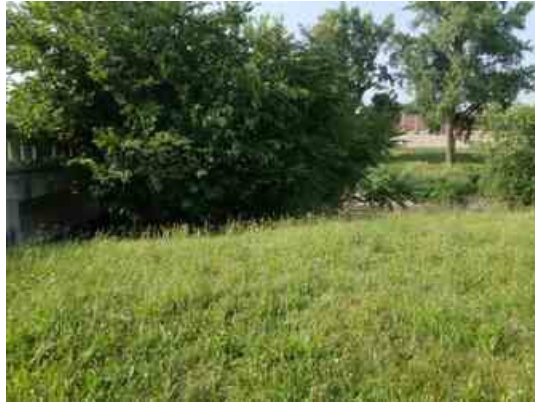
Inspect ID: 2020-0002 **Title:** 2604000010_CELRC_2020_A_0002_1_20200708T132631.jpg **Rated Item:** 1. Unwanted Vegetation Growth **Caption:** Minimally Acceptable - Trees on riverside toe.

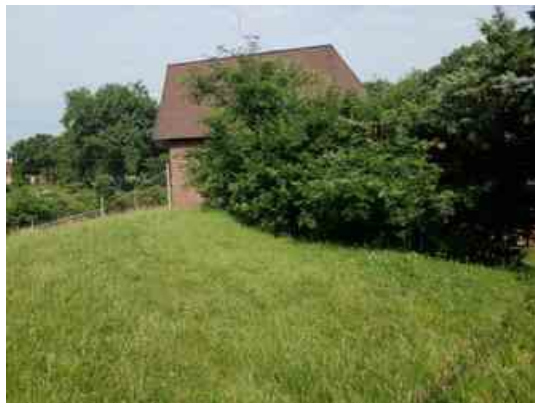
Inspect ID: 2020-0004 **Title:** 2604000010_CELRC_2020_A_0004_1_20200708T132723.jpg **Rated Item:** 1. Unwanted Vegetation Growth **Caption:** Minimally Acceptable - Trees on landside toe.

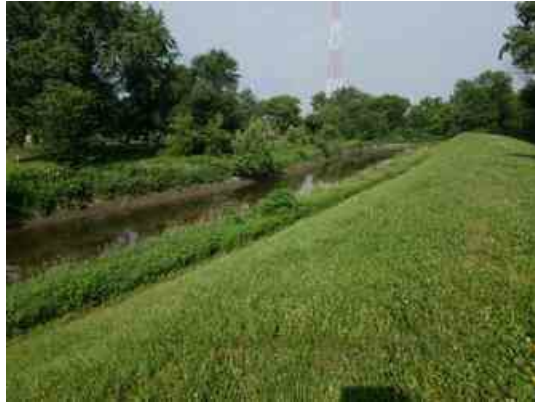
Inspect ID: 2020-0018 **Title:** 2604000010_CELRC_2020_A_0018_1_20200708T134149.jpg **Rated Item:** 1. Unwanted Vegetation Growth **Caption:** Minimally Acceptable - Tall vegetation on riverside toe.

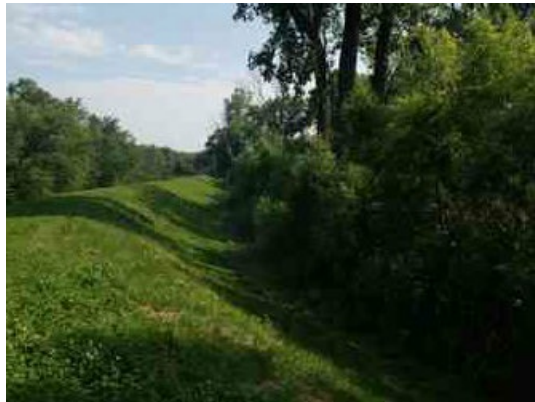
Inspect ID: 2020-0034 **Title:** 2604000010_CELRC_2020_A_0034_1_20200708T140902.jpg **Rated Item:** 1. Unwanted Vegetation Growth **Caption:** Minimally Acceptable - Trees on landslide toe.

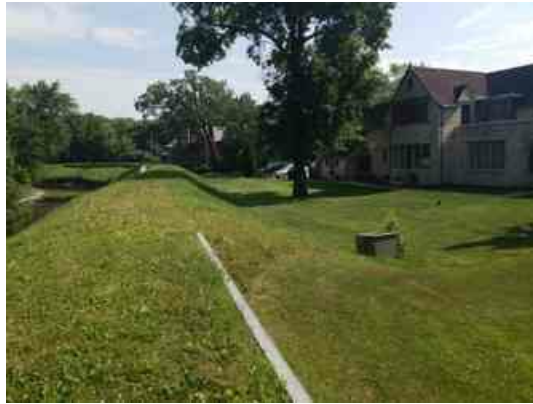
Inspect ID: 2020-0046 **Title:** 2604000010_CELRC_2020_A_0046_1_20200708T143214.jpg **Rated Item:** 1. Unwanted Vegetation Growth **Caption:** Minimally Acceptable - Small tree near the landslide toe.

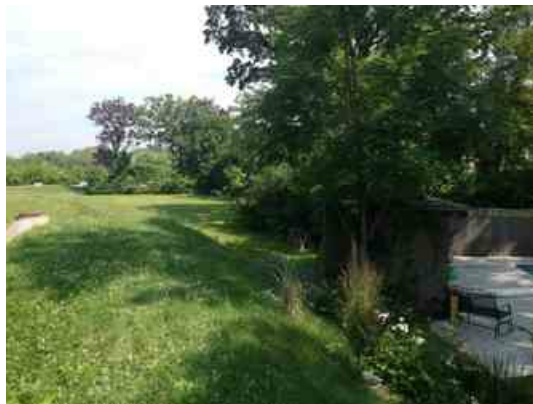
Inspect ID: 2020-0066 **Title:** 2604000010_CELRC_2020_A_0066_1_20200708T145018.jpg **Rated Item:** 1. Unwanted Vegetation Growth **Caption:** Minimally Acceptable - Large tree near the landslide toe.

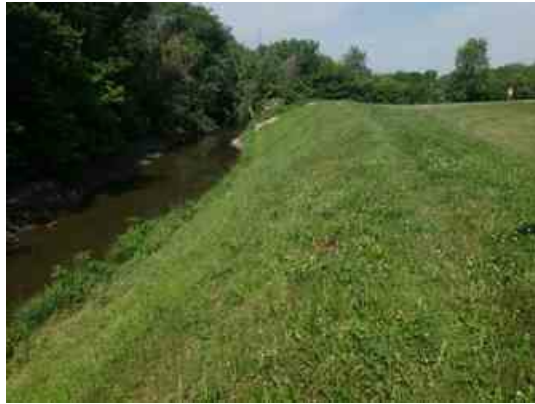
Inspect ID: 2020-0080 **Title:** 2604000010_CELRC_2020_A_0080_1_20200708T150243.jpg **Rated Item:** 1. Unwanted Vegetation Growth **Caption:** Minimally Acceptable - Tall vegetation on the riverside toe.

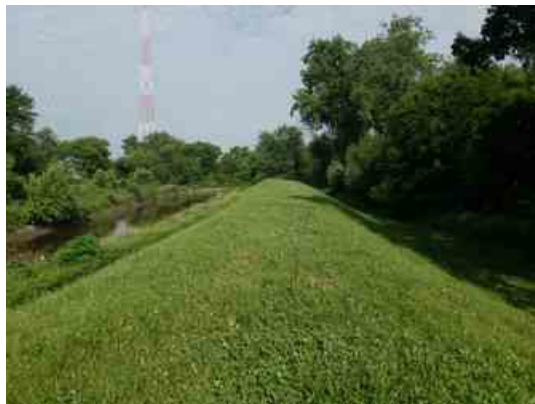
Inspect ID: 2020-0016 **Title:** 2604000010_CELRC_2020_A_0016_1_20200708T134007.jpg **Rated Item:** 2. Sod Cover **Caption:** Acceptable - Good sod cover.

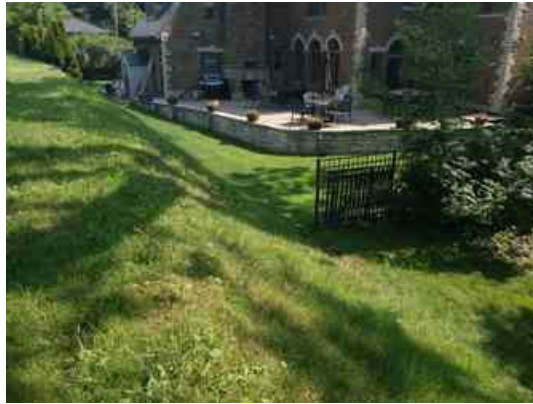
Inspect ID: 2020-0052 **Title:** 2604000010_CELRC_2020_A_0052_1_20200708T143903.jpg **Rated Item:** 3. Encroachments **Caption:** Minimally Acceptable - Fence at landside toe.

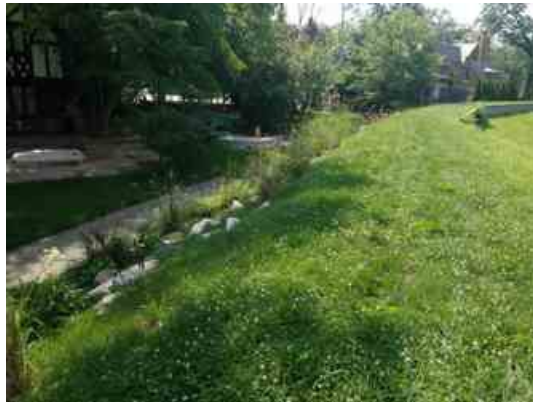
Inspect ID: 2020-0064 **Title:** 2604000010_CELRC_2020_A_0064_1_20200708T144832.jpg **Rated Item:** 3. Encroachments **Caption:** Minimally Acceptable - Rock garden and plants on the landside slope.

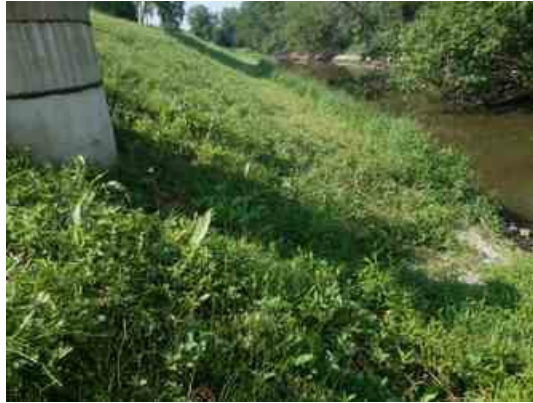
Rated Item	Rating	Rating Guidelines		Location/Remarks/Recommendations
5. Slope Stability	M	A	No slides, sloughs, tension cracking, slope depressions, or bulges are present.	2020-0050 : Steep slope below FA-04 manhole. Recommend adding material to regrade. (M)
		M	Minor slope stability problems that do not pose an immediate threat to the levee embankment.	
		U	Major slope stability problems (ex. deep seated sliding) identified that must be repaired to reestablish the integrity of the levee embankment.

Inspect ID: 2020-0050 **Title:** 2604000010_CELRC_2020_A_0050_1_20200708T143609.jpg **Rated Item:** 5. Slope Stability **Caption:** Minimally Acceptable - Steep slope below FA-04 manhole.

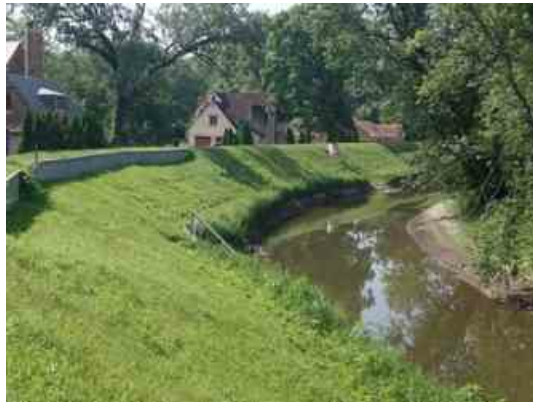
Inspect ID: 2020-0068 **Title:** 2604000010_CELRC_2020_A_0068_1_20200708T145344.jpg **Rated Item:** 6. Erosion/ Bank Caving **Caption:** Minimally Acceptable - Erosion on riverside toe.

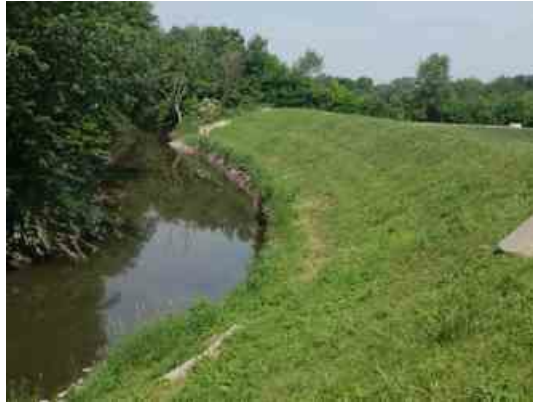
Inspect ID: 2020-0070 **Title:** 2604000010_CELRC_2020_A_0070_1_20200708T145440.jpg **Rated Item:** 6. Erosion/ Bank Caving **Caption:** Minimally Acceptable - Erosion on riverside toe.

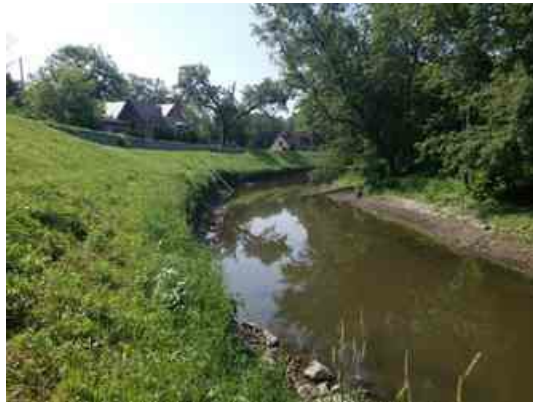
Inspect ID: 2020-0078 **Title:** 2604000010_CELRC_2020_A_0078_1_20200708T150057.jpg **Rated Item:** 6. Erosion/ Bank Caving **Caption:** Minimally Acceptable - Erosion on riverside toe.

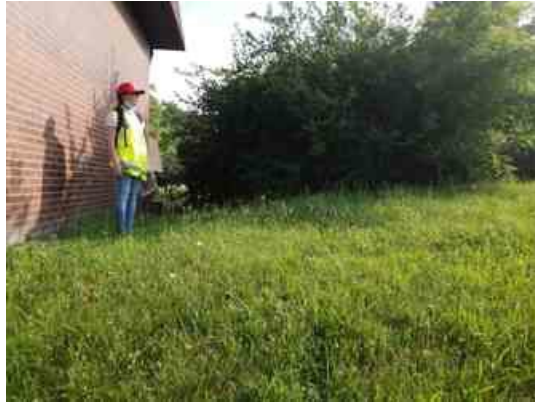
Inspect ID: 2020-0006 **Title:** 2604000010_CELRC_2020_A_0006_1_20200708T132829.jpg **Rated Item:** 7. Settlement **Caption:** Minimally Acceptable - Low spot on crest next to pump station.

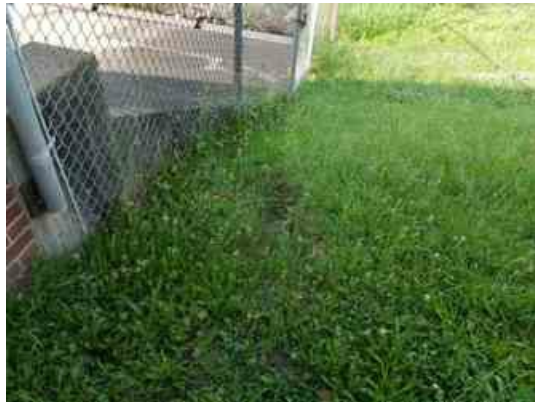
Inspect ID: 2020-0014 **Title:** 2604000010_CELRC_2020_A_0014_1_20200708T133726.jpg **Rated Item:** 8. Depressions/ Rutting **Caption:** Minimally Acceptable - Gully next to west side of spillway.

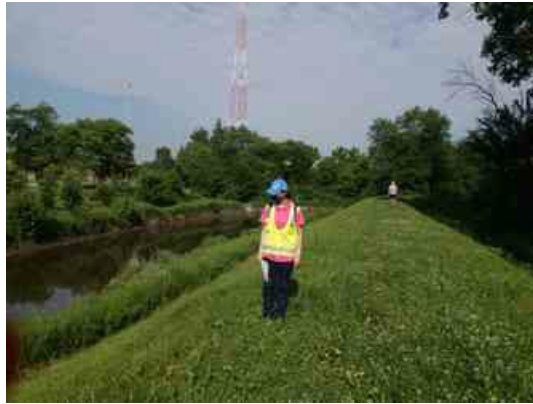
Inspect ID: 2020-0022 **Title:** 2604000010_CELRC_2020_A_0022_1_20200708T134524.jpg **Rated Item:** 8. Depressions/ Rutting **Caption:** Minimally Acceptable - Low spot, 4" inches deep on landslide crest.

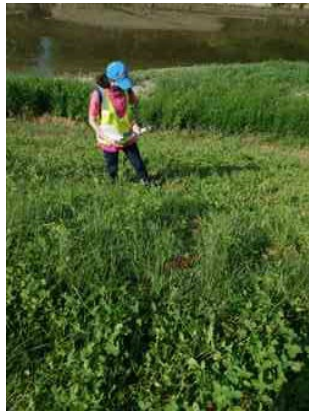
Inspect ID: 2020-0028 **Title:** 2604000010_CELRC_2020_A_0028_1_20200708T135826.jpg **Rated Item:** 8. Depressions/ Rutting **Caption:** Minimally Acceptable - Wide depression on riverside slope.

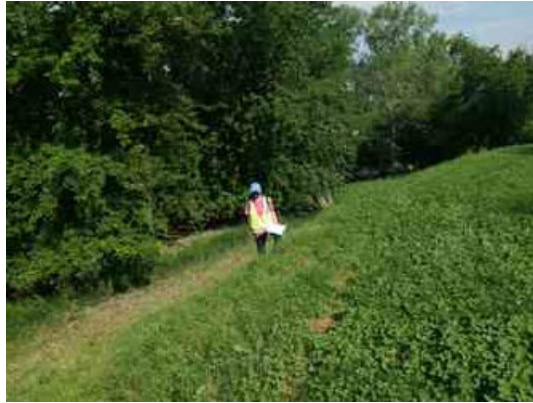
Inspect ID: 2020-0030 **Title:** 2604000010_CELRC_2020_A_0030_1_20200708T140022.jpg **Rated Item:** 8. Depressions/ Rutting **Caption:** Minimally Acceptable - Deep rut on riverside slope.

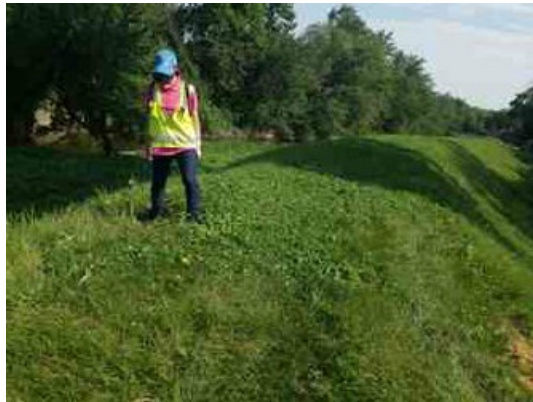
Inspect ID: 2020-0036 **Title:** 2604000010_CELRC_2020_A_0036_1_20200708T141221.jpg **Rated Item:** 8. Depressions/ Rutting **Caption:** Minimally Acceptable - Low spot on landslide crest.

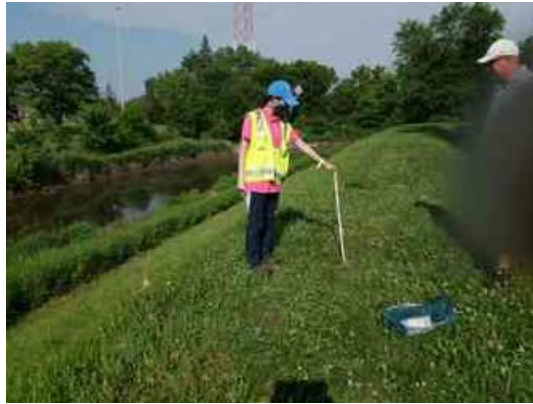
Inspect ID: 2020-0024 **Title:** 2604000010_CELRC_2020_A_0024_1_20200708T134916.jpg **Rated Item:** 10. Animal Control **Caption:** Minimally Acceptable - 5 inch deep burrow on crest.

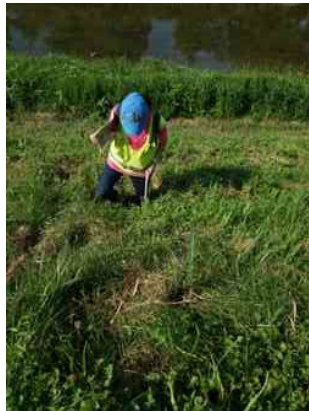
Inspect ID: 2020-0026 **Title:** 2604000010_CELRC_2020_A_0026_3_20200708T135525.jpg **Rated Item:** 10. Animal Control **Caption:** Minimally Acceptable - 2 ft deep burrow on river side slope.

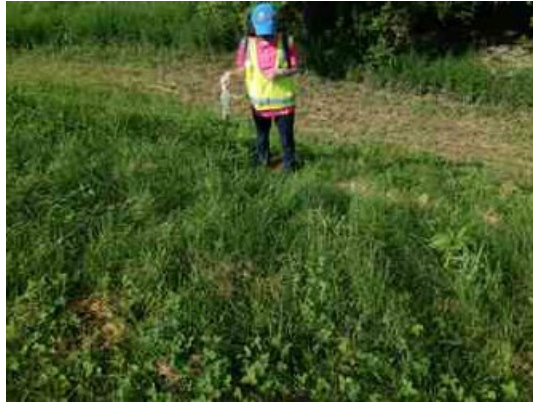
Inspect ID: 2020-0032 **Title:** 2604000010_CELRC_2020_A_0032_1_20200708T140454.jpg **Rated Item:** 10. Animal Control **Caption:** Minimally Acceptable - Collapsed burrow on riverside slope.

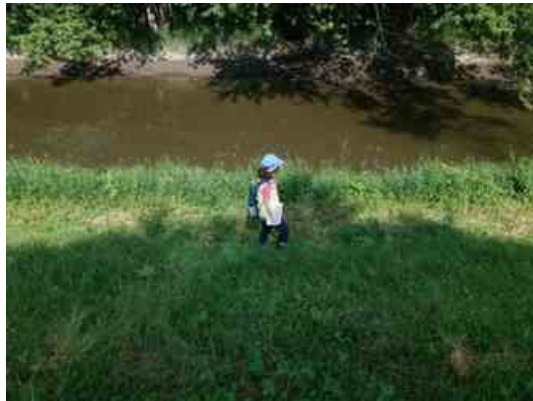
Inspect ID: 2020-0040 **Title:** 2604000010_CELRC_2020_A_0040_1_20200708T142434.jpg **Rated Item:** 10. Animal Control **Caption:** Minimally Acceptable - Collapsed burrow on riverside slope.

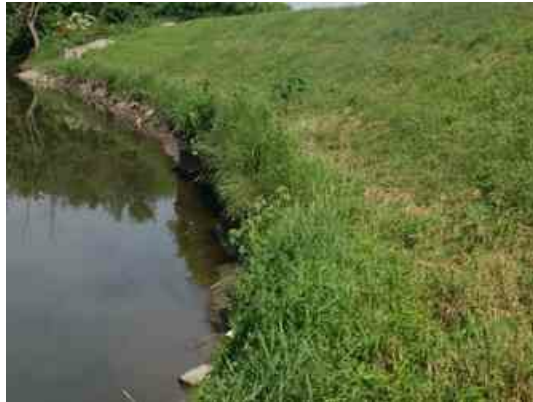
Inspect ID: 2020-0076 **Title:** 2604000010_CELRC_2020_A_0076_1_20200708T145929.jpg **Rated Item:** 13. Revetments other than Riprap **Caption:** Minimally Acceptable - Retaining wall at toe tilting. Repair or replace.

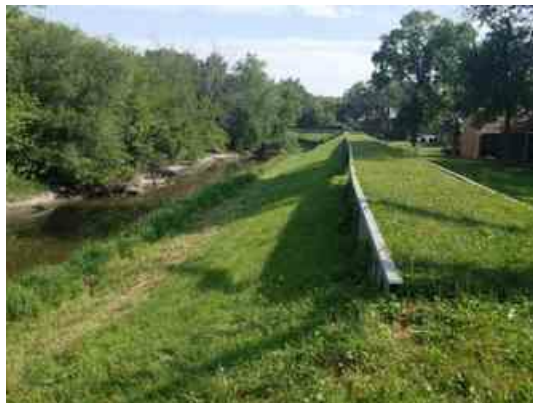
Inspect ID: 2020-0042 **Title:** 2604000010_CELRC_2020_A_0042_1_20200708T142716.jpg **Rated Item:** 1. Unwanted Vegetation Growth **Caption:** Minimally Acceptable - Small bushes on riverside.

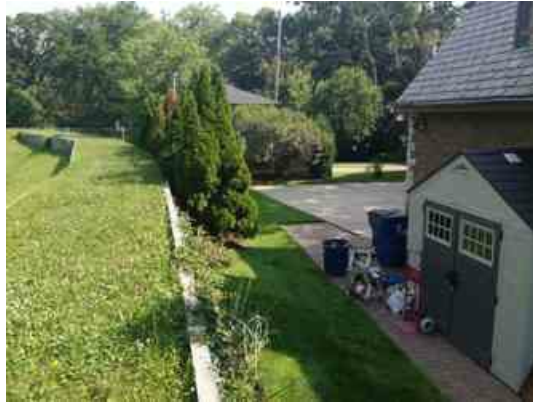
Inspect ID: 2020-0054 **Title:** 2604000010_CELRC_2020_A_0054_1_20200708T144037.jpg **Rated Item:** 1. Unwanted Vegetation Growth **Caption:** Minimally Acceptable - Decorative trees on landside.

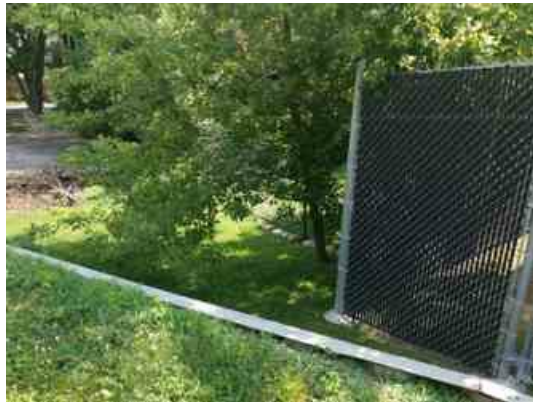
Inspect ID: 2020-0056 **Title:** 2604000010_CELRC_2020_A_0056_1_20200708T144229.jpg **Rated Item:** 1. Unwanted Vegetation Growth **Caption:** Minimally Acceptable - Tree near wall on landslide next to pump station.

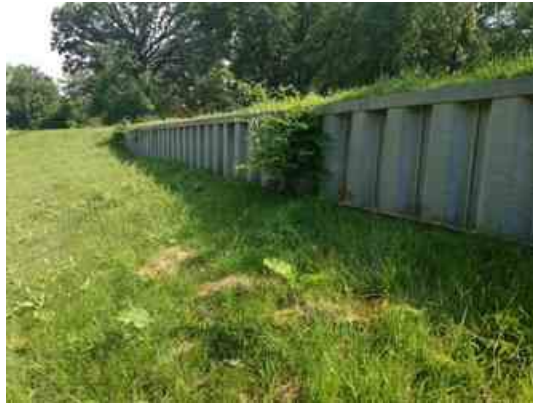
Inspect ID: 2020-0062 **Title:** 2604000010_CELRC_2020_A_0062_1_20200708T144630.jpg **Rated Item:** 1. Unwanted Vegetation Growth **Caption:** Minimally Acceptable - Small bush on riverside.

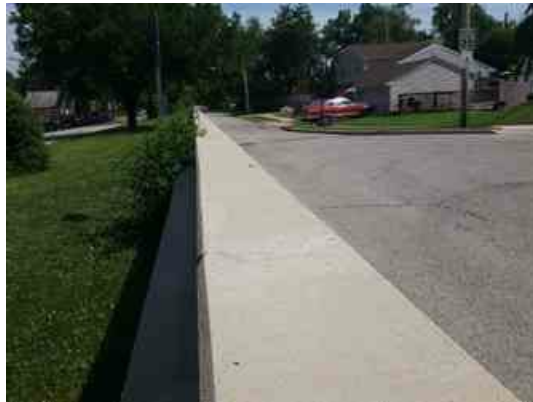
Inspect ID: 2020-0110 **Title:** 2604000010_CELRC_2020_A_0110_1_20200708T153341.jpg **Rated Item:** 1. Unwanted Vegetation Growth **Caption:** Minimally Acceptable - Tree on riverside.

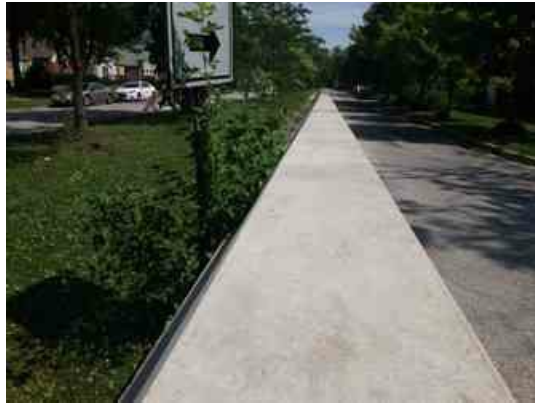
Inspect ID: 2020-0118 **Title:** 2604000010_CELRC_2020_A_0118_1_20200708T154130.jpg **Rated Item:** 1. Unwanted Vegetation Growth **Caption:** Minimally Acceptable - Tree on riverside.

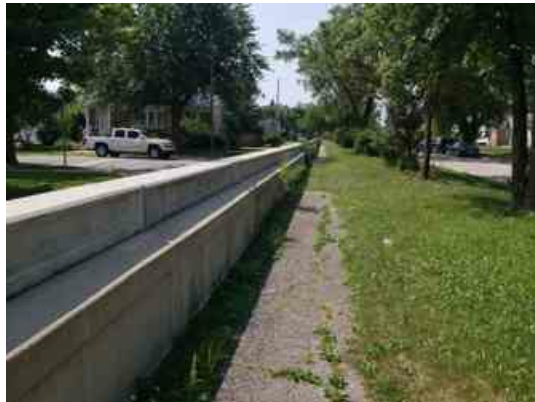
Inspect ID: 2020-0120 **Title:** 2604000010_CELRC_2020_A_0120_1_20200708T154247.jpg **Rated Item:** 1. Unwanted Vegetation Growth **Caption:** Minimally Acceptable - Small trees on riverside.

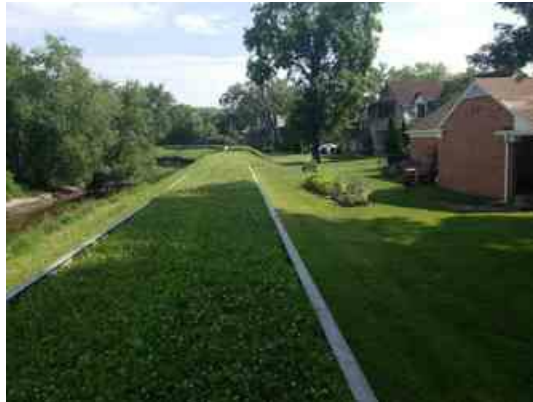
Inspect ID: 2020-0044 **Title:** 2604000010_CELRC_2020_A_0044_1_20200708T142956.jpg **Rated Item:** 2. Encroachments **Caption:** Minimally Acceptable - Garden beds within 10 ft of the wall.

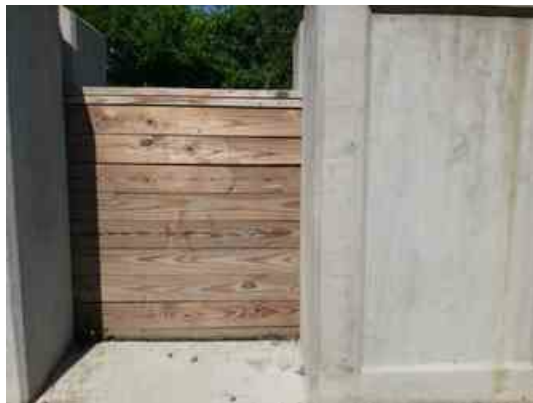
Inspect ID: 2020-0082 **Title:** 2604000010_CELRC_2020_A_0082_1_20200708T151233.jpg **Rated Item:** 3. Closure Structures (Stop Log Closures and Gates) (A or U only) **Caption:** Acceptable - South closure stop log warping. Last exercise performed in Oct 2017. Next exercise due in 2022.

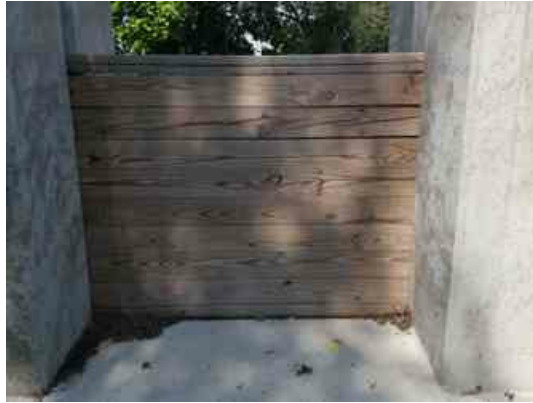
Inspect ID: 2020-0086 **Title:** 2604000010_CELRC_2020_A_0086_1_20200708T151705.jpg **Rated Item:** 3. Closure Structures (Stop Log Closures and Gates) (A or U only) **Caption:** Acceptable - North closure stop logs warping. Last exercise performed in Oct 2017. Next exercise due in 2022.

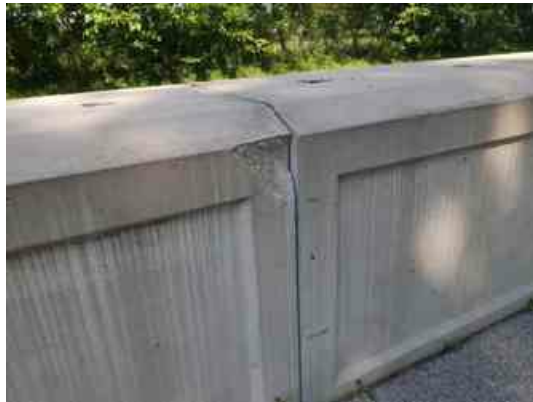
Inspect ID: 2020-0084 **Title:** 2604000010_CELRC_2020_A_0084_1_20200708T151550.jpg **Rated Item:** 4. Concrete Surfaces **Caption:** Minimally Acceptable - Broken concrete.

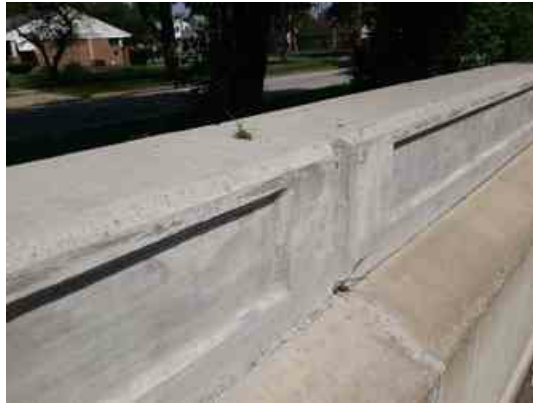
Inspect ID: 2020-0098 **Title:** 2604000010_CELRC_2020_A_0098_1_20200708T152830.jpg **Rated Item:** 7. Monolith Joints **Caption:** Minimally Acceptable - Vegetation growing in joint.

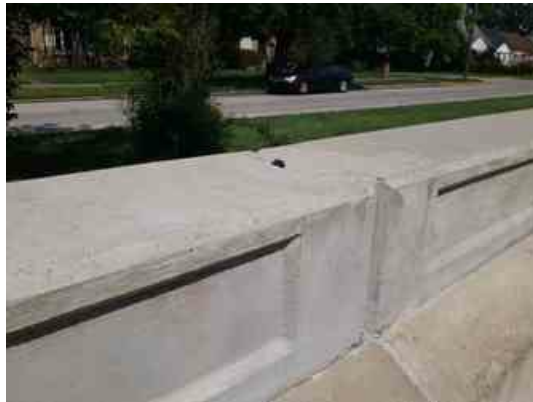
Inspect ID: 2020-0104 **Title:** 2604000010_CELRC_2020_A_0104_1_20200708T153115.jpg **Rated Item:** 7. Monolith Joints **Caption:** Minimally Acceptable - Water stop exposed. Reseal.

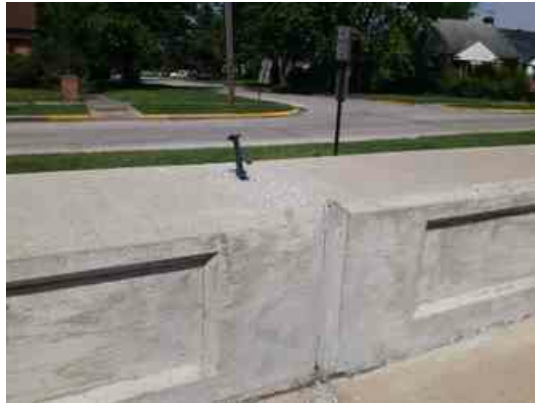
Inspect ID: 2020-0108 **Title:** 2604000010_CELRC_2020_A_0108_1_20200708T153251.jpg **Rated Item:** 7. Monolith Joints **Caption:** Minimally Acceptable - Water stop exposed. Repair and reseal.

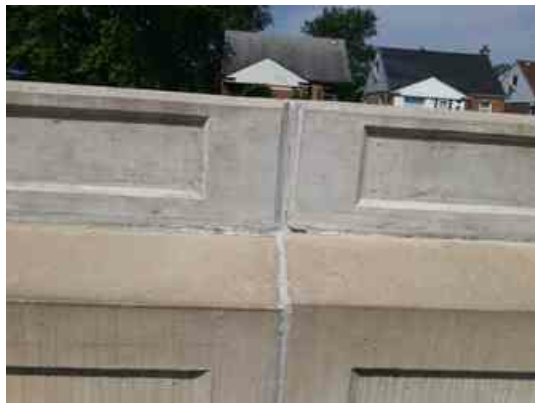
Inspect ID: 2020-0112 **Title:** 2604000010_CELRC_2020_A_0112_1_20200708T153508.jpg **Rated Item:** 7. Monolith Joints **Caption:** Minimally Acceptable - Crack in the sealant.

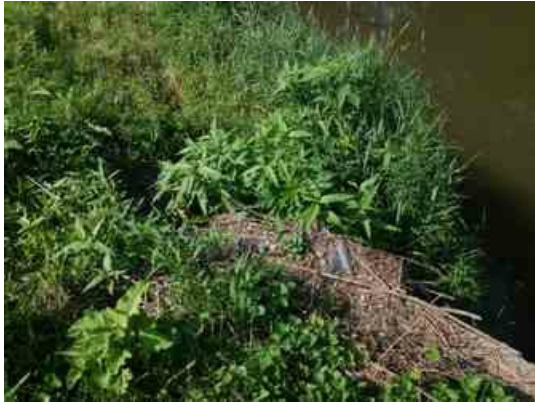
<p>Inspect ID: 2020-0058 Title: 2604000010_CELRC_2020_A_0058_1_20200708T144444.jpg Rated Item: 7. Foundation of Concrete Structures (Such as culverts, inlet and discharge structures, or gateways.) Caption: Minimally Acceptable - FA-03: Erosion on south side of headwall. Restore bank.</p>

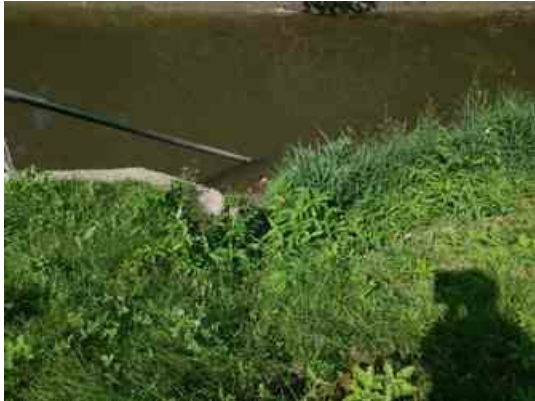
<p>Inspect ID: 2020-0060 Title: 2604000010_CELRC_2020_A_0060_1_20200708T144526.jpg Rated Item: 7. Foundation of Concrete Structures (Such as culverts, inlet and discharge structures, or gateways.) Caption: Minimally Acceptable - FA-03: Erosion on north side of headwall. Restore bank.</p>

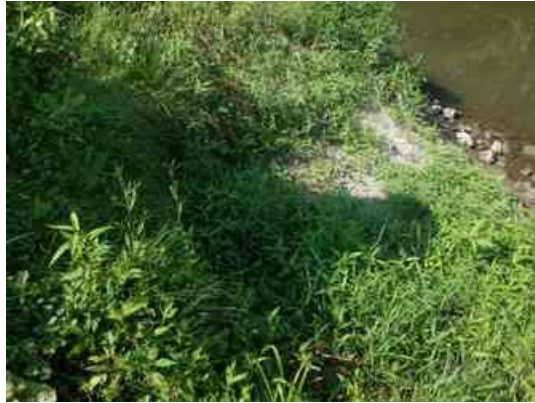
Inspect ID: 2020-0048 **Title:** 2604000010_CELRC_2020_A_0048_1_20200708T143541.jpg **Rated Item:** 11. Flap Gates/ Flap Valves/ Pinch Valves **Caption:** Minimally Acceptable - FA-04: Gate silted in.

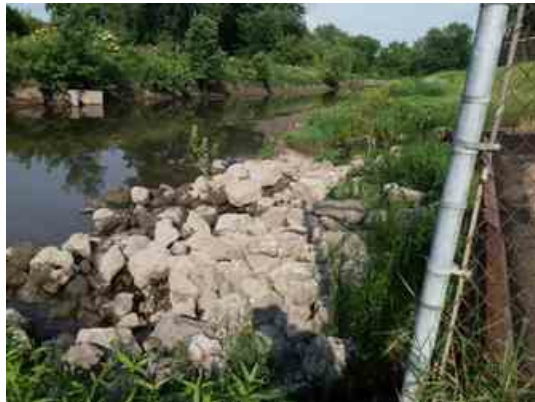
Inspect ID: 2020-0012 **Title:** 2604000010_CELRC_2020_A_0012_1_20200708T133204.jpg **Rated Item:** 14. Riprap Revetments of Inlet/ Discharge Areas **Caption:** Minimally Acceptable - Riprap has trees and some stone displaced.

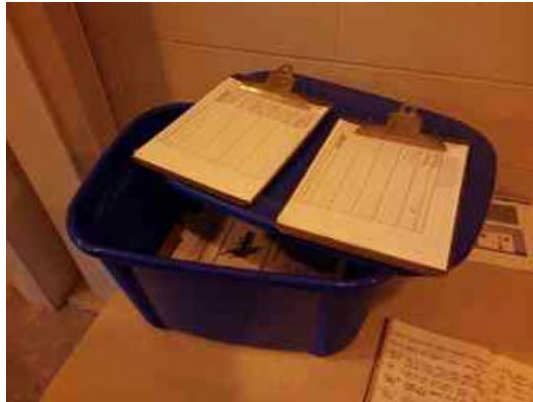
Inspect ID: 2020-0009 **Title:**
2604000010_CELRC_2020_A_0009_1_20200707T135143.jpg **Rated**
Item: 2. Pump Station Operations and Maintenance Equipment Manuals
Caption: Acceptable - PS-SH: Operation manuals inside the pump station.

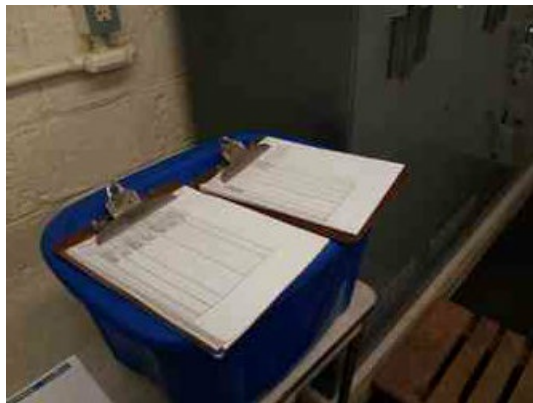
Inspect ID: 2020-0039 **Title:**
2604000010_CELRC_2020_A_0039_1_20200707T160054.jpg **Rated**
Item: 2. Pump Station Operations and Maintenance Equipment Manuals
Caption: Acceptable - PS-FA: Operation manuals present.

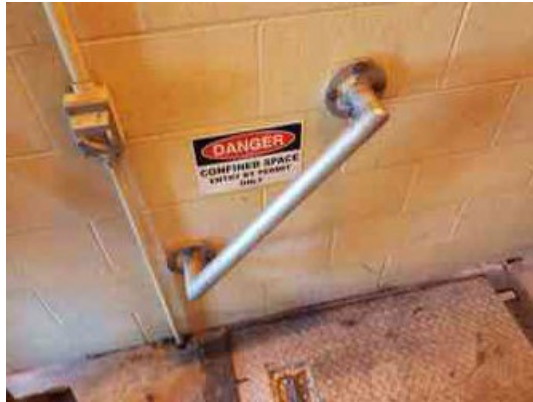
Inspect ID: 2020-0003 **Title:** 2604000010_CELRC_2020_A_0003_1_20200707T134709.jpg **Rated Item:** 3. Safety Compliance **Caption:** Acceptable - PS-SH: Added confined space warning label.

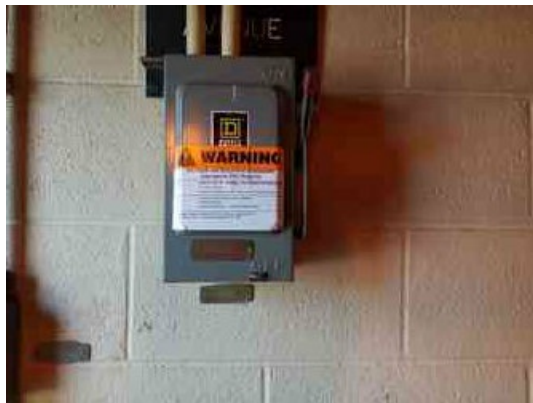
Inspect ID: 2020-0005 **Title:** 2604000010_CELRC_2020_A_0005_1_20200707T134759.jpg **Rated Item:** 3. Safety Compliance **Caption:** Acceptable - PS-SH: Arc flash warning label added.

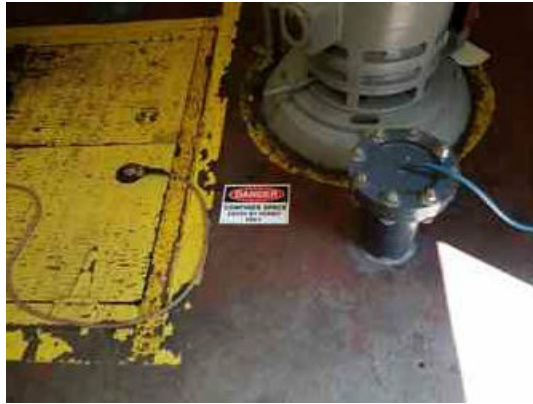
Inspect ID: 2020-0033 **Title:** 2604000010_CELRC_2020_A_0033_1_20200707T155658.jpg **Rated Item:** 3. Safety Compliance **Caption:** Acceptable - PS-FA: Confined space warning label added.

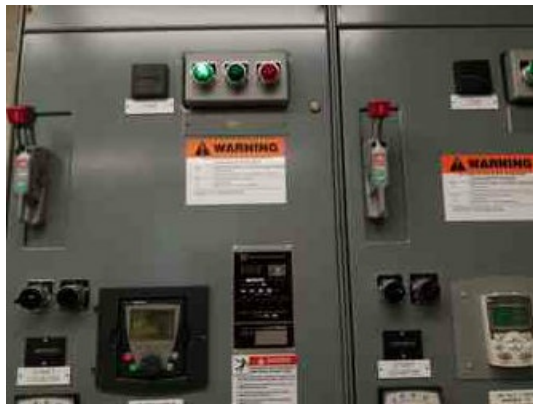
Inspect ID: 2020-0037 **Title:** 2604000010_CELRC_2020_A_0037_1_20200707T155942.jpg **Rated Item:** 3. Safety Compliance **Caption:** Acceptable - PS-FA: Arc flash warning labels added.

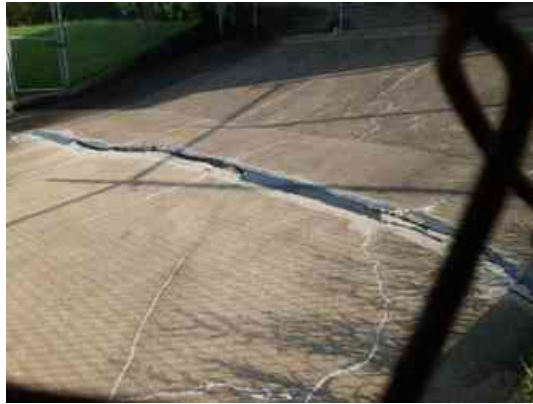
Inspect ID: 2020-0008 **Title:** 2604000010_CELRC_2020_A_0008_1_20200708T133032.jpg **Rated**
Item: 5. Plant Building **Caption:** Minimally Acceptable - PS-SH: Crack in spillway.

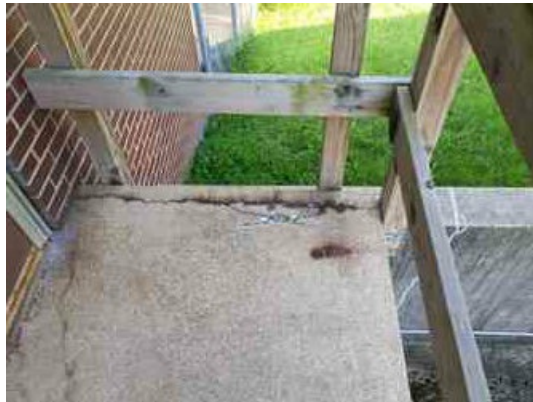
Inspect ID: 2020-0013 **Title:** 2604000010_CELRC_2020_A_0013_1_20200707T135634.jpg **Rated**
Item: 5. Plant Building **Caption:** Minimally Acceptable - PS-SH: Platform has a crack caused by railing.

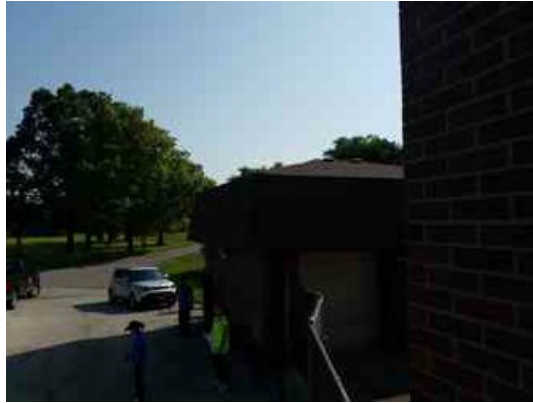
Inspect ID: 2020-0015 **Title:** 2604000010_CELRC_2020_A_0015_1_20200707T135723.jpg **Rated Item:** 5. Plant Building **Caption:** Acceptable - PS-SH: New roof put on both buildings.

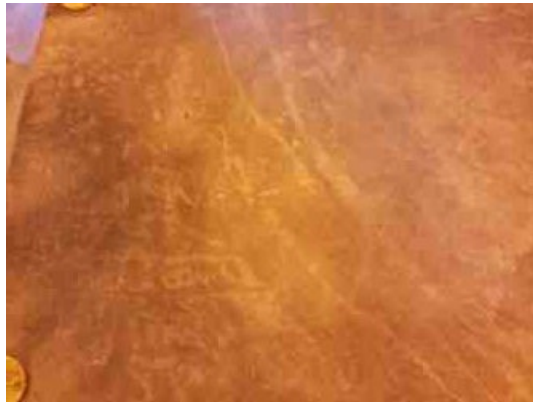
Inspect ID: 2020-0021 **Title:** 2604000010_CELRC_2020_A_0021_1_20200707T140210.jpg **Rated Item:** 5. Plant Building **Caption:** Minimally Acceptable - PS-SH: Cracked in platform in pump room has slight spalling.

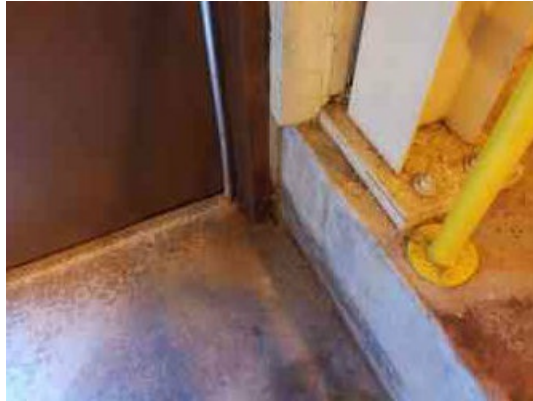
Inspect ID: 2020-0023 **Title:** 2604000010_CELRC_2020_A_0023_1_20200707T140257.jpg **Rated Item:** 5. Plant Building **Caption:** Minimally Acceptable - PS-SH: Corrosion on door frame. Needs cleaning.

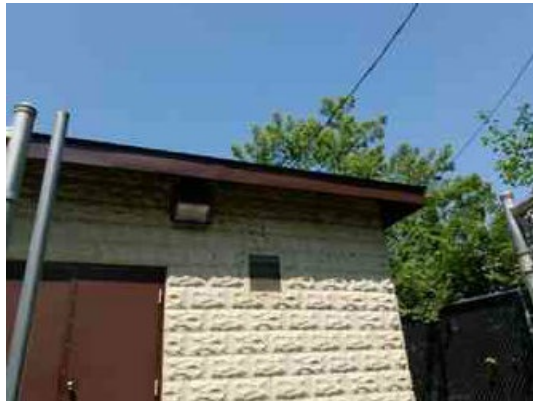
Inspect ID: 2020-0025 **Title:** 2604000010_CELRC_2020_A_0025_1_20200707T155305.jpg **Rated Item:** 5. Plant Building **Caption:** Acceptable - PS-FA: Roof beam replaced.

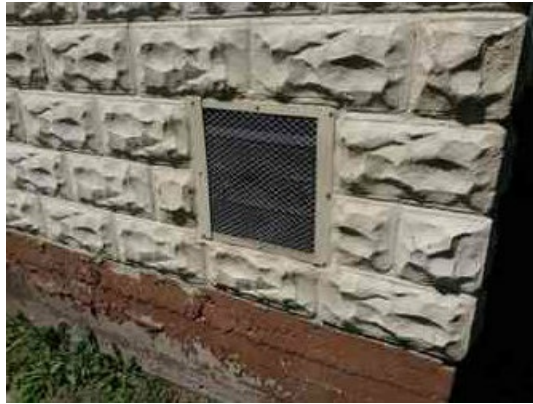
Inspect ID: 2020-0027 **Title:** 2604000010_CELRC_2020_A_0027_1_20200707T155401.jpg **Rated Item:** 5. Plant Building **Caption:** Minimally Acceptable - PS-FA: Vent screen dirty.

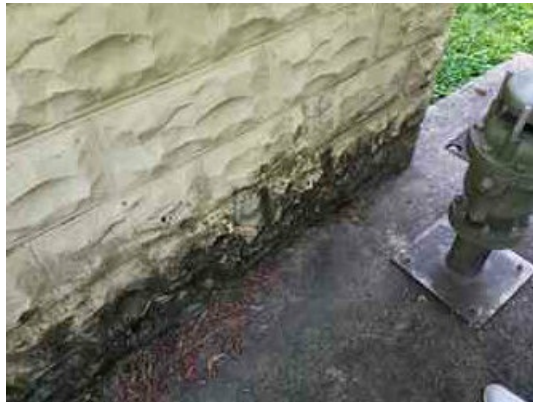
Inspect ID: 2020-0029 **Title:** 2604000010_CELRC_2020_A_0029_1_20200707T155503.jpg **Rated Item:** 5. Plant Building **Caption:** Minimally Acceptable - PS-FA: Paint peeling.

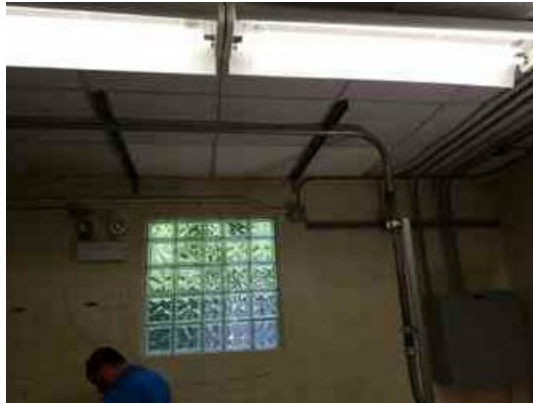
Inspect ID: 2020-0035 **Title:** 2604000010_CELRC_2020_A_0035_1_20200707T155823.jpg **Rated Item:** 5. Plant Building **Caption:** Acceptable - PS-FA: Drop ceiling tiles have been replaced.

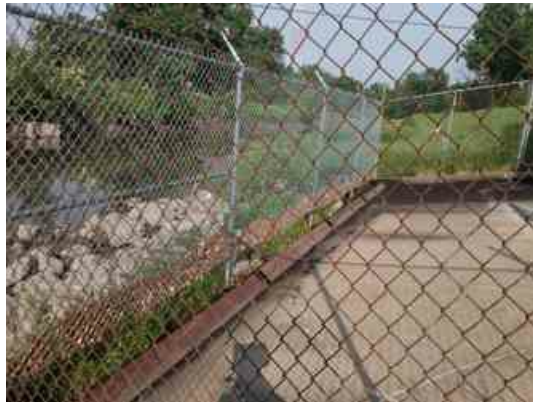
Inspect ID: 2020-0010 **Title:** 2604000010_CELRC_2020_A_0010_1_20200708T133117.jpg **Rated Item:** 6. Fencing and Gates **Caption:** Minimally Acceptable - PS-SH: Debris on fence.

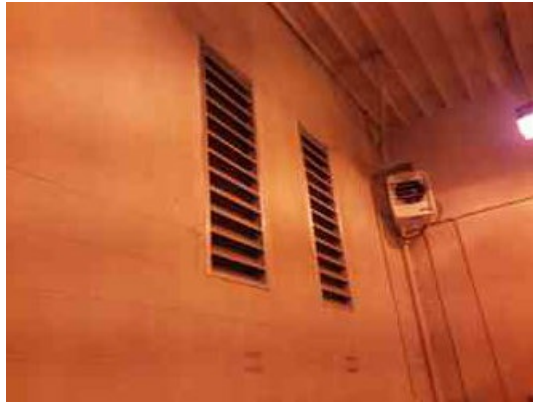
Inspect ID: 2020-0011 **Title:** 2604000010_CELRC_2020_A_0011_1_20200707T135440.jpg **Rated Item:** 8. Motors, Engines, Fans, Gear Reducers, Back Stop Devices, etc. **Caption:** Minimally Acceptable - PS-SH: Operator said vents open when pump is running, but couldn't verify.
