Levee Inspection Report

Name of System: Hammond

Name of Segment: Hammond

Date(s) of Inspection: 07/07/2020 - 07/08/2020

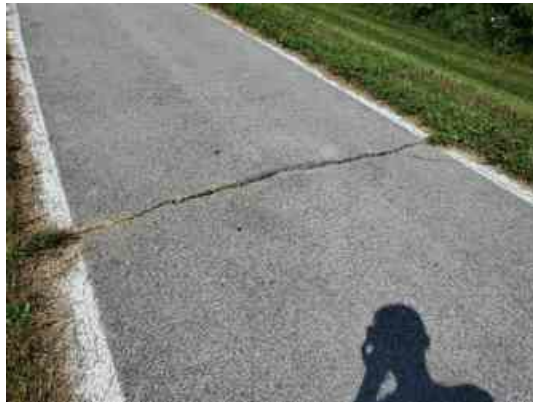
Inspect ID: 2020-0231 **Title:** 2604000008_CELRC_2020_A_0231_1_20200707T150718.jpg **Rated Item:** 9. Cracking **Caption:** Minimally Acceptable - Transverse crack in pavement. Investigate.

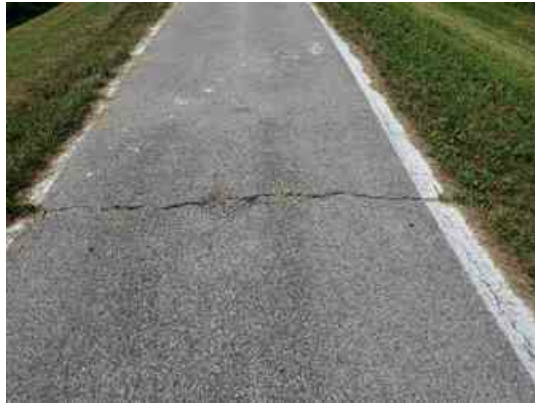
Inspect ID: 2020-0234 **Title:** 2604000008_CELRC_2020_A_0234_1_20200707T150830.jpg **Rated Item:** 9. Cracking **Caption:** Minimally Acceptable - Transverse crack in pavement. Investigate.

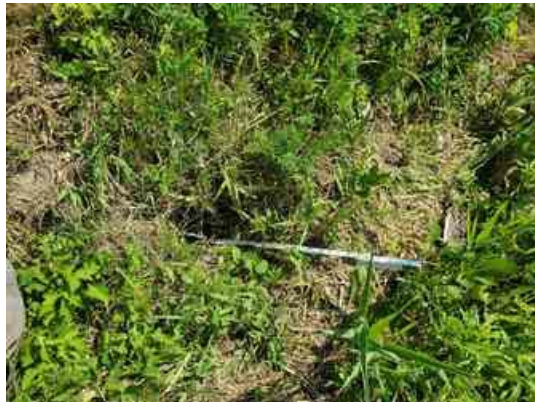
Inspect ID: 2020-0246 **Title:** 2604000008_CELRC_2020_A_0246_1_20200707T151612.jpg **Rated Item:** 10. Animal Control **Caption:** Minimally Acceptable - 18 inch deep burrow on riverside slope.

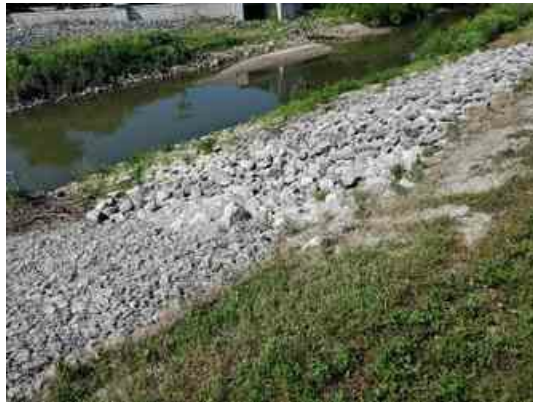
Inspect ID: 2020-0210 **Title:** 2604000008_CELRC_2020_A_0210_1_20200707T145033.jpg **Rated Item:** 12. Riprap Revetments & Bank Protection **Caption:** Minimally Acceptable - Missing riprap on upper half of slope .

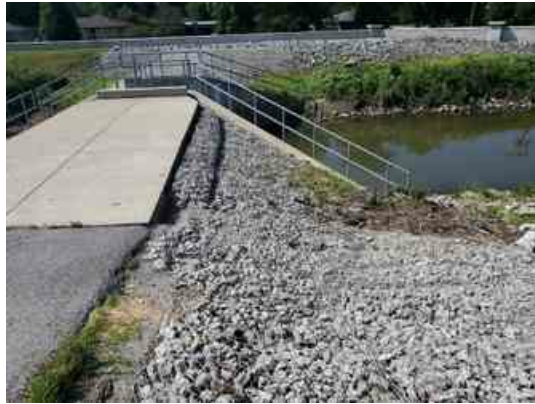
Inspect ID: 2020-0213 **Title:** 2604000008_CELRC_2020_A_0213_1_20200707T145116.jpg **Rated Item:** 13. Revetments other than Riprap **Caption:** Minimally Acceptable - Missing stone from gabion on west side of control structure.

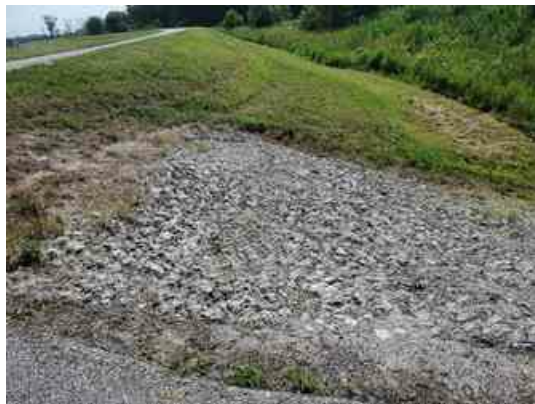
Inspect ID: 2020-0216 **Title:** 2604000008_CELRC_2020_A_0216_1_20200707T145258.jpg **Rated Item:** 13. Revetments other than Riprap **Caption:** Minimally Acceptable - Broken gabion basket.

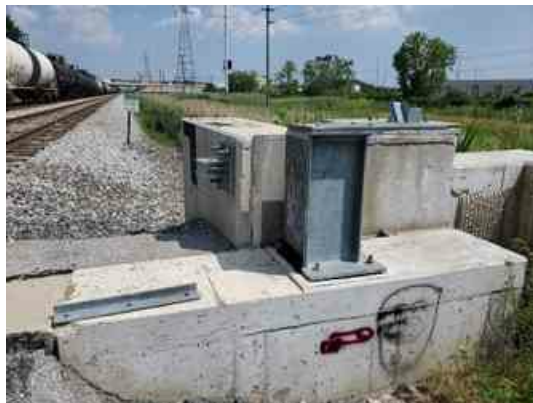
Inspect ID: 2020-0297 **Title:** 2604000008_CELRC_2020_A_0297_1_20200707T160223.jpg **Rated Item:** 3. Closure Structures (Stop Log Closures and Gates) (A or U only) **Caption:** Acceptable - Rubber seal missing at railroad. Last exercise performed in 2013. Exercise overdue.

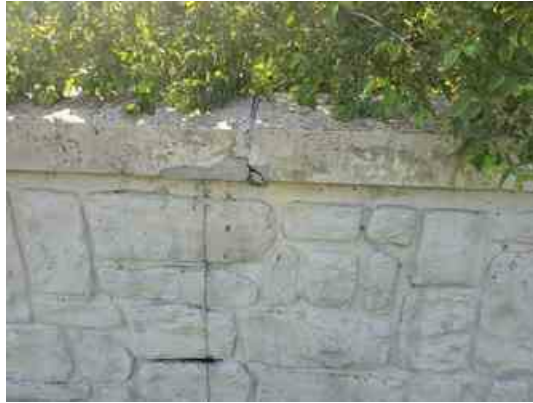
Inspect ID: 2020-0126 **Title:** 2604000008_CELRC_2020_A_0126_1_20200707T141838.jpg **Rated Item:** 4. Concrete Surfaces **Caption:** Minimally Acceptable - Spalling on cap.

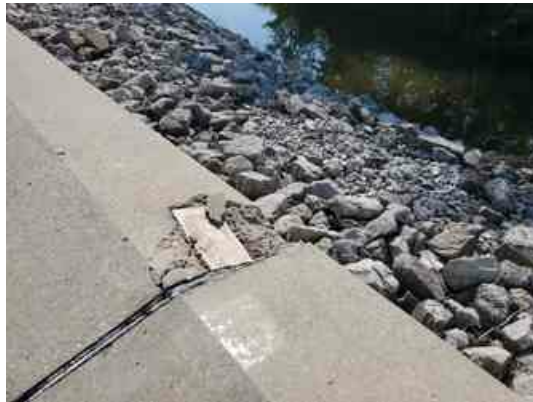
Inspect ID: 2020-0135 **Title:** 2604000008_CELRC_2020_A_0135_1_20200707T142135.jpg **Rated Item:** 4. Concrete Surfaces **Caption:** Minimally Acceptable - Broken concrete cap.

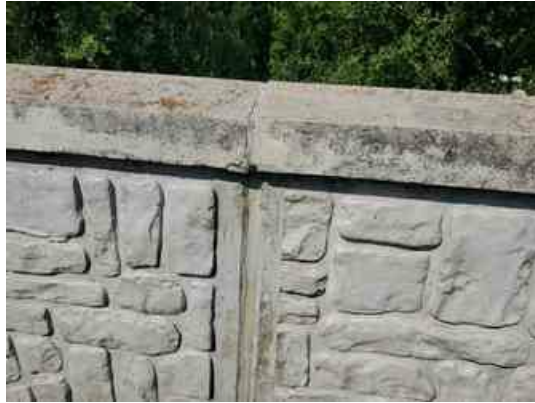
Inspect ID: 2020-0162 **Title:** 2604000008_CELRC_2020_A_0162_1_20200707T143223.jpg **Rated Item:** 4. Concrete Surfaces **Caption:** Minimally Acceptable - Spalling on cap.

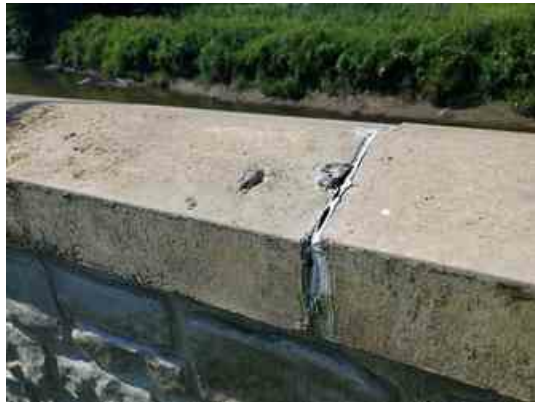
Inspect ID: 2020-0192 **Title:** 2604000008_CELRC_2020_A_0192_1_20200707T144341.jpg **Rated Item:** 4. Concrete Surfaces **Caption:** Minimally Acceptable - Exposed rebar on cap.

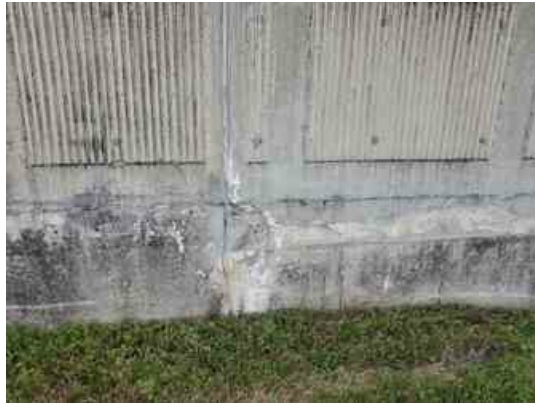
Inspect ID: 2020-0375 **Title:** 2604000008_CELRC_2020_A_0375_1_20200707T175124.jpg **Rated Item:** 4. Concrete Surfaces **Caption:** Minimally Acceptable - Spalling on riverside face.

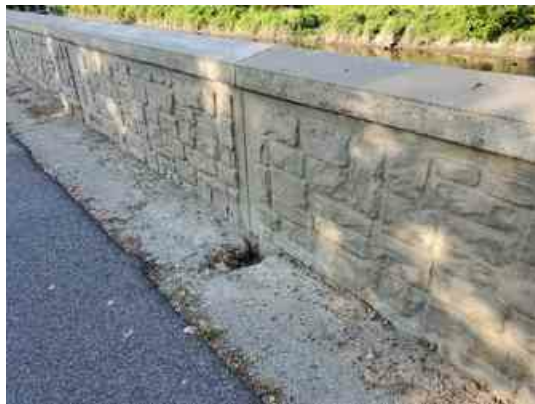
Inspect ID: 2020-0015 **Title:** 2604000008_CELRC_2020_A_0015_1_20200707T122345.jpg **Rated Item:** 6. Foundation of Concrete Structures **Caption:** Minimally Acceptable - Hole on landside.

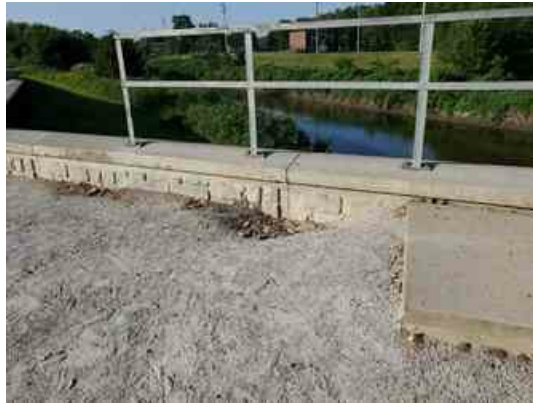
Inspect ID: 2020-0018 **Title:**
2604000008_CELRC_2020_A_0018_1_20200707T122615.jpg **Rated**
Item: 6. Foundation of Concrete Structures **Caption:** Minimally
Acceptable - Hole on landside.

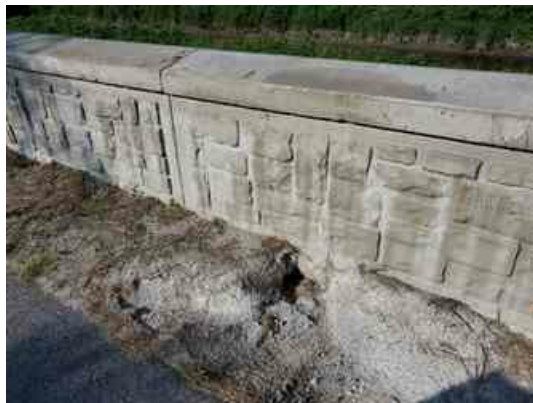
Inspect ID: 2020-0027 **Title:**
2604000008_CELRC_2020_A_0027_1_20200707T132323.jpg **Rated**
Item: 6. Foundation of Concrete Structures **Caption:** Minimally
Acceptable - Hole on landside.

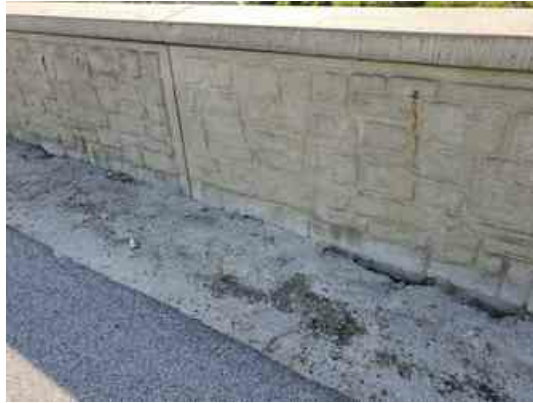
Inspect ID: 2020-0039 **Title:** 2604000008_CELRC_2020_A_0039_1_20200707T133126.jpg **Rated Item:** 6. Foundation of Concrete Structures **Caption:** Minimally Acceptable - Holes on landside.

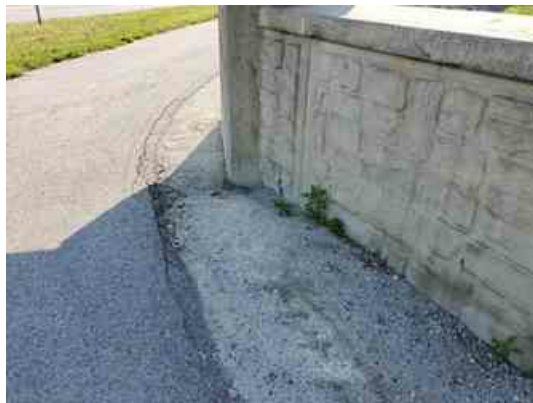
Inspect ID: 2020-0042 **Title:** 2604000008_CELRC_2020_A_0042_1_20200707T133217.jpg **Rated Item:** 6. Foundation of Concrete Structures **Caption:** Minimally Acceptable - Cracking of asphalt at pillar.

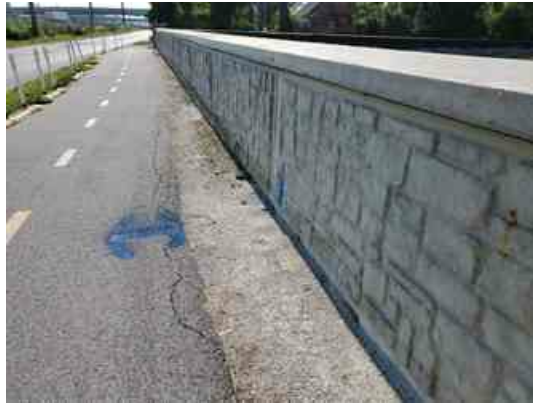
Inspect ID: 2020-0045 **Title:**
2604000008_CELRC_2020_A_0045_1_20200707T133327.jpg **Rated**
Item: 6. Foundation of Concrete Structures **Caption:** Minimally
Acceptable - Asphalt cracking toward wall.

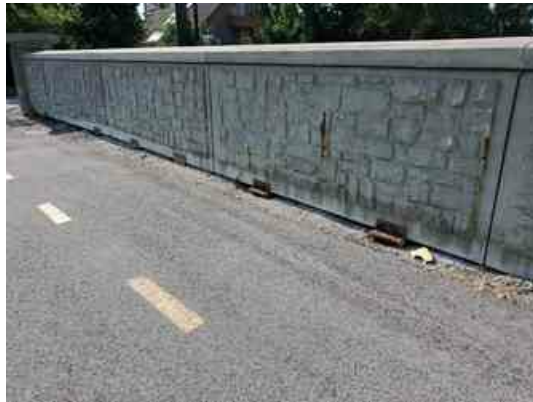
Inspect ID: 2020-0048 **Title:**
2604000008_CELRC_2020_A_0048_1_20200707T133414.jpg **Rated**
Item: 6. Foundation of Concrete Structures **Caption:** Minimally
Acceptable - Exposed panel base

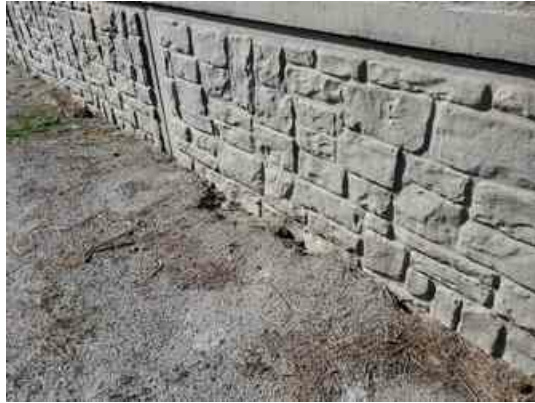
Inspect ID: 2020-0063 **Title:** 2604000008_CELRC_2020_A_0063_1_20200707T133911.jpg **Rated**
Item: 6. Foundation of Concrete Structures **Caption:** Minimally
Acceptable - Holes on landside.

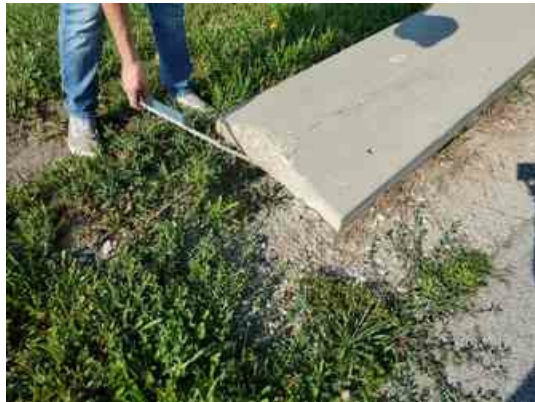
Inspect ID: 2020-0072 **Title:** 2604000008_CELRC_2020_A_0072_1_20200707T134028.jpg **Rated**
Item: 6. Foundation of Concrete Structures **Caption:** Minimally
Acceptable - Hole at transition.

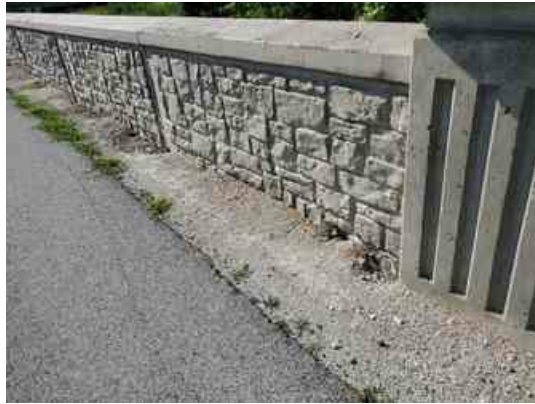
Inspect ID: 2020-0087 **Title:** 2604000008_CELRC_2020_A_0087_1_20200707T134740.jpg **Rated Item:** 6. Foundation of Concrete Structures **Caption:** Minimally Acceptable - Holes on landside.

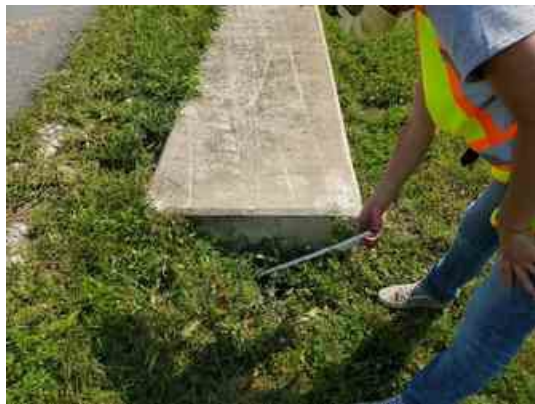
Inspect ID: 2020-0267 **Title:** 2604000008_CELRC_2020_A_0267_1_20200707T153829.jpg **Rated Item:** 6. Foundation of Concrete Structures **Caption:** Minimally Acceptable - Hole at transition, 18 inch deep.

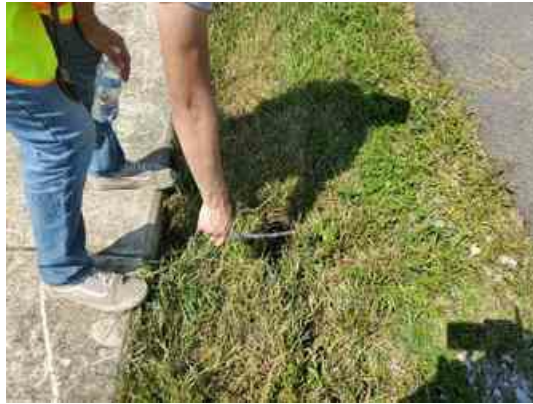
Inspect ID: 2020-0270 **Title:** 2604000008_CELRC_2020_A_0270_1_20200707T154010.jpg **Rated Item:** 6. Foundation of Concrete Structures **Caption:** Minimally Acceptable - 2.5 ft deep burrow on landside.

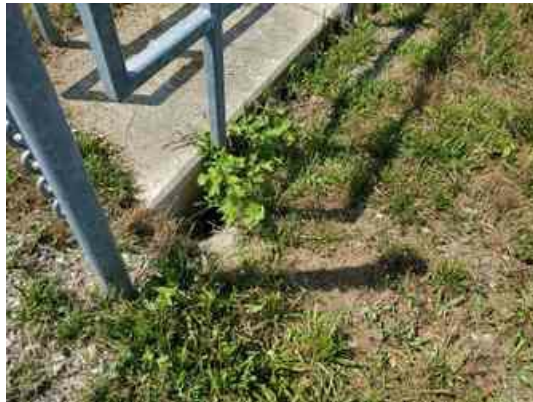
Inspect ID: 2020-0279 **Title:** 2604000008_CELRC_2020_A_0279_1_20200707T154659.jpg **Rated Item:** 6. Foundation of Concrete Structures **Caption:** Minimally Acceptable - 3 ft hole on landside.

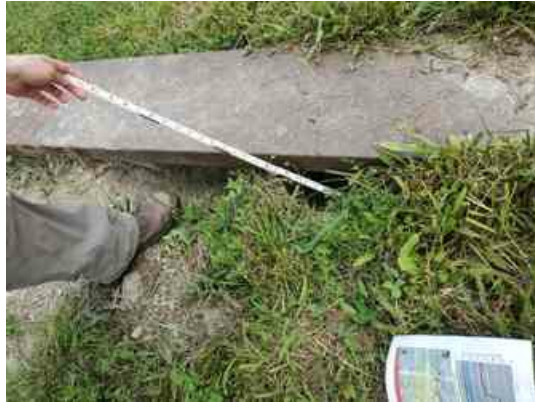
Inspect ID: 2020-0372 **Title:** 2604000008_CELRC_2020_A_0372_1_20200707T174947.jpg **Rated Item:** 6. Foundation of Concrete Structures **Caption:** Minimally Acceptable - 4 ft deep burrow on landside.

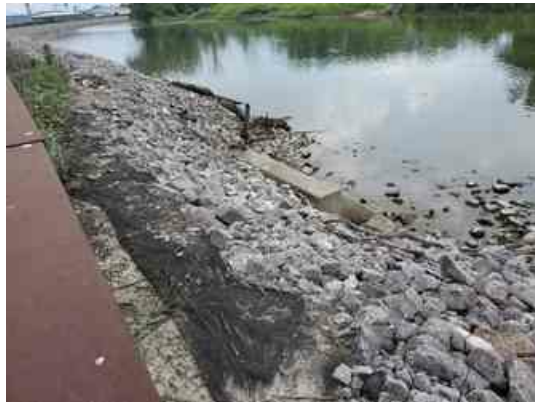
Inspect ID: 2020-0405 **Title:** 2604000008_CELRC_2020_A_0405_1_20200707T180617.jpg **Rated Item:** 6. Foundation of Concrete Structures **Caption:** Minimally Acceptable - Riprap displaced, fabric exposed.

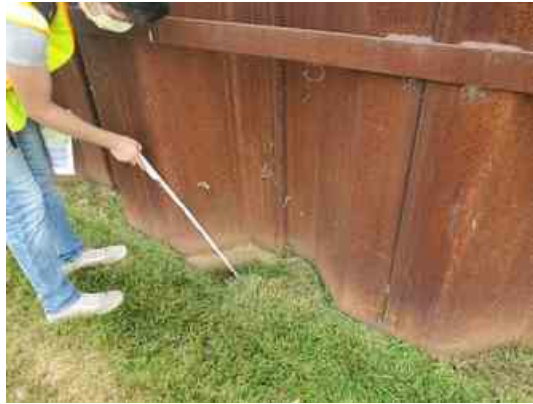
Inspect ID: 2020-0453 **Title:** 2604000008_CELRC_2020_A_0453_1_20200707T182806.jpg **Rated Item:** 6. Foundation of Concrete Structures **Caption:** Minimally Acceptable - 1 ft hole on landside.

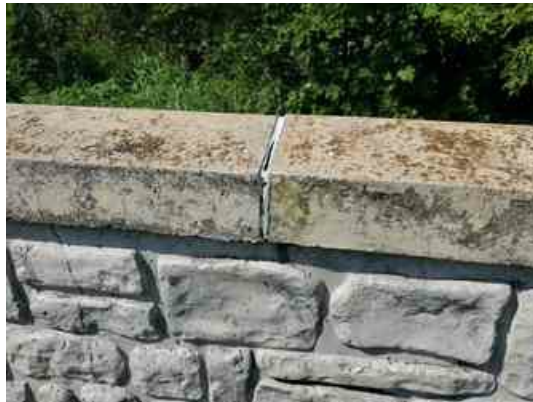
Inspect ID: 2020-0174 **Title:** 2604000008_CELRC_2020_A_0174_1_20200707T143644.jpg **Rated Item:** 7. Monolith Joints **Caption:** Minimally Acceptable - Crack in sealant.

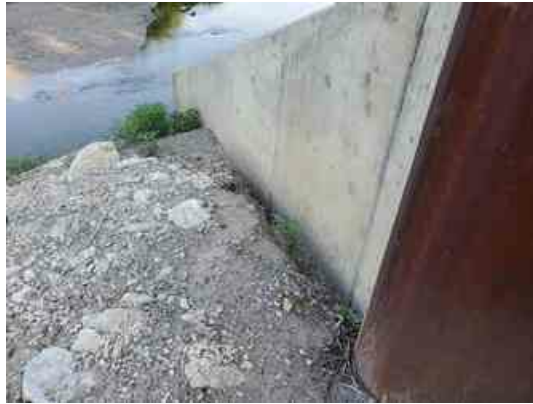
Inspect ID: 2020-0021 **Title:** 2604000008_CELRC_2020_A_0021_1_20200707T122719.jpg **Rated Item:** 7. Foundation of Concrete Structures (Such as culverts, inlet and discharge structures, or gateways.) **Caption:** Minimally Acceptable - HA-4: Erosion on east side of outlet wingwall.

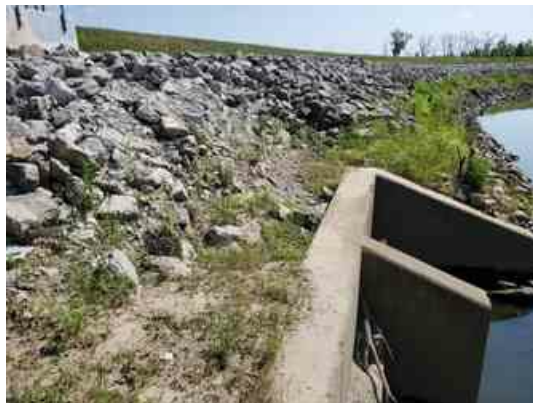
Inspect ID: 2020-0225 **Title:** 2604000008_CELRC_2020_A_0225_1_20200707T145928.jpg **Rated Item:** 7. Foundation of Concrete Structures (Such as culverts, inlet and discharge structures, or gateways.) **Caption:** Minimally Acceptable - HA-17: Erosion behind headwall.

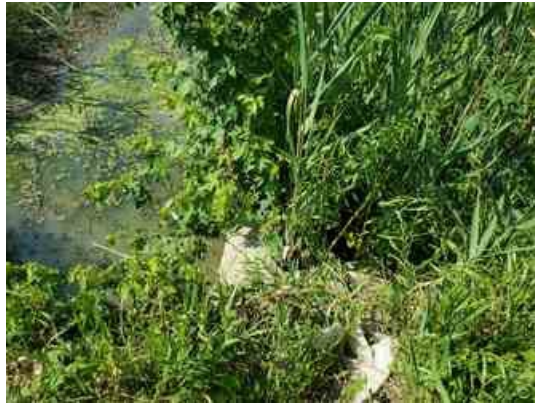
Inspect ID: 2020-0252 **Title:** 2604000008_CELRC_2020_A_0252_1_20200707T151836.jpg **Rated Item:** 7. Foundation of Concrete Structures (Such as culverts, inlet and discharge structures, or gateways.) **Caption:** Minimally Acceptable - HA-19: Erosion next to west wingwall.

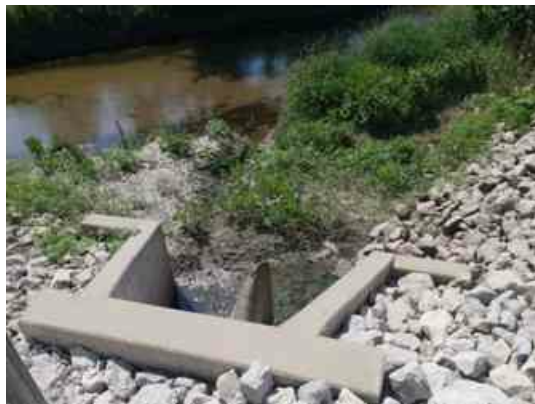
Inspect ID: 2020-0071 **Title:** 2604000008_CELRC_2020_A_0071_1_20200707T153709.jpg **Rated Item:** 9. Culverts/ Discharge Pipes **Caption:** Acceptable - HA 14 outlet structure clear of debris

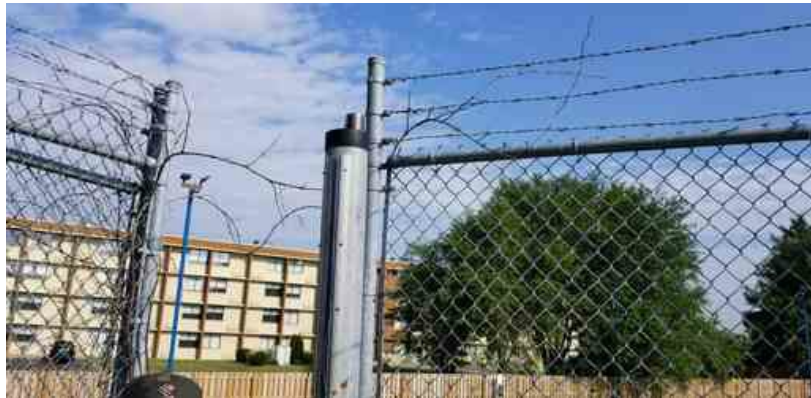
Inspect ID: 2020-0074 **Title:** 2604000008_CELRC_2020_A_0074_1_20200904T190017.jpg **Rated Item:** 10. Sluice/ Slide Gates **Caption:** Minimally Acceptable - HA-35: Riser stem casing is too short with damaged weather cap.

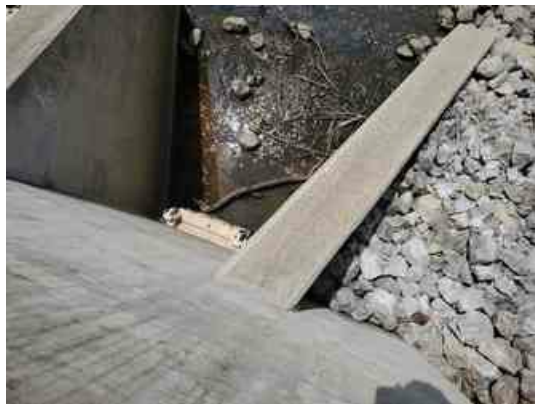
Inspect ID: 2020-0426 **Title:** 2604000008_CELRC_2020_A_0426_1_20200707T181704.jpg **Rated**
Item: 11. Flap Gates/ Flap Valves/ Pinch Valves **Caption:** Minimally
Acceptable - HA-34: Flap gate leaking.

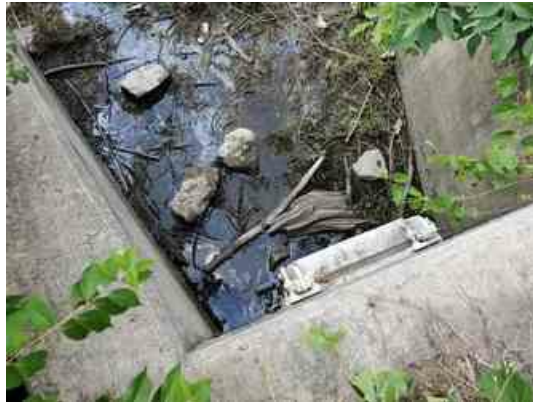
Inspect ID: 2020-0474 **Title:** 2604000008_CELRC_2020_A_0474_1_20200707T184800.jpg **Rated Item:** 11. Flap Gates/ Flap Valves/ Pinch Valves **Caption:** Minimally Acceptable - HA-36: Flap gate leaking.

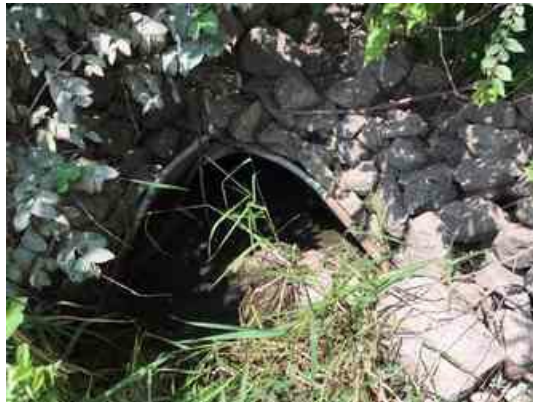
Inspect ID: 2020-0481 **Title:** 2604000008_CELRC_2020_A_0481_1_20200916T161015.jpg **Rated Item:** 11. Flap Gates/ Flap Valves/ Pinch Valves **Caption:** Unacceptable - HA-37: No gate on culvert. Coordinate with INDOT. The culvert is above 200 year elevation and within the freeboard so it is not critical to the design. This rating will not impact the overall item rating.

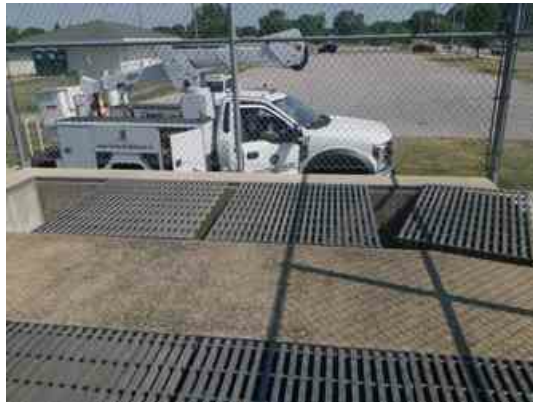
Inspect ID: 2020-0053 **Title:** 2604000008_CELRC_2020_A_0053_1_20200707T151804.jpg **Rated Item:** 13. Other Metallic Items **Caption:** Unacceptable - HA-13: Grating missing. Replace.

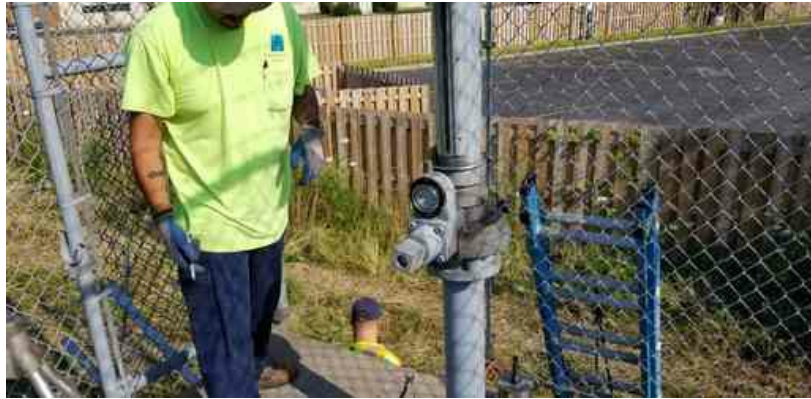
Inspect ID: 2020-0056 **Title:** 2604000008_CELRC_2020_A_0056_1_20200904T185111.jpg **Rated Item:** 13. Other Metallic Items **Caption:** Minimally Acceptable - HA-35: Ladder broken.

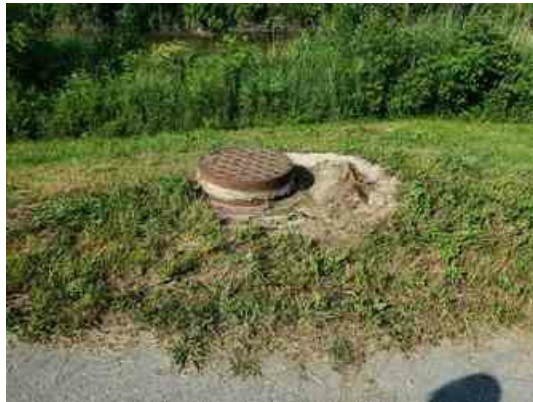
Inspect ID: 2020-0111 **Title:** 2604000008_CELRC_2020_A_0111_1_20200707T140839.jpg **Rated Item:** 13. Other Metallic Items **Caption:** Minimally Acceptable - HA-11: Manhole displaced.

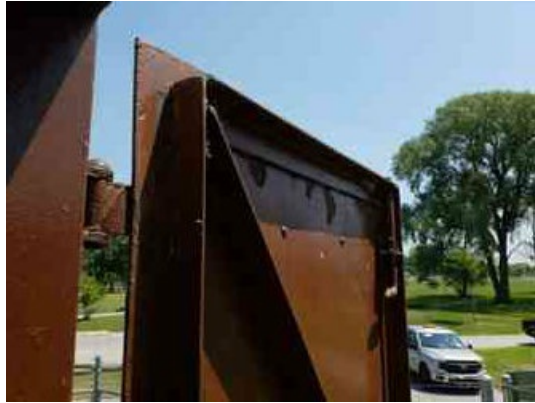
Inspect ID: 2020-0013 **Title:** 2604000008_CELRC_2020_A_0013_1_20200706T163656.jpg **Rated Item:** 5. Plant Building **Caption:** Minimally Acceptable - PS-TA: Corrosion on doors.

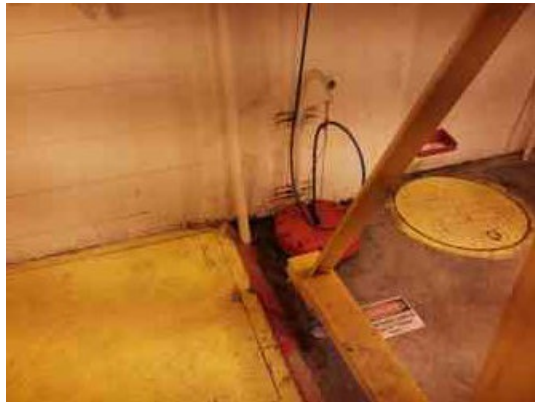
Inspect ID: 2020-0028 **Title:** 2604000008_CELRC_2020_A_0028_1_20200706T164950.jpg **Rated Item:** 5. Plant Building **Caption:** Minimally Acceptable - PS-WA: Growth from roof leak.

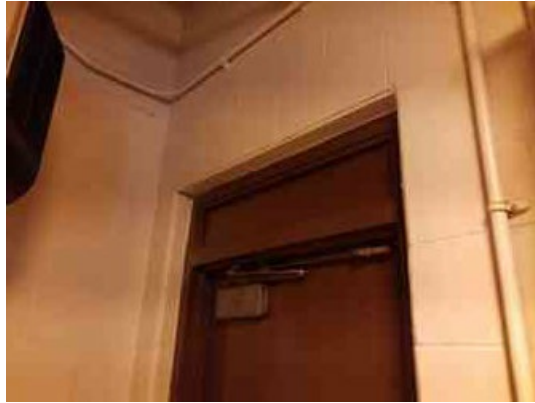
Inspect ID: 2020-0031 **Title:** 2604000008_CELRC_2020_A_0031_1_20200706T165059.jpg **Rated Item:** 5. Plant Building **Caption:** Minimally Acceptable - PS-WA: Masonry cracking in corners and above doors.

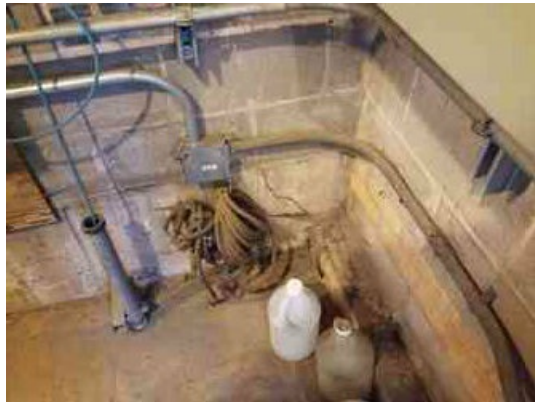
Inspect ID: 2020-0049 **Title:** 2604000008_CELRC_2020_A_0049_1_20200706T171143.jpg **Rated Item:** 5. Plant Building **Caption:** Minimally Acceptable - PS-KA: Crack in foundation.

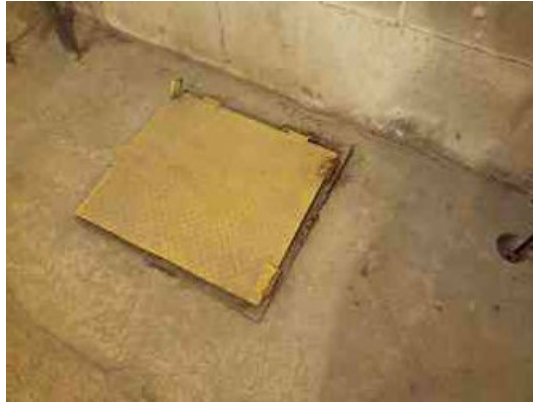
Inspect ID: 2020-0058 **Title:** 2604000008_CELRC_2020_A_0058_1_20200706T171414.jpg **Rated Item:** 5. Plant Building **Caption:** Minimally Acceptable - PS-KA: Hatch is corroded and broken.

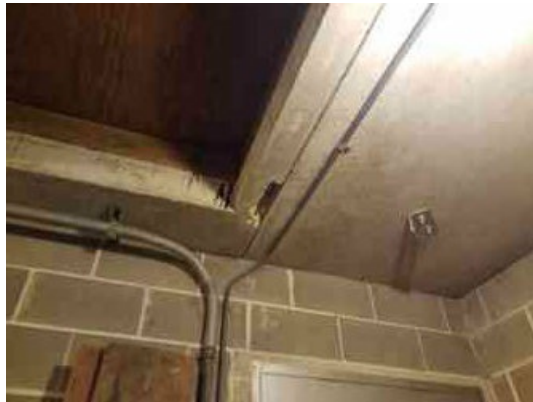
Inspect ID: 2020-0061 **Title:** 2604000008_CELRC_2020_A_0061_1_20200706T171531.jpg **Rated Item:** 5. Plant Building **Caption:** Minimally Acceptable - PS-KA: Exposed rebar in ceiling.

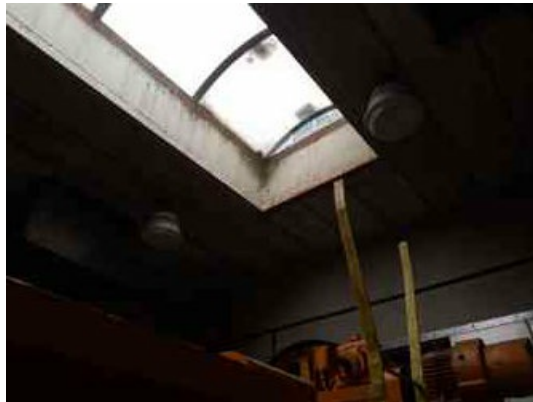
Inspect ID: 2020-0088 **Title:** 2604000008_CELRC_2020_A_0088_1_20200706T173358.jpg **Rated Item:** 5. Plant Building **Caption:** Minimally Acceptable - PS-HV: Roof leaking.

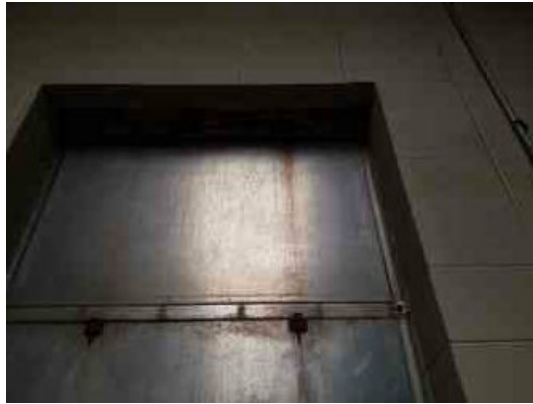
Inspect ID: 2020-0091 **Title:** 2604000008_CELRC_2020_A_0091_1_20200706T173458.jpg **Rated Item:** 5. Plant Building **Caption:** Minimally Acceptable - PS-HV: Deteriorating seal.

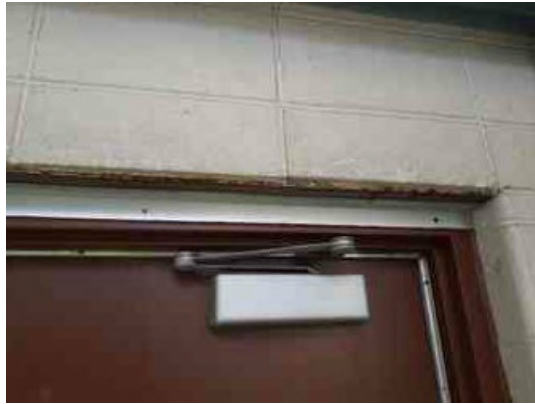
Inspect ID: 2020-0115 **Title:** 2604000008_CELRC_2020_A_0115_1_20200707T131430.jpg **Rated Item:** 5. Plant Building **Caption:** Minimally Acceptable - PS-JA: Rusting on lintel. Cracking above door.

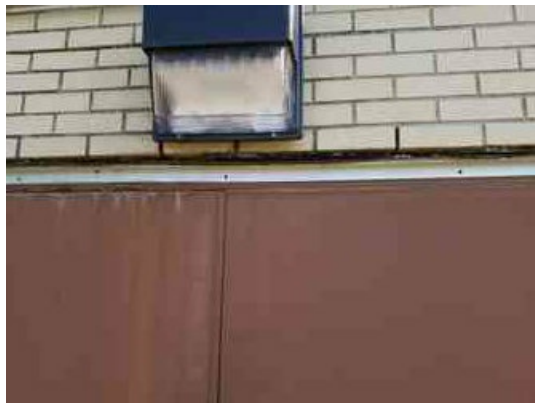
Inspect ID: 2020-0121 **Title:** 2604000008_CELRC_2020_A_0121_1_20200707T132002.jpg **Rated Item:** 5. Plant Building **Caption:** Minimally Acceptable - PS-JA: Rusting on lintel.

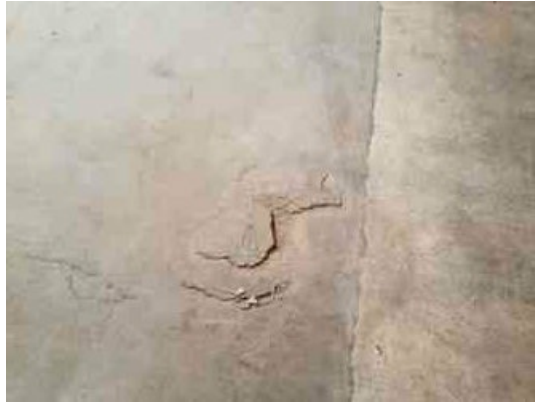
Inspect ID: 2020-0157 **Title:** 2604000008_CELRC_2020_A_0157_1_20200707T142005.jpg **Rated Item:** 5. Plant Building **Caption:** Minimally Acceptable - PS-SS: Spalling across floor.

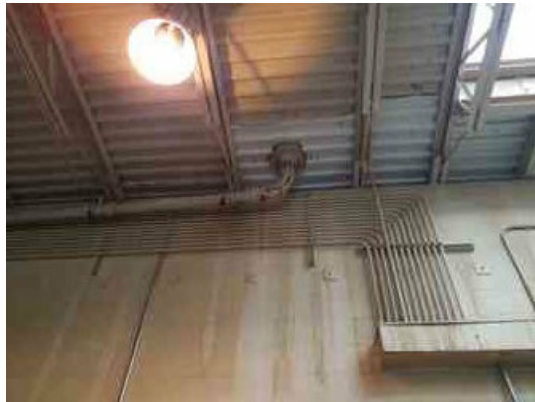
Inspect ID: 2020-0160 **Title:** 2604000008_CELRC_2020_A_0160_1_20200707T142053.jpg **Rated Item:** 5. Plant Building **Caption:** Minimally Acceptable - PS-SS: Paint peeling on pipe elbow.

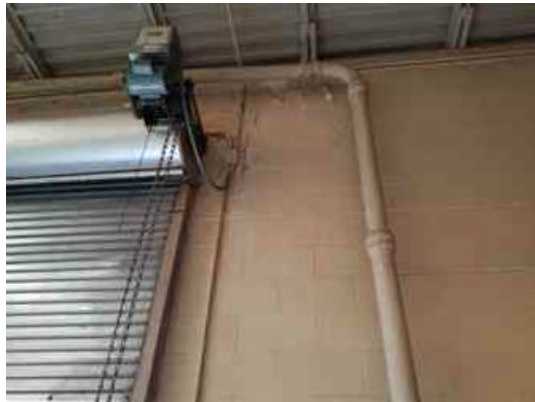
Inspect ID: 2020-0166 **Title:** 2604000008_CELRC_2020_A_0166_1_20200707T142231.jpg **Rated Item:** 5. Plant Building **Caption:** Minimally Acceptable - PS-SS: Cracking around door frame.

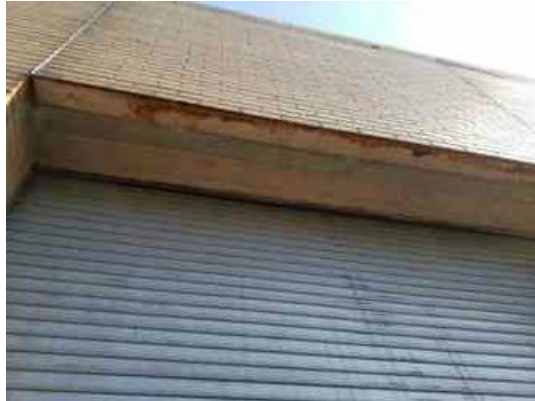
Inspect ID: 2020-0175 **Title:** 2604000008_CELRC_2020_A_0175_1_20200707T143103.jpg **Rated Item:** 5. Plant Building **Caption:** Minimally Acceptable - PS-SS: Rust on lintel.

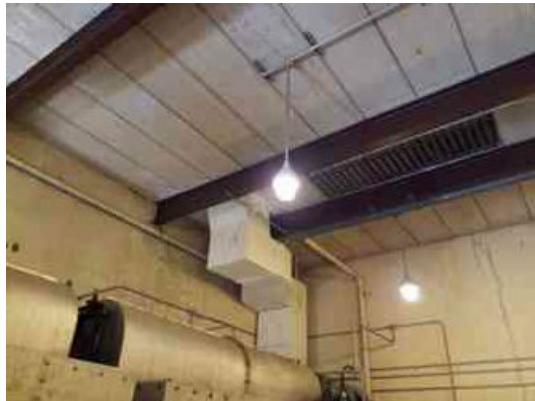
Inspect ID: 2020-0190 **Title:** 2604000008_CELRC_2020_A_0190_1_20200707T144726.jpg **Rated Item:** 5. Plant Building **Caption:** Minimally Acceptable - PS-IN: Peeling paint on ducts and ceiling.

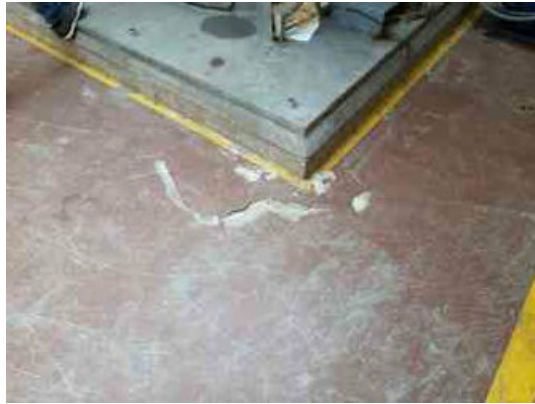
Inspect ID: 2020-0205 **Title:** 2604000008_CELRC_2020_A_0205_1_20200707T145224.jpg **Rated Item:** 5. Plant Building **Caption:** Minimally Acceptable - PS-IN: Spalling on floor.

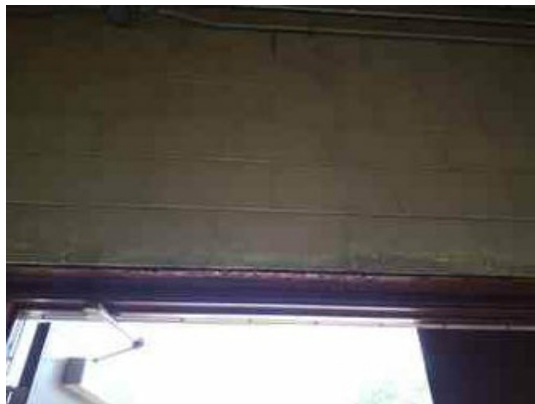
Inspect ID: 2020-0208 **Title:** 2604000008_CELRC_2020_A_0208_1_20200707T145404.jpg **Rated Item:** 5. Plant Building **Caption:** Minimally Acceptable - PS-IN: Corrosion on lintel.

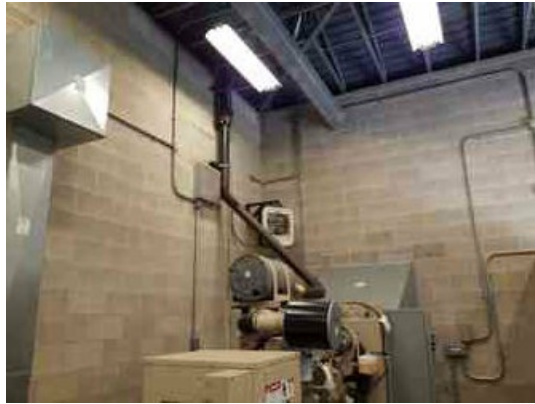
Inspect ID: 2020-0226 **Title:** 2604000008_CELRC_2020_A_0226_1_20200707T151429.jpg **Rated Item:** 5. Plant Building **Caption:** Minimally Acceptable - PS-CA: Corrosion on pipe.

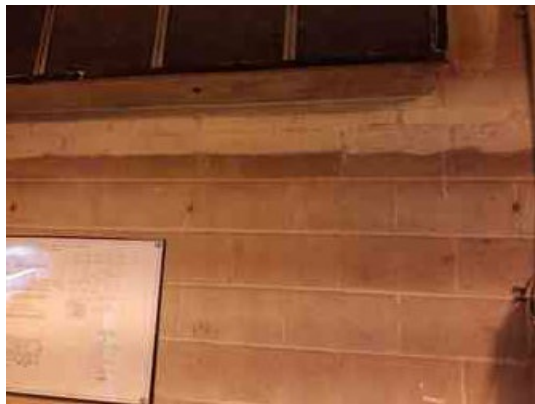
Inspect ID: 2020-0235 **Title:** 2604000008_CELRC_2020_A_0235_1_20200707T152643.jpg **Rated Item:** 5. Plant Building **Caption:** Minimally Acceptable - PS-SK: Paint peeling off walls.

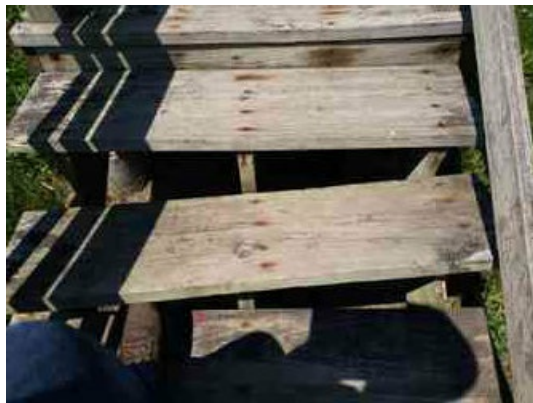
Inspect ID: 2020-0265 **Title:** 2604000008_CELRC_2020_A_0265_2_20200707T155150.jpg **Rated Item:** 5. Plant Building **Caption:** Minimally Acceptable - PS-TA: Stair is not connected.

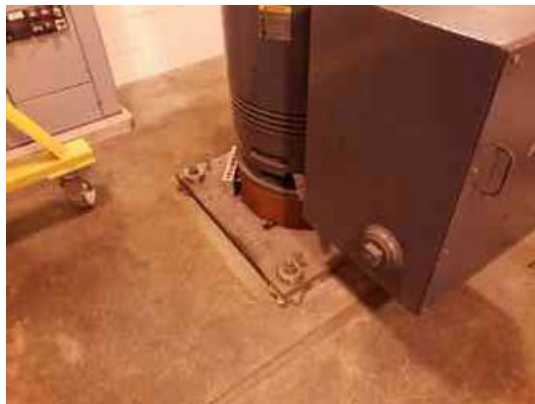
Inspect ID: 2020-0025 **Title:** 2604000008_CELRC_2020_A_0025_1_20200706T164857.jpg **Rated Item:** 7. Pumps **Caption:** Acceptable - PS-WA: SWP-2 shows no evidence of oil leak.
