**US Army Corps
of Engineers®**

Levee Inspection Report

Name of System: Highland

Date(s) of Inspection: 07/14/2020 - 07/14/2020

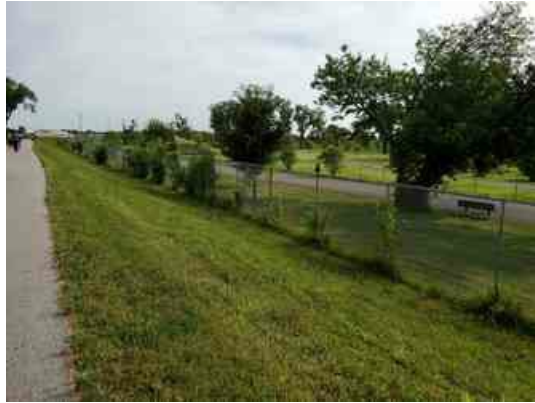
Inspect ID: 2020-0045 **Title:** 2604000007_CELRC_2020_A_0045_1_20200714T133343.jpg **Rated Item:** 1. Unwanted Vegetation Growth **Caption:** Minimally Acceptable - Tree close to landside toe.

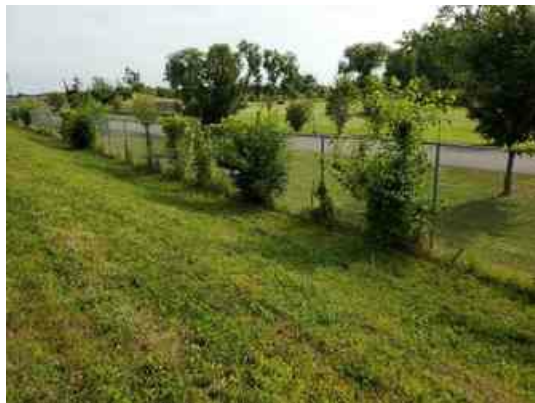
Inspect ID: 2020-0048 **Title:** 2604000007_CELRC_2020_A_0048_1_20200714T133412.jpg **Rated Item:** 1. Unwanted Vegetation Growth **Caption:** Minimally Acceptable - Small trees and bushes near landside toe.

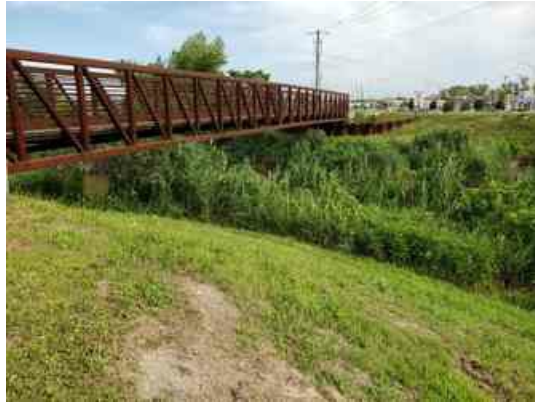
Inspect ID: 2020-0099 **Title:** 2604000007_CELRC_2020_A_0099_1_20200714T135704.jpg **Rated Item:** 1. Unwanted Vegetation Growth **Caption:** Minimally Acceptable - Tall vegetation on riverside toe.

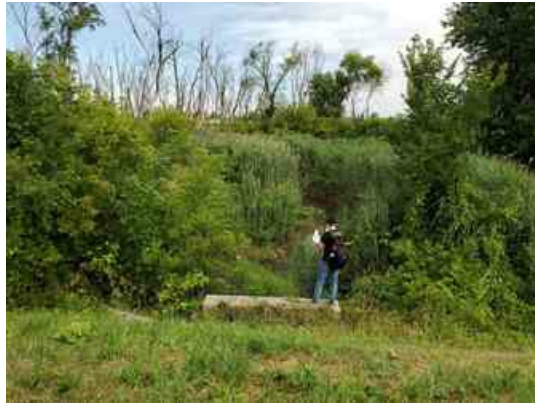
Inspect ID: 2020-0117 **Title:** 2604000007_CELRC_2020_A_0117_1_20200714T141722.jpg **Rated Item:** 1. Unwanted Vegetation Growth **Caption:** Minimally Acceptable - Trees on riverside toe.

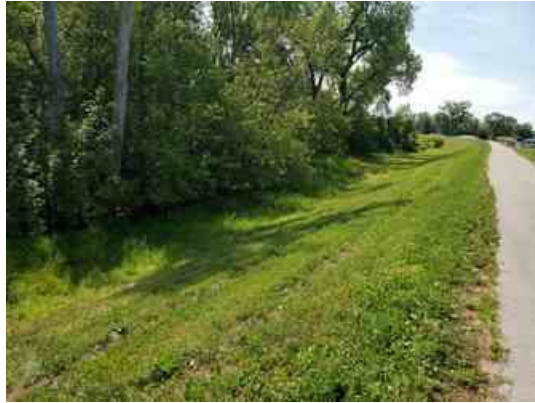
Inspect ID: 2020-0270 **Title:** 2604000007_CELRC_2020_A_0270_1_20200714T155834.jpg **Rated Item:** 1. Unwanted Vegetation Growth **Caption:** Minimally Acceptable - Trees near riverside toe.

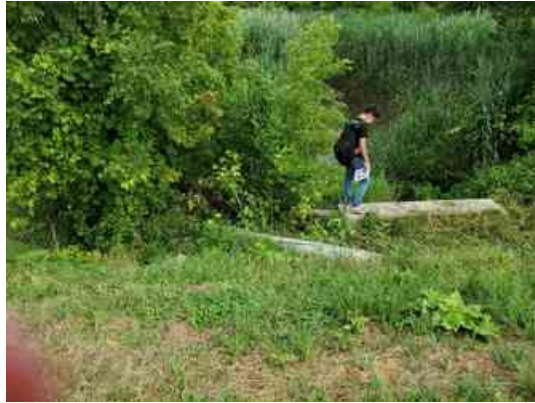
Inspect ID: 2020-0114 **Title:** 2604000007_CELRC_2020_A_2020-0114_1_20200714T141618.jpg **Rated Item:** 3. Encroachments **Caption:** Minimally Acceptable - Downed tree on riverside toe.

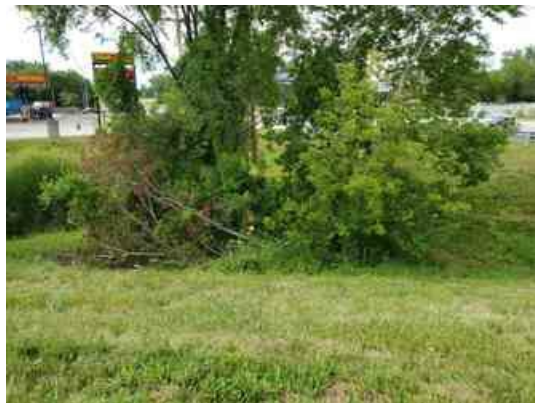
Inspect ID: 2020-0120 **Title:** 2604000007_CELRC_2020_A_0120_1_20200714T142118.jpg **Rated Item:** 3. Encroachments **Caption:** Minimally Acceptable - Downed tree

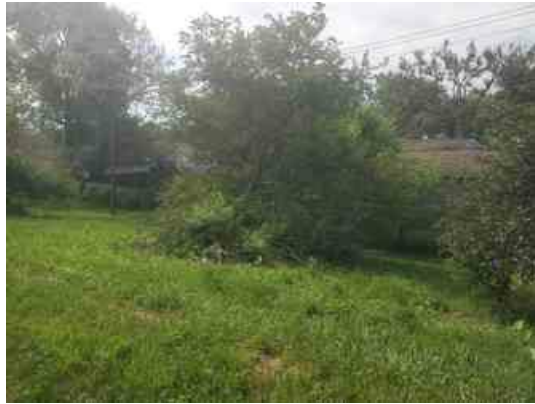
Inspect ID: 2020-0150 **Title:** 2604000007_CELRC_2020_A_0150_1_20200714T144625.jpg **Rated Item:** 3. Encroachments **Caption:** Minimally Acceptable - Pile of branches on landside slope.

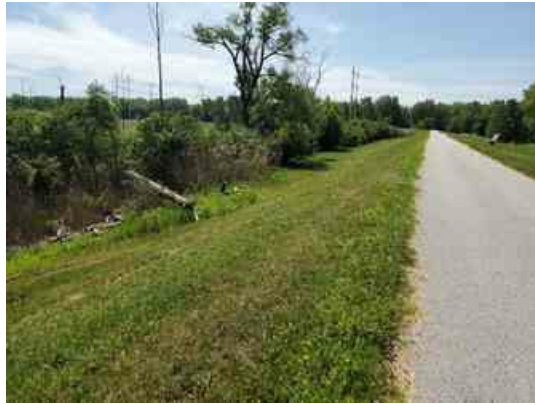
Inspect ID: 2020-0300 **Title:** 2604000007_CELRC_2020_A_0300_1_20200714T161824.jpg **Rated Item:** 3. Encroachments **Caption:** Minimally Acceptable - Downed trees and logs on riverside toe.

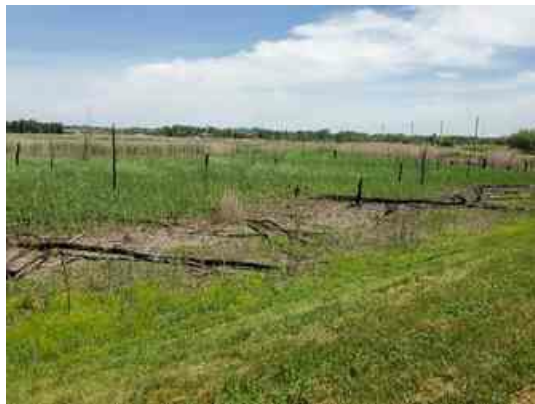
Inspect ID: 2020-0354 **Title:** 2604000007_CELRC_2020_A_0354_1_20200714T164917.jpg **Rated Item:** 3. Encroachments **Caption:** Minimally Acceptable - Downed trees on riverside.

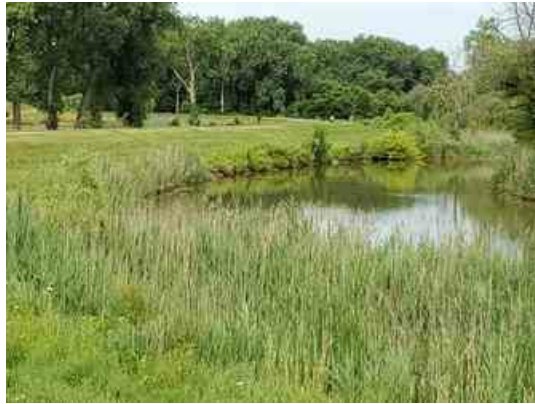
Inspect ID: 2020-0090 **Title:** 2604000007_CELRC_2020_A_0090_1_20200714T135210.jpg **Rated Item:** 6. Erosion/ Bank Caving **Caption:** Minimally Acceptable - Erosion along riverside toe.

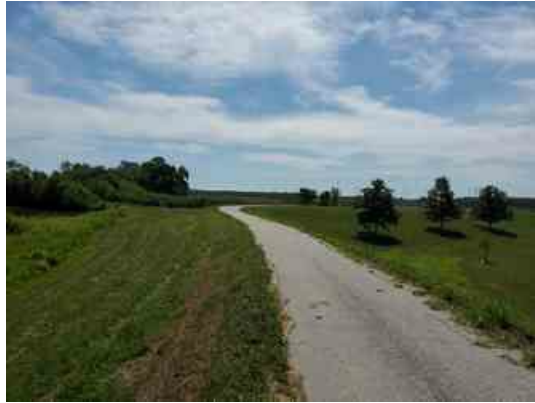
Inspect ID: 2020-0285 **Title:** 2604000007_CELRC_2020_A_0285_1_20200714T160413.jpg **Rated Item:** 7. Settlement **Caption:** Acceptable - Low spot on crest by bend. Location of 2 contract tie-ins. Monitoring.

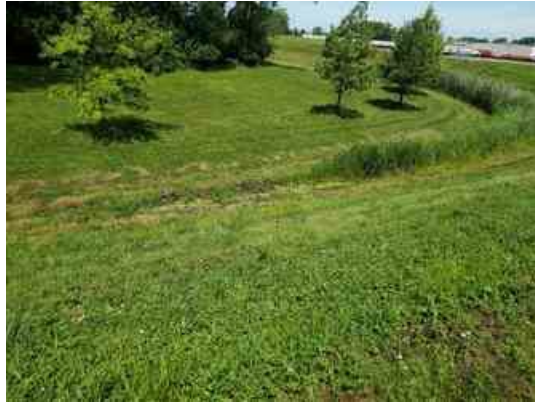
Inspect ID: 2020-0267 **Title:** 2604000007_CELRC_2020_A_0267_1_20200714T155709.jpg **Rated Item:** 8. Depressions/ Rutting **Caption:** Minimally Acceptable - Rutting on landside toe.

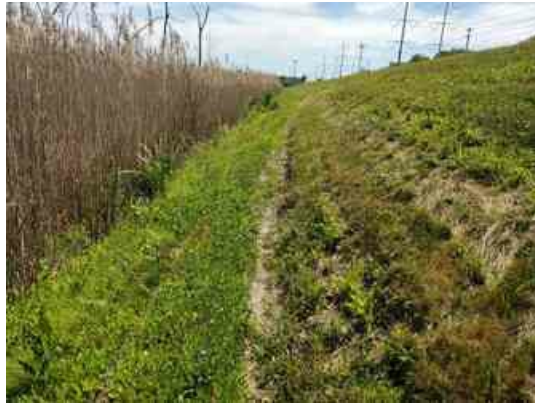
Inspect ID: 2020-0318 **Title:** 2604000007_CELRC_2020_A_0318_1_20200714T163024.jpg **Rated Item:** 8. Depressions/ Rutting **Caption:** Minimally Acceptable - Rutting on riverside slope.

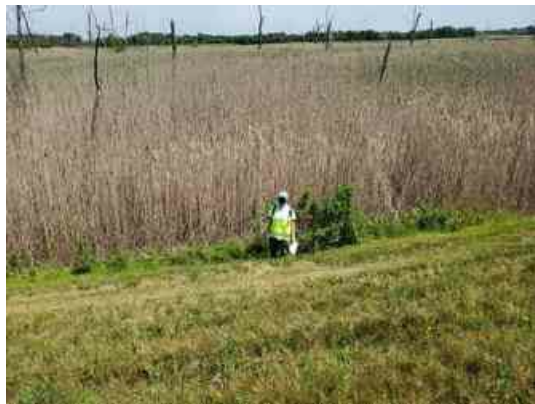
Inspect ID: 2020-0324 **Title:** 2604000007_CELRC_2020_A_0324_1_20200714T163358.jpg **Rated Item:** 8. Depressions/ Rutting **Caption:** Minimally Acceptable - Rutting on riverside toe.

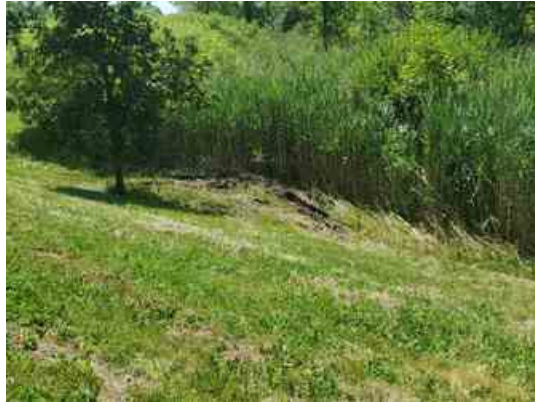
Inspect ID: 2020-0381 **Title:** 2604000007_CELRC_2020_A_0381_1_20200714T165847.jpg **Rated Item:** 8. Depressions/ Rutting **Caption:** Minimally Acceptable - Rutting on landside toe.

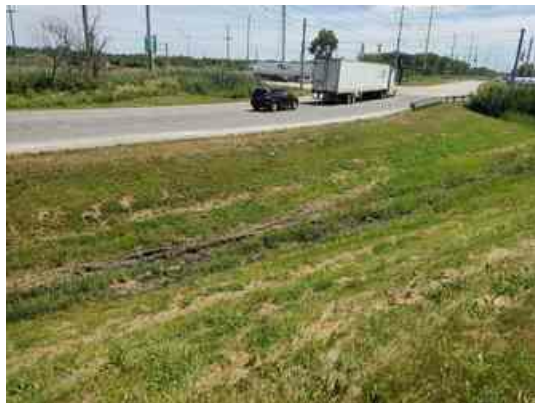
Inspect ID: 2020-0384 **Title:** 2604000007_CELRC_2020_A_0384_1_20200714T165929.jpg **Rated Item:** 8. Depressions/ Rutting **Caption:** Minimally Acceptable - Rutting on riverside toe.

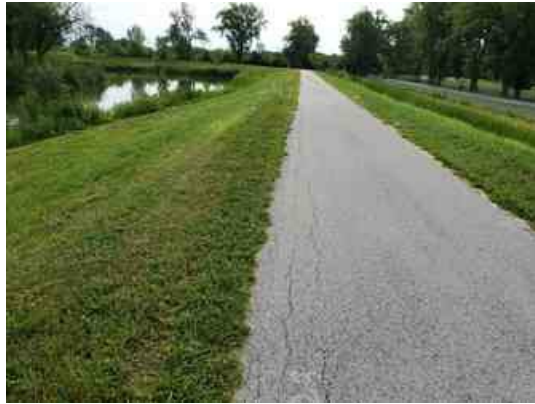
Inspect ID: 2020-0078 **Title:** 2604000007_CELRC_2020_A_0078_1_20200714T134630.jpg **Rated Item:** 9. Cracking **Caption:** Acceptable - Cracking of asphalt near pipe excavation.

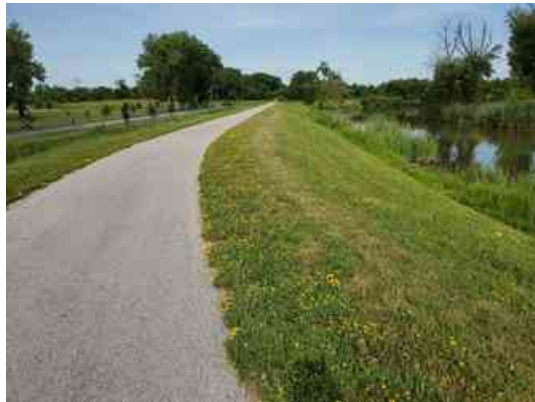
Inspect ID: 2020-0087 **Title:** 2604000007_CELRC_2020_A_0087_1_20200714T135035.jpg **Rated Item:** 9. Cracking **Caption:** Acceptable - Cracking of asphalt near bend where there is bank erosion.

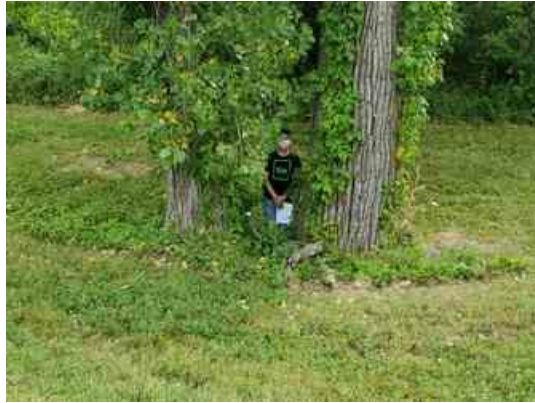
Inspect ID: 2020-0093 **Title:** 2604000007_CELRC_2020_A_0093_1_20200714T135301.jpg **Rated Item:** 10. Animal Control **Caption:** Minimally Acceptable - 1 ft deep hole between trees, 8 ft from landside toe.

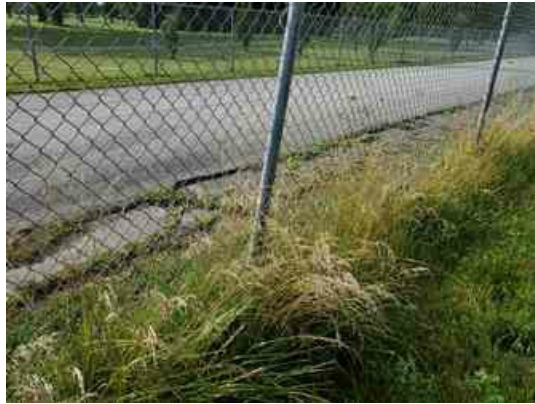
Inspect ID: 2020-0033 **Title:** 2604000007_CELRC_2020_A_0033_1_20200714T132911.jpg **Rated Item:** 15. Seepage **Caption:** Minimally Acceptable - Area of pin boils. No repairs performed but monitoring.

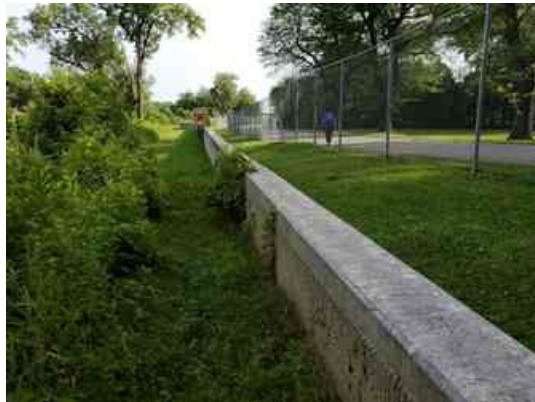
Inspect ID: 2020-0003 **Title:** 2604000007_CELRC_2020_A_0003_1_20200714T131320.jpg **Rated Item:** 1. Unwanted Vegetation Growth **Caption:** Minimally Acceptable - Trees on riverside.

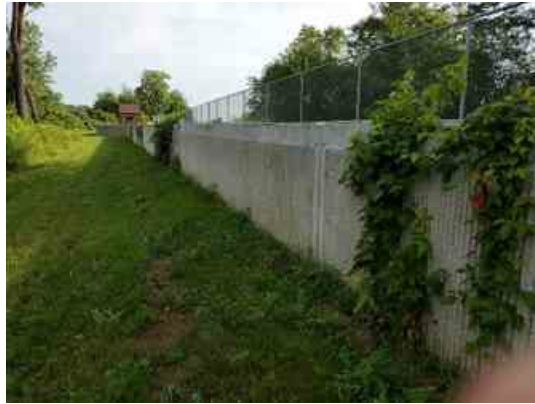
Inspect ID: 2020-0012 **Title:** 2604000007_CELRC_2020_A_0012_1_20200714T131626.jpg **Rated Item:** 1. Unwanted Vegetation Growth **Caption:** Minimally Acceptable - Vines on riverside.

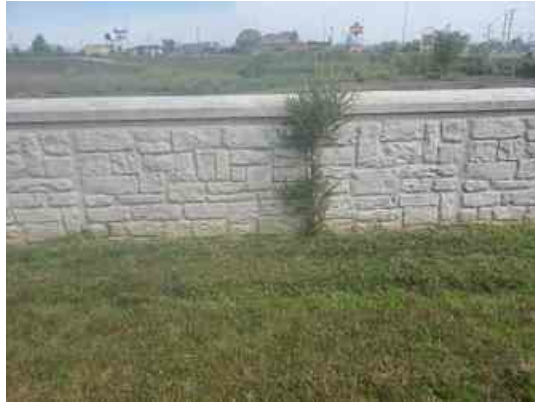
Inspect ID: 2020-0180 **Title:** 2604000007_CELRC_2020_A_0180_1_20200714T150856.jpg **Rated Item:** 1. Unwanted Vegetation Growth **Caption:** Minimally Acceptable - Small tree on landside.

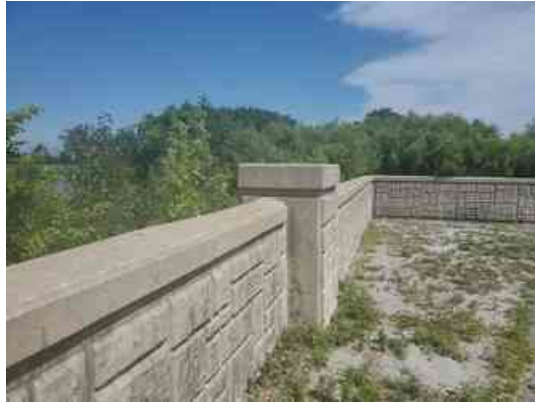
Inspect ID: 2020-0246 **Title:** 2604000007_CELRC_2020_A_0246_1_20200714T154729.jpg **Rated Item:** 1. Unwanted Vegetation Growth **Caption:** Minimally Acceptable - Trees on riverside.

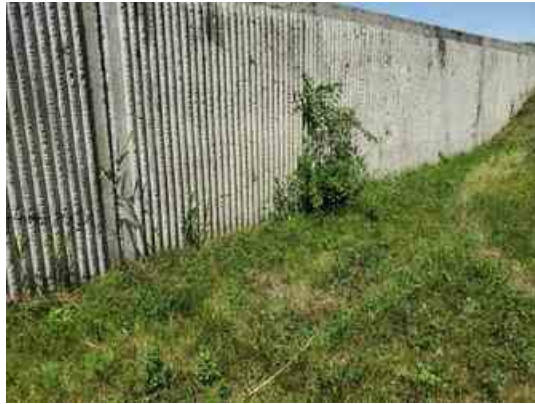
Inspect ID: 2020-0375 **Title:** 2604000007_CELRC_2020_A_0375_1_20200714T165553.jpg **Rated Item:** 1. Unwanted Vegetation Growth **Caption:** Minimally Acceptable - Small vegetation on riverside.

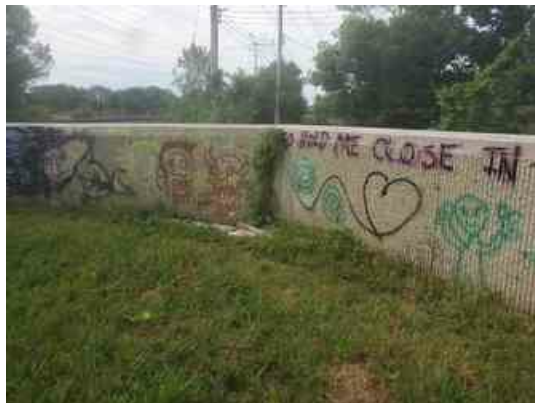
Inspect ID: 2020-0153 **Title:** 2604000007_CELRC_2020_A_0153_1_20200714T144925.jpg **Rated Item:** 2. Encroachments **Caption:** Minimally Acceptable - Debris on riverside.

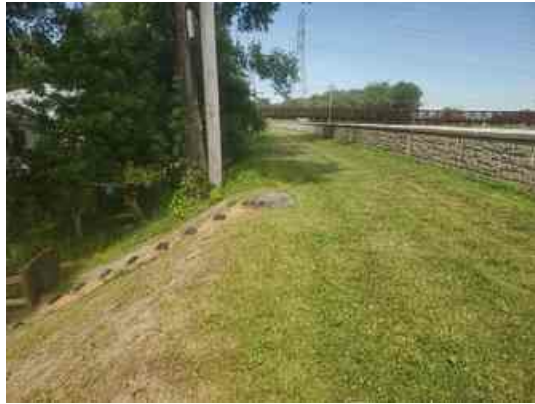
Inspect ID: 2020-0174 **Title:** 2604000007_CELRC_2020_A_0174_1_20200714T150143.jpg **Rated Item:** 2. Encroachments **Caption:** Minimally Acceptable - New stairs installed in embankment. Remove or request 408 permit.

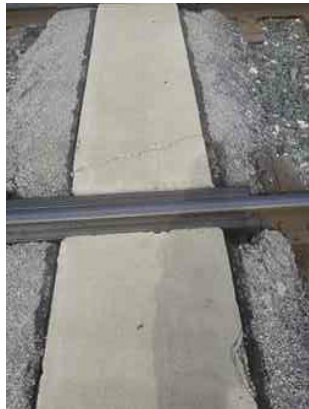
Inspect ID: 2020-0159 **Title:** 2604000007_CELRC_2020_A_0159_1_20200714T145238.jpg **Rated Item:** 3. Closure Structures (Stop Log Closures and Gates) (A or U only) **Caption:** Acceptable - Crack in sill. Last exercise performed in 2013. Exercise overdue.

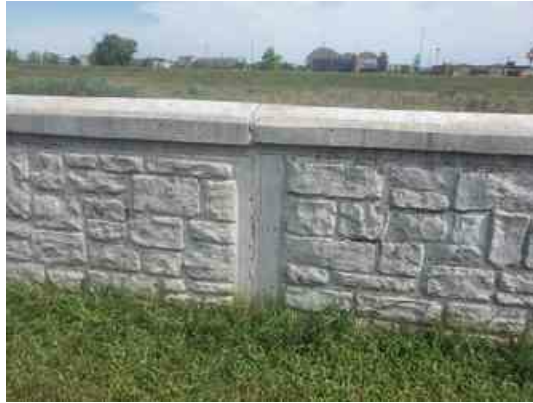
Inspect ID: 2020-0177 **Title:** 2604000007_CELRC_2020_A_0177_1_20200714T150600.jpg **Rated Item:** 4. Concrete Surfaces **Caption:** Minimally Acceptable - Crack on landside. Seal.

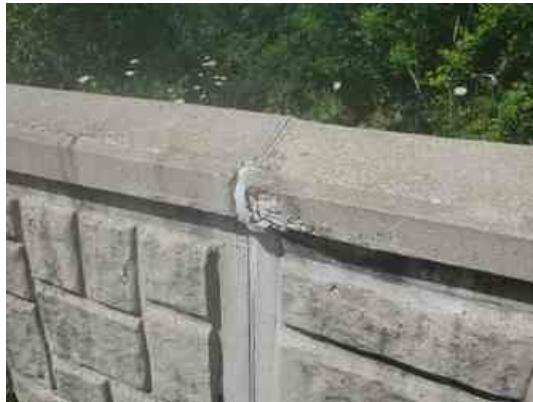
Inspect ID: 2020-0243 **Title:** 2604000007_CELRC_2020_A_0243_1_20200714T154646.jpg **Rated Item:** 4. Concrete Surfaces **Caption:** Minimally Acceptable - Spalling on cap. Patch.

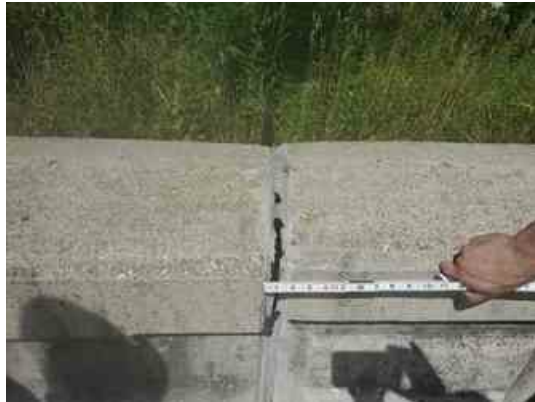
Inspect ID: 2020-0240 **Title:** 2604000007_CELRC_2020_A_0240_1_20200714T154449.jpg **Rated Item:** 5. Tilting, Sliding or Settlement of Concrete Structures **Caption:** Minimally Acceptable - 1 inch displacement. Noted on previous inspections. No continued movement.

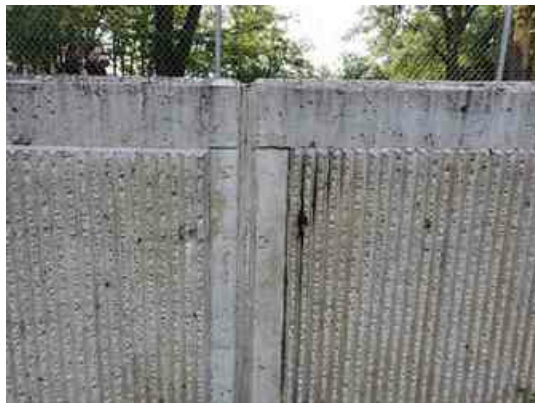
Inspect ID: 2020-0009 **Title:** 2604000007_CELRC_2020_A_0009_1_20200714T131538.jpg **Rated Item:** 7. Monolith Joints **Caption:** Minimally Acceptable - Deteriorating sealant on riverside.

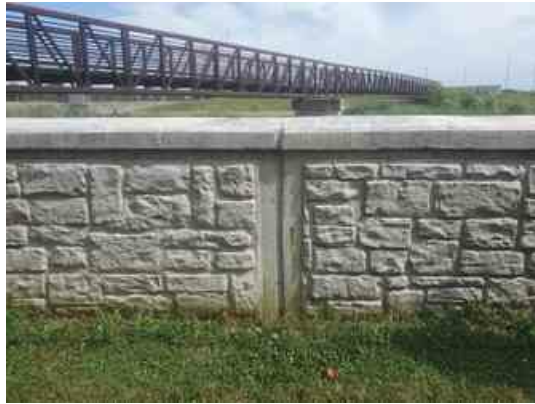
Inspect ID: 2020-0171 **Title:** 2604000007_CELRC_2020_A_0171_1_20200714T145941.jpg **Rated Item:** 7. Monolith Joints **Caption:** Minimally Acceptable - Crack in sealant.

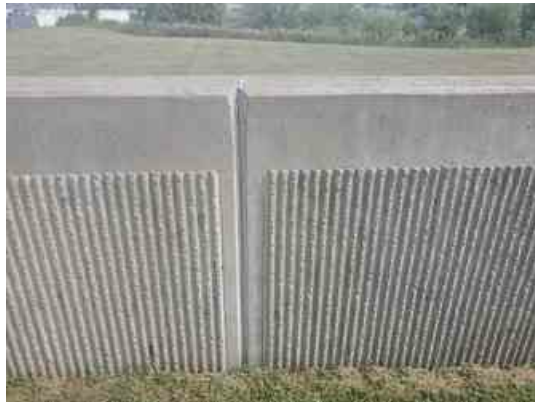
Inspect ID: 2020-0186 **Title:** 2604000007_CELRC_2020_A_0186_1_20200714T151205.jpg **Rated Item:** 7. Monolith Joints **Caption:** Minimally Acceptable - Crack in sealant.

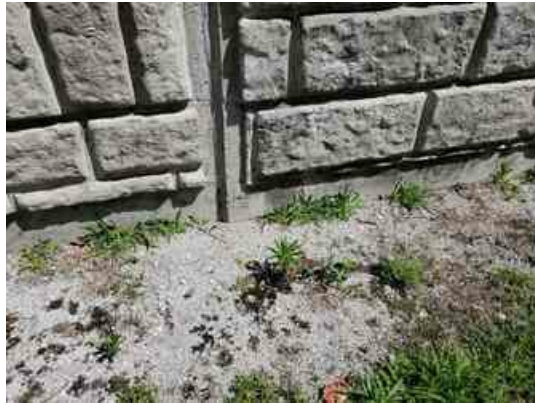
Inspect ID: 2020-0252 **Title:** 2604000007_CELRC_2020_A_0252_1_20200714T155204.jpg **Rated Item:** 7. Monolith Joints **Caption:** Minimally Acceptable - Missing sealant at bottom on landside.

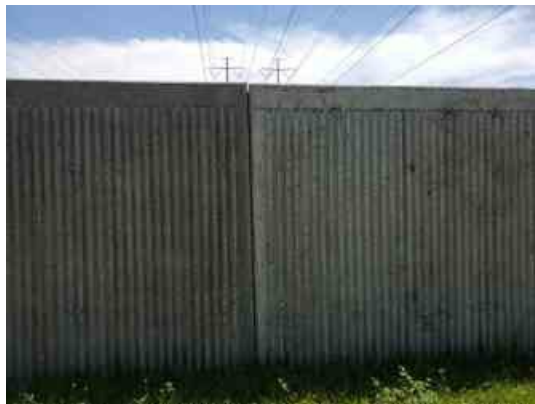
Inspect ID: 2020-0363 **Title:** 2604000007_CELRC_2020_A_0363_1_20200714T165250.jpg **Rated Item:** 7. Monolith Joints **Caption:** Minimally Acceptable - Missing sealant on landside.

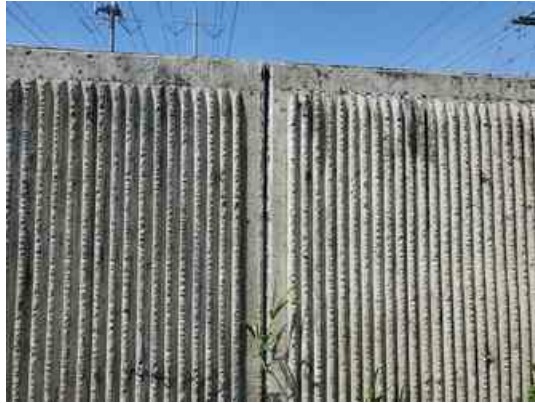
Inspect ID: 2020-0372 **Title:** 2604000007_CELRC_2020_A_0372_1_20200714T165533.jpg **Rated Item:** 7. Monolith Joints **Caption:** Minimally Acceptable - Missing sealant on riverside.

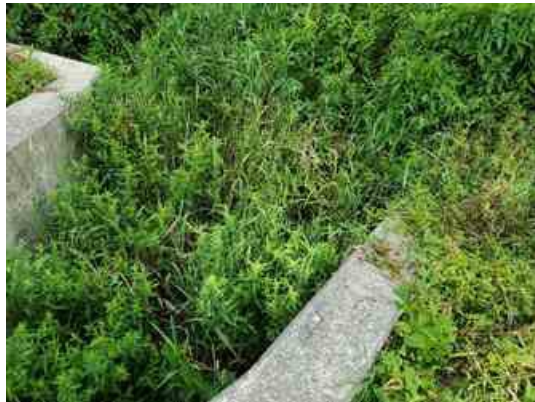
Inspect ID: 2020-0006 **Title:** 2604000007_CELRC_2020_A_0006_1_20200714T131409.jpg **Rated Item:** 1. Vegetation and Obstructions **Caption:** Minimally Acceptable - HI-1: Vegetation at outlet.

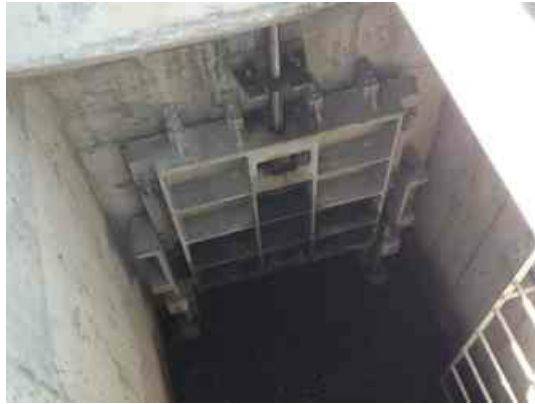
Inspect ID: 2020-0110 **Title:** 2604000007_CELRC_2020_A_0110_1_20200714T153920.jpg **Rated Item:** 10. Sluice/ Slide Gates **Caption:** Minimally Acceptable - HI-11: Sluice gate opened completely with a lot of debris on flanges.

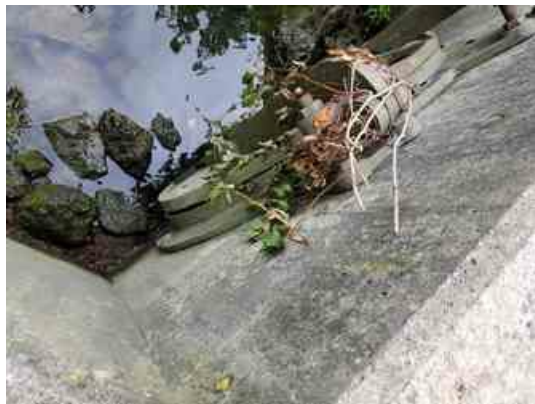
Inspect ID: 2020-0129 **Title:** 2604000007_CELRC_2020_A_0129_1_20200714T143003.jpg **Rated Item:** 11. Flap Gates/ Flap Valves/ Pinch Valves **Caption:** Minimally Acceptable - HI-6: Flap gate stuck open.

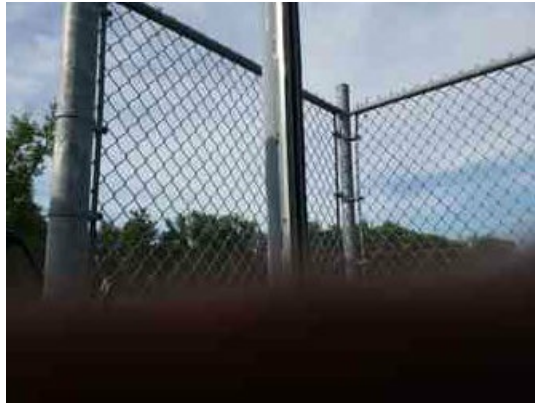
Inspect ID: 2020-0011 **Title:** 2604000007_CELRC_2020_A_0011_1_20200714T132134.jpg **Rated Item:** 13. Other Metallic Items **Caption:** Minimally Acceptable - HI-4: No glass covering riser.

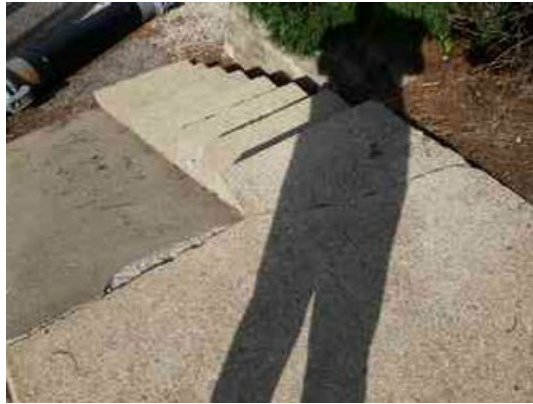
Inspect ID: 2020-0001 **Title:** 2604000007_CELRC_2020_A_0001_1_20200714T131345.jpg **Rated Item:** 5. Plant Building **Caption:** Minimally Acceptable - Ps-81 Cracking and spalling in concrete.

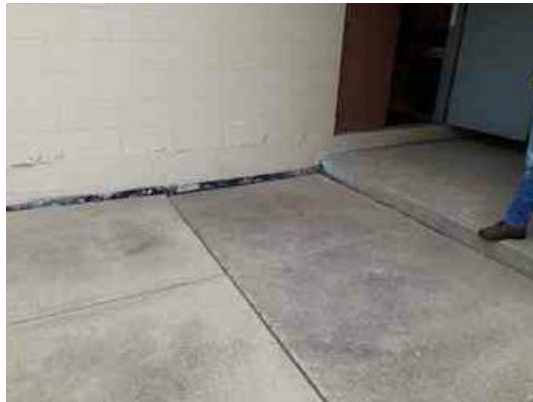
Inspect ID: 2020-0010 **Title:** 2604000007_CELRC_2020_A_0010_1_20200714T131748.jpg **Rated Item:** 5. Plant Building **Caption:** Minimally Acceptable - PS-81: Settling in concrete pad.

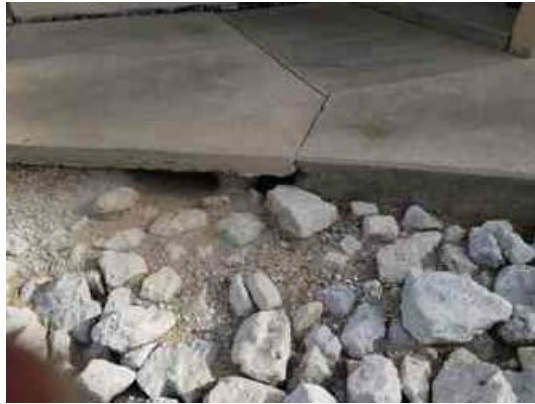
Inspect ID: 2020-0013 **Title:** 2604000007_CELRC_2020_A_0013_1_20200714T131833.jpg **Rated Item:** 5. Plant Building **Caption:** Minimally Acceptable - PS-81: Burrows under concrete pad.

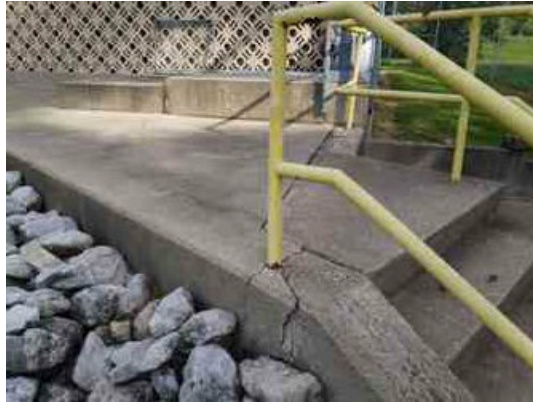
Inspect ID: 2020-0025 **Title:** 2604000007_CELRC_2020_A_0025_1_20200714T132628.jpg **Rated Item:** 5. Plant Building **Caption:** Minimally Acceptable - PS-81: Cracking on concrete pad. Handrail is loose.

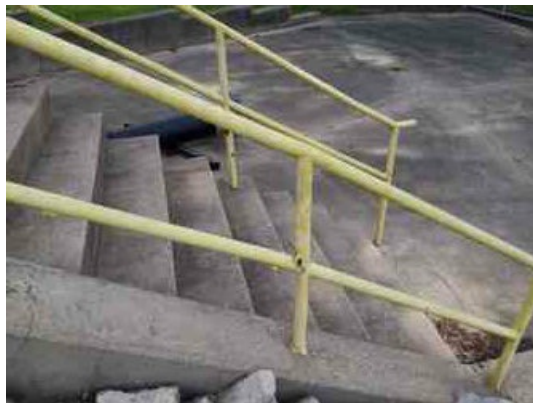
Inspect ID: 2020-0028 **Title:** 2604000007_CELRC_2020_A_0028_1_20200714T132714.jpg **Rated Item:** 5. Plant Building **Caption:** Minimally Acceptable - PS-81: Corrosion on handrail.

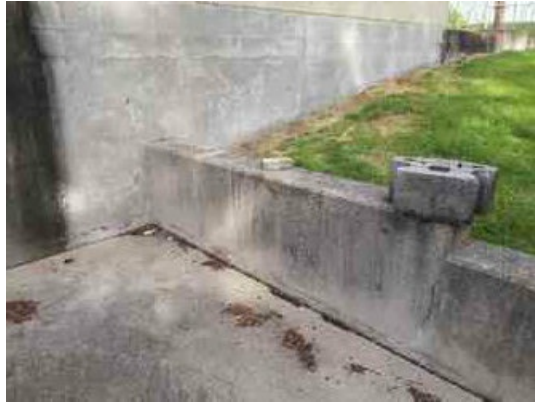
Inspect ID: 2020-0031 **Title:** 2604000007_CELRC_2020_A_0031_1_20200714T132837.jpg **Rated Item:** 5. Plant Building **Caption:** Minimally Acceptable - PS-81: Cracking in wing wall.

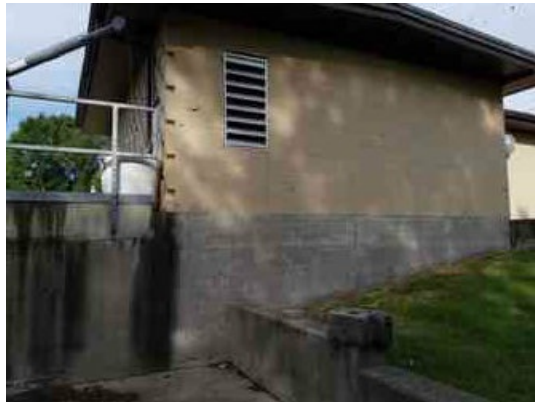
Inspect ID: 2020-0034 **Title:** 2604000007_CELRC_2020_A_0034_1_20200714T132907.jpg **Rated Item:** 5. Plant Building **Caption:** Minimally Acceptable - PS-81: Peeling paint.

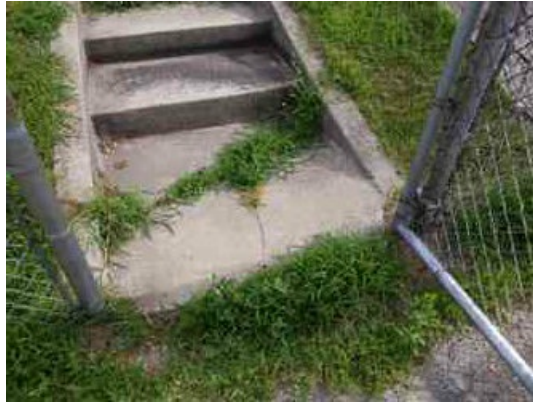
Inspect ID: 2020-0043 **Title:** 2604000007_CELRC_2020_A_0043_1_20200714T134729.jpg **Rated Item:** 5. Plant Building **Caption:** Minimally Acceptable - PS-N5: Concrete on stairs cracked.

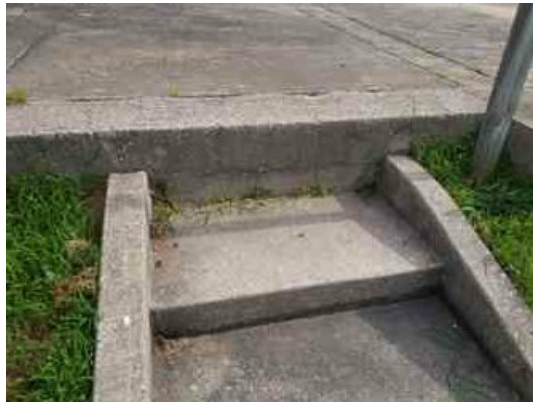
Inspect ID: 2020-0046 **Title:** 2604000007_CELRC_2020_A_0046_1_20200714T134859.jpg **Rated Item:** 5. Plant Building **Caption:** Minimally Acceptable - PS-N5: Stairs have settled about 6 inches.

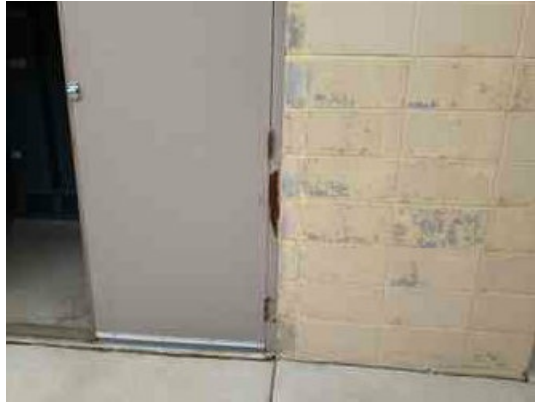
Inspect ID: 2020-0076 **Title:** 2604000007_CELRC_2020_A_0076_1_20200714T140337.jpg **Rated Item:** 5. Plant Building **Caption:** Minimally Acceptable - PS-N5: Corrosion on door frame.

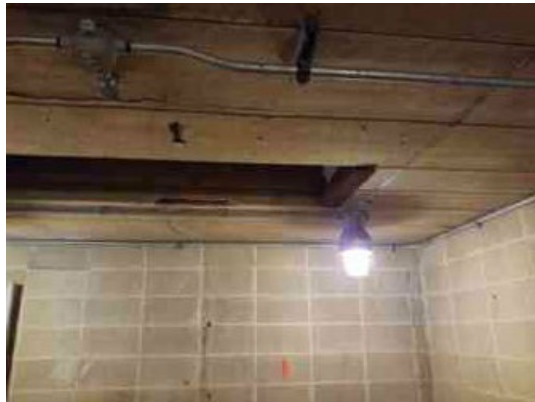
Inspect ID: 2020-0079 **Title:** 2604000007_CELRC_2020_A_0079_1_20200714T140604.jpg **Rated Item:** 5. Plant Building **Caption:** Minimally Acceptable - PS-N5: Cracking of ceiling and walls. Exposed rebar in ceiling.

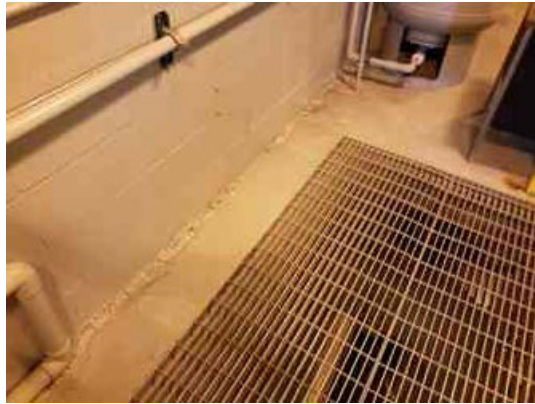
Inspect ID: 2020-0082 **Title:** 2604000007_CELRC_2020_A_0082_1_20200714T140901.jpg **Rated Item:** 5. Plant Building **Caption:** Minimally Acceptable - PS-N5: Investigate water damage in corner.

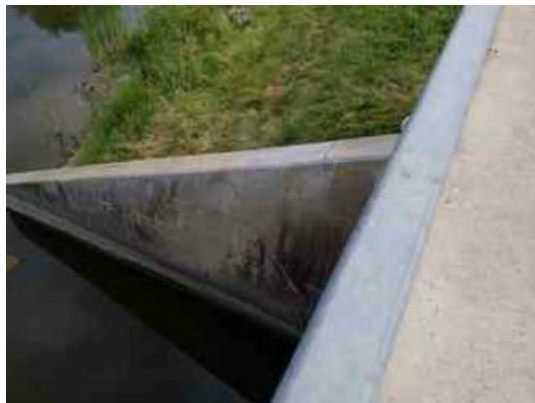
Inspect ID: 2020-0088 **Title:** 2604000007_CELRC_2020_A_0088_1_20200714T142558.jpg **Rated Item:** 5. Plant Building **Caption:** Minimally Acceptable - PS-ND: Cracking in headwall.

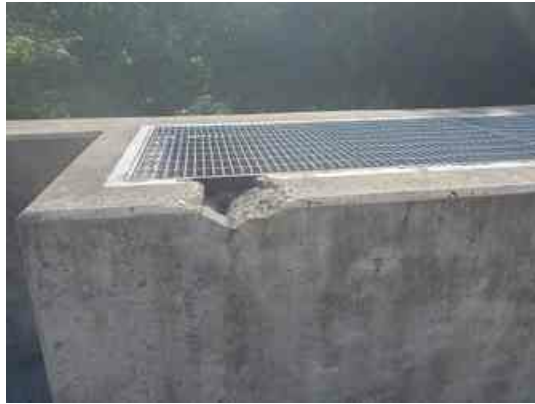
Inspect ID: 2020-0201 **Title:** 2604000007_CELRC_2020_A_0201_1_20200714T152302.jpg **Rated Item:** 5. Plant Building **Caption:** Minimally Acceptable - PS-N5: Broken concrete.

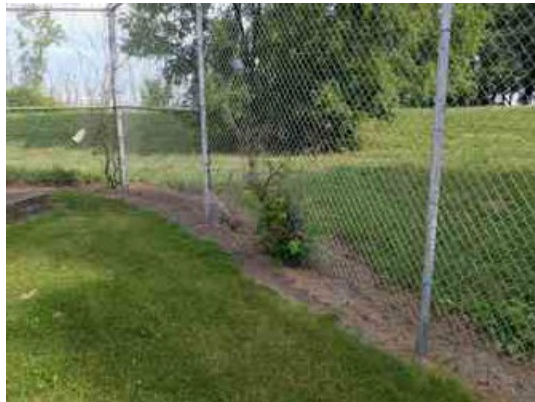
Inspect ID: 2020-0037 **Title:** 2604000007_CELRC_2020_A_0037_1_20200714T133449.jpg **Rated Item:** 6. Fencing and Gates **Caption:** Acceptable - PS-81: Vegetation growing in fence.

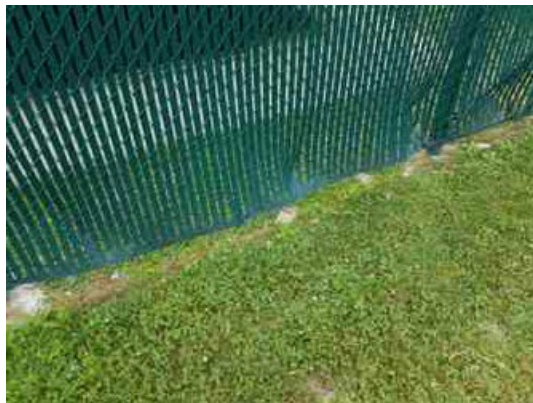
Inspect ID: 2020-0106 **Title:** 2604000007_CELRC_2020_A_0106_1_20200714T143903.jpg **Rated Item:** 6. Fencing and Gates **Caption:** Minimally Acceptable - PS-ND: Fence broken. Bottom bar needs replacing.

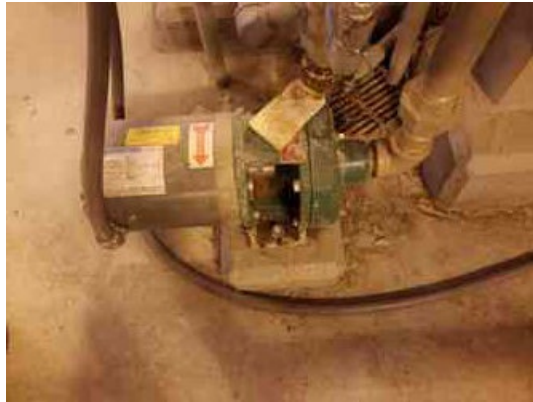
Inspect ID: 2020-0022 **Title:** 2604000007_CELRC_2020_A_0022_1_20200714T132334.jpg **Rated Item:** 7. Pumps **Caption:** Minimally Acceptable - PS-81: Water leaking out of pump on water sealage unit.

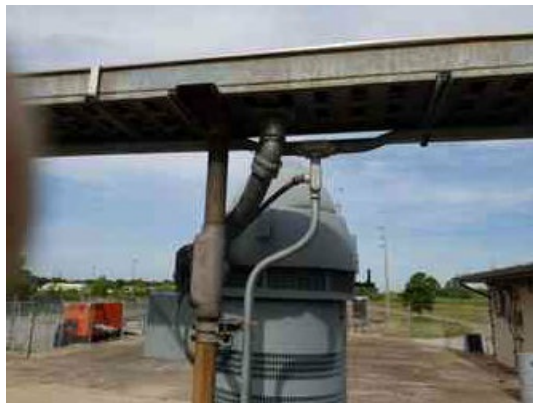
Inspect ID: 2020-0055 **Title:** 2604000007_CELRC_2020_A_0055_1_20200714T135644.jpg **Rated Item:** 7. Pumps **Caption:** Minimally Acceptable - PS-N5: Chipping paint and corrosion on pumps.

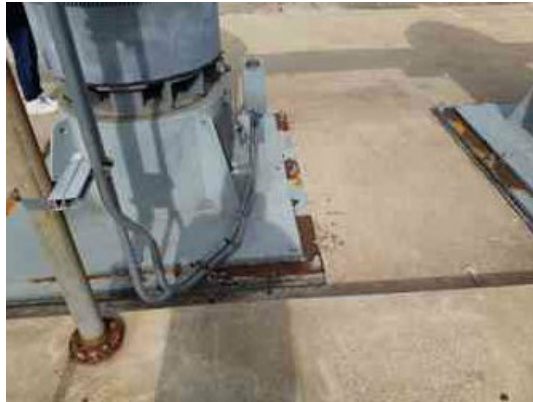
Inspect ID: 2020-0058 **Title:** 2604000007_CELRC_2020_A_0058_1_20200714T135731.jpg **Rated Item:** 7. Pumps **Caption:** Minimally Acceptable - PS-N5: Corrosion on base of pumps.

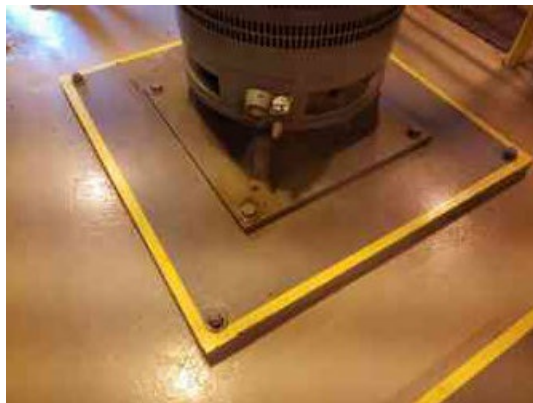
Inspect ID: 2020-0067 **Title:** 2604000007_CELRC_2020_A_0067_1_20200714T140021.jpg **Rated Item:** 7. Pumps **Caption:** Minimally Acceptable - PS-N5: SWP 3 has a small oil leak.
