**US Army Corps
of Engineers®**

Levee Inspection Report

Name of System: Munster

Date(s) of Inspection: 07/06/2020 - 07/06/2020

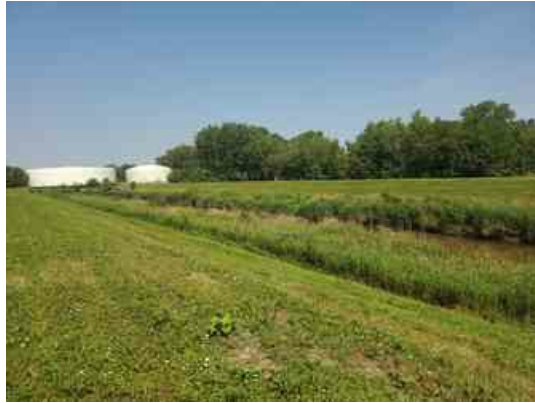
Inspect ID: 2020-0312 **Title:** 2604000009_CELRC_2020_A_0312_1_20200706T153909.jpg **Rated Item:** 1. Unwanted Vegetation Growth **Caption:** Minimally Acceptable - Tall vegetation on riverside toe.

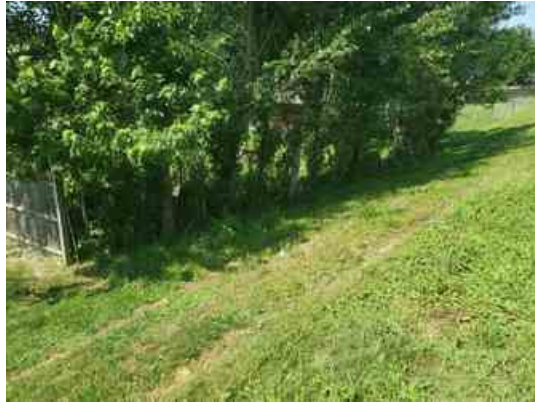
Inspect ID: 2020-0333 **Title:** 2604000009_CELRC_2020_A_0333_1_20200706T154516.jpg **Rated Item:** 1. Unwanted Vegetation Growth **Caption:** Minimally Acceptable - Large trees on landside toe.

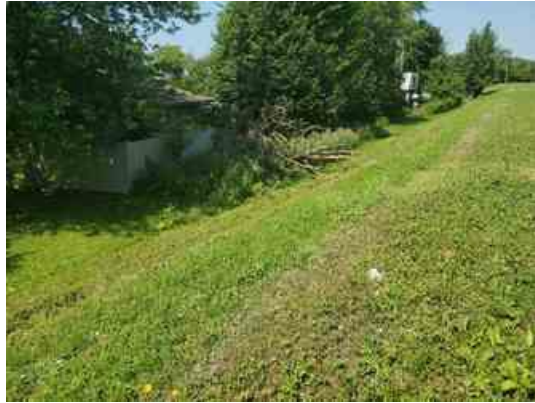
Inspect ID: 2020-0309 **Title:** 2604000009_CELRC_2020_A_0309_1_20200706T153831.jpg **Rated Item:** 3. Encroachments **Caption:** Minimally Acceptable - Downed tree on landside toe and slope.

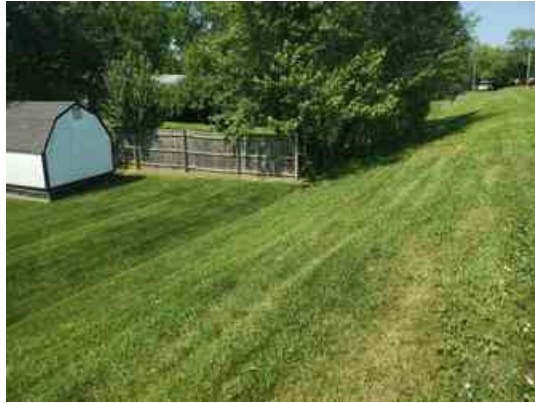
Inspect ID: 2020-0330 **Title:** 2604000009_CELRC_2020_A_0330_1_20200706T154438.jpg **Rated Item:** 3. Encroachments **Caption:** Minimally Acceptable - Fence on landside toe.

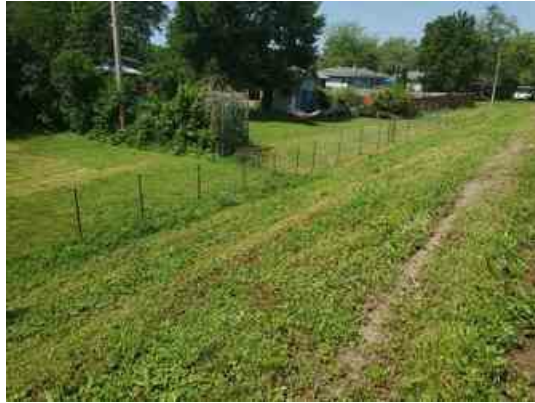
Inspect ID: 2020-0339 **Title:** 2604000009_CELRC_2020_A_0339_1_20200706T154629.jpg **Rated Item:** 3. Encroachments **Caption:** Minimally Acceptable - Fence on landside toe.

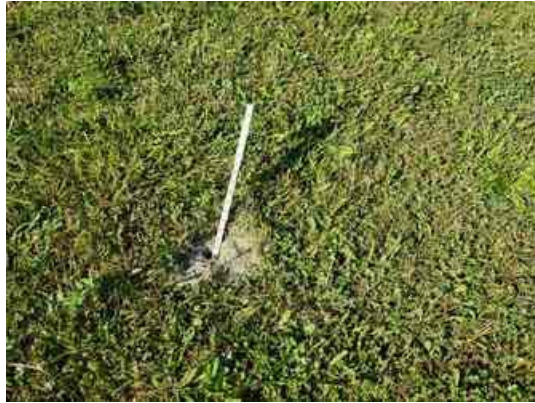
Inspect ID: 2020-0036 **Title:** 2604000009_CELRC_2020_A_0036_1_20200706T132619.jpg **Rated Item:** 10. Animal Control **Caption:** Minimally Acceptable - Tiny burrow in crest, one inch diameter, 3 inches deep.

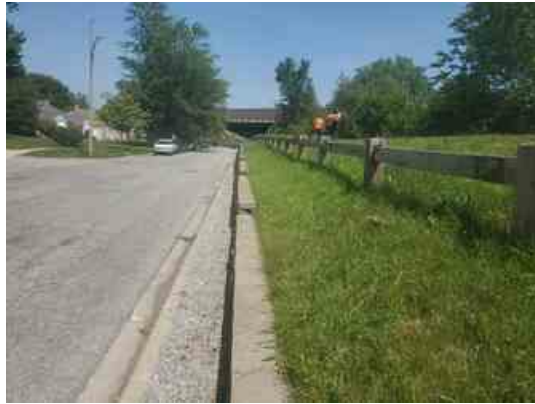
13. Revetments other than Riprap	A	A	Existing revetment protection is properly maintained, undamaged, and clearly visible.	2020-0402 : Slight tilting of retaining wall on landside. Monitor. (A)
		M	Minor revetment displacement or deterioration that does not pose an immediate threat to the integrity of the levee. Unwanted vegetation must be cleared or sprayed with an appropriate herbicide.	
		U	Significant revetment displacement, deterioration, or exposure of bedding observed. Scour activity is undercutting banks, eroding embankments, or impairing channel flows by causing turbulence or shoaling. Revetment protection is hidden by dense brush and trees.	
		N/A	There are no such revetments protecting this feature of the segment / system.

Inspect ID: 2020-0402 **Title:** 2604000009_CELRC_2020_A_0402_1_20200706T161910.jpg **Rated Item:** 13. Revetments other than Riprap **Caption:** Minimally Acceptable - Slight tilting of retaining wall on landside.

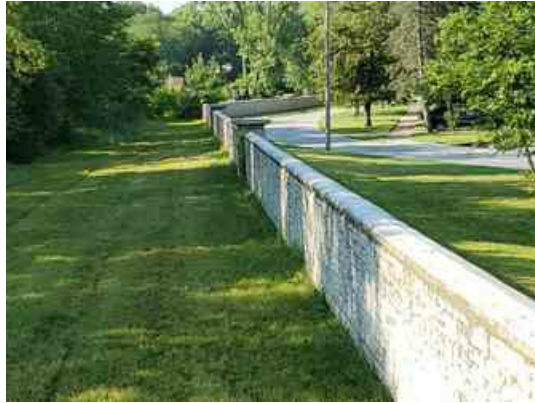
Inspect ID: 2020-0030 **Title:** 2604000009_CELRC_2020_A_0030_1_20200706T131924.jpg **Rated Item:** 1. Unwanted Vegetation Growth **Caption:** Minimally Acceptable - Vegetation on riverside.

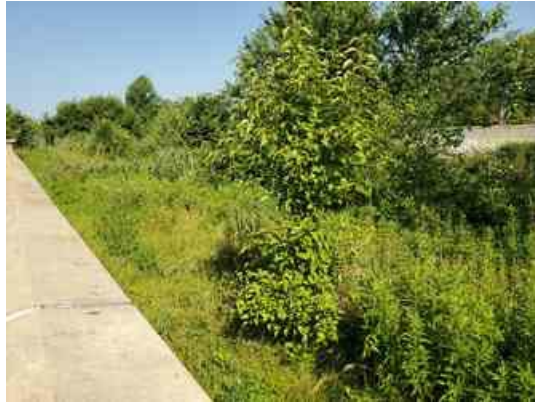
Rated Item	Rating	Rating Guidelines		Location/Remarks/Recommendations
1. Unwanted Vegetation Growth ¹	M	A	A grass-only or paved zone is maintained on both sides of the floodwall, free of all trees, brush, and undesirable weeds. The vegetation-free zone extends 15 feet from both the land and riverside of the floodwall, at ground-level, to the centerline of the tree. Additionally, an 8- foot root-free zone is maintained around the entire structure, including the floodwall toe, heel, and any toe-drains. If the floodwall access easement doesn't extend to the described limits, then the vegetation-free zone must be maintained to the easement limits. Reference EM 1110- 2-301 and/or Corps policy for regional vegetation variance.	2020-0012 : Trees on riverside. (M) 2020-0030 : Vegetation on riverside. (M) 2020-0063 : Trees on riverside. (M) 2020-0072 : Tall vegetation and trees close to riverside of wall. (M) 2020-0096 : Two small trees close to wall. (M) 2020-0099 : Small tree near wall. (M)

Inspect ID: 2020-0099 **Title:** 2604000009_CELRC_2020_A_0099_1_20200706T140057.jpg **Rated Item:** 1. Unwanted Vegetation Growth **Caption:** Minimally Acceptable - Small tree near wall.

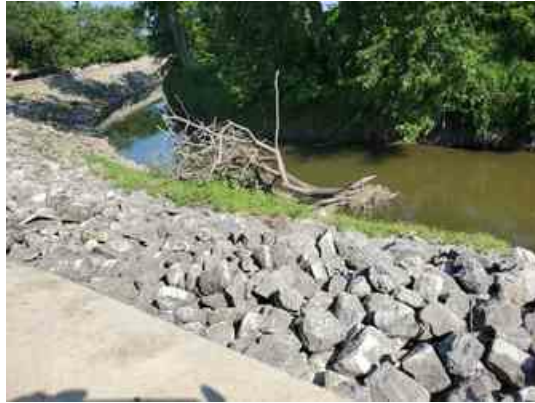
Inspect ID: 2020-0114 **Title:** 2604000009_CELRC_2020_A_0114_1_20200706T140918.jpg **Rated Item:** 2. Encroachments **Caption:** Minimally Acceptable - Downed tree in riprap on riverside.

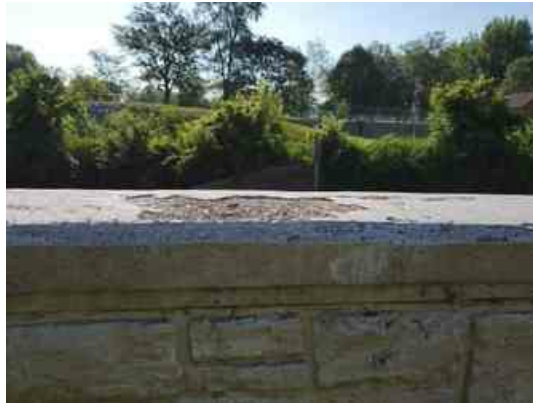
4. Concrete Surfaces	M	A	Negligible spalling, scaling or cracking. If the concrete surface is weathered or holds moisture, it is still satisfactory but should be seal coated to prevent freeze/ thaw damage.	2020-0018 : Spalling on cap. (M) 2020-0021 : Spalling, exposed waterstop. (M) 2020-0027 : Exposed rebar on landside. (M)
		M	Spalling, scaling, and open cracking present, but the immediate integrity or performance of the structure is not threatened. Reinforcing steel may be exposed. Repairs/ sealing is necessary to prevent additional damage during periods of thawing and freezing.	2020-0048 : Crack through levee. (M) 2020-0051 : Minor spalling on cap. (M) 2020-0054 : Crack on landside pillar. (M)
		U	Surface deterioration or deep cracks present that may result in an unreliable structure. Any surface deterioration that exposes the sheet piling or lies adjacent to monolith joints may indicate underlying reinforcement corrosion and is unacceptable.	2020-0057 : Crack on landside. (M) 2020-0060 : Crack on landside. (M) 2020-0066 : Crack on wingwall on landside. (M) 2020-0105 : Spalling on cap. (M) 2020-0147 : Exposed rebar on cap. (M) 2020-0231 : Exposed rebar in cap. (M) 2020-0306 : Broken cap at transition. (M)

Inspect ID: 2020-0018 **Title:** 2604000009_CELRC_2020_A_0018_1_20200706T131239.jpg **Rated Item:** 4. Concrete Surfaces **Caption:** Minimally Acceptable - Spalling on cap.

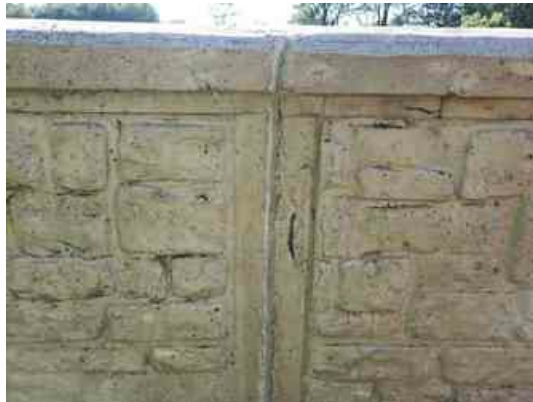
Inspect ID: 2020-0021 **Title:** 2604000009_CELRC_2020_A_0021_1_20200706T131347.jpg **Rated Item:** 4. Concrete Surfaces **Caption:** Minimally Acceptable - Spalling, exposed waterstop.

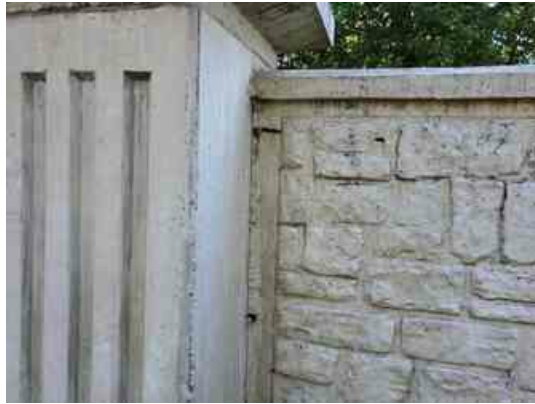
Inspect ID: 2020-0027 **Title:** 2604000009_CELRC_2020_A_0027_1_20200706T131659.jpg **Rated Item:** 4. Concrete Surfaces **Caption:** Minimally Acceptable - Exposed rebar on landside.

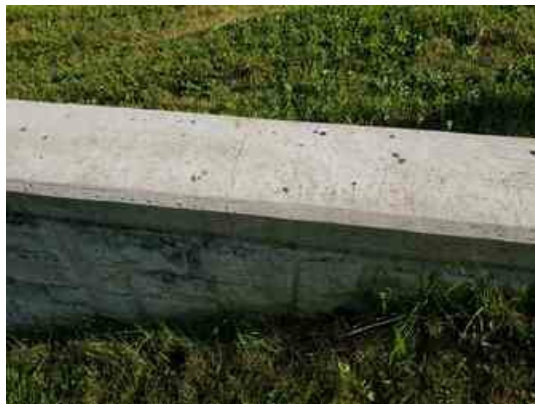
Inspect ID: 2020-0048 **Title:** 2604000009_CELRC_2020_A_0048_1_20200706T133726.jpg **Rated Item:** 4. Concrete Surfaces **Caption:** Minimally Acceptable - Crack through levee.

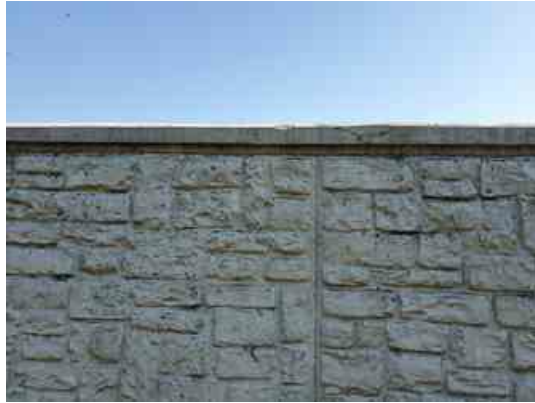
Inspect ID: 2020-0051 **Title:** 2604000009_CELRC_2020_A_0051_1_20200706T133946.jpg **Rated Item:** 4. Concrete Surfaces **Caption:** Minimally Acceptable - Minor spalling on cap.

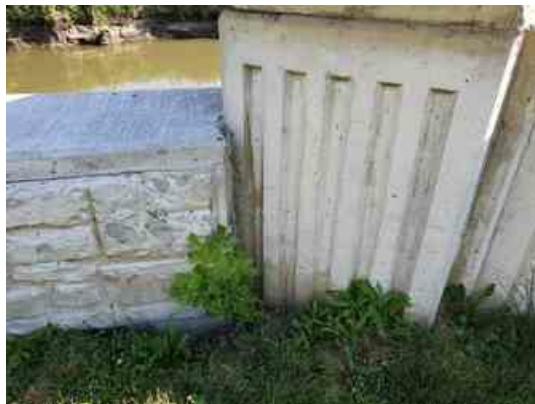
Inspect ID: 2020-0054 **Title:** 2604000009_CELRC_2020_A_0054_1_20200706T134211.jpg **Rated Item:** 4. Concrete Surfaces **Caption:** Minimally Acceptable - Crack on landside pillar.

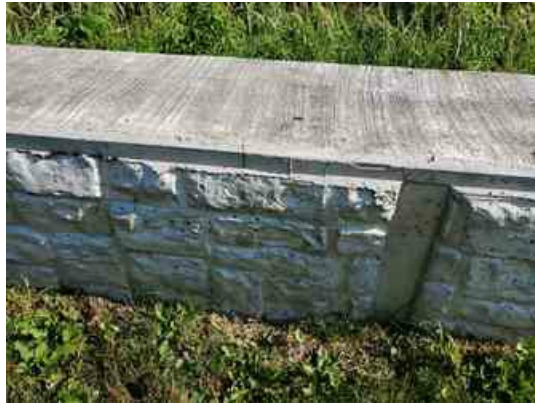
Inspect ID: 2020-0057 **Title:** 2604000009_CELRC_2020_A_0057_1_20200706T134337.jpg **Rated Item:** 4. Concrete Surfaces **Caption:** Minimally Acceptable - Crack on landside.

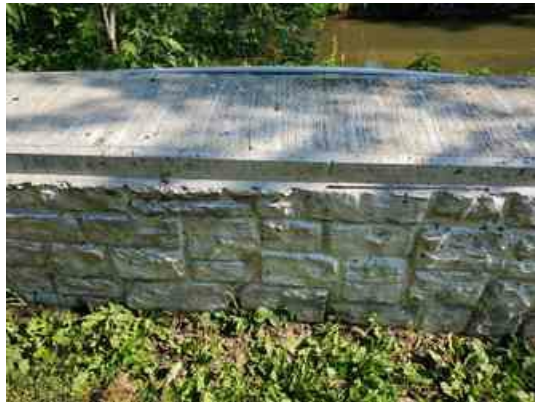
Inspect ID: 2020-0060 **Title:** 2604000009_CELRC_2020_A_0060_1_20200706T134447.jpg **Rated Item:** 4. Concrete Surfaces **Caption:** Minimally Acceptable - Crack on landside.

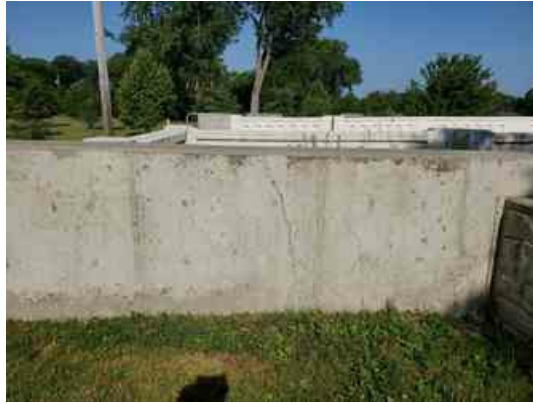
Inspect ID: 2020-0066 **Title:** 2604000009_CELRC_2020_A_0066_1_20200706T134629.jpg **Rated Item:** 4. Concrete Surfaces **Caption:** Minimally Acceptable - Crack on wingwall on landside.

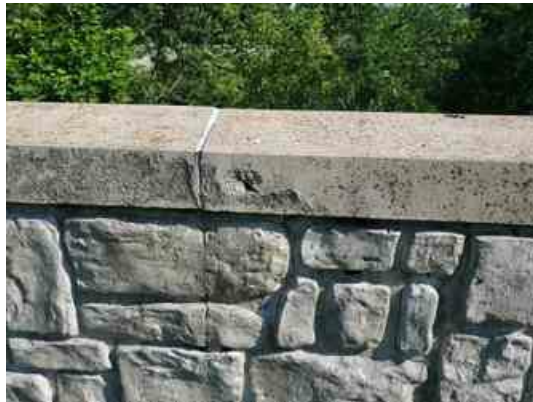
Inspect ID: 2020-0105 **Title:** 2604000009_CELRC_2020_A_0105_1_20200828T191650.jpg **Rated Item:** 4. Concrete Surfaces **Caption:** Minimally Acceptable - Spalling on cap.

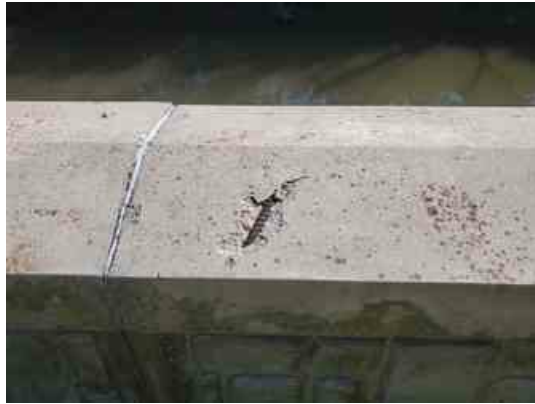
Inspect ID: 2020-0147 **Title:** 2604000009_CELRC_2020_A_0147_1_20200828T191849.jpg **Rated Item:** 4. Concrete Surfaces **Caption:** Minimally Acceptable - Exposed rebar on cap.

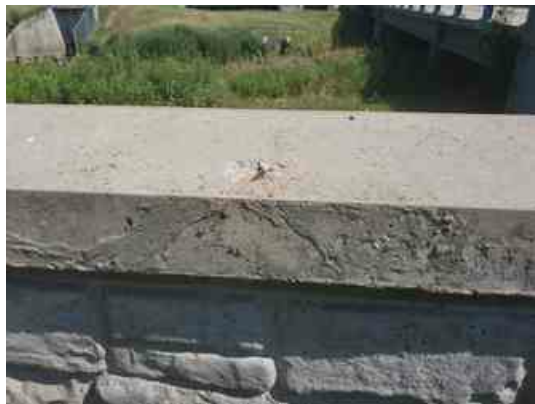
Inspect ID: 2020-0231 **Title:** 2604000009_CELRC_2020_A_0231_1_20200706T150313.jpg **Rated Item:** 4. Concrete Surfaces **Caption:** Minimally Acceptable - Exposed rebar in cap.

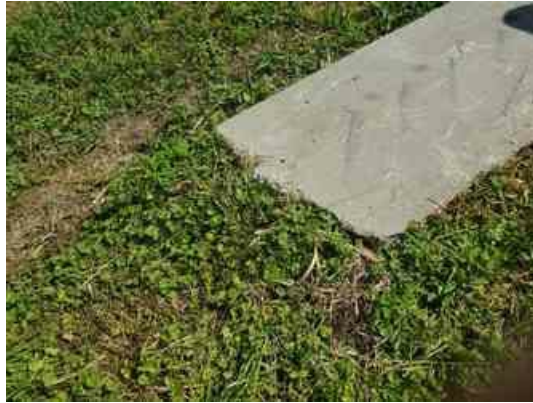
Inspect ID: 2020-0306 **Title:** 2604000009_CELRC_2020_A_0306_1_20200706T153726.jpg **Rated Item:** 4. Concrete Surfaces **Caption:** Minimally Acceptable - Broken cap at transition.

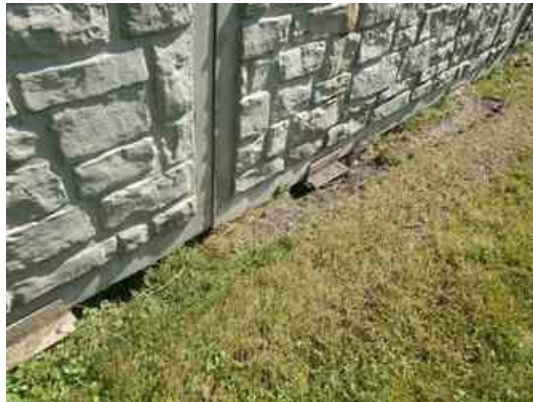
6. Foundation of Concrete Structures ¹	M	A	No active erosion, scouring, or bank caving that might endanger the structure's stability.	2020-0243 : Holes on landside. (M) 2020-0282 : 3.5 ft burrow leading to wall on landside. (M) 2020-0291 : Holes on landside. (M) 2020-0351 : Holes on landside. (M) 2020-0357 : Hole at wall transition. (M) 2020-0360 : Hole at wall transition. (M) 2020-0369 : Holes on landside. (M) 2020-0372 : Hole at wall transition. (M) 2020-0375 : Hole at wall transition. (M) 2020-0378 : Holes on landside. (M)
		M	There are areas where the ground is eroding towards the base of the structure. Efforts need to be taken to slow and repair this erosion, but it is not judged to be close enough to the structure or to be progressing rapidly enough to affect structural stability before the next inspection. For the purposes of inspection, the erosion or scour is not closer to the riverside face of the wall than twice the floodwall's underground base width if the wall is of L-wall or T-wall construction; or if the wall is of sheetpile or I-wall construction, the erosion is not closer than twice the wall's visible height. Additionally, rate of erosion is such that the wall is expected to remain stable until the next inspection.

Inspect ID: 2020-0243 **Title:** 2604000009_CELRC_2020_A_0243_1_20200828T164825.jpg **Rated Item:** 6. Foundation of Concrete Structures **Caption:** Minimally Acceptable - Holes on landside.

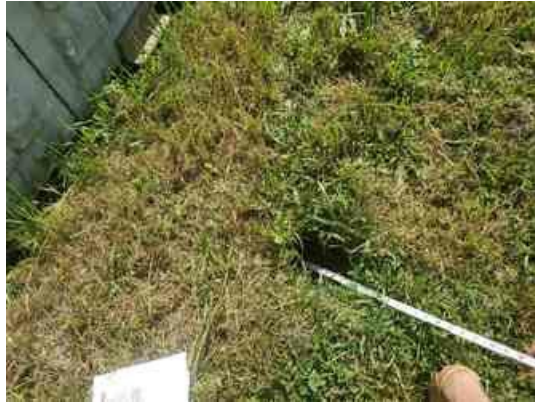
Inspect ID: 2020-0282 **Title:** 2604000009_CELRC_2020_A_0282_1_20200706T152034.jpg **Rated Item:** 6. Foundation of Concrete Structures **Caption:** Minimally Acceptable - 3.5 ft burrow leading to wall on landside.

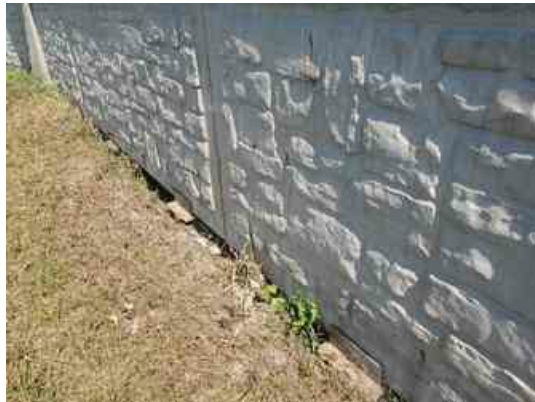
Inspect ID: 2020-0291 **Title:** 2604000009_CELRC_2020_A_0291_1_20200828T165630.jpg **Rated Item:** 6. Foundation of Concrete Structures **Caption:** Minimally Acceptable - Holes on landside.

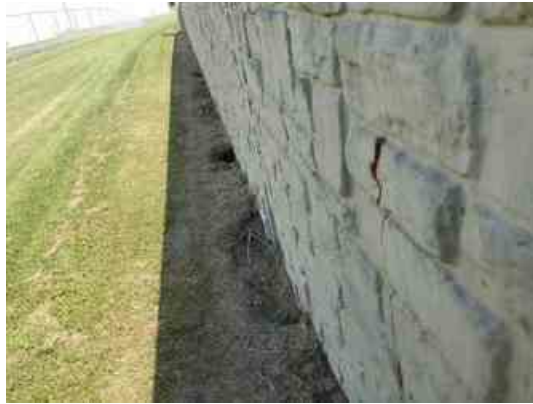
Inspect ID: 2020-0351 **Title:** 2604000009_CELRC_2020_A_0351_1_20200828T165710.jpg **Rated Item:** 6. Foundation of Concrete Structures **Caption:** Minimally Acceptable - Holes on landside.

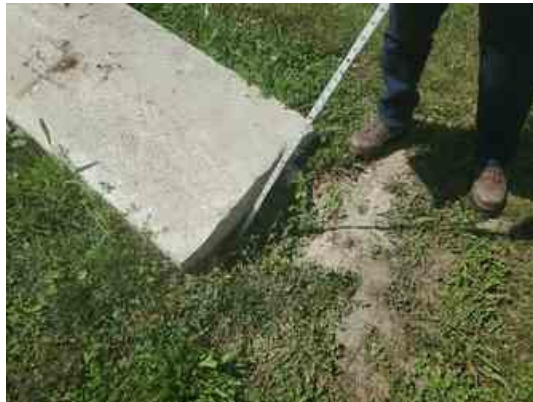
Inspect ID: 2020-0357 **Title:** 2604000009_CELRC_2020_A_0357_1_20200706T155342.jpg **Rated Item:** 6. Foundation of Concrete Structures **Caption:** Minimally Acceptable - Hole at wall transition.

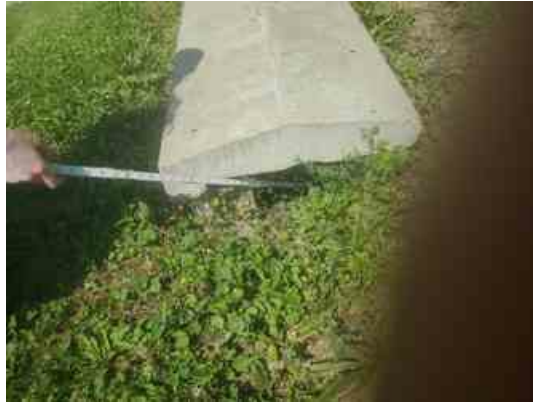
Inspect ID: 2020-0360 **Title:** 2604000009_CELRC_2020_A_0360_1_20200706T155618.jpg **Rated Item:** 6. Foundation of Concrete Structures **Caption:** Minimally Acceptable - Hole at wall transition.

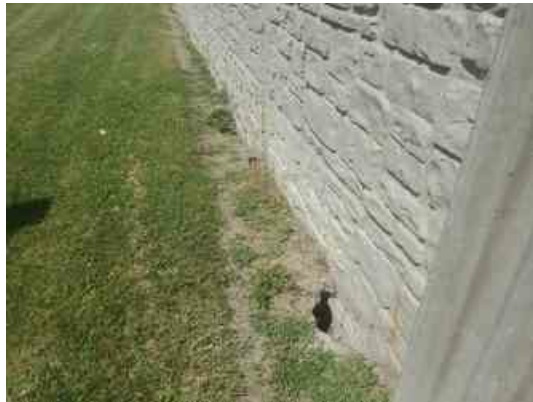
Inspect ID: 2020-0369 **Title:** 2604000009_CELRC_2020_A_0369_1_20200828T165801.jpg **Rated Item:** 6. Foundation of Concrete Structures **Caption:** Minimally Acceptable - Holes on landside.

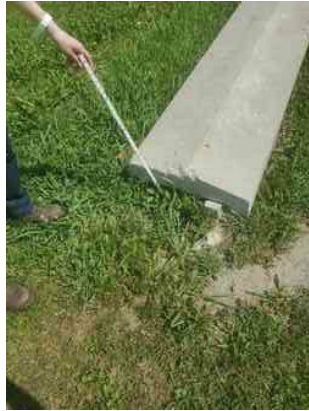
Inspect ID: 2020-0372 **Title:** 2604000009_CELRC_2020_A_0372_1_20200706T155942.jpg **Rated Item:** 6. Foundation of Concrete Structures **Caption:** Minimally Acceptable - Hole at wall transition.

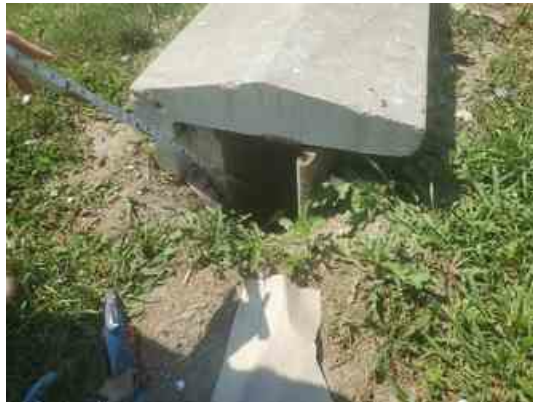
Inspect ID: 2020-0375 **Title:** 2604000009_CELRC_2020_A_0375_1_20200706T160138.jpg **Rated Item:** 6. Foundation of Concrete Structures **Caption:** Minimally Acceptable - Hole at transition

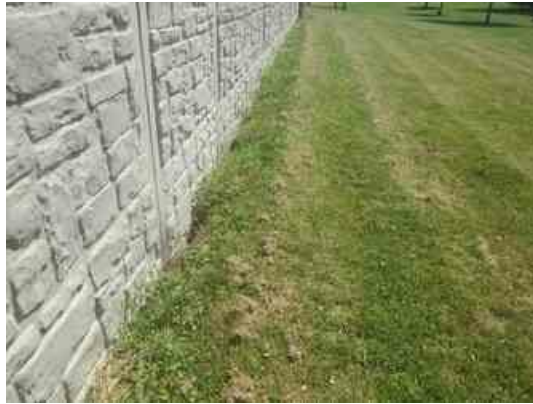
Inspect ID: 2020-0378 **Title:** 2604000009_CELRC_2020_A_0378_1_20200706T160314.jpg **Rated Item:** 6. Foundation of Concrete Structures **Caption:** Minimally Acceptable - Holes on landside.

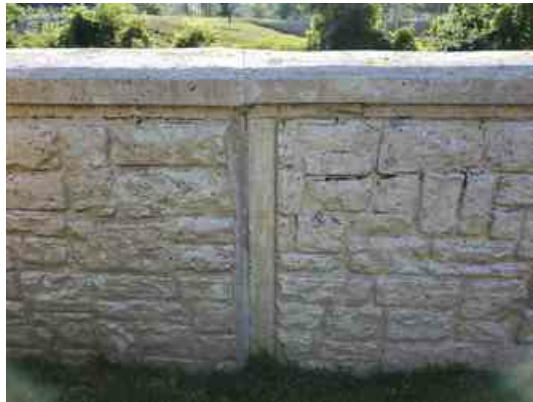
7. Monolith Joints	M	A	The joint material is in good condition. The exterior joint sealant is intact and cracking/ desiccation is minimal. Joint filler material and/or waterstop is not visible at any point.	2020-0015 : Deteriorating sealant on landside. (M) 2020-0084 : Deteriorating sealant on landside. (M) 2020-0093 : Filler material exposed in cap. (M) 2020-0126 : Deteriorating sealant at bottom on landside. (M) 2020-0144 : Deteriorating sealant on landside. (M) 2020-0195 : Deteriorating joints. (M)
		M	The joint material has appreciable deterioration to the point where joint filler material and/or waterstop is visible in some locations. This needs to be repaired or replaced to prevent spalling and cracking during freeze/ thaw cycles, and to ensure water tightness of the joint.	
		U	The joint material is severely deteriorated or the concrete adjacent to the monolith joints has spalled and cracked, damaging the waterstop; in either case damage has occurred to the point where it is apparent that the joint is no longer watertight and will not provide the intended level of protection during a flood.

Inspect ID: 2020-0015 **Title:** 2604000009_CELRC_2020_A_0015_1_20200706T131129.jpg **Rated Item:** 7. Monolith Joints **Caption:** Minimally Acceptable - Deteriorating sealant on landside.

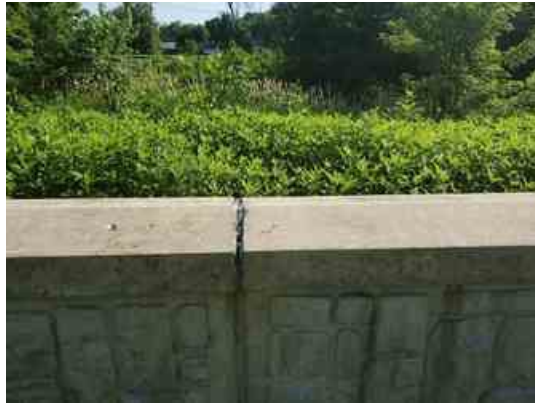
Inspect ID: 2020-0084 **Title:** 2604000009_CELRC_2020_A_0084_1_20200828T170624.jpg **Rated Item:** 7. Monolith Joints **Caption:** Minimally Acceptable - Deteriorating sealant on landside.

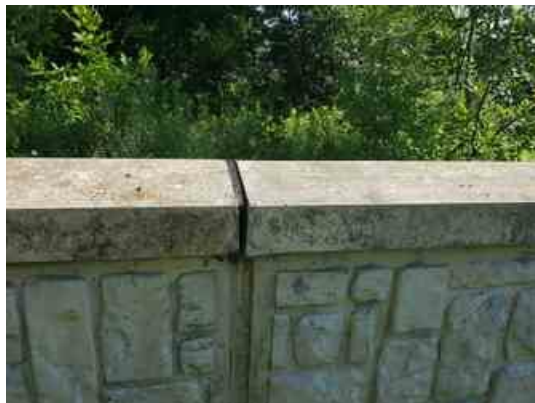
Inspect ID: 2020-0093 **Title:** 2604000009_CELRC_2020_A_0093_1_20200706T135820.jpg **Rated Item:** 7. Monolith Joints **Caption:** Minimally Acceptable - Filler material exposed in cap.

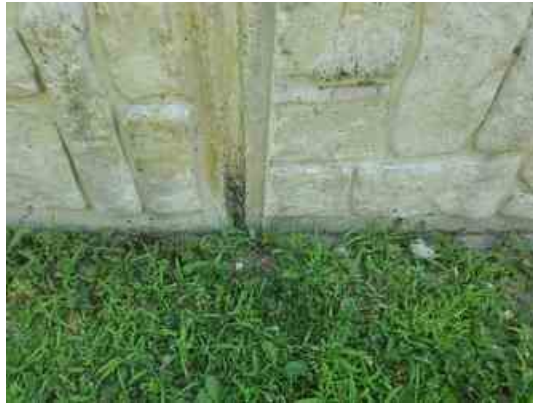
Inspect ID: 2020-0126 **Title:** 2604000009_CELRC_2020_A_0126_1_20200706T141546.jpg **Rated Item:** 7. Monolith Joints **Caption:** Minimally Acceptable - Deteriorating sealant at bottom on landside.

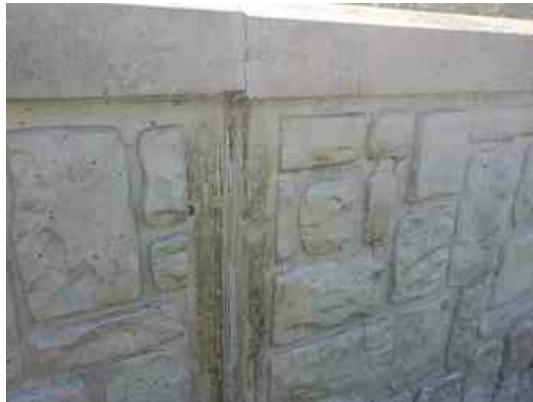
Inspect ID: 2020-0144 **Title:** 2604000009_CELRC_2020_A_0144_1_20200706T142232.jpg **Rated Item:** 7. Monolith Joints **Caption:** Minimally Acceptable - Deteriorating sealant on landside.

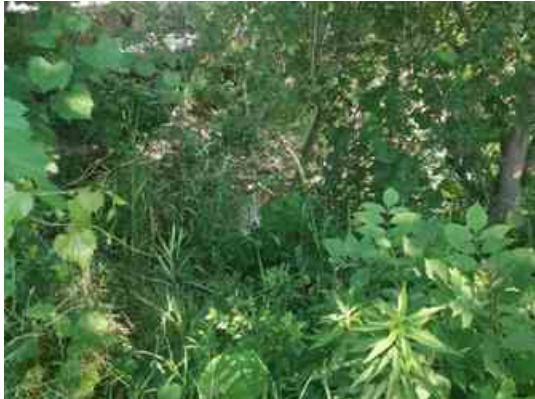
<p>Inspect ID: 2020-0020 Title: 2604000009_CELRC_2020_A_0020_1_20200706T134447.jpg Rated Item: 1. Vegetation and Obstructions Caption: Minimally Acceptable - MU-9: Overgrown vegetation at outlet.</p>

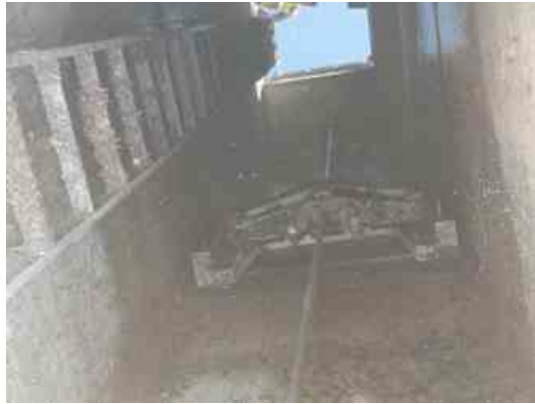
Inspect ID: 2020-0014 **Title:** 2604000009_CELRC_2020_A_0014_1_20200706T132159.jpg **Rated Item:** 10. Sluice/ Slide Gates **Caption:** Minimally Acceptable - MU-11: Gate not closed all the way. Sediment within gatewell.

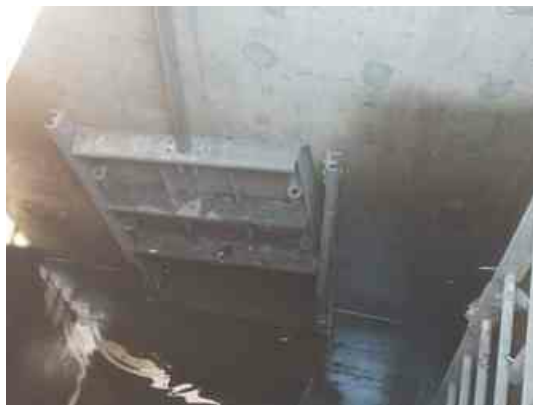
Inspect ID: 2020-0086 **Title:** 2604000009_CELRC_2020_A_0086_1_20200706T153036.jpg **Rated Item:** 10. Sluice/ Slide Gates **Caption:** Minimally Acceptable - MU-1: Sluice gate closed completely but guide rail is bent.

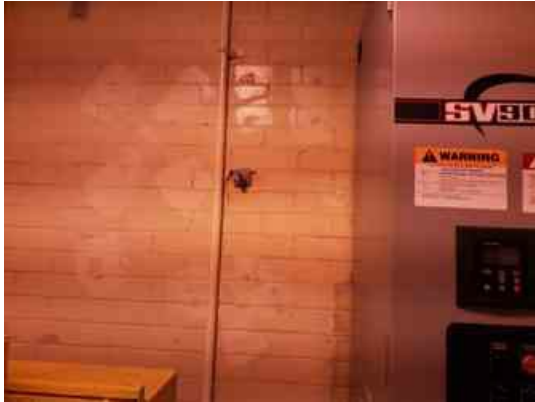
Inspect ID: 2020-0013 Title: 2604000009_CELRC_2020_A_0013_1_20200706T142902.jpg Rated Item: 5. Plant Building Caption: Minimally Acceptable - PS-BA: Broken masonry.

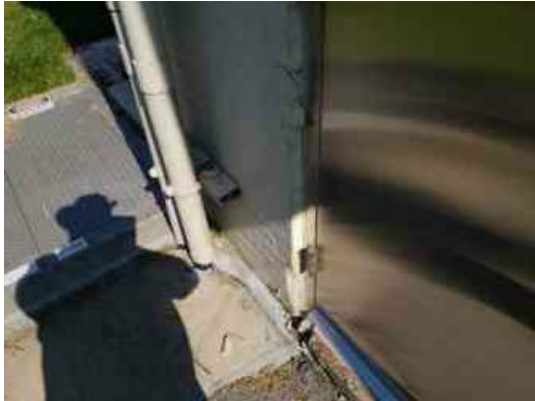
Inspect ID: 2020-0016 Title: 2604000009_CELRC_2020_A_0016_1_20200706T143055.jpg Rated Item: 5. Plant Building Caption: Minimally Acceptable - PS-BA: Broken concrete and masonry around doorway.

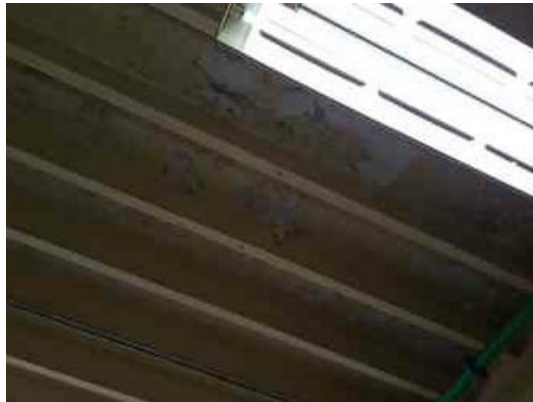
Inspect ID: 2020-0028 **Title:** 2604000009_CELRC_2020_A_0028_1_20200706T144915.jpg **Rated Item:** 5. Plant Building **Caption:** Minimally Acceptable - PS-CAL: Peeling paint on ceiling. Crack in concrete.

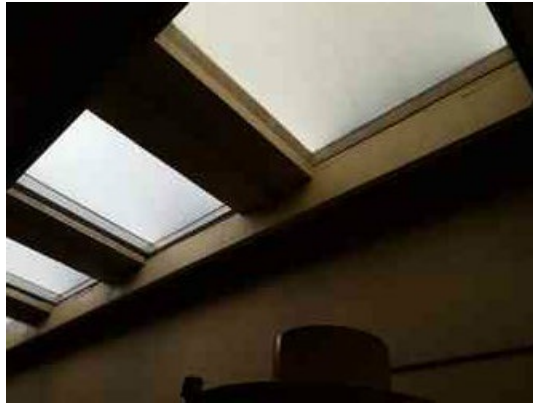
Inspect ID: 2020-0031 **Title:** 2604000009_CELRC_2020_A_0031_1_20200706T145009.jpg **Rated Item:** 5. Plant Building **Caption:** Minimally Acceptable - PS-CAL: Cracked concrete around skylight. Peeling weatherstrip.

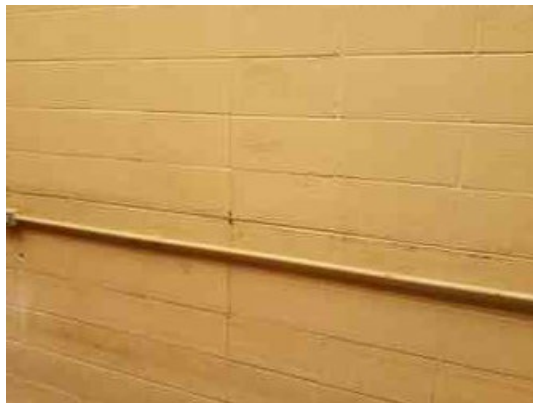
Inspect ID: 2020-0046 **Title:** 2604000009_CELRC_2020_A_0046_1_20200706T145924.jpg **Rated Item:** 5. Plant Building **Caption:** Minimally Acceptable - PS-CAL: Cracks in masonry all around the pump station.

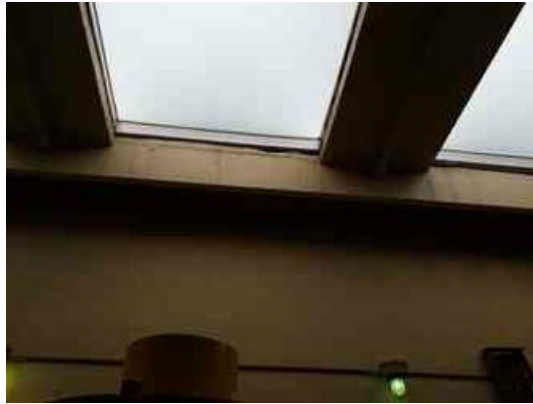
Inspect ID: 2020-0049 **Title:** 2604000009_CELRC_2020_A_0049_1_20200706T150113.jpg **Rated Item:** 5. Plant Building **Caption:** Minimally Acceptable - PS-CAL: Concrete missing around the skylight.

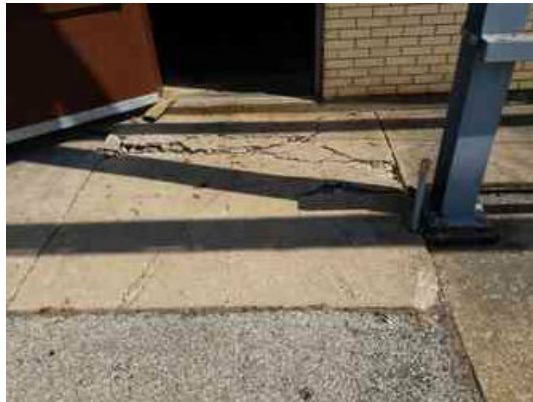
Inspect ID: 2020-0064 **Title:** 2604000009_CELRC_2020_A_0064_1_20200706T150752.jpg **Rated Item:** 5. Plant Building **Caption:** Minimally Acceptable - PS-CAL: Broken sidewalk.

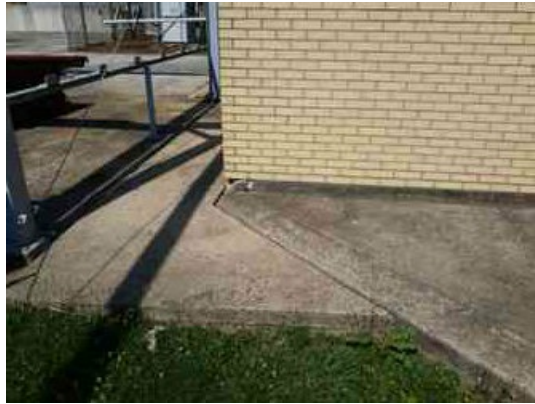
Inspect ID: 2020-0067 **Title:**
2604000009_CELRC_2020_A_0067_1_20200706T150857.jpg **Rated**
Item: 5. Plant Building **Caption:** Minimally Acceptable - PS-CAL:
Chipped foundation at corner.

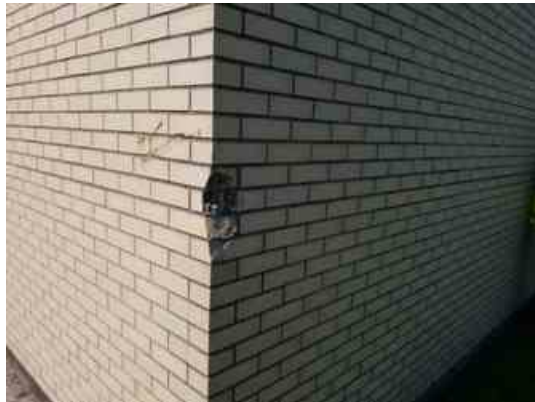
Inspect ID: 2020-0073 **Title:**
2604000009_CELRC_2020_A_0073_1_20200706T151128.jpg **Rated**
Item: 5. Plant Building **Caption:** Minimally Acceptable - PS-CAL: Broken
masonry on corner.

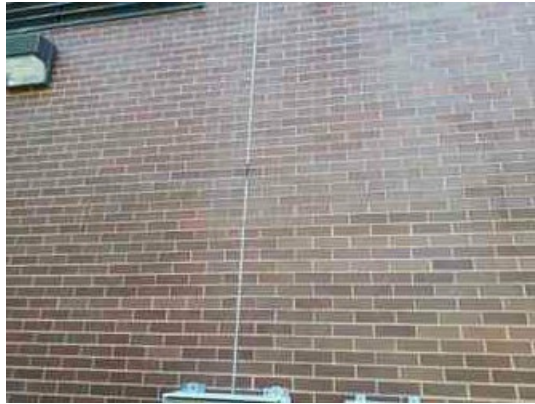
Inspect ID: 2020-0079 **Title:** 2604000009_CELRC_2020_A_0079_1_20200706T152441.jpg **Rated Item:** 5. Plant Building **Caption:** Minimally Acceptable - PS-OA: Splitting in the joint sealant.

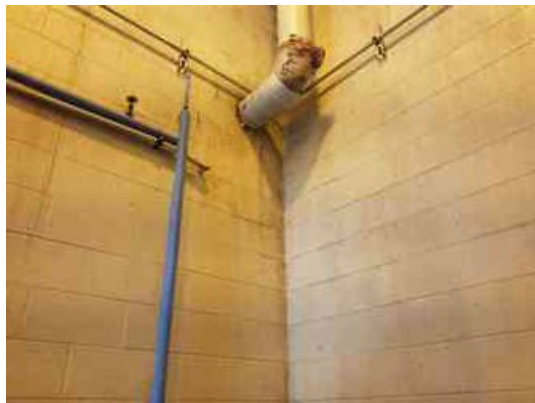
Inspect ID: 2020-0085 **Title:** 2604000009_CELRC_2020_A_0085_1_20200706T152651.jpg **Rated Item:** 5. Plant Building **Caption:** Minimally Acceptable - PS-OA: Cracking of masonry around pipe.

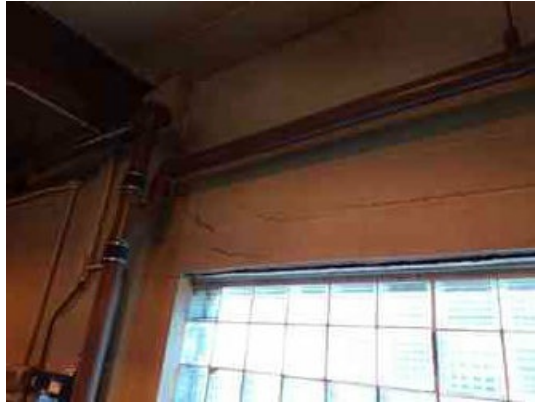
Inspect ID: 2020-0124 **Title:** 2604000009_CELRC_2020_A_0124_1_20200706T155426.jpg **Rated Item:** 5. Plant Building **Caption:** Minimally Acceptable - PS-HM: Cracking in masonry around all windows.

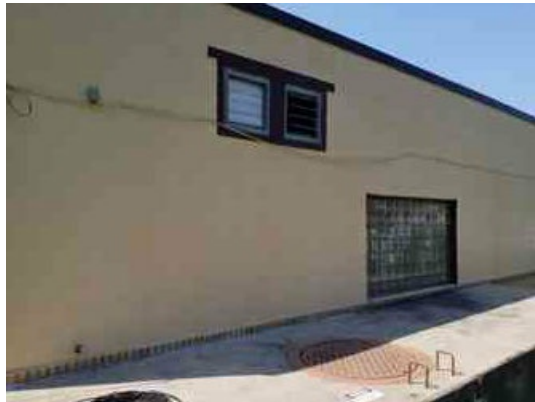
Inspect ID: 2020-0133 **Title:** 2604000009_CELRC_2020_A_0133_1_20200706T160006.jpg **Rated Item:** 5. Plant Building **Caption:** Acceptable - PS-HM: Cracked masonry repaired and new paint added.

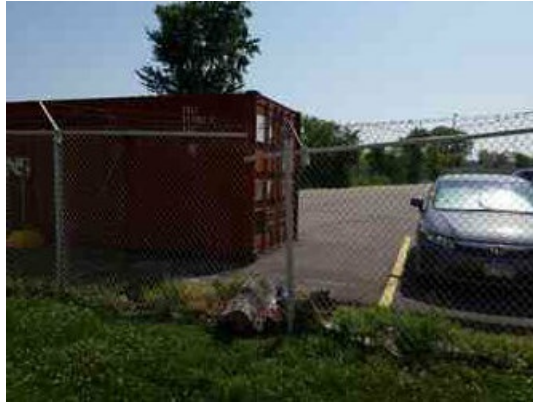
Inspect ID: 2020-0070 **Title:** 2604000009_CELRC_2020_A_0070_1_20200706T151028.jpg **Rated Item:** 6. Fencing and Gates **Caption:** Minimally Acceptable - PS-CAL: Broken fence.

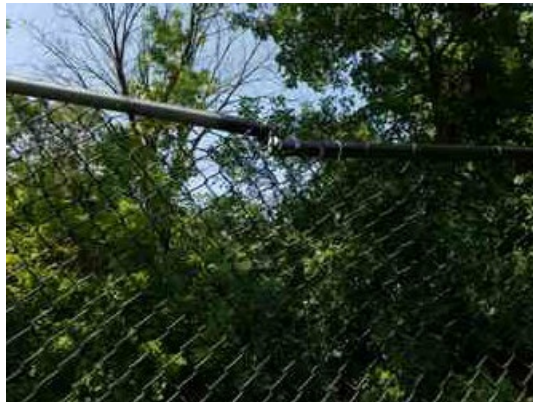
Inspect ID: 2020-0106 **Title:** 2604000009_CELRC_2020_A_0106_1_20200706T153621.jpg **Rated Item:** 6. Fencing and Gates **Caption:** Minimally Acceptable - PS-OA: Broken fence.

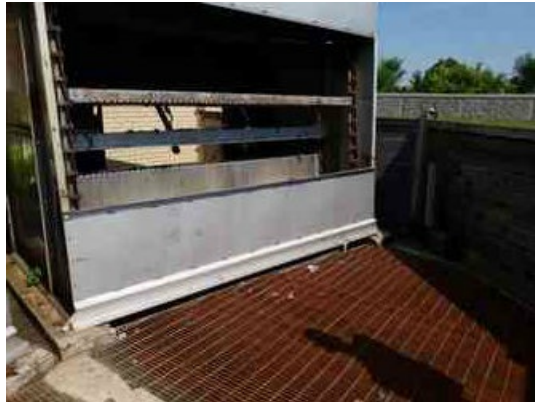
Inspect ID: 2020-0055 **Title:** 2604000009_CELRC_2020_A_0055_1_20200706T150410.jpg **Rated Item:** 10. Mechanical Operating Trash Rakes **Caption:** Acceptable - PS-CAL: Replaced the corroded trash rack members.

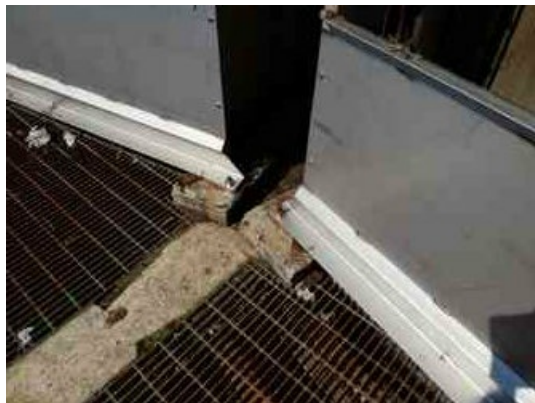
Inspect ID: 2020-0058 **Title:** 2604000009_CELRC_2020_A_0058_1_20200706T150541.jpg **Rated Item:** 10. Mechanical Operating Trash Rakes **Caption:** Minimally Acceptable - PS-CAL: Foundation crumbling.

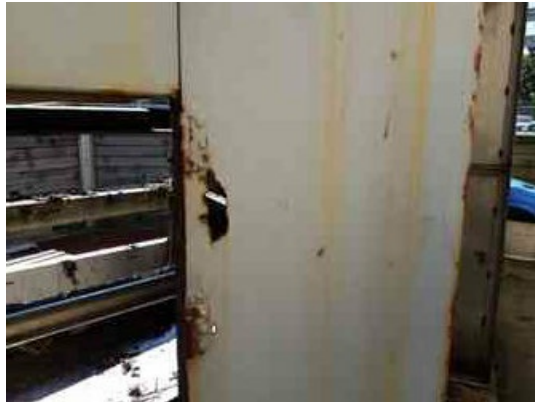
Inspect ID: 2020-0061 **Title:** 2604000009_CELRC_2020_A_0061_1_20200706T150629.jpg **Rated Item:** 10. Mechanical Operating Trash Rakes **Caption:** Minimally Acceptable - PS-CAL: Casing corroded.

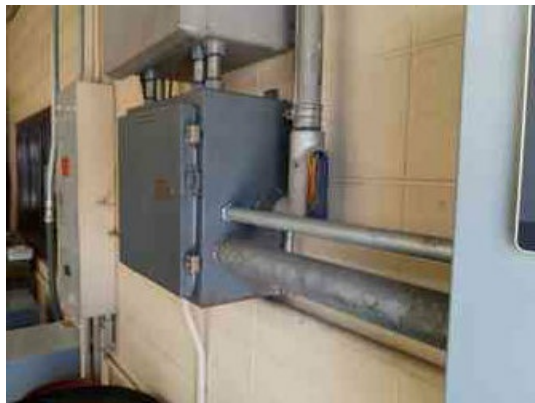
Inspect ID: 2020-0043 **Title:** 2604000009_CELRC_2020_A_0043_1_20200706T145443.jpg **Rated Item:** 16. Enclosures, Panels, Conduit and Ducts **Caption:** Minimally Acceptable - PS-CAL: Missing cover on elbow.

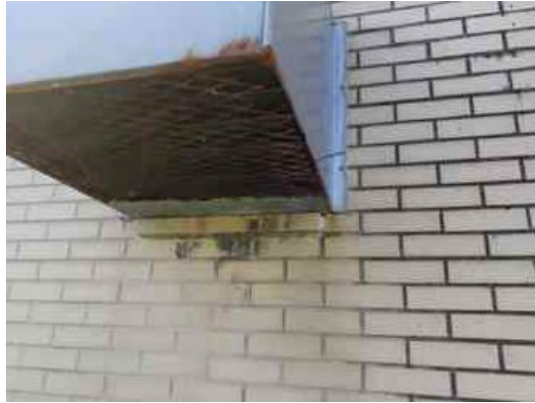
Inspect ID: 2020-0076 **Title:** 2604000009_CELRC_2020_A_0076_1_20200706T151318.jpg **Rated Item:** 16. Enclosures, Panels, Conduit and Ducts **Caption:** Minimally Acceptable - PS-CAL: Corroded screen.
