## Levee Inspection Report

Name of System: Hammond Forest Ave

NLD System ID: 2605000010

Date(s) of Inspection: 06/24/2021 - 06/24/2021

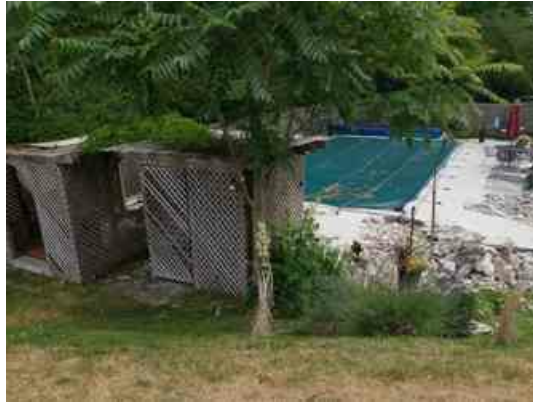
**Inspect ID:** 2021-0049 **Title:** 2604000010\_CELRC\_2021\_A\_0049\_1\_20210624T152517.jpg **Rated Item:** 1. Unwanted Vegetation Growth **Caption:** Minimally Acceptable - Tree too close to landside toe. Remove from 15 ft vegetation free zone.

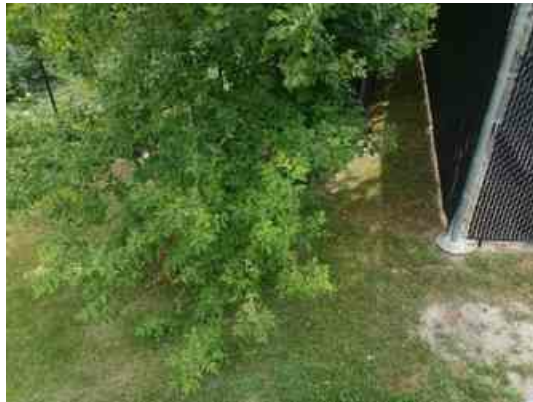
**Inspect ID:** 2021-0061 **Title:** 2604000010\_CELRC\_2021\_A\_0061\_1\_20210624T153045.jpg **Rated Item:** 1. Unwanted Vegetation Growth **Caption:** Minimally Acceptable - Tree on landside. Remove from 15 ft vegetation free zone.

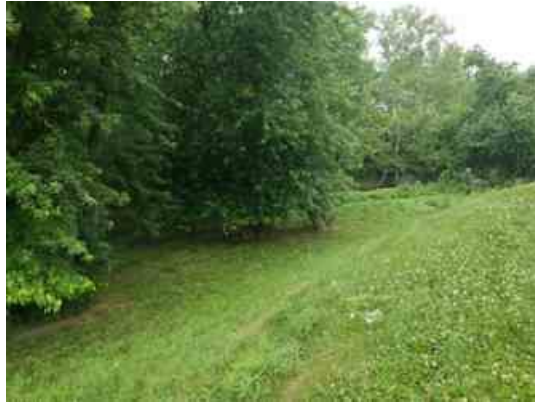
**Inspect ID:** 2021-0087 **Title:** 2604000010\_CELRC\_2021\_A\_0087\_1\_20210624T154725.jpg **Rated Item:** 1. Unwanted Vegetation Growth **Caption:** Minimally Acceptable - Large trees too close to riverside toe. Remove from 15 ft vegetation free zone.

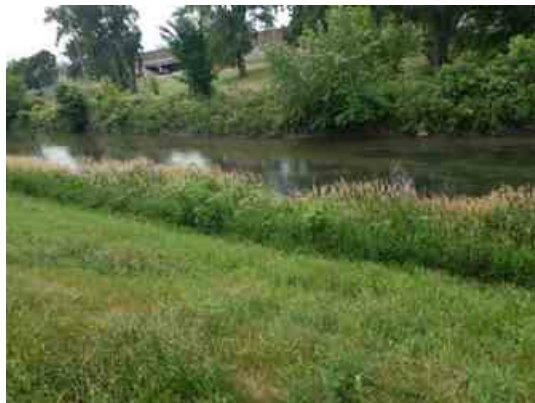
**Inspect ID:** 2021-0093 **Title:** 2604000010\_CELRC\_2021\_A\_0093\_1\_20210624T155010.jpg **Rated Item:** 1. Unwanted Vegetation Growth **Caption:** Minimally Acceptable - Tall vegetation along riverside toe. Remove from 15 ft vegetation free zone.

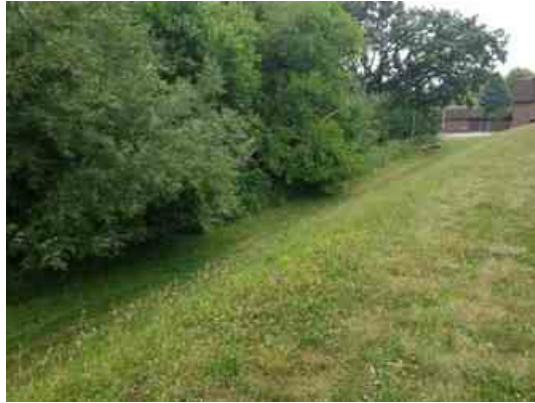
**Inspect ID:** 2021-0095 **Title:** 2604000010\_CELRC\_2021\_A\_0095\_1\_20210624T155051.jpg **Rated Item:** 1. Unwanted Vegetation Growth **Caption:** Minimally Acceptable - Trees overhanging on landside toe. Remove from 15 ft vegetation free zone.

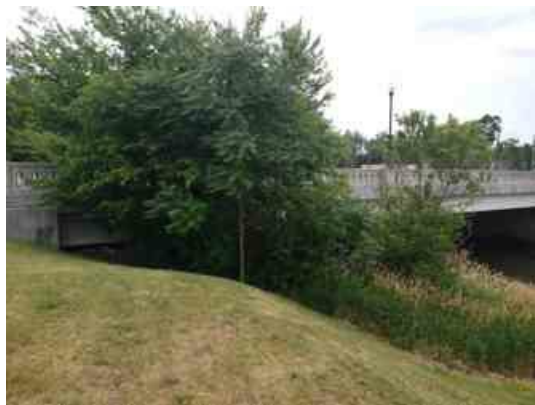
**Inspect ID:** 2021-0107 **Title:** 2604000010\_CELRC\_2021\_A\_0107\_1\_20210624T155853.jpg **Rated Item:** 1. Unwanted Vegetation Growth **Caption:** Minimally Acceptable - Trees on riverside slope. Remove from 15 ft vegetation free zone.

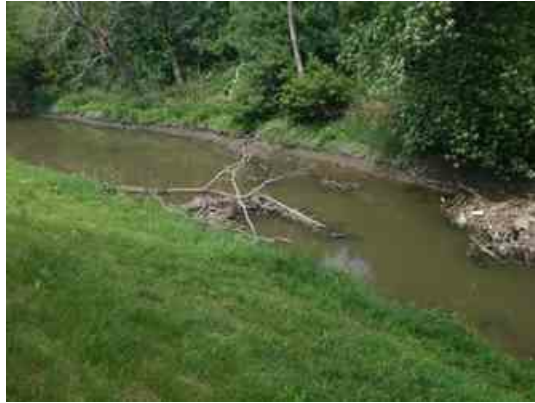
**Inspect ID:** 2021-0075 **Title:** 2604000010\_CELRC\_2021\_A\_0075\_1\_20210624T153846.jpg **Rated Item:** 3. Encroachments **Caption:** Minimally Acceptable - Downed tree riverside toe. Remove.

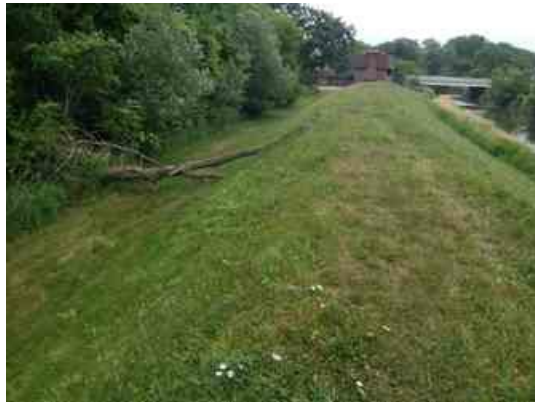
**Inspect ID:** 2021-0089 **Title:** 2604000010\_CELRC\_2021\_A\_0089\_1\_20210624T154834.jpg **Rated Item:** 3. Encroachments **Caption:** Minimally Acceptable - Downed tree landside toe. Remove.

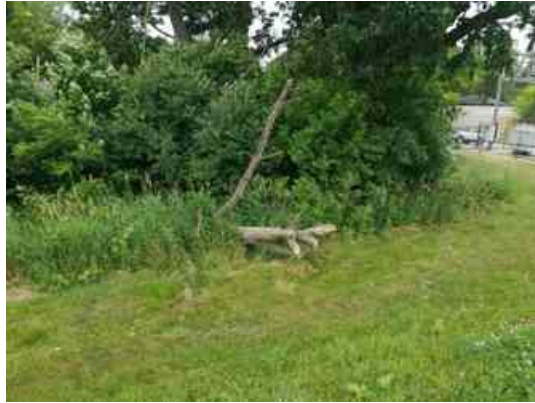
**Inspect ID:** 2021-0097 **Title:** 2604000010\_CELRC\_2021\_A\_0097\_1\_20210624T155131.jpg **Rated Item:** 3. Encroachments **Caption:** Minimally Acceptable - Downed tree landside toe. Remove.

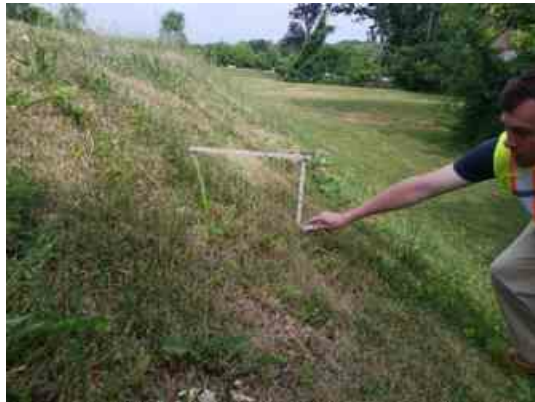
**Inspect ID:** 2021-0053 **Title:** 2604000010\_CELRC\_2021\_A\_0053\_1\_20210624T152620.jpg **Rated Item:** 5. Slope Stability **Caption:** Acceptable - Typical landside slope. 2:1, as constructed.

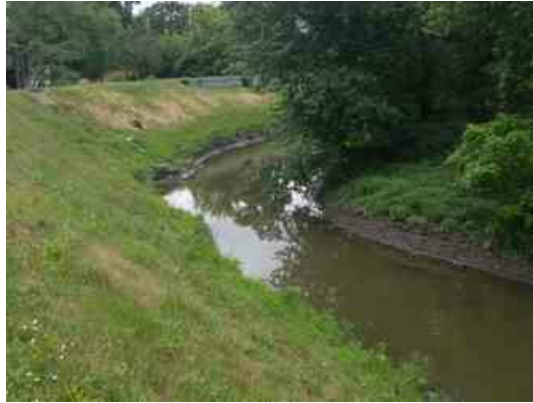
**Inspect ID:** 2021-0041 **Title:** 2604000010\_CELRC\_2021\_A\_0041\_1\_20210624T151431.jpg **Rated Item:** 6. Erosion/ Bank Caving **Caption:** Minimally Acceptable - Bank erosion. Stabilize with riprap.

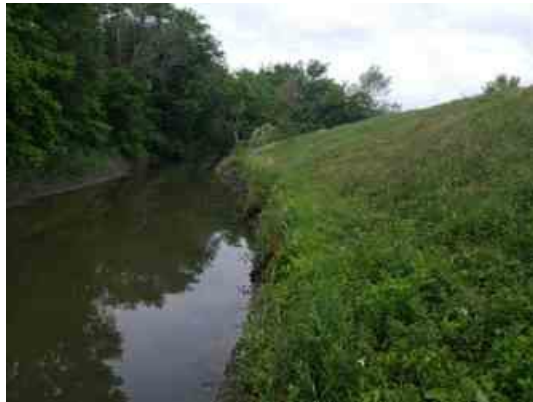
**Inspect ID:** 2021-0045 **Title:** 2604000010\_CELRC\_2021\_A\_0045\_1\_20210624T152154.jpg **Rated Item:** 6. Erosion/ Bank Caving **Caption:** Minimally Acceptable - Bank erosion along the line. Stabilize with riprap.

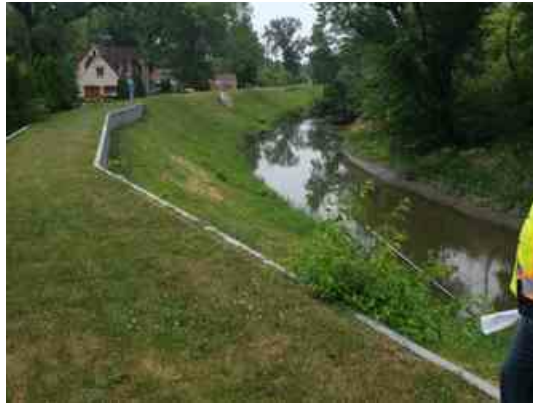
**Inspect ID:** 2021-0059 **Title:** 2604000010\_CELRC\_2021\_A\_0059\_1\_20210624T152917.jpg **Rated Item:** 6. Erosion/ Bank Caving **Caption:** Minimally Acceptable - Bank erosion. Stabilize with riprap.

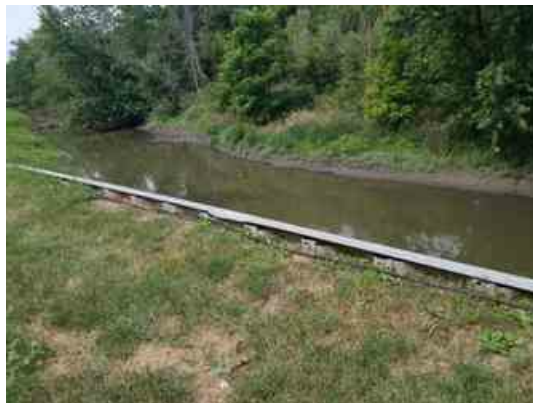
**Inspect ID:** 2021-0067 **Title:** 2604000010\_CELRC\_2021\_A\_0067\_1\_20210624T153357.jpg **Rated Item:** 7. Settlement **Caption:** Minimally Acceptable - Crest lower than top of sheet pile. Monitor.

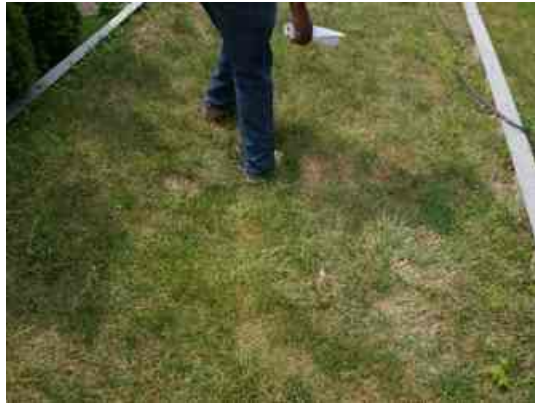
**Inspect ID:** 2021-0065 **Title:** 2604000010\_CELRC\_2021\_A\_0065\_1\_20210624T153222.jpg **Rated Item:** 8. Depressions/ Rutting **Caption:** Minimally Acceptable - Small depression on crown. Fill.

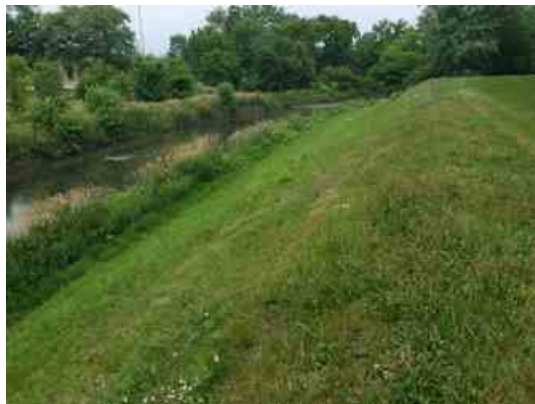
**Inspect ID:** 2021-0091 **Title:** 2604000010\_CELRC\_2021\_A\_0091\_1\_20210624T154923.jpg **Rated Item:** 8. Depressions/ Rutting **Caption:** Minimally Acceptable - Depressions on riverside slope. Fill and seed.

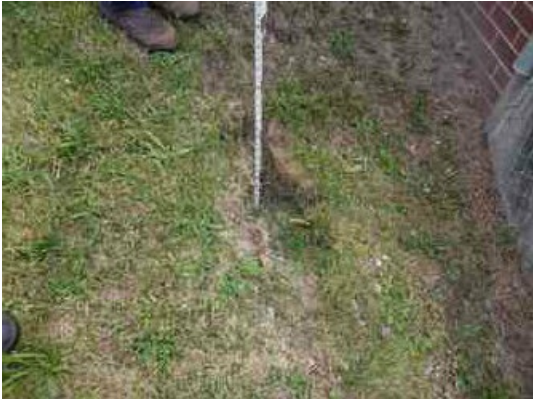
<p><b>Inspect ID:</b> 2021-0099 <b>Title:</b> 2604000010_CELRC_2021_A_0099_1_20210624T155229.jpg <b>Rated Item:</b> 10. Animal Control <b>Caption:</b> Minimally Acceptable - Burrow on riverside slope. Fill.</p>

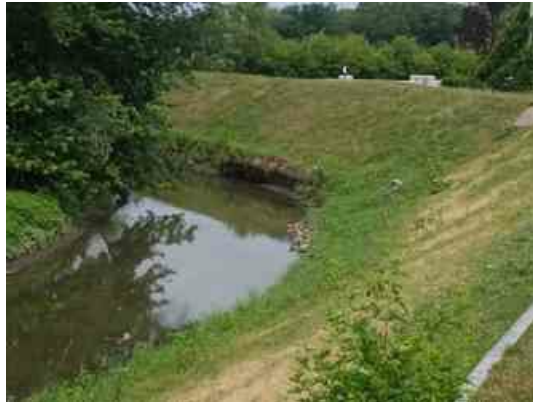
**Inspect ID:** 2021-0043 **Title:** 2604000010\_CELRC\_2021\_A\_2021-0043\_1\_20210624T153107.jpg **Rated Item:** 13. Revetments other than Riprap **Caption:** Minimally Acceptable - Retaining wall tilting. Recommend replacing.

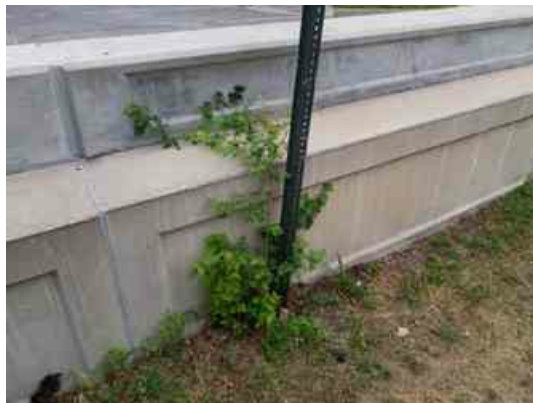
**Inspect ID:** 2021-0007 **Title:** 2604000010\_CELRC\_2021\_A\_0007\_1\_20210624T143254.jpg **Rated Item:** 1. Unwanted Vegetation Growth **Caption:** Minimally Acceptable - Remove tall vegetation on riverside.

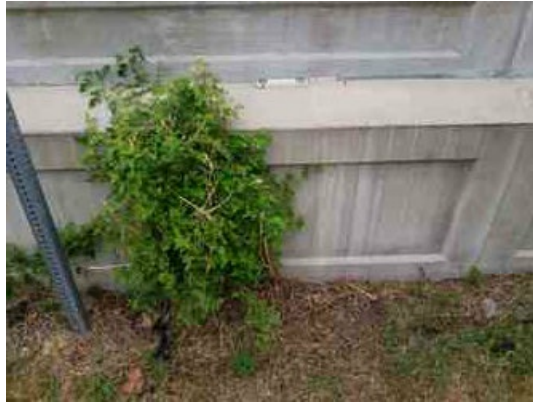
**Inspect ID:** 2021-0013 **Title:** 2604000010\_CELRC\_2021\_A\_0013\_1\_20210624T144005.jpg **Rated Item:** 1. Unwanted Vegetation Growth **Caption:** Minimally Acceptable - Remove tall vegetation on riverside.

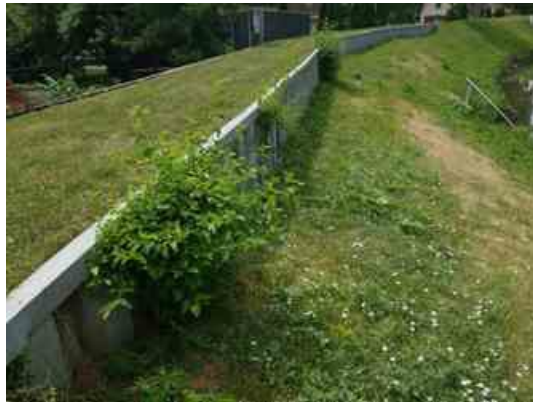
**Inspect ID:** 2021-0055 **Title:** 2604000010\_CELRC\_2021\_A\_0055\_1\_20210624T152739.jpg **Rated Item:** 1. Unwanted Vegetation Growth **Caption:** Minimally Acceptable - Bushes along sheet pile on riverside. Remove.

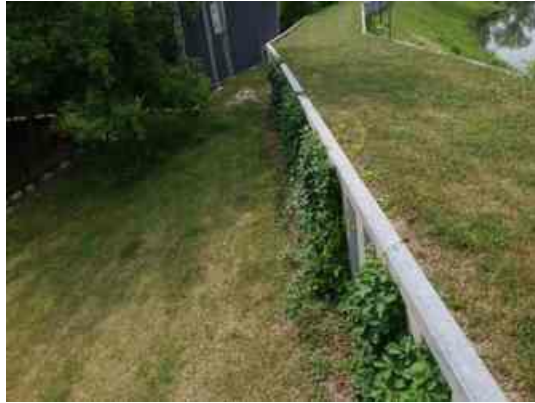
**Inspect ID:** 2021-0057 **Title:** 2604000010\_CELRC\_2021\_A\_0057\_1\_20210624T152816.jpg **Rated Item:** 1. Unwanted Vegetation Growth **Caption:** Minimally Acceptable - Tall vines on landside. Remove.

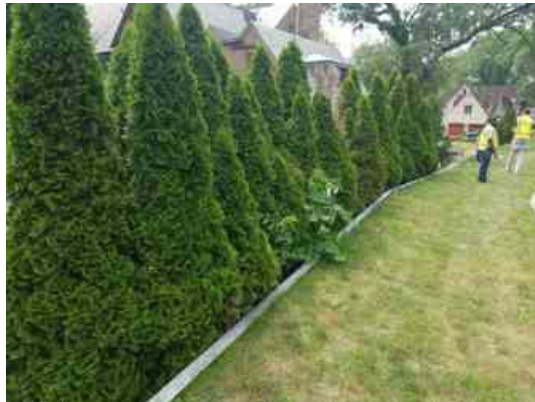
**Inspect ID:** 2021-0063 **Title:** 2604000010\_CELRC\_2021\_A\_0063\_1\_20210624T153153.jpg **Rated Item:** 1. Unwanted Vegetation Growth **Caption:** Minimally Acceptable - Ornamental trees on landside of floodwall. Remove.

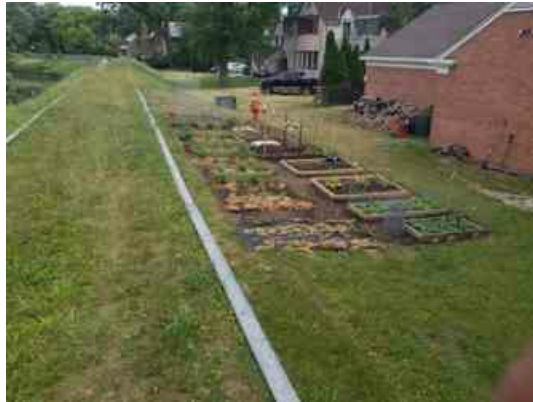
**Inspect ID:** 2021-0077 **Title:** 2604000010\_CELRC\_2021\_A\_0077\_1\_20210624T154012.jpg **Rated Item:** 2. Encroachments **Caption:** Minimally Acceptable - Garden next to the floodwall. Discuss the encroachments with the resident. Recommend removing or submitting a 408 request.

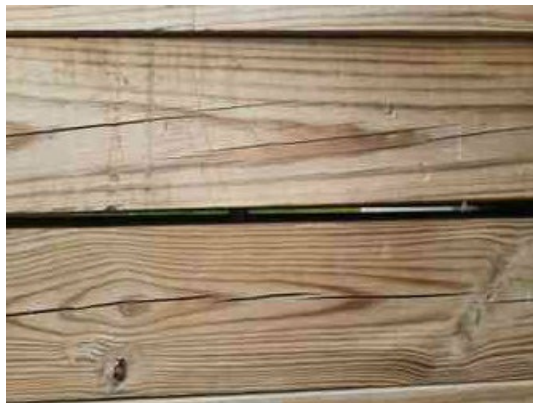
**Inspect ID:** 2021-0035 **Title:** 2604000010\_CELRC\_2021\_A\_0035\_1\_20210624T151012.jpg **Rated Item:** 3. Closure Structures (Stop Log Closures and Gates) (A or U only) **Caption:** Acceptable - Gaps between the stop log beams. Replace wooden beams.

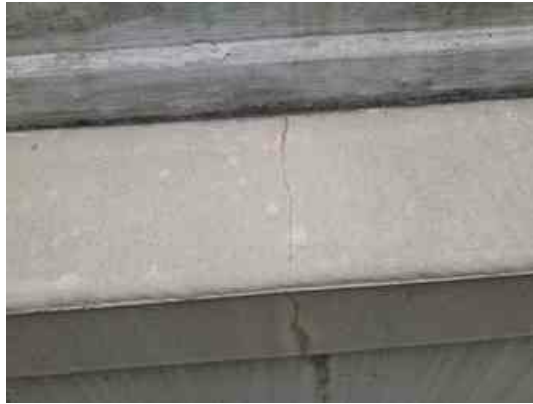
**Inspect ID:** 2021-0003 **Title:** 2604000010\_CELRC\_2021\_A\_0003\_1\_20210624T143032.jpg **Rated Item:** 4. Concrete Surfaces **Caption:** Acceptable - Minor crack. Monitor.

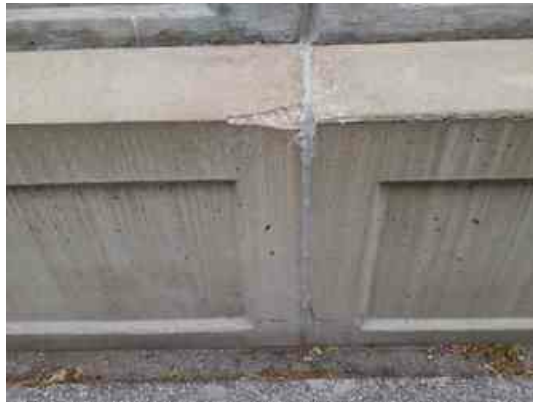
**Inspect ID:** 2021-0005 **Title:** 2604000010\_CELRC\_2021\_A\_0005\_1\_20210624T143154.jpg **Rated Item:** 4. Concrete Surfaces **Caption:** Acceptable - Spalling and crack on landside. Monitor.

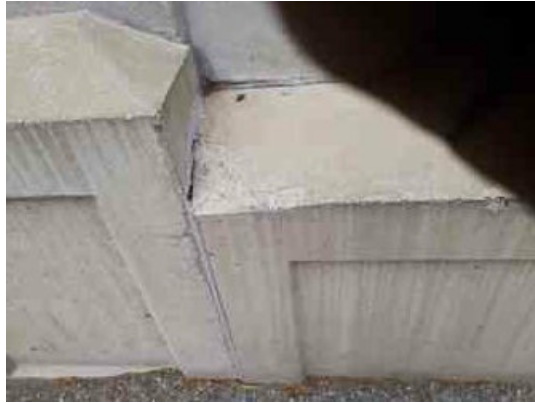
**Inspect ID:** 2021-0011 **Title:** 2604000010\_CELRC\_2021\_A\_0011\_1\_20210624T143828.jpg **Rated Item:** 4. Concrete Surfaces **Caption:** Minimally Acceptable - Spalling on top of wall. Patch.

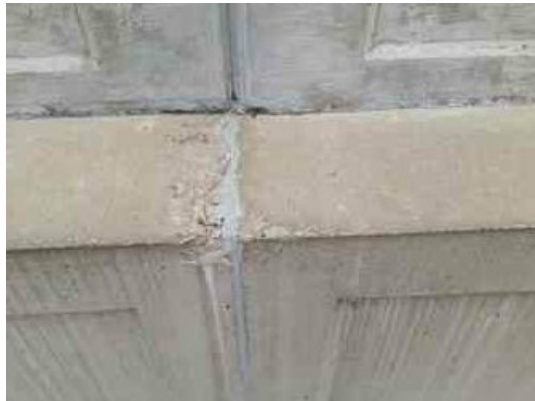
**Inspect ID:** 2021-0017 **Title:** 2604000010\_CELRC\_2021\_A\_0017\_1\_20210624T144256.jpg **Rated Item:** 4. Concrete Surfaces **Caption:** Acceptable - Spalling on top of wall. Monitor.

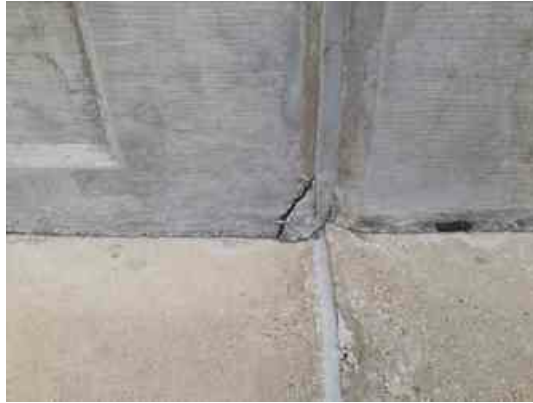
**Inspect ID:** 2021-0019 **Title:** 2604000010\_CELRC\_2021\_A\_0019\_1\_20210624T145300.jpg **Rated Item:** 4. Concrete Surfaces **Caption:** Minimally Acceptable - Crack on landside. Patch.

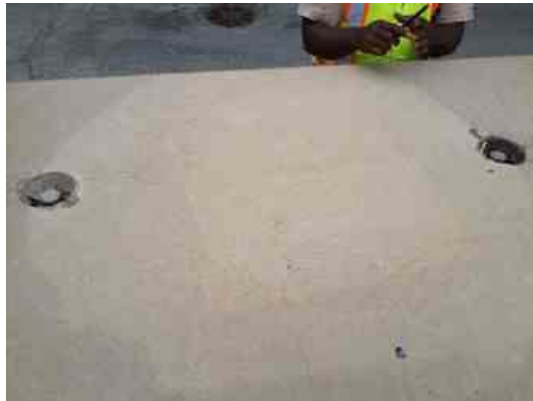
**Inspect ID:** 2021-0023 **Title:** 2604000010\_CELRC\_2021\_A\_0023\_1\_20210624T145516.jpg **Rated Item:** 4. Concrete Surfaces **Caption:** Minimally Acceptable - Minor cracking on top of wall. Monitor.

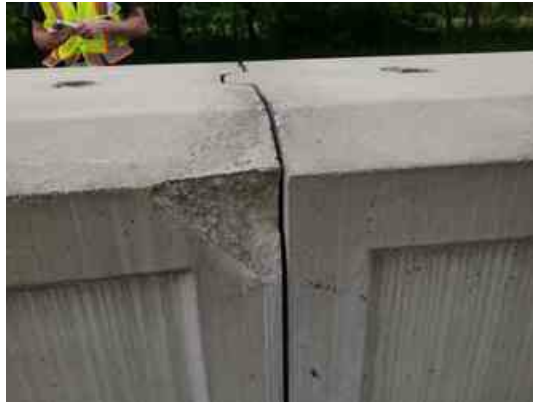
**Inspect ID:** 2021-0027 **Title:** 2604000010\_CELRC\_2021\_A\_0027\_1\_20210624T150020.jpg **Rated Item:** 4. Concrete Surfaces **Caption:** Minimally Acceptable - Spalling on top of wall. Patch.

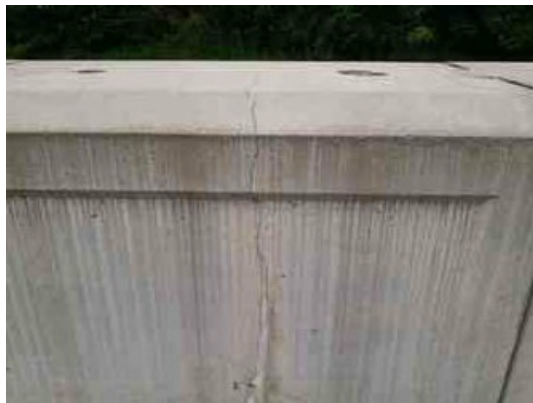
**Inspect ID:** 2021-0029 **Title:** 2604000010\_CELRC\_2021\_A\_0029\_1\_20210624T150335.jpg **Rated Item:** 4. Concrete Surfaces **Caption:** Minimally Acceptable - Cracking on both sides. Seal.

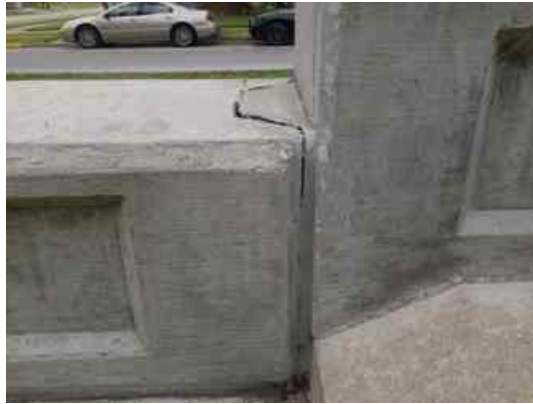
**Inspect ID:** 2021-0001 **Title:** 2604000010\_CELRC\_2021\_A\_0001\_1\_20210624T142940.jpg **Rated Item:** 7. Monolith Joints **Caption:** Minimally Acceptable - Crack in sealant. Reseal.

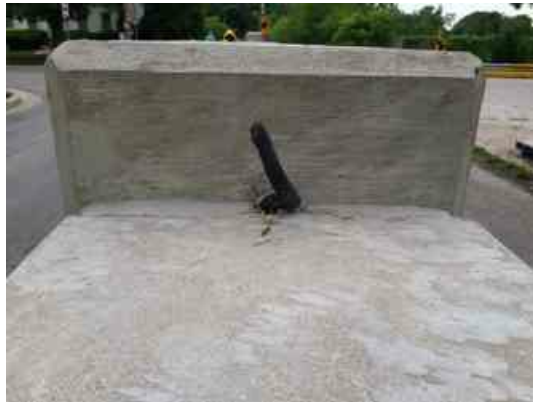
**Inspect ID:** 2021-0009 **Title:** 2604000010\_CELRC\_2021\_A\_2021-0009\_3\_20210624T145137.jpg **Rated Item:** 7. Monolith Joints **Caption:** Minimally Acceptable - Exposed filler material. Typical along wall. Reseal.

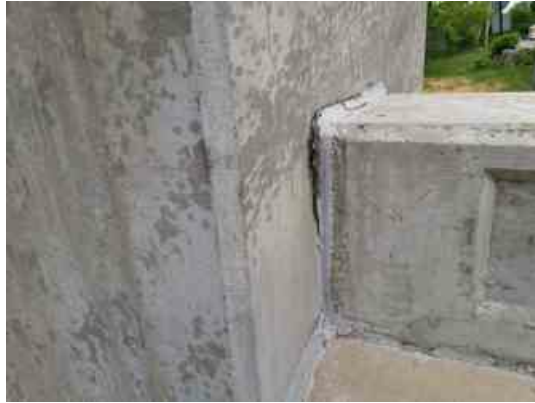
**Inspect ID:** 2021-0021 **Title:** 2604000010\_CELRC\_2021\_A\_0021\_1\_20210624T145428.jpg **Rated Item:** 7. Monolith Joints **Caption:** Minimally Acceptable - Crack in landside joint. Reseal.

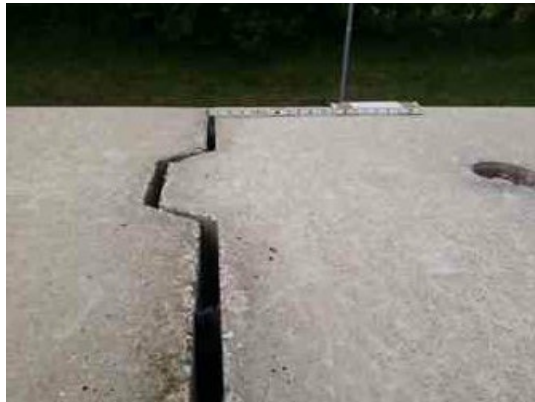
**Inspect ID:** 2021-0031 **Title:** 2604000010\_CELRC\_2021\_A\_0031\_1\_20210624T150625.jpg **Rated Item:** 7. Monolith Joints **Caption:** Minimally Acceptable - Loss of sealant. Replace sealant.

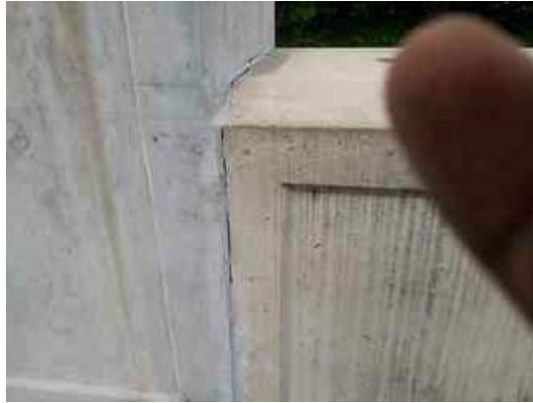
**Inspect ID:** 2021-0033 **Title:** 2604000010\_CELRC\_2021\_A\_0033\_1\_20210624T150804.jpg **Rated Item:** 7. Monolith Joints **Caption:** Minimally Acceptable - Crack in sealant. Replace sealant.

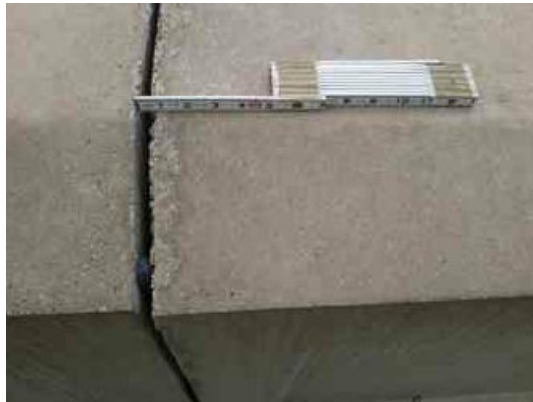
**Inspect ID:** 2021-0037 **Title:** 2604000010\_CELRC\_2021\_A\_0037\_1\_20210624T151121.jpg **Rated Item:** 7. Monolith Joints **Caption:** Minimally Acceptable - Gaps in sealant. Typical. Replace sealant.

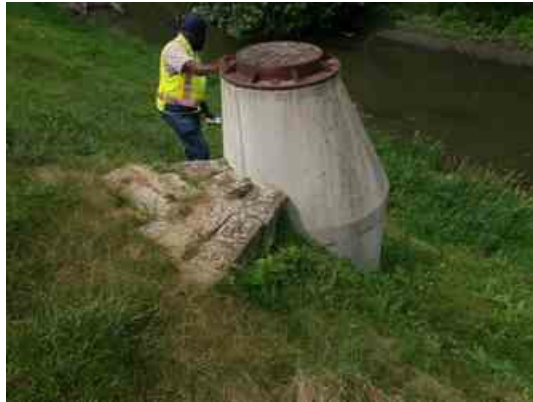
**Inspect ID:** 2021-0073 **Title:** 2604000010\_CELRC\_2021\_A\_0073\_1\_20210624T153800.jpg **Rated Item:** 1. Vegetation and Obstructions **Caption:** Minimally Acceptable - FA-4: Clear heavy vegetation at outlet.

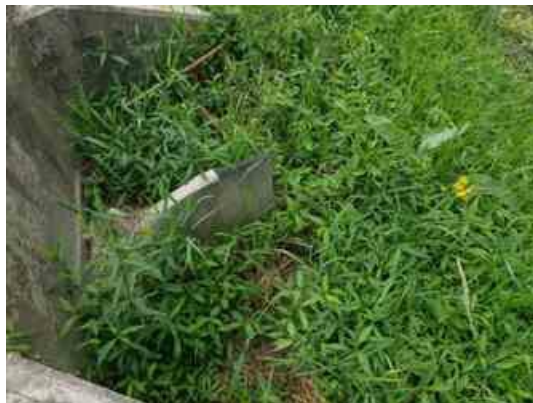
**Inspect ID:** 2021-0047 **Title:** 2604000010\_CELRC\_2021\_A\_0047\_1\_20210624T152401.jpg **Rated Item:** 11. Flap Gates/ Flap Valves/ Pinch Valves **Caption:** Minimally Acceptable - FA-2: Vegetation and silt at outlet. Clean.

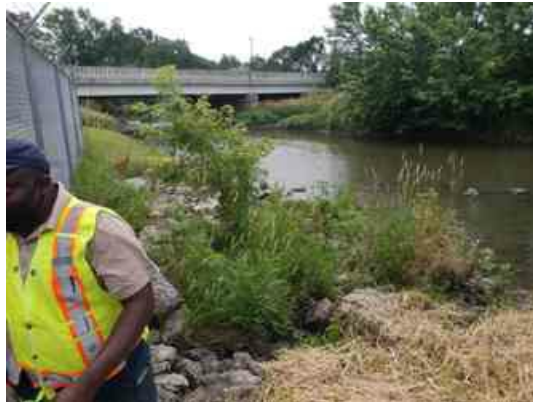
**Inspect ID:** 2021-0103 **Title:** 2604000010\_CELRC\_2021\_A\_0103\_1\_20210624T155600.jpg **Rated Item:** 14. Riprap Revetments of Inlet/ Discharge Areas **Caption:** Minimally Acceptable - Small trees and vegetation in riprap at outlet. Remove.

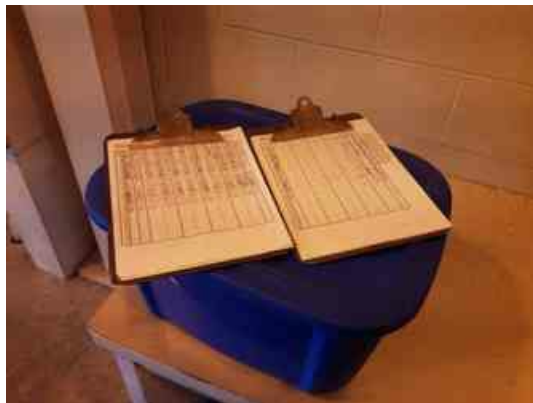
**Inspect ID:** 2021-0002 **Title:** 2604000010\_CELRC\_2021\_A\_0002\_1\_20210621T145358.jpg **Rated Item:** 2. Pump Station Operations and Maintenance Equipment Manuals **Caption:** Acceptable - PS-SH: Operation manuals on site.

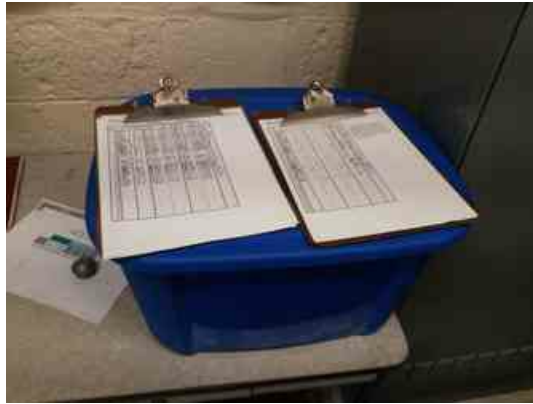
**Inspect ID:** 2021-0012 **Title:** 2604000010\_CELRC\_2021\_A\_0012\_1\_20210621T151741.jpg **Rated Item:** 2. Pump Station Operations and Maintenance Equipment Manuals **Caption:** Acceptable - Ps fa operations manuals on site

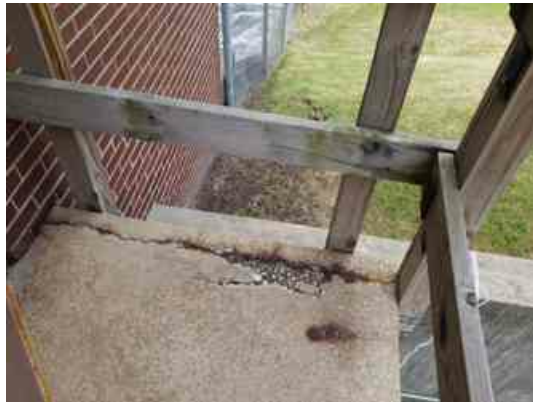
**Inspect ID:** 2021-0004 **Title:** 2604000010\_CELRC\_2021\_A\_0004\_1\_20210621T145658.jpg **Rated Item:** 5. Plant Building **Caption:** Minimally Acceptable - PS-SH: Crack along stairway landing pad.

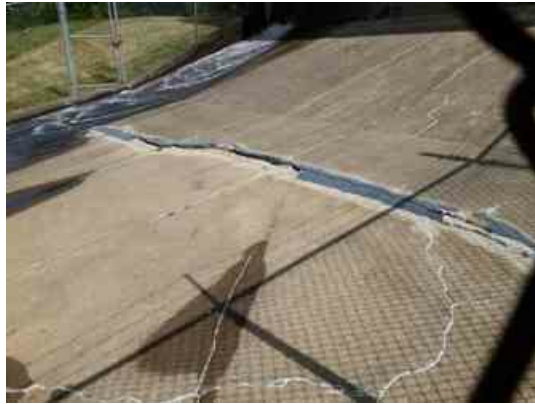
**Inspect ID:** 2021-0008 **Title:** 2604000010\_CELRC\_2021\_A\_0008\_1\_20210621T150829.jpg **Rated Item:** 5. Plant Building **Caption:** Minimally Acceptable - PS-SH: Discharge sluiceway has cracks. Repairs look to have failed. Repair cracks to prevent undercutting of structure.

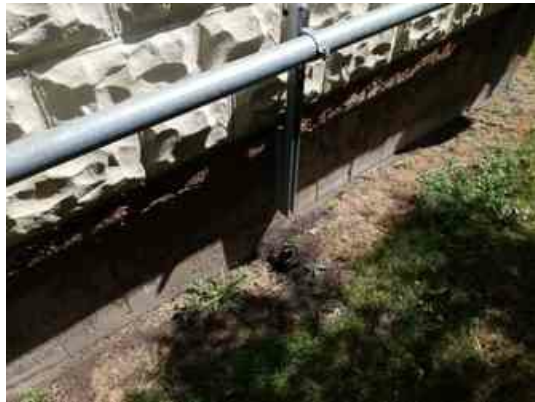
**Inspect ID:** 2021-0010 **Title:** 2604000010\_CELRC\_2021\_A\_0010\_1\_20210621T151550.jpg **Rated Item:** 5. Plant Building **Caption:** Minimally Acceptable - PS-FA: Subsidence near south wall foundation, fill and compact.

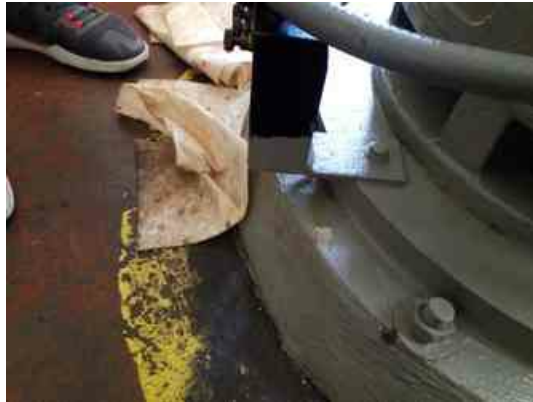
**Inspect ID:** 2021-0014 **Title:** 2604000010\_CELRC\_2021\_A\_0014\_1\_20210621T151834.jpg **Rated Item:** 7. Pumps **Caption:** Minimally Acceptable - PS-FA: SWP-1 hydraulic fluid active leak. Monitor and investigate.

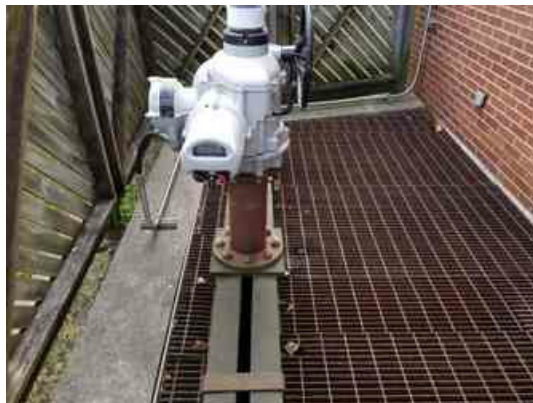
**Inspect ID:** 2021-0006 **Title:** 2604000010\_CELRC\_2021\_A\_2021-0006\_1\_20210621T150052.jpg **Rated Item:** 18. Sluice/ Slide Gates **Caption:** Acceptable - PS-SH: Sluice gate not initially working, it was over-torqued in the open position. It was repaired. Inspection showed that sluice gate closes as long as gate is left open less than 95%. Issue has been resolved. Recommend adding label to warn operators not to over-open gate.
