**US Army Corps
of Engineers®**

Levee Inspection Report

Name of System: Burr Street

Name of Segment: Gary Burr St

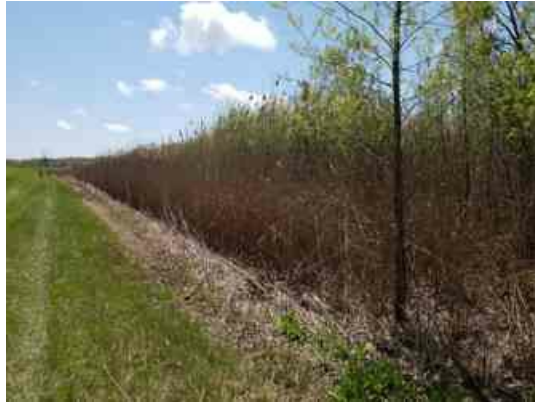
Inspect ID: 2021-0057 **Title:** 2604000005_CELRC_2021_A_0057_1_20210430T163818.jpg **Rated Item:** 1. Unwanted Vegetation Growth **Caption:** Minimally Acceptable - Tall vegetation near the landside toe.

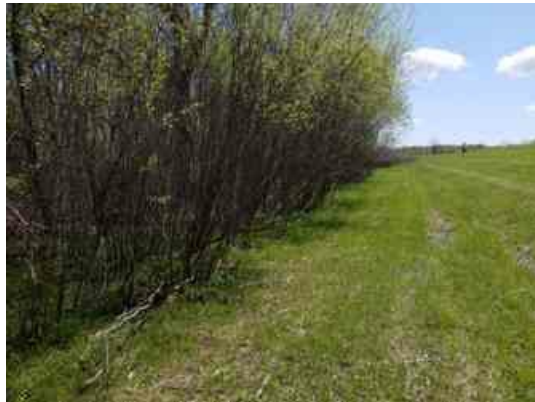
Inspect ID: 2021-0061 **Title:** 2604000005_CELRC_2021_A_0061_1_20210430T164026.jpg **Rated Item:** 1. Unwanted Vegetation Growth **Caption:** Minimally Acceptable - Trees near the riverside toe.

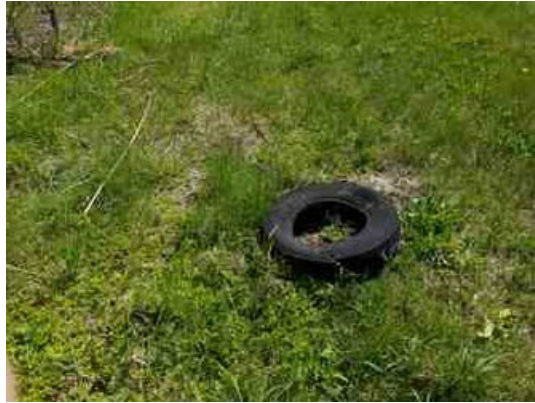
Inspect ID: 2021-0023 **Title:** 2604000005_CELRC_2021_A_0023_1_20210430T161003.jpg **Rated Item:** 3. Encroachments **Caption:** Minimally Acceptable - Debris on riverside toe.

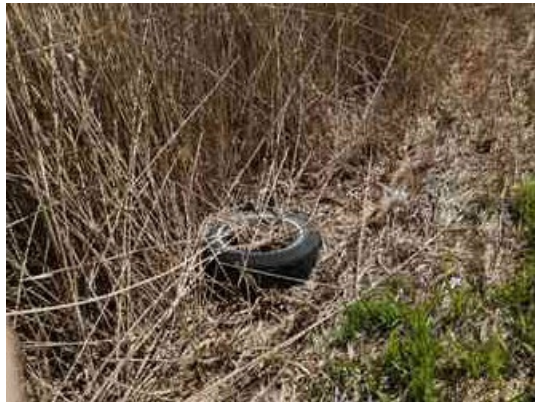
Inspect ID: 2021-0027 **Title:** 2604000005_CELRC_2021_A_0027_1_20210430T161326.jpg **Rated Item:** 3. Encroachments **Caption:** Minimally Acceptable - Debris on riverside toe.

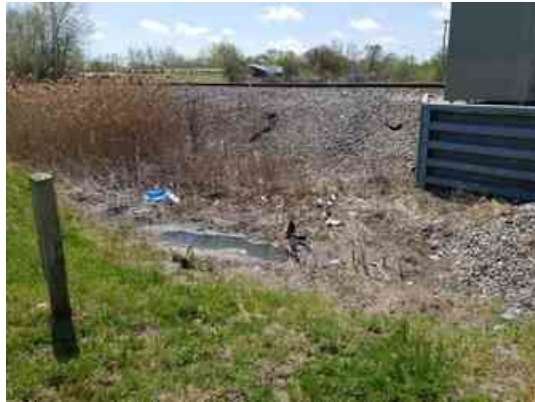
Inspect ID: 2021-0033 **Title:** 2604000005_CELRC_2021_A_0033_1_20210430T161915.jpg **Rated Item:** 3. Encroachments **Caption:** Minimally Acceptable - Debris on landside toe.

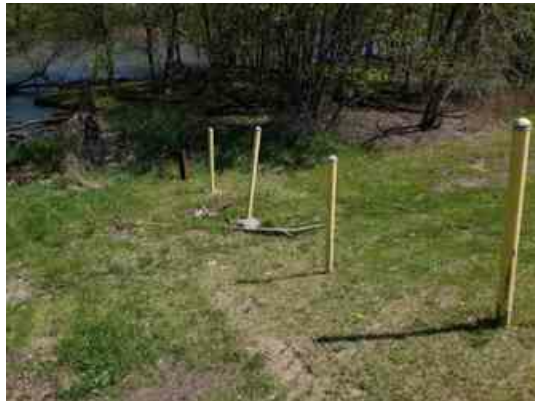
Inspect ID: 2021-0039 **Title:** 2604000005_CELRC_2021_A_0039_1_20210430T162151.jpg **Rated Item:** 3. Encroachments **Caption:** Minimally Acceptable - Debris on landside slope.

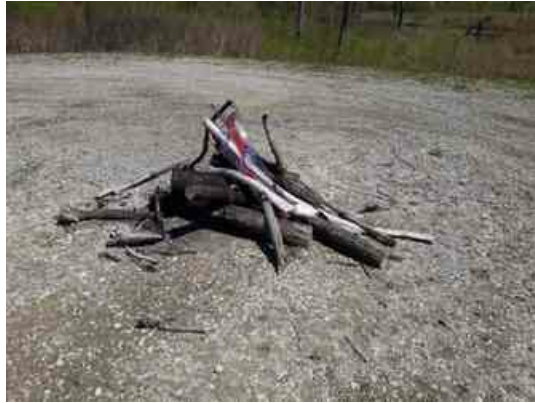
Inspect ID: 2021-0085 **Title:** 2604000005_CELRC_2021_A_0085_1_20210430T165337.jpg **Rated**
Item: 3. Encroachments **Caption:** Minimally Acceptable - Debris on crest.

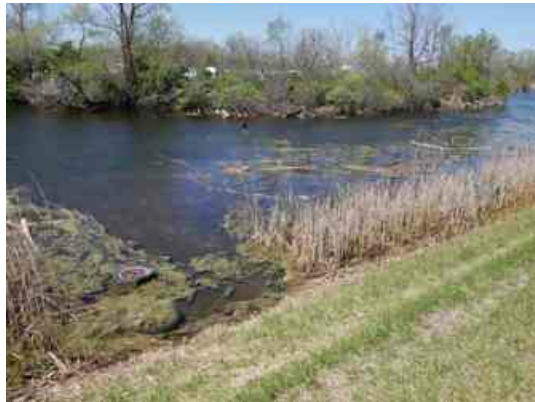
Inspect ID: 2021-0113 **Title:** 2604000005_CELRC_2021_A_0113_1_20210430T170852.jpg **Rated**
Item: 3. Encroachments **Caption:** Minimally Acceptable - Debris and drift wood at the landside toe.

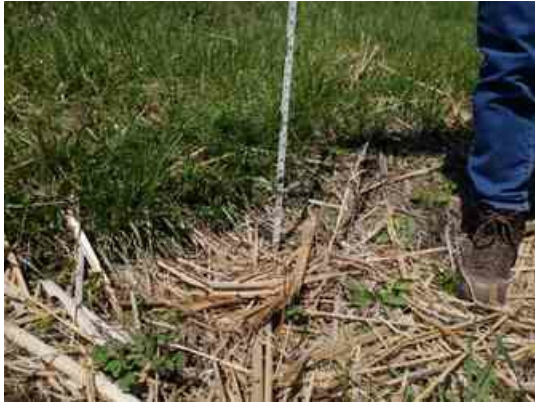
6. Erosion/ Bank Caving	M	A	No erosion or bank caving is observed on the landward or riverward sides of the levee that might endanger its stability.	2021-0127 : Minor erosion on riverside toe, 6" scarp. (M)
		M	There are areas where minor erosion is occurring or has occurred on or near the levee embankment, but levee integrity is not threatened.	
		U	Erosion or caving is occurring or has occurred that threatens the stability and integrity of the levee. The erosion or caving has progressed into the levee section or into the extended footprint of the levee foundation and has compromised the levee foundation stability.

<p>Inspect ID: 2021-0127 Title: 2604000005_CELRC_2021_A_0127_1_20210430T171620.jpg Rated Item: 6. Erosion/ Bank Caving Caption: Minimally Acceptable - Minor erosion on riverside toe, 6" scarp.</p>

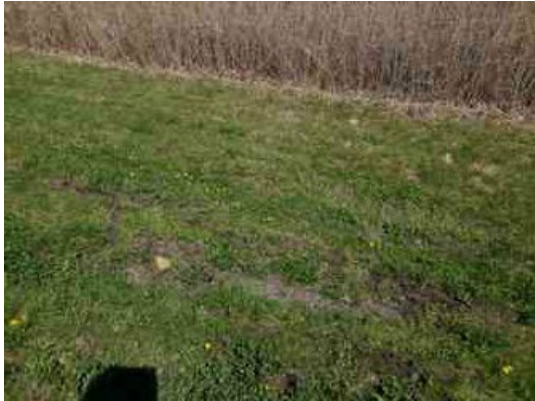
<p>Inspect ID: 2021-0005 Title: 2604000005_CELRC_2021_A_0005_1_20210430T154612.jpg Rated Item: 8. Depressions/ Rutting Caption: Acceptable - Rutting on riverside slope.</p>

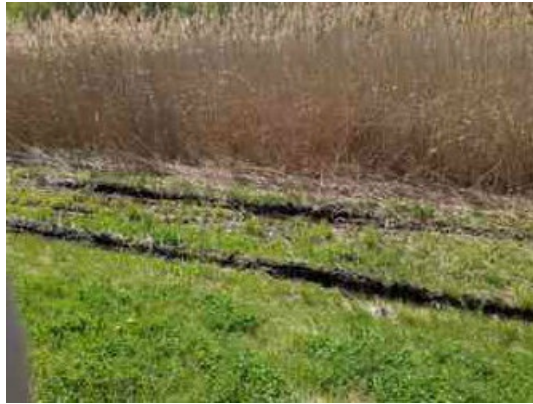
Inspect ID: 2021-0007 **Title:** 2604000005_CELRC_2021_A_0007_1_20210430T154716.jpg **Rated Item:** 8. Depressions/ Rutting **Caption:** Minimally Acceptable - Deep ruts on landside toe.

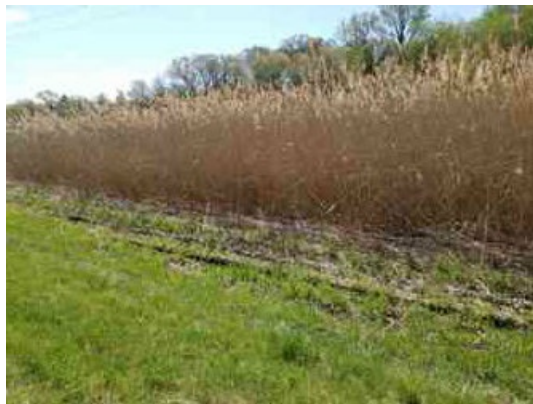
Inspect ID: 2021-0009 **Title:** 2604000005_CELRC_2021_A_0009_1_20210430T155147.jpg **Rated Item:** 8. Depressions/ Rutting **Caption:** Minimally Acceptable - Rutting on landside toe.

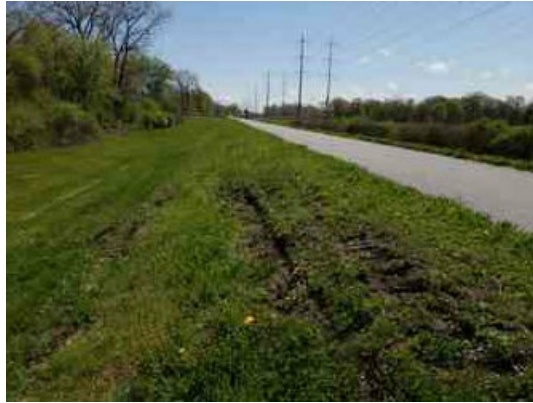
Inspect ID: 2021-0015 **Title:** 2604000005_CELRC_2021_A_0015_1_20210430T155740.jpg **Rated Item:** 8. Depressions/ Rutting **Caption:** Acceptable - Rutting on riverside slope.

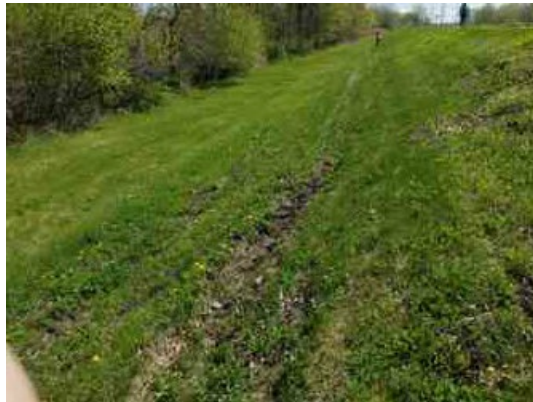
Inspect ID: 2021-0021 **Title:** 2604000005_CELRC_2021_A_0021_1_20210430T160723.jpg **Rated Item:** 8. Depressions/ Rutting **Caption:** Minimally Acceptable - Deep rutting on riverside slope.

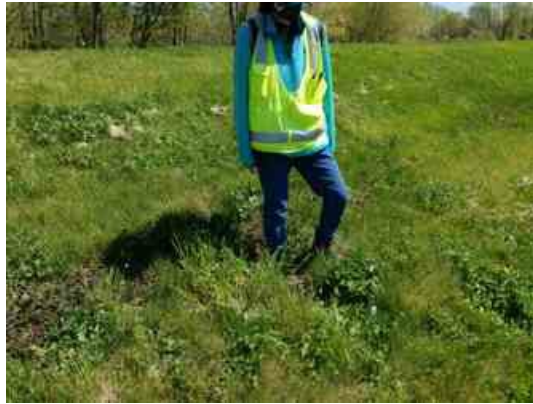
Inspect ID: 2021-0025 **Title:** 2604000005_CELRC_2021_A_0025_1_20210430T161109.jpg **Rated Item:** 8. Depressions/ Rutting **Caption:** Minimally Acceptable - Depression on landside slope.

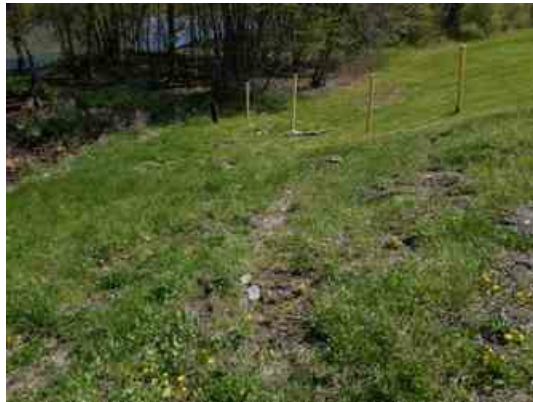
Inspect ID: 2021-0031 **Title:** 2604000005_CELRC_2021_A_0031_1_20210430T161824.jpg **Rated Item:** 8. Depressions/ Rutting **Caption:** Minimally Acceptable - Deep rutting on riverside slope.

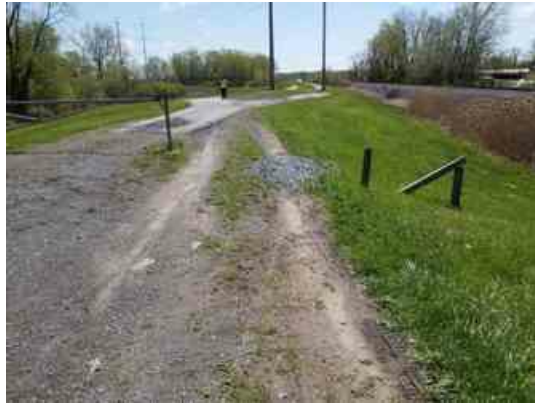
Inspect ID: 2021-0035 **Title:** 2604000005_CELRC_2021_A_0035_1_20210430T162021.jpg **Rated Item:** 8. Depressions/ Rutting **Caption:** Minimally Acceptable - Deep rutting on landside crest.

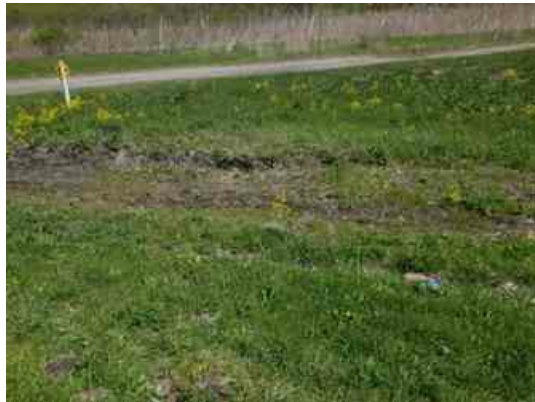
Inspect ID: 2021-0049 **Title:** 2604000005_CELRC_2021_A_0049_1_20210430T163319.jpg **Rated Item:** 8. Depressions/ Rutting **Caption:** Minimally Acceptable - Deep ruts on riverside toe.

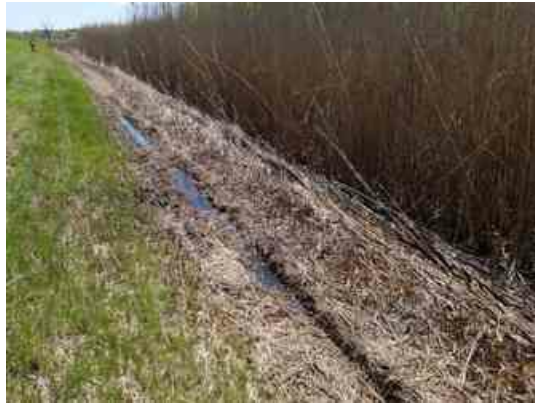
Inspect ID: 2021-0059 **Title:** 2604000005_CELRC_2021_A_0059_1_20210430T163912.jpg **Rated Item:** 8. Depressions/ Rutting **Caption:** Minimally Acceptable - Deep ruts and ponding on landside toe.

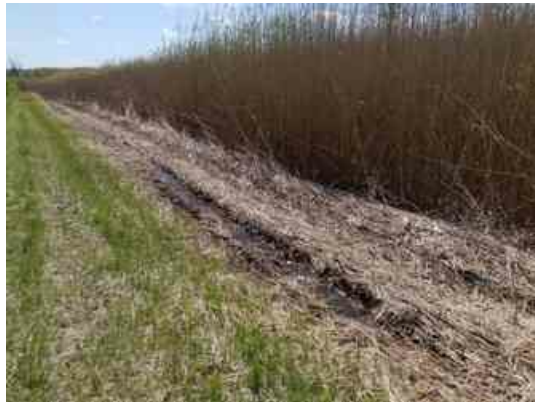
Inspect ID: 2021-0063 **Title:** 2604000005_CELRC_2021_A_0063_1_20210430T164129.jpg **Rated Item:** 8. Depressions/ Rutting **Caption:** Minimally Acceptable - Rutting and ponding alongside the landside toe.

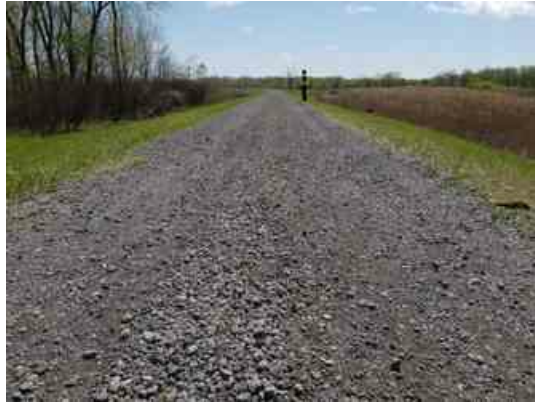
Inspect ID: 2021-0067 **Title:** 2604000005_CELRC_2021_A_0067_1_20210430T164355.jpg **Rated Item:** 8. Depressions/ Rutting **Caption:** Acceptable - Minor rutting on crest of levee.

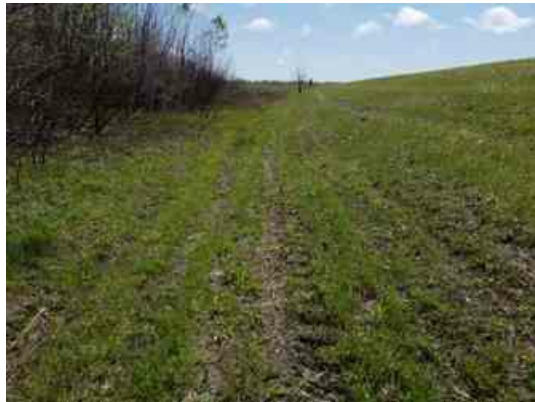
Inspect ID: 2021-0079 **Title:** 2604000005_CELRC_2021_A_0079_1_20210430T165009.jpg **Rated Item:** 8. Depressions/ Rutting **Caption:** Minimally Acceptable - Rutting alongside the riverside toe.

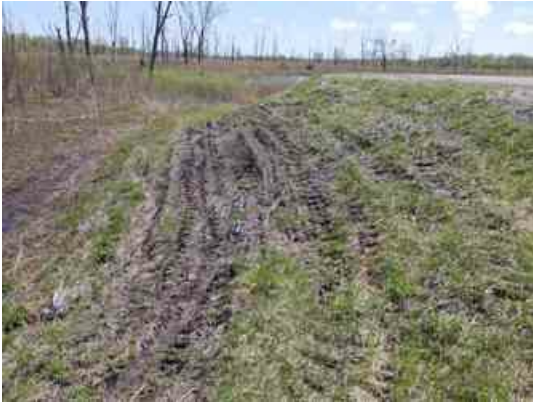
<p>Inspect ID: 2021-0083 Title: 2604000005_CELRC_2021_A_0083_1_20210430T165209.jpg Rated Item: 8. Depressions/ Rutting Caption: Minimally Acceptable - Multiple ruts on riverside slope.</p>

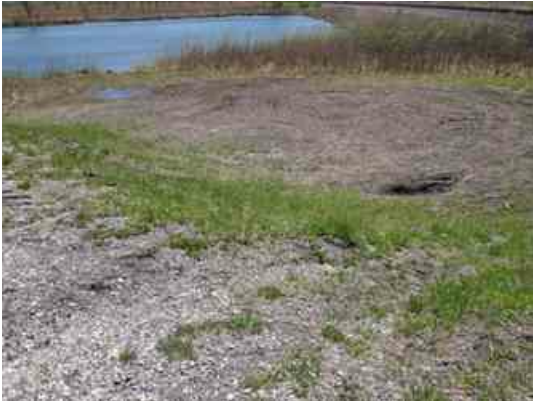
<p>Inspect ID: 2021-0087 Title: 2604000005_CELRC_2021_A_0087_1_20210430T165437.jpg Rated Item: 8. Depressions/ Rutting Caption: Minimally Acceptable - Deep ruts on riverside slope.</p>

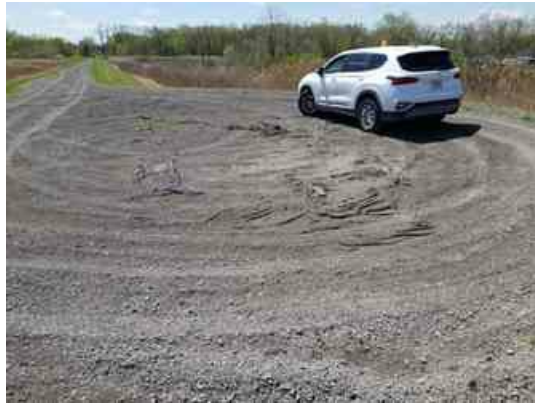
Inspect ID: 2021-0101 **Title:** 2604000005_CELRC_2021_A_0101_1_20210430T170305.jpg **Rated Item:** 8. Depressions/ Rutting **Caption:** Minimally Acceptable - Rutting on the crest.

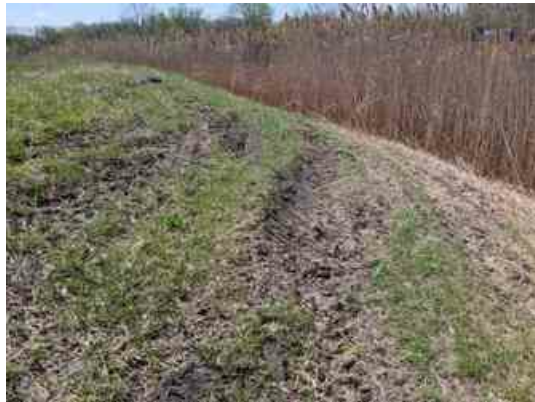
Inspect ID: 2021-0105 **Title:** 2604000005_CELRC_2021_A_0105_1_20210430T170427.jpg **Rated Item:** 8. Depressions/ Rutting **Caption:** Minimally Acceptable - Rutting on landside slope.

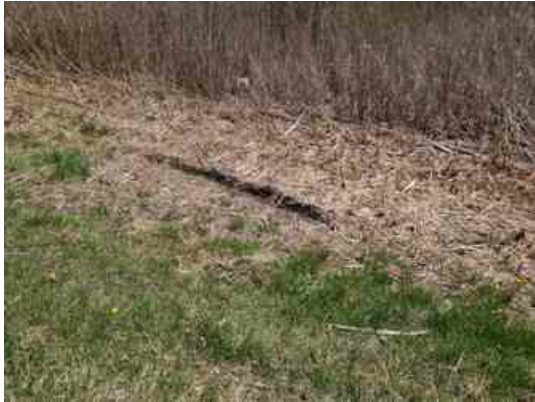
Inspect ID: 2021-0107 Title: 2604000005_CELRC_2021_A_0107_1_20210430T170512.jpg Rated Item: 8. Depressions/ Rutting Caption: Minimally Acceptable - Deep rut and ponding on riverside toe.

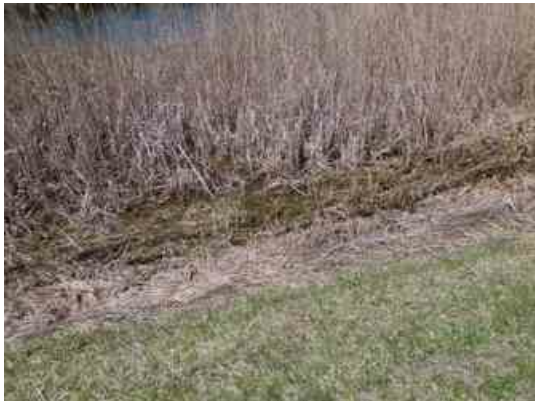
Inspect ID: 2021-0109 Title: 2604000005_CELRC_2021_A_0109_1_20210430T170614.jpg Rated Item: 8. Depressions/ Rutting Caption: Minimally Acceptable - Deep ruts and ponding on landside toe.

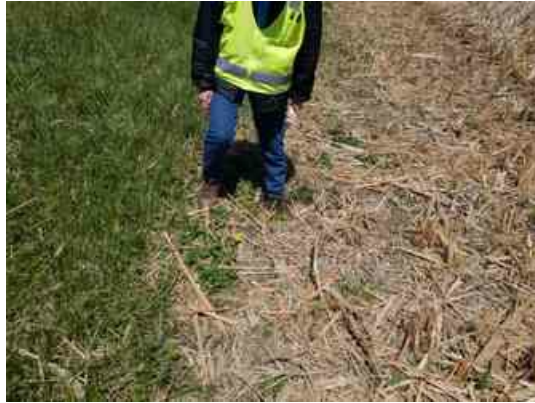
Inspect ID: 2021-0121 **Title:** 2604000005_CELRC_2021_A_0121_1_20210430T171341.jpg **Rated Item:** 8. Depressions/ Rutting **Caption:** Minimally Acceptable - Depression on riverside slope and toe.

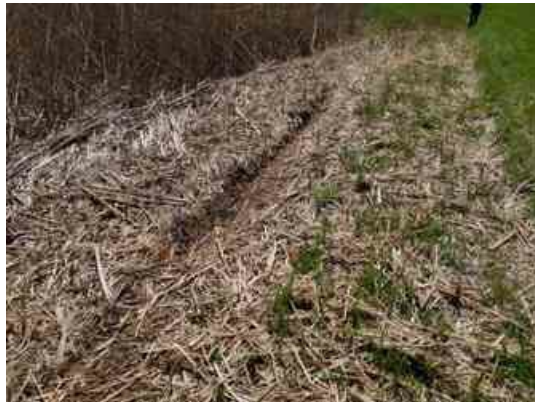
Inspect ID: 2021-0129 **Title:** 2604000005_CELRC_2021_A_0129_1_20210430T171705.jpg **Rated Item:** 8. Depressions/ Rutting **Caption:** Minimally Acceptable - Deep ruts and ponding on riverside toe.

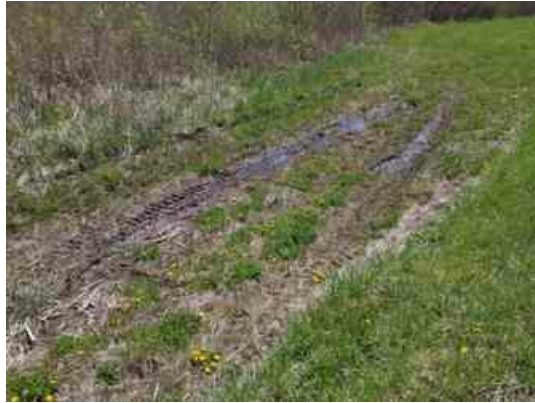
Inspect ID: 2021-0131 **Title:** 2604000005_CELRC_2021_A_0131_1_20210430T171743.jpg **Rated Item:** 8. Depressions/ Rutting **Caption:** Minimally Acceptable - Deep ruts and ponding on riverside toe.

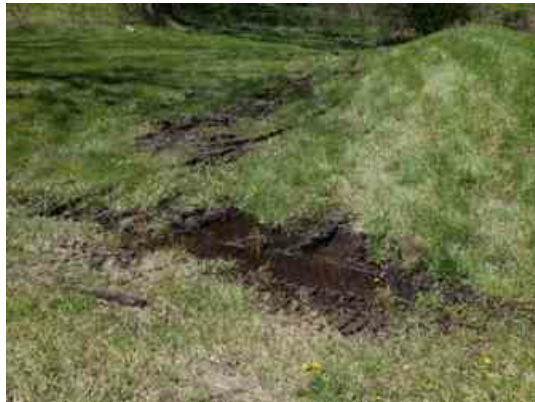
Inspect ID: 2021-0135 **Title:** 2604000005_CELRC_2021_A_0135_1_20210430T172025.jpg **Rated Item:** 8. Depressions/ Rutting **Caption:** Minimally Acceptable - Deep ruts and ponding on landside toe.

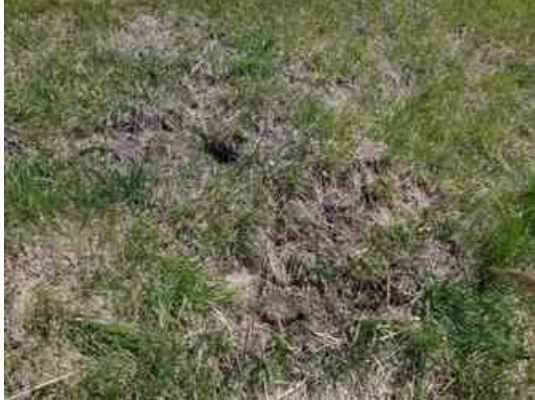
<p>Inspect ID: 2021-0075 Title: 2604000005_CELRC_2021_A_0075_1_20210430T164813.jpg Rated Item: 10. Animal Control Caption: Acceptable - Collapsed animal burrow on landside slope.</p>

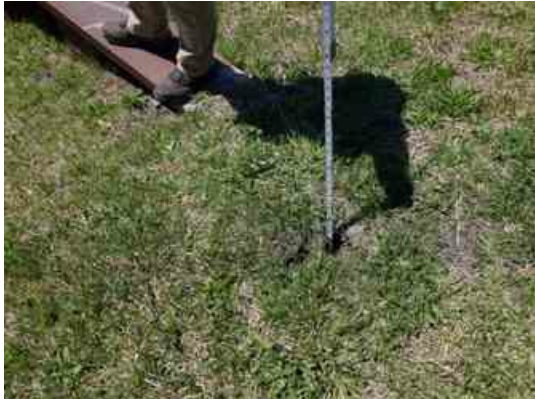
<p>Inspect ID: 2021-0089 Title: 2604000005_CELRC_2021_A_0089_1_20210430T165552.jpg Rated Item: 10. Animal Control Caption: Acceptable - Animal burrow, 6" deep, on crest.</p>

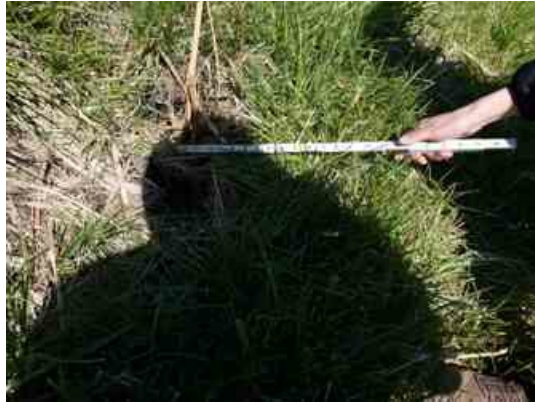
Inspect ID: 2021-0117 **Title:** 2604000005_CELRC_2021_A_0117_1_20210430T171051.jpg **Rated Item:** 10. Animal Control **Caption:** Minimally Acceptable - Animal burrow, 1.5 ft deep, on riverside toe and slope.

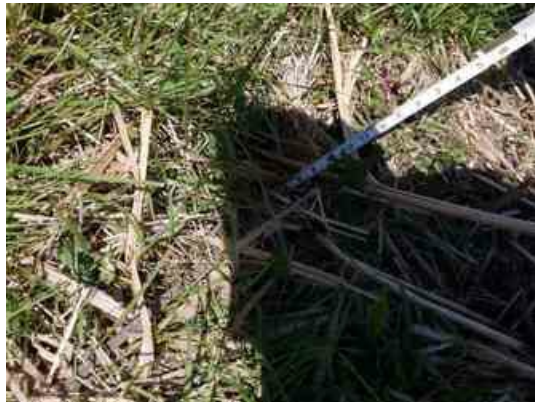
Inspect ID: 2021-0119 **Title:** 2604000005_CELRC_2021_A_0119_1_20210430T171228.jpg **Rated Item:** 10. Animal Control **Caption:** Minimally Acceptable - Collapsed and non collapsed animal burrows on riverside slope.

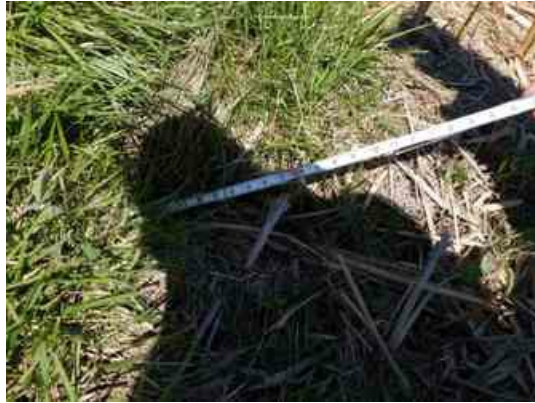
Inspect ID: 2021-0123 **Title:** 2604000005_CELRC_2021_A_0123_1_20210430T171420.jpg **Rated Item:** 10. Animal Control **Caption:** Minimally Acceptable - Animal burrow 10" deep on riverside toe.

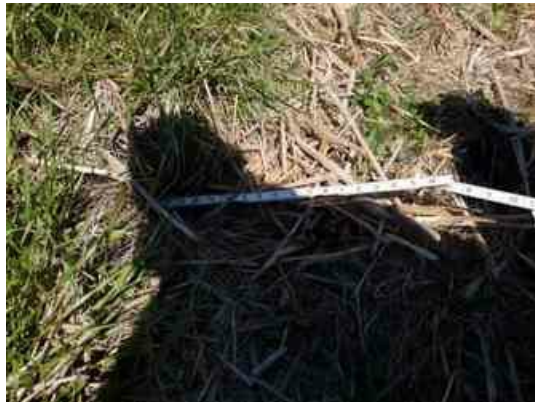
Inspect ID: 2021-0125 **Title:** 2604000005_CELRC_2021_A_0125_1_20210430T171520.jpg **Rated Item:** 10. Animal Control **Caption:** Minimally Acceptable - Animal burrow 14 inches deep on riverside toe.

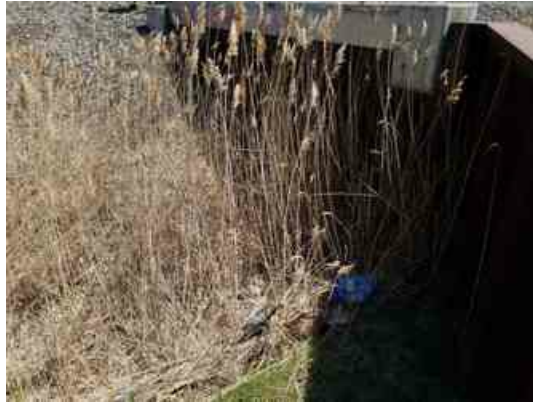
Inspect ID: 2021-0029 **Title:** 2604000005_CELRC_2021_A_0029_1_20210430T161458.jpg **Rated Item:** 1. Unwanted Vegetation Growth **Caption:** Acceptable - Vegetation on riverside.

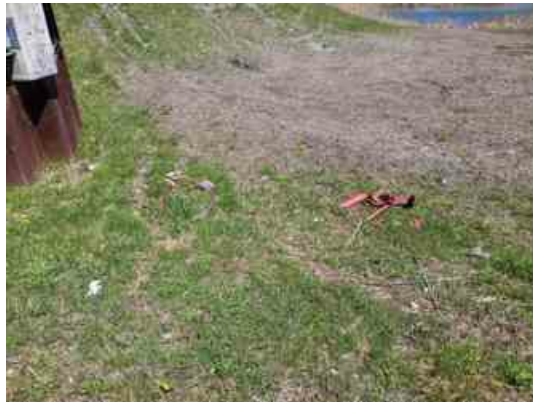
Inspect ID: 2021-0095 **Title:** 2604000005_CELRC_2021_A_0095_1_20210430T165958.jpg **Rated Item:** 2. Encroachments **Caption:** Minimally Acceptable - Debris on riverside of the flood wall.

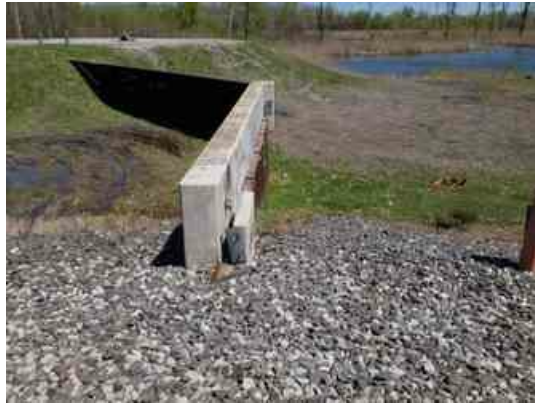
Inspect ID: 2021-0097 **Title:** 2604000005_CELRC_2021_A_0097_1_20210430T170100.jpg **Rated Item:** 3. Closure Structures (Stop Log Closures and Gates) (A or U only) **Caption:** Acceptable - Missing slide gate in storage at RR East.

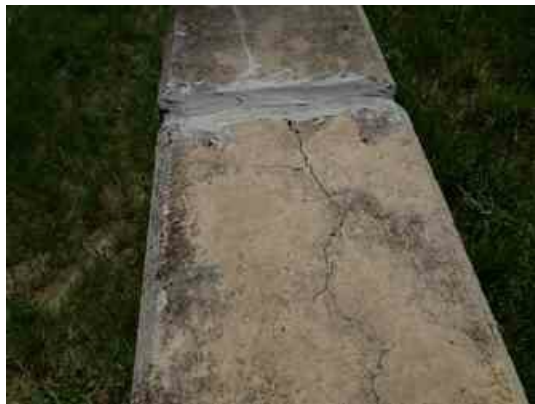
4. Concrete Surfaces	M	A	Negligible spalling, scaling or cracking. If the concrete surface is weathered or holds moisture, it is still satisfactory but should be seal coated to prevent freeze/ thaw damage.	2021-0041 : Cracking on top of floodwall leading to monolith joint. Seal. (M) 2021-0043 : Beginning signs of spalling on landside face. Monitor. (A) 2021-0047 : Cracking spanning the height of the wall on riverside face. Monitor. (A)
		M	Spalling, scaling, and open cracking present, but the immediate integrity or performance of the structure is not threatened. Reinforcing steel may be exposed. Repairs/ sealing is necessary to prevent additional damage during periods of thawing and freezing.	
		U	Surface deterioration or deep cracks present that may result in an unreliable structure. Any surface deterioration that exposes the sheet piling or lies adjacent to monolith joints may indicate underlying reinforcement corrosion and is unacceptable.

Inspect ID: 2021-0041 **Title:** 2604000005_CELRC_2021_A_0041_1_20210430T162343.jpg **Rated Item:** 4. Concrete Surfaces **Caption:** Minimally Acceptable - Cracking on top of floodwall leading to monolith joint. Seal.

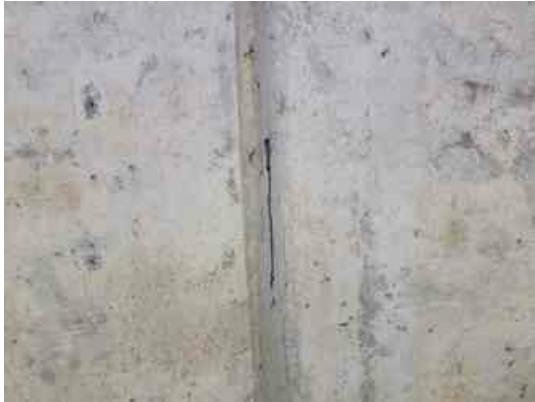
7. Monolith Joints	M	A	The joint material is in good condition. The exterior joint sealant is intact and cracking/ desiccation is minimal. Joint filler material and/or waterstop is not visible at any point.	2021-0045 : Crack in monolith joint sealant exposing filler material underneath. Repair. (M) 2021-0093 : Riverside joint sealant coming out of interlocks. (M) 2021-0099 : Riverside sealant coming out of interlocks. (M)
		M	The joint material has appreciable deterioration to the point where joint filler material and/or waterstop is visible in some locations. This needs to be repaired or replaced to prevent spalling and cracking during freeze/ thaw cycles, and to ensure water tightness of the joint.	
		U	The joint material is severely deteriorated or the concrete adjacent to the monolith joints has spalled and cracked, damaging the waterstop; in either case damage has occurred to the point where it is apparent that the joint is no longer watertight and will not provide the intended level of protection during a flood.

Inspect ID: 2021-0045 Title: 2604000005_CELRC_2021_A_0045_1_20210430T162857.jpg Rated Item: 7. Monolith Joints Caption: Minimally Acceptable - Crack in monolith joint sealant exposing filler material underneath. Repair.

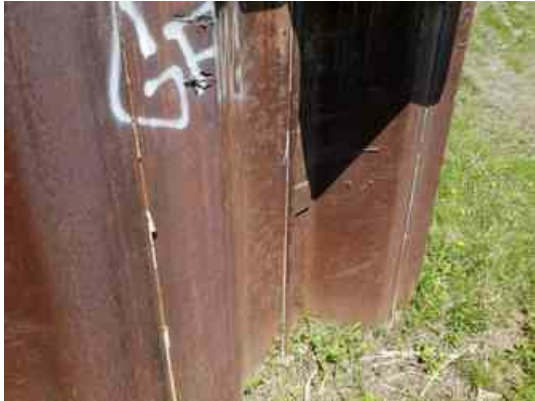
Inspect ID: 2021-0093 Title: 2604000005_CELRC_2021_A_0093_1_20210430T165909.jpg Rated Item: 7. Monolith Joints Caption: Minimally Acceptable - Riverside joint sealant coming out of interlocks.

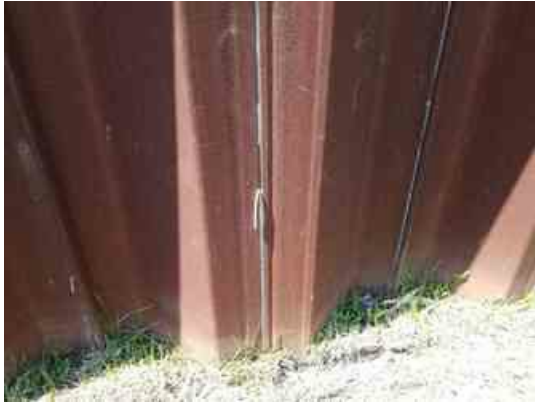
Inspect ID: 2021-0099 Title: 2604000005_CELRC_2021_A_0099_1_20210430T170212.jpg Rated Item: 7. Monolith Joints Caption: Minimally Acceptable - Riverside sealant coming out of interlocks.

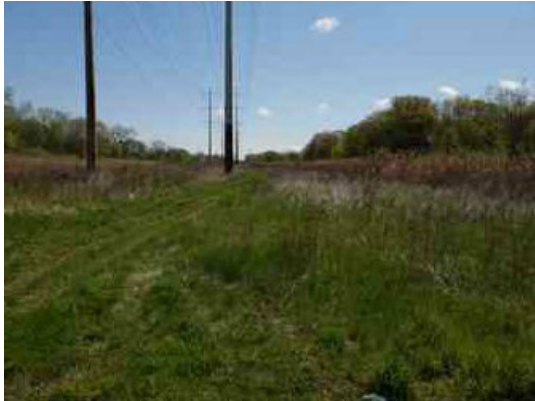
Inspect ID: 2021-0003 Title: 2604000005_CELRC_2021_A_0003_1_20210430T154346.jpg Rated Item: 1. Vegetation and Obstructions Caption: Minimally Acceptable - Small trees and tall vegetation in south ditch.

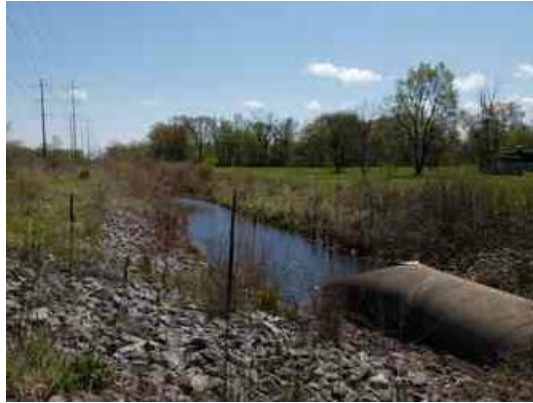
Inspect ID: 2021-0019 **Title:** 2604000005_CELRC_2021_A_0019_1_20210430T160334.jpg **Rated Item:** 1. Vegetation and Obstructions **Caption:** Acceptable - Small trees and vegetation in ditch

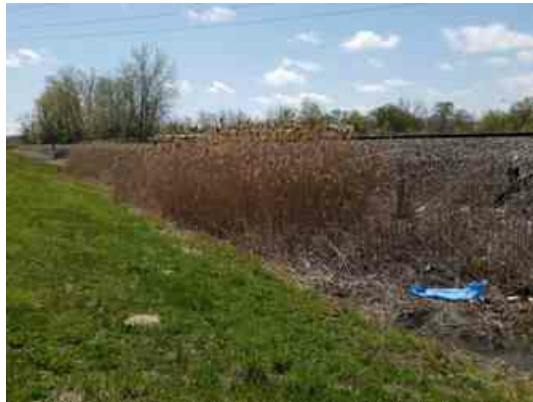
Inspect ID: 2021-0037 **Title:** 2604000005_CELRC_2021_A_0037_1_20210430T162104.jpg **Rated Item:** 1. Vegetation and Obstructions **Caption:** Minimally Acceptable - Tall vegetation in the ditch.

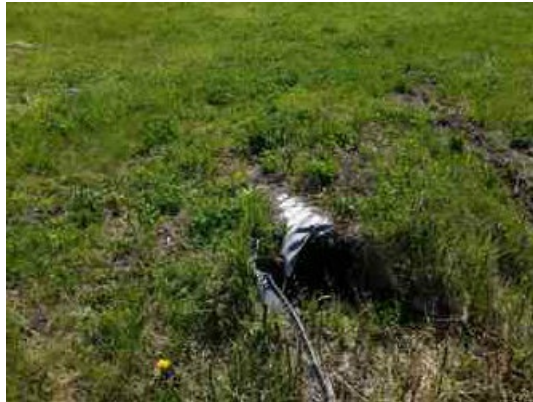
Inspect ID: 2021-0017 **Title:** 2604000005_CELRC_2021_A_0017_1_20210430T160058.jpg **Rated Item:** 9. Culverts/ Discharge Pipes **Caption:** Minimally Acceptable - Damaged CMP

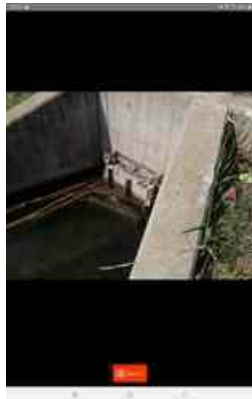
Inspect ID: 2021-0004 **Title:** 2604000005_CELRC_2021_A_0004_1_20210427T151346.jpg **Rated Item:** 11. Flap Gates/ Flap Valves/ Pinch Valves **Caption:** Minimally Acceptable - GB-4: There is a large amount of debris blocking the flap gate and a hearty amount of trash in the general area.

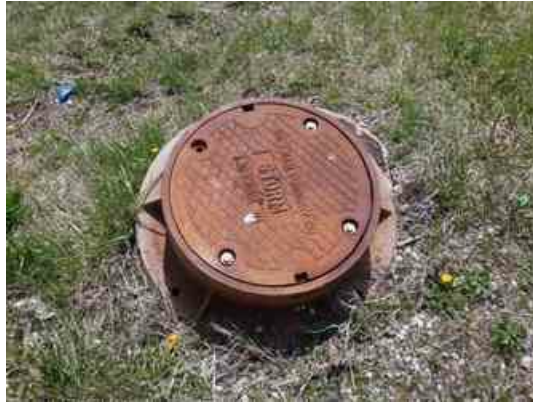
Inspect ID: 2021-0002 **Title:** 2604000005_CELRC_2021_A_0002_1_20210427T150402.jpg **Rated Item:** 13. Other Metallic Items **Caption:** Acceptable - The manhole cover was replaced since the last inspection.

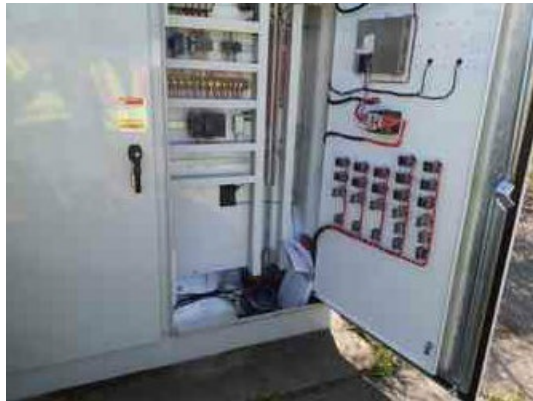
Inspect ID: 2021-0024 **Title:** 2604000005_CELRC_2021_A_0024_1_20210430T142738.jpg **Rated Item:** 2. Pump Station Operations and Maintenance Equipment Manuals **Caption:** Acceptable - PS-BS: Manuals present on site.

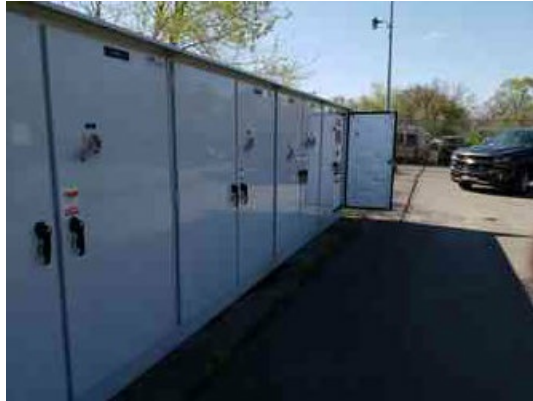
Inspect ID: 2021-0020 **Title:** 2604000005_CELRC_2021_A_0020_1_20210430T142553.jpg **Rated Item:** 3. Safety Compliance **Caption:** Acceptable - PS-BS: Arc flash labels present.

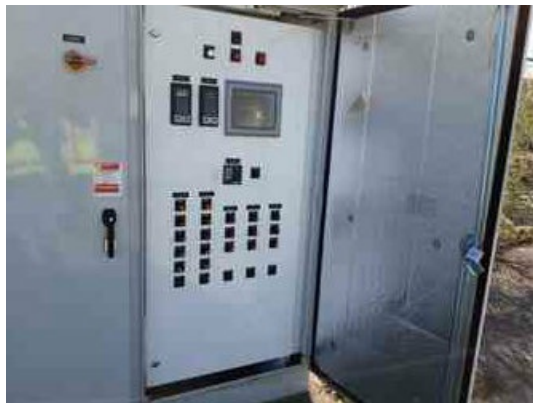
Inspect ID: 2021-0022 **Title:** 2604000005_CELRC_2021_A_0022_1_20210430T142701.jpg **Rated Item:** 4. Communications (A or M only) **Caption:** Acceptable - PS-BS: Communication present and working.

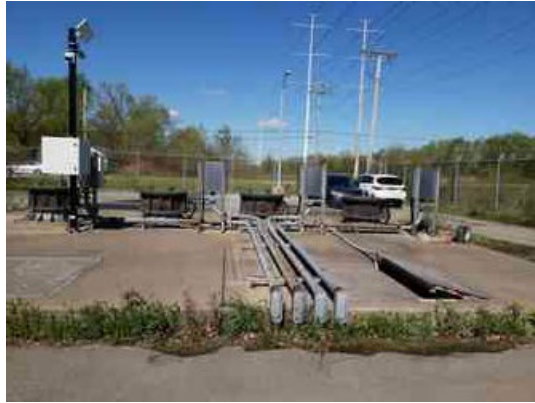
Inspect ID: 2021-0026 **Title:** 2604000005_CELRC_2021_A_0026_1_20210430T142833.jpg **Rated Item:** 5. Plant Building **Caption:** Acceptable - PS-BS: No issues.

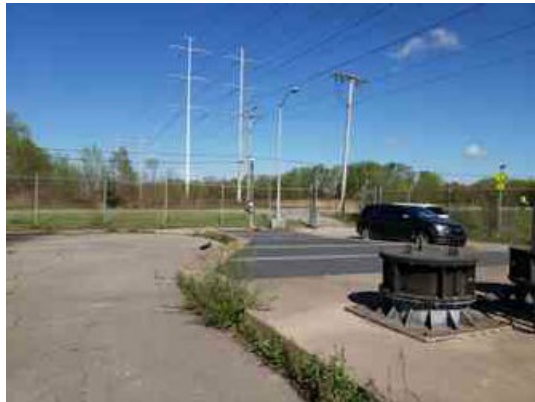
Inspect ID: 2021-0006 **Title:** 2604000005_CELRC_2021_A_0006_1_20210430T141828.jpg **Rated Item:** 6. Fencing and Gates **Caption:** Acceptable - PS-BS: Fence in good condition.

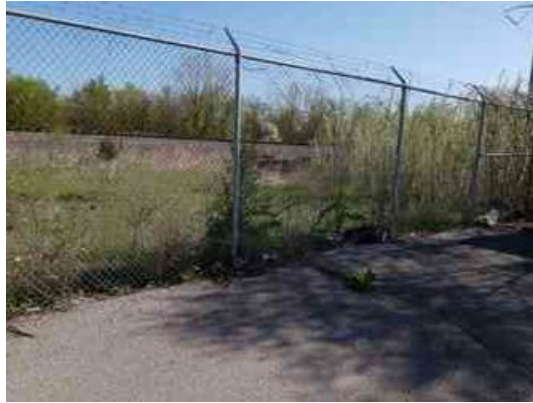
Inspect ID: 2021-0018 **Title:** 2604000005_CELRC_2021_A_0018_1_20210430T142442.jpg **Rated Item:** 6. Fencing and Gates **Caption:** Minimally Acceptable - PS-BS: Fence eroding away.

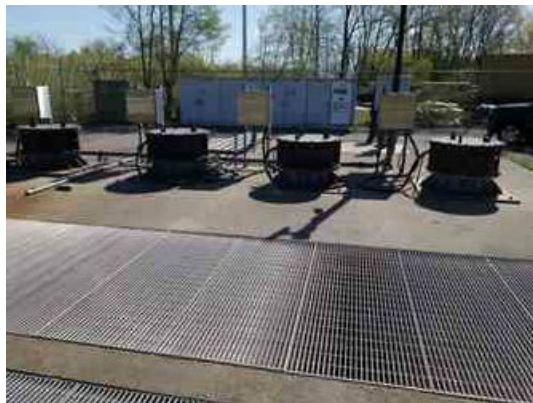
Inspect ID: 2021-0012 **Title:** 2604000005_CELRC_2021_A_0012_1_20210430T142141.jpg **Rated Item:** 7. Pumps **Caption:** Acceptable - PS-BS: Pumps were bumped and working.

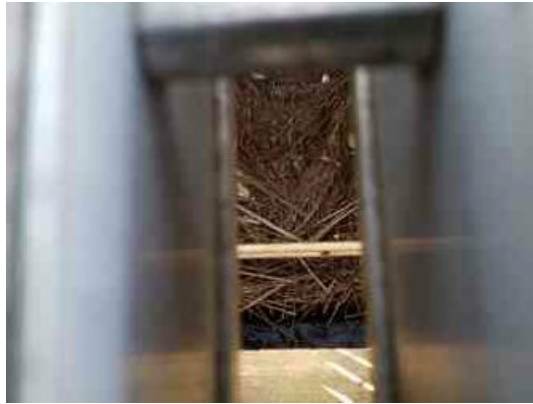
Inspect ID: 2021-0010 **Title:** 2604000005_CELRC_2021_A_0010_1_20210430T142053.jpg **Rated Item:** 9. Sumps/ Wet well **Caption:** Minimally Acceptable - PS-BS: Lots of debris in well.

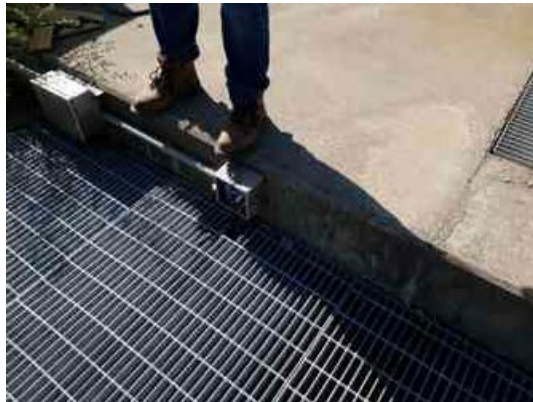
Inspect ID: 2021-0014 **Title:** 2604000005_CELRC_2021_A_0014_1_20210430T142241.jpg **Rated Item:** 16. Enclosures, Panels, Conduit and Ducts **Caption:** Minimally Acceptable - PS-BS: Missing covers on box.

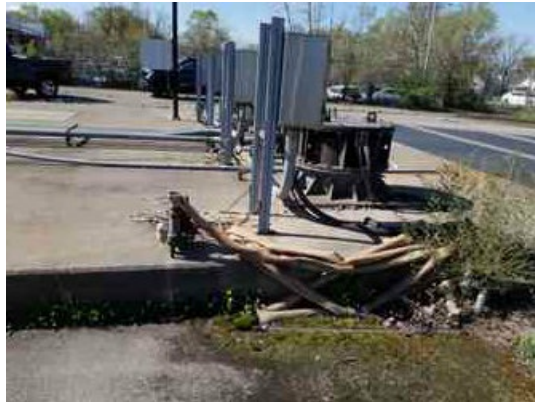
Inspect ID: 2021-0016 **Title:**
2604000005_CELRC_2021_A_0016_1_20210430T142347.jpg **Rated**
Item: 16. Enclosures, Panels, Conduit and Ducts **Caption:** Acceptable -
PS-BS: Conduits and panel good but lots of debris.
