Levee Inspection Report

Name of System: Burr Street

Name of Segment: Griffith River Road Levee

Date(s) of Inspection: 04/30/2021 - 04/30/2021

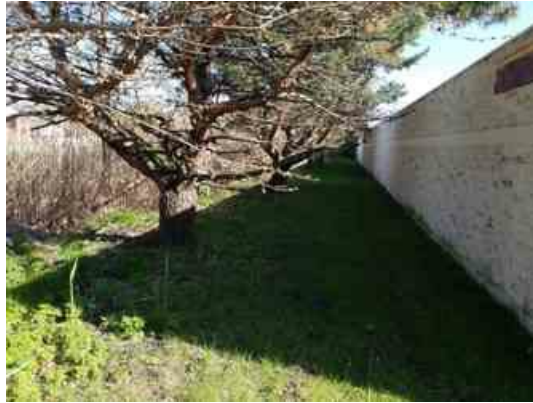
Inspect ID: 2021-0011 **Title:** 2604000014_CELRC_2021_A_0011_1_20210430T133453.jpg **Rated Item:** 1. Unwanted Vegetation Growth **Caption:** Unacceptable - Large trees on crest.

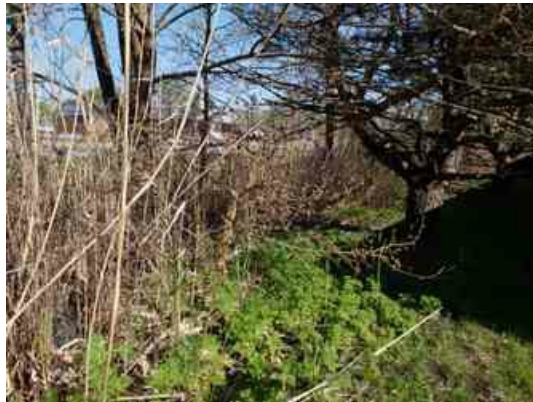
Inspect ID: 2021-0013 **Title:** 2604000014_CELRC_2021_A_0013_1_20210430T133600.jpg **Rated Item:** 1. Unwanted Vegetation Growth **Caption:** Minimally Acceptable - Vegetation and trees on riverside toe.

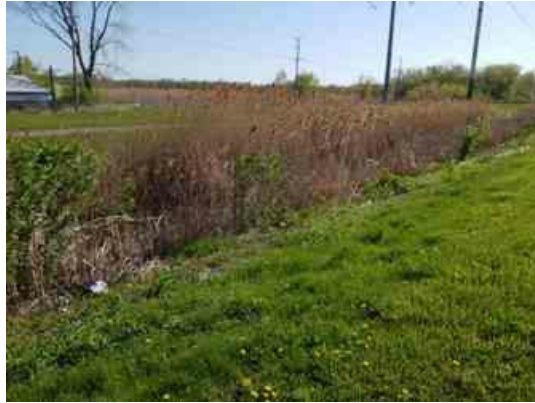
Inspect ID: 2021-0029 **Title:** 2604000014_CELRC_2021_A_0029_1_20210430T135740.jpg **Rated Item:** 1. Unwanted Vegetation Growth **Caption:** Minimally Acceptable - Small trees and vegetation on riverside toe.

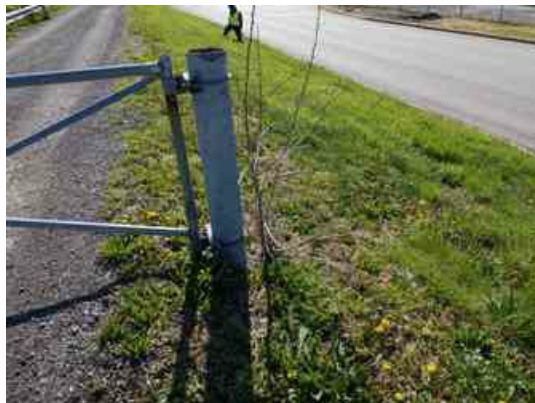
Inspect ID: 2021-0037 **Title:** 2604000014_CELRC_2021_A_0037_1_20210430T140719.jpg **Rated Item:** 1. Unwanted Vegetation Growth **Caption:** Minimally Acceptable - Small tree on landside slope.

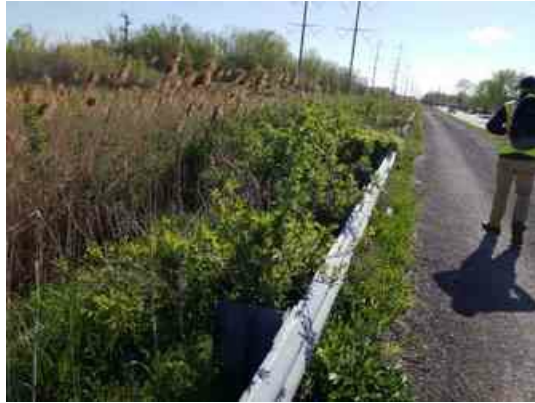
Inspect ID: 2021-0039 **Title:** 2604000014_CELRC_2021_A_0039_1_20210430T140823.jpg **Rated Item:** 1. Unwanted Vegetation Growth **Caption:** Minimally Acceptable - Tall vegetation on riverside slope.

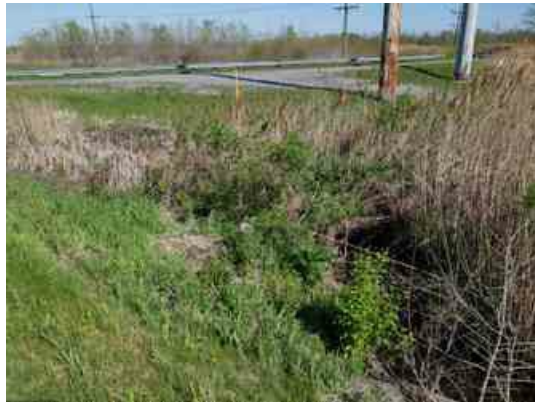
Inspect ID: 2021-0053 **Title:** 2604000014_CELRC_2021_A_0053_1_20210430T142454.jpg **Rated Item:** 1. Unwanted Vegetation Growth **Caption:** Minimally Acceptable - Small trees and tall vegetation in ditch on riverside toe.

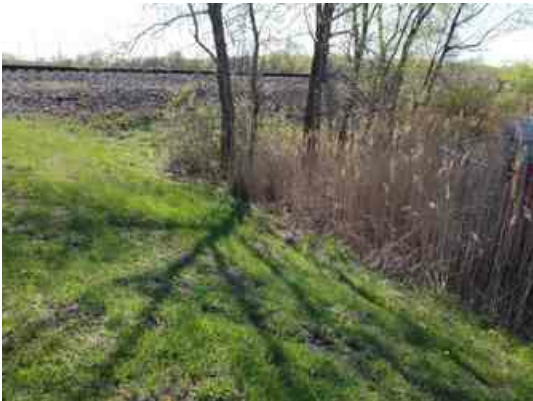
<p>Inspect ID: 2021-0080 Title: 2604000014_CELRC_2021_A_0080_1_20210430T145049.jpg Rated Item: 1. Unwanted Vegetation Growth Caption: Minimally Acceptable - Trees and tall vegetation on the landside toe.</p>

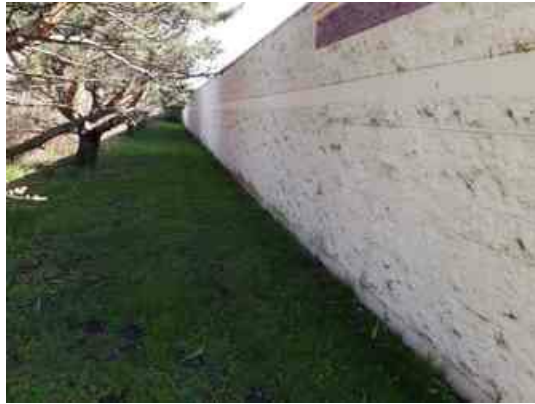
Inspect ID: 2021-0012 **Title:** 2604000014_CELRC_2021_A_0012_1_20210430T133528.jpg **Rated Item:** 3. Encroachments **Caption:** Unacceptable - Building in landside slope. Provide as-builts to evaluate the risk to the levee.

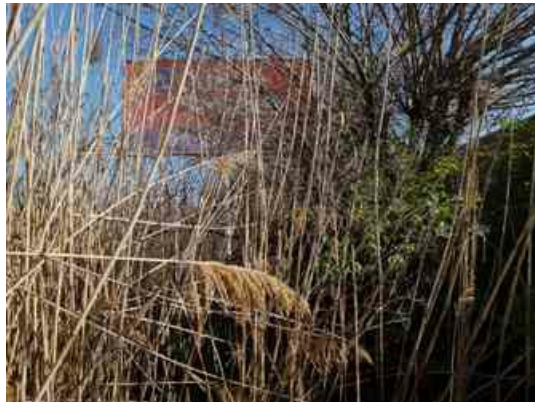
Inspect ID: 2021-0015 **Title:** 2604000014_CELRC_2021_A_0015_1_20210430T133751.jpg **Rated Item:** 3. Encroachments **Caption:** Minimally Acceptable - Sign post on crest.

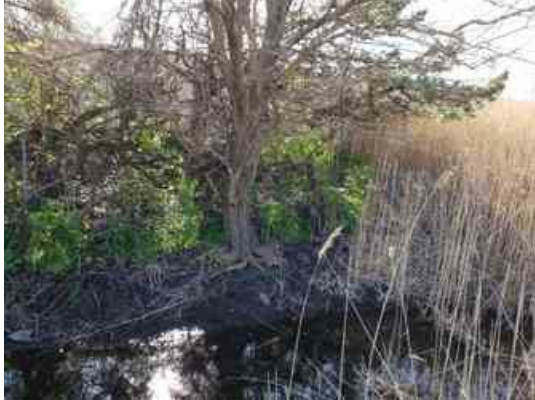
Inspect ID: 2021-0016 Title: 2604000014_CELRC_2021_A_2021-0016_2_20210430T134656.jpg Rated Item: 3. Encroachments Caption: Minimally Acceptable - Chain link fence on riverside toe.

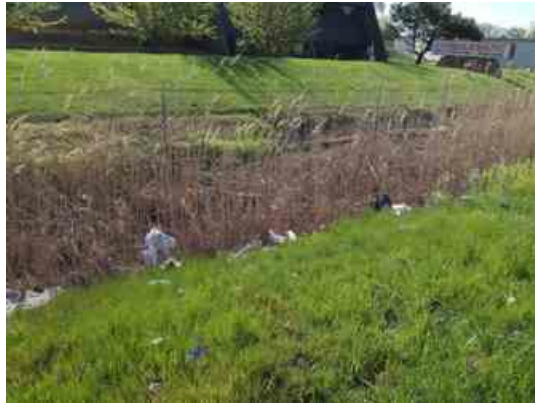
Inspect ID: 2021-0020 **Title:** 2604000014_CELRC_2021_A_0020_1_20210430T134948.jpg **Rated Item:** 3. Encroachments **Caption:** Minimally Acceptable - Trash on riverside toe.

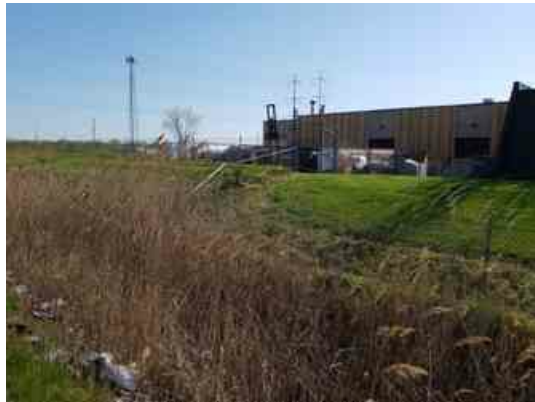
Inspect ID: 2021-0021 **Title:** 2604000014_CELRC_2021_A_0021_1_20210430T135025.jpg **Rated Item:** 3. Encroachments **Caption:** Minimally Acceptable - Fence across levee crest and slopes.

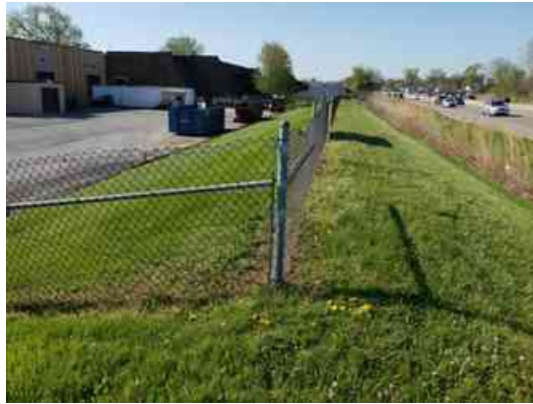
Inspect ID: 2021-0025 **Title:** 2604000014_CELRC_2021_A_0025_1_20210430T135409.jpg **Rated Item:** 3. Encroachments **Caption:** Minimally Acceptable - Fence on crest and landside slope.

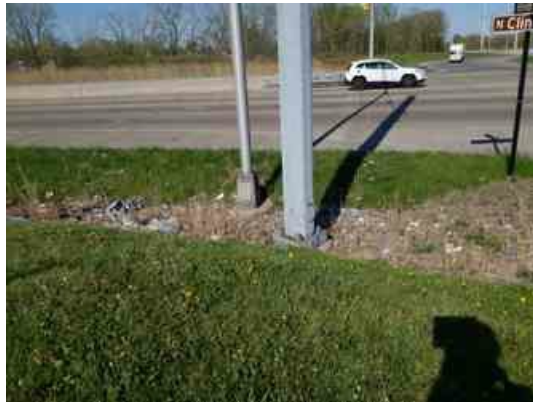
Inspect ID: 2021-0026 **Title:** 2604000014_CELRC_2021_A_0026_1_20210430T135445.jpg **Rated Item:** 3. Encroachments **Caption:** Acceptable - 2 poles on riverside toe. Installed by the owner.

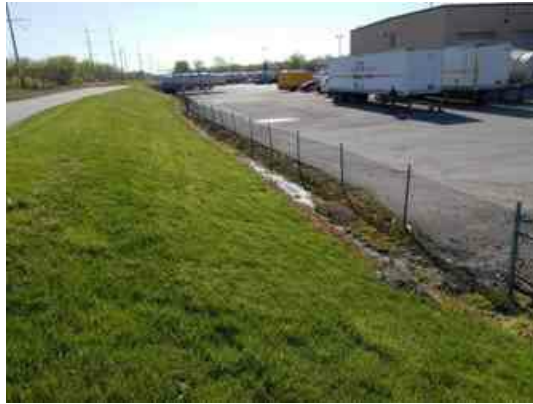
Inspect ID: 2021-0027 **Title:** 2604000014_CELRC_2021_A_0027_1_20210430T135513.jpg **Rated Item:** 3. Encroachments **Caption:** Minimally Acceptable - Fence on landside toe.

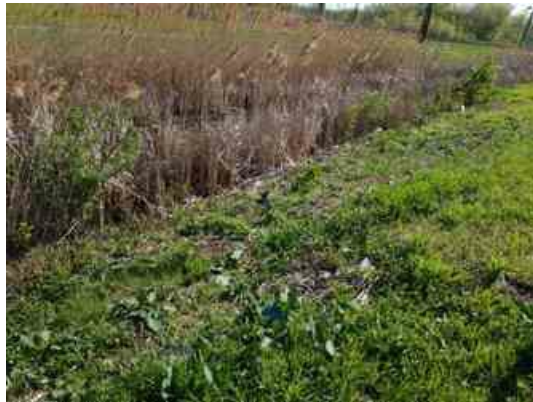
Inspect ID: 2021-0030 **Title:** 2604000014_CELRC_2021_A_0030_1_20210430T135851.jpg **Rated Item:** 3. Encroachments **Caption:** Minimally Acceptable - Area with trash on riverside slope.

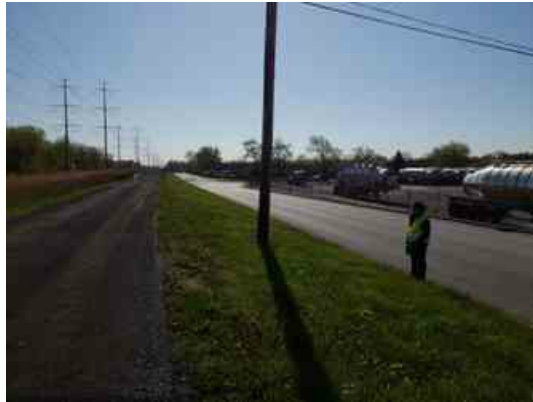
Inspect ID: 2021-0032 **Title:** 2604000014_CELRC_2021_A_0032_1_20210430T140102.jpg **Rated Item:** 3. Encroachments **Caption:** Acceptable - Pole on landside slope. Installed by owner.

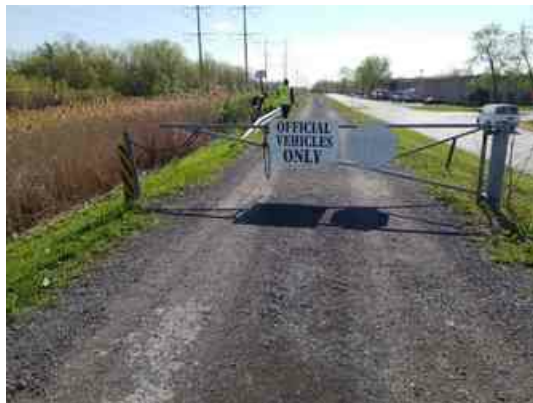
Inspect ID: 2021-0036 **Title:** 2604000014_CELRC_2021_A_0036_1_20210430T140635.jpg **Rated Item:** 3. Encroachments **Caption:** Acceptable - Gate on crest. Installed by owner.

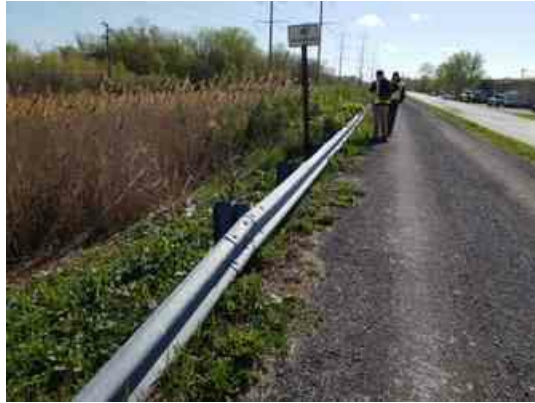
Inspect ID: 2021-0038 **Title:** 2604000014_CELRC_2021_A_0038_1_20210430T140746.jpg **Rated Item:** 3. Encroachments **Caption:** Acceptable - Guardrail on riverside slope. Installed by owner.

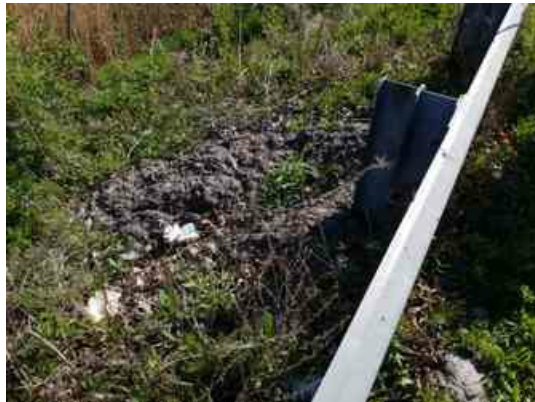
Inspect ID: 2021-0043 **Title:** 2604000014_CELRC_2021_A_0043_1_20210430T141453.jpg **Rated Item:** 3. Encroachments **Caption:** Minimally Acceptable - Dumped soil on riverside slope.

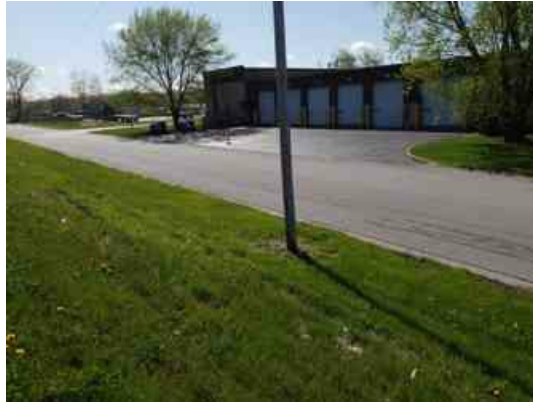
Inspect ID: 2021-0054 **Title:** 2604000014_CELRC_2021_A_0054_1_20210430T142555.jpg **Rated Item:** 3. Encroachments **Caption:** Acceptable - Pole on landside toe. Installed by owner.

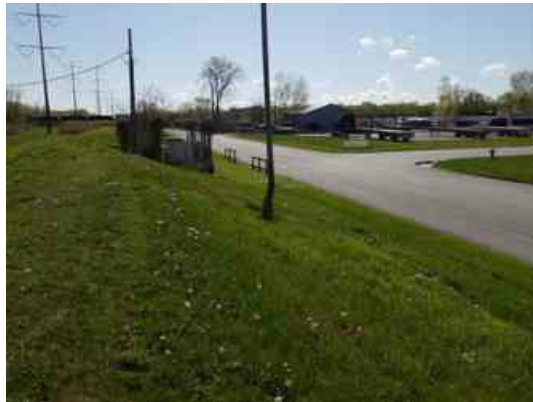
Inspect ID: 2021-0056 **Title:** 2604000014_CELRC_2021_A_0055_1_20210430T142634.jpg **Rated Item:** 3. Encroachments **Caption:** Acceptable - Pole on landside toe. Installed by owner.

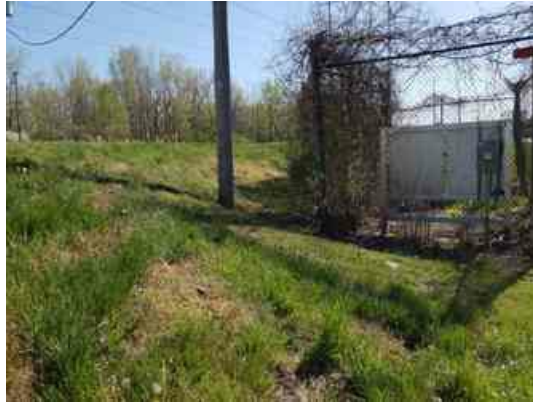
Inspect ID: 2021-0057 **Title:** 2604000014_CELRC_2021_A_0057_1_20210430T142723.jpg **Rated Item:** 3. Encroachments **Caption:** Acceptable - Pole on landside slope. Installed by owner.

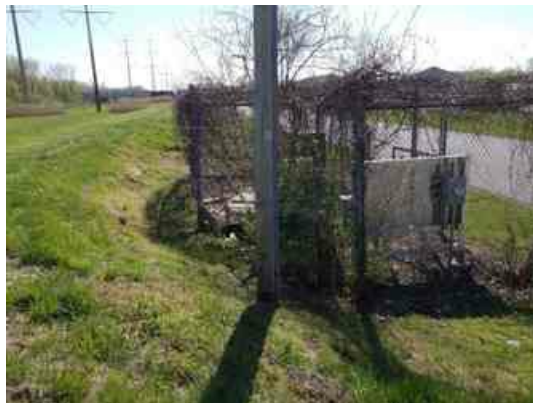
Inspect ID: 2021-0059 **Title:** 2604000014_CELRC_2021_A_0059_1_20210430T142832.jpg **Rated Item:** 3. Encroachments **Caption:** Minimally Acceptable - Fence on landside toe for lift station.

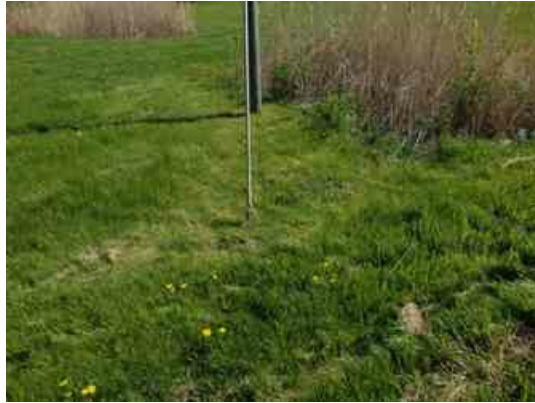
Inspect ID: 2021-0065 **Title:** 2604000014_CELRC_2021_A_0065_1_20210430T143301.jpg **Rated Item:** 3. Encroachments **Caption:** Acceptable - Guy wire on riverside toe.

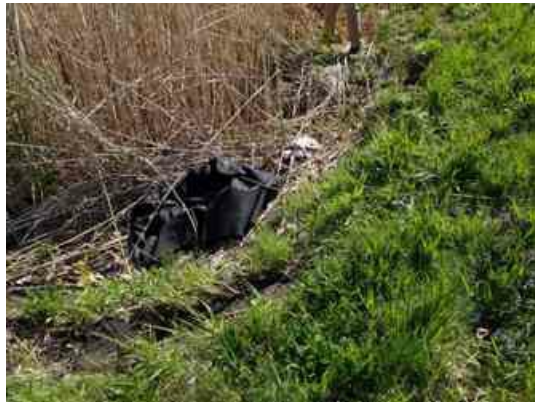
Inspect ID: 2021-0072 **Title:** 2604000014_CELRC_2021_A_0072_1_20210430T144304.jpg **Rated Item:** 3. Encroachments **Caption:** Minimally Acceptable - Debris on riverside toe.

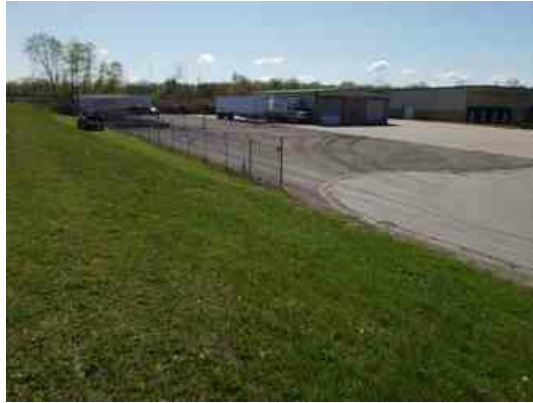
Inspect ID: 2021-0075 **Title:** 2604000014_CELRC_2021_A_0075_1_20210430T144639.jpg **Rated Item:** 3. Encroachments **Caption:** Acceptable - Fence close to landside toe.

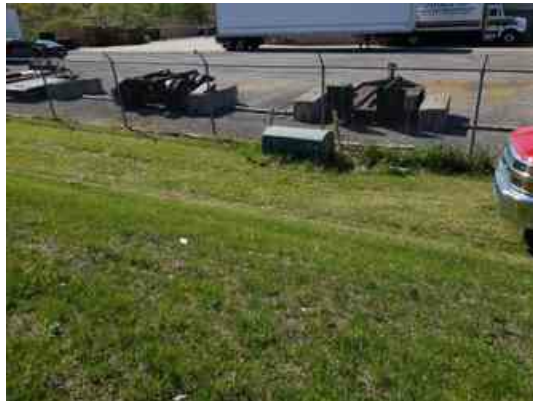
Inspect ID: 2021-0078 **Title:** 2604000014_CELRC_2021_A_0078_1_20210430T144916.jpg **Rated Item:** 3. Encroachments **Caption:** Acceptable - Box on landside toe.

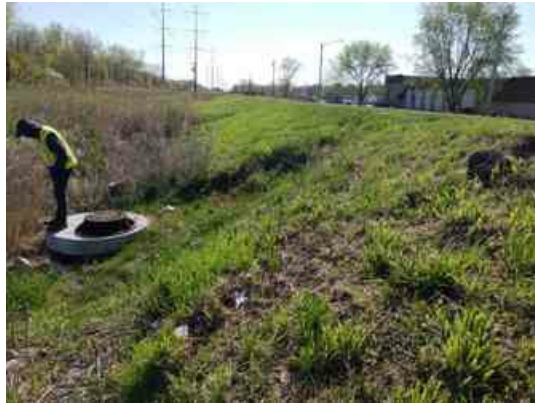
Inspect ID: 2021-0049 **Title:** 2604000014_CELRC_2021_A_0049_1_20210430T141854.jpg **Rated Item:** 5. Slope Stability **Caption:** Minimally Acceptable - Scarps from excavation on riverside slope.

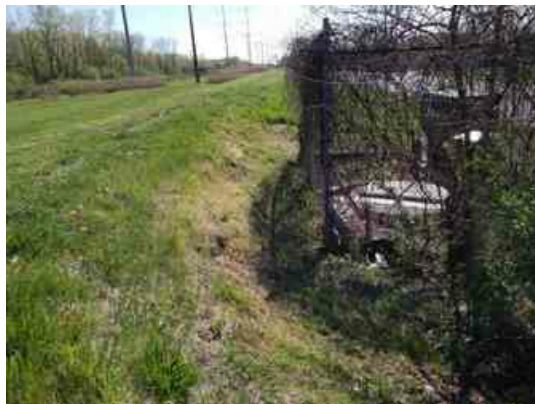
Inspect ID: 2021-0060 **Title:** 2604000014_CELRC_2021_A_0060_1_20210430T142917.jpg **Rated Item:** 5. Slope Stability **Caption:** Acceptable - Steep slopes on landside, as-built.

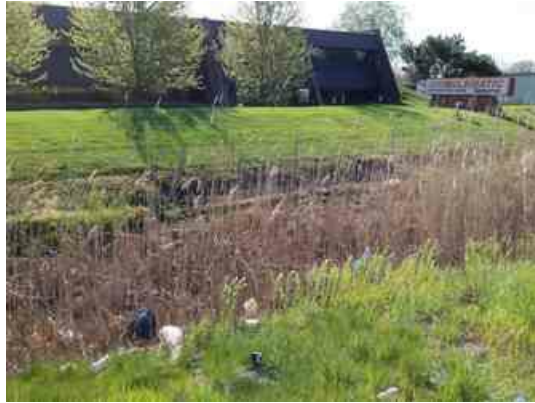
Inspect ID: 2021-0019 **Title:** 2604000014_CELRC_2021_A_0019_1_20210430T134905.jpg **Rated Item:** 6. Erosion/ Bank Caving **Caption:** Minimally Acceptable - Erosion on rs toe

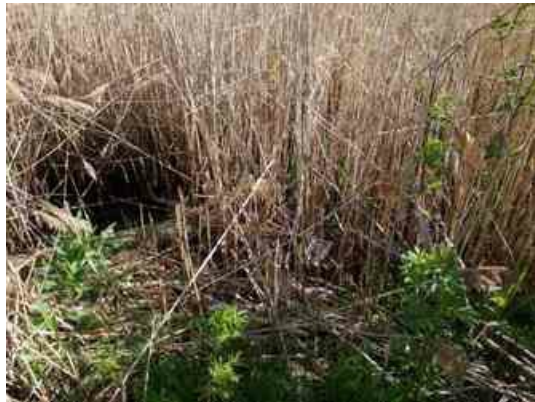
Inspect ID: 2021-0041 **Title:** 2604000014_CELRC_2021_A_0041_1_20210430T141226.jpg **Rated Item:** 6. Erosion/ Bank Caving **Caption:** Minimally Acceptable - Erosion around headwall on waterside toe.

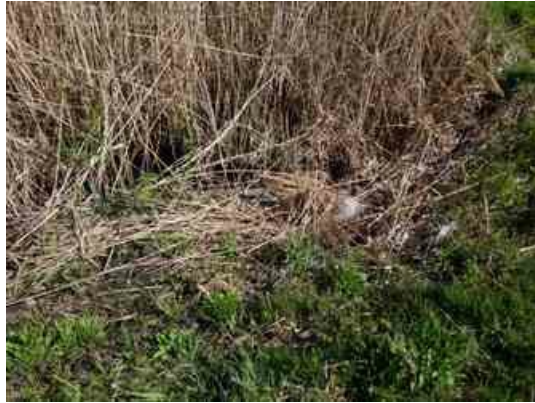
Inspect ID: 2021-0074 **Title:** 2604000014_CELRC_2021_A_0074_1_20210430T144509.jpg **Rated Item:** 6. Erosion/ Bank Caving **Caption:** Minimally Acceptable - Erosion around headwall on rs toe

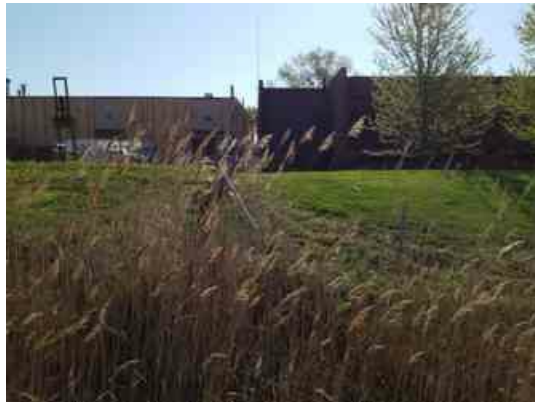
Inspect ID: 2021-0022 **Title:** 2604000014_CELRC_2021_A_0022_1_20210430T135122.jpg **Rated Item:** 7. Settlement **Caption:** Minimally Acceptable - Low spot on crest

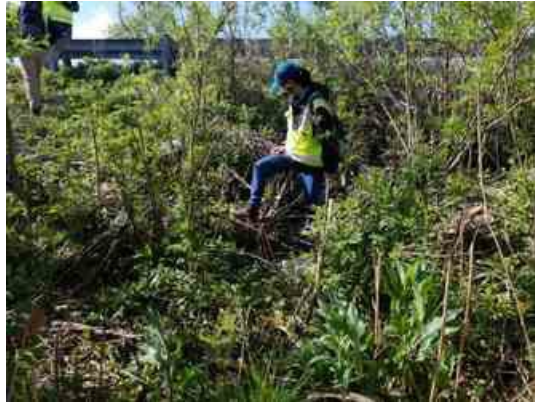
Inspect ID: 2021-0042 **Title:** 2604000014_CELRC_2021_A_0042_1_20210430T141315.jpg **Rated Item:** 8. Depressions/ Rutting **Caption:** Minimally Acceptable - Depression on riverside slope.

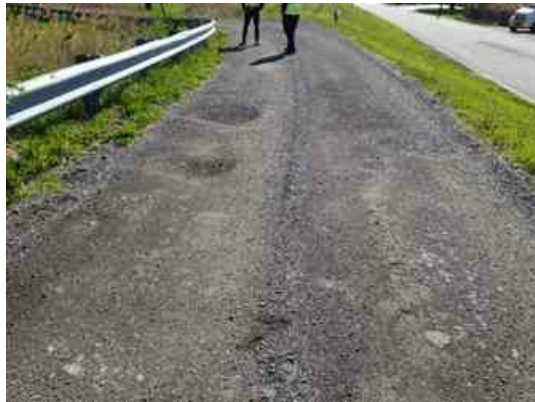
Inspect ID: 2021-0044 **Title:** 2604000014_CELRC_2021_A_0044_1_20210430T141529.jpg **Rated Item:** 8. Depressions/ Rutting **Caption:** Minimally Acceptable - Ruts on crest.

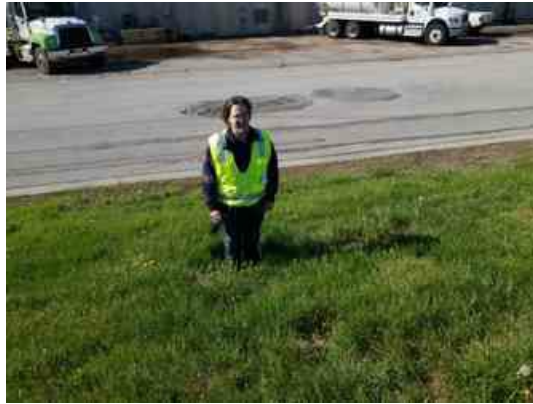
Inspect ID: 2021-0048 **Title:** 2604000014_CELRC_2021_A_0048_1_20210430T141807.jpg **Rated Item:** 8. Depressions/ Rutting **Caption:** Minimally Acceptable - Depression on landside slope.

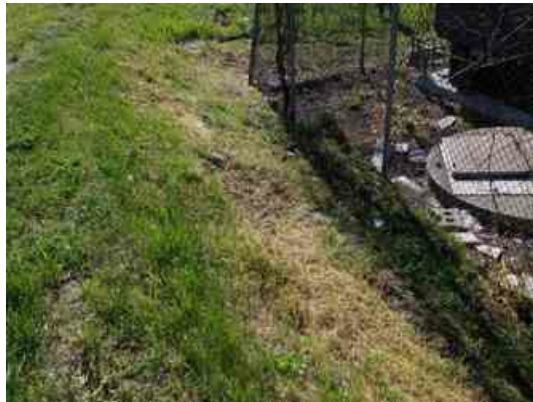
Inspect ID: 2021-0061 **Title:** 2604000014_CELRC_2021_A_0061_1_20210430T142956.jpg **Rated Item:** 8. Depressions/ Rutting **Caption:** Minimally Acceptable - Depression on landside slope.

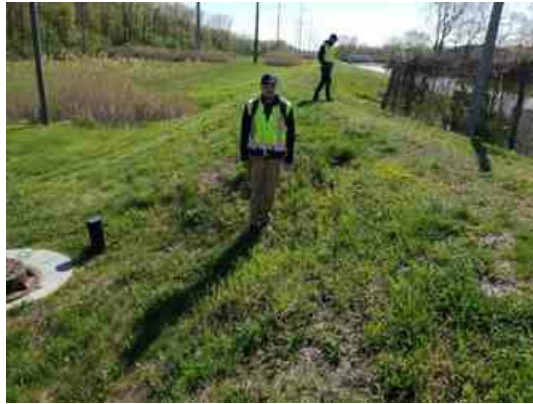
Inspect ID: 2021-0063 **Title:** 2604000014_CELRC_2021_A_0063_1_20210430T143118.jpg **Rated Item:** 8. Depressions/ Rutting **Caption:** Minimally Acceptable - Depression on riverside slope.

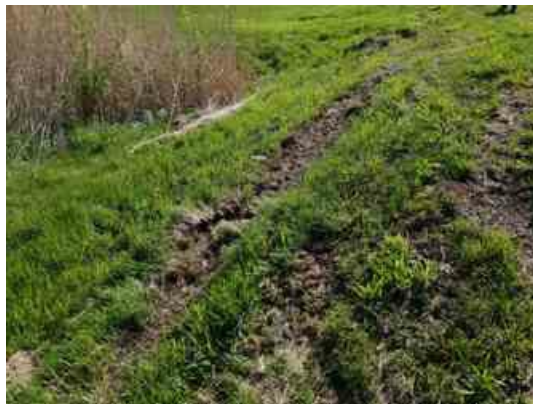
Inspect ID: 2021-0064 **Title:** 2604000014_CELRC_2021_A_0064_1_20210430T143223.jpg **Rated Item:** 8. Depressions/ Rutting **Caption:** Minimally Acceptable - Ruts on riverside slope.

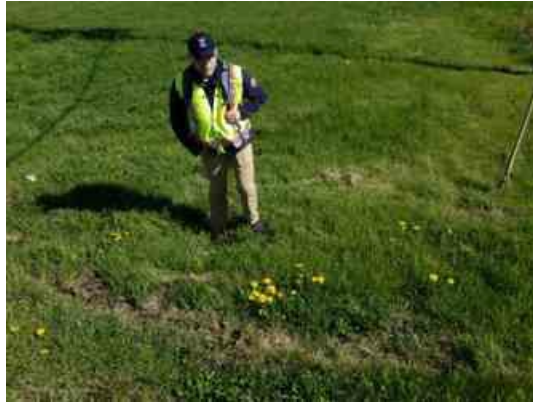
Inspect ID: 2021-0066 **Title:** 2604000014_CELRC_2021_A_0066_1_20210430T143341.jpg **Rated Item:** 8. Depressions/ Rutting **Caption:** Minimally Acceptable - Hole on riverside toe.

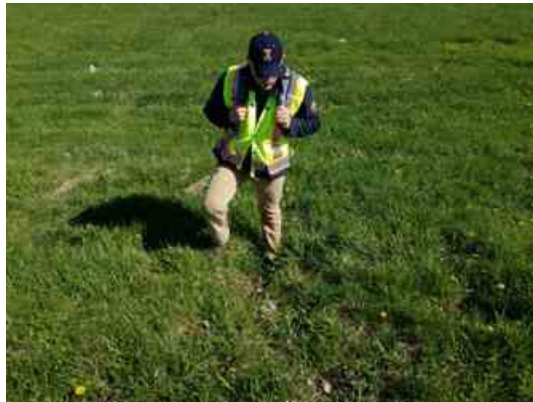
Inspect ID: 2021-0076 **Title:** 2604000014_CELRC_2021_A_0076_1_20210430T144722.jpg **Rated Item:** 8. Depressions/ Rutting **Caption:** Minimally Acceptable - Hole on riverside slope.

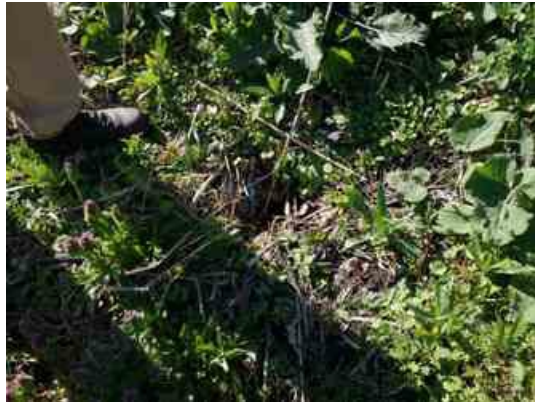
Inspect ID: 2021-0034 **Title:** 2604000014_CELRC_2021_A_0034_2_20210430T140337.jpg **Rated Item:** 10. Animal Control **Caption:** Minimally Acceptable - 2 burrows on riverside slope, 3 ft deep sloping towards river.

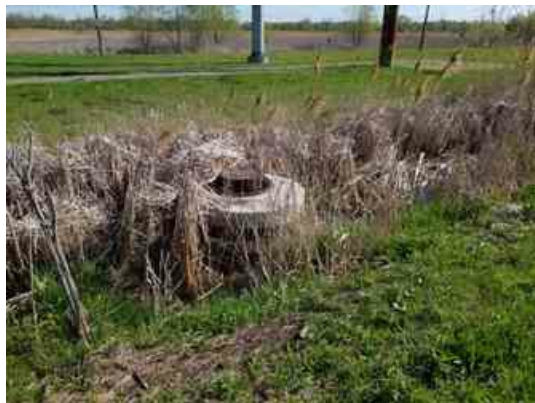
Inspect ID: 2021-0031 **Title:** 2604000014_CELRC_2021_A_0031_1_20210430T140014.jpg **Rated Item:** 11. Culverts/ Discharge Pipes (This item includes both concrete and corrugated metal pipes.) **Caption:** Acceptable - Manhole on riverside toe installed in 2018.

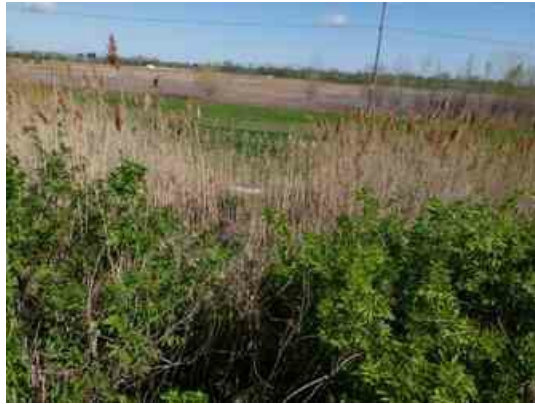
Inspect ID: 2021-0040 **Title:** 2604000014_CELRC_2021_A_0040_1_20210430T140930.jpg **Rated Item:** 11. Culverts/ Discharge Pipes (This item includes both concrete and corrugated metal pipes.) **Caption:** Acceptable - Manhole on riverside toe installed in 2018.

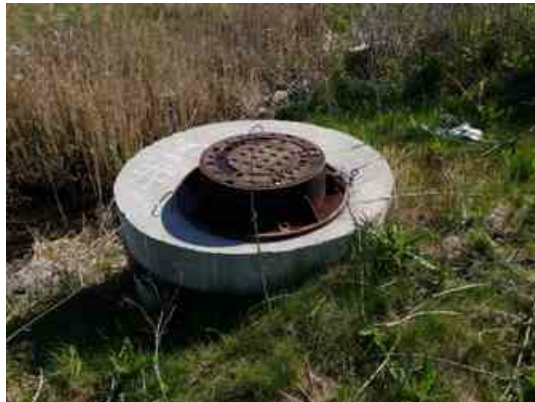
Inspect ID: 2021-0050 **Title:** 2604000014_CELRC_2021_A_0050_1_20210430T141950.jpg **Rated Item:** 11. Culverts/ Discharge Pipes (This item includes both concrete and corrugated metal pipes.) **Caption:** Acceptable - Manhole on riverside toe installed in 2018.

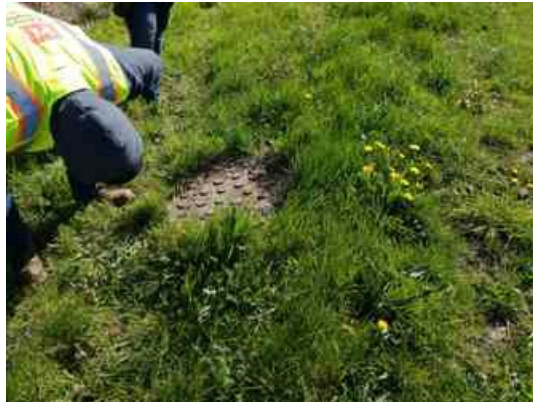
Inspect ID: 2021-0051 **Title:** 2604000014_CELRC_2021_A_0051_1_20210430T142051.jpg **Rated Item:** 11. Culverts/ Discharge Pipes (This item includes both concrete and corrugated metal pipes.) **Caption:** Acceptable - Manhole cover on riverside slope.

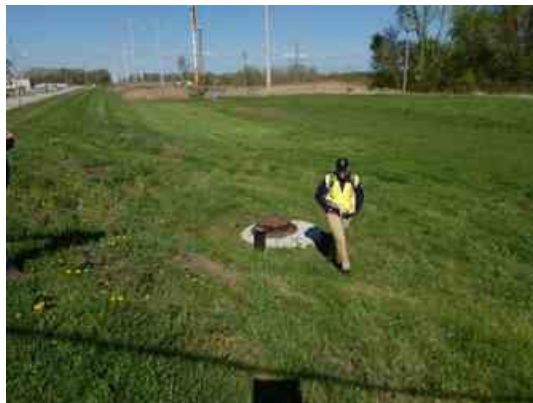
Inspect ID: 2021-0062 **Title:** 2604000014_CELRC_2021_A_0062_1_20210430T143032.jpg **Rated Item:** 11. Culverts/ Discharge Pipes (This item includes both concrete and corrugated metal pipes.) **Caption:** Minimally Acceptable - Manhole cover on riverside toe installed in 2018. Manhole lid wasn't bolted in.

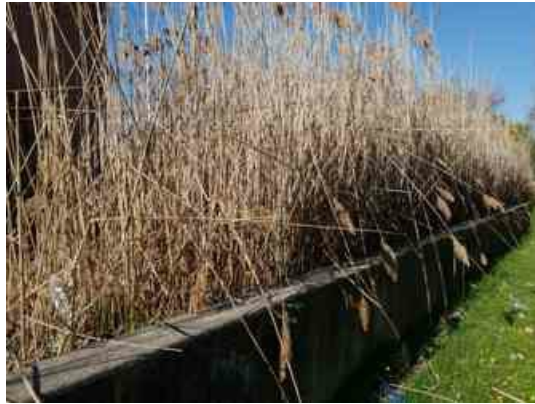
Inspect ID: 2021-0007 **Title:** 2604000014_CELRC_2021_A_0007_1_20210430T133014.jpg **Rated Item:** 1. Unwanted Vegetation Growth **Caption:** Minimally Acceptable - Tall vegetation on riverside.

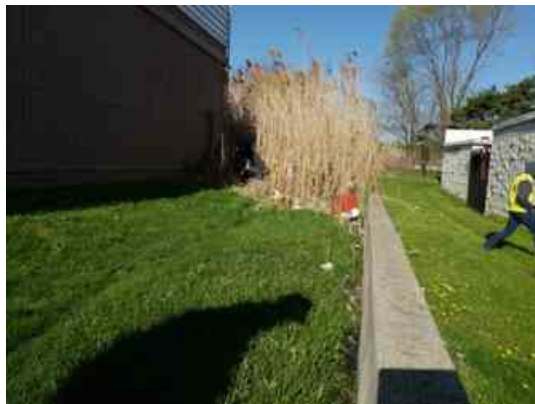
Inspect ID: 2021-0004 **Title:** 2604000014_CELRC_2021_A_0004_1_20210430T132745.jpg **Rated Item:** 2. Encroachments **Caption:** Minimally Acceptable - Debris on riverside.

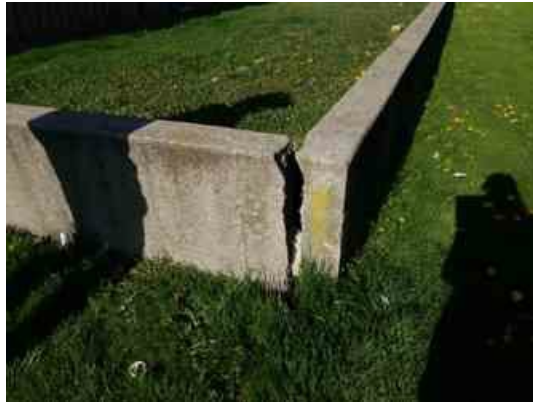
4. Concrete Surfaces	U	A	Negligible spalling, scaling or cracking. If the concrete surface is weathered or holds moisture, it is still satisfactory but should be seal coated to prevent freeze/ thaw damage.	2021-0001 : Crack/separation at the corner of the floodwall. Further, in-depth inspection is recommended to assess the extent of concrete damage and below-grade condition. Once investigated, repair wall in accordance with EM 1110-2-2002. (U) 2021-0002 : Typical crack on both sides. Seal. (M) 2021-0003 : Large crack. Seal (M) 2021-0005 : Spalling on riverside at monolith. (M) 2021-0006 : Crack and minor spalling. Patch and seal (M) 2021-0008 : Crack on wall along the tieback extension that is not part of the line of protection. (A)
		M	Spalling, scaling, and open cracking present, but the immediate integrity or performance of the structure is not threatened. Reinforcing steel may be exposed. Repairs/ sealing is necessary to prevent additional damage during periods of thawing and freezing.

Inspect ID: 2021-0001 **Title:** 2604000014_CELRC_2021_A_0001_1_20210430T132517.jpg **Rated Item:** 4. Concrete Surfaces **Caption:** Unacceptable - Crack/separation at the corner of the floodwall. Further, in-depth inspection is recommended to assess the extent of concrete damage and below-grade condition. Once investigated, repair wall in accordance with EM 1110-2-2002.

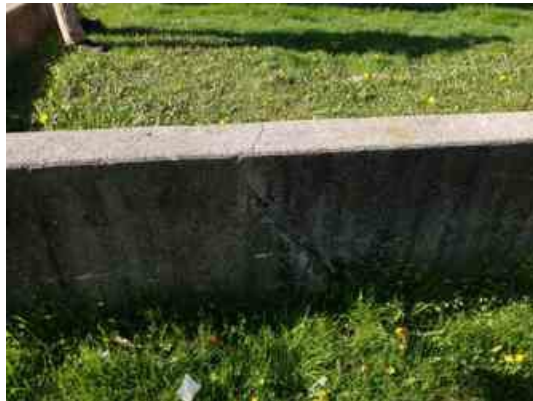
Inspect ID: 2021-0002 **Title:** 2604000014_CELRC_2021_A_0002_1_20210430T132559.jpg **Rated Item:** 4. Concrete Surfaces **Caption:** Minimally Acceptable - Crack on both sides. Seal.

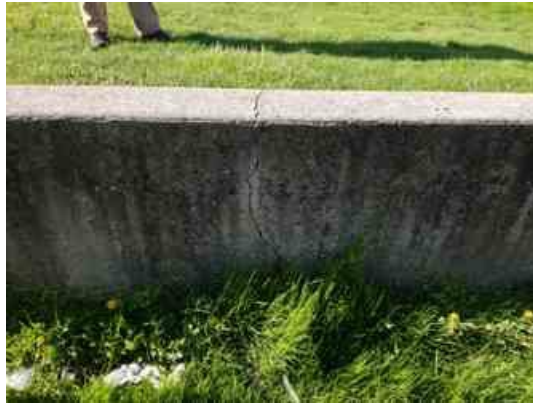
Inspect ID: 2021-0003 **Title:** 2604000014_CELRC_2021_A_0003_1_20210430T132657.jpg **Rated Item:** 4. Concrete Surfaces **Caption:** Minimally Acceptable - Large crack. Seal

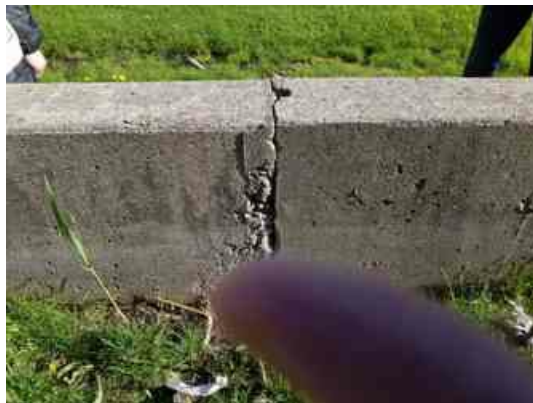
Inspect ID: 2021-0005 **Title:** 2604000014_CELRC_2021_A_0005_1_20210430T132834.jpg **Rated Item:** 4. Concrete Surfaces **Caption:** Minimally Acceptable - Spalling on riverside at monolith.

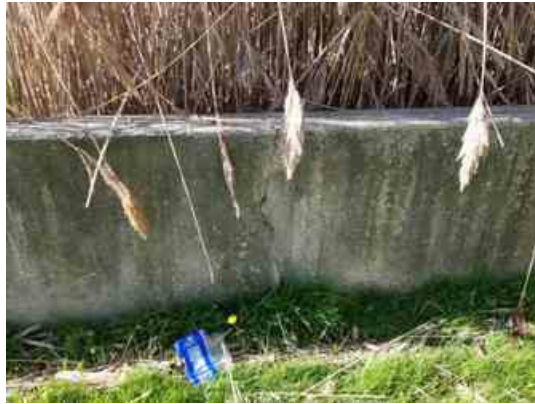
Inspect ID: 2021-0006 **Title:** 2604000014_CELRC_2021_A_0006_1_20210430T132938.jpg **Rated Item:** 4. Concrete Surfaces **Caption:** Minimally Acceptable - Crack and minor spalling. Patch and seal

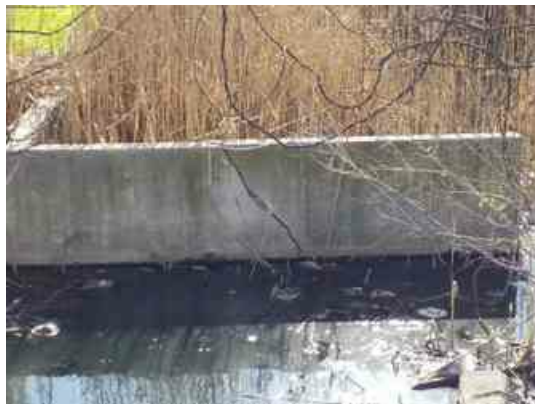
Inspect ID: 2021-0008 **Title:** 2604000014_CELRC_2021_A_2021-0008_2_20210430T134212.jpg **Rated Item:** 4. Concrete Surfaces **Caption:** Acceptable - Crack on wall along the tieback extension that is not part of the line of protection.

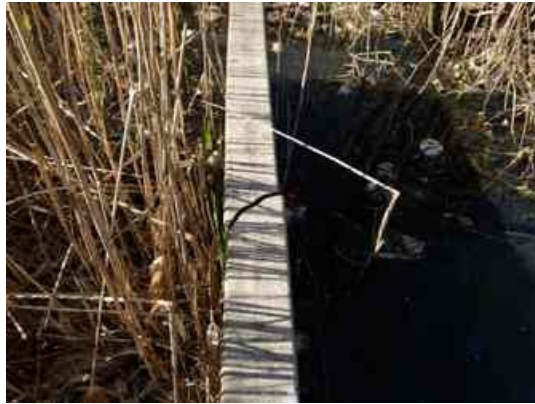
Inspect ID: 2021-0009 **Title:** 2604000014_CELRC_2021_A_0009_1_20210430T133212.jpg **Rated Item:** 5. Tilting, Sliding or Settlement of Concrete Structures **Caption:** Acceptable - Tilting of tieback extension that is not part of the line of protection.

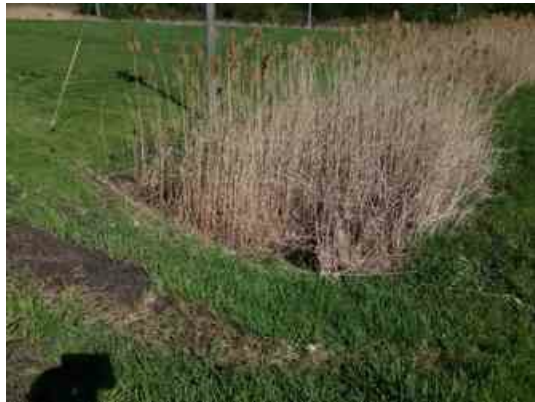
Inspect ID: 2021-0069 **Title:** 2604000014_CELRC_2021_A_0069_1_20210430T143649.jpg **Rated Item:** 1. Vegetation and Obstructions **Caption:** Minimally Acceptable - Tall vegetation on riverside toe.

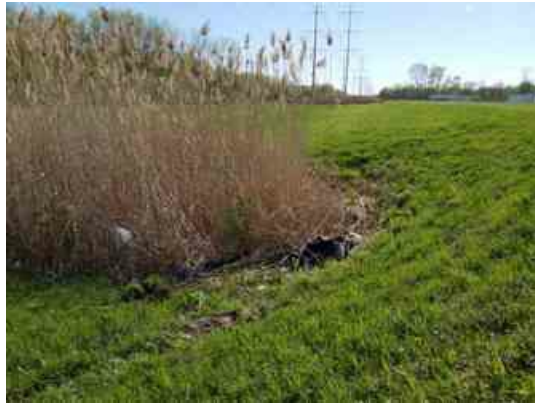
Inspect ID: 2021-0071 **Title:** 2604000014_CELRC_2021_A_0071_1_20210430T144225.jpg **Rated Item:** 1. Vegetation and Obstructions **Caption:** Minimally Acceptable - Tall vegetation on riverside toe.
