**US Army Corps
of Engineers®**

Levee Inspection Report

Name of System: Burr Street

Name of Segment: Griffith

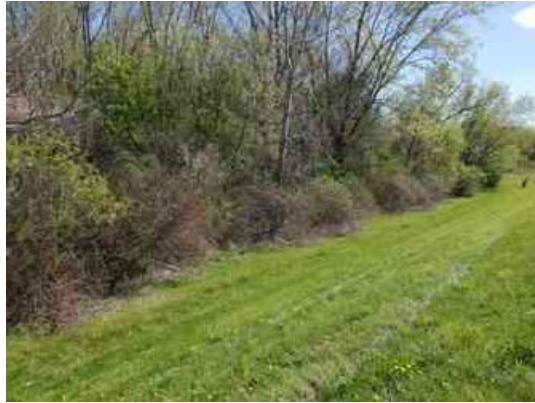
Inspect ID: 2021-0033 **Title:** 2604000006_CELRC_2021_A_0033_1_20210430T151832.jpg **Rated Item:** 1. Unwanted Vegetation Growth **Caption:** Minimally Acceptable - Bushes within 15 ft of riverside toe.

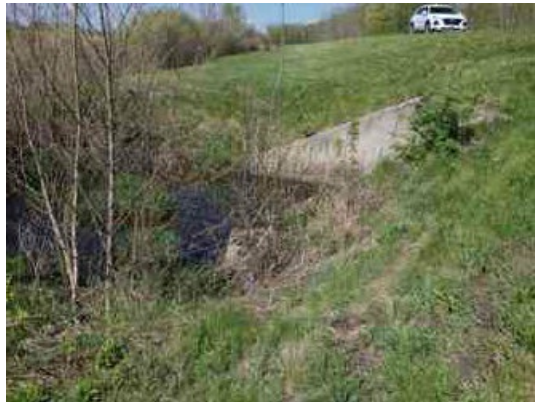
Inspect ID: 2021-0041 **Title:** 2604000006_CELRC_2021_A_0041_1_20210430T152442.jpg **Rated Item:** 1. Unwanted Vegetation Growth **Caption:** Acceptable - Small woody vegetation and bushes on land side slope.

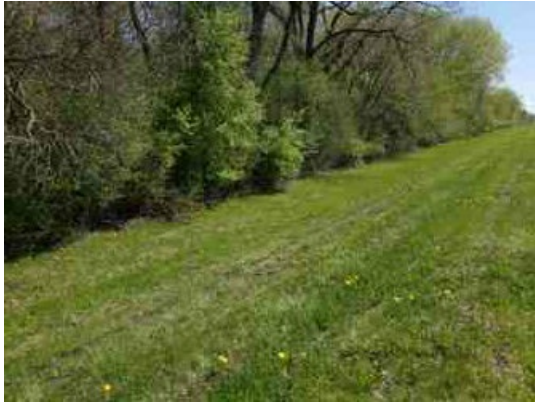
Rated Item	Rating	Rating Guidelines		Location/Remarks/Recommendations
1. Unwanted Vegetation Growth	M	A	The levee has little or no unwanted vegetation (trees, bush, or undesirable weeds), except for vegetation that is properly contained and/or situated on overbuilt sections, such that the mandatory 3-foot root-free zone is preserved around the levee profile. The levee has been recently mowed. The vegetation-free zone extends 15 feet from both the landside and riverside toes of the levee to the centerline of the tree. If the levee access easement doesn't extend to the described limits, then the vegetation-free zone must be maintained to the easement limits. Reference EM 1110-2-301 or Corps policy for regional vegetation variance.	2021-0033 : Bushes within 15 ft of riverside toe. (M) 2021-0041 : Small woody vegetation and bushes on land side slope. (A) 2021-0057 : Vegetation growth along riverside toe, within 15 ft. (M)

Inspect ID: 2021-0057 Title: 2604000006_CELRC_2021_A_0057_1_20210430T153739.jpg Rated Item: 1. Unwanted Vegetation Growth Caption: Minimally Acceptable - Vegetation growth along riverside toe, within 15 ft.

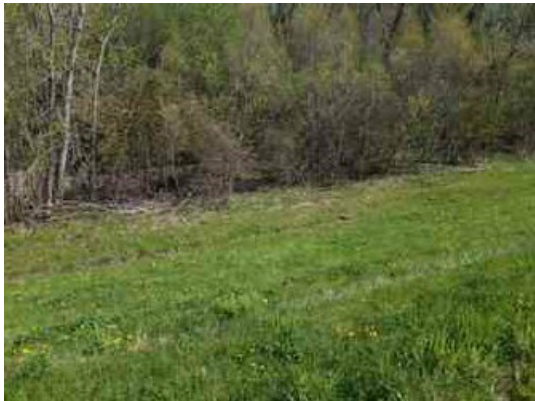
Inspect ID: 2021-0031 Title: 2604000006_CELRC_2021_A_0031_1_20210430T151723.jpg Rated Item: 3. Encroachments Caption: Minimally Acceptable - Logs/branches near riverside toe.

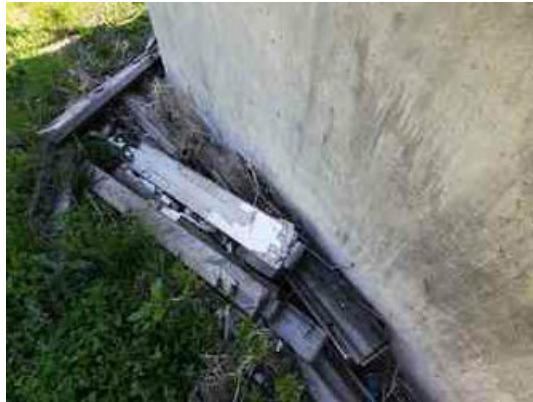
Inspect ID: 2021-0039 **Title:** 2604000006_CELRC_2021_A_0039_1_20210430T152341.jpg **Rated Item:** 3. Encroachments **Caption:** Minimally Acceptable - Pile of timber debris on riverside slope.

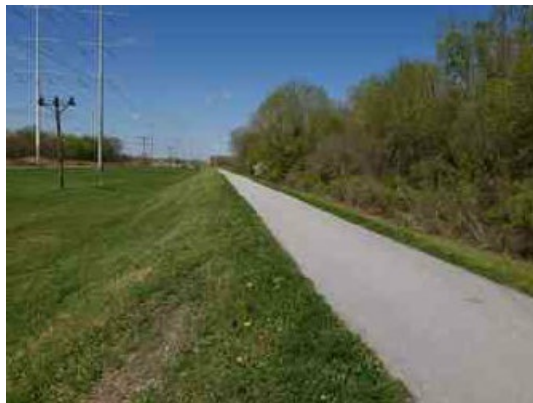
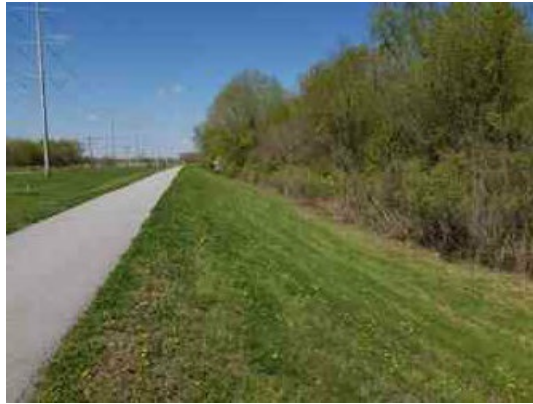
Rated Item	Rating	Rating Guidelines		Location/Remarks/Recommendations
5. Slope Stability	M	A	No slides, sloughs, tension cracking, slope depressions, or bulges are present.	2021-0059 : Large depression on both sides, uneven slopes. (M)
		M	Minor slope stability problems that do not pose an immediate threat to the levee embankment.	
		U	Major slope stability problems (ex. deep seated sliding) identified that must be repaired to reestablish the integrity of the levee embankment.

Inspect ID: 2021-0059 **Title:** 2604000006_CELRC_2021_A_0059_1_20210430T154918.jpg **Rated Item:** 5. Slope Stability **Caption:** Minimally Acceptable - Large depression on both sides, uneven slopes. Landside.

Inspect ID: 2021-0059 **Title:** 2604000006_CELRC_2021_A_0059_2_20210430T154932.jpg **Rated Item:** 5. Slope Stability **Caption:** Minimally Acceptable - Large depression on both sides, uneven slopes. Riverside.

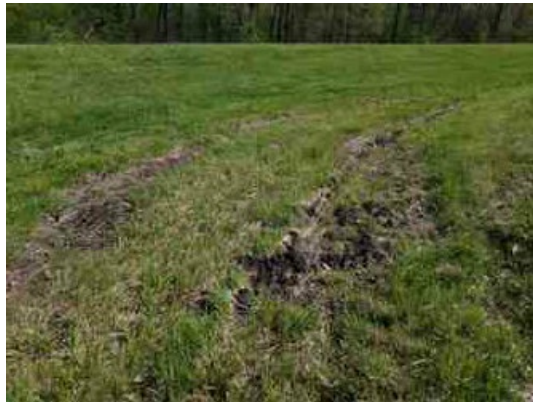
Inspect ID: 2021-0021 **Title:** 2604000006_CELRC_2021_A_0021_1_20210430T150938.jpg **Rated Item:** 8. Depressions/ Rutting **Caption:** Acceptable - Rutting at river side toe.

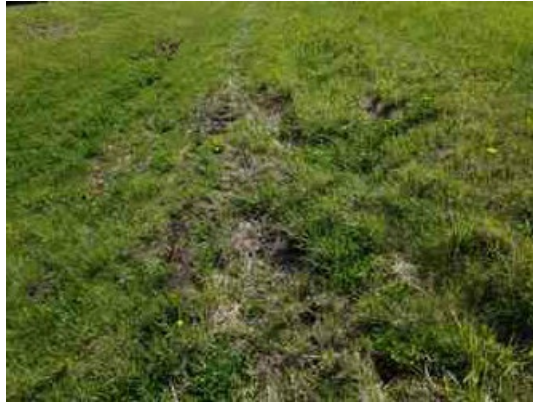
Inspect ID: 2021-0023 **Title:** 2604000006_CELRC_2021_A_0023_1_20210430T151032.jpg **Rated Item:** 8. Depressions/ Rutting **Caption:** Acceptable - Small rut on riverside slope.

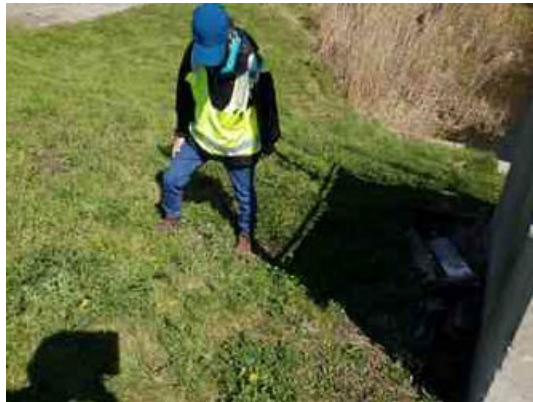
Inspect ID: 2021-0037 **Title:** 2604000006_CELRC_2021_A_0037_1_20210430T152130.jpg **Rated Item:** 8. Depressions/ Rutting **Caption:** Acceptable - Two small depressions on riverside slope.

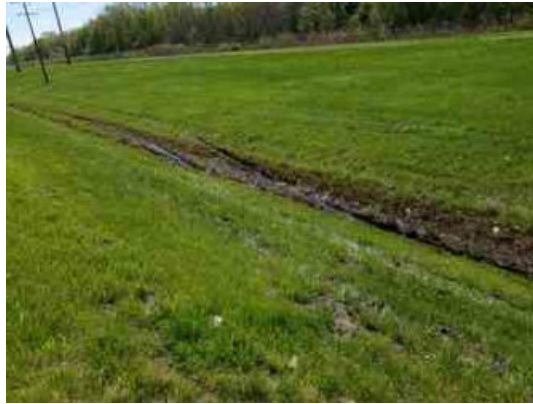
Inspect ID: 2021-0053 **Title:** 2604000006_CELRC_2021_A_0053_1_20210430T153600.jpg **Rated Item:** 8. Depressions/ Rutting **Caption:** Minimally Acceptable - Rutting in interior drainage ditch bottom at landside toe, ponding water.

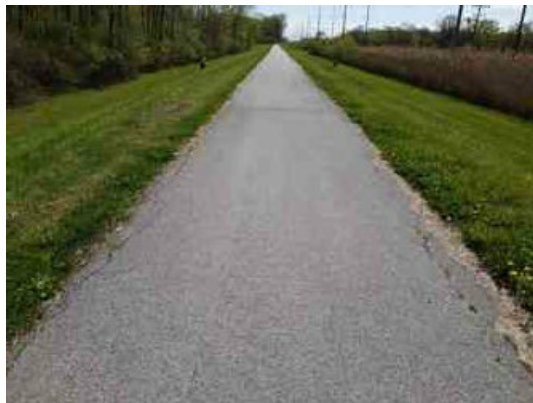
9. Cracking	A	A	Minor longitudinal, transverse, or desiccation cracks with no vertical movement along the crack. No cracks extend continuously through the levee crest.	2021-0025 : Longitudinal surface cracking along pavement edges along crown. Both sides. (A)
		M	Longitudinal and/or transverse cracks up to 6 inches in depth with no vertical movement along the crack. No cracks extend continuously through the levee crest. Longitudinal cracks are no longer than the height of the levee.	
		U	Cracks exceed 6 inches in depth. Longitudinal cracks are longer than the height of the levee and/or exhibit vertical movement along the crack. Transverse cracks extend through the entire levee width.

Inspect ID: 2021-0025 **Title:** 2604000006_CELRC_2021_A_0025_1_20210430T151211.jpg **Rated Item:** 9. Cracking **Caption:** Acceptable - Longitudinal surface cracking along pavement edges along crown. Both sides.

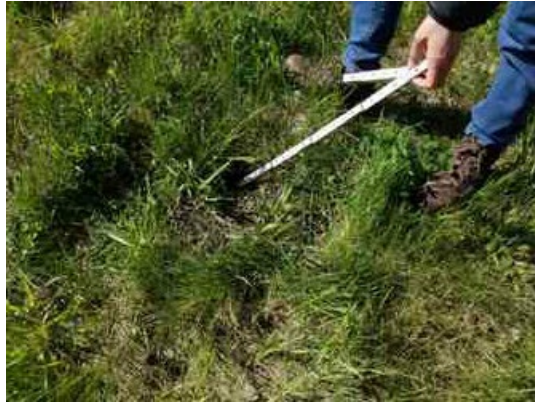
Inspect ID: 2021-0027 **Title:** 2604000006_CELRC_2021_A_0027_1_20210430T151345.jpg **Rated Item:** 10. Animal Control **Caption:** Acceptable - Small animal burrow, 3 in deep, in riverside slope.

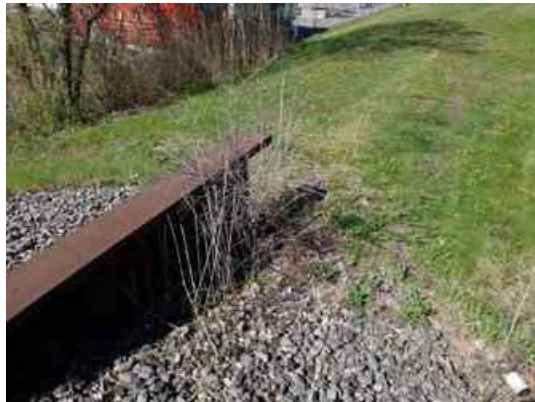
Inspect ID: 2021-0001 **Title:** 2604000006_CELRC_2021_A_2021-0001_1_20210430T145532.jpg **Rated Item:** 1. Unwanted Vegetation Growth **Caption:** Acceptable - Small woody vegetation on riverside.

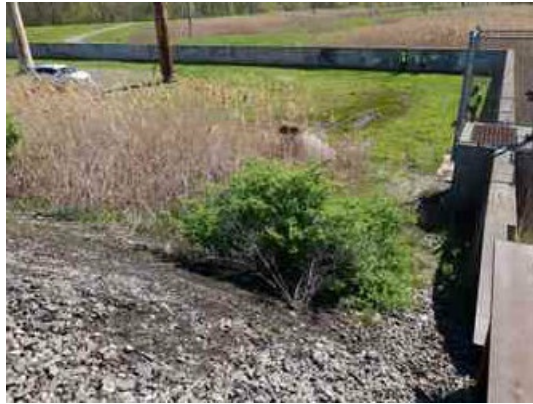
Inspect ID: 2021-0003 **Title:** 2604000006_CELRC_2021_A_0003_2_20210430T145807.jpg **Rated Item:** 1. Unwanted Vegetation Growth **Caption:** Minimally Acceptable - Bush on riverside.

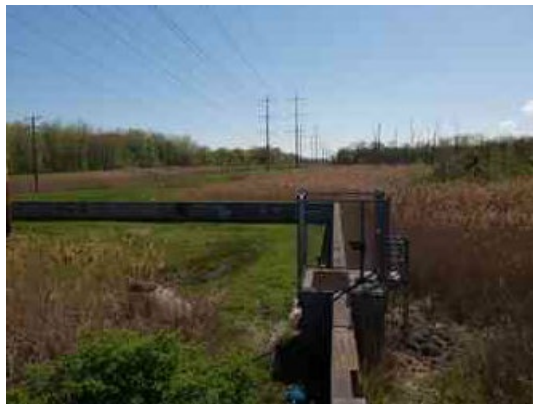
Inspect ID: 2021-0005 **Title:** 2604000006_CELRC_2021_A_0005_1_20210726T230648.jpg **Rated Item:** 1. Unwanted Vegetation Growth **Caption:** Minimally Acceptable - Phragmites on landside.

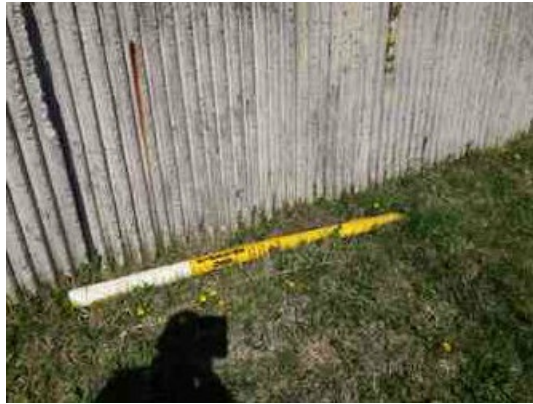
Inspect ID: 2021-0019 **Title:** 2604000006_CELRC_2021_A_0019_1_20210430T150704.jpg **Rated Item:** 2. Encroachments **Caption:** Minimally Acceptable - Gas pipeline marker knocked over on landside.

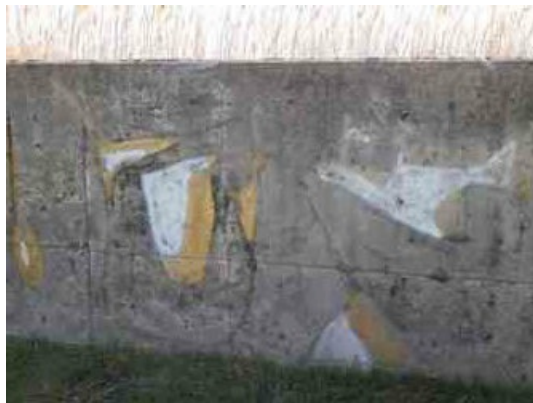
4. Concrete Surfaces	M	A	Negligible spalling, scaling or cracking. If the concrete surface is weathered or holds moisture, it is still satisfactory but should be seal coated to prevent freeze/ thaw damage.	2021-0009 : Surface cracking, river side face. Typical. (A) 2021-0011 : Minor spalling on riverside. (M) 2021-0013 : Spalling/cracking on landside face. (M) 2021-0015 : Minor spalling on landside face. (A) 2021-0017 : Spalling on landside. (A)
		M	Spalling, scaling, and open cracking present, but the immediate integrity or performance of the structure is not threatened. Reinforcing steel may be exposed. Repairs/ sealing is necessary to prevent additional damage during periods of thawing and freezing.	
		U	Surface deterioration or deep cracks present that may result in an unreliable structure. Any surface deterioration that exposes the sheet piling or lies adjacent to monolith joints may indicate underlying reinforcement corrosion and is unacceptable.

Inspect ID: 2021-0009 **Title:** 2604000006_CELRC_2021_A_0009_1_20210430T150140.jpg **Rated Item:** 4. Concrete Surfaces **Caption:** Acceptable - Surface cracking, river side face. Typical.

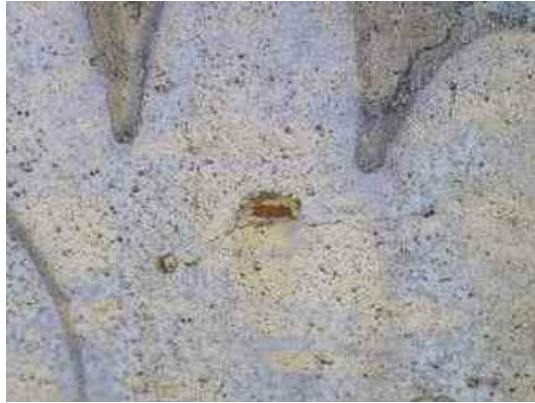
Inspect ID: 2021-0011 **Title:** 2604000006_CELRC_2021_A_0011_1_20210430T150251.jpg **Rated Item:** 4. Concrete Surfaces **Caption:** Minimally Acceptable - Minor spalling on riverside.

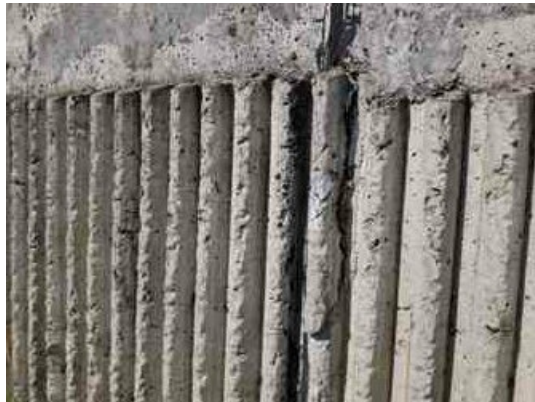
Inspect ID: 2021-0013 **Title:** 2604000006_CELRC_2021_A_0013_1_20210430T150412.jpg **Rated Item:** 4. Concrete Surfaces **Caption:** Minimally Acceptable - Spalling/cracking on landside face.

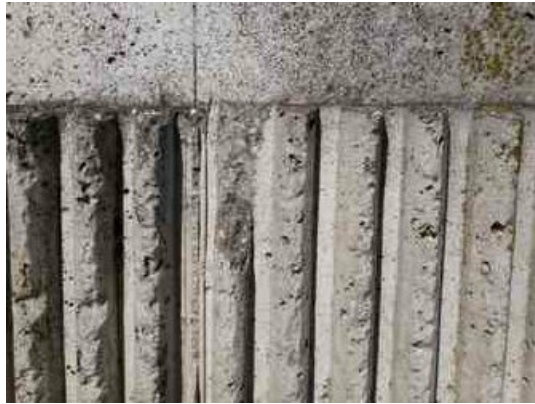
Inspect ID: 2021-0015 **Title:** 2604000006_CELRC_2021_A_0015_1_20210430T150530.jpg **Rated Item:** 4. Concrete Surfaces **Caption:** Acceptable - Minor spalling on landside face.

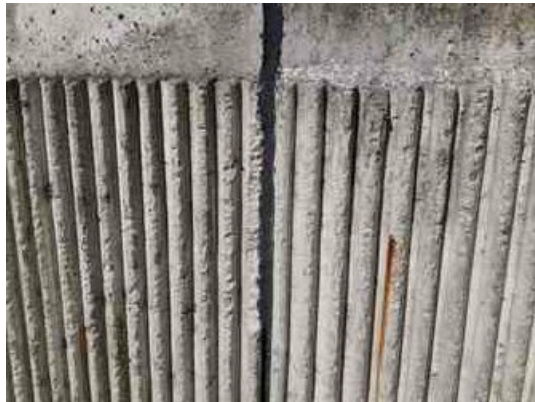
Inspect ID: 2021-0017 **Title:** 2604000006_CELRC_2021_A_0017_1_20210430T150609.jpg **Rated Item:** 4. Concrete Surfaces **Caption:** Acceptable - Spalling on landside.

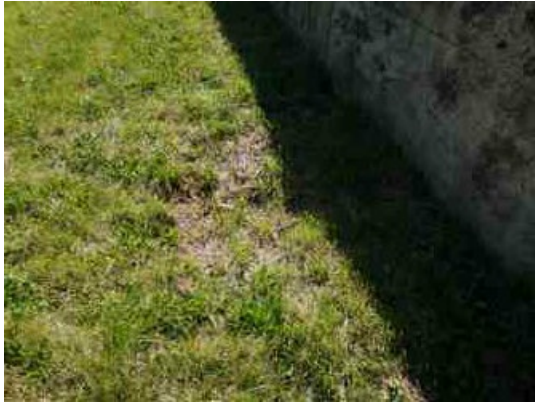
6. Foundation of Concrete Structures	A	A	No active erosion, scouring, or bank caving that might endanger the structure's stability.	2021-0007 : Small depression, river side near wall. (A)
		M	There are areas where the ground is eroding towards the base of the structure. Efforts need to be taken to slow and repair this erosion, but it is not judged to be close enough to the structure or to be progressing rapidly enough to affect structural stability before the next inspection. For the purposes of inspection, the erosion or scour is not closer to the riverside face of the wall than twice the floodwall's underground base width if the wall is of L-wall or T-wall construction; or if the wall is of sheetpile or I-wall construction, the erosion is not closer than twice the wall's visible height. Additionally, rate of erosion is such that the wall is expected to remain stable until the next inspection.

Inspect ID: 2021-0007 Title: 2604000006_CELRC_2021_A_0007_1_20210430T150039.jpg Rated Item: 6. Foundation of Concrete Structures Caption: Acceptable - Small depression, river side near wall.

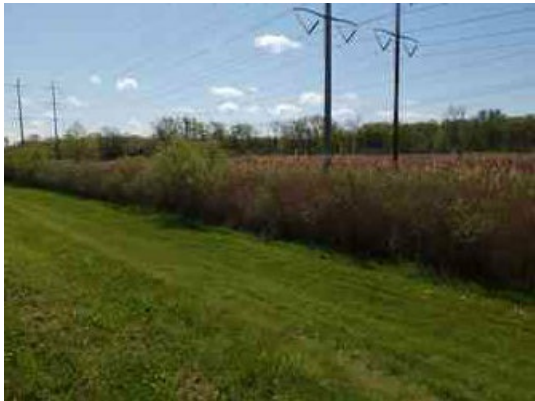
Inspect ID: 2021-0029 Title: 2604000006_CELRC_2021_A_0029_1_20210430T151553.jpg Rated Item: 1. Vegetation and Obstructions Caption: Minimally Acceptable - Typical photo for entire interior drainage ditch. Phragmites and tree/bush growth in ditch.

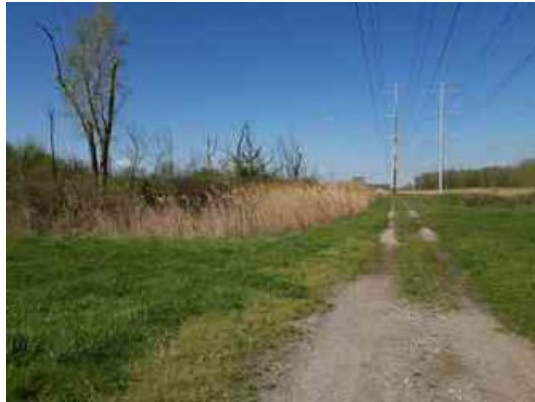
Inspect ID: 2021-0043 **Title:** 2604000006_CELRC_2021_A_0043_1_20210430T152646.jpg **Rated Item:** 1. Vegetation and Obstructions **Caption:** Minimally Acceptable - Representative photo for interior drainage ditch segment. Looking west.

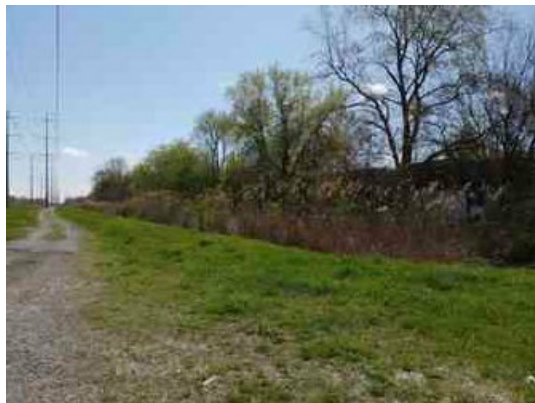
Inspect ID: 2021-0045 **Title:** 2604000006_CELRC_2021_A_0045_1_20210430T152818.jpg **Rated Item:** 1. Vegetation and Obstructions **Caption:** Minimally Acceptable - Representative photo for interior drainage ditch segment. Looking east.

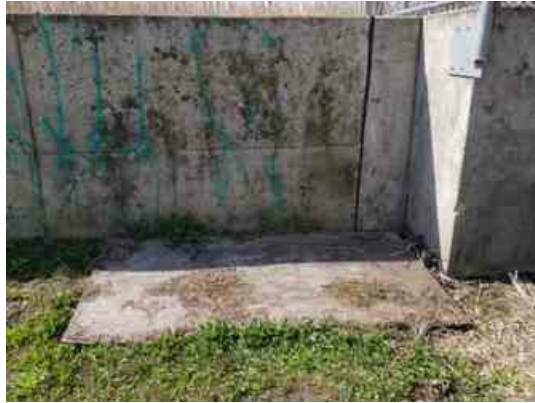
Inspect ID: 2021-0010 **Title:** 2604000006_CELRC_2021_A_0010_1_20210427T144954.jpg **Rated Item:** 2. Encroachments **Caption:** Minimally Acceptable - GR-1: Debris on riverside.

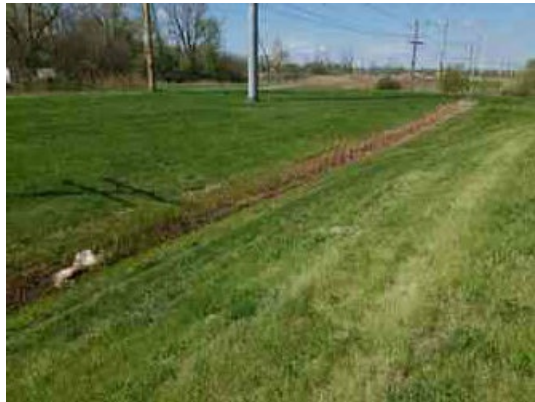
Inspect ID: 2021-0051 **Title:** 2604000006_CELRC_2021_A_0051_1_20210430T153323.jpg **Rated Item:** 2. Encroachments **Caption:** Minimally Acceptable - Trash in ditch.

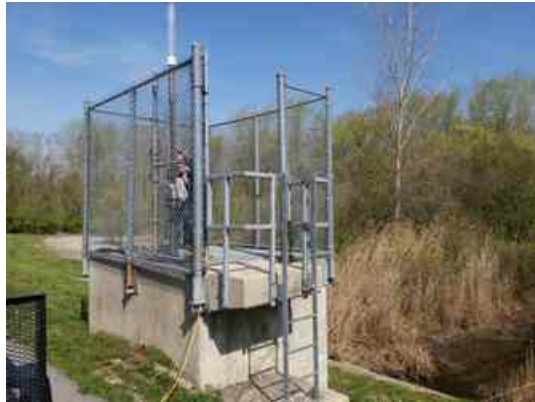
Inspect ID: 2021-0004 **Title:** 2604000006_CELRC_2021_A_2021-0004_2_20210427T143733.jpg **Rated Item:** 10. Sluice/ Slide Gates
Caption: Acceptable - GR-2: The sluice gate opened and closed with little to no resistance. The gate stem appears to be oiled regularly. The gate was open on arrival and we left it open when we left.

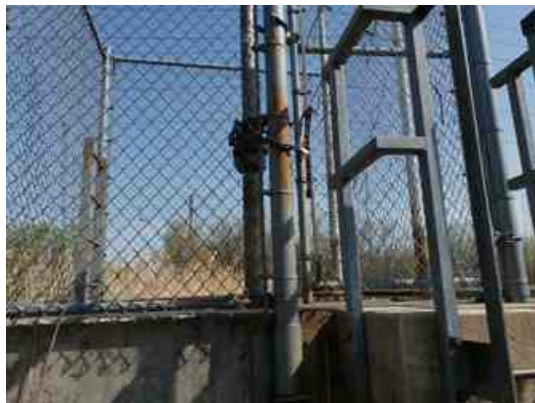
Inspect ID: 2021-0008 **Title:** 2604000006_CELRC_2021_A_0008_1_20210427T144746.jpg **Rated Item:** 10. Sluice/ Slide Gates **Caption:** Acceptable - GR-1: The sluice gate was exercised. No issues.

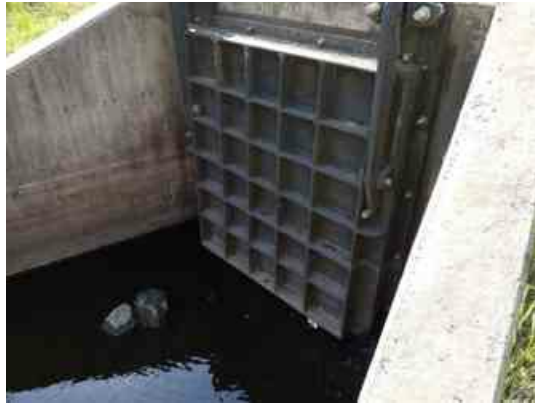
Inspect ID: 2021-0002 **Title:** 2604000006_CELRC_2021_A_2021-0002_3_20210427T143859.jpg **Rated Item:** 11. Flap Gates/ Flap Valves/ Pinch Valves **Caption:** Minimally Acceptable - GR-2: There appears to be a small leak when the gate is fully closed.

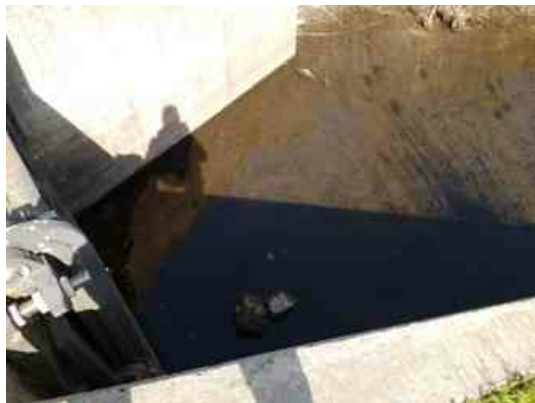
Inspect ID: 2021-0006 **Title:** 2604000006_CELRC_2021_A_0006_1_20210427T143418.jpg **Rated Item:** 11. Flap Gates/ Flap Valves/ Pinch Valves **Caption:** Acceptable - GR-2: Silt removed since last inspection.
