**US Army Corps
of Engineers®**

Levee Inspection Report

Name of System: Hammond

Date(s) of Inspection: 06/23/2021 - 06/24/2021

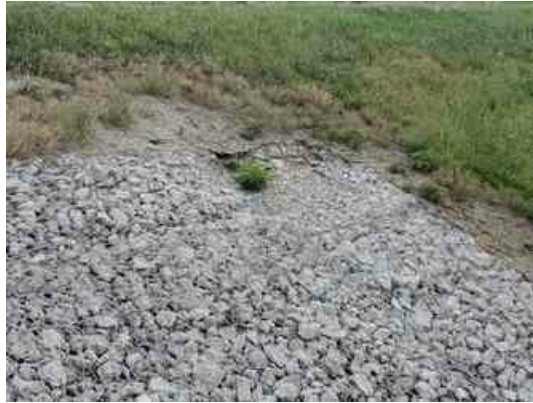
Inspect ID: 2021-0356 **Title:** 2604000008_CELRC_2021_A_0356_1_20210623T155203.jpg **Rated Item:** 13. Revetments other than Riprap **Caption:** Minimally Acceptable - Damaged gabion. Repair basket.

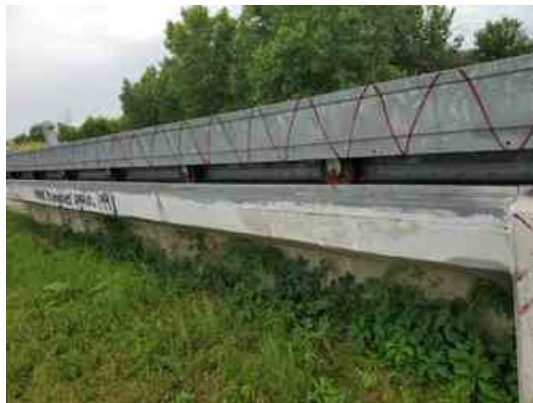
Inspect ID: 2021-0500 **Title:** 2604000008_CELRC_2021_A_0500_1_20210623T171514.jpg **Rated Item:** 3. Closure Structures (Stop Log Closures and Gates) (A or U only) **Caption:** Acceptable - Corrosion on the wheels. Clean.

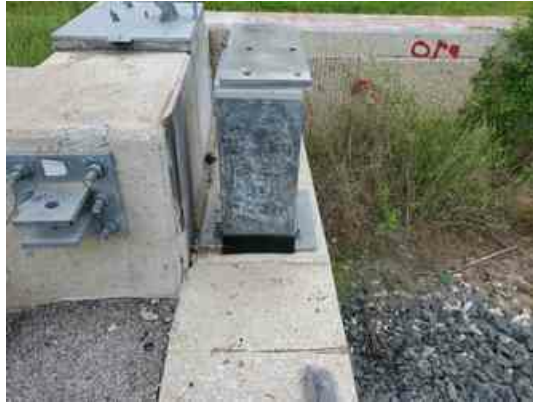
Inspect ID: 2021-0504 **Title:** 2604000008_CELRC_2021_A_0504_1_20210623T171703.jpg **Rated Item:** 3. Closure Structures (Stop Log Closures and Gates) (A or U only) **Caption:** Acceptable - Missing rubber seal. Replace.

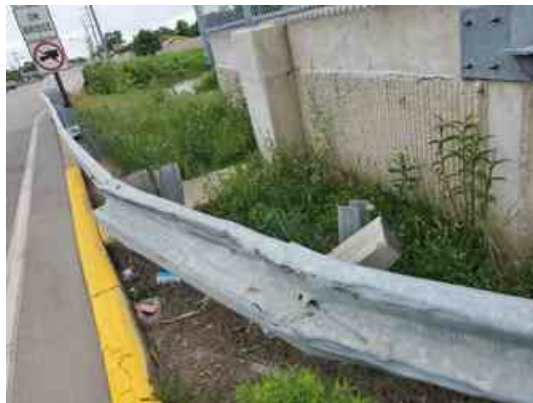
Inspect ID: 2021-0576 **Title:** 2604000008_CELRC_2021_A_0576_1_20210623T180238.jpg **Rated Item:** 3. Closure Structures (Stop Log Closures and Gates) (A or U only) **Caption:** Acceptable - Guardrail is blocking the closure. Consider new layout for closure installation.

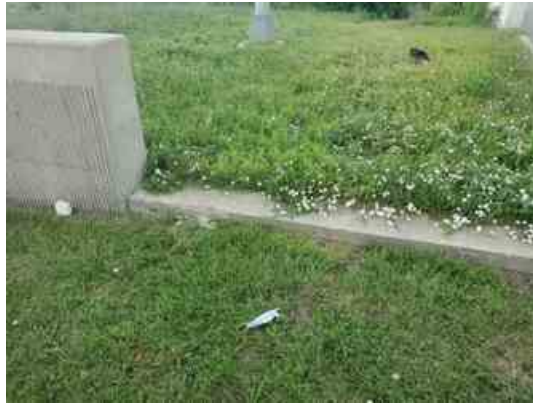
Inspect ID: 2021-0580 **Title:** 2604000008_CELRC_2021_A_0580_1_20210623T185620.jpg **Rated Item:** 3. Closure Structures (Stop Log Closures and Gates) (A or U only) **Caption:** Minimally Acceptable - Spalling and cracking on sill. Seal.

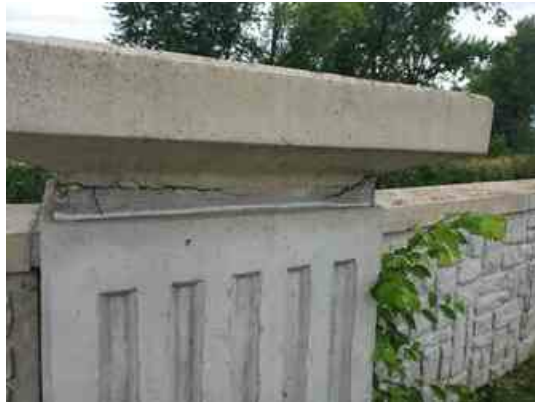
Inspect ID: 2021-0252 **Title:** 2604000008_CELRC_2021_A_0252_1_20210623T151226.jpg **Rated Item:** 4. Concrete Surfaces **Caption:** Minimally Acceptable - Spalling and cracking. Repair.

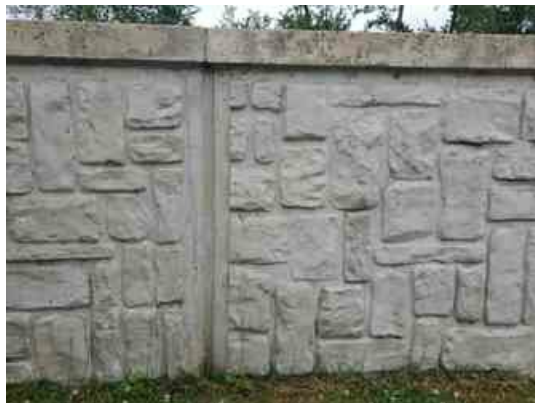
Inspect ID: 2021-0280 **Title:** 2604000008_CELRC_2021_A_0280_1_20210623T152150.jpg **Rated Item:** 4. Concrete Surfaces **Caption:** Minimally Acceptable - Crack on landside. Seal.

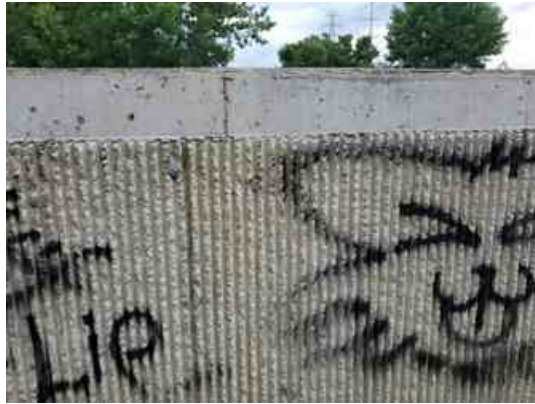
Inspect ID: 2021-0496 **Title:** 2604000008_CELRC_2021_A_0496_1_20210623T171312.jpg **Rated Item:** 4. Concrete Surfaces **Caption:** Minimally Acceptable - Multiple cracks on both sides of the floodwall. Seal.

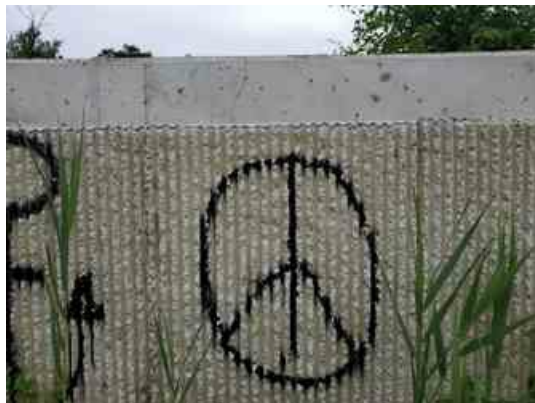
Inspect ID: 2021-0512 **Title:** 2604000008_CELRC_2021_A_0512_1_20210623T172037.jpg **Rated Item:** 4. Concrete Surfaces **Caption:** Minimally Acceptable - Cracking on landside. Seal.

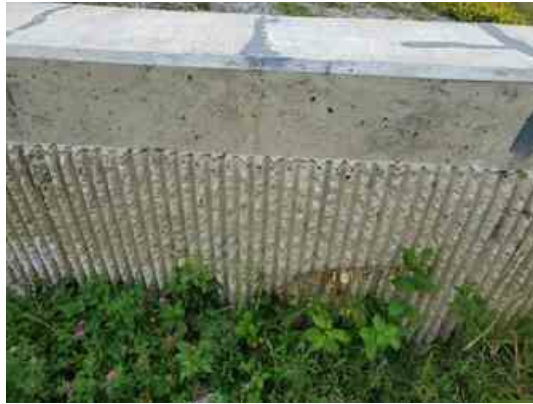
Inspect ID: 2021-0528 **Title:** 2604000008_CELRC_2021_A_0528_1_20210623T173608.jpg **Rated Item:** 4. Concrete Surfaces **Caption:** Minimally Acceptable - Multiples cracks on landside. Seal.

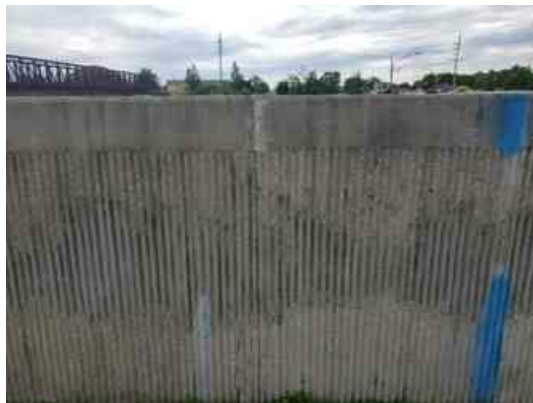
Inspect ID: 2021-0588 **Title:** 2604000008_CELRC_2021_A_0588_1_20210623T185758.jpg **Rated Item:** 4. Concrete Surfaces **Caption:** Minimally Acceptable - Crack on both sides. Seal.

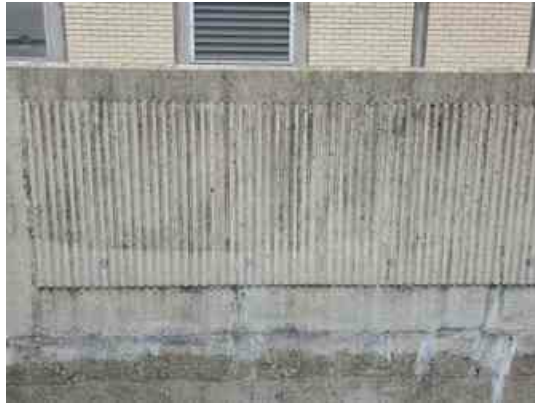
Inspect ID: 2021-0688 **Title:** 2604000008_CELRC_2021_A_0688_1_20210623T193845.jpg **Rated Item:** 4. Concrete Surfaces **Caption:** Minimally Acceptable - Typical cracking along entire section on riverside. Seal.

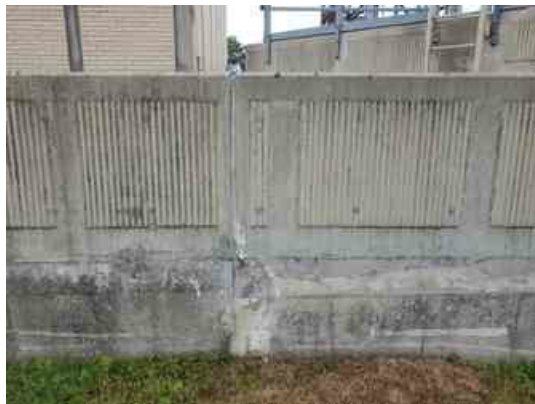
Inspect ID: 2021-0692 **Title:** 2604000008_CELRC_2021_A_0692_1_20210623T193921.jpg **Rated Item:** 4. Concrete Surfaces **Caption:** Minimally Acceptable - Spalling on riverside. Patch.

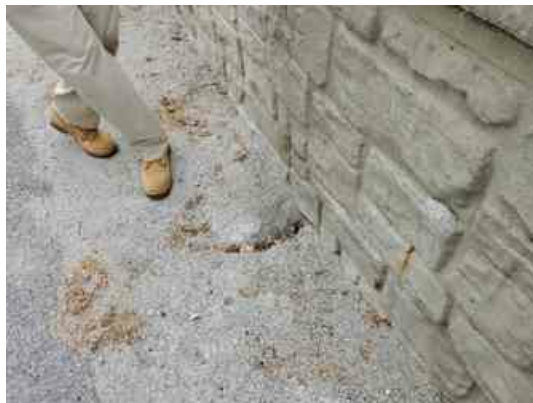
Inspect ID: 2021-0056 **Title:**
2604000008_CELRC_2021_A_0056_1_20210623T132407.jpg **Rated**
Item: 6. Foundation of Concrete Structures **Caption:** Acceptable - Gully on
ls. Fill.

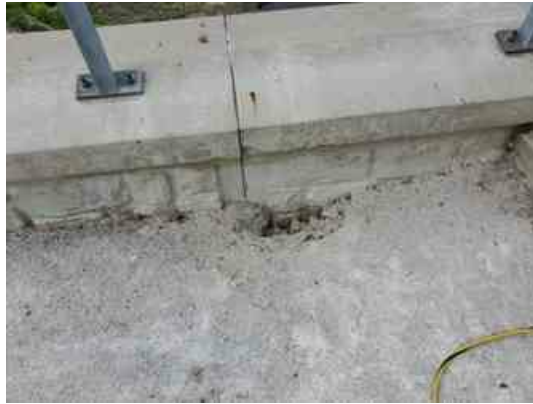
Inspect ID: 2021-0060 **Title:** 2604000008_CELRC_2021_A_0060_1_20210623T132502.jpg **Rated Item:** 6. Foundation of Concrete Structures **Caption:** Minimally Acceptable - Hole on landside. Fill.

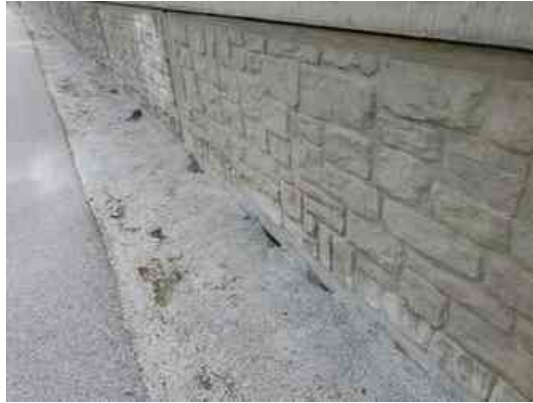
Inspect ID: 2021-0084 **Title:** 2604000008_CELRC_2021_A_0084_1_20210623T133716.jpg **Rated**
Item: 6. Foundation of Concrete Structures **Caption:** Minimally Acceptable - Line for holes on ls

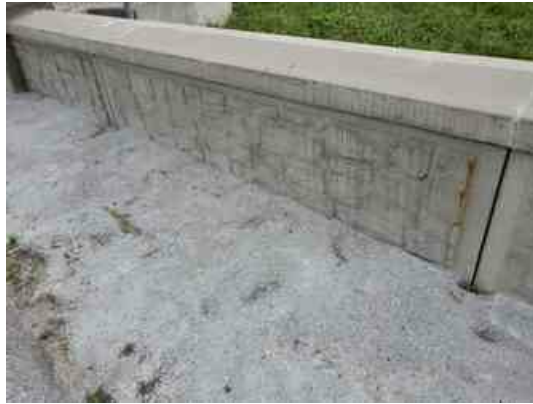
Inspect ID: 2021-0144 **Title:** 2604000008_CELRC_2021_A_0144_1_20210623T135956.jpg **Rated Item:** 6. Foundation of Concrete Structures **Caption:** Minimally Acceptable - 2 holes on landside. Fill.

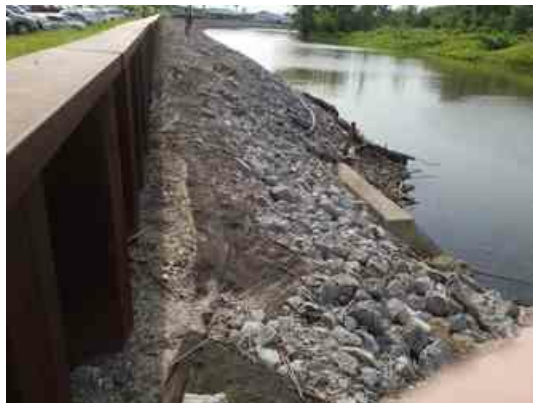
Inspect ID: 2021-0189 **Title:** 2604000008_CELRC_2021_A_0189_1_20210624T130830.jpg **Rated Item:** 6. Foundation of Concrete Structures **Caption:** Minimally Acceptable - Exposed geotextile on riverside. Replace.

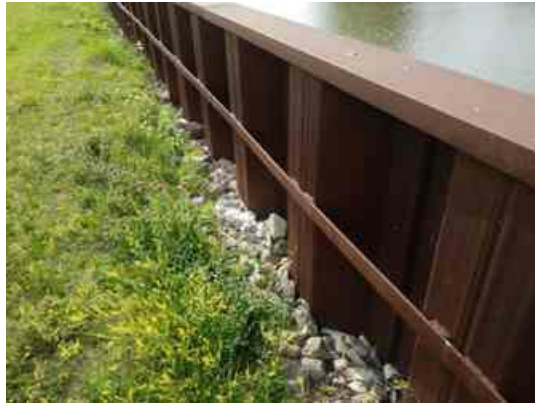
Inspect ID: 2021-0197 **Title:** 2604000008_CELRC_2021_A_2021-0197_2_20210624T131220.jpg **Rated Item:** 6. Foundation of Concrete Structures **Caption:** Minimally Acceptable - Settlement again sheet pile. Fill to drain away from the wall.

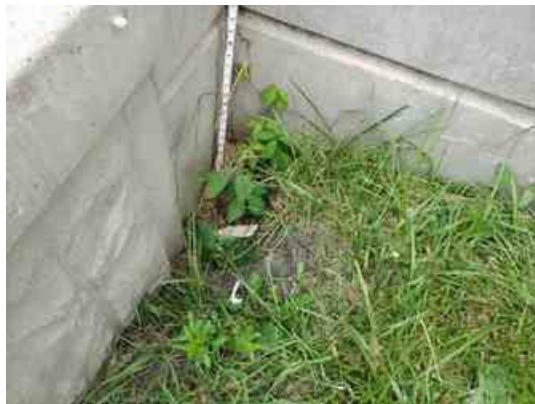
Inspect ID: 2021-0212 **Title:** 2604000008_CELRC_2021_A_0212_1_20210623T145722.jpg **Rated Item:** 6. Foundation of Concrete Structures **Caption:** Minimally Acceptable - Hole on the landside. Fill.

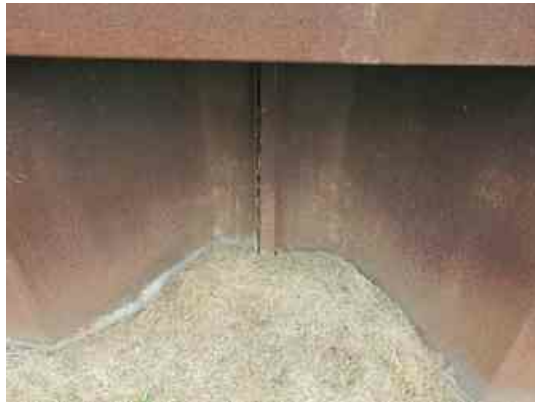
Inspect ID: 2021-0168 **Title:** 2604000008_CELRC_2021_A_0168_1_20210623T142041.jpg **Rated Item:** 7. Monolith Joints **Caption:** Minimally Acceptable - Grass in the interlocks. Clean.

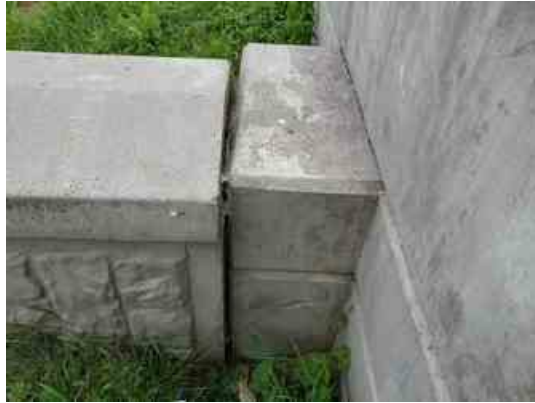
Inspect ID: 2021-0216 **Title:** 2604000008_CELRC_2021_A_0216_1_20210623T145842.jpg **Rated Item:** 7. Monolith Joints **Caption:** Minimally Acceptable - Deteriorating sealant. Remove old caulk and reseal.

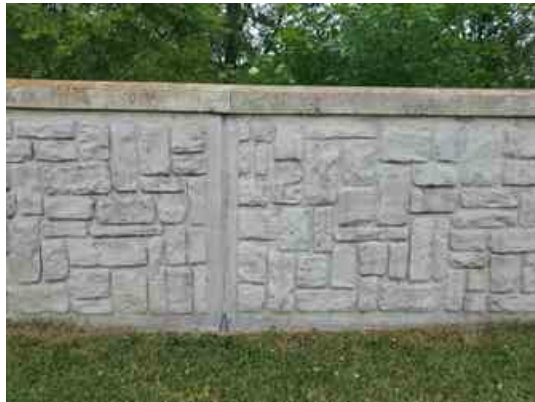
Inspect ID: 2021-0236 **Title:** 2604000008_CELRC_2021_A_0236_1_20210623T150618.jpg **Rated Item:** 7. Monolith Joints **Caption:** Minimally Acceptable - Deteriorating sealant. Remove old caulk and reseal.

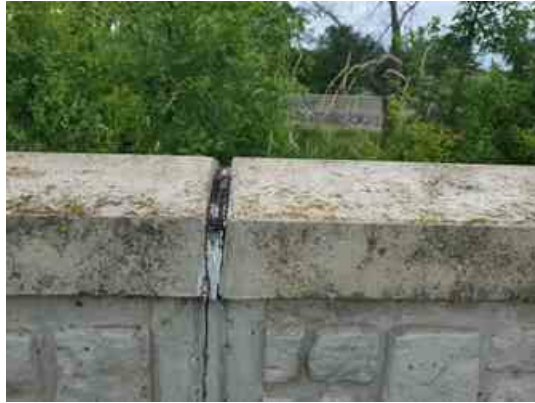
Inspect ID: 2021-0264 **Title:** 2604000008_CELRC_2021_A_0264_1_20210623T151725.jpg **Rated Item:** 7. Monolith Joints **Caption:** Minimally Acceptable - Deteriorating sealant. Remove old caulk and reseal.

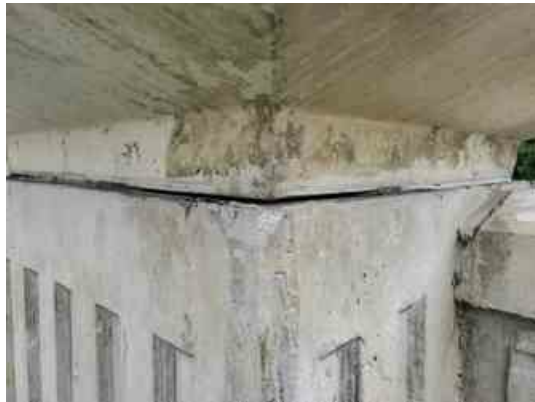
Inspect ID: 2021-0292 **Title:** 2604000008_CELRC_2021_A_0292_1_20210623T152436.jpg **Rated Item:** 7. Monolith Joints **Caption:** Minimally Acceptable - Missing sealant. Reseal.

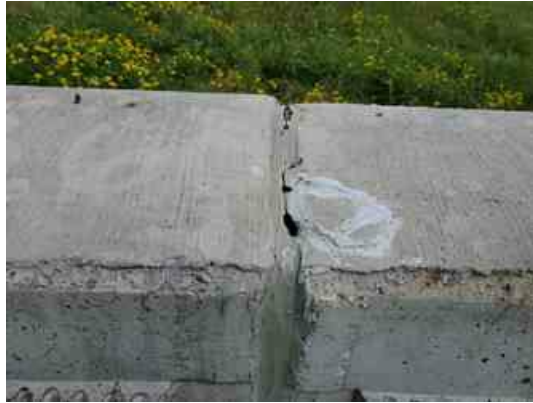
Inspect ID: 2021-0492 **Title:** 2604000008_CELRC_2021_A_0492_1_20210623T171057.jpg **Rated Item:** 7. Monolith Joints **Caption:** Minimally Acceptable - Deteriorating sealant. Remove old caulk and reseal.

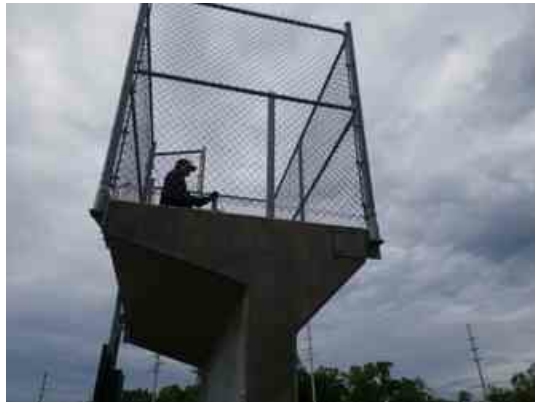
Inspect ID: 2021-0009 **Title:** 2604000008_CELRC_2021_A_0009_1_20210623T132408.jpg **Rated Item:** 4. Fencing and Gates **Caption:** Acceptable - HA-4: The fence is in good condition.

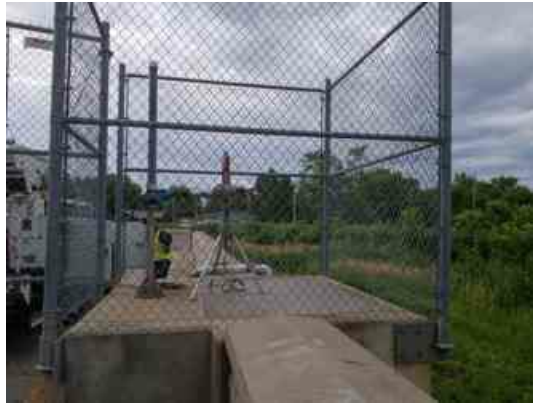
Inspect ID: 2021-0029 **Title:** 2604000008_CELRC_2021_A_0029_1_20210623T135706.jpg **Rated Item:** 4. Fencing and Gates **Caption:** Acceptable - HA-6: The fence is in good condition. Remove the small twigs that are on the fence.

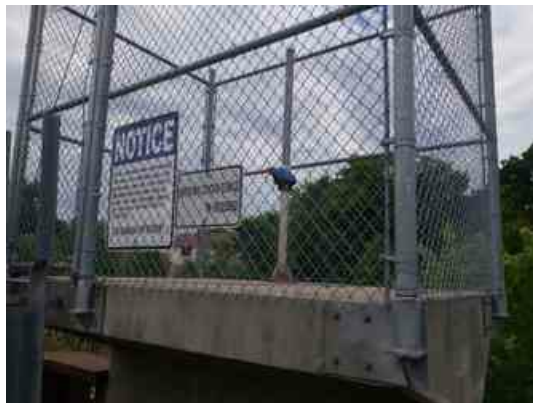
Inspect ID: 2021-0069 **Title:** 2604000008_CELRC_2021_A_0069_1_20210623T142929.jpg **Rated Item:** 4. Fencing and Gates **Caption:** Acceptable - HA-10: The sluice gate fencing is in good condition.

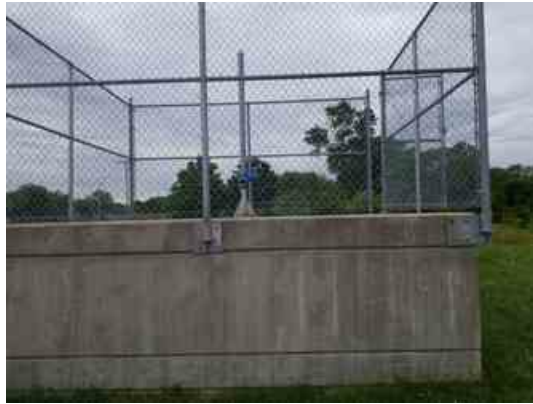
Inspect ID: 2021-0097 **Title:** 2604000008_CELRC_2021_A_0097_1_20210623T145801.jpg **Rated Item:** 4. Fencing and Gates **Caption:** Acceptable - Ha12 the fencing is in good condition

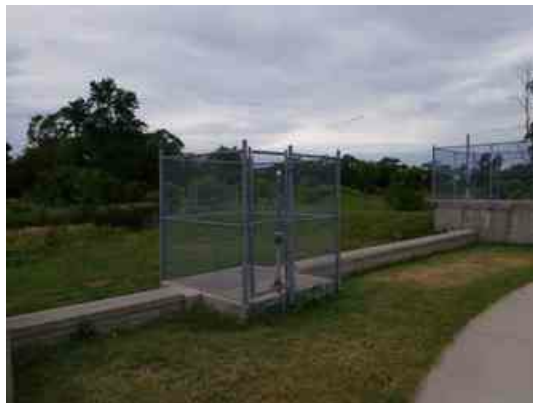
Inspect ID: 2021-0109 **Title:** 2604000008_CELRC_2021_A_0109_1_20210623T150538.jpg **Rated Item:** 4. Fencing and Gates **Caption:** Acceptable - HA-13: The fence is in good condition.

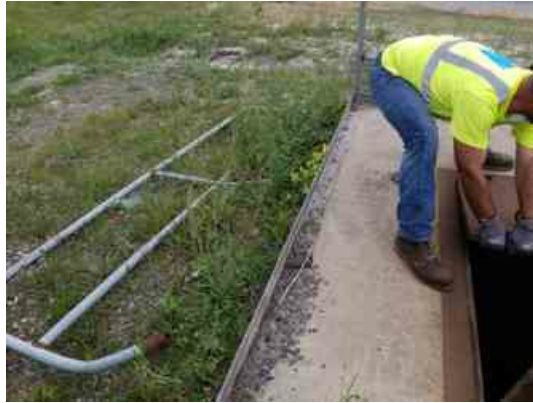
Inspect ID: 2021-0122 **Title:** 2604000008_CELRC_2021_A_0122_1_20210623T180510.jpg **Rated Item:** 4. Fencing and Gates **Caption:** Minimally Acceptable - HA-20: Broken rail. Repair.

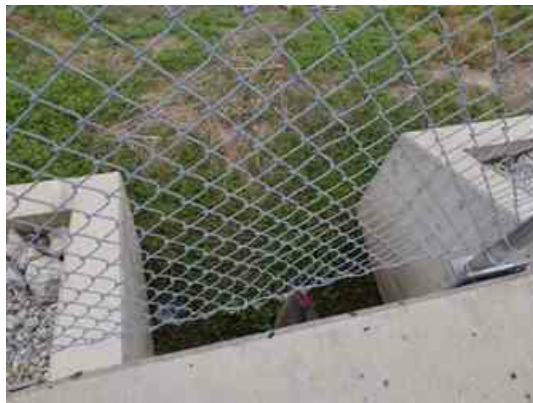
Inspect ID: 2021-0129 **Title:** 2604000008_CELRC_2021_A_0129_1_20210623T155430.jpg **Rated Item:** 9. Culverts/ Discharge Pipes **Caption:** Acceptable - Ha16 The discharge culvert is in good condition.

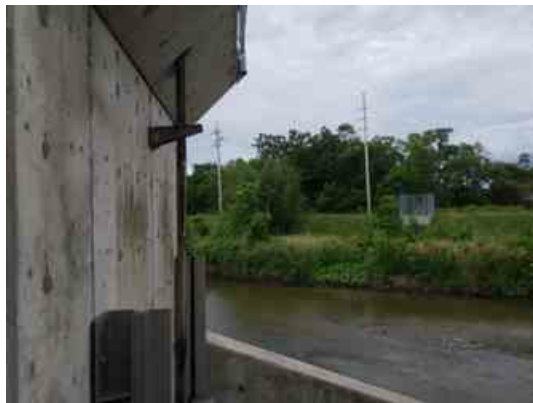
Inspect ID: 2021-0017 **Title:** 2604000008_CELRC_2021_A_0017_1_20210623T132931.jpg **Rated Item:** 10. Sluice/ Slide Gates **Caption:** Acceptable - HA-4: The sluice gate was in good condition. The operator used the day to service the gates and greased them the day of the inspection.

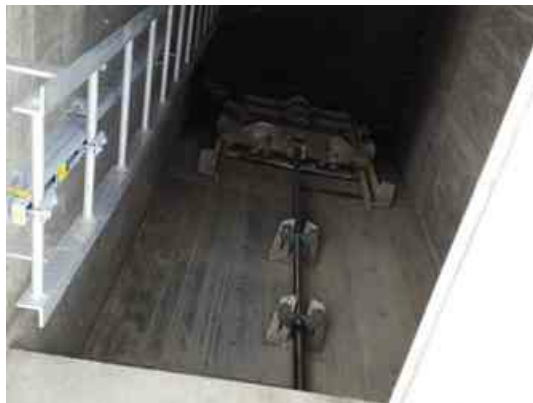
Inspect ID: 2021-0026 **Title:** 2604000008_CELRC_2021_A_0026_1_20210623T134925.jpg **Rated Item:** 10. Sluice/ Slide Gates **Caption:** Acceptable - HA-35: Closed and opened without issue, lubricated in the process.

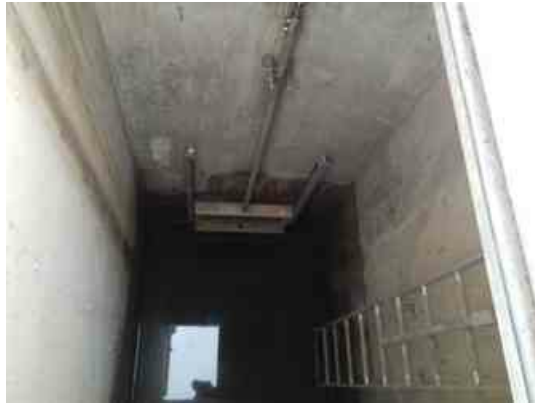
Inspect ID: 2021-0033 **Title:** 2604000008_CELRC_2021_A_0033_1_20210623T140042.jpg **Rated Item:** 10. Sluice/ Slide Gates **Caption:** Acceptable - HA-6: The sluice gate is in good condition and closed and opened completely. It was opened when we arrived we left it open when we left.

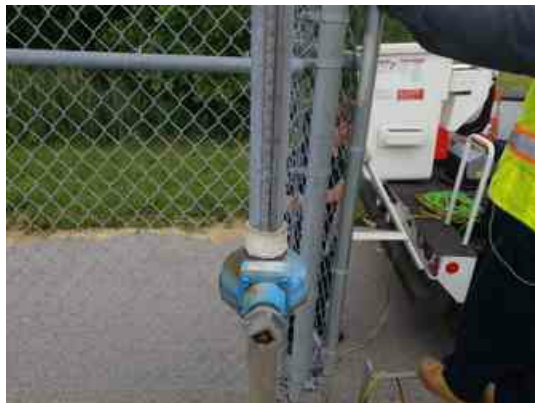
Inspect ID: 2021-0037 **Title:** 2604000008_CELRC_2021_A_0037_1_20210623T140327.jpg **Rated Item:** 10. Sluice/ Slide Gates **Caption:** Acceptable - HA-6: The sluice gate pinion is in good good condition, the operator oiled it the day of.

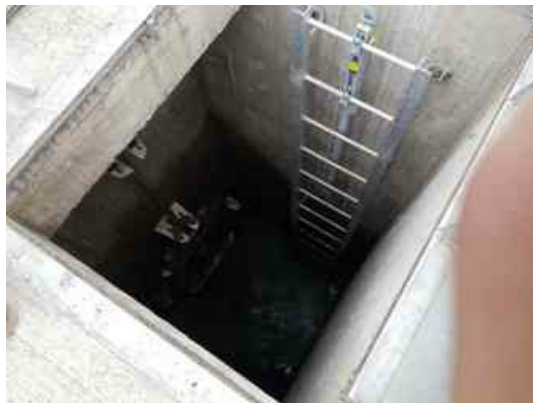
Inspect ID: 2021-0042 **Title:** 2604000008_CELRC_2021_A_0042_1_20210623T141000.jpg **Rated Item:** 10. Sluice/ Slide Gates **Caption:** Acceptable - HA-31: Closed and opened without issue.

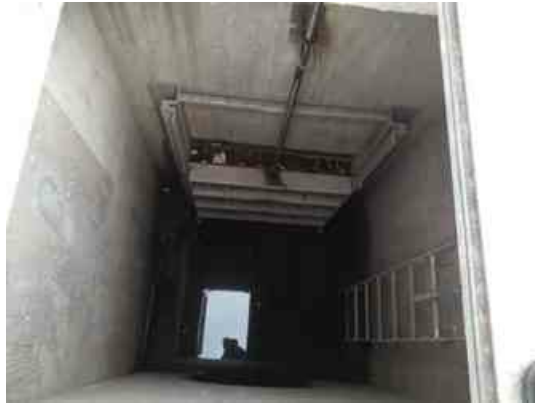
Inspect ID: 2021-0045 **Title:** 2604000008_CELRC_2021_A_0045_1_20210623T141350.jpg **Rated Item:** 10. Sluice/ Slide Gates **Caption:** Acceptable - HA-8: The sluice gate is in good condition, it opened and closed completely. When we arrived it was opened and we left it open when we left.

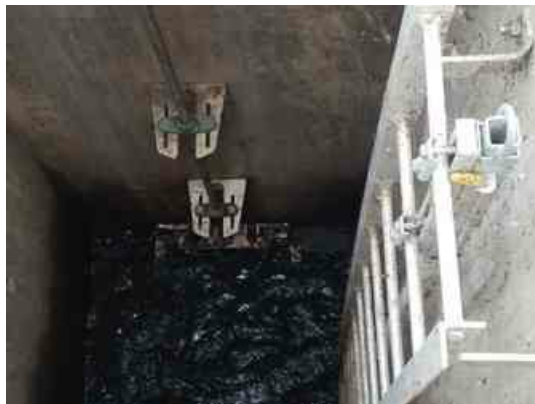
Inspect ID: 2021-0050 **Title:** 2604000008_CELRC_2021_A_0050_1_20210623T142048.jpg **Rated Item:** 10. Sluice/ Slide Gates **Caption:** Acceptable - HA-30: Opened and closed without issue. Inlet and outlet are below water level.

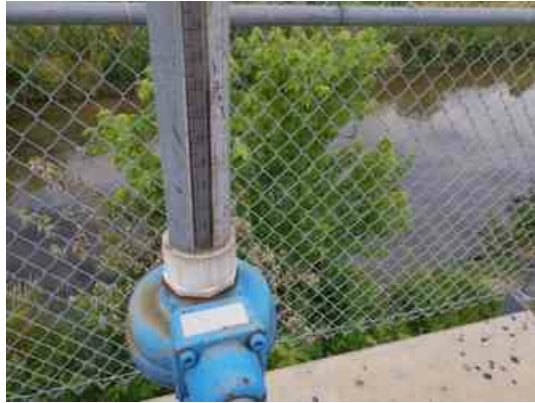
Inspect ID: 2021-0065 **Title:** 2604000008_CELRC_2021_A_0065_1_20210623T142827.jpg **Rated Item:** 10. Sluice/ Slide Gates **Caption:** Minimally Acceptable - HA-10: The sluice gate is well greased and in good condition. The operator greased them the day of.

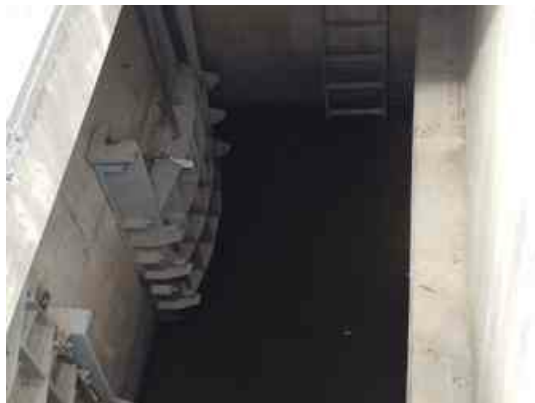
Inspect ID: 2021-0066 **Title:** 2604000008_CELRC_2021_A_0066_1_20210623T145134.jpg **Rated Item:** 10. Sluice/ Slide Gates **Caption:** Acceptable - HA-26a: Operates without issue.

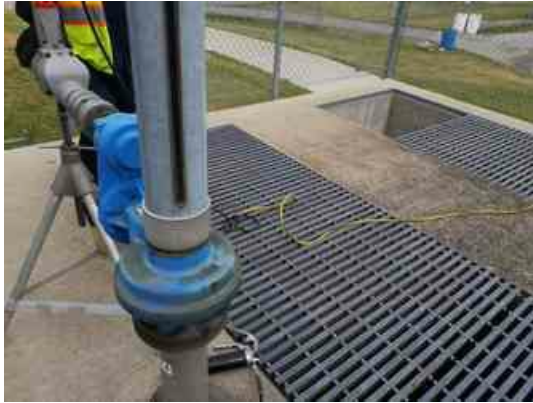
Inspect ID: 2021-0077 **Title:** 2604000008_CELRC_2021_A_0077_1_20210623T144258.jpg **Rated Item:** 10. Sluice/ Slide Gates **Caption:** Acceptable - HA-12: The sluice gates pinion is in good condition. He crew greased the gates while we were on site.

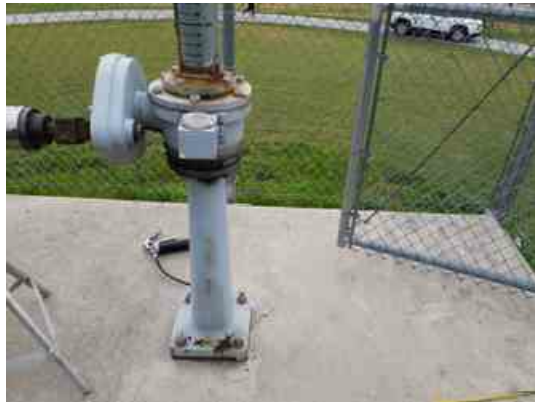
Inspect ID: 2021-0133 **Title:** 2604000008_CELRC_2021_A_0133_1_20210623T155955.jpg **Rated Item:** 10. Sluice/ Slide Gates **Caption:** Minimally Acceptable - HA-16: The pinion goes up and down with little to no resistance. Slight rusting on outer metallic casing. Recommended painting.

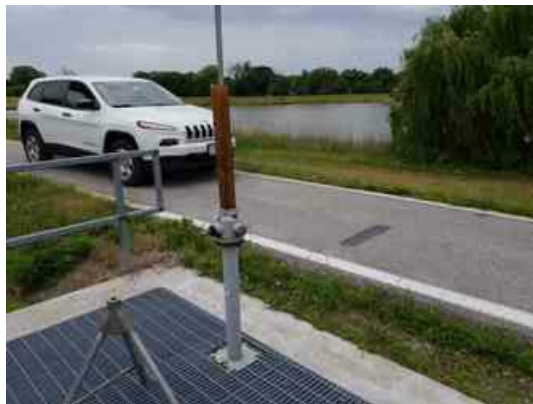
Inspect ID: 2021-0161 **Title:** 2604000008_CELRC_2021_A_0161_1_20210623T164500.jpg **Rated Item:** 10. Sluice/ Slide Gates **Caption:** Minimally Acceptable - HA-17: Sluice gate pinion case is broken and rusting. Recommend replacing case and painted rusted parts. The operator greased the pinon that day.

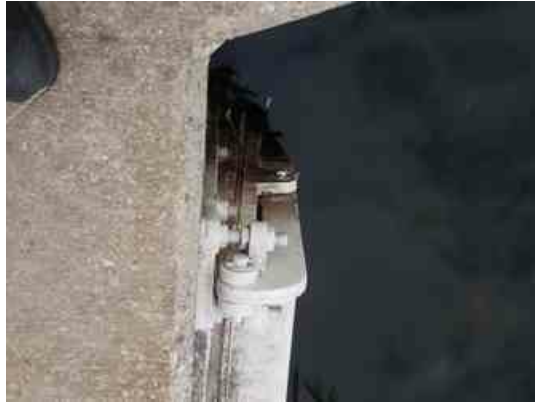
Inspect ID: 2021-0014 **Title:** 2604000008_CELRC_2021_A_0014_1_20210623T133621.jpg **Rated Item:** 11. Flap Gates/ Flap Valves/ Pinch Valves **Caption:** Minimally Acceptable - HA-35: Flap gate cracked open. Clear debris.

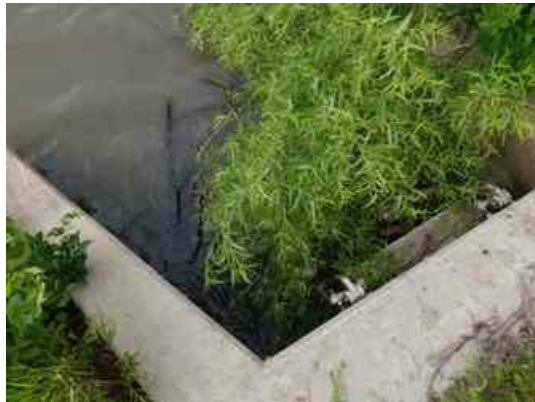
Inspect ID: 2021-0034 **Title:** 2604000008_CELRC_2021_A_0034_2_20210623T140618.jpg **Rated Item:** 11. Flap Gates/ Flap Valves/ Pinch Valves **Caption:** Minimally Acceptable - HA-31: Vegetation and debris too close outlet. Flap gate slightly open. Clear.

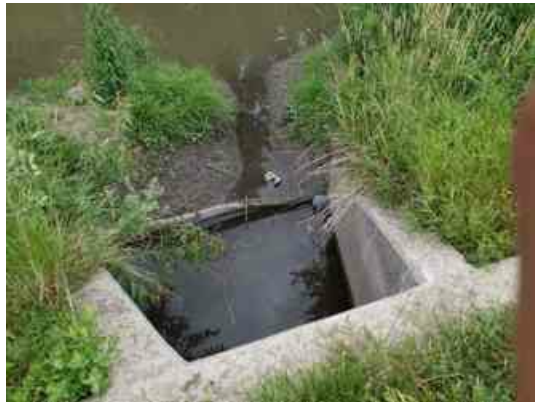
Inspect ID: 2021-0094 **Title:** 2604000008_CELRC_2021_A_0094_1_20210623T155711.jpg **Rated Item:** 11. Flap Gates/ Flap Valves/ Pinch Valves **Caption:** Minimally Acceptable - HA-23: Flap gate leaking, tree logs in the way, too much vegetation. Clear obstructions and vegetation.

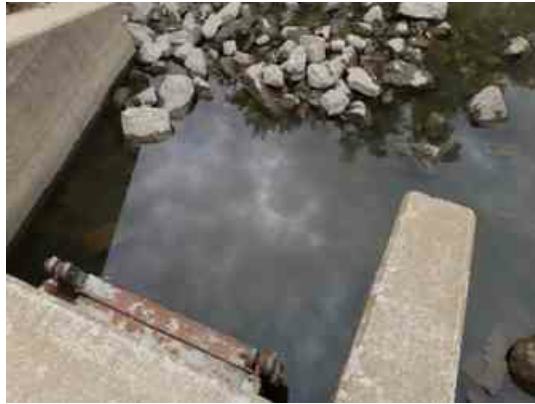
Inspect ID: 2021-0169 **Title:** 2604000008_CELRC_2021_A_0169_1_20210623T164837.jpg **Rated Item:** 11. Flap Gates/ Flap Valves/ Pinch Valves **Caption:** Minimally Acceptable - HA-18: Flap gate is closed completely, mild rusting on the top. Repaint.

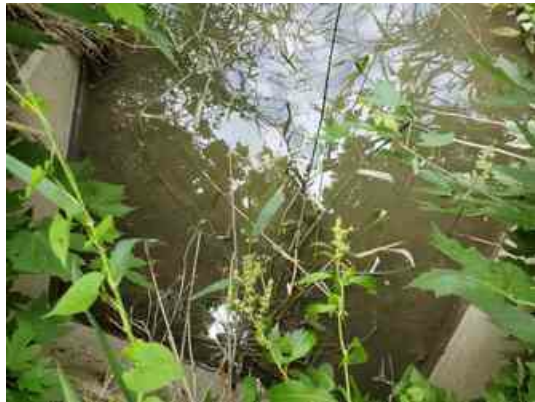
Inspect ID: 2021-0184 **Title:** 2604000008_CELRC_2021_A_0184_1_20210623T142801.jpg **Rated Item:** 11. Flap Gates/ Flap Valves/ Pinch Valves **Caption:** Minimally Acceptable - HA-11: Pinch valve covered in sediment. Clear.

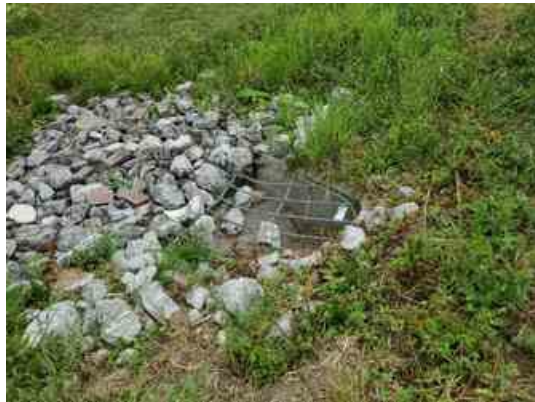
Inspect ID: 2021-0156 **Title:** 2604000008_CELRC_2021_A_0156_1_20210623T141133.jpg **Rated Item:** 12. Trash Racks (non-mechanical) **Caption:** Minimally Acceptable - HA-9: Trash rack is deformed. Repair.

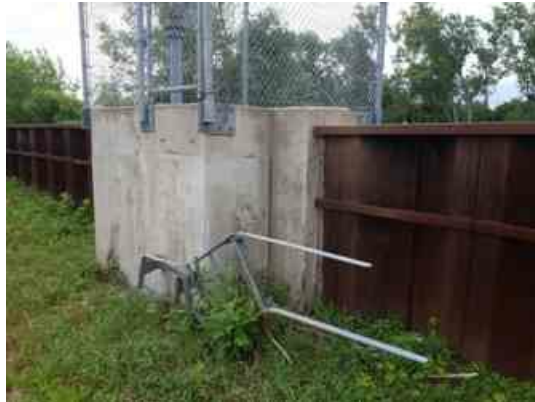
Inspect ID: 2021-0010 **Title:** 2604000008_CELRC_2021_A_0010_1_20210623T133452.jpg **Rated Item:** 13. Other Metallic Items **Caption:** Unacceptable - Broken ladder at sluice gate HA-35. Sponsor looking into replacement.

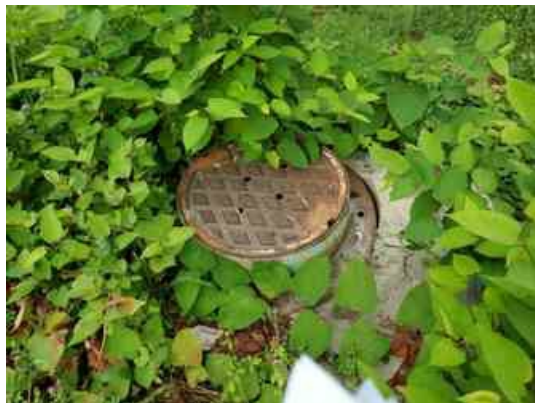
Inspect ID: 2021-0012 **Title:** 2604000008_CELRC_2021_A_0012_1_20210623T130749.jpg **Rated Item:** 13. Other Metallic Items **Caption:** Minimally Acceptable - HA-1: Secure manhole cover.

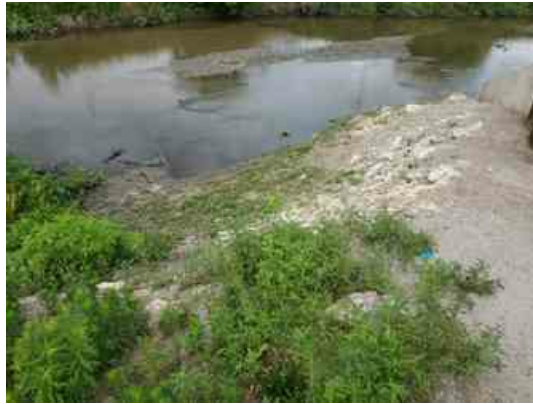
Inspect ID: 2021-0064 **Title:** 2604000008_CELRC_2021_A_0064_1_20210623T132727.jpg **Rated Item:** 14. Riprap Revetments of Inlet/ Discharge Areas **Caption:** Minimally Acceptable - Riprap missing and some covered with silt. Add riprap.

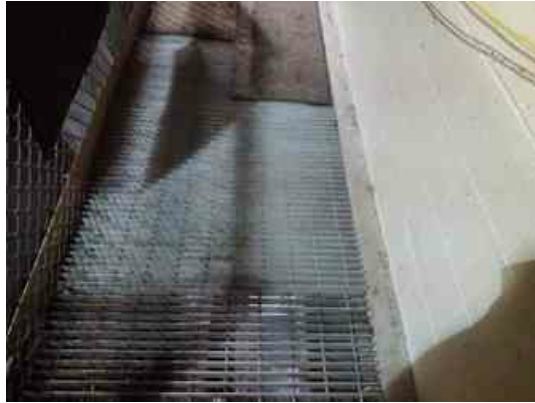
Inspect ID: 2021-0055 **Title:** 2604000008_CELRC_2021_A_0055_1_20210621T161913.jpg **Rated Item:** 3. Safety Compliance **Caption:** Minimally Acceptable - PS-SS: Grate clamps missing near trash rakes. Replace or install as this is a trip and fall hazard.

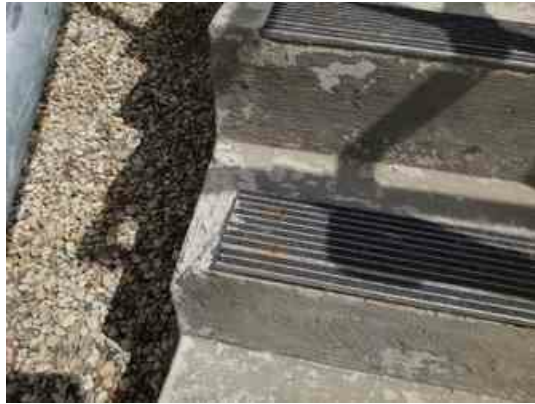
Inspect ID: 2021-0003 **Title:** 2604000008_CELRC_2021_A_0003_1_20210621T153050.jpg **Rated Item:** 5. Plant Building **Caption:** Minimally Acceptable - PS-JA: Spalling on concrete steps. Patch.
