**US Army Corps
of Engineers®**

Levee Inspection Report

Name of System: Highland

Date(s) of Inspection: 06/22/2021 - 06/22/2021

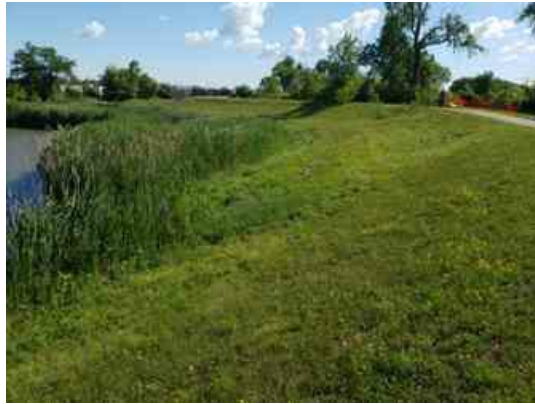
Inspect ID: 2021-0064 **Title:** 2604000007_CELRC_2021_A_0064_1_20210622T140354.jpg **Rated Item:** 6. Erosion/ Bank Caving **Caption:** Minimally Acceptable - Erosion cutting into corner. Add riprap to restore bank.

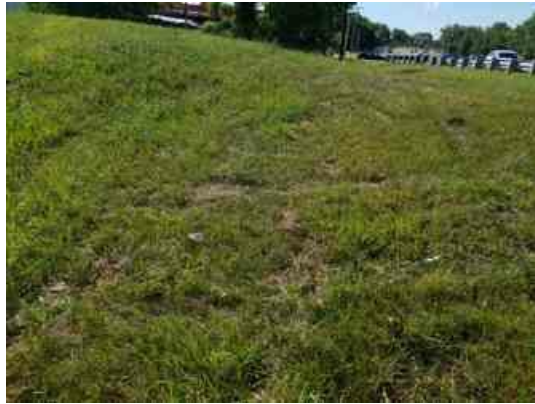
Inspect ID: 2021-0088 **Title:** 2604000007_CELRC_2021_A_0088_1_20210622T141725.jpg **Rated Item:** 8. Depressions/ Rutting **Caption:** Acceptable - Low area east of Indianapolis Blvd. Monitor.

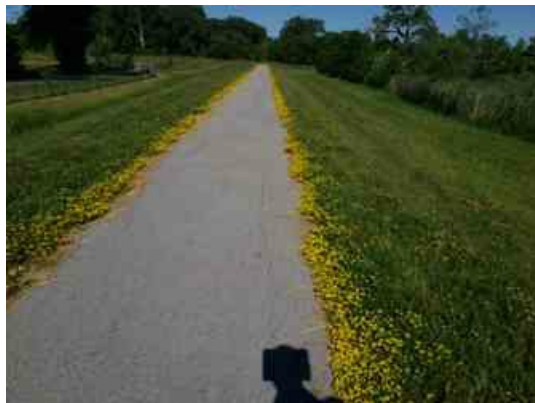
Inspect ID: 2021-0058 **Title:** 2604000007_CELRC_2021_A_0058_1_20210622T135924.jpg **Rated Item:** 9. Cracking **Caption:** Acceptable - Pavement cracking. Monitor.

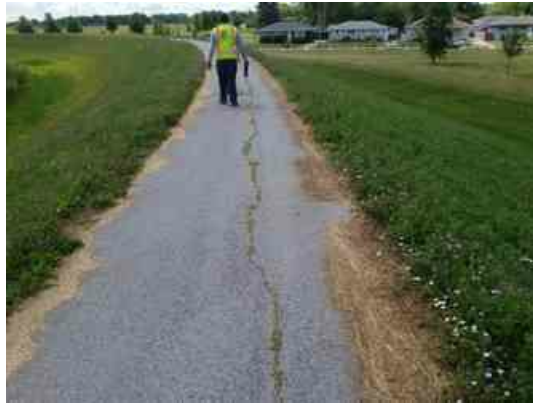
Inspect ID: 2021-0211 **Title:** 2604000007_CELRC_2021_A_0211_1_20210622T161451.jpg **Rated Item:** 9. Cracking **Caption:** Acceptable - Long longitudinal cracking on crown. Monitor.

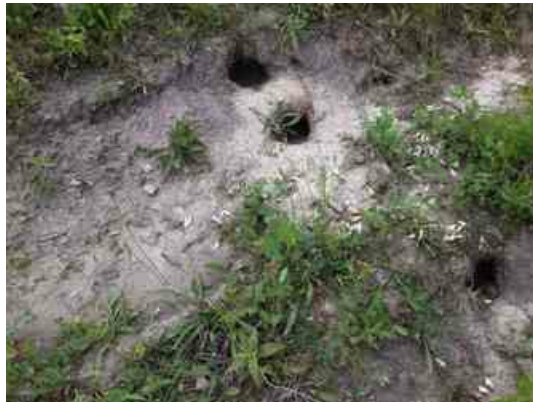
Inspect ID: 2021-0176 **Title:** 2604000007_CELRC_2021_A_0176_1_20210622T165147.jpg **Rated Item:** 10. Animal Control **Caption:** Minimally Acceptable - Animal burrows on riverside slope, around 10 in deep. Fill holes.

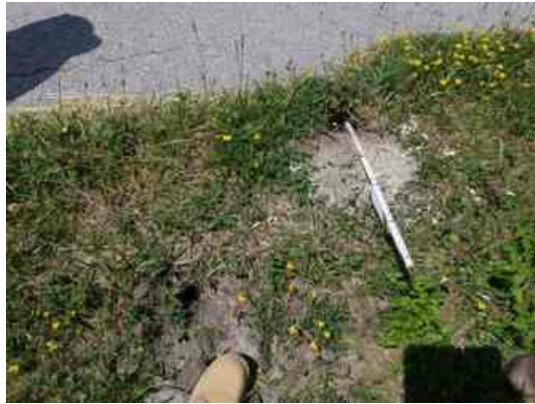
Inspect ID: 2021-0244 **Title:** 2604000007_CELRC_2021_A_0244_1_20210622T163828.jpg **Rated Item:** 10. Animal Control **Caption:** Minimally Acceptable - 2 turtle egg holes on riverside slope. Fill holes.

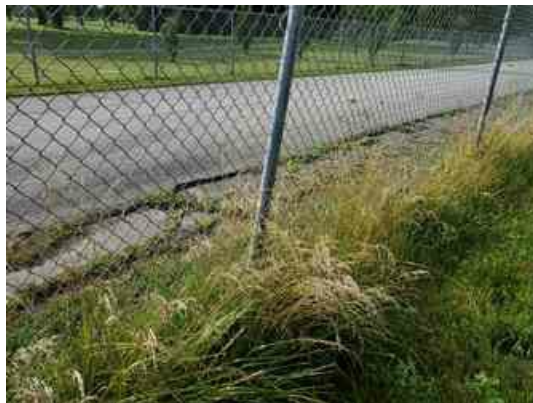
N/A	There are no relief wells/ toe drainage systems along this component of the FDR segment / system.	
15. Seepage	M	A	No evidence or history of unrepaired seepage, saturated areas, or boils.	2021-0263 : Area of pin boils on landside toe by asphalt path. No repairs performed but monitoring. (M) Justification: Area of pin boils. No repairs performed but monitoring.
		M	Evidence or history of minor unrepaired seepage or small saturated areas at or beyond the landside toe but not on the landward slope of levee. No evidence of soil transport.	
		U	Evidence or history of active seepage, extensive saturated areas, or boils.

Inspect ID: 2021-0263 **Title:** 2604000007_CELRC_2021_A_0263_1_20210913T144720.jpg **Rated Item:** 15. Seepage **Caption:** Minimally Acceptable - Area of pin boils on landside toe by asphalt path. No repairs performed but monitoring.

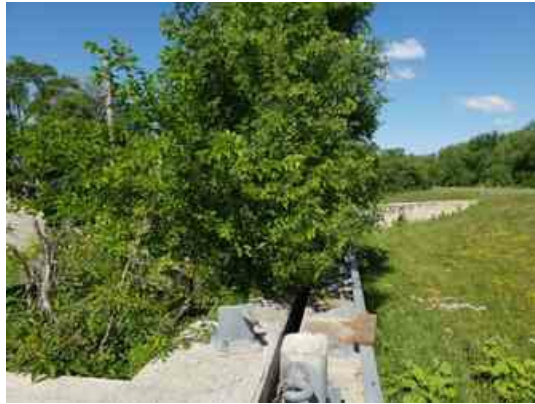
Inspect ID: 2021-0103 **Title:** 2604000007_CELRC_2021_A_0103_1_20210622T144427.jpg **Rated Item:** 1. Unwanted Vegetation Growth **Caption:** Minimally Acceptable - Trees on landside. Cut.

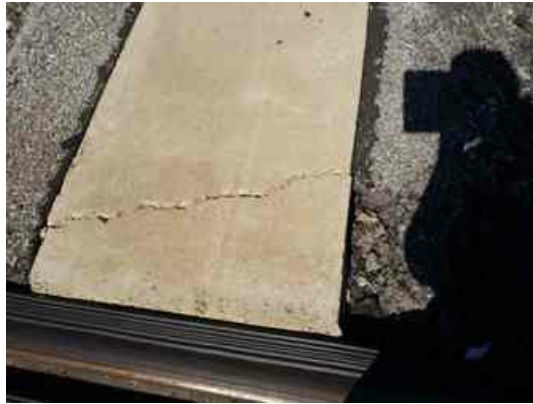
Inspect ID: 2021-0106 **Title:** 2604000007_CELRC_2021_A_0106_1_20210622T144607.jpg **Rated Item:** 3. Closure Structures (Stop Log Closures and Gates) (A or U only) **Caption:** Acceptable - Crack on concrete sill. Repair.

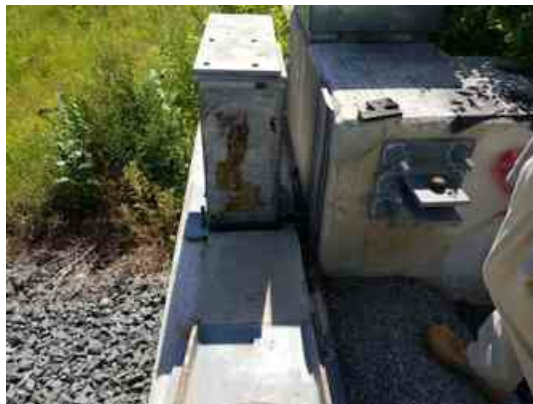
Inspect ID: 2021-0109 **Title:** 2604000007_CELRC_2021_A_0109_1_20210622T144909.jpg **Rated Item:** 3. Closure Structures (Stop Log Closures and Gates) (A or U only) **Caption:** Acceptable - Missing rubber seal. Replace.

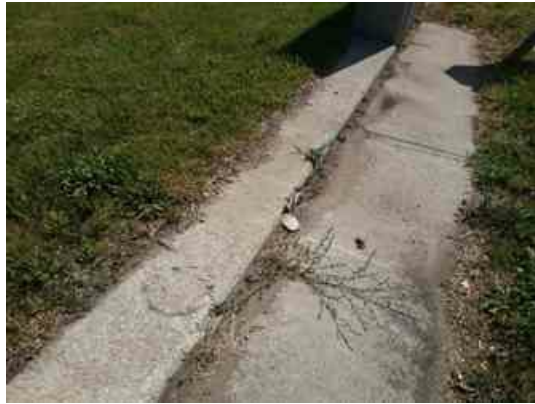
Inspect ID: 2021-0130 **Title:** 2604000007_CELRC_2021_A_0130_1_20210622T151234.jpg **Rated Item:** 3. Closure Structures (Stop Log Closures and Gates) (A or U only) **Caption:** Acceptable - Spalling and grass on sill. Clear off concrete.

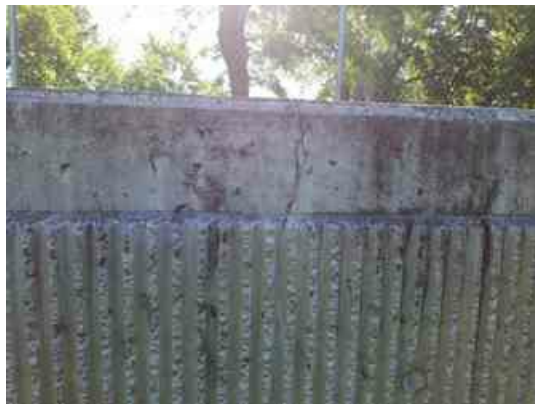
Inspect ID: 2021-0013 **Title:** 2604000007_CELRC_2021_A_0013_1_20210622T132200.jpg **Rated Item:** 4. Concrete Surfaces **Caption:** Minimally Acceptable - Crack on riverside. Seal.

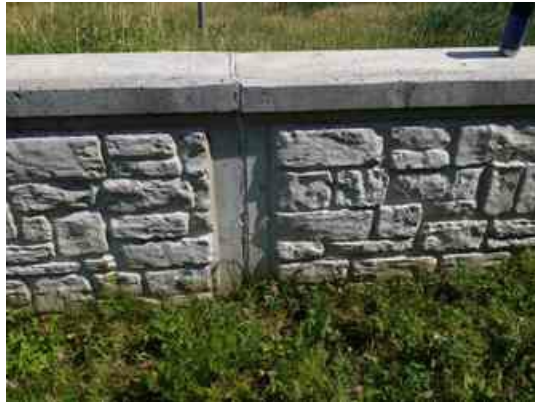
Inspect ID: 2021-0118 **Title:** 2604000007_CELRC_2021_A_0118_1_20210622T145630.jpg **Rated Item:** 4. Concrete Surfaces **Caption:** Minimally Acceptable - Crack on landside. Seal.

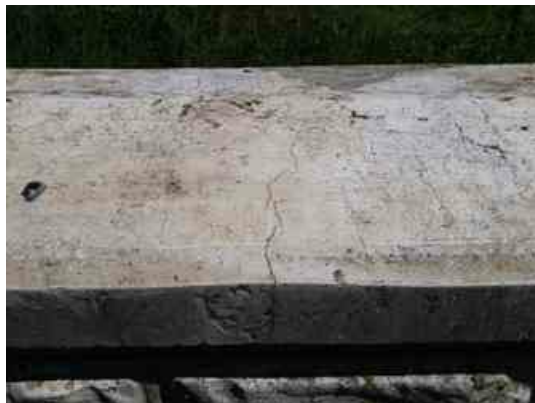
Inspect ID: 2021-0121 **Title:** 2604000007_CELRC_2021_A_0121_1_20210622T150007.jpg **Rated Item:** 4. Concrete Surfaces **Caption:** Acceptable - Minor cracking on top, typical. Monitor.

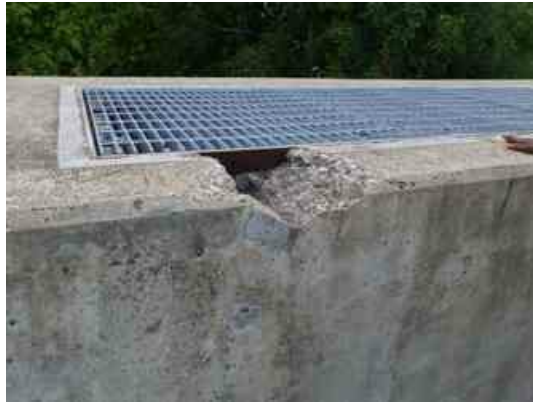
Inspect ID: 2021-0148 **Title:** 2604000007_CELRC_2021_A_0148_1_20210622T153751.jpg **Rated Item:** 4. Concrete Surfaces **Caption:** Minimally Acceptable - Spalling by North 5th PS outlet. Patch.

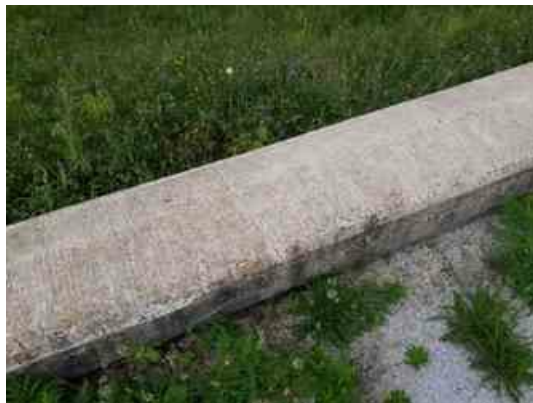
Inspect ID: 2021-0175 **Title:** 2604000007_CELRC_2021_A_0175_1_20210622T155400.jpg **Rated Item:** 4. Concrete Surfaces **Caption:** Minimally Acceptable - Crack in cap, typical. Seal.

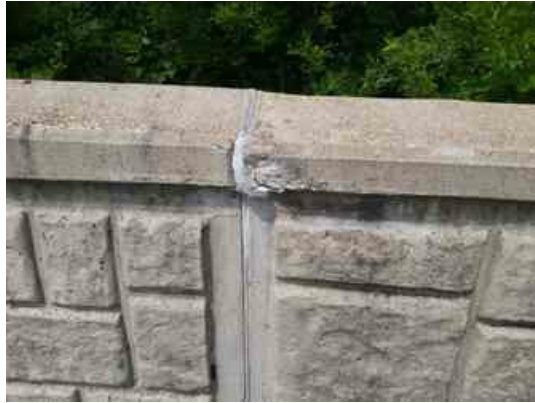
Inspect ID: 2021-0181 **Title:** 2604000007_CELRC_2021_A_0181_1_20210622T155637.jpg **Rated Item:** 4. Concrete Surfaces **Caption:** Minimally Acceptable - Spalling on landside cap. Patch.

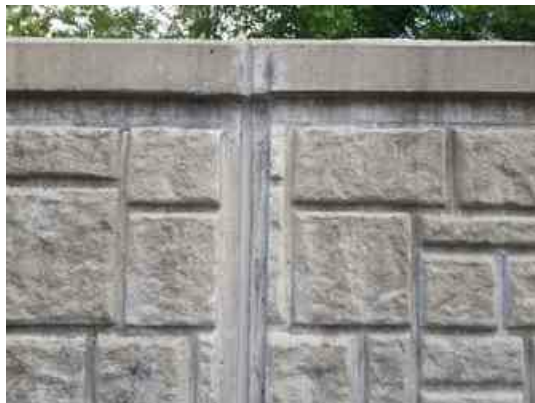
Inspect ID: 2021-0187 **Title:** 2604000007_CELRC_2021_A_0187_1_20210622T160001.jpg **Rated Item:** 4. Concrete Surfaces **Caption:** Minimally Acceptable - Crack on landside. Seal.

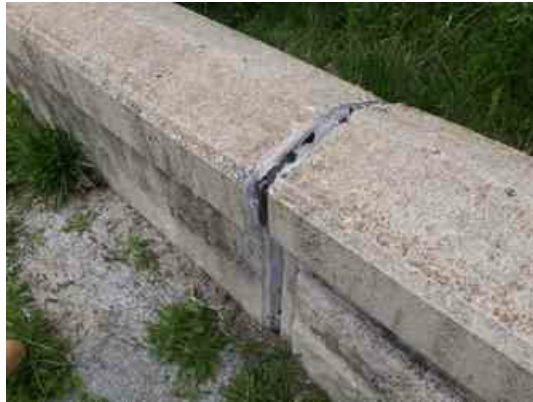
Inspect ID: 2021-0178 **Title:** 2604000007_CELRC_2021_A_0178_1_20210622T155446.jpg **Rated Item:** 5. Tilting, Sliding or Settlement of Concrete Structures **Caption:** Minimally Acceptable - 1.5 inch offset. Continued deterioration of sealant. Remove old sealant, seal, and monitor for continued movement.

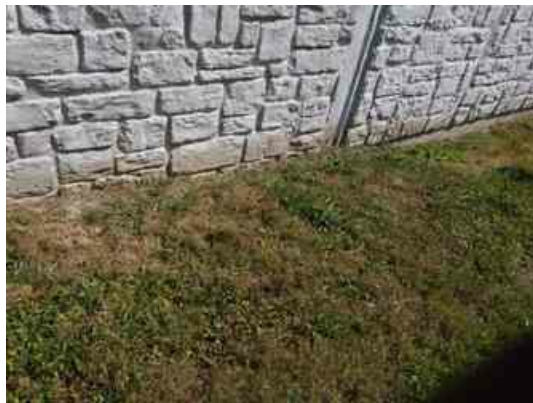
Inspect ID: 2021-0127 **Title:** 2604000007_CELRC_2021_A_0127_1_20210622T151045.jpg **Rated Item:** 6. Foundation of Concrete Structures **Caption:** Minimally Acceptable - Low spot along wall on landside. Fill.

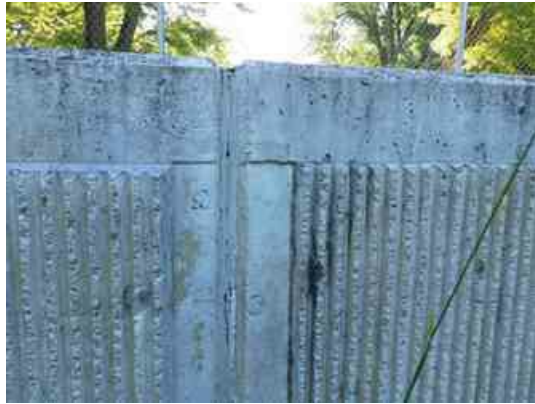
Inspect ID: 2021-0016 **Title:** 2604000007_CELRC_2021_A_0016_1_20210622T132404.jpg **Rated Item:** 7. Monolith Joints **Caption:** Minimally Acceptable - Deterioration of sealant. Remove old caulking and reseal.

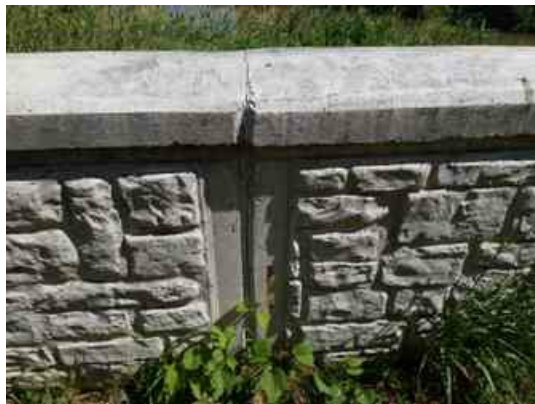
Inspect ID: 2021-0124 **Title:** 2604000007_CELRC_2021_A_0124_1_20210622T150320.jpg **Rated Item:** 7. Monolith Joints **Caption:** Minimally Acceptable - Deteriorating sealant on both sides, typical. Remove old caulking and reseal.

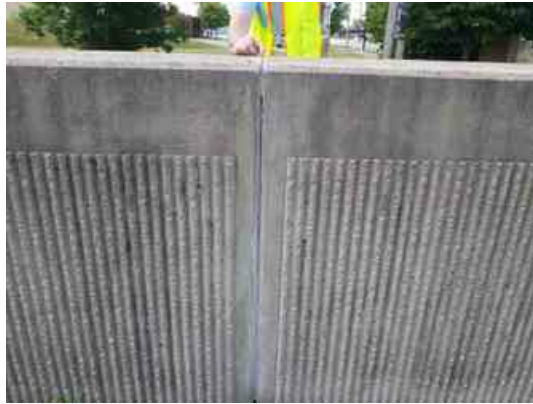
Inspect ID: 2021-0133 **Title:** 2604000007_CELRC_2021_A_0133_1_20210622T151322.jpg **Rated Item:** 7. Monolith Joints **Caption:** Minimally Acceptable - Deteriorating sealant on both sides. Remove old caulking and reseal.

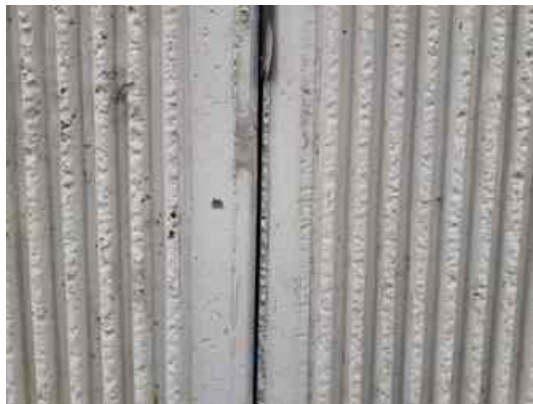
Inspect ID: 2021-0143 **Title:** 2604000007_CELRC_2021_A_0143_1_20210622T162939.jpg **Rated Item:** 7. Monolith Joints **Caption:** Minimally Acceptable - Missing sealant on both sides of the floodwall. Check that filler is present and seal.

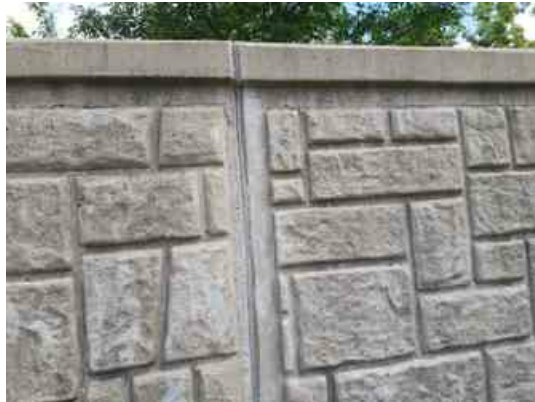
Inspect ID: 2021-0184 **Title:** 2604000007_CELRC_2021_A_0184_1_20210622T155910.jpg **Rated Item:** 7. Monolith Joints **Caption:** Minimally Acceptable - Deteriorating sealant. Remove old caulking and reseal.

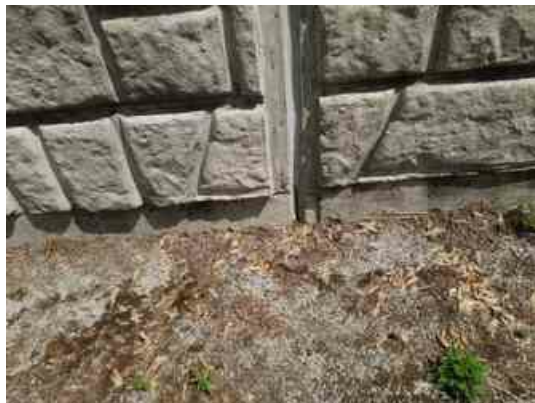
Inspect ID: 2021-0193 **Title:** 2604000007_CELRC_2021_A_0193_1_20210622T160142.jpg **Rated Item:** 7. Monolith Joints **Caption:** Minimally Acceptable - Sealant missing from bottom of joint. Seal.

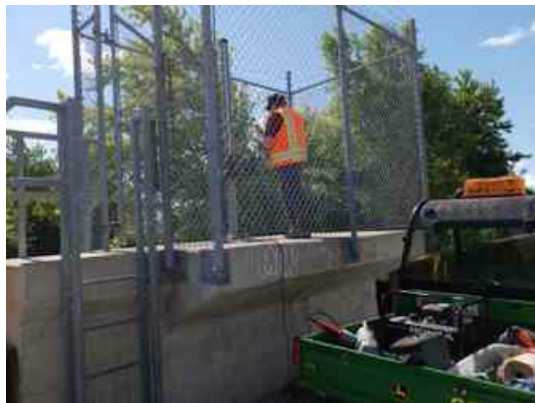
Inspect ID: 2021-0047 **Title:** 2604000007_CELRC_2021_A_0047_1_20210622T145229.jpg **Rated Item:** 4. Fencing and Gates **Caption:** Acceptable - HI-7: The fence is intact and in good condition. There is a small amount of graffiti on the side of the concrete structure.

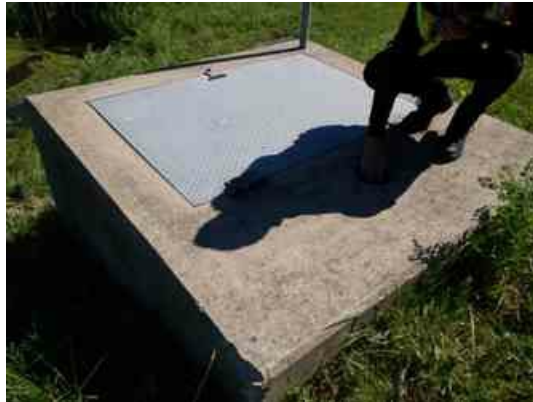
Inspect ID: 2021-0023 **Title:** 2604000007_CELRC_2021_A_0023_1_20210622T140602.jpg **Rated Item:** 5. Concrete Surfaces (Such as gate wells, outfalls, intakes, or culverts) **Caption:** Acceptable - HI-5: Minor spalling at the edges.

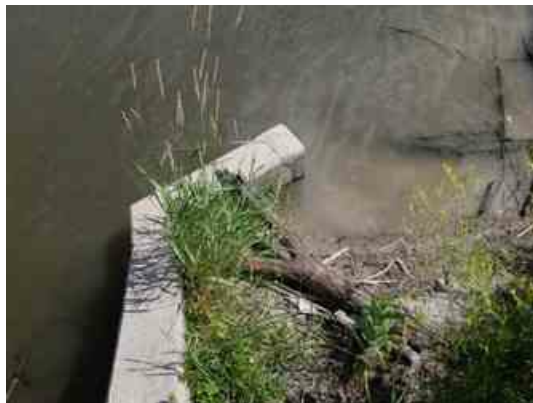
Inspect ID: 2021-0065 **Title:** 2604000007_CELRC_2021_A_0065_1_20210622T150934.jpg **Rated Item:** 5. Concrete Surfaces (Such as gate wells, outfalls, intakes, or culverts) **Caption:** Minimally Acceptable - HI-9: There is a crack reforming on the outlet headwall. Seal or repair.

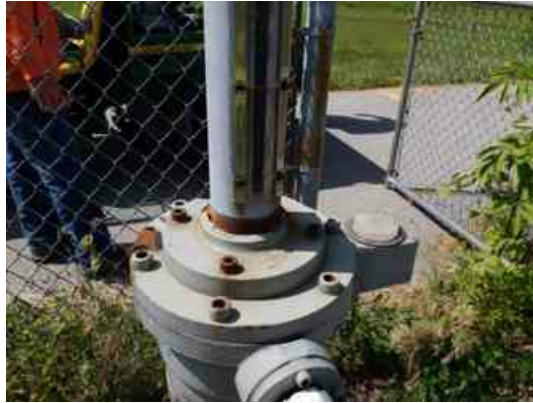
Inspect ID: 2021-0086 **Title:** 2604000007_CELRC_2021_A_0086_1_20210622T153148.jpg **Rated Item:** 10. Sluice/ Slide Gates **Caption:** Minimally Acceptable - HI-10c: The sluice gate opened and closed without any resistance. There is some mild cohesion outside the Matlin casting. Recommend painting. The operators oiled them the day of the inspection.

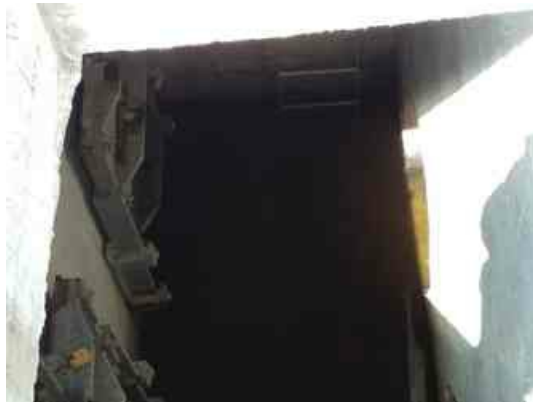
Inspect ID: 2021-0089 **Title:** 2604000007_CELRC_2021_A_0089_1_20210622T153440.jpg **Rated Item:** 10. Sluice/ Slide Gates **Caption:** Acceptable - HI-10c: The sluice gate opens and closes without any resistance.

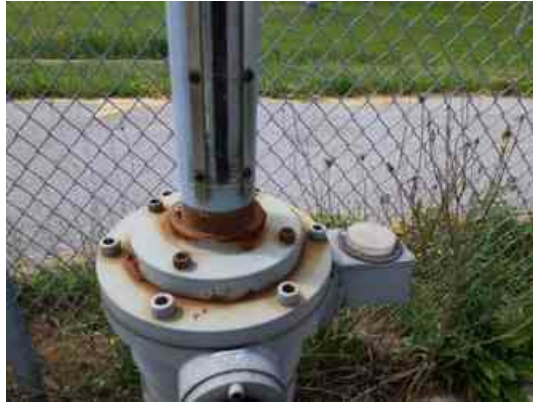
Inspect ID: 2021-0092 **Title:** 2604000007_CELRC_2021_A_0092_1_20210622T153954.jpg **Rated Item:** 10. Sluice/ Slide Gates **Caption:** Minimally Acceptable - HI-10a: The sluice gate opened and closed with little to no resistance. There is some mild corrosion on the outside. Recommend painting.

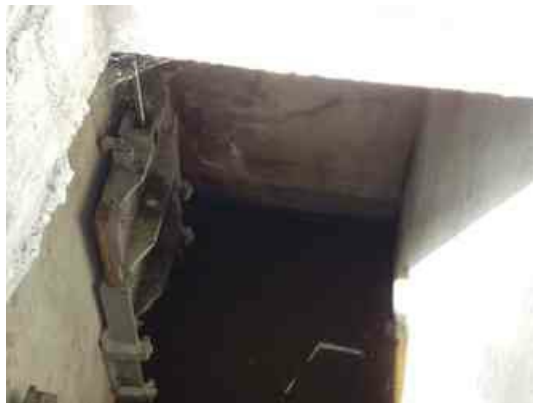
Inspect ID: 2021-0095 **Title:** 2604000007_CELRC_2021_A_0095_1_20210622T154304.jpg **Rated Item:** 10. Sluice/ Slide Gates **Caption:** Minimally Acceptable - HI-10a: The sluice gate opened and closed without any resistance. There is mild corrosion on top of the gate, recommend painting.

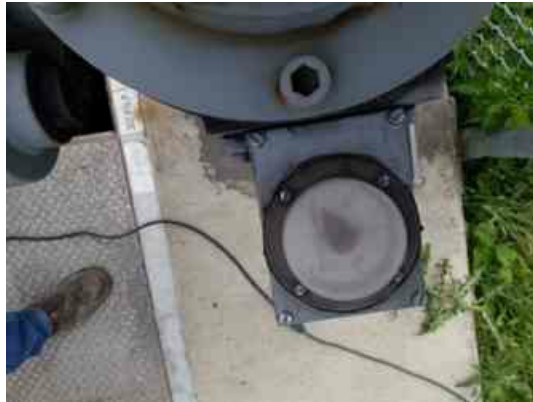
Inspect ID: 2021-0113 **Title:** 2604000007_CELRC_2021_A_0113_1_20210622T160102.jpg **Rated Item:** 10. Sluice/ Slide Gates **Caption:** Minimally Acceptable - HI-11: SG gage hard to see, replace lens.

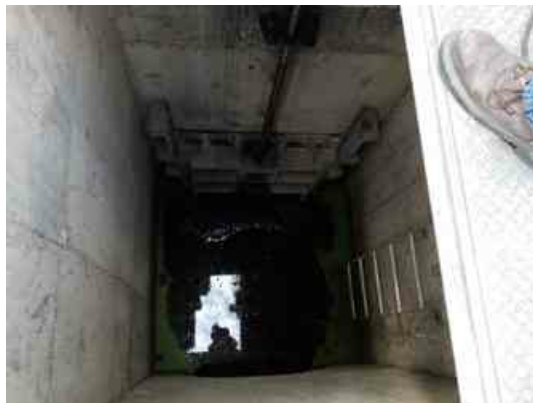
Inspect ID: 2021-0116 **Title:** 2604000007_CELRC_2021_A_0116_1_20210622T160122.jpg **Rated Item:** 10. Sluice/ Slide Gates **Caption:** Minimally Acceptable - HI-11: The sluice gate was able to close completely without resistance. There is a large amount of sediment in the gate pit. The gate struggled to open but was eventually opened. Might need to reinstall side railing.

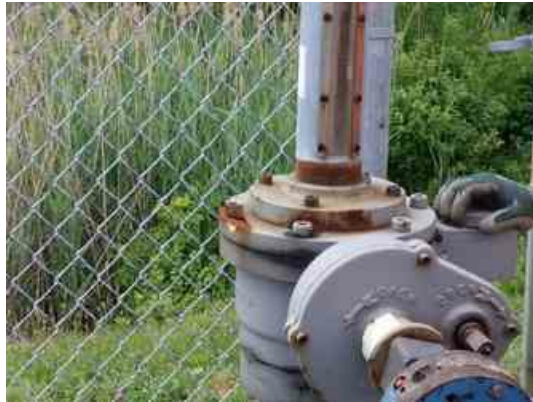
Inspect ID: 2021-0119 **Title:** 2604000007_CELRC_2021_A_0119_1_20210622T160250.jpg **Rated Item:** 10. Sluice/ Slide Gates **Caption:** Minimally Acceptable - HI-11: Sluice gate was oiled the same day. The outside, attic casing is starting to rust, recommend painting.

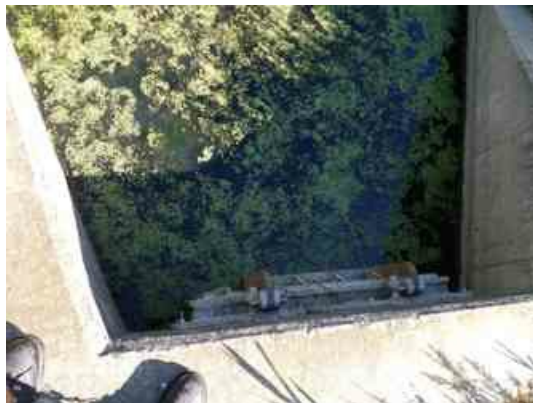
Inspect ID: 2021-0005 **Title:** 2604000007_CELRC_2021_A_0005_1_20210622T132623.jpg **Rated Item:** 11. Flap Gates/ Flap Valves/ Pinch Valves **Caption:** Acceptable - HI-4: The flap gate is fully closed and nothing is blocking the outlet.

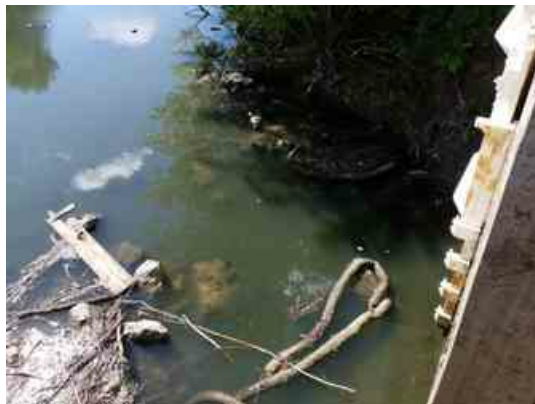
Inspect ID: 2021-0038 **Title:** 2604000007_CELRC_2021_A_0038_1_20210622T144558.jpg **Rated Item:** 11. Flap Gates/ Flap Valves/ Pinch Valves **Caption:** Acceptable - HI-9: The flap gate is closed completely. There is a very small amount of debris around the exit. Mild corrosion along bottom of the flap gate.

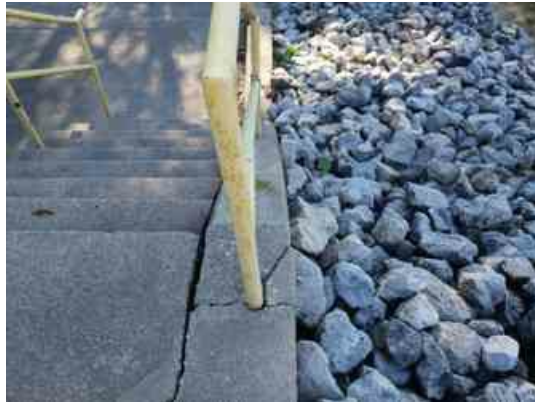
Inspect ID: 2021-0003 **Title:** 2604000007_CELRC_2021_A_0003_1_20210622T131830.jpg **Rated Item:** 5. Plant Building **Caption:** Minimally Acceptable - Ps-81: Concrete cracked and loose near handrail. Repair.

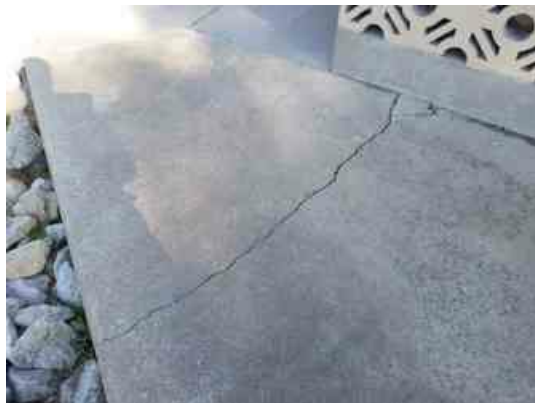
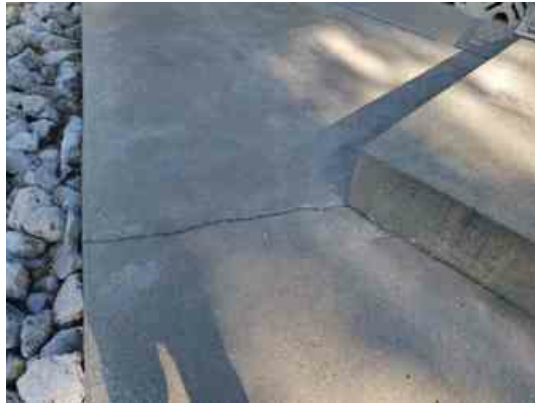
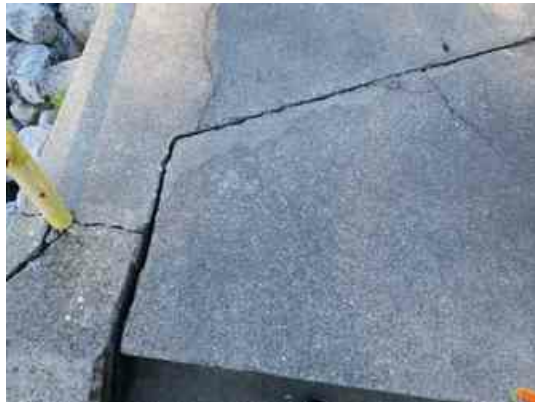
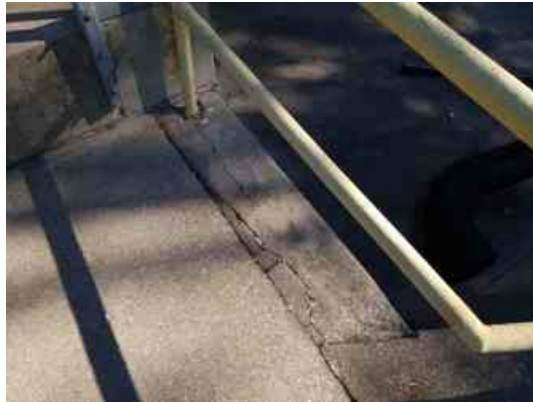
Inspect ID: 2021-0006 **Title:** 2604000007_CELRC_2021_A_0006_1_20210622T132039.jpg **Rated Item:** 5. Plant Building **Caption:** Minimally Acceptable - PS-81: Surface cracking of concrete pad. Monitor and repair as needed.

Inspect ID: 2021-0006 **Title:** 2604000007_CELRC_2021_A_0006_2_20210622T132055.jpg **Rated Item:** 5. Plant Building **Caption:** Minimally Acceptable - PS-81: Surface cracking of concrete pad. Monitor and repair as needed.

Inspect ID: 2021-0006 **Title:** 2604000007_CELRC_2021_A_0006_3_20210622T132110.jpg **Rated Item:** 5. Plant Building **Caption:** Minimally Acceptable - PS-81: Surface cracking of concrete pad. Monitor and repair as needed.

Inspect ID: 2021-0006 **Title:** 2604000007_CELRC_2021_A_0006_4_20210622T132120.jpg **Rated Item:** 5. Plant Building **Caption:** Minimally Acceptable - PS-81: Surface cracking of concrete pad. Monitor and repair as needed.

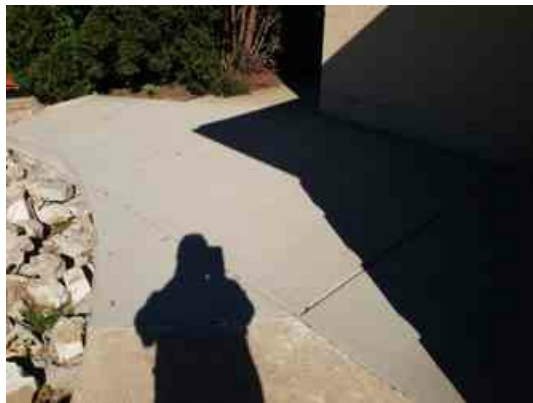
Inspect ID: 2021-0015 **Title:** 2604000007_CELRC_2021_A_0015_1_20210622T133206.jpg **Rated Item:** 5. Plant Building **Caption:** Acceptable - PS-81: Concrete section of approach has been replaced early 2021. Good condition.

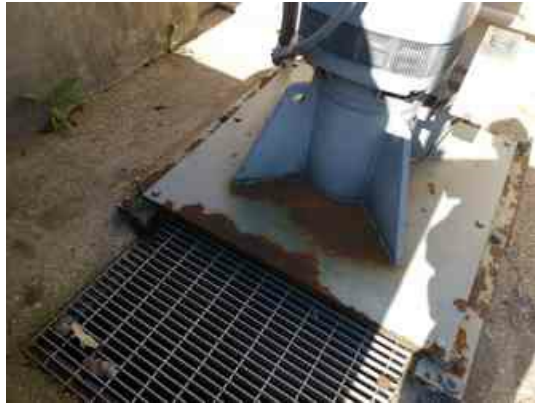
Inspect ID: 2021-0033 **Title:** 2604000007_CELRC_2021_A_0033_1_20210622T140203.jpg **Rated Item:** 5. Plant Building **Caption:** Minimally Acceptable - PS-N5: Minor surface rust on SWP-5 and SWP-6. Perform regular maintenance by painting and scaling.

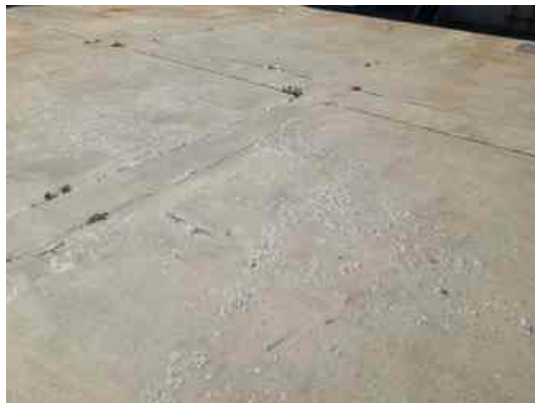
Inspect ID: 2021-0036 **Title:** 2604000007_CELRC_2021_A_0036_1_20210622T140352.jpg **Rated Item:** 5. Plant Building **Caption:** Acceptable - PS-N5: Minor spalling on exterior pads. Monitor and repair as necessary.

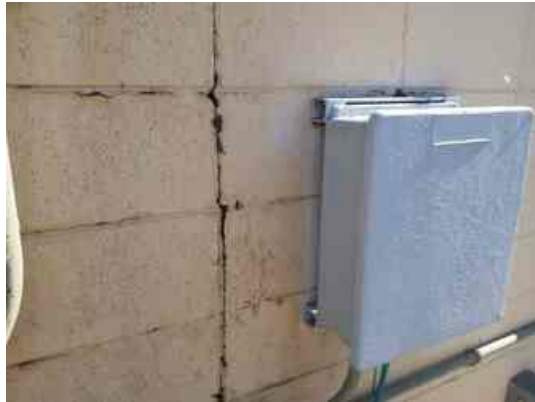
Inspect ID: 2021-0039 **Title:** 2604000007_CELRC_2021_A_0039_1_20210622T140515.jpg **Rated Item:** 5. Plant Building **Caption:** Minimally Acceptable - PS-N5: Crack along exterior wall infiltrated with moss. Remove vegetation and seal crack.

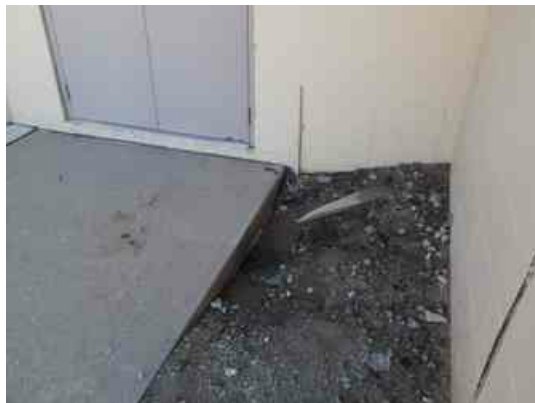
Inspect ID: 2021-0042 **Title:** 2604000007_CELRC_2021_A_0042_1_20210622T140818.jpg **Rated Item:** 5. Plant Building **Caption:** Minimally Acceptable - PS-N5: Erosion of soil near door. Replace soil to avoid undercutting of pavement.

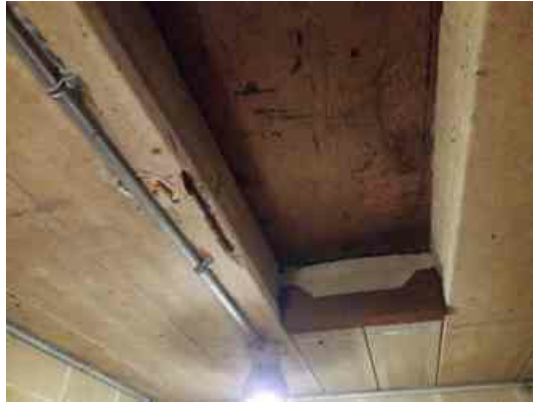
Inspect ID: 2021-0057 **Title:** 2604000007_CELRC_2021_A_0057_1_20210622T142535.jpg **Rated Item:** 5. Plant Building **Caption:** Minimally Acceptable - PS-N5: Ceiling showing rust spalling near old skylight. Monitor and repair If additional concrete becomes loose.

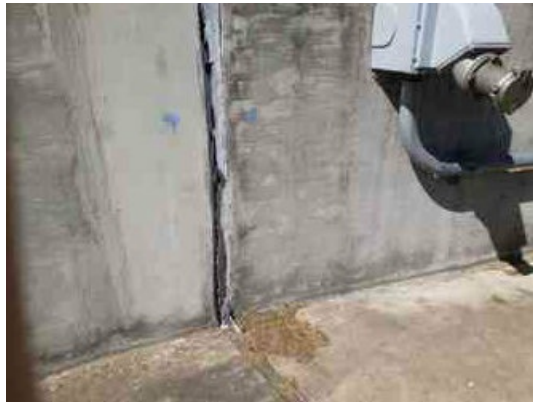
Inspect ID: 2021-0060 **Title:** 2604000007_CELRC_2021_A_0060_1_20210622T144117.jpg **Rated Item:** 5. Plant Building **Caption:** Minimally Acceptable - PS-ND: Joint seal failed on south side near entrance., water stop exposed. Repair and replace along entire length.

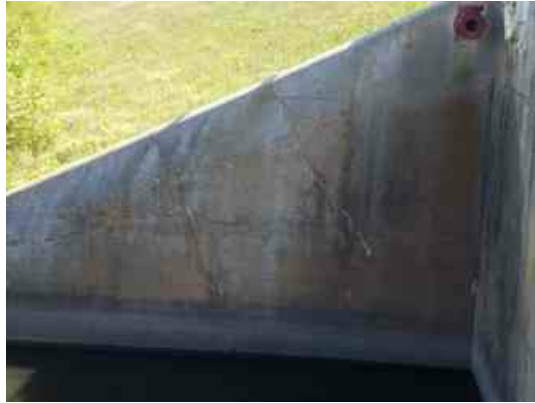
Inspect ID: 2021-0063 **Title:** 2604000007_CELRC_2021_A_0063_1_20210622T144556.jpg **Rated Item:** 5. Plant Building **Caption:** Acceptable - PS-ND: Minor cracking along riverside headwall. Monitor for growth.

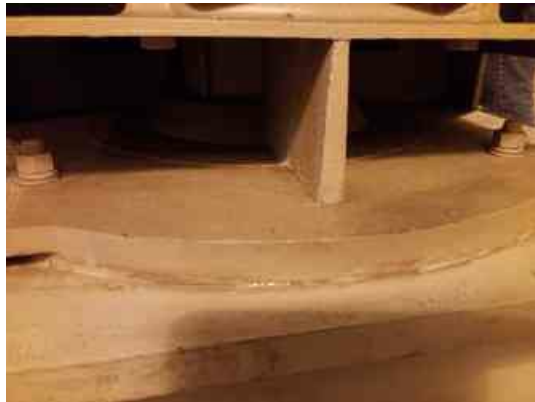
Inspect ID: 2021-0012 **Title:** 2604000007_CELRC_2021_A_0012_1_20210622T132547.jpg **Rated Item:** 7. Pumps **Caption:** Minimally Acceptable - PS-81: Hydraulic fluid leak coming from pump DWP-2. Monitor and investigate.

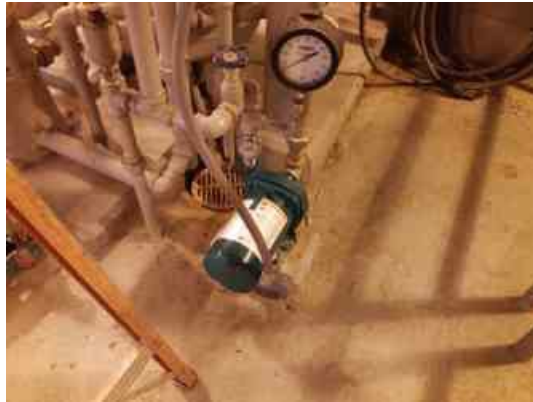
Inspect ID: 2021-0018 **Title:** 2604000007_CELRC_2021_A_0018_1_20210622T133435.jpg **Rated Item:** 7. Pumps **Caption:** Acceptable - PS-81: Replaced pump on water sealage unit in 2021.
