## Levee Inspection Report

Name of System: Marshalltown

NLD System ID: 2605000002

Date(s) of Inspection: 04/28/2021 - 04/30/2021

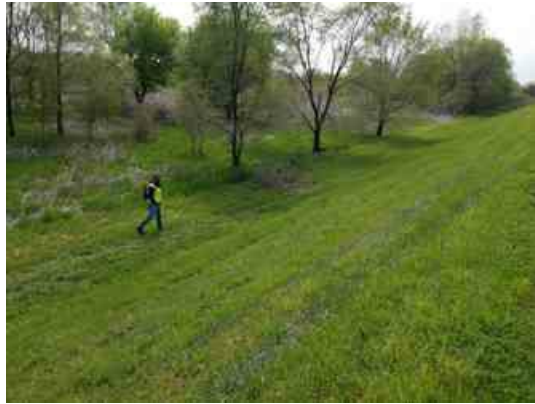
**Inspect ID:** 2021-0033 **Title:** 2604000002\_CELRC\_2021\_A\_0033\_1\_20210429T194206.jpg **Rated Item:** 1. Unwanted Vegetation Growth **Caption:** Minimally Acceptable - Trees near the riverside toe.

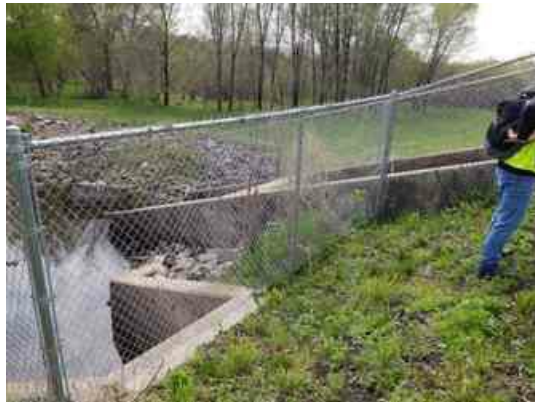
**Inspect ID:** 2021-0043 **Title:** 2604000002\_CELRC\_2021\_A\_0043\_1\_20210429T194809.jpg **Rated Item:** 1. Unwanted Vegetation Growth **Caption:** Acceptable - Small trees on the riverside slope.

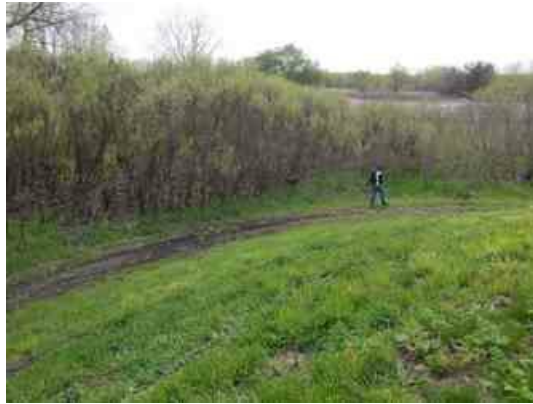
**Inspect ID:** 2021-0047 **Title:** 2604000002\_CELRC\_2021\_A\_0047\_1\_20210429T195059.jpg **Rated Item:** 1. Unwanted Vegetation Growth **Caption:** Minimally Acceptable - Small trees near the riverside toe.

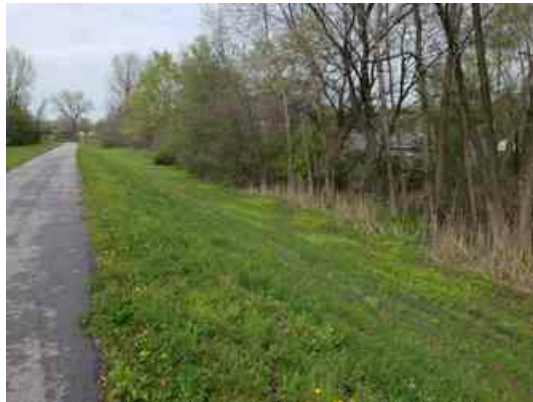
**Inspect ID:** 2021-0055 **Title:** 2604000002\_CELRC\_2021\_A\_0055\_1\_20210429T195657.jpg **Rated Item:** 1. Unwanted Vegetation Growth **Caption:** Minimally Acceptable - Trees along the landside toe.

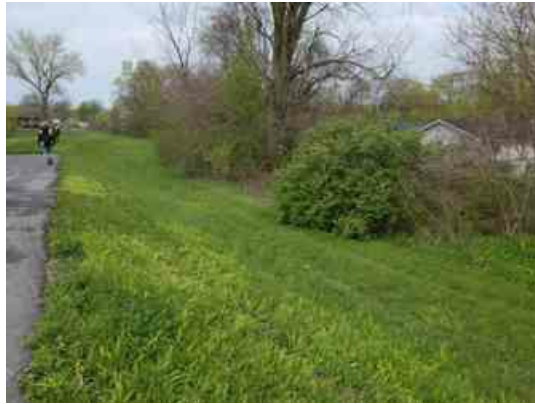
**Inspect ID:** 2021-0065 **Title:** 2604000002\_CELRC\_2021\_A\_0065\_1\_20210429T200120.jpg **Rated Item:** 1. Unwanted Vegetation Growth **Caption:** Minimally Acceptable - Trees near the landside toe.

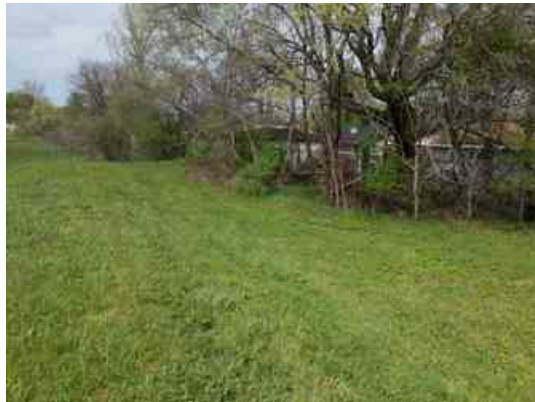
**Inspect ID:** 2021-0067 **Title:** 2604000002\_CELRC\_2021\_A\_0067\_1\_20210429T200217.jpg **Rated Item:** 1. Unwanted Vegetation Growth **Caption:** Minimally Acceptable - Trees near the landside toe.

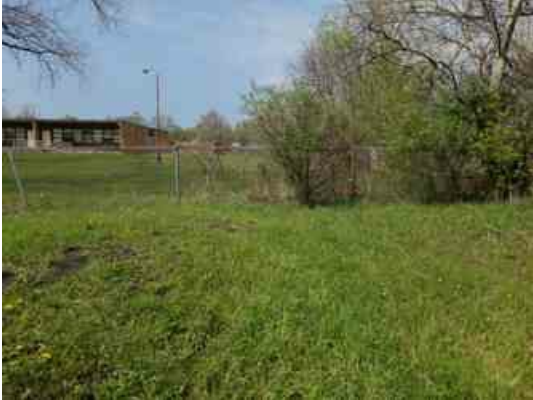
Rated Item	Rating	Rating Guidelines		Location/Remarks/Recommendations
1. Unwanted Vegetation Growth	<b>M</b>	<b>A</b>	The levee has little or no unwanted vegetation (trees, bush, or undesirable weeds), except for vegetation that is properly contained and/or situated on overbuilt sections, such that the mandatory 3-foot root-free zone is preserved around the levee profile. The levee has been recently mowed. The vegetation-free zone extends 15 feet from both the landside and riverside toes of the levee to the centerline of the tree. If the levee access easement doesn't extend to the described limits, then the vegetation-free zone must be maintained to the easement limits. Reference EM 1110-2-301 or Corps policy for regional vegetation variance.	2021-0033 : Trees near the riverside toe. (M) 2021-0043 : Small trees on the riverside slope. (A) 2021-0047 : Small trees near the riverside toe. (M) 2021-0055 : Trees along the landside toe. (M) 2021-0065 : Trees near the landside toe. (M) 2021-0067 : Trees near the landside toe. (M) 2021-0069 : Tree on the crest at the end of the levee. (M)

<p><b>Inspect ID:</b> 2021-0069 <b>Title:</b> 2604000002_CELRC_2021_A_0069_1_20210429T200314.jpg <b>Rated Item:</b> 1. Unwanted Vegetation Growth <b>Caption:</b> Minimally Acceptable - Tree on the crest at the end of the levee.</p>

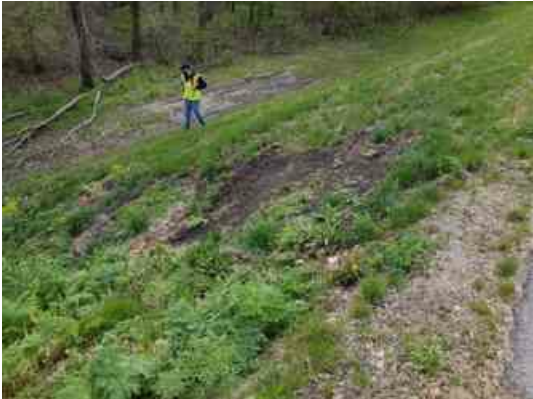
2. Sod Cover	<b>M</b>	<b>A</b>	There is good coverage of sod over the levee.	2021-0017 : Poor sod on the riverside slope. (M)
		<b>M</b>	Approximately 25% of the sod cover is missing or damaged over a significant portion or over significant portions of the levee embankment. This may be the result of over-grazing or feeding on the levee, unauthorized vehicular traffic, chemical or insect problems, or burning during inappropriate seasons.	
		<b>U</b>	Over 50% of the sod cover is missing or damaged over a significant portion or portions of the levee embankment.	
		<b>N/A</b>	Surface protection is provided by other means.

<p><b>Inspect ID:</b> 2021-0017 <b>Title:</b> 2604000002_CELRC_2021_A_0017_1_20210429T193124.jpg <b>Rated Item:</b> 2. Sod Cover <b>Caption:</b> Minimally Acceptable - Poor sod on the riverside slope.</p>

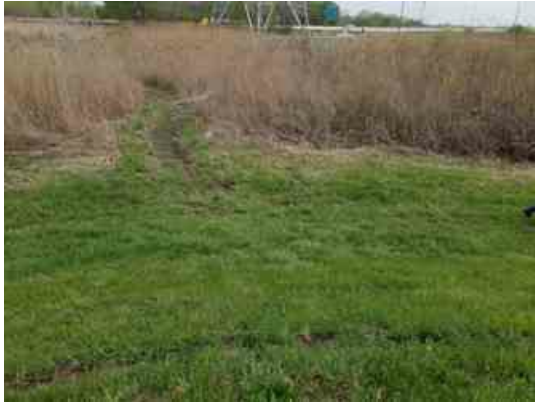
<b>Inspect ID:</b> 2021-0013 <b>Title:</b> 2604000002_CELRC_2021_A_0013_1_20210429T192921.jpg <b>Rated Item:</b> 3. Encroachments <b>Caption:</b> Minimally Acceptable - Debris on the riverside toe.

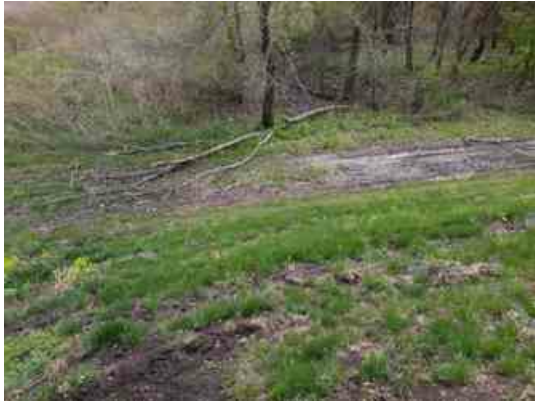
<b>Inspect ID:</b> 2021-0019 <b>Title:</b> 2604000002_CELRC_2021_A_0019_1_20210429T193201.jpg <b>Rated Item:</b> 3. Encroachments <b>Caption:</b> Minimally Acceptable - Logs on the riverside toe.

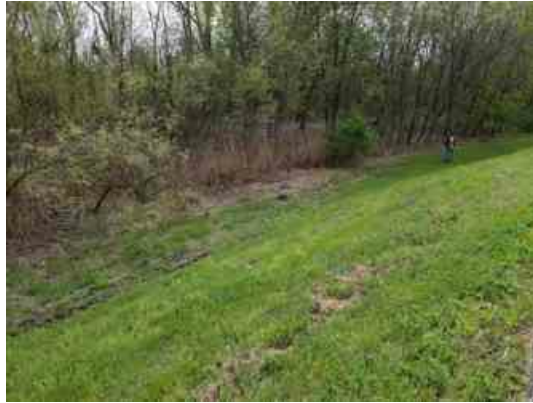
**Inspect ID:** 2021-0023 **Title:** 2604000002\_CELRC\_2021\_A\_0023\_1\_20210429T193445.jpg **Rated Item:** 3. Encroachments **Caption:** Minimally Acceptable - Debris on the riverside toe.

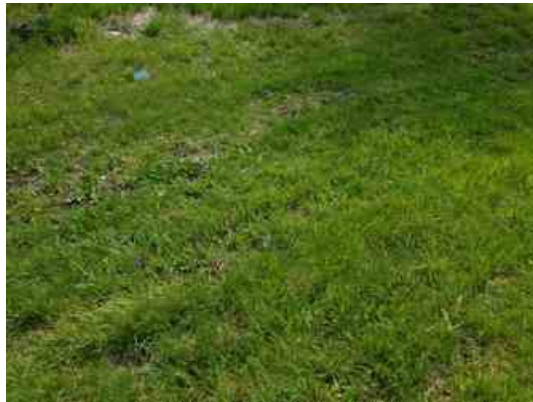
**Inspect ID:** 2021-0035 **Title:** 2604000002\_CELRC\_2021\_A\_0035\_1\_20210429T194255.jpg **Rated Item:** 3. Encroachments **Caption:** Minimally Acceptable - Debris on the riverside toe.

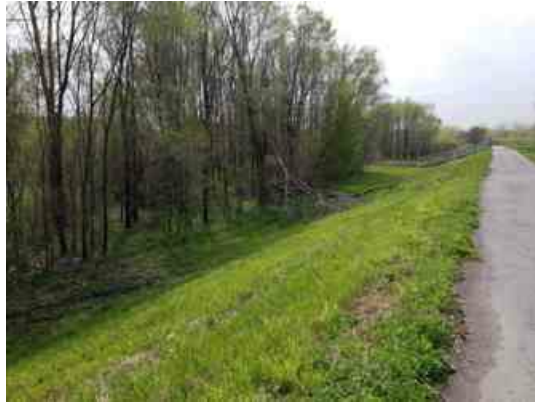
**Inspect ID:** 2021-0037 **Title:** 2604000002\_CELRC\_2021\_A\_0037\_1\_20210429T194411.jpg **Rated Item:** 3. Encroachments **Caption:** Minimally Acceptable - Logs on the riverside toe.

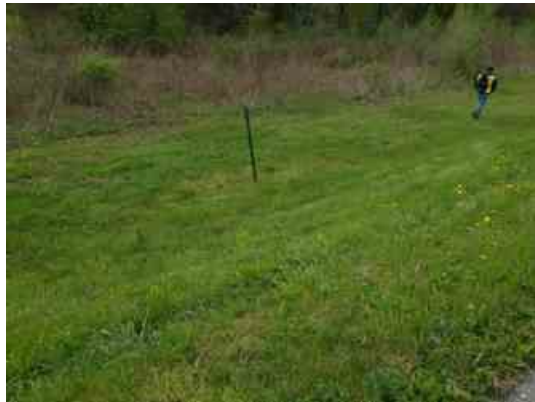
**Inspect ID:** 2021-0061 **Title:** 2604000002\_CELRC\_2021\_A\_0061\_1\_20210429T195909.jpg **Rated Item:** 3. Encroachments **Caption:** Minimally Acceptable - Pole on the riverside toe.

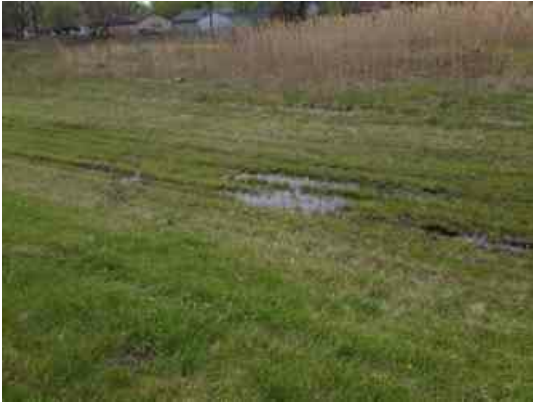
<b>Inspect ID:</b> 2021-0001 <b>Title:</b> 2604000002_CELRC_2021_A_0001_1_20210429T192039.jpg <b>Rated Item:</b> 8. Depressions/ Rutting <b>Caption:</b> Minimally Acceptable - Rutting on the landside toe.

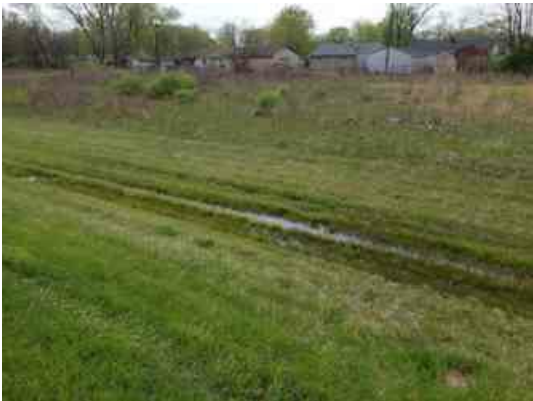
<b>Inspect ID:</b> 2021-0003 <b>Title:</b> 2604000002_CELRC_2021_A_0003_1_20210429T192123.jpg <b>Rated Item:</b> 8. Depressions/ Rutting <b>Caption:</b> Minimally Acceptable - Ruts on the landside toe.

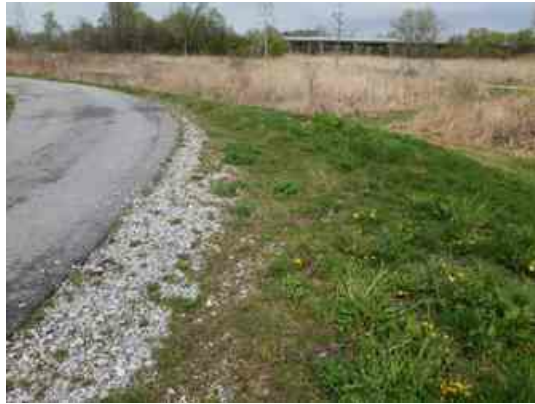
**Inspect ID:** 2021-0015 **Title:** 2604000002\_CELRC\_2021\_A\_0015\_1\_20210429T193001.jpg **Rated Item:** 8. Depressions/ Rutting **Caption:** Minimally Acceptable - Low area on the riverside crest. Drainage issue due to grading.

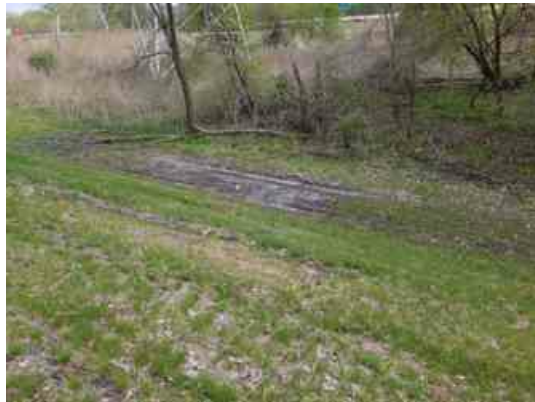
**Inspect ID:** 2021-0021 **Title:** 2604000002\_CELRC\_2021\_A\_0021\_1\_20210429T193302.jpg **Rated Item:** 8. Depressions/ Rutting **Caption:** Minimally Acceptable - Ruts on the riverside toe.

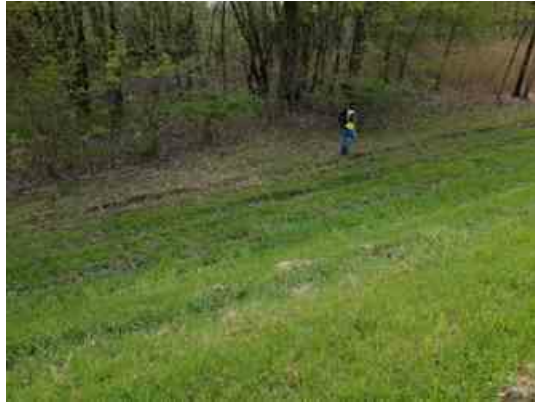
**Inspect ID:** 2021-0025 **Title:** 2604000002\_CELRC\_2021\_A\_0025\_1\_20210429T193717.jpg **Rated Item:** 8. Depressions/ Rutting **Caption:** Minimally Acceptable - Rutting on the riverside toe.

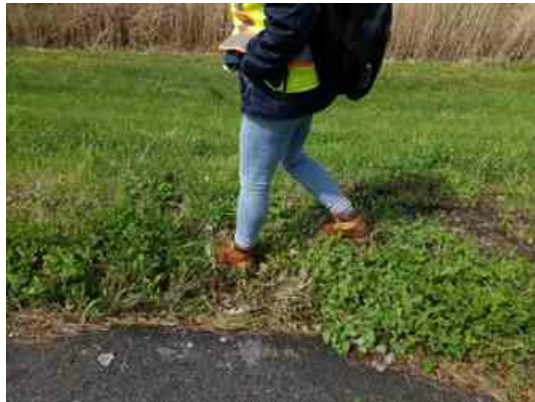
**Inspect ID:** 2021-0029 **Title:** 2604000002\_CELRC\_2021\_A\_0029\_1\_20210429T193906.jpg **Rated Item:** 8. Depressions/ Rutting **Caption:** Acceptable - Depression on the landside crest.

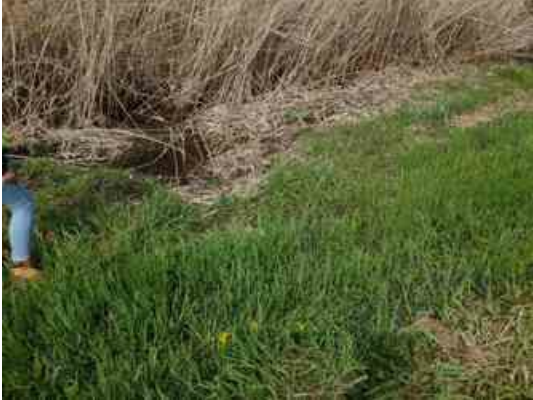
<p><b>Inspect ID:</b> 2021-0039 <b>Title:</b> 2604000002_CELRC_2021_A_0039_1_20210429T194511.jpg <b>Rated Item:</b> 8. Depressions/ Rutting <b>Caption:</b> Minimally Acceptable - Depression on the landside toe.</p>

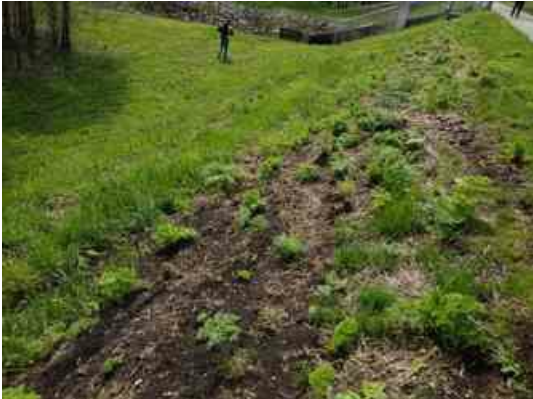
<p><b>Inspect ID:</b> 2021-0041 <b>Title:</b> 2604000002_CELRC_2021_A_0041_1_20210429T194624.jpg <b>Rated Item:</b> 8. Depressions/ Rutting <b>Caption:</b> Minimally Acceptable - Ruts on the riverside slope.</p>

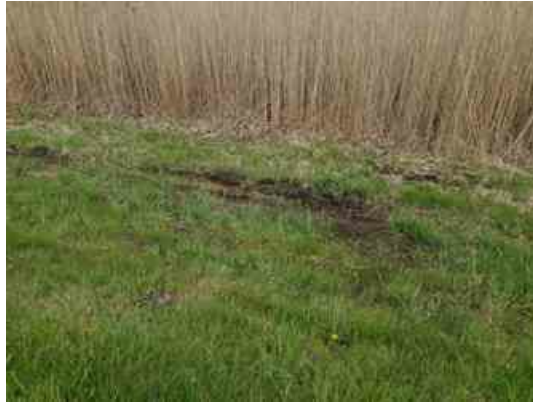
**Inspect ID:** 2021-0051 **Title:** 2604000002\_CELRC\_2021\_A\_0051\_1\_20210429T195326.jpg **Rated Item:** 8. Depressions/ Rutting **Caption:** Minimally Acceptable - Rutting on the landside toe.

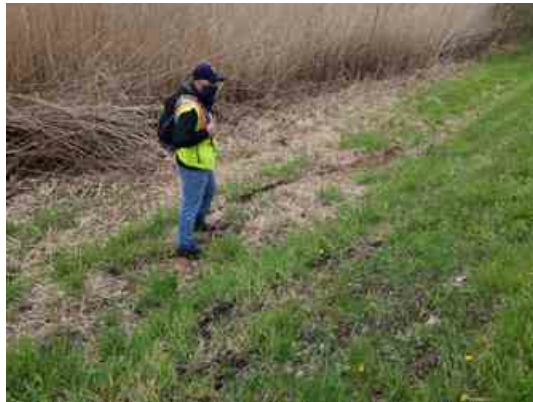
**Inspect ID:** 2021-0057 **Title:** 2604000002\_CELRC\_2021\_A\_0057\_1\_20210429T195748.jpg **Rated Item:** 8. Depressions/ Rutting **Caption:** Minimally Acceptable - Ruts on the riverside toe.

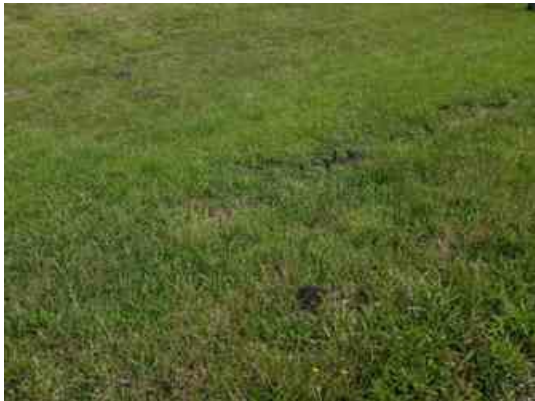
<b>Inspect ID:</b> 2021-0007 <b>Title:</b> 2604000002_CELRC_2021_A_0007_1_20210429T192407.jpg <b>Rated Item:</b> 10. Animal Control <b>Caption:</b> Acceptable - Mounds on riverside slope.

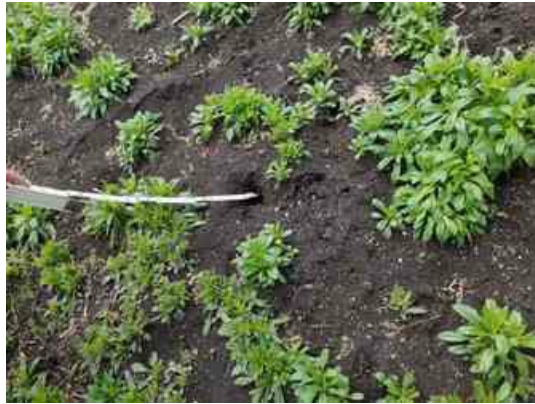
**Inspect ID:** 2021-0045 **Title:** 2604000002\_CELRC\_2021\_A\_0045\_1\_20210429T194844.jpg **Rated Item:** 10. Animal Control **Caption:** Minimally Acceptable - 6 inch burrow on riverside slope.

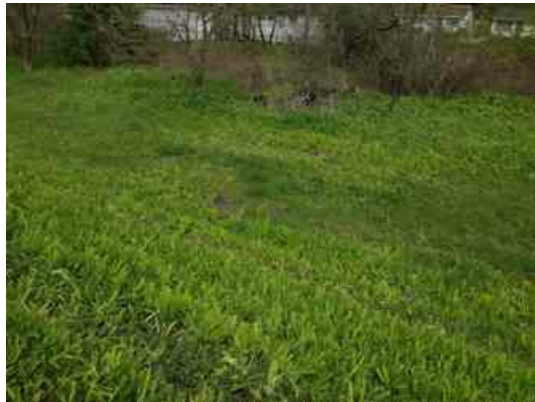
**Inspect ID:** 2021-0063 **Title:** 2604000002\_CELRC\_2021\_A\_0063\_1\_20210429T200040.jpg **Rated Item:** 10. Animal Control **Caption:** Acceptable - Cluster of mounds on landside toe.

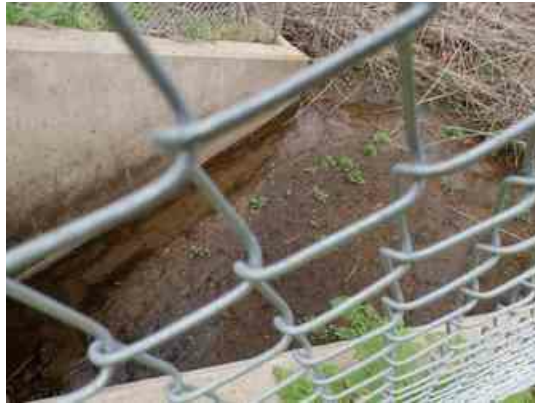
**Inspect ID:** 2021-0002 **Title:** 2604000002\_CELRC\_2021\_A\_0002\_1\_20210428T160755.jpg **Rated Item:** 1. Vegetation and Obstructions **Caption:** Acceptable - MR-2: A large amount of sediment near the inlet pipe.

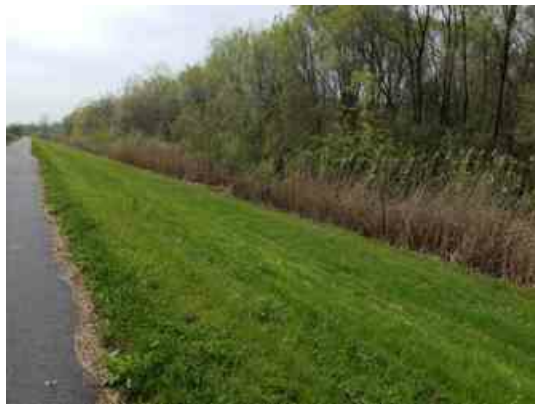
**Inspect ID:** 2021-0031 **Title:** 2604000002\_CELRC\_2021\_A\_0031\_1\_20210429T194015.jpg **Rated Item:** 1. Vegetation and Obstructions **Caption:** Minimally Acceptable - Small trees in ditch.

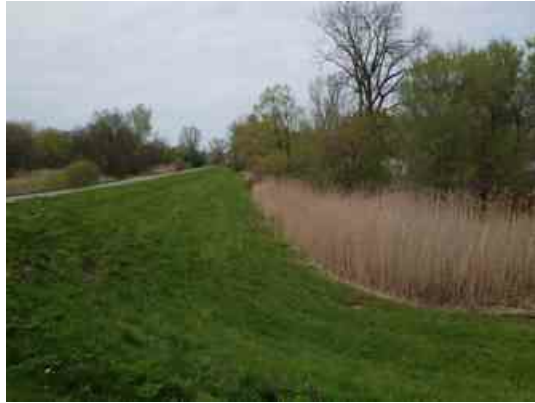
**Inspect ID:** 2021-0049 **Title:** 2604000002\_CELRC\_2021\_A\_0049\_1\_20210429T195226.jpg **Rated Item:** 1. Vegetation and Obstructions **Caption:** Minimally Acceptable - Tall vegetation in ditch.

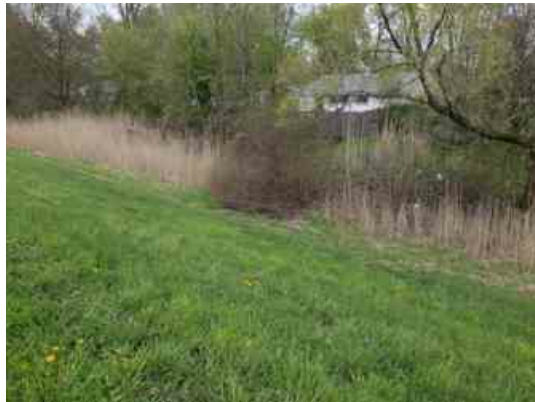
**Inspect ID:** 2021-0053 **Title:** 2604000002\_CELRC\_2021\_A\_0053\_1\_20210429T195447.jpg **Rated Item:** 1. Vegetation and Obstructions **Caption:** Minimally Acceptable - Tree in ditch.

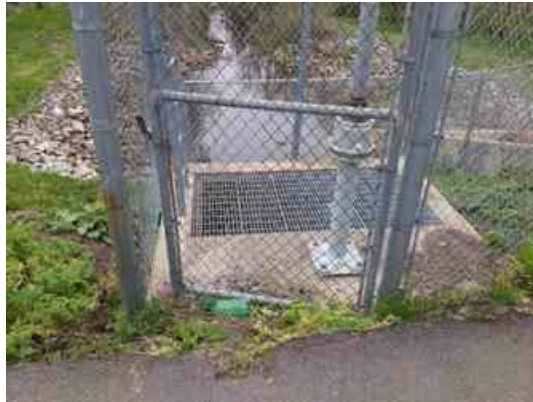
4. Fencing and Gates	<b>M</b>	<b>A</b>	Fencing is in good condition and provides protection against falling or unauthorized access. Gates open and close freely, locks are in place, and there is little corrosion on metal parts.	2021-0008 : MR-2: The gate can't close and there is no lock on the gate. (M)
		<b>M</b>	Fencing or gates are damaged or corroded but appear to be maintainable. Locks may be missing or damaged.	
		<b>U</b>	Fencing and gates are damaged or corroded to the point that replacement is required, or potentially dangerous features are not secured.	
		<b>N/A</b>	There are no features noted that require safety fencing.

**Inspect ID:** 2021-0008 **Title:** 2604000002\_CELRC\_2021\_A\_0008\_1\_20210428T161633.jpg **Rated Item:** 4. Fencing and Gates **Caption:** Minimally Acceptable - MR-2: The gate can't close and there is no lock on the gate.

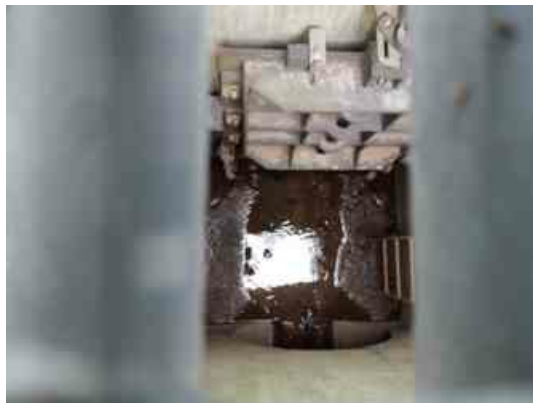
**Inspect ID:** 2021-0006 **Title:** 2604000002\_CELRC\_2021\_A\_0006\_2\_20210428T161427.jpg **Rated Item:** 10. Sluice/ Slide Gates **Caption:** Minimally Acceptable - MR-2: The gate couldn't close all of the way due to the large amount of sediment.

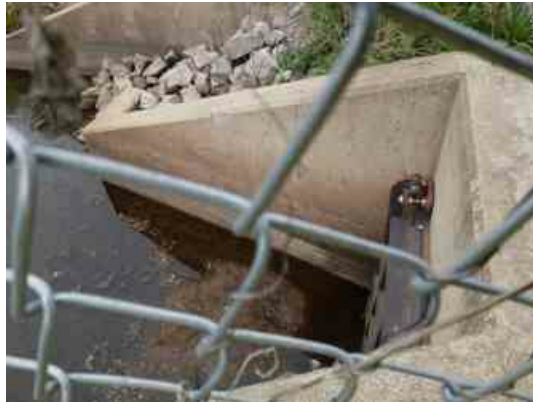
**Inspect ID:** 2021-0004 **Title:** 2604000002\_CELRC\_2021\_A\_0004\_1\_20210428T161020.jpg **Rated Item:** 11. Flap Gates/ Flap Valves/ Pinch Valves **Caption:** Acceptable - MR-2: Hearty amount of sediment near the discharge side. The flap gate is closed.

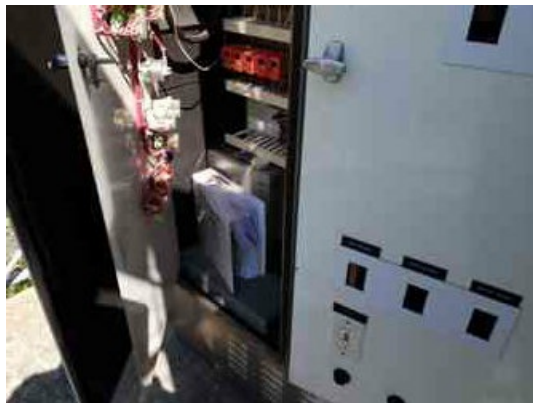
**Inspect ID:** 2021-0014 **Title:** 2604000002\_CELRC\_2021\_A\_0014\_1\_20210430T150706.jpg **Rated Item:** 2. Pump Station Operations and Maintenance Equipment Manuals **Caption:** Acceptable - PS-MR: Manuals present.

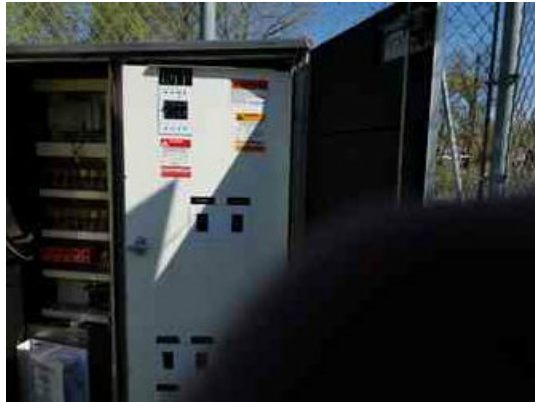
**Inspect ID:** 2021-0012 **Title:** 2604000002\_CELRC\_2021\_A\_0012\_1\_20210430T150601.jpg **Rated Item:** 3. Safety Compliance **Caption:** Acceptable - PS-MR: Arc flash present.

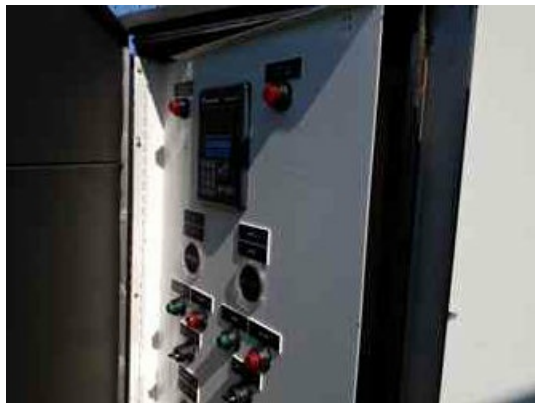
**Inspect ID:** 2021-0016 **Title:** 2604000002\_CELRC\_2021\_A\_0016\_1\_20210430T150751.jpg **Rated Item:** 4. Communications (A or M only) **Caption:** Acceptable - PS-MR: Communication present working

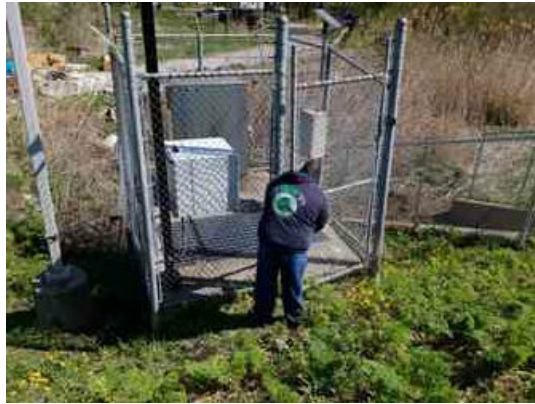
**Inspect ID:** 2021-0020 **Title:** 2604000002\_CELRC\_2021\_A\_0020\_1\_20210430T151007.jpg **Rated Item:** 6. Fencing and Gates **Caption:** Acceptable - PS-MR: Fencing in good condition but has some vegetation.

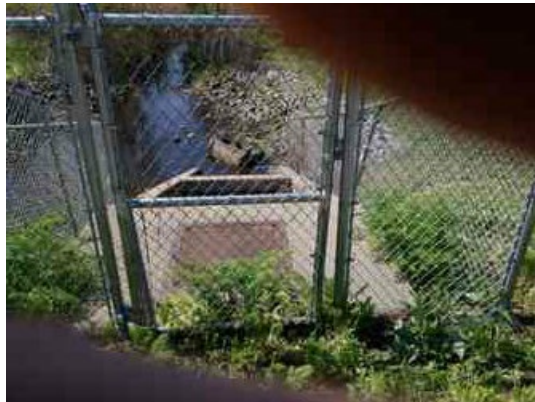
**Inspect ID:** 2021-0024 **Title:** 2604000002\_CELRC\_2021\_A\_0024\_1\_20210430T151257.jpg **Rated Item:** 6. Fencing and Gates **Caption:** Minimally Acceptable - PS-MR: Fence not opening due to levee overbuild.

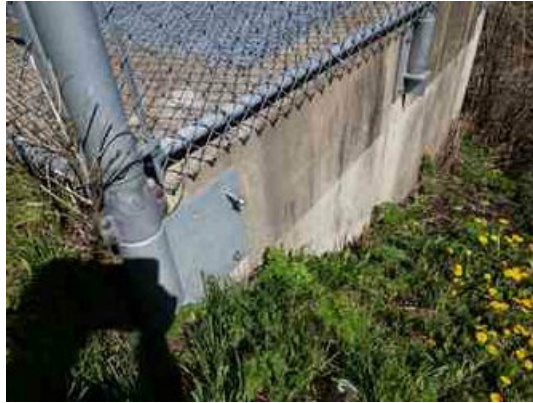
**Inspect ID:** 2021-0026 **Title:** 2604000002\_CELRC\_2021\_A\_0026\_1\_20210430T151440.jpg **Rated Item:** 6. Fencing and Gates **Caption:** Minimally Acceptable - PS-MR: Bolts missing and falling out.

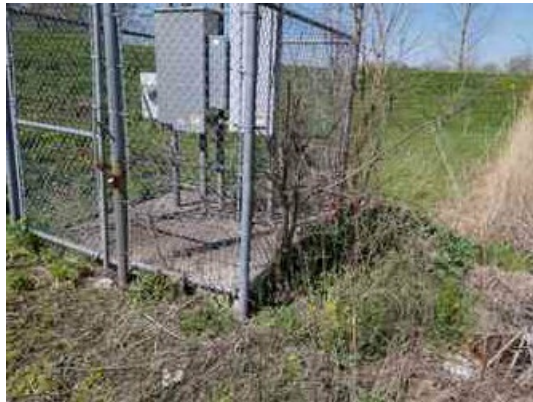
**Inspect ID:** 2021-0028 **Title:** 2604000002\_CELRC\_2021\_A\_0028\_1\_20210430T151633.jpg **Rated Item:** 6. Fencing and Gates **Caption:** Minimally Acceptable - PS-MR: Vegetation around fence of power.

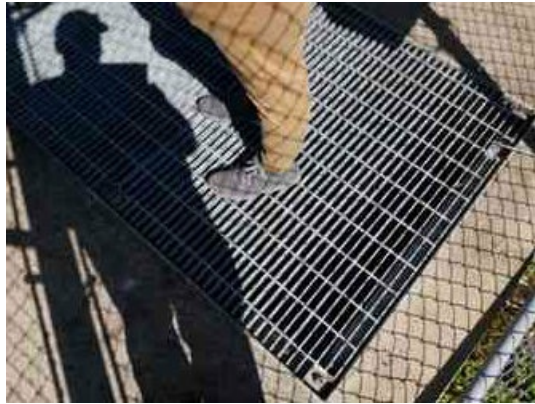
**Inspect ID:** 2021-0010 **Title:** 2604000002\_CELRC\_2021\_A\_0010\_1\_20210430T150526.jpg **Rated Item:** 7. Pumps **Caption:** Acceptable - PS-MR: Pumps bumped and working.

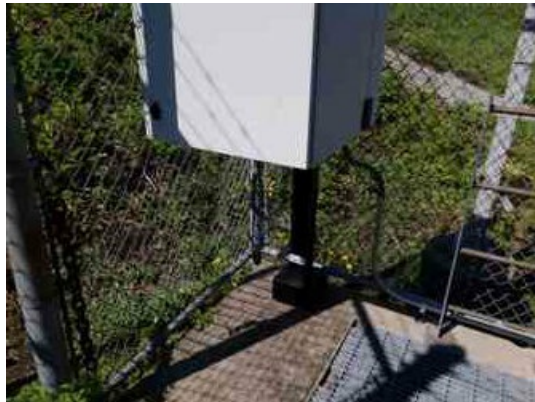
**Inspect ID:** 2021-0018 **Title:** 2604000002\_CELRC\_2021\_A\_0018\_1\_20210430T150913.jpg **Rated Item:** 16. Enclosures, Panels, Conduit and Ducts **Caption:** Acceptable - PS-MR: Conduits and panels in good condition.

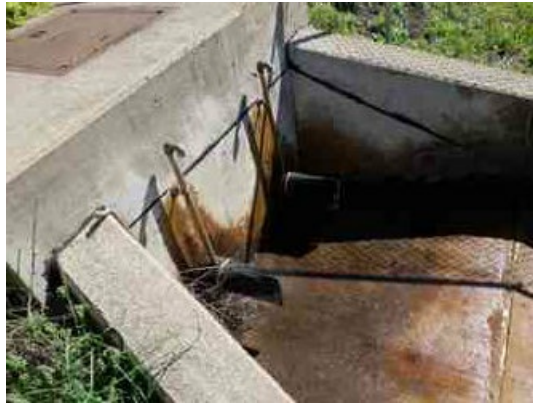
**Inspect ID:** 2021-0022 **Title:** 2604000002\_CELRC\_2021\_A\_0022\_1\_20210430T151131.jpg **Rated**  
**Item:** 17. Intake and Discharge Pipelines **Caption:** Acceptable - PS-MR:  
Duck bills look good.
