**US Army Corps
of Engineers®**

Levee Inspection Report

Name of System: Munster

Date(s) of Inspection: 06/21/2021 - 06/21/2021

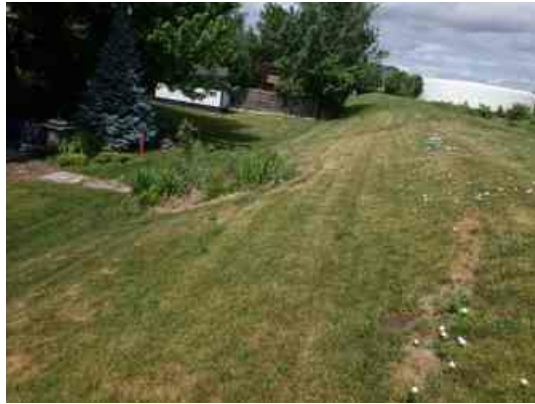
Inspect ID: 2021-0208 **Title:** 2604000009_CELRC_2021_A_0208_1_20210621T154020.jpg **Rated Item:** 3. Encroachments **Caption:** Minimally Acceptable - Garden on landside slope. Talk to resident. Recommend removing or have them submit a 408 request.

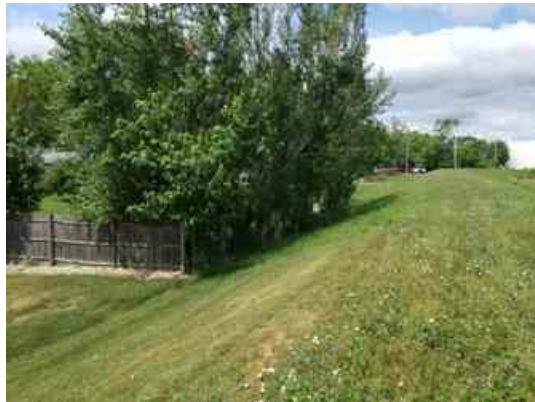
Inspect ID: 2021-0211 **Title:** 2604000009_CELRC_2021_A_0211_1_20210621T154127.jpg **Rated Item:** 3. Encroachments **Caption:** Minimally Acceptable - Fence on landside. Talk to resident. Recommend removing or have them submit a 408 request.

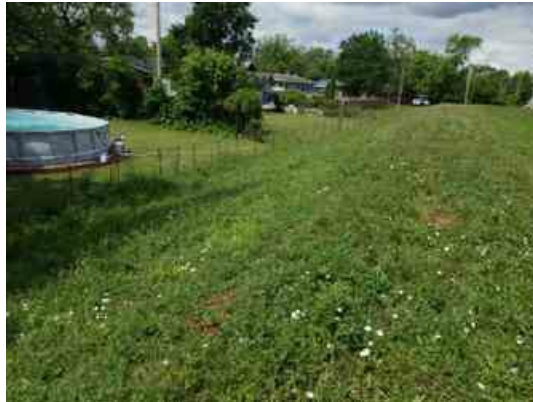
U	Unauthorized encroachments or inappropriate activities noted are likely to inhibit operations and maintenance, emergency operations, or negatively impact the integrity of the levee.	2021-0217 : Chicken fence on landside. Talk to resident. Recommend removing or have them submit a 408 request. (M) 2021-0283 : Sign on crest. Recommend relocating or have them submit a 408 request. (M)

Inspect ID: 2021-0217 **Title:** 2604000009_CELRC_2021_A_0217_1_20210621T154327.jpg **Rated Item:** 3. Encroachments **Caption:** Minimally Acceptable - Chicken fence on landside. Talk to resident. Recommend removing or have them submit a 408 request.

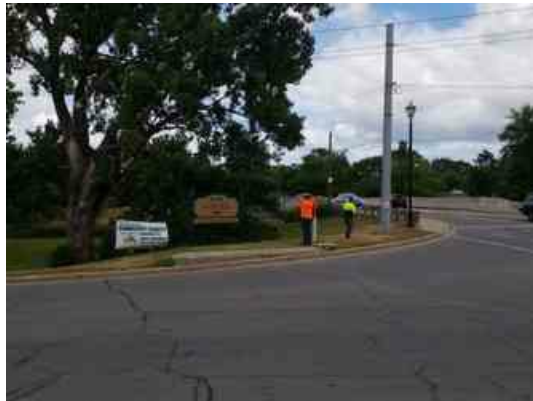
Inspect ID: 2021-0283 **Title:** 2604000009_CELRC_2021_A_0283_1_20210621T163310.jpg **Rated Item:** 3. Encroachments **Caption:** Minimally Acceptable - Sign on crest. Recommend relocating or have them submit a 408 request.

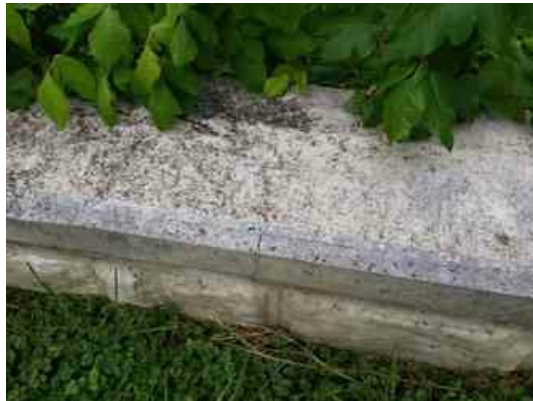
Inspect ID: 2021-0007 **Title:** 2604000009_CELRC_2021_A_0007_1_20210621T132201.jpg **Rated Item:** 4. Concrete Surfaces **Caption:** Acceptable - Small cracks on cap, typical. Monitor.

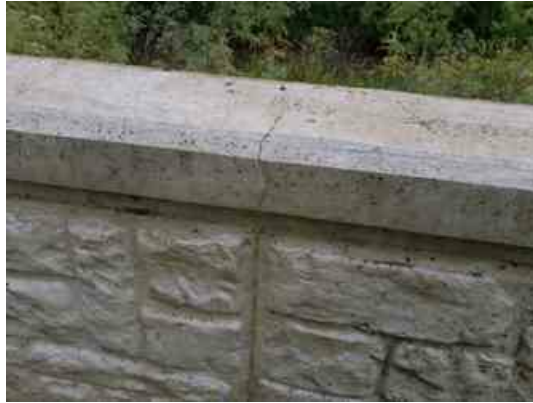
Inspect ID: 2021-0010 **Title:** 2604000009_CELRC_2021_A_0010_1_20210621T132432.jpg **Rated Item:** 4. Concrete Surfaces **Caption:** Minimally Acceptable - Cracks on landside. Seal.

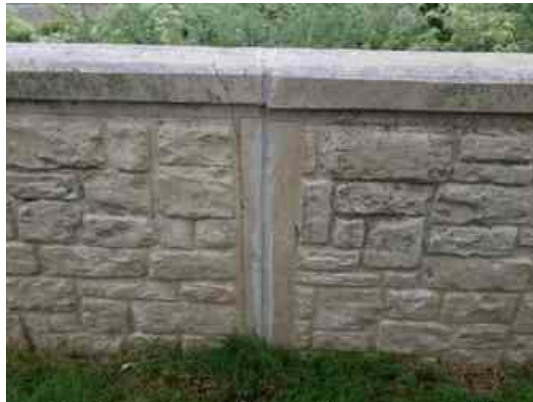
Inspect ID: 2021-0013 **Title:** 2604000009_CELRC_2021_A_0013_1_20210621T132539.jpg **Rated Item:** 4. Concrete Surfaces **Caption:** Minimally Acceptable - Crack on landside. Seal.

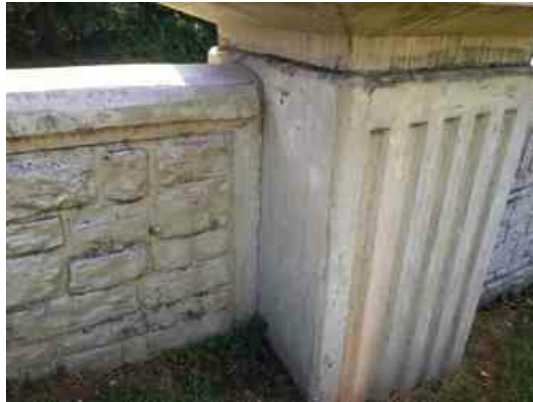
Inspect ID: 2021-0040 **Title:** 2604000009_CELRC_2021_A_0040_1_20210621T133606.jpg **Rated Item:** 4. Concrete Surfaces **Caption:** Minimally Acceptable - Crack on both landside and riverside. Seal.

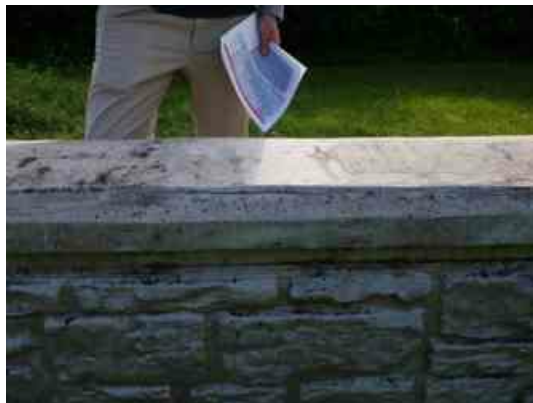
Inspect ID: 2021-0043 **Title:** 2604000009_CELRC_2021_A_0043_1_20210621T133651.jpg **Rated Item:** 4. Concrete Surfaces **Caption:** Minimally Acceptable - Cracking on cap. Seal.

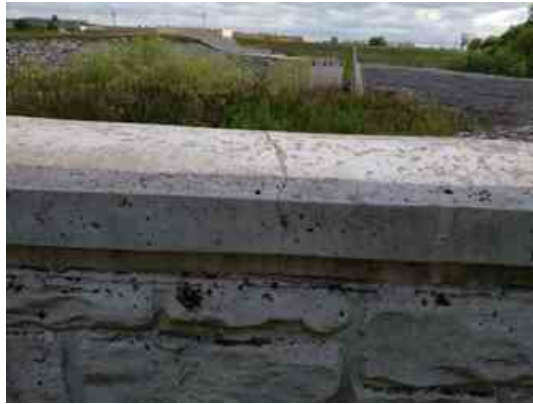
Inspect ID: 2021-0070 **Title:** 2604000009_CELRC_2021_A_0070_1_20210621T135720.jpg **Rated Item:** 4. Concrete Surfaces **Caption:** Minimally Acceptable - Crack on cap. Seal.

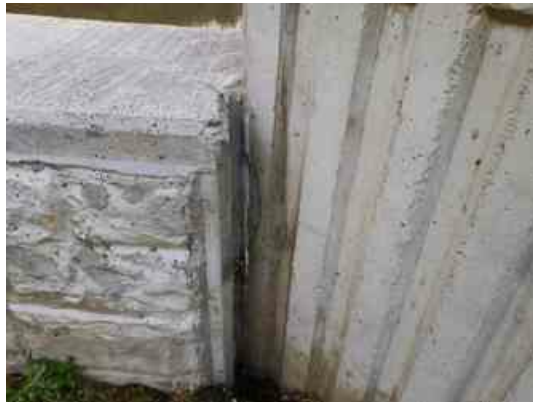
Inspect ID: 2021-0076 **Title:** 2604000009_CELRC_2021_A_0076_1_20210621T140103.jpg **Rated Item:** 4. Concrete Surfaces **Caption:** Minimally Acceptable - Crack on landside. Seal.

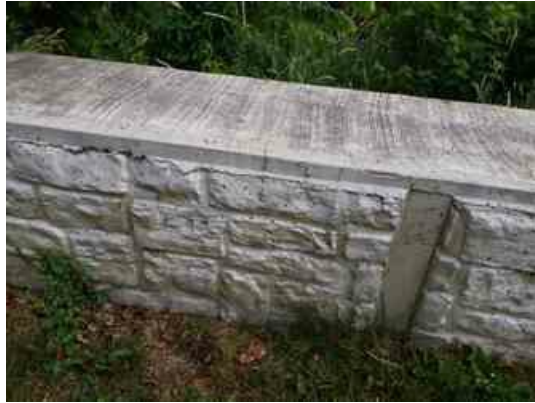
Inspect ID: 2021-0082 **Title:** 2604000009_CELRC_2021_A_0082_1_20210621T140257.jpg **Rated Item:** 4. Concrete Surfaces **Caption:** Acceptable - Small crack on landside, typical. Monitor.

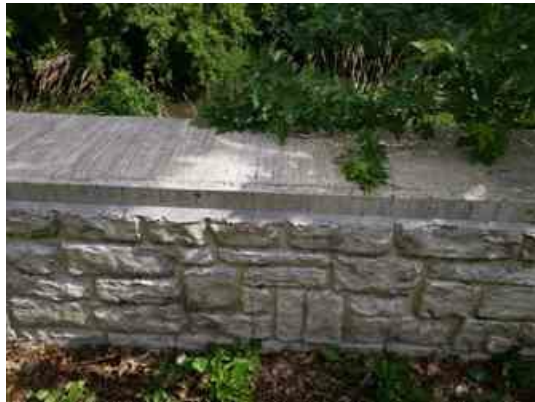
Inspect ID: 2021-0088 **Title:** 2604000009_CELRC_2021_A_0088_1_20210621T140442.jpg **Rated Item:** 4. Concrete Surfaces **Caption:** Minimally Acceptable - Seal crack.

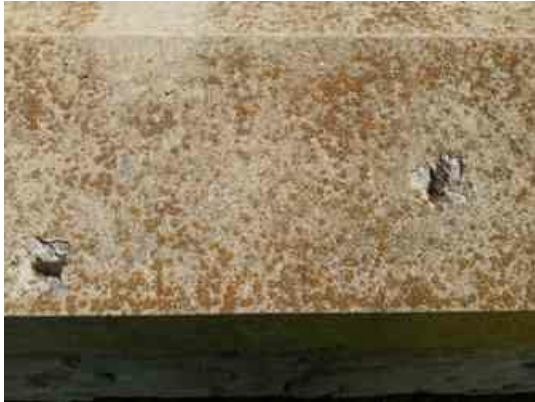
Inspect ID: 2021-0103 Title: 2604000009_CELRC_2021_A_0103_1_20210621T141154.jpg Rated Item: 4. Concrete Surfaces Caption: Minimally Acceptable - Spalling and exposed rebar, typical. Patch.

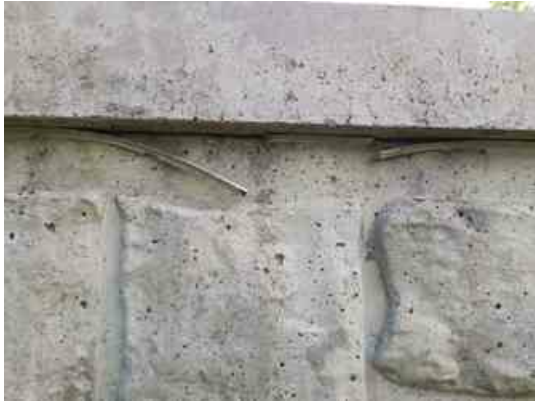
Inspect ID: 2021-0106 Title: 2604000009_CELRC_2021_A_0106_1_20210621T141331.jpg Rated Item: 4. Concrete Surfaces Caption: Minimally Acceptable - Deteriorating sealant under cap. Replace.

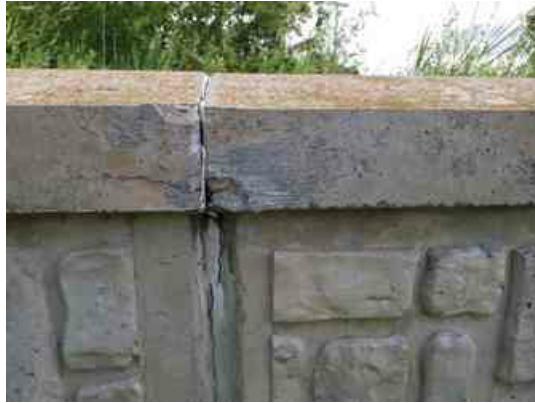
Rated Item	Rating	Rating Guidelines		Location/Remarks/Recommendations
4. Concrete Surfaces	M	A	Negligible spalling, scaling or cracking. If the concrete surface is weathered or holds moisture, it is still satisfactory but should be seal coated to prevent freeze/ thaw damage.	2021-0007 : Small cracks on cap, typical. Monitor. (A) 2021-0010 : Cracks on landside. Seal. (M) 2021-0013 : Crack on landside. Seal. (M) 2021-0016 : Crack on landside. Monitor. (A) 2021-0037 : Minor spalling, exposed rebar. Patch. (M) 2021-0040 : Crack on both landside and riverside. Seal. (M) 2021-0043 : Cracking on cap. Seal. (M) 2021-0070 : Crack on cap. Seal. (M) 2021-0076 : Crack on landside. Seal. (M) 2021-0082 : Small crack on landside, typical. Monitor. (A) 2021-0088 : Seal crack. (M) 2021-0103 : Spalling and exposed rebar, typical. Patch. (M) 2021-0106 : Deteriorating sealant under cap. Replace. (M) 2021-0109 : Cracking, spalling. Repair. (M)

Inspect ID: 2021-0109 **Title:** 2604000009_CELRC_2021_A_0109_1_20210621T141457.jpg **Rated Item:** 4. Concrete Surfaces **Caption:** Minimally Acceptable - Cracking, spalling. Repair.

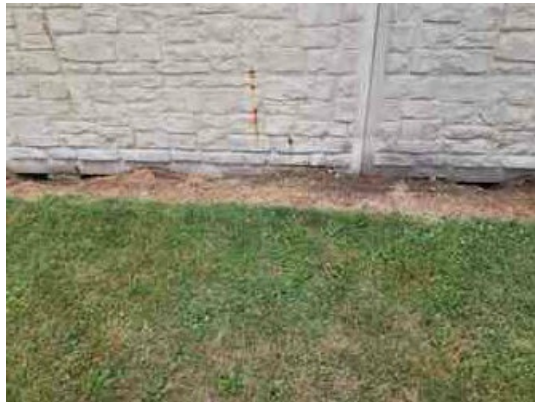
Inspect ID: 2021-0032 **Title:** 2604000009_CELRC_2021_A_0032_1_20210621T140438.jpg **Rated Item:** 6. Foundation of Concrete Structures **Caption:** Minimally Acceptable - Erosion on the slope next to floodwall near MU-8. Fill.

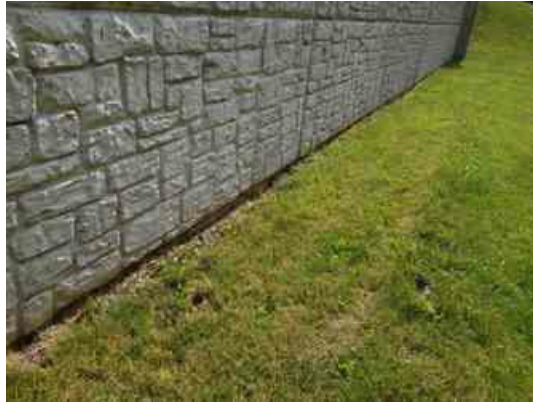
Inspect ID: 2021-0061 **Title:**
2604000009_CELRC_2021_A_0061_1_20210621T135422.jpg **Rated**
Item: 6. Foundation of Concrete Structures **Caption:** Minimally
Acceptable - Ground settling on landside base. Fill.

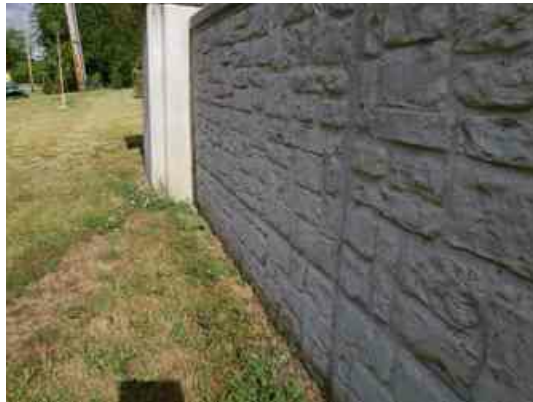
Inspect ID: 2021-0067 **Title:**
2604000009_CELRC_2021_A_0067_1_20210621T135640.jpg **Rated**
Item: 6. Foundation of Concrete Structures **Caption:** Minimally
Acceptable - Settling on landside. Fill.

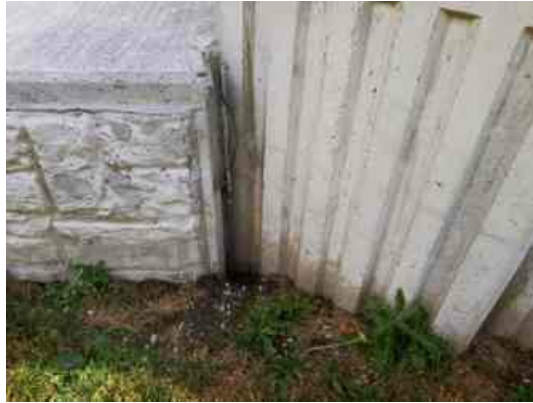
Inspect ID: 2021-0073 **Title:**
2604000009_CELRC_2021_A_0073_1_20210621T140025.jpg **Rated**
Item: 6. Foundation of Concrete Structures **Caption:** Minimally
Acceptable - Depression on landside. Fill.

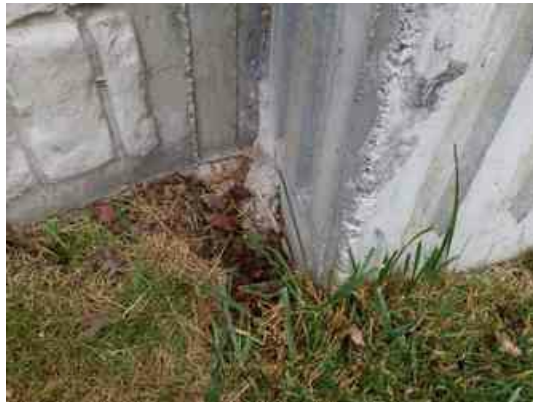
Inspect ID: 2021-0115 **Title:**
2604000009_CELRC_2021_A_0115_1_20210621T142301.jpg **Rated**
Item: 6. Foundation of Concrete Structures **Caption:** Minimally
Acceptable - Fill low spot.

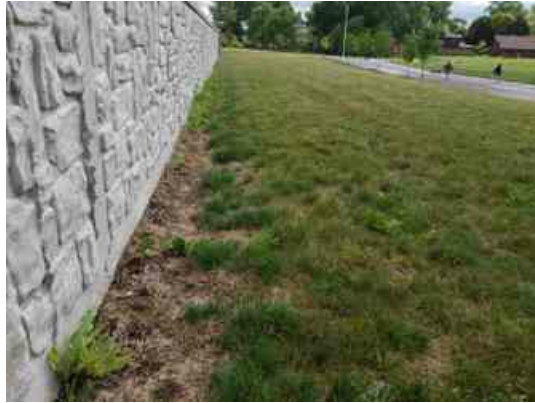
Inspect ID: 2021-0127 **Title:** 2604000009_CELRC_2021_A_0127_1_20210621T142927.jpg **Rated**
Item: 6. Foundation of Concrete Structures **Caption:** Minimally
Acceptable - Settlement along base. Fill.

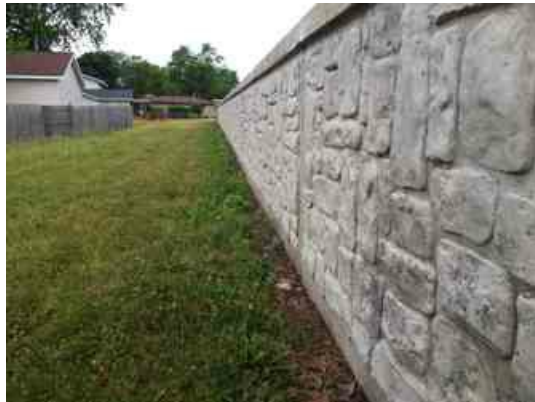
Inspect ID: 2021-0145 **Title:** 2604000009_CELRC_2021_A_0145_1_20210621T144918.jpg **Rated**
Item: 6. Foundation of Concrete Structures **Caption:** Minimally
Acceptable - Settlement on landside. Fill.

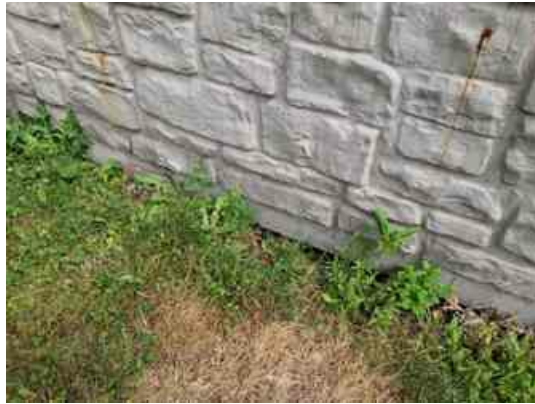
Inspect ID: 2021-0166 **Title:** 2604000009_CELRC_2021_A_2021-0166_3_20210621T150830.jpg **Rated Item:** 6. Foundation of Concrete Structures **Caption:** Minimally Acceptable - Fill holes on landside toe.

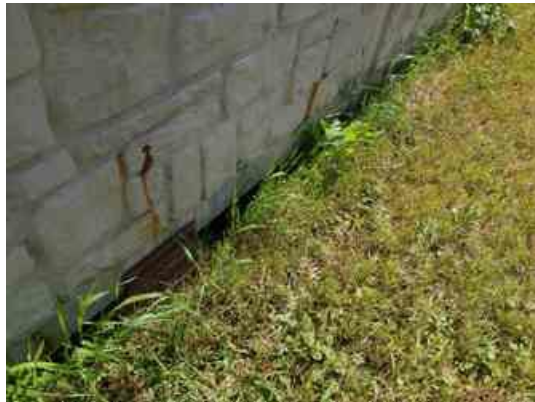
Inspect ID: 2021-0172 **Title:** 2604000009_CELRC_2021_A_0172_1_20210621T151746.jpg **Rated Item:** 6. Foundation of Concrete Structures **Caption:** Minimally Acceptable - Fill holes on landside toe.

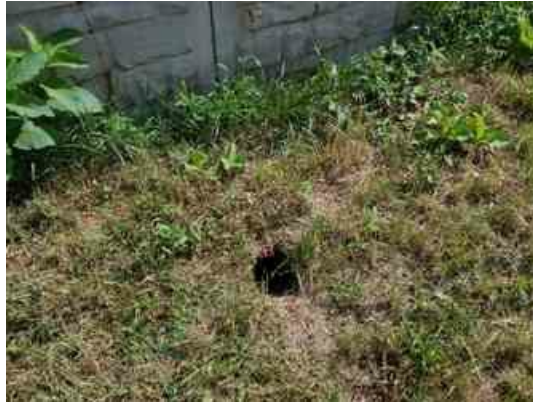
Inspect ID: 2021-0175 **Title:** 2604000009_CELRC_2021_A_0175_1_20210621T151847.jpg **Rated Item:** 6. Foundation of Concrete Structures **Caption:** Minimally Acceptable - 6 inch wide burrow on landside. Fill.

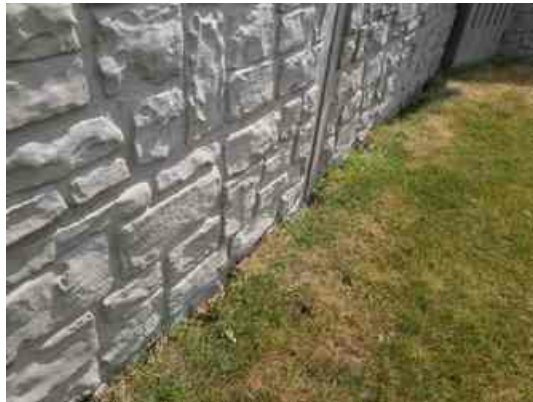
Inspect ID: 2021-0190 **Title:** 2604000009_CELRC_2021_A_0190_1_20210621T153114.jpg **Rated Item:** 6. Foundation of Concrete Structures **Caption:** Minimally Acceptable - Holes on landside, fill.

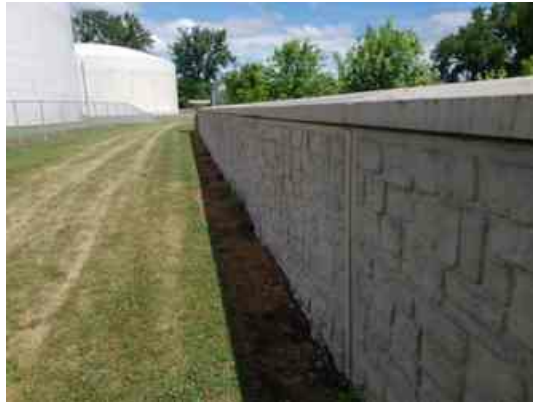
Inspect ID: 2021-0226 **Title:** 2604000009_CELRC_2021_A_0226_1_20210621T154839.jpg **Rated Item:** 6. Foundation of Concrete Structures **Caption:** Minimally Acceptable - Settlement on landside, fill.

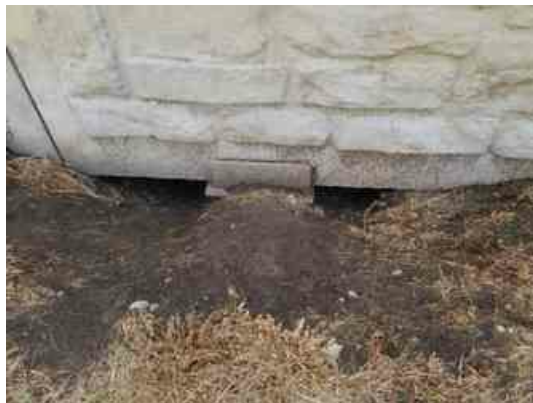
Inspect ID: 2021-0229 **Title:** 2604000009_CELRC_2021_A_2021-0229_2_20210621T155239.jpg **Rated Item:** 6. Foundation of Concrete Structures **Caption:** Minimally Acceptable - Larger holes, fill.

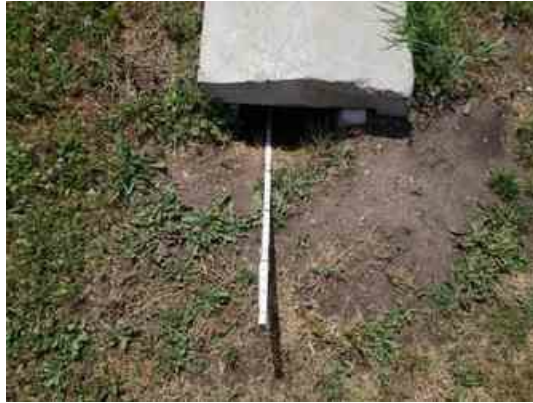
Inspect ID: 2021-0238 **Title:**
2604000009_CELRC_2021_A_0238_1_20210621T155426.jpg **Rated**
Item: 6. Foundation of Concrete Structures **Caption:** Minimally
Acceptable - 1 ft deep hole at transition, fill.

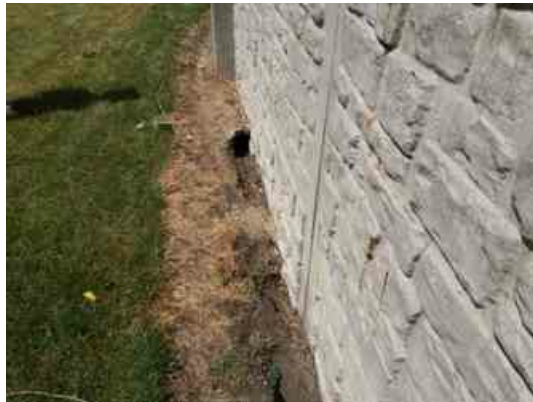
Inspect ID: 2021-0244 **Title:**
2604000009_CELRC_2021_A_0244_1_20210621T155736.jpg **Rated**
Item: 6. Foundation of Concrete Structures **Caption:** Minimally
Acceptable - Holes on landside. Fill.

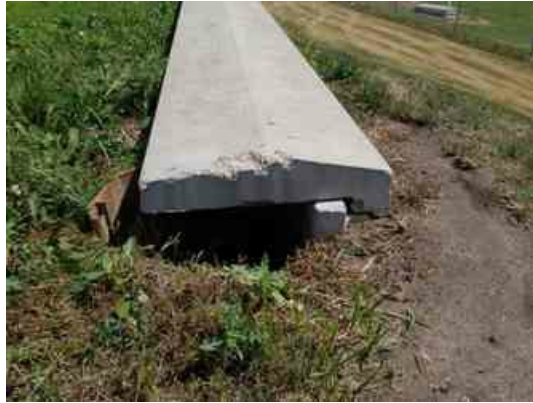
Inspect ID: 2021-0250 **Title:** 2604000009_CELRC_2021_A_0250_1_20210621T160039.jpg **Rated Item:** 6. Foundation of Concrete Structures **Caption:** Minimally Acceptable - Settlement at transition, fill.

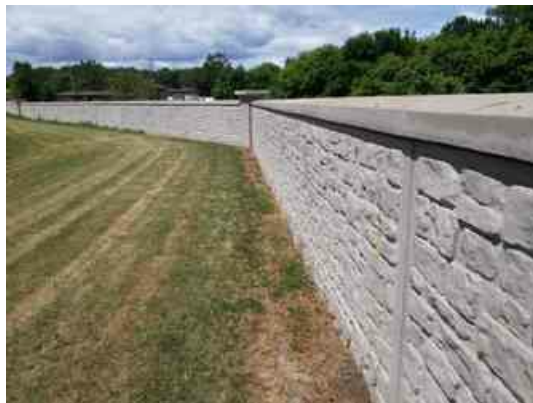
Inspect ID: 2021-0256 **Title:** 2604000009_CELRC_2021_A_0256_1_20210621T160539.jpg **Rated Item:** 6. Foundation of Concrete Structures **Caption:** Minimally Acceptable - Holes on landside, fill.

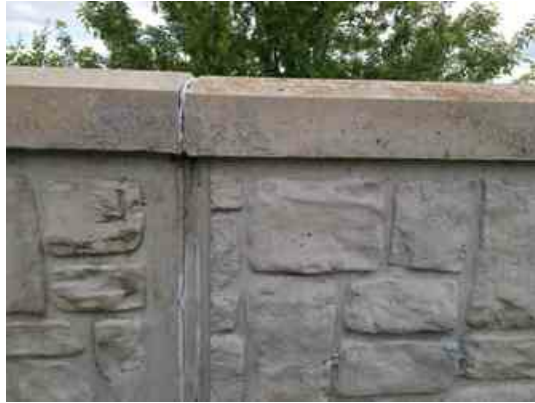
Inspect ID: 2021-0097 **Title:** 2604000009_CELRC_2021_A_0097_1_20210621T140947.jpg **Rated Item:** 7. Monolith Joints **Caption:** Minimally Acceptable - Deteriorating sealant. Replace.

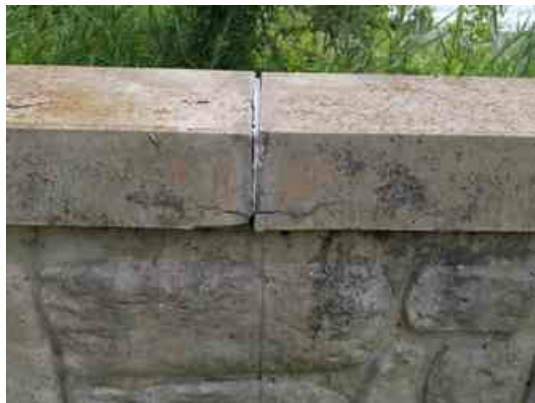
Inspect ID: 2021-0100 **Title:** 2604000009_CELRC_2021_A_0100_1_20210621T141052.jpg **Rated Item:** 7. Monolith Joints **Caption:** Minimally Acceptable - Deteriorating sealant in cap. Replace.

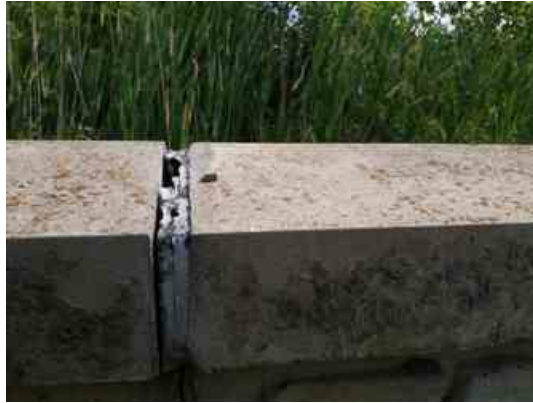
Inspect ID: 2021-0112 **Title:** 2604000009_CELRC_2021_A_0112_1_20210621T141559.jpg **Rated Item:** 7. Monolith Joints **Caption:** Minimally Acceptable - Joint sealant deteriorating, completely gone, 1 inch deep. Replace.

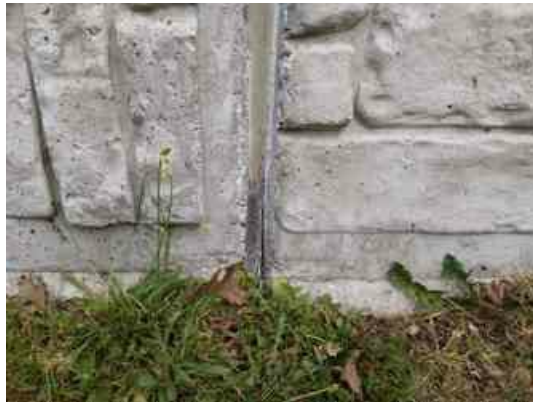
Inspect ID: 2021-0118 **Title:** 2604000009_CELRC_2021_A_0118_1_20210621T142349.jpg **Rated Item:** 7. Monolith Joints **Caption:** Minimally Acceptable - Deteriorating sealant at bottom of joint. Replace.

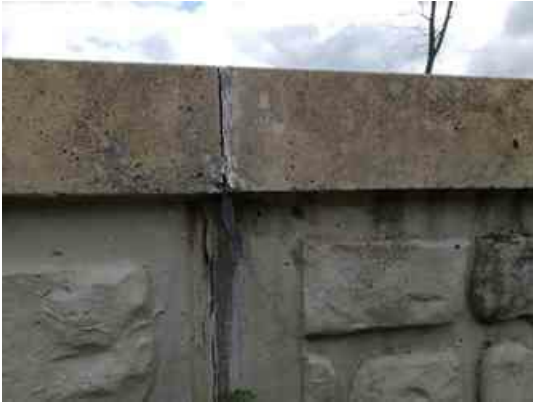
<p>Inspect ID: 2021-0148 Title: 2604000009_CELRC_2021_A_0148_1_20210621T145240.jpg Rated Item: 7. Monolith Joints Caption: Minimally Acceptable - Waterstop exposed. Replace sealant.</p>

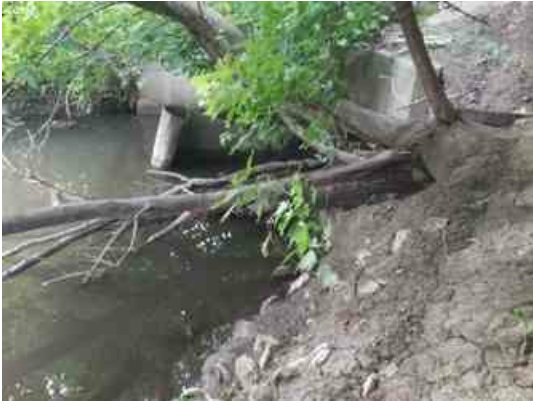
<p>Inspect ID: 2021-0017 Title: 2604000009_CELRC_2021_A_0017_1_20210621T134836.jpg Rated Item: 1. Vegetation and Obstructions Caption: Minimally Acceptable - MU-10: Fallen tree at outlet river side. Remove.</p>

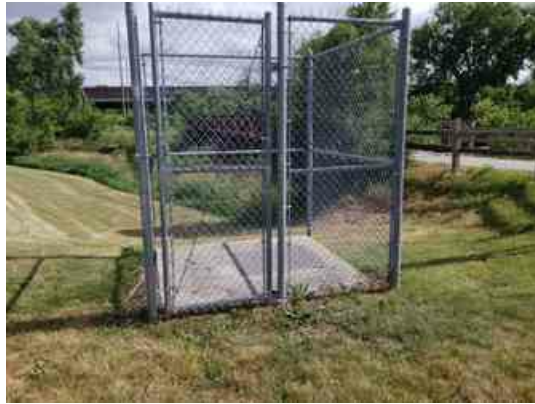
Inspect ID: 2021-0056 **Title:** 2604000009_CELRC_2021_A_0056_1_20210621T142318.jpg **Rated Item:** 4. Fencing and Gates **Caption:** Acceptable - MU-5: Flap gate fence is in good condition.

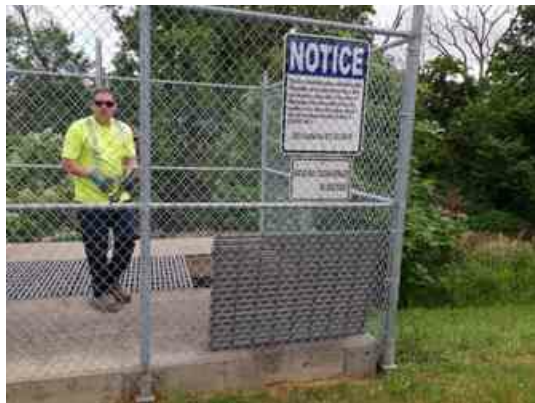
Inspect ID: 2021-0086 **Title:** 2604000009_CELRC_2021_A_0086_1_20210621T145231.jpg **Rated Item:** 4. Fencing and Gates **Caption:** Acceptable - MU-3: Gates are in good condition.

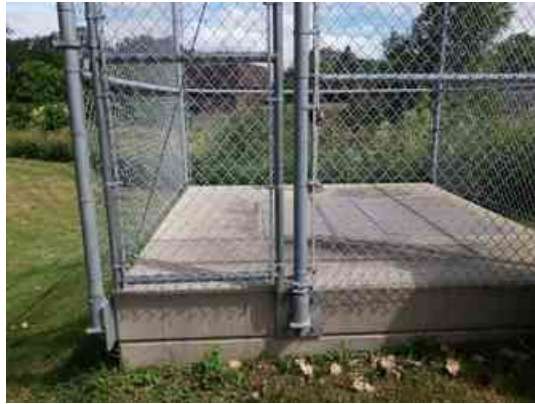
Inspect ID: 2021-0098 **Title:** 2604000009_CELRC_2021_A_0098_1_20210621T150326.jpg **Rated Item:** 4. Fencing and Gates **Caption:** Acceptable - MU-1: The fence in was in good condition.

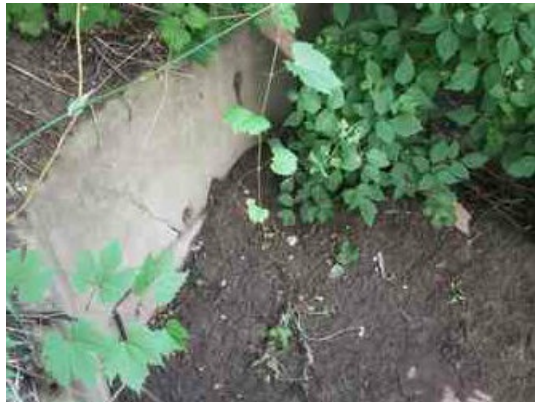
Inspect ID: 2021-0014 **Title:** 2604000009_CELRC_2021_A_0014_1_20210621T134632.jpg **Rated Item:** 5. Concrete Surfaces (Such as gate wells, outfalls, intakes, or culverts) **Caption:** Minimally Acceptable - MU-10: Cracking in the concrete structure. Seal.

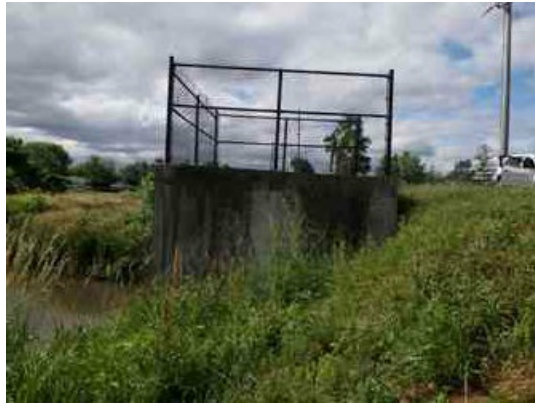
Inspect ID: 2021-0035 **Title:** 2604000009_CELRC_2021_A_0035_1_20210621T141056.jpg **Rated Item:** 5. Concrete Surfaces (Such as gate wells, outfalls, intakes, or culverts) **Caption:** Acceptable - MU-7: Some minor damage on the concrete structure. Monitor.

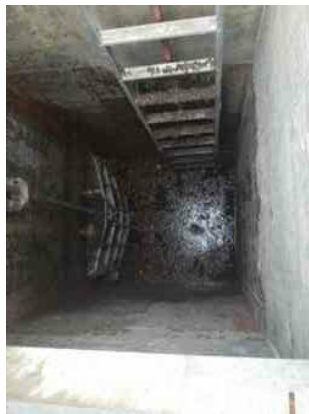
Inspect ID: 2021-0002 **Title:** 2604000009_CELRC_2021_A_0002_1_20210621T132348.jpg **Rated Item:** 10. Sluice/ Slide Gates **Caption:** Minimally Acceptable - MU-11: Silt inside of the gatewell. Recommend clearing out.

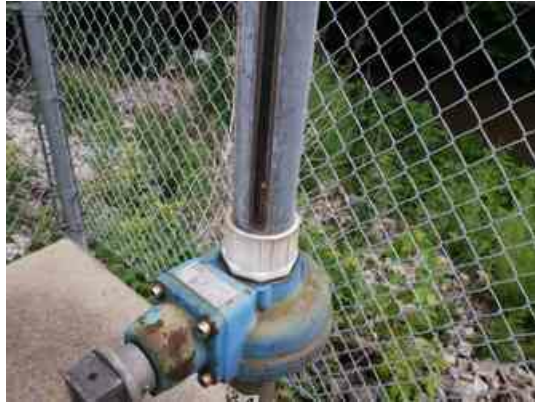
Inspect ID: 2021-0062 **Title:** 2604000009_CELRC_2021_A_0062_1_20210621T142944.jpg **Rated Item:** 10. Sluice/ Slide Gates **Caption:** Acceptable - MU-4: Sluice gate in good condition.

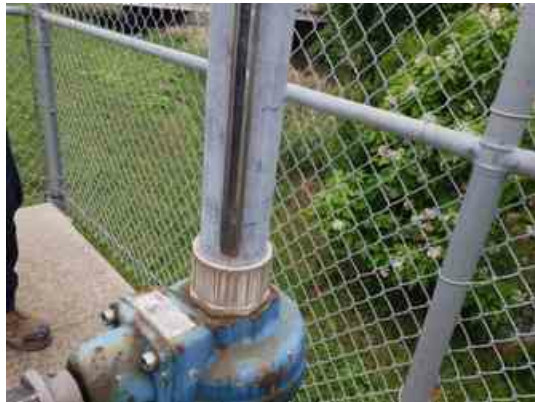
Inspect ID: 2021-0077 **Title:** 2604000009_CELRC_2021_A_0077_1_20210621T144615.jpg **Rated Item:** 10. Sluice/ Slide Gates **Caption:** Acceptable - MU-3: Slice gate opens and closes with no resistance.

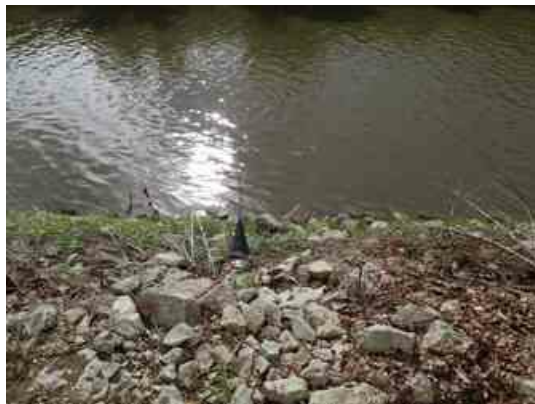
Inspect ID: 2021-0022 **Title:** 2604000009_CELRC_2021_A_0022_1_20210621T132953.jpg **Rated Item:** 11. Flap Gates/ Flap Valves/ Pinch Valves **Caption:** Acceptable - MU-12: Good condition.

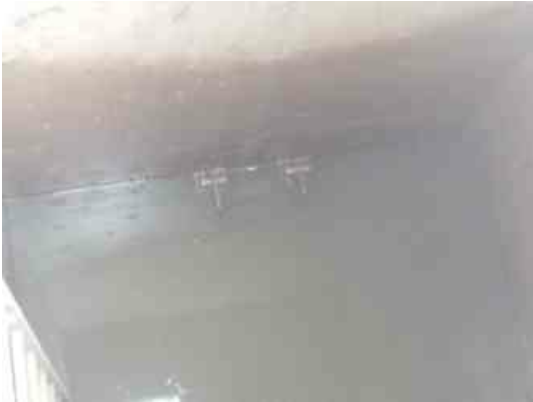
<p>Inspect ID: 2021-0029 Title: 2604000009_CELRC_2021_A_0029_1_20210621T140223.jpg Rated Item: 11. Flap Gates/ Flap Valves/ Pinch Valves Caption: Acceptable - MU-11: Flap gate fully closed and in good condition.</p>

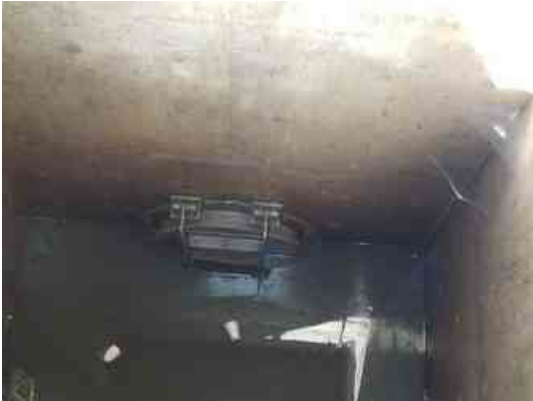
<p>Inspect ID: 2021-0044 Title: 2604000009_CELRC_2021_A_0044_1_20210621T141803.jpg Rated Item: 11. Flap Gates/ Flap Valves/ Pinch Valves Caption: Acceptable - MU-6: Flap gate closed completely.</p>

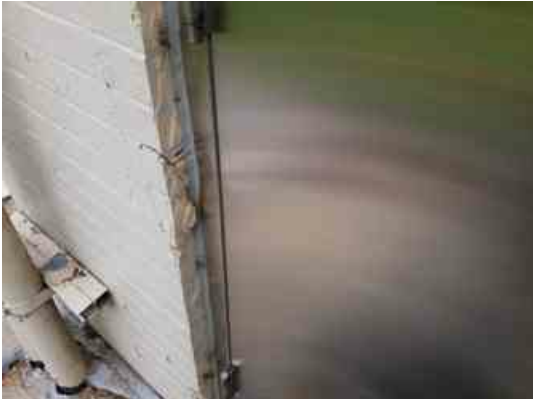
<p>Inspect ID: 2021-0009 Title: 2604000009_CELRC_2021_A_2021-0009_1_20210621T132816.jpg Rated Item: 5. Plant Building Caption: Acceptable - PS-BA: Exterior cracks look sealed, masonry is firm.</p>

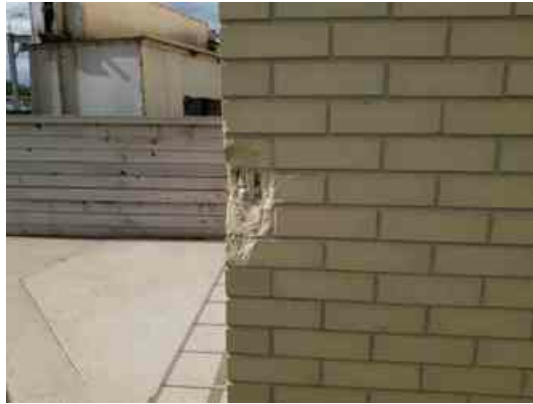
Inspect ID: 2021-0033 **Title:** 2604000009_CELRC_2021_A_0033_1_20210621T135818.jpg **Rated Item:** 5. Plant Building **Caption:** Minimally Acceptable - PS-CA: NE corner has minor exterior damage. Patch.

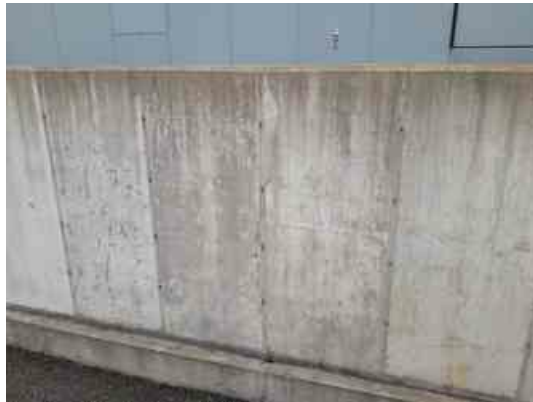
Inspect ID: 2021-0036 **Title:** 2604000009_CELRC_2021_A_0036_1_20210621T140021.jpg **Rated Item:** 5. Plant Building **Caption:** Acceptable - PS-CA: Minor surface cracks on generator wall. Monitor for progression.

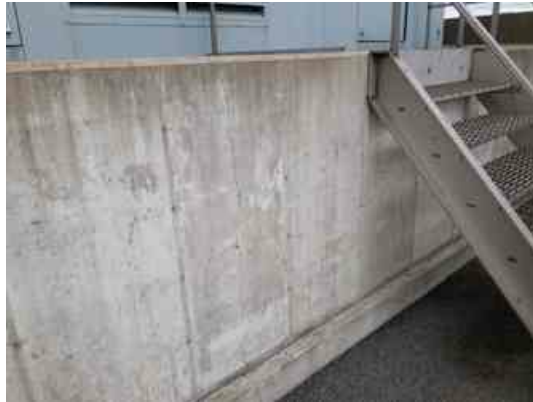
Inspect ID: 2021-0036 **Title:** 2604000009_CELRC_2021_A_0036_2_20210621T140036.jpg **Rated Item:** 5. Plant Building **Caption:** Acceptable - PS-CA: Minor surface cracks on generator wall. Monitor for progression.

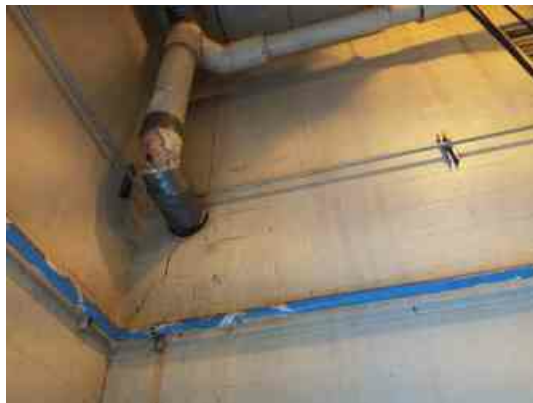
Inspect ID: 2021-0039 **Title:** 2604000009_CELRC_2021_A_0039_1_20210621T141159.jpg **Rated Item:** 5. Plant Building **Caption:** Minimally Acceptable - PS-OA: Crack running from roof down to pipe. Seal.

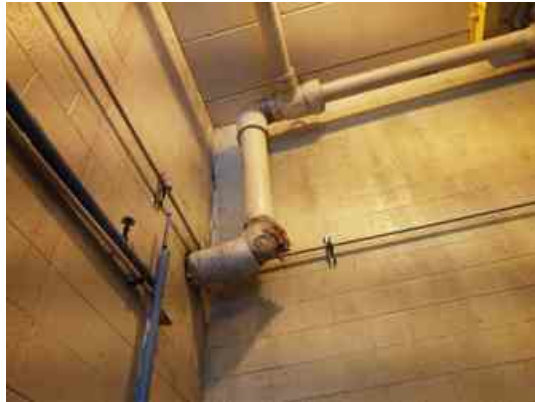
Inspect ID: 2021-0042 **Title:** 2604000009_CELRC_2021_A_0042_1_20210621T141401.jpg **Rated Item:** 5. Plant Building **Caption:** Minimally Acceptable - PS-OA: Crack running along corner of interior. Seal.

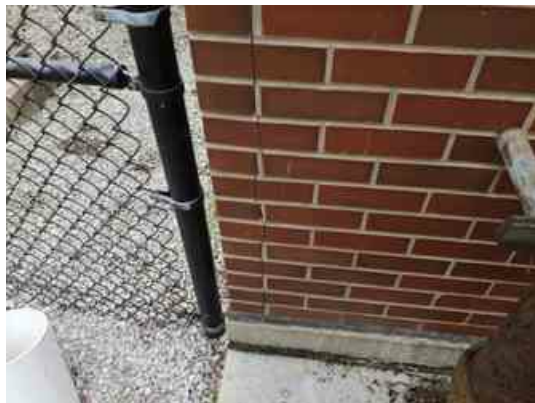
Inspect ID: 2021-0054 **Title:** 2604000009_CELRC_2021_A_0054_1_20210621T142758.jpg **Rated Item:** 5. Plant Building **Caption:** Minimally Acceptable - PS-OA: Cracks on exterior corner of building from roof to foundation. Repair.

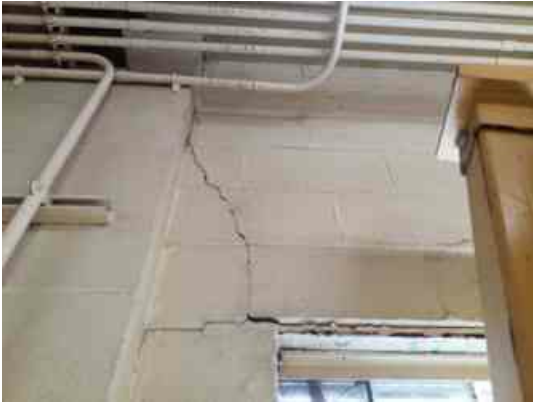
Inspect ID: 2021-0060 Title: 2604000009_CELRC_2021_A_0060_1_20210621T144049.jpg Rated Item: 5. Plant Building Caption: Minimally Acceptable - PS-HM: Cracks near window frames should be repaired.
