## Levee Inspection Report

Name of System: Hammond Forest Ave

NLD System ID: 2605000010

Date(s) of Inspection: 04/13/2022 - 04/13/2022

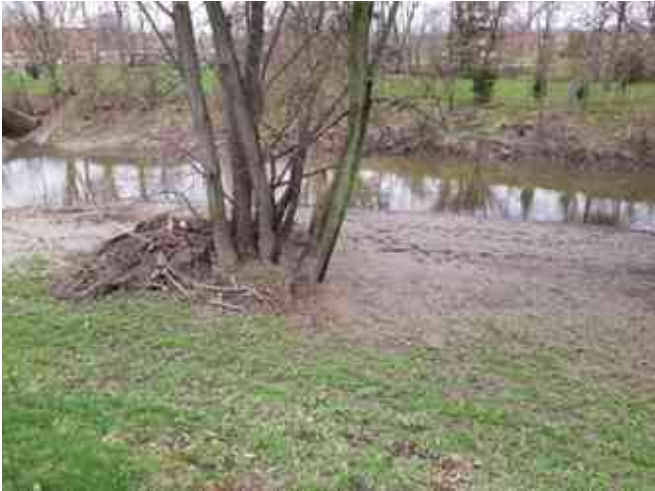
<p><b>Inspect ID:</b> 2022-0023 <b>Title:</b> 2604000010_CELRC_2022_A_0023_1_20220413T182146.jpg <b>Rated Item:</b> 1. Unwanted Vegetation Growth <b>Caption:</b> Minimally Acceptable - Tree within 10 ft of landside toe.</p>

Rated Item	Rating	Rating Guidelines		Location/Remarks/Recommendations
1. Unwanted Vegetation Growth	<b>M</b>	<b>A</b>	The levee has little or no unwanted vegetation (trees, bush, or undesirable weeds), except for vegetation that is properly contained and/or situated on overbuilt sections, such that the mandatory 3-foot root-free zone is preserved around the levee profile. The levee has been recently mowed. The vegetation-free zone extends 15 feet from both the landside and riverside toes of the levee to the centerline of the tree. If the levee access easement doesn't extend to the described limits, then the vegetation-free zone must be maintained to the easement limits. Reference EM 1110-2-301 or Corps policy for regional vegetation variance.	2022-0001 : Trees on embankment crown. (M) 2022-0003 : Trees on riverside embankment. (M) 2022-0023 : Tree within 10 ft of landside toe. (M) 2022-0025 : Both trees are within 10ft of landside toe. (M) 2022-0031 : Brush growth along length of landside toe. (M) 2022-0059 : Trees and plantings along landside of sheet pile tieback wall. (M) 2022-0075 : Tree on landside toe too close to levee. (M) <b>Recommendation:</b> Remove trees and vegetation from 15 foot vegetation free zone.

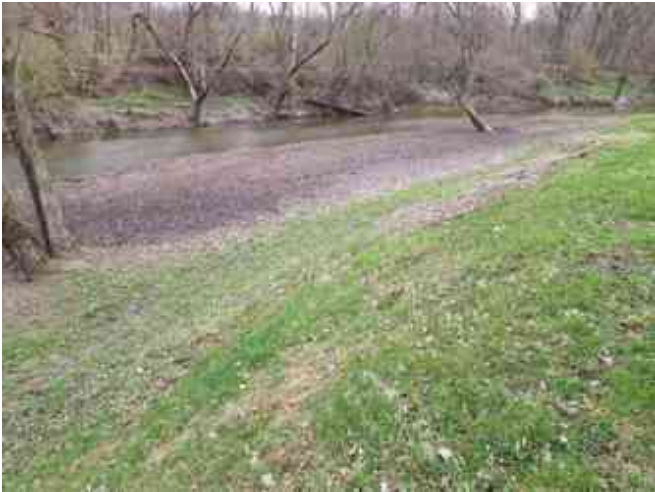
<p><b>Inspect ID:</b> 2022-0025 <b>Title:</b> 2604000010_CELRC_2022_A_0025_1_20220413T182222.jpg <b>Rated Item:</b> 1. Unwanted Vegetation Growth <b>Caption:</b> Minimally Acceptable - Both trees are within 10ft of landside toe.</p>

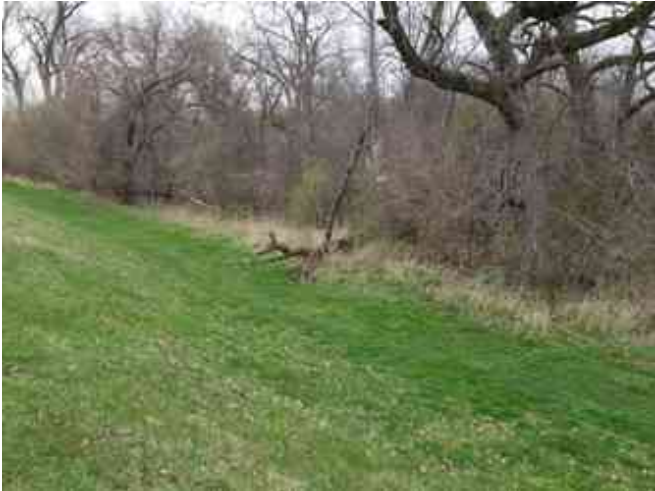
<p><b>Inspect ID:</b> 2022-0009 <b>Title:</b> 2604000010_CELRC_2022_A_0009_1_20220413T181155.jpg <b>Rated Item:</b> 3. Encroachments <b>Caption:</b> Minimally Acceptable - Fallen tree within 15 feet of landside toe.</p>

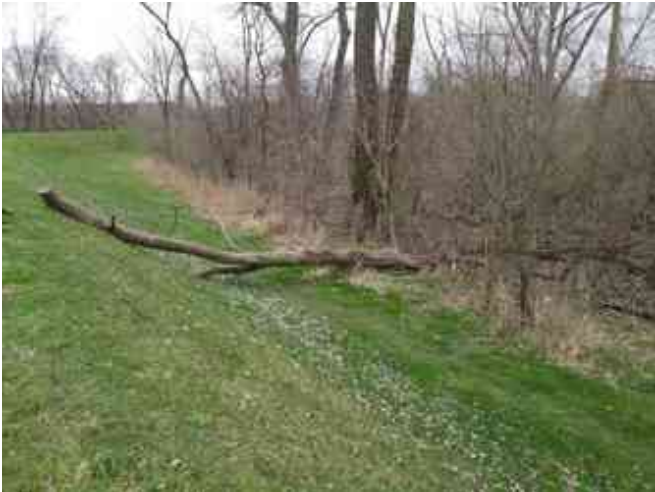
<p><b>Inspect ID:</b> 2022-0011 <b>Title:</b> 2604000010_CELRC_2022_A_0011_1_20220413T181236.jpg <b>Rated Item:</b> 3. Encroachments <b>Caption:</b> Minimally Acceptable - Fallen tree within 15 feet of landside toe.</p>

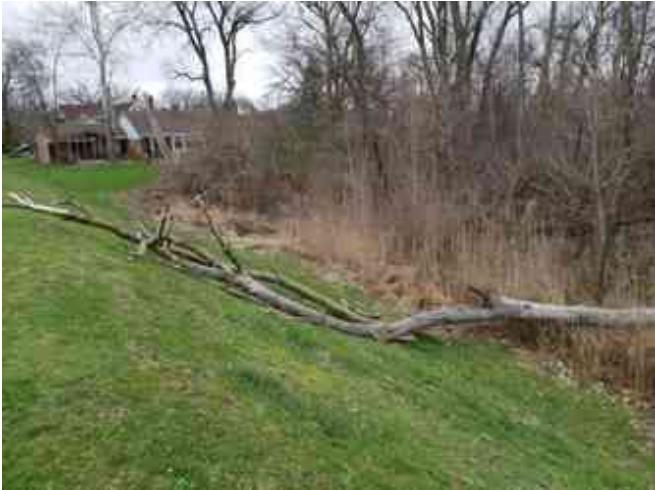
Rated Item	Rating	Rating Guidelines		Location/Remarks/Recommendations
3. Encroachments	<b>M</b>	<b>A</b>	No trash, debris, unauthorized farming activity, structures, excavations, or other obstructions present within the easement area. Encroachments have been previously reviewed by the Corps, and it was determined that they do not diminish proper functioning of the levee.	2022-0009 : Fallen tree within 15 feet of landside toe. (M) 2022-0011 : Fallen tree within 15 feet of landside toe. (M)
		<b>M</b>	Trash, debris, unauthorized farming activity, structures, excavations, or other obstructions present, or inappropriate activities noted that should be corrected but will not inhibit operations and maintenance or emergency operations. Encroachments have not been reviewed by the Corps.	2022-0019 : Debris within 10 ft of riverside toe. (M) 2022-0037 : Fallen Tree on landside slope of levee. (M) 2022-0039 : Fallen tree on landside slope. (M)

<p><b>Inspect ID:</b> 2022-0039 <b>Title:</b> 2604000010_CELRC_2022_A_0039_1_20220413T182959.jpg <b>Rated Item:</b> 3. Encroachments <b>Caption:</b> Minimally Acceptable - Fallen tree on landside slope.</p>

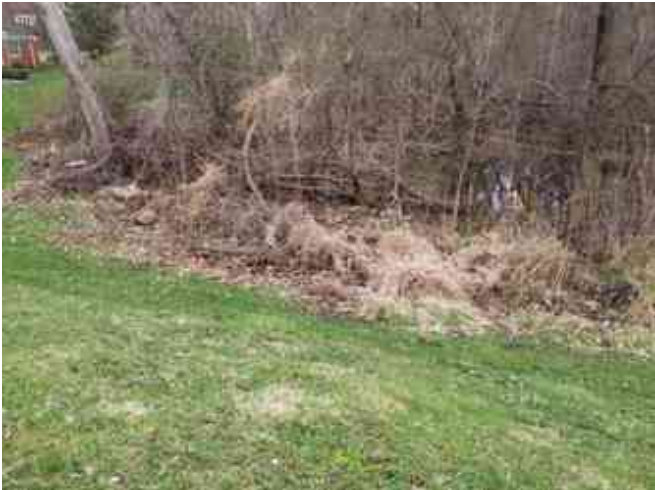
<b>U</b>	Unauthorized encroachments or inappropriate activities noted are likely to inhibit operations and maintenance, emergency operations, or negatively impact the integrity of the levee.	2022-0041 : Debris on landside toe. (M) 2022-0051 : Coaxial cable installed on crown of levee. (M) 2022-0055 : Fence encroaching access on landside toe and slope. (M) 2022-0057 : Unauthorized stairs encroaching on landside slope. (M) 2022-0073 : Garden and lawn furniture encroaching landside slope and toe. (M) <b>Recommendation:</b> Remove debris . Discuss structure encroachments with owner. Remove or submit Section 408 requests for fence, garden, and steps. Remove coaxial cable from crest of levee.

<p><b>Inspect ID:</b> 2022-0041 <b>Title:</b> 2604000010_CELRC_2022_A_0041_1_20220413T183109.jpg <b>Rated Item:</b> 3. Encroachments <b>Caption:</b> Minimally Acceptable - Debris on landside toe.</p>

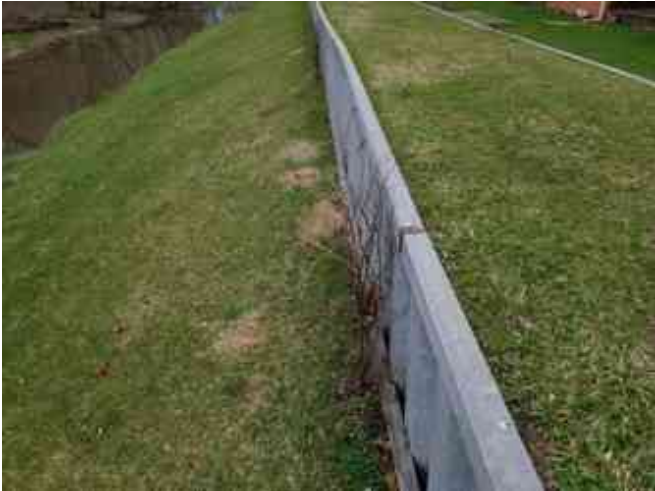
<p><b>Inspect ID:</b> 2022-0047 <b>Title:</b> 2604000010_CELRC_2022_A_0047_1_20220413T183448.jpg <b>Rated Item:</b> 1. Unwanted Vegetation Growth <b>Caption:</b> Minimally Acceptable - Small trees along riverside of floodwall.</p>

Rated Item	Rating	Rating Guidelines		Location/Remarks/Recommendations
1. Unwanted Vegetation Growth	<b>M</b>	<b>A</b>	A grass-only or paved zone is maintained on both sides of the floodwall, free of all trees, brush, and undesirable weeds. The vegetation-free zone extends 15 feet from both the land and riverside of the floodwall, at ground-level, to the centerline of the tree. Additionally, an 8- foot root-free zone is maintained around the entire structure, including the floodwall toe, heel, and any toe-drains. If the floodwall access easement doesn't extend to the described limits, then the vegetation-free zone must be maintained to the easement limits. Reference EM 1110- 2-301 and/or Corps policy for regional vegetation variance.	2022-0047 : Small trees along riverside of floodwall. (M) 2022-0067 : Small trees along riverside of floodwall. (M) 2022-0091 : Weed growing in landside wall joint. (M) 2022-0095 : Small bush along riverside of floodwall. (M) 2022-0097 : Small bush on riverside of floodwall. (M) 2022-0099 : Small bush on riverside of floodwall. (M) <b>Recommendation:</b> Remove vegetation around floodwalls.

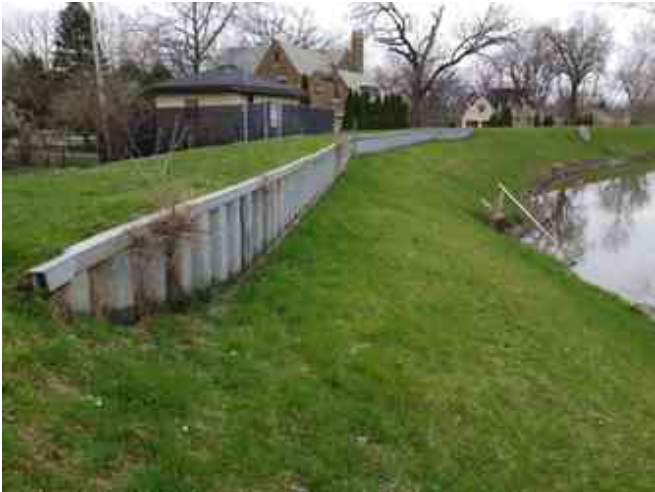
<p><b>Inspect ID:</b> 2022-0067 <b>Title:</b> 2604000010_CELRC_2022_A_0067_1_20220413T184834.jpg <b>Rated Item:</b> 1. Unwanted Vegetation Growth <b>Caption:</b> Minimally Acceptable - Small trees along riverside of floodwall.</p>

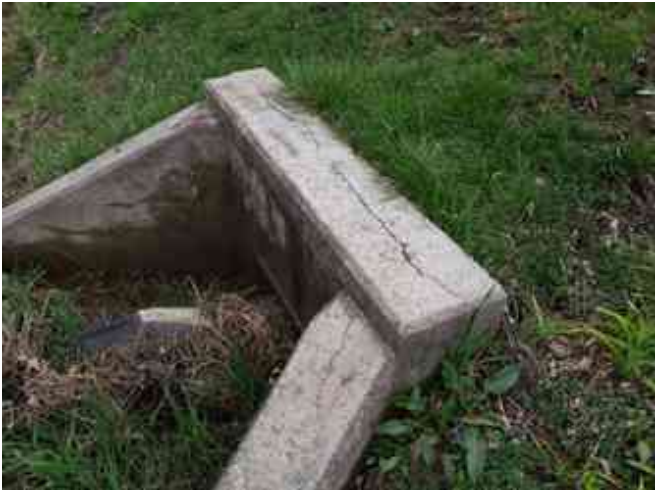
<p><b>Inspect ID:</b> 2022-0079 <b>Title:</b> 2604000010_CELRC_2022_A_0079_1_20220413T185354.jpg <b>Rated Item:</b> 5. Concrete Surfaces (Such as gate wells, outfalls, intakes, or culverts) <b>Caption:</b> Minimally Acceptable - FA-2: Large cracks in headwall concrete.</p>

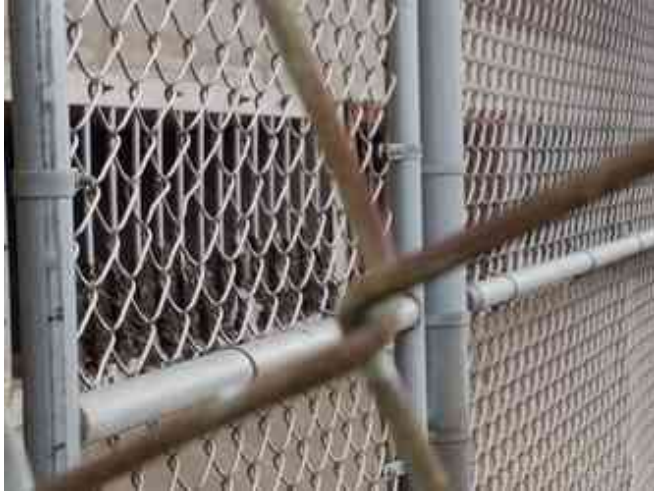
**Inspect ID:** 2022-0008 **Title:**  
2604000010\_CELRC\_2022\_A\_0008\_1\_20220411T151313.jpg  
**Rated Item:** 11. Non-Mechanical Trash Racks **Caption:**  
Minimally Acceptable - PS-SH: Pump station outlet grating  
needs cleaning.
