Levee Inspection Report

Name of System: Burr Street
 Name of Segment: Gary Burr St
 NLD System ID: 2605000004 NLD Segment ID: 2604000005

Segment Type: USACE Federally constructed, turned over to public sponsor operations and maintenance
 Levee Sponsor (Name and Organization): Little Calumet River Basin Development Commission
 Inspection Report Prepared by: Chris Schaal Date(s) of Inspection: 06/09/2022 - 06/09/2022

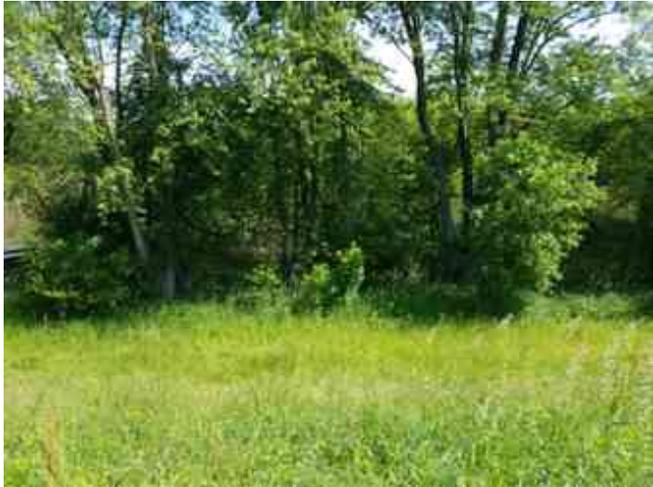
<p>Inspect ID: 2022-0055 Title: 2604000005_CELRC_2022_A_0055_1_20220609T150412.jpg Rated Item: 1. Unwanted Vegetation Growth Caption: Minimally Acceptable - Trees on riverside.</p>

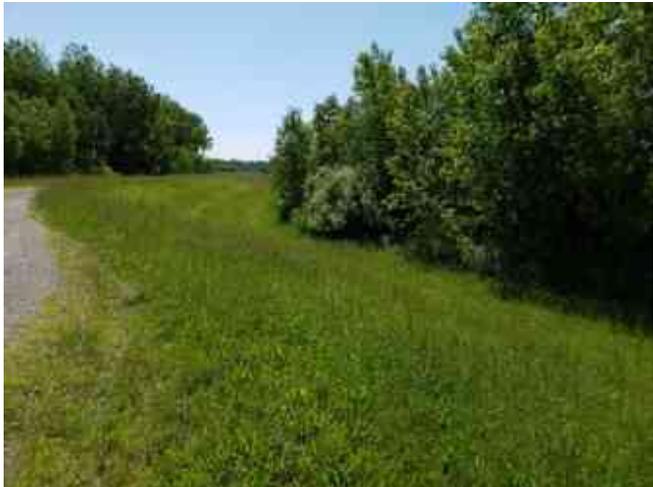
<p>Inspect ID: 2022-0115 Title: 2604000005_CELRC_2022_A_0115_1_20220609T153630.jpg Rated Item: 1. Unwanted Vegetation Growth Caption: Unacceptable - Large trees close to landside toe.</p>

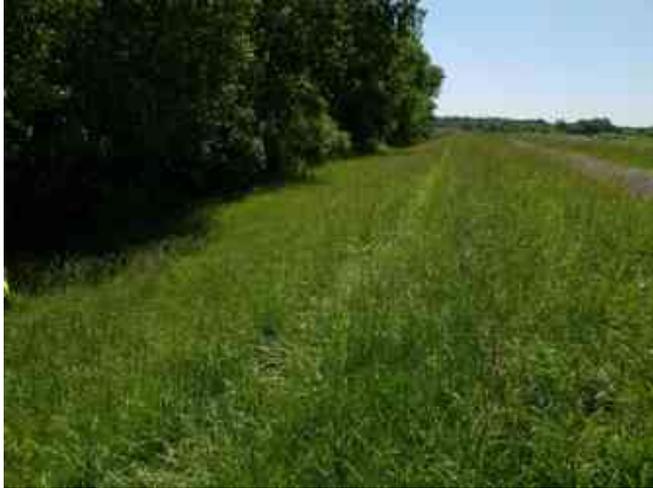
<p>Inspect ID: 2022-0121 Title: 2604000005_CELRC_2022_A_0121_1_20220609T153826.jpg Rated Item: 1. Unwanted Vegetation Growth Caption: Unacceptable - Large trees and tall vegetation on riverside.</p>

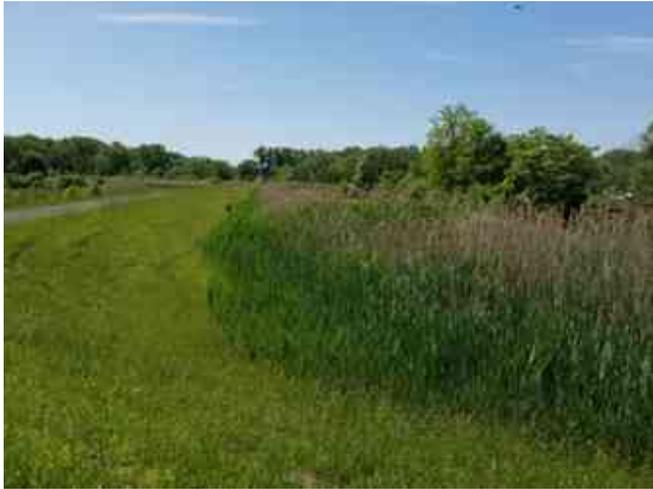
<p>Inspect ID: 2022-0151 Title: 2604000005_CELRC_2022_A_0151_1_20220609T160022.jpg Rated Item: 1. Unwanted Vegetation Growth Caption: Minimally Acceptable - Tall vegetation on landside.</p>

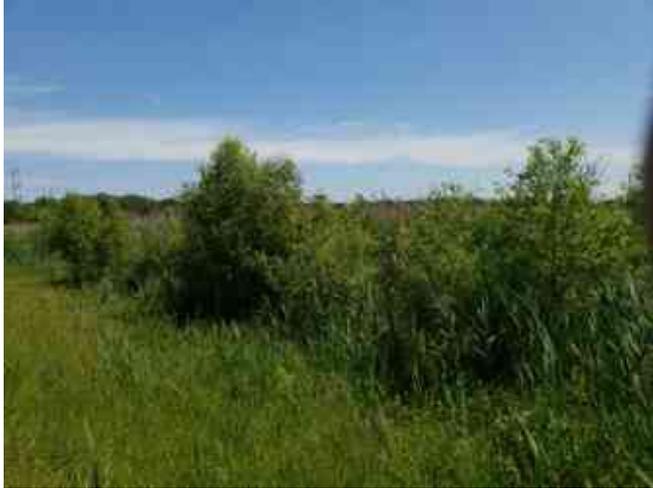
<p>Inspect ID: 2022-0154 Title: 2604000005_CELRC_2022_A_0154_1_20220609T160245.jpg Rated Item: 1. Unwanted Vegetation Growth Caption: Minimally Acceptable - Small tree growth on waterside toe.</p>

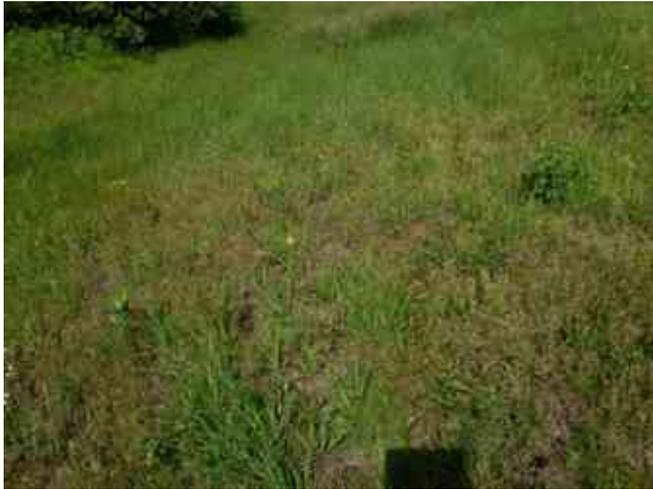
<p>Inspect ID: 2022-0049 Title: 2604000005_CELRC_2022_A_2022-0049_1_20220609T145838.jpg Rated Item: 2. Sod Cover Caption: Minimally Acceptable - Sod cover on landside slope is poor</p>

2. Sod Cover	M	A	There is good coverage of sod over the levee.	2022-0049 : Sod cover on landside slope is poor. (M) 2022-0133 : Poor sod on riverside slope due to old ruts. (M) Recommendation: Restore sod cover.
		M	Approximately 25% of the sod cover is missing or damaged over a significant portion or over significant portions of the levee embankment. This may be the result of over-grazing or feeding on the levee, unauthorized vehicular traffic, chemical or insect problems, or burning during inappropriate seasons.	
		U	Over 50% of the sod cover is missing or damaged over a significant portion or portions of the levee embankment.	
		N/A	Surface protection is provided by other means.

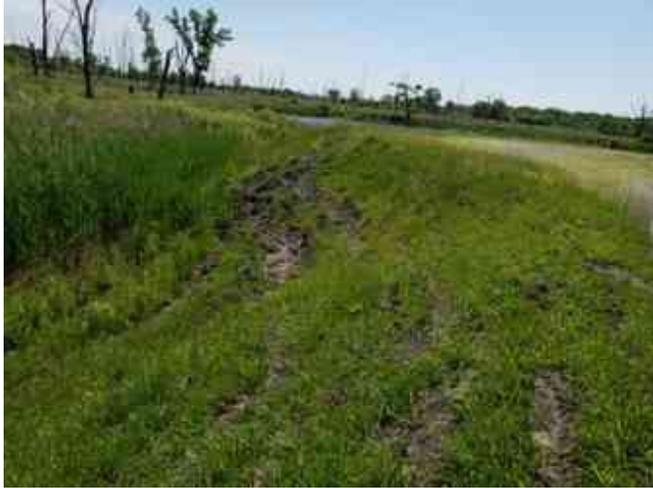
<p>Inspect ID: 2022-0133 Title: 2604000005_CELRC_2022_A_0133_1_20220609T154503.jpg Rated Item: 2. Sod Cover Caption: Minimally Acceptable - Poor sod on riverside slope due to old ruts.</p>

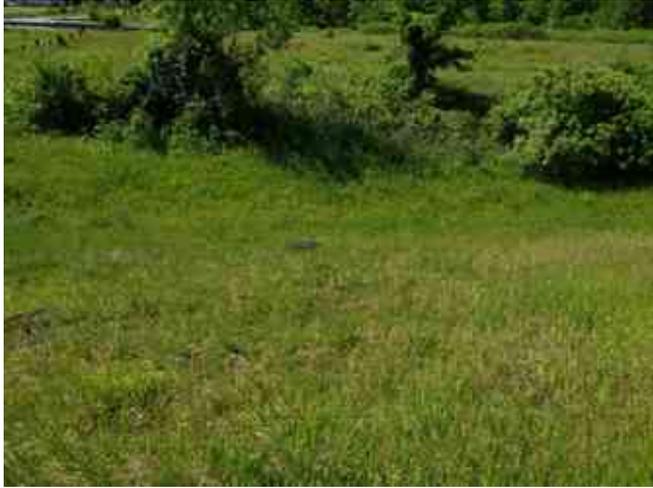
<p>Inspect ID: 2022-0040 Title: 2604000005_CELRC_2022_A_0040_1_20220609T145244.jpg Rated Item: 3. Encroachments Caption: Minimally Acceptable - Debris on landside toe.</p>

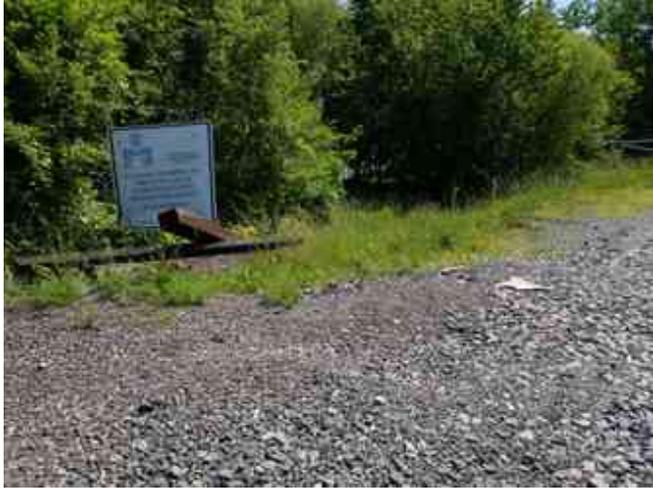
<p>Inspect ID: 2022-0088 Title: 2604000005_CELRC_2022_A_0088_1_20220609T151922.jpg Rated Item: 3. Encroachments Caption: Minimally Acceptable - Railroad ties on riverside slope.</p>

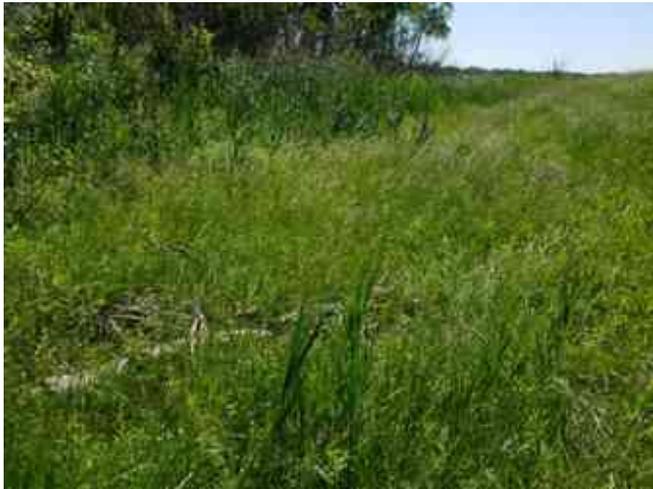
<p>Inspect ID: 2022-0127 Title: 2604000005_CELRC_2022_A_0127_1_20220609T154235.jpg Rated Item: 3. Encroachments Caption: Minimally Acceptable - Branches on riverside toe.</p>

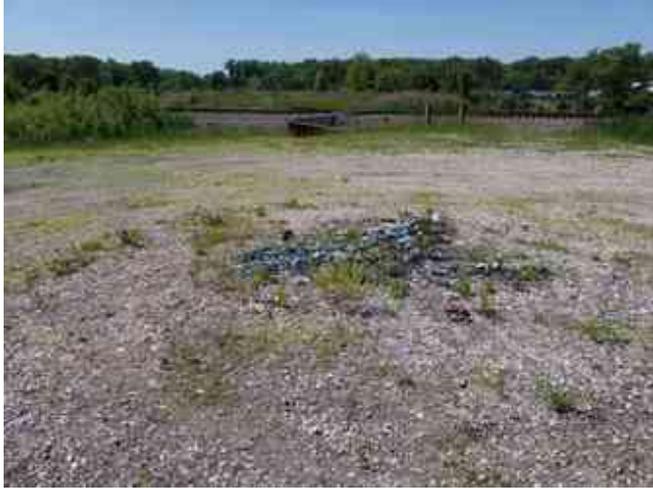
<p>Inspect ID: 2022-0136 Title: 2604000005_CELRC_2022_A_0136_1_20220609T154818.jpg Rated Item: 3. Encroachments Caption: Minimally Acceptable - Broken glass and debris on the crest.</p>

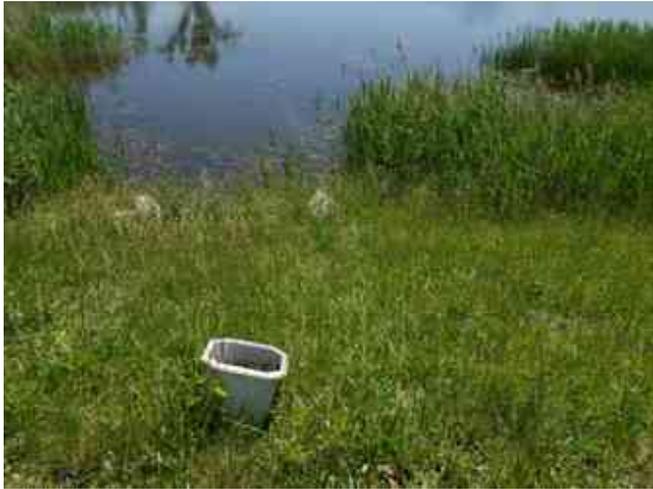
<p>Inspect ID: 2022-0139 Title: 2604000005_CELRC_2022_A_0139_1_20220609T155034.jpg Rated Item: 3. Encroachments Caption: Minimally Acceptable - Debris on riverside slope.</p>

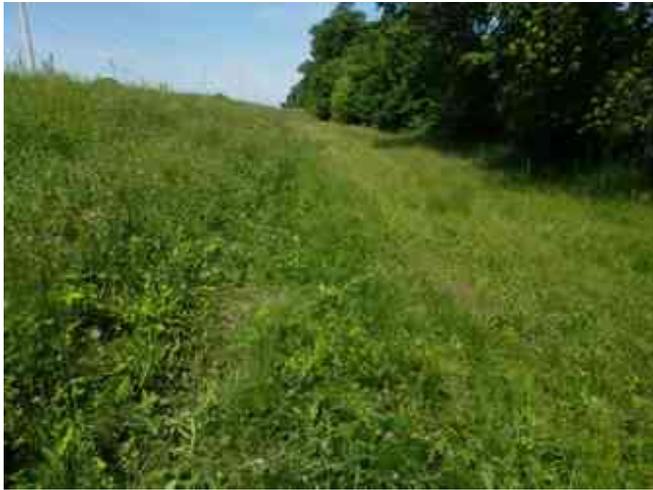
5. Slope Stability	A	A	No slides, sloughs, tension cracking, slope depressions, or bulges are present.	2022-0058 : Slight change in slope. No active movement. Monitor. (A)
		M	Minor slope stability problems that do not pose an immediate threat to the levee embankment.	
		U	Major slope stability problems (ex. deep seated sliding) identified that must be repaired to reestablish the integrity of the levee embankment.

<p>Inspect ID: 2022-0058 Title: 2604000005_CELRC_2022_A_0058_1_20220609T150559.jpg Rated Item: 5. Slope Stability Caption: Acceptable - Slope is different from rest of levee. No active movement. Monitor.</p>

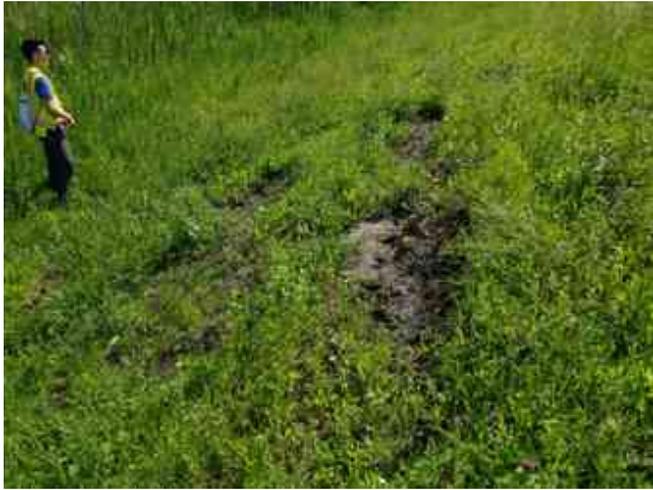
<p>Inspect ID: 2022-0034 Title: 2604000005_CELRC_2022_A_0034_1_20220609T144256.jpg Rated Item: 8. Depressions/ Rutting Caption: Minimally Acceptable - Rutting on riverside slope.</p>

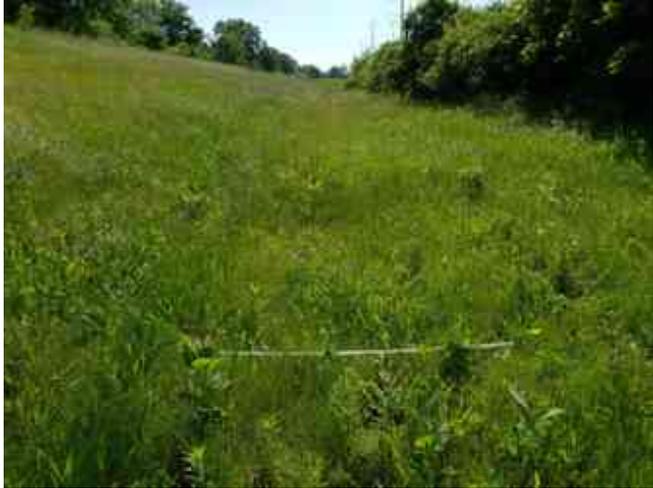
<p>Inspect ID: 2022-0037 Title: 2604000005_CELRC_2022_A_0037_1_20220609T145010.jpg Rated Item: 8. Depressions/ Rutting Caption: Minimally Acceptable - 8 in deep depression along lansside toe.</p>

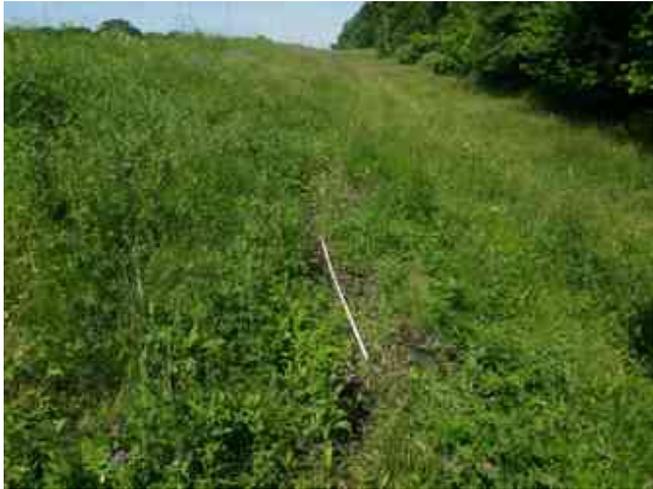
<p>Inspect ID: 2022-0052 Title: 2604000005_CELRC_2022_A_0052_1_20220609T150121.jpg Rated Item: 8. Depressions/ Rutting Caption: Minimally Acceptable - Deep rut on riverside slope.</p>

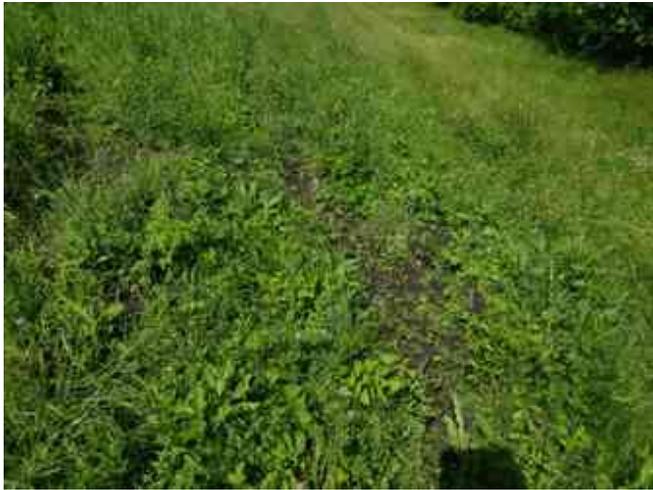
<p>Inspect ID: 2022-0061 Title: 2604000005_CELRC_2022_A_0061_1_20220609T150813.jpg Rated Item: 8. Depressions/ Rutting Caption: Minimally Acceptable - Rutting riverside toe.</p>

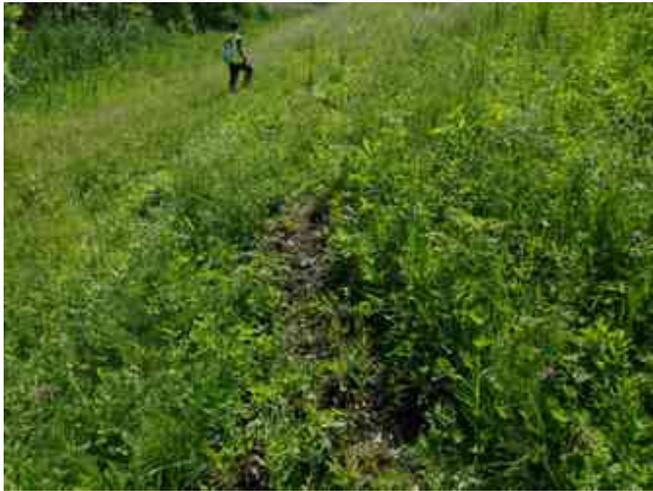
<p>Inspect ID: 2022-0064 Title: 2604000005_CELRC_2022_A_0064_1_20220609T150859.jpg Rated Item: 8. Depressions/ Rutting Caption: Minimally Acceptable - Rutting on riverside slope.</p>

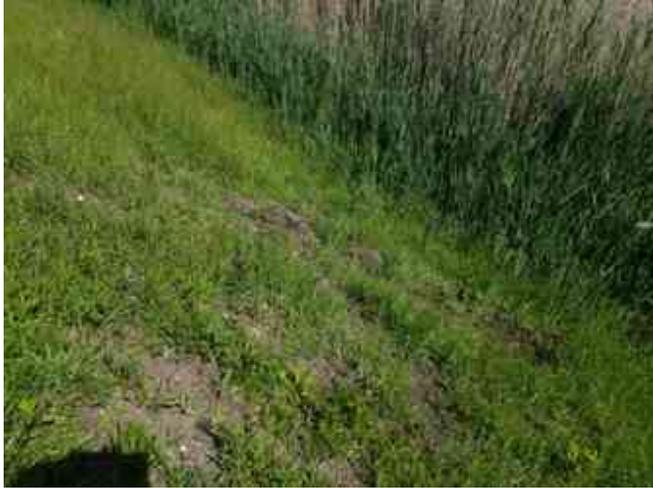
<p>Inspect ID: 2022-0070 Title: 2604000005_CELRC_2022_A_0070_1_20220609T151222.jpg Rated Item: 8. Depressions/ Rutting Caption: Minimally Acceptable - Ruttings riverside</p>

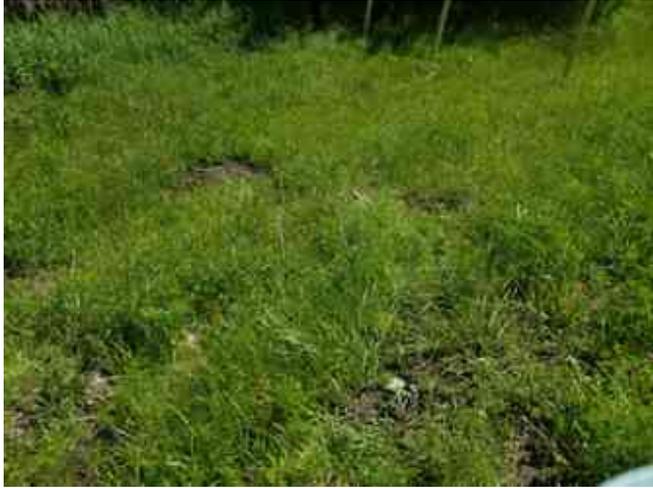
<p>Inspect ID: 2022-0091 Title: 2604000005_CELRC_2022_A_0091_1_20220609T152050.jpg Rated Item: 8. Depressions/ Rutting Caption: Minimally Acceptable - Deep ruts on riverside slope</p>

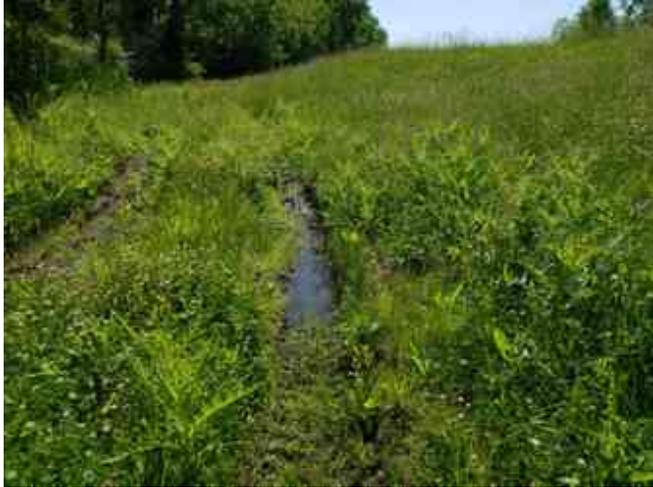
<p>Inspect ID: 2022-0109 Title: 2604000005_CELRC_2022_A_0109_2_20220609T153435.jpg Rated Item: 8. Depressions/ Rutting Caption: Minimally Acceptable - Line for deep rut on riverside toe. Ponding water.</p>

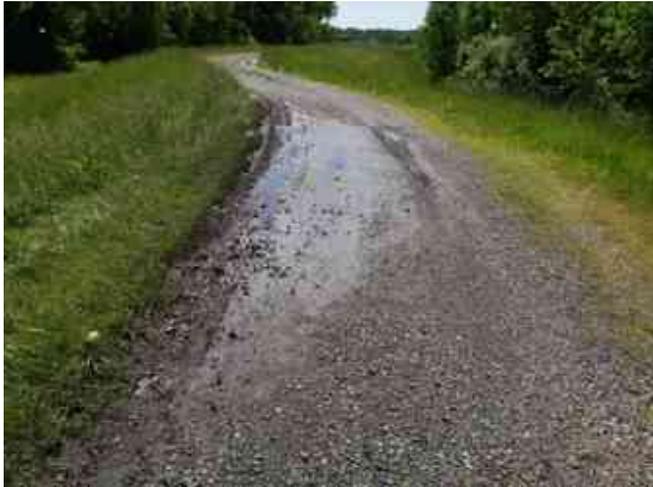
<p>Inspect ID: 2022-0112 Title: 2604000005_CELRC_2022_A_0112_1_20220609T153526.jpg Rated Item: 8. Depressions/ Rutting Caption: Minimally Acceptable - Rutting on crest.</p>

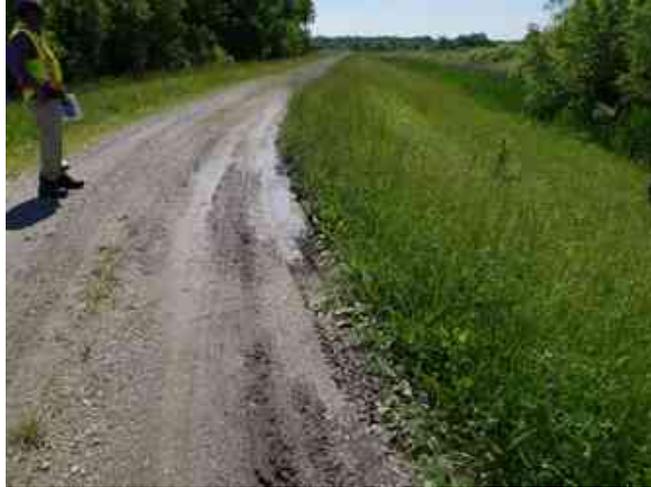
Inspect ID: 2022-0118 **Title:** 2604000005_CELRC_2022_A_0118_1_20220609T153724.jpg
Rated Item: 8. Depressions/ Rutting **Caption:** Minimally Acceptable - Rutting on crest

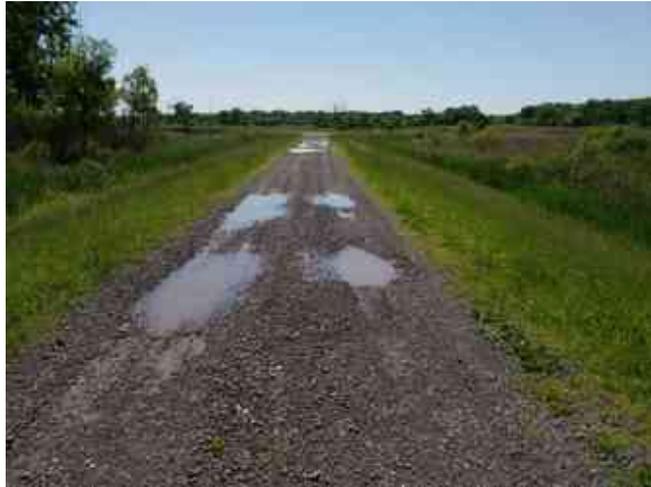
Inspect ID: 2022-0124 **Title:** 2604000005_CELRC_2022_A_2022-0124_2_20220609T154138.jpg **Rated Item:** 8. Depressions/ Rutting **Caption:** Minimally Acceptable - Typical rutting on crest. Ponding 2-3 inches.

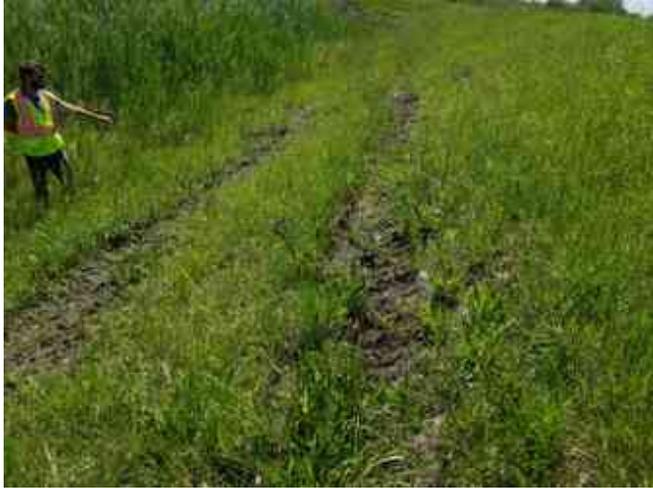
<p>Inspect ID: 2022-0130 Title: 2604000005_CELRC_2022_A_0130_1_20220609T154358.jpg Rated Item: 8. Depressions/ Rutting Caption: Minimally Acceptable - Rutting on riverside slope.</p>

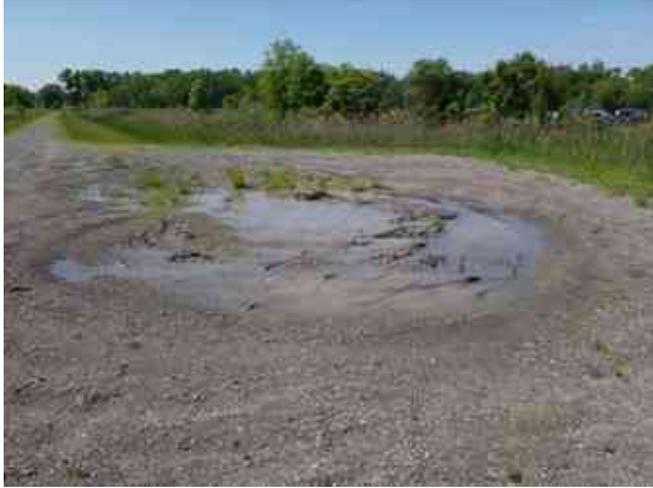
<p>Inspect ID: 2022-0148 Title: 2604000005_CELRC_2022_A_0148_1_20220609T155846.jpg Rated Item: 8. Depressions/ Rutting Caption: Minimally Acceptable - Depression and standing water.</p>

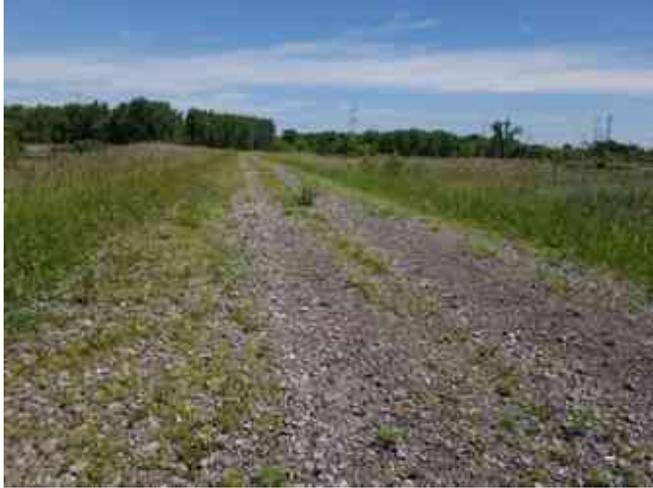
A photograph showing a gravel path or road surface with several small depressions or ruts. The path is surrounded by grass and vegetation. The sky is blue with some light clouds.	<p>Inspect ID: 2022-0157 Title: 2604000005_CELRC_2022_A_0157_1_20220609T160353.jpg Rated Item: 8. Depressions/ Rutting Caption: Minimally Acceptable - Depressions that hold water.</p>

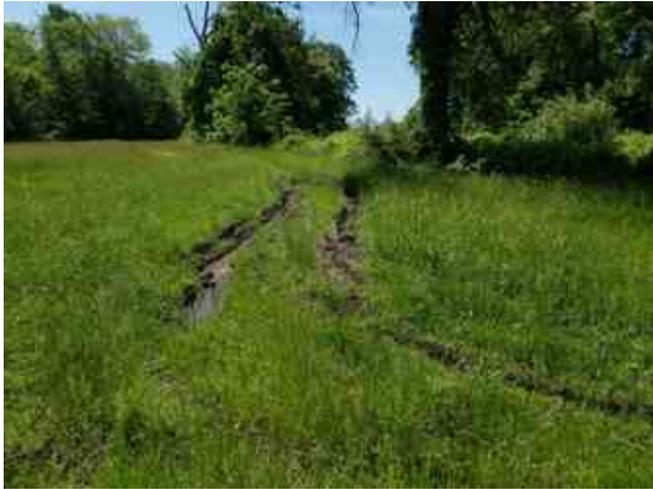
A photograph showing a grassy area with a path or road surface. The path has several deep ruts that appear to be holding water. The area is surrounded by trees and vegetation.	<p>Inspect ID: 2022-0160 Title: 2604000005_CELRC_2022_A_0160_1_20220609T161008.jpg Rated Item: 8. Depressions/ Rutting Caption: Minimally Acceptable - Ruts holding water on landside toe.</p>

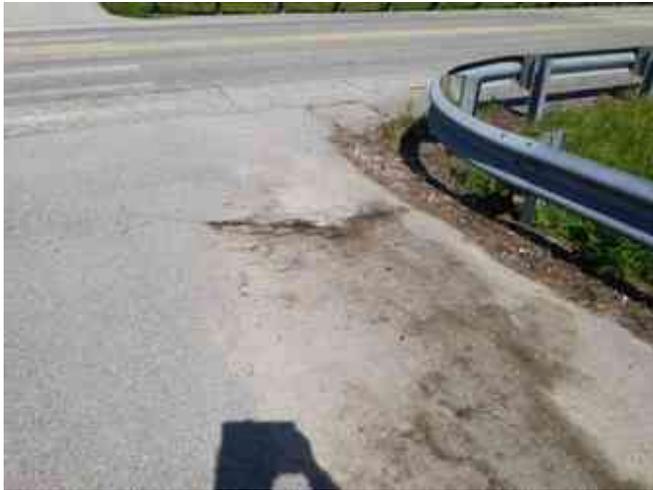
9. Cracking	A	A	Minor longitudinal, transverse, or desiccation cracks with no vertical movement along the crack. No cracks extend continuously through the levee crest.	2022-0043 : Minor asphalt cracking on crest. Monitor. (A)
		M	Longitudinal and/or transverse cracks up to 6 inches in depth with no vertical movement along the crack. No cracks extend continuously through the levee crest. Longitudinal cracks are no longer than the height of the levee.	
		U	Cracks exceed 6 inches in depth. Longitudinal cracks are longer than the height of the levee and/or exhibit vertical movement along the crack. Transverse cracks extend through the entire levee width.

<p>Inspect ID: 2022-0043 Title: 2604000005_CELRC_2022_A_0043_1_20220609T145432.jpg Rated Item: 9. Cracking Caption: Acceptable - Minor asphalt cracking on crest. Monitor.</p>

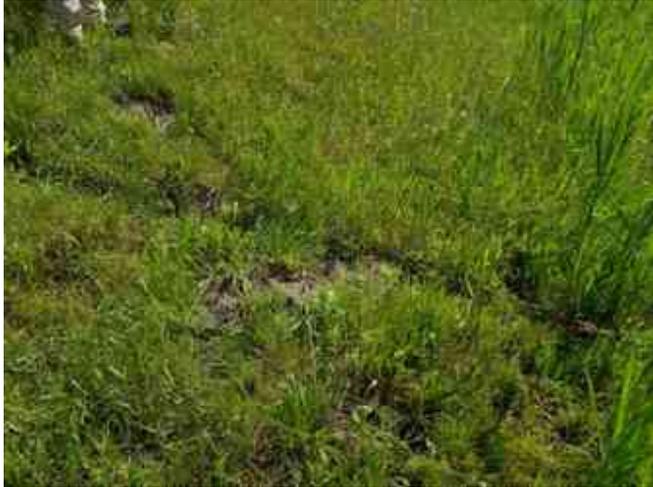
<p>Inspect ID: 2022-0067 Title: 2604000005_CELRC_2022_A_0067_1_20220609T151038.jpg Rated Item: 10. Animal Control Caption: Acceptable - Landside slope has inactive animal burrows.</p>

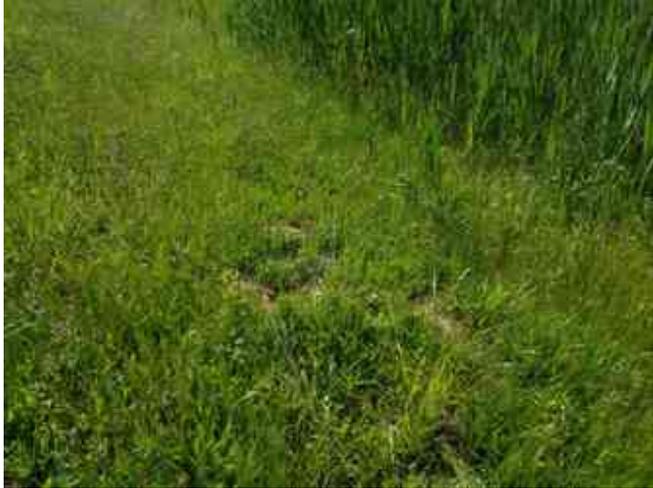
<p>Inspect ID: 2022-0097 Title: 2604000005_CELRC_2022_A_0097_1_20220609T152319.jpg Rated Item: 10. Animal Control Caption: Minimally Acceptable - Animal mounds on landside toe.</p>

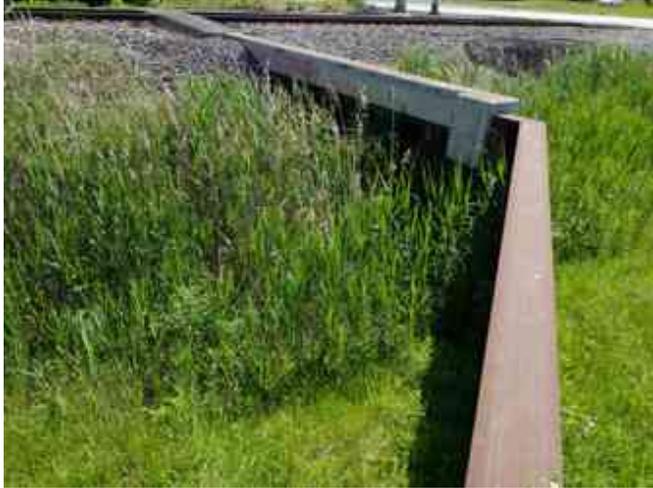
<p>Inspect ID: 2022-0073 Title: 2604000005_CELRC_2022_A_0073_1_20220609T151337.jpg Rated Item: 1. Unwanted Vegetation Growth Caption: Minimally Acceptable - Tall vegetation on riverside.</p>

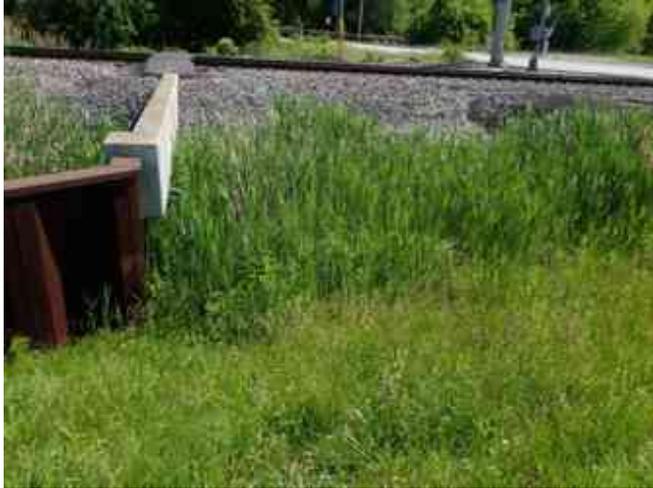
<p>Inspect ID: 2022-0076 Title: 2604000005_CELRC_2022_A_0076_1_20220609T151412.jpg Rated Item: 1. Unwanted Vegetation Growth Caption: Minimally Acceptable - Tall vegetation on landside.</p>

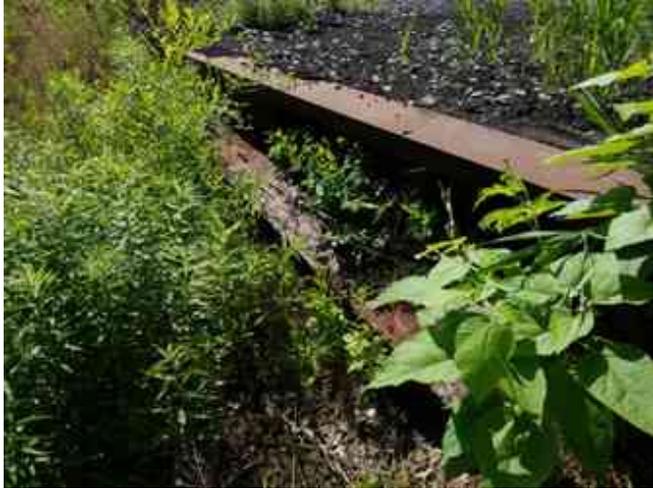
<p>Inspect ID: 2022-0085 Title: 2604000005_CELRC_2022_A_0085_1_20220609T151809.jpg Rated Item: 2. Encroachments Caption: Minimally Acceptable - Railroad ties next to floodwall.</p>

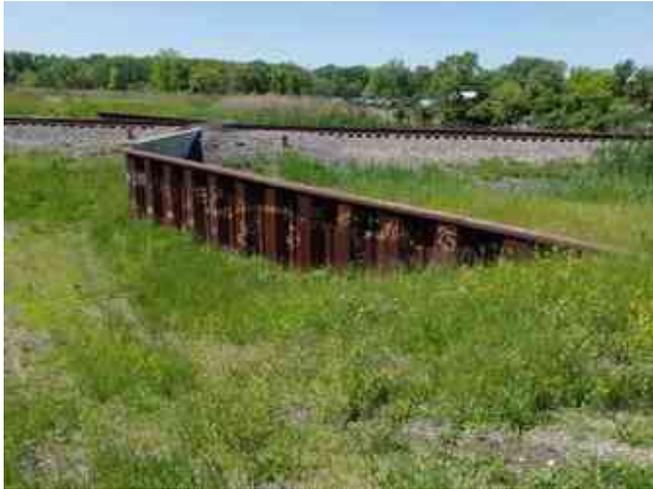
<p>Inspect ID: 2022-0142 Title: 2604000005_CELRC_2022_A_0142_1_20220609T155157.jpg Rated Item: 2. Encroachments Caption: Minimally Acceptable - Graffiti on riverside and landside.</p>

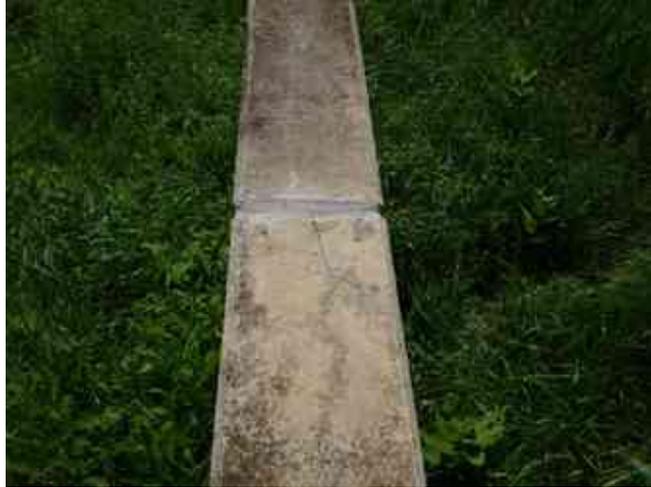
4. Concrete Surfaces	M	A	Negligible spalling, scaling or cracking. If the concrete surface is weathered or holds moisture, it is still satisfactory but should be seal coated to prevent freeze/ thaw damage.	2022-0100 : Crack on top of floodwall. (M) 2022-0103 : 6 inch diameter spall on landside. (M) Recommendation: Seal crack and sawcut spall to replace concrete.
		M	Spalling, scaling, and open cracking present, but the immediate integrity or performance of the structure is not threatened. Reinforcing steel may be exposed. Repairs/ sealing is necessary to prevent additional damage during periods of thawing and freezing.	
		U	Surface deterioration or deep cracks present that may result in an unreliable structure. Any surface deterioration that exposes the sheet piling or lies adjacent to monolith joints may indicate underlying reinforcement corrosion and is unacceptable.

Inspect ID: 2022-0100 **Title:** 2604000005_CELRC_2022_A_0100_1_20220609T152455.jpg
Rated Item: 4. Concrete Surfaces **Caption:** Minimally Acceptable - Crack on top of floodwall.

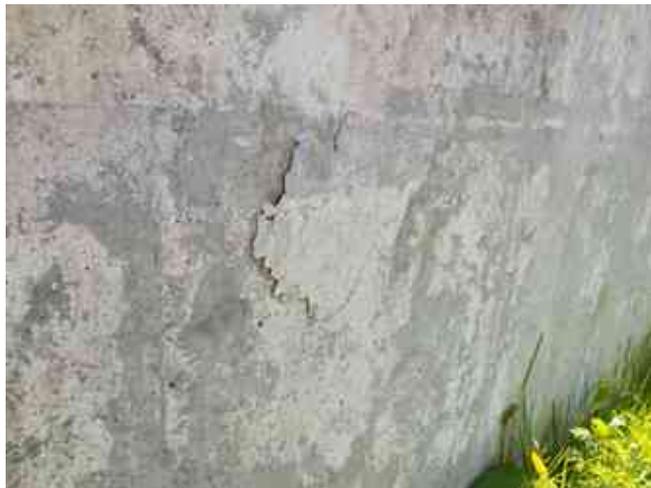
Inspect ID: 2022-0103 **Title:** 2604000005_CELRC_2022_A_0103_1_20220609T152726.jpg
Rated Item: 4. Concrete Surfaces **Caption:** Minimally Acceptable - 6 inch diameter spall on landside.

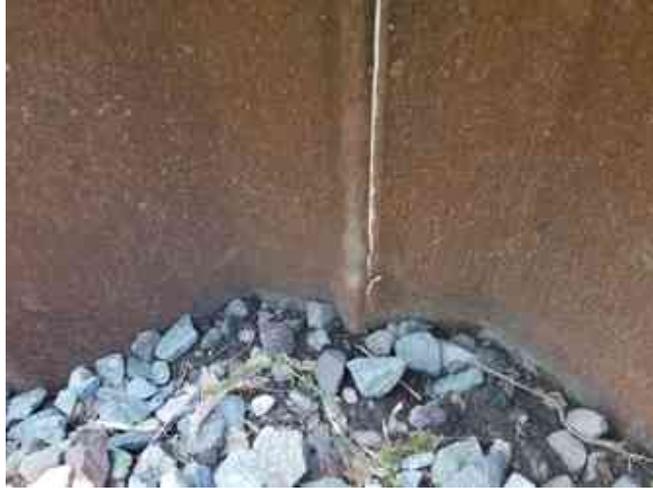
Inspect ID: 2022-0079 **Title:** 2604000005_CELRC_2022_A_2022-0079_1_20220609T151711.jpg **Rated Item:** 7. Monolith Joints **Caption:** Minimally Acceptable - Sealant cracking.

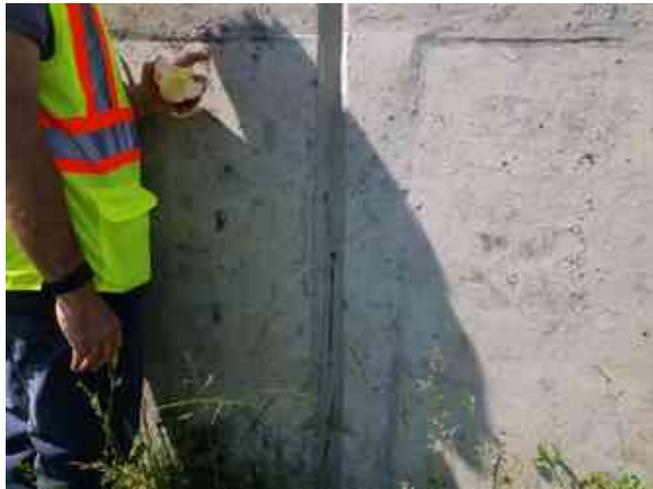
Inspect ID: 2022-0106 **Title:** 2604000005_CELRC_2022_A_0106_2_20220609T152928.jpg **Rated Item:** 7. Monolith Joints **Caption:** Minimally Acceptable - Cracks in sealant.

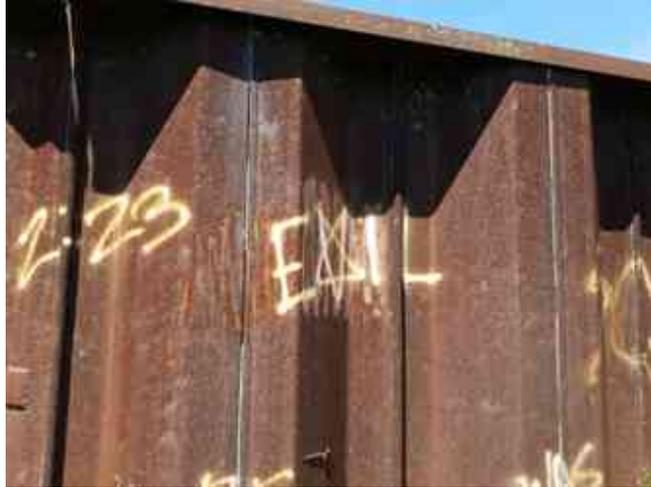
Inspect ID: 2022-0145 **Title:** 2604000005_CELRC_2022_A_2022-0145_2_20220609T155556.jpg **Rated Item:** 7. Monolith Joints **Caption:** Minimally Acceptable - Sealant coming out of interlocks.

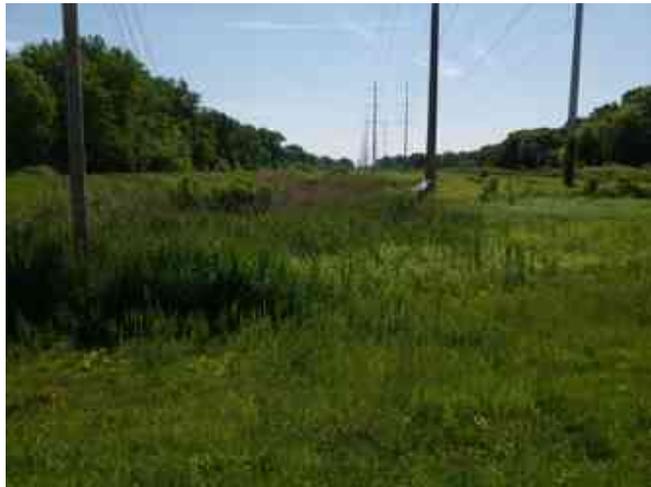
Inspect ID: 2022-0028 **Title:** 2604000005_CELRC_2022_A_0028_1_20220609T144104.jpg **Rated Item:** 1. Vegetation and Obstructions **Caption:** Minimally Acceptable - Drainage ditch full of vegetation.

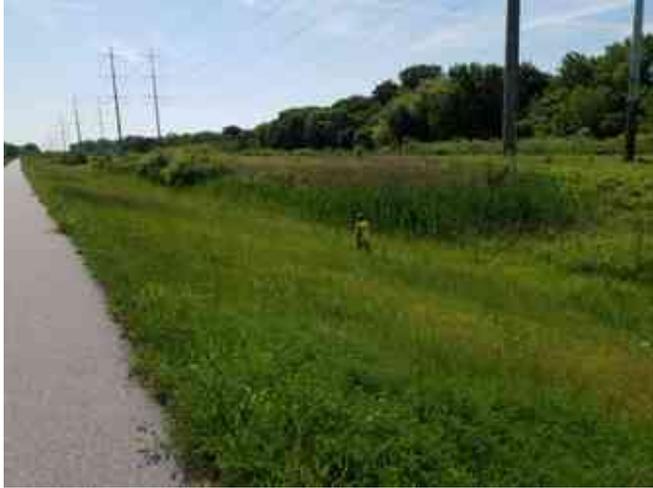
<p>Inspect ID: 2022-0031 Title: 2604000005_CELRC_2022_A_0031_1_20220609T144221.jpg Rated Item: 1. Vegetation and Obstructions Caption: Minimally Acceptable - Vegetation within 15 ft of landside toe</p>

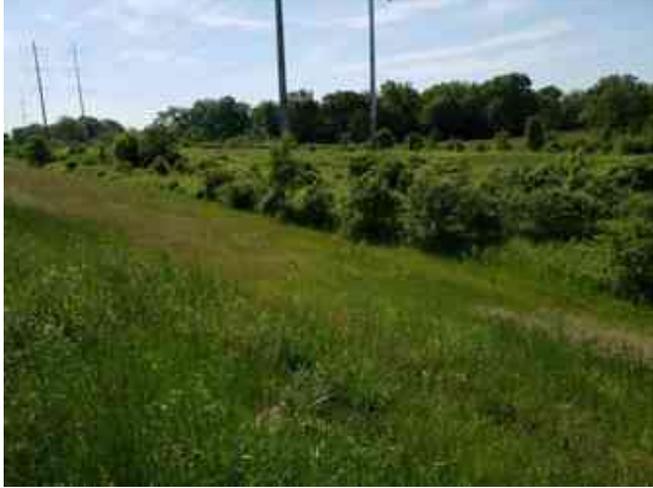
<p>Inspect ID: 2022-0046 Title: 2604000005_CELRC_2022_A_0046_1_20220609T145526.jpg Rated Item: 1. Vegetation and Obstructions Caption: Minimally Acceptable - Line along vegetation</p>

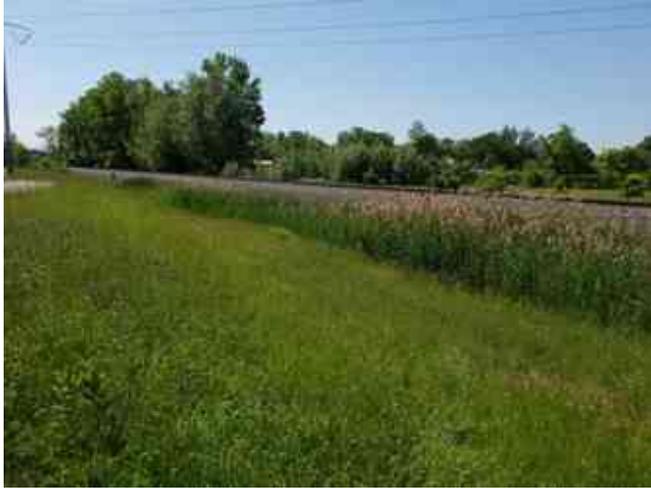
Inspect ID: 2022-0094 **Title:**
2604000005_CELRC_2022_A_0094_1_20220609T152151.jpg
Rated Item: 1. Vegetation and Obstructions **Caption:**
Minimally Acceptable - Vegetation in ditch

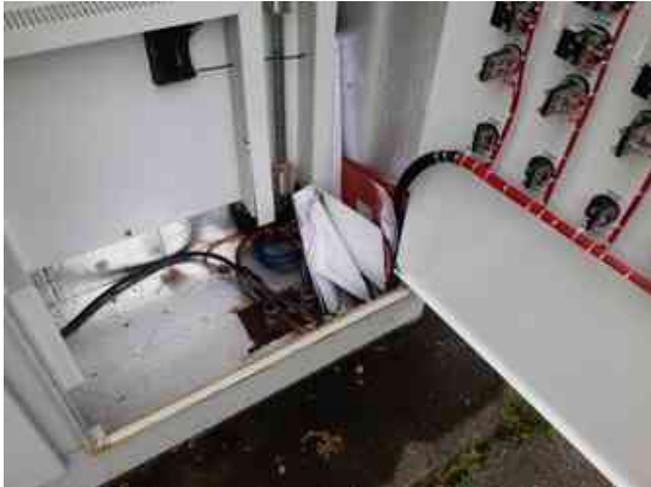
Inspect ID: 2022-0012 **Title:**
2604000005_CELRC_2022_A_0012_1_20220607T153108.jpg
Rated Item: 2. Pump Station Operations and Maintenance
Equipment Manuals **Caption:** Acceptable - PS-BS: Operations
manuals present onsite

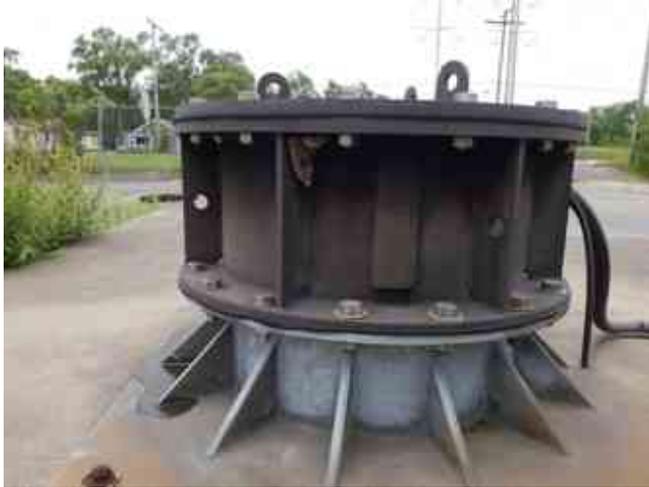
Inspect ID: 2022-0003 **Title:**
2604000005_CELRC_2022_A_0003_1_20220607T152425.jpg
Rated Item: 7. Pumps **Caption:** Minimally Acceptable - PS-
BS: Clear hive resting on exterior of pump 4.

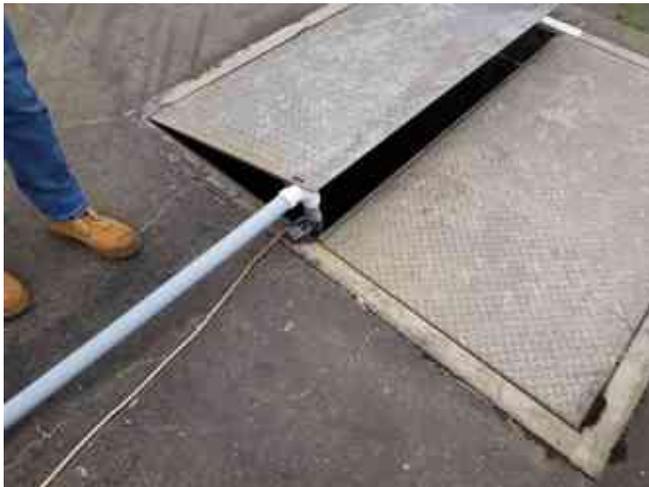
Inspect ID: 2022-0015 **Title:**
2604000005_CELRC_2022_A_0015_1_20220607T153231.jpg
Rated Item: 9. Sumps/ Wet well **Caption:** Acceptable - PS-
BS: Temporary piping keeping open grate cover for interior of
wet well. Recommend clearing as soon as work has been
completed.

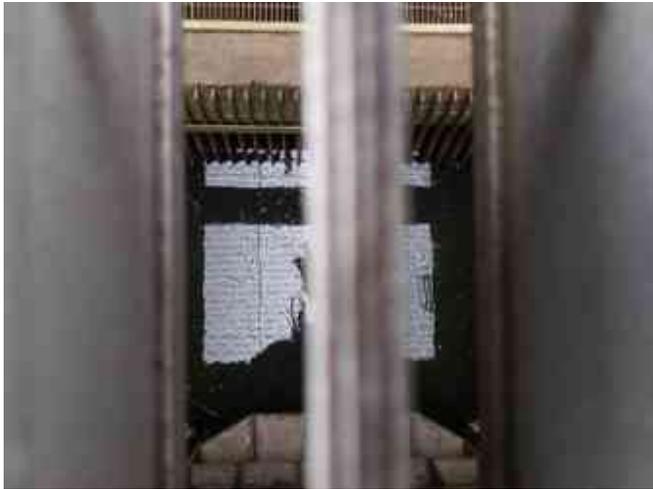
<p>Inspect ID: 2022-0018 Title: 2604000005_CELRC_2022_A_0018_1_20220607T153421.jpg Rated Item: 11. Non-Mechanical Trash Racks Caption: Acceptable - PS-BS: Intake trash rack could not be fully inspected because water was too high. Last inspection recommended removing debris.</p>

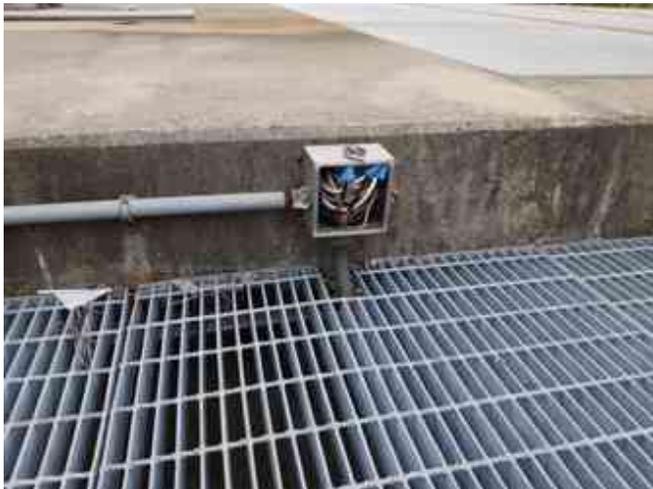
<p>Inspect ID: 2022-0006 Title: 2604000005_CELRC_2022_A_0006_1_20220607T152713.jpg Rated Item: 16. Enclosures, Panels, Conduit and Ducts Caption: Minimally Acceptable - PS-BS: Add cover to enclosure near sump pump.</p>

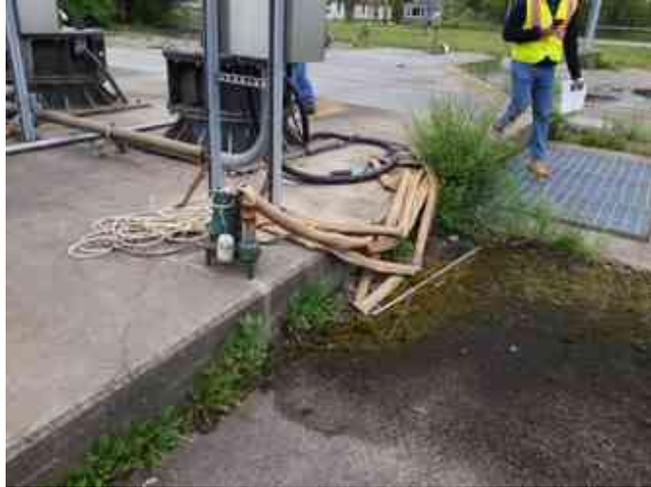
Inspect ID: 2022-0009 **Title:** 2604000005_CELRC_2022_A_0009_1_20220607T152853.jpg
Rated Item: 21. Other Metallic Items (Equipment, Ladders, Platform Anchors, etc) **Caption:** Minimally Acceptable - PS-BS: Clear built up debris and equipment from concrete pad of station.
