## Levee Inspection Report

Name of System: Gary  
Name of Segment: Gary North  
NLD System ID: 2605000003 NLD Segment ID: 2604000003

Segment Type: USACE Federally constructed, turned over to public sponsor operations and maintenance  
Levee Sponsor (Name and Organization): Little Calumet River Basin Development Commission  
Inspection Report Prepared by: Christopher Schaal Date(s) of Inspection: 06/06/2022 - 06/10/2022

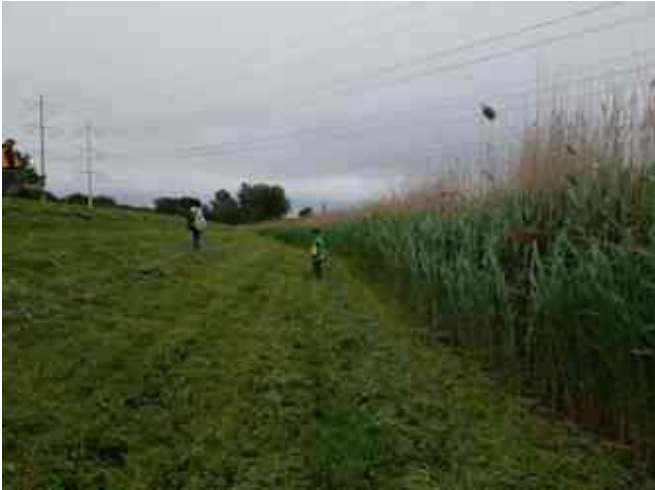
<p><b>Inspect ID:</b> 2022-0082 <b>Title:</b> 2604000003_CELRC_2022_A_0082_1_20220607T143513.jpg <b>Rated Item:</b> 1. Unwanted Vegetation Growth <b>Caption:</b> Minimally Acceptable - Tall vegetation close to the riverside slope.</p>

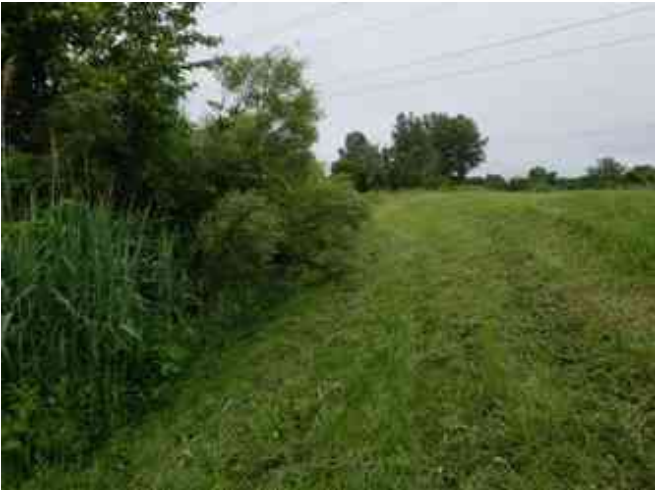
<p><b>Inspect ID:</b> 2022-0085 <b>Title:</b> 2604000003_CELRC_2022_A_0085_1_20220607T143726.jpg <b>Rated Item:</b> 1. Unwanted Vegetation Growth <b>Caption:</b> Minimally Acceptable - Tall vegetation and small trees close to the riverside toe.</p>

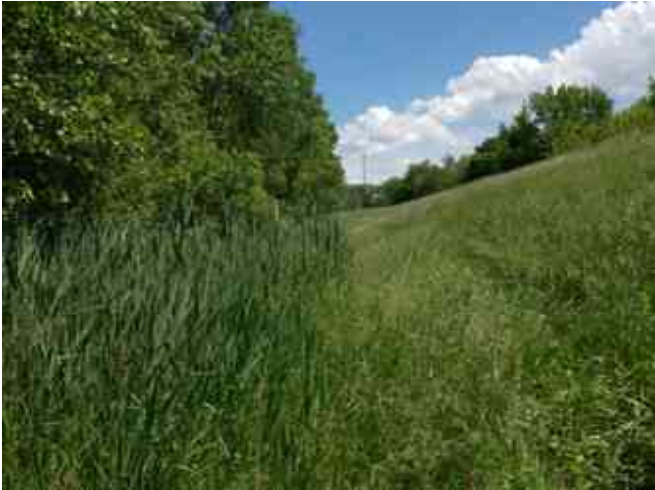
<p><b>Inspect ID:</b> 2022-0176 <b>Title:</b> 2604000003_CELRC_2022_A_0176_1_20220609T190205.jpg <b>Rated Item:</b> 1. Unwanted Vegetation Growth <b>Caption:</b> Minimally Acceptable - Tall vegetation on landside toe.</p>

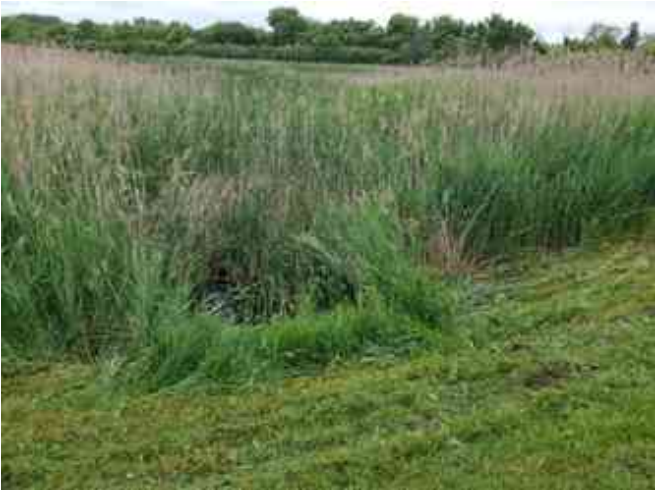
<p><b>Inspect ID:</b> 2022-0190 <b>Title:</b> 2604000003_CELRC_2022_A_0190_1_20220607T163034.jpg <b>Rated Item:</b> 1. Unwanted Vegetation Growth <b>Caption:</b> Minimally Acceptable - Tall vegetation by culvert headwall.</p>

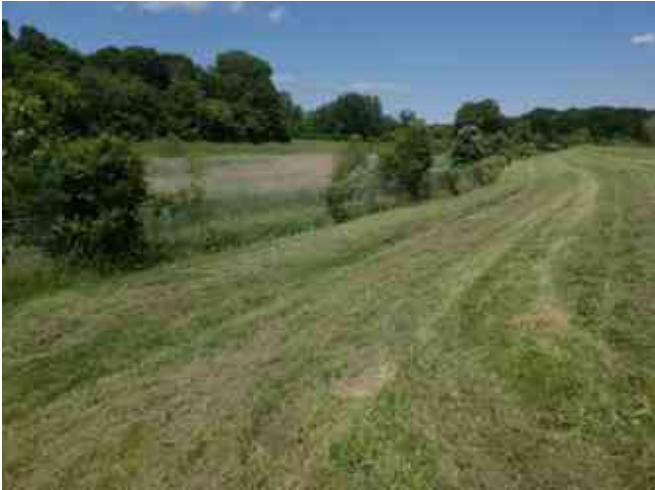
<p><b>Inspect ID:</b> 2022-0215 <b>Title:</b> 2604000003_CELRC_2022_A_0215_1_20220609T194642.jpg <b>Rated Item:</b> 1. Unwanted Vegetation Growth <b>Caption:</b> Minimally Acceptable - Small trees along fence.</p>

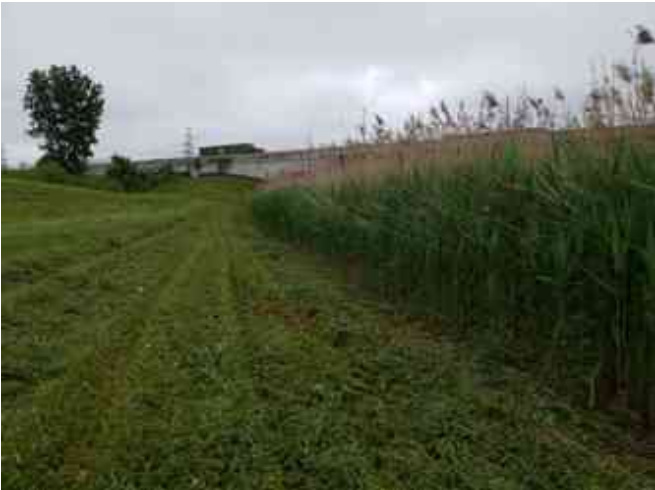
<p><b>Inspect ID:</b> 2022-0220 <b>Title:</b> 2604000003_CELRC_2022_A_0220_1_20220607T164437.jpg <b>Rated Item:</b> 1. Unwanted Vegetation Growth <b>Caption:</b> Minimally Acceptable - Tall vegetation near riverside toe.</p>

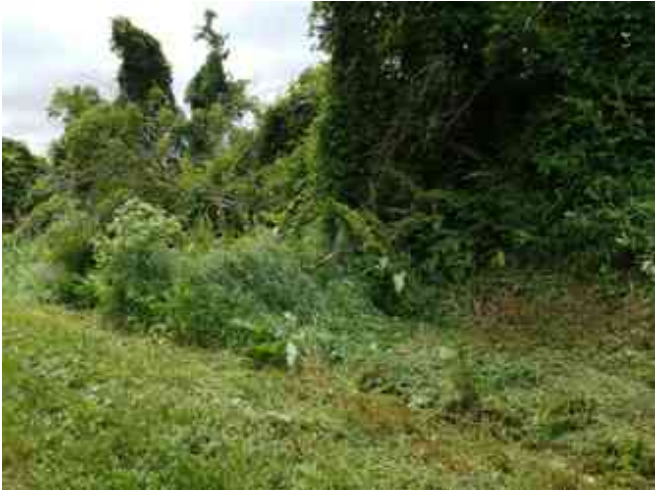
<p><b>Inspect ID:</b> 2022-0241 <b>Title:</b> 2604000003_CELRC_2022_A_0241_1_20220607T171844.jpg <b>Rated Item:</b> 1. Unwanted Vegetation Growth <b>Caption:</b> Minimally Acceptable - Bushes on landside slope.</p>

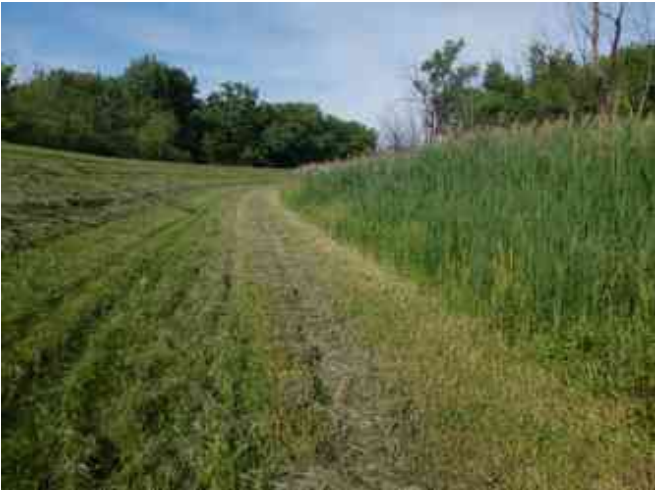
<p><b>Inspect ID:</b> 2022-0251 <b>Title:</b> 2604000003_CELRC_2022_A_0251_1_20220610T132451.jpg <b>Rated Item:</b> 1. Unwanted Vegetation Growth <b>Caption:</b> Minimally Acceptable - Tall vegetation within 15 feet of landside toe.</p>

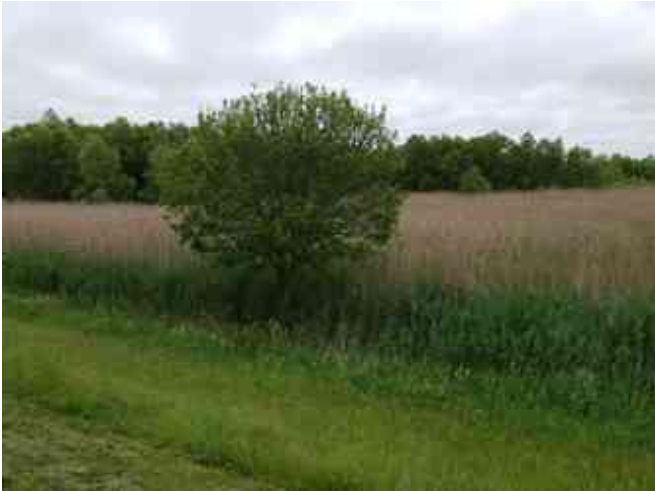
<p><b>Inspect ID:</b> 2022-0268 <b>Title:</b> 2604000003_CELRC_2022_A_0268_1_20220607T173742.jpg <b>Rated Item:</b> 1. Unwanted Vegetation Growth <b>Caption:</b> Unacceptable - Large tree within 15 feet of riverside toe.</p>

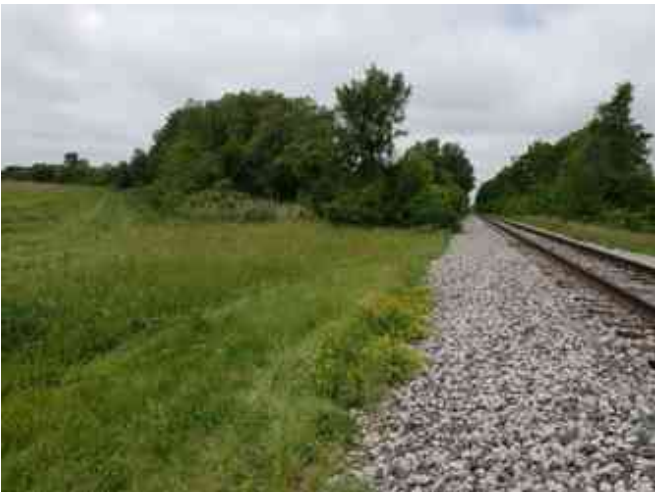
<p><b>Inspect ID:</b> 2022-0274 <b>Title:</b> 2604000003_CELRC_2022_A_0274_1_20220607T174824.jpg <b>Rated Item:</b> 1. Unwanted Vegetation Growth <b>Caption:</b> Minimally Acceptable - Small trees on landside slope.</p>

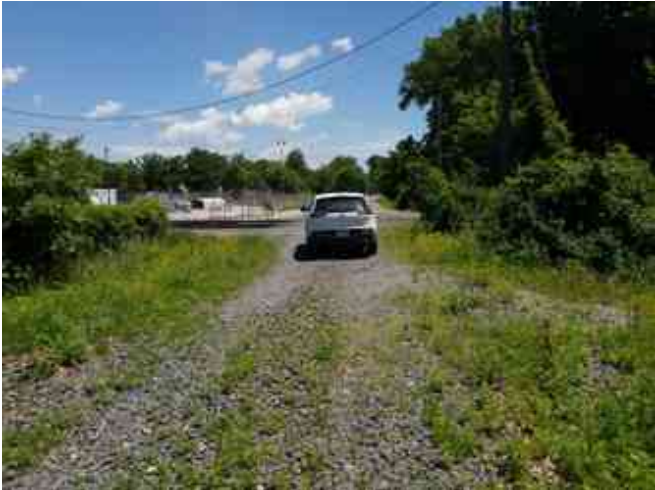
<p><b>Inspect ID:</b> 2022-0331 <b>Title:</b> 2604000003_CELRC_2022_A_0331_1_20220609T174717.jpg <b>Rated Item:</b> 1. Unwanted Vegetation Growth <b>Caption:</b> Unacceptable - Large trees on both landside and riverside slopes</p>

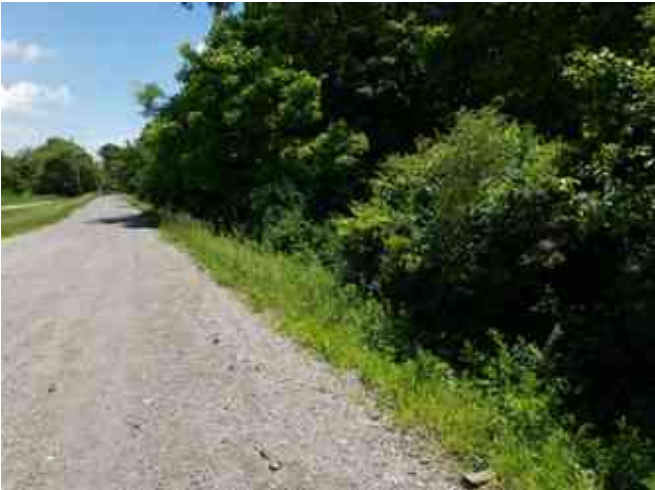
Rated Item	Rating	Rating Guidelines		Location/Remarks/Recommendations
				2022-0334 : Large trees along riverside slope (U) 2022-0358 : Large trees and tall vegetation along riverside toe. (U) 2022-0388 : Small tree growth close to landside toe. (M) 2022-0424 : Tall vegetation growth along landside toe. (M) 2022-0430 : Large tree growth close to riverside toe. (U) 2022-0472 : GN-7: Tall vegetation inside fence (M) 2022-0475 : Small trees and tall vegetation close to riverside toe. (M) 2022-0496 : Small tree on riverside near toe. (M) 2022-0505 : Tall vegetation within 5 from the riverside toe (M) 2022-0517 : Tall vegetation within 5 feet of riverside toe (M) 2022-0535 : Tall vegetation on the riverside toe.(M) 2022-0565 : Large tree growing close to landside toe and utility pole. (U) <b>Recommendation:</b> Remove trees and vegetation from within the 15 foot vegetation free zone.

<p><b>Inspect ID:</b> 2022-0334 <b>Title:</b> 2604000003_CELRC_2022_A_0334_1_20220609T174837.jpg <b>Rated Item:</b> 1. Unwanted Vegetation Growth <b>Caption:</b> Unacceptable - Large trees along riverside slope</p>

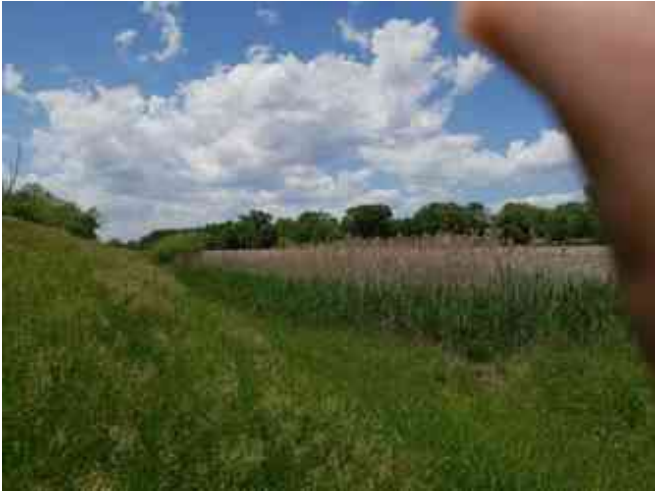
<p><b>Inspect ID:</b> 2022-0424 <b>Title:</b> 2604000003_CELRC_2022_A_0424_1_20220609T185540.jpg <b>Rated Item:</b> 1. Unwanted Vegetation Growth <b>Caption:</b> Minimally Acceptable - Tall vegetation growth along landside toe.</p>

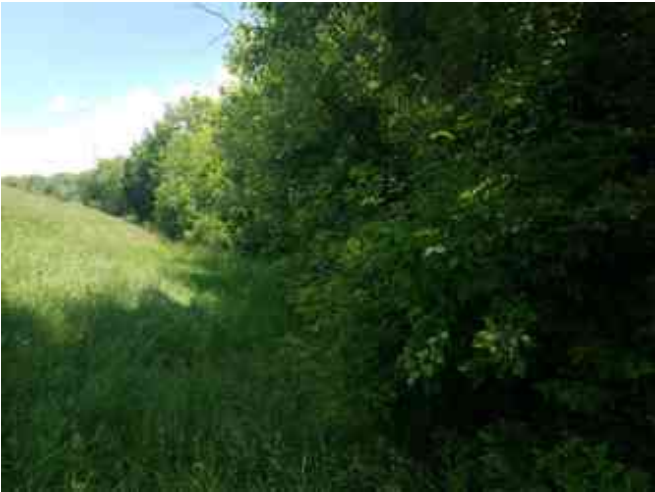
<p><b>Inspect ID:</b> 2022-0430 <b>Title:</b> 2604000003_CELRC_2022_A_0430_1_20220609T190141.jpg <b>Rated Item:</b> 1. Unwanted Vegetation Growth <b>Caption:</b> Unacceptable - Large tree growth close to riverside toe.</p>

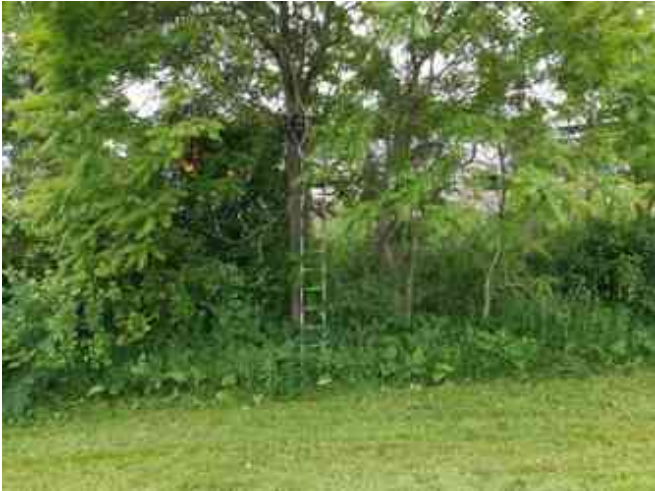
<p><b>Inspect ID:</b> 2022-0238 <b>Title:</b> 2604000003_CELRC_2022_A_0238_1_20220607T171746.jpg <b>Rated Item:</b> 3. Encroachments <b>Caption:</b> Minimally Acceptable - Unauthorized hunter's stand on the landside toe.</p>

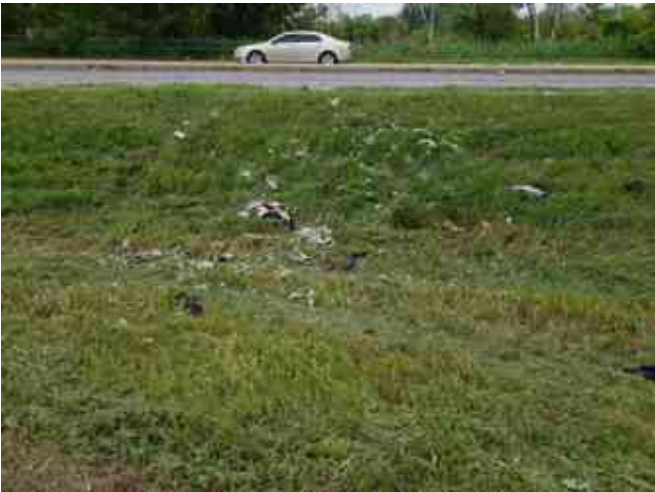
<p><b>Inspect ID:</b> 2022-0247 <b>Title:</b> 2604000003_CELRC_2022_A_0247_1_20220607T172110.jpg <b>Rated Item:</b> 3. Encroachments <b>Caption:</b> Minimally Acceptable - Debris on the landside slope</p>

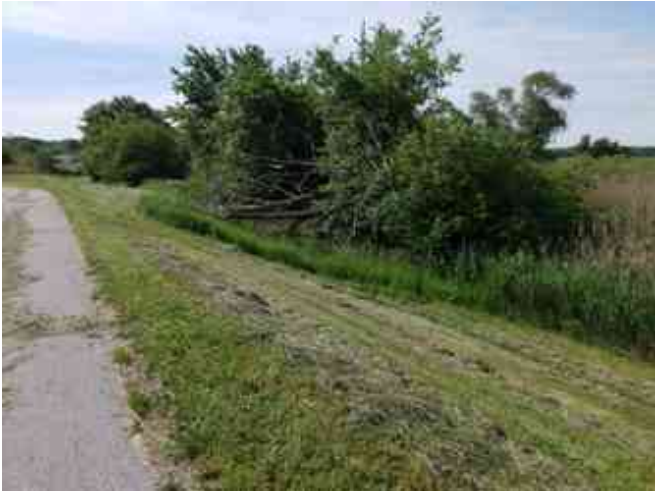
<p><b>Inspect ID:</b> 2022-0305 <b>Title:</b> 2604000003_CELRC_2022_A_0305_1_20220610T143506.jpg <b>Rated Item:</b> 3. Encroachments <b>Caption:</b> Minimally Acceptable - Tree downed on the riverside slope.</p>

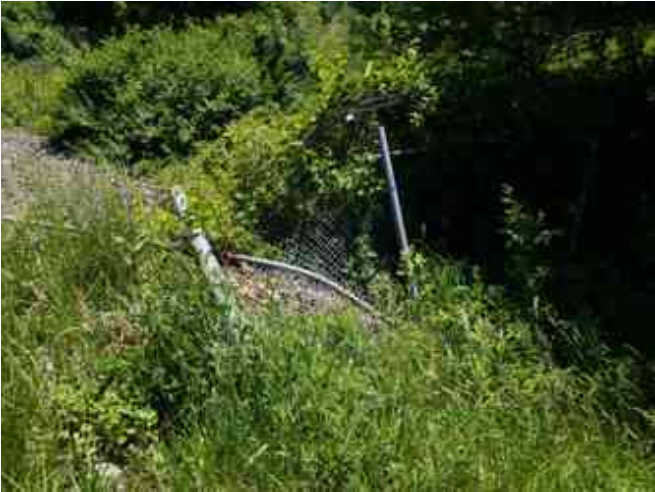
<p><b>Inspect ID:</b> 2022-0307 <b>Title:</b> 2604000003_CELRC_2022_A_0307_1_20220609T173713.jpg <b>Rated Item:</b> 3. Encroachments <b>Caption:</b> Minimally Acceptable - Downed fence near the railroad</p>

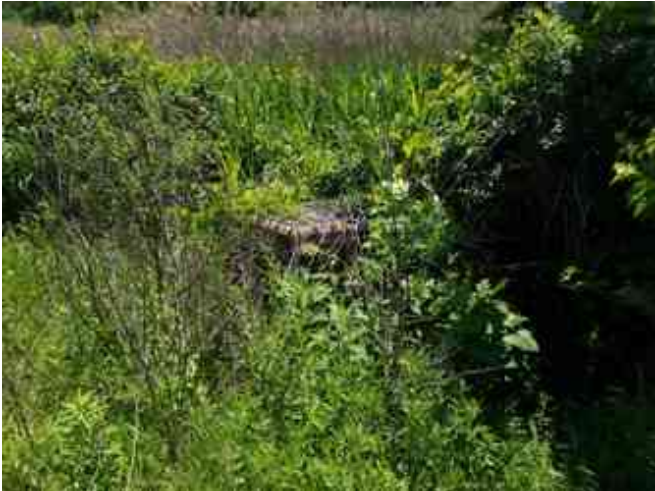
<p><b>Inspect ID:</b> 2022-0340 <b>Title:</b> 2604000003_CELRC_2022_A_0340_1_20220609T175226.jpg <b>Rated Item:</b> 3. Encroachments <b>Caption:</b> Minimally Acceptable - Industrial tank on the riverside slope</p>

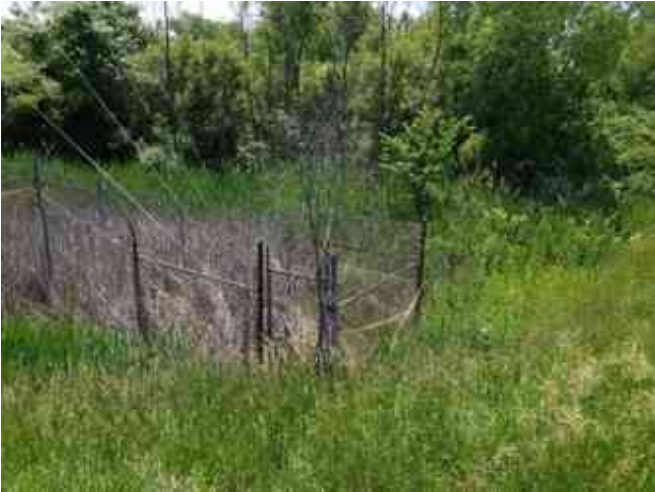
<p><b>Inspect ID:</b> 2022-0355 <b>Title:</b> 2604000003_CELRC_2022_A_0355_1_20220609T180752.jpg <b>Rated Item:</b> 3. Encroachments <b>Caption:</b> Minimally Acceptable - Dead tree near the riverside toe.</p>

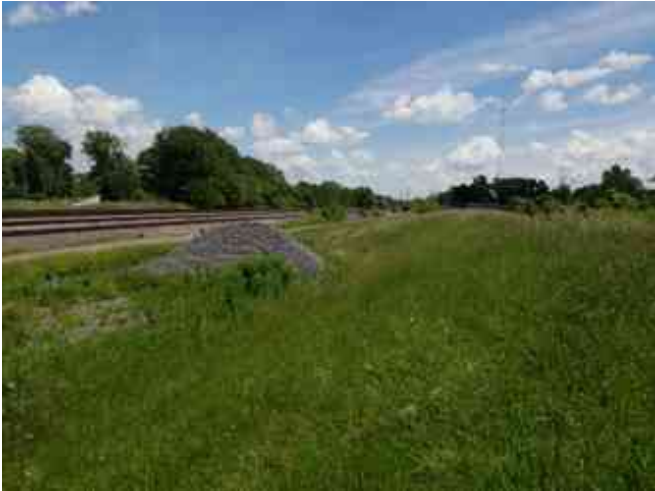
<p><b>Inspect ID:</b> 2022-0361 <b>Title:</b> 2604000003_CELRC_2022_A_0361_1_20220609T181126.jpg <b>Rated Item:</b> 3. Encroachments <b>Caption:</b> Minimally Acceptable - Railroad gravel stockpile on the landside toe.</p>

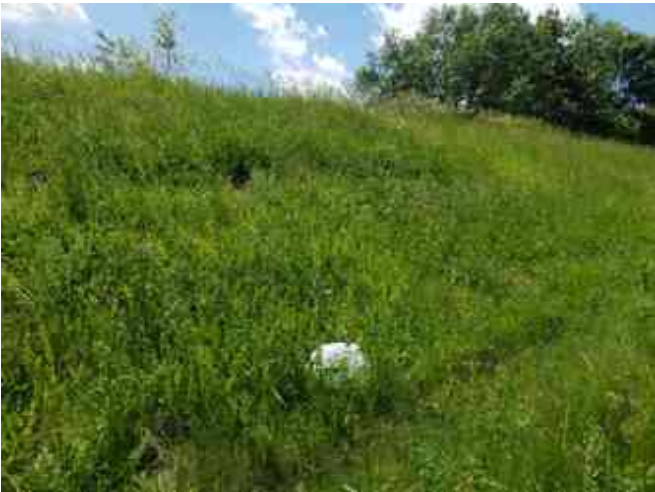
<p><b>Inspect ID:</b> 2022-0394 <b>Title:</b> 2604000003_CELRC_2022_A_0394_1_20220609T183019.jpg <b>Rated Item:</b> 3. Encroachments <b>Caption:</b> Minimally Acceptable - Plastic debris on the landside slope.</p>

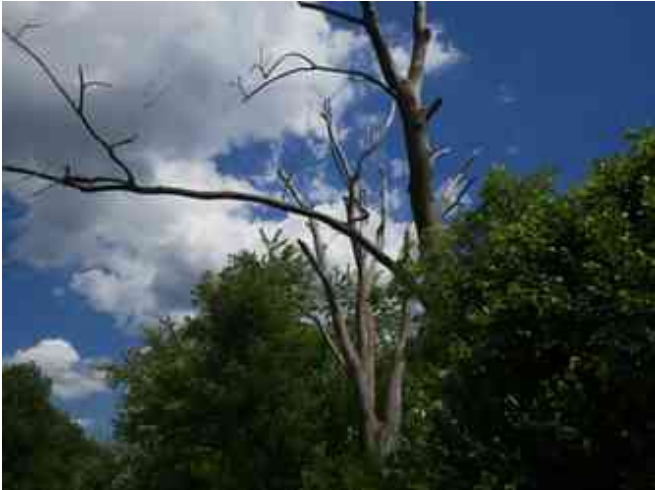
<p><b>Inspect ID:</b> 2022-0484 <b>Title:</b> 2604000003_CELRC_2022_A_0484_1_20220609T195702.jpg <b>Rated Item:</b> 3. Encroachments <b>Caption:</b> Minimally Acceptable - Dead trees dropping large branches on the riverside toe.</p>

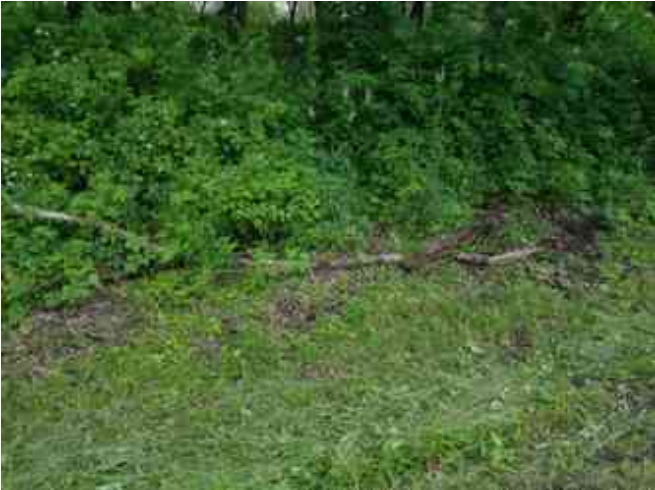
<p><b>Inspect ID:</b> 2022-0490 <b>Title:</b> 2604000003_CELRC_2022_A_0490_1_20220609T200316.jpg <b>Rated Item:</b> 3. Encroachments <b>Caption:</b> Minimally Acceptable - Fallen tree debris on riverside toe</p>

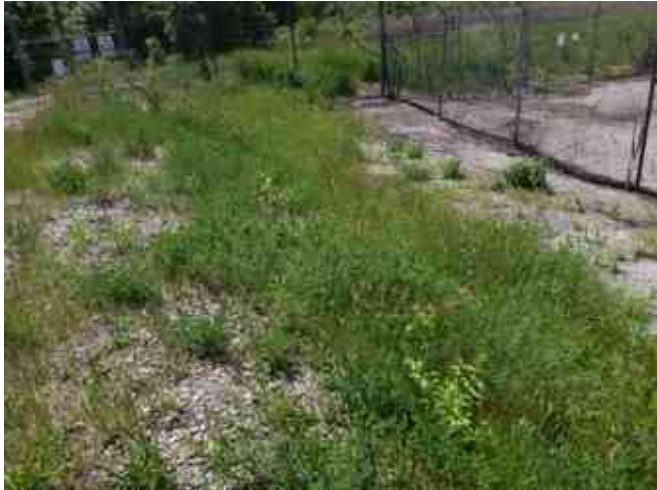
<p><b>Inspect ID:</b> 2022-0134 <b>Title:</b> 2604000003_CELRC_2022_A_0134_1_20220609T182339.jpg <b>Rated Item:</b> 5. Slope Stability <b>Caption:</b> Acceptable - Steep slope on landside.</p>

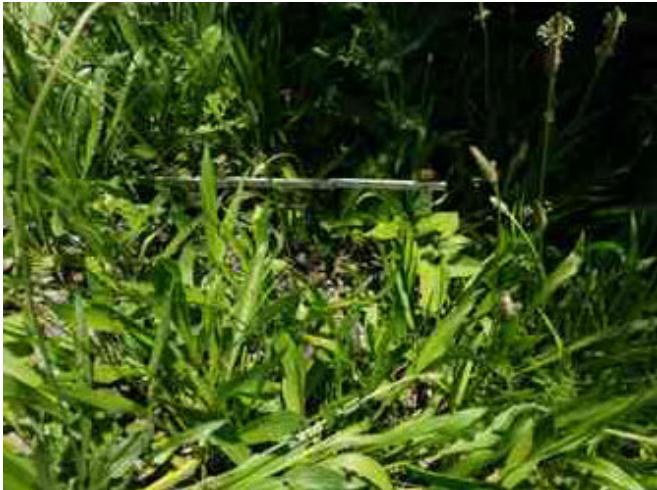
<p><b>Inspect ID:</b> 2022-0337 <b>Title:</b> 2604000003_CELRC_2022_A_0337_2_20220609T175106.jpg <b>Rated Item:</b> 5. Slope Stability <b>Caption:</b> Minimally Acceptable - 1.5H:1V slope on landside and riverside.</p>

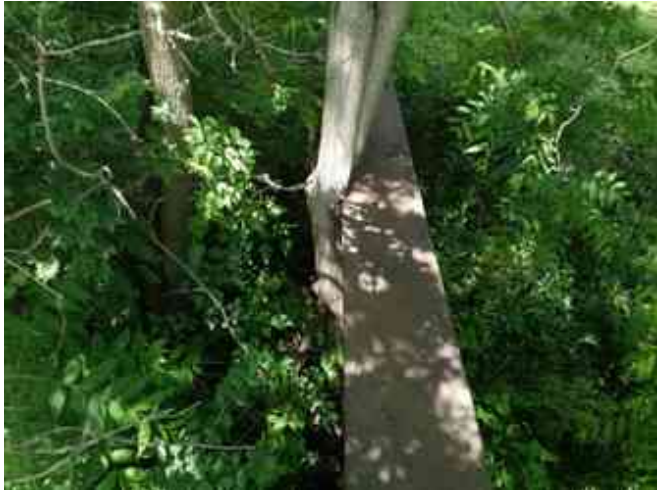
<p><b>Inspect ID:</b> 2022-0185 <b>Title:</b> 2604000003_CELRC_2022_A_0185_1_20220609T191039.jpg <b>Rated Item:</b> 1. Unwanted Vegetation Growth <b>Caption:</b> Unacceptable - Tree pushing against floodwall on riverside.</p>

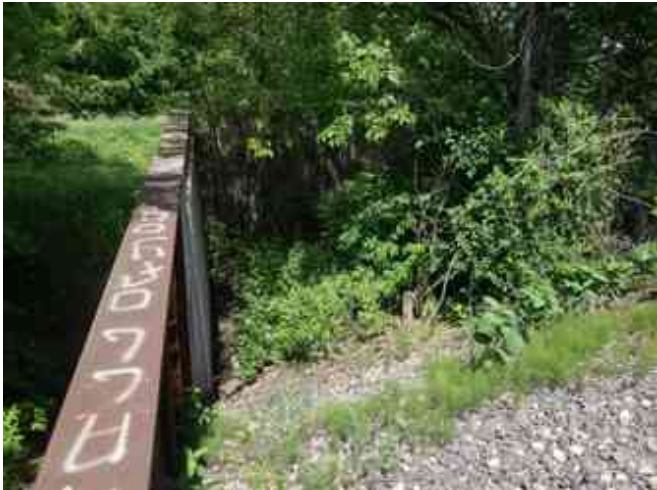
<p><b>Inspect ID:</b> 2022-0191 <b>Title:</b> 2604000003_CELRC_2022_A_0191_1_20220609T191731.jpg <b>Rated Item:</b> 1. Unwanted Vegetation Growth <b>Caption:</b> Unacceptable - Large trees on riverside.</p>

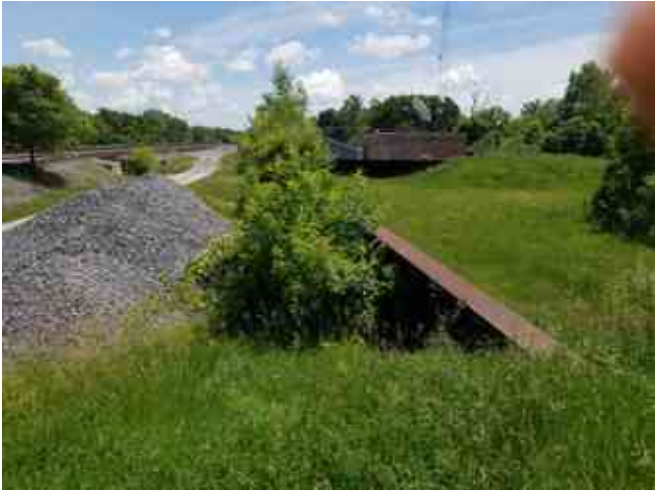
<p><b>Inspect ID:</b> 2022-0367 <b>Title:</b> 2604000003_CELRC_2022_A_0367_1_20220609T181507.jpg <b>Rated Item:</b> 1. Unwanted Vegetation Growth <b>Caption:</b> Minimally Acceptable - Small tree on landside.</p>

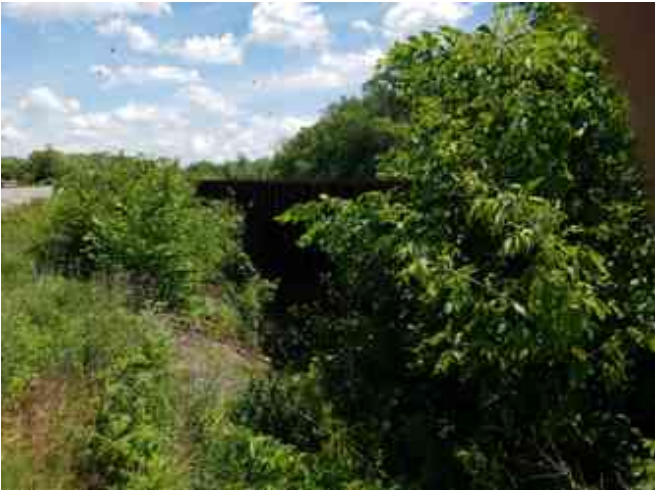
<p><b>Inspect ID:</b> 2022-0403 <b>Title:</b> 2604000003_CELRC_2022_A_0403_1_20220609T183447.jpg <b>Rated Item:</b> 1. Unwanted Vegetation Growth <b>Caption:</b> Minimally Acceptable - Small trees along landside.</p>

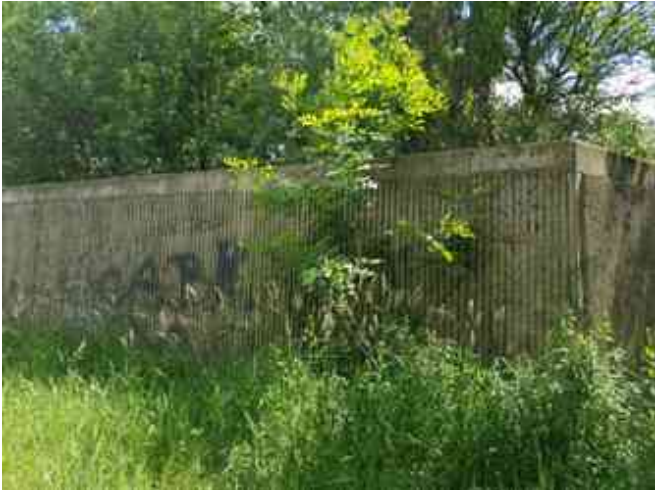
Rated Item	Rating	Rating Guidelines		Location/Remarks/Recommendations
1. Unwanted Vegetation Growth	U	A	A grass-only or paved zone is maintained on both sides of the floodwall, free of all trees, brush, and undesirable weeds. The vegetation-free zone extends 15 feet from both the land and riverside of the floodwall, at ground-level, to the centerline of the tree. Additionally, an 8- foot root-free zone is maintained around the entire structure, including the floodwall toe, heel, and any toe-drains. If the floodwall access easement doesn't extend to the described limits, then the vegetation-free zone must be maintained to the easement limits. Reference EM 1110- 2-301 and/or Corps policy for regional vegetation variance.	2022-0128 : Small tree on riverside. (M) 2022-0149 : Small trees on floodwall's river side. (M) 2022-0185 : Tree pushing against floodwall on riverside. (U) 2022-0191 : Large trees on riverside. (U) 2022-0367 : Small tree on landside. (M) 2022-0403 : Small trees along landside. (M) 2022-0412 : Tall vegetation growth on landside of floodwall. (M) 2022-0439 : Large trees growing from base of riverside floodwall. (U) 2022-0457 : Small tree on landside base of floodwall. (M)

<p><b>Inspect ID:</b> 2022-0457 <b>Title:</b> 2604000003_CELRC_2022_A_0457_1_20220609T192159.jpg <b>Rated Item:</b> 1. Unwanted Vegetation Growth <b>Caption:</b> Minimally Acceptable - Small tree on landside base of floodwall.</p>

M	Minimal vegetation growth (brush, weeds, or trees 2 inches in diameter or smaller) is present within the zones described above. This vegetation must be removed but does not currently threaten the operation or integrity of the floodwall.	
		U	Significant vegetation growth (brush, weeds, or any trees greater than 2 inches in diameter) is present within the zones described above. This vegetation threatens the operation or integrity of the floodwall and must be removed.	<b>Recommendation:</b> Remove vegetation within 15 ft of the floodwall.

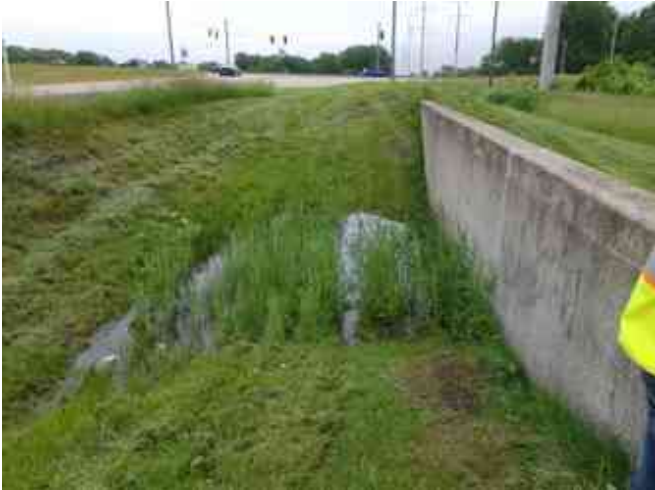
<p><b>Inspect ID:</b> 2022-0097 <b>Title:</b> 2604000003_CELRC_2022_A_0097_1_20220607T144352.jpg <b>Rated Item:</b> 2. Encroachments <b>Caption:</b> Minimally Acceptable - Ponding on landside of floodwall</p>

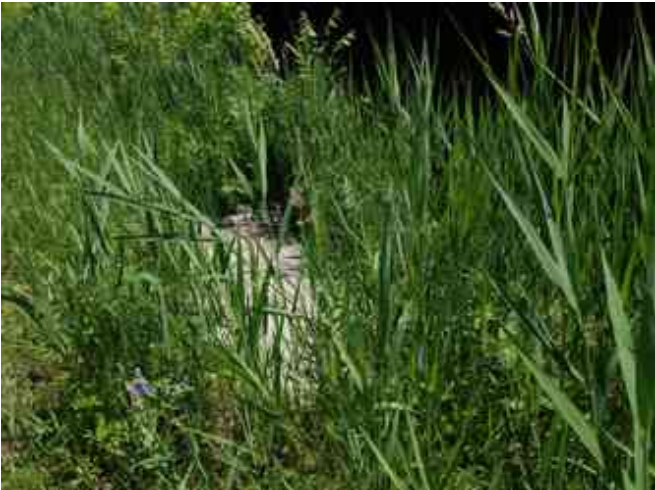
Rated Item	Rating	Rating Guidelines		Location/Remarks/Recommendations
2. Encroachments	<b>M</b>	<b>A</b>	No trash, debris, unauthorized structures, excavations, or other obstructions present within the easement area. Encroachments have been previously reviewed by the Corps, and it was determined that they do not diminish proper functioning of the floodwall.	2022-0004 : Fence on both landside and riverside has fallen over. (M) 2022-0007 : Encroaching fence on the landside. (M)
		<b>M</b>	Trash, debris, unauthorized structures, excavations, or other obstructions present, or inappropriate activities noted that should be corrected but will not inhibit operations and maintenance or emergency operations. Encroachments have not been reviewed by the Corps.	2022-0070 : Broken post and exposed hole in the levee crest. (M) 2022-0097 : Ponding on landside of floodwall (M) 2022-0161 : Wooden debris on landside of floodwall (M)

<p><b>Inspect ID:</b> 2022-0161 <b>Title:</b> 2604000003_CELRC_2022_A_0161_1_20220609T184112.jpg <b>Rated Item:</b> 2. Encroachments <b>Caption:</b> Minimally Acceptable - Wooden debris on landside of floodwall</p>

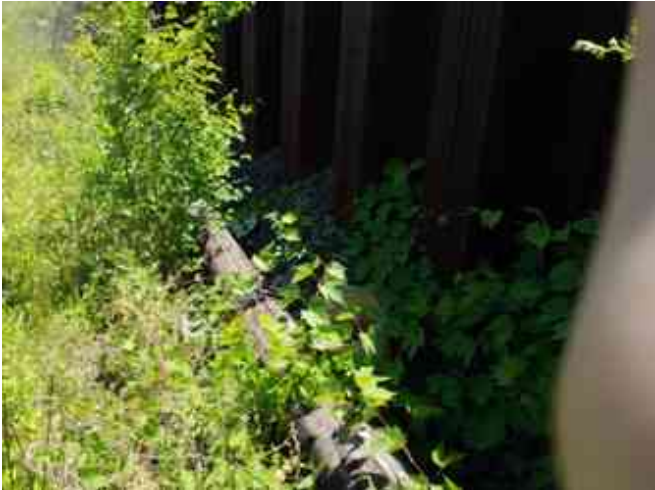
<p><b>Inspect ID:</b> 2022-0376 <b>Title:</b> 2604000003_CELRC_2022_A_0376_1_20220609T181954.jpg <b>Rated Item:</b> 2. Encroachments <b>Caption:</b> Minimally Acceptable - Old utility pole debris near landside base of floodwall.</p>

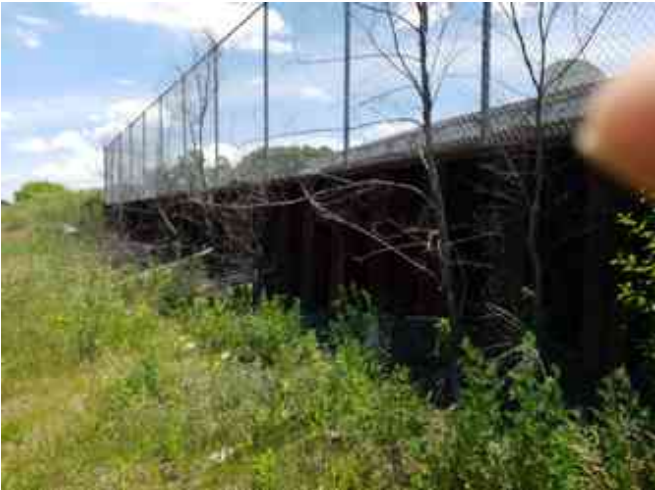
<p><b>Inspect ID:</b> 2022-0379 <b>Title:</b> 2604000003_CELRC_2022_A_0379_1_20220609T182057.jpg <b>Rated Item:</b> 2. Encroachments <b>Caption:</b> Minimally Acceptable - Dead trees remain near base of landside floodwall.</p>

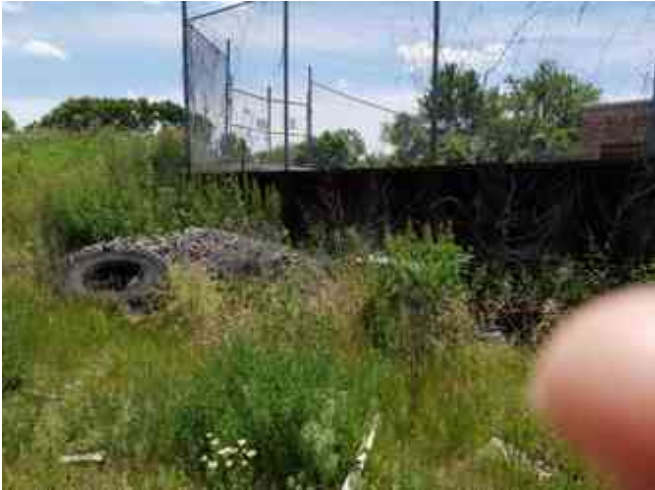
<p><b>Inspect ID:</b> 2022-0382 <b>Title:</b> 2604000003_CELRC_2022_A_0382_1_20220609T182204.jpg <b>Rated Item:</b> 2. Encroachments <b>Caption:</b> Minimally Acceptable - Railroad surplus and debris at landside of floodwall.</p>

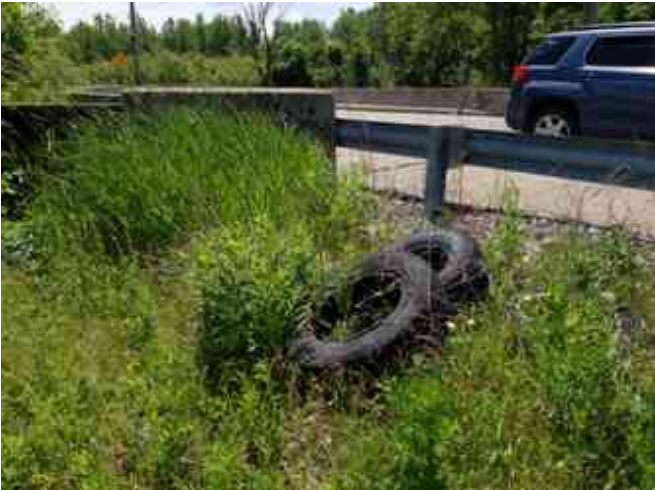
<p><b>Inspect ID:</b> 2022-0400 <b>Title:</b> 2604000003_CELRC_2022_A_0400_1_20220609T183344.jpg <b>Rated Item:</b> 2. Encroachments <b>Caption:</b> Minimally Acceptable - Debris at landside base of floodwall near Colfax St.</p>

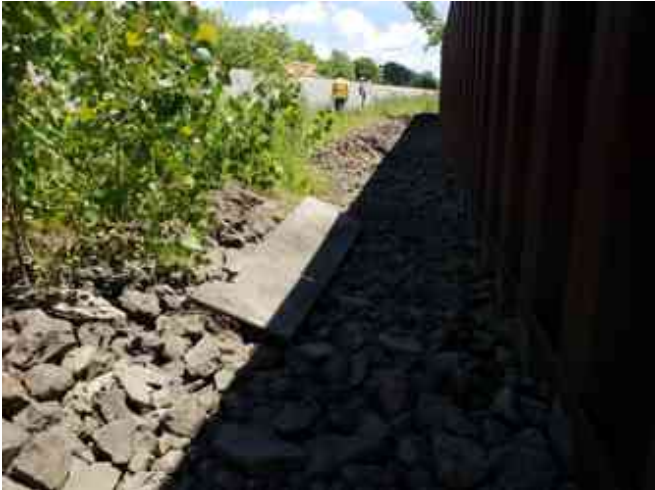
A photograph showing the base of a floodwall. The wall is made of dark, vertical corrugated metal. To the left of the wall, there is a pile of dark, irregularly shaped debris, possibly rocks or broken concrete, and some green vegetation. The ground in the foreground is covered with dark, loose material.	<p><b>Inspect ID:</b> 2022-0406 <b>Title:</b> 2604000003_CELRC_2022_A_0406_1_20220609T183808.jpg <b>Rated Item:</b> 2. Encroachments <b>Caption:</b> Minimally Acceptable - Plywood debris on landside of floodwall.</p>

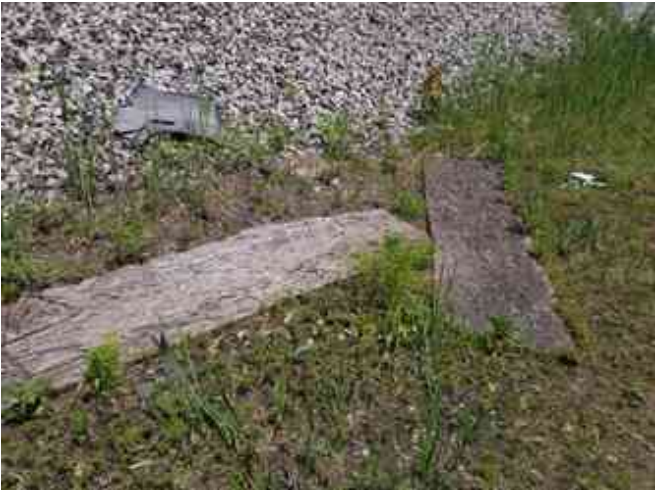
A photograph showing the base of a floodwall. The wall is made of dark, vertical corrugated metal. To the left of the wall, there is a pile of dark, irregularly shaped debris, possibly rocks or broken concrete, and some green vegetation. The ground in the foreground is covered with dark, loose material.	<p><b>Inspect ID:</b> 2022-0409 <b>Title:</b> 2604000003_CELRC_2022_A_0409_1_20220609T183935.jpg <b>Rated Item:</b> 2. Encroachments <b>Caption:</b> Minimally Acceptable - Chip board debris on landside of floodwall.</p>

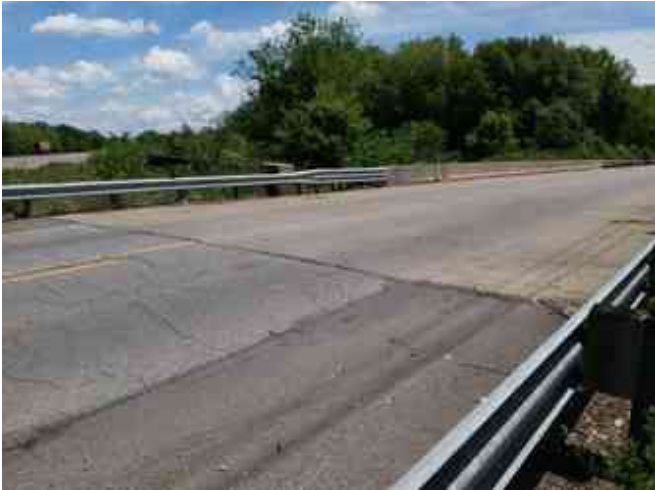
<p><b>Inspect ID:</b> 2022-0146 <b>Title:</b> 2604000003_CELRC_2022_A_0146_1_20220609T183054.jpg <b>Rated Item:</b> 3. Closure Structures (Stop Log Closures and Gates) (A or U only) <b>Caption:</b> Acceptable - Guardrail blocking sandbag closure at Colfax.</p>
 	<p><b>Inspect ID:</b> 2022-0541 <b>Title:</b> 2604000003_CELRC_2022_A_0541_1_20220610T134845.jpg <b>Rated Item:</b> 3. Closure Structures (Stop Log Closures and Gates) (A or U only) <b>Caption:</b> Acceptable - Minor spalling on landside face of Chase St. closure.</p>

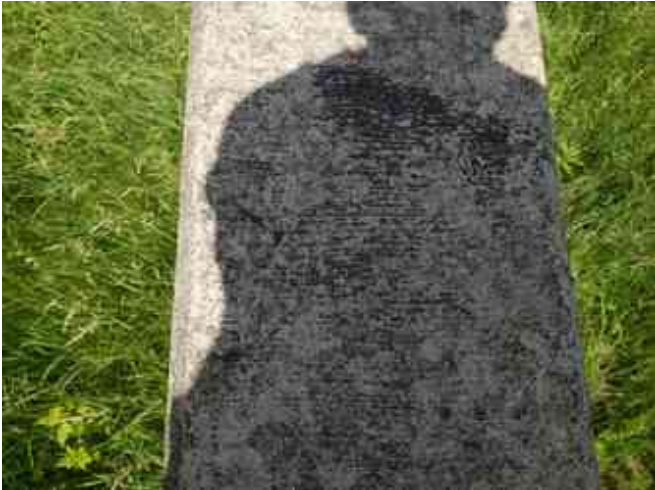
<p><b>Inspect ID:</b> 2022-0436 <b>Title:</b> 2604000003_CELRC_2022_A_0436_1_20220609T190840.jpg <b>Rated Item:</b> 4. Concrete Surfaces <b>Caption:</b> Minimally Acceptable - Crack on top of flood wall that is seen on both side faces. Penetrates 1 ft from top.</p>

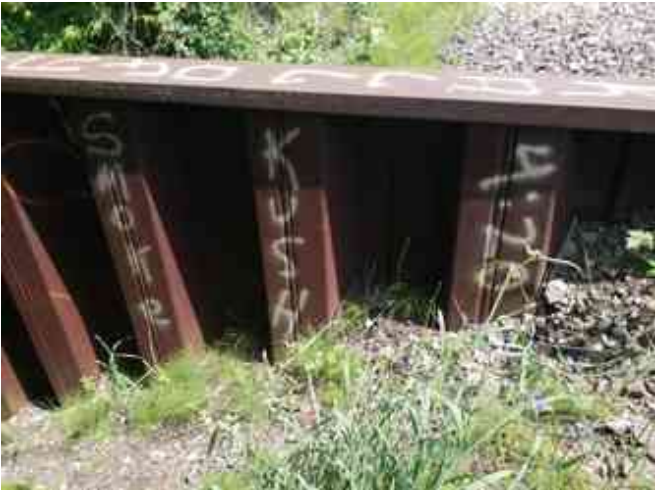
<p><b>Inspect ID:</b> 2022-0448 <b>Title:</b> 2604000003_CELRC_2022_A_0448_1_20220609T191734.jpg <b>Rated Item:</b> 4. Concrete Surfaces <b>Caption:</b> Minimally Acceptable - Graffiti on landside face of floodwall.</p>

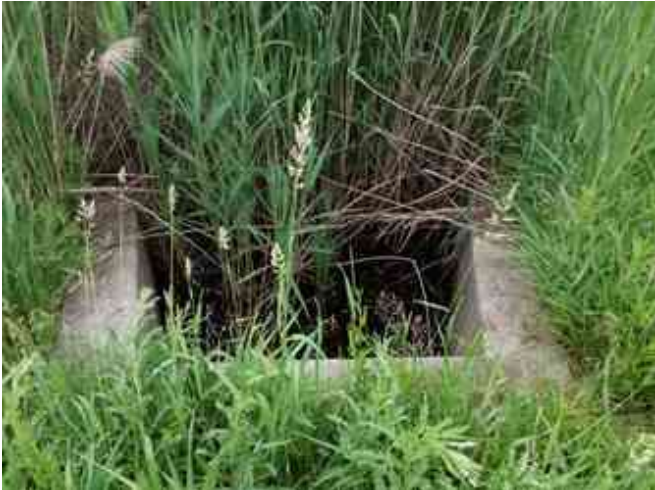
<p><b>Inspect ID:</b> 2022-0029 <b>Title:</b> 2604000003_CELRC_2022_A_0029_1_20220607T165748.jpg <b>Rated Item:</b> 1. Vegetation and Obstructions <b>Caption:</b> Minimally Acceptable - GN-16: Vegetation in outlet.</p>

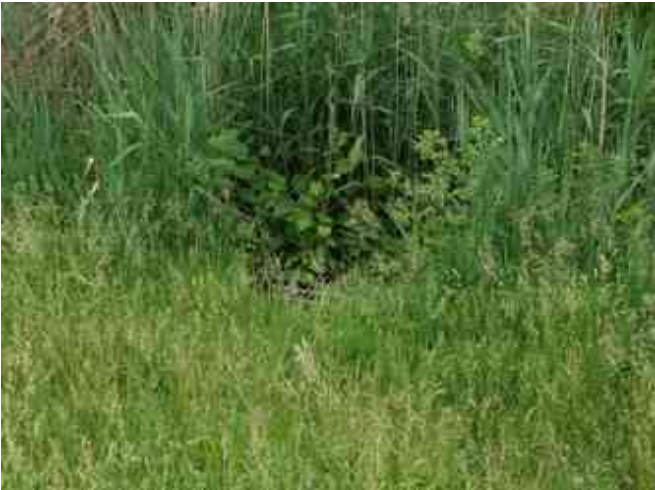
<p><b>Inspect ID:</b> 2022-0050 <b>Title:</b> 2604000003_CELRC_2022_A_0050_1_20220607T171540.jpg <b>Rated Item:</b> 1. Vegetation and Obstructions <b>Caption:</b> Minimally Acceptable - GN-18: Vegetation by grate.</p>

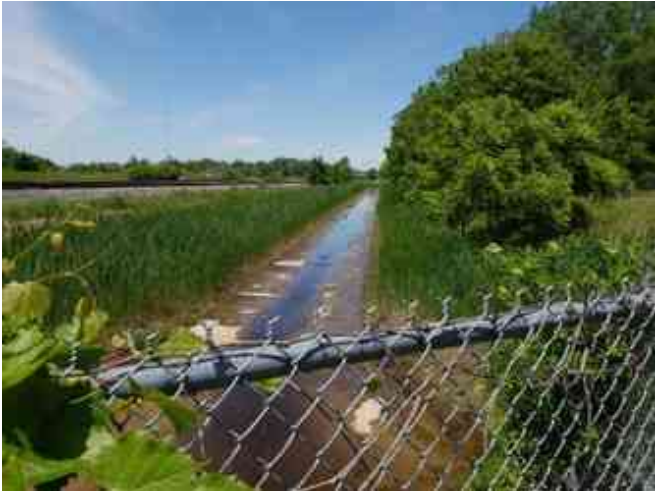
<p><b>Inspect ID:</b> 2022-0295 <b>Title:</b> 2604000003_CELRC_2022_A_0295_1_20220609T172248.jpg <b>Rated Item:</b> 1. Vegetation and Obstructions <b>Caption:</b> Acceptable - Ditch in good condition. Looking west from Colfax Ave.</p>

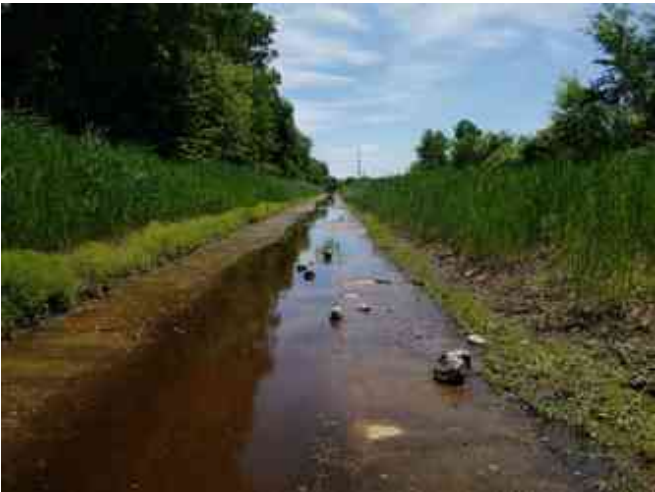
<p><b>Inspect ID:</b> 2022-0304 <b>Title:</b> 2604000003_CELRC_2022_A_0304_1_20220609T172939.jpg <b>Rated Item:</b> 1. Vegetation and Obstructions <b>Caption:</b> Acceptable - Ditch looking east from 29th and Black Oak Rd. Good condition.</p>

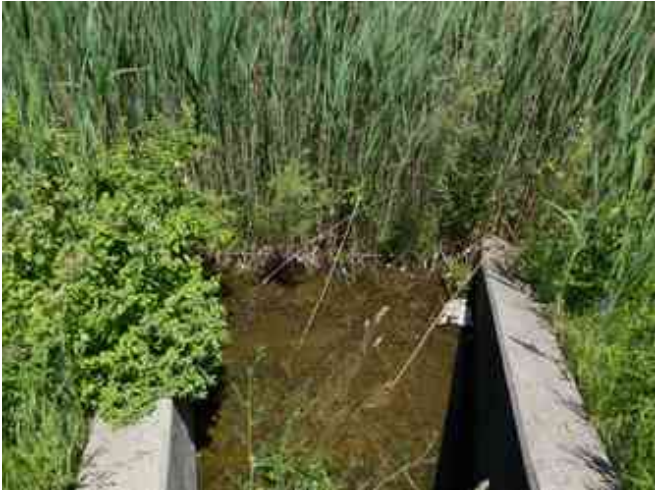
<p><b>Inspect ID:</b> 2022-0352 <b>Title:</b> 2604000003_CELRC_2022_A_0352_1_20220609T180156.jpg <b>Rated Item:</b> 1. Vegetation and Obstructions <b>Caption:</b> Minimally Acceptable - GN-2: Vegetation in inlet.</p>

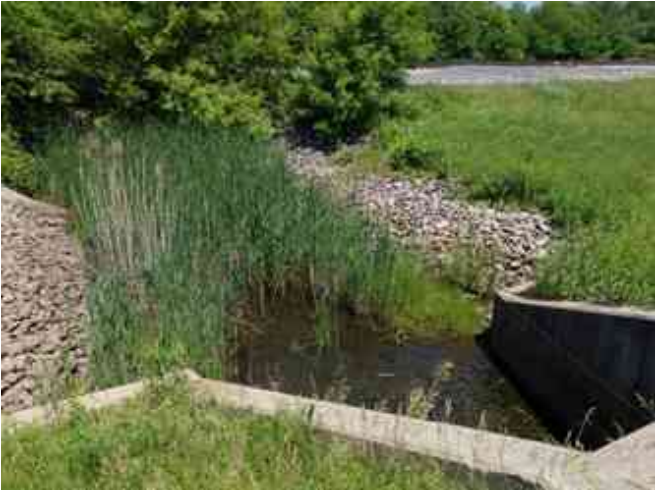
<p><b>Inspect ID:</b> 2022-0385 <b>Title:</b> 2604000003_CELRC_2022_A_0385_1_20220609T182522.jpg <b>Rated Item:</b> 1. Vegetation and Obstructions <b>Caption:</b> Minimally Acceptable - GN-3: Vegetation growth in outlet structure.</p>

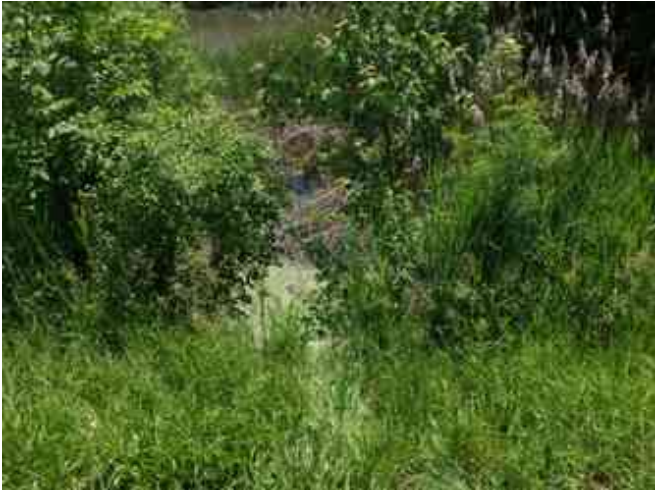
<p><b>Inspect ID:</b> 2022-0182 <b>Title:</b> 2604000003_CELRC_2022_A_0182_1_20220609T190829.jpg <b>Rated Item:</b> 2. Encroachments <b>Caption:</b> Minimally Acceptable - GN-4: Trees around outlet structure.</p>
