Levee Inspection Report

Name of System: Gary

Name of Segment: Gary South

Inspection Report Prepared by: Christopher Schaal Date(s) of Inspection: 06/07/2022 - 06/10/2022

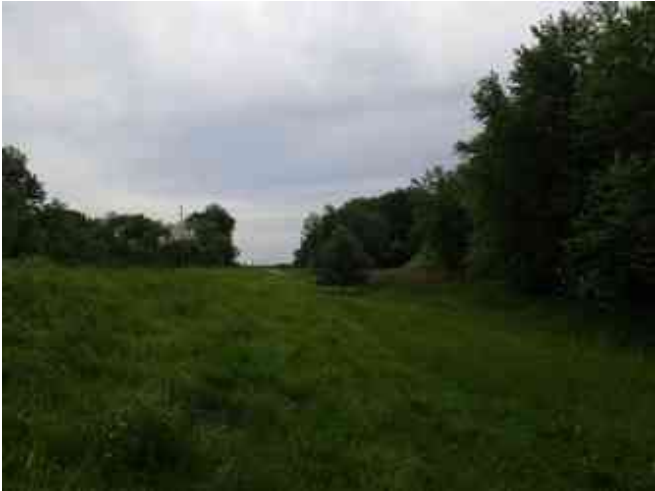
<p>Inspect ID: 2022-0046 Title: 2604000004_CELRC_2022_A_2022-0046_3_20220608T140355.jpg Rated Item: 1. Unwanted Vegetation Growth Caption: Unacceptable - Large tree on landside toe.</p>

Rated Item	Rating	Rating Guidelines		Location/Remarks/Recommendations
				riverside ditch. (U) 2022-0283 : Large tree growing in waterside drainage ditch. (U) Recommendation: Remove trees and tall vegetation from 15 foot zone around levee toe

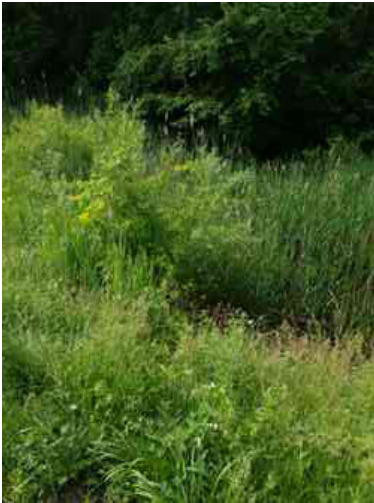
<p>Inspect ID: 2022-0073 Title: 2604000004_CELRC_2022_A_0073_1_20220608T141307.jpg Rated Item: 1. Unwanted Vegetation Growth Caption: Minimally Acceptable - Large shrub growth on riverside slope.</p>

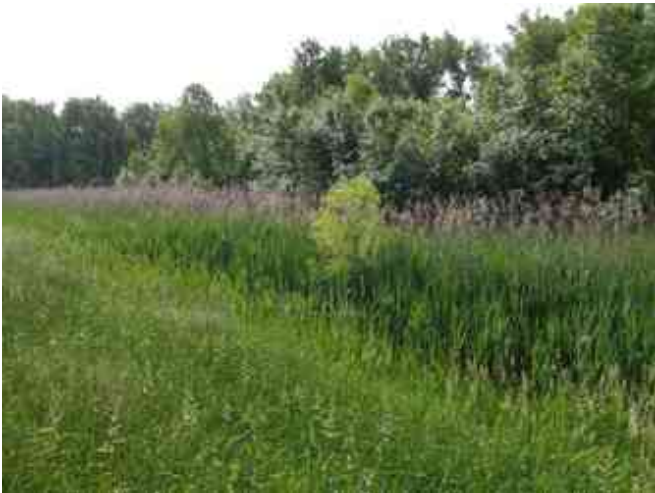
<p>Inspect ID: 2022-0085 Title: 2604000004_CELRC_2022_A_0085_1_20220608T142003.jpg Rated Item: 1. Unwanted Vegetation Growth Caption: Minimally Acceptable - Small tree on the landside toe.</p>

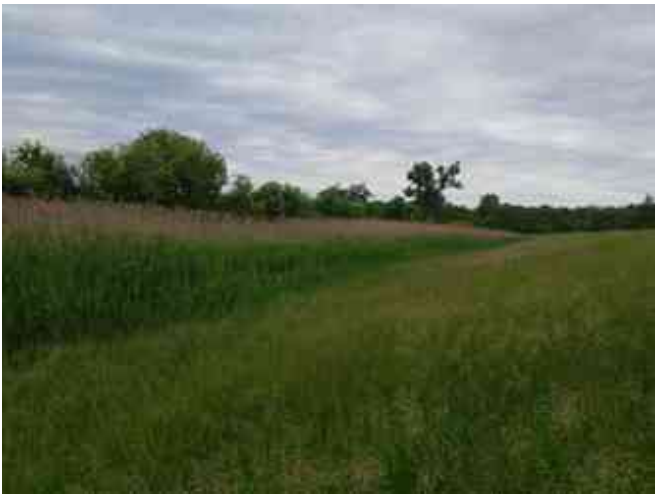
<p>Inspect ID: 2022-0130 Title: 2604000004_CELRC_2022_A_0130_1_20220608T145437.jpg Rated Item: 1. Unwanted Vegetation Growth Caption: Minimally Acceptable - Typical tall vegetative growth on landside toe.</p>

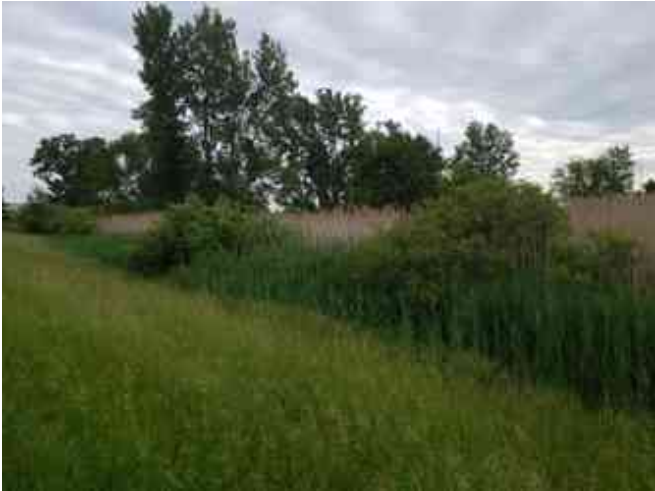
<p>Inspect ID: 2022-0163 Title: 2604000004_CELRC_2022_A_0163_1_20220608T150922.jpg Rated Item: 1. Unwanted Vegetation Growth Caption: Minimally Acceptable - Small trees on the landside toe.</p>

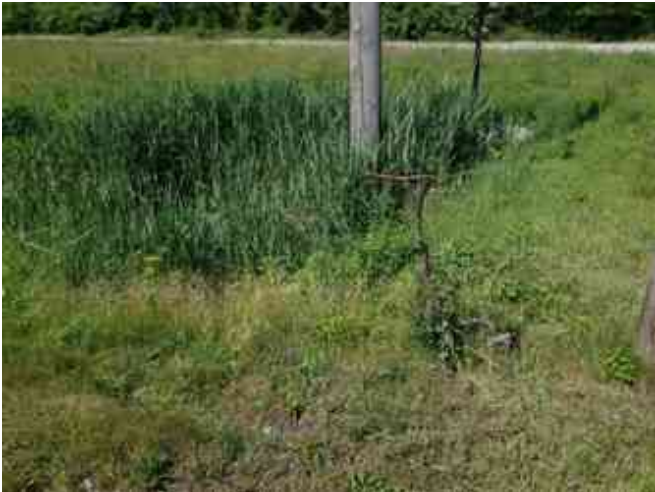
<p>Inspect ID: 2022-0173 Title: 2604000004_CELRC_2022_A_0173_1_20220610T151700.jpg Rated Item: 1. Unwanted Vegetation Growth Caption: Minimally Acceptable - Small tree and tall vegetation on riverside toe.</p>

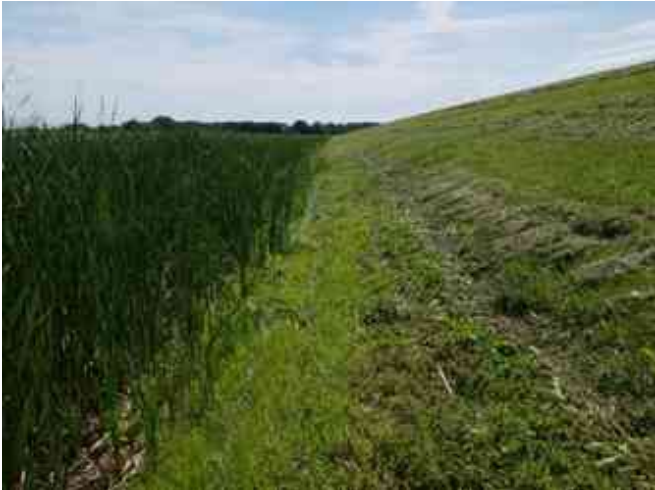
<p>Inspect ID: 2022-0185 Title: 2604000004_CELRC_2022_A_0185_1_20220610T153252.jpg Rated Item: 1. Unwanted Vegetation Growth Caption: Minimally Acceptable - Tall Vegetation along riverside toe.</p>

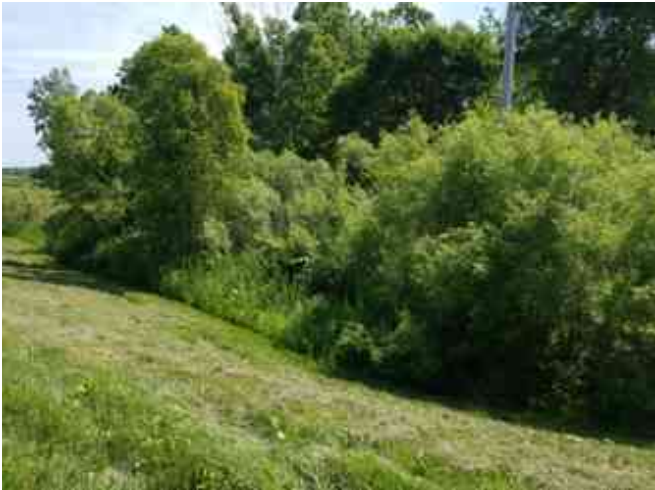
<p>Inspect ID: 2022-0190 Title: 2604000004_CELRC_2022_A_0190_1_20220610T150551.jpg Rated Item: 1. Unwanted Vegetation Growth Caption: Unacceptable - Large tree growth in landside ditch and close to toe.</p>

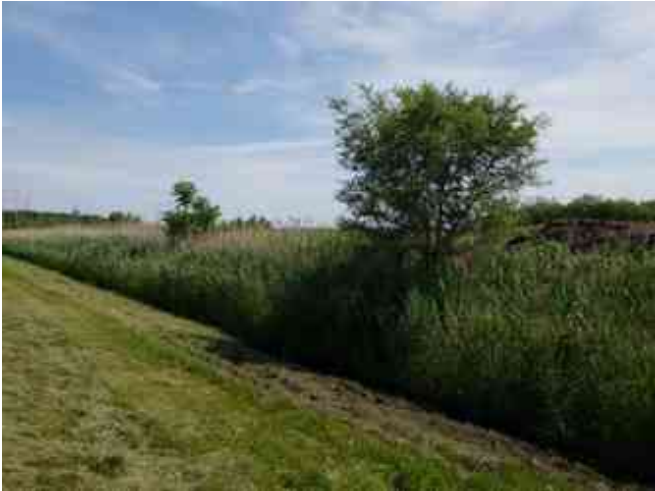
<p>Inspect ID: 2022-0196 Title: 2604000004_CELRC_2022_A_0196_1_20220610T150932.jpg Rated Item: 1. Unwanted Vegetation Growth Caption: Minimally Acceptable - Large trees growing in landside drainage ditch.</p>

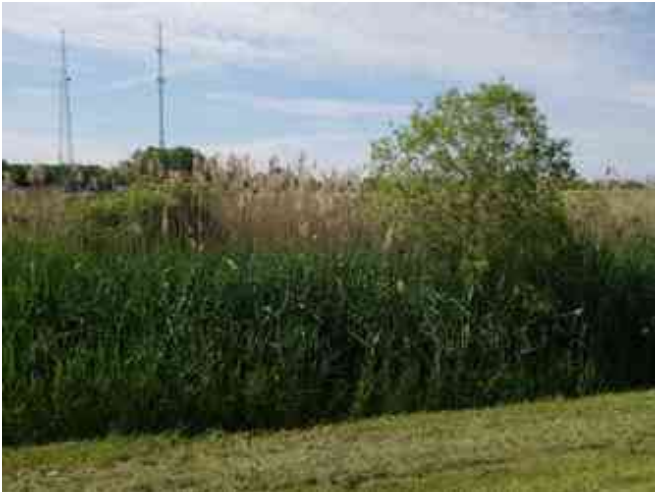
<p>Inspect ID: 2022-0202 Title: 2604000004_CELRC_2022_A_0202_1_20220610T151407.jpg Rated Item: 1. Unwanted Vegetation Growth Caption: Minimally Acceptable - Small trees growing in landside drainage ditch.</p>

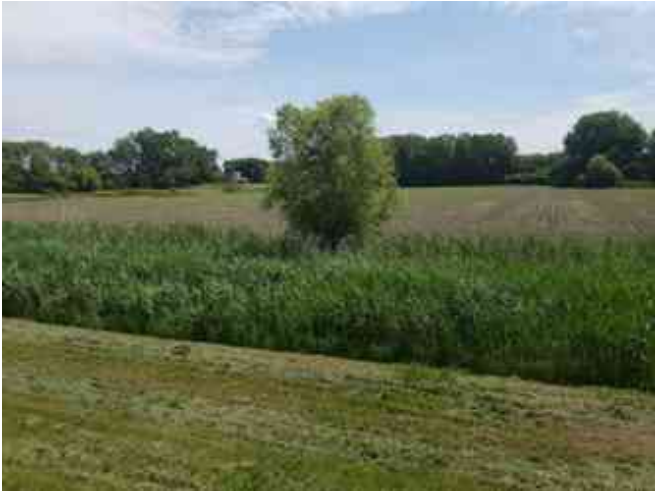
<p>Inspect ID: 2022-0229 Title: 2604000004_CELRC_2022_A_0229_1_20220610T155845.jpg Rated Item: 1. Unwanted Vegetation Growth Caption: Unacceptable - Large tree growing in drainage ditch on landside toe.</p>

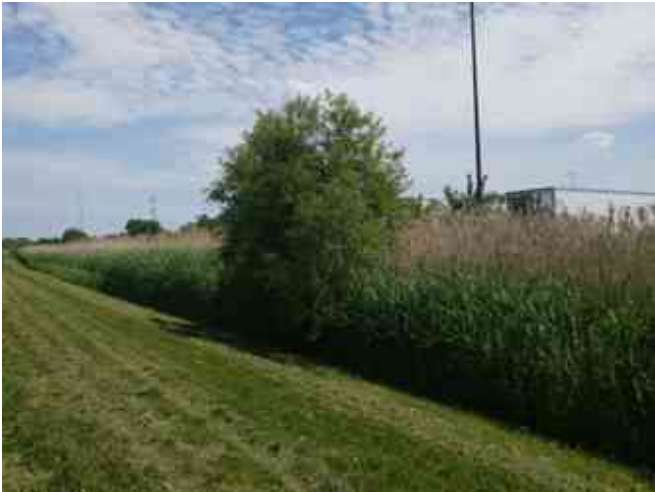
<p>Inspect ID: 2022-0238 Title: 2604000004_CELRC_2022_A_0238_1_20220610T160540.jpg Rated Item: 1. Unwanted Vegetation Growth Caption: Unacceptable - Large tree growing in landside drainage ditch.</p>

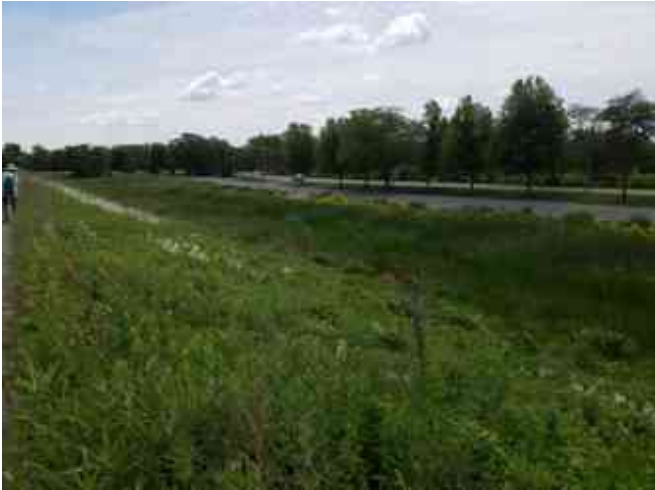
<p>Inspect ID: 2022-0239 Title: 2604000004_CELRC_2022_A_0239_1_20220610T170158.jpg Rated Item: 1. Unwanted Vegetation Growth Caption: Minimally Acceptable - Typical dense and tall vegetation along section 408 section.</p>

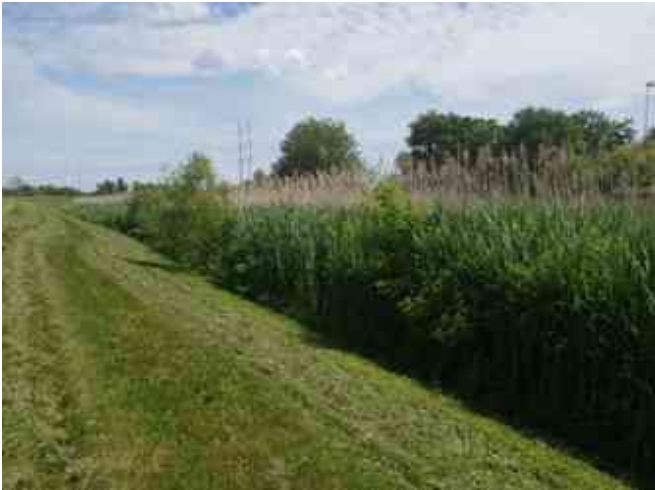
<p>Inspect ID: 2022-0241 Title: 2604000004_CELRC_2022_A_0241_1_20220610T160949.jpg Rated Item: 1. Unwanted Vegetation Growth Caption: Minimally Acceptable - Small tree growing in the landside drainage ditch.</p>

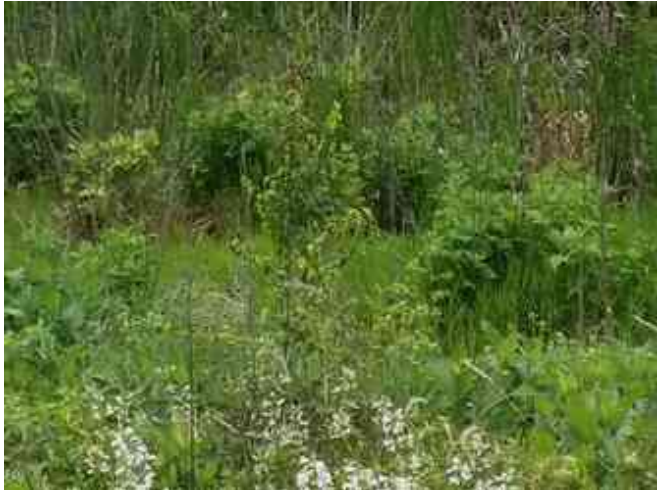
<p>Inspect ID: 2022-0242 Title: 2604000004_CELRC_2022_A_0242_1_20220610T170319.jpg Rated Item: 1. Unwanted Vegetation Growth Caption: Minimally Acceptable - Small trees growing, and are not allowed in 408 permission zone.</p>

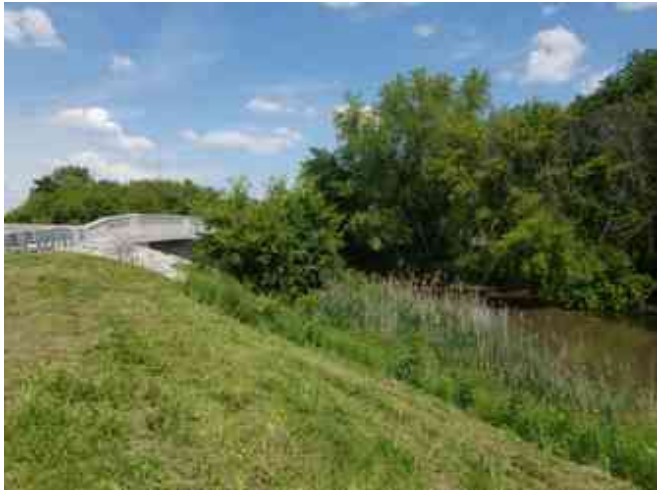
<p>Inspect ID: 2022-0262 Title: 2604000004_CELRC_2022_A_0262_1_20220610T164350.jpg Rated Item: 1. Unwanted Vegetation Growth Caption: Unacceptable - Large trees growing and vegetation along waterside ditch.</p>

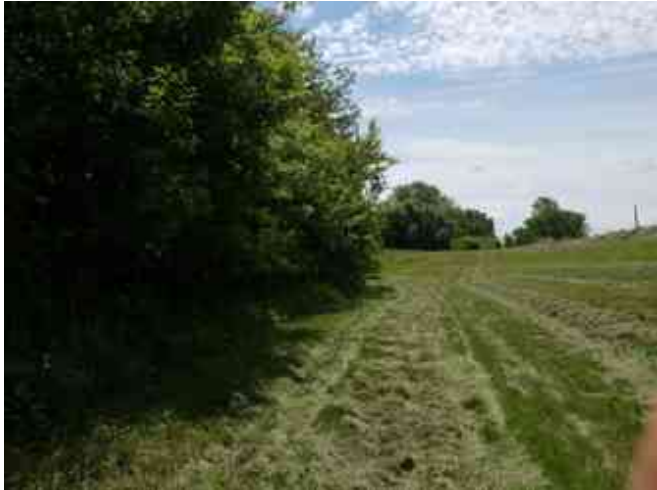
<p>Inspect ID: 2022-0268 Title: 2604000004_CELRC_2022_A_0268_1_20220610T164832.jpg Rated Item: 1. Unwanted Vegetation Growth Caption: Unacceptable - Large tree growth close to levee on riverside ditch.</p>

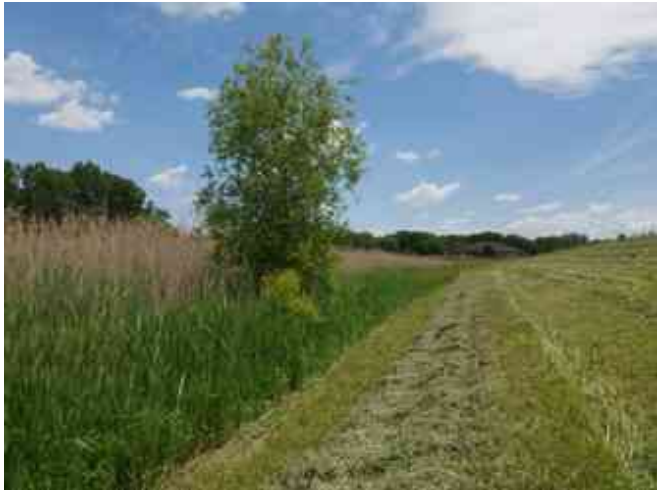
<p>Inspect ID: 2022-0283 Title: 2604000004_CELRC_2022_A_0283_1_20220610T170801.jpg Rated Item: 1. Unwanted Vegetation Growth Caption: Unacceptable - Large tree growing in waterside drainage ditch.</p>

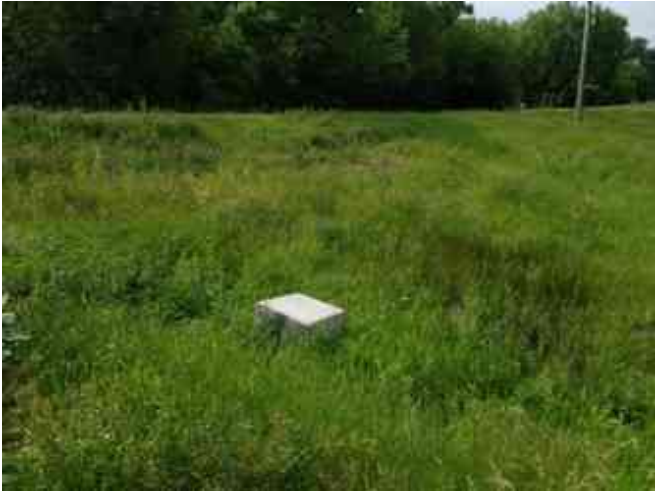
<p>Inspect ID: 2022-0064 Title: 2604000004_CELRC_2022_A_0064_1_20220608T140854.jpg Rated Item: 3. Encroachments Caption: Minimally Acceptable - Concrete block on landside toe.</p>

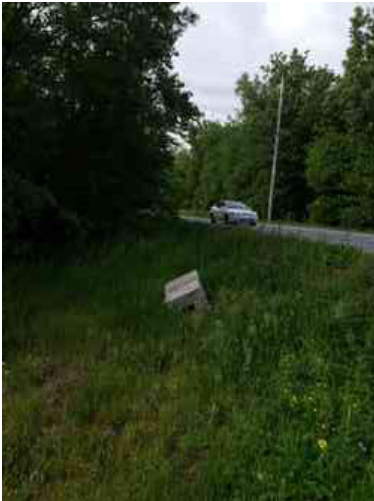
<p>Inspect ID: 2022-0079 Title: 2604000004_CELRC_2022_A_0079_1_20220608T141455.jpg Rated Item: 3. Encroachments Caption: Minimally Acceptable - Concrete block near levee crown.</p>

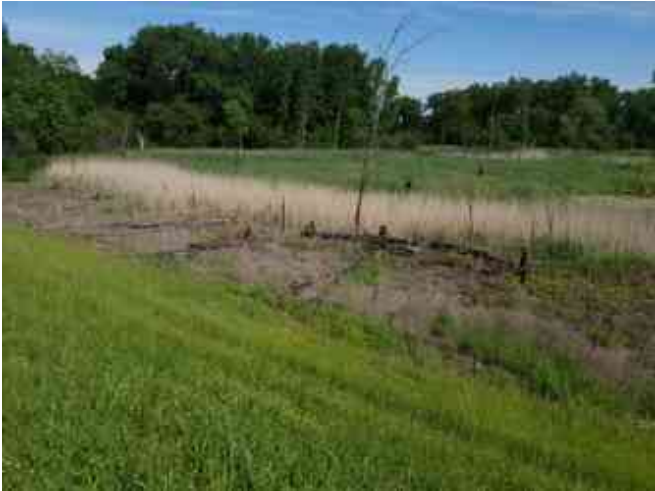
<p>Inspect ID: 2022-0088 Title: 2604000004_CELRC_2022_A_0088_1_20220608T142104.jpg Rated Item: 3. Encroachments Caption: Minimally Acceptable - Typical burned and fallen debris on riverside toe near Martin Luther King Drive and area paralleling 32nd ave toward Georgia ave.</p>

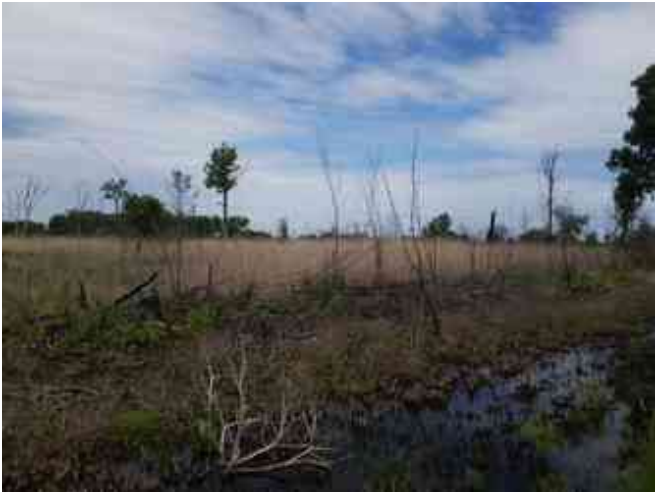
<p>Inspect ID: 2022-0106 Title: 2604000004_CELRC_2022_A_0106_1_20220608T143603.jpg Rated Item: 3. Encroachments Caption: Minimally Acceptable - Fallen tree debris on waterside toe.</p>

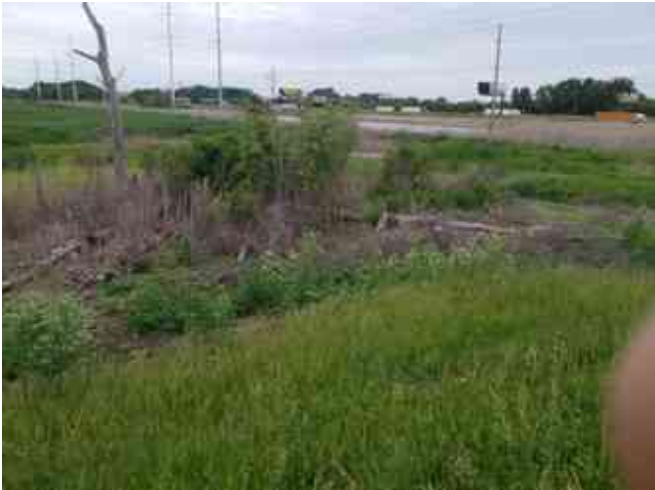
<p>Inspect ID: 2022-0169 Title: 2604000004_CELRC_2022_A_0169_1_20220608T151312.jpg Rated Item: 3. Encroachments Caption: Minimally Acceptable - Fallen tree debris</p>

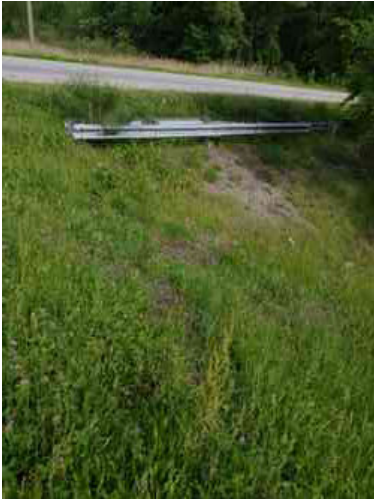
<p>Inspect ID: 2022-0070 Title: 2604000004_CELRC_2022_A_0070_1_20220608T141212.jpg Rated Item: 8. Depressions/ Rutting Caption: Minimally Acceptable - Rutting caused by mowing, riverside slope</p>

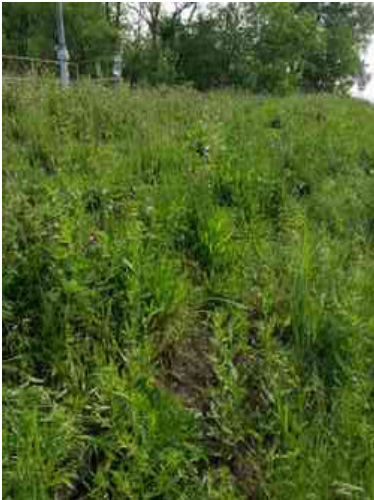
<p>Inspect ID: 2022-0076 Title: 2604000004_CELRC_2022_A_0076_1_20220608T141402.jpg Rated Item: 8. Depressions/ Rutting Caption: Minimally Acceptable - Rutting caused by mowing, landside slope.</p>

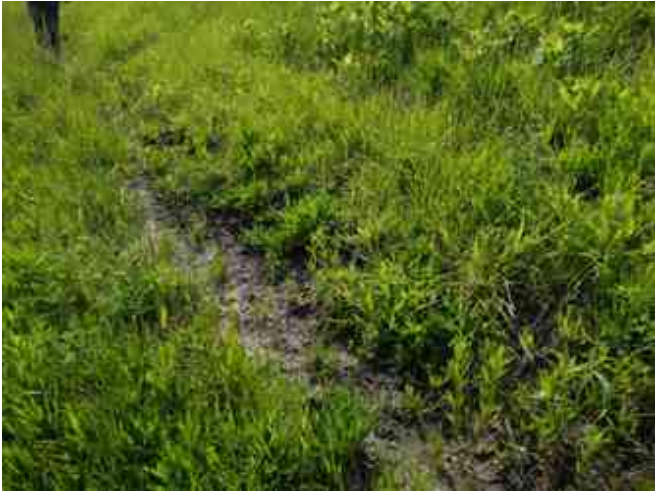
<p>Inspect ID: 2022-0091 Title: 2604000004_CELRC_2022_A_0091_1_20220608T142239.jpg Rated Item: 8. Depressions/ Rutting Caption: Minimally Acceptable - Rutting caused by mowing, riverside slope.</p>

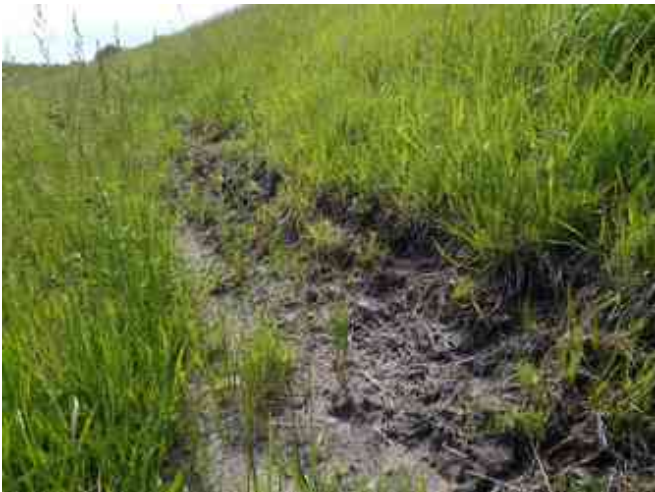
<p>Inspect ID: 2022-0094 Title: 2604000004_CELRC_2022_A_0094_1_20220608T142610.jpg Rated Item: 8. Depressions/ Rutting Caption: Minimally Acceptable - Rutting caused by mowing. Riverside slope</p>

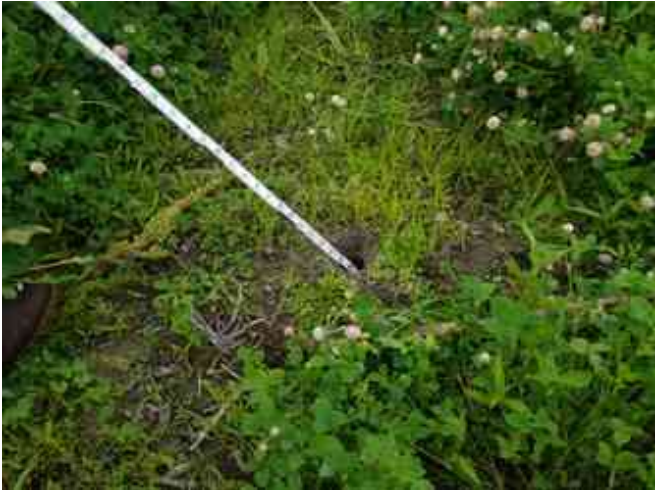
<p>Inspect ID: 2022-0142 Title: 2604000004_CELRC_2022_A_0142_1_20220608T150029.jpg Rated Item: 10. Animal Control Caption: Minimally Acceptable - Animal burrow riverside slope.</p>
 	<p>Inspect ID: 2022-0148 Title: 2604000004_CELRC_2022_A_0148_1_20220608T150256.jpg Rated Item: 10. Animal Control Caption: Minimally Acceptable - Animal burrow, riverside toe.</p>

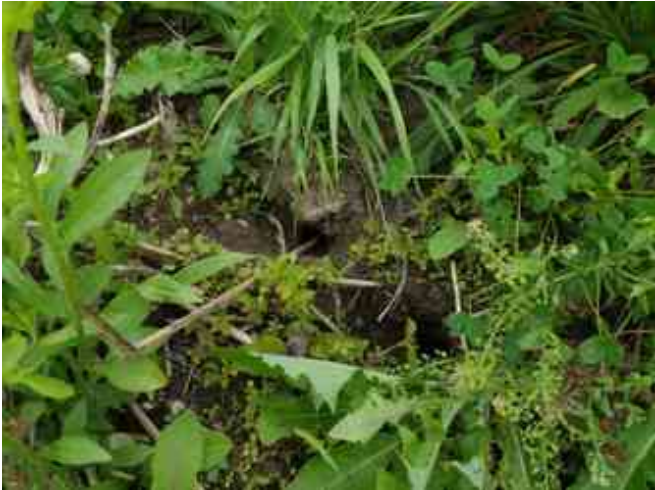
<p>Inspect ID: 2022-0154 Title: 2604000004_CELRC_2022_A_0154_1_20220608T150551.jpg Rated Item: 10. Animal Control Caption: Minimally Acceptable - Animal burrow, riverside toe. Along North-south running portion of waterside toe along Martin Luther King Drive</p>

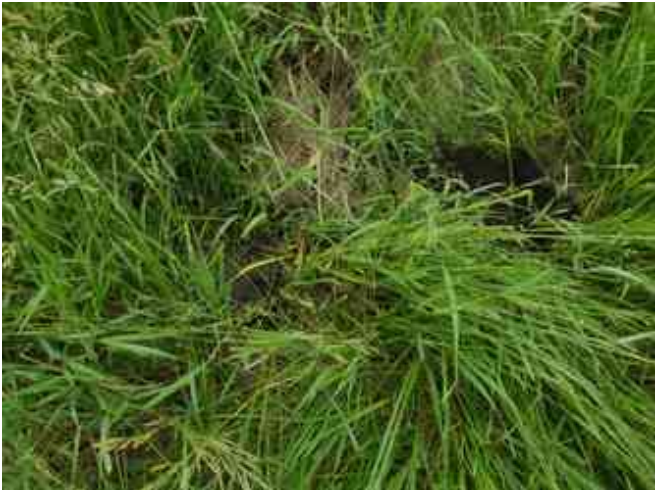
<p>Inspect ID: 2022-0166 Title: 2604000004_CELRC_2022_A_0166_1_20220608T151113.jpg Rated Item: 10. Animal Control Caption: Acceptable - Animal droppings indicative of high activity</p>

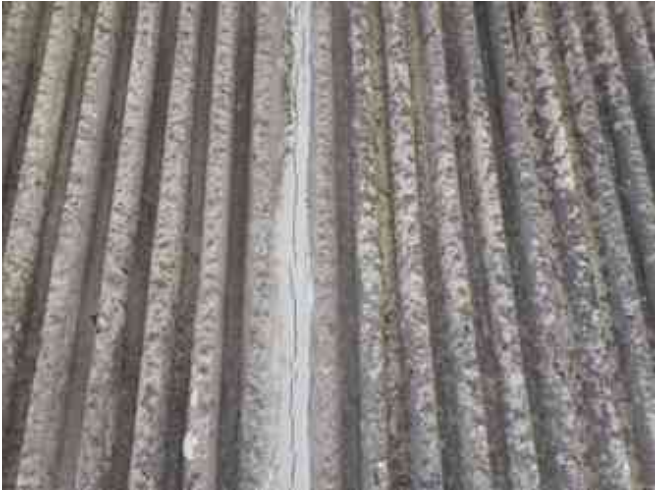
<p>Inspect ID: 2022-0271 Title: 2604000004_CELRC_2022_A_0271_1_20220610T165126.jpg Rated Item: 7. Monolith Joints Caption: Minimally Acceptable - Joint splitting g on waterside</p>

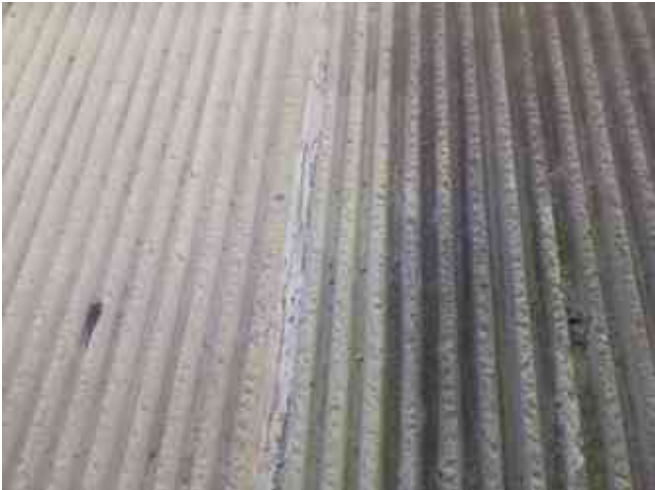
<p>Inspect ID: 2022-0274 Title: 2604000004_CELRC_2022_A_0274_1_20220610T165252.jpg Rated Item: 7. Monolith Joints Caption: Minimally Acceptable - Deteriorating sealant on waterside.</p>

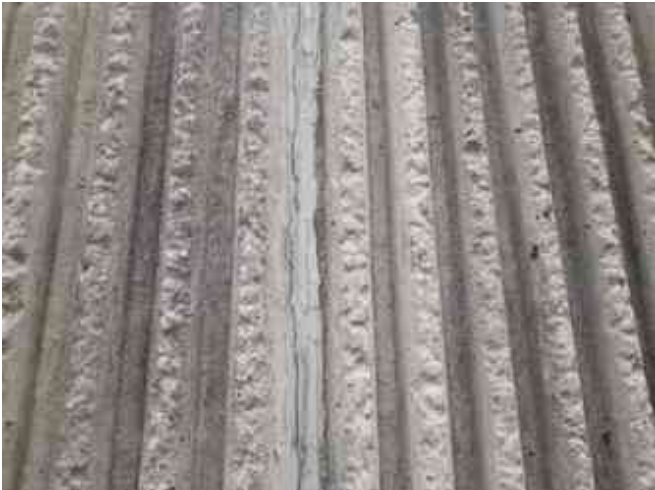
<p>Inspect ID: 2022-0298 Title: 2604000004_CELRC_2022_A_0298_1_20220610T172137.jpg Rated Item: 7. Monolith Joints Caption: Minimally Acceptable - Deteriorating sealant on waterside face.</p>

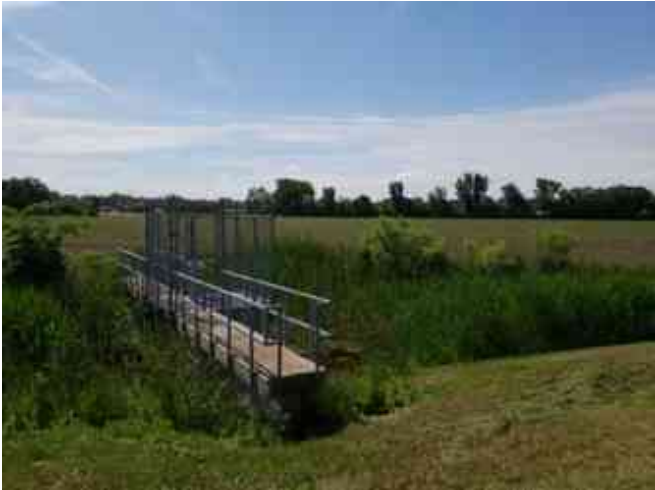
<p>Inspect ID: 2022-0223 Title: 2604000004_CELRC_2022_A_0223_1_20220610T154614.jpg Rated Item: 1. Vegetation and Obstructions Caption: Minimally Acceptable - GS-3: Trees growing in drainage ditch on landside.</p>

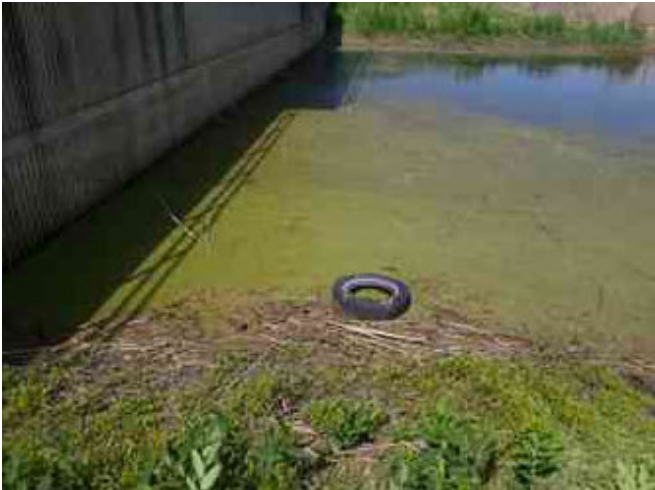
<p>Inspect ID: 2022-0211 Title: 2604000004_CELRC_2022_A_0211_1_20220610T153049.jpg Rated Item: 2. Encroachments Caption: Minimally Acceptable - Debris in outlet structure.</p>

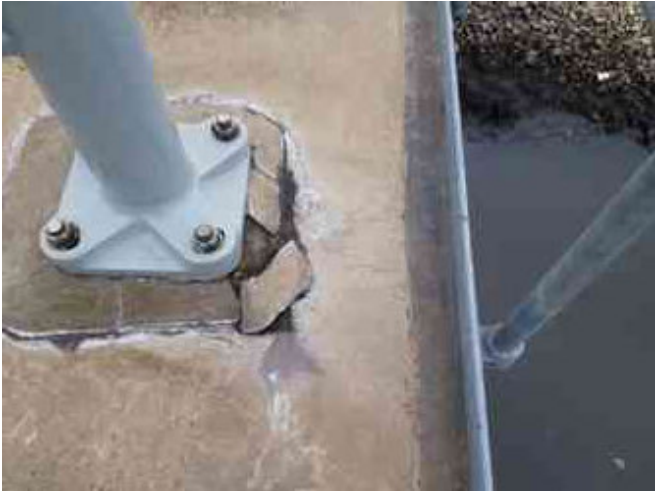
<p>Inspect ID: 2022-0020 Title: 2604000004_CELRC_2022_A_0020_1_20220607T133604.jpg Rated Item: 5. Concrete Surfaces (Such as gate wells, outfalls, intakes, or culverts) Caption: Minimally Acceptable - GS-8c: Concrete at gate stem cracking.</p>

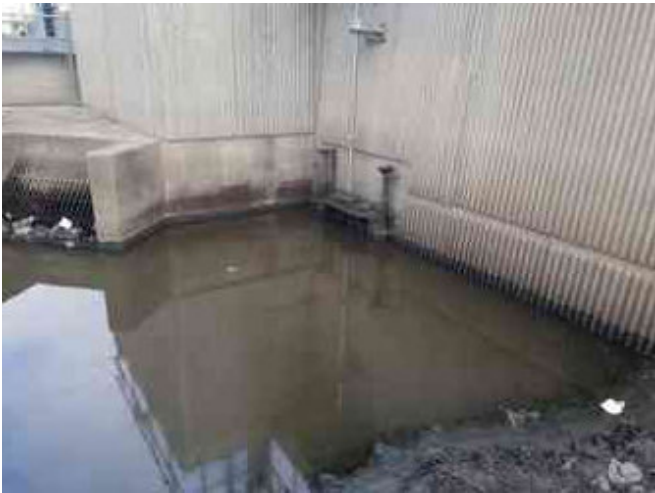
<p>Inspect ID: 2022-0002 Title: 2604000004_CELRC_2022_A_0002_1_20220607T131447.jpg Rated Item: 10. Sluice/ Slide Gates Caption: Minimally Acceptable - GS 7, Sluice gate did not shut completely.</p>

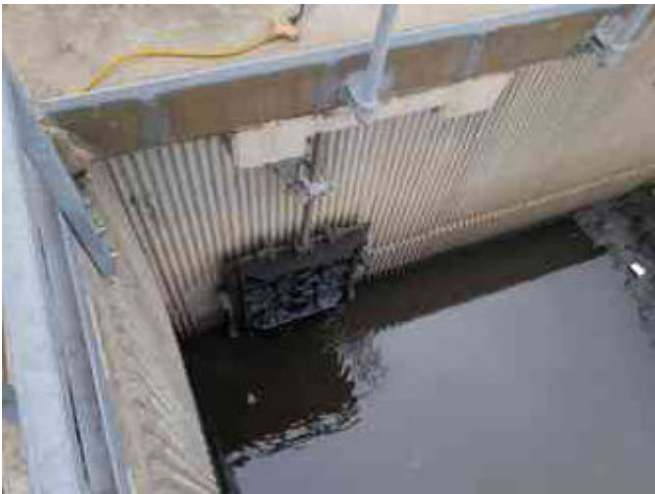
<p>Inspect ID: 2022-0005 Title: 2604000004_CELRC_2022_A_0005_1_20220607T132235.jpg Rated Item: 10. Sluice/ Slide Gates Caption: Minimally Acceptable - GS-8: luice gate did not shut and sediment present. Gate always shut.</p>

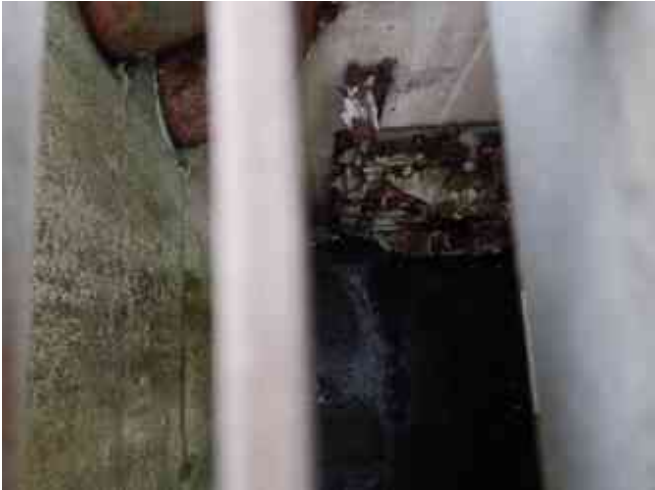
<p>Inspect ID: 2022-0074 Title: 2604000004_CELRC_2022_A_0074_1_20220607T150416.jpg Rated Item: 10. Sluice/ Slide Gates Caption: Minimally Acceptable - GS-12a: Gate did not close completely.</p>

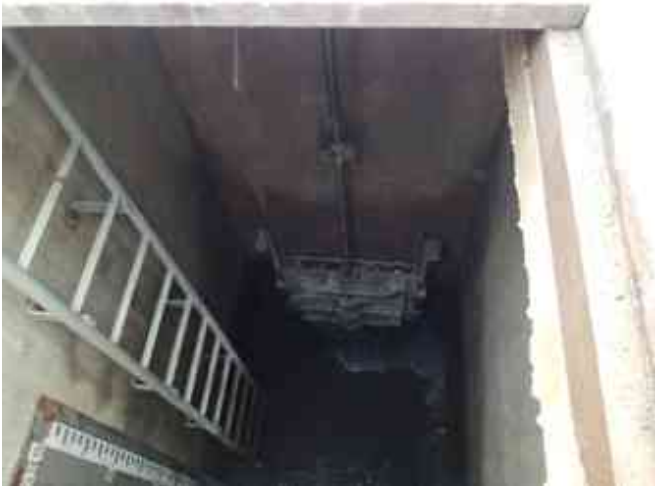
<p>Inspect ID: 2022-0086 Title: 2604000004_CELRC_2022_A_0086_1_20220607T153313.jpg Rated Item: 10. Sluice/ Slide Gates Caption: Minimally Acceptable - GS-15: Gate closed completely, sediment present outside of gate.</p>

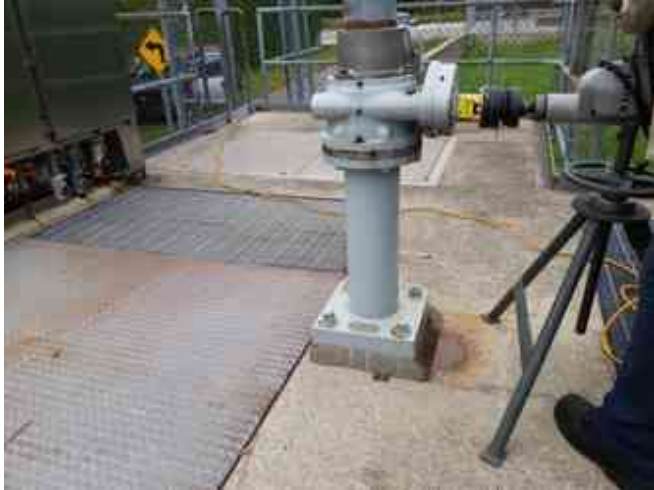
Inspect ID: 2022-0068 **Title:**
2604000004_CELRC_2022_A_0068_1_20220607T150026.jpg
Rated Item: 13. Other Metallic Items **Caption:** Minimally
Acceptable - GS-12a: Gate stem leaking water when running,
greased while running

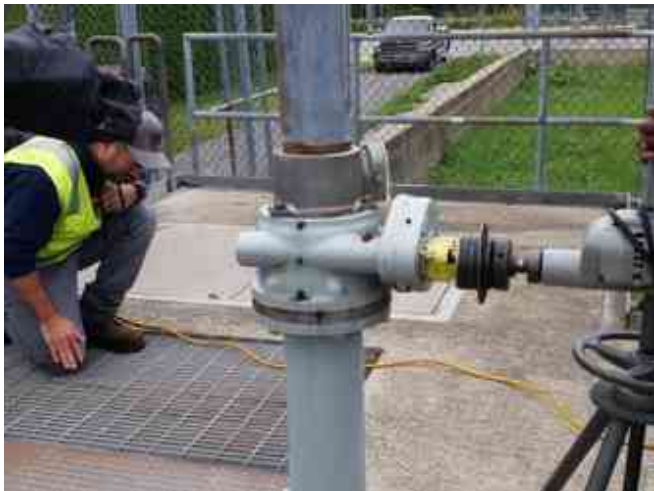
Inspect ID: 2022-0071 **Title:**
2604000004_CELRC_2022_A_0071_1_20220607T150300.jpg
Rated Item: 13. Other Metallic Items **Caption:** Minimally
Acceptable - GS-12a: Crack and rust

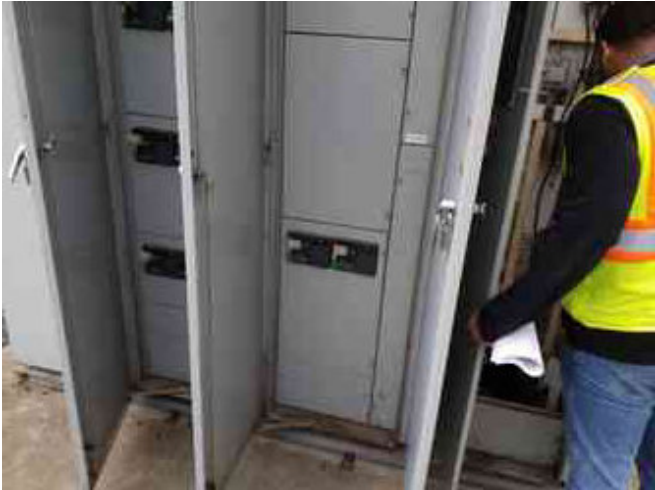
<p>Inspect ID: 2022-0027 Title: 2604000004_CELRC_2022_A_0027_1_20220607T132855.jpg Rated Item: 2. Pump Station Operations and Maintenance Equipment Manuals Caption: Unacceptable - PS-GW: No manuals onsite. Recommend adding to cabinet</p>

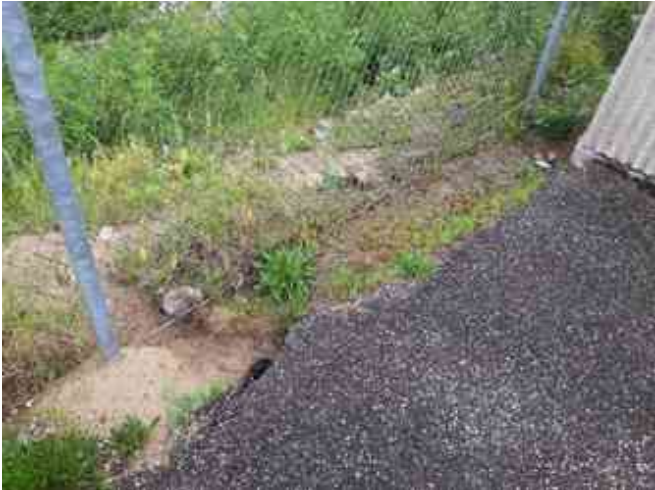
<p>Inspect ID: 2022-0021 Title: 2604000004_CELRC_2022_A_0021_1_20220607T132050.jpg Rated Item: 6. Fencing and Gates Caption: Minimally Acceptable - PS-GW: Multiple potential animal burrows through fence. Recommend filling cavities with soil or desert to prevent entry.</p>
 	<p>Inspect ID: 2022-0003 Title: 2604000004_CELRC_2022_A_0003_1_20220607T130514.jpg Rated Item: 7. Pumps Caption: Minimally Acceptable - PS-GE: Sump pump is out of service. Plan already in place to replace pump.</p>
