Levee Inspection Report

Name of System: Highland

NLD System ID: 2605000005

Date(s) of Inspection: 04/14/2022 - 04/14/2022

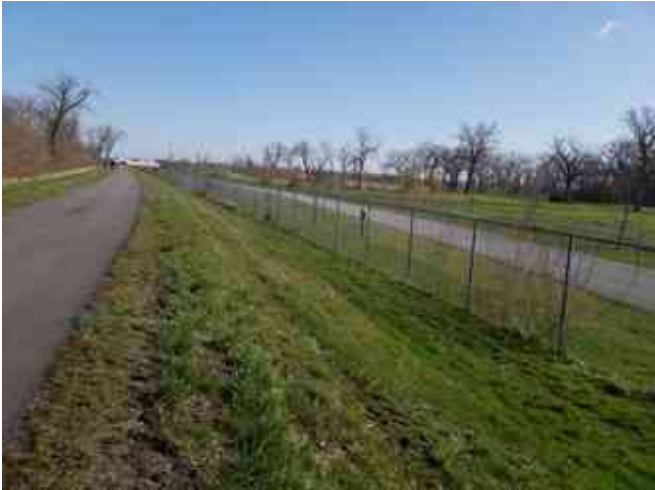
<p>Inspect ID: 2022-0040 Title: 2604000007_CELRC_2022_A_0040_1_20220414T133752.jpg Rated Item: 1. Unwanted Vegetation Growth Caption: Minimally Acceptable - Small brush on landside toe along fence.</p>

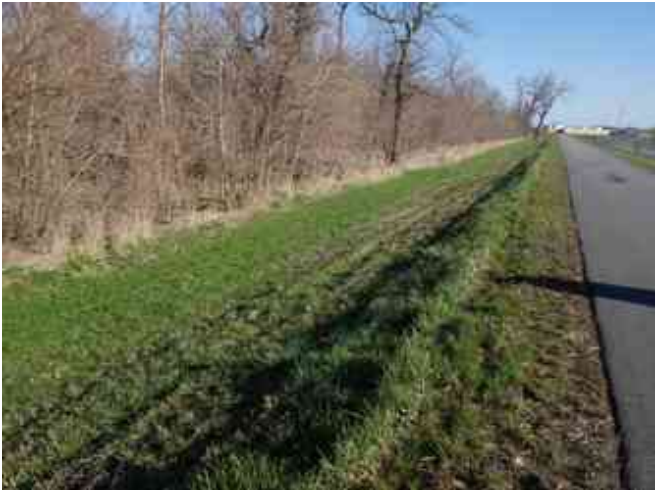
<p>Inspect ID: 2022-0043 Title: 2604000007_CELRC_2022_A_0043_1_20220414T134115.jpg Rated Item: 1. Unwanted Vegetation Growth Caption: Minimally Acceptable - Trees and brush within 12 ft of riverside toe.</p>

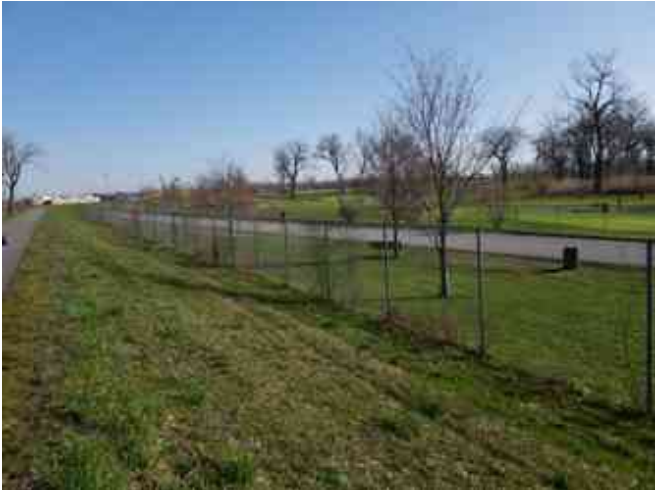
<p>Inspect ID: 2022-0046 Title: 2604000007_CELRC_2022_A_0046_1_20220414T134231.jpg Rated Item: 1. Unwanted Vegetation Growth Caption: Minimally Acceptable - 2 trees about 10 ft from landside toe.</p>

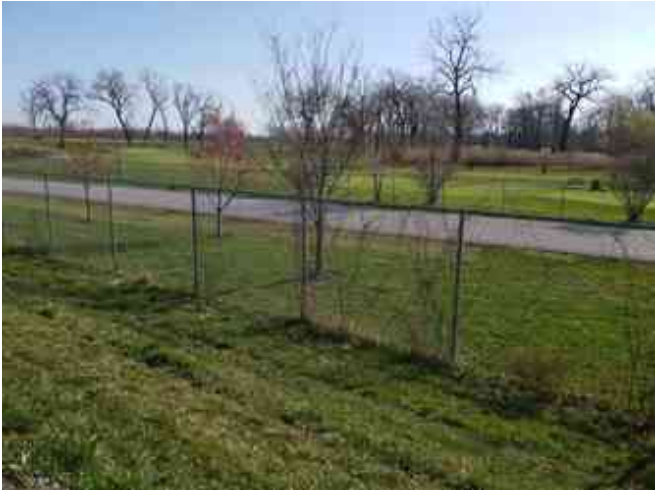
<p>Inspect ID: 2022-0049 Title: 2604000007_CELRC_2022_A_0049_1_20220414T134344.jpg Rated Item: 1. Unwanted Vegetation Growth Caption: Minimally Acceptable - Tree about 10 ft from landside toe.</p>

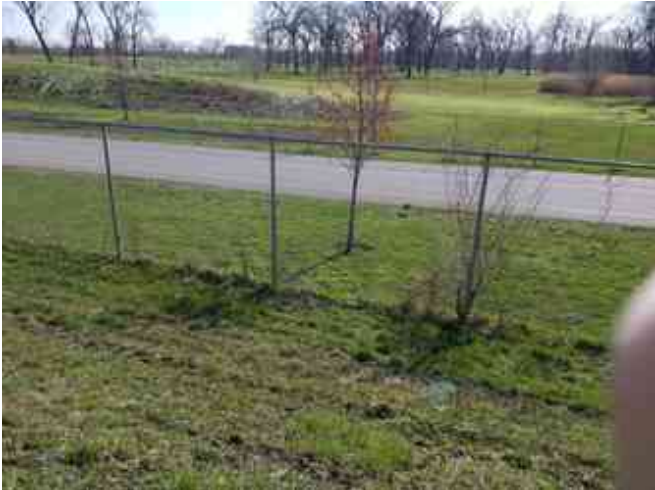
<p>Inspect ID: 2022-0055 Title: 2604000007_CELRC_2022_A_0055_1_20220414T134631.jpg</p> <p>Rated Item: 1. Unwanted Vegetation Growth Caption: Minimally Acceptable - Tree within 5 from landside toe.</p>

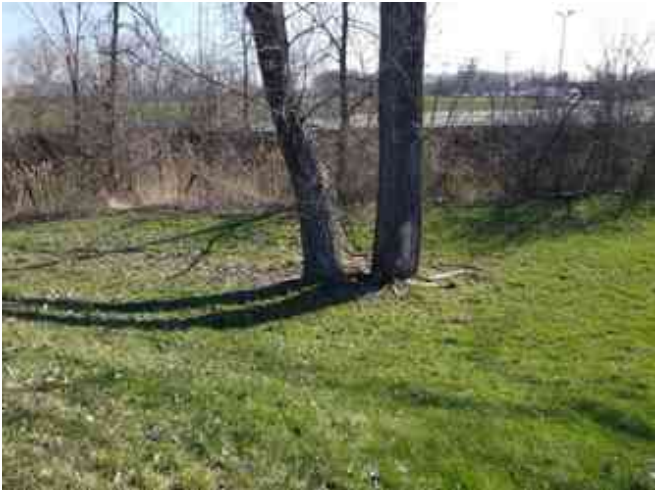
<p>Inspect ID: 2022-0082 Title: 2604000007_CELRC_2022_A_0082_1_20220414T140143.jpg</p> <p>Rated Item: 1. Unwanted Vegetation Growth Caption: Minimally Acceptable - 2 trees within 10 ft on landside toe.</p>

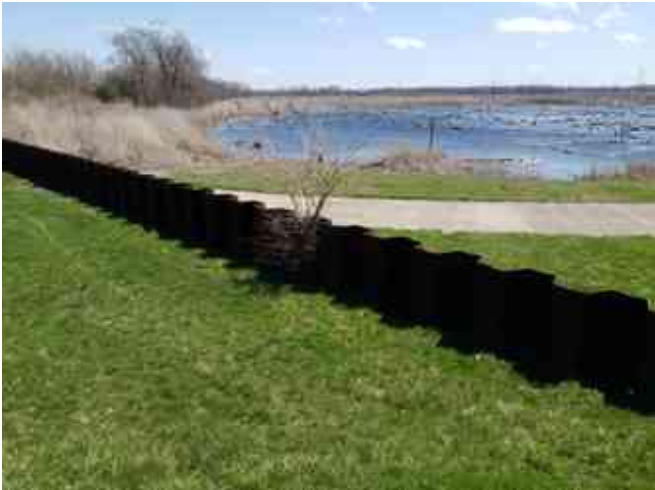
<p>Inspect ID: 2022-0253 Title: 2604000007_CELRC_2022_A_0253_1_20220414T164941.jpg Rated Item: 1. Unwanted Vegetation Growth Caption: Minimally Acceptable - Tree near riverside toe.</p>

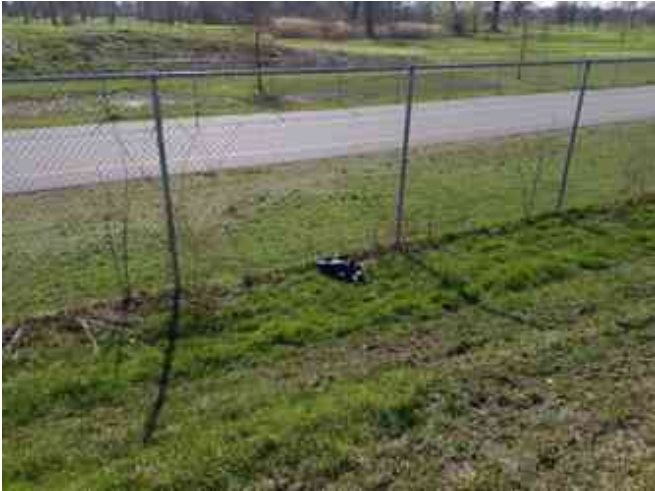
<p>Inspect ID: 2022-0058 Title: 2604000007_CELRC_2022_A_0058_1_20220414T134810.jpg Rated Item: 3. Encroachments Caption: Minimally Acceptable - Debris on landside toe.</p>

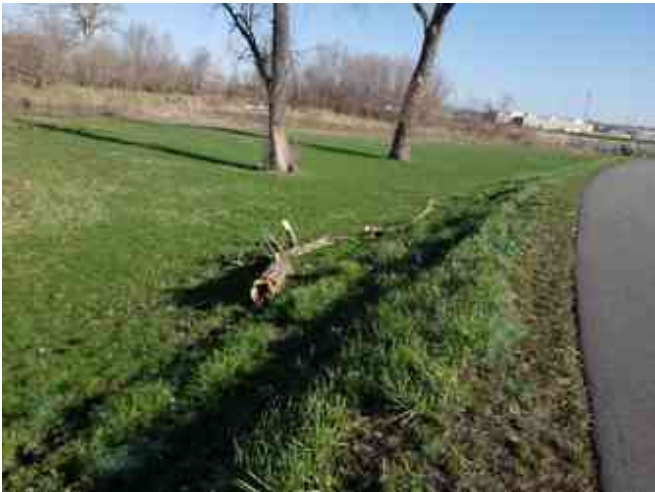
<p>Inspect ID: 2022-0064 Title: 2604000007_CELRC_2022_A_0064_1_20220414T135036.jpg Rated Item: 3. Encroachments Caption: Minimally Acceptable - Logs on riverside slope.</p>

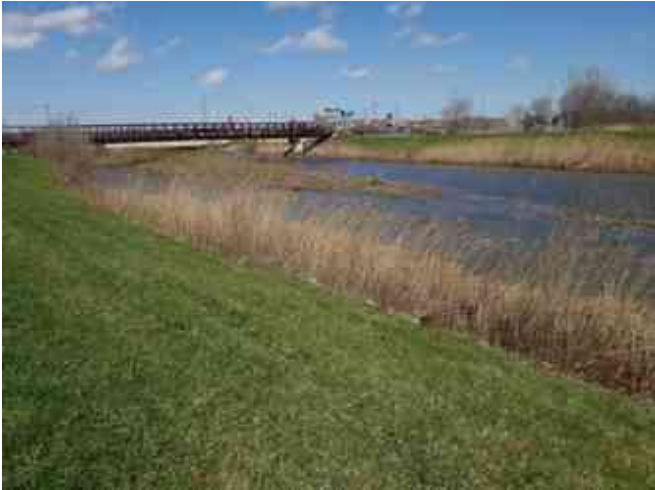
<p>Inspect ID: 2022-0199 Title: 2604000007_CELRC_2022_A_0199_1_20220414T154224.jpg Rated Item: 3. Encroachments Caption: Minimally Acceptable - Line of garbage on riverside toe.</p>

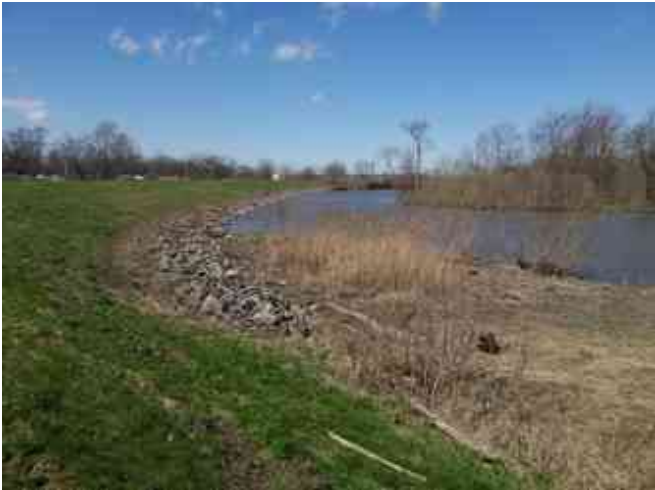
<p>Inspect ID: 2022-0229 Title: 2604000007_CELRC_2022_A_0229_1_20220414T161243.jpg Rated Item: 3. Encroachments Caption: Minimally Acceptable - Debris along riverside toe.</p>

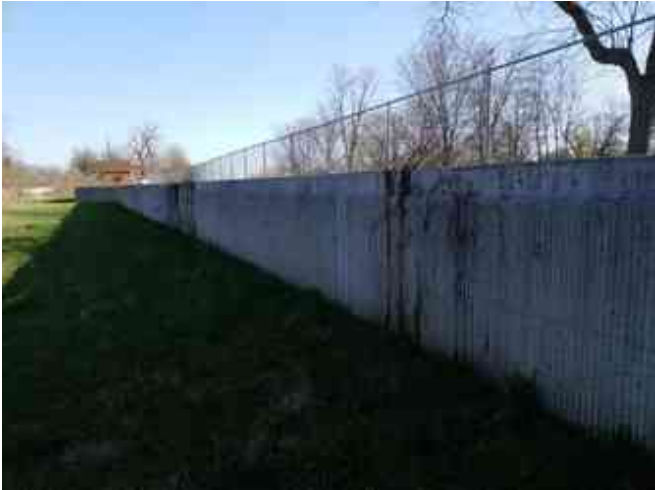
<p>Inspect ID: 2022-0013 Title: 2604000007_CELRC_2022_A_0013_1_20220414T132302.jpg Rated Item: 1. Unwanted Vegetation Growth Caption: Minimally Acceptable - Small vines on riverside of floodwall.</p>

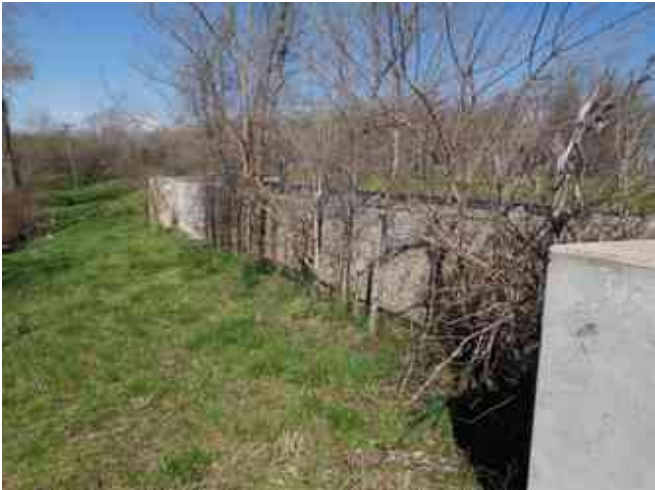
<p>Inspect ID: 2022-0145 Title: 2604000007_CELRC_2022_A_0145_1_20220414T150118.jpg Rated Item: 1. Unwanted Vegetation Growth Caption: Minimally Acceptable - Small trees on landside of floodwall.</p>

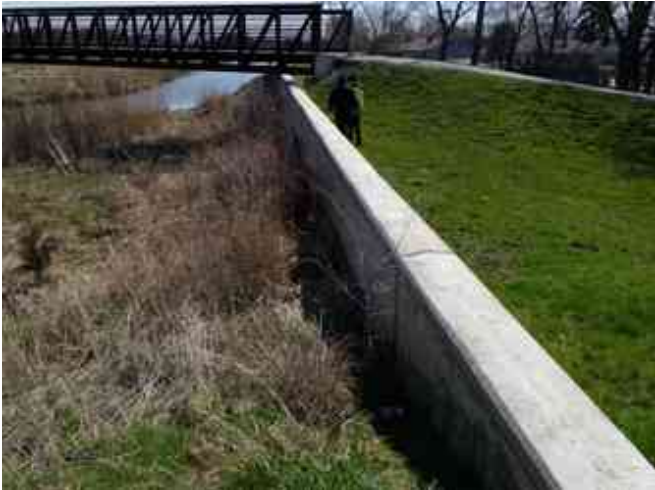
<p>Inspect ID: 2022-0163 Title: 2604000007_CELRC_2022_A_0163_1_20220414T151142.jpg Rated Item: 1. Unwanted Vegetation Growth Caption: Minimally Acceptable - Brush on riverside of floodwall.</p>

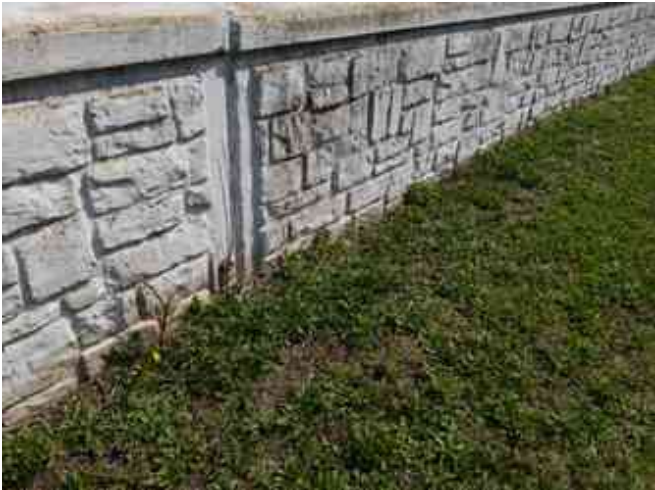
<p>Inspect ID: 2022-0172 Title: 2604000007_CELRC_2022_A_0172_1_20220414T152524.jpg Rated Item: 1. Unwanted Vegetation Growth Caption: Minimally Acceptable - Small tree on landside of floodwall.</p>

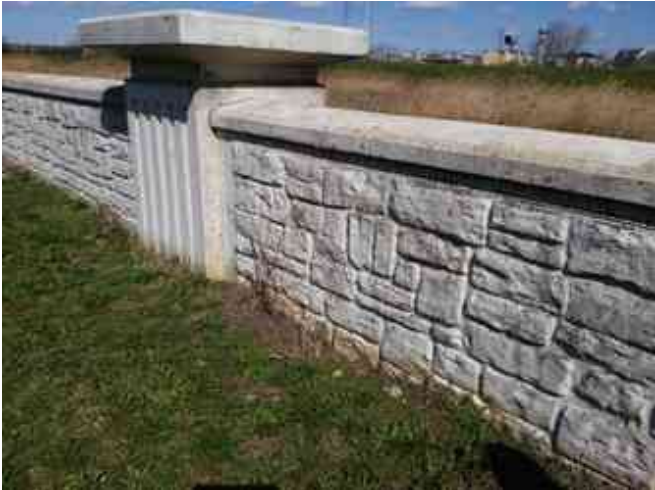
<p>Inspect ID: 2022-0178 Title: 2604000007_CELRC_2022_A_0178_1_20220414T152804.jpg Rated Item: 1. Unwanted Vegetation Growth Caption: Minimally Acceptable - Small tree on landside of floodwall.</p>

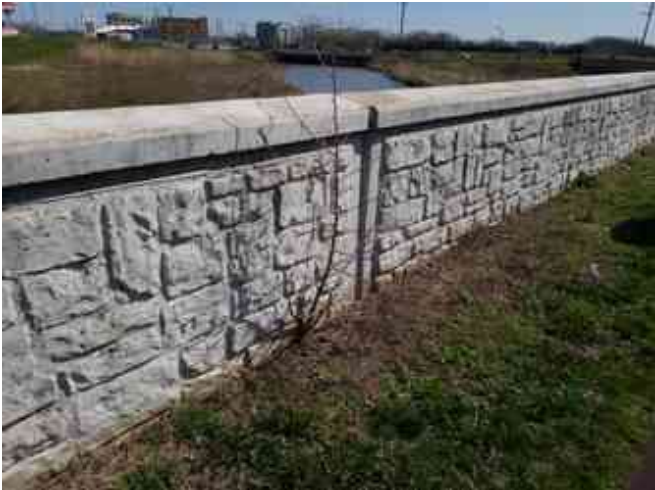
<p>Inspect ID: 2022-0181 Title: 2604000007_CELRC_2022_A_0181_1_20220414T152844.jpg Rated Item: 1. Unwanted Vegetation Growth Caption: Minimally Acceptable - Small tree on landside of floodwall.</p>

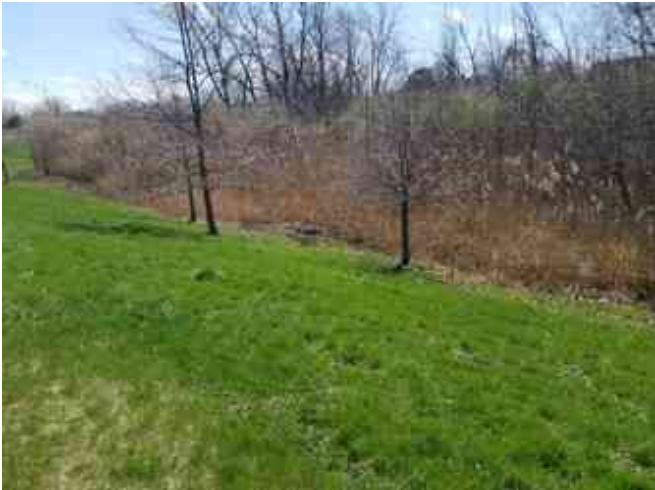
<p>Inspect ID: 2022-0355 Title: 2604000007_CELRC_2022_A_0355_1_20220414T175720.jpg Rated Item: 1. Unwanted Vegetation Growth Caption: Minimally Acceptable - Brush at landside toe of floodwall area.</p>

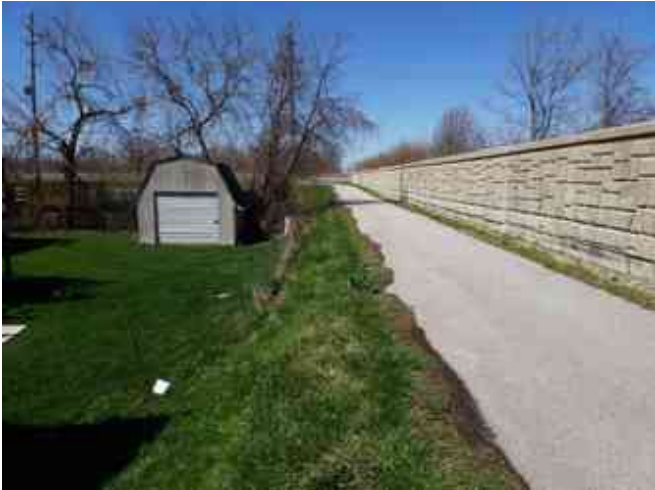
<p>Inspect ID: 2022-0241 Title: 2604000007_CELRC_2022_A_0241_1_20220414T162954.jpg</p> <p>Rated Item: 2. Encroachments Caption: Minimally Acceptable - Fence and debris on berm.</p>

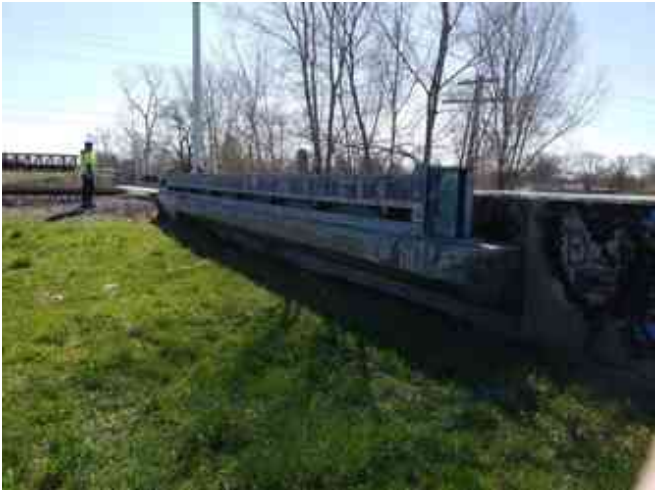
<p>Inspect ID: 2022-0142 Title: 2604000007_CELRC_2022_A_0142_1_20220414T150031.jpg</p> <p>Rated Item: 3. Closure Structures (Stop Log Closures and Gates) (A or U only) Caption: Acceptable - Graffiti on slide gate.</p>

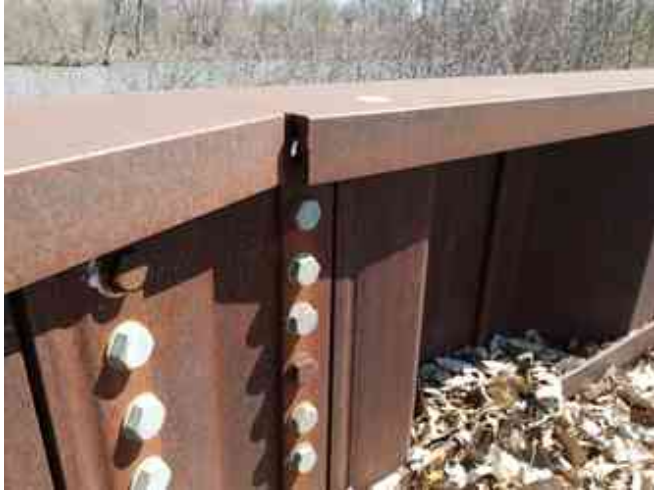
Inspect ID: 2022-0217 **Title:**
2604000007_CELRC_2022_A_0217_1_20220414T160232.jpg
Rated Item: 4. Concrete Surfaces **Caption:** Minimally
Acceptable - Missing bolt on sheetpile under cap.

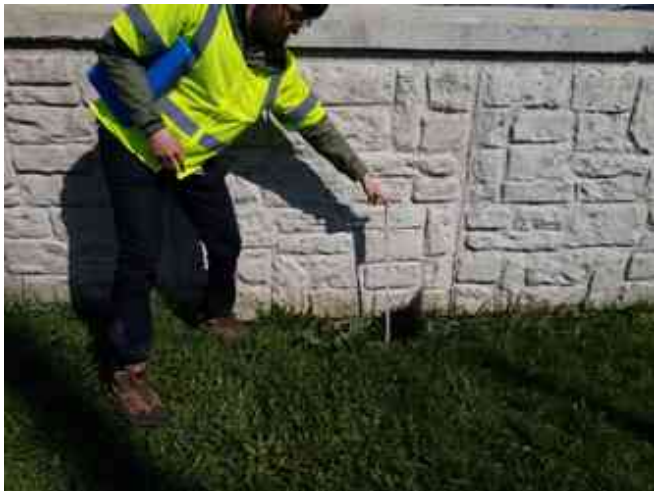
6. Foundation of Concrete Structures	M	A	No active erosion, scouring, or bank caving that might endanger the structure's stability.	2022-0184 : 6 inch depression next to landside wall. (M) Recommendation: Add fill to depressions next to landside wall.
		M	There are areas where the ground is eroding towards the base of the structure. Efforts need to be taken to slow and repair this erosion, but it is not judged to be close enough to the structure or to be progressing rapidly enough to affect structural stability before the next inspection. For the purposes of inspection, the erosion or scour is not closer to the riverside face of the wall than twice the floodwall's underground base width if the wall is of L-wall or T-wall construction; or if the wall is of sheetpile or I-wall construction, the erosion is not closer than twice the wall's visible height. Additionally, rate of erosion is such that the wall is expected to remain stable until the next inspection.

Inspect ID: 2022-0184 **Title:**
2604000007_CELRC_2022_A_0184_1_20220414T153135.jpg
Rated Item: 6. Foundation of Concrete Structures **Caption:**
Minimally Acceptable - 6 inch depression next to landside
wall.

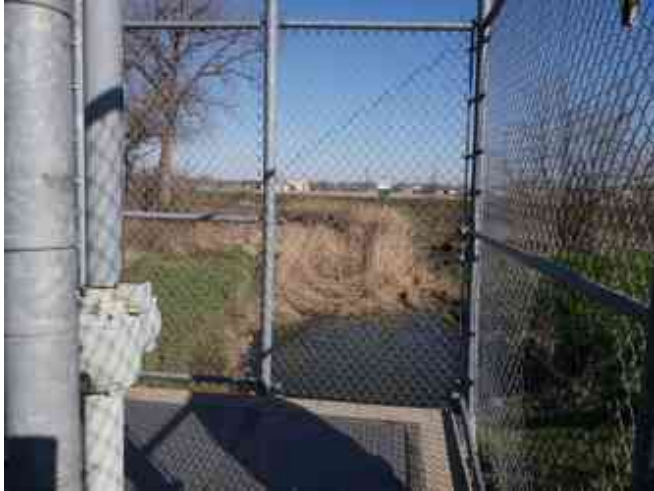
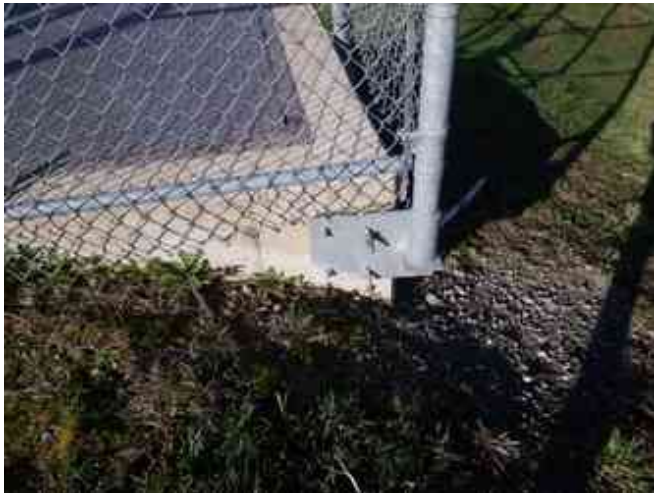
Rated Item: 4. Fencing and Gates **Caption:** Minimally Acceptable - HI-4: Fence and gate missing mid are and bottom bar on north side of fence. East side of fence not connected. Bolts not secured on bottom north east side of concrete.

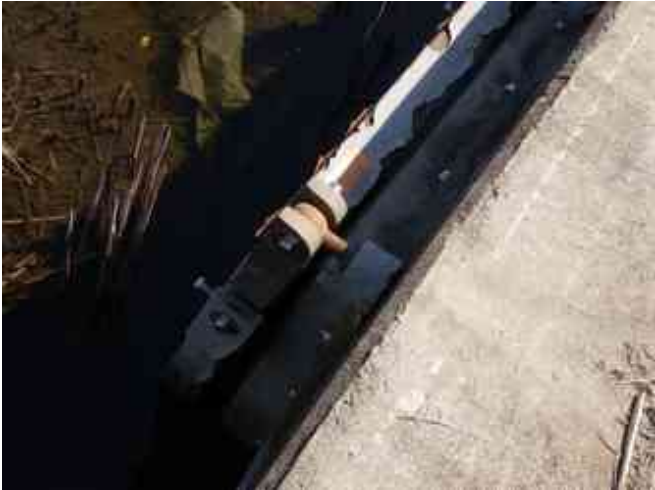
<p>Inspect ID: 2022-0041 Title: 2604000007_CELRC_2022_A_0041_3_20220414T152559.jpg Rated Item: 10. Sluice/ Slide Gates Caption: Minimally Acceptable - HI-10: outlet gate C stuck open. Wildlife appears to be burrowing in gates. Sluice gates all look clean and in proper condition.</p>

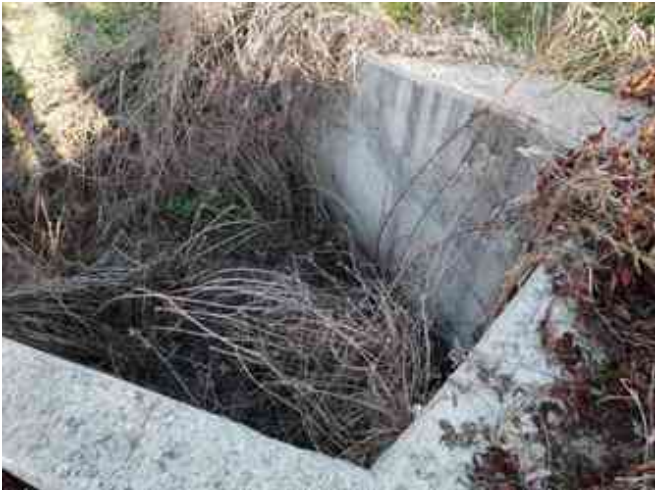
<p>Inspect ID: 2022-0007 Title: 2604000007_CELRC_2022_A_0007_1_20220414T132002.jpg Rated Item: 11. Flap Gates/ Flap Valves/ Pinch Valves Caption: Minimally Acceptable - HI-1: Debris on the check valve.</p>

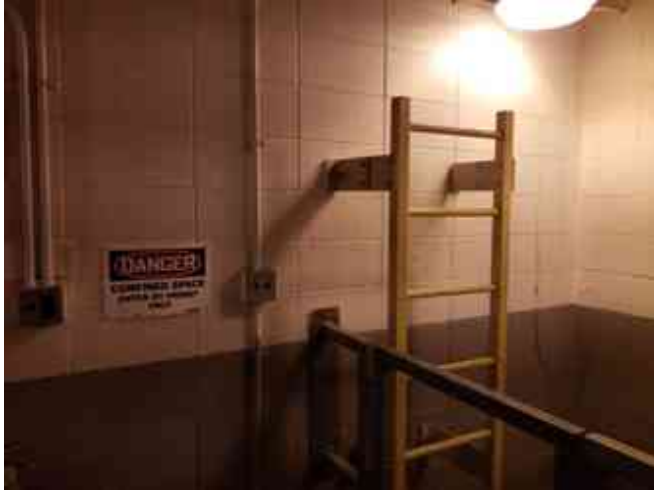
Inspect ID: 2022-0021 **Title:**
2604000007_CELRC_2022_A_0021_1_20220414T133046.jpg
Rated Item: 3. Safety Compliance **Caption:** Acceptable - PS-81: Confined space labels added.

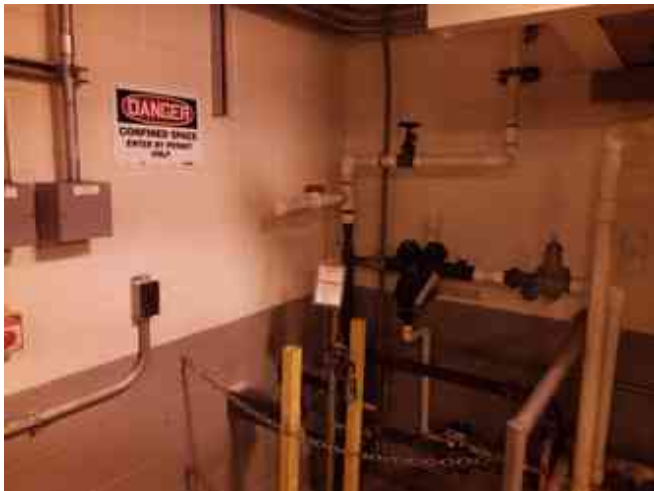
Inspect ID: 2022-0066 **Title:**
2604000007_CELRC_2022_A_0066_1_20220414T140637.jpg
Rated Item: 3. Safety Compliance **Caption:** Acceptable - PS-N5: Confined space labels added throughout building.

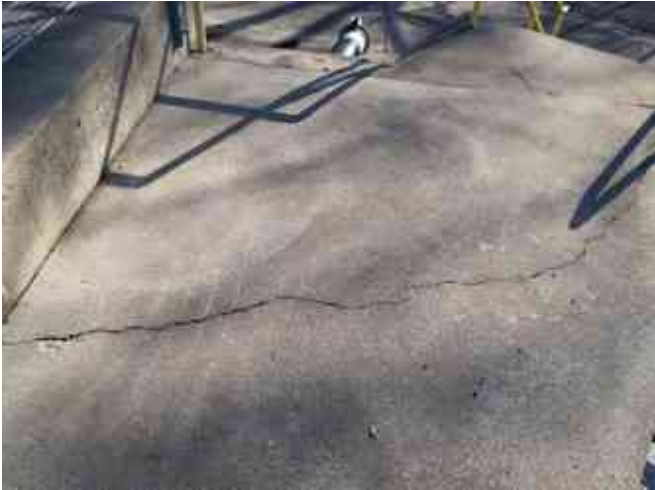
<p>Inspect ID: 2022-0030 Title: 2604000007_CELRC_2022_A_0030_1_20220414T133732.jpg Rated Item: 5. Plant Building Caption: Minimally Acceptable - PS-81: Minor cracking on sidewalk.</p>

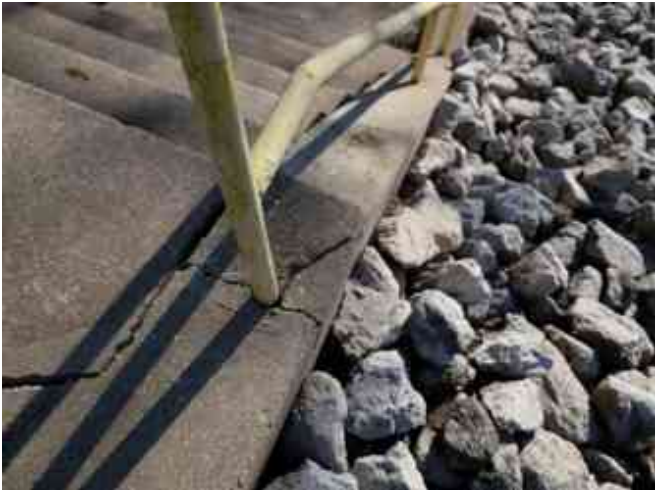
<p>Inspect ID: 2022-0033 Title: 2604000007_CELRC_2022_A_0033_1_20220414T133814.jpg Rated Item: 5. Plant Building Caption: Minimally Acceptable - PS-81: Cracking near stairwell</p>

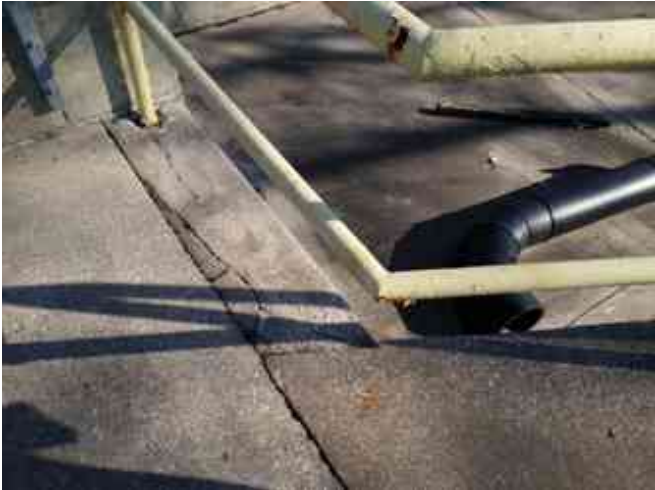
A photograph showing a concrete surface with a prominent crack running diagonally. A yellow guardrail is visible in the upper right, and a black pipe or hose lies on the ground near the crack.	<p>Inspect ID: 2022-0036 Title: 2604000007_CELRC_2022_A_0036_1_20220414T133851.jpg Rated Item: 5. Plant Building Caption: Minimally Acceptable - PS-81: Cracking near guardrail.</p>

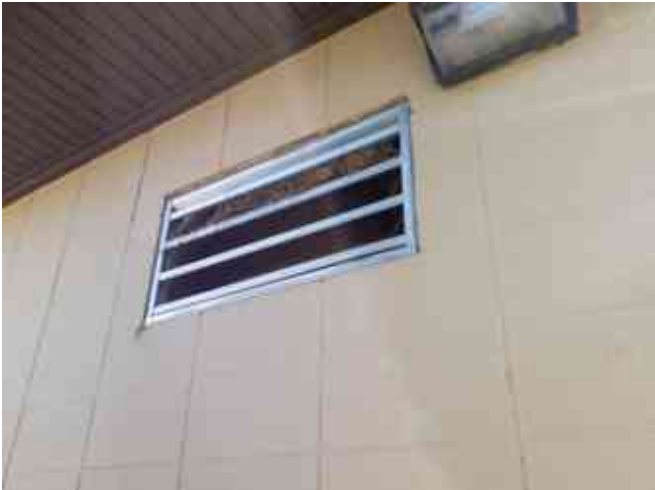
A photograph of a rectangular ventilation louver on a light-colored wall. A dark, cup-shaped bird's nest is visible inside the louver.	<p>Inspect ID: 2022-0045 Title: 2604000007_CELRC_2022_A_0045_1_20220414T134220.jpg Rated Item: 5. Plant Building Caption: Minimally Acceptable - PS-81: Bird nest in ventilation louvers. Monitor for building and remove if necessary.</p>

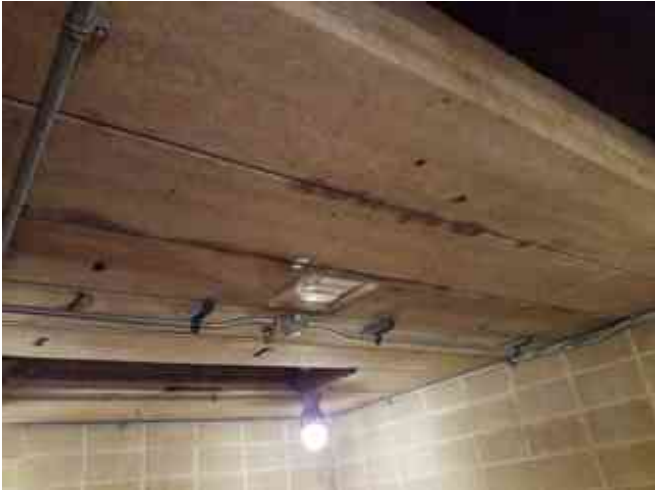
<p>Inspect ID: 2022-0075 Title: 2604000007_CELRC_2022_A_0075_1_20220414T141159.jpg Rated Item: 5. Plant Building Caption: Minimally Acceptable - PS-N5: Active water leak in roof.</p>

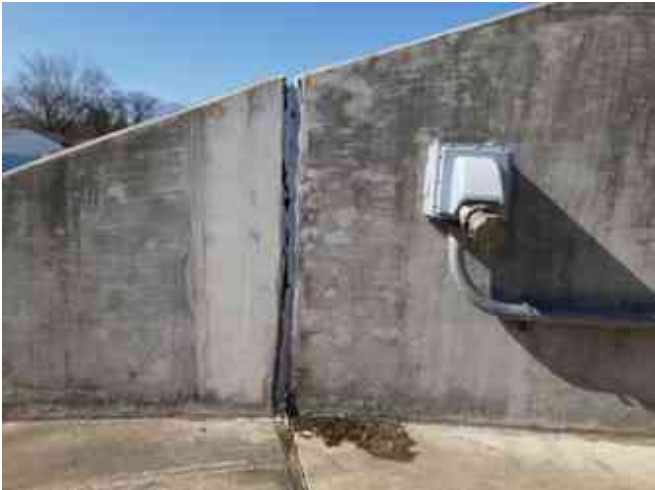
<p>Inspect ID: 2022-0090 Title: 2604000007_CELRC_2022_A_0090_1_20220414T143719.jpg Rated Item: 5. Plant Building Caption: Minimally Acceptable - PS-ND: Weather seal and expansion joint missing on south side. 4 inch crack on top. Install survey points to monitor abutment movement.</p>

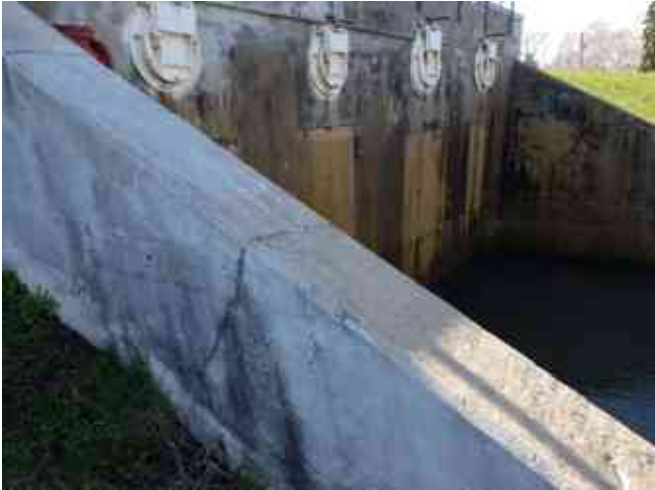
<p>Inspect ID: 2022-0099 Title: 2604000007_CELRC_2022_A_0099_1_20220414T144650.jpg Rated Item: 5. Plant Building Caption: Minimally Acceptable - PS-ND: Large thin crack through North wing wall.</p>
 	<p>Inspect ID: 2022-0099 Title: 2604000007_CELRC_2022_A_0099_2_20220414T144711.jpg Rated Item: 5. Plant Building Caption: Minimally Acceptable - PS-ND: Large thin crack through North wing wall.</p>

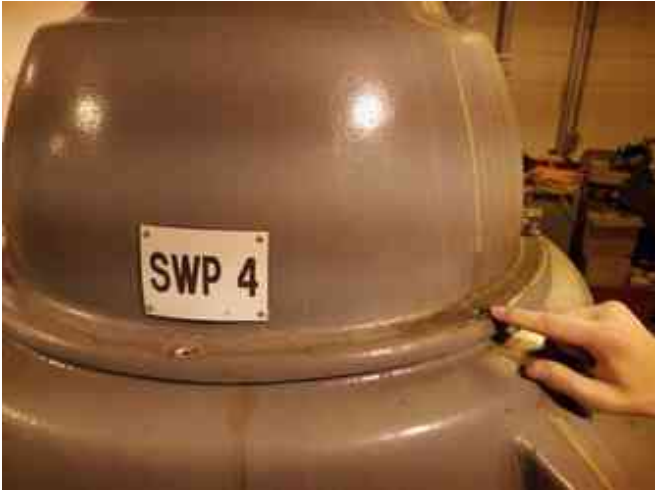
<p>Inspect ID: 2022-0063 Title: 2604000007_CELRC_2022_A_0063_1_20220414T140457.jpg Rated Item: 7. Pumps Caption: Minimally Acceptable - PS-N5: Missing bolts on top of pump SWP-4, with some evidence of leakage on at those points . Picture of SWP-5 for comparison</p>

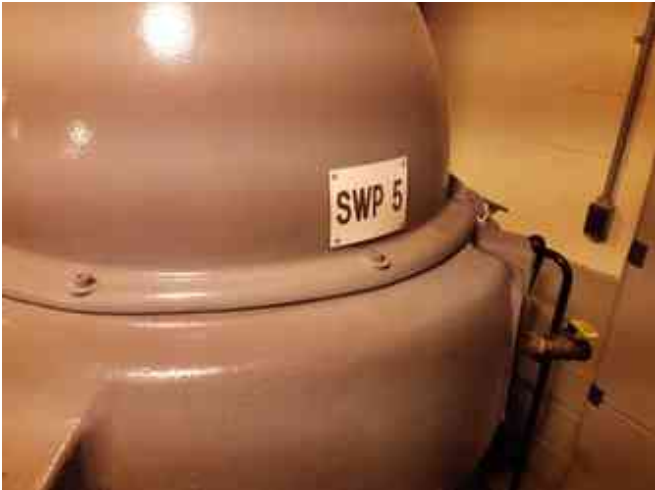
<p>Inspect ID: 2022-0063 Title: 2604000007_CELRC_2022_A_0063_2_20220414T140522.jpg Rated Item: 7. Pumps Caption: Minimally Acceptable - PS-N5: Missing bolts on top of pump SWP-4, with some evidence of leakage on at those points . Picture of SWP-5 for comparison</p>

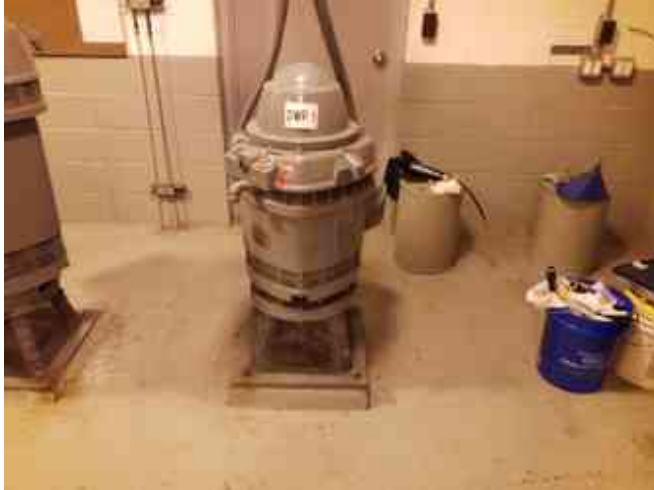
Caption: Minimally Acceptable - PS-N5: Pump DWP-1 out of service, staff reported evidence of cavitation on impeller. Pump is out for repairs and will be rebuilt.

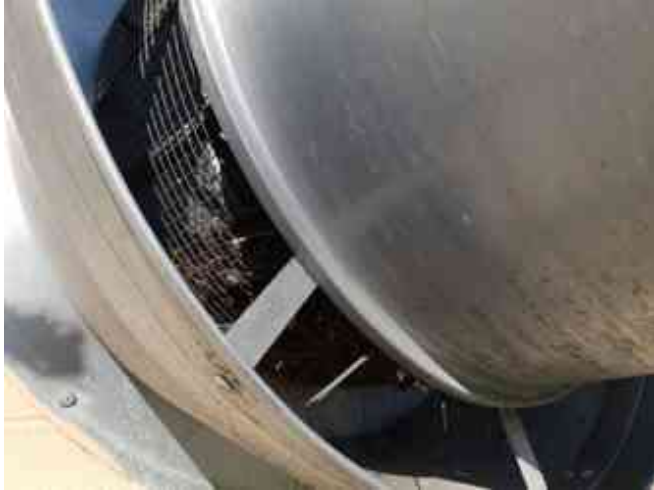
Inspect ID: 2022-0015 **Title:** 2604000007_CELRC_2022_A_0015_2_20220414T132730.jpg
Rated Item: 8. Motors, Engines, Fans, Gear Reducers, Back Stop Devices, etc. **Caption:** Minimally Acceptable - PS-81: Birds nesting in exhaust fan cowling. Inspect and remove if necessary.

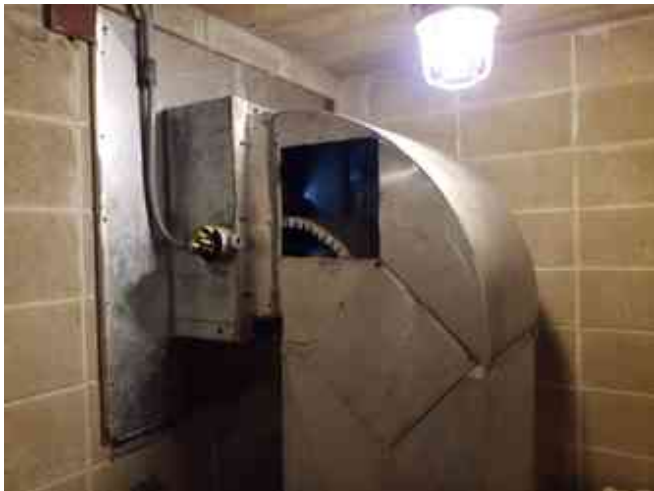
Inspect ID: 2022-0078 **Title:** 2604000007_CELRC_2022_A_0078_1_20220414T141413.jpg
Rated Item: 8. Motors, Engines, Fans, Gear Reducers, Back Stop Devices, etc. **Caption:** Minimally Acceptable - PS-N5: EF3 exhaust fan is inoperable, local sponsor is aware and planning for replacement.

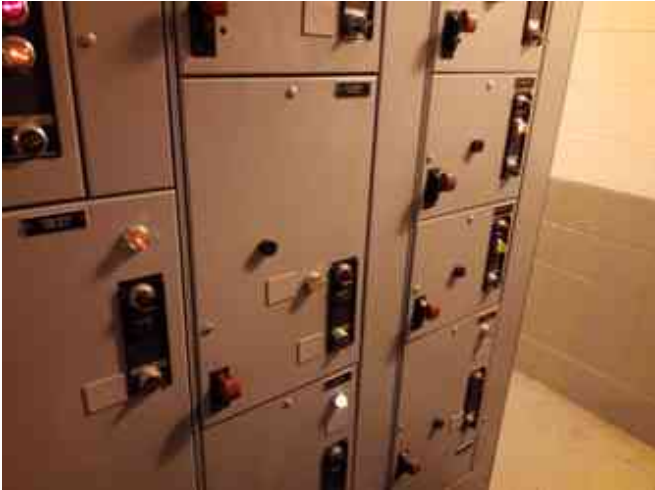
<p>Inspect ID: 2022-0039 Title: 2604000007_CELRC_2022_A_0039_1_20220414T134000.jpg Rated Item: 14. Electrical Systems Caption: Acceptable - PS-81: Contactor fixed for pump.</p>

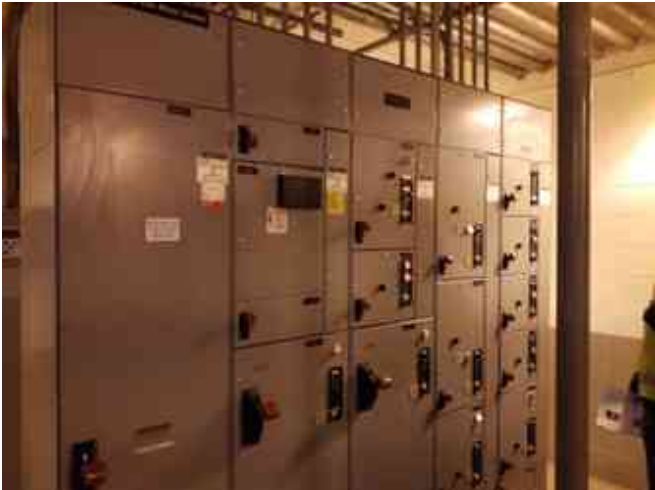
<p>Inspect ID: 2022-0042 Title: 2604000007_CELRC_2022_A_0042_1_20220414T134054.jpg Rated Item: 14. Electrical Systems Caption: Minimally Acceptable - PS-81: Arc flash warnings needed.</p>

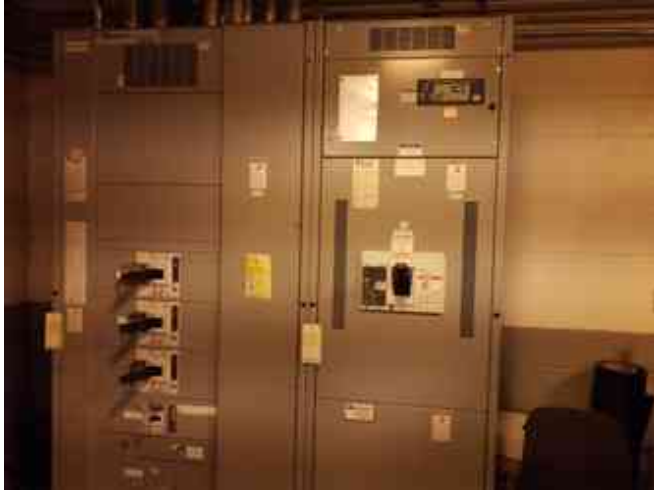
Inspect ID: 2022-0081 **Title:**
2604000007_CELRC_2022_A_0081_1_20220414T141535.jpg
Rated Item: 14. Electrical Systems **Caption:** Minimally
Acceptable - PS-N5: Arc flash labels missing on switchboard.

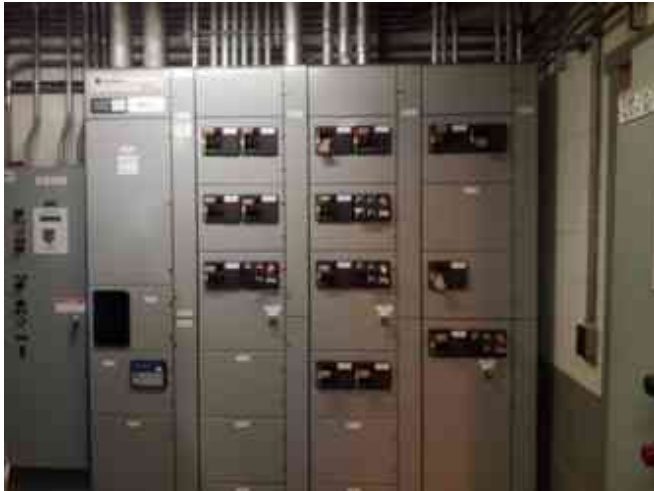
Inspect ID: 2022-0084 **Title:**
2604000007_CELRC_2022_A_0084_1_20220414T141706.jpg
Rated Item: 14. Electrical Systems **Caption:** Minimally
Acceptable - PS-N5: Arc flash labels missing on all 3 MCCs.

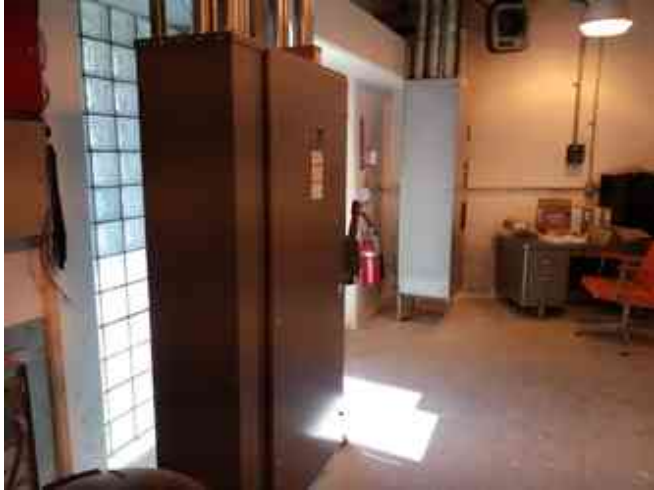
Inspect ID: 2022-0102 **Title:**
2604000007_CELRC_2022_A_0102_1_20220414T144947.jpg
Rated Item: 14. Electrical Systems **Caption:** Acceptable - PS-ND: New electrical safety disconnect switch installed in early 2022.

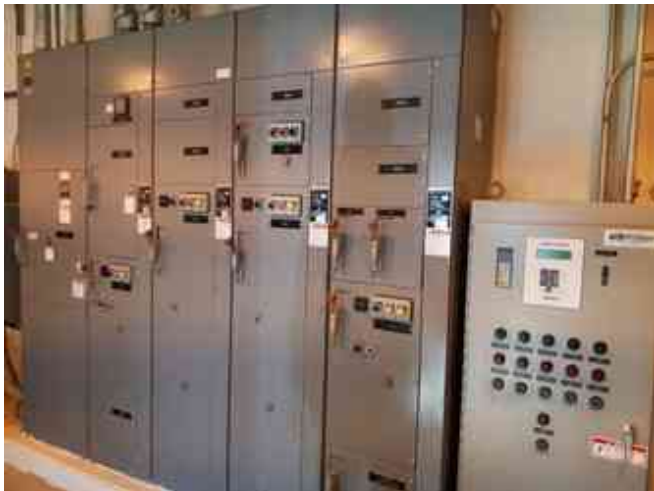
Inspect ID: 2022-0105 **Title:**
2604000007_CELRC_2022_A_0105_1_20220414T145301.jpg
Rated Item: 14. Electrical Systems **Caption:** Minimally Acceptable - PS-ND: Electrical arc flash labels need updating. Install new arc flash labels.

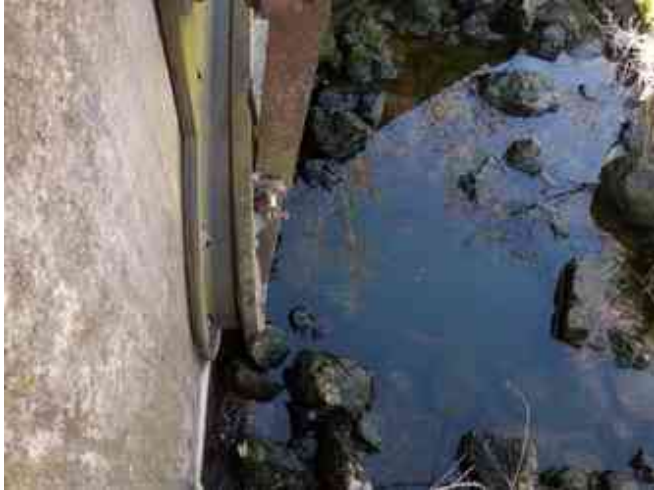
Inspect ID: 2022-0051 **Title:**
2604000007_CELRC_2022_A_0051_1_20220414T134616.jpg
Rated Item: 19. Flap Gates/ Flap Valves/ Pinch Valves
Caption: Minimally Acceptable - PS-81: Flap gate slightly ajar, and unlikely to seal in a flood.
