Levee Inspection Report

Name of System: Gary
Name of Segment: INDOT
NLD System ID: 2605000003 NLD Segment ID: 2604000015

Segment Type: Locally Constructed, Locally Operated and Maintained
Levee Sponsor (Name and Organization): Little Calumet River Basin Development Commission, INDOT
Inspection Report Prepared by: Chris Schaal Date(s) of Inspection: 06/06/2022 - 06/07/2022

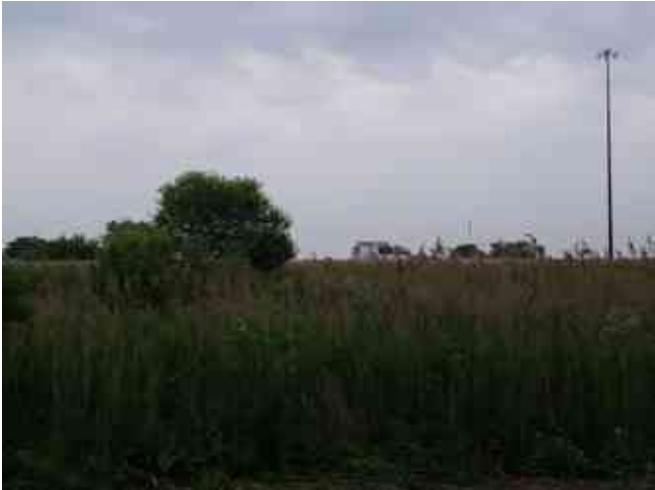
<p>Inspect ID: 2022-0017 Title: 2604000015_CELRC_2022_A_0017_1_20220606T143007.jpg Rated Item: 1. Unwanted Vegetation Growth Caption: Minimally Acceptable - Trees along riverside slope.</p>

M	Minimal vegetation growth (brush, weeds, or trees 2 inches in diameter or smaller) is present within the zones described above. This vegetation must be removed but does not currently threaten the operation or integrity of the levee.	
		U	Significant vegetation growth (brush, weeds, or any trees greater than 2 inches in diameter) is present within the zones described above and must to be removed to reestablish or ascertain levee integrity.	Recommendation: Mow tall vegetation on the slopes and cut down large trees.

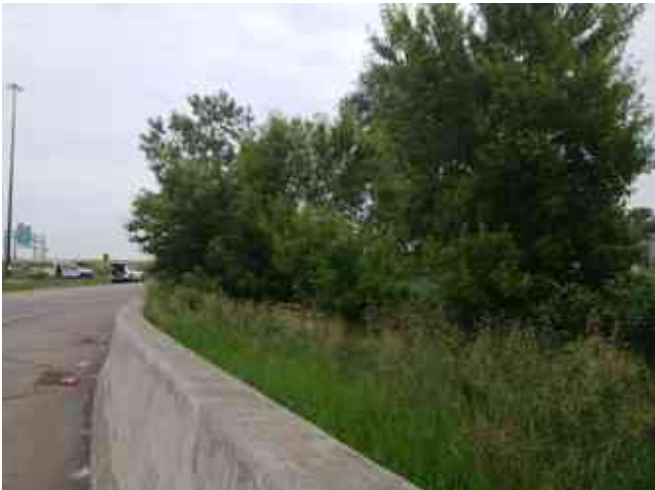
<p>Inspect ID: 2022-0019 Title: 2604000015_CELRC_2022_A_0019_1_20220606T144106.jpg Rated Item: 1. Unwanted Vegetation Growth Caption: Unacceptable - Large trees and tall vegetation on riverside slope.</p>

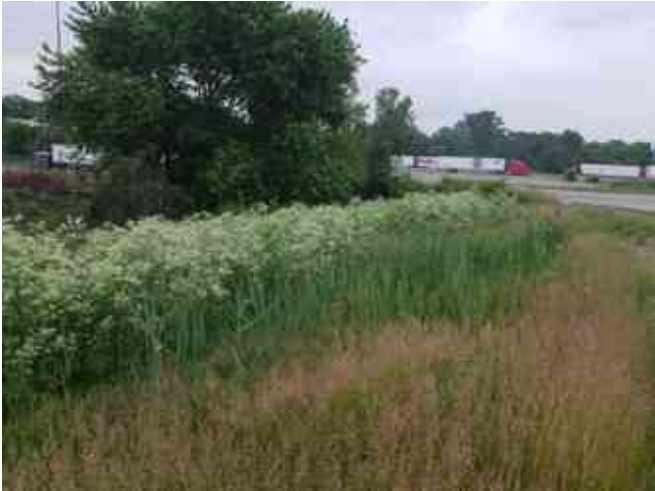
<p>Inspect ID: 2022-0023 Title: 2604000015_CELRC_2022_A_0023_1_20220606T144816.jpg Rated Item: 1. Unwanted Vegetation Growth Caption: Minimally Acceptable - Tall vegetation on riverside slope.</p>

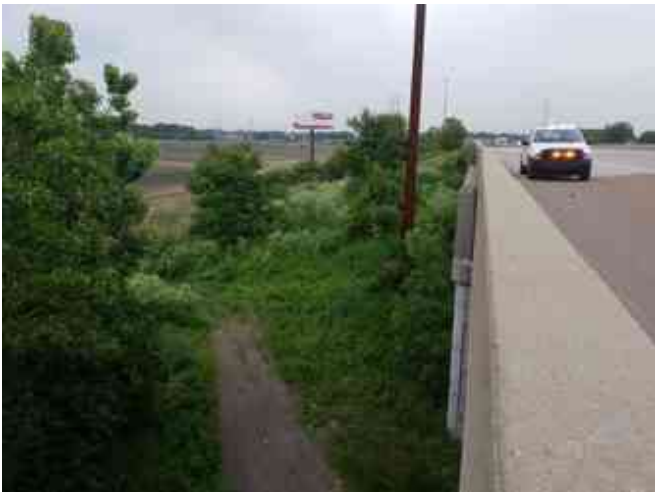
<p>Inspect ID: 2022-0029 Title: 2604000015_CELRC_2022_A_0029_1_20220606T150114.jpg Rated Item: 1. Unwanted Vegetation Growth Caption: Unacceptable - Large trees on riverside slope.</p>

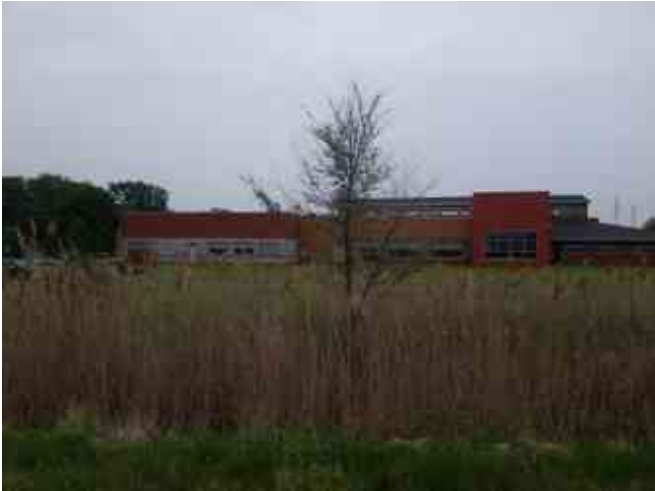
Rated Item	Rating	Rating Guidelines		Location/Remarks/Recommendations
1. Unwanted Vegetation Growth	U	A	The levee has little or no unwanted vegetation (trees, bush, or undesirable weeds), except for vegetation that is properly contained and/or situated on overbuilt sections, such that the mandatory 3-foot root-free zone is preserved around the levee profile. The levee has been recently mowed. The vegetation-free zone extends 15 feet from both the landside and riverside toes of the levee to the centerline of the tree. If the levee access easement doesn't extend to the described limits, then the vegetation-free zone must be maintained to the easement limits. Reference EM 1110-2-301 or Corps policy for regional vegetation variance.	2022-0017 : Trees along riverside slope. (M) 2022-0019 : Large trees and tall vegetation on riverside slope. (U) 2022-0023 : Tall vegetation on riverside slope. (M) 2022-0029 : Large trees on riverside slope. (U) 2022-0031 : Large trees on riverside slope. (U) 2022-0037 : Large tree on riverside slope. (U) 2022-0039 : Large trees on riverside. (U) 2022-0041 : Tall vegetation on riverside slope. (M) 2022-0043 : Tree on riverside. (M) 2022-0045 : Trees on riverside. (M)

<p>Inspect ID: 2022-0043 Title: 2604000015_CELRC_2022_A_0043_1_20220606T152255.jpg Rated Item: 1. Unwanted Vegetation Growth Caption: Minimally Acceptable - Tree on riverside.</p>
 	<p>Inspect ID: 2022-0045 Title: 2604000015_CELRC_2022_A_0045_1_20220606T152415.jpg Rated Item: 1. Unwanted Vegetation Growth Caption: Minimally Acceptable - Trees on riverside.</p>

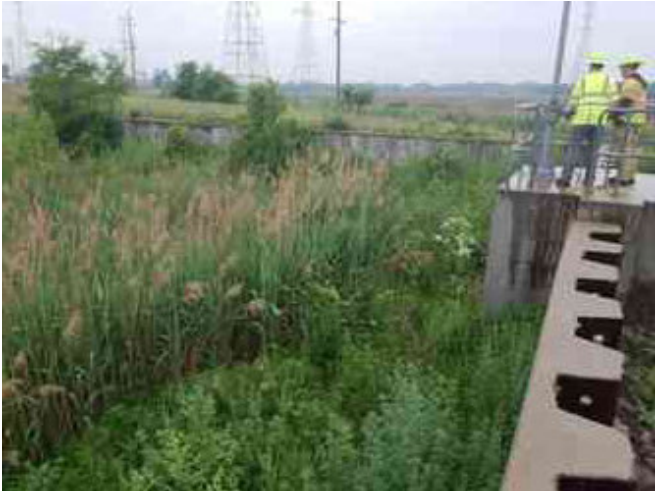
U	Obstructions, vegetation, debris, or sediment have impaired the channel flow capacity or blocked more than 10% of a culvert opening. Sediment and debris removal required to reestablish flow capacity.	2022-0038 : 906: Outlet needs vegetation cleared. (M) Recommendation: Remove vegetation and clean out silt and debris.

<p>Inspect ID: 2022-0038 Title: 2604000015_CELRC_2022_A_0038_1_20220606T155034.jpg Rated Item: 1. Vegetation and Obstructions Caption: Minimally Acceptable - 906 Outlet needs vegetation cleared</p>

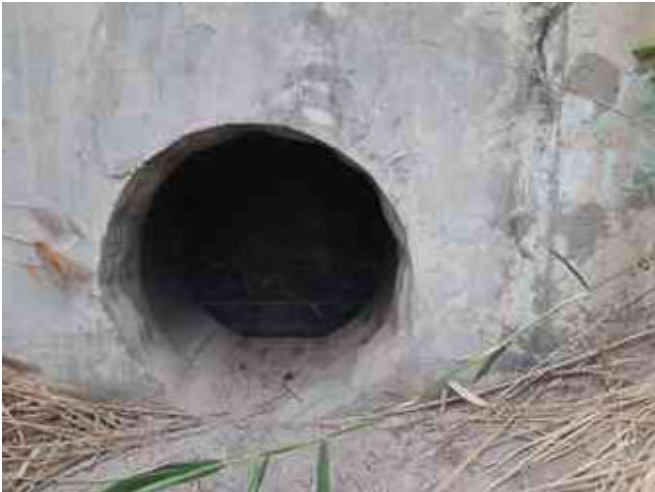
<p>Inspect ID: 2022-0008 Title: 2604000015_CELRC_2022_A_0008_1_20220606T141109.jpg Rated Item: 10. Sluice/ Slide Gates Caption: Acceptable - 903: Closed completely.</p>

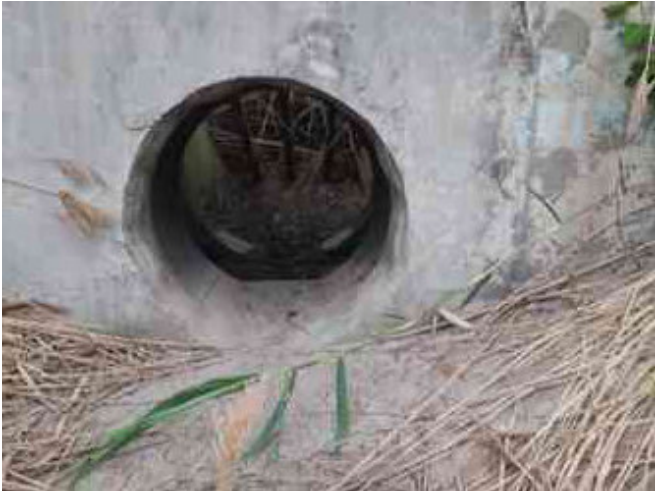
<p>Inspect ID: 2022-0010 Title: 2604000015_CELRC_2022_A_0010_1_20220606T141256.jpg Rated Item: 10. Sluice/ Slide Gates Caption: Acceptable - 903: Opened completely.</p>

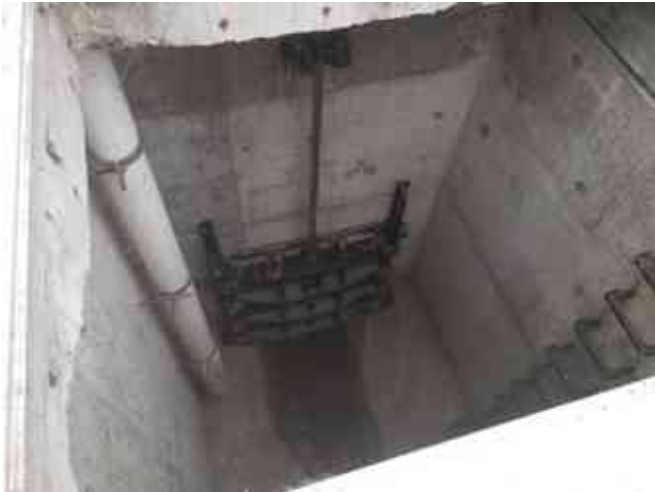
<p>Inspect ID: 2022-0016 Title: 2604000015_CELRC_2022_A_0016_1_20220606T143955.jpg Rated Item: 10. Sluice/ Slide Gates Caption: Acceptable - 910: Gate closed completely and no sediment.</p>

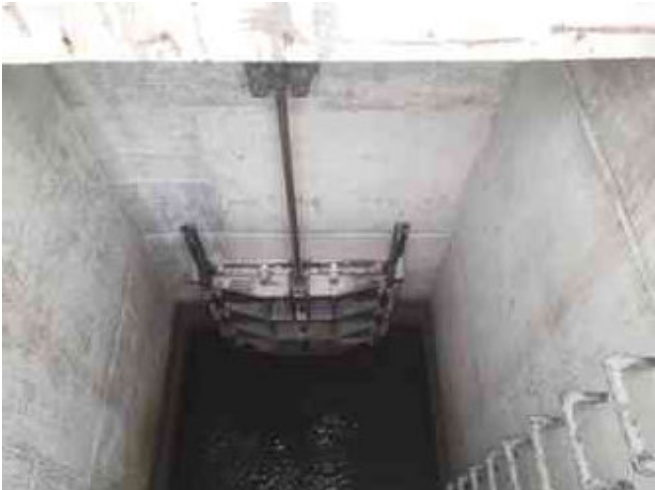
<p>Inspect ID: 2022-0026 Title: 2604000015_CELRC_2022_A_0026_1_20220606T152524.jpg Rated Item: 10. Sluice/ Slide Gates Caption: Acceptable - 901: Gate closed completely. All gates were recently greased.</p>

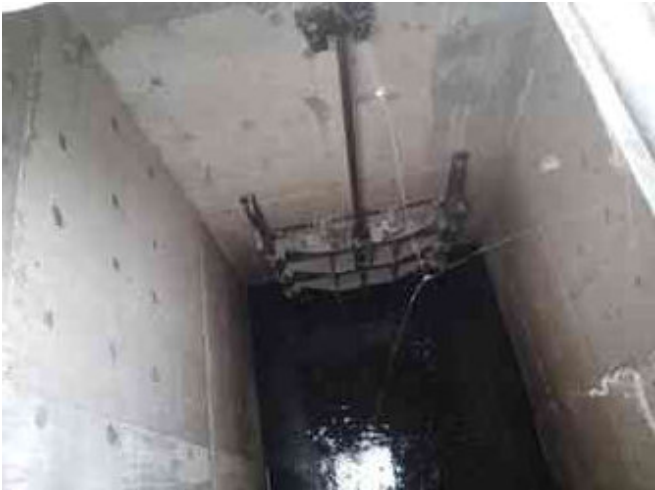
<p>Inspect ID: 2022-0042 Title: 2604000015_CELRC_2022_A_0042_1_20220606T155312.jpg Rated Item: 10. Sluice/ Slide Gates Caption: Acceptable - 906: Gate closed completely.</p>

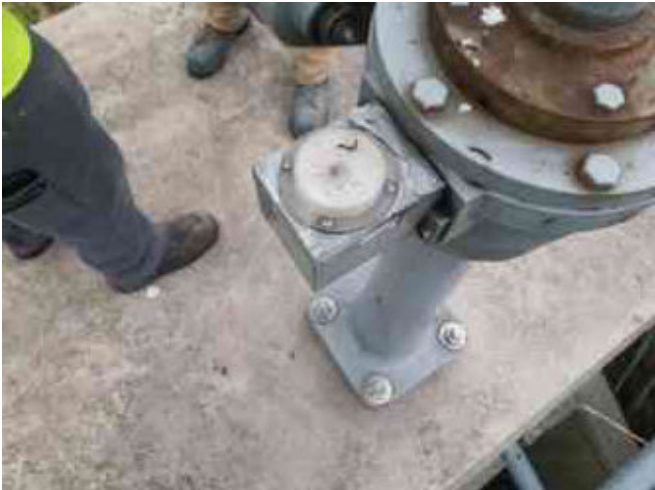
13. Other Metallic Items	M	A	All metal parts are protected from corrosion damage and show no rust, damage, or deterioration that would cause a safety concern.	2022-0006 : 903: Open and close dial not visible. (M) 2022-0014 : 910: Gauge is not working. (M) 2022-0024 : 901: Gauge not functional. (M) 2022-0032 : 908: Gauge not functional. (M) 2022-0046 : 906: Gauge not functional. (M) Recommendation: Replace gauges.
		M	Corrosion seen on metallic parts appears to be maintainable.	
		U	Metallic parts are severely corroded and require replacement to prevent failure, equipment damage, or safety issues.	
		N/A	There are no other significant metallic items.

<p>Inspect ID: 2022-0006 Title: 2604000015_CELRC_2022_A_0006_1_20220606T134036.jpg Rated Item: 13. Other Metallic Items Caption: Minimally Acceptable - 903: Open and close dial not visible.</p>
