DEPARTMENT OF THE ARMY
CORPS OF ENGINEERS, CHICAGO DISTRICT
231 SOUTH LA SALLE STREET, SUITE 1500
CHICAGO IL 60604

May 11, 2022

The Chicago District performed an inspection of the Munster Levee on April 11, 2022. The purpose of the U.S. Army Corps of Engineers (Corps) Levee Safety Program is to make sure levee systems are reliable and do not present unacceptable risks to the public, property, or the environment, with the emphasis on public safety. Two important principles that guide our program are the shared responsibility among partners at all levels for levee safety and the need for continuous and periodic project inspections and assessments. More information about the Levee Safety Program can be found in EC 1165-2-218.

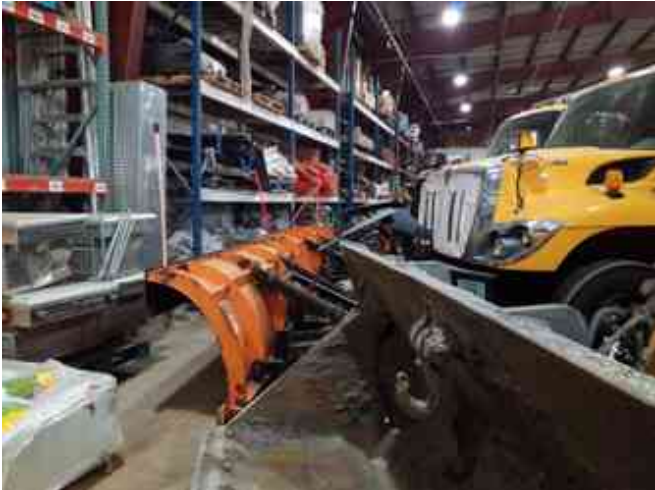
<p>Inspect ID: 2022-0023 Title: 2604000009_CELRC_2022_A_0023_5_20220411T151849.jpg Rated Item: 2. Emergency Supplies and Equipment (A or M only) Caption: Acceptable - Equipment at the Public Works facility..</p>

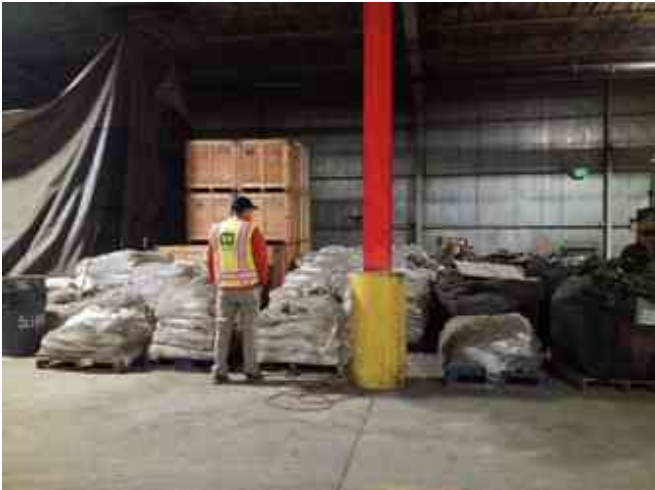
<p>Inspect ID: 2022-0026 Title: 2604000009_CELRC_2022_A_0026_1_20220411T153620.jpg Rated Item: 2. Emergency Supplies and Equipment (A or M only) Caption: Acceptable - 20 pallets of sandbags and 12 super bags at the Calumet facility.</p>

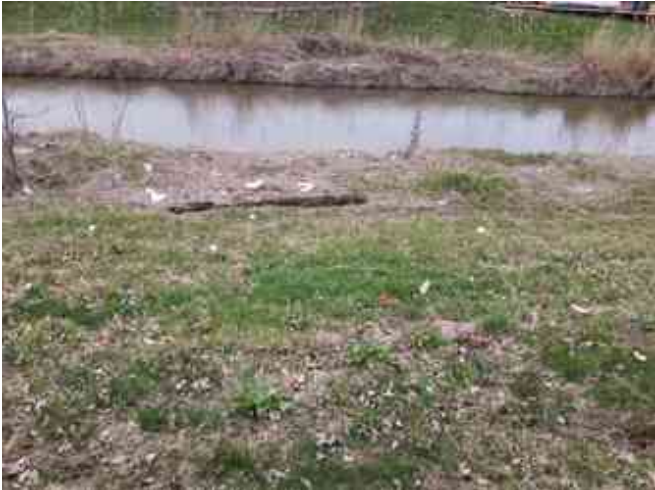
<p>Inspect ID: 2022-0047 Title: 2604000009_CELRC_2022_A_0047_1_20220411T163759.jpg Rated Item: 3. Encroachments Caption: Minimally Acceptable - Log on riverside toe.</p>

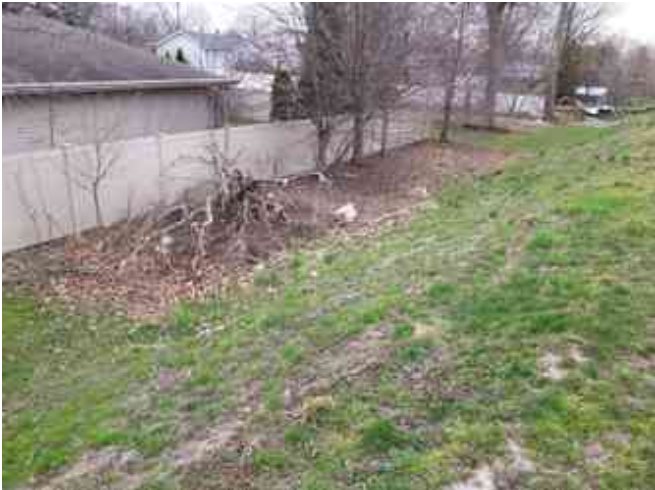
<p>Inspect ID: 2022-0050 Title: 2604000009_CELRC_2022_A_0050_1_20220411T163908.jpg Rated Item: 3. Encroachments Caption: Minimally Acceptable - Downed trees on landside toe.</p>

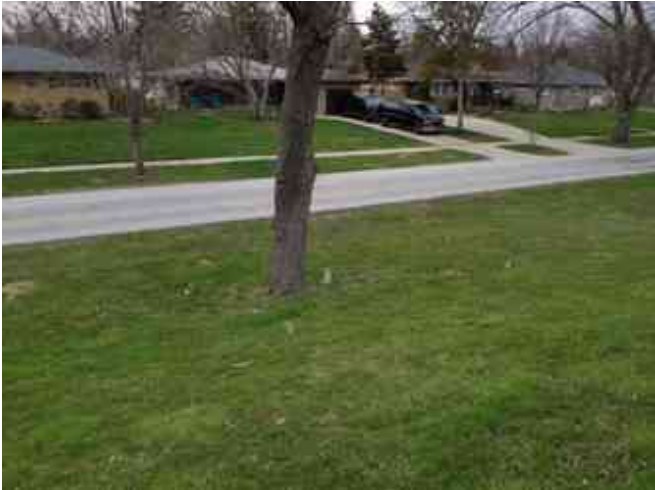
<p>Inspect ID: 2022-0082 Title: 2604000009_CELRC_2022_A_0082_1_20220411T141626.jpg Rated Item: 3. Encroachments Caption: Minimally Acceptable - Large tree within 6 feet of landside toe.</p>

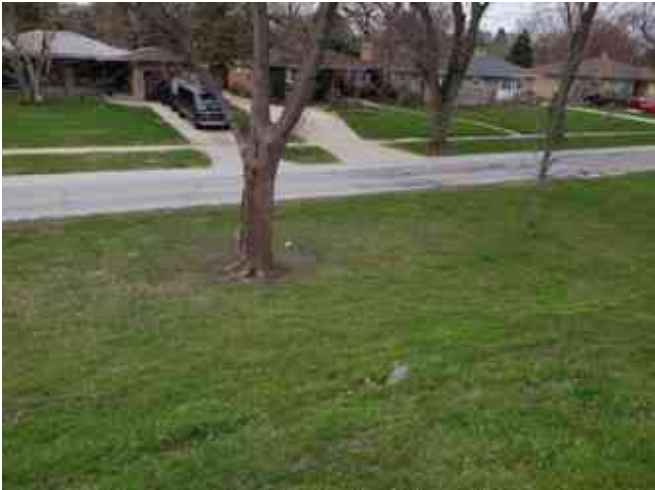
<p>Inspect ID: 2022-0085 Title: 2604000009_CELRC_2022_A_0085_1_20220411T141713.jpg Rated Item: 3. Encroachments Caption: Minimally Acceptable - Large tree within 6 feet of landside toe.</p>

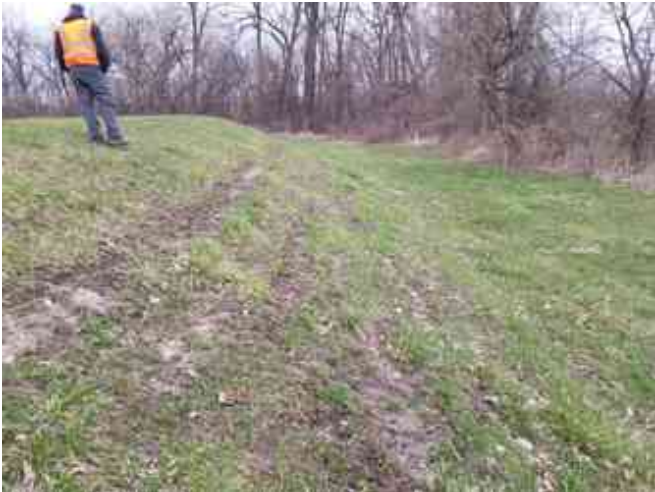
<p>Inspect ID: 2022-0070 Title: 2604000009_CELRC_2022_A_0070_1_20220411T140735.jpg Rated Item: 8. Depressions/ Rutting Caption: Minimally Acceptable - Rutting on riverside slope.</p>

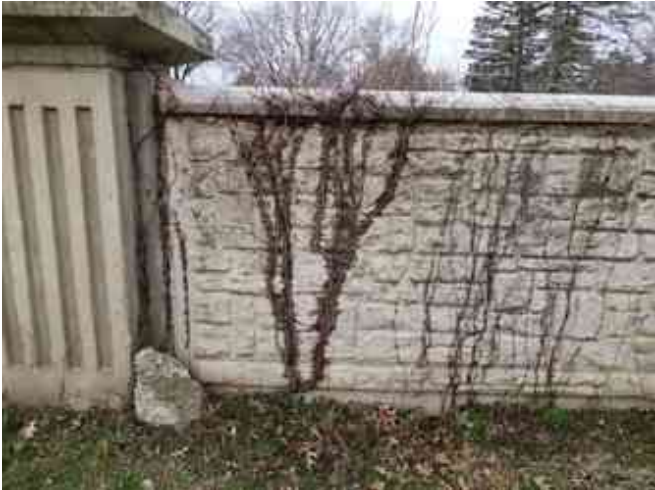
<p>Inspect ID: 2022-0052 Title: 2604000009_CELRC_2022_A_0052_1_20220411T135144.jpg Rated Item: 1. Unwanted Vegetation Growth Caption: Acceptable - Vines on riverside face.</p>

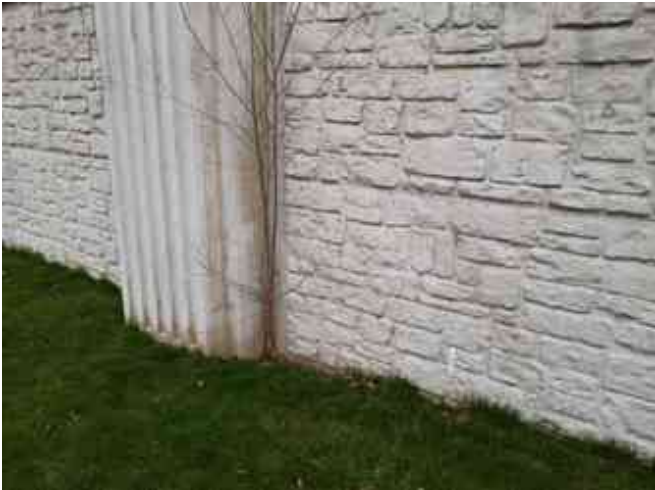
<p>Inspect ID: 2022-0091 Title: 2604000009_CELRC_2022_A_0091_1_20220411T142011.jpg Rated Item: 1. Unwanted Vegetation Growth Caption: Minimally Acceptable - Small tree against landside wall</p>

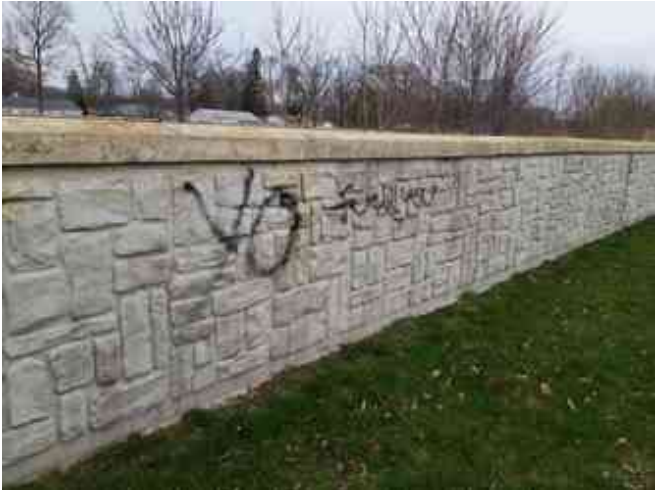
<p>Inspect ID: 2022-0160 Title: 2604000009_CELRC_2022_A_0160_1_20220411T150024.jpg Rated Item: 2. Encroachments Caption: Minimally Acceptable - Graffiti on landside wall.</p>

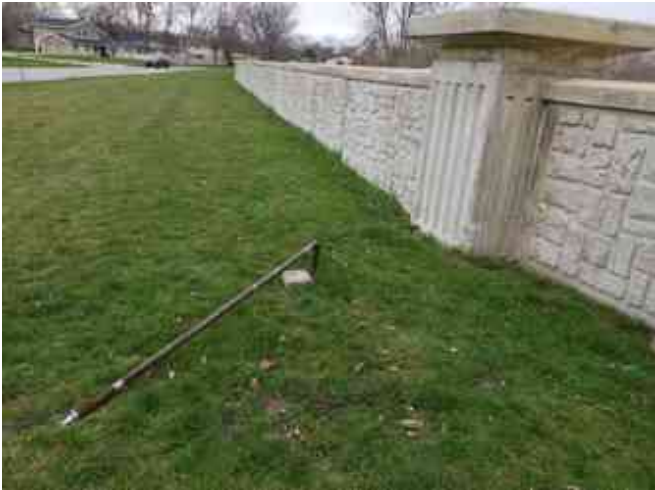
<p>Inspect ID: 2022-0163 Title: 2604000009_CELRC_2022_A_0163_1_20220411T150120.jpg Rated Item: 2. Encroachments Caption: Minimally Acceptable - Pipe on landside.</p>

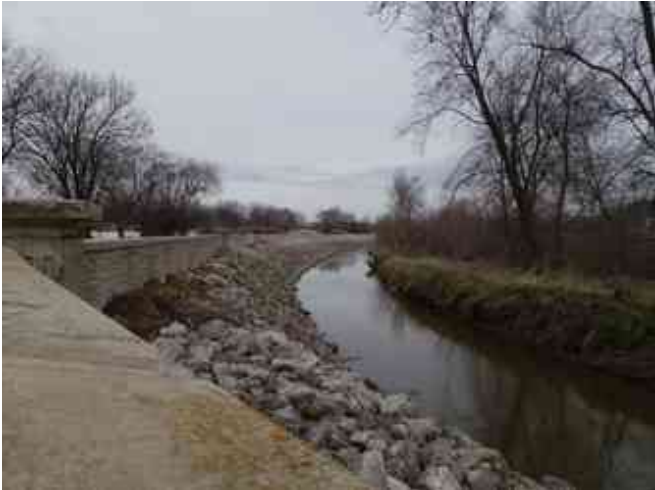
<p>Inspect ID: 2022-0166 Title: 2604000009_CELRC_2022_A_2022-0166_2_20220411T150715.jpg Rated Item: 2. Encroachments Caption: Minimally Acceptable - Garbage and yard waste on riverside.</p>

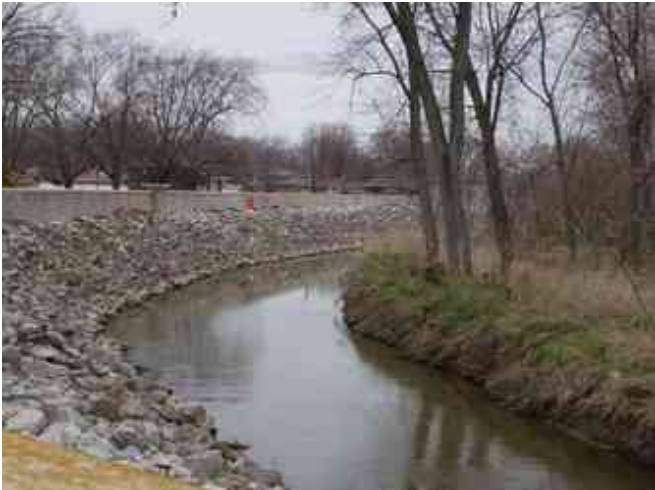
<p>Inspect ID: 2022-0169 Title: 2604000009_CELRC_2022_A_0169_1_20220411T150516.jpg Rated Item: 2. Encroachments Caption: Minimally Acceptable - Graffiti on riverside.</p>

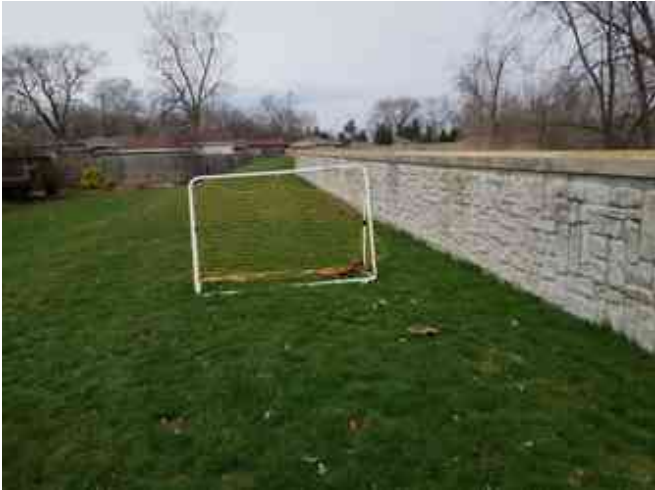
<p>Inspect ID: 2022-0187 Title: 2604000009_CELRC_2022_A_0187_1_20220411T152233.jpg Rated Item: 2. Encroachments Caption: Minimally Acceptable - Soccer net on landside.</p>
 	<p>Inspect ID: 2022-0196 Title: 2604000009_CELRC_2022_A_0196_1_20220411T152728.jpg Rated Item: 2. Encroachments Caption: Minimally Acceptable - Statue and plant holder on landside.</p>

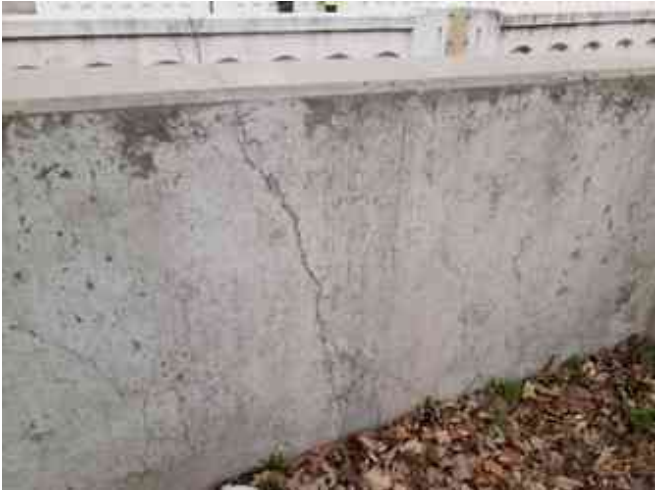
<p>Inspect ID: 2022-0127 Title: 2604000009_CELRC_2022_A_0127_1_20220411T144231.jpg Rated Item: 4. Concrete Surfaces Caption: Minimally Acceptable - Crack on wingwall.</p>

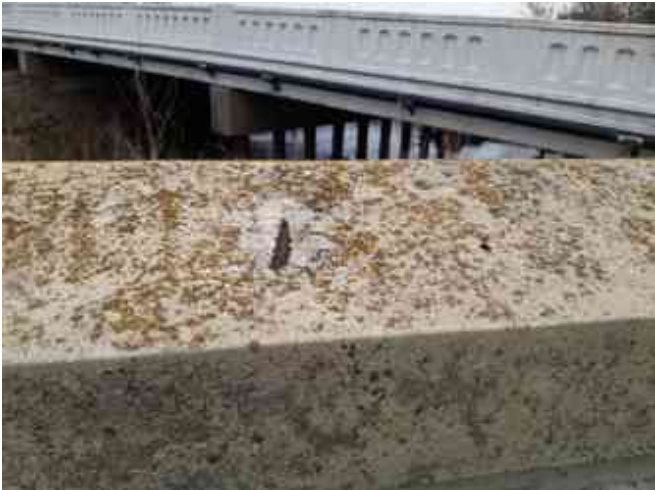
<p>Inspect ID: 2022-0133 Title: 2604000009_CELRC_2022_A_0133_1_20220411T144500.jpg Rated Item: 4. Concrete Surfaces Caption: Minimally Acceptable - Exposed rebar on cap.</p>

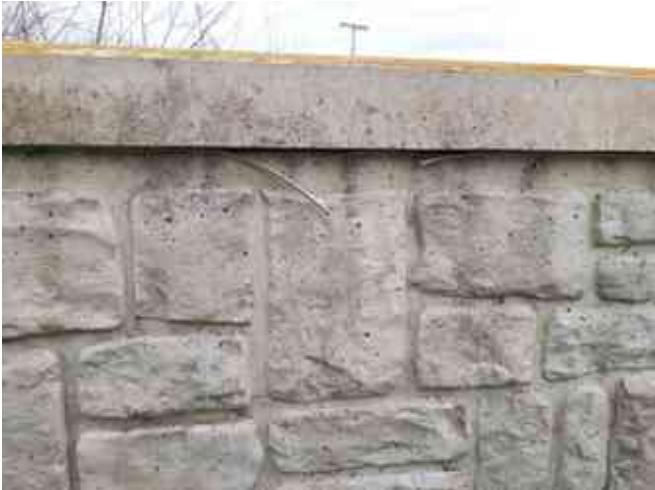
<p>Inspect ID: 2022-0145 Title: 2604000009_CELRC_2022_A_0145_1_20220411T144907.jpg Rated Item: 4. Concrete Surfaces Caption: Minimally Acceptable - Sealant under cap peeling.</p>

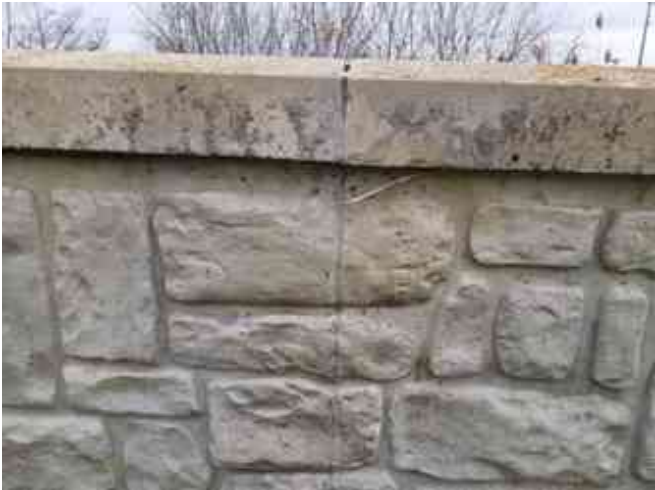
<p>Inspect ID: 2022-0148 Title: 2604000009_CELRC_2022_A_0148_1_20220411T145050.jpg Rated Item: 4. Concrete Surfaces Caption: Minimally Acceptable - Sealant peeling under cap.</p>

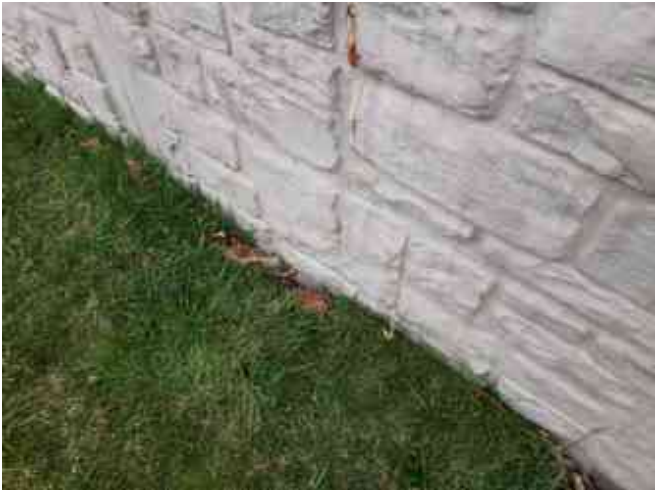
6. Foundation of Concrete Structures	M	A	No active erosion, scouring, or bank caving that might endanger the structure's stability.	2022-0035 : Holes on landside. (M) 2022-0041 : Hole at tie in to levee, 4 in deep. (M) 2022-0077 : Holes on landside. (M) 2022-0088 : Ponding of water near floodwall foundation on landside. (M) 2022-0089 : Hole on landside, 2.3 ft deep. (M) 2022-0092 : Holes on landside. (M) 2022-0118 : Surface starting to slope toward landside wall leading to ponding against the wall. (A) 2022-0217 : Rutting and depressions along the foundation on landside. (M) 2022-0232 : Holes on landside. (M) 2022-0250 : Holes on landside. (M) 2022-0256 : Holes on landside. (M) Recommendation: Grade foundation away from the wall to drain water away from the wall. Fill between the sheet pile and the concrete panel with shotcrete to prevent animal activity and further settlement.
		M	There are areas where the ground is eroding towards the base of the structure. Efforts need to be taken to slow and repair this erosion, but it is not judged to be close enough to the structure or to be progressing rapidly enough to affect structural stability before the next inspection. For the purposes of inspection, the erosion or scour is not closer to the riverside face of the wall than twice the floodwall's underground base width if the wall is of L-wall or T-wall construction; or if the wall is of sheetpile or I-wall construction, the erosion is not closer than twice the wall's visible height. Additionally, rate of erosion is such that the wall is expected to remain stable until the next inspection.

<p>Inspect ID: 2022-0035 Title: 2604000009_CELRC_2022_A_0035_1_20220411T163139.jpg Rated Item: 6. Foundation of Concrete Structures Caption: Minimally Acceptable - Holes on landside.</p>

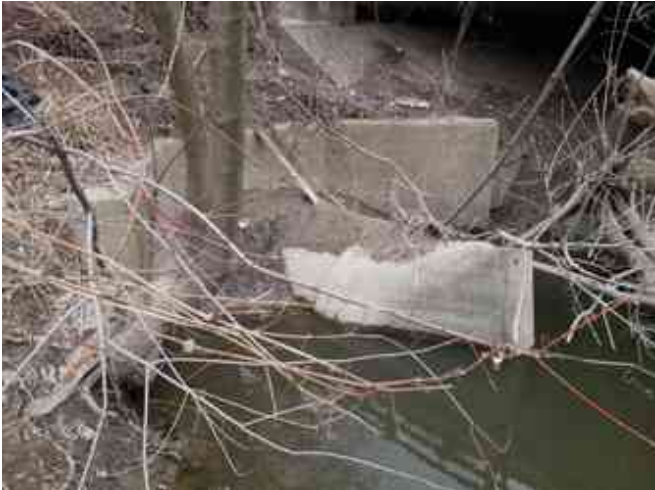
<p>Inspect ID: 2022-0032 Title: 2604000009_CELRC_2022_A_0032_1_20220510T115412.jpg Rated Item: 2. Encroachments Caption: Minimally Acceptable - MU-9: Trees surrounding outlet structure.</p>

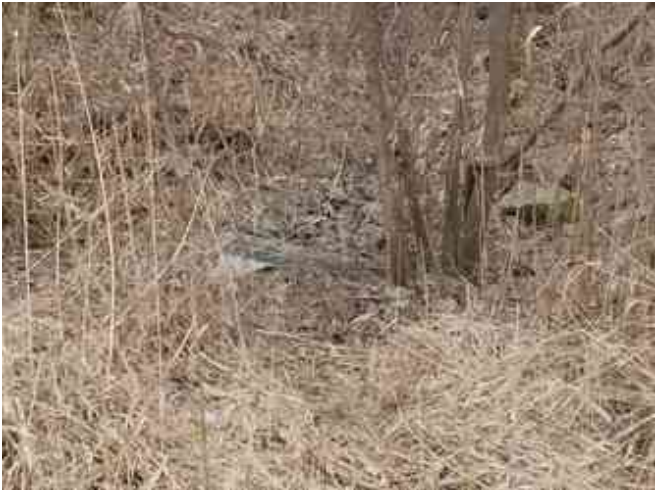
<p>Inspect ID: 2022-0257 Title: 2604000009_CELRC_2022_A_0257_1_20220510T122145.jpg Rated Item: 2. Encroachments Caption: Minimally Acceptable - MU-3: Inlet has overgrown vegetation and trees.</p>

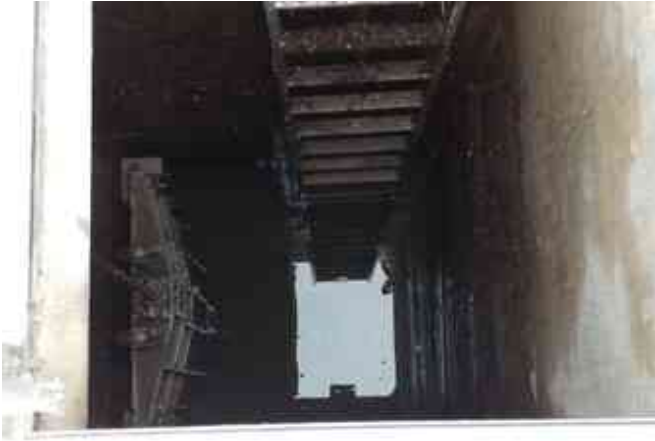
<p>Inspect ID: 2022-0002 Title: 2604000009_CELRC_2022_A_0002_7_20220411T133749.jpg Rated Item: 10. Sluice/ Slide Gates Caption: Acceptable - MU-11: No issues.</p>

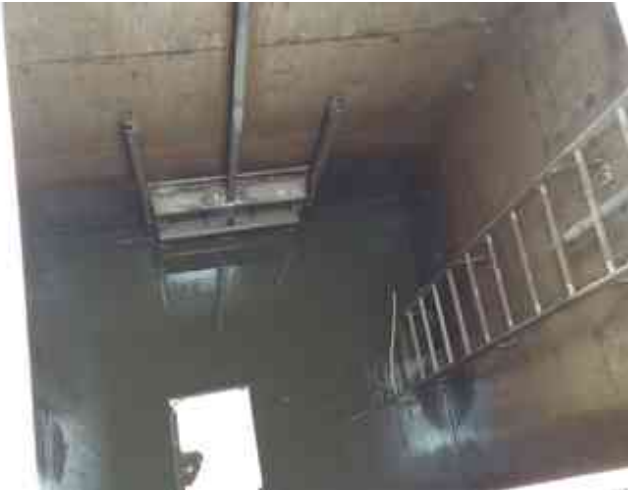
<p>Inspect ID: 2022-0008 Title: 2604000009_CELRC_2022_A_0008_5_20220411T141432.jpg Rated Item: 10. Sluice/ Slide Gates Caption: Acceptable - MU-7: No issues.</p>

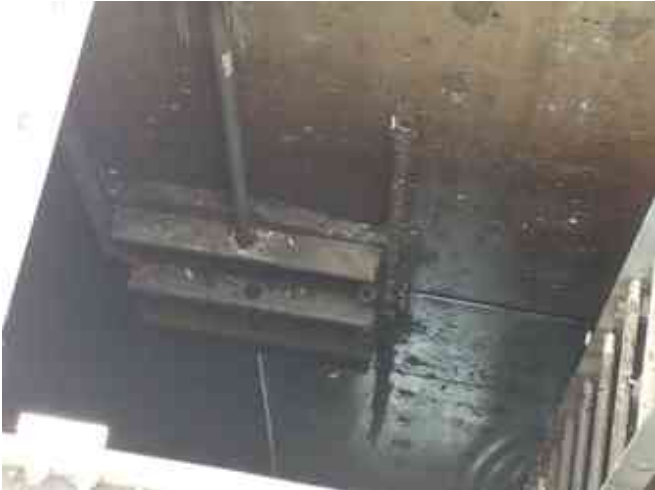
<p>Inspect ID: 2022-0020 Title: 2604000009_CELRC_2022_A_0020_4_20220411T145859.jpg Rated Item: 10. Sluice/ Slide Gates Caption: Acceptable - MU-1: No issues.</p>

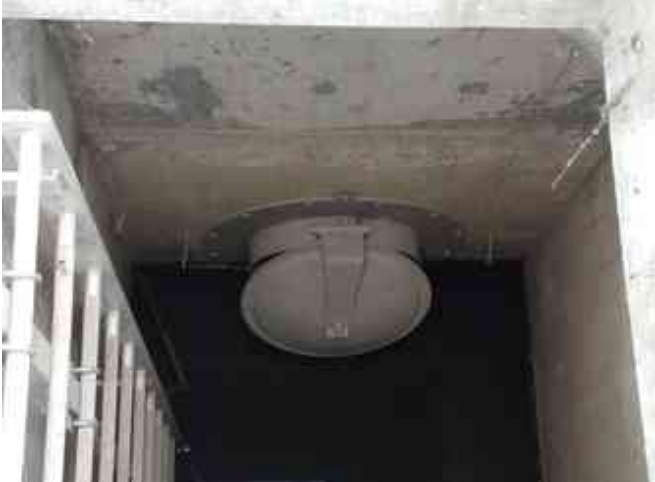
<p>Inspect ID: 2022-0017 Title: 2604000009_CELRC_2022_A_0017_3_20220411T144641.jpg Rated Item: 11. Flap Gates/ Flap Valves/ Pinch Valves Caption: Minimally Acceptable - MU-3: Flap gate stuck open.</p>

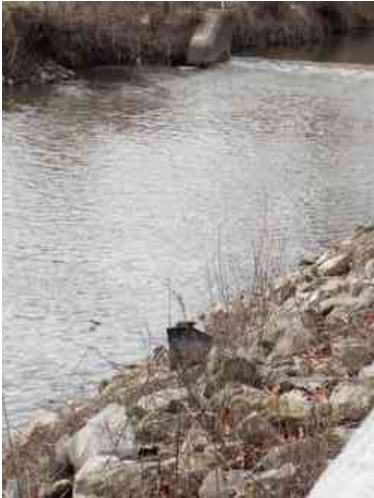
<p>Inspect ID: 2022-0025 Title: 2604000009_CELRC_2022_A_0025_1_20220411T134059.jpg Rated Item: 11. Flap Gates/ Flap Valves/ Pinch Valves Caption: Acceptable - MU-12: No issues.</p>

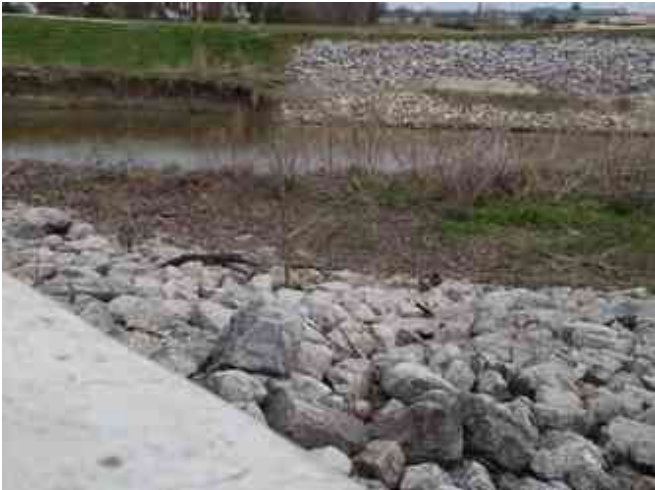
<p>Inspect ID: 2022-0097 Title: 2604000009_CELRC_2022_A_0097_1_20220411T142514.jpg Rated Item: 14. Riprap Revetments of Inlet/ Discharge Areas Caption: Minimally Acceptable - Tree growing in riprap.</p>

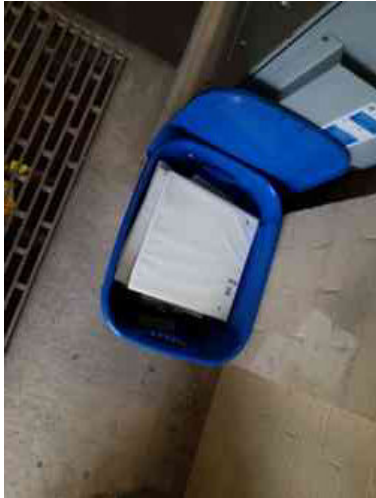
<p>Inspect ID: 2022-0003 Title: 2604000009_CELRC_2022_A_0003_1_20220411T131859.jpg Rated Item: 2. Pump Station Operations and Maintenance Equipment Manuals Caption: Acceptable - PS-BA: Operations manuals present on-site.</p>

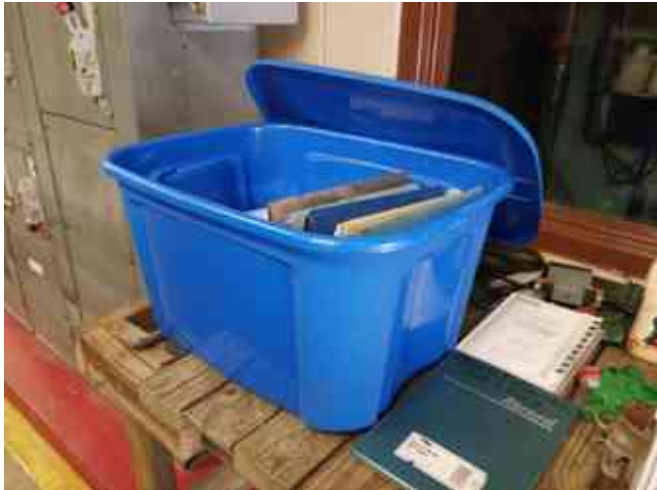
<p>Inspect ID: 2022-0021 Title: 2604000009_CELRC_2022_A_0021_1_20220411T134243.jpg Rated Item: 2. Pump Station Operations and Maintenance Equipment Manuals Caption: Acceptable - PS-CA: Operations manuals present on-site.</p>

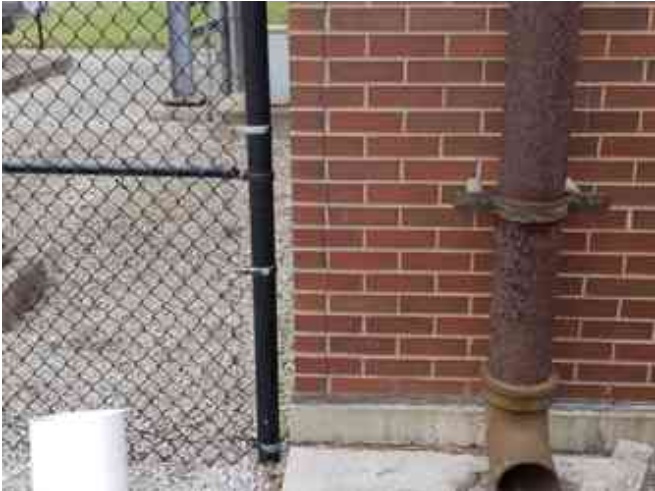
<p>Inspect ID: 2022-0078 Title: 2604000009_CELRC_2022_A_0078_1_20220411T142624.jpg Rated Item: 5. Plant Building Caption: Minimally Acceptable - PS-OA: Crack along exterior corner of building.</p>

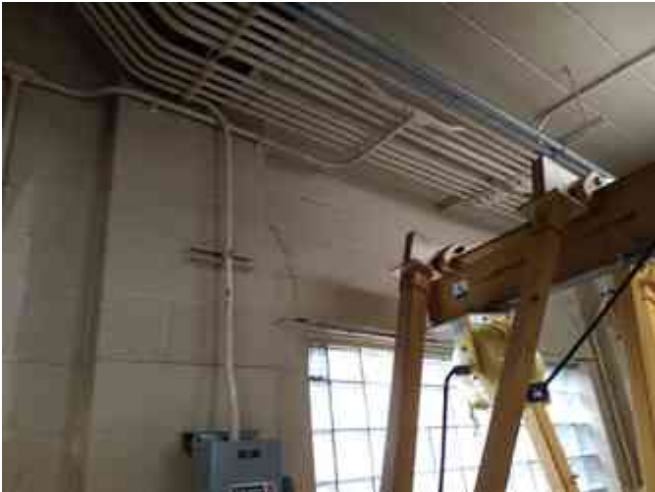
<p>Inspect ID: 2022-0084 Title: 2604000009_CELRC_2022_A_0084_1_20220411T144106.jpg Rated Item: 5. Plant Building Caption: Minimally Acceptable - PS-HM: Cracks near window frame should be repaired.</p>

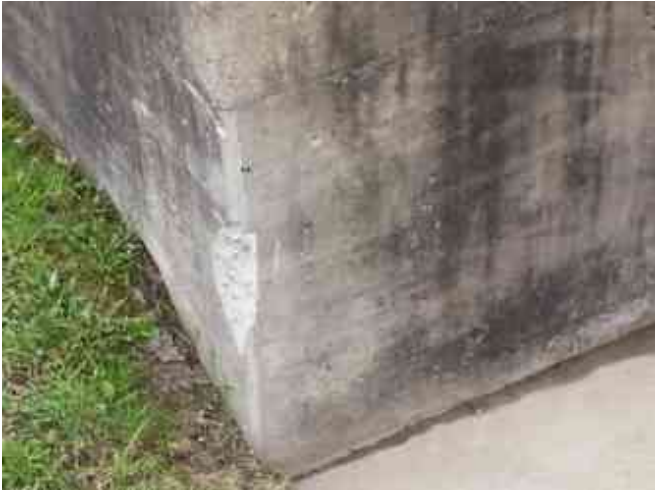
<p>Inspect ID: 2022-0090 Title: 2604000009_CELRC_2022_A_0090_1_20220411T145423.jpg Rated Item: 5. Plant Building Caption: Minimally Acceptable - PS-HM: Spalling along corner.</p>

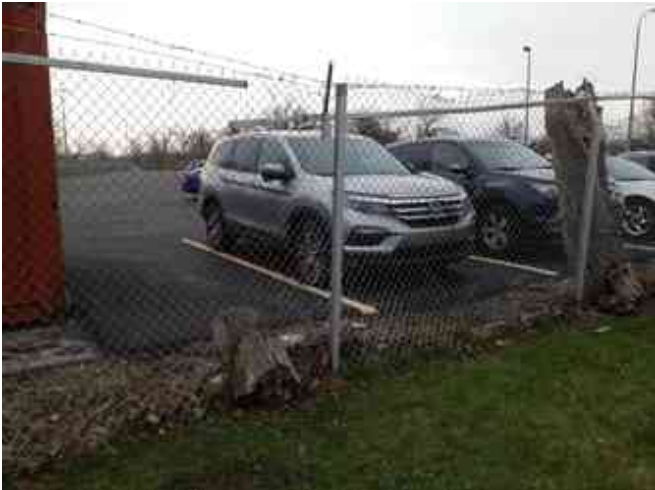
<p>Inspect ID: 2022-0048 Title: 2604000009_CELRC_2022_A_0048_2_20220411T140225.jpg Rated Item: 6. Fencing and Gates Caption: Minimally Acceptable - PS-CA: Fence is broken on the east end.</p>

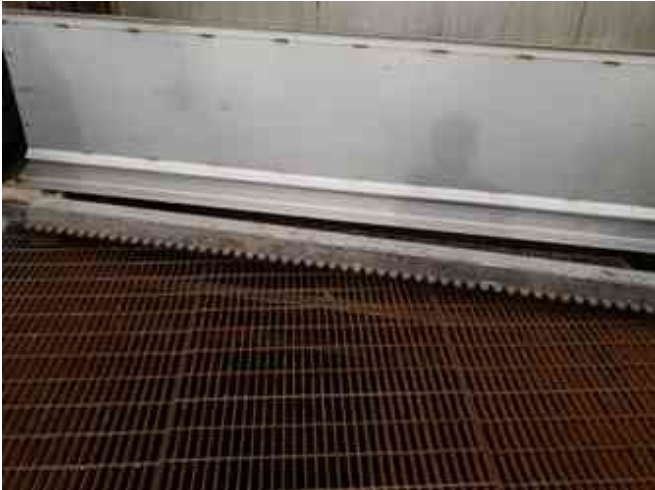
<p>Inspect ID: 2022-0030 Title: 2604000009_CELRC_2022_A_0030_1_20220411T135015.jpg Rated Item: 10. Mechanical Operating Trash Rakes Caption: Minimally Acceptable - PS-CA: Trash Rack component to be repaired. Trash rack currently locked out.</p>
 	<p>Inspect ID: 2022-0069 Title: 2604000009_CELRC_2022_A_0069_1_20220411T142018.jpg Rated Item: 14. Electrical Systems Caption: Acceptable - PS-OA: Indicator lights fixed</p>

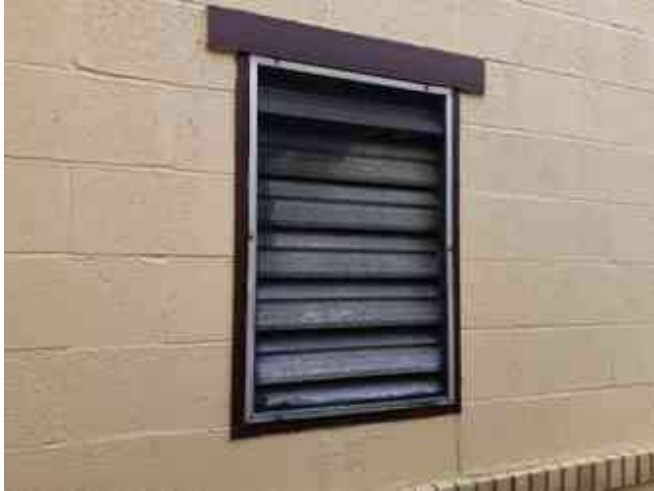
Inspect ID: 2022-0093 **Title:**
2604000009_CELRC_2022_A_0093_1_20220411T145823.jpg
Rated Item: 16. Enclosures, Panels, Conduit and Ducts
Caption: Minimally Acceptable - PS-HM: Louver screen is broken.
