US Army Corps
of Engineers ®

Site Visit Summary

Name of System: Hammond

Date of Site Visit: 04/29/2024 - 04/30/2024

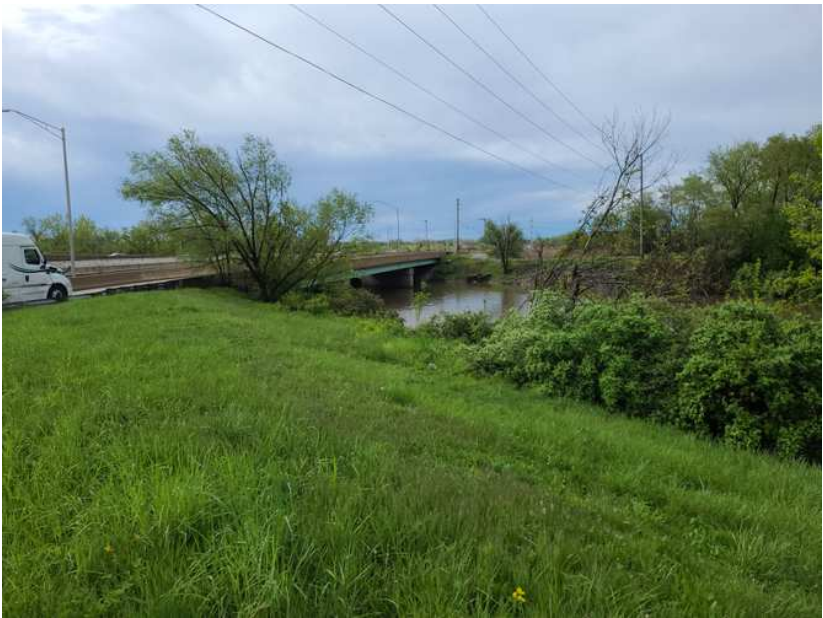
Inspect ID: 2024-0005
Rated Item: 1. Unwanted Vegetation Growth
Lat/Long: 41.56770/-87.43326
Caption:
No User Rating (Site Visit) - Trees and brush on riverside toe.

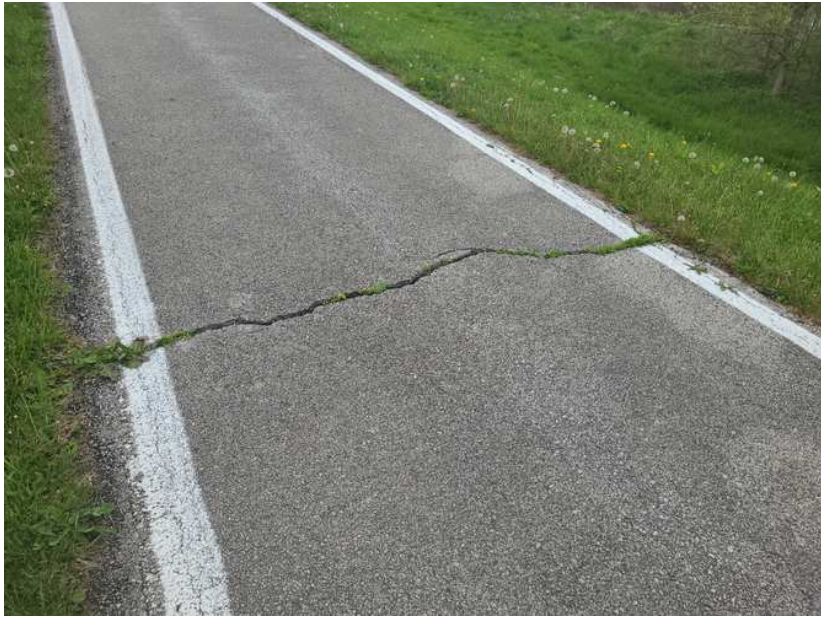
No User Rating (Site Visit) - Asphalt cracking on crest

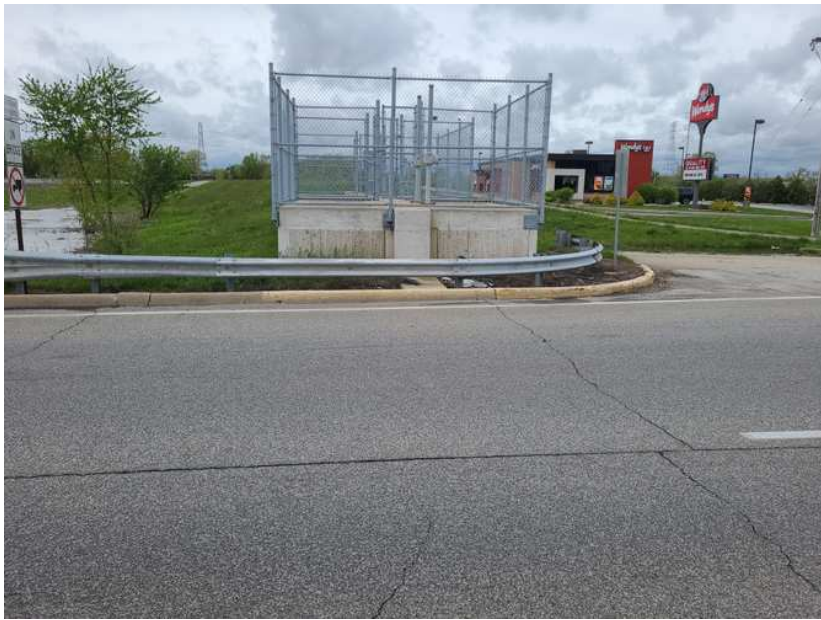
No User Rating (Site Visit) - Closure structure at Kennedy has spalling concrete.

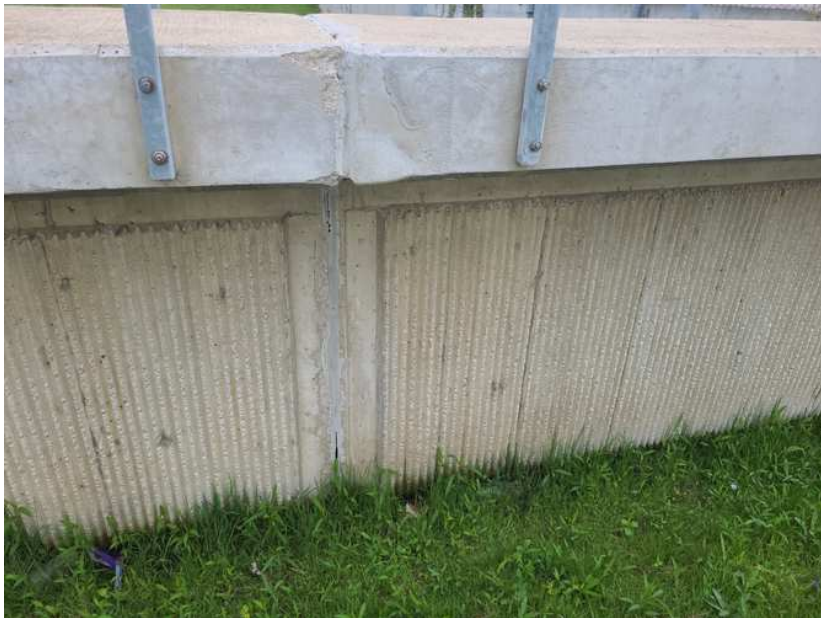
No User Rating (Site Visit) - Typical crack through floodwall.

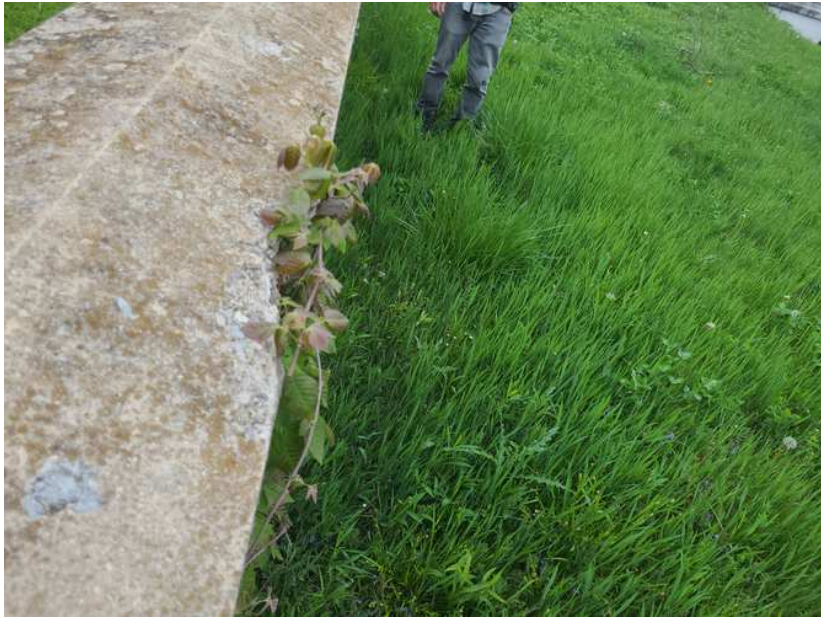
No User Rating (Site Visit) - Typical cracked sealant and spelling at joint.

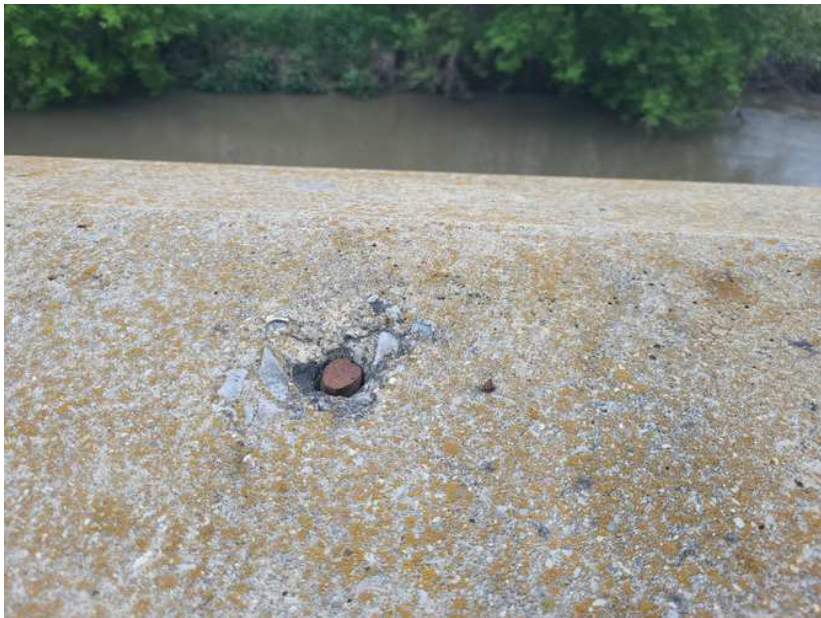
No User Rating (Site Visit) - Riverside cap is spalling

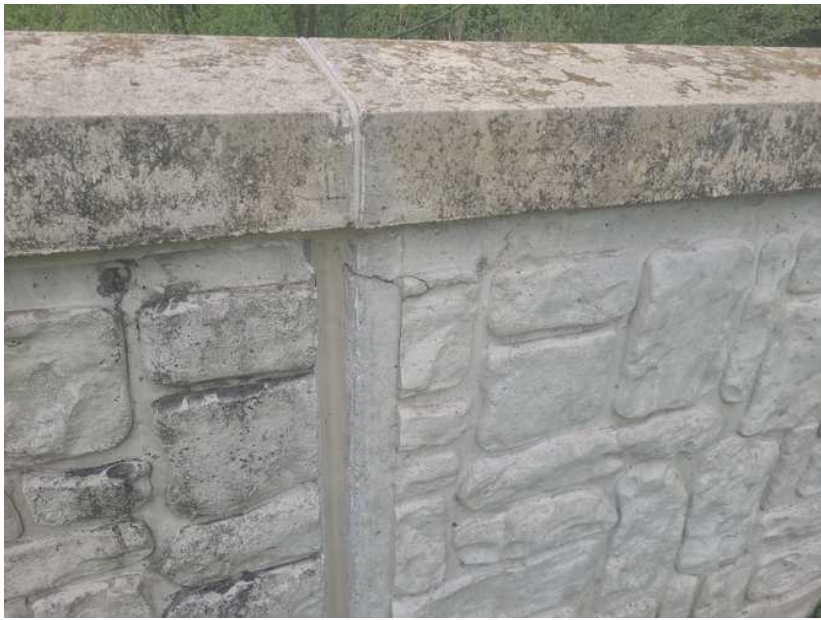
No User Rating (Site Visit) - Typical spalling of concrete cap

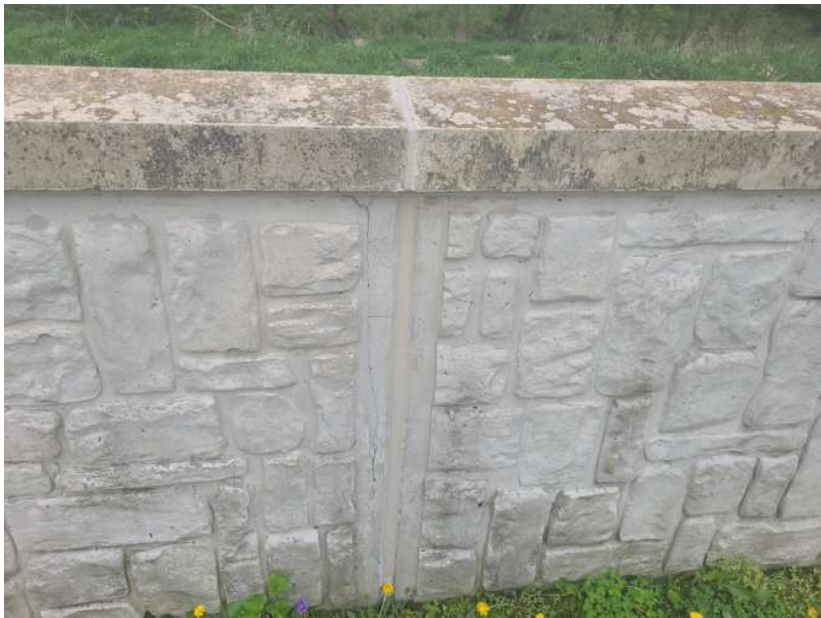
No User Rating (Site Visit) - Crack near joint on landside of floodwall.

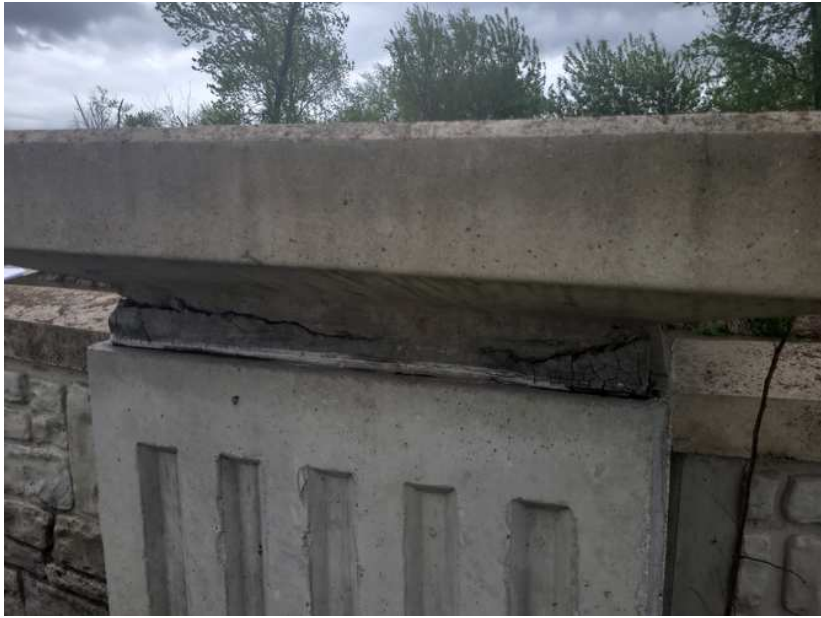
No User Rating (Site Visit) - Crack on landside of floodwall

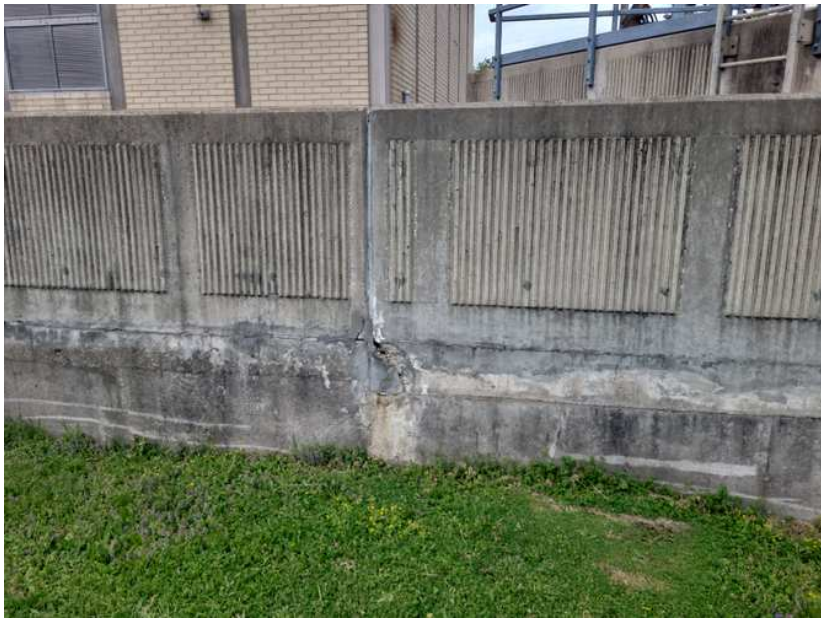
No User Rating (Site Visit) - Cracking of column on landside of floodwall.

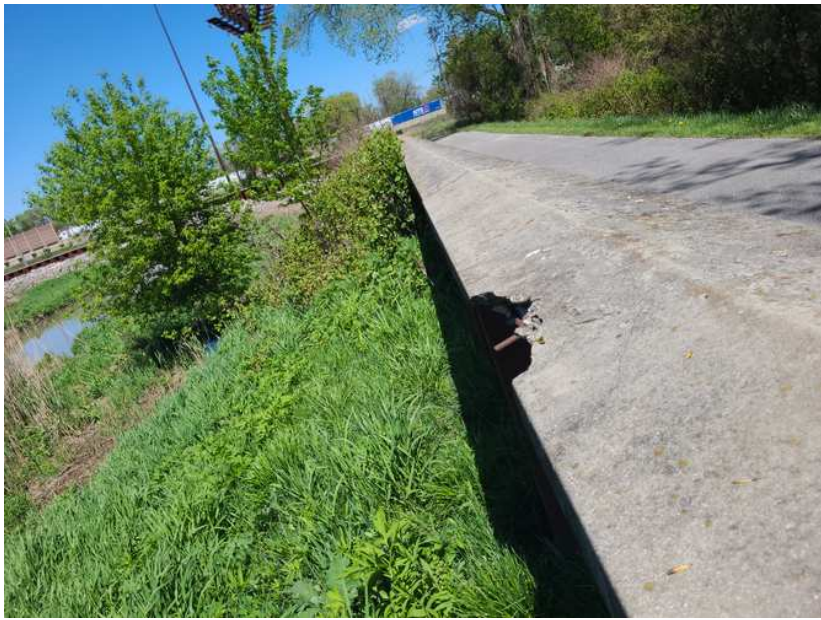
No User Rating (Site Visit) - Spalling around riverside joint patch.

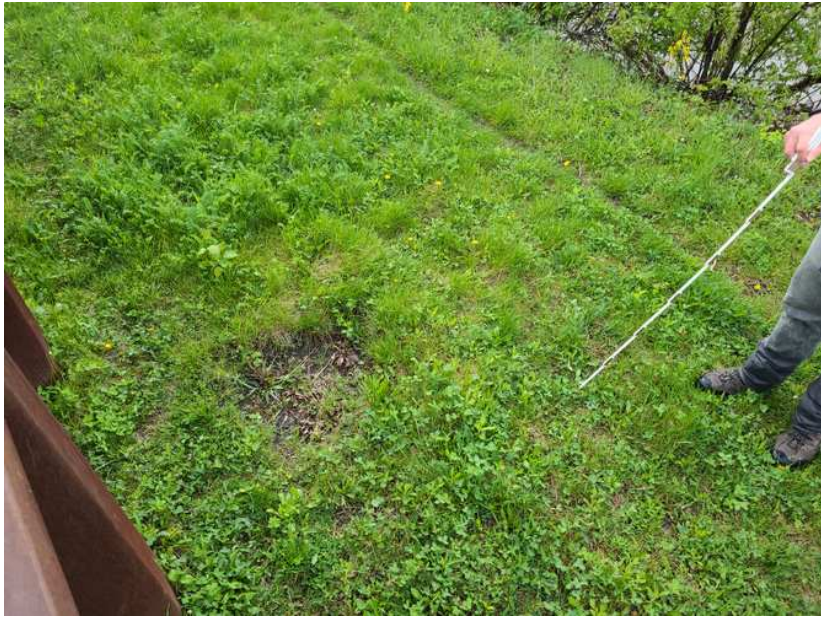
No User Rating (Site Visit) - Ponding against landside of floodwall

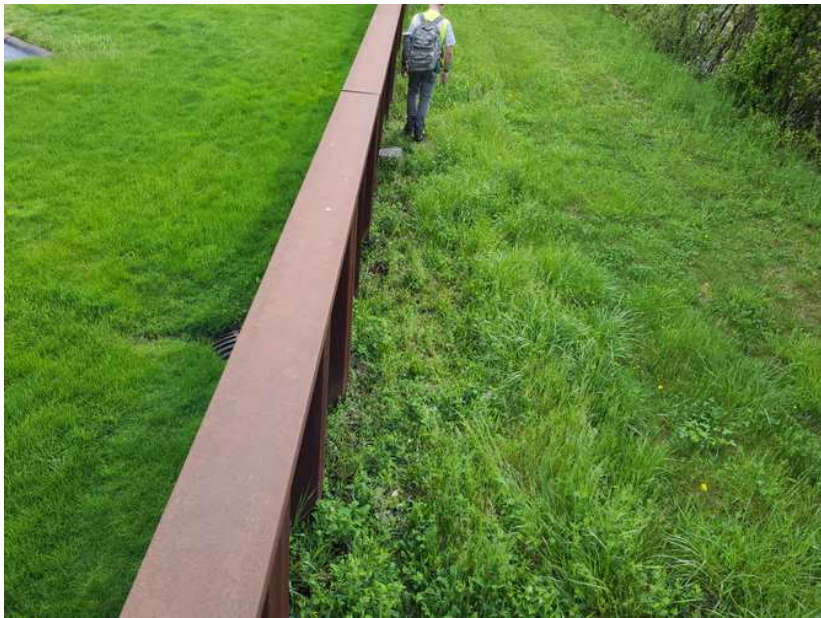
No User Rating (Site Visit) - Depression on riverside, likely an old tree stump removal

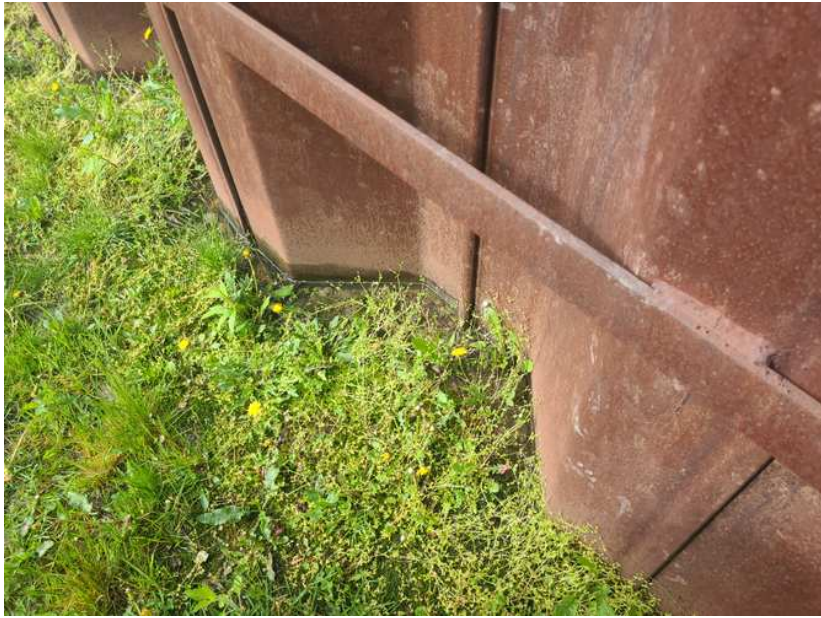
No User Rating (Site Visit) - Soil on riverside has subsided near storm drain

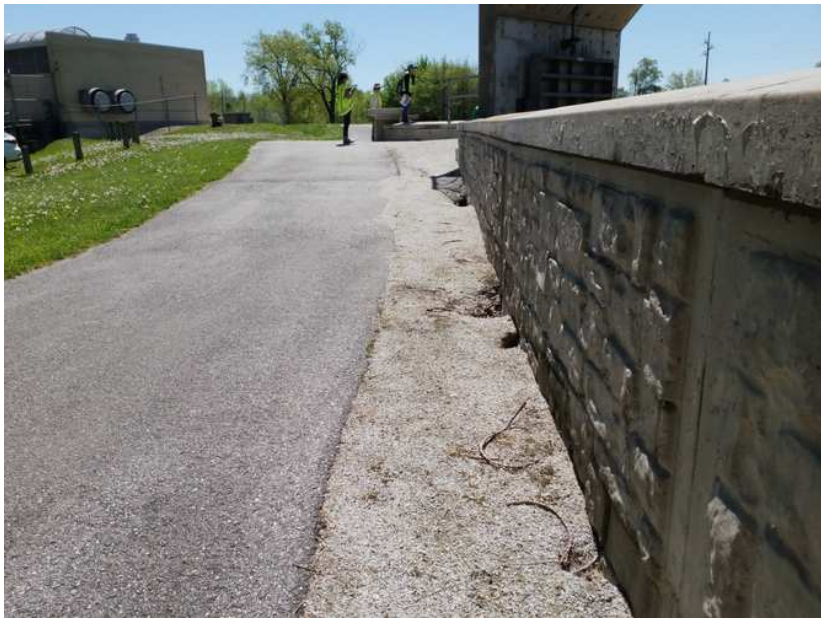
No User Rating (Site Visit) - Exposed geotextile riverside slope.

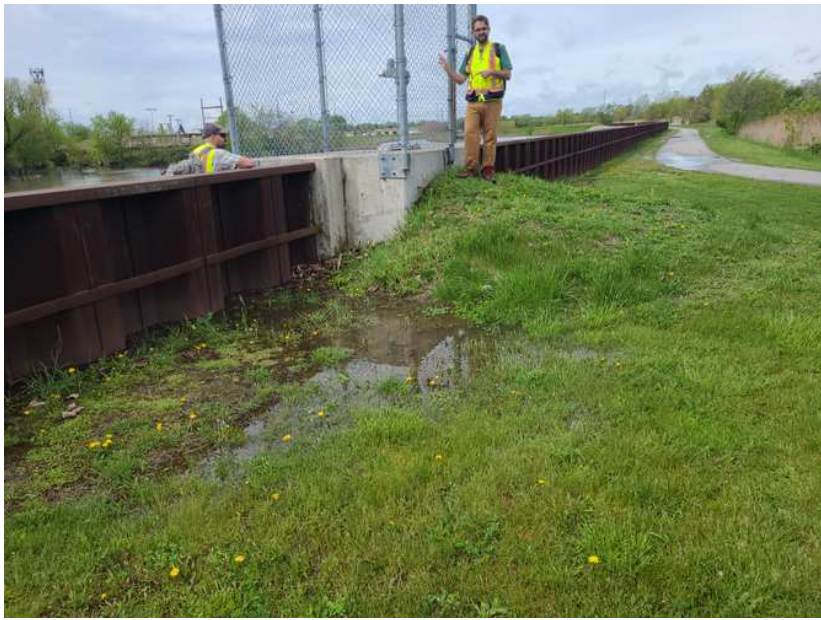
No User Rating (Site Visit) - Settlement on the landside of the floodwall.

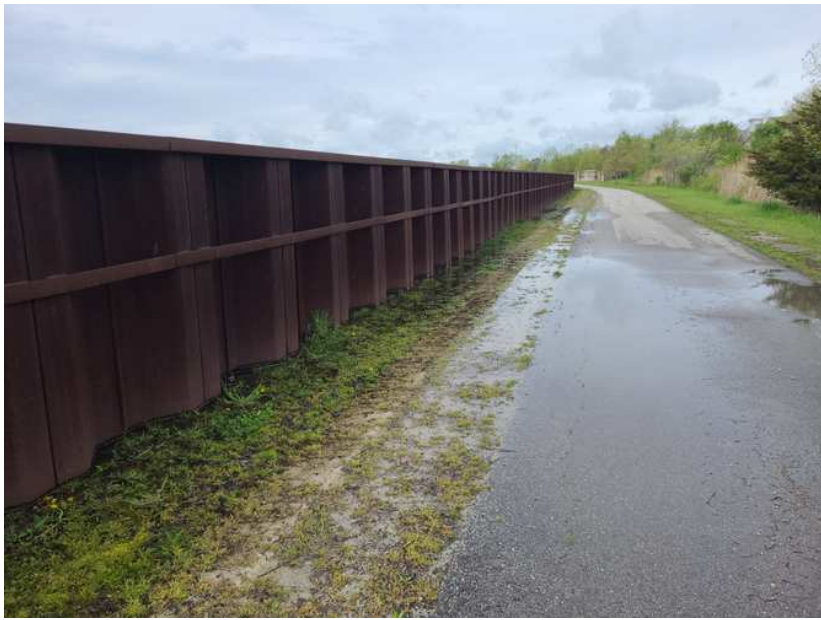
No User Rating (Site Visit) - Depression due to settling/animal burrows

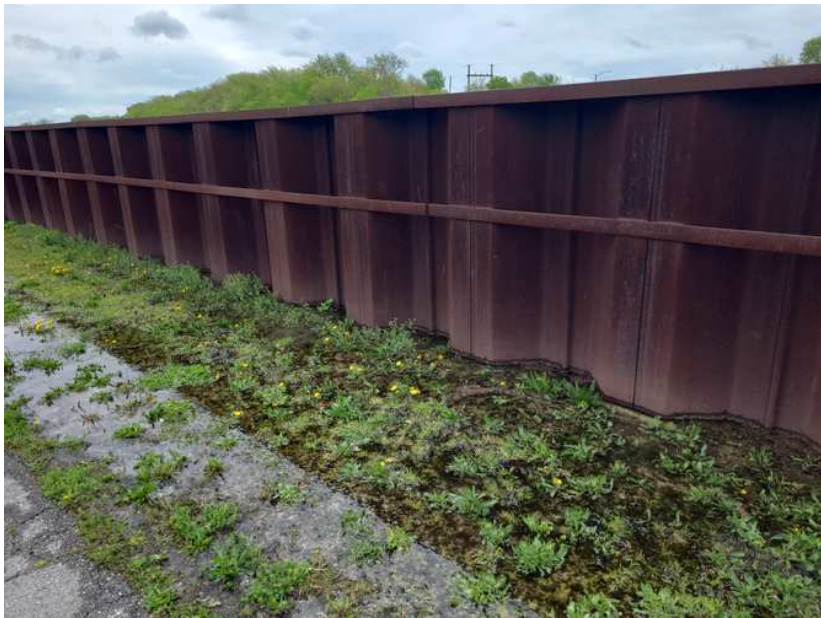
No User Rating (Site Visit) - Ponding on landside

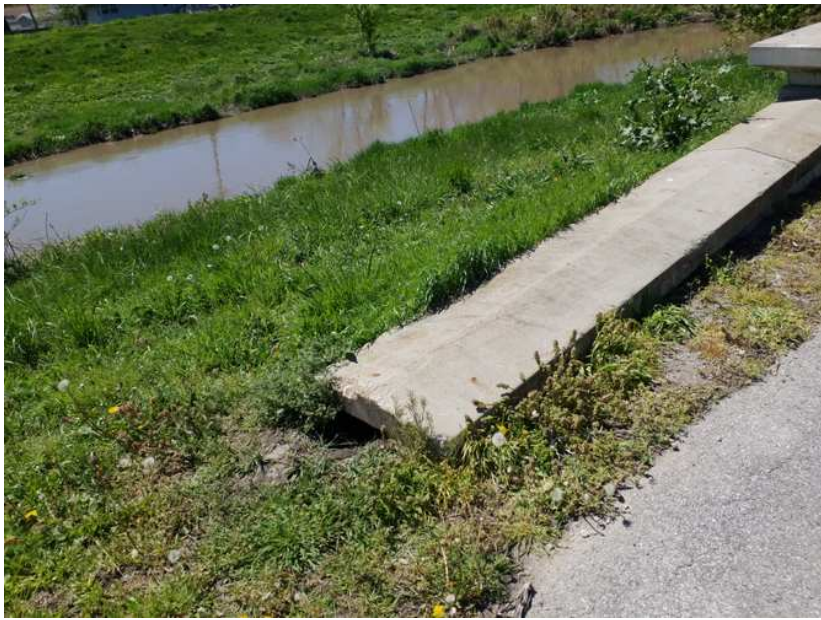
No User Rating (Site Visit) - Ponding on landside

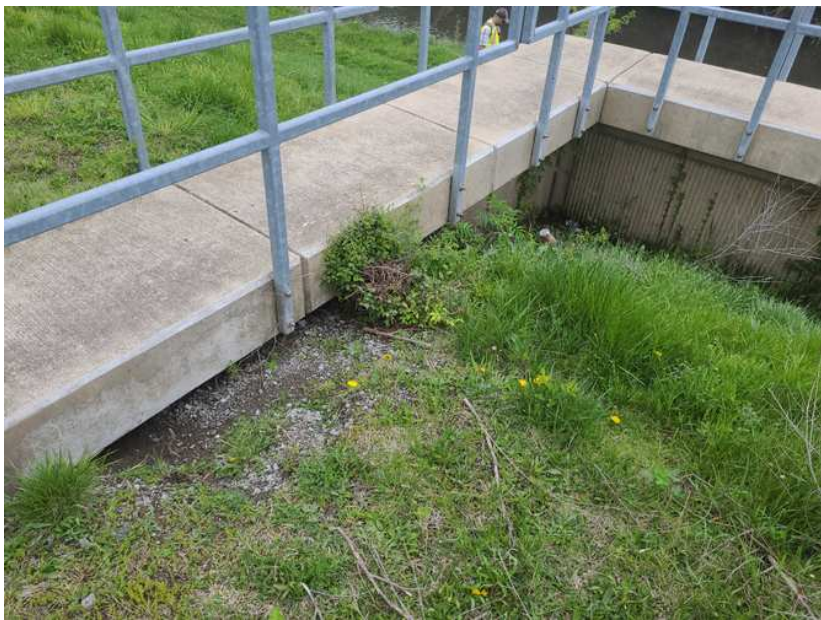
No User Rating (Site Visit) - Hole about 6 inches deep at tie-in

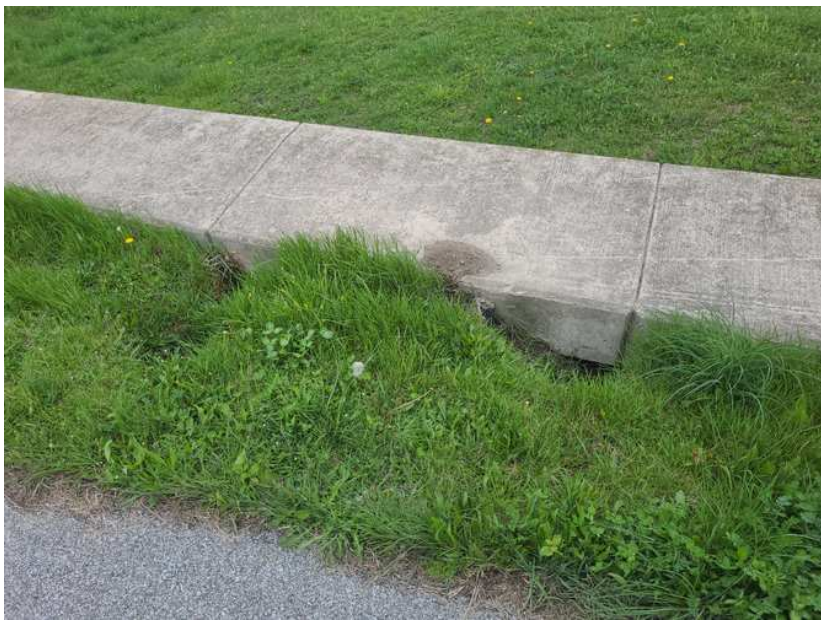
No User Rating (Site Visit) - Ponding on landside of floodwall

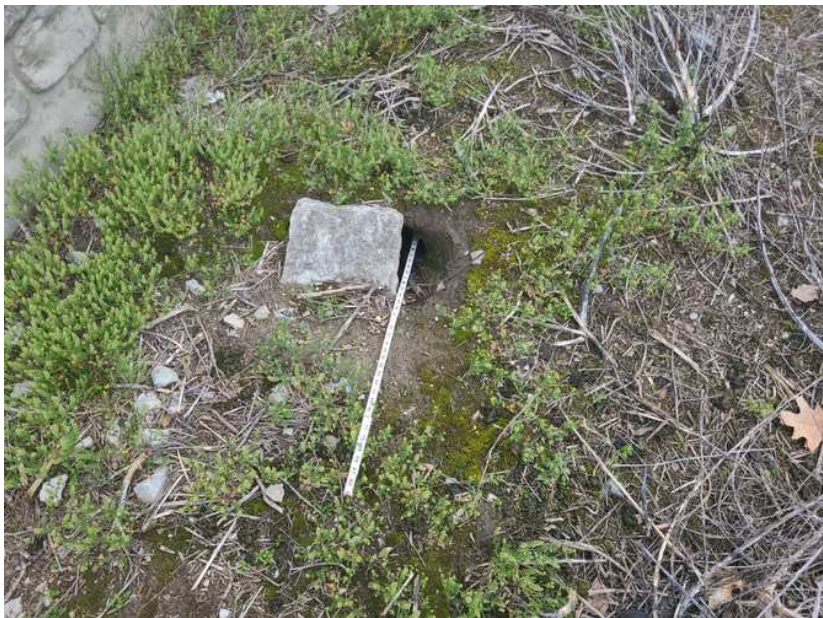
No User Rating (Site Visit) - Settlement at tie-in to levee

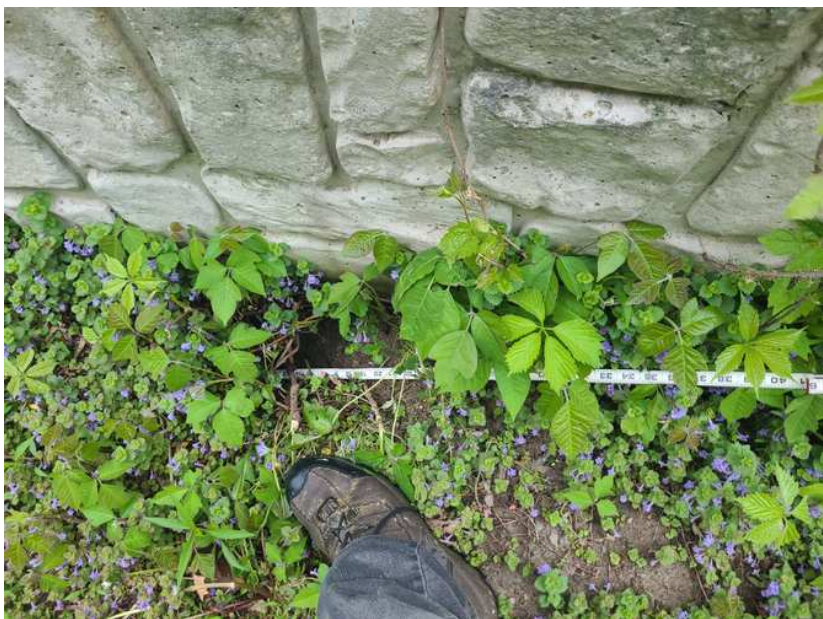
No User Rating (Site Visit) - 3-foot burrow on riverside.

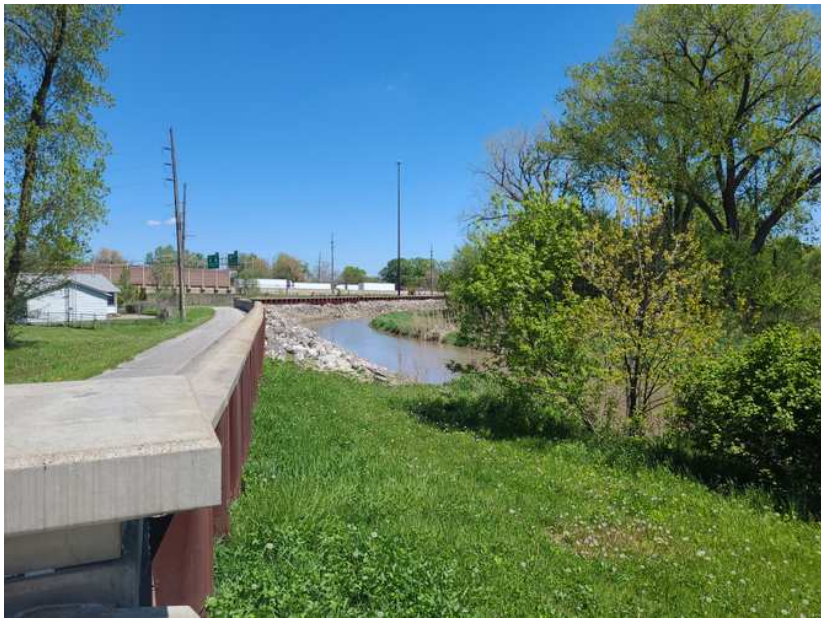
No User Rating (Site Visit) - HA-04: Animal burrow behind sheetpile wall and eroding above.

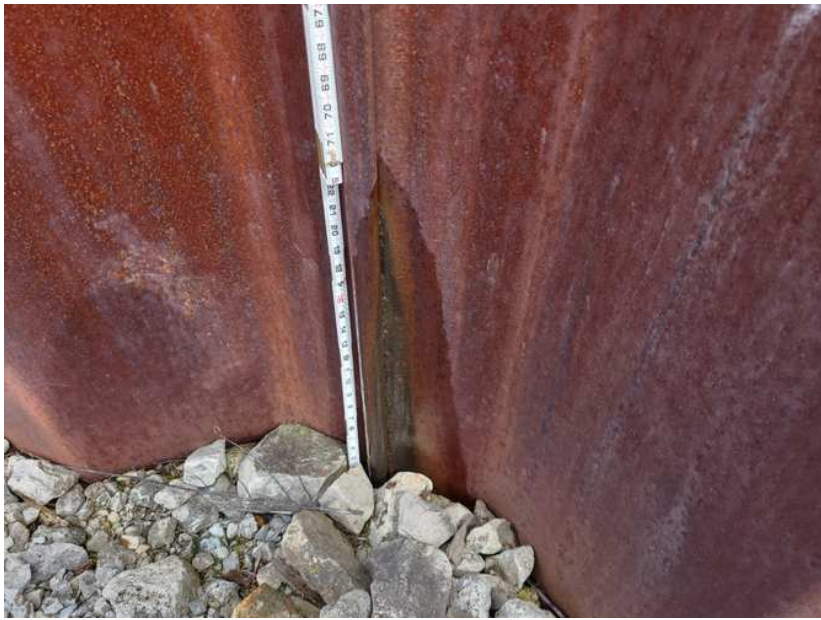
No User Rating (Site Visit) - Typical sealant cracking

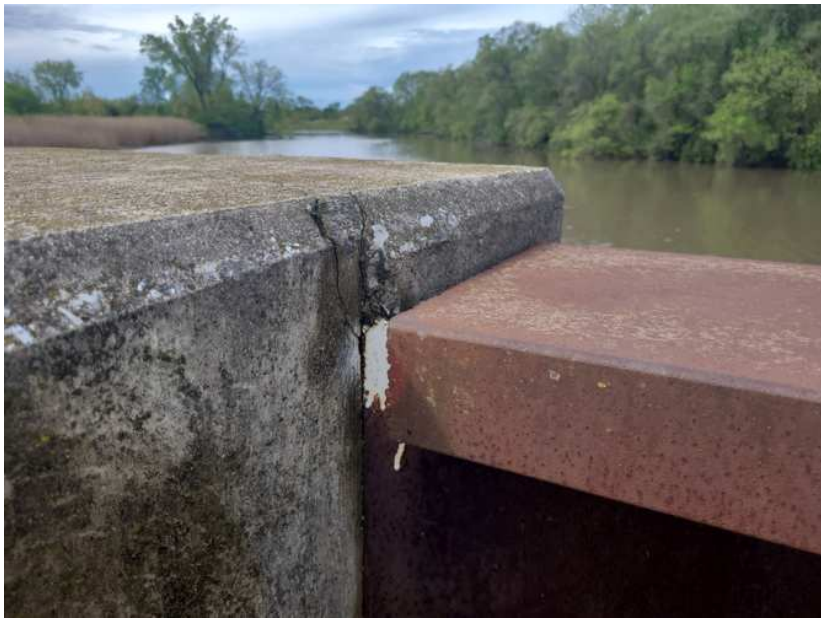
No User Rating (Site Visit) - HA-04: Spalling on wingwall on outlet structure.

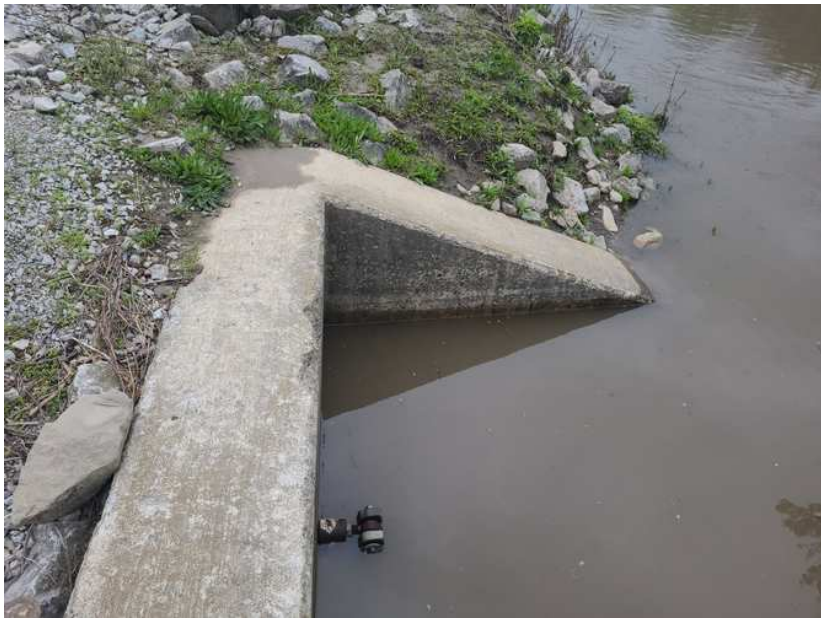
No User Rating (Site Visit) - HA-26: Spalling concrete around the inlet structure.

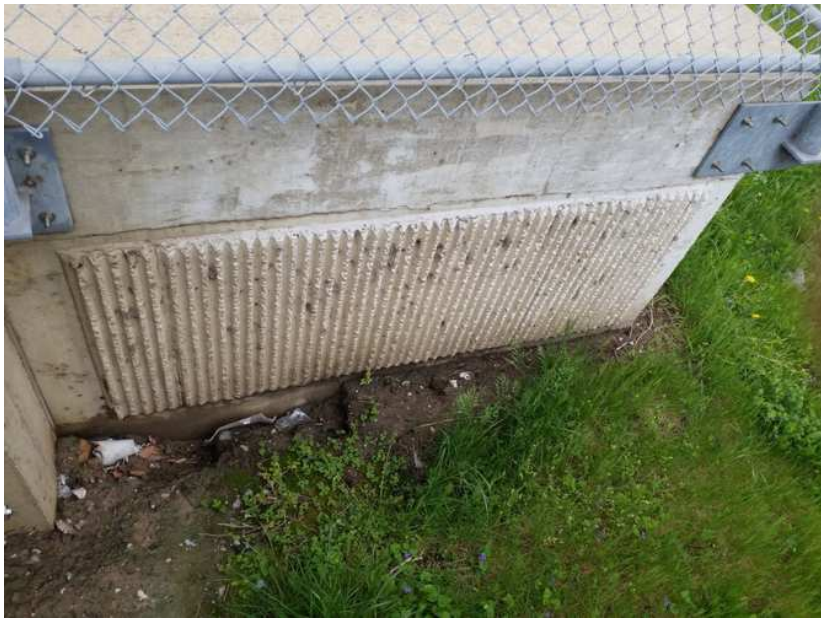
No User Rating (Site Visit) - HA-12: Hole near foundation of gatewell.

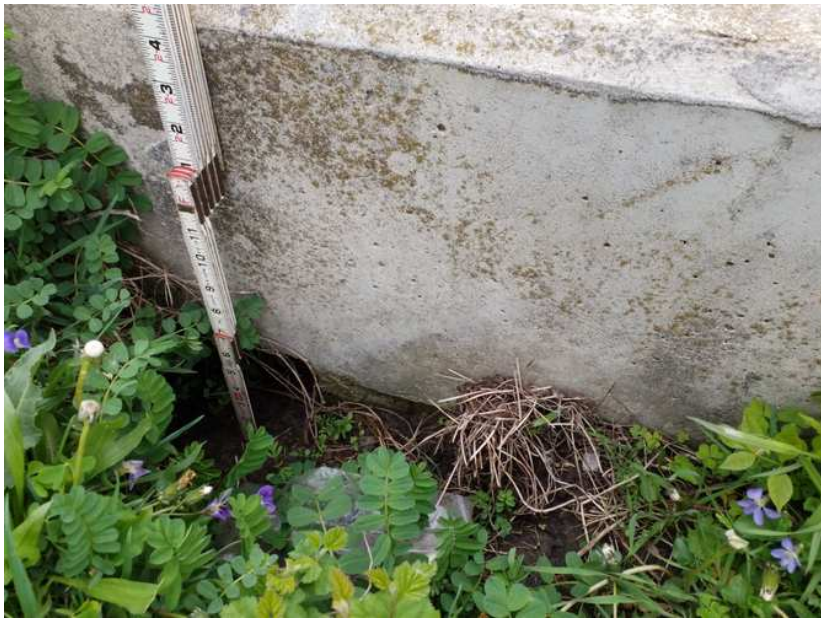
No User Rating (Site Visit) - HA-17: Some erosion at wingwall

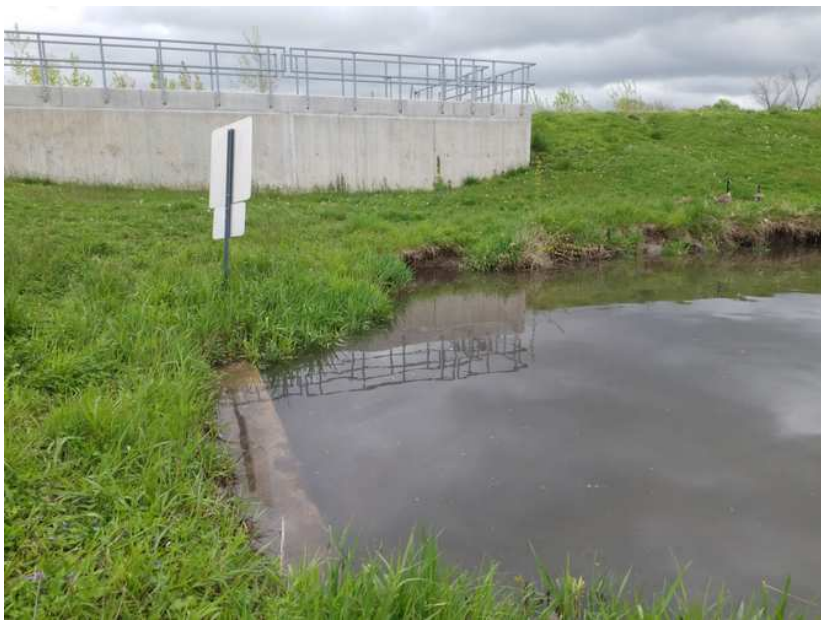
No User Rating (Site Visit) - HA-21: Erosion hole approximately 6 inches deep near structure.

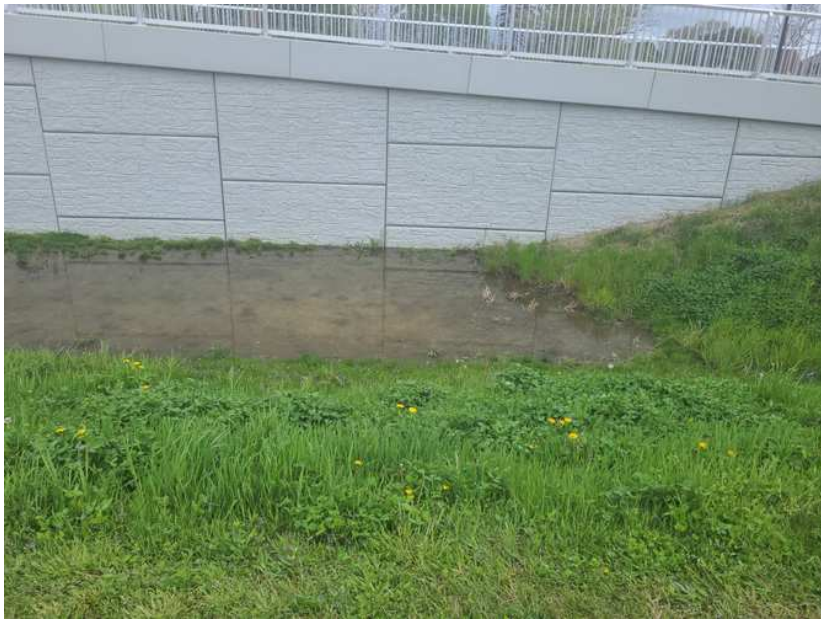
No User Rating (Site Visit) - Ladder slab settling at gatewell structure.

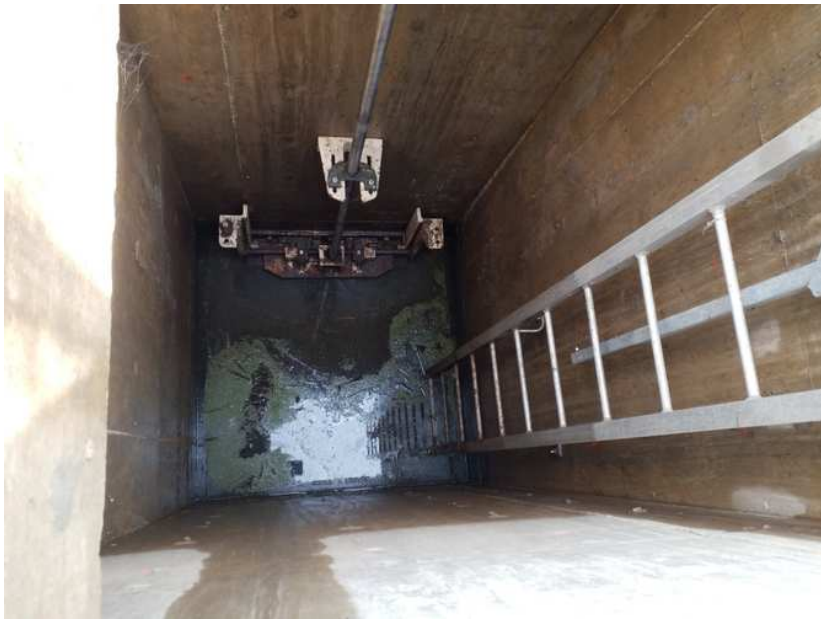
No User Rating (Site Visit) - HA-31: Gauge is broken, does not indicate open/close position

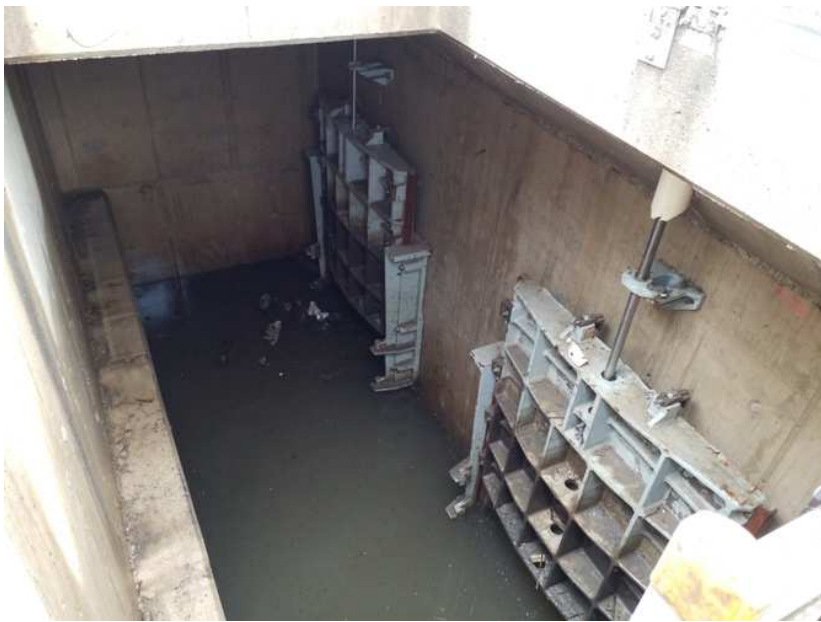
No User Rating (Site Visit) - HA-14: General rusting around gate mechanism.

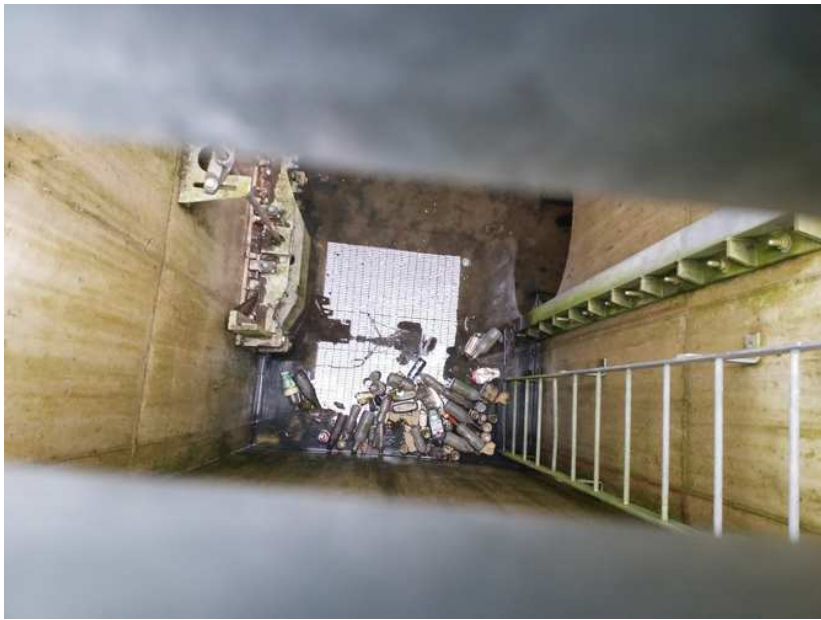
No User Rating (Site Visit) - HA-16: Gate open when we arrived. Left open 15 inches from the sill. Some corrosion on the inside.

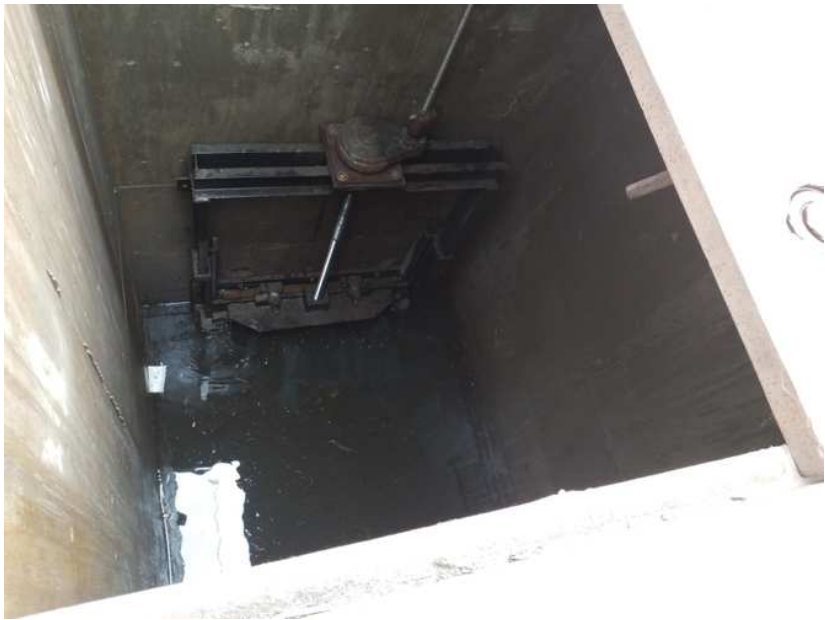
No User Rating (Site Visit) - HA-20: Found halfway closed. Left gate the way it was found.

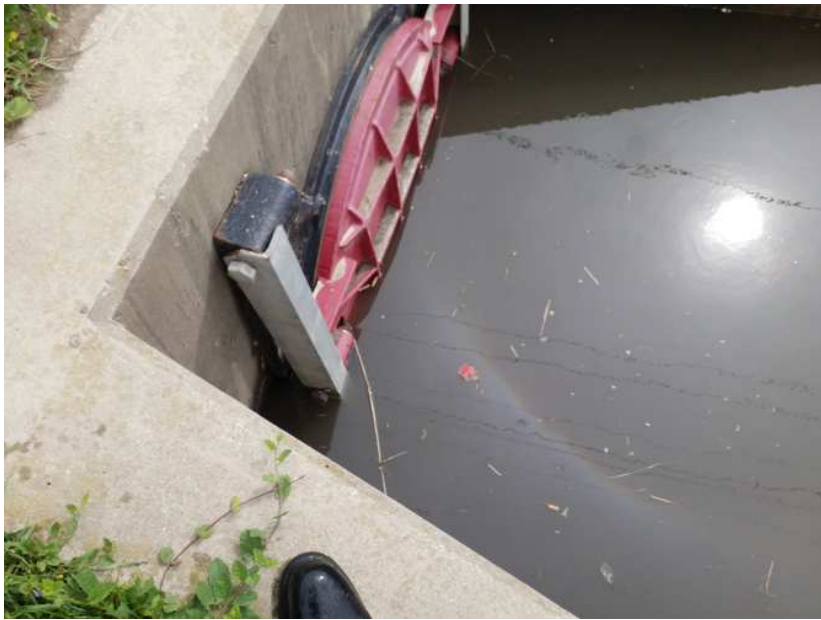
No User Rating (Site Visit) - HA-17: Pipe stem cover missing

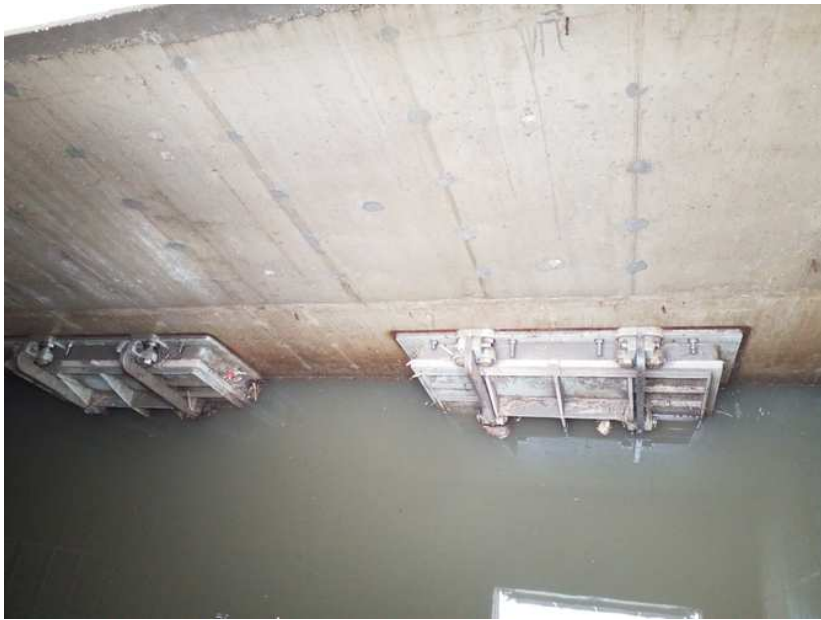
No User Rating (Site Visit) - HA-14: Duckbill isn't completely sealed and is leaking

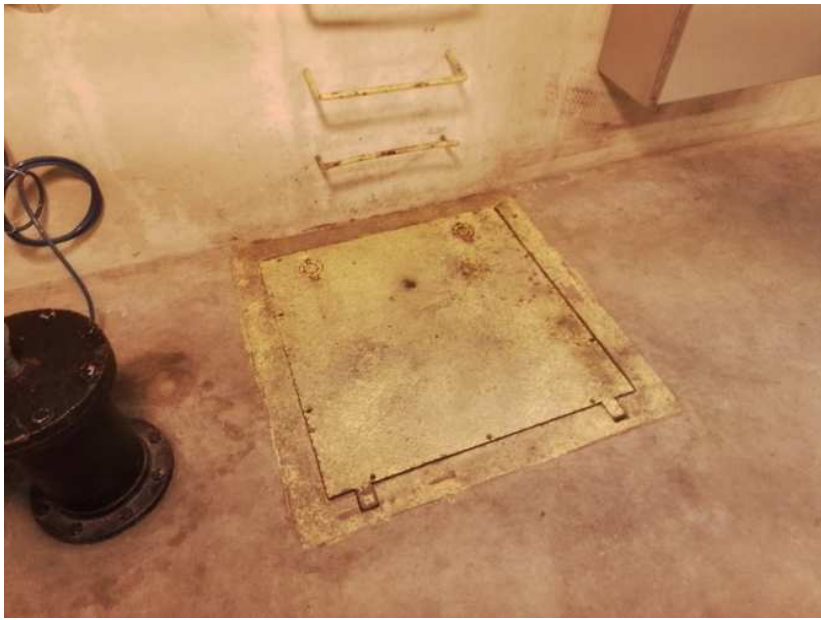
No User Rating (Site Visit) - PS-HV: Missing confined space label

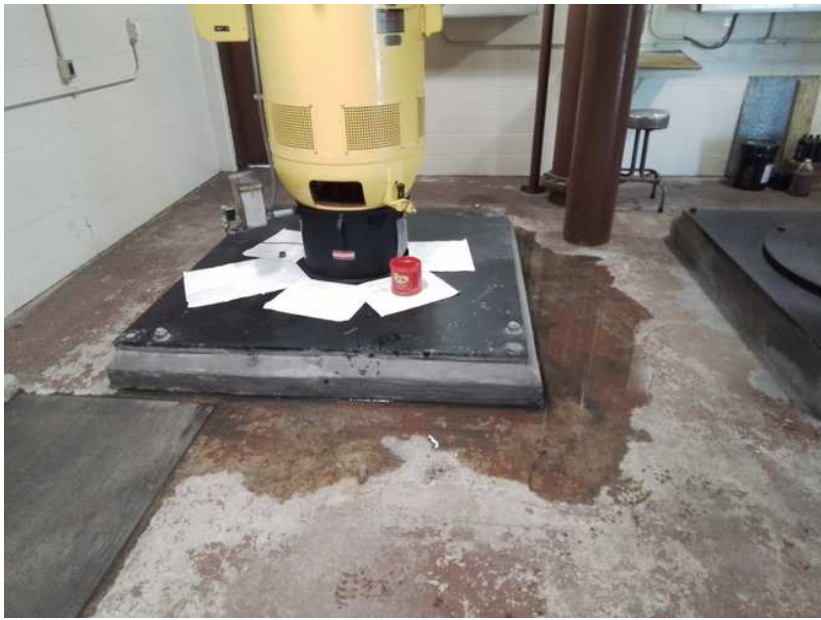
No User Rating (Site Visit) - PS-WA: Leak in building

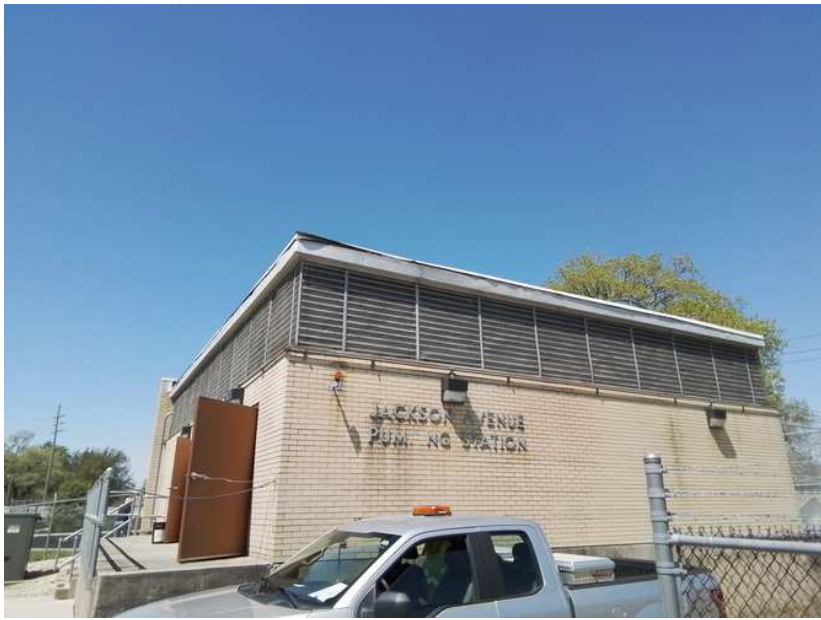
No User Rating (Site Visit) - PS-JA: Wall cracks in building (widest crack pictured)

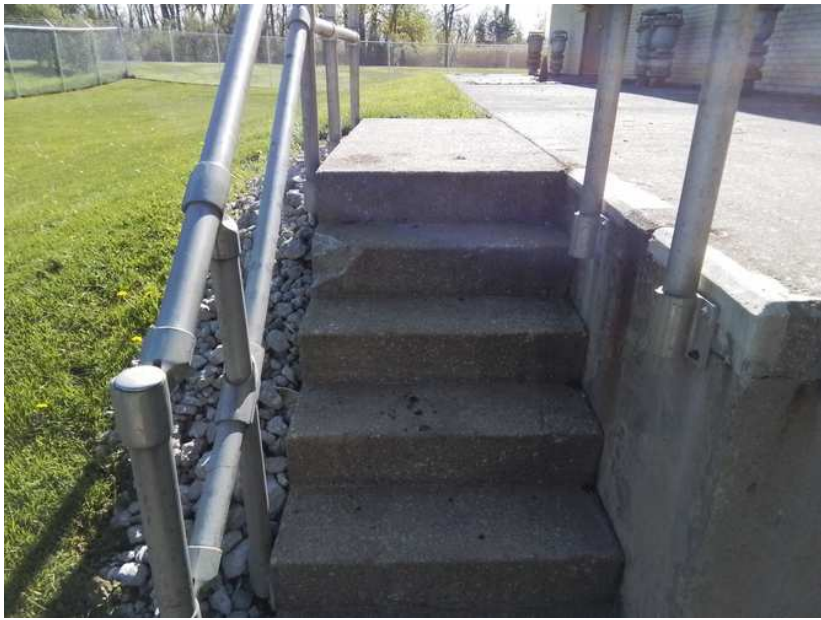
No User Rating (Site Visit) - PS-JA: Exterior wall crack

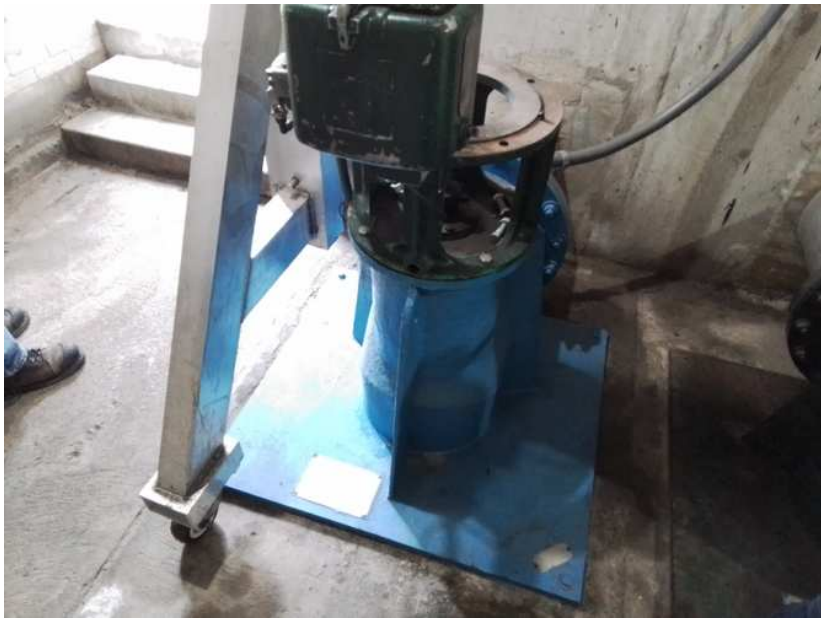
No User Rating (Site Visit) - PS-HV: Corrosion on DWP shaft - noted during previous inspections

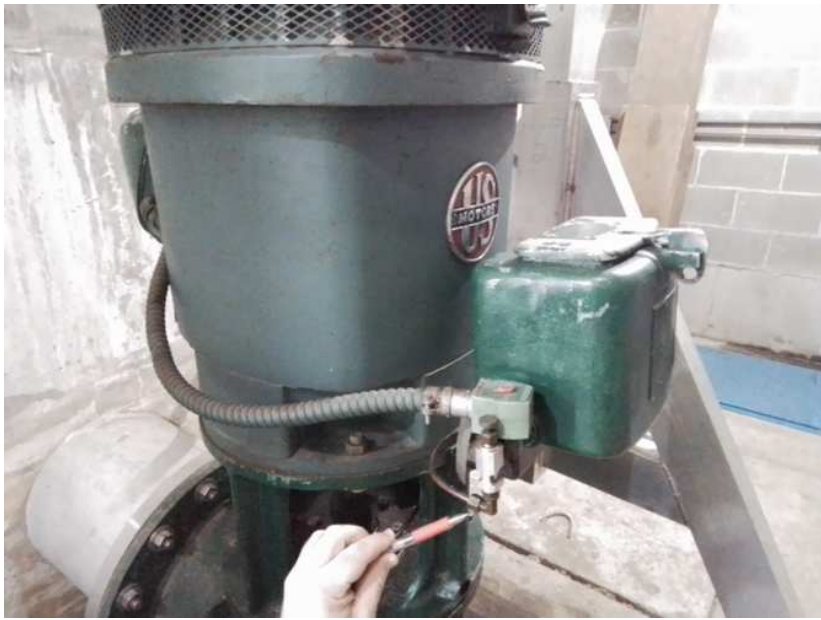
No User Rating (Site Visit) - PS-KA: Pump 2 - Evidence of oil leak on electrical motor shaft coupling

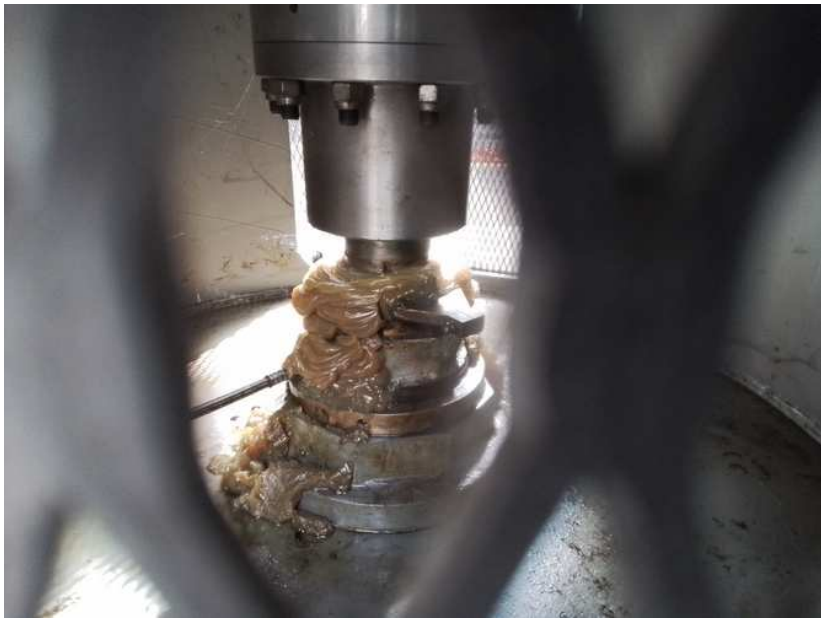
No User Rating (Site Visit) - PS-KA: Corrosion on pump 2 housing - noted during previous inspections
