US Army Corps
of Engineers ®

Site Visit Summary

Name of System: Hammond

Date of Site Visit: 04/29/2024 - 04/30/2024

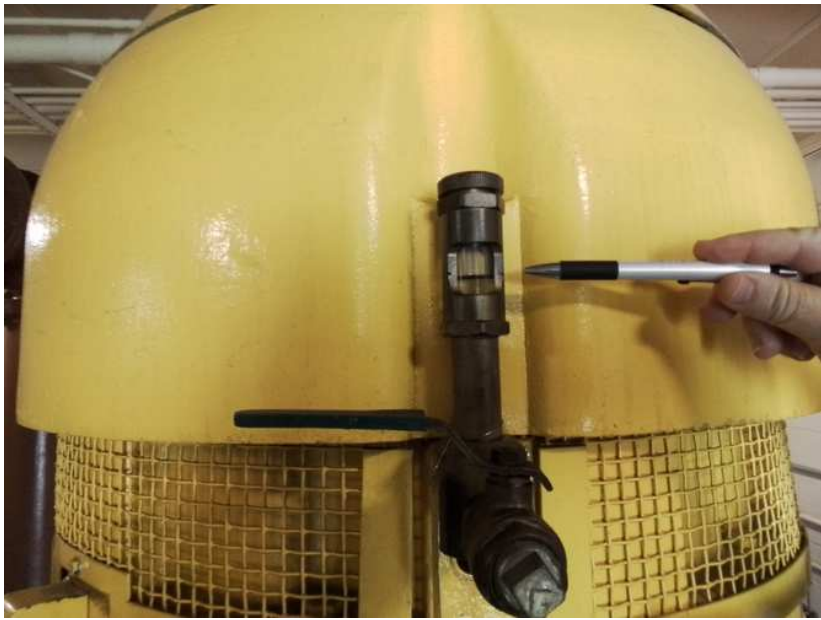
No User Rating (Site Visit) - PS-WA: Leak at electric motor drain valve on SWP-4

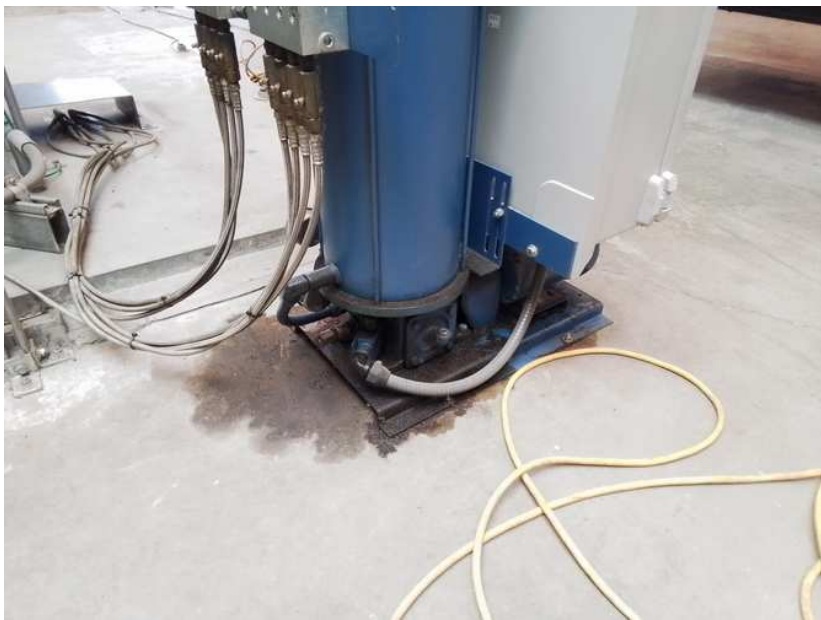
No User Rating (Site Visit) - PS-SS: Metal base for the SWP-4 lubricating grease system is heavily corroded - noted during previous inspections

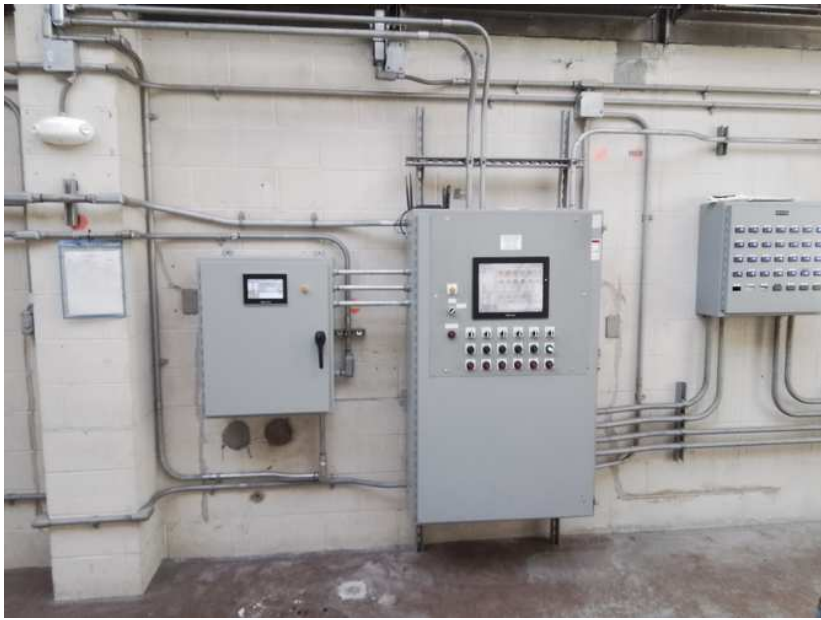
No User Rating (Site Visit) - PS-SK: Electrical enclosure for trash rake is highly corroded, does not appear to have worsened since last inspection
