## Site Visit Summary

Name of System: Marshalltown

NLD System ID: 2605000002

Date of Site Visit: 04/08/2024 - 04/10/2024

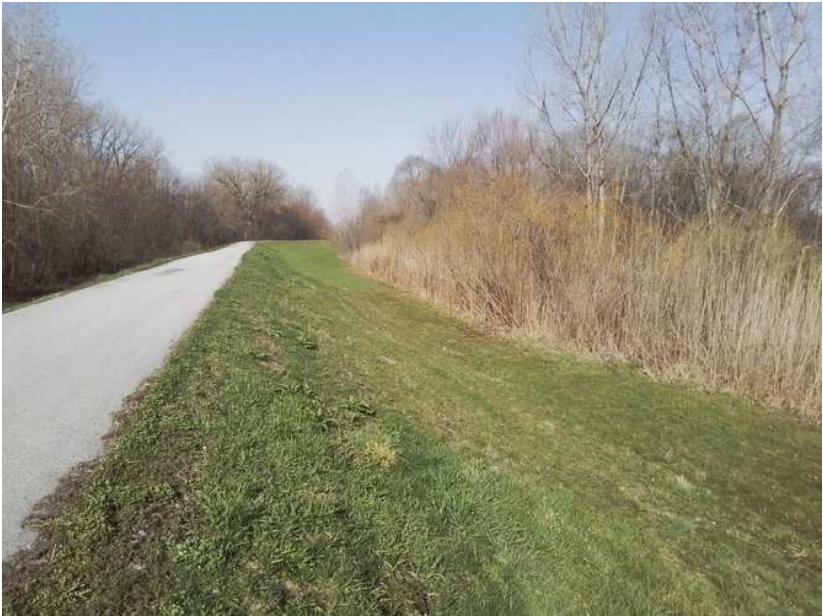
**Inspect ID:** 2024-0024  
**Rated Item:** 1. Unwanted Vegetation Growth  
**Lat/Long:** 41.57480/-87.29934  
**Caption:**  
No User Rating (Site Visit) - Vegetation encroaching on landside toe.

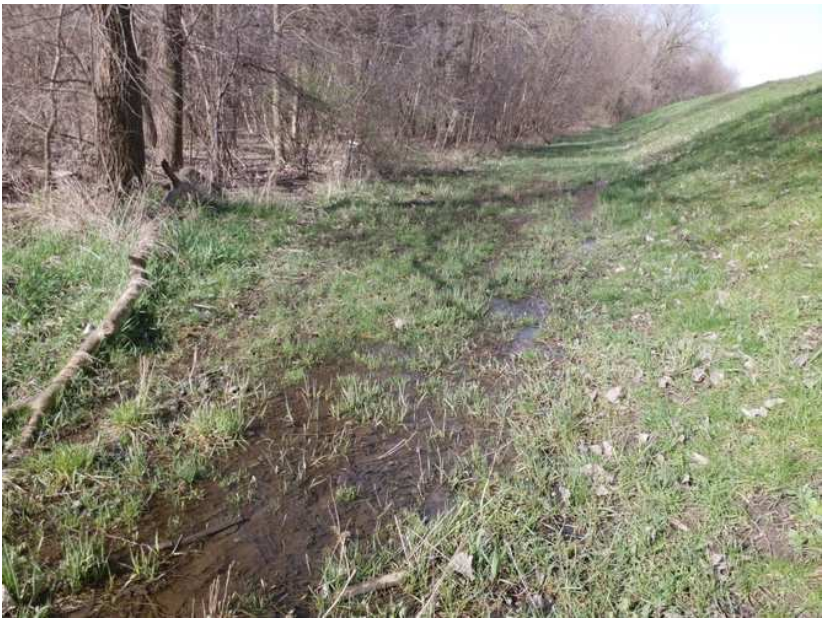
**Inspect ID:** 2024-0027  
**Rated Item:** 1. Unwanted Vegetation Growth  
**Lat/Long:** 41.57468/-87.29909  
**Caption:**  
No User Rating (Site Visit) - Riverside vegetation encroachment.

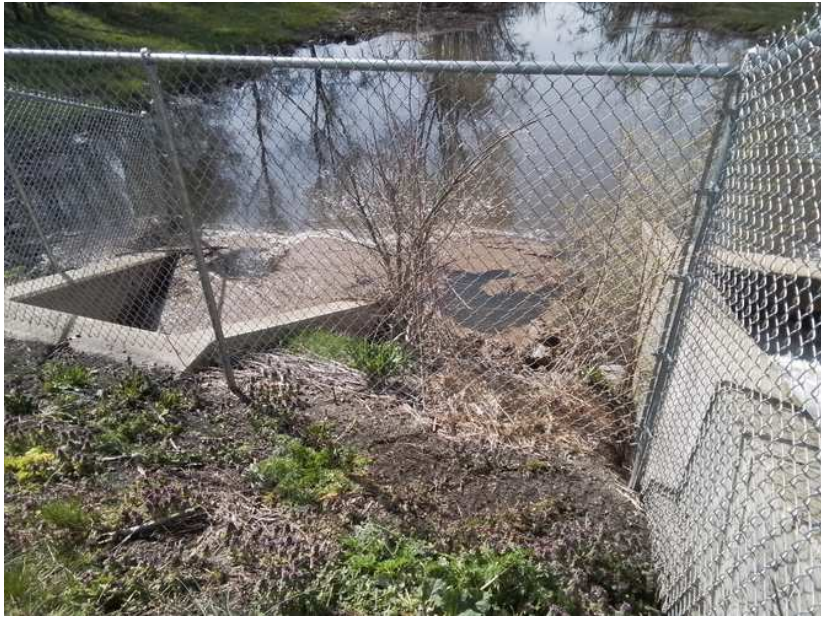
**Inspect ID:** 2024-0048

No User Rating (Site Visit) - Tree observed along the toe/slope on riverside.

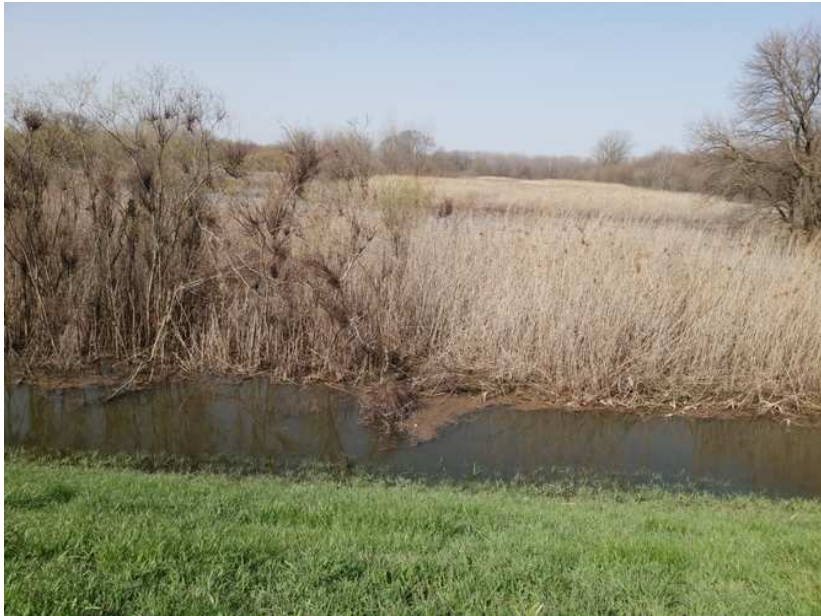
**Inspect ID:** 2024-0059

No User Rating (Site Visit) - Tree branches encroaching on riverside toe.

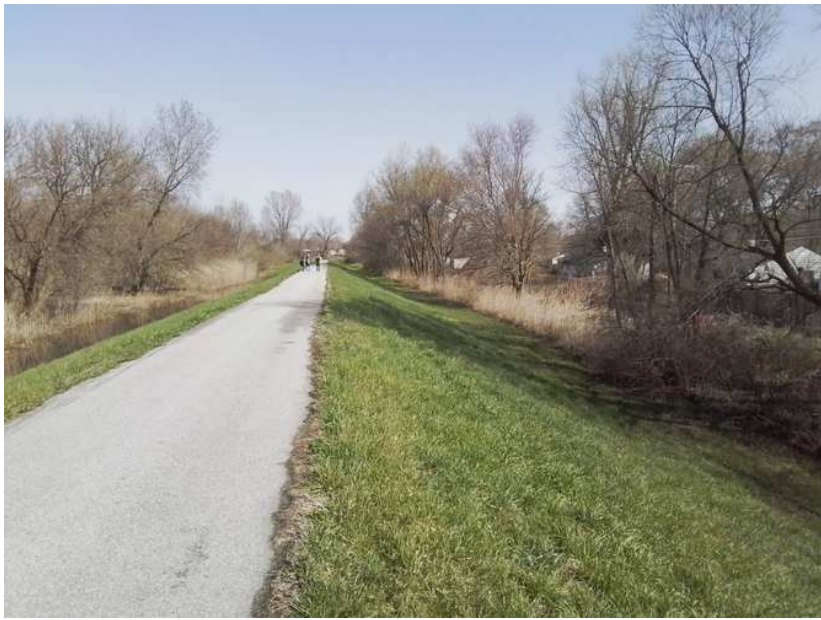
**Inspect ID:** 2024-0068

No User Rating (Site Visit) - Unwanted vegetation growth along the landside toe within the 15' vegetation free zone

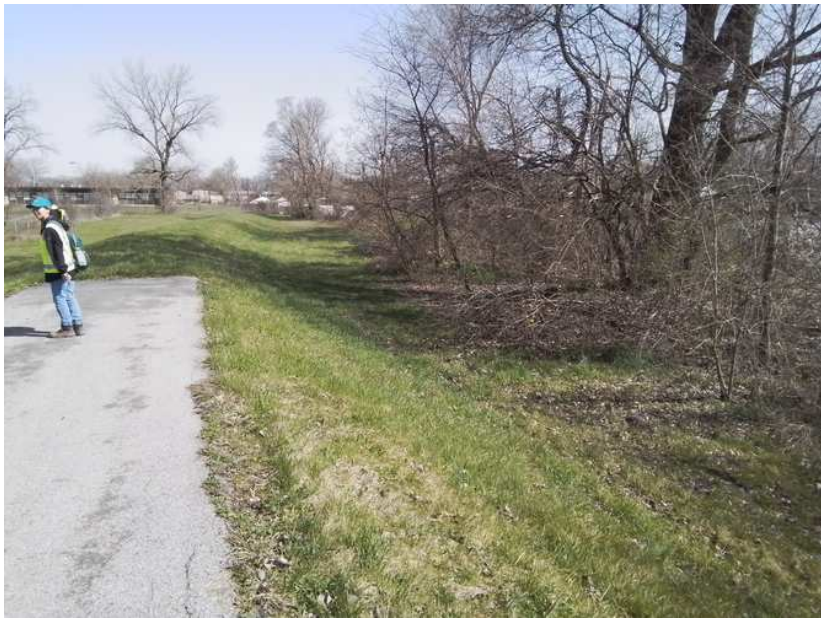
**Inspect ID:** 2024-0080

No User Rating (Site Visit) - Vegetation growth observed along landside toe.

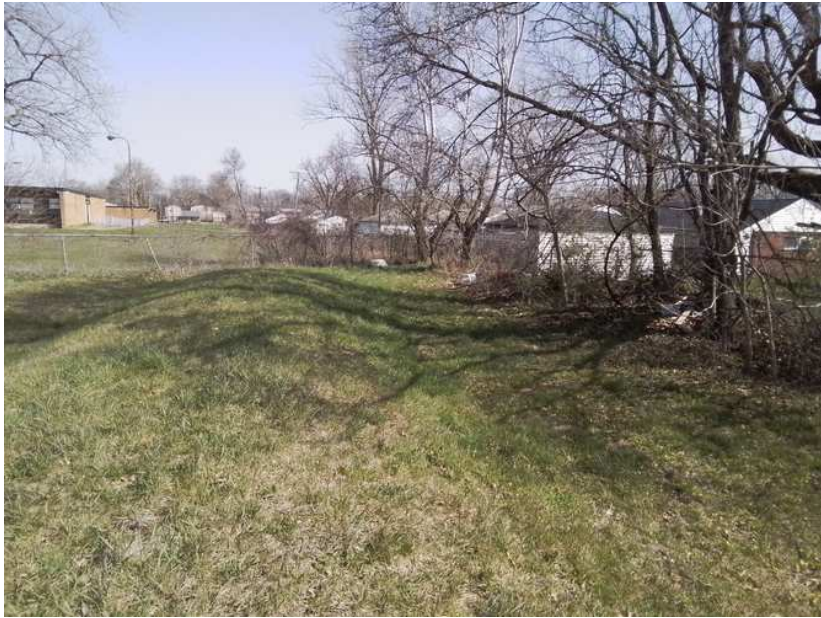
**Inspect ID:** 2024-0084

No User Rating (Site Visit) - Vegetation and debris observed along landside toe.

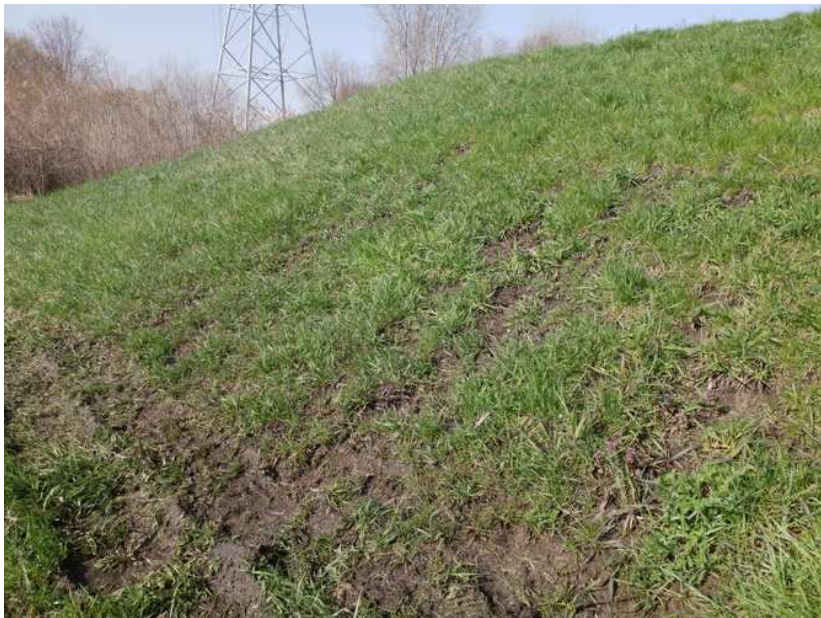
**Inspect ID:** 2024-0023

No User Rating (Site Visit) - Minor rutting on the riverside slope

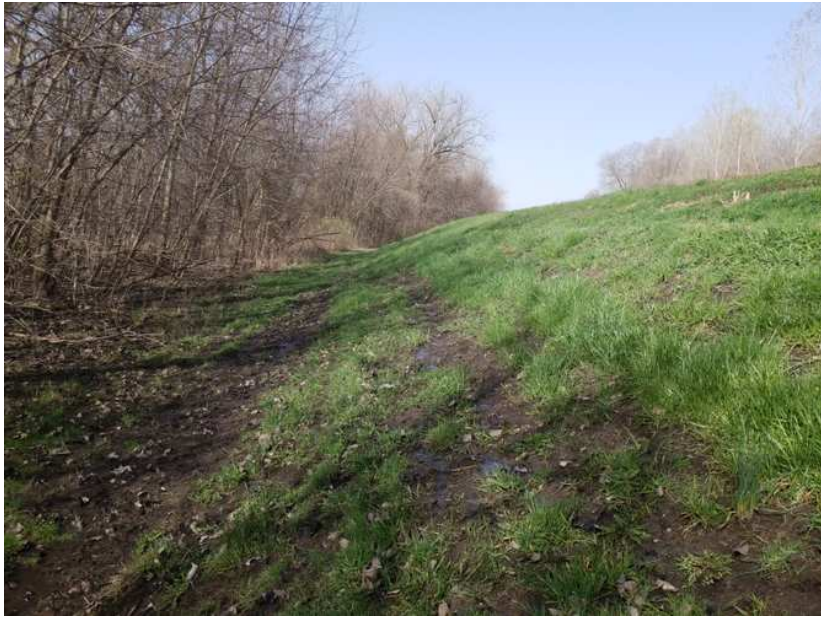
**Inspect ID:** 2024-0031

No User Rating (Site Visit) - Bare vegetation coverage on the riverside slope.

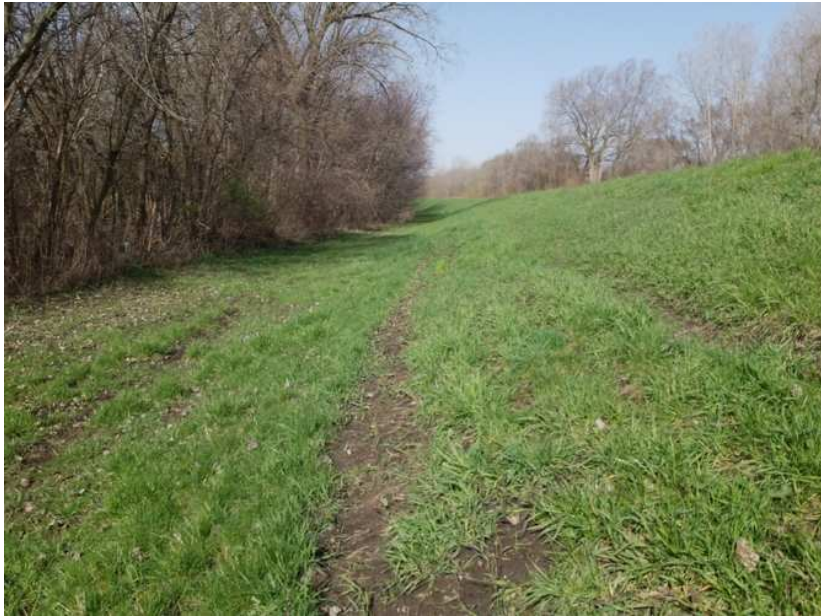
**Inspect ID:** 2024-0035

No User Rating (Site Visit) - Minor poor sod cover on the riverside slope

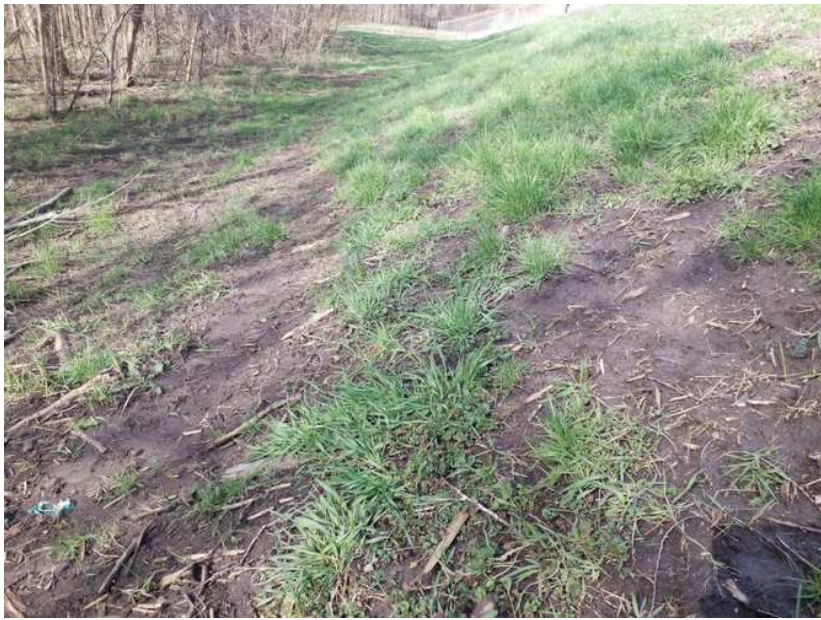
**Inspect ID:** 2024-0047

No User Rating (Site Visit) - Poor sod cover on the riverside slope

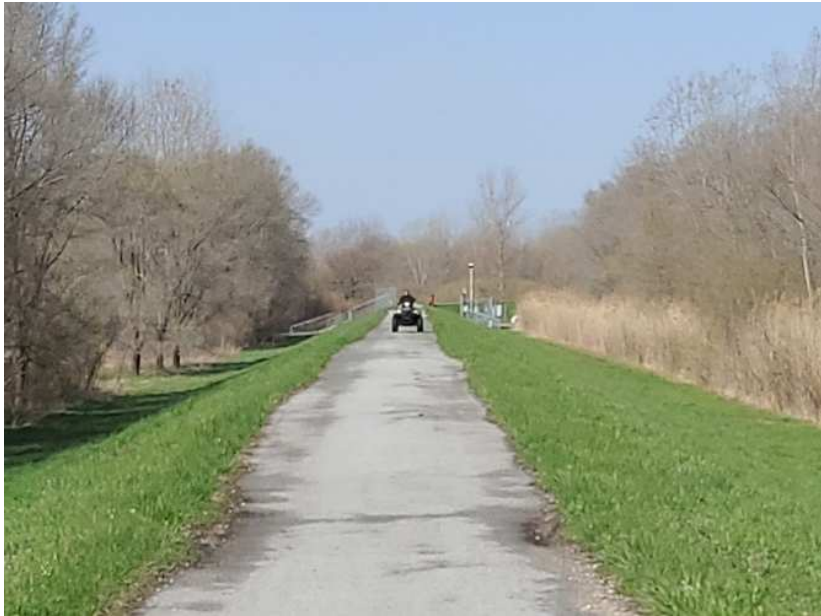
**Inspect ID:** 2024-0021

No User Rating (Site Visit) - 4 wheeler activity on levee.

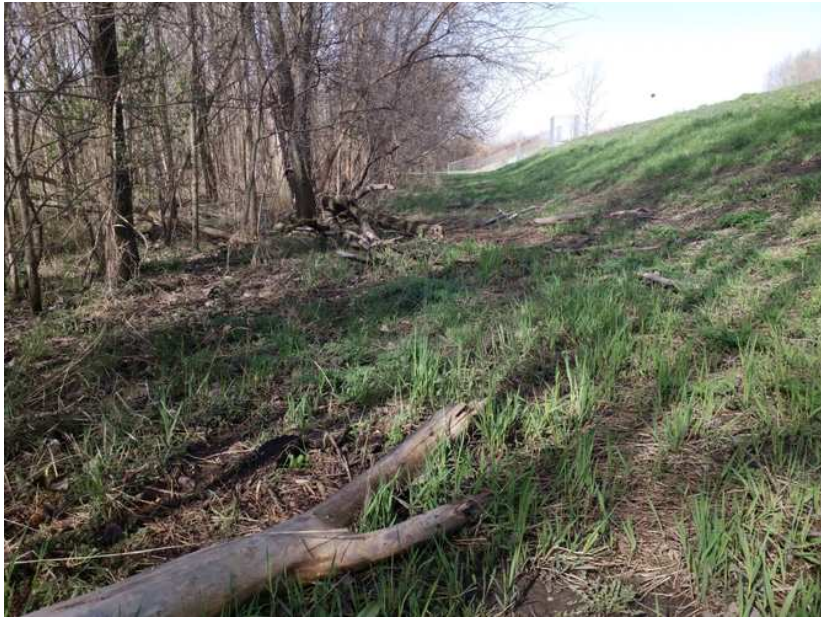
**Inspect ID:** 2024-0043

No User Rating (Site Visit) - Trees and fallen branches along riverside toe.

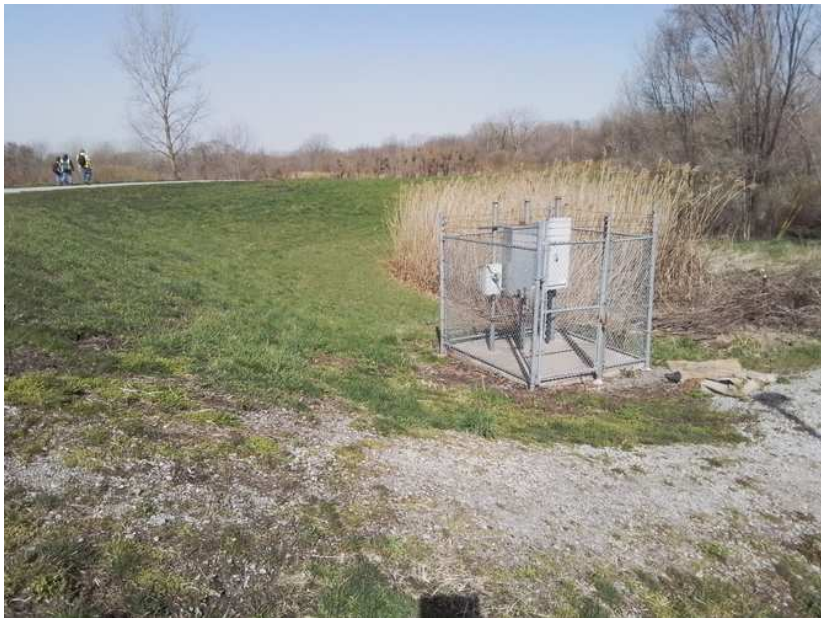
**Inspect ID:** 2024-0056

No User Rating (Site Visit) - Debris observed along landside toe.

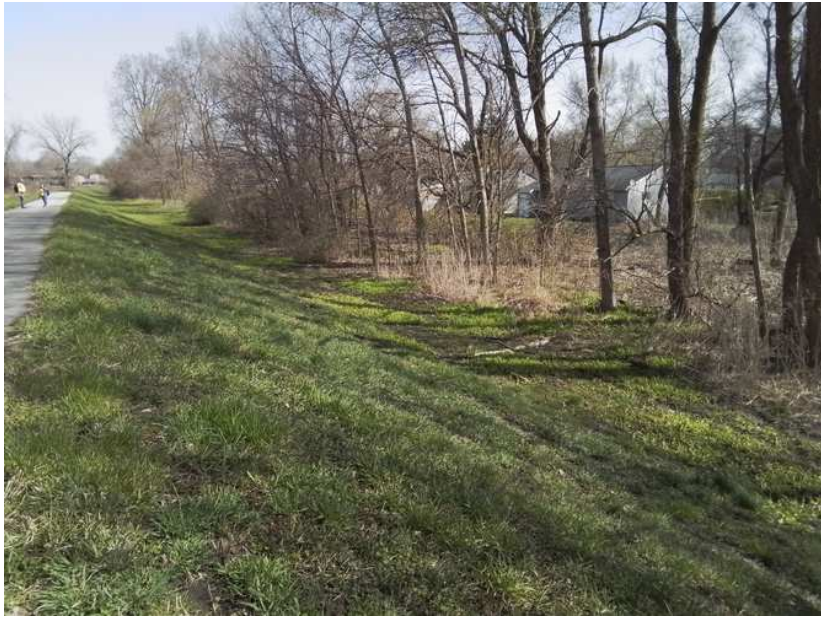
**Inspect ID:** 2024-0076

No User Rating (Site Visit) - Logs observed along landside toe of levee.

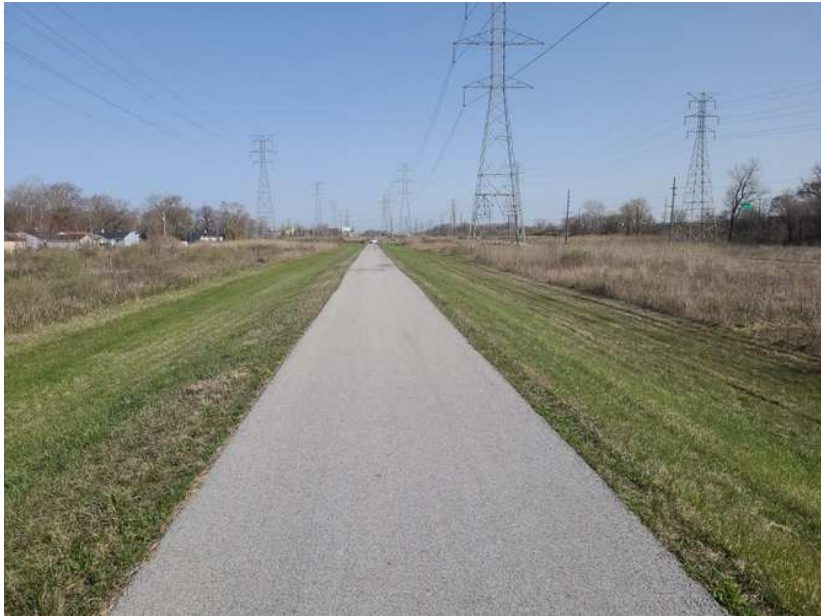
**Inspect ID:** 2024-0001

No User Rating (Site Visit) - Typical levee slopes on south end of levee.

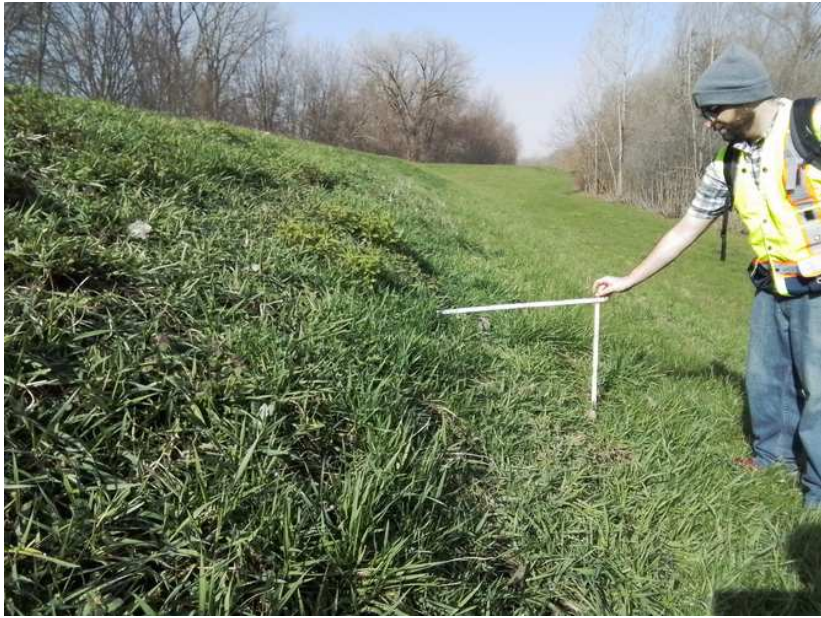
**Inspect ID:** 2024-0028

No User Rating (Site Visit) - Landslide slope observed to be 5:3 (H:V) along area where levee was raised.

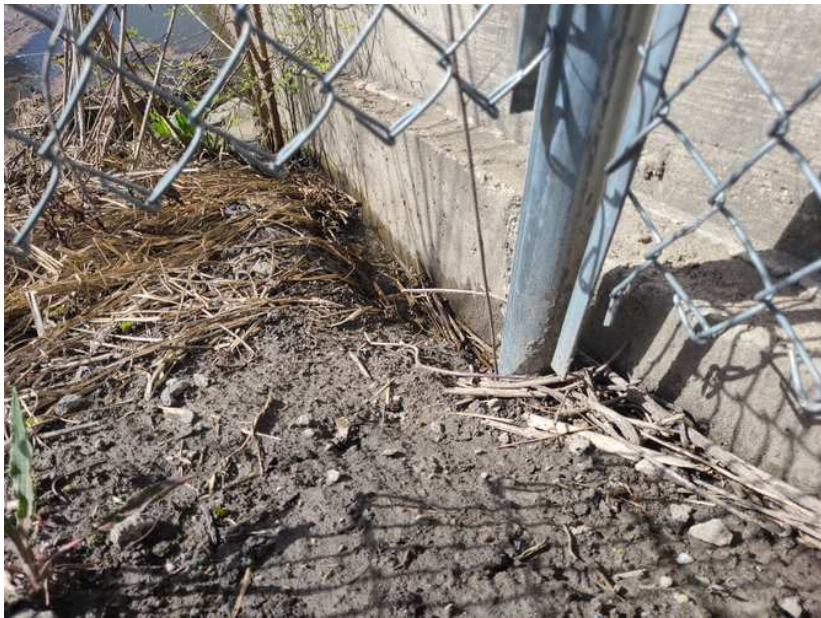
**Inspect ID:** 2024-0037

No User Rating (Site Visit) - Seepage from pump station outlet wall scouring side of slope.

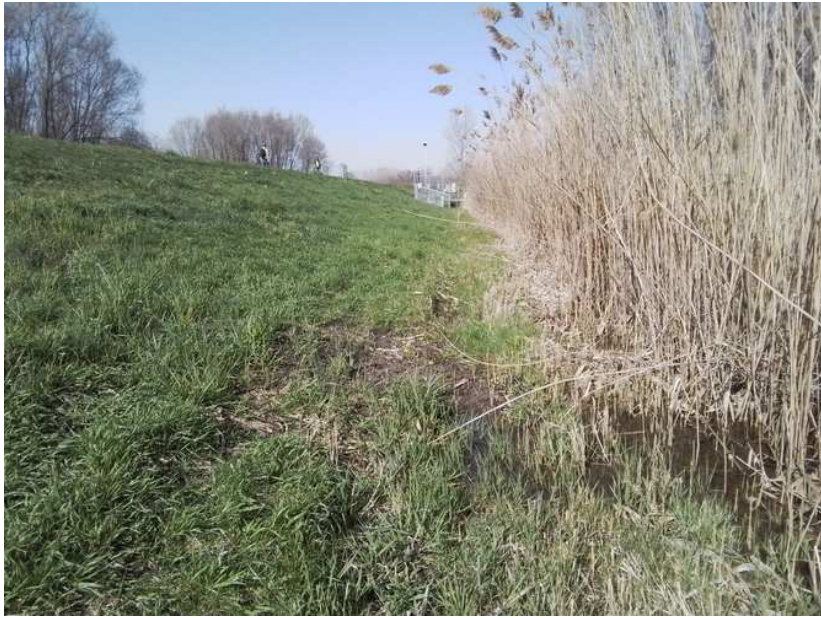
**Inspect ID:** 2024-0040

No User Rating (Site Visit) - Area along landside toe partially collapsed, ponding observed.

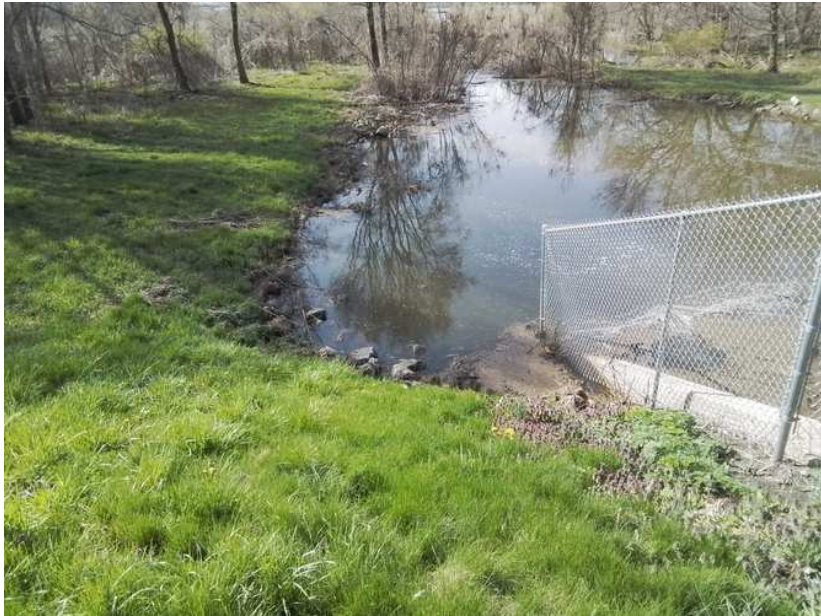
**Inspect ID:** 2024-0044

No User Rating (Site Visit) - Erosion and scour observed along riverside toe.

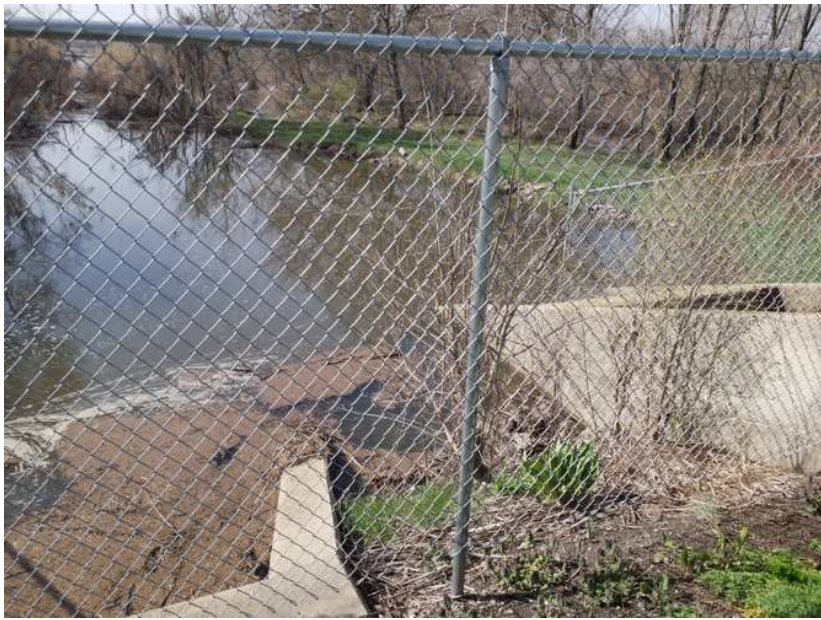
**Inspect ID:** 2024-0051

No User Rating (Site Visit) - Erosion cutting into riverside toe and slope

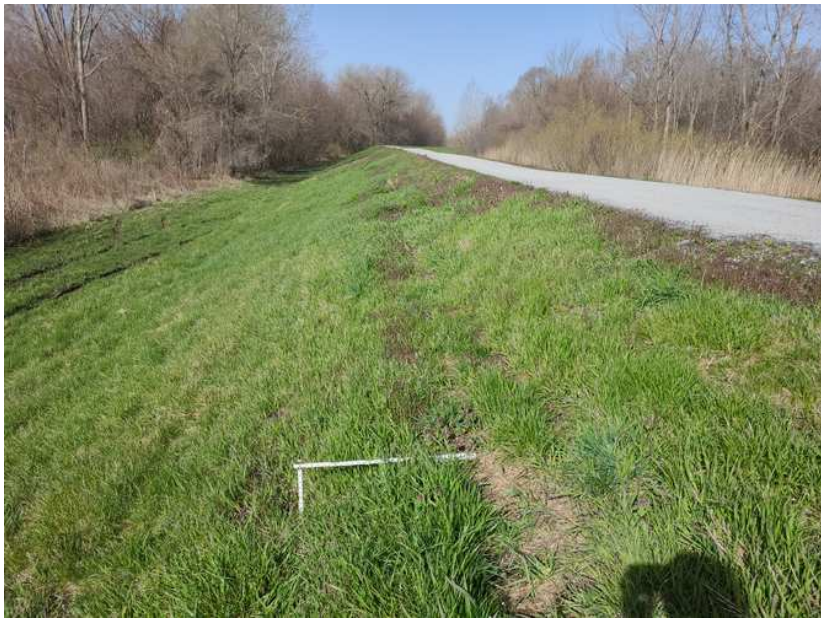
**Inspect ID:** 2024-0009

No User Rating (Site Visit) - Uneven slopes leading up to transition on riverside.

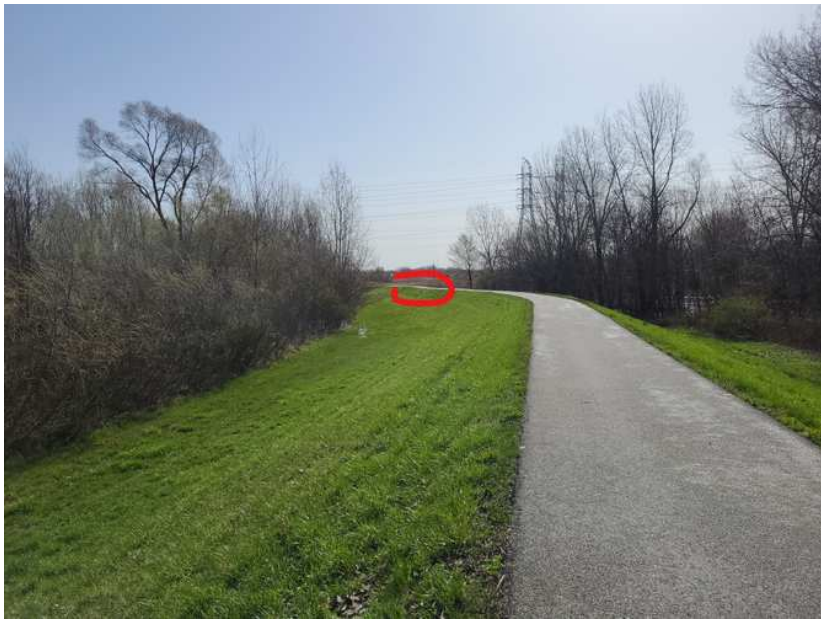
**Inspect ID:** 2024-0017

No User Rating (Site Visit) - Minor settlement of crest just north of first bend.

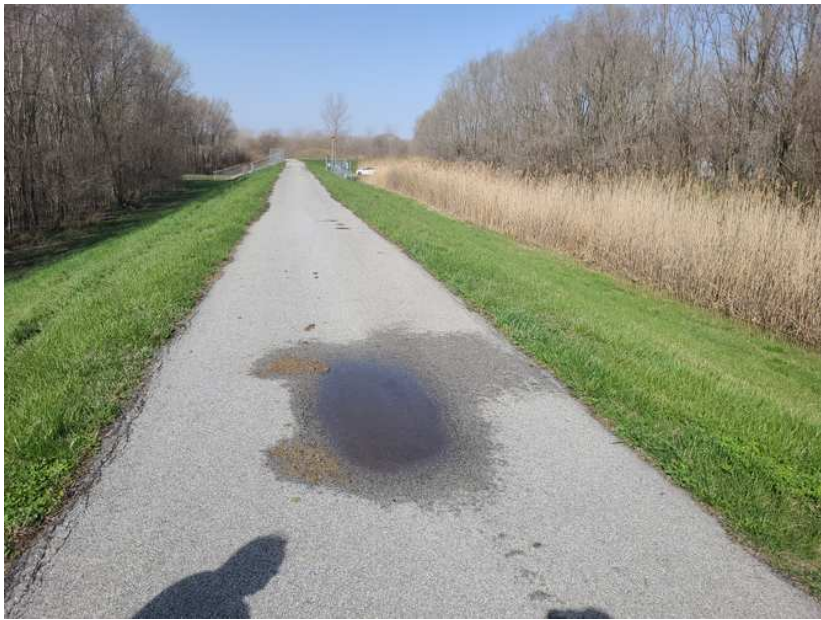
**Inspect ID:** 2024-0025

No User Rating (Site Visit) - Low point in crest

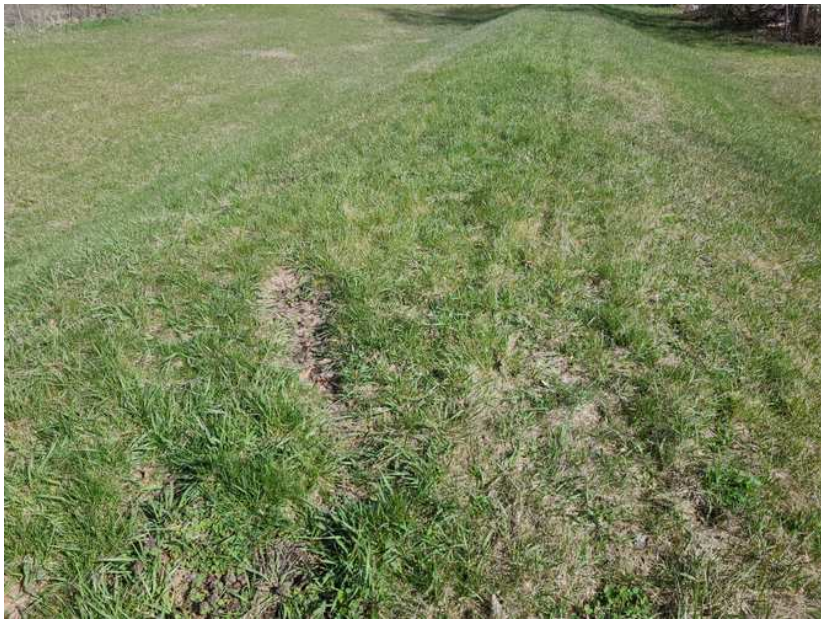
**Inspect ID:** 2024-0049  
**Rated Item:** 7. Settlement  
**Lat/Long:** 41.57804/-87.30667  
**Caption:**  
No User Rating (Site Visit) - Gouge in crest

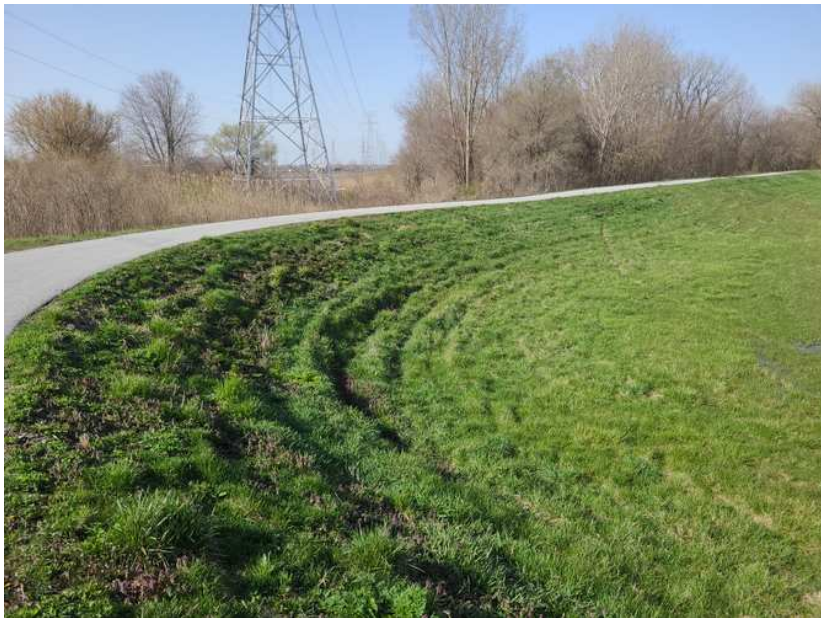
**Inspect ID:** 2024-0005  
**Rated Item:** 8. Depressions/ Rutting  
**Lat/Long:** 41.57491/-87.29858  
**Caption:**  
No User Rating (Site Visit) - Landside rutting on corner bend.

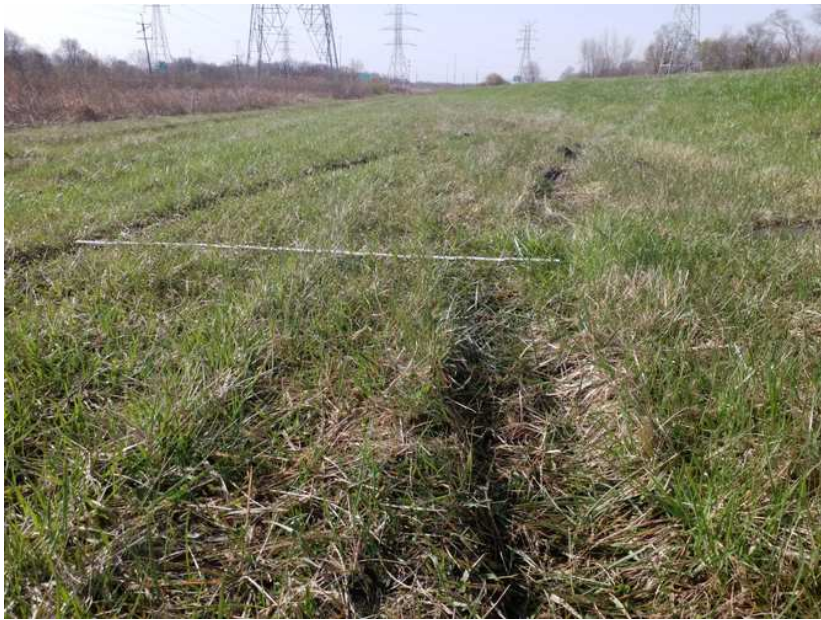
**Inspect ID:** 2024-0007

No User Rating (Site Visit) - Riverside toe rutting from vehicle.

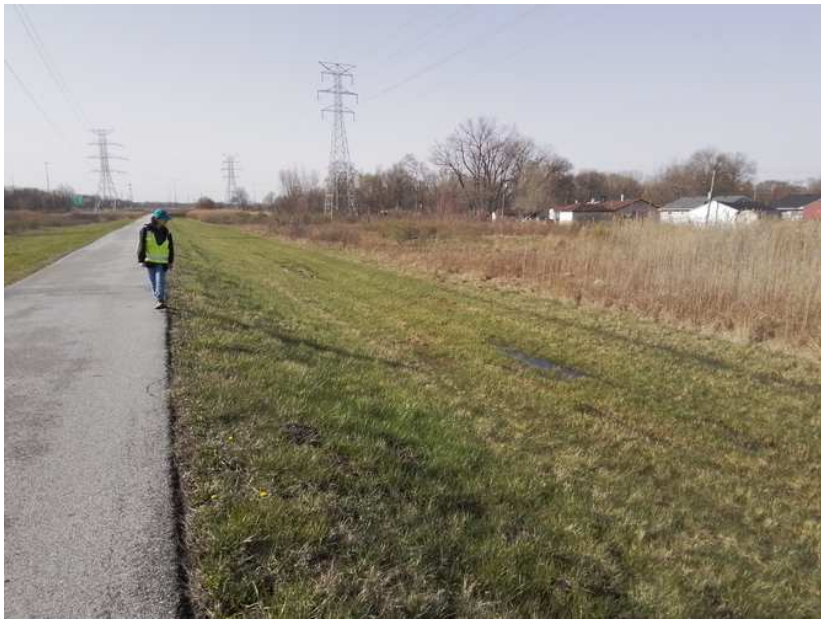
**Inspect ID:** 2024-0008

No User Rating (Site Visit) - Ponded water and rutting observed along landside toe.

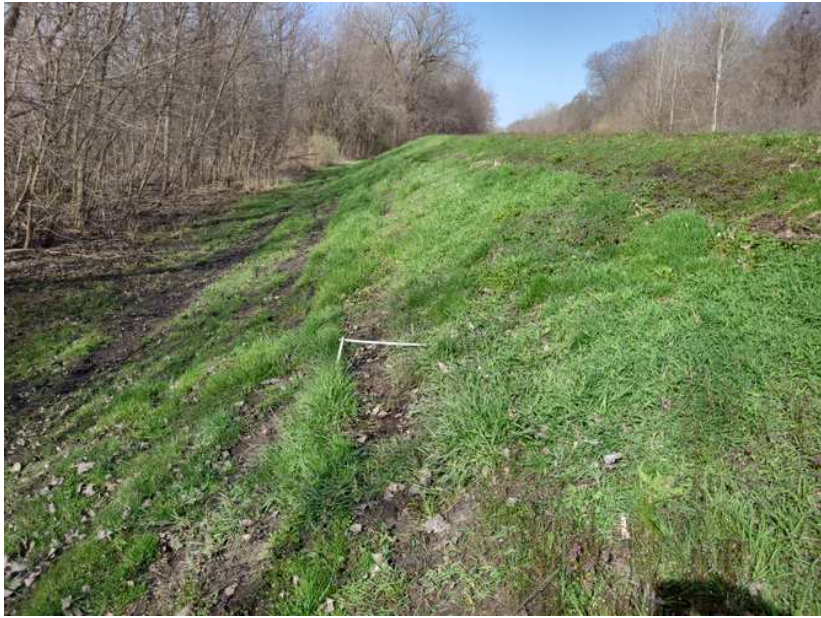
**Inspect ID:** 2024-0013

No User Rating (Site Visit) - Ruts on riverside slope. Some settlement in slope as well.

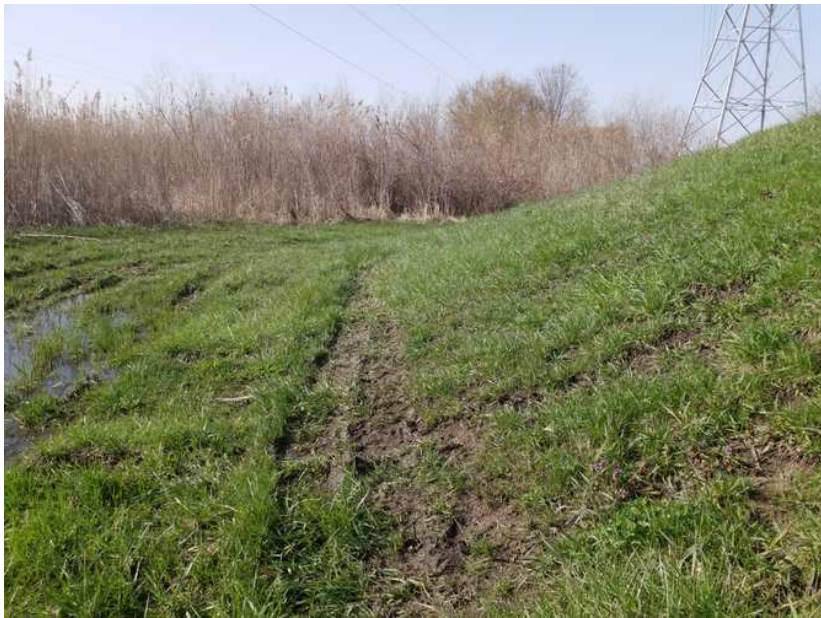
**Inspect ID:** 2024-0019

No User Rating (Site Visit) - Rutting continues around riverside bend.

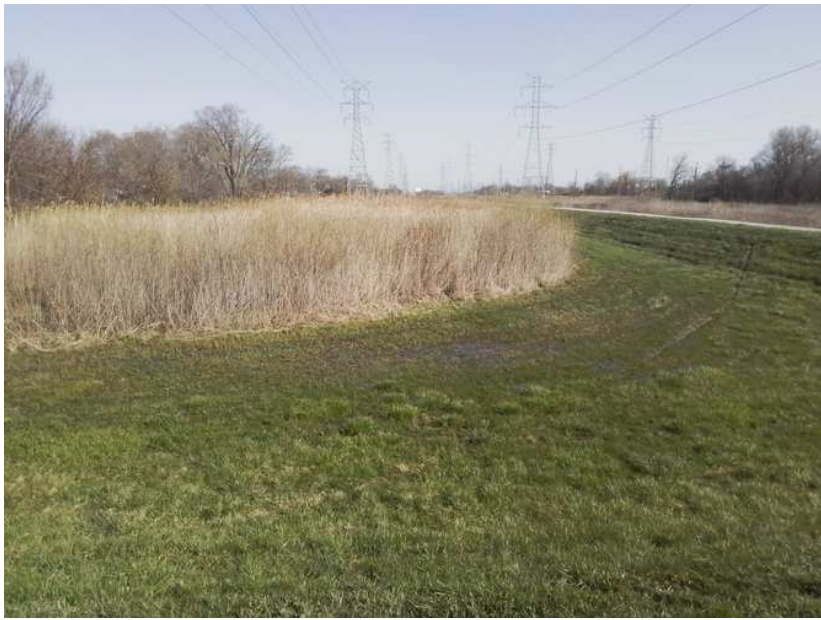
**Inspect ID:** 2024-0020

No User Rating (Site Visit) - Pondered water in ruts observed along landside toe.

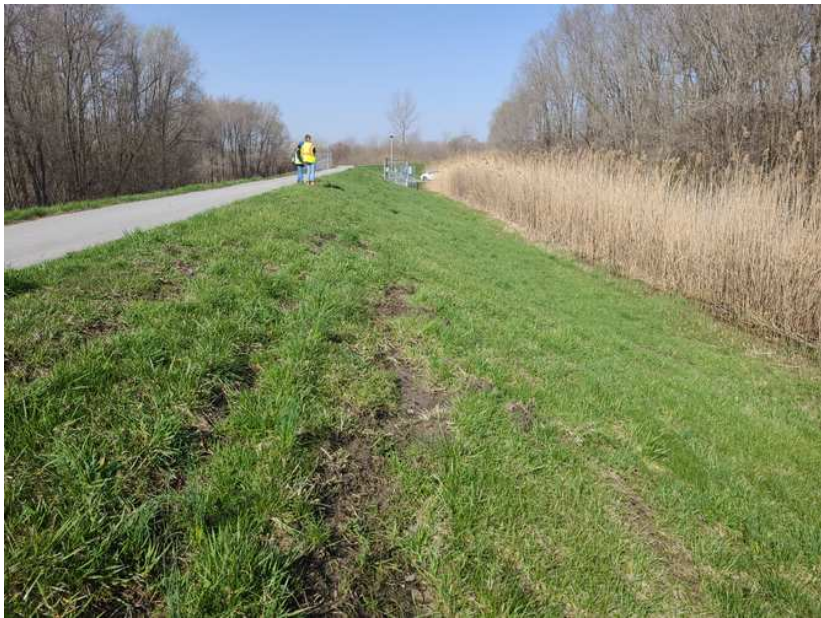
**Inspect ID:** 2024-0029

No User Rating (Site Visit) - Minor rutting on landside slope

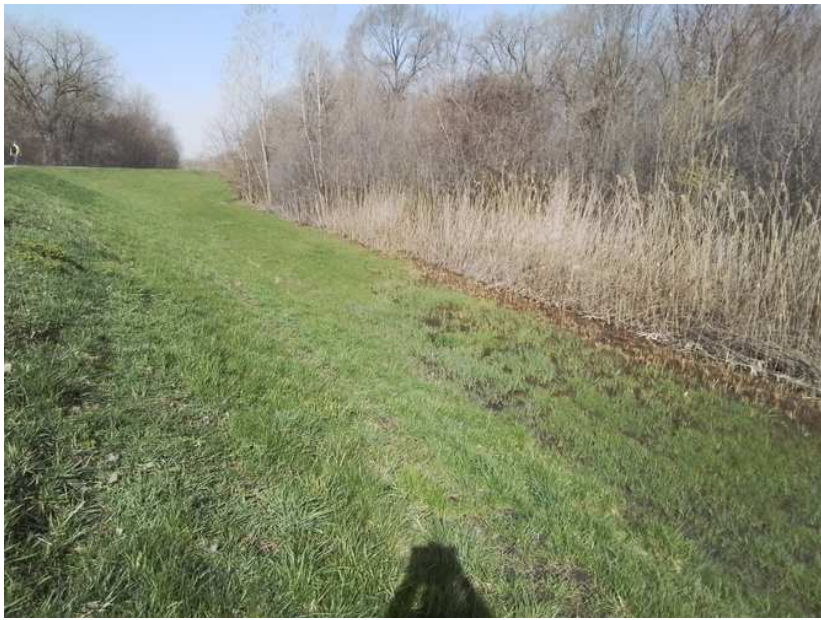
**Inspect ID:** 2024-0032

No User Rating (Site Visit) - Ponding observed along landslide toe.

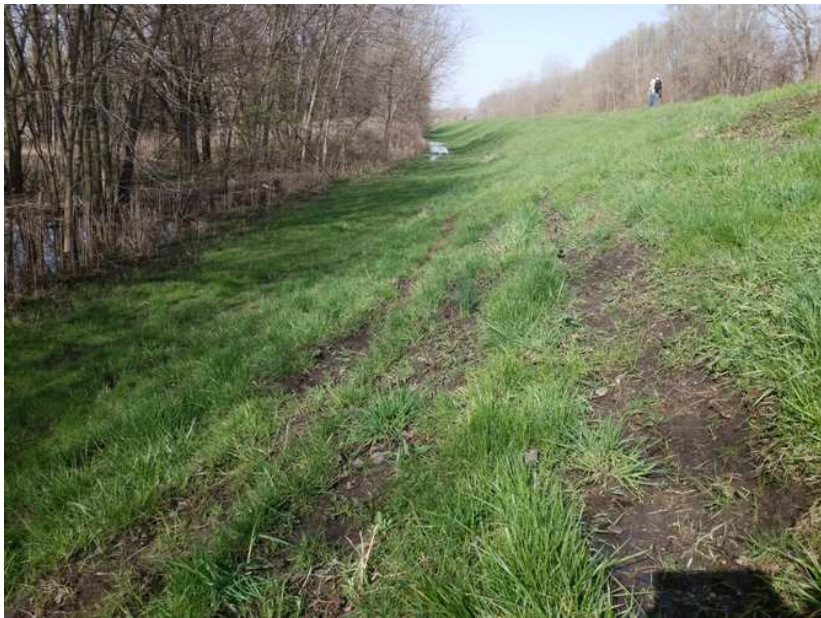
**Inspect ID:** 2024-0039

No User Rating (Site Visit) - Riverside rutting on slope by vehicle tires, loss of vegetation coverage. About 100 ft long going east to west.

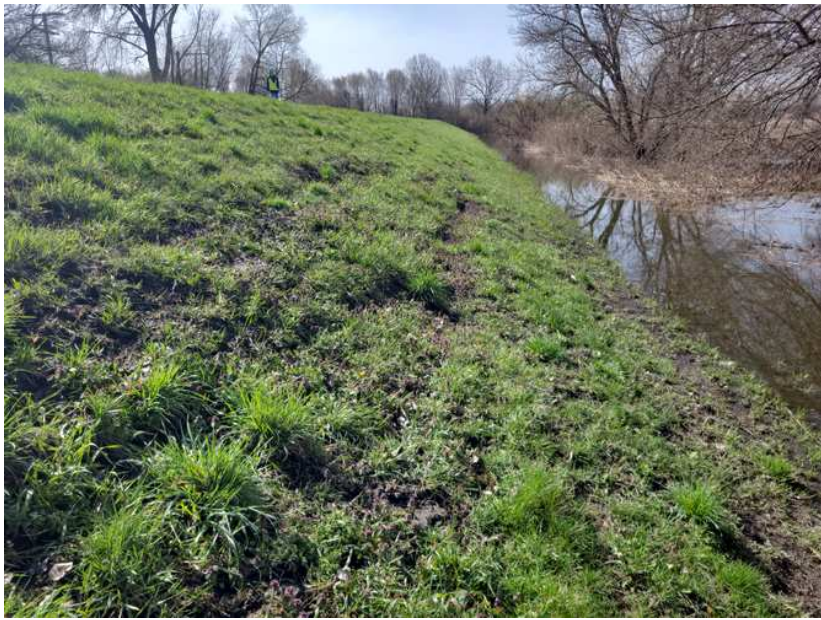
**Inspect ID:** 2024-0041

No User Rating (Site Visit) - Large rutting on riverside slope

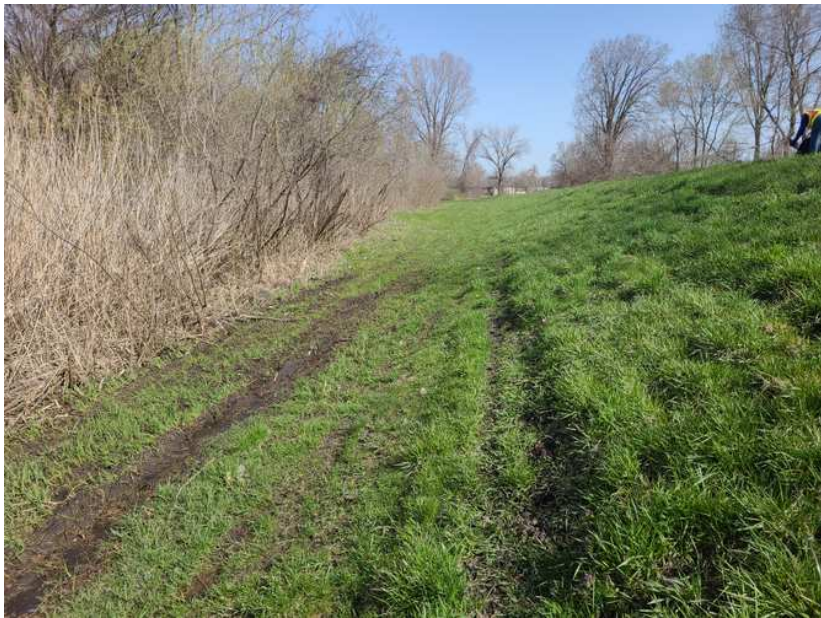
**Inspect ID:** 2024-0045

No User Rating (Site Visit) - Rutting on riverside toe.

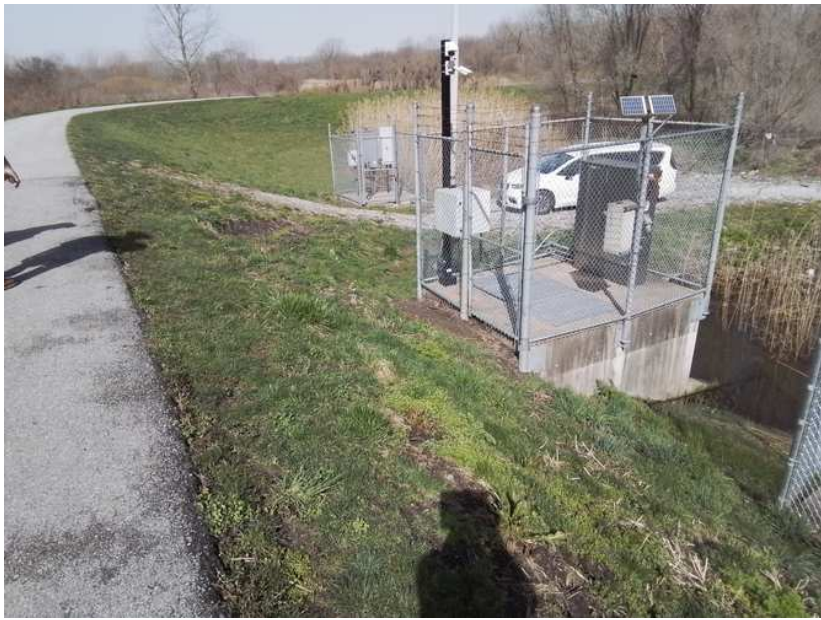
**Inspect ID:** 2024-0052

No User Rating (Site Visit) - Rutting observed along landside slope.

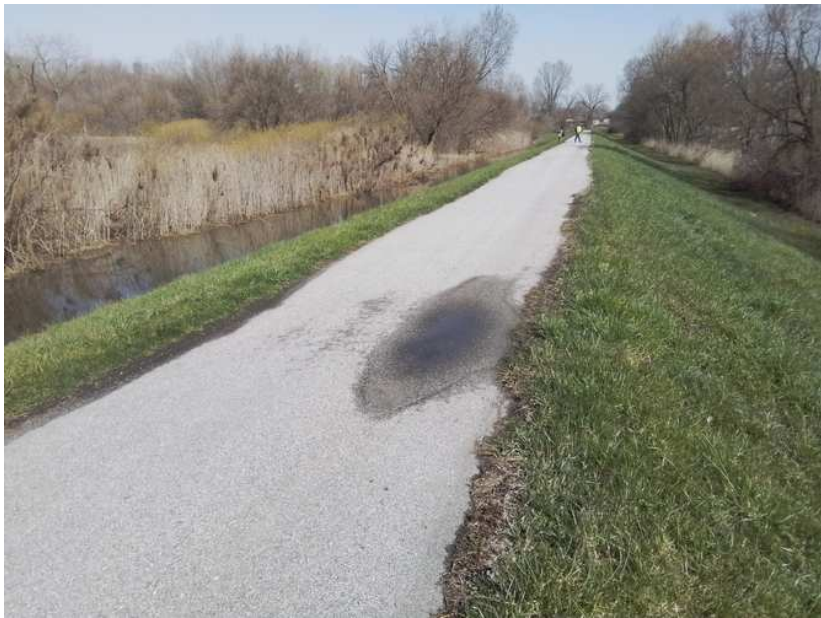
**Inspect ID:** 2024-0064

No User Rating (Site Visit) - Depression and ponding observed along levee crown.

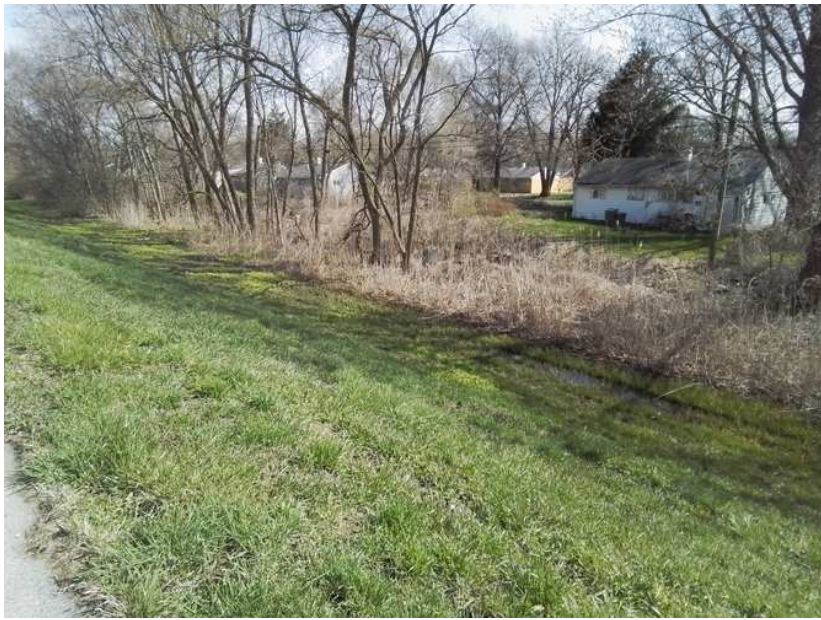
**Inspect ID:** 2024-0072

No User Rating (Site Visit) - Rutting and ponding observed along landside toe.

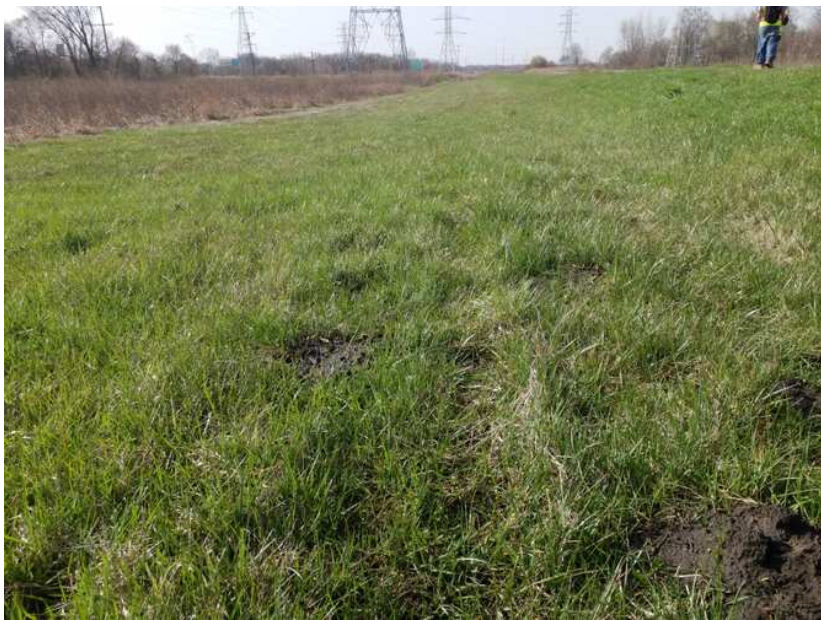
**Inspect ID:** 2024-0003

No User Rating (Site Visit) - Lot of burrows in this area of riverside slope.

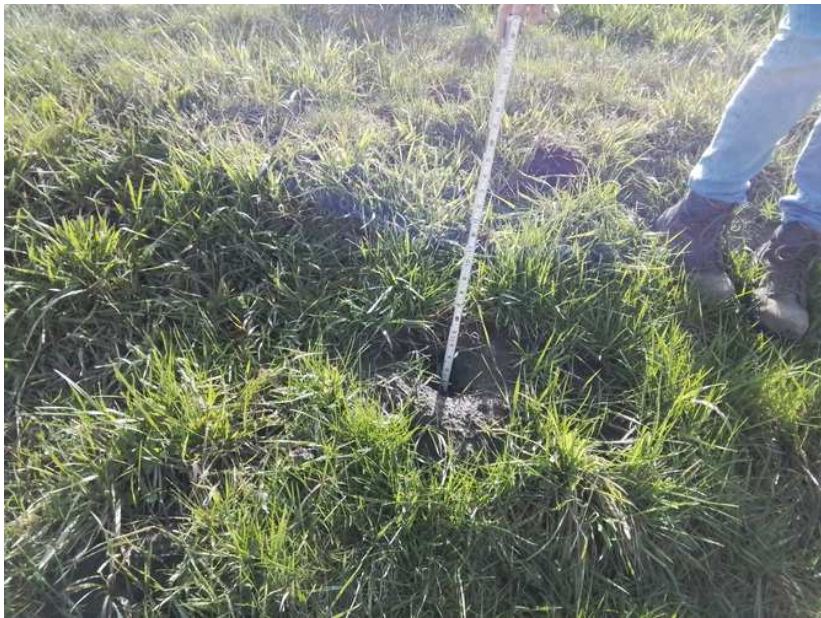
**Inspect ID:** 2024-0004

No User Rating (Site Visit) - Small hole (3" deep , 3" wide) observed along landside slope.

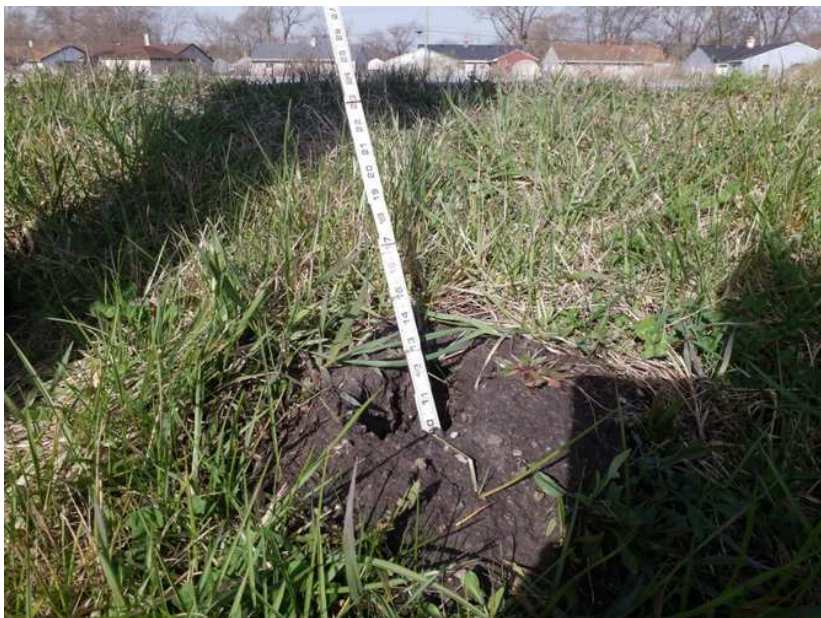
**Inspect ID:** 2024-0011

No User Rating (Site Visit) - Animal burrow 8 inches deep on riverside slope.

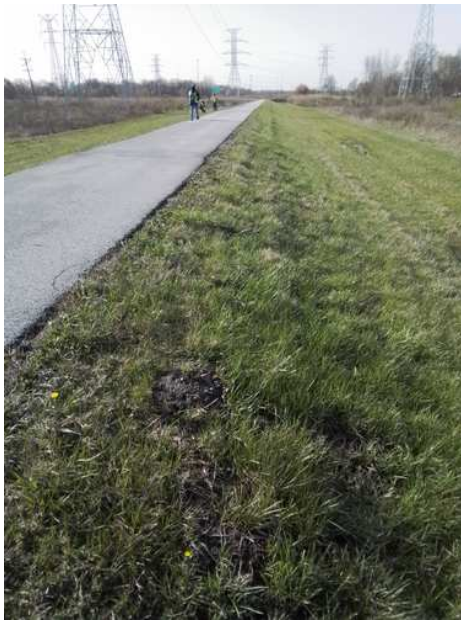
**Inspect ID:** 2024-0012

No User Rating (Site Visit) - Animal burrows observed along landside slope.
