## Site Visit Summary

Name of System: Marshalltown

NLD System ID: 2605000002

Date of Site Visit: 04/08/2024 - 04/10/2024

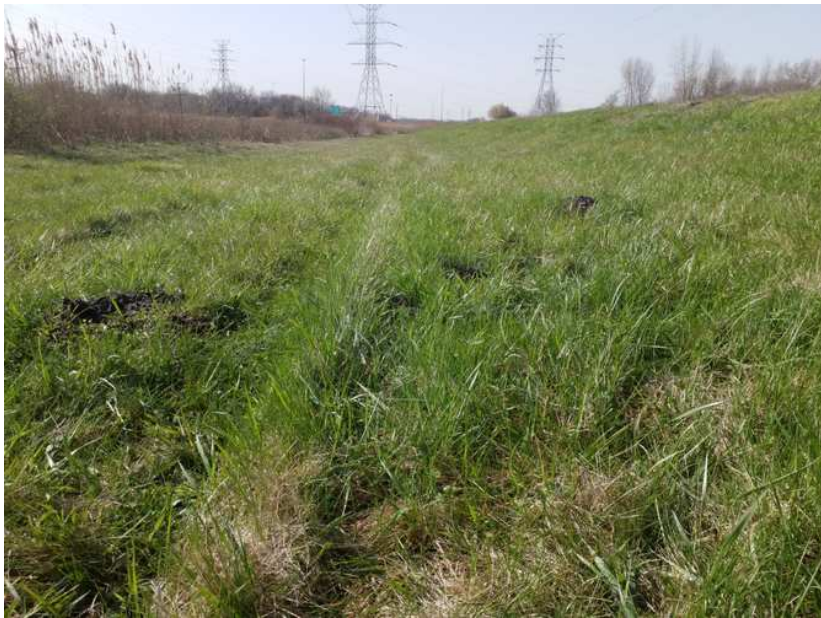
**Inspect ID:** 2024-0015

No User Rating (Site Visit) -Typical animal burrows on riverside toe.

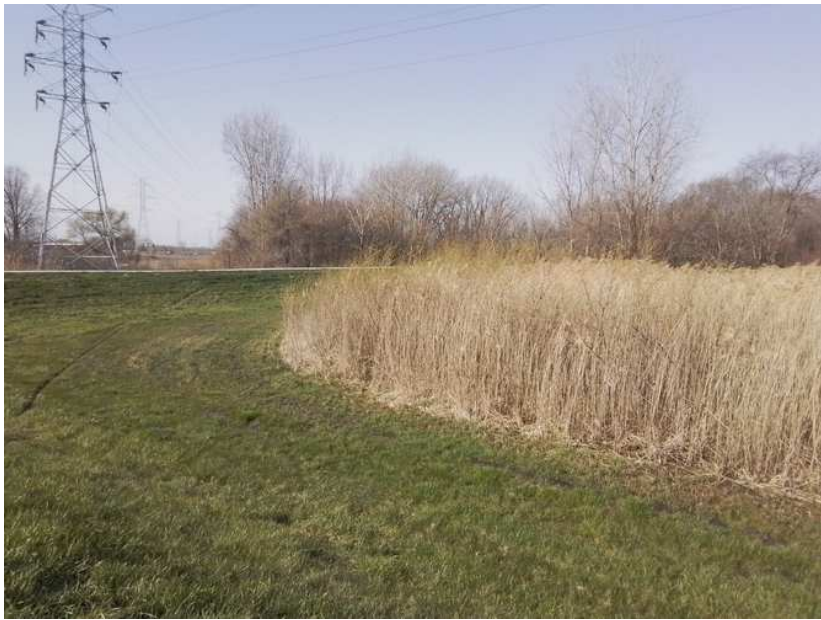
**Inspect ID:** 2024-0016

No User Rating (Site Visit) - Small trees and phragmites growing in landside ditch.

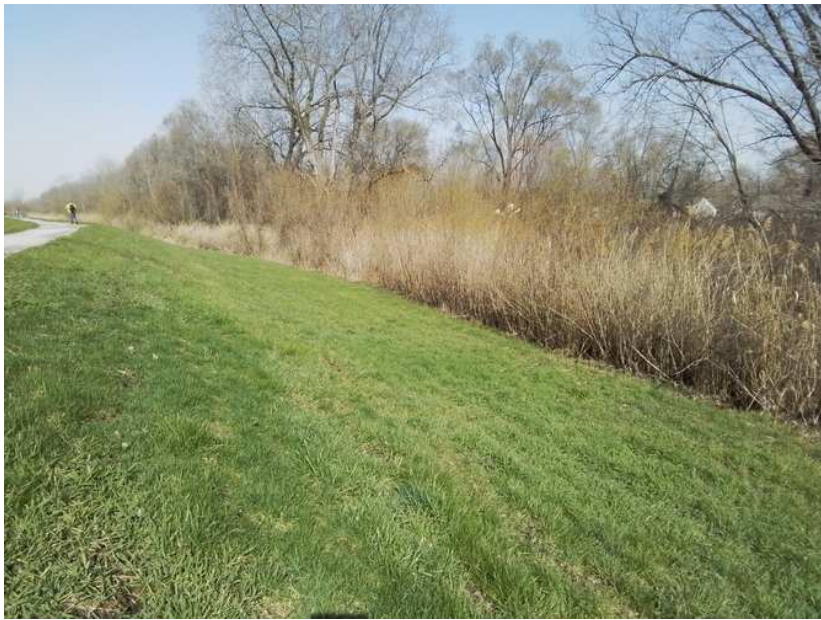
**Inspect ID:** 2024-0036

No User Rating (Site Visit) - Small trees growing in landside ditch.

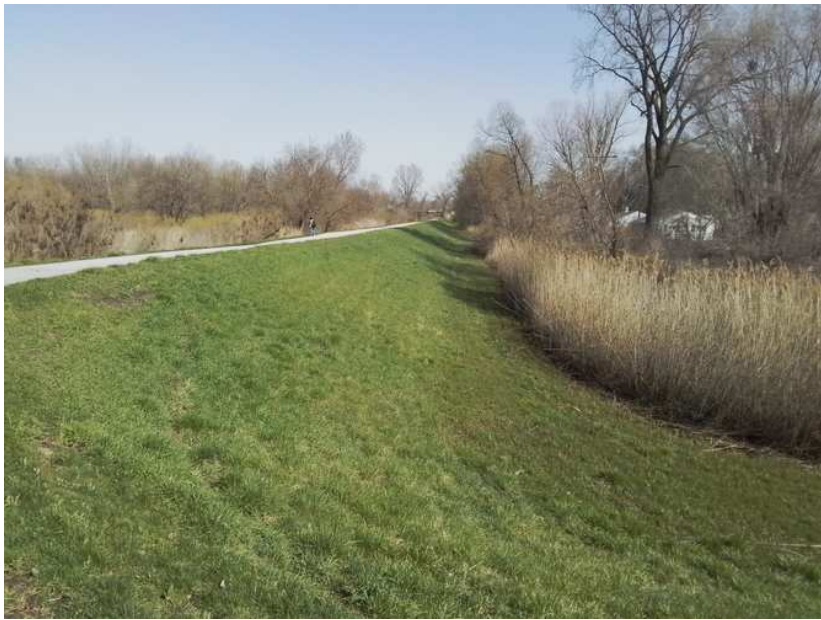
**Inspect ID:** 2024-0060

No User Rating (Site Visit) - Tree and phragmite growth observed in landside ditch.

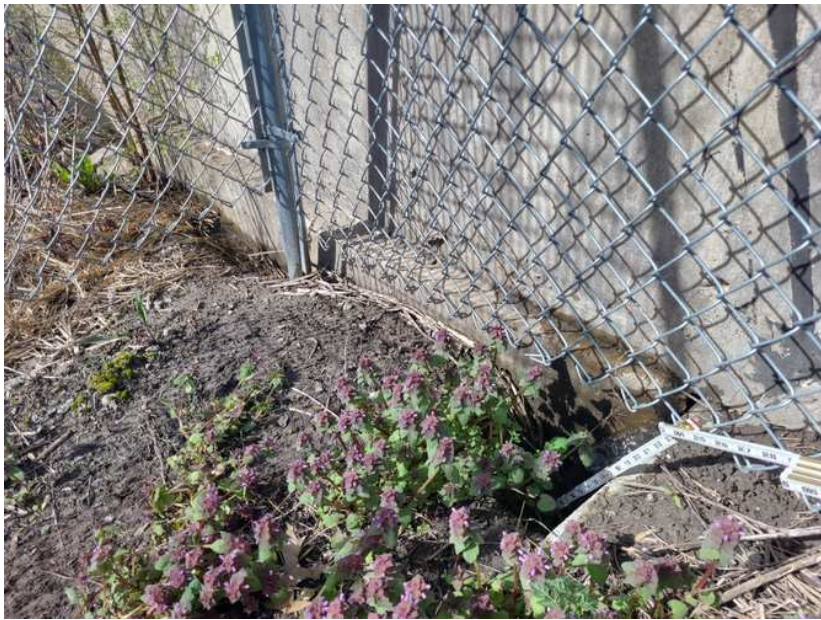
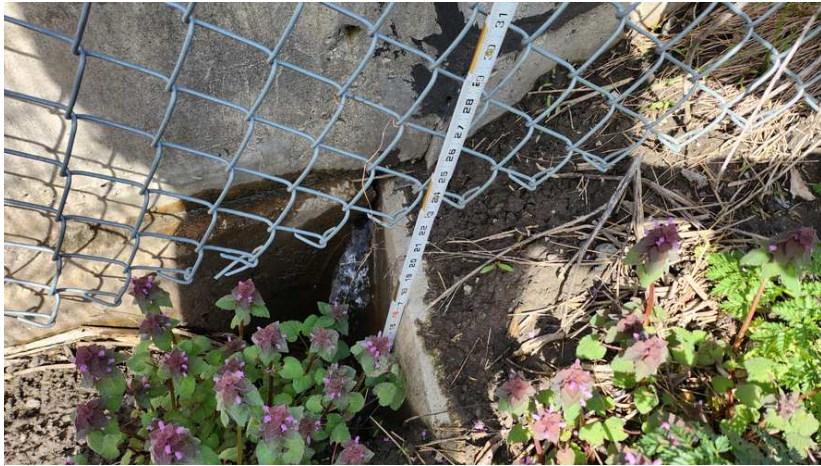
**Inspect ID:** 2024-0033

Significant issues with a crack in the pump station spillway leading to erosion. There were also minor issues with unwanted vegetation, debris encroachments, animal burrows, rutting, sod cover, asphalt cracking, uneven slopes, depressions on the crest, concrete cracking and spalling, pump station electrical switch issues, and a pump station secondary closure stuck open.

No User Rating (Site Visit) - Hole in wall leading to large amount of water, which is eroding soils adjacent to the spillway

0033 - No User Rating (Site Visit) - Hole in wall leading to large amount of water, which is eroding soils adjacent to the spillway

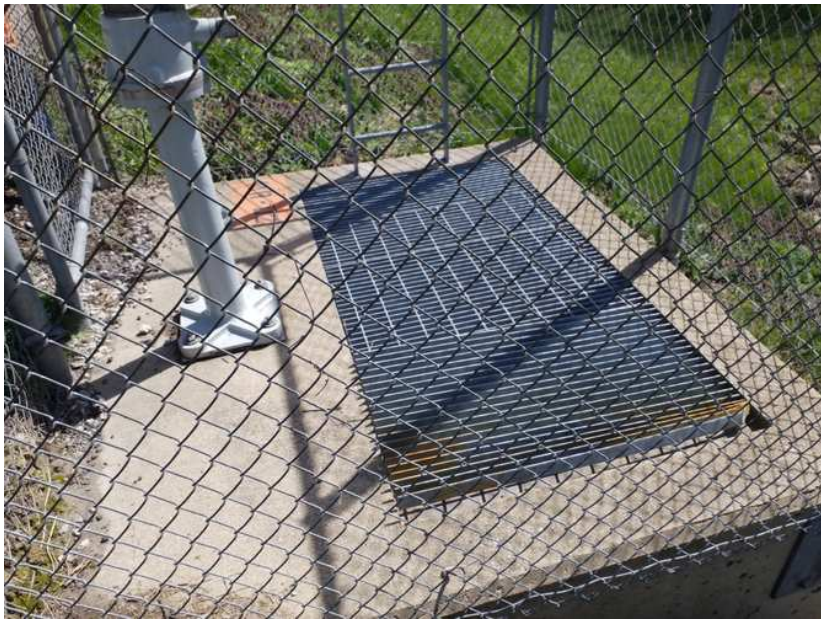
**Inspect ID:** 2024-0085

0085 - No User Rating (Site Visit) MR-02: operated successfully. Damage to grate.

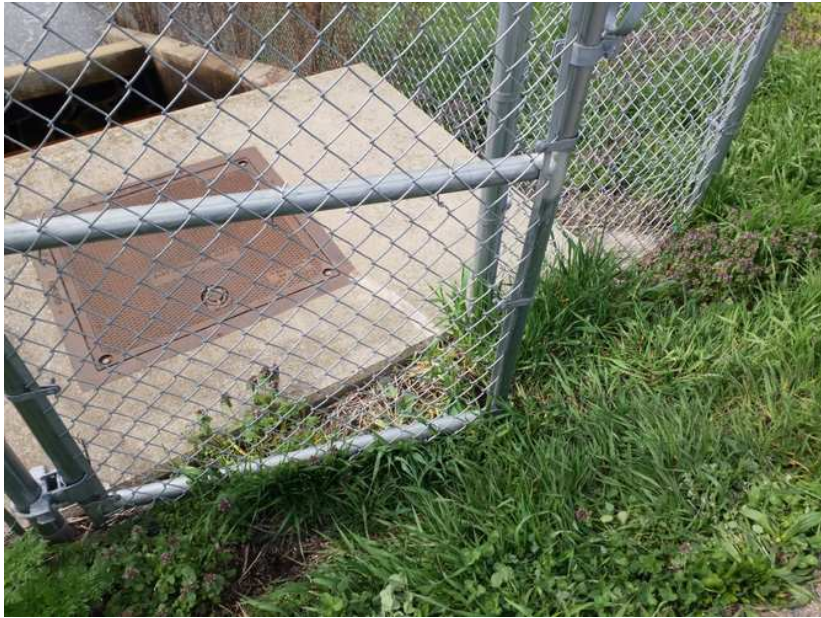
**Inspect ID:** 2024-0010

No User Rating (Site Visit) - PS-MR gate is hard to open because of soil blocking it.

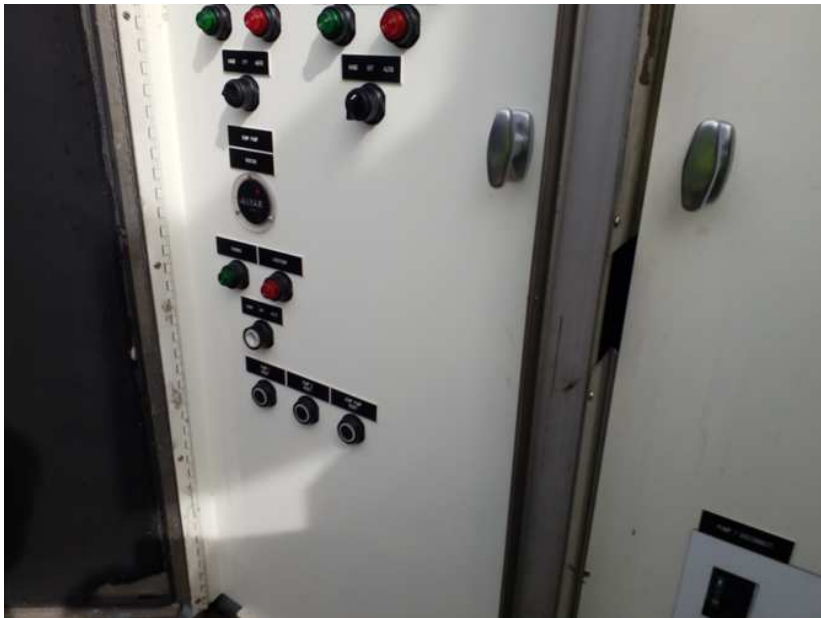
**Inspect ID:** 2024-0002

No User Rating (Site Visit) -PS-MR hand auto off switch for sump missing.

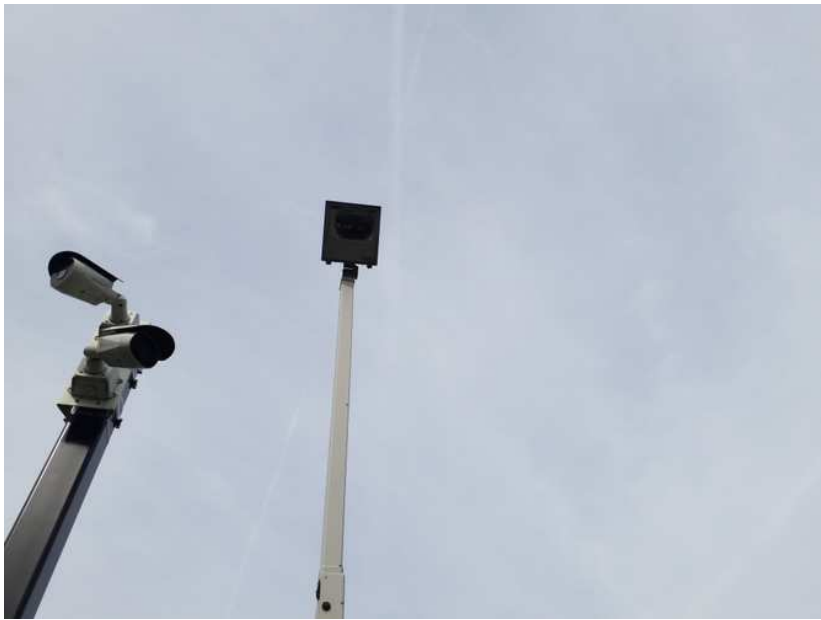
**Inspect ID:** 2024-0006

No User Rating (Site Visit) - PS-MR cover missing on light.

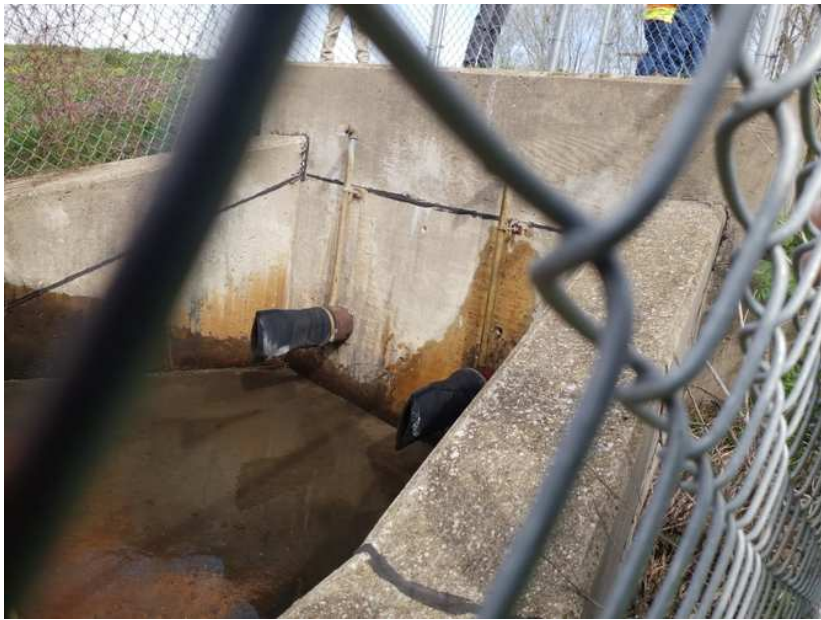
**Inspect ID:** 2024-0014

No User Rating (Site Visit) - PS-MR duckbills not closing after operation of pump. Possibly needs to be replaced.
