**US Army Corps
of Engineers®**

Flood Damage Reduction Segment / System Inspection Report

Name of Segment / System: Little Cal - Munster

Inspection Start Date: 4/29/2014

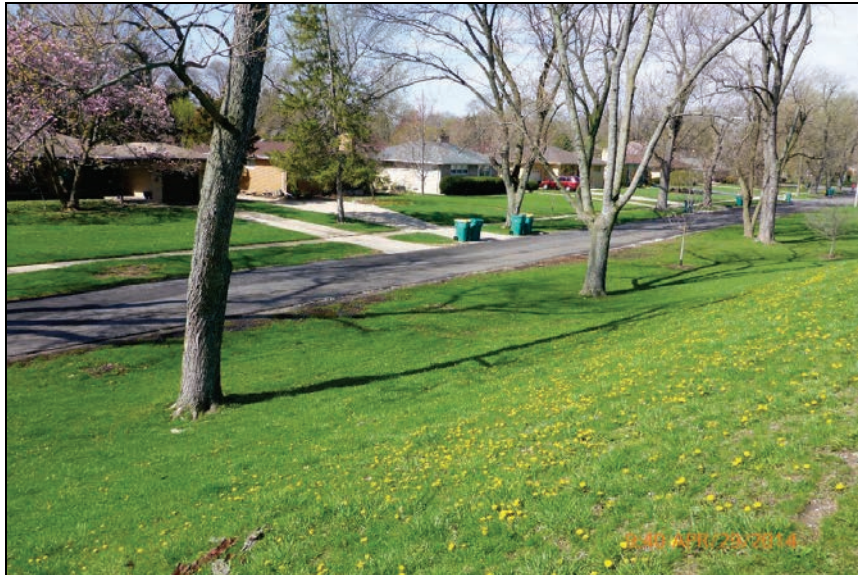
Inspect ID: LCMN_2014_a_0010 **Title:** USACE_CELRC_LCMN_2014_a_0010_1.jpg
Rated Item: 1. Unwanted Vegetation Growth **Caption:** Rating: Minimally Acceptable;
Remarks: 2 trees on landside; **Action:** These are dying and are recommended to be removed.

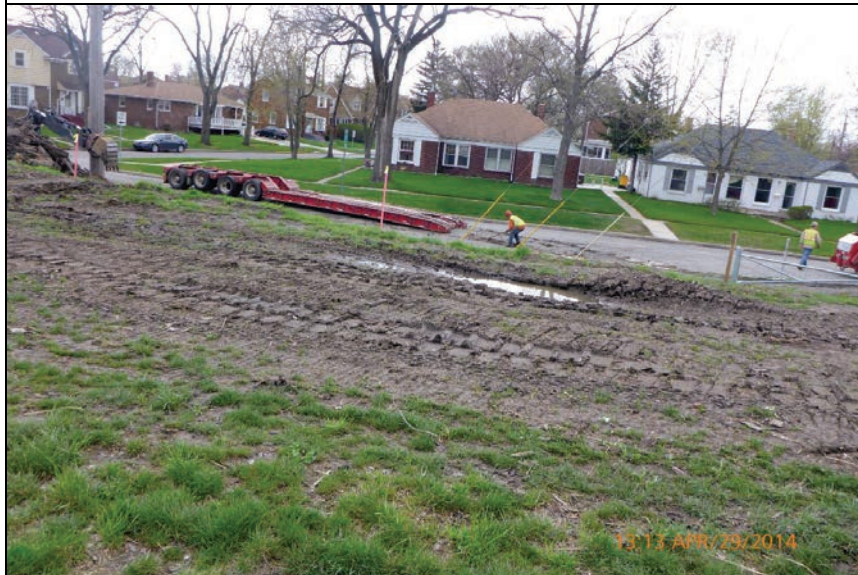
Inspect ID: LCMN_2014_a_0062 **Title:** USACE_CELRC_LCMN_2014_a_0062_1.jpg
Rated Item: 2. Sod Cover **Caption:** Rating: Minimally Acceptable; **Remarks:** Rutting due to temporary construction; **Action:** Check that the levee is restored once construction is complete

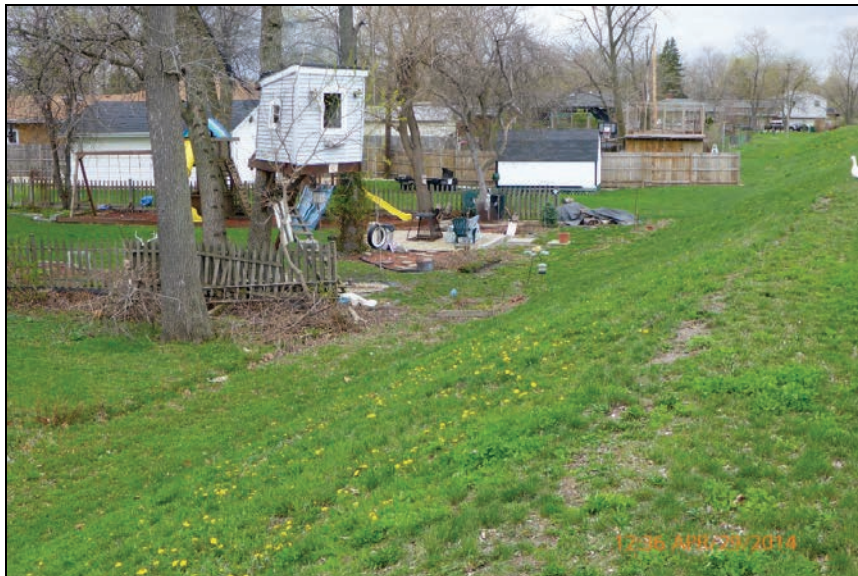
Inspect ID: LCMN_2014_a_0046 **Title:** USACE_CELRC_LCMN_2014_a_0046_1.jpg
Rated Item: 3. Encroachments **Caption:** Rating: Minimally Acceptable; Remarks: Gardens and items on landside toe; Action: Talk to resident to request action or submit permit request

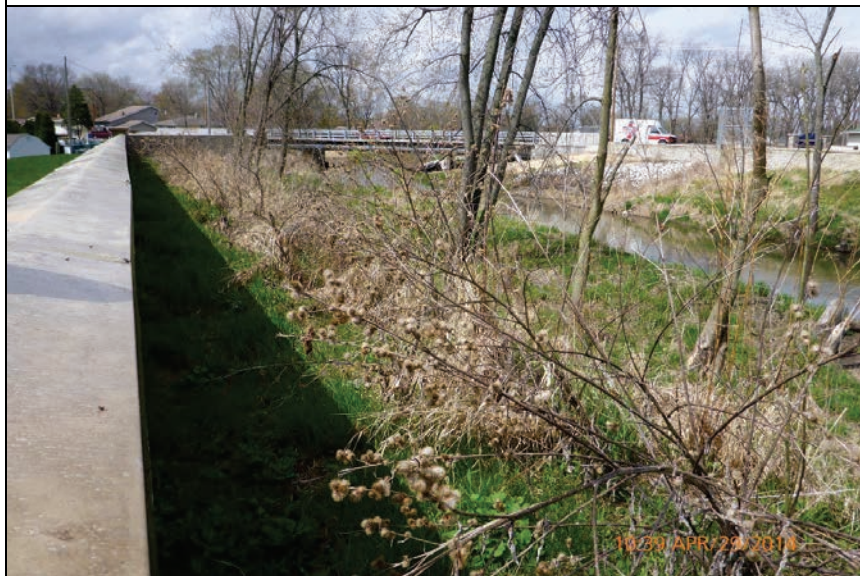
Inspect ID: LCMN_2014_a_0021 **Title:** USACE_CELRC_LCMN_2014_a_0021_1.jpg
Rated Item: 1. Unwanted Vegetation Growth **Caption:** Rating: Minimally Acceptable;
Remarks: Tall brush on riverside; Action: Clear

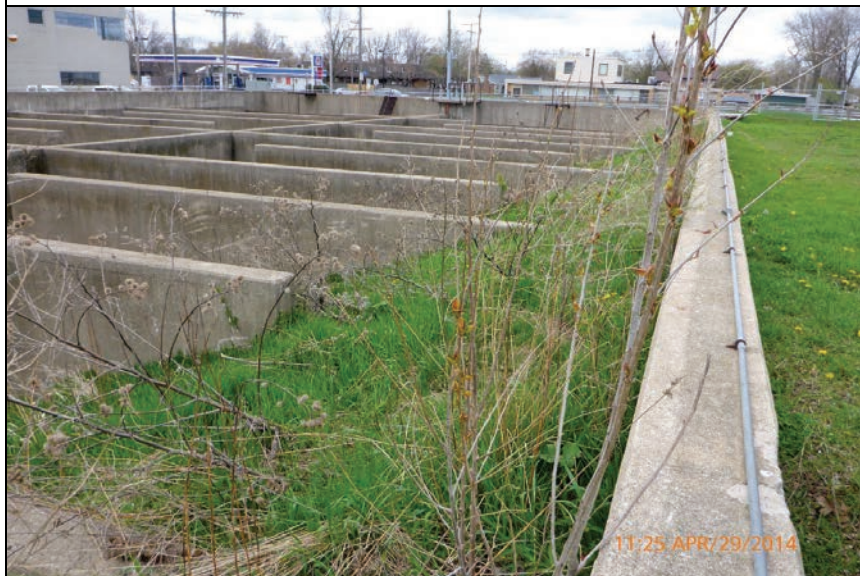
Inspect ID: LCMN_2014_a_0041 **Title:** USACE_CELRC_LCMN_2014_a_0041_1.jpg
Rated Item: 1. Unwanted Vegetation Growth **Caption:** Rating: Minimally Acceptable;
Remarks: Small trees on landside; Action: Clear

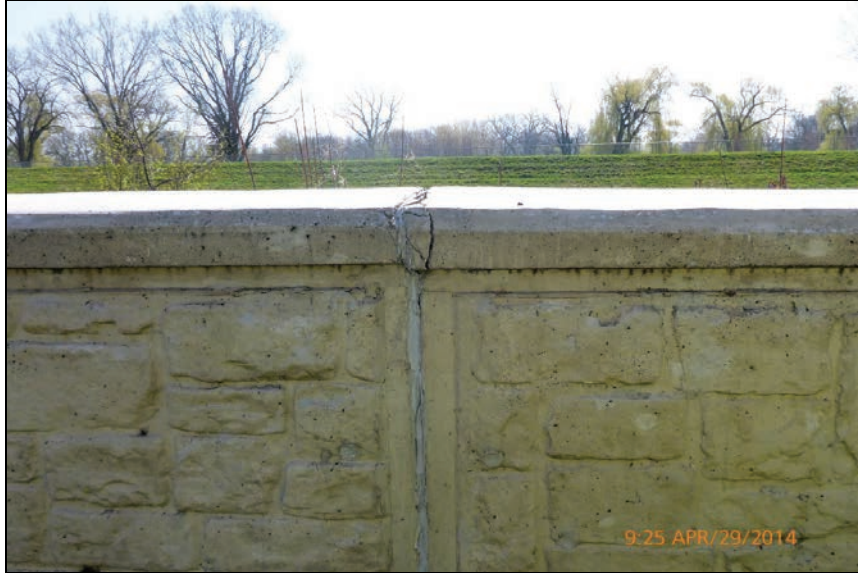
Inspect ID: LCMN_2014_a_0009 **Title:** USACE_CELRC_LCMN_2014_a_0009_1.jpg
Rated Item: 4. Concrete Surfaces **Caption:** Rating: Minimally Acceptable; Remarks:
Cracks in concrete cap and spalling; Action: Patch

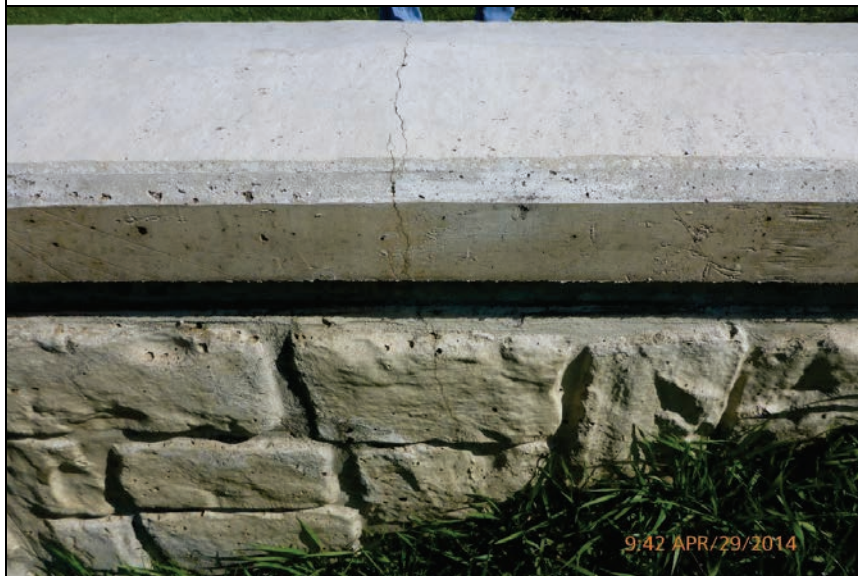
Inspect ID: LCMN_2014_a_0011 **Title:** USACE_CELRC_LCMN_2014_a_0011_1.jpg
Rated Item: 4. Concrete Surfaces **Caption:** Rating: Minimally Acceptable; Remarks:
Cracking in cap and floodwall; Action: Seal

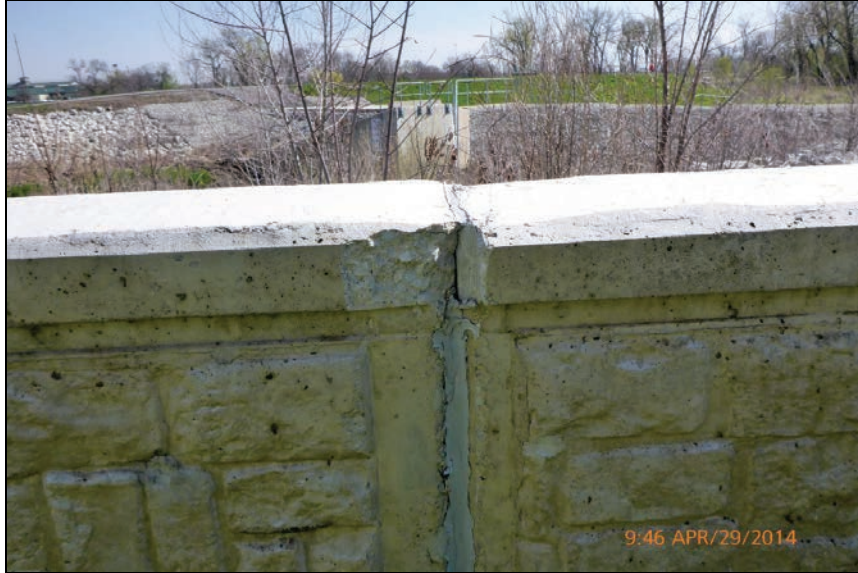
Inspect ID: LCMN_2014_a_0013 **Title:** USACE_CELRC_LCMN_2014_a_0013_1.jpg
Rated Item: 4. Concrete Surfaces **Caption:** Rating: Minimally Acceptable; Remarks:
Spalling on landside floodwall; Action: Patch

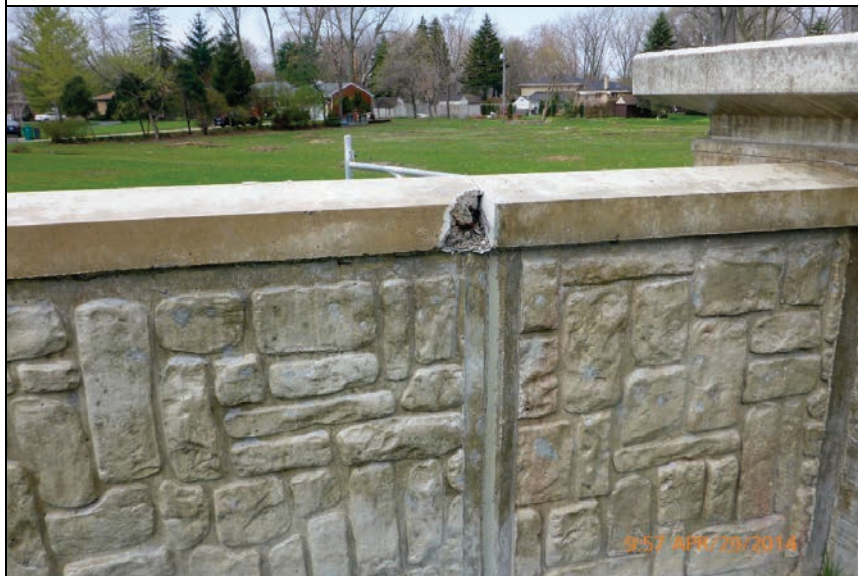
Inspect ID: LCMN_2014_a_0017 **Title:** USACE_CELRC_LCMN_2014_a_0017_1.jpg
Rated Item: 4. Concrete Surfaces **Caption:** Rating: Minimally Acceptable; Remarks:
Concrete cap broken; Action: Patch

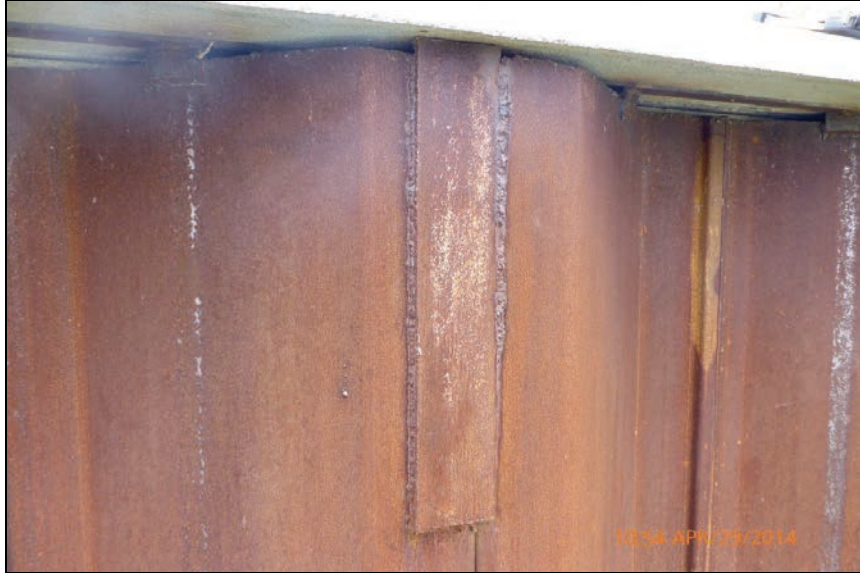
Inspect ID: LCMN_2014_a_0024 **Title:** USACE_CELRC_LCMN_2014_a_0024_1.jpg
Rated Item: 4. Concrete Surfaces **Caption:** Rating: Acceptable; Remarks: Sheetpile interlock joint needs repairing.; Action: monitor the existing splice repair

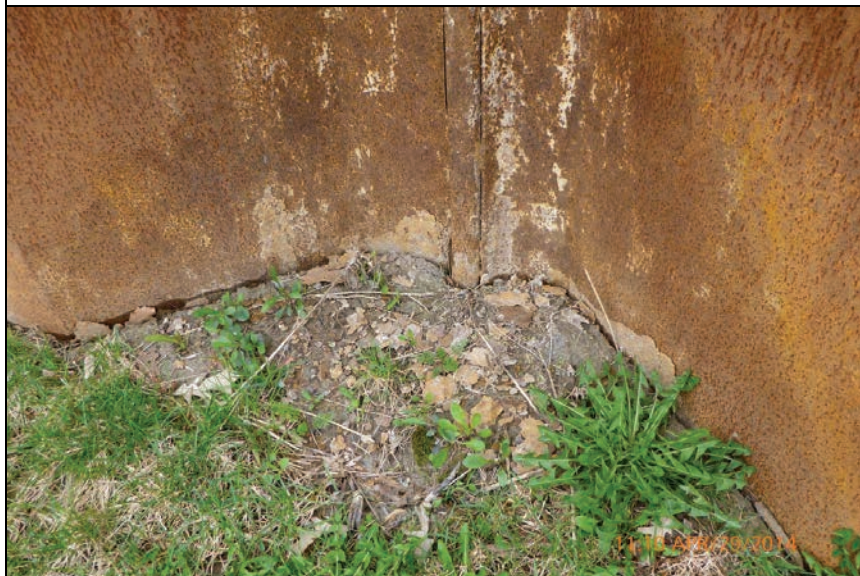
Inspect ID: LCMN_2014_a_0033 **Title:** USACE_CELRC_LCMN_2014_a_0033_1.jpg
Rated Item: 4. Concrete Surfaces **Caption:** Rating: Acceptable; Remarks: Typical sheetpile scaling; Action: Monitor for any increased scaling or section loss

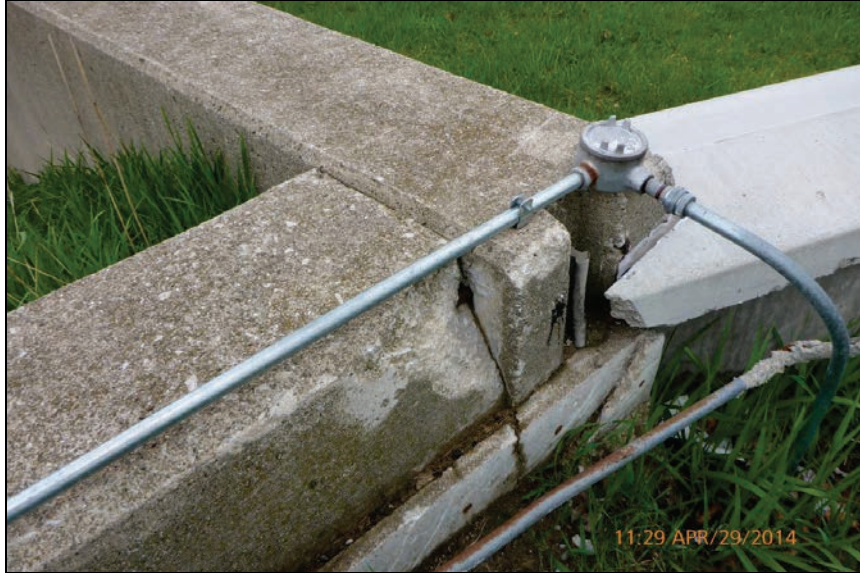
Inspect ID: LCMN_2014_a_0039 **Title:** USACE_CELRC_LCMN_2014_a_0039_1.jpg
Rated Item: 4. Concrete Surfaces **Caption:** Rating: Minimally Acceptable; Remarks: Spalling and exposed rebar; Action: Clean rebar and patch concrete

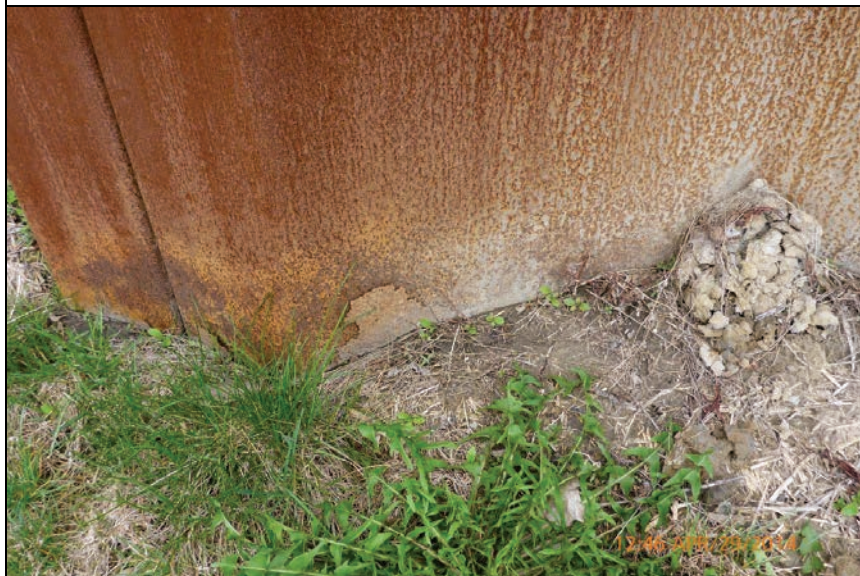
Inspect ID: LCMN_2014_a_0052 **Title:** USACE_CELRC_LCMN_2014_a_0052_1.jpg
Rated Item: 4. Concrete Surfaces **Caption:** Rating: Acceptable; Remarks: Scaling at base of sheetpile; Action: Monitor for any increased scaling or section loss; and possible sheetpile alignment issues

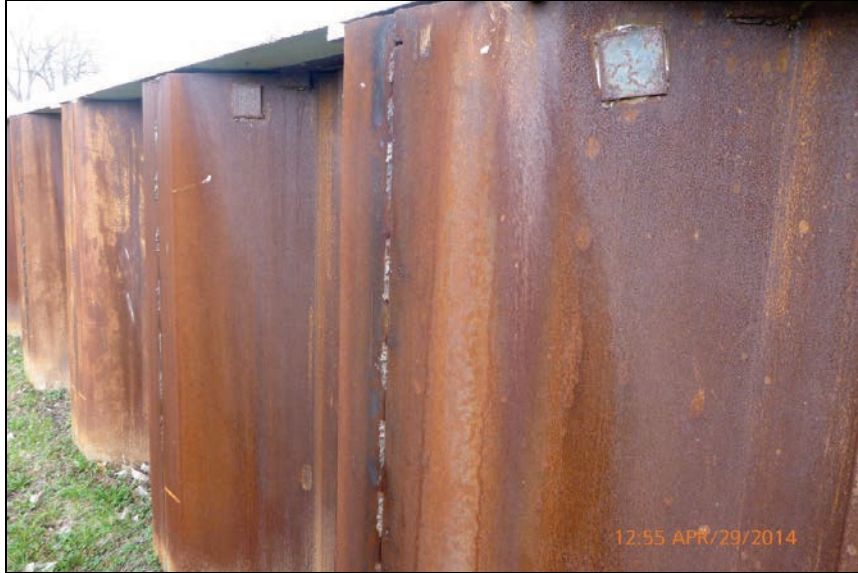
Inspect ID: LCMN_2014_a_0057 **Title:** USACE_CELRC_LCMN_2014_a_0057_1.jpg
Rated Item: 4. Concrete Surfaces **Caption:** Rating: Acceptable; Remarks: It is not normal practice or recommended to weld the interlocks of the sheet pile; Action: Monitor

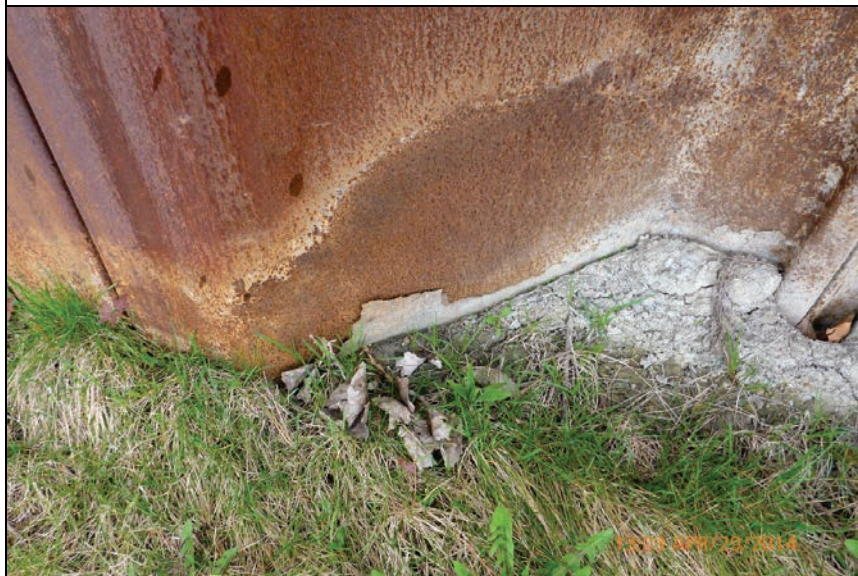
Inspect ID: LCMN_2014_a_0060 **Title:** USACE_CELRC_LCMN_2014_a_0060_1.jpg
Rated Item: 4. Concrete Surfaces **Caption:** Rating: Acceptable; Remarks: Scaling of sheetpile; Action: Monitor for any increased scaling or section loss

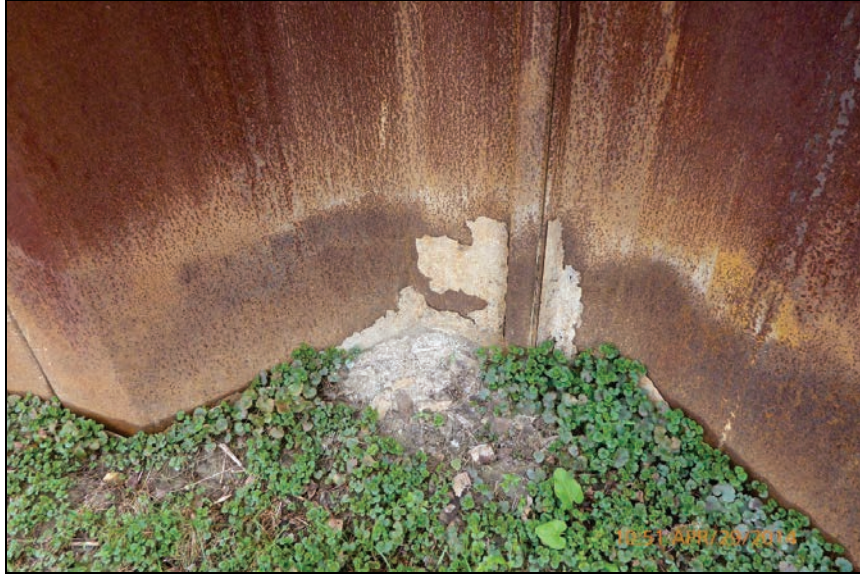
Inspect ID: LCMN_2014_a_0066 **Title:** USACE_CELRC_LCMN_2014_a_0066_1.jpg
Rated Item: 4. Concrete Surfaces **Caption:** Rating: Acceptable; Remarks: Steel sheetpile has minor corrosion at ground level, typical throughout; Action: Monitor for any increased scaling or section loss

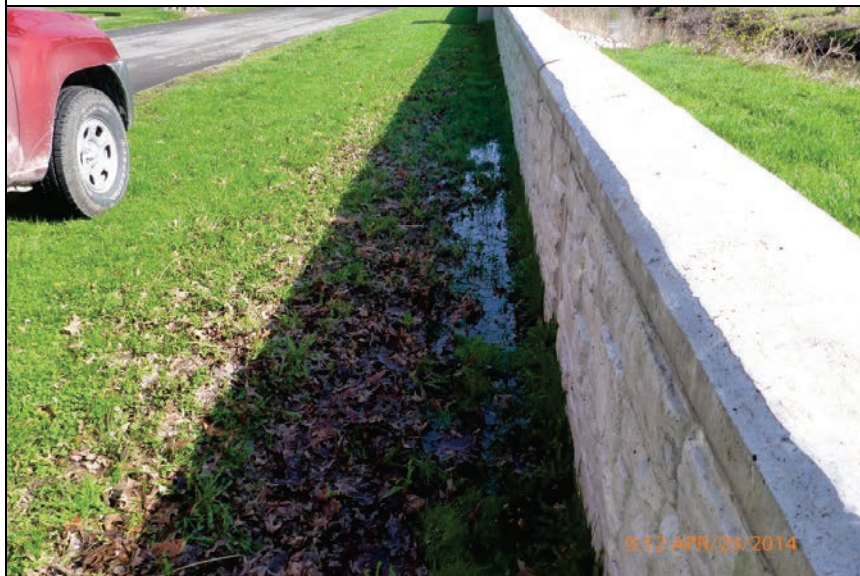
Inspect ID: LCMN_2014_a_0006 **Title:** USACE_CELRC_LCMN_2014_a_0006_1.jpg
Rated Item: 6. Foundation of Concrete Structures **Caption:** Rating: Minimally Acceptable; Remarks: Water ponding on landside floodwall; Action: Grade to drain away from wall

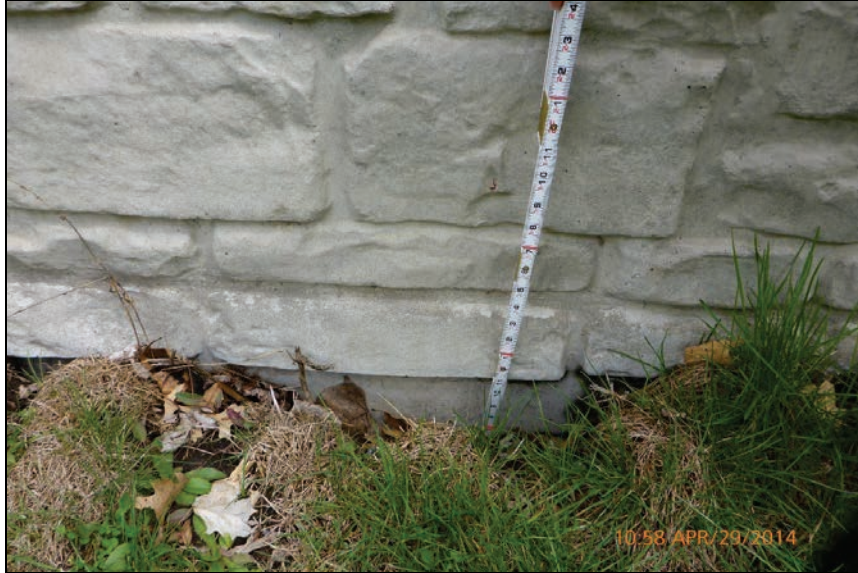
Inspect ID: LCMN_2014_a_0026 **Title:** USACE_CELRC_LCMN_2014_a_0026_1.jpg
Rated Item: 6. Foundation of Concrete Structures **Caption:** Rating: Minimally Acceptable; Remarks: 1 ft. deep settlement/erosion holes in fill material along base of floodwall.; Action: Fill with stone or grout

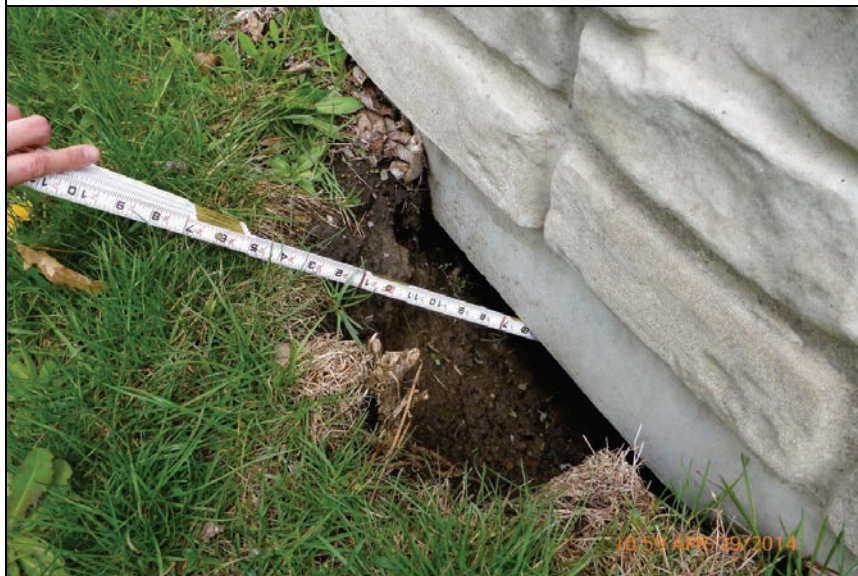
Inspect ID: LCMN_2014_a_0027 **Title:** USACE_CELRC_LCMN_2014_a_0027_1.jpg
Rated Item: 6. Foundation of Concrete Structures **Caption:** Rating: Minimally Acceptable; Remarks: 2 ft. deep settlement/erosion holes in fill material along base of floodwall.; Action: Fill with stone or grout

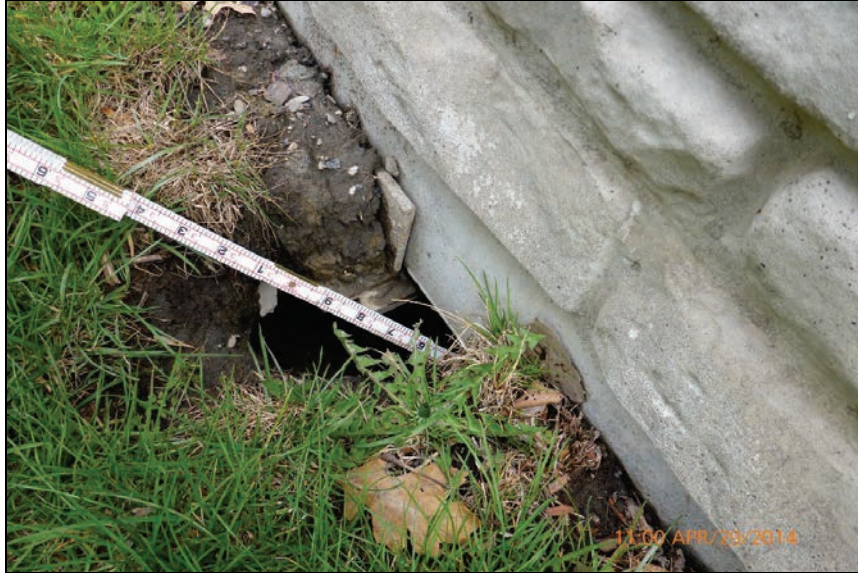
Inspect ID: LCMN_2014_a_0028 **Title:** USACE_CELRC_LCMN_2014_a_0028_1.jpg
Rated Item: 6. Foundation of Concrete Structures **Caption:** Rating: Minimally Acceptable; Remarks: 3 ft. deep settlement/erosion holes in fill material along base of floodwall.; Action: Fill with stone or grout

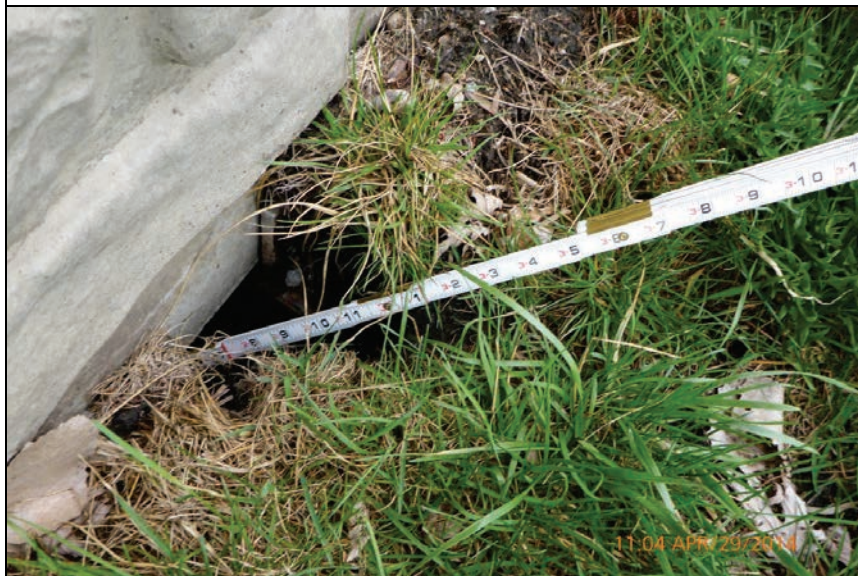
Inspect ID: LCMN_2014_a_0029 **Title:** USACE_CELRC_LCMN_2014_a_0029_1.jpg
Rated Item: 6. Foundation of Concrete Structures **Caption:** Rating: Minimally Acceptable; Remarks: 3 ft. deep settlement/erosion holes in fill material along base of floodwall, on landside.; Action: Fill with stone or grout

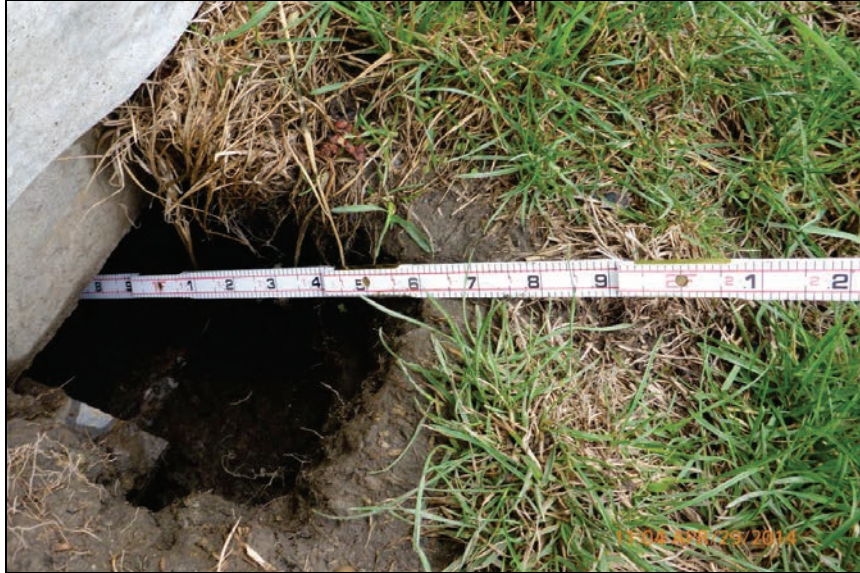
Inspect ID: LCMN_2014_a_0030 **Title:** USACE_CELRC_LCMN_2014_a_0030_1.jpg
Rated Item: 6. Foundation of Concrete Structures **Caption:** Rating: Minimally Acceptable; Remarks: 1.5 ft. deep settlement/erosion holes in fill material along base of floodwall.; Action: Fill with stone or grout

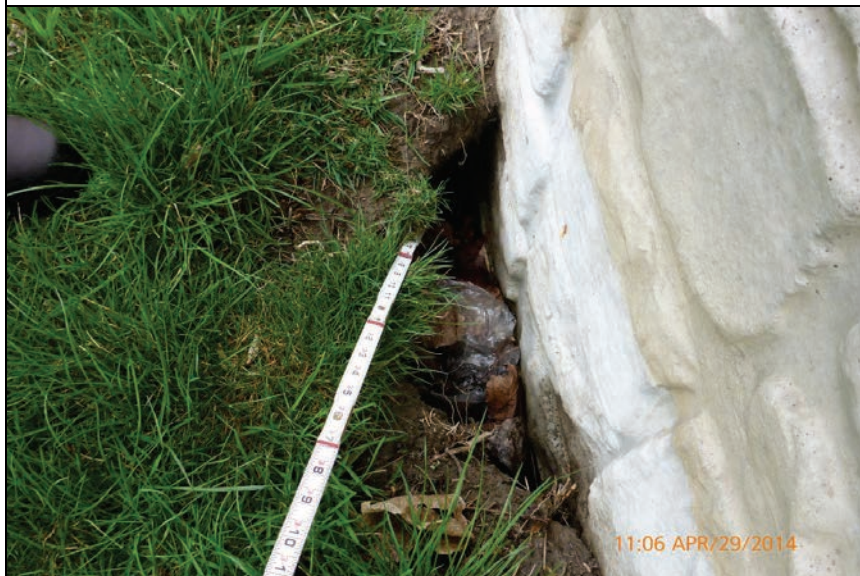
Inspect ID: LCMN_2014_a_0031 **Title:** USACE_CELRC_LCMN_2014_a_0031_1.jpg
Rated Item: 6. Foundation of Concrete Structures **Caption:** Rating: Minimally Acceptable; Remarks: 3 ft. deep settlement/erosion holes in fill material along base of floodwall.; Action: Fill with stone or grout

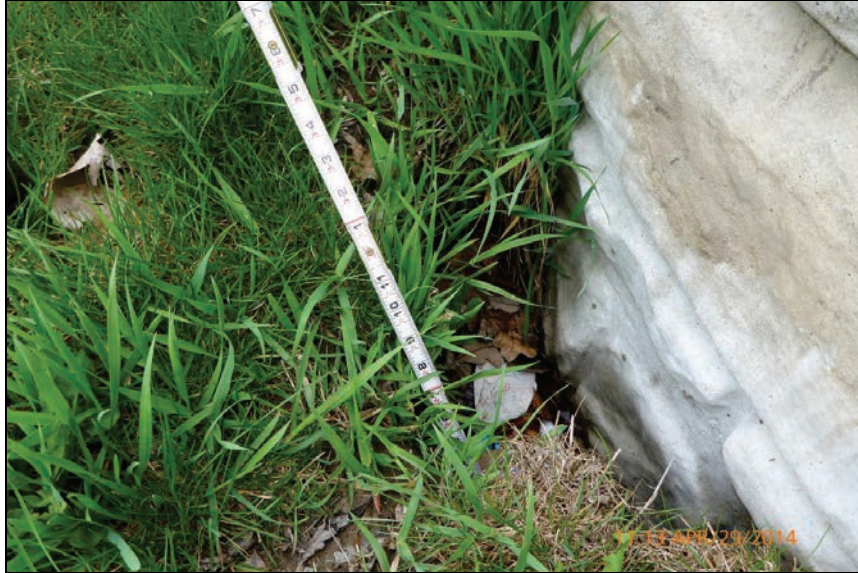
Inspect ID: LCMN_2014_a_0032 **Title:** USACE_CELRC_LCMN_2014_a_0032_1.jpg
Rated Item: 6. Foundation of Concrete Structures **Caption:** Rating: Minimally Acceptable; Remarks: 3 ft. deep settlement/erosion holes in fill material along base of floodwall, on landside.; Action: Fill with stone or grout

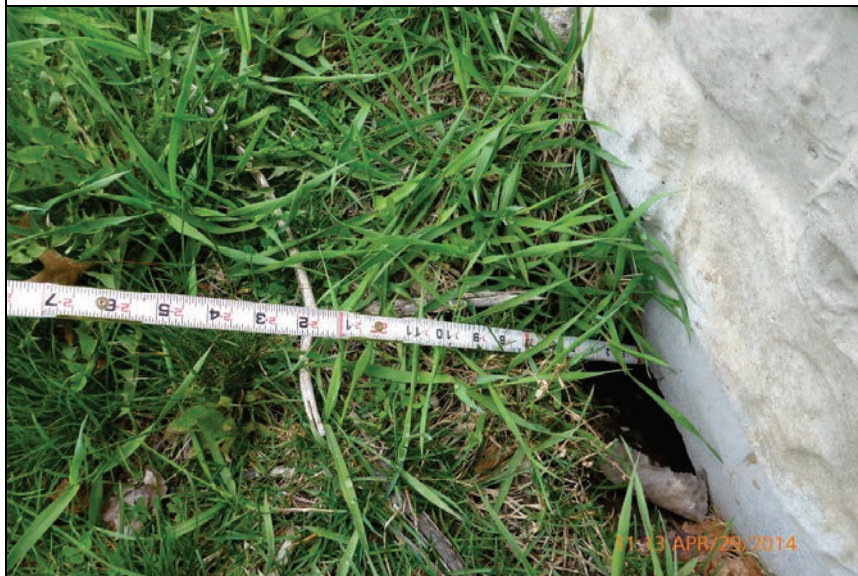
Inspect ID: LCMN_2014_a_0034 **Title:** USACE_CELRC_LCMN_2014_a_0034_1.jpg
Rated Item: 6. Foundation of Concrete Structures **Caption:** Rating: Minimally Acceptable; Remarks: 1.5 ft. deep settlement/erosion holes in fill material along base of floodwall.; Action: Fill with stone or grout

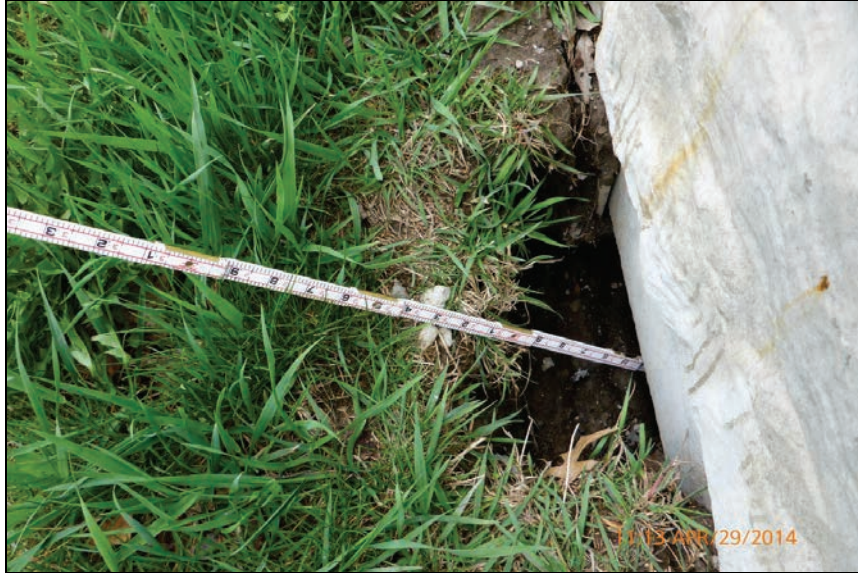
Inspect ID: LCMN_2014_a_0035 **Title:** USACE_CELRC_LCMN_2014_a_0035_1.jpg
Rated Item: 6. Foundation of Concrete Structures **Caption:** Rating: Minimally Acceptable; Remarks: 2 ft. deep settlement/erosion holes in fill material along base of floodwall.; Action: Fill with stone or grout

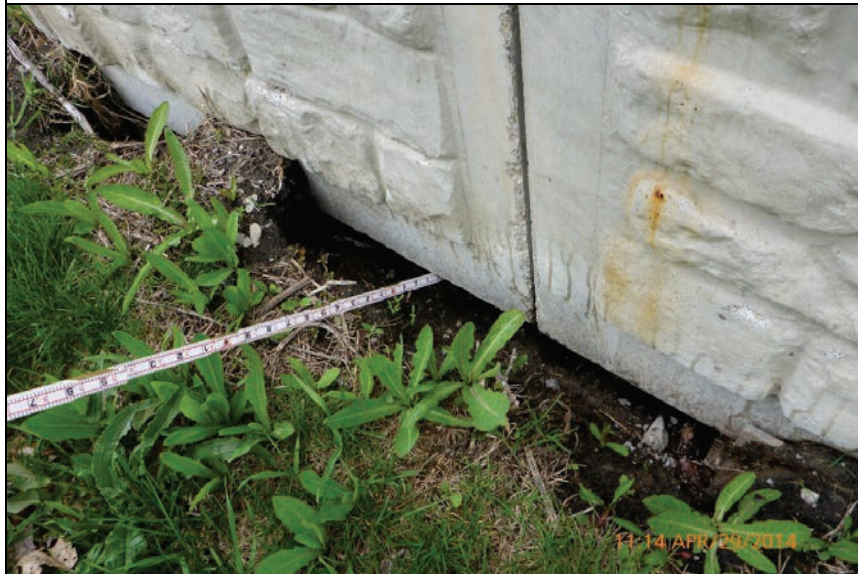
Inspect ID: LCMN_2014_a_0036 **Title:** USACE_CELRC_LCMN_2014_a_0036_1.jpg
Rated Item: 6. Foundation of Concrete Structures **Caption:** Rating: Minimally Acceptable; Remarks: 2 ft. deep settlement/erosion holes in fill material along base of floodwall.; Action: Fill with stone or grout

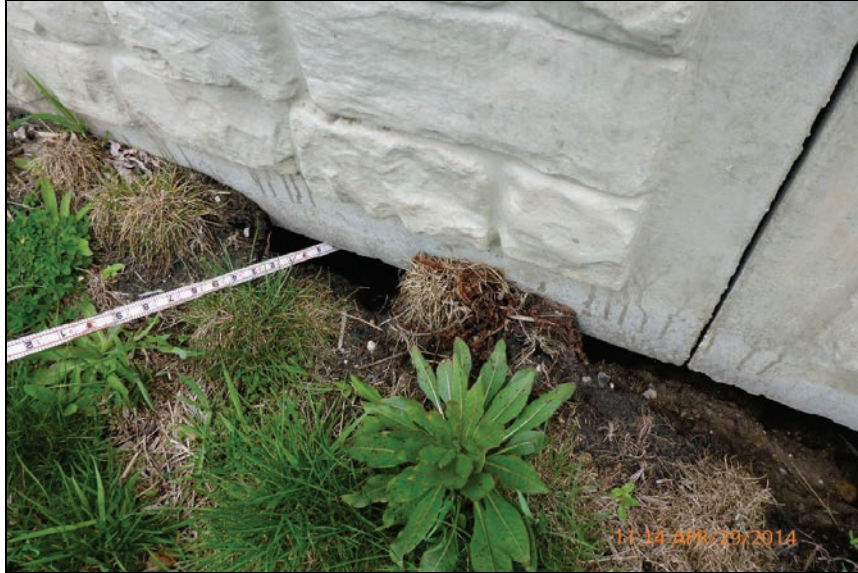
Inspect ID: LCMN_2014_a_0037 **Title:** USACE_CELRC_LCMN_2014_a_0037_1.jpg
Rated Item: 6. Foundation of Concrete Structures **Caption:** Rating: Minimally Acceptable; Remarks: 2 ft. deep settlement/erosion holes in fill material along base of floodwall.; Action: Fill with stone or grout

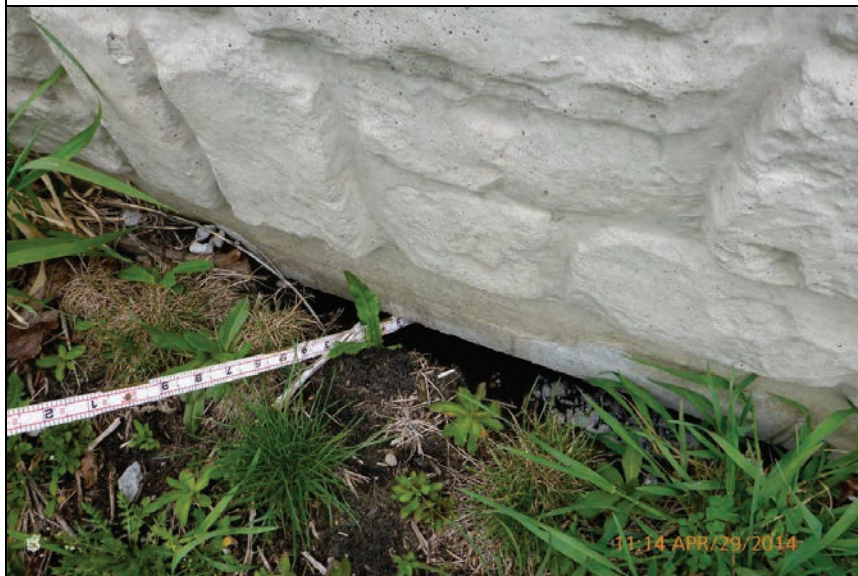
Inspect ID: LCMN_2014_a_0038 **Title:** USACE_CELRC_LCMN_2014_a_0038_1.jpg
Rated Item: 6. Foundation of Concrete Structures **Caption:** Rating: Minimally Acceptable; Remarks: 1 ft. deep settlement/erosion holes in fill material along base of floodwall.; Action: Fill with stone or grout

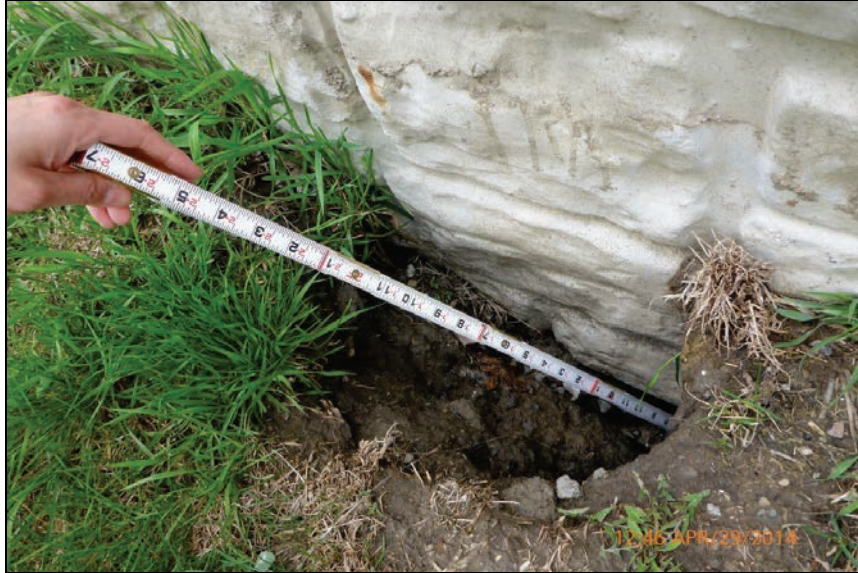
Inspect ID: LCMN_2014_a_0045 **Title:** USACE_CELRC_LCMN_2014_a_0045_1.jpg
Rated Item: 6. Foundation of Concrete Structures **Caption:** Rating: Minimally Acceptable; Remarks: 2 ft. deep large settlement/erosion holes in fill material along base of floodwall.; Action: Fill with stone or grout

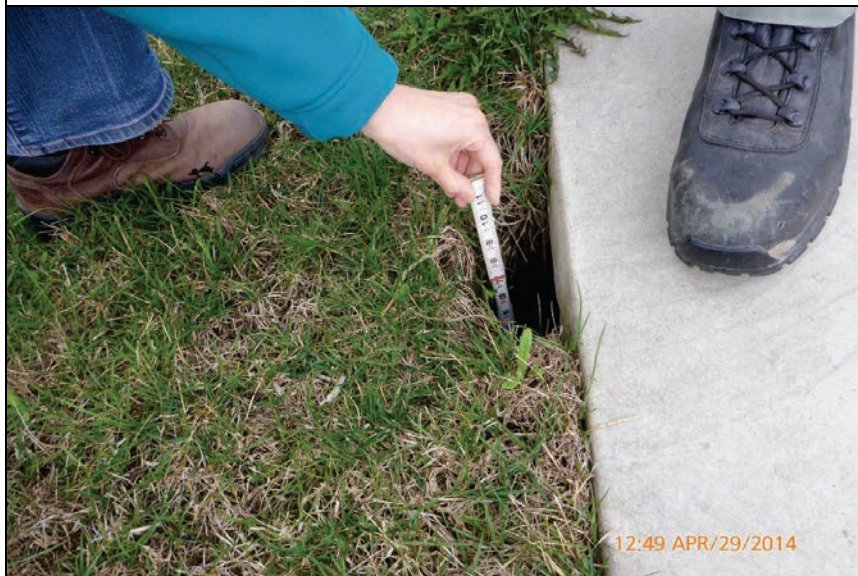
Inspect ID: LCMN_2014_a_0051 **Title:** USACE_CELRC_LCMN_2014_a_0051_1.jpg
Rated Item: 6. Foundation of Concrete Structures **Caption:** Rating: Minimally Acceptable; Remarks: 6 ft. deep settlement/erosion holes in fill material along base of floodwall.; Action: Fill with stone or grout

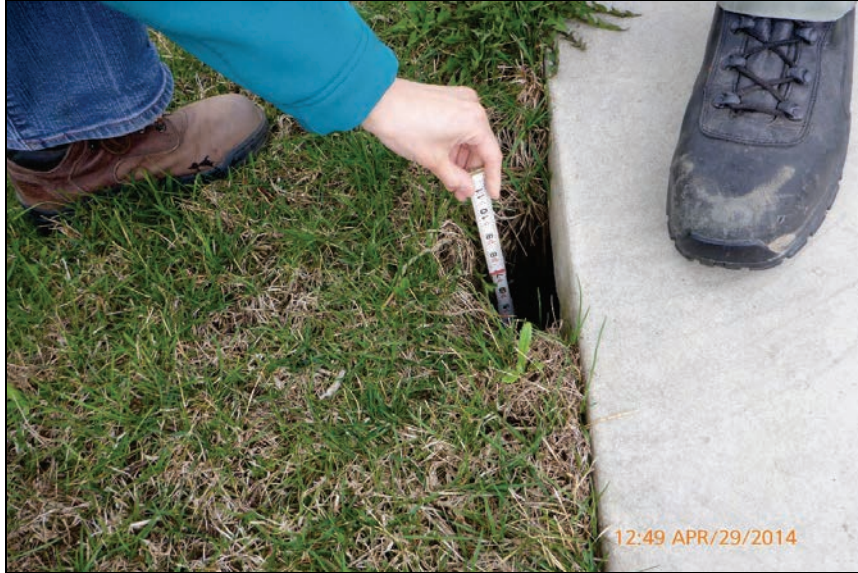
Inspect ID: LCMN_2014_a_0053 **Title:** USACE_CELRC_LCMN_2014_a_0053_1.jpg
Rated Item: 6. Foundation of Concrete Structures **Caption:** Rating: Minimally Acceptable; Remarks: Deep settlement/erosion hole in fill material along base of floodwall.; Action: Fill with stone or grout

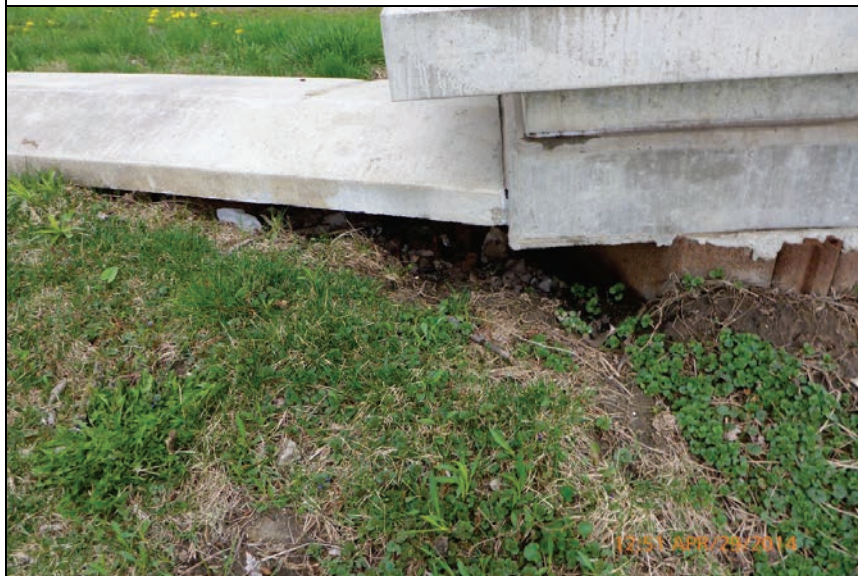
Inspect ID: LCMN_2014_a_0055 **Title:** USACE_CELRC_LCMN_2014_a_0055_1.jpg
Rated Item: 6. Foundation of Concrete Structures **Caption:** Rating: Minimally Acceptable; Remarks: Erosion next to sheetpile on riverside; Action: Fill with grout

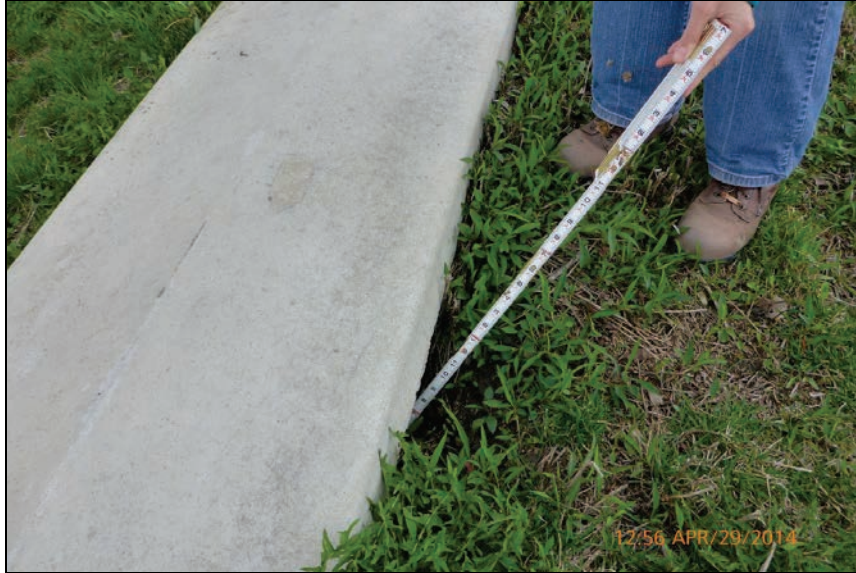
Inspect ID: LCMN_2014_a_0056 **Title:** USACE_CELRC_LCMN_2014_a_0056_1.jpg
Rated Item: 6. Foundation of Concrete Structures **Caption:** Rating: Minimally Acceptable; Remarks: 1 ft. deep settlement/erosion holes in fill material along base of floodwall.; Action: Fill with stone or grout

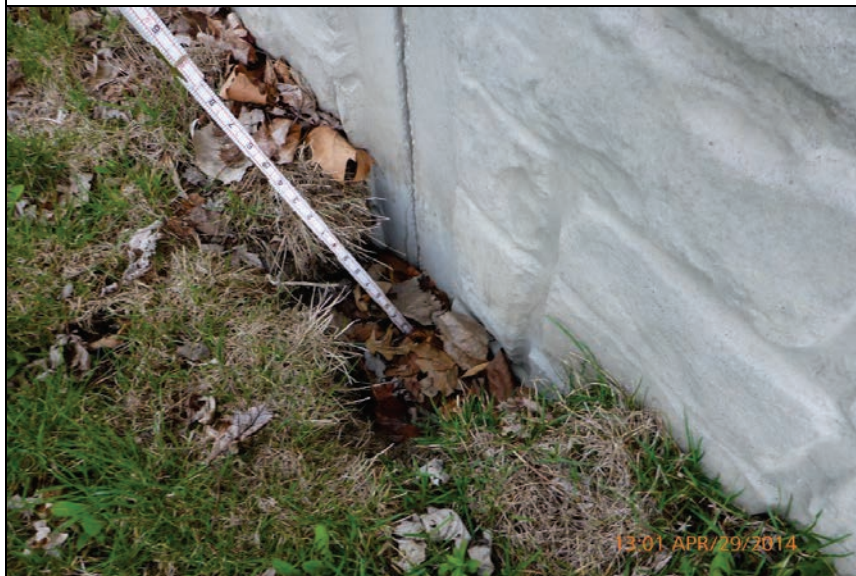
Inspect ID: LCMN_2014_a_0058 **Title:** USACE_CELRC_LCMN_2014_a_0058_1.jpg
Rated Item: 6. Foundation of Concrete Structures **Caption:** Rating: Minimally Acceptable; Remarks: 1 ft. deep settlement/erosion holes in fill material along base of floodwall.; Action: Fill with stone or grout

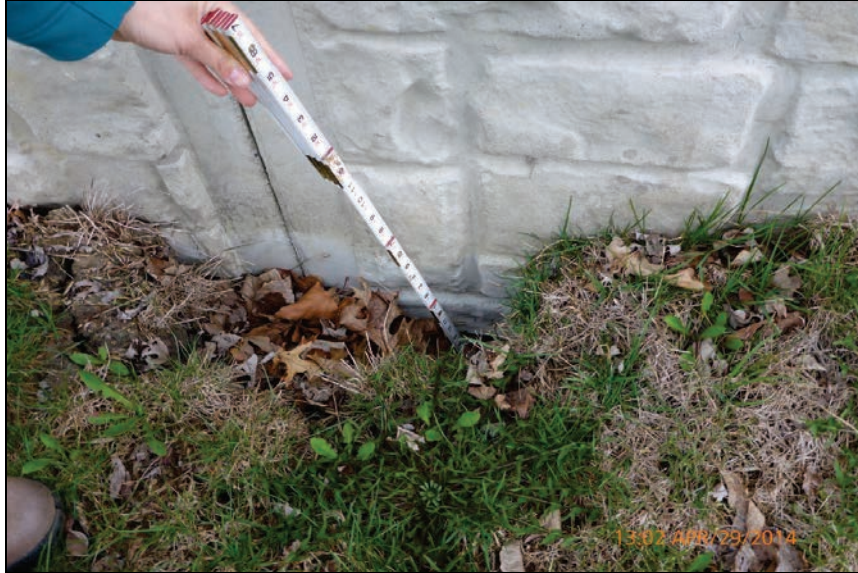
Inspect ID: LCMN_2014_a_0059 **Title:** USACE_CELRC_LCMN_2014_a_0059_1.jpg
Rated Item: 6. Foundation of Concrete Structures **Caption:** Rating: Minimally Acceptable; Remarks: 1.5 ft. deep settlement/erosion holes in fill material along base of floodwall.; Action: Fill with stone

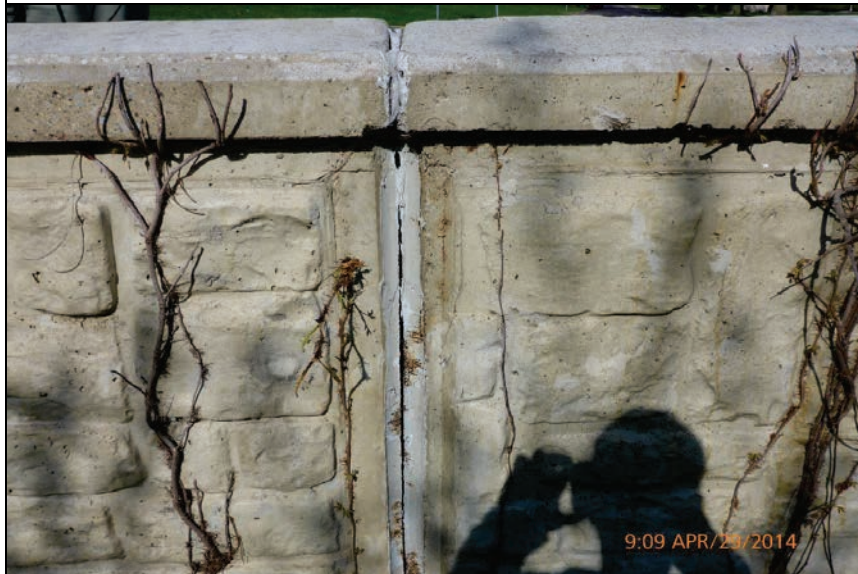
Inspect ID: LCMN_2014_a_0001 **Title:** USACE_CELRC_LCMN_2014_a_0001_1.jpg
Rated Item: 7. Monolith Joints **Caption:** Rating: Minimally Acceptable; Remarks: Monolith joint should be re-caulked on riverside; Action: Re-caulk

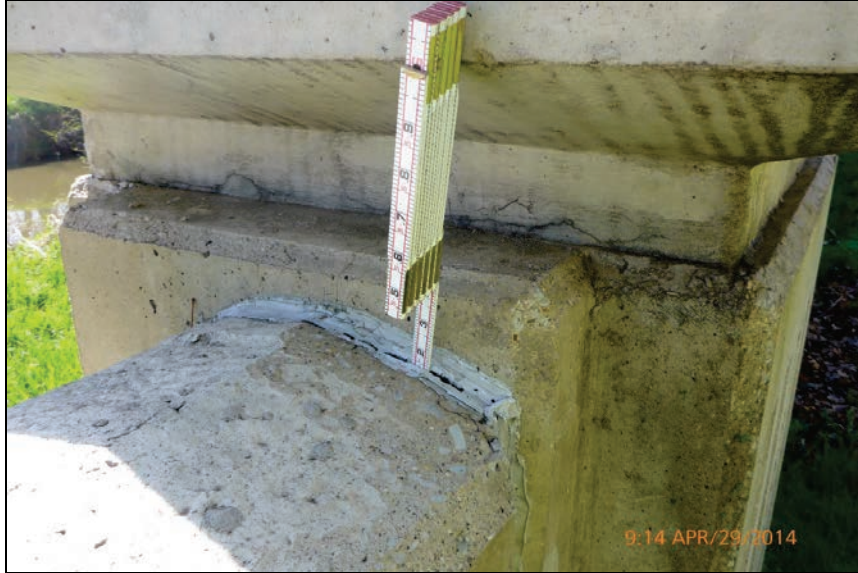
Inspect ID: LCMN_2014_a_0002 **Title:** USACE_CELRC_LCMN_2014_a_0002_1.jpg
Rated Item: 7. Monolith Joints **Caption:** Rating: Minimally Acceptable; Remarks: Joint sealant deterioration; Action: Re-caulk

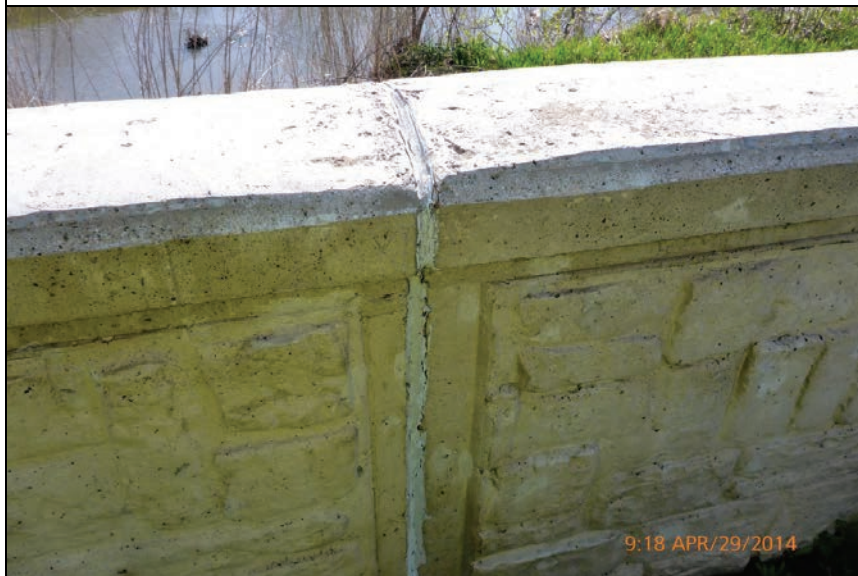
Inspect ID: LCMN_2014_a_0004 **Title:** USACE_CELRC_LCMN_2014_a_0004_1.jpg
Rated Item: 7. Monolith Joints **Caption:** Rating: Minimally Acceptable; Remarks: Joint sealant deterioration on landside, prior issue still exists in 2014; Action: Re-caulk

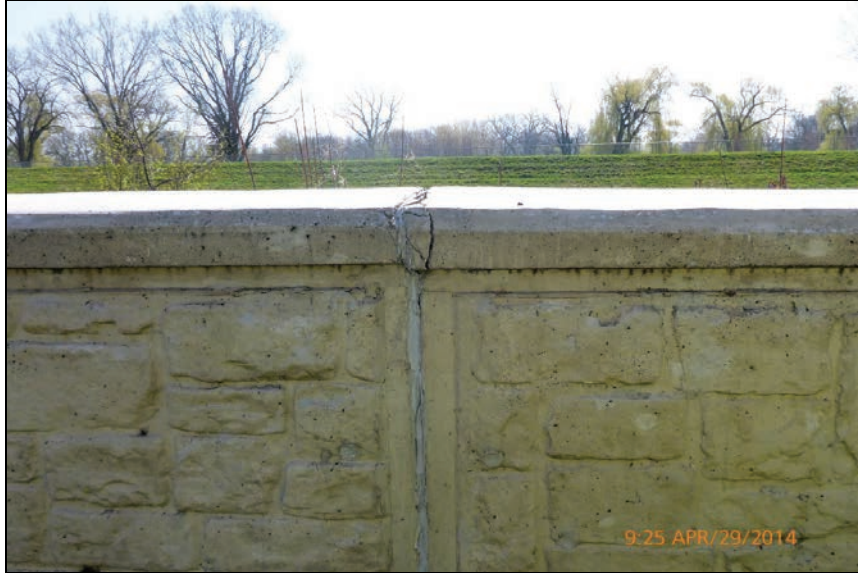
Inspect ID: LCMN_2014_a_0007 **Title:** USACE_CELRC_LCMN_2014_a_0007_1.jpg
Rated Item: 7. Monolith Joints **Caption:** Rating: Minimally Acceptable; Remarks: Joint sealant deteriorating; Action: Re-caulk
