**US Army Corps
of Engineers®**

Flood Damage Reduction Segment / System Inspection Report

Name of Segment / System: Little Cal - Munster

Inspection Start Date: 4/29/2014

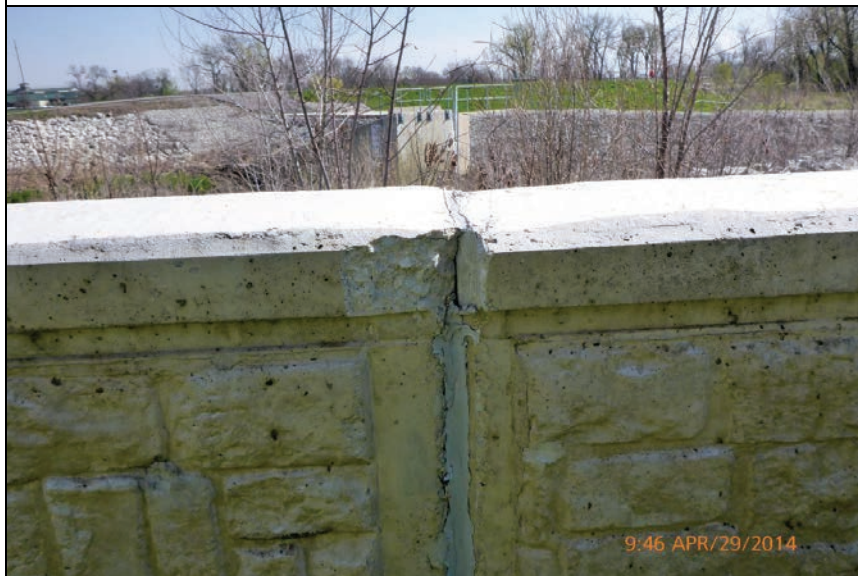
Inspect ID: LCMN_2014_a_0008 **Title:** USACE_CELRC_LCMN_2014_a_0008_1.jpg
Rated Item: 7. Monolith Joints **Caption:** Rating: Minimally Acceptable; Remarks: Joint sealant deteriorating; Action: Re-caulk

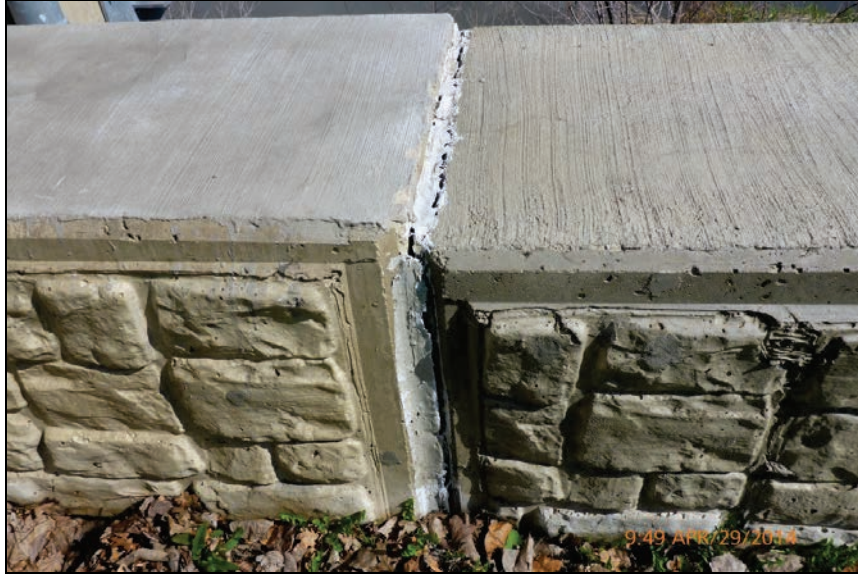
Inspect ID: LCMN_2014_a_0015 **Title:** USACE_CELRC_LCMN_2014_a_0015_1.jpg
Rated Item: 7. Monolith Joints **Caption:** Rating: Minimally Acceptable; Remarks: Joint cracked and requires caulking; Action: NA

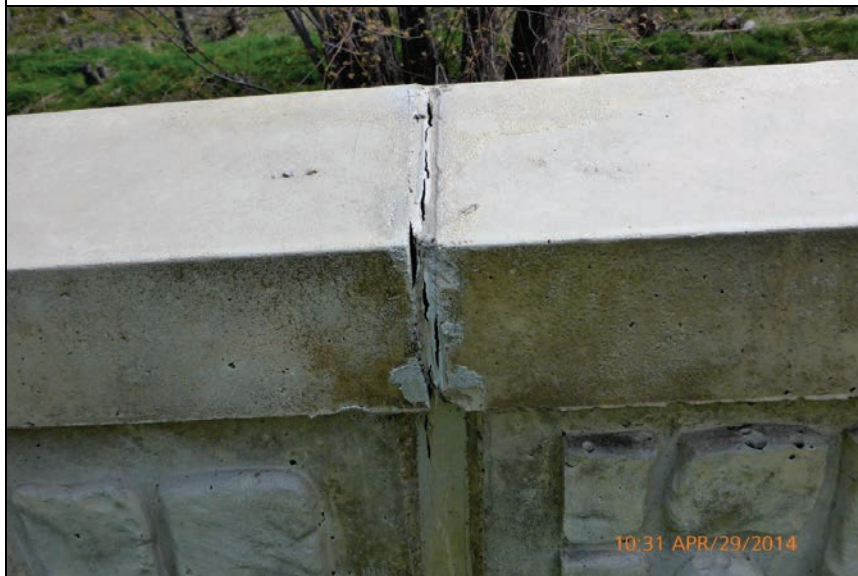
Inspect ID: LCMN_2014_a_0019 **Title:** USACE_CELRC_LCMN_2014_a_0019_1.jpg
Rated Item: 7. Monolith Joints **Caption:** Rating: Minimally Acceptable; Remarks: Joint deterioration; Action: Re-caulk

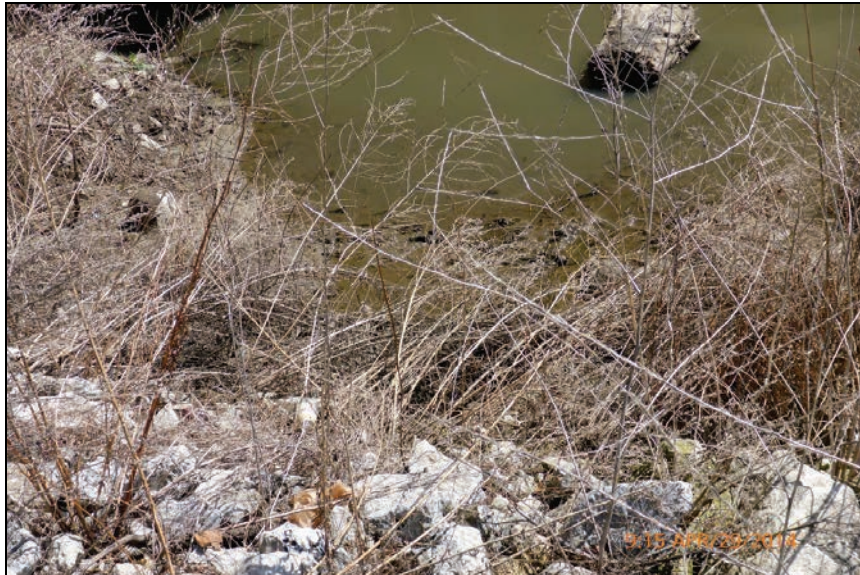
Inspect ID: LCMN_2014_a_0070 **Title:** USACE_CELRC_LCMN_2014_a_0070_1.jpg
Rated Item: 1. Vegetation and Obstructions **Caption:** Rating: Minimally Acceptable;
Remarks: MU-4: Thick vegetation at outlet; Action: Clear

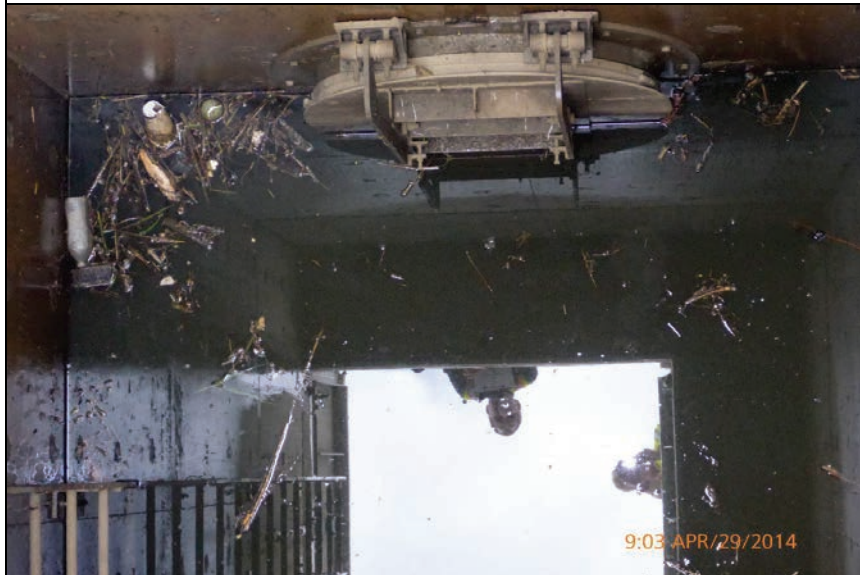
Inspect ID: LCMN_2014_a_0071 **Title:** USACE_CELRC_LCMN_2014_a_0071_1.jpg
Rated Item: 1. Vegetation and Obstructions **Caption:** Rating: Acceptable; **Remarks:** MU-7: Minor debris at outlet; Action: Clean

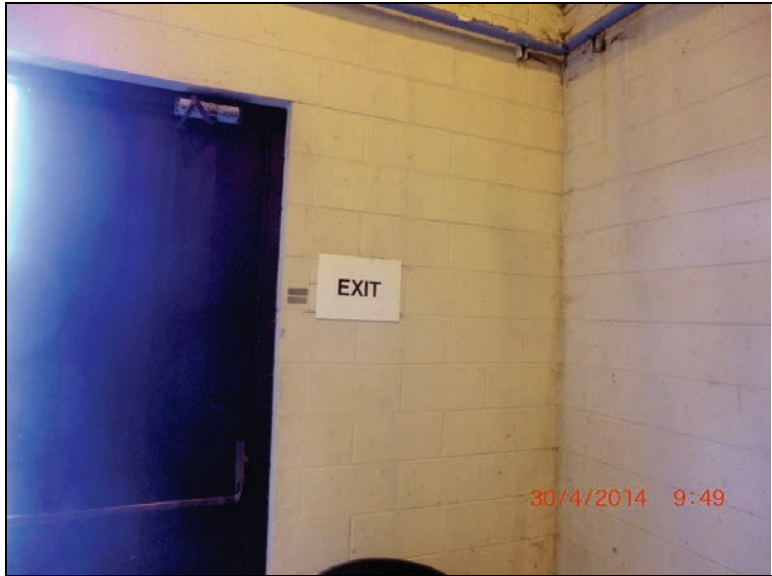
<p>Inspect ID: LCMN_2014_a_0075 Title: USACE_CELRC_LCMN_2014_a_0075_1.jpg Rated Item: 3. Safety Compliance Caption: Rating: Minimally Acceptable; Remarks: PS-OA: Non-standard exit sign; Action: Replace with compliant signage</p>

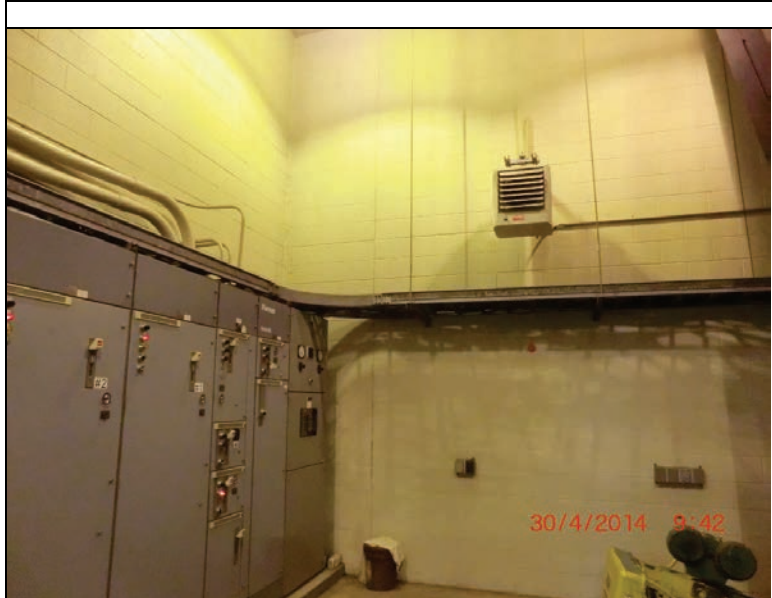
<p>Inspect ID: LCMN_2014_a_0081 Title: USACE_CELRC_LCMN_2014_a_0081_1.jpg Rated Item: 3. Safety Compliance Caption: Rating: Minimally Acceptable; Remarks: PS-OA: MCC and pump control cabinet must be posted with proper Arc-Flash warning sign per latest NFPA 70 and NFPA70E; Action: Post Arc-Flash warning signs</p>

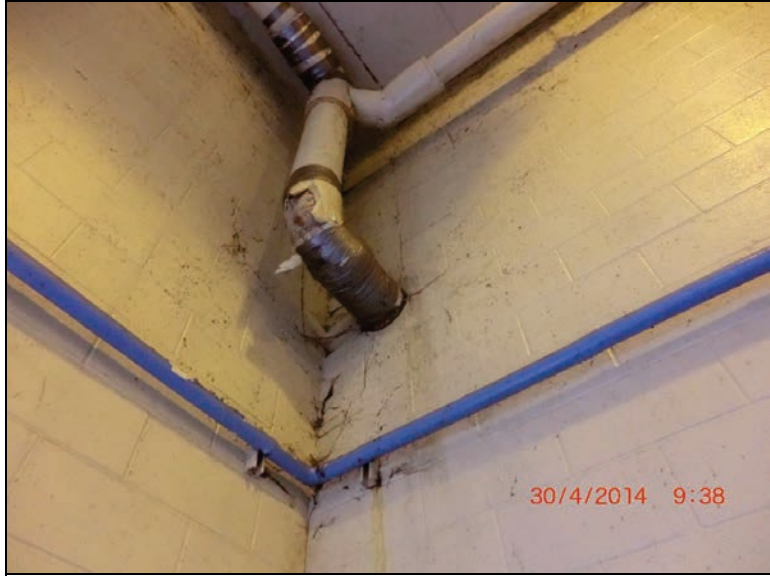
A photograph showing a white pipe with a section of its insulation missing, revealing the metal pipe. The pipe is mounted on a light-colored, possibly concrete or masonry, wall. A blue horizontal pipe runs across the lower part of the frame. A red timestamp "30/4/2014 9:38" is visible in the bottom right corner of the photo.	<p>Inspect ID: LCMN_2014_a_0076 Title: USACE_CELRC_LCMN_2014_a_0076_1.jpg Rated Item: 5. Plant Building Caption: Rating: Minimally Acceptable; Remarks: PS-OA: Insulation starting to peel off of pipe in trash rake room and possible water damage to the masonry wall.; Action: Repair insulation, clean wall</p>

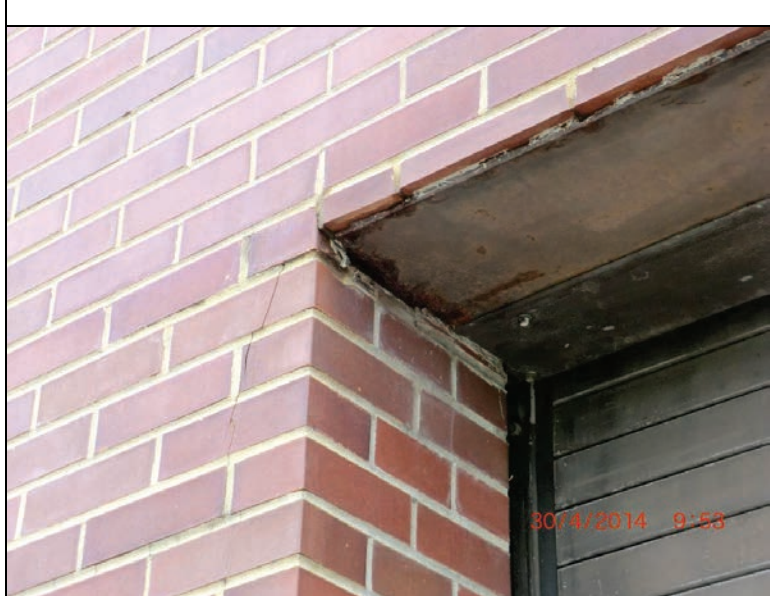
A photograph of a brick wall corner. The bricks are reddish-brown with white mortar. Above a dark window frame, the seal at the lintel is deteriorating and peeling away from the brick. A red timestamp "30/4/2014 9:53" is visible in the bottom right corner of the photo.	<p>Inspect ID: LCMN_2014_a_0077 Title: USACE_CELRC_LCMN_2014_a_0077_1.jpg Rated Item: 5. Plant Building Caption: Rating: Minimally Acceptable; Remarks: PS-OA: Deteriorating seal at lintel ; Action: Seal; ;</p>
