# Flood Damage Reduction Segment / System Inspection Report

## US Army Corps of Engineers®

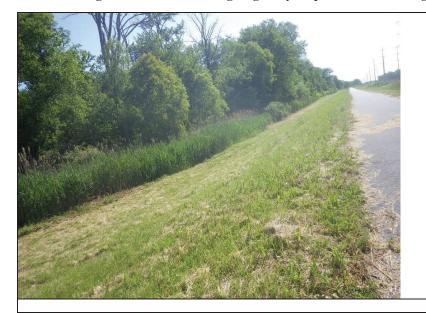
Inspect ID: LCGB\_2019\_a\_0003 Title: USACE\_CELRC\_LCGB\_2019\_a\_0003\_1.jpg Rated Item: 1. Unwanted Vegetation Growth Caption: Rating: Minimally Acceptable; Remarks: Trees and tall vegetation enchroaching on riverside toe.; Action: Cut.

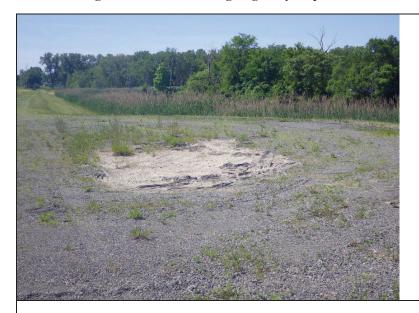
Inspect ID: LCGB\_2019\_a\_0071 Title: USACE\_CELRC\_LCGB\_2019\_a\_0071\_1.jpg Rated Item: 8. Depressions/ Rutting Caption: Rating: Minimally Acceptable; Remarks: Depression on turn around, exposed filter fabric.; Action: Replace filter fabric and fill to grade.

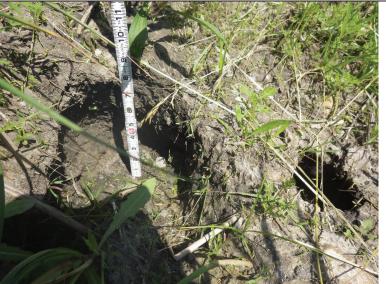
**Inspect ID:** LCGB\_2019\_a\_0059 **Title:** USACE\_CELRC\_LCGB\_2019\_a\_0059\_1.jpg **Rated Item:** 10. Animal Control **Caption:** Rating: Minimally Acceptable; Remarks: 10 inch deep burrow on riverside slope.; Action: Fill.

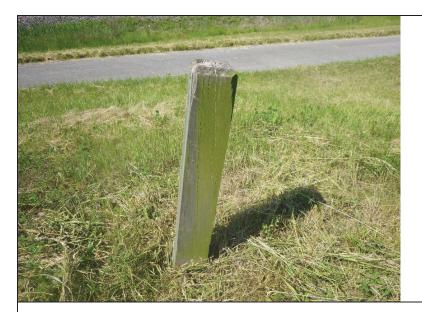
Inspect ID: LCGB\_2019\_a\_0039 Title: USACE\_CELRC\_LCGB\_2019\_a\_0039\_1.jpg Rated Item: 2. Encroachments Caption: Rating: Minimally Acceptable; Remarks: Bollard on landside of wall.; Action: Remove.

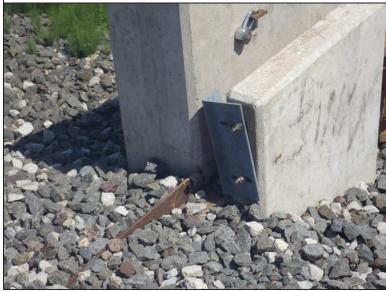
Inspect ID: LCGB\_2019\_a\_0069 Title: USACE\_CELRC\_LCGB\_2019\_a\_0069\_1.jpg Rated Item: 3. Closure Structures (Stop Log Closures and Gates) (A or U only) Caption: Rating: Acceptable; Remarks: Loose plate on closure on north side.; Action: Repair.

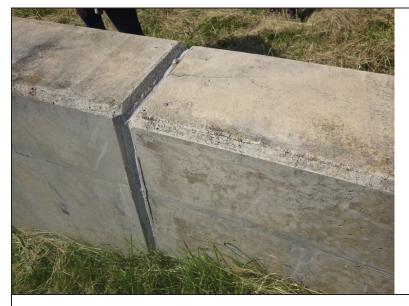
Inspect ID: LCGB\_2019\_a\_0027 Title: USACE\_CELRC\_LCGB\_2019\_a\_0027\_1.jpg Rated Item: 4. Concrete Surfaces Caption: Rating: Minimally Acceptable; Remarks: Cracking on top on wall and riverside.; Action: Repair.

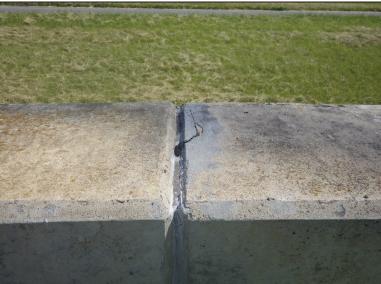
Inspect ID: LCGB\_2019\_a\_0029 Title: USACE\_CELRC\_LCGB\_2019\_a\_0029\_1.jpg Rated Item: 4. Concrete Surfaces Caption: Rating: Minimally Acceptable; Remarks: Crack on top of wall poorly patched.; Action: Repair.

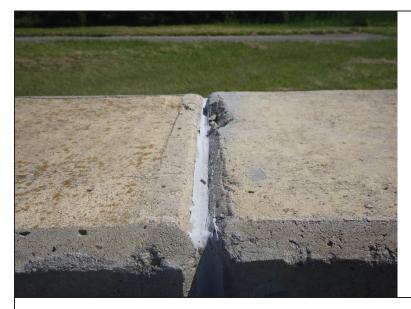
Inspect ID: LCGB\_2019\_a\_0031 Title: USACE\_CELRC\_LCGB\_2019\_a\_0031\_1.jpg Rated Item: 4. Concrete Surfaces Caption: Rating: Minimally Acceptable; Remarks: Spalling on top of floodwall.; Action: Patch.

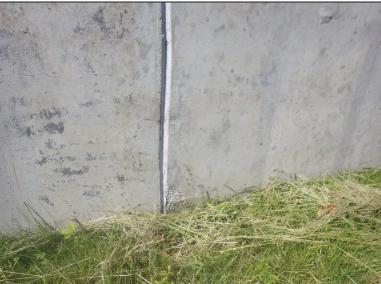
Inspect ID: LCGB\_2019\_a\_0033 Title: USACE\_CELRC\_LCGB\_2019\_a\_0033\_1.jpg Rated Item: 4. Concrete Surfaces Caption: Rating: Minimally Acceptable; Remarks: Spalling on riverside.; Action: Patch.

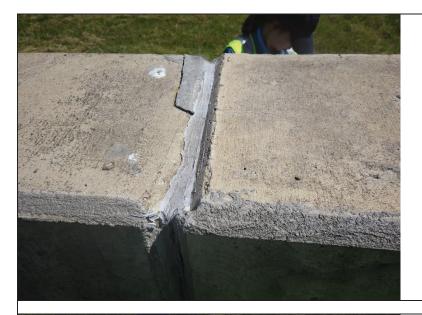
Inspect ID: LCGB\_2019\_a\_0041 Title: USACE\_CELRC\_LCGB\_2019\_a\_0041\_1.jpg Rated Item: 4. Concrete Surfaces Caption: Rating: Minimally Acceptable; Remarks: Cracked concrete on top of wall.; Action: Repair.

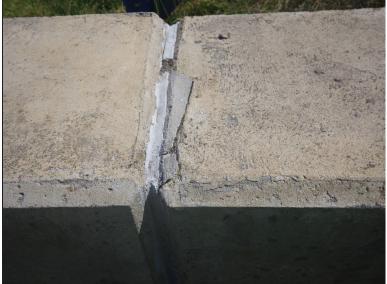
**Inspect ID:** LCGB\_2019\_a\_0045 **Title:** USACE\_CELRC\_LCGB\_2019\_a\_0045\_1.jpg **Rated Item:** 4. Concrete Surfaces **Caption:** Rating: Minimally Acceptable; Remarks: Cracking of concrete on floodwall.; Action: Repair.

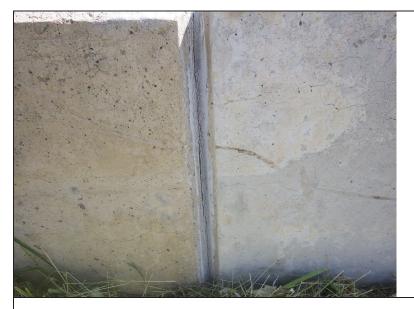
Inspect ID: LCGB\_2019\_a\_0025 Title: USACE\_CELRC\_LCGB\_2019\_a\_0025\_1.jpg Rated Item: 7. Monolith Joints Caption: Rating: Minimally Acceptable; Remarks: Joint sealant cracking on landside. Local Sponsor resealed after inspection.; Action: Provide documentation.

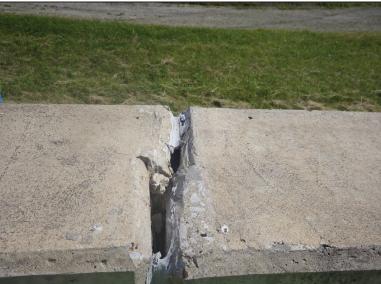
Inspect ID: LCGB\_2019\_a\_0035 Title: USACE\_CELRC\_LCGB\_2019\_a\_0035\_1.jpg Rated Item: 7. Monolith Joints Caption: Rating: Minimally Acceptable; Remarks: No backer rod or joint sealant, spalling. Local Sponsor resealed after inspection.; Action: Provide documentation.

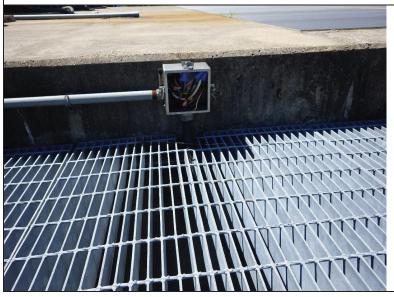
Inspect ID: LCGB\_2019\_a\_0078 Title: USACE\_CELRC\_LCGB\_2019\_a\_0078\_1.jpg Rated Item: 16. Enclosures, Panels, Conduit and Ducts Caption: Rating: Minimally Acceptable; Remarks: PS-BS: Missing electrical cover plate.; Action: Replace.

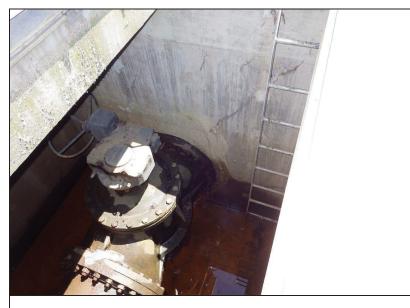
Inspect ID: LCGB\_2019\_a\_0090 Title: USACE\_CELRC\_LCGB\_2019\_a\_0090\_1.jpg Rated Item: 19. Flap Gates/ Flap Valves/ Pinch Valves Caption: Rating: Minimally Acceptable; Remarks: PS-BS: Check valve is leaking.; Action: Repair.

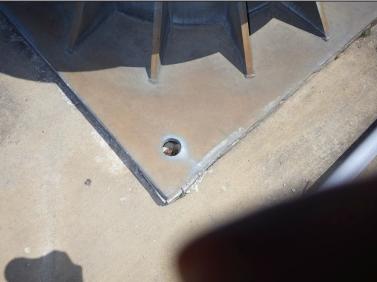
Inspect ID: LCGB\_2019\_a\_0092 Title: USACE\_CELRC\_LCGB\_2019\_a\_0092\_1.jpg
Rated Item: 21. Other Metallic Items (Equipment, Ladders, Platform Anchors, etc)
Caption: Rating: Minimally Acceptable; Remarks: PS-BS: Missing bolt.; Action:
Replace.
