# Levee Inspection Report

Name of System: Gary  
 Name of Segment: Gary North  
 NLD System ID: 2605000003 NLD Segment ID: 2604000003

Segment Type: USACE Constructed, Public sponsor O&M  
 Levee Sponsor (Name and Organization): Little Calumet River Basin Development Commission, Little Calumet River Basin Development Commission  
 Inspection Report Prepared by: \_\_\_\_\_ Date(s) of Inspection: 05/11/2020 - 05/13/2020

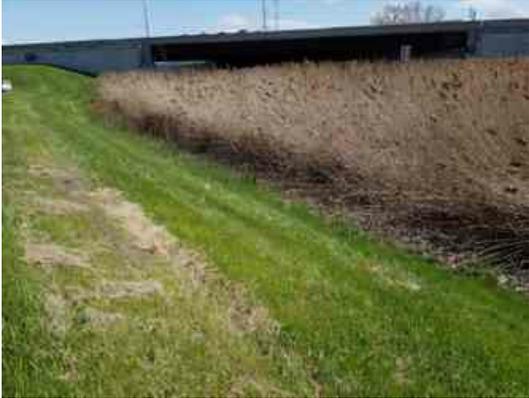
<p><b>Inspect ID:</b> 2020-0017 <b>Title:</b> 2604000003_CELRC_2020_A_0017_1_20200511T201126.jpg <b>Rated Item:</b> 1. Unwanted Vegetation Growth <b>Caption:</b> Minimally Acceptable - Small trees near landside toe.</p>

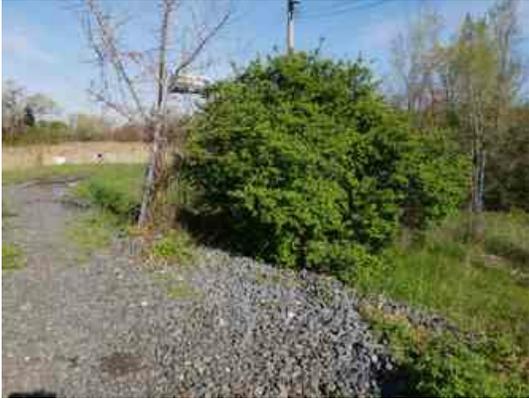
<p><b>Inspect ID:</b> 2020-0037 <b>Title:</b> 2604000003_CELRC_2020_A_0037_1_20200512T131813.jpg <b>Rated Item:</b> 1. Unwanted Vegetation Growth <b>Caption:</b> Minimally Acceptable - Tree on landside slope.</p>

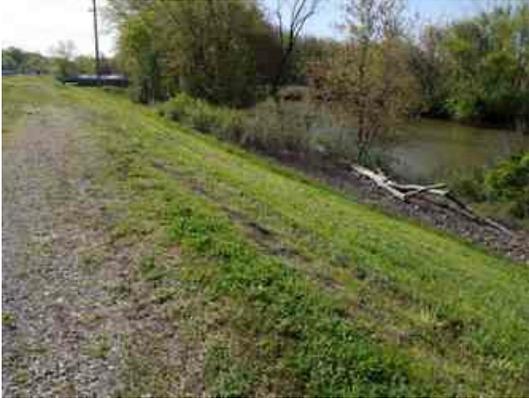
<p><b>Inspect ID:</b> 2020-0101 <b>Title:</b> 2604000003_CELRC_2020_A_0101_1_20200512T140359.jpg <b>Rated Item:</b> 1. Unwanted Vegetation Growth <b>Caption:</b> Minimally Acceptable - Bushes on riverside toe and slope.</p>

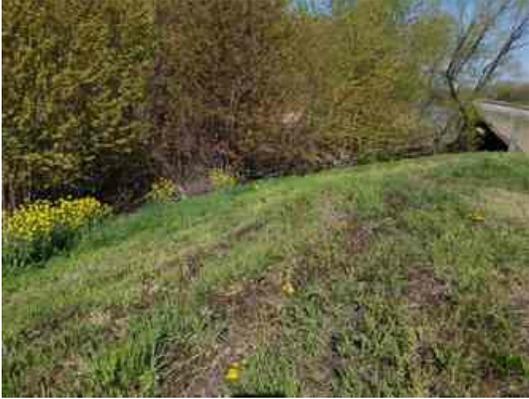
<p><b>Inspect ID:</b> 2020-0129 <b>Title:</b> 2604000003_CELRC_2020_A_0129_1_20200512T143110.jpg <b>Rated Item:</b> 1. Unwanted Vegetation Growth <b>Caption:</b> Minimally Acceptable - Trees on the riverside toe.</p>

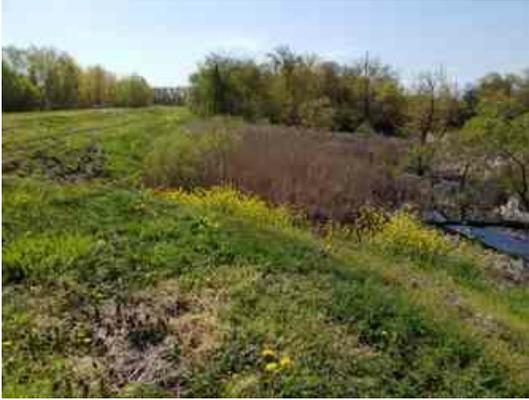
<p><b>Inspect ID:</b> 2020-0133 <b>Title:</b> 2604000003_CELRC_2020_A_0133_1_20200512T143529.jpg <b>Rated Item:</b> 1. Unwanted Vegetation Growth <b>Caption:</b> Minimally Acceptable - Small trees on the riverside toe and slope.</p>

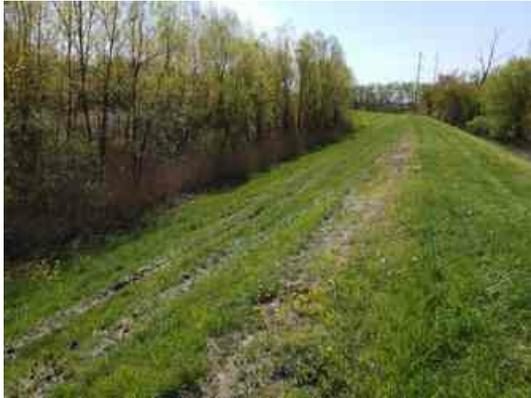
<p><b>Inspect ID:</b> 2020-0141 <b>Title:</b> 2604000003_CELRC_2020_A_0141_1_20200512T144207.jpg <b>Rated Item:</b> 1. Unwanted Vegetation Growth <b>Caption:</b> Minimally Acceptable - Trees on the landside toe.</p>

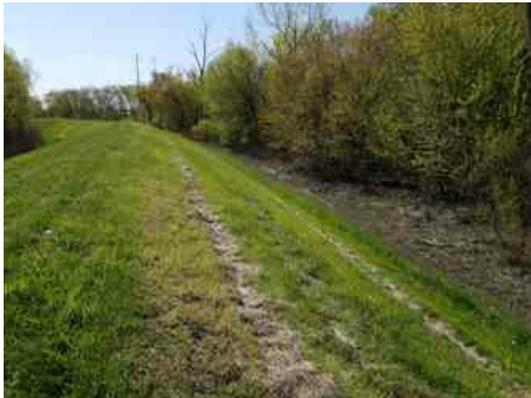
<p><b>Inspect ID:</b> 2020-0143 <b>Title:</b> 2604000003_CELRC_2020_A_0143_1_20200512T144304.jpg <b>Rated Item:</b> 1. Unwanted Vegetation Growth <b>Caption:</b> Minimally Acceptable - Trees on the riverside toe.</p>

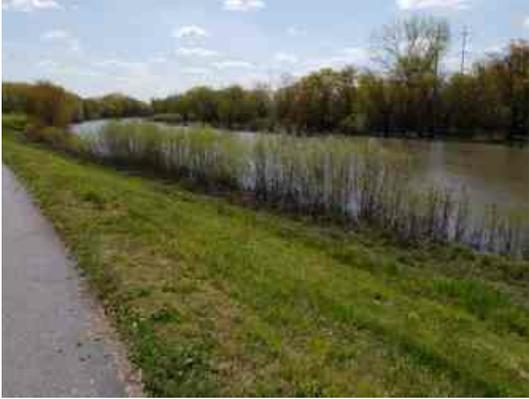
<p><b>Inspect ID:</b> 2020-0173 <b>Title:</b> 2604000003_CELRC_2020_A_0173_1_20200512T151801.jpg <b>Rated Item:</b> 1. Unwanted Vegetation Growth <b>Caption:</b> Minimally Acceptable - Small trees on the riverside toe.</p>

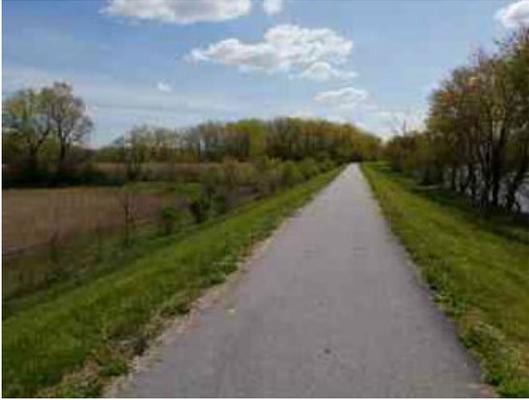
<p><b>Inspect ID:</b> 2020-0177 <b>Title:</b> 2604000003_CELRC_2020_A_0177_1_20200512T152107.jpg <b>Rated Item:</b> 1. Unwanted Vegetation Growth <b>Caption:</b> Minimally Acceptable - Small trees along the fence on landside slope.</p>

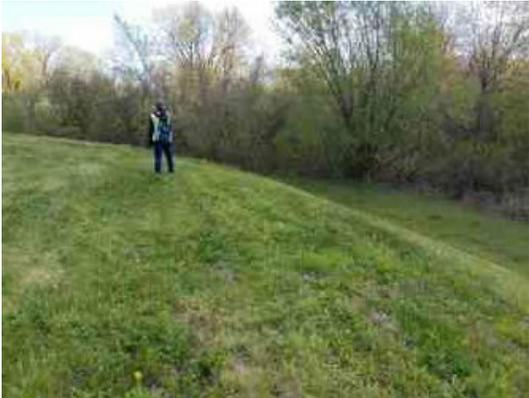
<p><b>Inspect ID:</b> 2020-0197 <b>Title:</b> 2604000003_CELRC_2020_A_0197_1_20200512T153503.jpg <b>Rated Item:</b> 1. Unwanted Vegetation Growth <b>Caption:</b> Minimally Acceptable - Trees near riverside toe.</p>

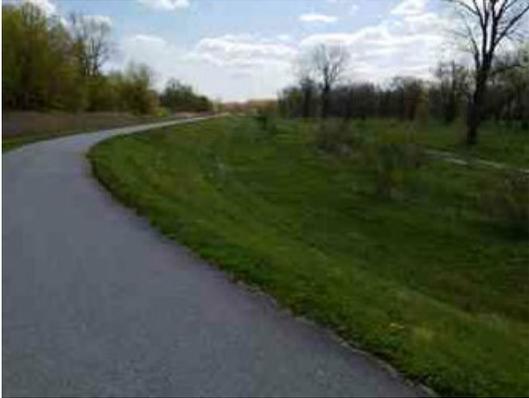
<p><b>Inspect ID:</b> 2020-0209 <b>Title:</b> 2604000003_CELRC_2020_A_0209_1_20200512T154550.jpg <b>Rated Item:</b> 1. Unwanted Vegetation Growth <b>Caption:</b> Acceptable - No trees near riverside toe.</p>

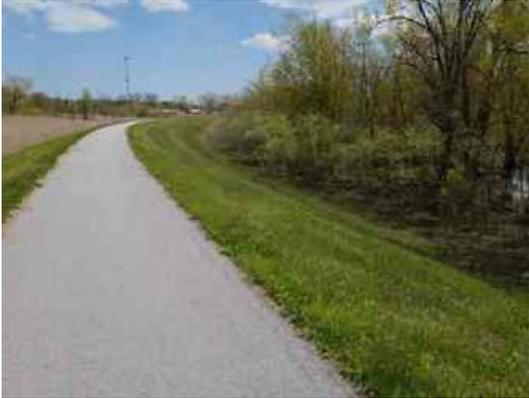
<p><b>Inspect ID:</b> 2020-0231 <b>Title:</b> 2604000003_CELRC_2020_A_0231_1_20200512T161355.jpg <b>Rated Item:</b> 1. Unwanted Vegetation Growth <b>Caption:</b> Minimally Acceptable - Trees on riverside toe.</p>

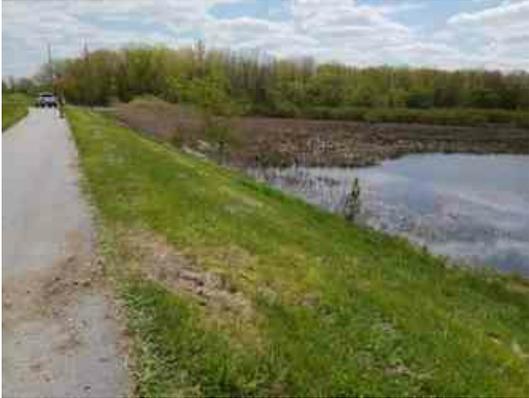
<p><b>Inspect ID:</b> 2020-0239 <b>Title:</b> 2604000003_CELRC_2020_A_0239_1_20200512T162417.jpg <b>Rated Item:</b> 1. Unwanted Vegetation Growth <b>Caption:</b> Minimally Acceptable - Small trees on riverside toe.</p>

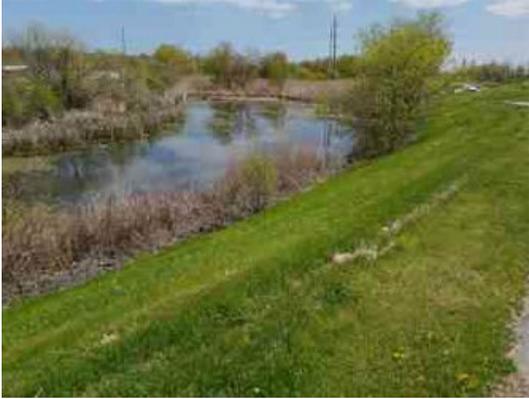
<p><b>Inspect ID:</b> 2020-0243 <b>Title:</b> 2604000003_CELRC_2020_A_0243_1_20200512T162644.jpg <b>Rated Item:</b> 1. Unwanted Vegetation Growth <b>Caption:</b> Minimally Acceptable - Trees on landside toe.</p>

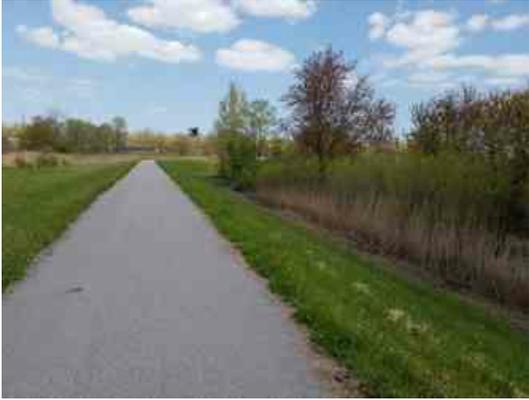
<p><b>Inspect ID:</b> 2020-0255 <b>Title:</b> 2604000003_CELRC_2020_A_0255_1_20200512T164553.jpg <b>Rated Item:</b> 1. Unwanted Vegetation Growth <b>Caption:</b> Minimally Acceptable - Trees near riverside toe.</p>

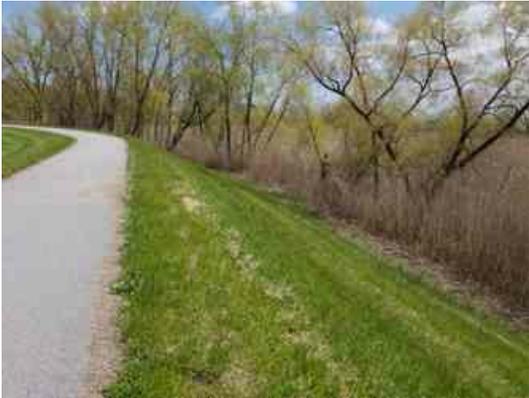
<p><b>Inspect ID:</b> 2020-0261 <b>Title:</b> 2604000003_CELRC_2020_A_0261_1_20200512T164958.jpg <b>Rated Item:</b> 1. Unwanted Vegetation Growth <b>Caption:</b> Minimally Acceptable - Small trees near riverside toe.</p>

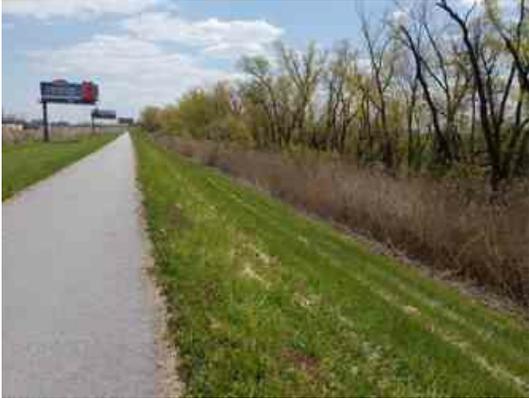
<p><b>Inspect ID:</b> 2020-0269 <b>Title:</b> 2604000003_CELRC_2020_A_0269_1_20200512T165756.jpg <b>Rated Item:</b> 1. Unwanted Vegetation Growth <b>Caption:</b> Minimally Acceptable - Small trees on riverside toe.</p>

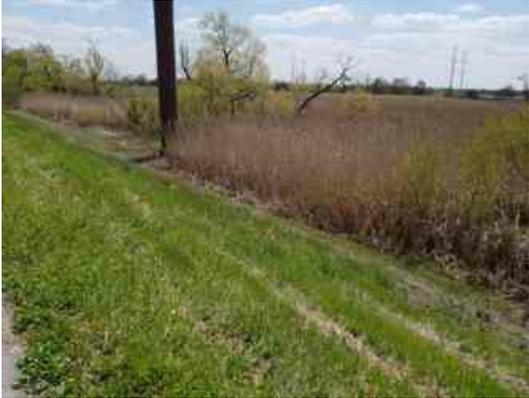
<p><b>Inspect ID:</b> 2020-0275 <b>Title:</b> 2604000003_CELRC_2020_A_0275_1_20200512T170615.jpg <b>Rated Item:</b> 1. Unwanted Vegetation Growth <b>Caption:</b> Minimally Acceptable - Small trees near riverside toe.</p>

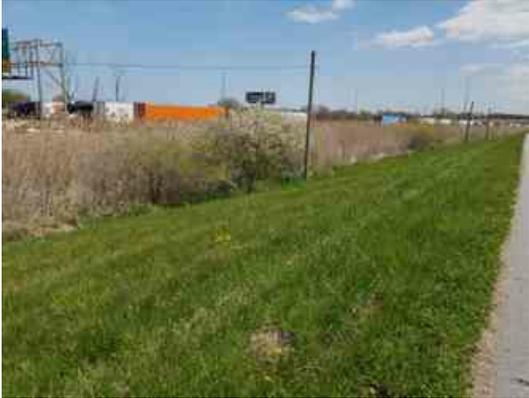
<p><b>Inspect ID:</b> 2020-0283 <b>Title:</b> 2604000003_CELRC_2020_A_0283_1_20200512T171100.jpg <b>Rated Item:</b> 1. Unwanted Vegetation Growth <b>Caption:</b> Minimally Acceptable - Small trees on landside toe.</p>

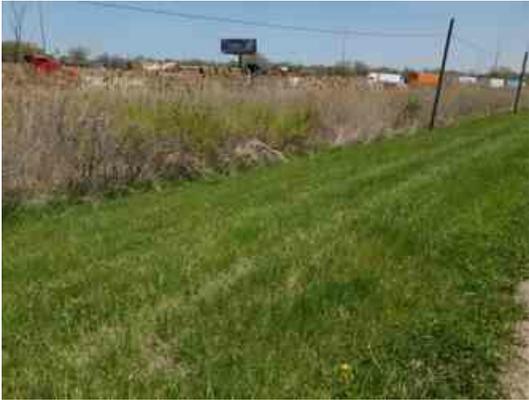
<p><b>Inspect ID:</b> 2020-0285 <b>Title:</b> 2604000003_CELRC_2020_A_0285_1_20200512T171157.jpg <b>Rated Item:</b> 1. Unwanted Vegetation Growth <b>Caption:</b> Minimally Acceptable - Small trees on landside toe.</p>

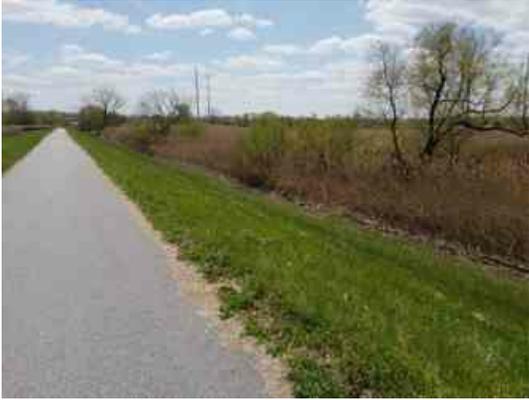
<p><b>Inspect ID:</b> 2020-0287 <b>Title:</b> 2604000003_CELRC_2020_A_0287_1_20200512T171453.jpg <b>Rated Item:</b> 1. Unwanted Vegetation Growth <b>Caption:</b> Minimally Acceptable - Small trees near riverside toe.</p>

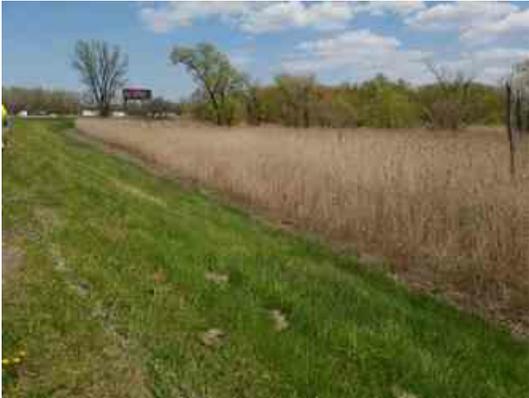
<p><b>Inspect ID:</b> 2020-0303 <b>Title:</b> 2604000003_CELRC_2020_A_0303_1_20200512T181348.jpg <b>Rated Item:</b> 1. Unwanted Vegetation Growth <b>Caption:</b> Minimally Acceptable - Small trees near riverside toe.</p>

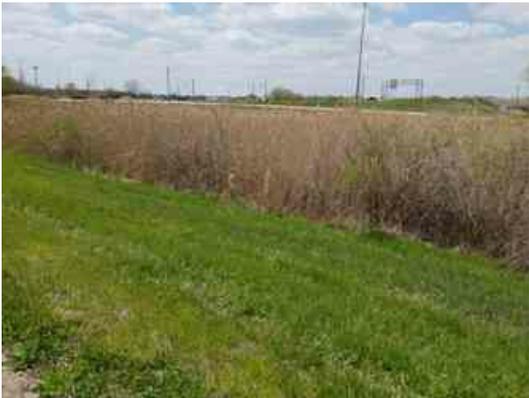
<p><b>Inspect ID:</b> 2020-0305 <b>Title:</b> 2604000003_CELRC_2020_A_0305_1_20200512T181507.jpg <b>Rated Item:</b> 1. Unwanted Vegetation Growth <b>Caption:</b> Minimally Acceptable - Small trees on landside toe.</p>

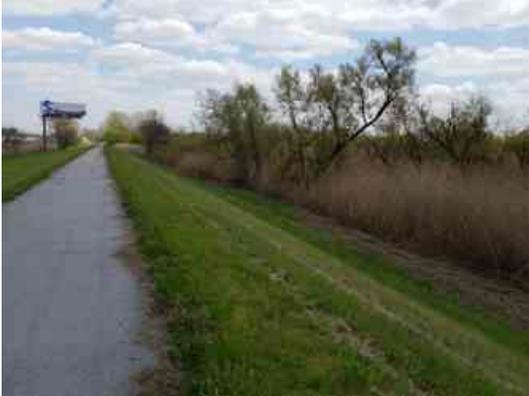
<p><b>Inspect ID:</b> 2020-0307 <b>Title:</b> 2604000003_CELRC_2020_A_0307_1_20200512T181819.jpg <b>Rated Item:</b> 1. Unwanted Vegetation Growth <b>Caption:</b> Minimally Acceptable - Trees near riverside toe.</p>

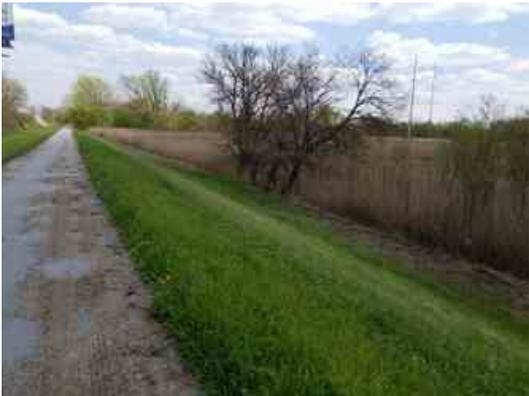
<p><b>Inspect ID:</b> 2020-0309 <b>Title:</b> 2604000003_CELRC_2020_A_0309_1_20200512T182034.jpg <b>Rated Item:</b> 1. Unwanted Vegetation Growth <b>Caption:</b> Minimally Acceptable - Large trees near riverside toe.</p>

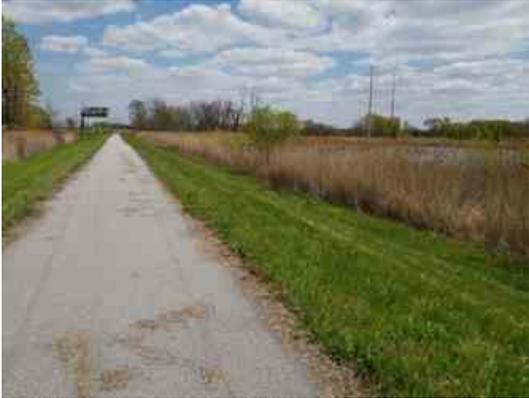
<p><b>Inspect ID:</b> 2020-0329 <b>Title:</b> 2604000003_CELRC_2020_A_0329_1_20200512T183429.jpg <b>Rated Item:</b> 1. Unwanted Vegetation Growth <b>Caption:</b> Minimally Acceptable - Small trees near riverside toe.</p>

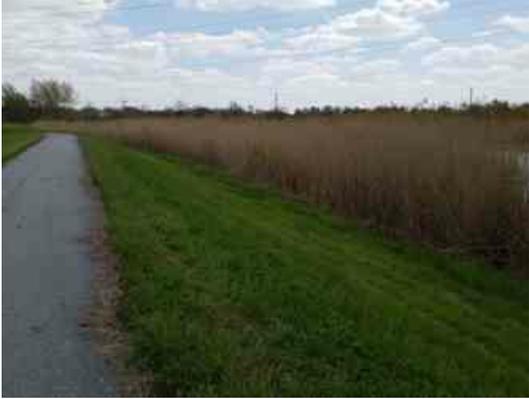
<p><b>Inspect ID:</b> 2020-0335 <b>Title:</b> 2604000003_CELRC_2020_A_0335_1_20200512T184321.jpg <b>Rated Item:</b> 1. Unwanted Vegetation Growth <b>Caption:</b> Minimally Acceptable - Small trees near riverside toe.</p>

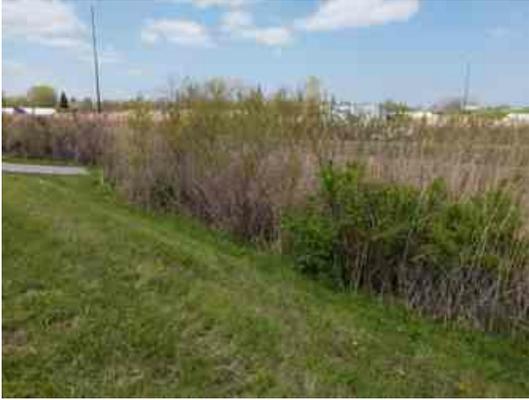
<p><b>Inspect ID:</b> 2020-0339 <b>Title:</b> 2604000003_CELRC_2020_A_0339_1_20200512T184552.jpg <b>Rated Item:</b> 1. Unwanted Vegetation Growth <b>Caption:</b> Minimally Acceptable - Trees on landside toe.</p>

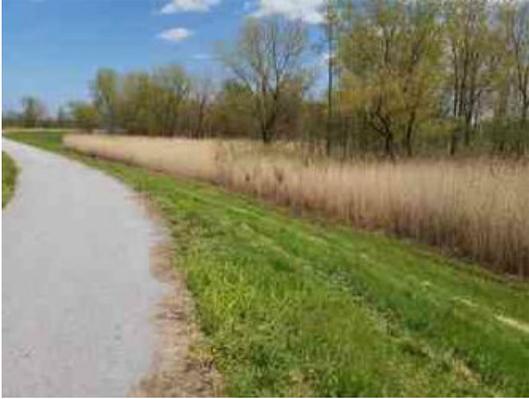
<p><b>Inspect ID:</b> 2020-0347 <b>Title:</b> 2604000003_CELRC_2020_A_0347_1_20200512T185606.jpg <b>Rated Item:</b> 1. Unwanted Vegetation Growth <b>Caption:</b> Minimally Acceptable - Trees near riverside toe.</p>

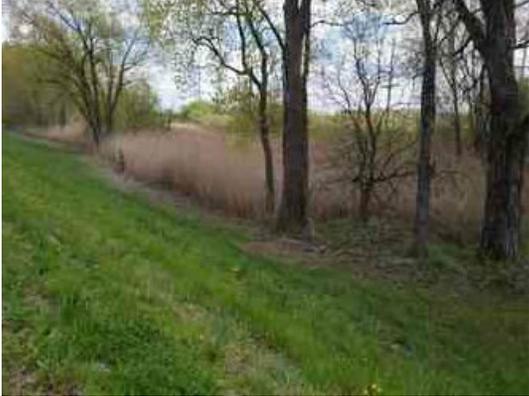
<p><b>Inspect ID:</b> 2020-0355 <b>Title:</b> 2604000003_CELRC_2020_A_0355_1_20200512T190346.jpg <b>Rated Item:</b> 1. Unwanted Vegetation Growth <b>Caption:</b> Minimally Acceptable - Large tree near riverside toe.</p>

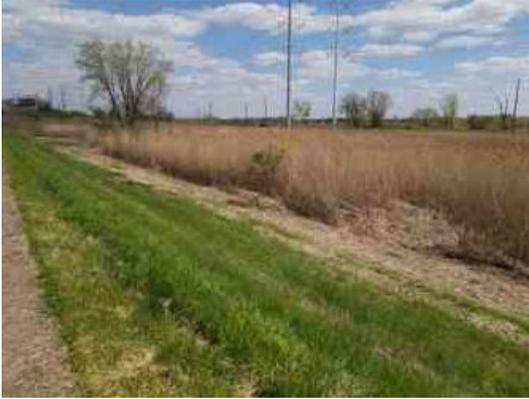
<p><b>Inspect ID:</b> 2020-0379 <b>Title:</b> 2604000003_CELRC_2020_A_0379_1_20200512T192329.jpg <b>Rated Item:</b> 1. Unwanted Vegetation Growth <b>Caption:</b> Minimally Acceptable - Small trees near riverside toe.</p>

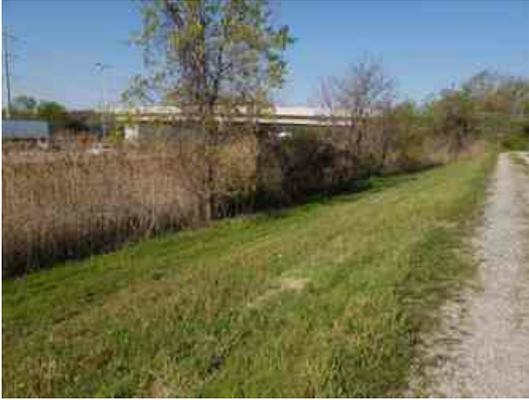
<p><b>Inspect ID:</b> 2020-0401 <b>Title:</b> 2604000003_CELRC_2020_A_0401_1_20200513T134407.jpg <b>Rated Item:</b> 1. Unwanted Vegetation Growth <b>Caption:</b> Minimally Acceptable - Trees near landside toe.</p>

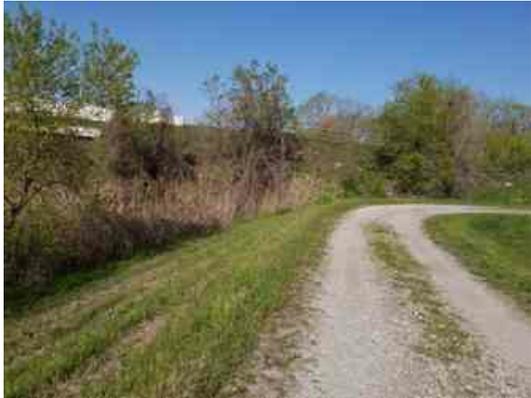
<p><b>Inspect ID:</b> 2020-0405 <b>Title:</b> 2604000003_CELRC_2020_A_0405_1_20200513T134533.jpg <b>Rated Item:</b> 1. Unwanted Vegetation Growth <b>Caption:</b> Minimally Acceptable - Large trees near landside toe.</p>

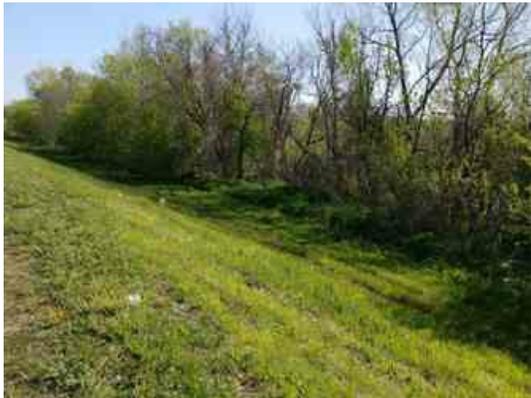
<p><b>Inspect ID:</b> 2020-0409 <b>Title:</b> 2604000003_CELRC_2020_A_0409_1_20200513T134827.jpg <b>Rated Item:</b> 1. Unwanted Vegetation Growth <b>Caption:</b> Minimally Acceptable - Trees near riverside toe.</p>

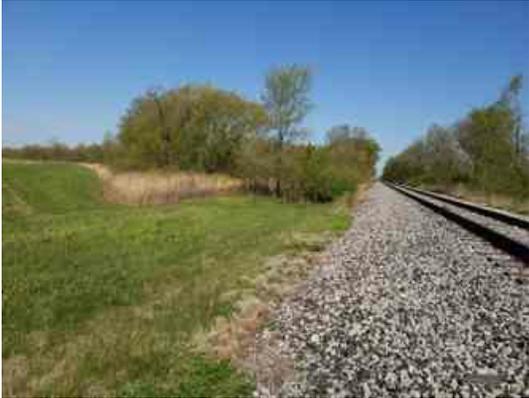
<p><b>Inspect ID:</b> 2020-0437 <b>Title:</b> 2604000003_CELRC_2020_A_0437_1_20200513T140935.jpg <b>Rated Item:</b> 1. Unwanted Vegetation Growth <b>Caption:</b> Minimally Acceptable - Trees on tieback crest.</p>

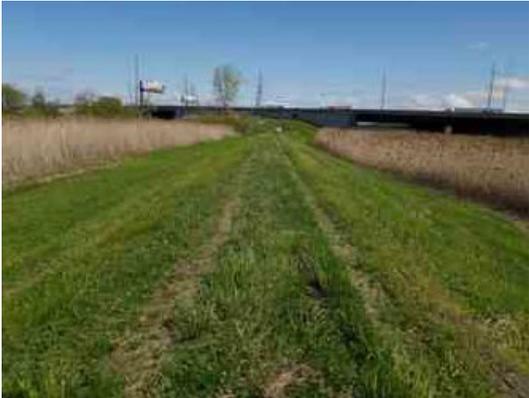
<p><b>Inspect ID:</b> 2020-0015 <b>Title:</b> 2604000003_CELRC_2020_A_0015_1_20200511T201006.jpg <b>Rated Item:</b> 2. Sod Cover <b>Caption:</b> Acceptable - Good sod cover on crest and slopes.</p>

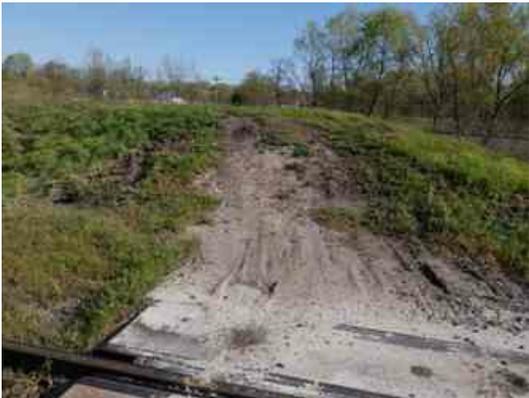
<p><b>Inspect ID:</b> 2020-0061 <b>Title:</b> 2604000003_CELRC_2020_A_0061_1_20200512T133225.jpg <b>Rated Item:</b> 2. Sod Cover <b>Caption:</b> Minimally Acceptable - Poor sod cover on slope at closure.</p>

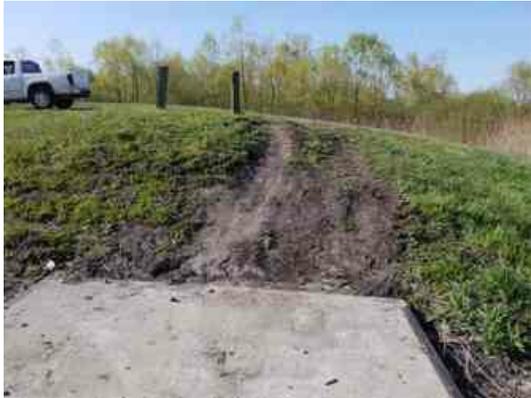
<p><b>Inspect ID:</b> 2020-0063 <b>Title:</b> 2604000003_CELRC_2020_A_0063_1_20200512T133329.jpg <b>Rated Item:</b> 2. Sod Cover <b>Caption:</b> Minimally Acceptable - Poor sod cover on slope at closure.</p>

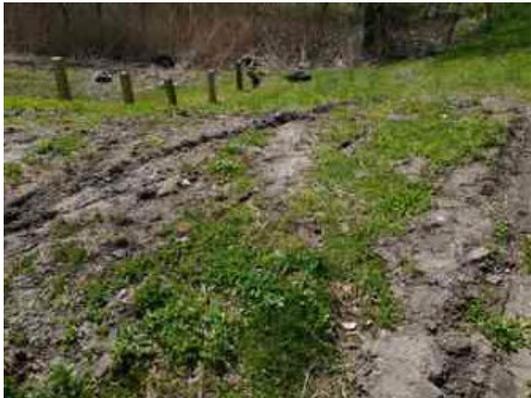
<p><b>Inspect ID:</b> 2020-0195 <b>Title:</b> 2604000003_CELRC_2020_A_0195_1_20200512T153340.jpg <b>Rated Item:</b> 2. Sod Cover <b>Caption:</b> Minimally Acceptable - Poor sod cover on crest.</p>

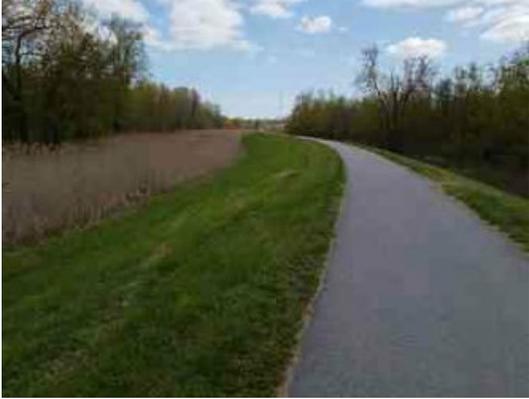
<p><b>Inspect ID:</b> 2020-0229 <b>Title:</b> 2604000003_CELRC_2020_A_0229_1_20200512T161020.jpg <b>Rated Item:</b> 2. Sod Cover <b>Caption:</b> Acceptable - Good sod cover on landside slope.</p>

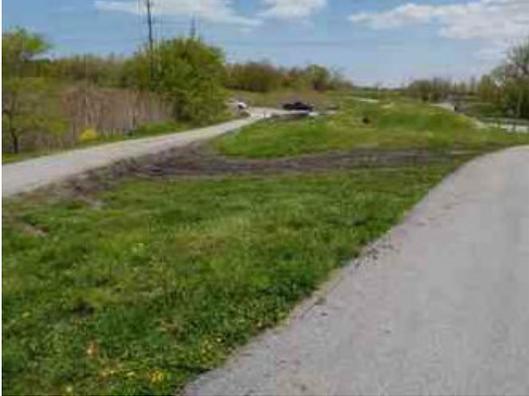
<p><b>Inspect ID:</b> 2020-0245 <b>Title:</b> 2604000003_CELRC_2020_A_0245_1_20200512T162756.jpg <b>Rated Item:</b> 2. Sod Cover <b>Caption:</b> Minimally Acceptable - Poor sod due to rutting on crest.</p>

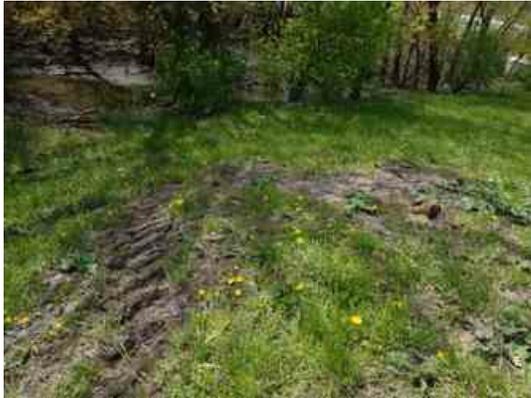
<p><b>Inspect ID:</b> 2020-0251 <b>Title:</b> 2604000003_CELRC_2020_A_0251_1_20200512T164355.jpg <b>Rated Item:</b> 2. Sod Cover <b>Caption:</b> Minimally Acceptable - Poor sod cover on riverside slope and crest.</p>

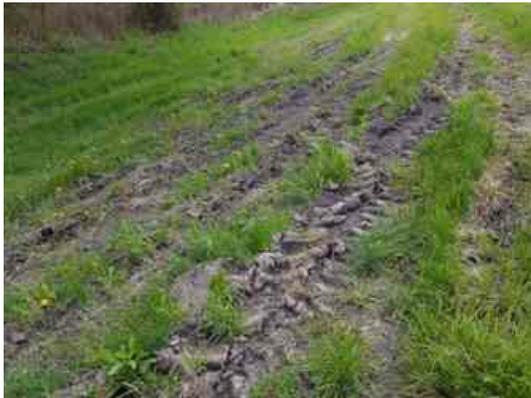
<p><b>Inspect ID:</b> 2020-0319 <b>Title:</b> 2604000003_CELRC_2020_A_0319_1_20200512T182814.jpg <b>Rated Item:</b> 2. Sod Cover <b>Caption:</b> Minimally Acceptable - Poor sod cover on riverside slope due to rutting.</p>

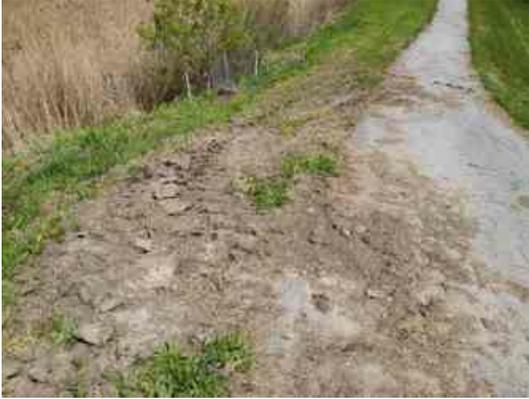
<p><b>Inspect ID:</b> 2020-0321 <b>Title:</b> 2604000003_CELRC_2020_A_0321_1_20200512T182958.jpg <b>Rated Item:</b> 2. Sod Cover <b>Caption:</b> Minimally Acceptable - Poor sod cover on landside slope due to rutting.</p>

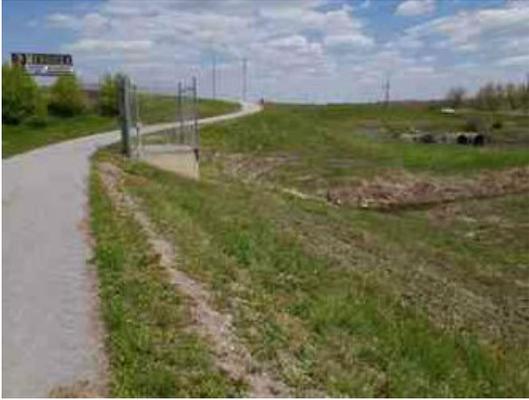
<p><b>Inspect ID:</b> 2020-0367 <b>Title:</b> 2604000003_CELRC_2020_A_0367_1_20200512T191146.jpg <b>Rated Item:</b> 2. Sod Cover <b>Caption:</b> Minimally Acceptable - Poor sod cover on riverside slope due to rutting.</p>

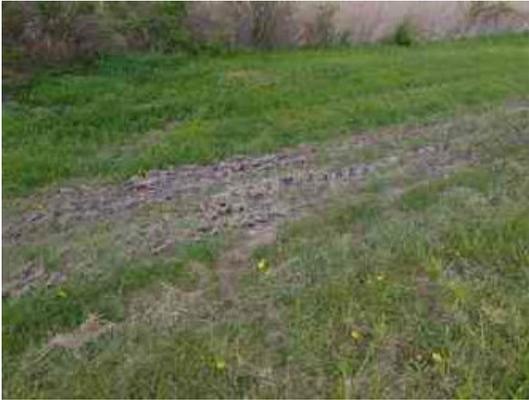
<p><b>Inspect ID:</b> 2020-0375 <b>Title:</b> 2604000003_CELRC_2020_A_0375_1_20200512T192013.jpg <b>Rated Item:</b> 2. Sod Cover <b>Caption:</b> Minimally Acceptable - Poor sod cover on landside slope.</p>

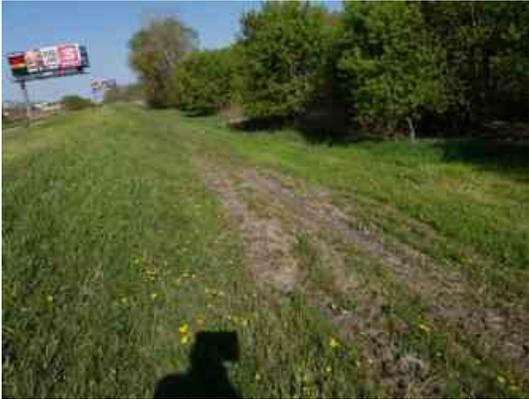
<p><b>Inspect ID:</b> 2020-0387 <b>Title:</b> 2604000003_CELRC_2020_A_0387_1_20200513T133223.jpg <b>Rated Item:</b> 2. Sod Cover <b>Caption:</b> Minimally Acceptable - Poor sod on riverside slope due to rutting.</p>

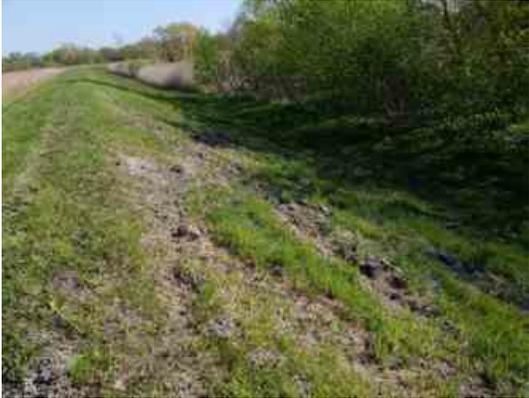
<p><b>Inspect ID:</b> 2020-0417 <b>Title:</b> 2604000003_CELRC_2020_A_0417_1_20200513T135236.jpg <b>Rated Item:</b> 2. Sod Cover <b>Caption:</b> Minimally Acceptable - Poor sod cover on riverside slope due to ruts.</p>

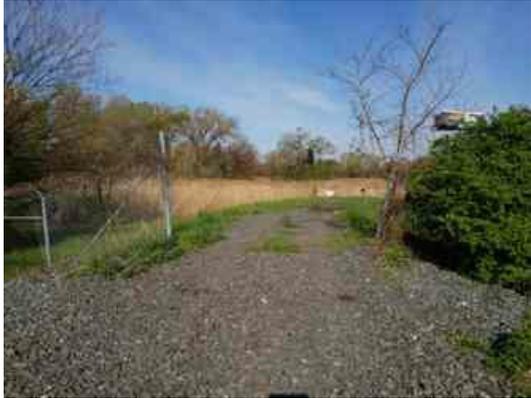
<p><b>Inspect ID:</b> 2020-0035 <b>Title:</b> 2604000003_CELRC_2020_A_0035_1_20200512T131712.jpg <b>Rated Item:</b> 3. Encroachments <b>Caption:</b> Minimally Acceptable - Fence across levee.</p>

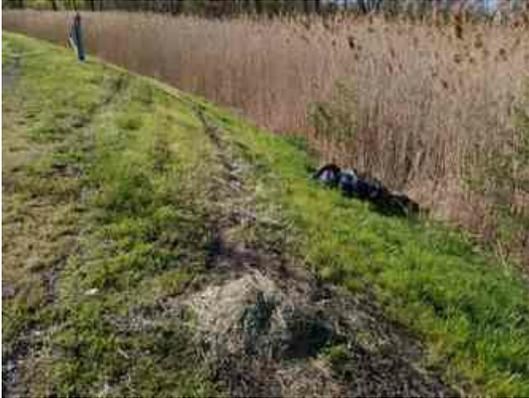
<p><b>Inspect ID:</b> 2020-0049 <b>Title:</b> 2604000003_CELRC_2020_A_0049_1_20200512T132334.jpg <b>Rated Item:</b> 3. Encroachments <b>Caption:</b> Minimally Acceptable - Trash on riverside slope.</p>

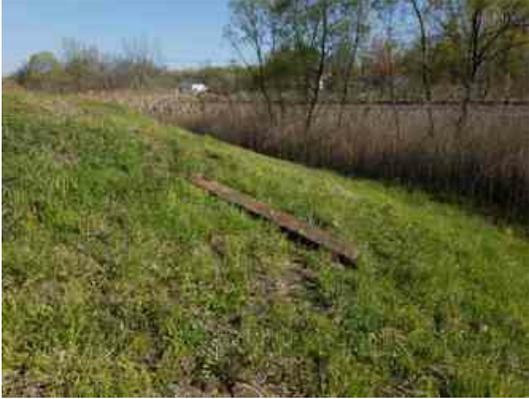
<p><b>Inspect ID:</b> 2020-0059 <b>Title:</b> 2604000003_CELRC_2020_A_0059_1_20200512T133152.jpg <b>Rated Item:</b> 3. Encroachments <b>Caption:</b> Minimally Acceptable - Debris on landside slope.</p>

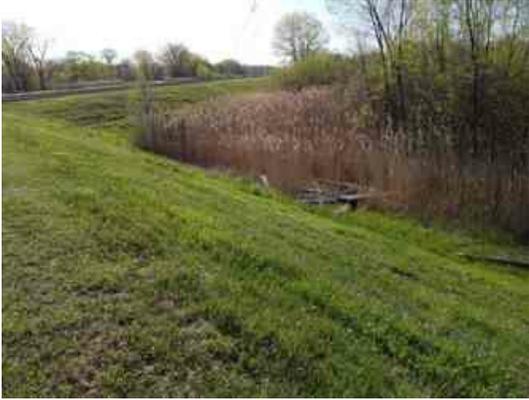
<p><b>Inspect ID:</b> 2020-0071 <b>Title:</b> 2604000003_CELRC_2020_A_0071_1_20200512T134008.jpg <b>Rated Item:</b> 3. Encroachments <b>Caption:</b> Minimally Acceptable - Debris on riverside toe.</p>

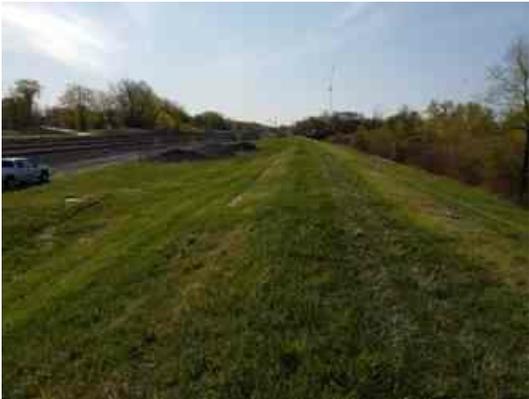
<p><b>Inspect ID:</b> 2020-0075 <b>Title:</b> 2604000003_CELRC_2020_A_0075_1_20200512T134228.jpg <b>Rated Item:</b> 3. Encroachments <b>Caption:</b> Minimally Acceptable - Ballast stockpile on landside toe.</p>

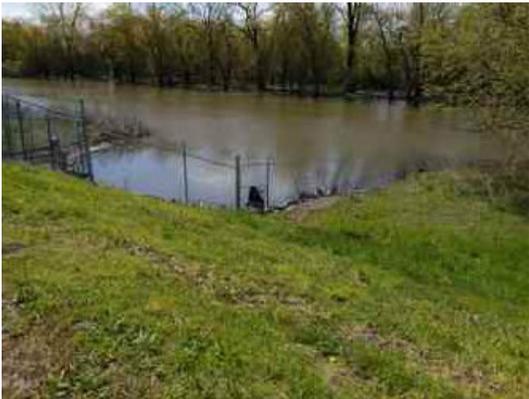
<p><b>Inspect ID:</b> 2020-0171 <b>Title:</b> 2604000003_CELRC_2020_A_0171_1_20200512T151523.jpg <b>Rated Item:</b> 3. Encroachments <b>Caption:</b> Minimally Acceptable - Shopping cart on riverside toe.</p>

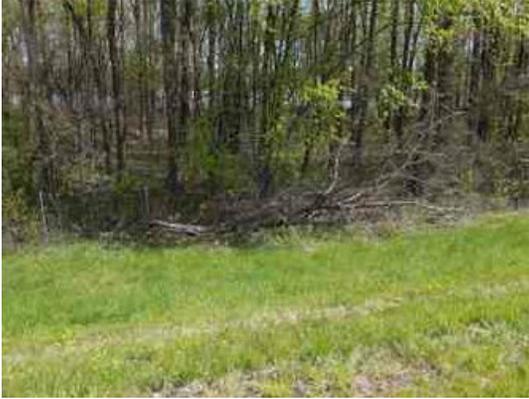
<p><b>Inspect ID:</b> 2020-0185 <b>Title:</b> 2604000003_CELRC_2020_A_0185_1_20200512T152721.jpg <b>Rated Item:</b> 3. Encroachments <b>Caption:</b> Minimally Acceptable - Downed tree on landside toe.</p>

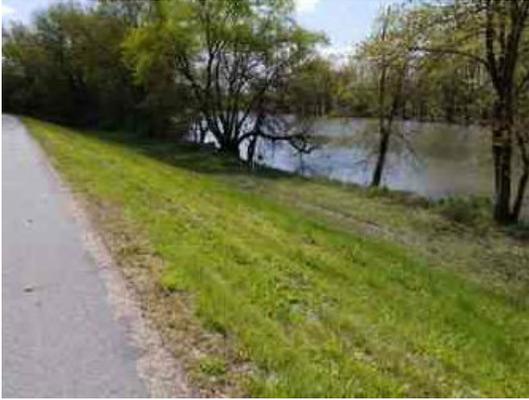
<p><b>Inspect ID:</b> 2020-0187 <b>Title:</b> 2604000003_CELRC_2020_A_0187_1_20200512T152839.jpg <b>Rated Item:</b> 3. Encroachments <b>Caption:</b> Minimally Acceptable - Tree branch on riverside toe.</p>

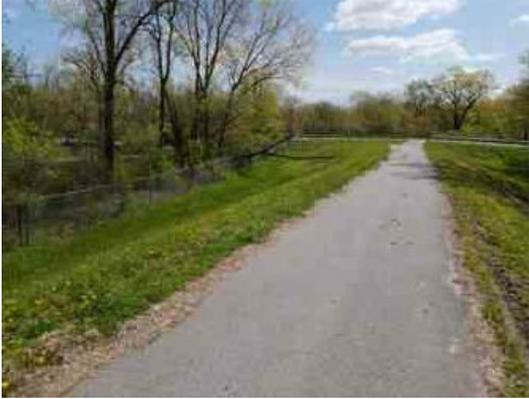
<p><b>Inspect ID:</b> 2020-0191 <b>Title:</b> 2604000003_CELRC_2020_A_0191_1_20200512T153123.jpg <b>Rated Item:</b> 3. Encroachments <b>Caption:</b> Minimally Acceptable - Downed tree on landside slope.</p>

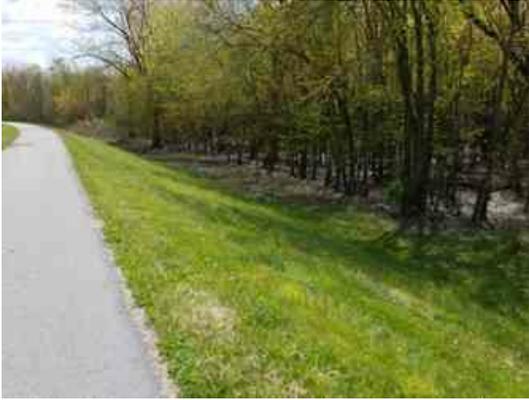
<p><b>Inspect ID:</b> 2020-0223 <b>Title:</b> 2604000003_CELRC_2020_A_0223_1_20200512T160622.jpg <b>Rated Item:</b> 3. Encroachments <b>Caption:</b> Minimally Acceptable - Branch on riverside toe.</p>

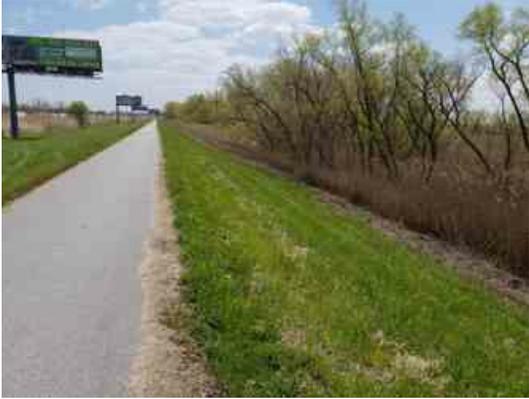
<p><b>Inspect ID:</b> 2020-0267 <b>Title:</b> 2604000003_CELRC_2020_A_0267_1_20200512T165541.jpg <b>Rated Item:</b> 3. Encroachments <b>Caption:</b> Minimally Acceptable - Tree falling over near riverside toe.</p>

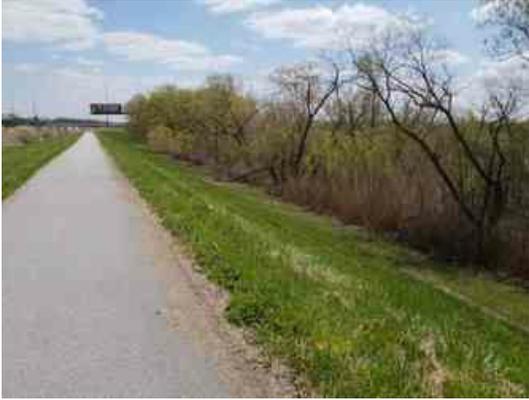
<p><b>Inspect ID:</b> 2020-0281 <b>Title:</b> 2604000003_CELRC_2020_A_0281_1_20200512T170935.jpg <b>Rated Item:</b> 3. Encroachments <b>Caption:</b> Minimally Acceptable - Downed trees at riverside toe.</p>

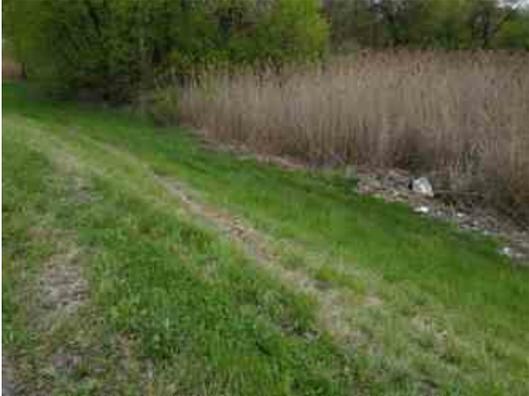
<p><b>Inspect ID:</b> 2020-0313 <b>Title:</b> 2604000003_CELRC_2020_A_0313_1_20200512T182525.jpg <b>Rated Item:</b> 3. Encroachments <b>Caption:</b> Minimally Acceptable - Debris near riverside toe.</p>

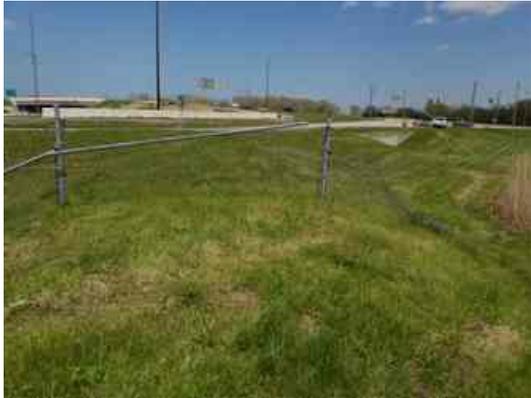
<p><b>Inspect ID:</b> 2020-0341 <b>Title:</b> 2604000003_CELRC_2020_A_0341_1_20200512T184653.jpg <b>Rated Item:</b> 3. Encroachments <b>Caption:</b> Minimally Acceptable - Fence across levee.</p>

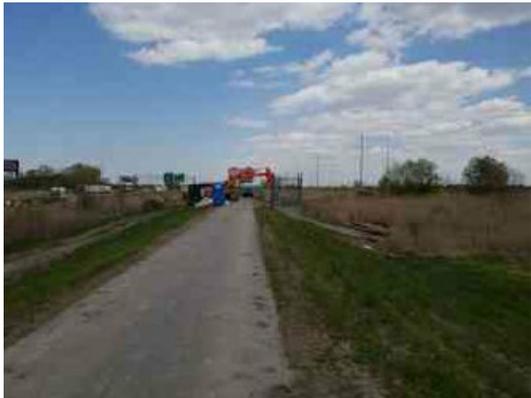
<p><b>Inspect ID:</b> 2020-0371 <b>Title:</b> 2604000003_CELRC_2020_A_0371_1_20200512T191546.jpg <b>Rated Item:</b> 3. Encroachments <b>Caption:</b> Acceptable - Ongoing work. Culvert cleaning.</p>

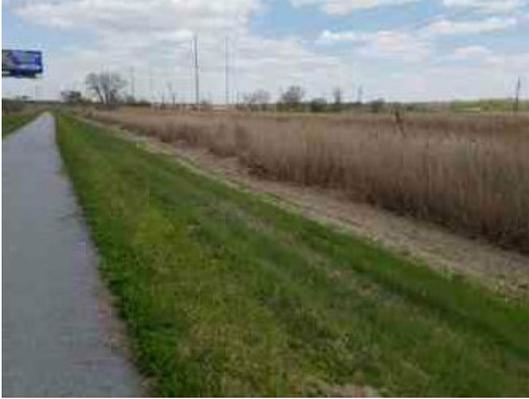
<p><b>Inspect ID:</b> 2020-0377 <b>Title:</b> 2604000003_CELRC_2020_A_0377_1_20200512T192112.jpg <b>Rated Item:</b> 3. Encroachments <b>Caption:</b> Minimally Acceptable - Downed tree near riverside toe.</p>

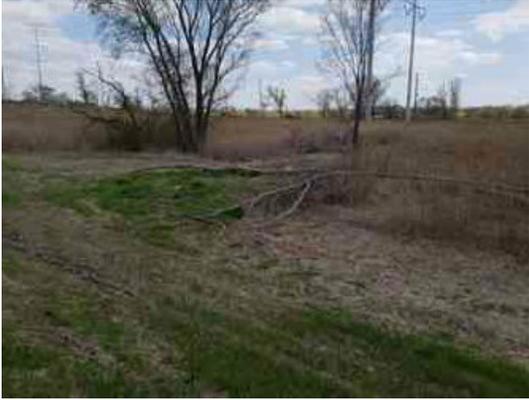
<p><b>Inspect ID:</b> 2020-0383 <b>Title:</b> 2604000003_CELRC_2020_A_0383_1_20200512T192521.jpg <b>Rated Item:</b> 3. Encroachments <b>Caption:</b> Minimally Acceptable - Downed tree on riverside toe.</p>

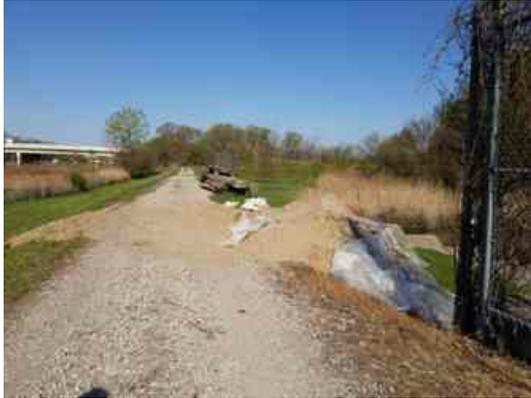
<p><b>Inspect ID:</b> 2020-0393 <b>Title:</b> 2604000003_CELRC_2020_A_0393_1_20200513T134002.jpg <b>Rated Item:</b> 3. Encroachments <b>Caption:</b> Minimally Acceptable - Sand and timber on riverside slope.</p>

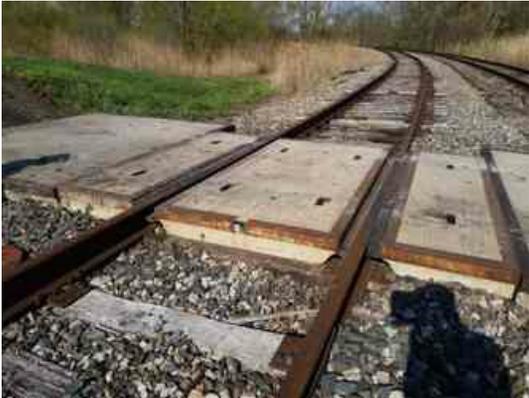
<p><b>Inspect ID:</b> 2020-0065 <b>Title:</b> 2604000003_CELRC_2020_A_0065_1_20200512T133620.jpg <b>Rated Item:</b> 4. Closure Structures (Stop Log, Earthen Closures, Gates, or Sandbag Closures) (A or U only) <b>Caption:</b> Acceptable - Rubber seals lower than platform at RR (E).</p>

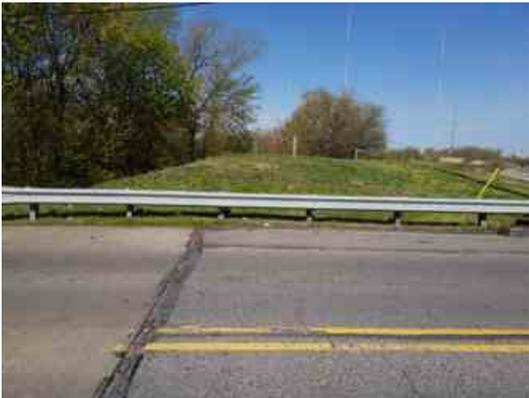
<p><b>Inspect ID:</b> 2020-0103 <b>Title:</b> 2604000003_CELRC_2020_A_0103_1_20200512T140807.jpg <b>Rated Item:</b> 4. Closure Structures (Stop Log, Earthen Closures, Gates, or Sandbag Closures) (A or U only) <b>Caption:</b> Acceptable - Guardrail blocking levee at Colfax.</p>

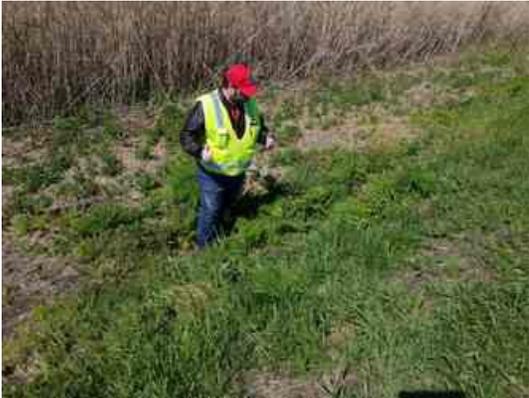
<p><b>Inspect ID:</b> 2020-0007 <b>Title:</b> 2604000003_CELRC_2020_A_0007_1_20200511T200428.jpg <b>Rated Item:</b> 6. Erosion/ Bank Caving <b>Caption:</b> Minimally Acceptable - Erosion on riverside toe.</p>

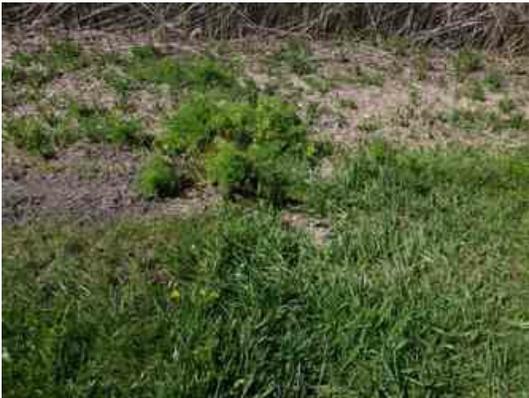
<p><b>Inspect ID:</b> 2020-0009 <b>Title:</b> 2604000003_CELRC_2020_A_0009_1_20200511T200557.jpg <b>Rated Item:</b> 6. Erosion/ Bank Caving <b>Caption:</b> Minimally Acceptable - Erosion on riverside toe.</p>

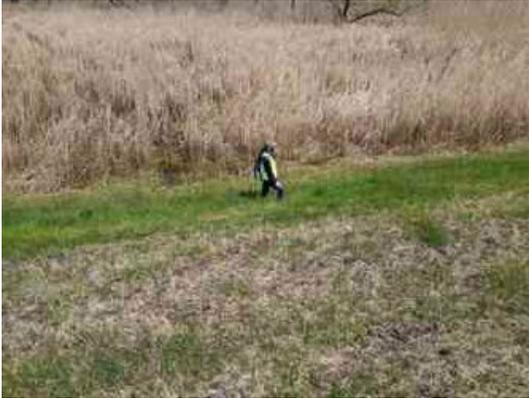
<p><b>Inspect ID:</b> 2020-0237 <b>Title:</b> 2604000003_CELRC_2020_A_0237_1_20200512T162002.jpg <b>Rated Item:</b> 6. Erosion/ Bank Caving <b>Caption:</b> Minimally Acceptable - 2 ft scarp on landside toe and slope.</p>

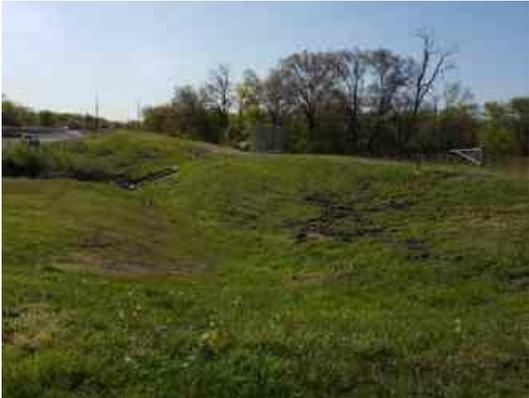
<p><b>Inspect ID:</b> 2020-0091 <b>Title:</b> 2604000003_CELRC_2020_A_0091_1_20200512T135812.jpg <b>Rated Item:</b> 7. Settlement <b>Caption:</b> Minimally Acceptable - Low spot on crest by gatewell.</p>

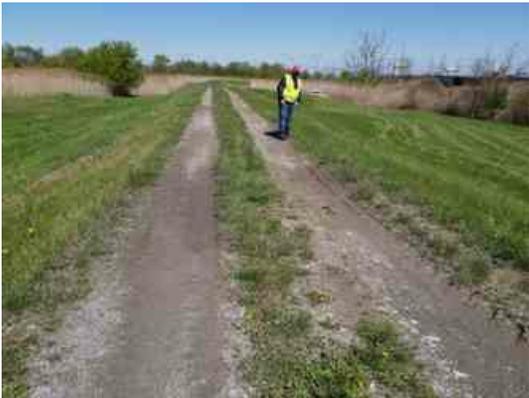
<p><b>Inspect ID:</b> 2020-0001 <b>Title:</b> 2604000003_CELRC_2020_A_0001_1_20200511T200005.jpg <b>Rated Item:</b> 8. Depressions/ Rutting <b>Caption:</b> Minimally Acceptable - Rutting on crest.</p>

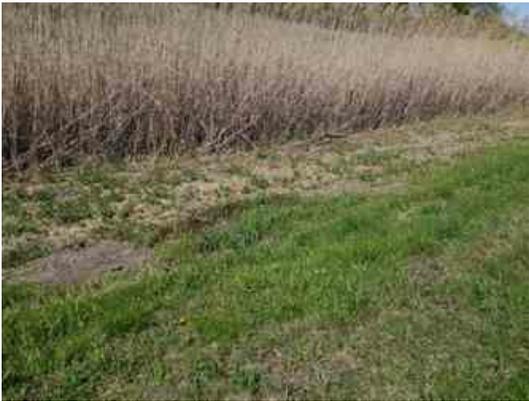
<p><b>Inspect ID:</b> 2020-0011 <b>Title:</b> 2604000003_CELRC_2020_A_0011_1_20200511T200649.jpg <b>Rated Item:</b> 8. Depressions/ Rutting <b>Caption:</b> Minimally Acceptable - 2 holes on riverside toe.</p>

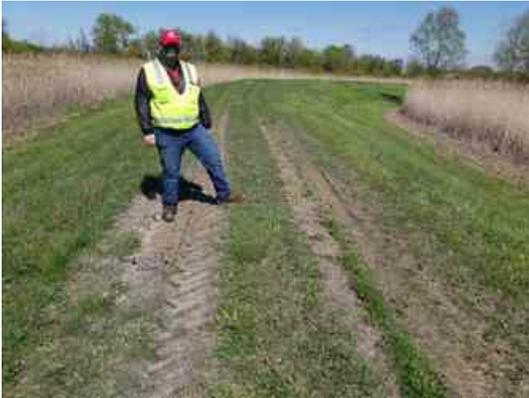
<p><b>Inspect ID:</b> 2020-0013 <b>Title:</b> 2604000003_CELRC_2020_A_0013_1_20200511T200730.jpg <b>Rated Item:</b> 8. Depressions/ Rutting <b>Caption:</b> Minimally Acceptable - Rutting, 5-inches deep.</p>

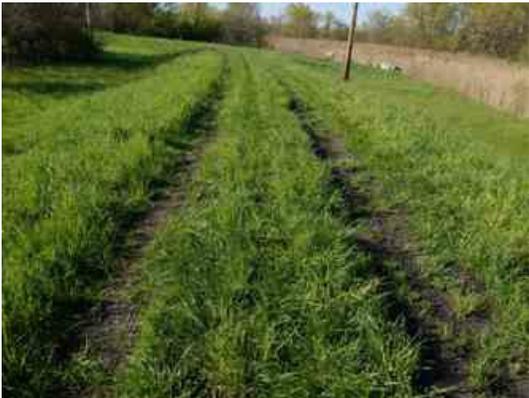
<p><b>Inspect ID:</b> 2020-0029 <b>Title:</b> 2604000003_CELRC_2020_A_0029_1_20200512T131429.jpg <b>Rated Item:</b> 8. Depressions/ Rutting <b>Caption:</b> Minimally Acceptable - Minor rutting on crest.</p>

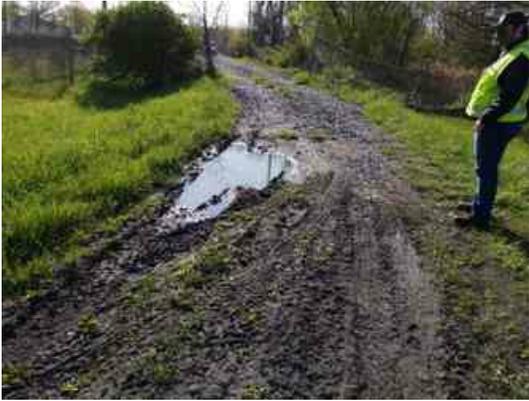
<p><b>Inspect ID:</b> 2020-0033 <b>Title:</b> 2604000003_CELRC_2020_A_0033_1_20200512T131634.jpg <b>Rated Item:</b> 8. Depressions/ Rutting <b>Caption:</b> Minimally Acceptable - Rut on landside crest.</p>

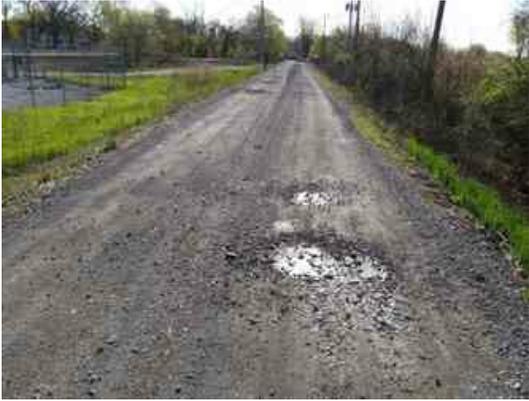
<p><b>Inspect ID:</b> 2020-0043 <b>Title:</b> 2604000003_CELRC_2020_A_0043_1_20200512T132017.jpg <b>Rated Item:</b> 8. Depressions/ Rutting <b>Caption:</b> Minimally Acceptable - Potholes on crest.</p>

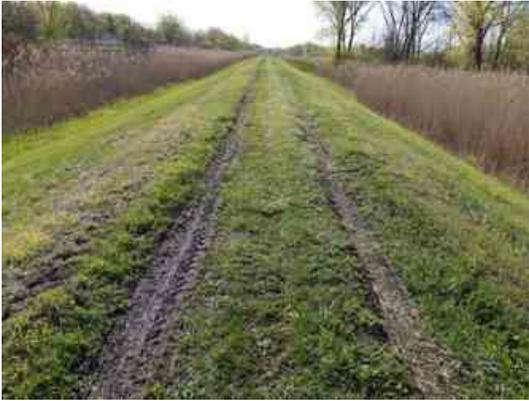
<p><b>Inspect ID:</b> 2020-0053 <b>Title:</b> 2604000003_CELRC_2020_A_0053_1_20200512T132454.jpg <b>Rated Item:</b> 8. Depressions/ Rutting <b>Caption:</b> Minimally Acceptable - Rutting on crest, couple inches deep.</p>

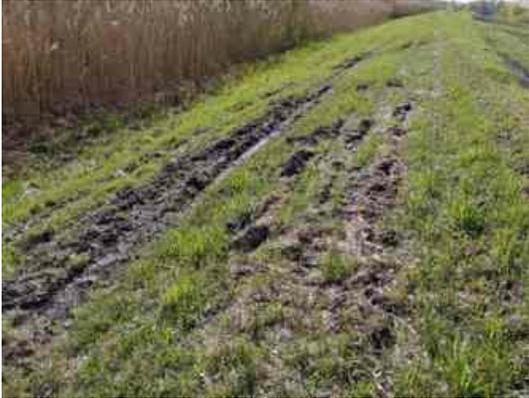
<p><b>Inspect ID:</b> 2020-0055 <b>Title:</b> 2604000003_CELRC_2020_A_0055_1_20200512T132654.jpg <b>Rated Item:</b> 8. Depressions/ Rutting <b>Caption:</b> Minimally Acceptable - Rutting on landside slope.</p>

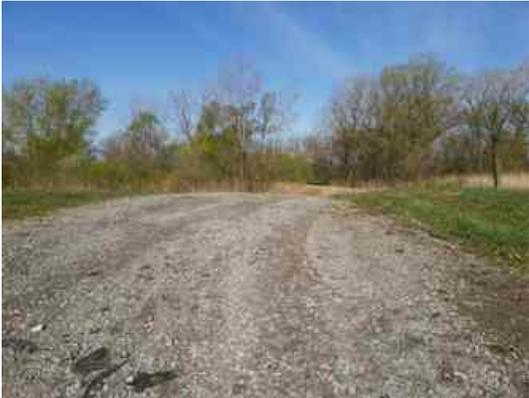
<p><b>Inspect ID:</b> 2020-0067 <b>Title:</b> 2604000003_CELRC_2020_A_0067_1_20200512T133833.jpg <b>Rated Item:</b> 8. Depressions/ Rutting <b>Caption:</b> Minimally Acceptable - Low spot on crest where ramp crosses over.</p>

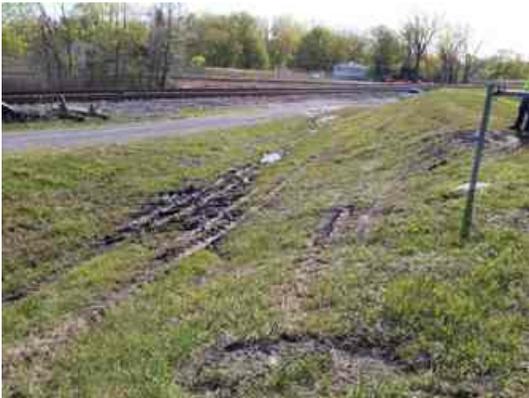
<p><b>Inspect ID:</b> 2020-0069 <b>Title:</b> 2604000003_CELRC_2020_A_0069_1_20200512T133936.jpg <b>Rated Item:</b> 8. Depressions/ Rutting <b>Caption:</b> Minimally Acceptable - Rutting on landside toe.</p>

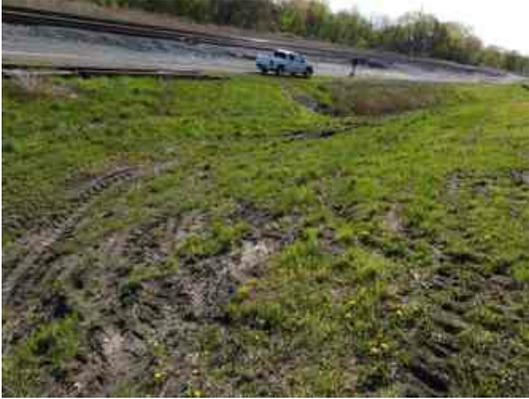
<p><b>Inspect ID:</b> 2020-0093 <b>Title:</b> 2604000003_CELRC_2020_A_0093_1_20200512T140015.jpg <b>Rated Item:</b> 8. Depressions/ Rutting <b>Caption:</b> Minimally Acceptable - Rutting on landside slope.</p>
