# Levee Inspection Report

Name of System: Gary  
 Name of Segment: Gary North  
 NLD System ID: 2605000003 NLD Segment ID: 2604000003

Segment Type: USACE Constructed, Public sponsor O&M  
 Levee Sponsor (Name and Organization): Little Calumet River Basin Development Commission, Little Calumet River Basin Development Commission  
 Inspection Report Prepared by: \_\_\_\_\_ Date(s) of Inspection: 05/11/2020 - 05/13/2020

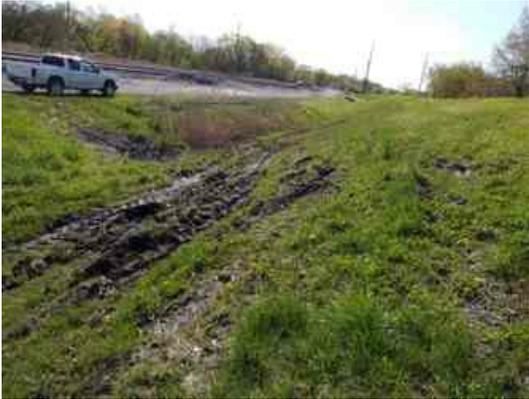
<p><b>Inspect ID:</b> 2020-0095 <b>Title:</b> 2604000003_CELRC_2020_A_0095_1_20200512T140106.jpg <b>Rated Item:</b> 8. Depressions/ Rutting <b>Caption:</b> Minimally Acceptable - Rutting on landside toe and slope.</p>

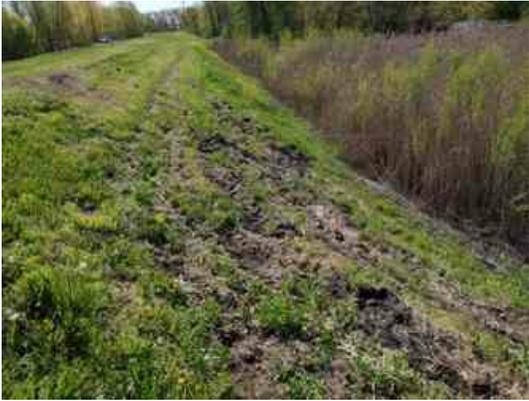
<p><b>Inspect ID:</b> 2020-0137 <b>Title:</b> 2604000003_CELRC_2020_A_0137_1_20200512T143750.jpg <b>Rated Item:</b> 8. Depressions/ Rutting <b>Caption:</b> Minimally Acceptable - Rutting on riverside slope.</p>

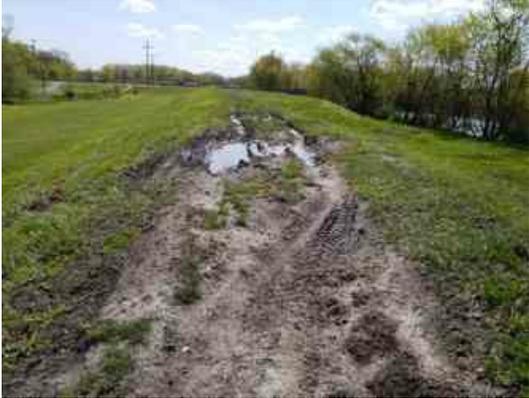
<p><b>Inspect ID:</b> 2020-0161 <b>Title:</b> 2604000003_CELRC_2020_A_0161_1_20200512T150545.jpg <b>Rated Item:</b> 8. Depressions/ Rutting <b>Caption:</b> Minimally Acceptable - Deep rut on crest, 8 inches deep, ponding.</p>

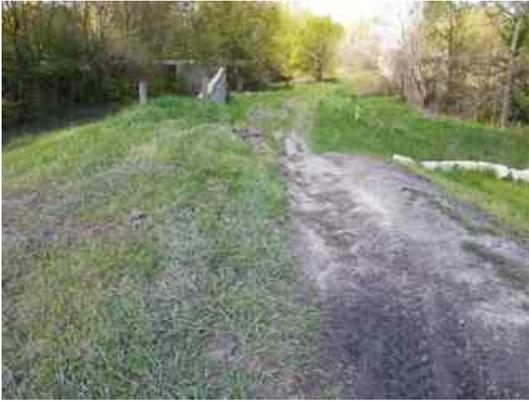
<p><b>Inspect ID:</b> 2020-0163 <b>Title:</b> 2604000003_CELRC_2020_A_0163_1_20200512T150710.jpg <b>Rated Item:</b> 8. Depressions/ Rutting <b>Caption:</b> Minimally Acceptable - Rutting on riverside slope and crest.</p>

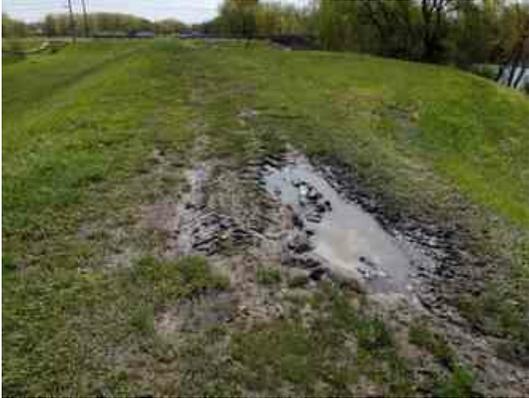
<p><b>Inspect ID:</b> 2020-0165 <b>Title:</b> 2604000003_CELRC_2020_A_0165_1_20200512T150842.jpg <b>Rated Item:</b> 8. Depressions/ Rutting <b>Caption:</b> Minimally Acceptable - 6-inch deep rut on crest.</p>

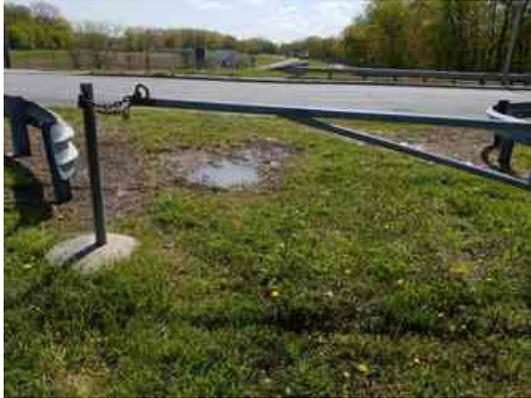
<p><b>Inspect ID:</b> 2020-0169 <b>Title:</b> 2604000003_CELRC_2020_A_0169_1_20200512T151111.jpg <b>Rated Item:</b> 8. Depressions/ Rutting <b>Caption:</b> Minimally Acceptable - Rut on crest.</p>

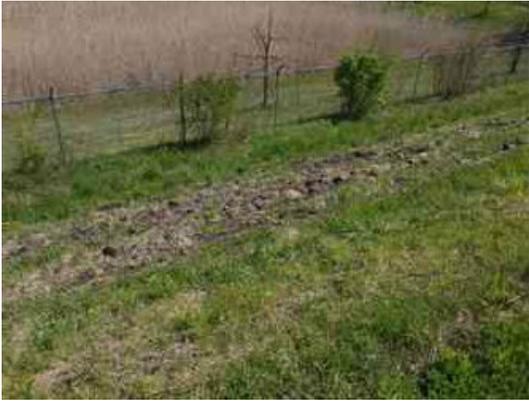
<p><b>Inspect ID:</b> 2020-0179 <b>Title:</b> 2604000003_CELRC_2020_A_0179_1_20200512T152209.jpg <b>Rated Item:</b> 8. Depressions/ Rutting <b>Caption:</b> Minimally Acceptable - Rutting on landside slope.</p>

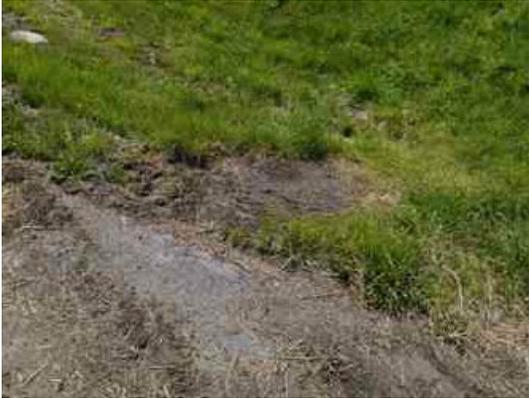
<p><b>Inspect ID:</b> 2020-0181 <b>Title:</b> 2604000003_CELRC_2020_A_0181_1_20200512T152544.jpg <b>Rated Item:</b> 8. Depressions/ Rutting <b>Caption:</b> Minimally Acceptable - Depressions on riverside slope near crown.</p>

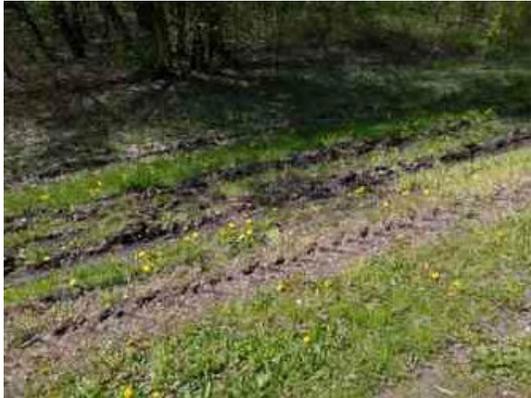
<p><b>Inspect ID:</b> 2020-0193 <b>Title:</b> 2604000003_CELRC_2020_A_0193_1_20200512T153218.jpg <b>Rated Item:</b> 8. Depressions/ Rutting <b>Caption:</b> Minimally Acceptable - Rutting on riverside slope.</p>

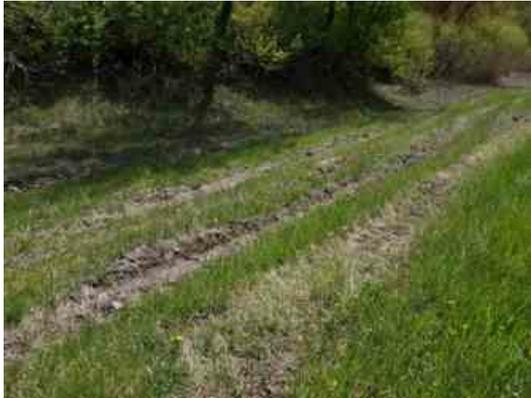
<p><b>Inspect ID:</b> 2020-0257 <b>Title:</b> 2604000003_CELRC_2020_A_0257_1_20200512T164739.jpg <b>Rated Item:</b> 8. Depressions/ Rutting <b>Caption:</b> Minimally Acceptable - Ruts on riverside slope.</p>

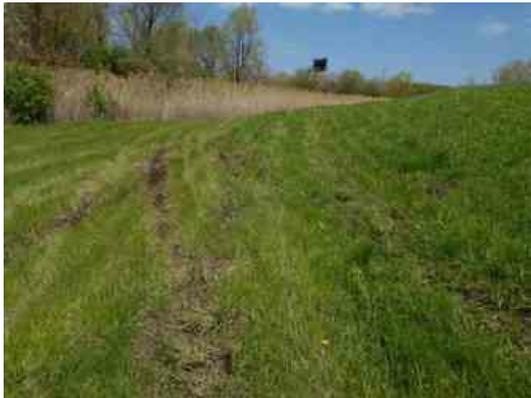
<p><b>Inspect ID:</b> 2020-0259 <b>Title:</b> 2604000003_CELRC_2020_A_0259_1_20200512T164831.jpg <b>Rated Item:</b> 8. Depressions/ Rutting <b>Caption:</b> Minimally Acceptable - Rutting with ponding on landside toe.</p>

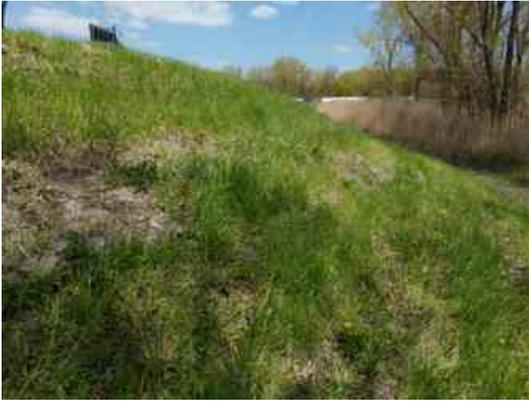
<p><b>Inspect ID:</b> 2020-0263 <b>Title:</b> 2604000003_CELRC_2020_A_0263_1_20200512T165056.jpg <b>Rated Item:</b> 8. Depressions/ Rutting <b>Caption:</b> Minimally Acceptable - Rutting on riverside slope.</p>

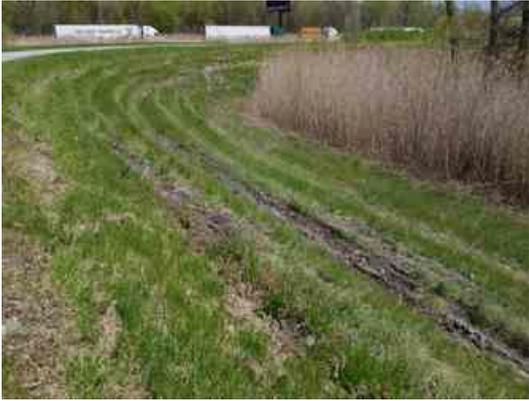
<p><b>Inspect ID:</b> 2020-0265 <b>Title:</b> 2604000003_CELRC_2020_A_0265_1_20200512T165248.jpg <b>Rated Item:</b> 8. Depressions/ Rutting <b>Caption:</b> Minimally Acceptable - Rutting on riverside slope.</p>

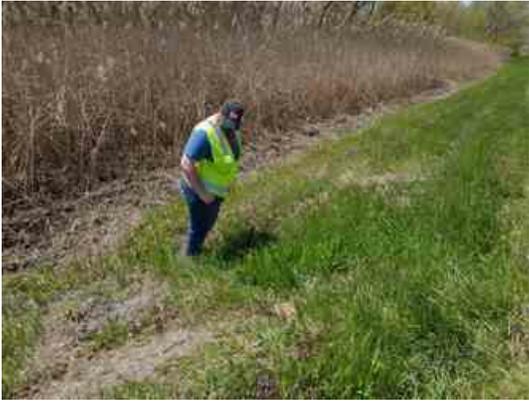
<p><b>Inspect ID:</b> 2020-0271 <b>Title:</b> 2604000003_CELRC_2020_A_0271_1_20200512T165933.jpg <b>Rated Item:</b> 8. Depressions/ Rutting <b>Caption:</b> Minimally Acceptable - 1 ft deep hole on riverside toe and slope.</p>

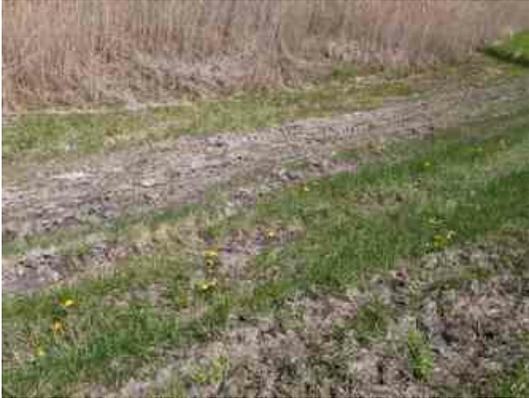
<p><b>Inspect ID:</b> 2020-0277 <b>Title:</b> 2604000003_CELRC_2020_A_0277_1_20200512T170654.jpg <b>Rated Item:</b> 8. Depressions/ Rutting <b>Caption:</b> Minimally Acceptable - Rutting on landside toe and slope.</p>

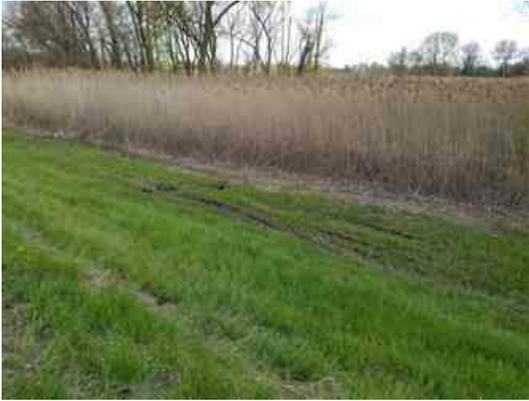
<p><b>Inspect ID:</b> 2020-0333 <b>Title:</b> 2604000003_CELRC_2020_A_0333_1_20200512T184121.jpg <b>Rated Item:</b> 8. Depressions/ Rutting <b>Caption:</b> Minimally Acceptable - Rutting on riverside toe.</p>

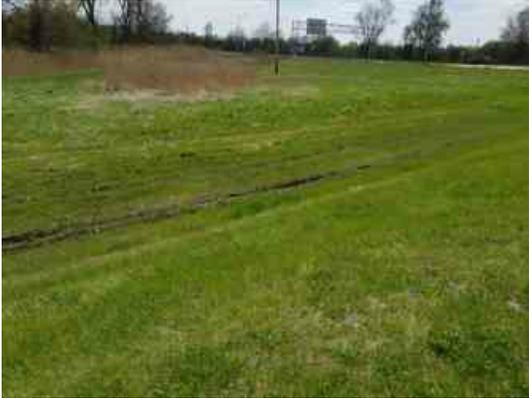
<p><b>Inspect ID:</b> 2020-0345 <b>Title:</b> 2604000003_CELRC_2020_A_0345_1_20200512T185335.jpg <b>Rated Item:</b> 8. Depressions/ Rutting <b>Caption:</b> Minimally Acceptable - Rutting on riverside toe.</p>

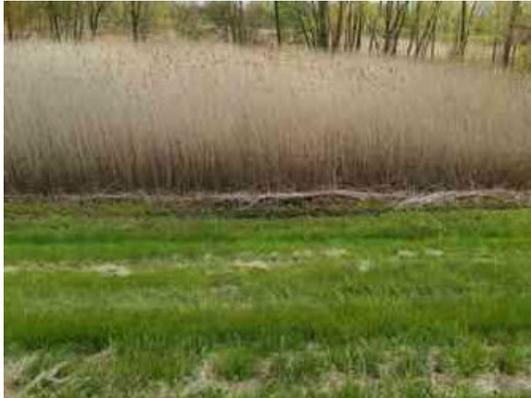
<p><b>Inspect ID:</b> 2020-0349 <b>Title:</b> 2604000003_CELRC_2020_A_0349_1_20200512T185738.jpg <b>Rated Item:</b> 8. Depressions/ Rutting <b>Caption:</b> Minimally Acceptable - Rutting on riverside toe.</p>

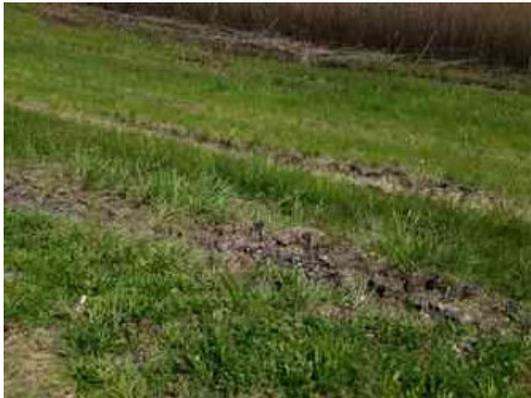
<p><b>Inspect ID:</b> 2020-0351 <b>Title:</b> 2604000003_CELRC_2020_A_0351_1_20200512T185838.jpg <b>Rated Item:</b> 8. Depressions/ Rutting <b>Caption:</b> Minimally Acceptable - Rutting on riverside slope.</p>

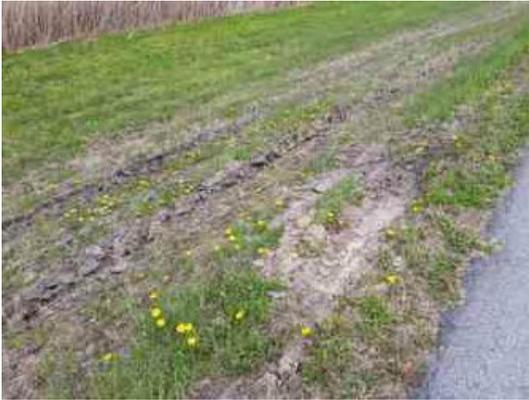
<p><b>Inspect ID:</b> 2020-0359 <b>Title:</b> 2604000003_CELRC_2020_A_0359_1_20200512T190552.jpg <b>Rated Item:</b> 8. Depressions/ Rutting <b>Caption:</b> Minimally Acceptable - Rutting on landside slope.</p>

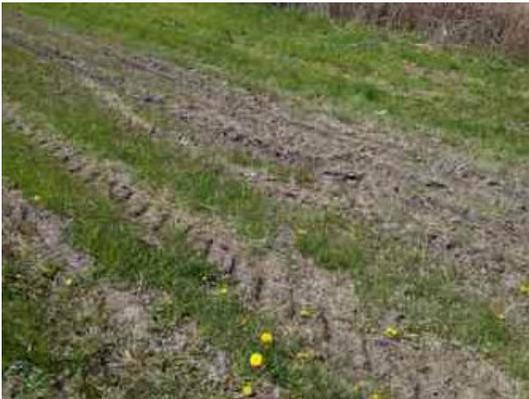
<p><b>Inspect ID:</b> 2020-0363 <b>Title:</b> 2604000003_CELRC_2020_A_0363_1_20200512T191005.jpg <b>Rated Item:</b> 8. Depressions/ Rutting <b>Caption:</b> Minimally Acceptable - Rutting on landside slope.</p>

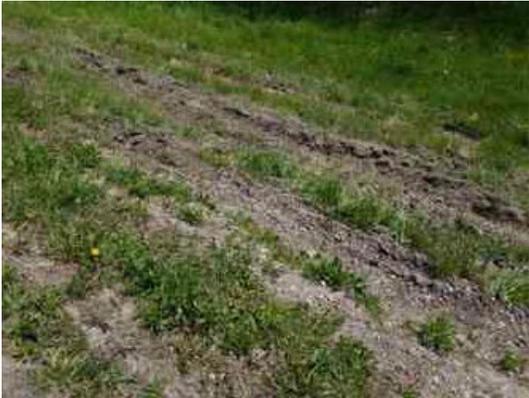
<p><b>Inspect ID:</b> 2020-0365 <b>Title:</b> 2604000003_CELRC_2020_A_0365_1_20200512T191034.jpg <b>Rated Item:</b> 8. Depressions/ Rutting <b>Caption:</b> Minimally Acceptable - Rutting on riverside slope.</p>

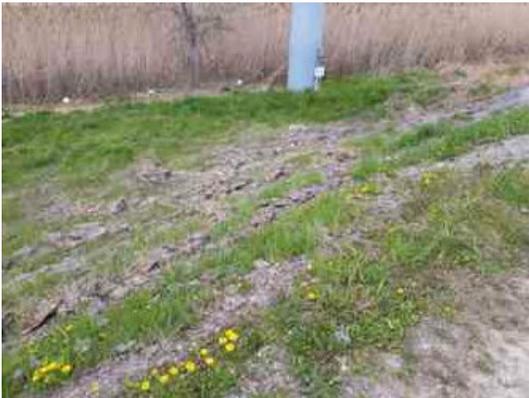
<p><b>Inspect ID:</b> 2020-0369 <b>Title:</b> 2604000003_CELRC_2020_A_0369_1_20200512T191454.jpg <b>Rated Item:</b> 8. Depressions/ Rutting <b>Caption:</b> Minimally Acceptable - Rutting on landside slope.</p>

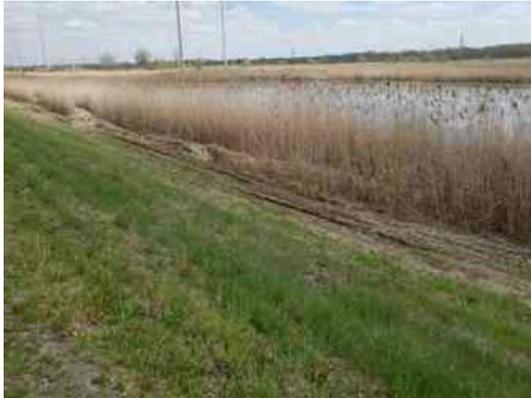
<p><b>Inspect ID:</b> 2020-0373 <b>Title:</b> 2604000003_CELRC_2020_A_0373_1_20200512T191855.jpg <b>Rated Item:</b> 8. Depressions/ Rutting <b>Caption:</b> Minimally Acceptable - Rutting on riverside toe.</p>

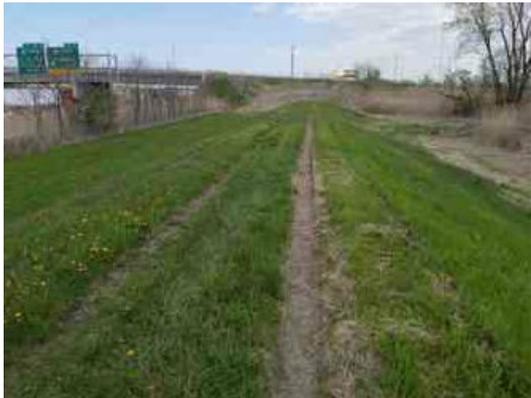
<p><b>Inspect ID:</b> 2020-0381 <b>Title:</b> 2604000003_CELRC_2020_A_0381_1_20200512T192423.jpg <b>Rated Item:</b> 8. Depressions/ Rutting <b>Caption:</b> Minimally Acceptable - Rutting on crest.</p>

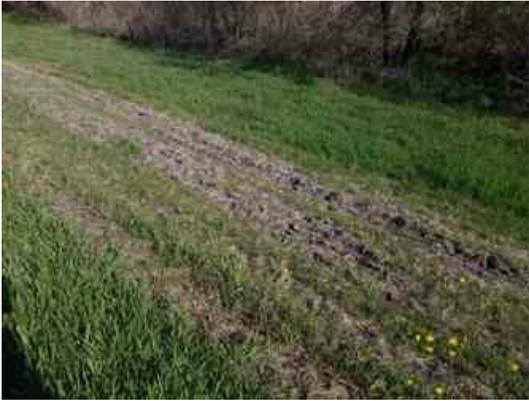
<p><b>Inspect ID:</b> 2020-0389 <b>Title:</b> 2604000003_CELRC_2020_A_0389_1_20200513T133628.jpg <b>Rated Item:</b> 8. Depressions/ Rutting <b>Caption:</b> Minimally Acceptable - Rutting on riverside slope.</p>

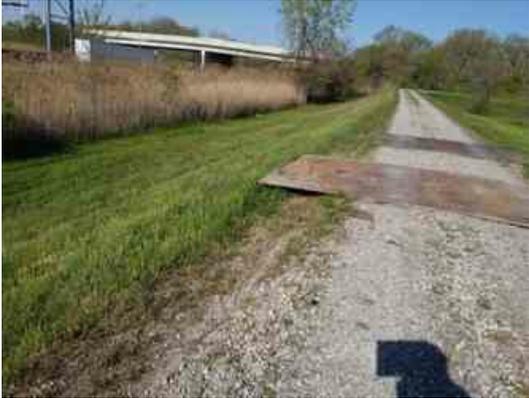
<p><b>Inspect ID:</b> 2020-0397 <b>Title:</b> 2604000003_CELRC_2020_A_0397_1_20200513T134222.jpg <b>Rated Item:</b> 8. Depressions/ Rutting <b>Caption:</b> Minimally Acceptable - Rutting on landside slope.</p>

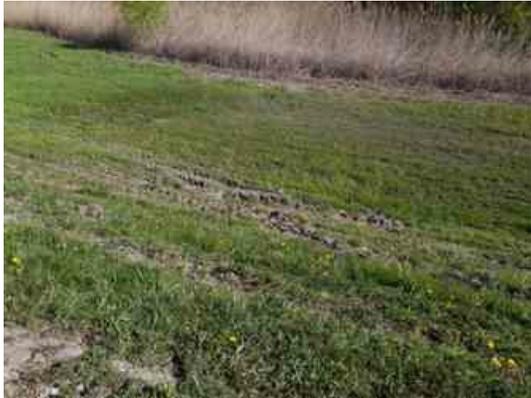
<p><b>Inspect ID:</b> 2020-0399 <b>Title:</b> 2604000003_CELRC_2020_A_0399_1_20200513T134332.jpg <b>Rated Item:</b> 8. Depressions/ Rutting <b>Caption:</b> Minimally Acceptable - Rutting on riverside toe slope.</p>

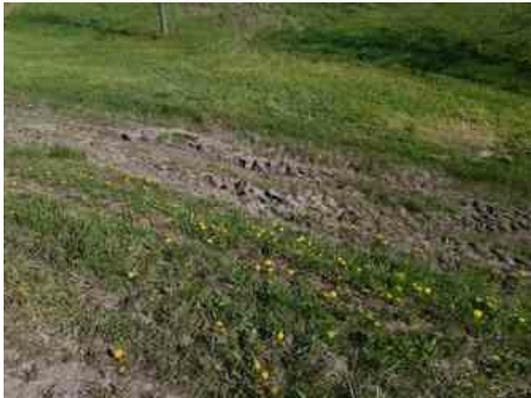
<p><b>Inspect ID:</b> 2020-0403 <b>Title:</b> 2604000003_CELRC_2020_A_0403_1_20200513T134445.jpg <b>Rated Item:</b> 8. Depressions/ Rutting <b>Caption:</b> Minimally Acceptable - Rutting on riverside slope.</p>

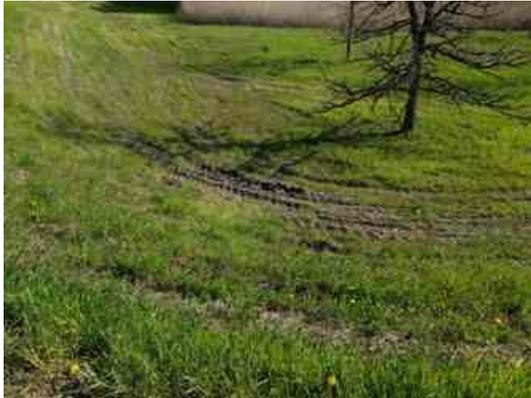
<p><b>Inspect ID:</b> 2020-0407 <b>Title:</b> 2604000003_CELRC_2020_A_0407_1_20200513T134617.jpg <b>Rated Item:</b> 8. Depressions/ Rutting <b>Caption:</b> Minimally Acceptable - Rutting on riverside toe.</p>

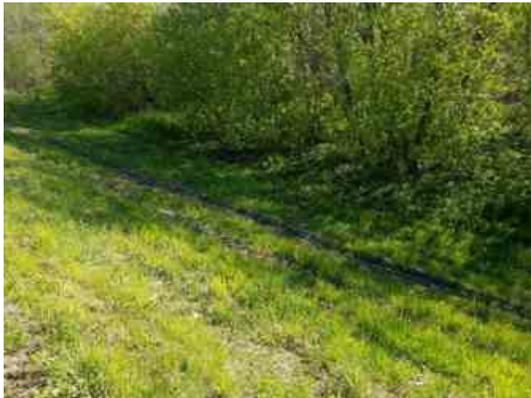
<p><b>Inspect ID:</b> 2020-0411 <b>Title:</b> 2604000003_CELRC_2020_A_0411_1_20200513T135014.jpg <b>Rated Item:</b> 8. Depressions/ Rutting <b>Caption:</b> Minimally Acceptable - Rutting on riverside toe and slope.</p>

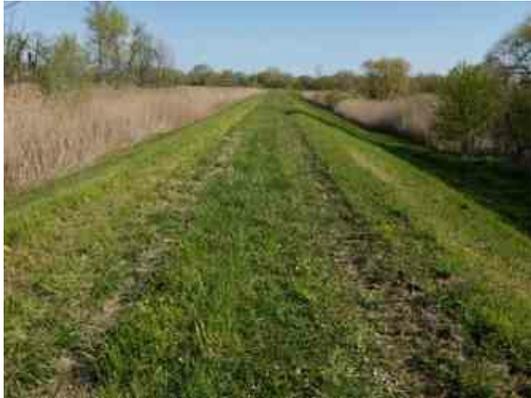
<p><b>Inspect ID:</b> 2020-0419 <b>Title:</b> 2604000003_CELRC_2020_A_0419_1_20200513T135354.jpg <b>Rated Item:</b> 8. Depressions/ Rutting <b>Caption:</b> Minimally Acceptable - Rutting in the crest, 1 to 2 inches deep.</p>

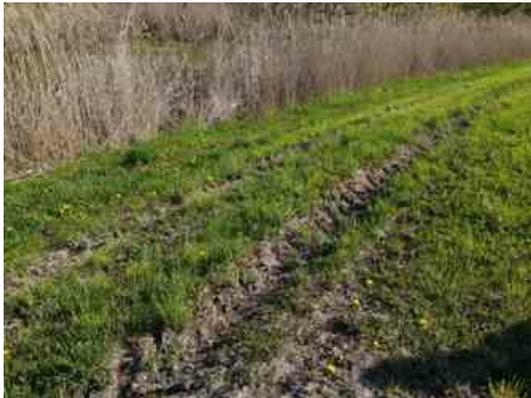
<p><b>Inspect ID:</b> 2020-0423 <b>Title:</b> 2604000003_CELRC_2020_A_0423_1_20200513T135859.jpg <b>Rated Item:</b> 8. Depressions/ Rutting <b>Caption:</b> Minimally Acceptable - Rutting on landside slope.</p>

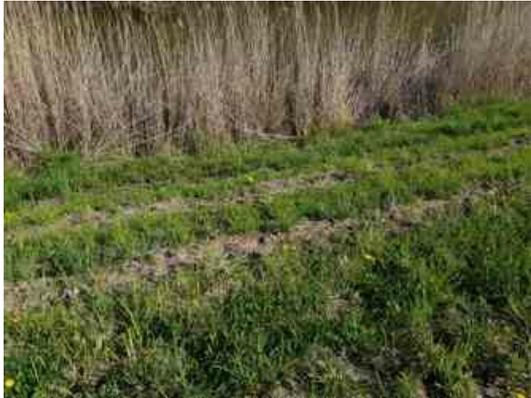
<p><b>Inspect ID:</b> 2020-0427 <b>Title:</b> 2604000003_CELRC_2020_A_0427_1_20200513T140054.jpg <b>Rated Item:</b> 8. Depressions/ Rutting <b>Caption:</b> Minimally Acceptable - Rutting on landside slope.</p>

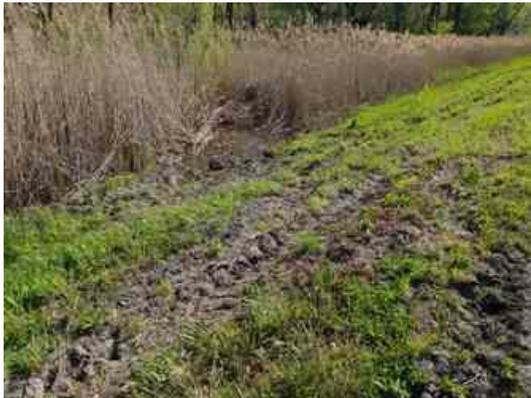
<p><b>Inspect ID:</b> 2020-0429 <b>Title:</b> 2604000003_CELRC_2020_A_0429_1_20200513T140300.jpg <b>Rated Item:</b> 8. Depressions/ Rutting <b>Caption:</b> Minimally Acceptable - Ruts and large hole on landside toe and slope.</p>

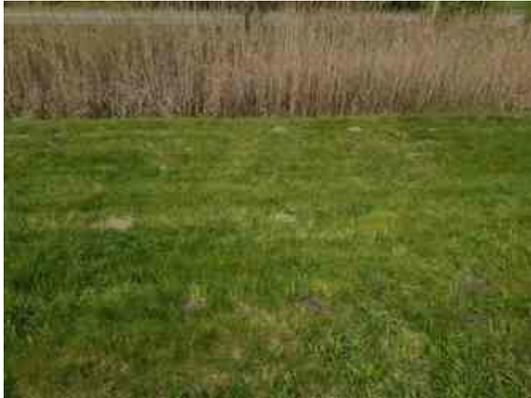
<p><b>Inspect ID:</b> 2020-0205 <b>Title:</b> 2604000003_CELRC_2020_A_0205_1_20200512T154255.jpg <b>Rated Item:</b> 10. Animal Control <b>Caption:</b> Minimally Acceptable - Animal burrows on landside slope.</p>

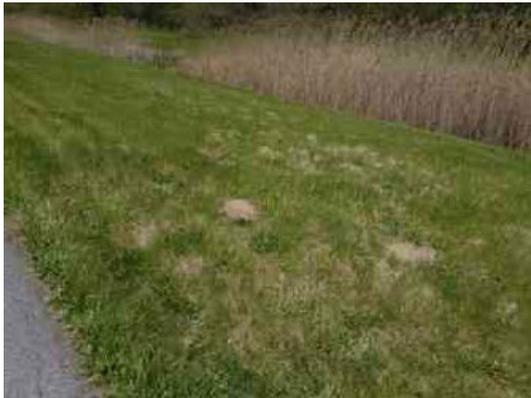
<p><b>Inspect ID:</b> 2020-0215 <b>Title:</b> 2604000003_CELRC_2020_A_0215_1_20200512T155816.jpg <b>Rated Item:</b> 10. Animal Control <b>Caption:</b> Minimally Acceptable - Animal mounds on landside slope.</p>

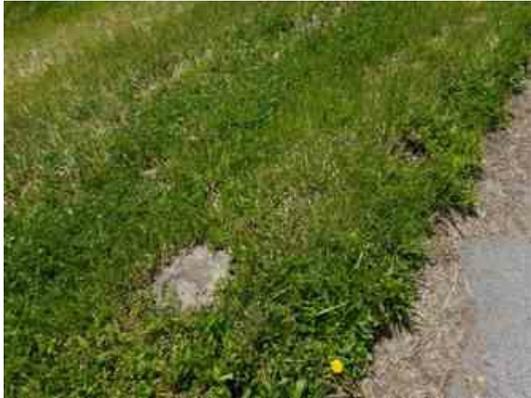
<p><b>Inspect ID:</b> 2020-0311 <b>Title:</b> 2604000003_CELRC_2020_A_0311_1_20200512T182221.jpg <b>Rated Item:</b> 10. Animal Control <b>Caption:</b> Minimally Acceptable - Multiple burrow mounds on riverside slope.</p>

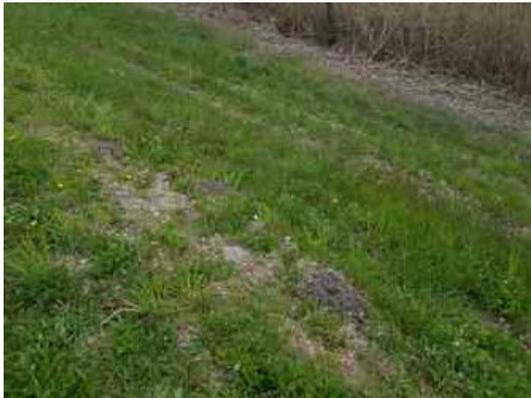
<p><b>Inspect ID:</b> 2020-0357 <b>Title:</b> 2604000003_CELRC_2020_A_0357_1_20200512T190439.jpg <b>Rated Item:</b> 10. Animal Control <b>Caption:</b> Minimally Acceptable - Animal mounds on riverside slope.</p>

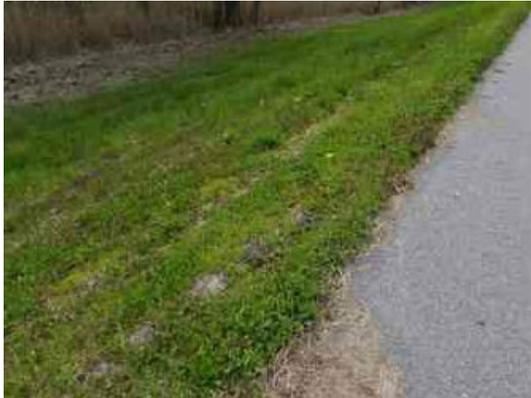
<p><b>Inspect ID:</b> 2020-0361 <b>Title:</b> 2604000003_CELRC_2020_A_0361_1_20200512T190634.jpg <b>Rated Item:</b> 10. Animal Control <b>Caption:</b> Minimally Acceptable - Animal mounds on riverside slope.</p>

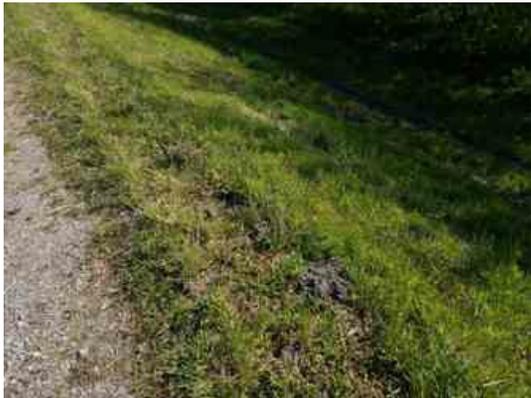
<p><b>Inspect ID:</b> 2020-0413 <b>Title:</b> 2604000003_CELRC_2020_A_0413_1_20200513T135048.jpg <b>Rated Item:</b> 10. Animal Control <b>Caption:</b> Minimally Acceptable - Burrow mounds near crest and riverside slope.</p>

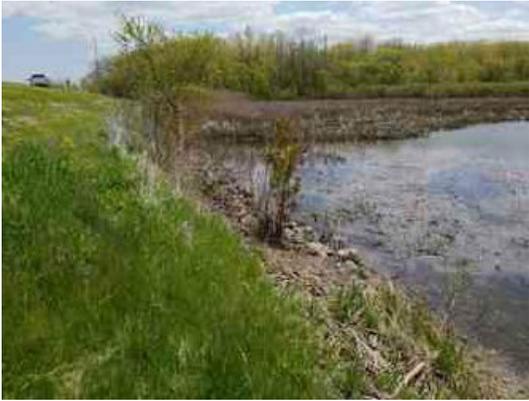
<p><b>Inspect ID:</b> 2020-0241 <b>Title:</b> 2604000003_CELRC_2020_A_0241_1_20200512T162532.jpg <b>Rated Item:</b> 12. Riprap Revetments &amp; Bank Protection <b>Caption:</b> Minimally Acceptable - Trees in riprap on riverside.</p>

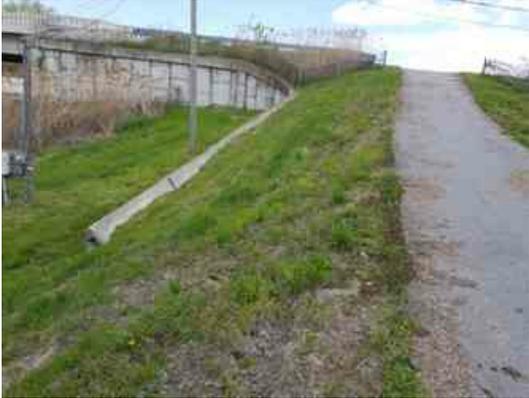
<p><b>Inspect ID:</b> 2020-0315 <b>Title:</b> 2604000003_CELRC_2020_A_0315_1_20200512T182650.jpg <b>Rated Item:</b> 13. Revetments other than Riprap <b>Caption:</b> Minimally Acceptable - Retaining wall tilting on landside.</p>

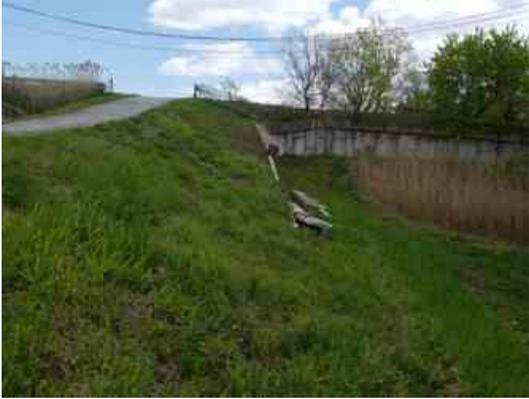
<p><b>Inspect ID:</b> 2020-0317 <b>Title:</b> 2604000003_CELRC_2020_A_0317_1_20200512T182719.jpg <b>Rated Item:</b> 13. Revetments other than Riprap <b>Caption:</b> Minimally Acceptable - Retaining wall toppled on riverside.</p>

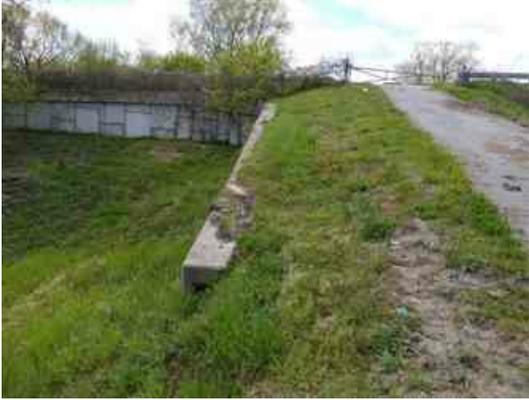
<p><b>Inspect ID:</b> 2020-0323 <b>Title:</b> 2604000003_CELRC_2020_A_0323_1_20200512T183136.jpg <b>Rated Item:</b> 13. Revetments other than Riprap <b>Caption:</b> Minimally Acceptable - Retaining wall starting to tilt on riverside.</p>

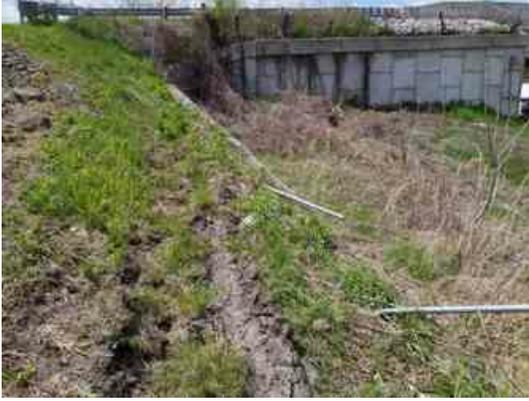
<p><b>Inspect ID:</b> 2020-0325 <b>Title:</b> 2604000003_CELRC_2020_A_0325_1_20200512T183251.jpg <b>Rated Item:</b> 13. Revetments other than Riprap <b>Caption:</b> Minimally Acceptable - Retaining wall tilting on landside.</p>

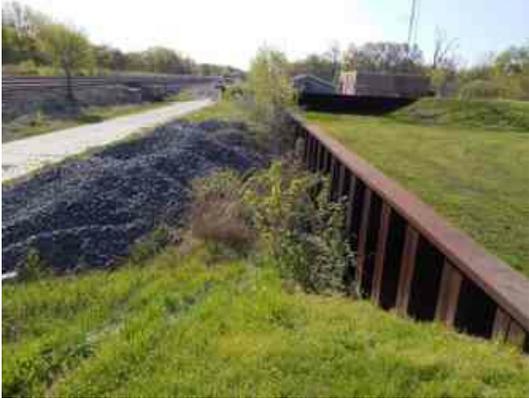
<p><b>Inspect ID:</b> 2020-0081 <b>Title:</b> 2604000003_CELRC_2020_A_0081_1_20200512T134638.jpg <b>Rated Item:</b> 1. Unwanted Vegetation Growth <b>Caption:</b> Minimally Acceptable - Trees next on landside.</p>

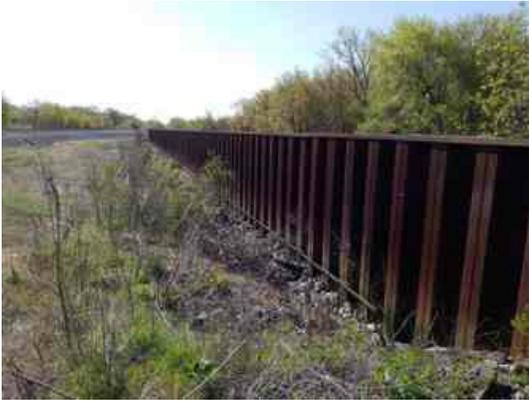
<p><b>Inspect ID:</b> 2020-0109 <b>Title:</b> 2604000003_CELRC_2020_A_0109_1_20200512T141041.jpg <b>Rated Item:</b> 1. Unwanted Vegetation Growth <b>Caption:</b> Minimally Acceptable - Trees on landside.</p>

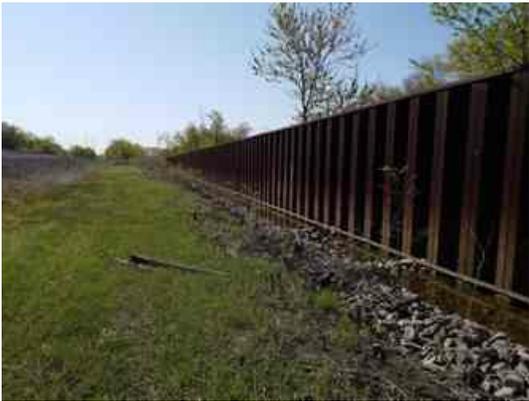
<p><b>Inspect ID:</b> 2020-0117 <b>Title:</b> 2604000003_CELRC_2020_A_0117_1_20200512T141841.jpg <b>Rated Item:</b> 1. Unwanted Vegetation Growth <b>Caption:</b> Minimally Acceptable - Small trees on landside.</p>

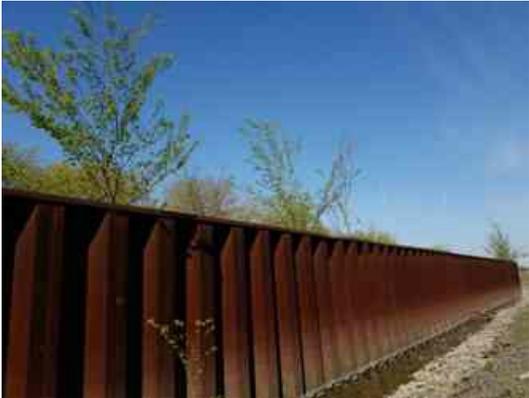
<p><b>Inspect ID:</b> 2020-0119 <b>Title:</b> 2604000003_CELRC_2020_A_0119_1_20200512T141934.jpg <b>Rated Item:</b> 1. Unwanted Vegetation Growth <b>Caption:</b> Minimally Acceptable - Trees on riverside.</p>

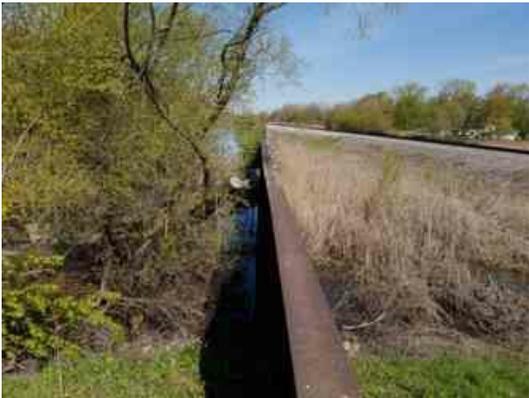
<p><b>Inspect ID:</b> 2020-0127 <b>Title:</b> 2604000003_CELRC_2020_A_0127_1_20200512T143016.jpg <b>Rated Item:</b> 1. Unwanted Vegetation Growth <b>Caption:</b> Minimally Acceptable - Trees on riverside.</p>

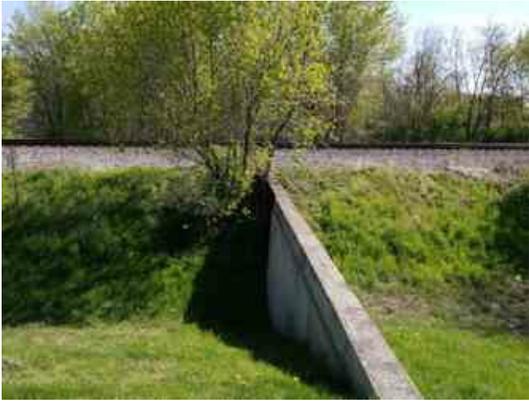
<p><b>Inspect ID:</b> 2020-0147 <b>Title:</b> 2604000003_CELRC_2020_A_0147_1_20200512T144903.jpg <b>Rated Item:</b> 1. Unwanted Vegetation Growth <b>Caption:</b> Minimally Acceptable - Tree on landside.</p>

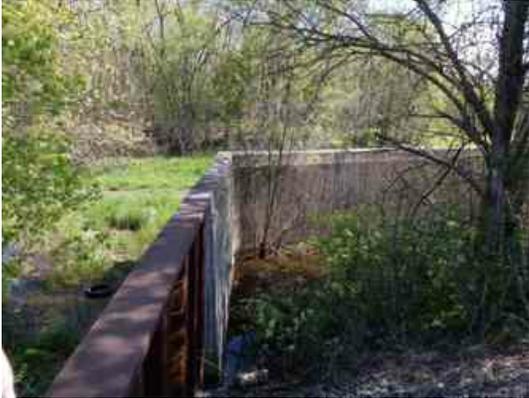
<p><b>Inspect ID:</b> 2020-0155 <b>Title:</b> 2604000003_CELRC_2020_A_0155_1_20200512T145431.jpg <b>Rated Item:</b> 1. Unwanted Vegetation Growth <b>Caption:</b> Minimally Acceptable - Trees on riverside.</p>

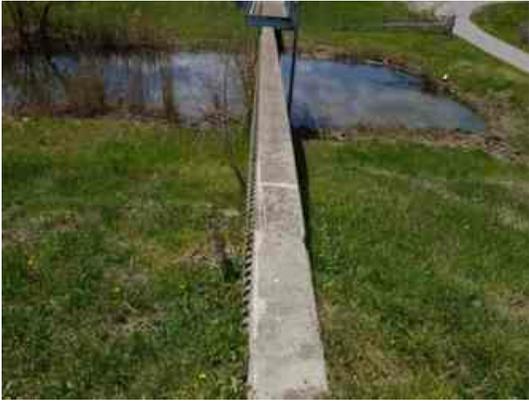
<p><b>Inspect ID:</b> 2020-0293 <b>Title:</b> 2604000003_CELRC_2020_A_0293_1_20200512T172511.jpg <b>Rated Item:</b> 1. Unwanted Vegetation Growth <b>Caption:</b> Minimally Acceptable - Small trees on riverside.</p>

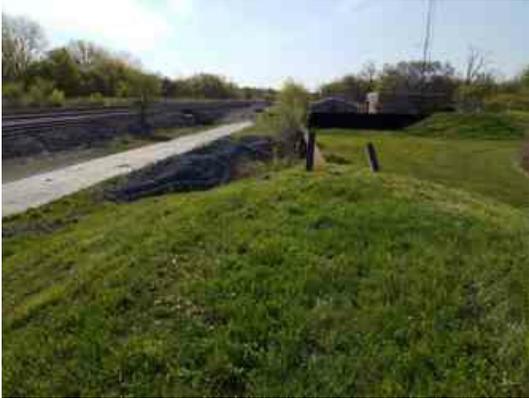
<p><b>Inspect ID:</b> 2020-0079 <b>Title:</b> 2604000003_CELRC_2020_A_0079_1_20200512T134546.jpg <b>Rated Item:</b> 2. Encroachments <b>Caption:</b> Minimally Acceptable - Ballast near landside toe.</p>

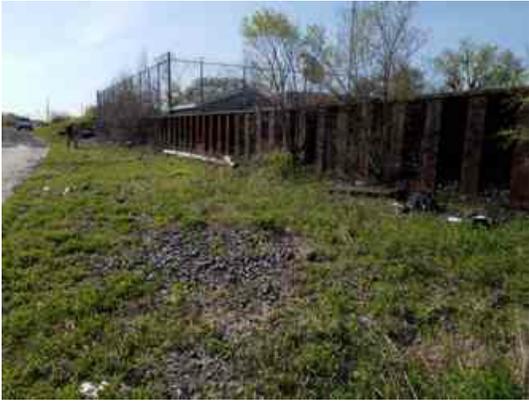
<p><b>Inspect ID:</b> 2020-0083 <b>Title:</b> 2604000003_CELRC_2020_A_0083_1_20200512T134727.jpg <b>Rated Item:</b> 2. Encroachments <b>Caption:</b> Minimally Acceptable - Debris along landside.</p>

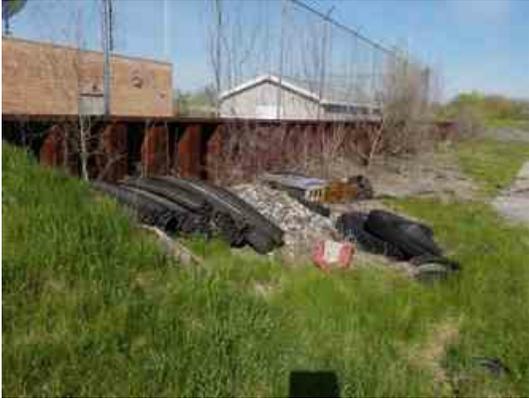
<p><b>Inspect ID:</b> 2020-0085 <b>Title:</b> 2604000003_CELRC_2020_A_0085_1_20200512T134936.jpg <b>Rated Item:</b> 2. Encroachments <b>Caption:</b> Minimally Acceptable - Debris on landside.</p>

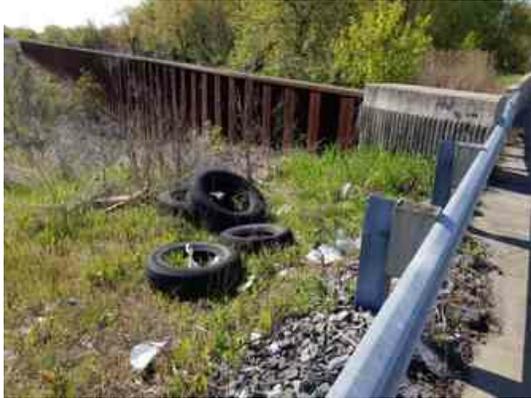
<p><b>Inspect ID:</b> 2020-0107 <b>Title:</b> 2604000003_CELRC_2020_A_0107_1_20200512T141003.jpg <b>Rated Item:</b> 2. Encroachments <b>Caption:</b> Minimally Acceptable - Debris on landside.</p>

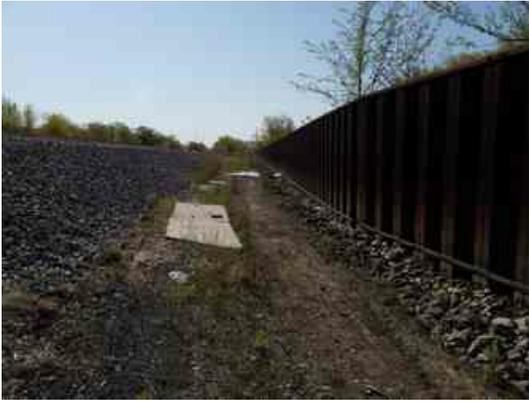
<p><b>Inspect ID:</b> 2020-0111 <b>Title:</b> 2604000003_CELRC_2020_A_0111_1_20200512T141555.jpg <b>Rated Item:</b> 2. Encroachments <b>Caption:</b> Minimally Acceptable - Debris on landside.</p>

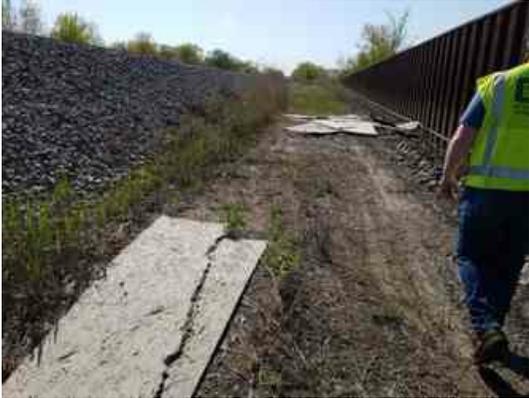
<p><b>Inspect ID:</b> 2020-0115 <b>Title:</b> 2604000003_CELRC_2020_A_0115_1_20200512T141744.jpg <b>Rated Item:</b> 2. Encroachments <b>Caption:</b> Minimally Acceptable - Debris on landside.</p>

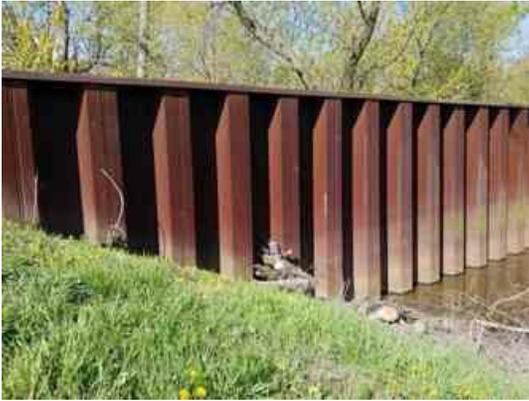
<p><b>Inspect ID:</b> 2020-0121 <b>Title:</b> 2604000003_CELRC_2020_A_0121_1_20200512T142404.jpg <b>Rated Item:</b> 2. Encroachments <b>Caption:</b> Minimally Acceptable - Debris on landside.</p>

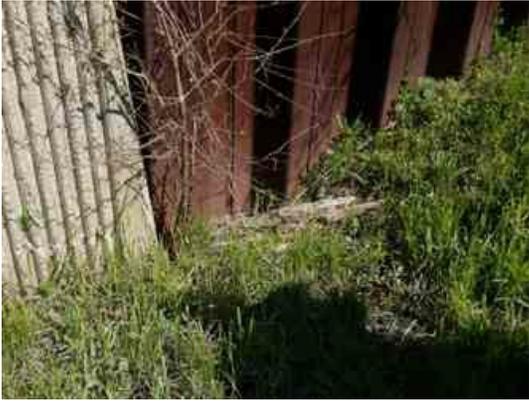
<p><b>Inspect ID:</b> 2020-0151 <b>Title:</b> 2604000003_CELRC_2020_A_0151_1_20200512T145205.jpg <b>Rated Item:</b> 2. Encroachments <b>Caption:</b> Minimally Acceptable - Debris on riverside.</p>

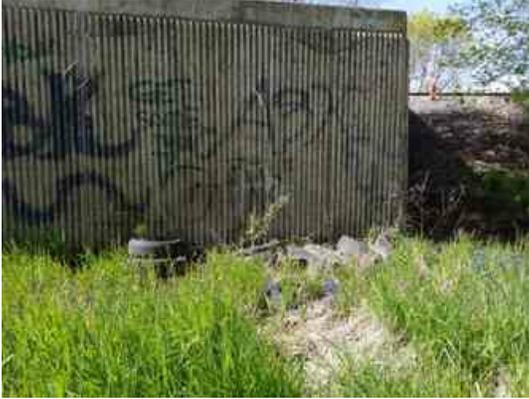
<p><b>Inspect ID:</b> 2020-0157 <b>Title:</b> 2604000003_CELRC_2020_A_0157_1_20200512T150220.jpg <b>Rated Item:</b> 2. Encroachments <b>Caption:</b> Minimally Acceptable - Tires on landside.</p>

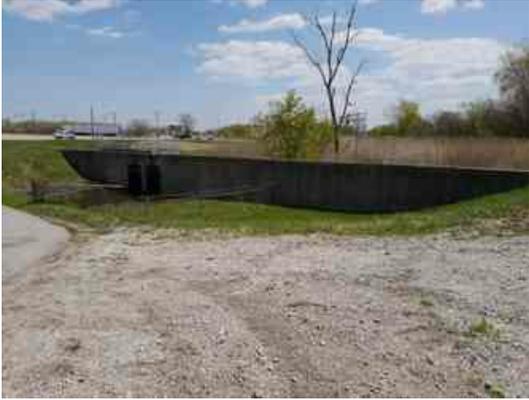
<p><b>Inspect ID:</b> 2020-0289 <b>Title:</b> 2604000003_CELRC_2020_A_0289_1_20200512T171910.jpg <b>Rated Item:</b> 2. Encroachments <b>Caption:</b> Minimally Acceptable - Fence on landside.</p>

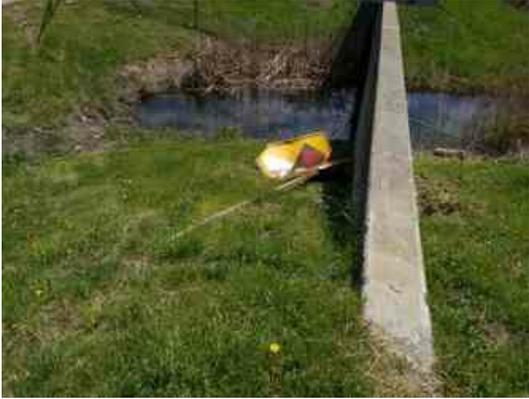
<p><b>Inspect ID:</b> 2020-0295 <b>Title:</b> 2604000003_CELRC_2020_A_0295_1_20200512T181019.jpg <b>Rated Item:</b> 2. Encroachments <b>Caption:</b> Minimally Acceptable - Debris on landside.</p>

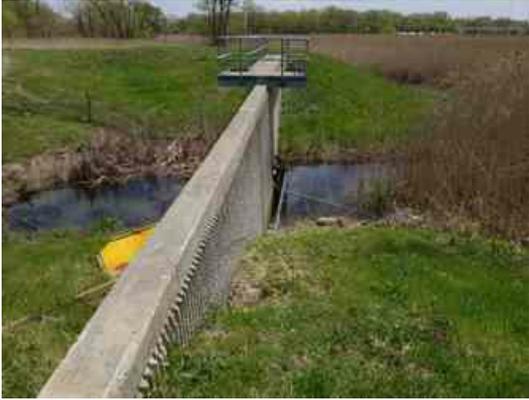
<p><b>Inspect ID:</b> 2020-0297 <b>Title:</b> 2604000003_CELRC_2020_A_0297_1_20200512T181043.jpg <b>Rated Item:</b> 2. Encroachments <b>Caption:</b> Minimally Acceptable - Fence on riverside.</p>

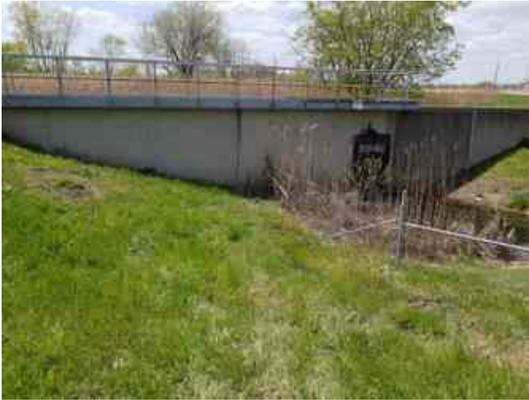
<p><b>Inspect ID:</b> 2020-0299 <b>Title:</b> 2604000003_CELRC_2020_A_0299_1_20200512T181202.jpg <b>Rated Item:</b> 2. Encroachments <b>Caption:</b> Minimally Acceptable - Fence on landside.</p>

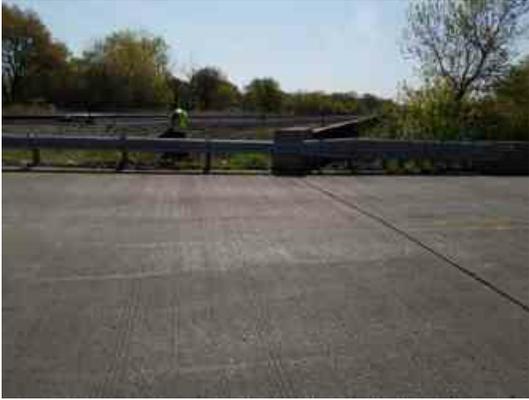
<p><b>Inspect ID:</b> 2020-0105 <b>Title:</b> 2604000003_CELRC_2020_A_0105_1_20200512T140930.jpg <b>Rated Item:</b> 3. Closure Structures (Stop Log Closures and Gates) (A or U only) <b>Caption:</b> Acceptable - Guardrail blocking floodwall at Colfax.</p>

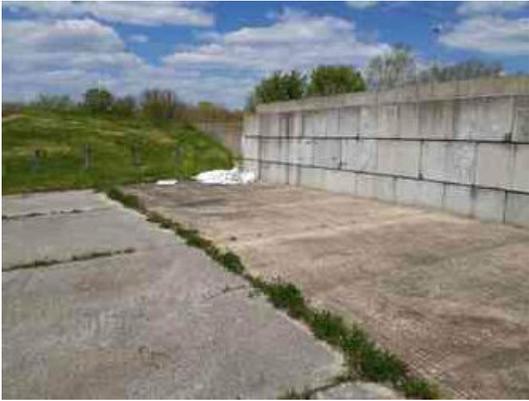
<p><b>Inspect ID:</b> 2020-0247 <b>Title:</b> 2604000003_CELRC_2020_A_0247_1_20200512T163031.jpg <b>Rated Item:</b> 3. Closure Structures (Stop Log Closures and Gates) (A or U only) <b>Caption:</b> Acceptable - Debris near closure structure on riverside at Chase St.</p>

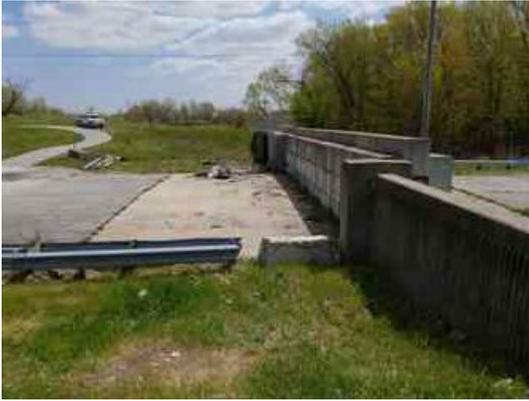
<p><b>Inspect ID:</b> 2020-0249 <b>Title:</b> 2604000003_CELRC_2020_A_0249_1_20200512T164150.jpg <b>Rated Item:</b> 3. Closure Structures (Stop Log Closures and Gates) (A or U only) <b>Caption:</b> Acceptable - Debris near the closure structure at Chase St on the landside.</p>

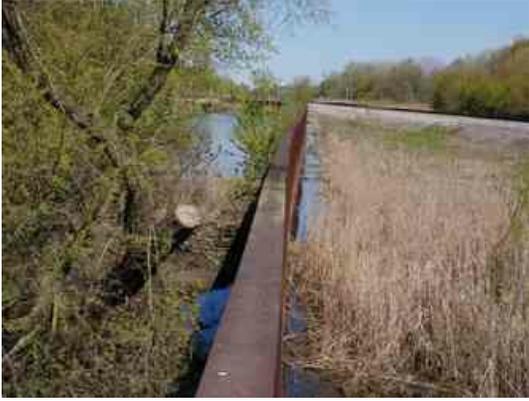
<p><b>Inspect ID:</b> 2020-0125 <b>Title:</b> 2604000003_CELRC_2020_A_0125_1_20200512T142932.jpg <b>Rated Item:</b> 5. Tilting, Sliding or Settlement of Concrete Structures <b>Caption:</b> Minimally Acceptable - Large bend in alignment.</p>

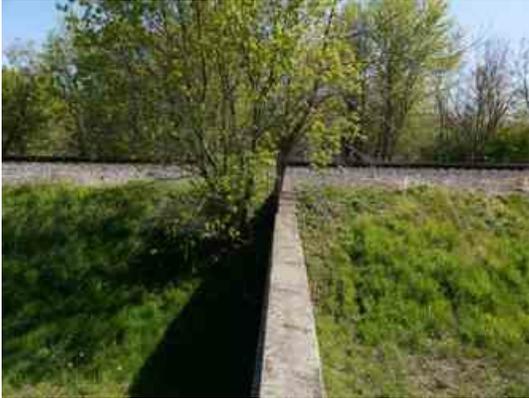
<p><b>Inspect ID:</b> 2020-0149 <b>Title:</b> 2604000003_CELRC_2020_A_0149_1_20200512T145045.jpg <b>Rated Item:</b> 5. Tilting, Sliding or Settlement of Concrete Structures <b>Caption:</b> Minimally Acceptable - Tree has pushed the sheetpile.</p>

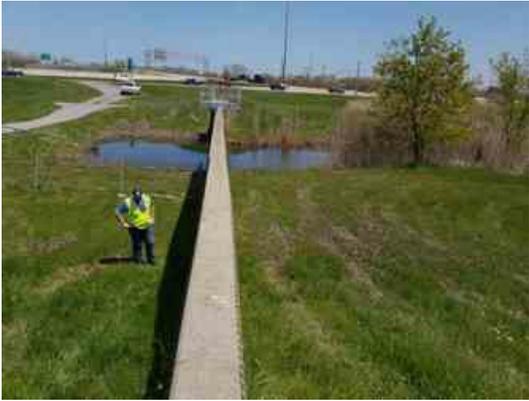
<p><b>Inspect ID:</b> 2020-0291 <b>Title:</b> 2604000003_CELRC_2020_A_0291_1_20200512T172112.jpg <b>Rated Item:</b> 5. Tilting, Sliding or Settlement of Concrete Structures <b>Caption:</b> Minimally Acceptable - Wall seems to have shifted slightly from original alignment. Sealant is pulling away due to movement.</p>

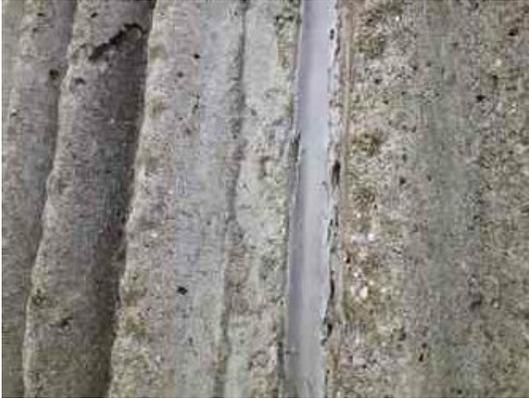
<p><b>Inspect ID:</b> 2020-0291 <b>Title:</b> 2604000003_CELRC_2020_A_0291_2_20200512T172155.jpg <b>Rated Item:</b> 5. Tilting, Sliding or Settlement of Concrete Structures <b>Caption:</b> Minimally Acceptable - Wall seems to have shifted slightly from original alignment. Sealant is pulling away due to movement.</p>

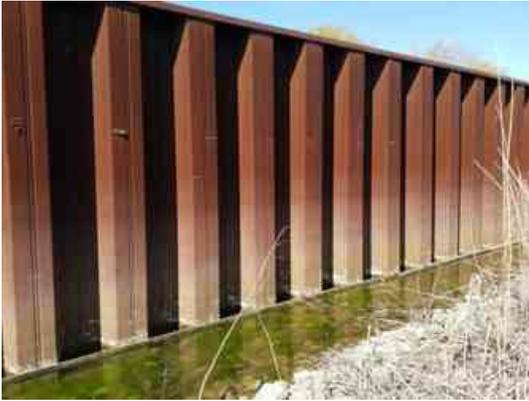
<p><b>Inspect ID:</b> 2020-0440 <b>Title:</b> 2604000003_CELRC_2020_A_0440_1_20200523T224725.jpg <b>Rated Item:</b> 9. Seepage <b>Caption:</b> Minimally Acceptable - Evidence on landside of seepage through joints in sheetpile.</p>

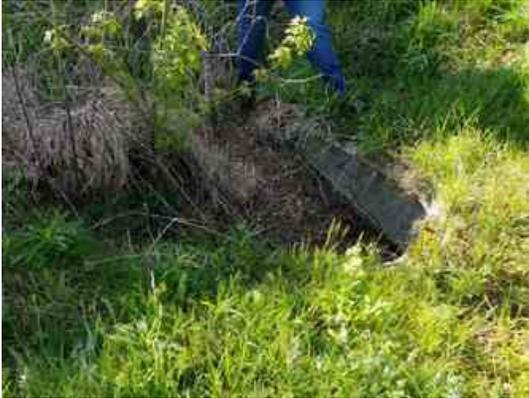
<p><b>Inspect ID:</b> 2020-0019 <b>Title:</b> 2604000003_CELRC_2020_A_0019_1_20200512T130855.jpg <b>Rated Item:</b> 1. Vegetation and Obstructions <b>Caption:</b> Minimally Acceptable - GN-1: Silt and tree at inlet.</p>

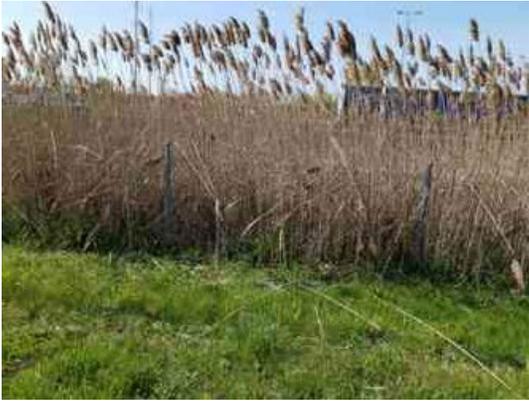
<p><b>Inspect ID:</b> 2020-0038 <b>Title:</b> 2604000003_CELRC_2020_A_0038_1_20200512T143738.jpg <b>Rated Item:</b> 1. Vegetation and Obstructions <b>Caption:</b> Minimally Acceptable - GN-16: Inlet covered in vegetation.</p>

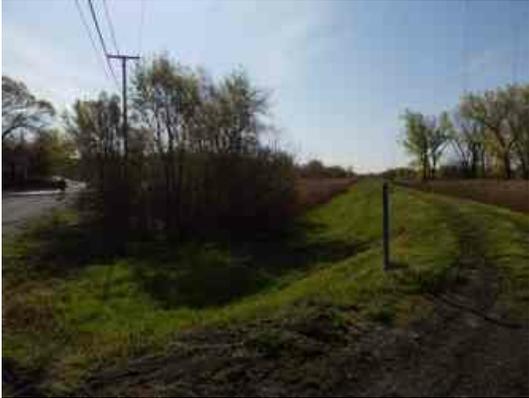
<p><b>Inspect ID:</b> 2020-0045 <b>Title:</b> 2604000003_CELRC_2020_A_0045_1_20200512T132212.jpg <b>Rated Item:</b> 1. Vegetation and Obstructions <b>Caption:</b> Minimally Acceptable - Vegetation in ditch.</p>

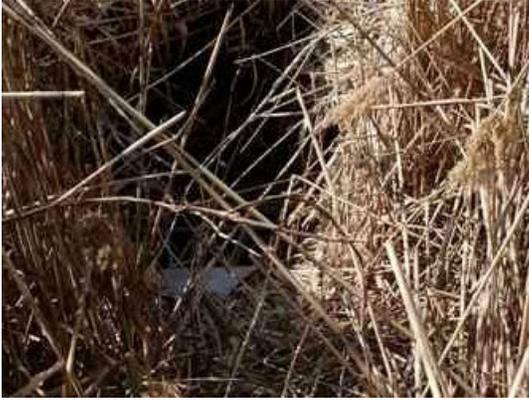
<p><b>Inspect ID:</b> 2020-0050 <b>Title:</b> 2604000003_CELRC_2020_A_0050_1_20200512T144917.jpg <b>Rated Item:</b> 1. Vegetation and Obstructions <b>Caption:</b> Acceptable - GN-17: Inlet clear.</p>

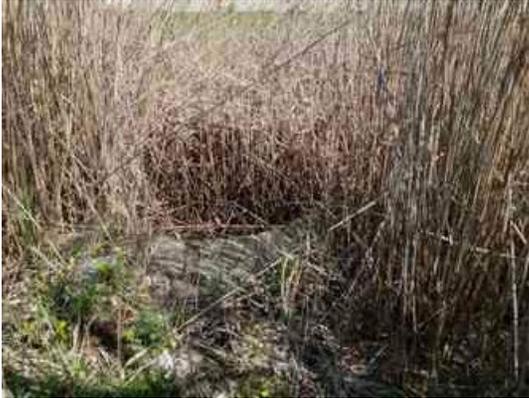
<p><b>Inspect ID:</b> 2020-0052 <b>Title:</b> 2604000003_CELRC_2020_A_0052_1_20200512T145635.jpg <b>Rated Item:</b> 1. Vegetation and Obstructions <b>Caption:</b> Acceptable - GN-12: Inlet clear.</p>

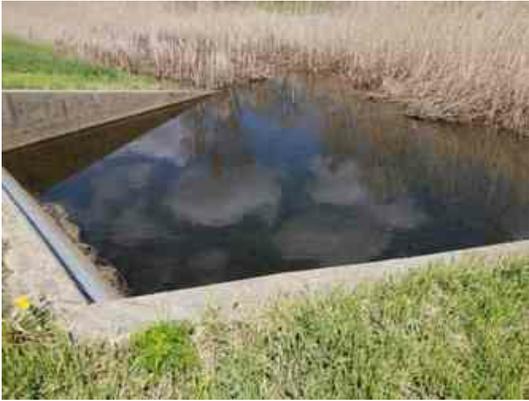
<p><b>Inspect ID:</b> 2020-0058 <b>Title:</b> 2604000003_CELRC_2020_A_0058_1_20200512T154518.jpg <b>Rated Item:</b> 1. Vegetation and Obstructions <b>Caption:</b> Acceptable - GN-8: Inlet clear.</p>

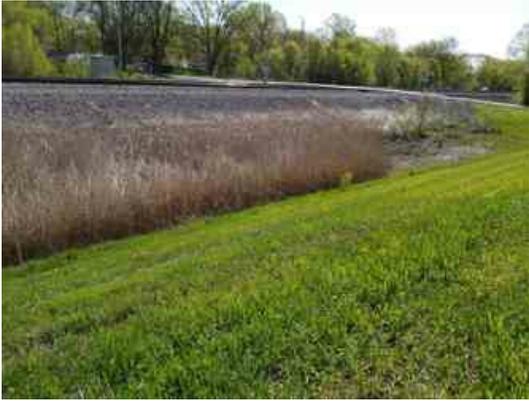
<p><b>Inspect ID:</b> 2020-0135 <b>Title:</b> 2604000003_CELRC_2020_A_0135_1_20200512T143659.jpg <b>Rated Item:</b> 1. Vegetation and Obstructions <b>Caption:</b> Minimally Acceptable - Small trees in ditch.</p>

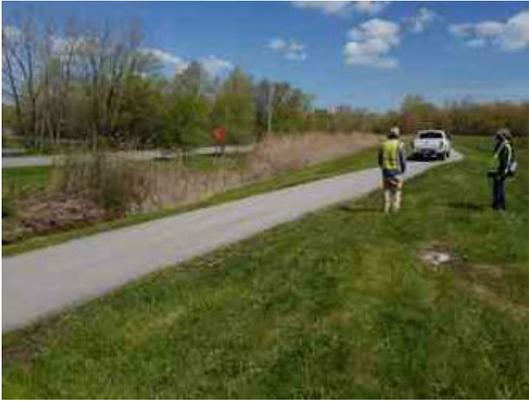
<p><b>Inspect ID:</b> 2020-0203 <b>Title:</b> 2604000003_CELRC_2020_A_0203_1_20200512T153914.jpg <b>Rated Item:</b> 1. Vegetation and Obstructions <b>Caption:</b> Minimally Acceptable - Small trees in ditch.</p>
