# Levee Inspection Report

Name of System: Gary  
 Name of Segment: Gary North  
 NLD System ID: 2605000003 NLD Segment ID: 2604000003

Segment Type: USACE Constructed, Public sponsor O&M  
 Levee Sponsor (Name and Organization): Little Calumet River Basin Development Commission, Little Calumet River Basin Development Commission  
 Inspection Report Prepared by: \_\_\_\_\_ Date(s) of Inspection: 05/11/2020 - 05/13/2020

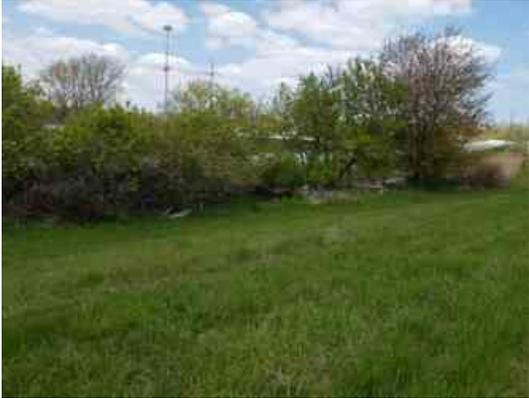
<p><b>Inspect ID:</b> 2020-0253 <b>Title:</b> 2604000003_CELRC_2020_A_0253_1_20200512T164521.jpg <b>Rated Item:</b> 1. Vegetation and Obstructions <b>Caption:</b> Minimally Acceptable - Trees in ditch.</p>

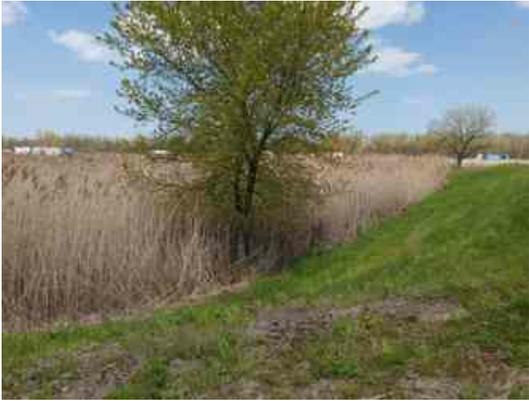
<p><b>Inspect ID:</b> 2020-0301 <b>Title:</b> 2604000003_CELRC_2020_A_0301_1_20200512T181237.jpg <b>Rated Item:</b> 1. Vegetation and Obstructions <b>Caption:</b> Minimally Acceptable - Tree in ditch.</p>

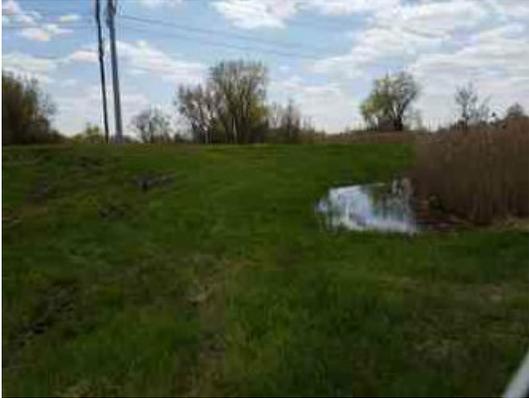
<p><b>Inspect ID:</b> 2020-0353 <b>Title:</b> 2604000003_CELRC_2020_A_0353_1_20200512T190130.jpg <b>Rated Item:</b> 1. Vegetation and Obstructions <b>Caption:</b> Minimally Acceptable - Potential pipe blockage under the ramp, ditch not draining.</p>

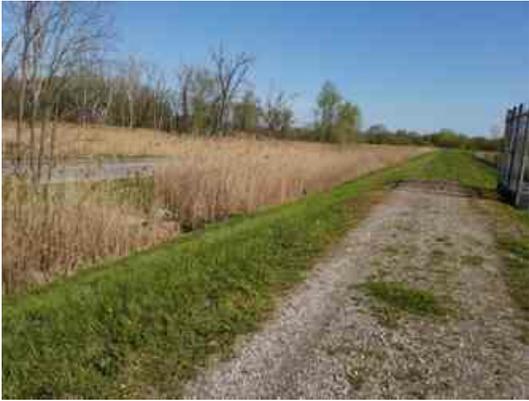
<p><b>Inspect ID:</b> 2020-0415 <b>Title:</b> 2604000003_CELRC_2020_A_0415_1_20200513T135142.jpg <b>Rated Item:</b> 1. Vegetation and Obstructions <b>Caption:</b> Minimally Acceptable - Small trees in ditch.</p>

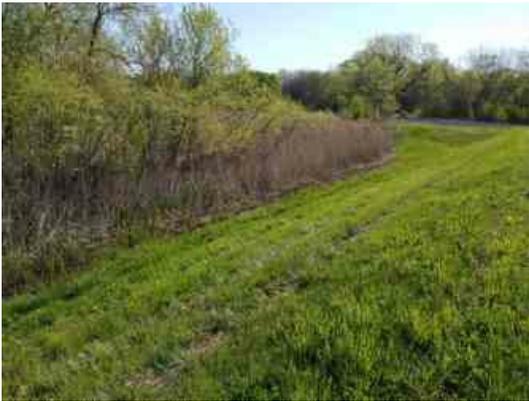
<p><b>Inspect ID:</b> 2020-0435 <b>Title:</b> 2604000003_CELRC_2020_A_0435_1_20200513T140702.jpg <b>Rated Item:</b> 1. Vegetation and Obstructions <b>Caption:</b> Minimally Acceptable - Trees in ditch.</p>

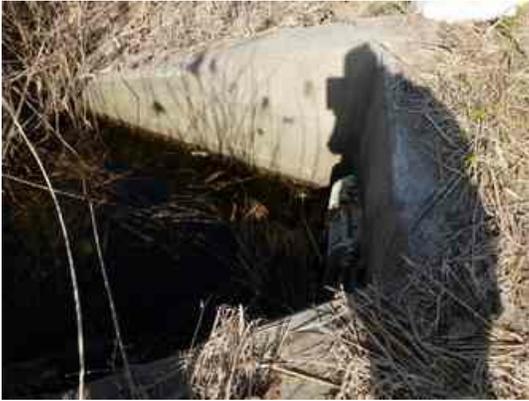
<p><b>Inspect ID:</b> 2020-0020 <b>Title:</b> 2604000003_CELRC_2020_A_0020_1_20200512T135054.jpg <b>Rated Item:</b> 2. Encroachments <b>Caption:</b> Acceptable - GN-15: Outlet clean of debris.</p>

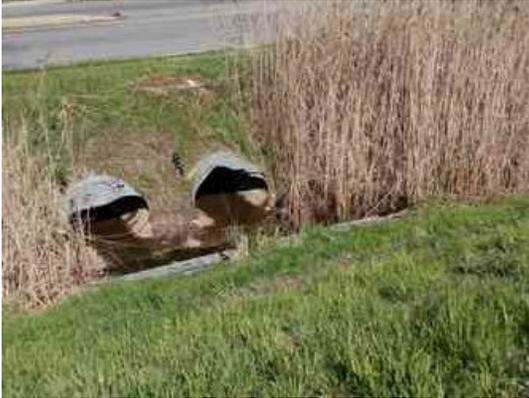
<p><b>Inspect ID:</b> 2020-0022 <b>Title:</b> 2604000003_CELRC_2020_A_0022_1_20200512T135855.jpg <b>Rated Item:</b> 2. Encroachments <b>Caption:</b> Acceptable - GN-18: Inlet free of debris.</p>

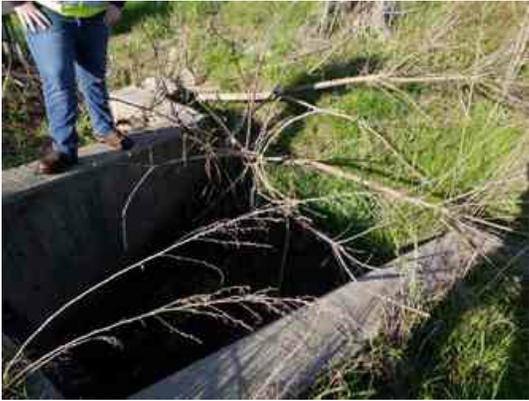
<p><b>Inspect ID:</b> 2020-0023 <b>Title:</b> 2604000003_CELRC_2020_A_0023_1_20200512T131130.jpg <b>Rated Item:</b> 2. Encroachments <b>Caption:</b> Minimally Acceptable - Downed tree on wingwall.</p>

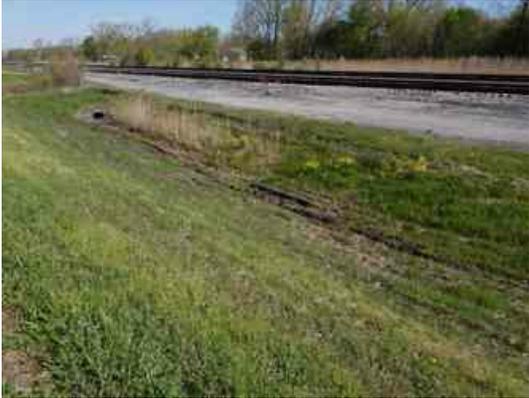
<p><b>Inspect ID:</b> 2020-0097 <b>Title:</b> 2604000003_CELRC_2020_A_0097_1_20200512T140237.jpg <b>Rated Item:</b> 2. Encroachments <b>Caption:</b> Minimally Acceptable - Debris in ditch.</p>

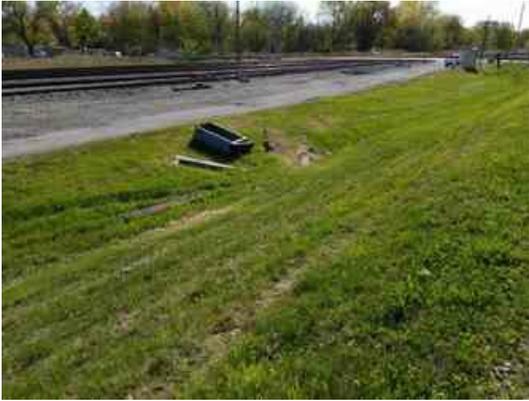
<p><b>Inspect ID:</b> 2020-0099 <b>Title:</b> 2604000003_CELRC_2020_A_0099_1_20200512T140333.jpg <b>Rated Item:</b> 2. Encroachments <b>Caption:</b> Minimally Acceptable - Debris in ditch.</p>

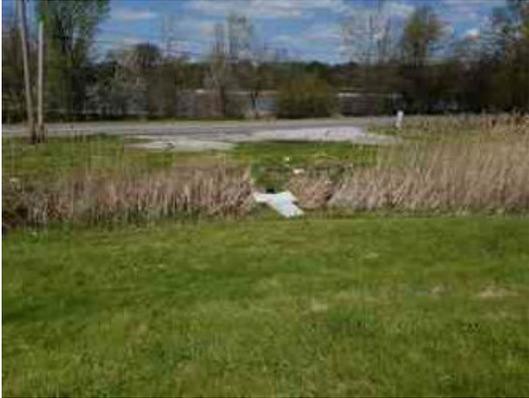
<p><b>Inspect ID:</b> 2020-0207 <b>Title:</b> 2604000003_CELRC_2020_A_0207_1_20200512T154446.jpg <b>Rated Item:</b> 2. Encroachments <b>Caption:</b> Minimally Acceptable - Debris in ditch.</p>

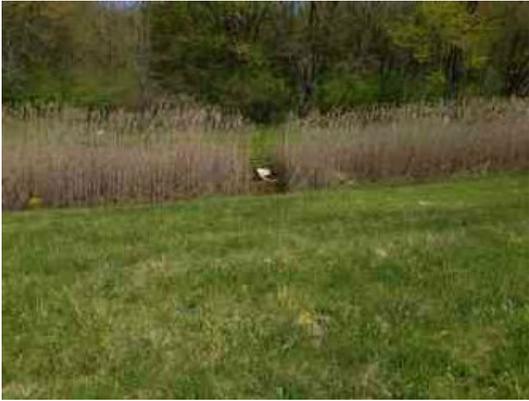
<p><b>Inspect ID:</b> 2020-0225 <b>Title:</b> 2604000003_CELRC_2020_A_0225_1_20200512T160654.jpg <b>Rated Item:</b> 2. Encroachments <b>Caption:</b> Minimally Acceptable - Debris in ditch.</p>

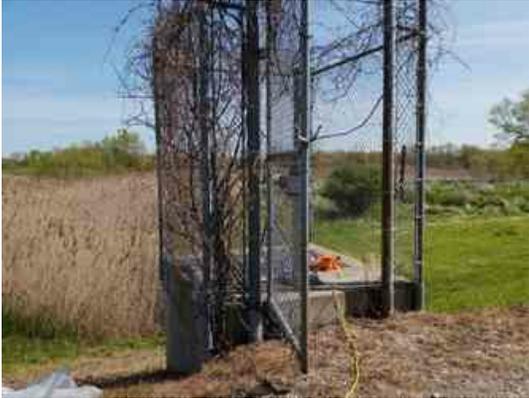
<p><b>Inspect ID:</b> 2020-0044 <b>Title:</b> 2604000003_CELRC_2020_A_0044_1_20200512T144314.jpg <b>Rated Item:</b> 4. Fencing and Gates <b>Caption:</b> Minimally Acceptable - GN-18: Vegetation around fence.</p>

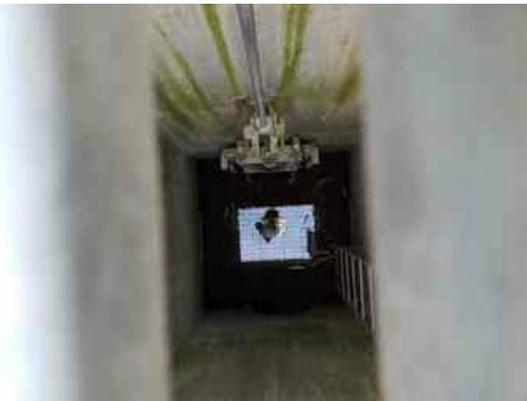
<p><b>Inspect ID:</b> 2020-0016 <b>Title:</b> 2604000003_CELRC_2020_A_2020-0016_2_20200512T134812.jpg <b>Rated Item:</b> 10. Sluice/ Slide Gates <b>Caption:</b> Acceptable - GN-15: Sluice gate closed and opened completely.</p>

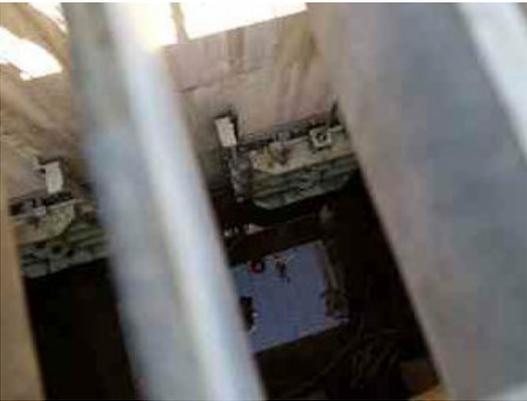
<p><b>Inspect ID:</b> 2020-0026 <b>Title:</b> 2604000003_CELRC_2020_A_0026_1_20200512T140213.jpg <b>Rated Item:</b> 10. Sluice/ Slide Gates <b>Caption:</b> Acceptable - GN-18a and GN-18b: Closed completely.</p>

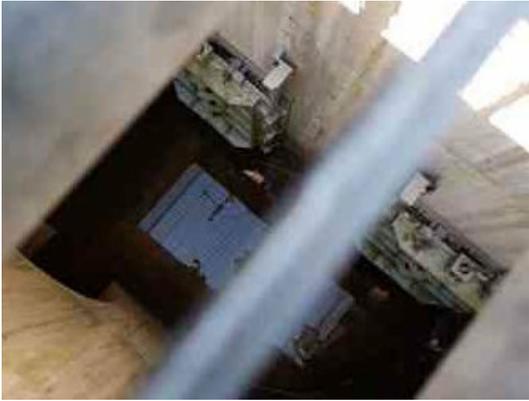
A photograph showing a sluice gate in a closed position. The gate is a large, dark structure with a blue panel in the center. It is situated in a concrete-lined channel. A vertical metal rod or pipe is visible in the foreground, slightly out of focus.	<p><b>Inspect ID:</b> 2020-0026 <b>Title:</b> 2604000003_CELRC_2020_A_0026_2_20200512T140248.jpg <b>Rated Item:</b> 10. Sluice/ Slide Gates <b>Caption:</b> Acceptable - GN-18a and GN-18b: Closed completely.</p>

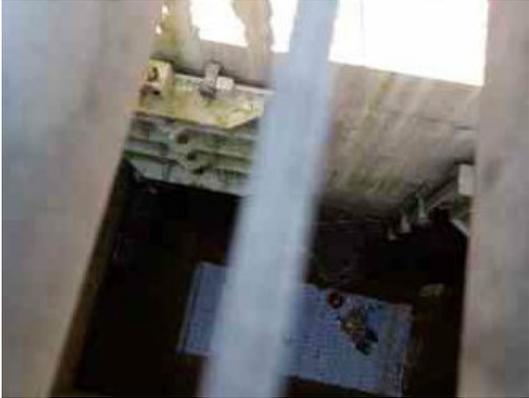
A photograph showing a sluice gate in an open position. The gate is a large, dark structure with a blue panel in the center. It is situated in a concrete-lined channel. A vertical metal rod or pipe is visible in the foreground, slightly out of focus.	<p><b>Inspect ID:</b> 2020-0028 <b>Title:</b> 2604000003_CELRC_2020_A_0028_1_20200512T140433.jpg <b>Rated Item:</b> 10. Sluice/ Slide Gates <b>Caption:</b> Acceptable - GN-18a and GN-18b: Opened completely.</p>

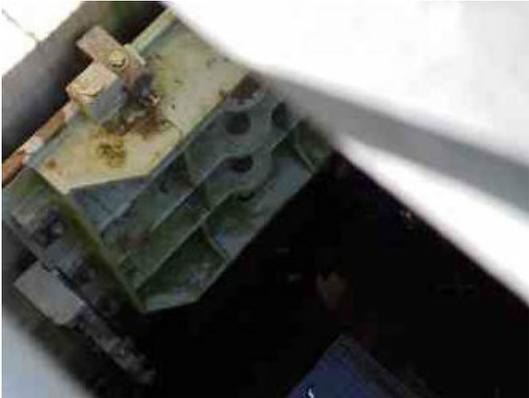
<p><b>Inspect ID:</b> 2020-0028 <b>Title:</b> 2604000003_CELRC_2020_A_0028_2_20200512T140451.jpg <b>Rated Item:</b> 10. Sluice/ Slide Gates <b>Caption:</b> Acceptable - GN-18a and GN-18b: Opened completely.</p>

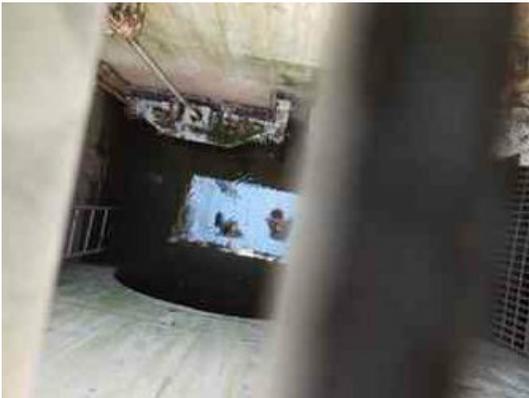
<p><b>Inspect ID:</b> 2020-0032 <b>Title:</b> 2604000003_CELRC_2020_A_0032_1_20200512T141903.jpg <b>Rated Item:</b> 10. Sluice/ Slide Gates <b>Caption:</b> Acceptable - GN-19a: Completely closed and opened.</p>

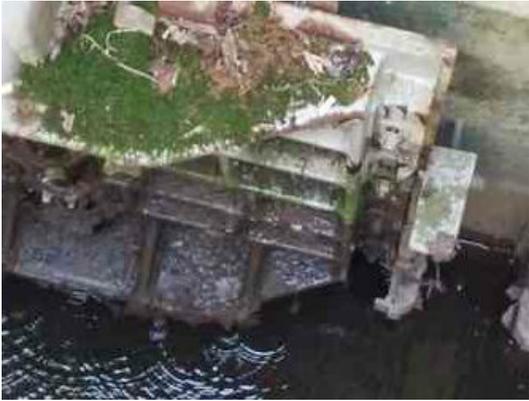
<p><b>Inspect ID:</b> 2020-0032 <b>Title:</b> 2604000003_CELRC_2020_A_0032_2_20200512T142231.jpg <b>Rated Item:</b> 10. Sluice/ Slide Gates <b>Caption:</b> Acceptable - GN-19a: Completely closed and opened.</p>

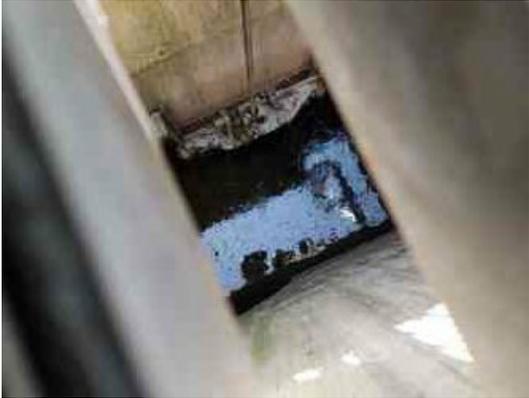
<p><b>Inspect ID:</b> 2020-0034 <b>Title:</b> 2604000003_CELRC_2020_A_0034_1_20200512T142433.jpg <b>Rated Item:</b> 10. Sluice/ Slide Gates <b>Caption:</b> Acceptable - GN-18b: Sluice gate completely closed and opened showing some sediment.</p>

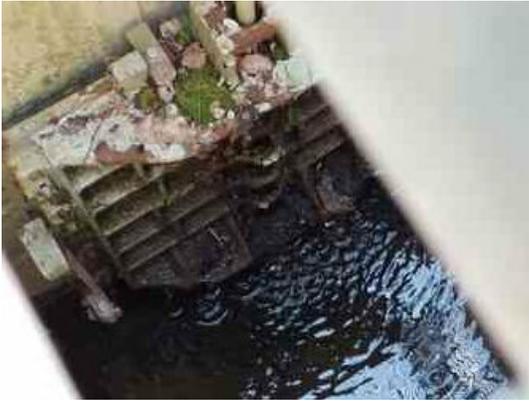
<p><b>Inspect ID:</b> 2020-0034 <b>Title:</b> 2604000003_CELRC_2020_A_0034_2_20200512T142514.jpg <b>Rated Item:</b> 10. Sluice/ Slide Gates <b>Caption:</b> Acceptable - GN-18b: Sluice gate completely closed and opened showing some sediment.</p>

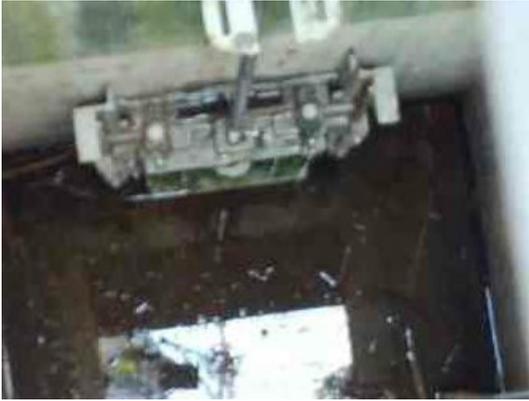
<p><b>Inspect ID:</b> 2020-0042 <b>Title:</b> 2604000003_CELRC_2020_A_0042_1_20200512T143957.jpg <b>Rated Item:</b> 10. Sluice/ Slide Gates <b>Caption:</b> Acceptable - GN-16: Completely closed and opened.</p>

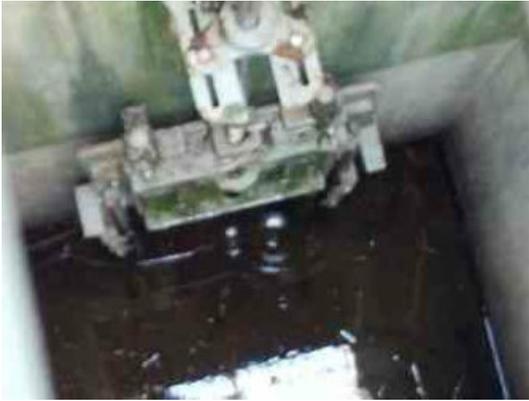
<p><b>Inspect ID:</b> 2020-0042 <b>Title:</b> 2604000003_CELRC_2020_A_2020-0042_2_20200512T144113.jpg <b>Rated Item:</b> 10. Sluice/ Slide Gates <b>Caption:</b> Acceptable - GN-16: Completely closed and opened.</p>

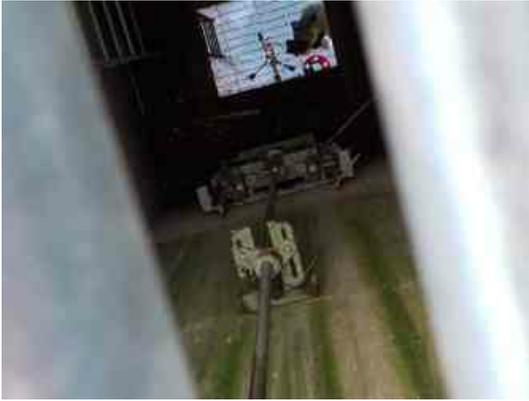
<p><b>Inspect ID:</b> 2020-0046 <b>Title:</b> 2604000003_CELRC_2020_A_0046_1_20200512T144419.jpg <b>Rated Item:</b> 10. Sluice/ Slide Gates <b>Caption:</b> Acceptable - GN-17: Completely closed and opened.</p>

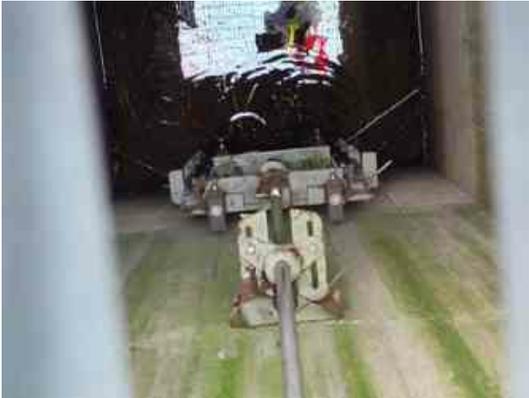
<p><b>Inspect ID:</b> 2020-0046 <b>Title:</b> 2604000003_CELRC_2020_A_0046_2_20200512T144525.jpg <b>Rated Item:</b> 10. Sluice/ Slide Gates <b>Caption:</b> Acceptable - GN-17: Completely closed and opened.</p>

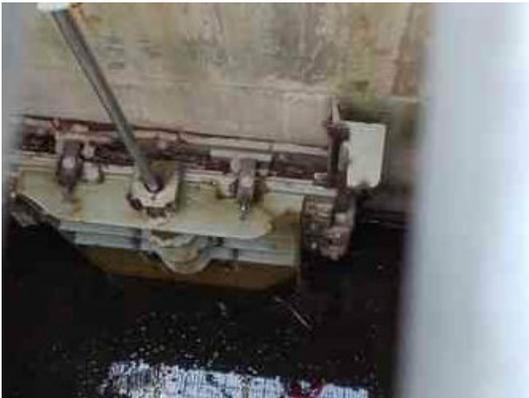
<p><b>Inspect ID:</b> 2020-0056 <b>Title:</b> 2604000003_CELRC_2020_A_0056_1_20200512T150002.jpg <b>Rated Item:</b> 10. Sluice/ Slide Gates <b>Caption:</b> Acceptable - GN-12: Sluice gate closed completely and opened completely.</p>

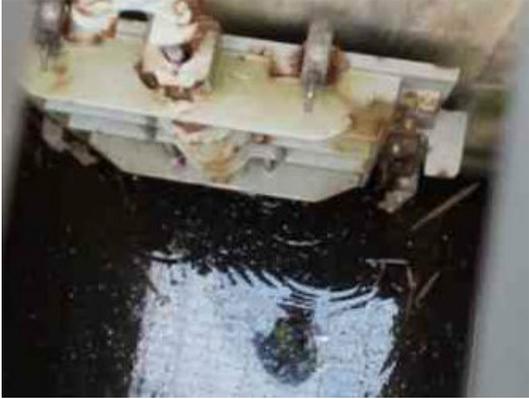
<p><b>Inspect ID:</b> 2020-0056 <b>Title:</b> 2604000003_CELRC_2020_A_0056_2_20200512T150054.jpg <b>Rated Item:</b> 10. Sluice/ Slide Gates <b>Caption:</b> Acceptable - GN-12: Sluice gate closed completely and opened completely.</p>

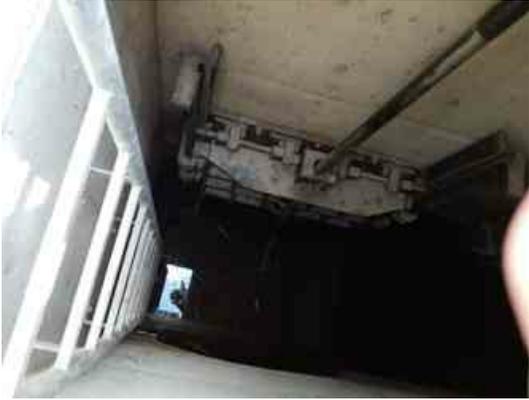
<p><b>Inspect ID:</b> 2020-0062 <b>Title:</b> 2604000003_CELRC_2020_A_0062_1_20200512T155305.jpg <b>Rated Item:</b> 10. Sluice/ Slide Gates <b>Caption:</b> Acceptable - GN-8: Able to see GN-8a and GN-8b closed but can't see GN-8c. GN-8a and GN-8b closed fully. Operated GN-8c up and down.</p>

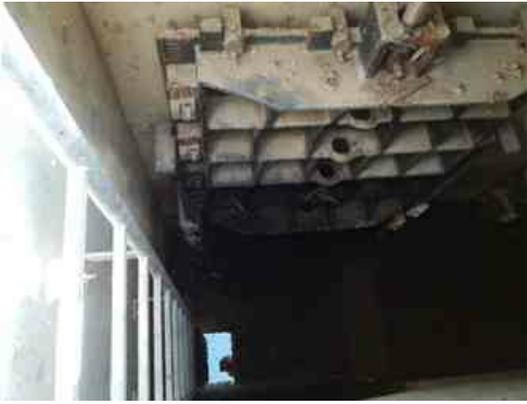
<p><b>Inspect ID:</b> 2020-0062 <b>Title:</b> 2604000003_CELRC_2020_A_2020-0062_2_20200512T155947.jpg <b>Rated Item:</b> 10. Sluice/ Slide Gates <b>Caption:</b> Acceptable - GN-8: Able to see GN-8a and GN-8b closed but can't see GN-8c. GN-8a and GN-8b closed fully. Operated GN-8c up and down.</p>

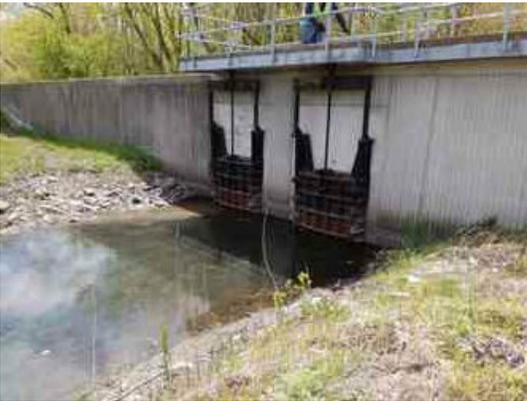
<p><b>Inspect ID:</b> 2020-0070 <b>Title:</b> 2604000003_CELRC_2020_A_0070_1_20200512T161712.jpg <b>Rated Item:</b> 10. Sluice/ Slide Gates <b>Caption:</b> Acceptable - GN-9: Sluice gate closed completely and opened completely.</p>

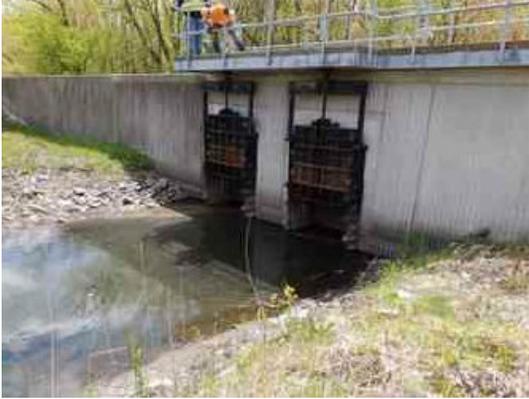
<p><b>Inspect ID:</b> 2020-0070 <b>Title:</b> 2604000003_CELRC_2020_A_0070_2_20200512T161931.jpg <b>Rated Item:</b> 10. Sluice/ Slide Gates <b>Caption:</b> Acceptable - GN-9: Sluice gate closed completely and opened completely.</p>

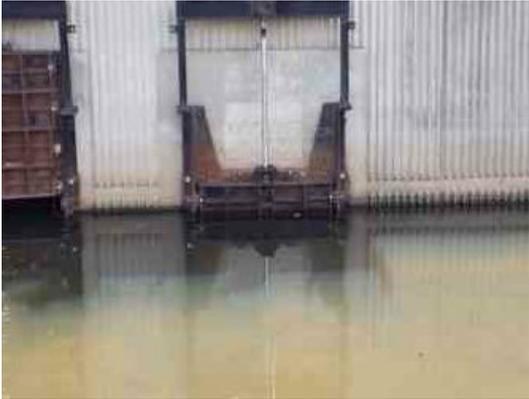
<p><b>Inspect ID:</b> 2020-0074 <b>Title:</b> 2604000003_CELRC_2020_A_0074_1_20200512T164704.jpg <b>Rated Item:</b> 10. Sluice/ Slide Gates <b>Caption:</b> Acceptable - GN-10a: Sluice gate completely closed and opened.</p>

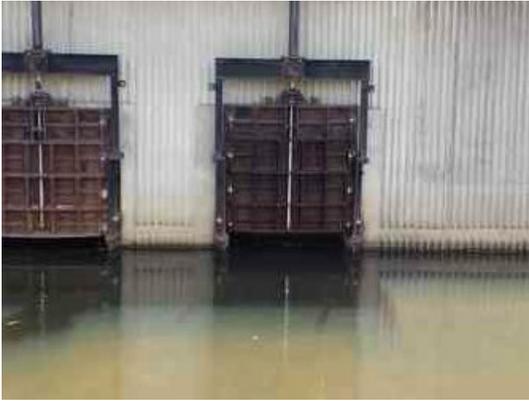
<p><b>Inspect ID:</b> 2020-0074 <b>Title:</b> 2604000003_CELRC_2020_A_0074_2_20200512T165110.jpg <b>Rated Item:</b> 10. Sluice/ Slide Gates <b>Caption:</b> Acceptable - GN-10a: Sluice gate completely closed and opened.</p>

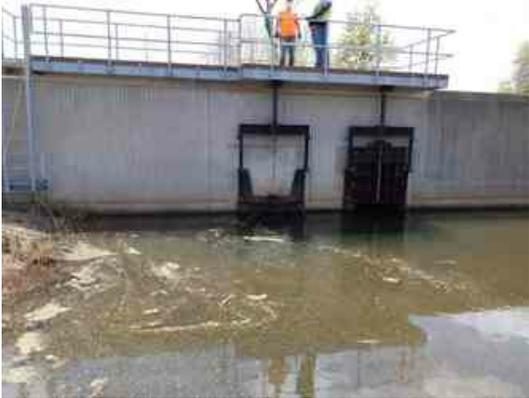
<p><b>Inspect ID:</b> 2020-0076 <b>Title:</b> 2604000003_CELRC_2020_A_0076_1_20200512T170804.jpg <b>Rated Item:</b> 10. Sluice/ Slide Gates <b>Caption:</b> Minimally Acceptable - GN-10b: Sluice gate closed but took time getting it down. Fully operated going down and went back up up to 90 percent. Suggest greasing it.</p>

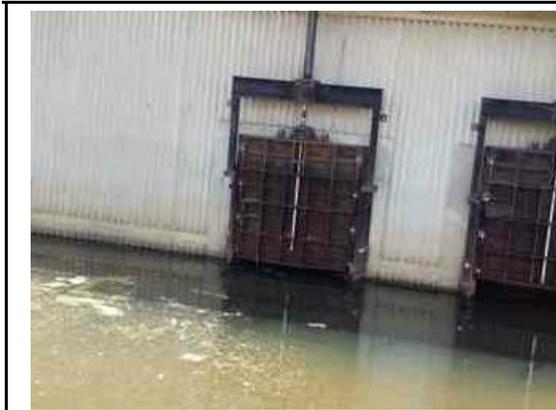
**Inspect ID:** 2020-0076 **Title:** 2604000003\_CELRC\_2020\_A\_0076\_2\_20200512T170916.jpg **Rated Item:** 10. Sluice/ Slide Gates **Caption:** Minimally Acceptable - GN-10b: Sluice gate closed but took time getting it down. Fully operated going down and went back up up to 90 percent. Suggest greasing it.

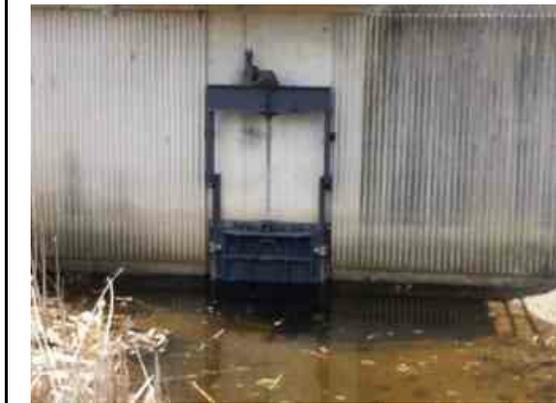
**Inspect ID:** 2020-0078 **Title:** 2604000003\_CELRC\_2020\_A\_0078\_1\_20200512T173253.jpg **Rated Item:** 10. Sluice/ Slide Gates **Caption:** Acceptable - GN-11: Sluice gate completely closed and opened.

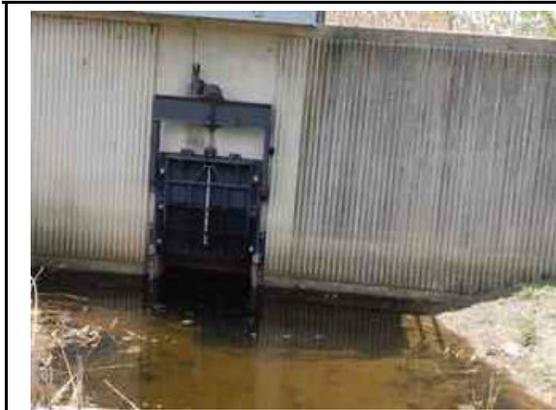
**Inspect ID:** 2020-0078 **Title:** 2604000003\_CELRC\_2020\_A\_0078\_2\_20200512T173450.jpg **Rated Item:** 10. Sluice/ Slide Gates **Caption:** Acceptable - GN-11: Sluice gate completely closed and opened.

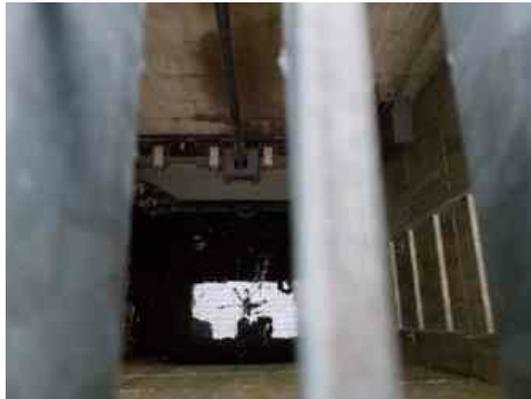
**Inspect ID:** 2020-0439 **Title:** 2604000003\_CELRC\_2020\_A\_0439\_1\_20200523T222114.jpg **Rated Item:** 10. Sluice/ Slide Gates **Caption:** Acceptable - GN-3: Sluice gate opened and closed.

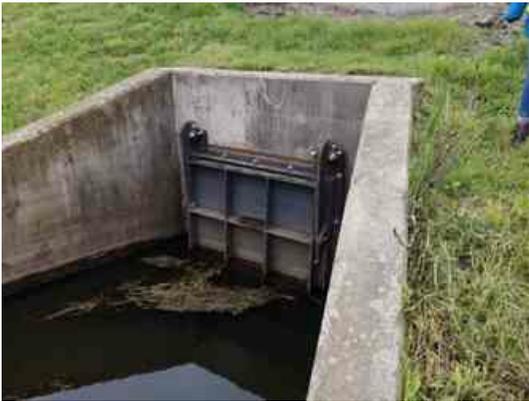
<p><b>Inspect ID:</b> 2020-0002 <b>Title:</b> 2604000003_CELRC_2020_A_0002_1_20200512T112752.jpg <b>Rated Item:</b> 11. Flap Gates/ Flap Valves/ Pinch Valves <b>Caption:</b> Acceptable - GN-3: Flap gate closed completely.</p>

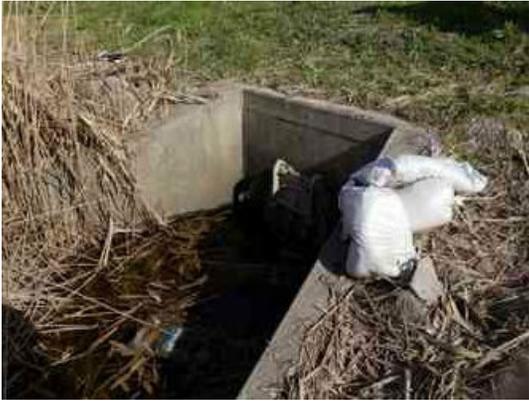
<p><b>Inspect ID:</b> 2020-0012 <b>Title:</b> 2604000003_CELRC_2020_A_0012_1_20200512T134303.jpg <b>Rated Item:</b> 11. Flap Gates/ Flap Valves/ Pinch Valves <b>Caption:</b> Acceptable - GN-13: No debris in outlet.</p>

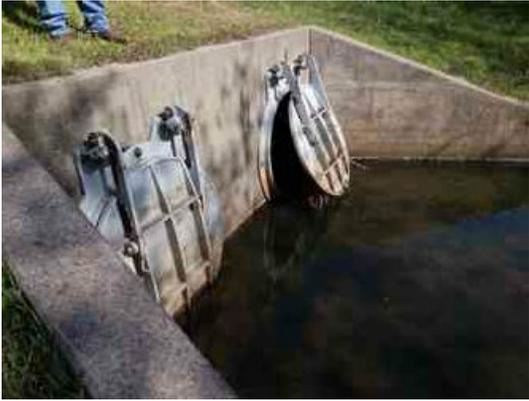
<p><b>Inspect ID:</b> 2020-0024 <b>Title:</b> 2604000003_CELRC_2020_A_0024_1_20200512T135940.jpg <b>Rated Item:</b> 11. Flap Gates/ Flap Valves/ Pinch Valves <b>Caption:</b> Minimally Acceptable - GN-18: Debris blocking flap gate.</p>

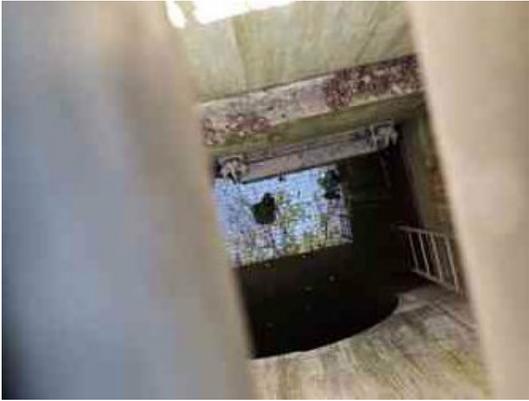
<p><b>Inspect ID:</b> 2020-0030 <b>Title:</b> 2604000003_CELRC_2020_A_0030_1_20200512T141441.jpg <b>Rated Item:</b> 11. Flap Gates/ Flap Valves/ Pinch Valves <b>Caption:</b> Acceptable - GN-18a and GN-18b: Flap gate closed but under water.</p>

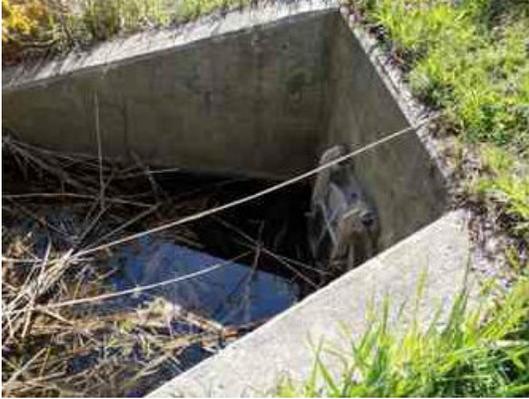
<p><b>Inspect ID:</b> 2020-0040 <b>Title:</b> 2604000003_CELRC_2020_A_0040_1_20200512T143834.jpg <b>Rated Item:</b> 11. Flap Gates/ Flap Valves/ Pinch Valves <b>Caption:</b> Acceptable - GN-16: Outlet clear of debris.</p>

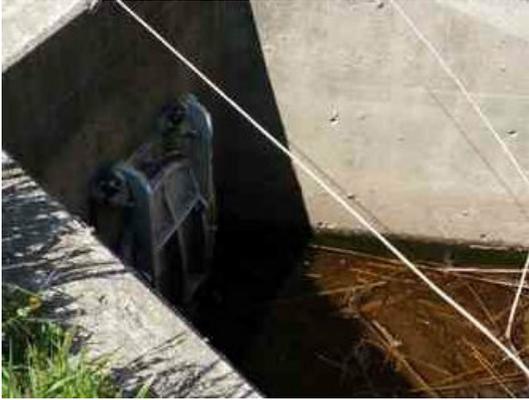
<p><b>Inspect ID:</b> 2020-0048 <b>Title:</b> 2604000003_CELRC_2020_A_0048_1_20200512T144703.jpg <b>Rated Item:</b> 11. Flap Gates/ Flap Valves/ Pinch Valves <b>Caption:</b> Acceptable - GN-17: Outlet clean of debris.</p>

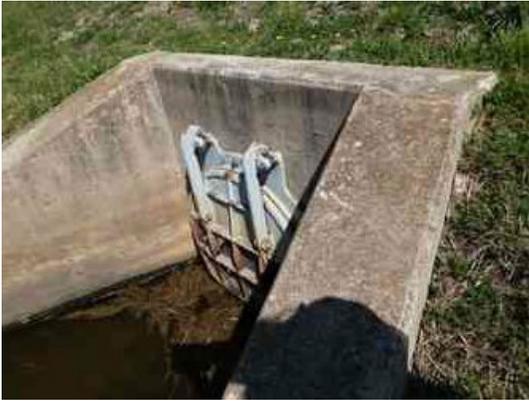
<p><b>Inspect ID:</b> 2020-0054 <b>Title:</b> 2604000003_CELRC_2020_A_0054_1_20200512T145859.jpg <b>Rated Item:</b> 11. Flap Gates/ Flap Valves/ Pinch Valves <b>Caption:</b> Acceptable - GN-12: Outlet clean of debris.</p>

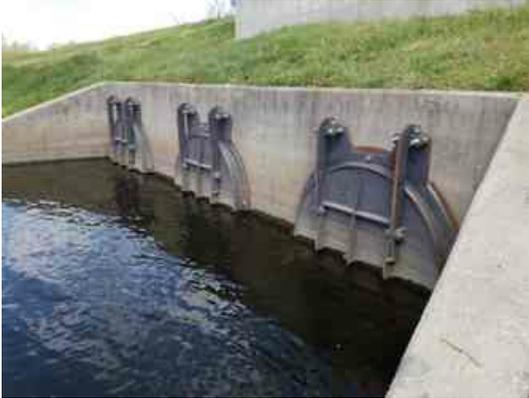
<p><b>Inspect ID:</b> 2020-0060 <b>Title:</b> 2604000003_CELRC_2020_A_0060_1_20200512T154639.jpg <b>Rated Item:</b> 11. Flap Gates/ Flap Valves/ Pinch Valves <b>Caption:</b> Acceptable - GN-8: Flap gates are closed.</p>

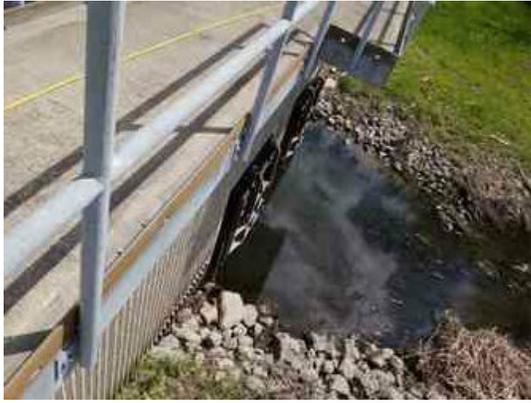
<p><b>Inspect ID:</b> 2020-0068 <b>Title:</b> 2604000003_CELRC_2020_A_0068_1_20200512T161525.jpg <b>Rated Item:</b> 11. Flap Gates/ Flap Valves/ Pinch Valves <b>Caption:</b> Acceptable - GN-9: Flap gates have no debris.</p>

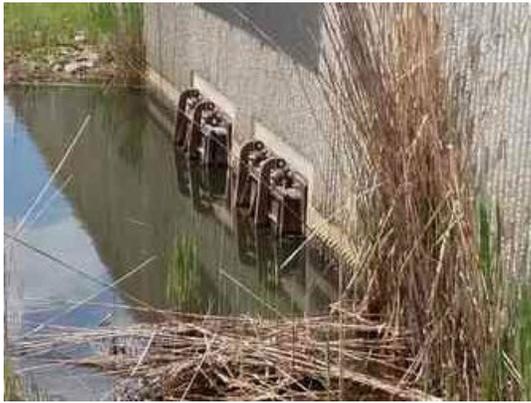
<p><b>Inspect ID:</b> 2020-0072 <b>Title:</b> 2604000003_CELRC_2020_A_0072_1_20200512T164322.jpg <b>Rated Item:</b> 11. Flap Gates/ Flap Valves/ Pinch Valves <b>Caption:</b> Acceptable - GN-10: Flap gate no debris.</p>

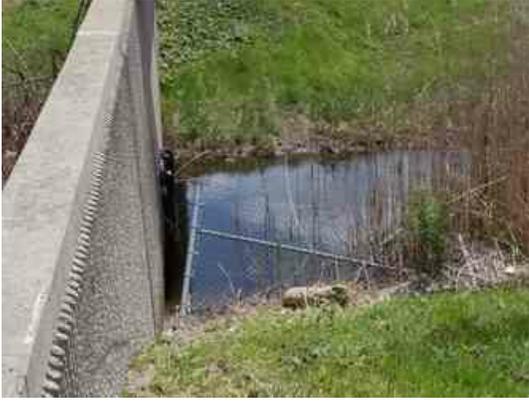
<p><b>Inspect ID:</b> 2020-0080 <b>Title:</b> 2604000003_CELRC_2020_A_0080_1_20200512T173905.jpg <b>Rated Item:</b> 11. Flap Gates/ Flap Valves/ Pinch Valves <b>Caption:</b> Acceptable - GN-11: Flap gate has no debris.</p>

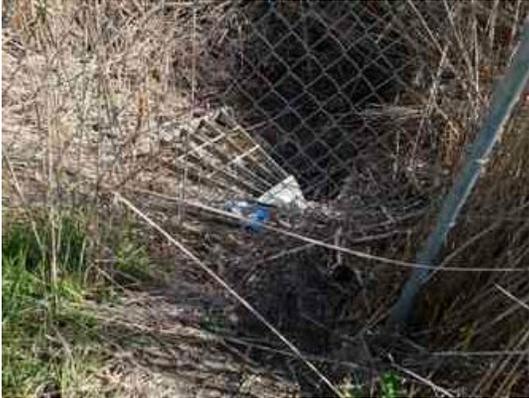
<p><b>Inspect ID:</b> 2020-0008 <b>Title:</b> 2604000003_CELRC_2020_A_0008_1_20200512T133820.jpg <b>Rated Item:</b> 12. Trash Racks (non-mechanical) <b>Caption:</b> Minimally Acceptable - GN-13: Inlet cover detached.</p>

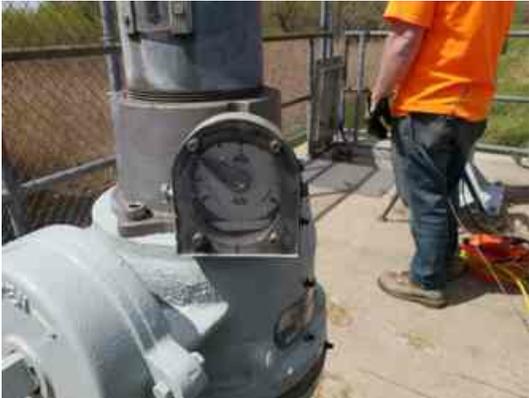
<p><b>Inspect ID:</b> 2020-0064 <b>Title:</b> 2604000003_CELRC_2020_A_0064_1_20200512T155549.jpg <b>Rated Item:</b> 13. Other Metallic Items <b>Caption:</b> Minimally Acceptable - GN-8: All 3 gauges are not functioning.</p>

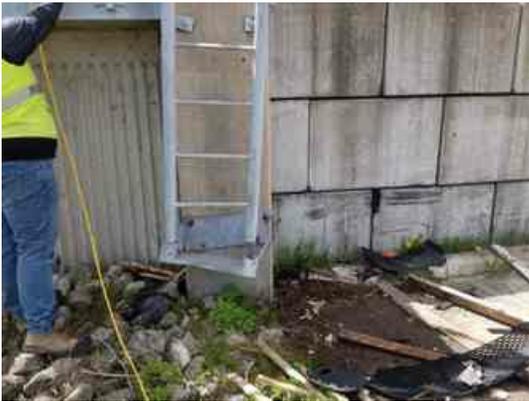
<p><b>Inspect ID:</b> 2020-0066 <b>Title:</b> 2604000003_CELRC_2020_A_0066_1_20200512T160937.jpg <b>Rated Item:</b> 13. Other Metallic Items <b>Caption:</b> Minimally Acceptable - GN-9: Ladder is broken.</p>

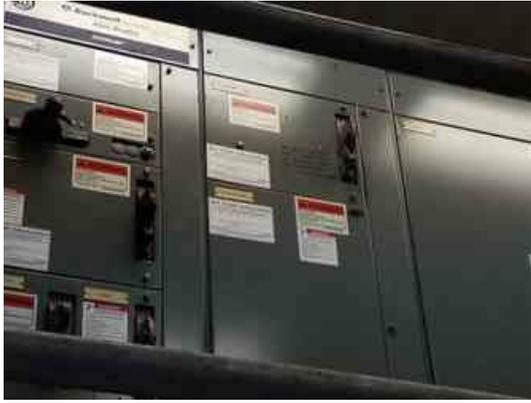
<p><b>Inspect ID:</b> 2020-0086 <b>Title:</b> 2604000003_CELRC_2020_A_0086_1_20200513T140804.jpg <b>Rated Item:</b> 3. Safety Compliance <b>Caption:</b> Acceptable - PS-BR: New Arc-flash warning labels added.</p>

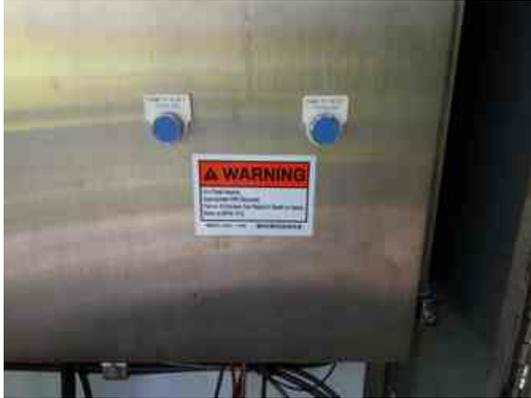
<p><b>Inspect ID:</b> 2020-0092 <b>Title:</b> 2604000003_CELRC_2020_A_0092_1_20200513T150653.jpg <b>Rated Item:</b> 3. Safety Compliance <b>Caption:</b> Acceptable - PS-IW: Arc-flash labels present.</p>

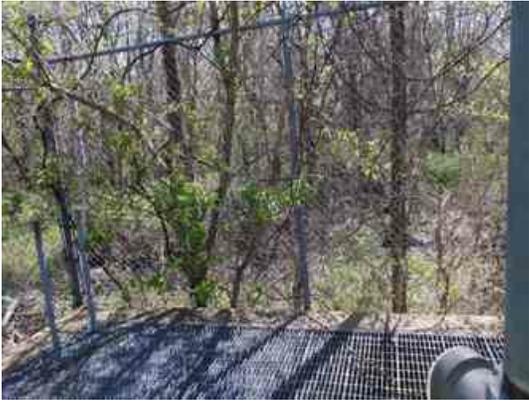
<p><b>Inspect ID:</b> 2020-0094 <b>Title:</b> 2604000003_CELRC_2020_A_0094_1_20200513T150805.jpg <b>Rated Item:</b> 6. Fencing and Gates <b>Caption:</b> Minimally Acceptable - PS-IW: Thick vegetation on fence.</p>

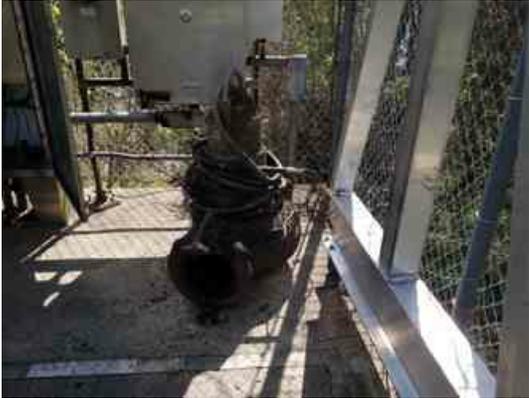
<p><b>Inspect ID:</b> 2020-0090 <b>Title:</b> 2604000003_CELRC_2020_A_0090_1_20200513T150544.jpg <b>Rated Item:</b> 7. Pumps <b>Caption:</b> Minimally Acceptable - PS-IW: Pump 1 has been pulled out and still not working. There is enough capacity with one pump.</p>

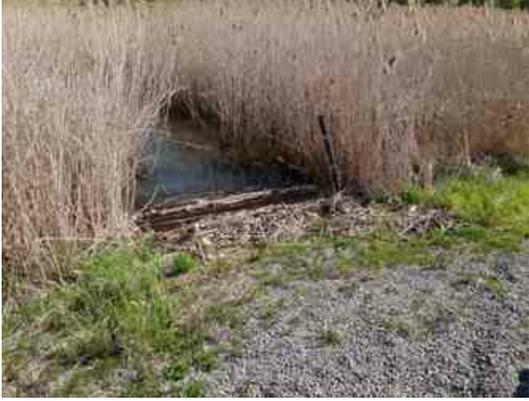
<p><b>Inspect ID:</b> 2020-0088 <b>Title:</b> 2604000003_CELRC_2020_A_0088_1_20200513T140923.jpg <b>Rated Item:</b> 11. Non-Mechanical Trash Racks <b>Caption:</b> Minimally Acceptable - PS-BR: Trash rack has debris and needs to be cleaned.</p>

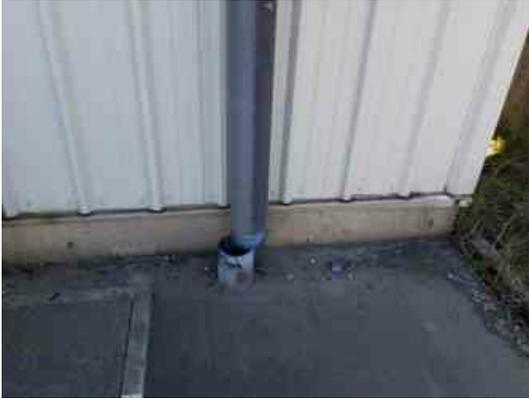
<p><b>Inspect ID:</b> 2020-0084 <b>Title:</b> 2604000003_CELRC_2020_A_0084_1_20200513T140611.jpg <b>Rated Item:</b> 17. Intake and Discharge Pipelines <b>Caption:</b> Minimally Acceptable - PS-BR: Sump exhaust line disconnected.</p>
