## Site Visit Summary

Name of System: Hammond

Name of Segment: Hammond

Date of Site Visit: 06/05/2023 - 06/09/2023

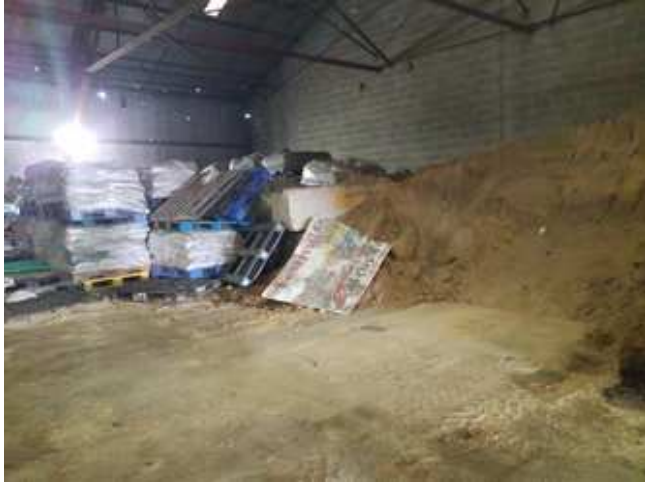
Category:	General Items	Item:	Emergency Supplies a
Observation ID:	2023-0226		
Description:	Several pallets of sandbags at 601 Conkey, Public Works garage. Visqueen in a shed in the garage.		
Caption:	0226 - No User Rating (Site Visit) - Several pallets of sandbags at 601 Conkey, Public Works garage. Visqueen in a shed in the garage.		
Lat/Long:	41.60251/-87.51439

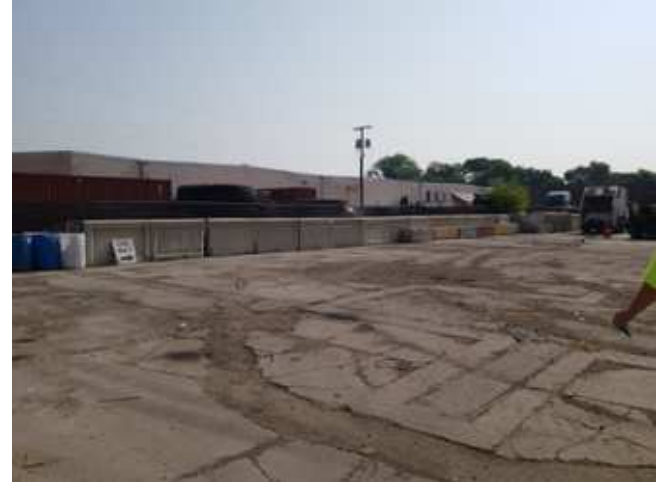
Category:	General Items	Item:	Emergency Supplies a
Observation ID:	2023-0230		
Description:	Blocks stored in the Public Works lot.		
Caption:	0230 - No User Rating (Site Visit) - Blocks stored in the Public Works lot.		
Lat/Long:	41.60285/-87.51325

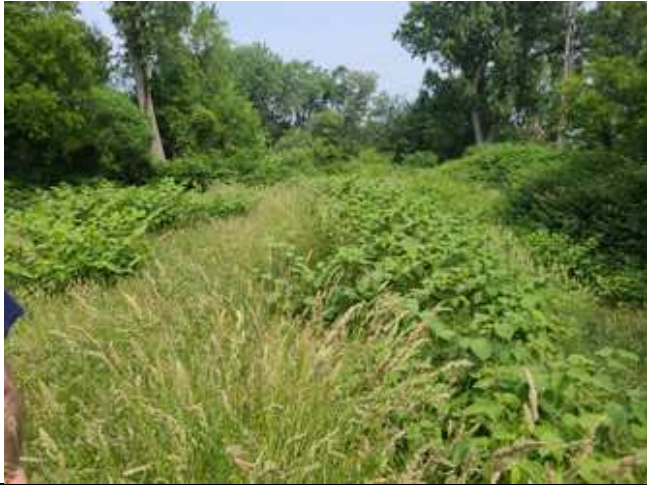
Category:	Levee Embankments	Item:	Unwanted Vegetation
Observation ID:	2023-0007		
Description:	Tall vegetation on the crest and slopes due to limited access from construction of the railroad		
Caption:	0007 - No User Rating (Site Visit) - Tall vegetation on the crest and slopes due to limited access from construction of the railroad		
Lat/Long:	41.57590/-87.51893

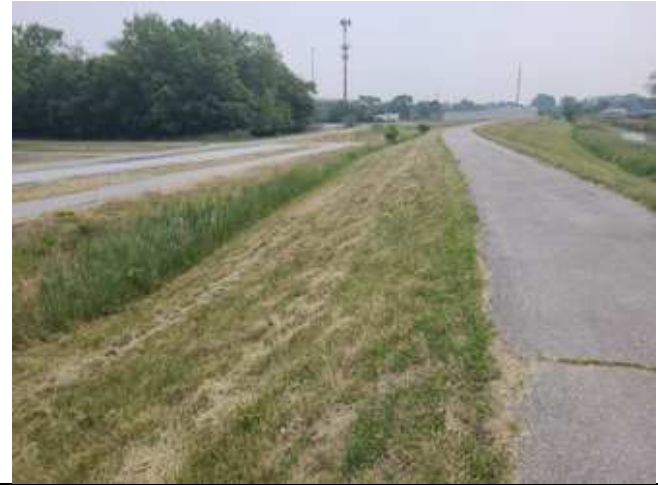
Category:	Levee Embankments	Item:	Unwanted Vegetation
Observation ID:	2023-0083		
Description:	Vegetation along landside toe - extends along much of levee		
Caption:	0083 - No User Rating (Site Visit) - Vegetation along landside toe - extends along much of levee		
Lat/Long:	41.57198/-87.51300

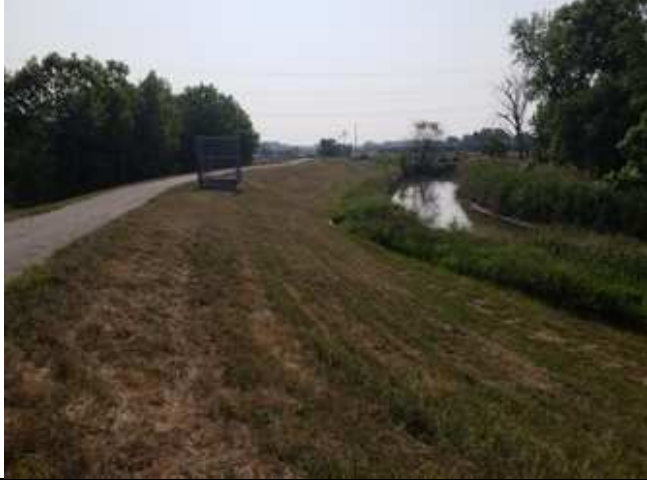
Category:	Levee Embankments	Item:	Unwanted Vegetation
Observation ID:	2023-0136		
Description:	Vegetation along riverside toe		
Caption:	0136 - No User Rating (Site Visit) - Vegetation along riverside toe		
Lat/Long:	41.57042/-87.46851

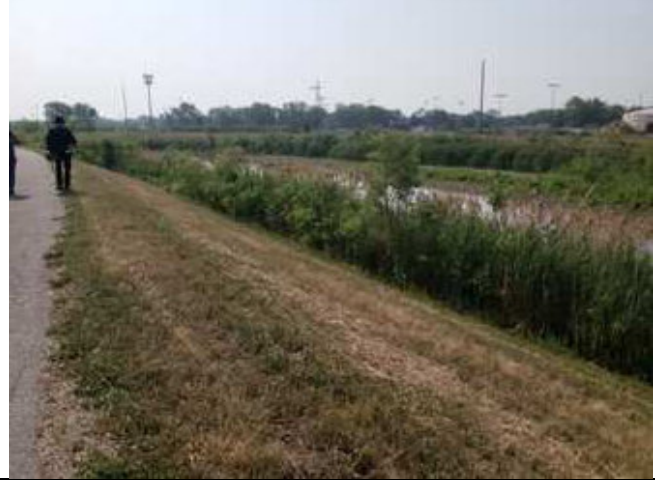
Category:	Levee Embankments	Item:	Unwanted Vegetation
Observation ID:	2023-0152		
Description:	Vegetation along riverside toe		
Caption:	0152 - No User Rating (Site Visit) - Vegetation along riverside toe		
Lat/Long:	41.56974/-87.46052

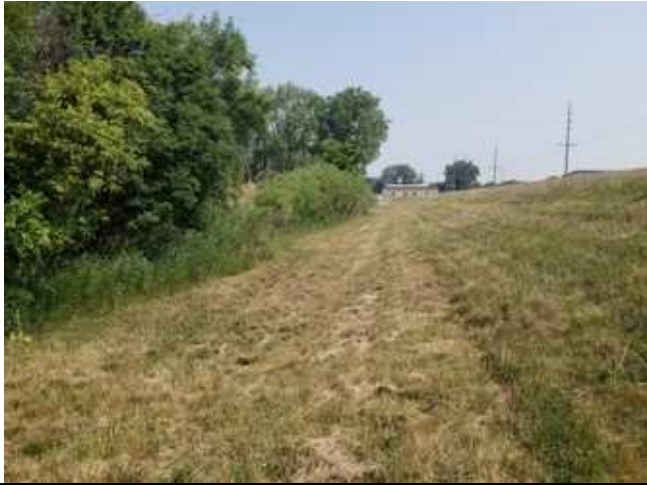
Category:	Levee Embankments	Item:	Unwanted Vegetation
Observation ID:	2023-0160		
Description:	Vegetation along landside toe		
Caption:	0160 - No User Rating (Site Visit) - Vegetation along landside toe		
Lat/Long:	41.57124/-87.44805

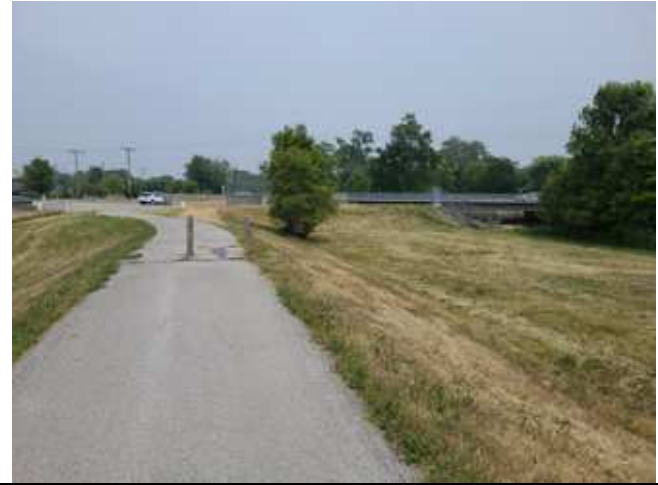
Category:	Levee Embankments	Item:	Unwanted Vegetation
Observation ID:	2023-0171		
Description:	Encroaching tree and debris on riverside slope		
Caption:	0171 - No User Rating (Site Visit) - Encroaching tree and debris on riverside slope		
Lat/Long:	41.56908/-87.50129

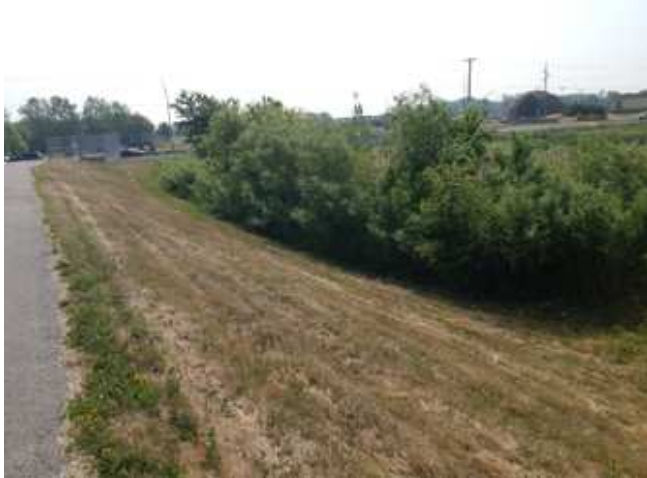
Category:	Levee Embankments	Item:	Unwanted Vegetation
Observation ID:	2023-0246		
Description:	Small trees and tall vegetation on riverside toe		
Caption:	0246 - No User Rating (Site Visit) - Small trees and tall vegetation on riverside toe		
Lat/Long:	41.56985/-87.46222

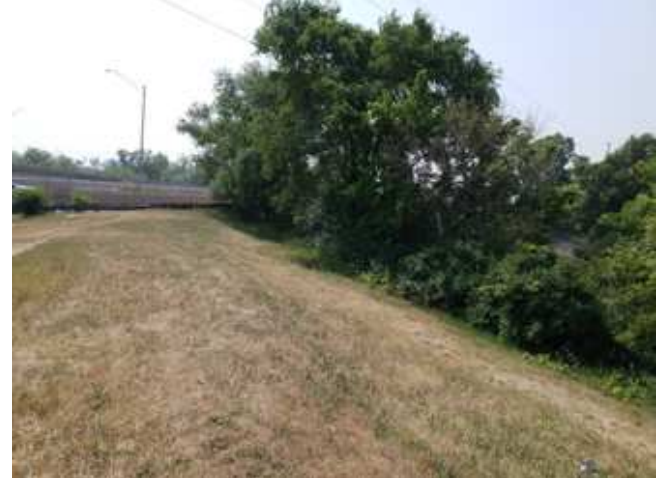
Category:	Levee Embankments	Item:	Unwanted Vegetation
Observation ID:	2023-0250		
Description:	Trees on the riverside slope and toe		
Caption:	0250 - No User Rating (Site Visit) - Trees on the riverside slope and toe		
Lat/Long:	41.56755/-87.43319

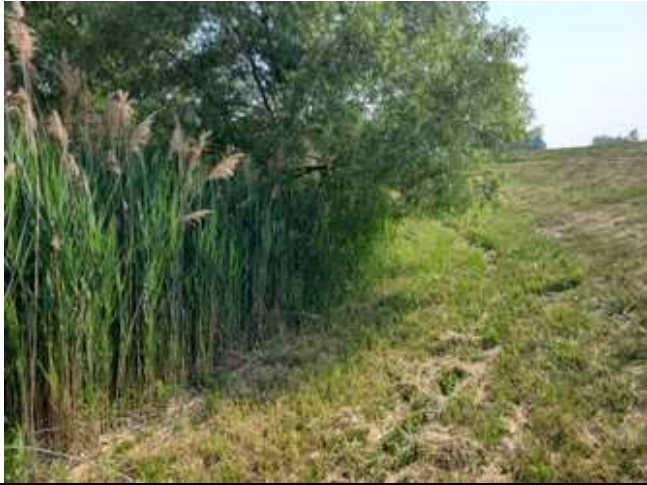
Category:	Levee Embankments	Item:	Unwanted Vegetation
Observation ID:	2023-0303		
Description:	Tree & vegetation along landside toe		
Caption:	0303 - No User Rating (Site Visit) - Tree & vegetation along landside toe		
Lat/Long:	41.56971/-87.45940

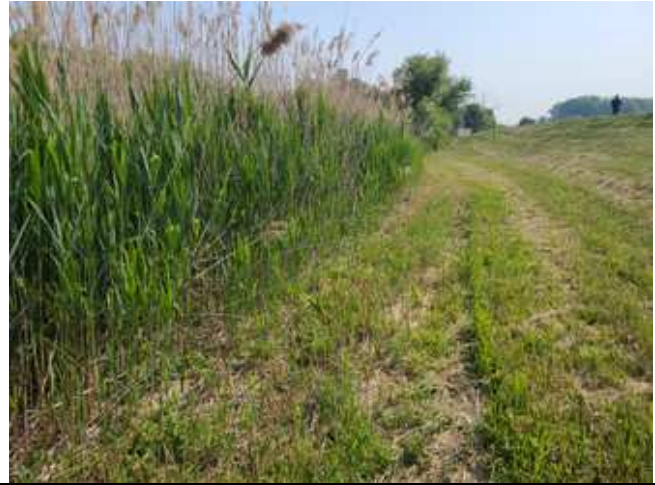
Category:	Levee Embankments	Item:	Unwanted Vegetation
Observation ID:	2023-0307		
Description:	Vegetation along landside toe		
Caption:	0307 - No User Rating (Site Visit) - Vegetation along landside toe		
Lat/Long:	41.56977/-87.45926

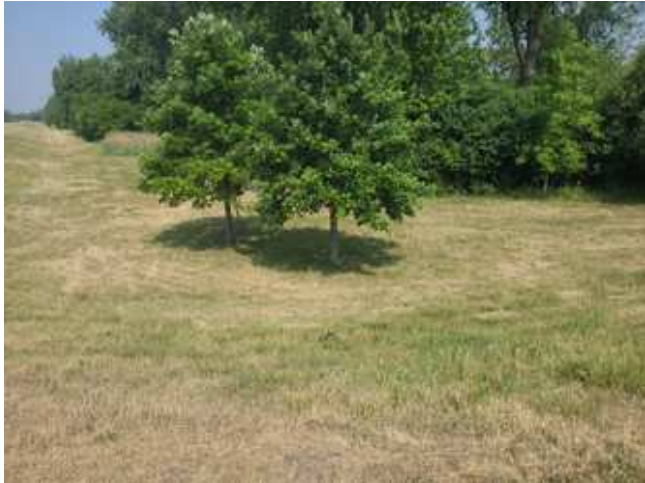
Category:	Levee Embankments	Item:	Unwanted Vegetation
Observation ID:	2023-0323		
Description:	Trees on landside toe		
Caption:	0323 - No User Rating (Site Visit) - Trees on landside toe		
Lat/Long:	41.57087/-87.44792

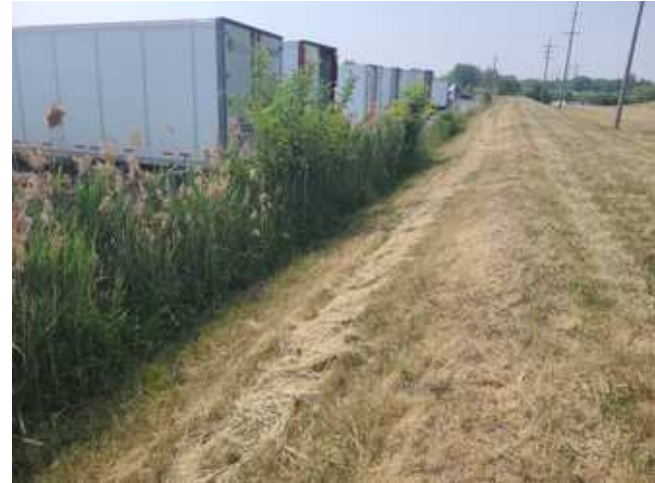
Category:	Levee Embankments	Item:	Unwanted Vegetation
Observation ID:	2023-0343		
Description:	Vegetation along landside toe		
Caption:	0343 - No User Rating (Site Visit) - Vegetation along landside toe		
Lat/Long:	41.57200/-87.44754

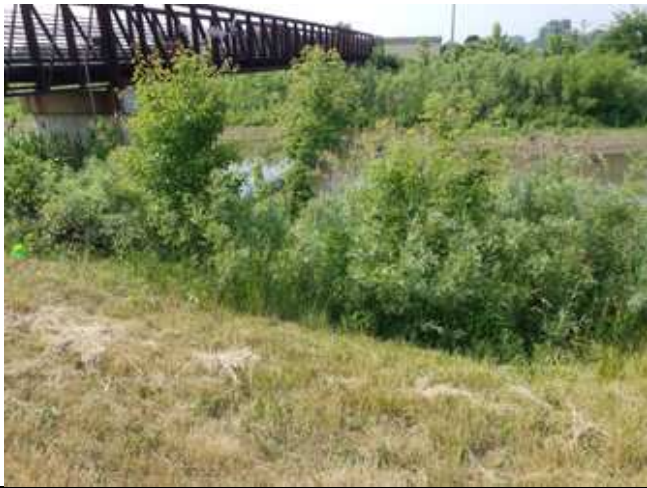
Category:	Levee Embankments	Item:	Unwanted Vegetation
Observation ID:	2023-0353		
Description:	Trees & vegetation along riverside toe		
Caption:	0353 - No User Rating (Site Visit) - Trees & vegetation along riverside toe		
Lat/Long:	41.56983/-87.46110

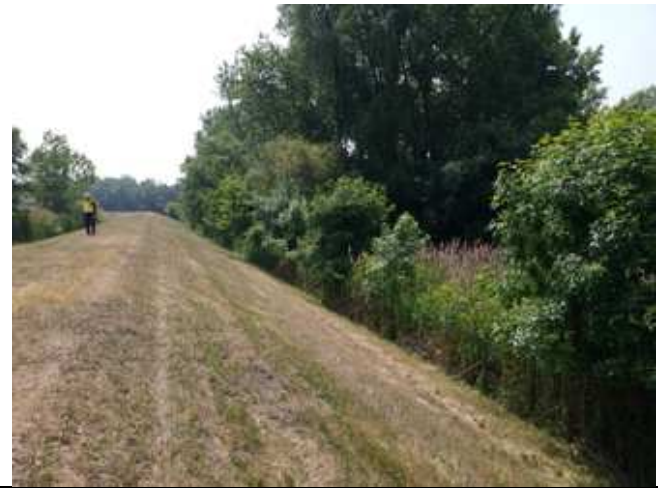
Category:	Levee Embankments	Item:	Unwanted Vegetation
Observation ID:	2023-0405		
Description:	Vegetation on riverside slope and toe		
Caption:	0405 - No User Rating (Site Visit) - Vegetation on riverside slope and toe - typical		
Lat/Long:	41.56869/-87.44072

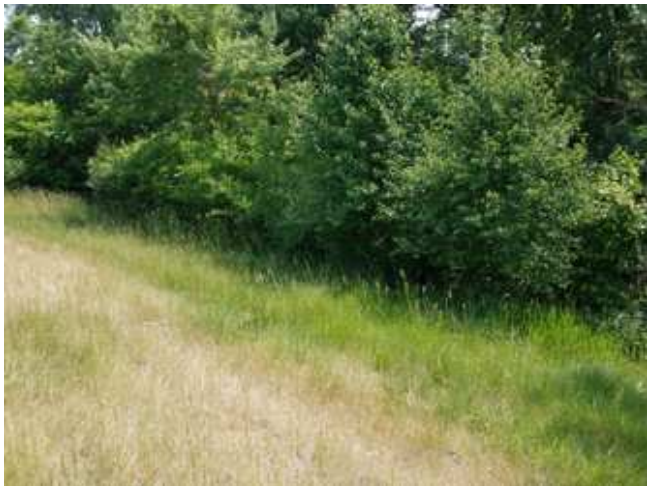
Category:	Levee Embankments	Item:	Unwanted Vegetation
Observation ID:	2023-0417		
Description:	Vegetation along riverside toe		
Caption:	0417 - No User Rating (Site Visit) - Vegetation along riverside toe		
Lat/Long:	41.56696/-87.43105

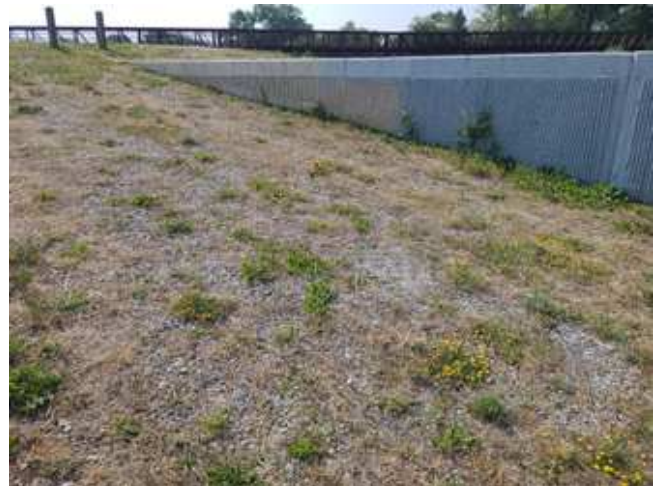
Category:	Levee Embankments	Item:	Sod Cover
Observation ID:	2023-0287		
Description:	Poor sod cover on landside slope		
Caption:	0287 - No User Rating (Site Visit) - Poor sod cover on landside slope		
Lat/Long:	41.56991/-87.46597

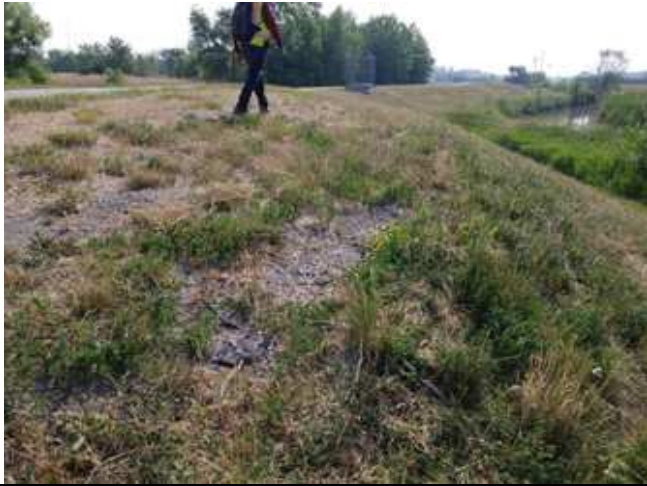
Category:	Levee Embankments	Item:	Sod Cover
Observation ID:	2023-0321		
Description:	Poor sod cover on crown		
Caption:	0321 - No User Rating (Site Visit) - Poor sod cover on crown		
Lat/Long:	41.57041/-87.46872

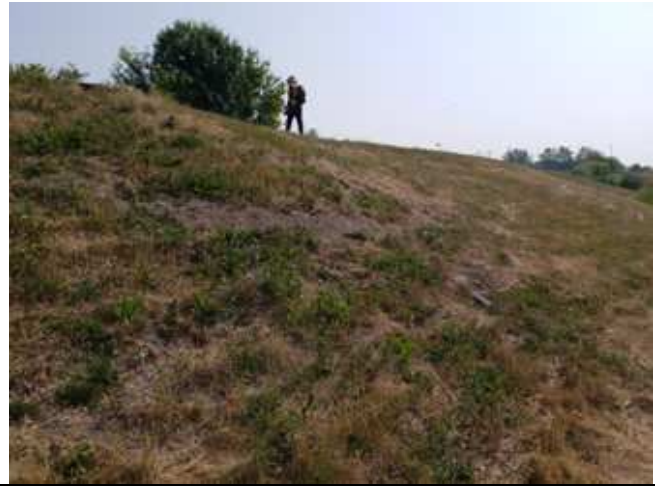
Category:	Levee Embankments	Item:	Sod Cover
Observation ID:	2023-0337		
Description:	Poor sod cover on riverside slope		
Caption:	0337 - No User Rating (Site Visit) - Poor sod cover on riverside slope		
Lat/Long:	41.56950/-87.46388

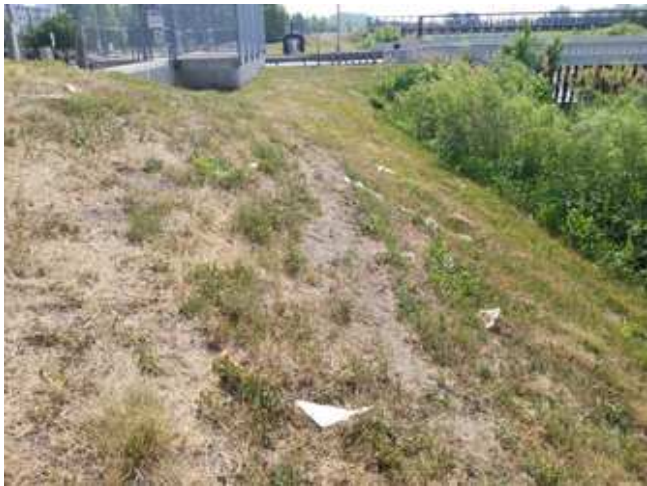
Category:	Levee Embankments	Item:	Sod Cover
Observation ID:	2023-0349		
Description:	Poor sod cover on riverside slope		
Caption:	0349 - No User Rating (Site Visit) - Poor sod cover on riverside slope		
Lat/Long:	41.56986/-87.46224

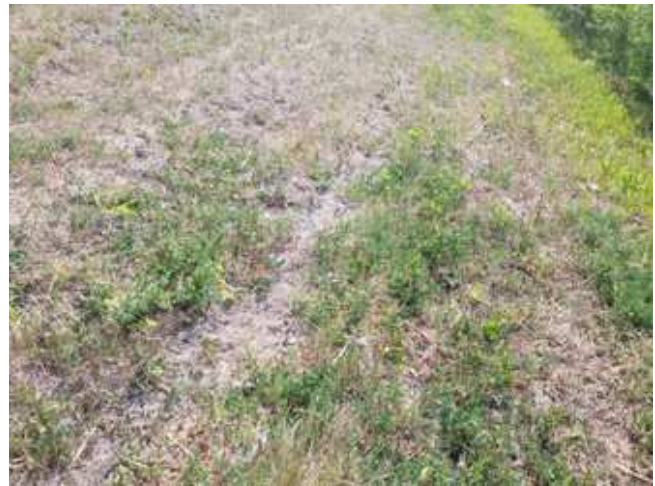
Category:	Levee Embankments	Item:	Sod Cover
Observation ID:	2023-0369		
Description:	Poor sod cover on riverside slope		
Caption:	0369 - No User Rating (Site Visit) - Poor sod cover on riverside slope		
Lat/Long:	41.57071/-87.45322

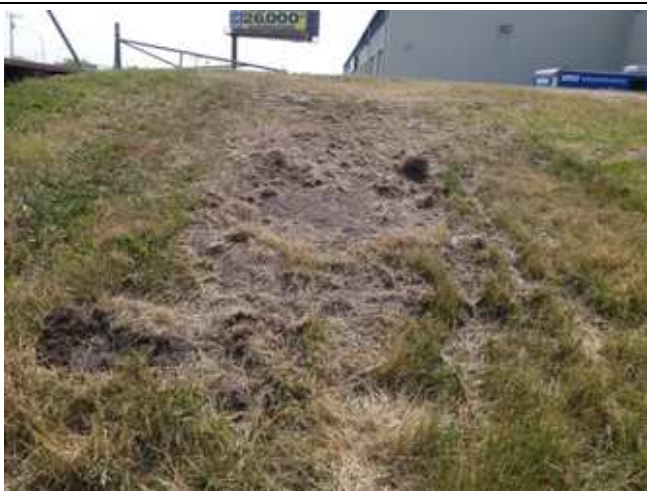
Category:	Levee Embankments	Item:	Sod Cover
Observation ID:	2023-0385		
Description:	Poor sod cover on riverside slope		
Caption:	0385 - No User Rating (Site Visit) - Poor sod cover on riverside slope		
Lat/Long:	41.57294/-87.44770

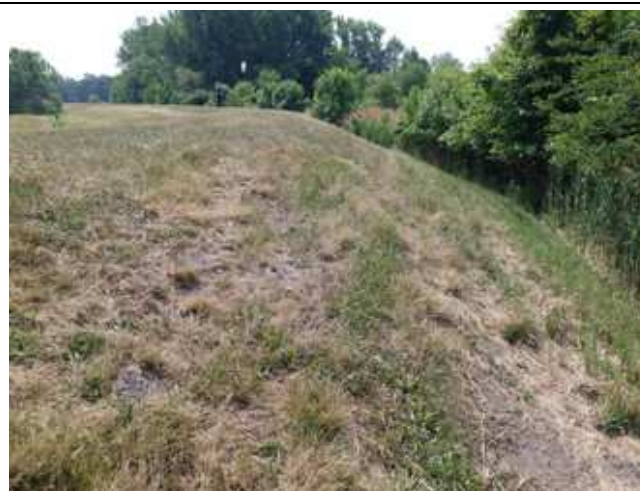
Category:	Levee Embankments	Item:	Sod Cover
Observation ID:	2023-0401		
Description:	Poor sod cover on riverside slope		
Caption:	0401 - No User Rating (Site Visit) - Poor sod cover on riverside slope		
Lat/Long:	41.56907/-87.44131

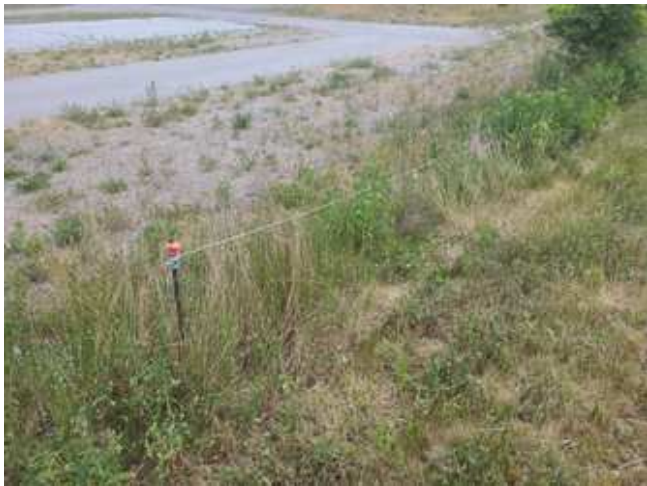
Category:	Levee Embankments	Item:	Encroachments
Observation ID:	2023-0087		
Description:	Stakes and rope along landside toe		
Caption:	0087 - No User Rating (Site Visit) - Stakes and rope along landside toe		
Lat/Long:	41.57199/-87.51258

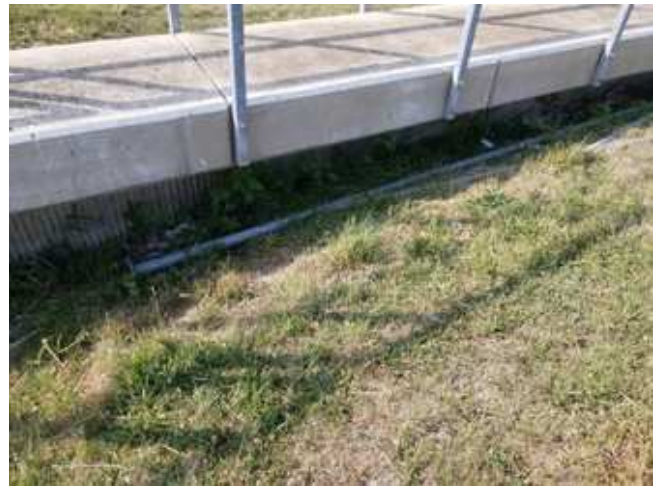
Category:	Levee Embankments	Item:	Encroachments
Observation ID:	2023-0132		
Description:	Gate encroachment on riverside slope		
Caption:	0132 - No User Rating (Site Visit) - Gate encroachment on riverside slope		
Lat/Long:	41.56999/-87.47280

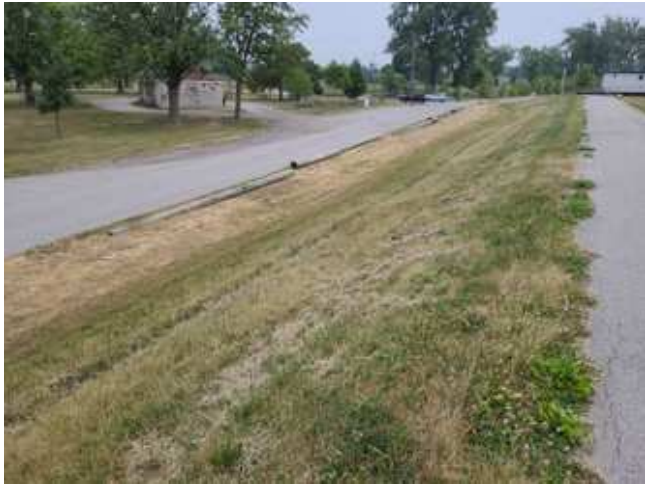
Category:	Levee Embankments	Item:	Encroachments
Observation ID:	2023-0147		
Description:	Poles along roadway within 15 feet of landside toe		
Caption:	0147 - No User Rating (Site Visit) - Poles along roadway within 15 feet of landside toe		
Lat/Long:	41.57108/-87.50610

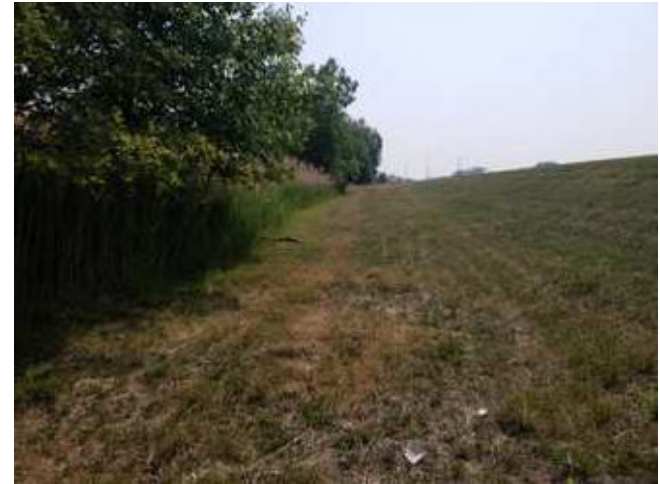
Category:	Levee Embankments	Item:	Encroachments
Observation ID:	2023-0156		
Description:	Log within 15 feet of landside toe		
Caption:	0156 - No User Rating (Site Visit) - Log within 15 feet of landside toe		
Lat/Long:	41.57088/-87.45141

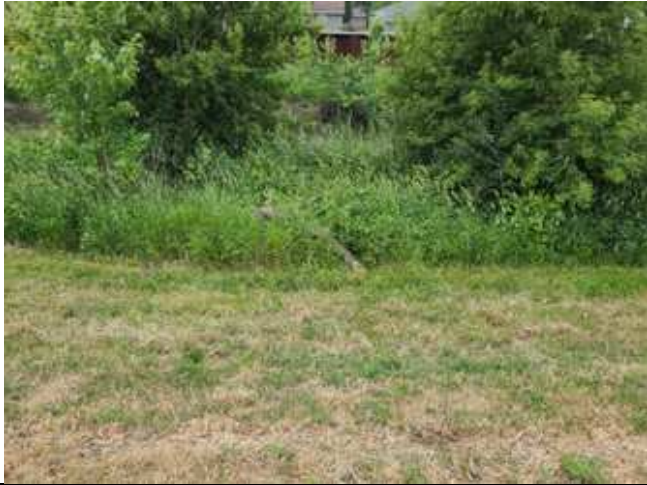
Category:	Levee Embankments	Item:	Encroachments
Observation ID:	2023-0163		
Description:	Log within 15 feet of riverside toe		
Caption:	0163 - No User Rating (Site Visit) - Log within 15 feet of riverside toe		
Lat/Long:	41.56958/-87.50353

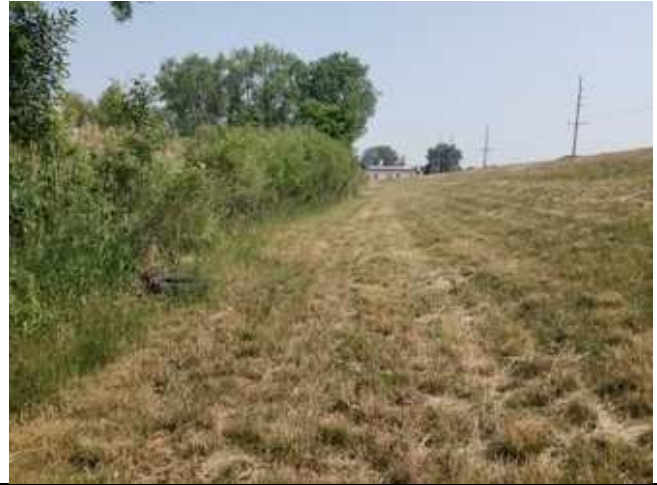
Category:	Levee Embankments	Item:	Encroachments
Observation ID:	2023-0164		
Description:	Discarded tire within 15 feet of landside toe		
Caption:	0164 - No User Rating (Site Visit) - Discarded tire within 15 feet of landside toe		
Lat/Long:	41.57123/-87.44806

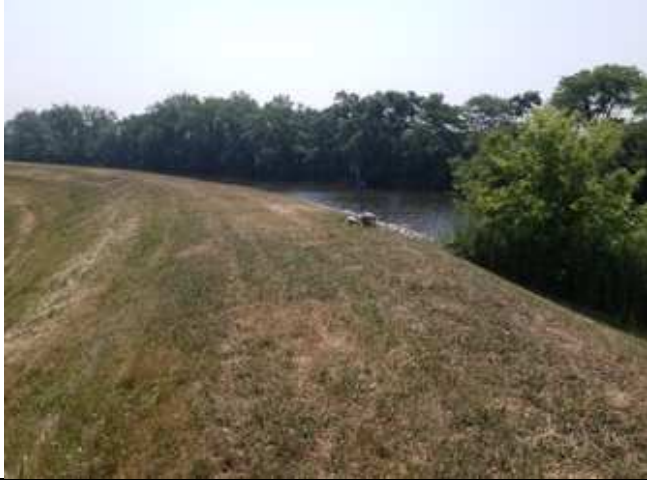
Category:	Levee Embankments	Item:	Encroachments
Observation ID:	2023-0184		
Description:	Memorial on riverside crown		
Caption:	0184 - No User Rating (Site Visit) - Memorial on riverside crown		
Lat/Long:	41.56811/-87.43927

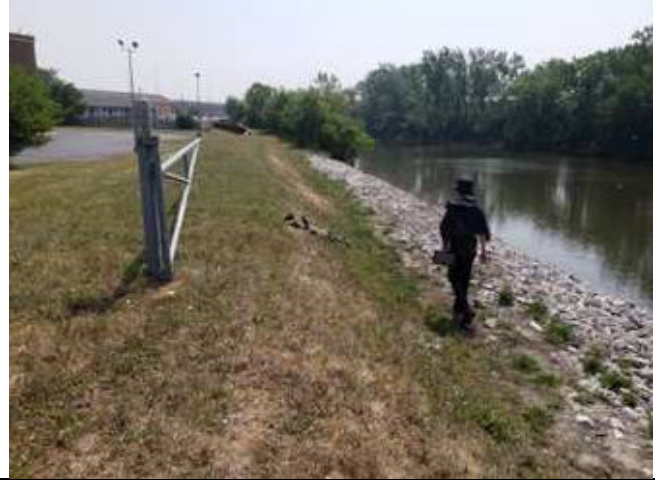
Category:	Levee Embankments	Item:	Encroachments
Observation ID:	2023-0188		
Description:	Debris on riverside slope		
Caption:	0188 - No User Rating (Site Visit) - Debris on riverside slope		
Lat/Long:	41.56805/-87.43798

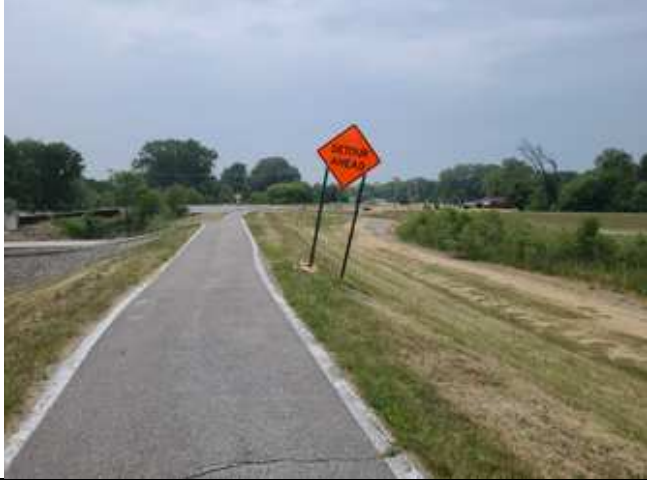
Category:	Levee Embankments	Item:	Encroachments
Observation ID:	2023-0203		
Description:	Sign on landside slope		
Caption:	0203 - No User Rating (Site Visit) - Sign on landside slope		
Lat/Long:	41.56679/-87.48420

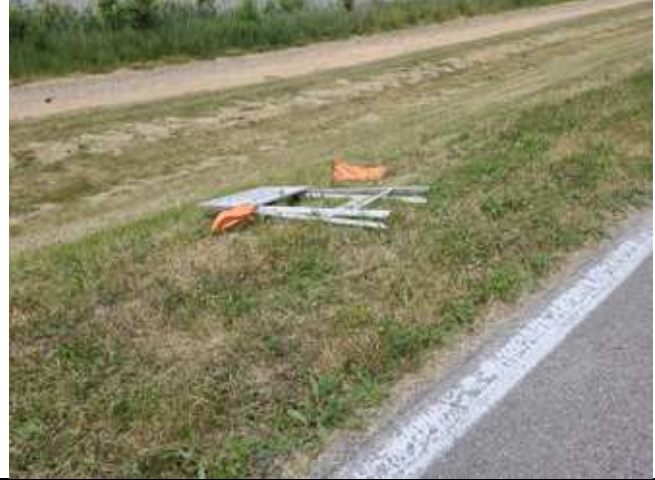
Category:	Levee Embankments	Item:	Encroachments
Observation ID:	2023-0211		
Description:	Sign on crest		
Caption:	0211 - No User Rating (Site Visit) - Sign on crest		
Lat/Long:	41.56685/-87.48377

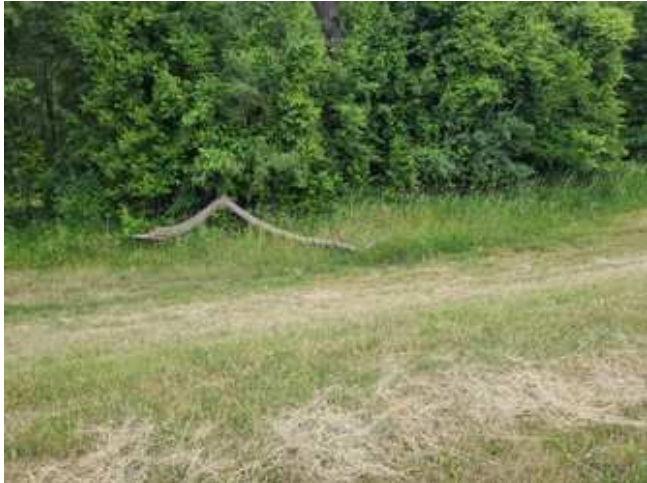
Category:	Levee Embankments	Item:	Encroachments
Observation ID:	2023-0219		
Description:	Downed tree on landside toe		
Caption:	0219 - No User Rating (Site Visit) - Downed tree on landside toe		
Lat/Long:	41.56810/-87.47870

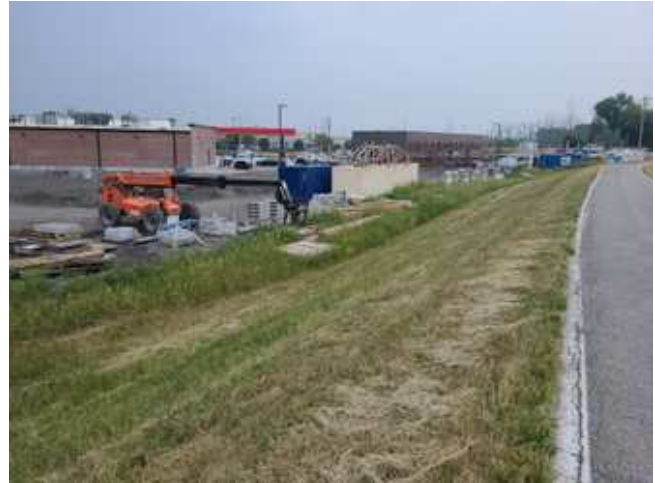
Category:	Levee Embankments	Item:	Encroachments
Observation ID:	2023-0223		
Description:	Construction equipment on landside toe		
Caption:	0223 - No User Rating (Site Visit) - Construction equipment on landside toe		
Lat/Long:	41.56856/-87.47751

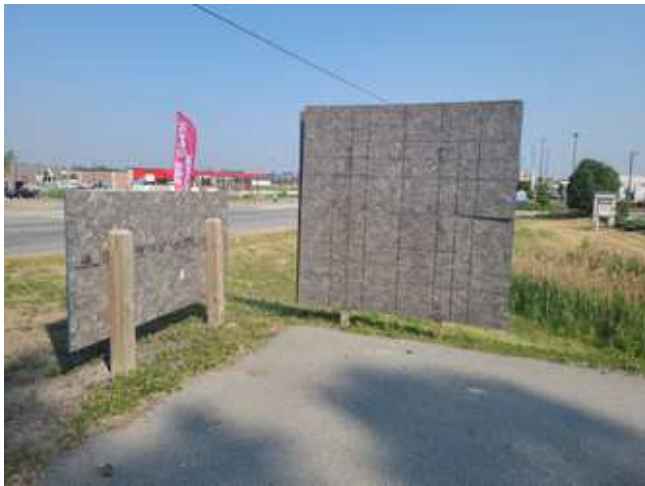
Category:	Levee Embankments	Item:	Encroachments
Observation ID:	2023-0231		
Description:	Signs on crown		
Caption:	0231 - No User Rating (Site Visit) - Signs on crown		
Lat/Long:	41.56881/-87.47489

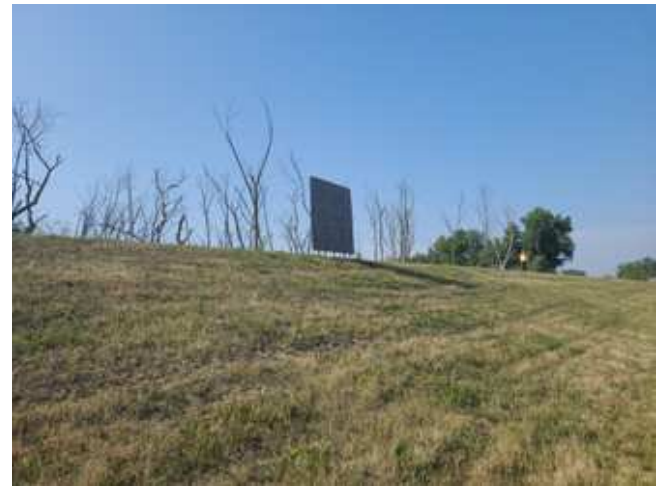
Category:	Levee Embankments	Item:	Encroachments
Observation ID:	2023-0247		
Description:	Sign on crown		
Caption:	0247 - No User Rating (Site Visit) - Sign on crown		
Lat/Long:	41.56987/-87.47327

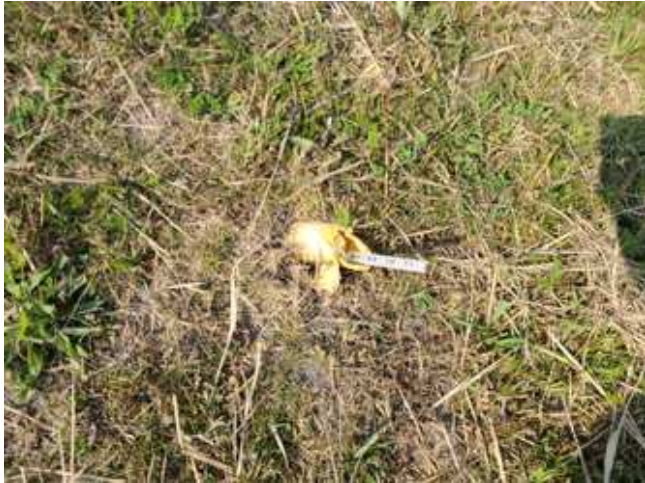
Category:	Levee Embankments	Item:	Encroachments
Observation ID:	2023-0259		
Description:	Pipe penetrating 72 in. into landside toe		
Caption:	0259 - No User Rating (Site Visit) - Pipe penetrating 72 in. into landside toe		
Lat/Long:	41.56989/-87.47081

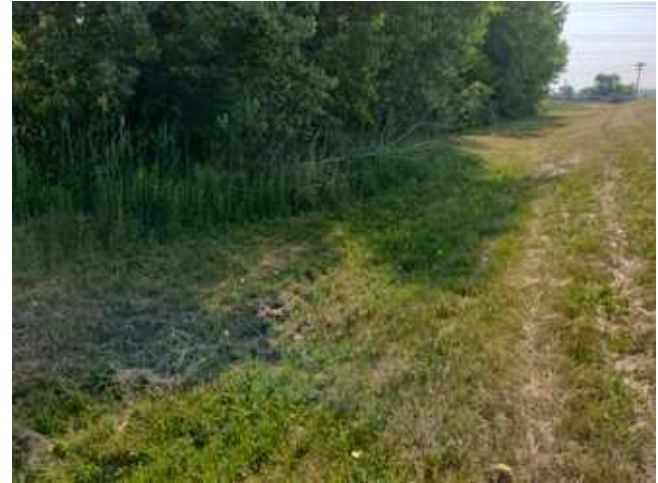
Category:	Levee Embankments	Item:	Encroachments
Observation ID:	2023-0271		
Description:	Downed tree on landside toe		
Caption:	0271 - No User Rating (Site Visit) - Downed tree on landside toe		
Lat/Long:	41.57055/-87.46802

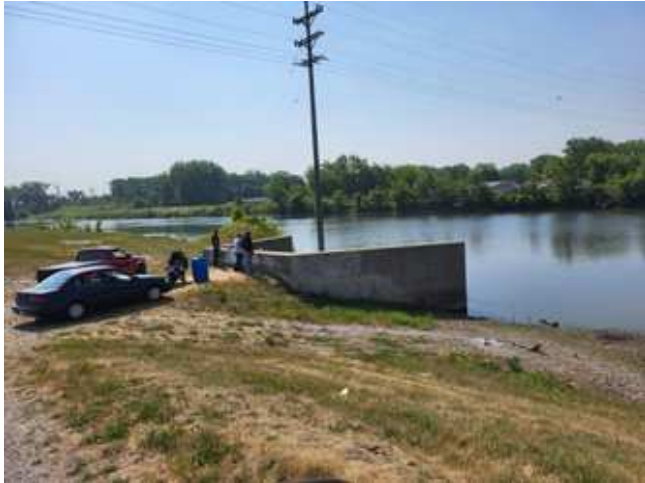
Category:	Levee Embankments	Item:	Encroachments
Observation ID:	2023-0339		
Description:	Debris on landside toe		
Caption:	0339 - No User Rating (Site Visit) - Debris on landside toe		
Lat/Long:	41.57218/-87.44752

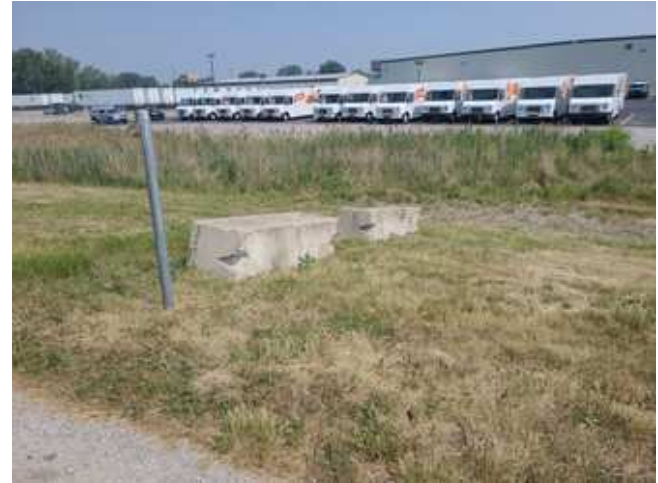
Category:	Levee Embankments	Item:	Encroachments
Observation ID:	2023-0355		
Description:	Vehicles on levee toe		
Caption:	0355 - No User Rating (Site Visit) - Vehicles on levee toe		
Lat/Long:	41.57070/-87.44709

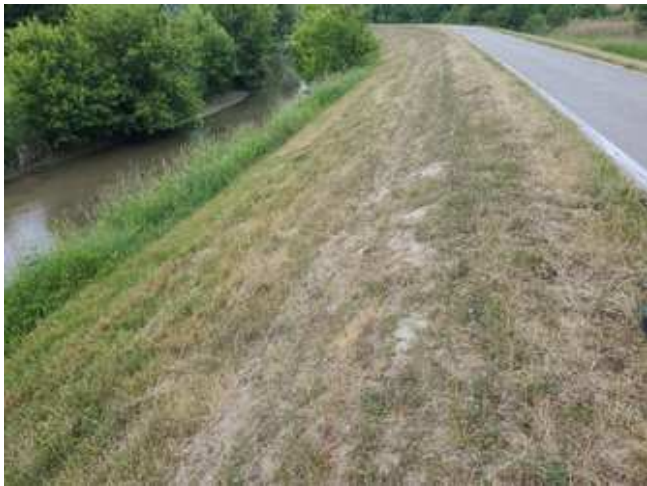
Category:	Levee Embankments	Item:	Erosion/ Bank Caving
Observation ID:	2023-0003		
Description:	Erosion on riverside slope		
Caption:	0003 - No User Rating (Site Visit) - Erosion on riverside slope		
Lat/Long:	41.56647/-87.48515

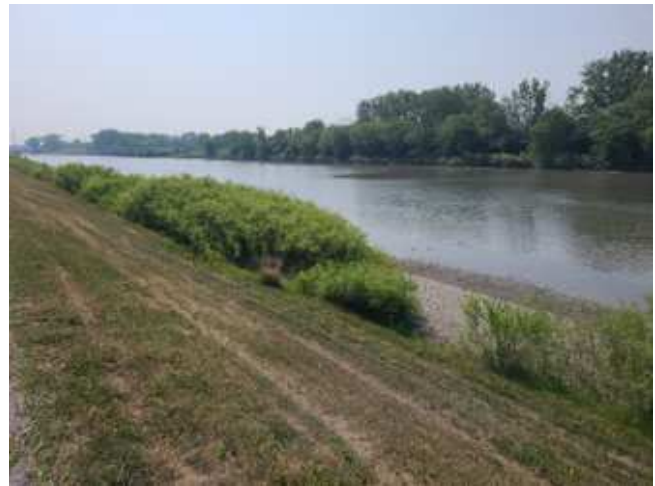
Category:	Levee Embankments	Item:	Erosion/ Bank Caving
Observation ID:	2023-0227		
Description:	Erosion on riverside slope		
Caption:	0227 - No User Rating (Site Visit) - Erosion on riverside slope		
Lat/Long:	41.56858/-87.47714

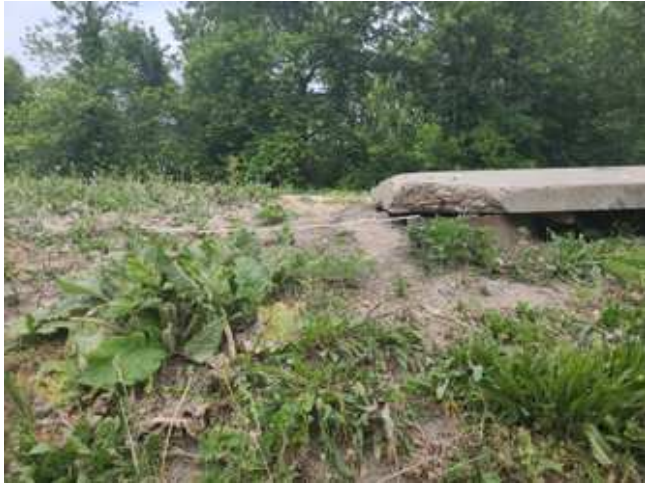
Category:	Levee Embankments	Item:	Erosion/ Bank Caving
Observation ID:	2023-0319		
Description:	Erosion along riverside slope		
Caption:	0319 - No User Rating (Site Visit) - Erosion along riverside slope		
Lat/Long:	41.57077/-87.45254

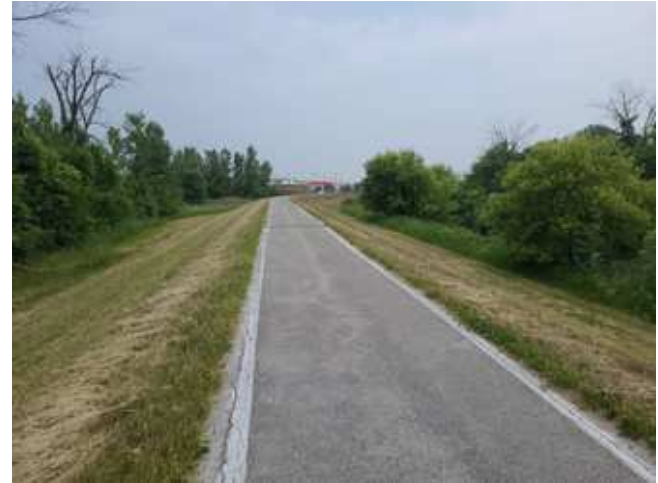
Category:	Levee Embankments	Item:	Settlement
Observation ID:	2023-0055		
Description:	Low point at transition		
Caption:	0055 - No User Rating (Site Visit) - Low point at transition		
Lat/Long:	41.57282/-87.51563

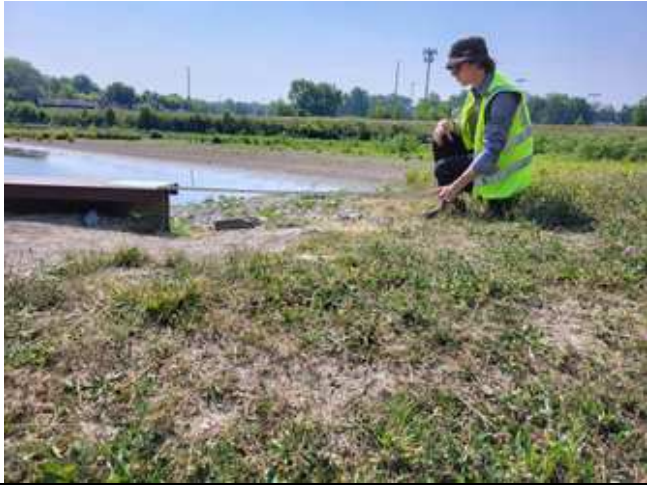
Category:	Levee Embankments	Item:	Settlement
Observation ID:	2023-0215		
Description:	Settlement along crest		
Caption:	0215 - No User Rating (Site Visit) - Settlement along crest		
Lat/Long:	41.56788/-87.47906

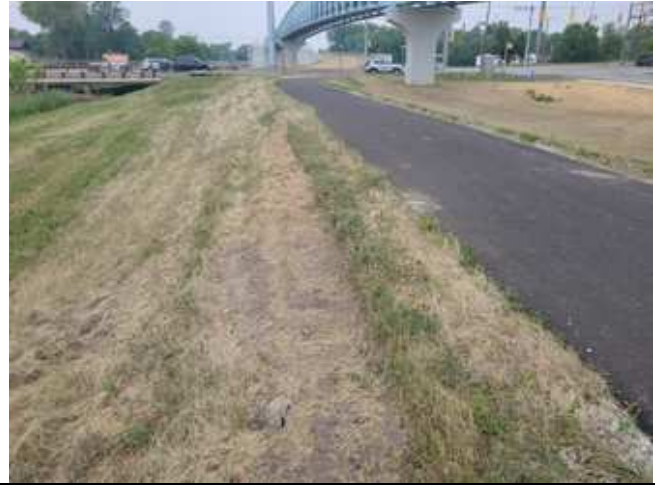
Category:	Levee Embankments	Item:	Settlement
Observation ID:	2023-0421		
Description:	Settlement around levee tie-in		
Caption:	0421 - No User Rating (Site Visit) - Settlement around levee tie-in		
Lat/Long:	41.57023/-87.45858

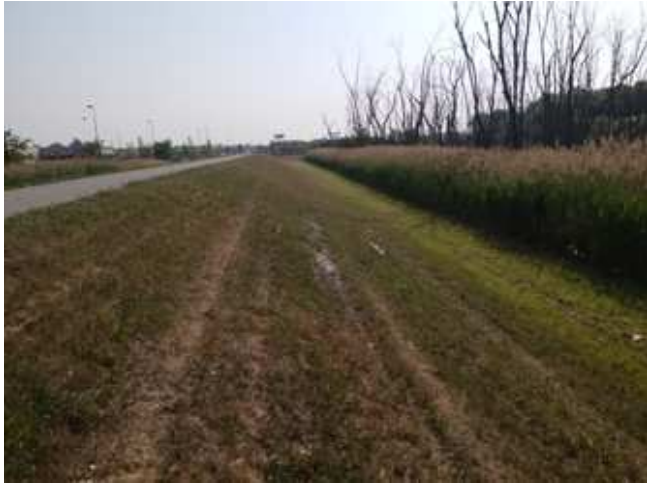
Category:	Levee Embankments	Item:	Depressions/ Rutting
Observation ID:	2023-0123		
Description:	Rutting near crest		
Caption:	0123 - No User Rating (Site Visit) - Rutting near crest		
Lat/Long:	41.57148/-87.50825

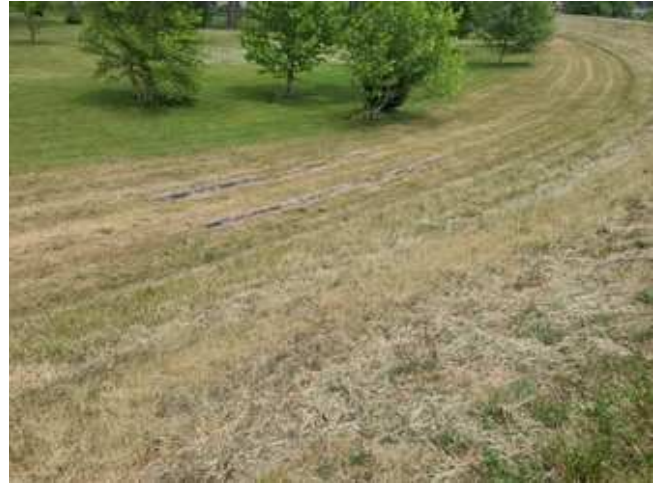
Category:	Levee Embankments	Item:	Depressions/ Rutting
Observation ID:	2023-0124		
Description:	Rutting on riverside slope		
Caption:	0124 - No User Rating (Site Visit) - Rutting on riverside slope		
Lat/Long:	41.56908/-87.47444

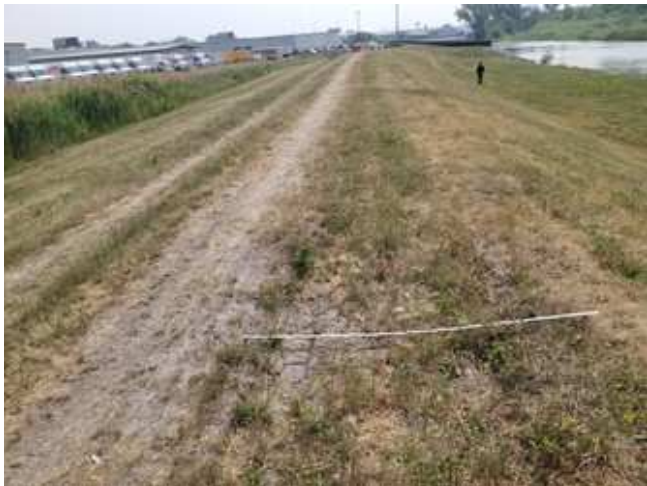
Category:	Levee Embankments	Item:	Depressions/ Rutting
Observation ID:	2023-0167		
Description:	Rutting on landside toe		
Caption:	0167 - No User Rating (Site Visit) - Rutting on landside toe		
Lat/Long:	41.56902/-87.50234

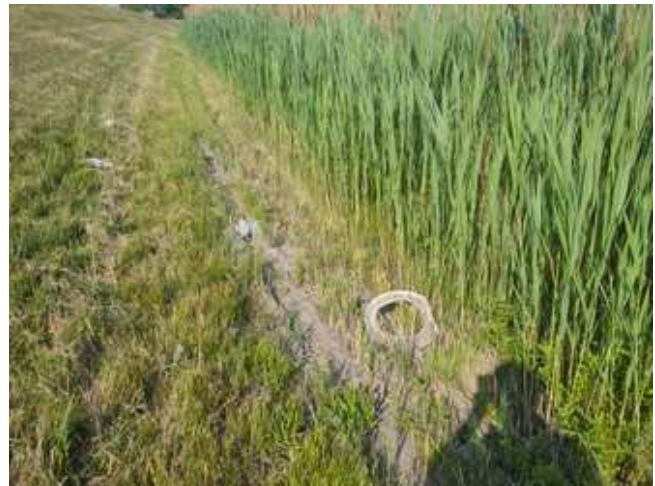
Category:	Levee Embankments	Item:	Depressions/ Rutting
Observation ID:	2023-0168		
Description:	Depression on crown		
Caption:	0168 - No User Rating (Site Visit) - Depression on crown		
Lat/Long:	41.57070/-87.44696

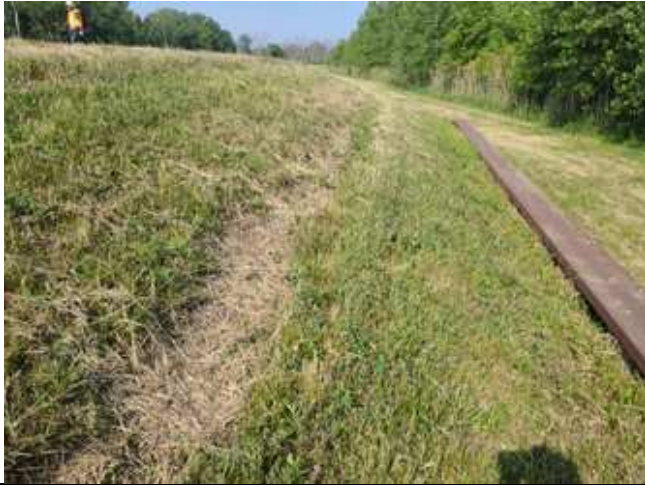
Category:	Levee Embankments	Item:	Depressions/ Rutting
Observation ID:	2023-0243		
Description:	Rutting along landside toe		
Caption:	0243 - No User Rating (Site Visit) - Rutting along landside toe		
Lat/Long:	41.56969/-87.47356

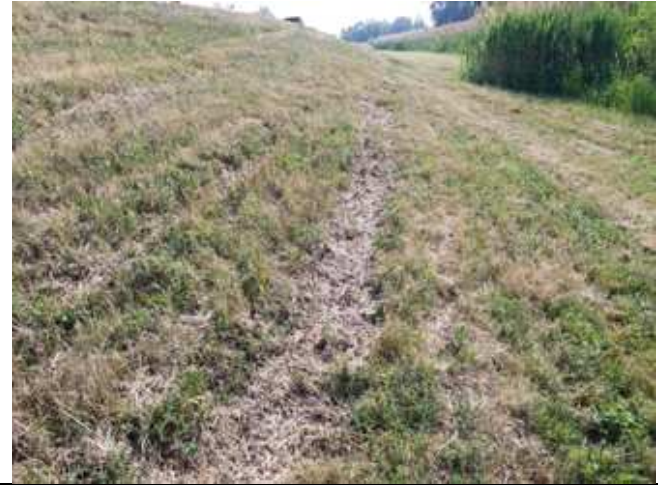
Category:	Levee Embankments	Item:	Depressions/ Rutting
Observation ID:	2023-0263		
Description:	Rutting on landside slope		
Caption:	0263 - No User Rating (Site Visit) - Rutting on landside slope		
Lat/Long:	41.57055/-87.46850

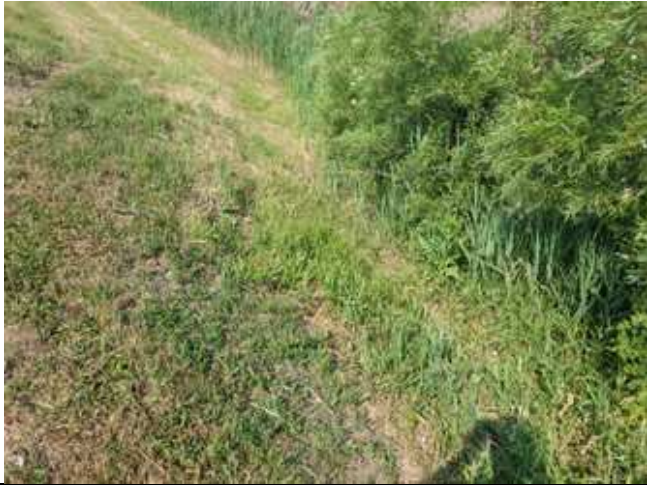
Category:	Levee Embankments	Item:	Depressions/ Rutting
Observation ID:	2023-0309		
Description:	Rutting on riverside slope		
Caption:	0309 - No User Rating (Site Visit) - Rutting on riverside slope		
Lat/Long:	41.56953/-87.47151

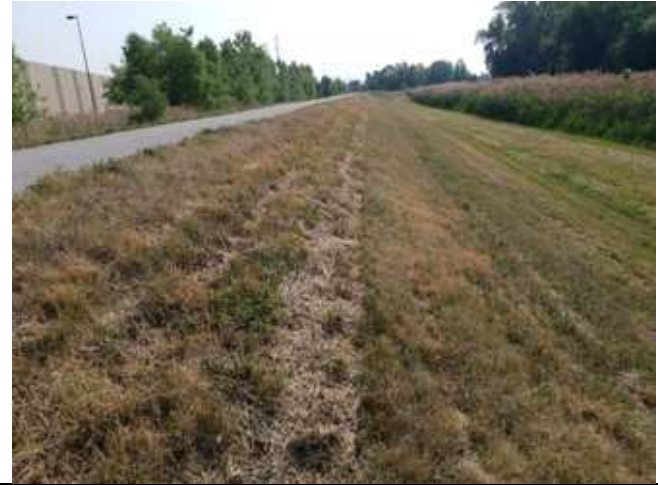
Category:	Levee Embankments	Item:	Depressions/ Rutting
Observation ID:	2023-0311		
Description:	Rutting on landside slope - on transition up to access walkway		
Caption:	0311 - No User Rating (Site Visit) - Rutting on landside slope - on transition up to access walkway		
Lat/Long:	41.57005/-87.45883

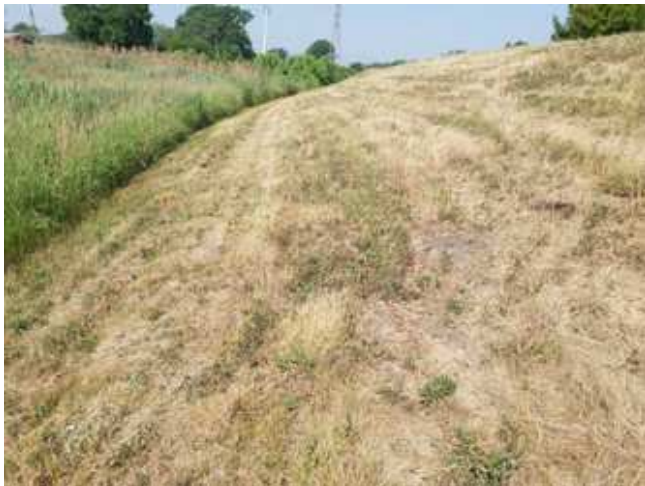
Category:	Levee Embankments	Item:	Depressions/ Rutting
Observation ID:	2023-0317		
Description:	Rutting on riverside slope		
Caption:	0317 - No User Rating (Site Visit) - Rutting on riverside slope		
Lat/Long:	41.56978/-87.47072

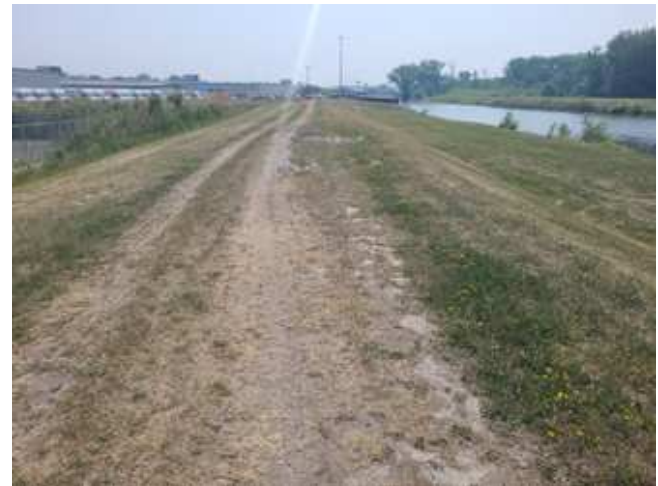
Category:	Levee Embankments	Item:	Depressions/ Rutting
Observation ID:	2023-0345		
Description:	Depression and rutting on riverside slope		
Caption:	0345 - No User Rating (Site Visit) - Depression and rutting on riverside slope		
Lat/Long:	41.56961/-87.46320

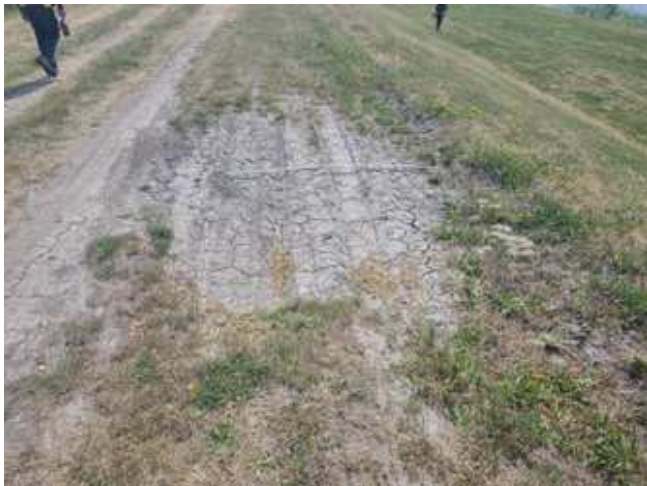
Category:	Levee Embankments	Item:	Depressions/ Rutting
Observation ID:	2023-0347		
Description:	Rutting on levee crown		
Caption:	0347 - No User Rating (Site Visit) - Rutting on levee crown		
Lat/Long:	41.57073/-87.44732

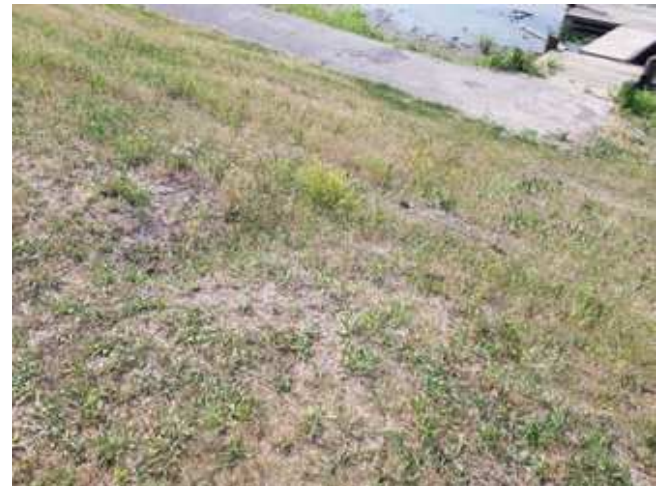
Category:	Levee Embankments	Item:	Depressions/ Rutting
Observation ID:	2023-0351		
Description:	6 in. deep depression on crown		
Caption:	0351 - No User Rating (Site Visit) - 6 in. deep depression on crown		
Lat/Long:	41.57071/-87.44709
