## Site Visit Summary

Name of System: Hammond

Name of Segment: Hammond

Date of Site Visit: 06/05/2023 - 06/09/2023

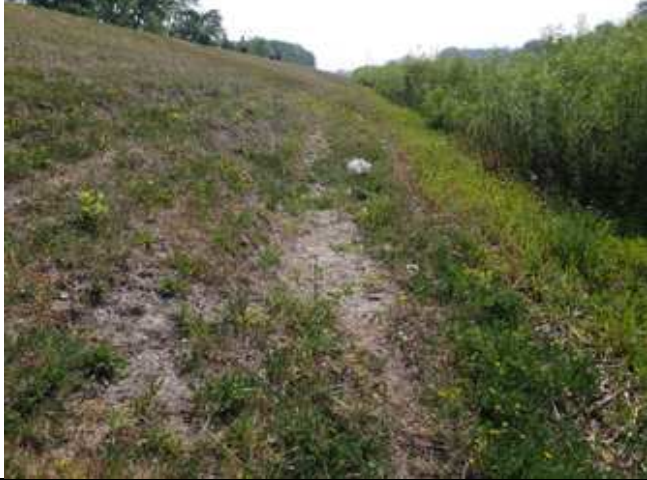
Category:	Levee Embankments	Item:	Depressions/ Rutting
Observation ID:	2023-0357		
Description:	Depression on crown		
Caption:	0357 - No User Rating (Site Visit) - Depression on crown		
Lat/Long:	41.57077/-87.45461

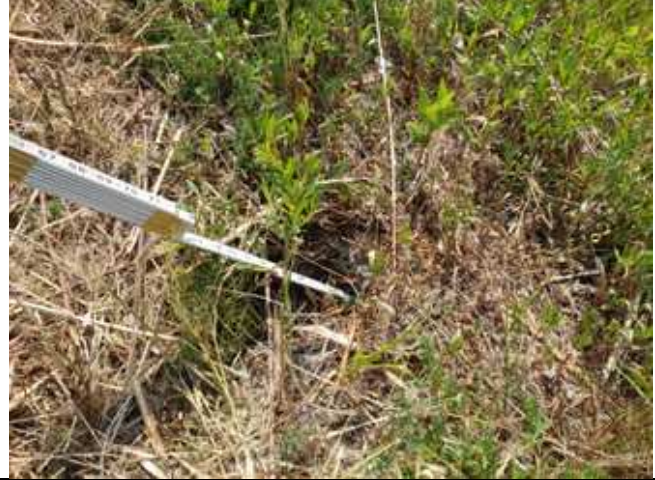
Category:	Levee Embankments	Item:	Depressions/ Rutting
Observation ID:	2023-0361		
Description:	Rutting on riverside toe and slope		
Caption:	0361 - No User Rating (Site Visit) - Rutting on riverside toe and slope		
Lat/Long:	41.57072/-87.45361

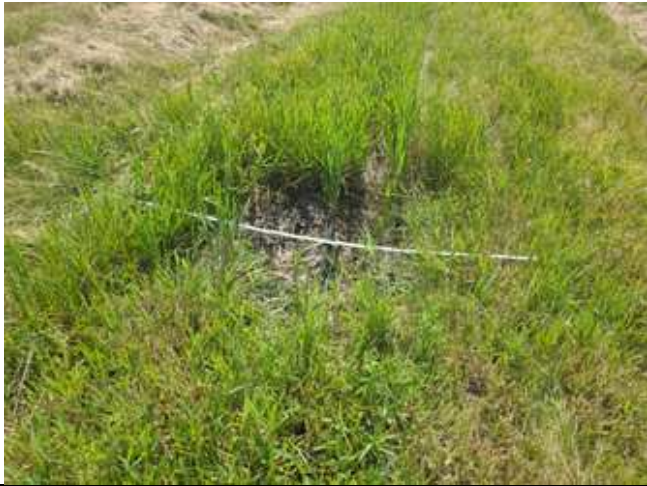
Category:	Levee Embankments	Item:	Depressions/ Rutting
Observation ID:	2023-0365		
Description:	Depression in riverside toe		
Caption:	0365 - No User Rating (Site Visit) - Depression in riverside toe		
Lat/Long:	41.57072/-87.45331

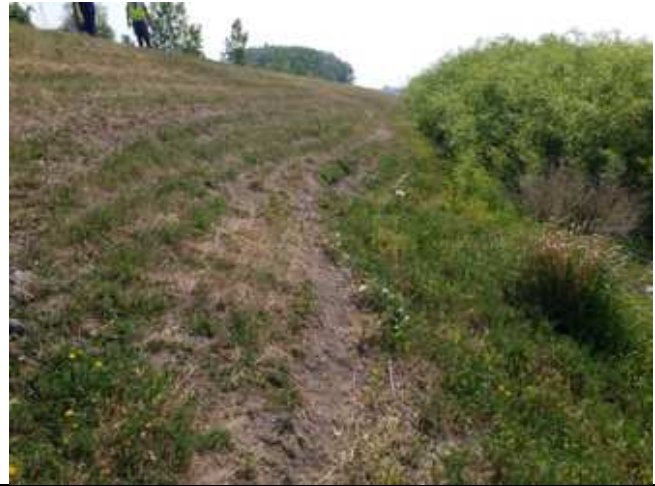
Category:	Levee Embankments	Item:	Depressions/ Rutting
Observation ID:	2023-0367		
Description:	8 in. deep depression on landside toe		
Caption:	0367 - No User Rating (Site Visit) - 8 in. deep depression on landside toe		
Lat/Long:	41.56872/-87.44051

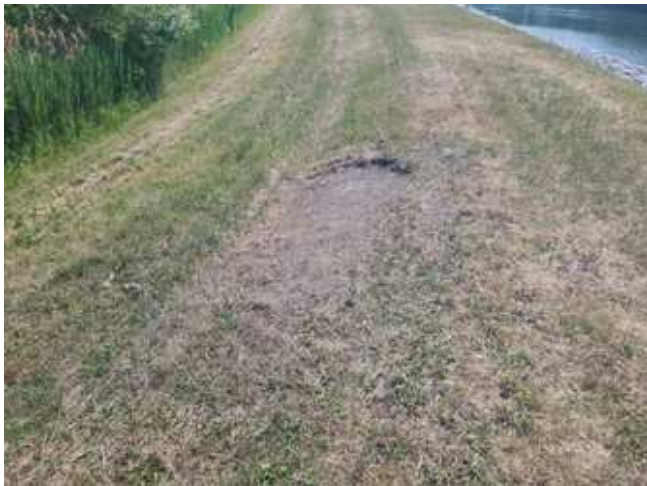
Category:	Levee Embankments	Item:	Depressions/ Rutting
Observation ID:	2023-0373		
Description:	Rutting on riverside slope and toe		
Caption:	0373 - No User Rating (Site Visit) - Rutting on riverside slope and toe		
Lat/Long:	41.57072/-87.45249

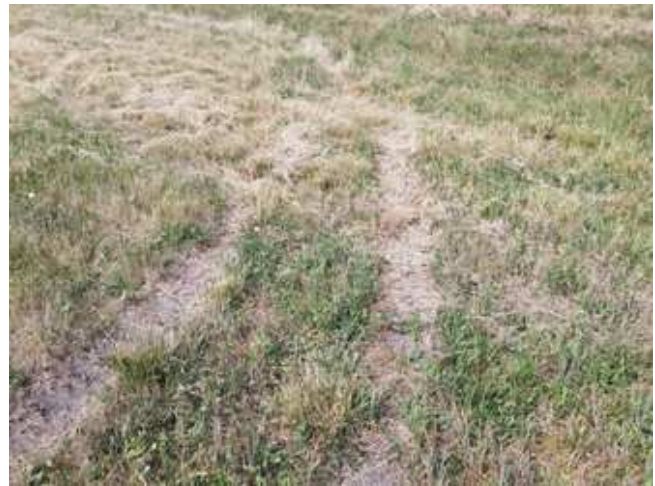
Category:	Levee Embankments	Item:	Depressions/ Rutting
Observation ID:	2023-0375		
Description:	5 foot wide by 1 in. deep depression on landside slope		
Caption:	0375 - No User Rating (Site Visit) - 5 foot wide by 1 in. deep depression on landside slope		
Lat/Long:	41.56802/-87.43891

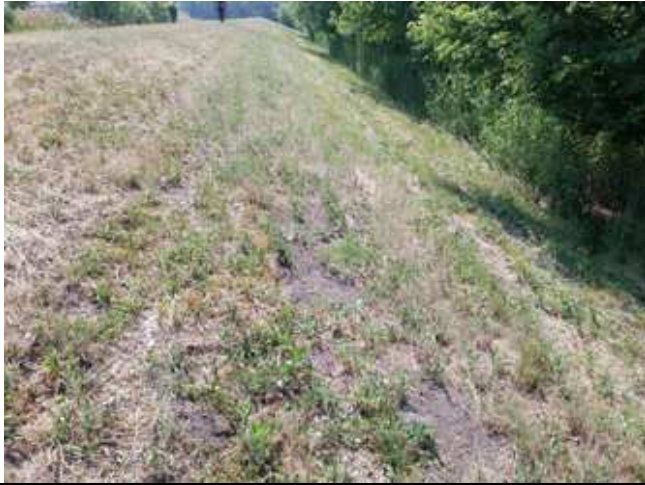
Category:	Levee Embankments	Item:	Depressions/ Rutting
Observation ID:	2023-0381		
Description:	Rutting along riverside toe		
Caption:	0381 - No User Rating (Site Visit) - Rutting along riverside toe		
Lat/Long:	41.57270/-87.44773

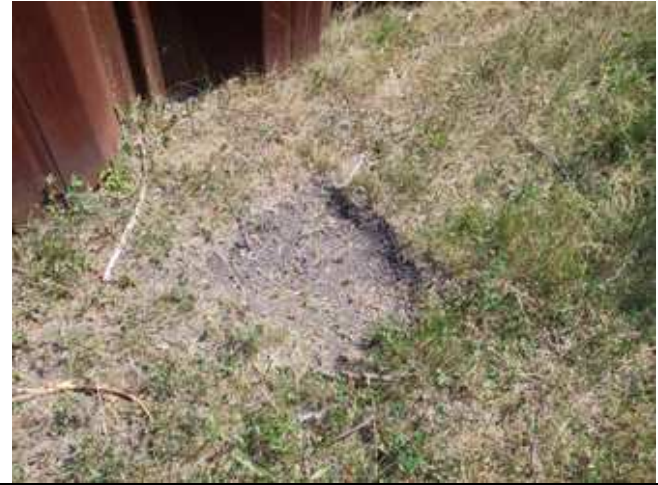
Category:	Levee Embankments	Item:	Depressions/ Rutting
Observation ID:	2023-0409		
Description:	Rutting on riverside slope		
Caption:	0409 - No User Rating (Site Visit) - Rutting on riverside slope		
Lat/Long:	41.56855/-87.44043

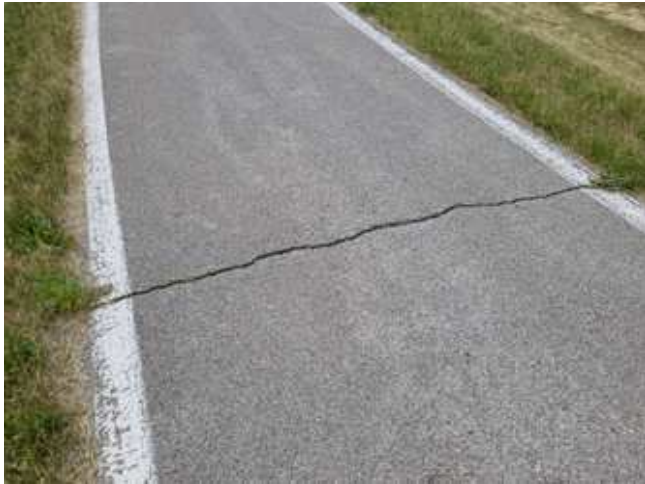
Category:	Levee Embankments	Item:	Depressions/ Rutting
Observation ID:	2023-0413		
Description:	Depression on crown		
Caption:	0413 - No User Rating (Site Visit) - Depression on crown		
Lat/Long:	41.56836/-87.43602

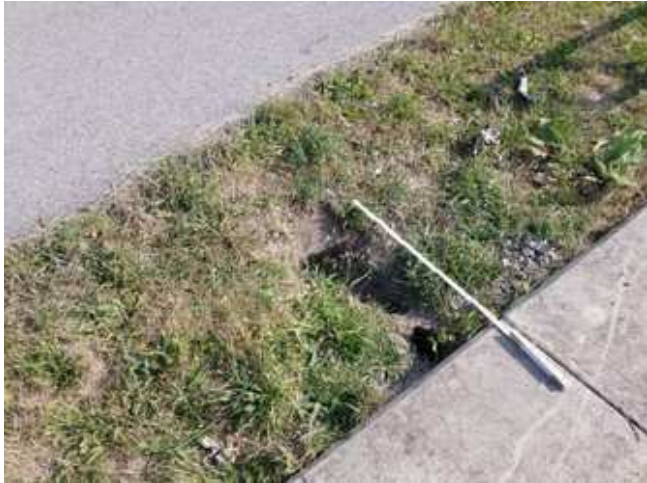
Category:	Levee Embankments	Item:	Animal Control
Observation ID:	2023-0002		
Description:	3 animal burrows in the eroded part of the riverside bank.		
Caption:	0002 - No User Rating (Site Visit) - 3 animal burrows in the eroded part of the riverside bank.		
Lat/Long:	41.56646/-87.48504

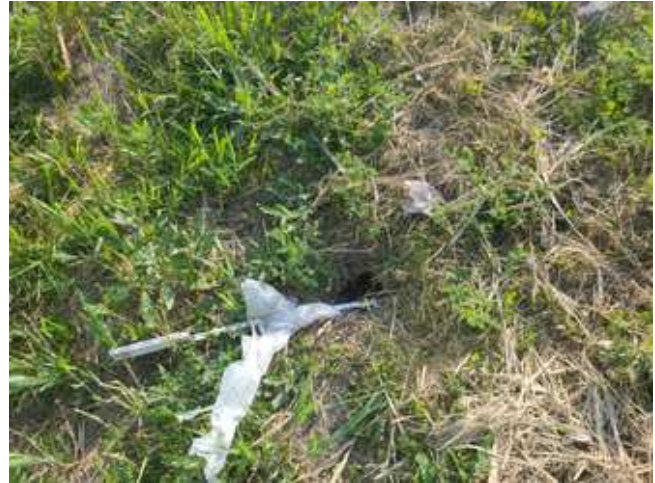
Category:	Levee Embankments	Item:	Animal Control
Observation ID:	2023-0128		
Description:	Animal burrow on riverside crown		
Caption:	0128 - No User Rating (Site Visit) - Animal burrow on riverside crown		
Lat/Long:	41.56978/-87.47284

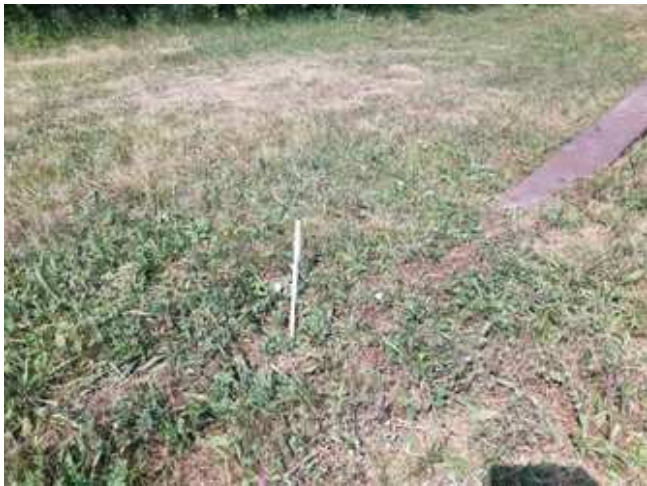
Category:	Levee Embankments	Item:	Animal Control
Observation ID:	2023-0239		
Description:	Animal burrows on landside toe		
Caption:	0239 - No User Rating (Site Visit) - Animal burrows on landside toe		
Lat/Long:	41.56942/-87.47397

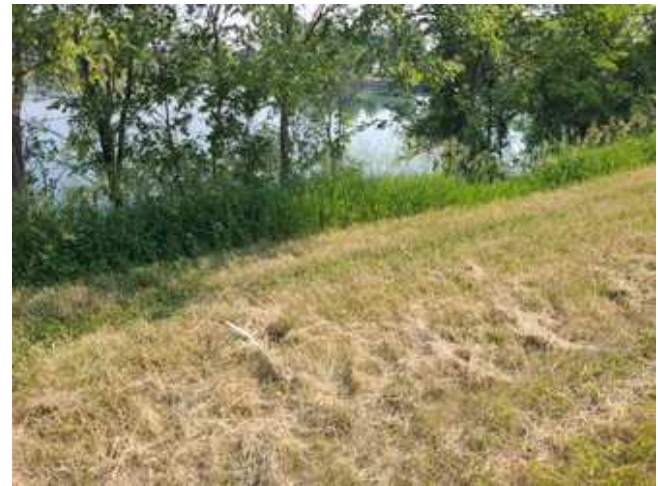
Category:	Levee Embankments	Item:	Animal Control
Observation ID:	2023-0258		
Description:	2 animal burrows on the crest, ~9 in. deep		
Caption:	0258 - No User Rating (Site Visit) - 2 animal burrows on the crest, ~9 in. deep		
Lat/Long:	41.56772/-87.43333

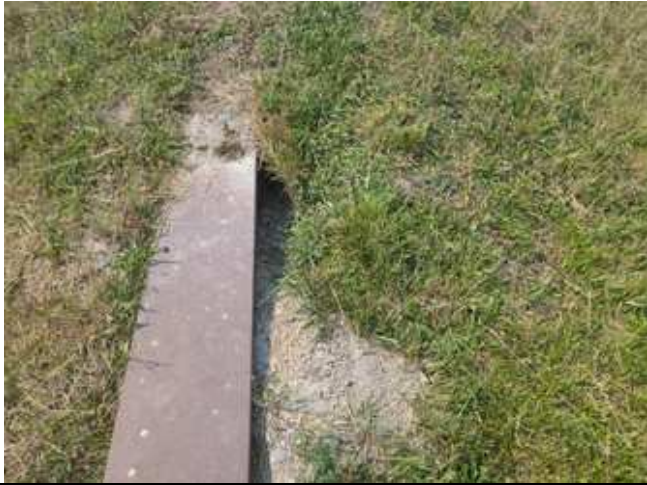
Category:	Levee Embankments	Item:	Animal Control
Observation ID:	2023-0291		
Description:	Animal burrows on landside toe, 20 in. deep		
Caption:	0291 - No User Rating (Site Visit) - Animal burrows on landside toe, 20 in. deep		
Lat/Long:	41.56972/-87.46432

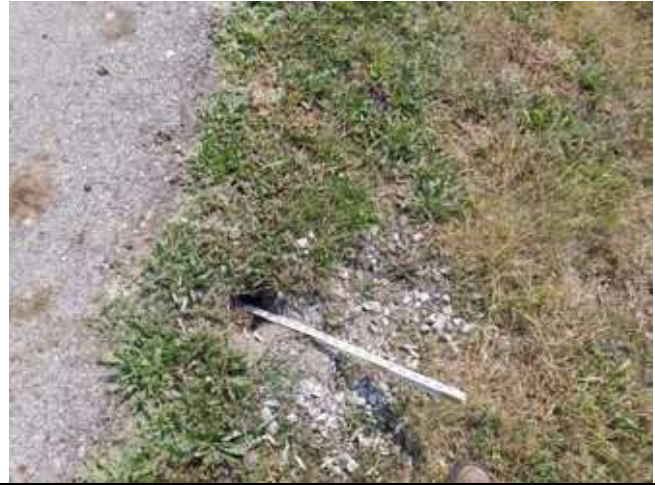
Category:	Levee Embankments	Item:	Animal Control
Observation ID:	2023-0331		
Description:	Animal burrow -near transition at PS-HV pump station		
Caption:	0331 - No User Rating (Site Visit) - Animal burrow -near transition at PS-HV pump station		
Lat/Long:	41.57285/-87.44789

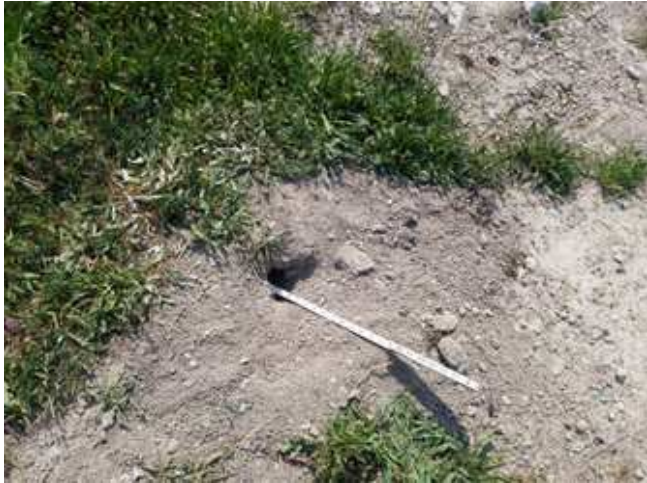
Category:	Levee Embankments	Item:	Animal Control
Observation ID:	2023-0377		
Description:	Animal burrow in crown		
Caption:	0377 - No User Rating (Site Visit) - Animal burrow in crown		
Lat/Long:	41.57074/-87.44923

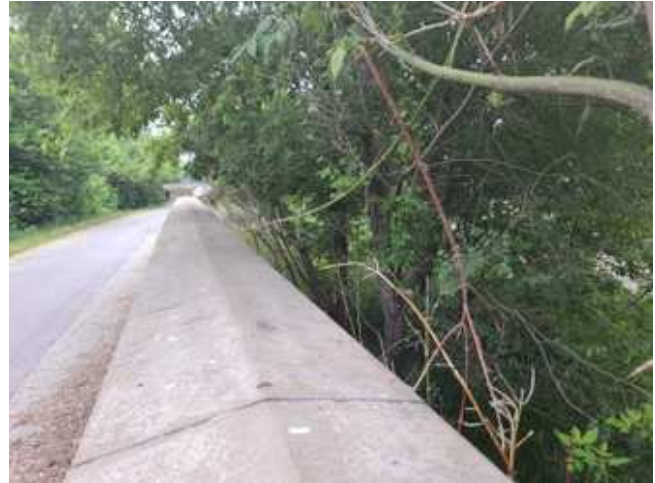
Category:	Levee Embankments	Item:	Animal Control
Observation ID:	2023-0393		
Description:	Animal burrow in crown		
Caption:	0393 - No User Rating (Site Visit) - Animal burrow in crown		
Lat/Long:	41.57050/-87.44576

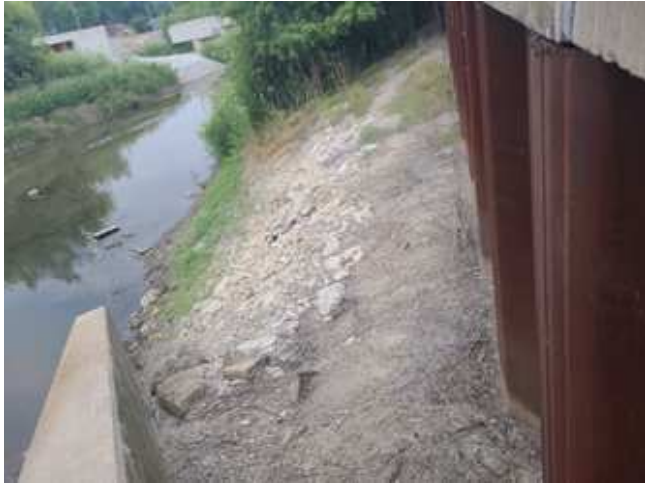
Category:	Floodwalls	Item:	Unwanted Vegetation
Observation ID:	2023-0031		
Description:	Vegetation along riverside of floodwall - continues to end		
Caption:	0031 - No User Rating (Site Visit) - Vegetation along riverside of floodwall - continues to end		
Lat/Long:	41.57400/-87.51830

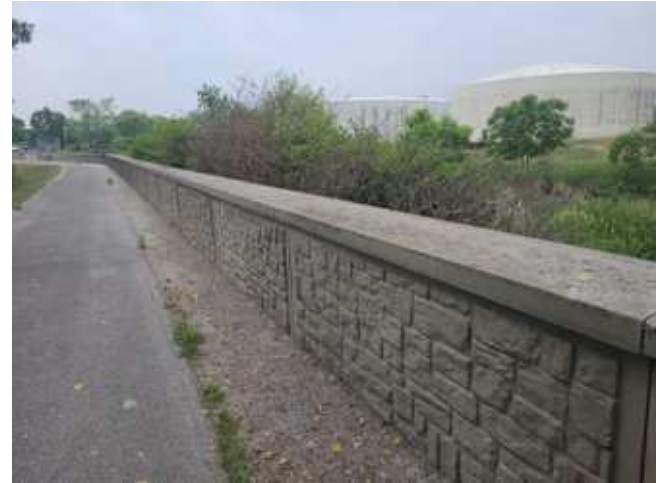
Category:	Floodwalls	Item:	Unwanted Vegetation
Observation ID:	2023-0035		
Description:	Poor sod cover on riverside of floodwall		
Caption:	0035 - No User Rating (Site Visit) - Poor sod cover on riverside of floodwall		
Lat/Long:	41.57323/-87.51803

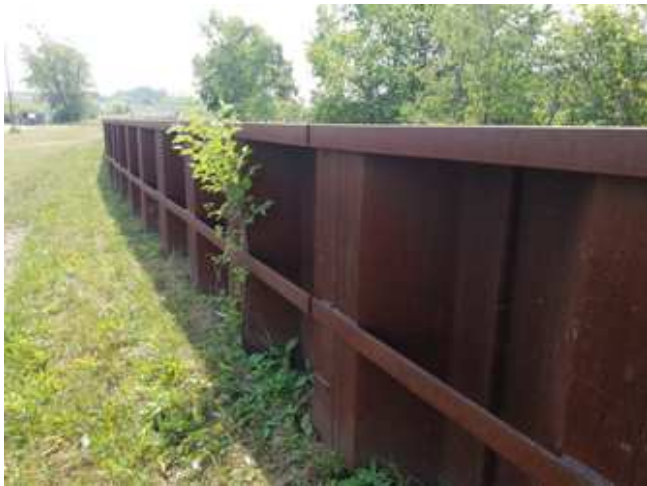
Category:	Floodwalls	Item:	Unwanted Vegetation
Observation ID:	2023-0067		
Description:	Vegetation along riverside of floodwall		
Caption:	0067 - No User Rating (Site Visit) - Vegetation along riverside of floodwall		
Lat/Long:	41.57309/-87.51350

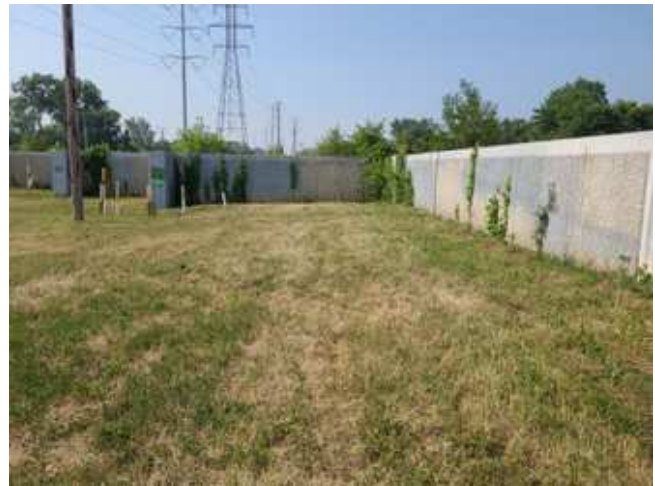
Category:	Floodwalls	Item:	Unwanted Vegetation
Observation ID:	2023-0274		
Description:	Small tree on landside floodwall		
Caption:	0274 - No User Rating (Site Visit) - Small tree on landside floodwall		
Lat/Long:	41.56837/-87.43516

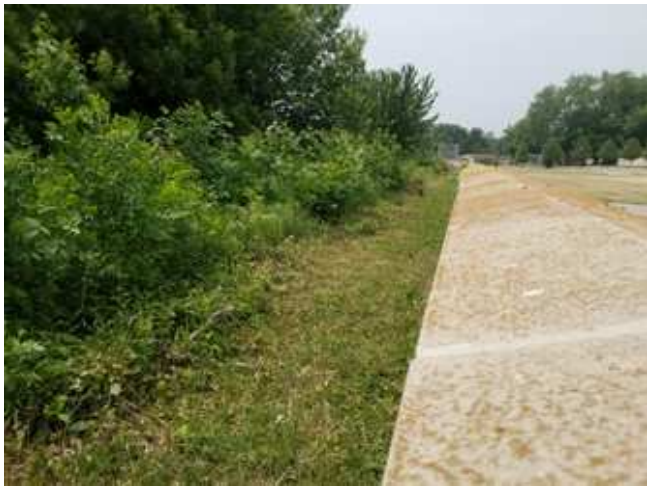
Category:	Floodwalls	Item:	Unwanted Vegetation
Observation ID:	2023-0279		
Description:	Landside floodwall vegetation		
Caption:	0279 - No User Rating (Site Visit) - Landside floodwall vegetation		
Lat/Long:	41.57019/-87.46654

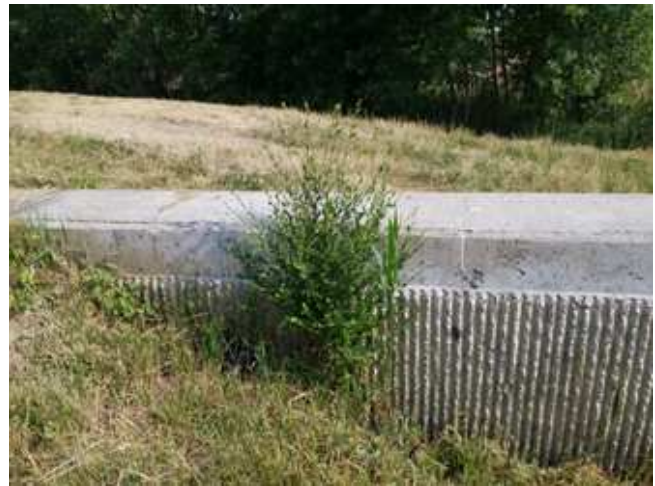
Category:	Floodwalls	Item:	Unwanted Vegetation
Observation ID:	2023-0285		
Description:	Vegetation within 5 ft of riverside floodwall		
Caption:	0285 - No User Rating (Site Visit) - Vegetation within 5 ft of riverside floodwall		
Lat/Long:	41.56722/-87.48680

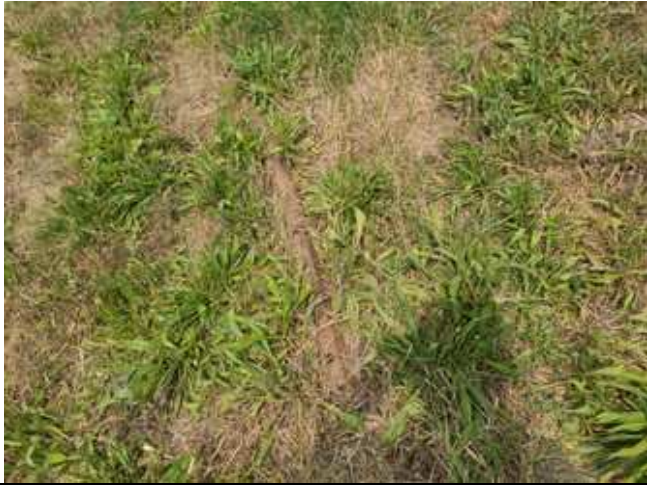
Category:	Floodwalls	Item:	Unwanted Vegetation
Observation ID:	2023-0325		
Description:	Vegetation - typical near railroad closure, landside and riverside		
Caption:	0325 - No User Rating (Site Visit) - Vegetation - typical near railroad closure, landside and riverside		
Lat/Long:	41.57023/-87.46707

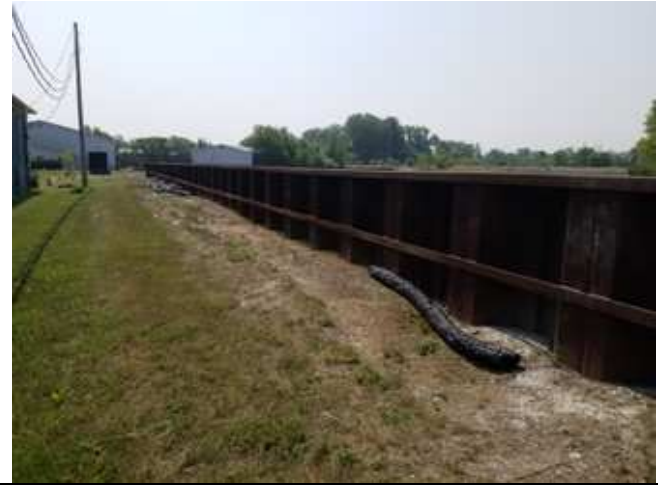
Category:	Floodwalls	Item:	Encroachments
Observation ID:	2023-0099		
Description:	Steel bar along waterside slope		
Caption:	0099 - No User Rating (Site Visit) - Steel bar along riverside slope		
Lat/Long:	41.57140/-87.50946

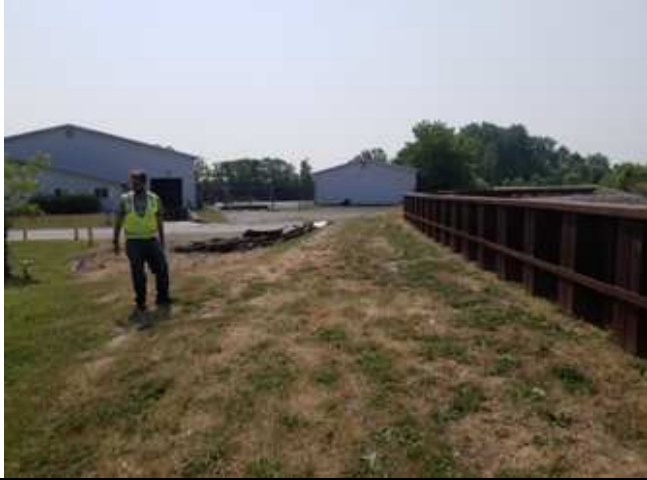
Category:	Floodwalls	Item:	Encroachments
Observation ID:	2023-0172		
Description:	Debris near landside floodwall		
Caption:	0172 - No User Rating (Site Visit) - Debris near landside floodwall		
Lat/Long:	41.57022/-87.44210

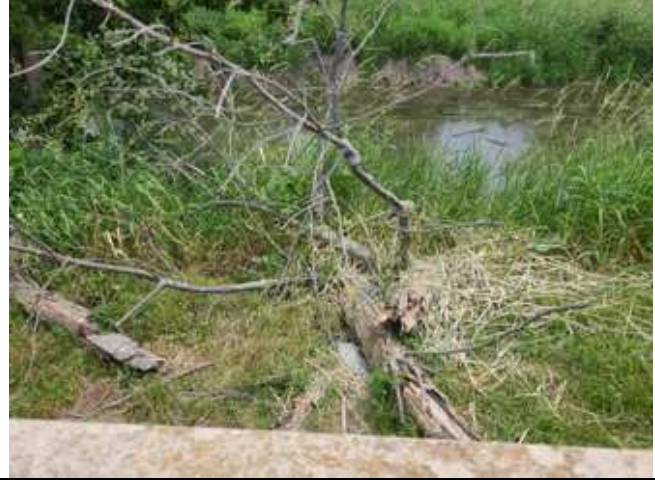
Category:	Floodwalls	Item:	Encroachments
Observation ID:	2023-0176		
Description:	Debris near landside floodwall		
Caption:	0176 - No User Rating (Site Visit) - Debris near landside floodwall		
Lat/Long:	41.57003/-87.44167

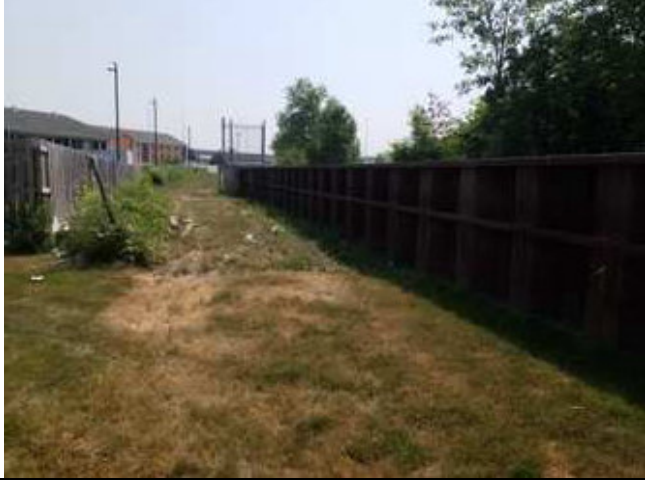
Category:	Floodwalls	Item:	Encroachments
Observation ID:	2023-0183		
Description:	Downed tree near riverside floodwall		
Caption:	0183 - No User Rating (Site Visit) - Downed tree near riverside floodwall		
Lat/Long:	41.57015/-87.49947

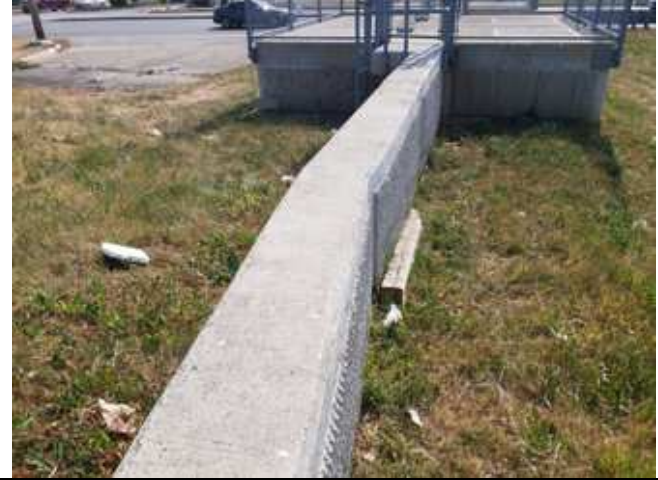
Category:	Floodwalls	Item:	Encroachments
Observation ID:	2023-0192		
Description:	Debris and unwanted vegetation on landside floodwall		
Caption:	0192 - No User Rating (Site Visit) - Debris and unwanted vegetation on landside floodwall		
Lat/Long:	41.56827/-87.43672

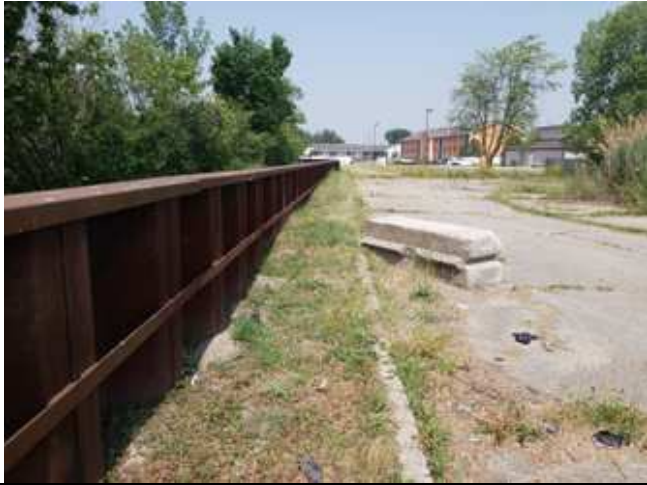
Category:	Floodwalls	Item:	Encroachments
Observation ID:	2023-0242		
Description:	Debris on both sides of floodwall		
Caption:	0242 - No User Rating (Site Visit) - Debris on both sides of floodwall		
Lat/Long:	41.56991/-87.46204

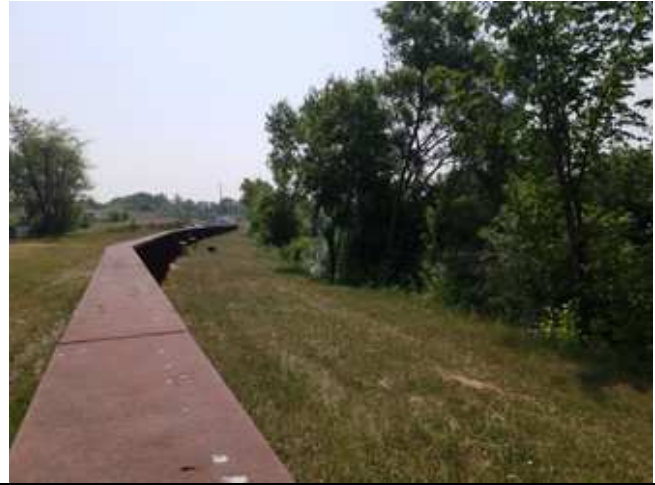
Category:	Floodwalls	Item:	Encroachments
Observation ID:	2023-0262		
Description:	Concrete block on landside floodwall		
Caption:	0262 - No User Rating (Site Visit) - Concrete block on landside floodwall		
Lat/Long:	41.56786/-87.43358

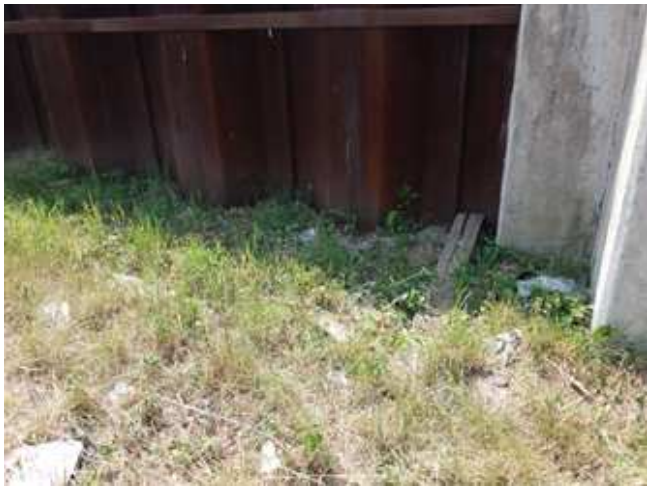
Category:	Floodwalls	Item:	Encroachments
Observation ID:	2023-0270		
Description:	Chairs on riverside floodwall		
Caption:	0270 - No User Rating (Site Visit) - Chairs on riverside floodwall		
Lat/Long:	41.56824/-87.43461

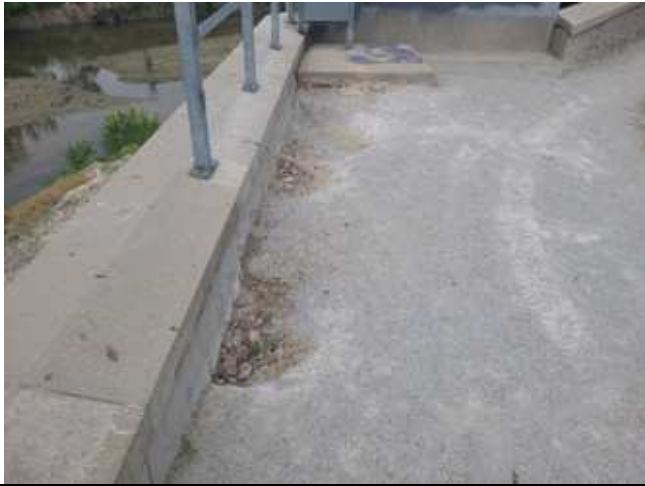
Category:	Floodwalls	Item:	Closure Structures (
Observation ID:	2023-0299		
Description:	Concrete spalling - closure structure at Kennedy		
Caption:	0299 - No User Rating (Site Visit) - Concrete spalling - closure structure at Kennedy		
Lat/Long:	41.56985/-87.46136

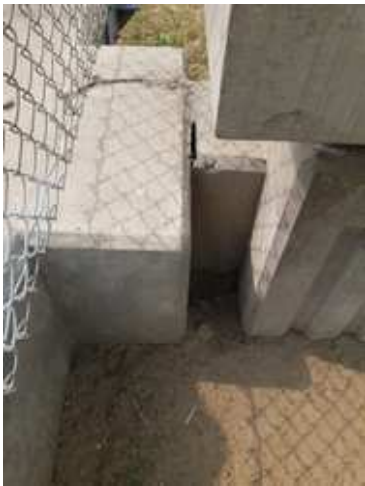
Category:	Floodwalls	Item:	Concrete Surfaces
Observation ID:	2023-0059		
Description:	Damaged concrete cap		
Caption:	0059 - No User Rating (Site Visit) - Damaged concrete cap		
Lat/Long:	41.57281/-87.51564

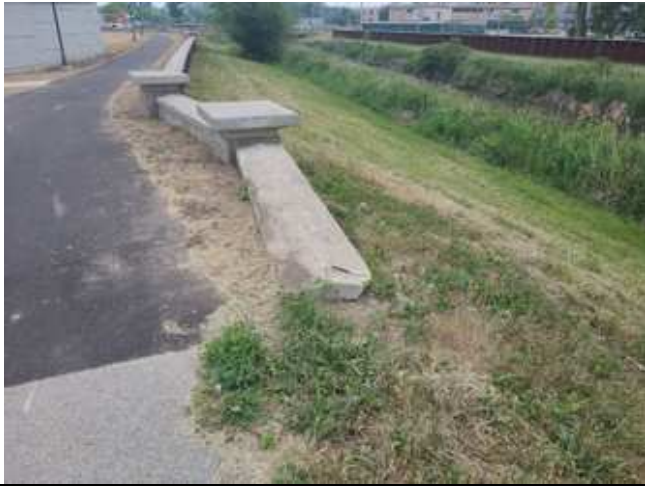
Category:	Floodwalls	Item:	Concrete Surfaces
Observation ID:	2023-0075		
Description:	Damaged concrete cap		
Caption:	0075 - No User Rating (Site Visit) - Damaged concrete cap		
Lat/Long:	41.57276/-87.51359

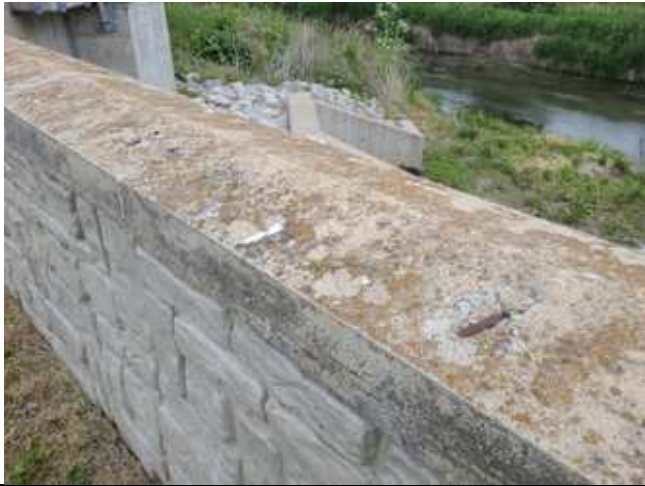
Category:	Floodwalls	Item:	Concrete Surfaces
Observation ID:	2023-0144		
Description:	Spalling on cap - near railroad gate		
Caption:	0144 - No User Rating (Site Visit) - Spalling on cap - near railroad gate		
Lat/Long:	41.57024/-87.46682

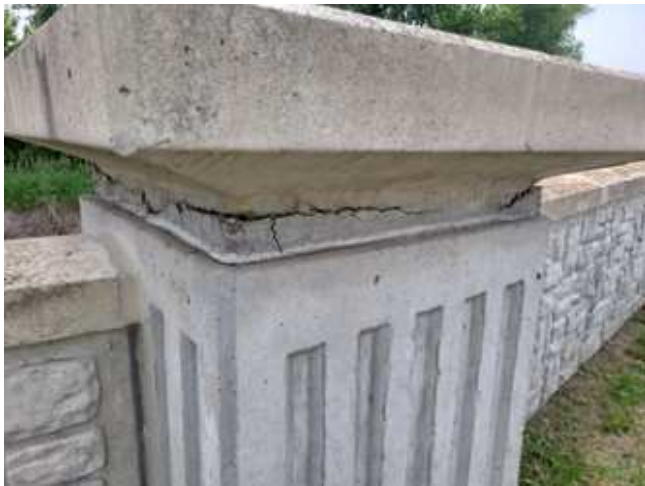
Category:	Floodwalls	Item:	Concrete Surfaces
Observation ID:	2023-0187		
Description:	Spalled surface on cap		
Caption:	0187 - No User Rating (Site Visit) - Spalled surface on cap		
Lat/Long:	41.57072/-87.49866

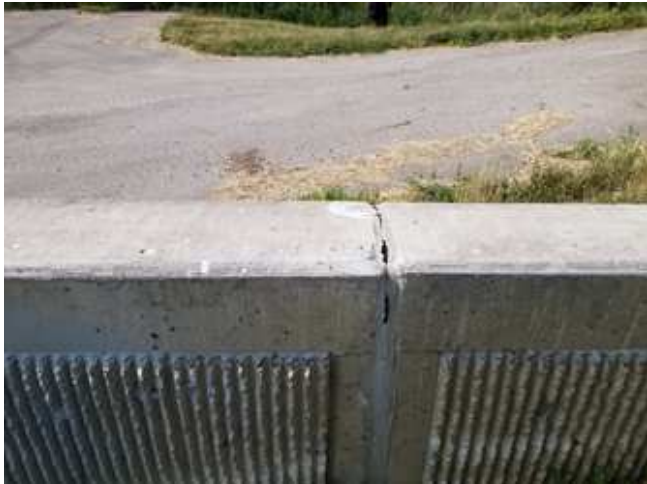
Category:	Floodwalls	Item:	Foundation of Concre
Observation ID:	2023-0266		
Description:	Two 2.5 ft deep burrows on landside of wall		
Caption:	0266 - No User Rating (Site Visit) - Two 2.5 ft deep burrows on landside of wall		
Lat/Long:	41.56782/-87.43360

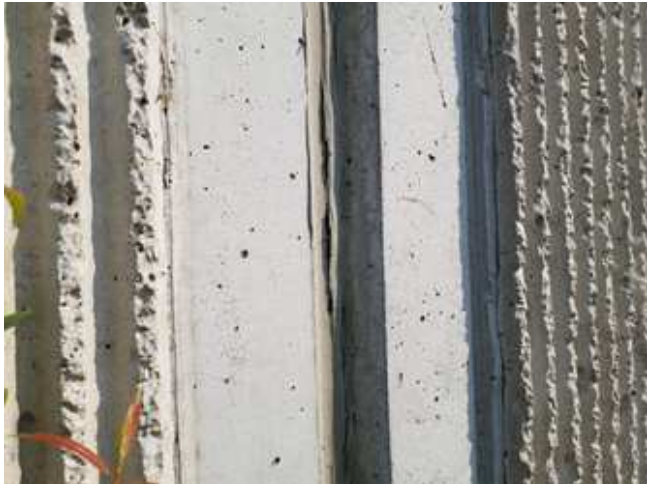
Category:	Floodwalls	Item:	Monolith Joints
Observation ID:	2023-0199		
Description:	Joint sealant repaired		
Caption:	0199 - No User Rating (Site Visit) - Joint sealant repaired		
Lat/Long:	41.56692/-87.48976

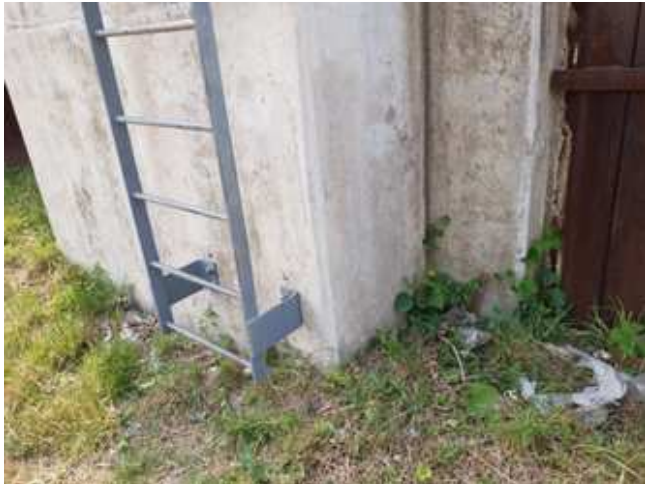
Category:	Floodwalls	Item:	Monolith Joints
Observation ID:	2023-0335		
Description:	Deteriorating riverside joint sealant		
Caption:	0335 - No User Rating (Site Visit) - Deteriorating riverside joint sealant		
Lat/Long:	41.57293/-87.44775

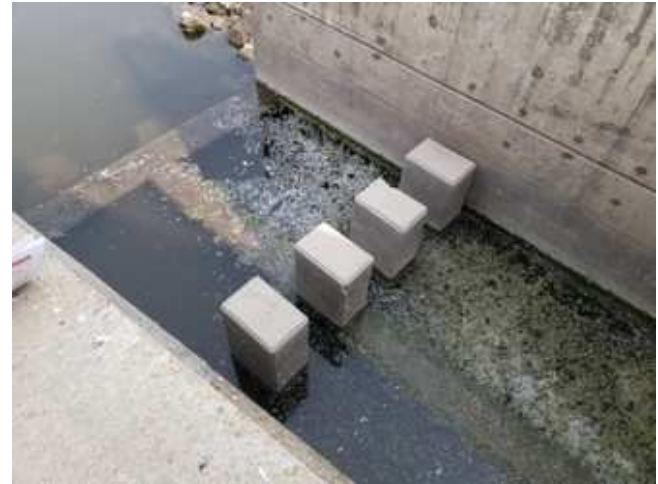
Category:	Interior Drainage System	Item:	Vegetation and Obstr
Observation ID:	2023-0008		
Description:	HA-35: Vegetation around inlet structure		
Caption:	0008 - No User Rating (Site Visit) - HA-35: Vegetation around inlet structure		
Lat/Long:	41.56832/-87.43647

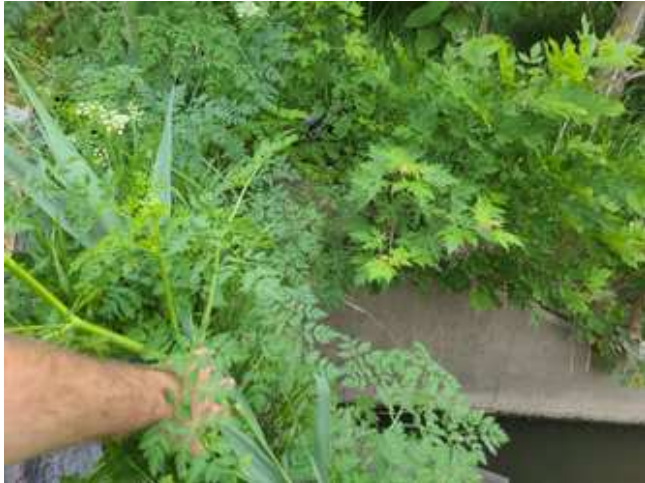
Category:	Interior Drainage System	Item:	Vegetation and Obstr
Observation ID:	2023-0015		
Description:	HA-02: Heavy vegetation around structure		
Caption:	0015 - No User Rating (Site Visit) - HA-02: Heavy vegetation around structure		
Lat/Long:	41.57460/-87.51866

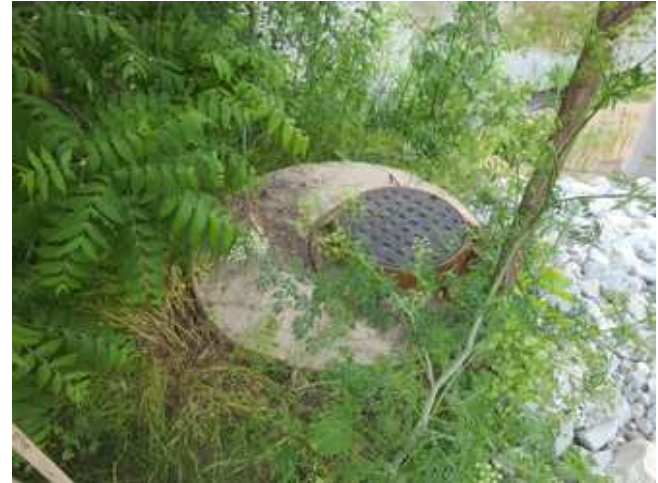
Category:	Interior Drainage System	Item:	Vegetation and Obstr
Observation ID:	2023-0023		
Description:	HA-03: Vegetation at outlet structure		
Caption:	0023 - No User Rating (Site Visit) - HA-03: Vegetation at outlet structure		
Lat/Long:	41.57408/-87.51872

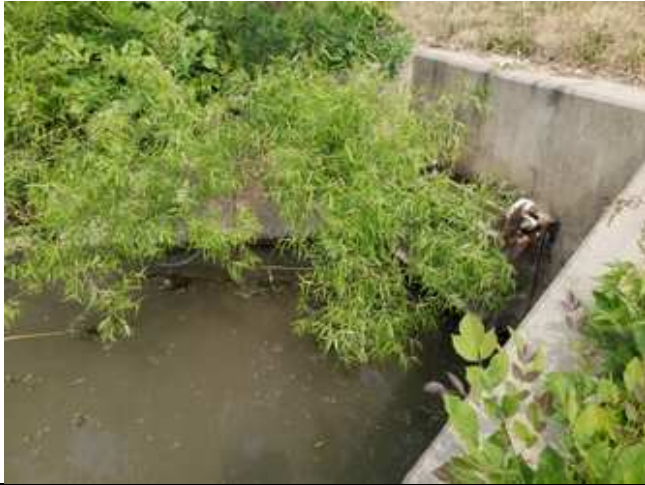
Category:	Interior Drainage System	Item:	Vegetation and Obstr
Observation ID:	2023-0027		
Description:	HA-03: Heavy vegetation around manhole		
Caption:	0027 - No User Rating (Site Visit) - HA-03: Heavy vegetation around manhole		
Lat/Long:	41.57404/-87.51839

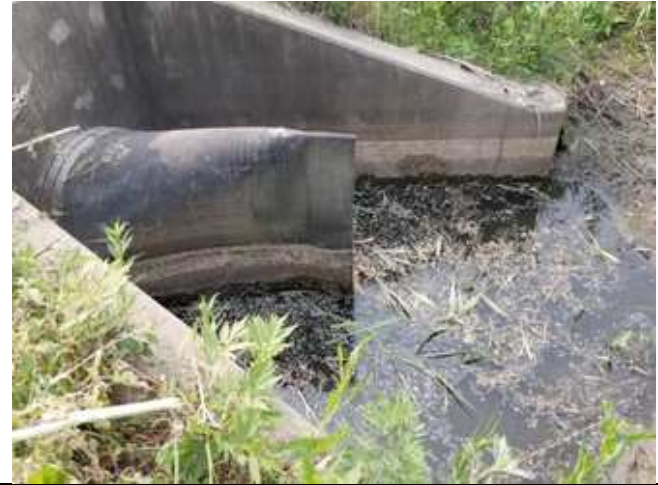
Category:	Interior Drainage System	Item:	Vegetation and Obstr
Observation ID:	2023-0036		
Description:	HA-31: Vegetation and obstructions at outlet		
Caption:	0036 - No User Rating (Site Visit) - HA-31: Vegetation and obstructions at outlet		
Lat/Long:	41.57069/-87.44874

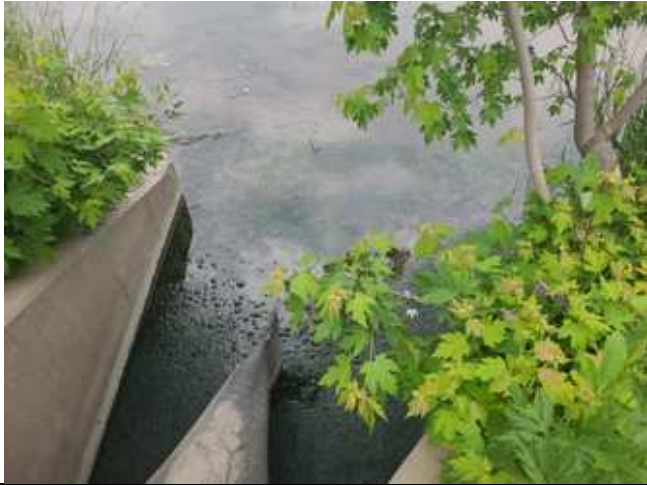
Category:	Interior Drainage System	Item:	Vegetation and Obstr
Observation ID:	2023-0038		
Description:	HA-06: Outlet has some vegetation/sediment buildup		
Caption:	0038 - No User Rating (Site Visit) - HA-06: Outlet has some vegetation/sediment buildup		
Lat/Long:	41.57230/-87.51363

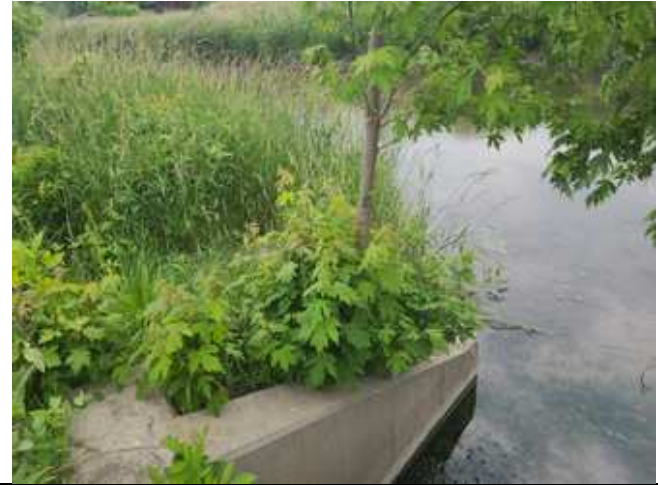
Category:	Interior Drainage System	Item:	Vegetation and Obstr
Observation ID:	2023-0047		
Description:	HA-05: Sediment blocking duckbill at outlet		
Caption:	0047 - No User Rating (Site Visit) - HA-05: Sediment blocking duckbill at outlet		
Lat/Long:	41.57246/-87.51583

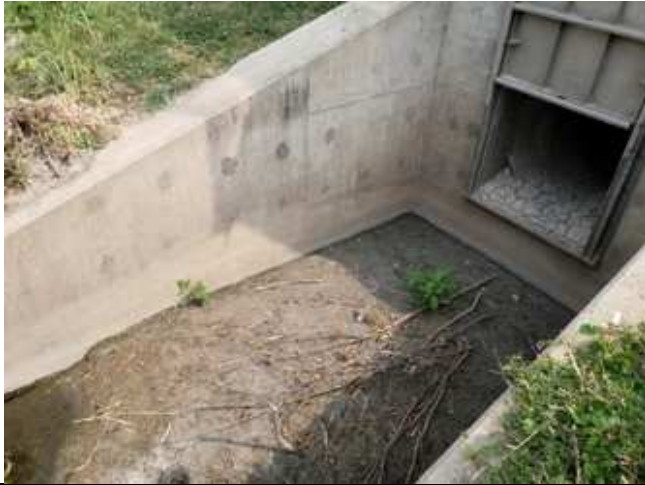
Category:	Interior Drainage System	Item:	Vegetation and Obstr
Observation ID:	2023-0051		
Description:	HA-05: Vegetation around outlet		
Caption:	0051 - No User Rating (Site Visit) - HA-05: Vegetation around outlet		
Lat/Long:	41.57247/-87.51579

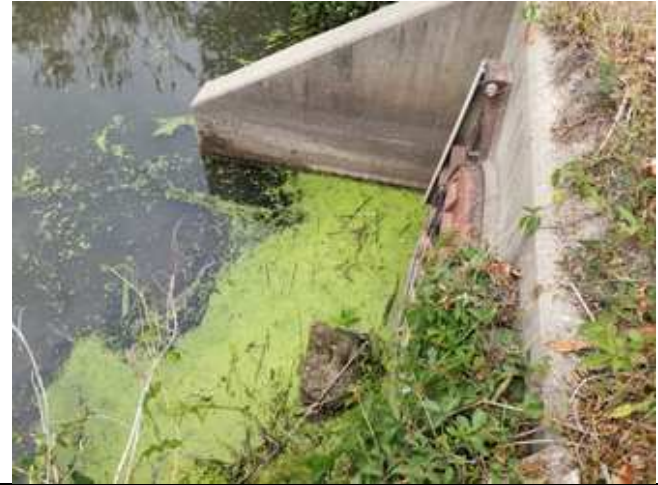
Category:	Interior Drainage System	Item:	Vegetation and Obstr
Observation ID:	2023-0070		
Description:	HA-10: Sediment and vegetation outside and within sluice gate at outlet		
Caption:	0070 - No User Rating (Site Visit) - HA-10: Sediment and vegetation outside and within sluice gate at outlet		
Lat/Long:	41.57052/-87.50511

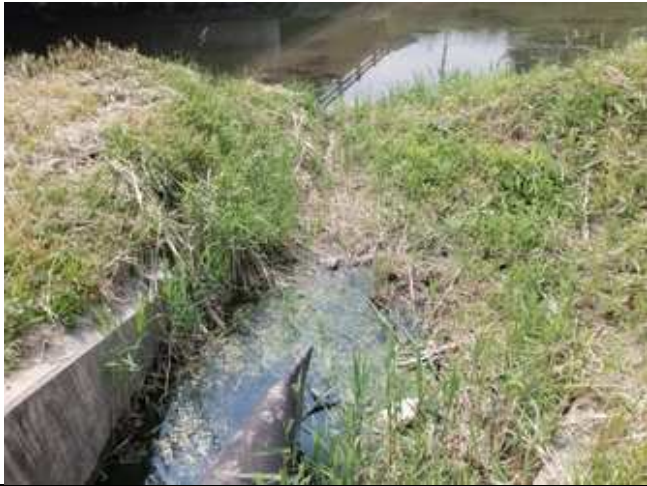
Category:	Interior Drainage System	Item:	Vegetation and Obstr
Observation ID:	2023-0072		
Description:	HA-27: Debris and vegetation in the outlet		
Caption:	0072 - No User Rating (Site Visit) - HA-27: Debris and vegetation in the outlet		
Lat/Long:	41.56987/-87.46190

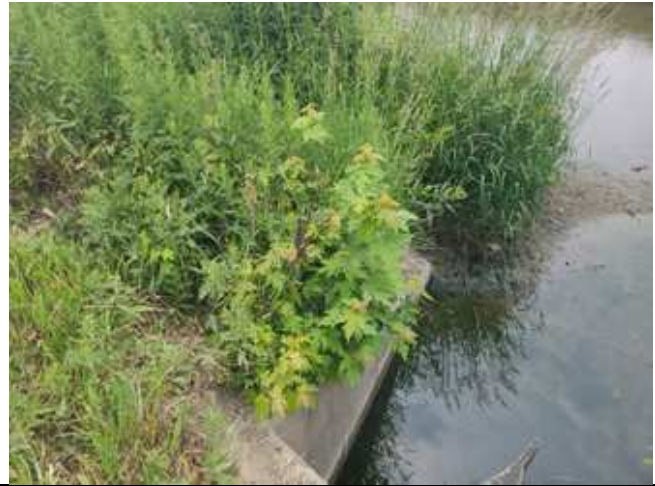
Category:	Interior Drainage System	Item:	Vegetation and Obstr
Observation ID:	2023-0094		
Description:	HA-13: Vegetation and sediment buildup at outlet		
Caption:	0094 - No User Rating (Site Visit) - HA-13: Vegetation and sediment buildup at outlet		
Lat/Long:	41.56920/-87.50043

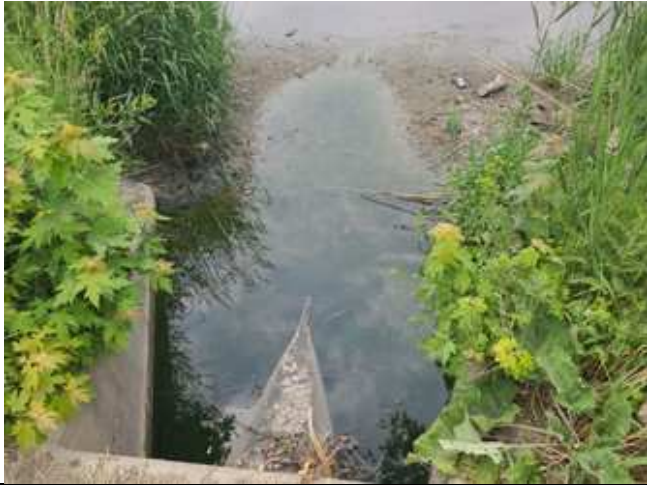
Category:	Interior Drainage System	Item:	Vegetation and Obstr
Observation ID:	2023-0103		
Description:	HA-07: Vegetation near outlet wingwall		
Caption:	0103 - No User Rating (Site Visit) - HA-07: Vegetation near outlet wingwall		
Lat/Long:	41.57133/-87.50942

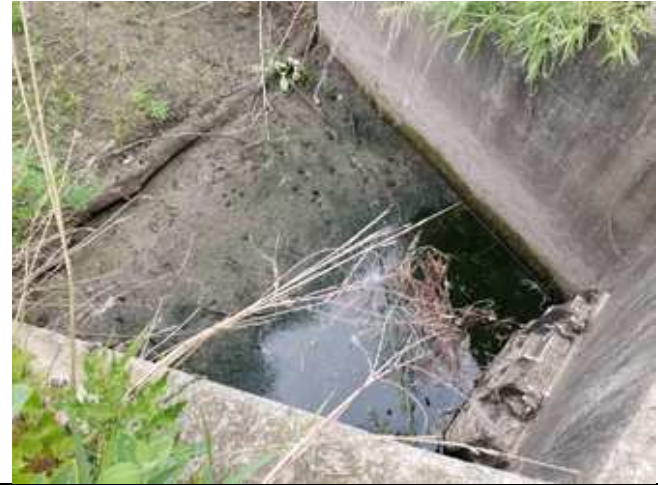
Category:	Interior Drainage System	Item:	Vegetation and Obstr
Observation ID:	2023-0107		
Description:	HA-05: Sediment obstructing duckbill at outlet		
Caption:	0107 - No User Rating (Site Visit) - HA-05: Sediment obstructing duckbill at outlet		
Lat/Long:	41.57135/-87.50943

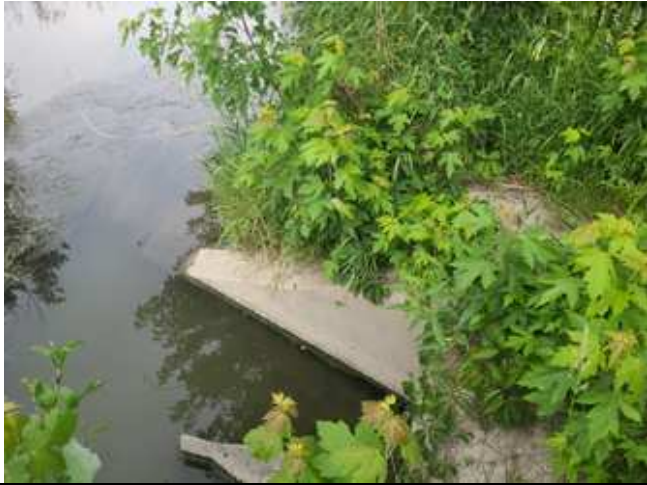
Category:	Interior Drainage System	Item:	Vegetation and Obstr
Observation ID:	2023-0116		
Description:	HA-23: sediment in outlet structure		
Caption:	0116 - No User Rating (Site Visit) - HA-23: sediment in outlet structure		
Lat/Long:	41.57047/-87.46808

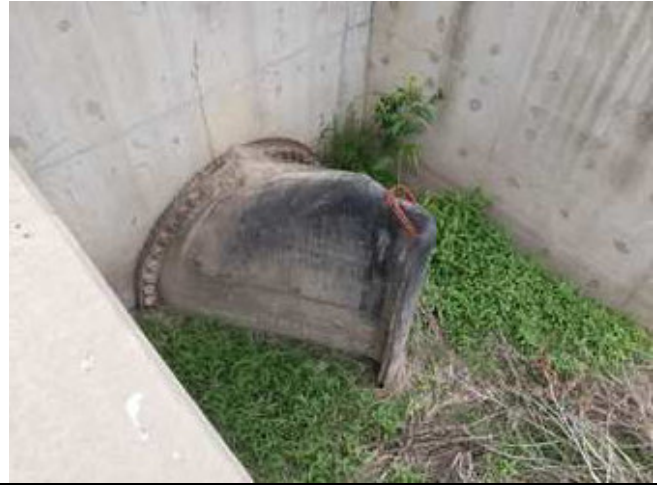
Category:	Interior Drainage System	Item:	Vegetation and Obstr
Observation ID:	2023-0127		
Description:	HA-09: Vegetation and silt around outlet		
Caption:	0127 - No User Rating (Site Visit) - HA-09: Vegetation and silt around outlet		
Lat/Long:	41.57120/-87.50691

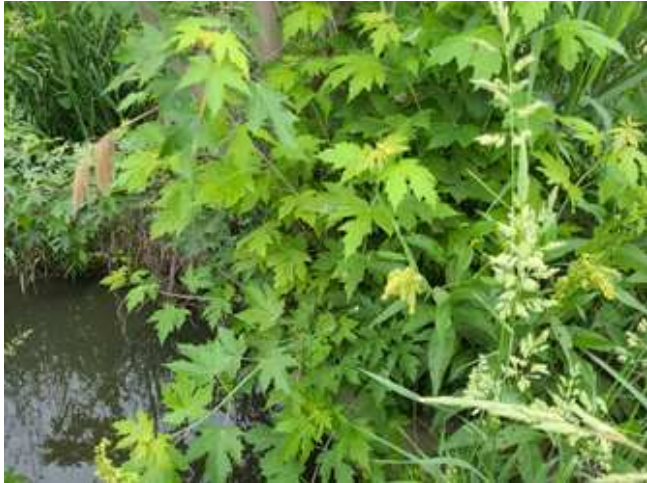
Category:	Interior Drainage System	Item:	Vegetation and Obstr
Observation ID:	2023-0150		
Description:	HA-16: Vegetation surrounding duckbill and sediment atop		
Caption:	0150 - No User Rating (Site Visit) - HA-16: Vegetation surrounding duckbill and sediment atop		
Lat/Long:	41.56731/-87.48710

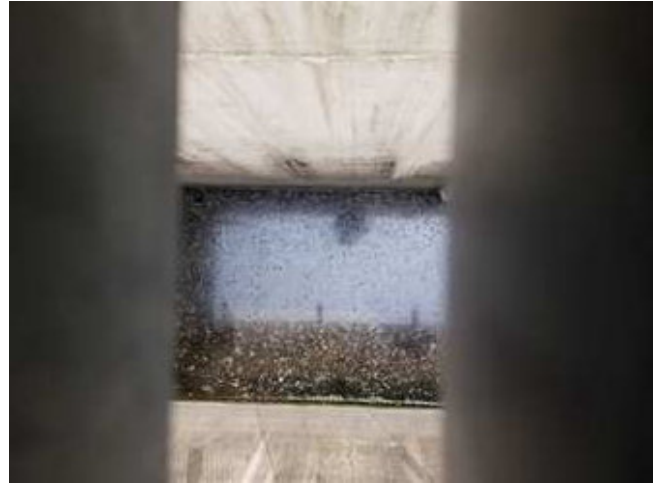
Category:	Interior Drainage System	Item:	Vegetation and Obstr
Observation ID:	2023-0159		
Description:	HA-11: Heavy vegetation at outlet		
Caption:	0159 - No User Rating (Site Visit) - HA-11: Heavy vegetation at outlet		
Lat/Long:	41.56980/-87.50418

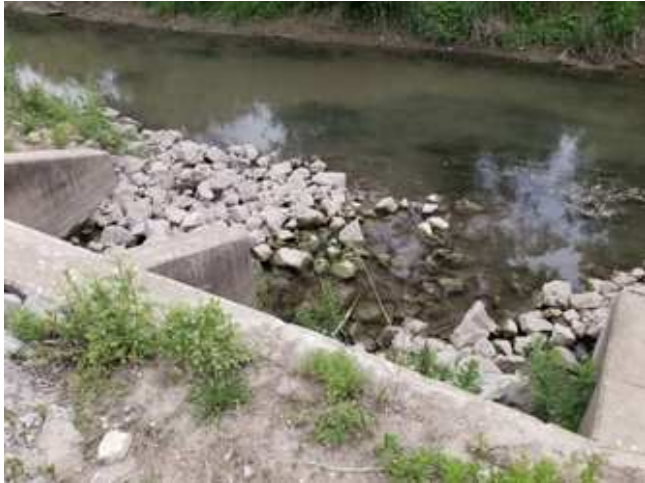
Category:	Interior Drainage System	Item:	Vegetation and Obstr
Observation ID:	2023-0166		
Description:	HA-18A-D: Flap gates closed. Some sediment buildup in gatewell		
Caption:	0166 - No User Rating (Site Visit) - HA-18A-D: Flap gates closed. Some sediment buildup in gatewell		
Lat/Long:	41.56766/-87.48213

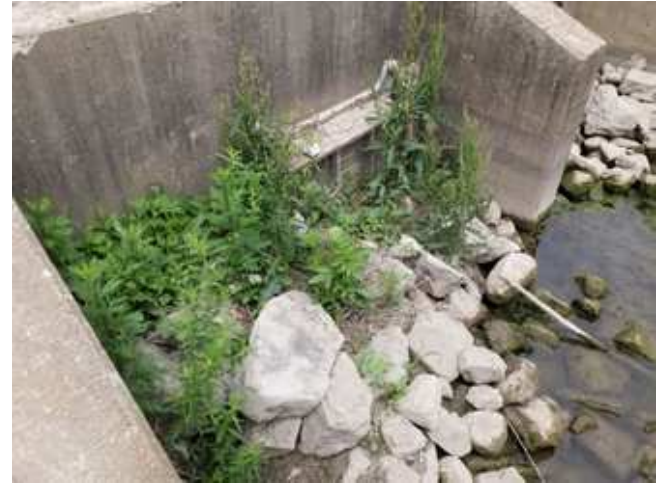
Category:	Interior Drainage System	Item:	Vegetation and Obstr
Observation ID:	2023-0170		
Description:	HA-18A-D: Flap gates may be blocked by rip rap or vegetation (vegetation mainly on west side)		
Caption:	0170_1 - No User Rating (Site Visit) - HA-18A-D: Flap gates may be blocked by rip rap or vegetation (vegetation mainly on west side)		
Lat/Long:	41.56772/-87.48199
