## Site Visit Summary

Name of System: Hammond

Name of Segment: Hammond

Date of Site Visit: 06/05/2023 - 06/09/2023

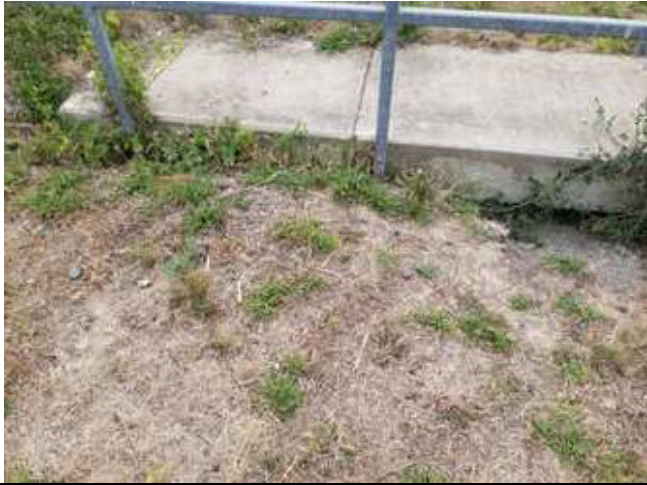
Category:	Interior Drainage System	Item:	Vegetation and Obstr
Observation ID:	2023-0170		
Description:	HA-18A-D: Flap gates may be blocked by rip rap or vegetation (vegetation mainly on west side)		
Caption:	0170_2 - No User Rating (Site Visit) - HA-18A-D: Flap gates may be blocked by rip rap or vegetation (vegetation mainly on west side)		
Lat/Long:	41.56772/-87.48199

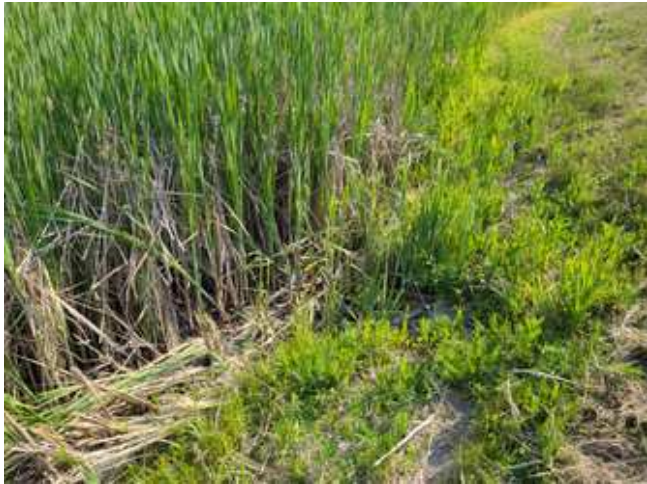
Category:	Interior Drainage System	Item:	Vegetation and Obstr
Observation ID:	2023-0235		
Description:	Vegetation in landside drainage ditch		
Caption:	0235 - No User Rating (Site Visit) - Vegetation in landside drainage ditch		
Lat/Long:	41.56884/-87.47486

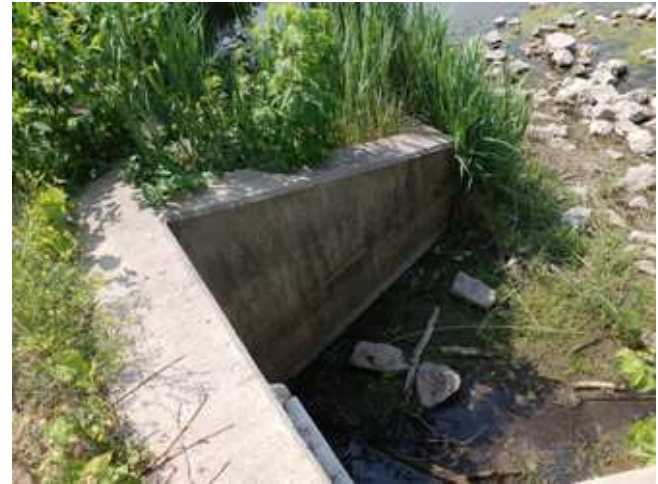
Category:	Interior Drainage System	Item:	Vegetation and Obstr
Observation ID:	2023-0251		
Description:	HA-22: Inlet surrounded by vegetation		
Caption:	0251 - No User Rating (Site Visit) - HA-22: Inlet surrounded by vegetation		
Lat/Long:	41.56975/-87.47142

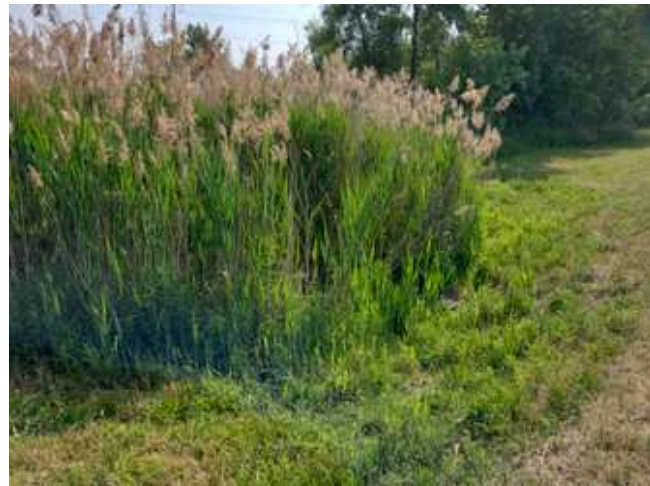
Category:	Interior Drainage System	Item:	Vegetation and Obstr
Observation ID:	2023-0255		
Description:	Vegetation in landside ditch		
Caption:	0255 - No User Rating (Site Visit) - Vegetation in landside ditch		
Lat/Long:	41.56972/-87.47139

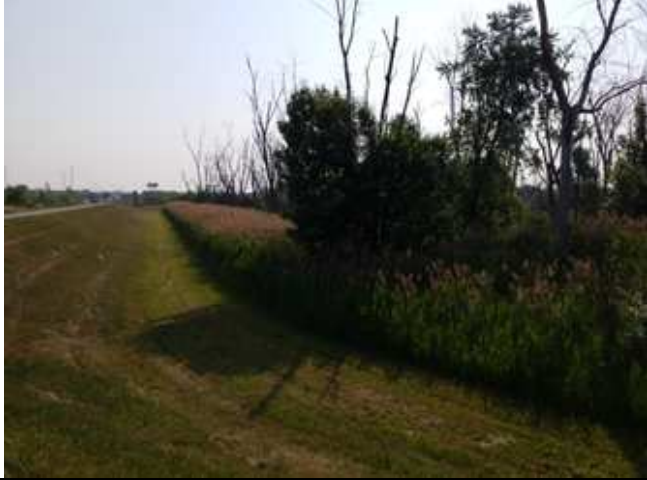
Category:	Interior Drainage System	Item:	Vegetation and Obstr
Observation ID:	2023-0267		
Description:	Landside ditch vegetation		
Caption:	0267 - No User Rating (Site Visit) - Landside ditch vegetation		
Lat/Long:	41.57055/-87.46813

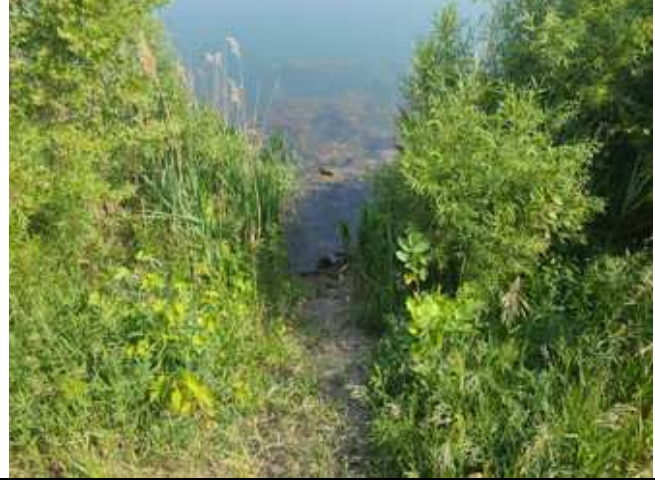
Category:	Interior Drainage System	Item:	Vegetation and Obstr
Observation ID:	2023-0293		
Description:	Phragmites in riverside wetland		
Caption:	0293 - No User Rating (Site Visit) - Phragmites in riverside wetland		
Lat/Long:	41.56893/-87.47461

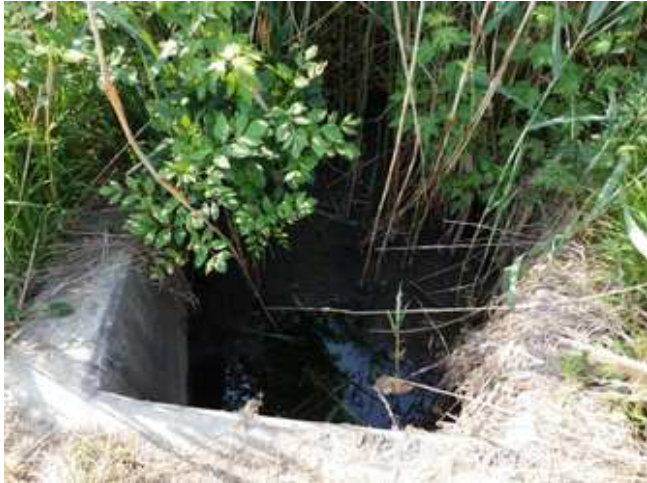
Category:	Interior Drainage System	Item:	Vegetation and Obstr
Observation ID:	2023-0295		
Description:	HA-25: Inlet obscured by vegetation		
Caption:	0295 - No User Rating (Site Visit) - HA-25: Inlet obscured by vegetation		
Lat/Long:	41.56962/-87.46385

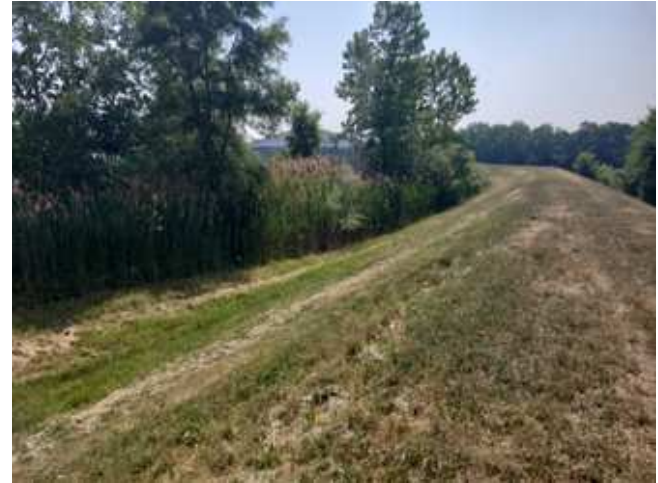
Category:	Interior Drainage System	Item:	Vegetation and Obstr
Observation ID:	2023-0313		
Description:	HA-22: Vegetation in outlet		
Caption:	0313 - No User Rating (Site Visit) - HA-22: Vegetation in outlet		
Lat/Long:	41.56957/-87.47127

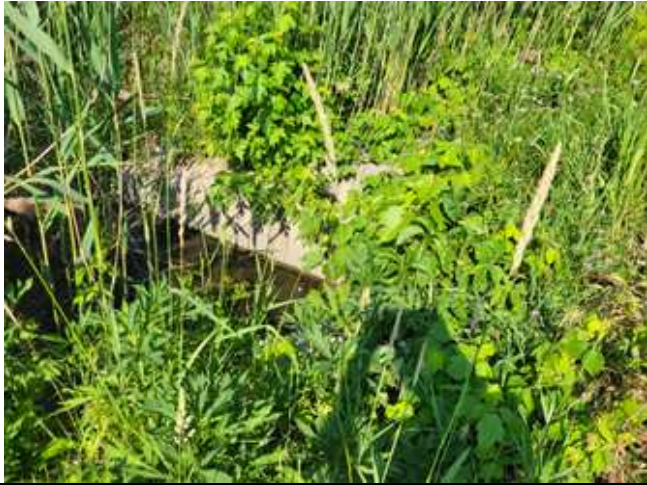
Category:	Interior Drainage System	Item:	Vegetation and Obstr
Observation ID:	2023-0371		
Description:	Landside ditch heavily vegetated		
Caption:	0371 - No User Rating (Site Visit) - Landside ditch heavily vegetated		
Lat/Long:	41.56854/-87.44022

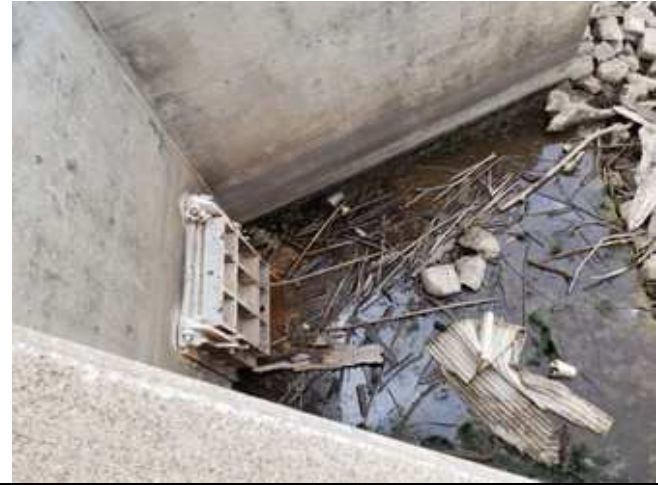
Category:	Interior Drainage System	Item:	Vegetation and Obstr
Observation ID:	2023-0420		
Description:	HA-19: Vegetation around outlet headwall		
Caption:	0420 - No User Rating (Site Visit) - HA-19: Vegetation around outlet headwall		
Lat/Long:	41.56846/-87.47542

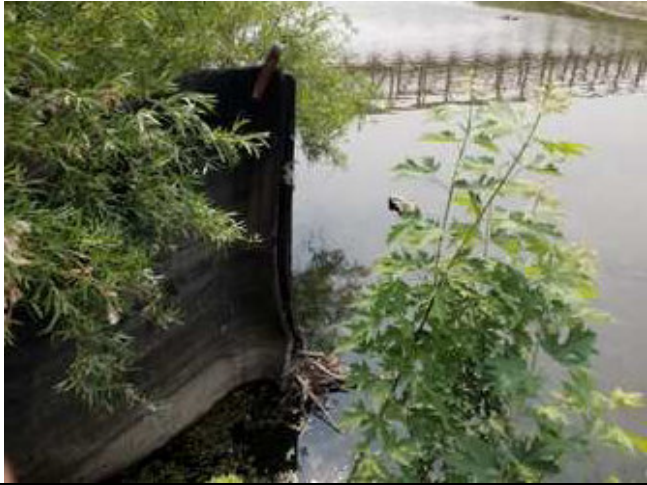
Category:	Interior Drainage System	Item:	Encroachments
Observation ID:	2023-0016		
Description:	HA-34: Debris in outlet		
Caption:	0016 - No User Rating (Site Visit) - HA-34: Debris in outlet		
Lat/Long:	41.56978/-87.44139

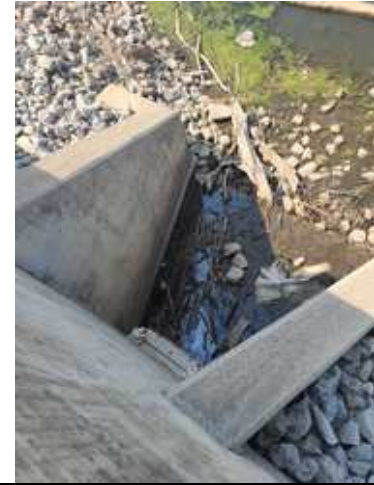
Category:	Interior Drainage System	Item:	Encroachments
Observation ID:	2023-0060		
Description:	HA-28: Debris at flap gate		
Caption:	0060 - No User Rating (Site Visit) - HA-28: Debris at flap gate		
Lat/Long:	41.56975/-87.46138

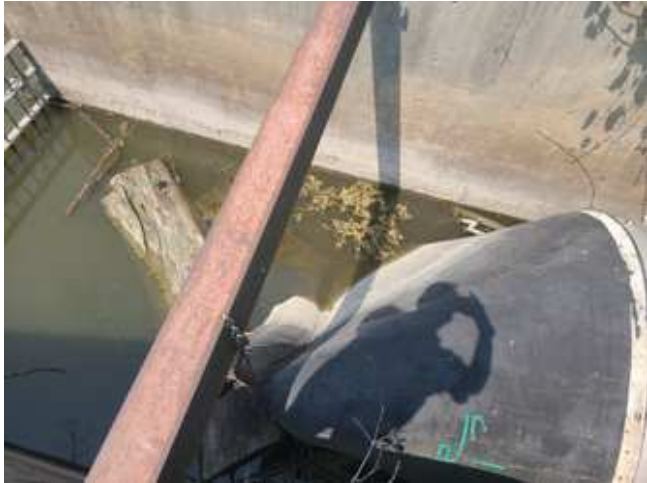
Category:	Interior Drainage System	Item:	Encroachments
Observation ID:	2023-0363		
Description:	HA-34: Debris at outlet flap gate		
Caption:	0363 - No User Rating (Site Visit) - HA-34: Debris at outlet flap gate		
Lat/Long:	41.56980/-87.44145

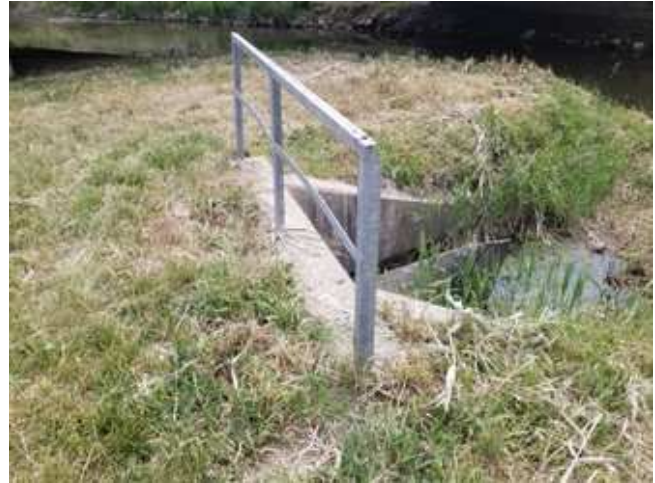
Category:	Interior Drainage System	Item:	Encroachments
Observation ID:	2023-0383		
Description:	HA-38: Debris in outlet		
Caption:	0383 - No User Rating (Site Visit) - HA-38: Debris in outlet		
Lat/Long:	41.56699/-87.43118

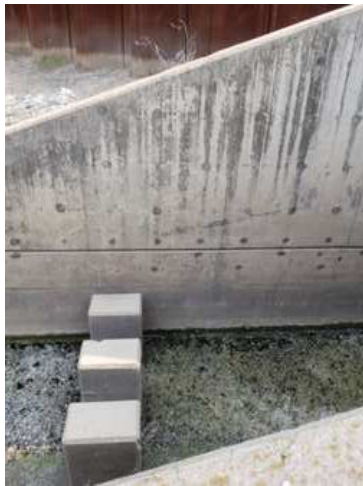
Category:	Interior Drainage System	Item:	Concrete Surfaces (S
Observation ID:	2023-0014		
Description:	HA-04: Spalling on west wingwall at outlet		
Caption:	0014 - No User Rating (Site Visit) - HA-04: Spalling on west wingwall at outlet		
Lat/Long:	41.57326/-87.51787

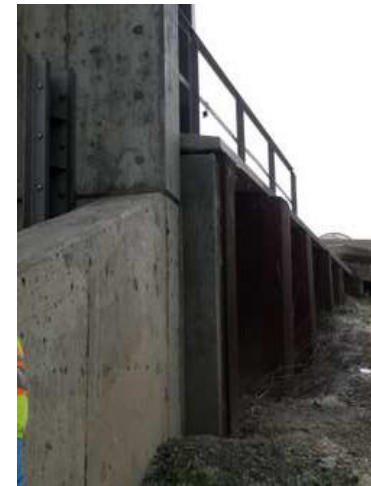
Category:	Interior Drainage System	Item:	Concrete Surfaces (S
Observation ID:	2023-0026		
Description:	HA-04: Concrete deteriorating and chipping in outlet baffle blocks		
Caption:	0026 - No User Rating (Site Visit) - HA-04: Concrete deteriorating and chipping in outlet baffle blocks		
Lat/Long:	41.57323/-87.51792

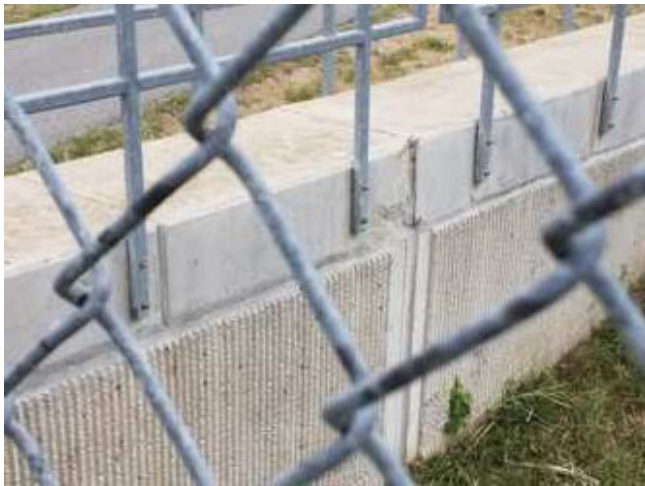
Category:	Interior Drainage System	Item:	Concrete Surfaces (S
Observation ID:	2023-0130		
Description:	HA-14: Spalling on corner of outlet structure		
Caption:	0130 - No User Rating (Site Visit) - HA-14: Spalling on corner of outlet structure		
Lat/Long:	41.56950/-87.50000

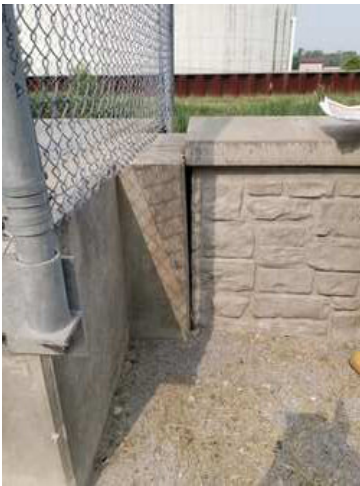
Category:	Interior Drainage System	Item:	Concrete Surfaces (S
Observation ID:	2023-0422		
Description:	HA-29: Deteriorating joint material		
Caption:	0422 - No User Rating (Site Visit) - HA-29: Deteriorating joint material		
Lat/Long:	41.57036/-87.45825

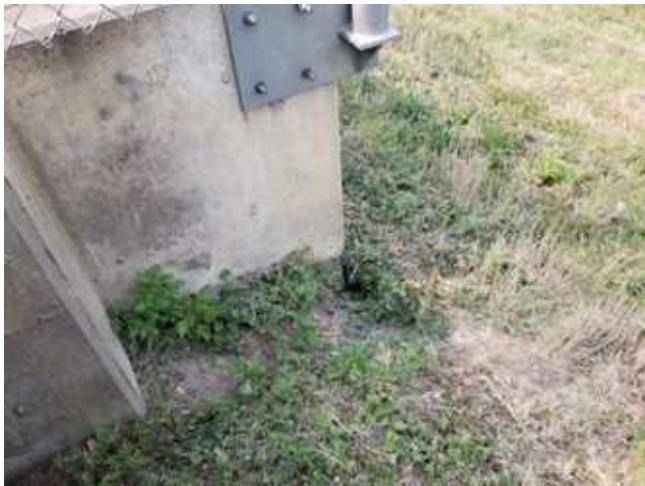
Category:	Interior Drainage System	Item:	Foundation of Concre
Observation ID:	2023-0024		
Description:	HA-33: Erosion along outlet wingwall		
Caption:	0024 - No User Rating (Site Visit) - HA-33: Erosion along outlet wingwall		
Lat/Long:	41.57058/-87.44766

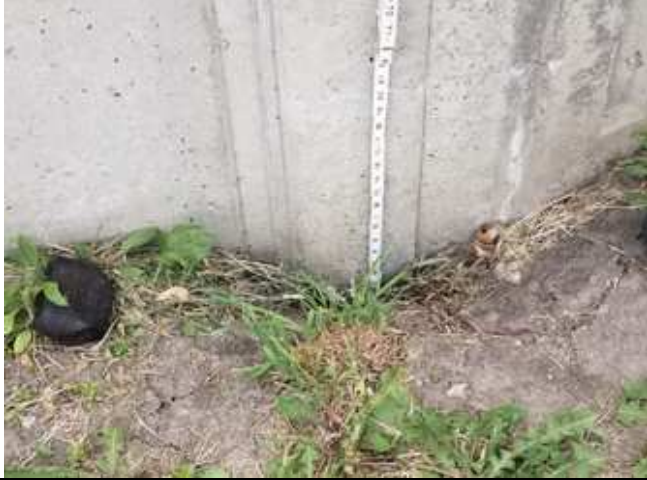
Category:	Interior Drainage System	Item:	Foundation of Concre
Observation ID:	2023-0114		
Description:	HA-13: Animal burrow near inlet structure		
Caption:	0114 - No User Rating (Site Visit) - HA-13: Animal burrow near inlet structure		
Lat/Long:	41.56940/-87.50043

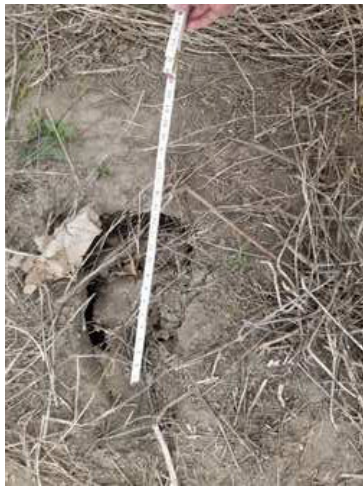
Category:	Interior Drainage System	Item:	Foundation of Concre
Observation ID:	2023-0131		
Description:	HA-09: Erosion around wingwalls at outlet		
Caption:	0131 - No User Rating (Site Visit) - HA-09: Erosion around wingwalls at outlet		
Lat/Long:	41.57118/-87.50694

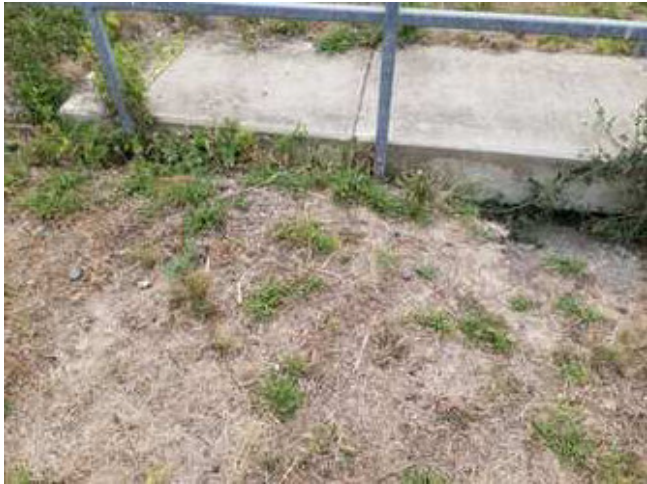
Category:	Interior Drainage System	Item:	Foundation of Concre
Observation ID:	2023-0178		
Description:	HA-17: Erosion around headwall at outlet		
Caption:	0178 - No User Rating (Site Visit) - HA-17: Erosion around headwall at outlet		
Lat/Long:	41.56860/-87.47560

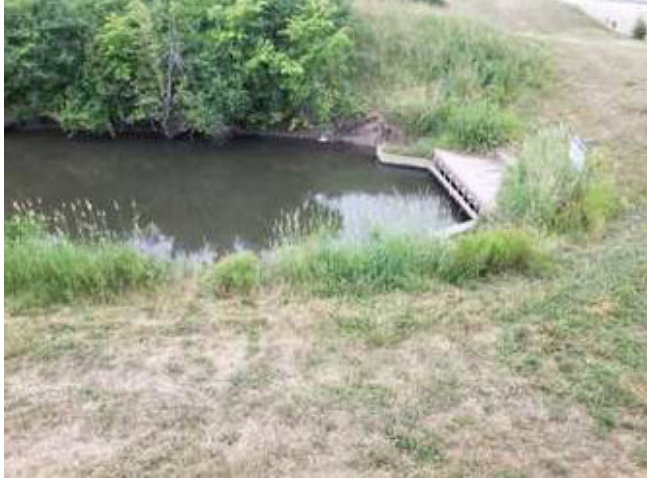
Category:	Interior Drainage System	Item:	Foundation of Concre
Observation ID:	2023-0202		
Description:	HA-21: Erosion on sides of outlet		
Caption:	0202 - No User Rating (Site Visit) - HA-21: Erosion on sides of outlet		
Lat/Long:	41.57009/-87.47258

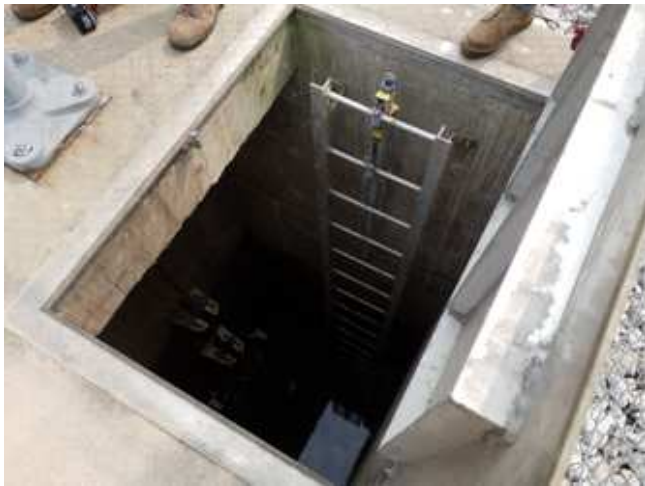
Category:	Interior Drainage System	Item:	Sluice / Slide Gates
Observation ID:	2023-0028		
Description:	HA-31: Difficulties closing the sluice gate		
Caption:	0028 - No User Rating (Site Visit) - HA-31: Difficulties closing the sluice gate		
Lat/Long:	41.57075/-87.44874

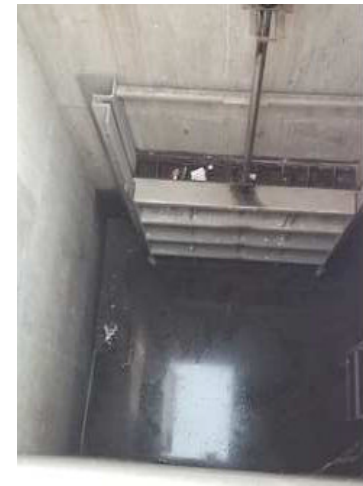
Category:	Interior Drainage System	Item:	Sluice / Slide Gates
Observation ID:	2023-0044		
Description:	HA-30: Minor debris in gatewell		
Caption:	0044 - No User Rating (Site Visit) - HA-30: Minor debris in gatewell		
Lat/Long:	41.57079/-87.45528

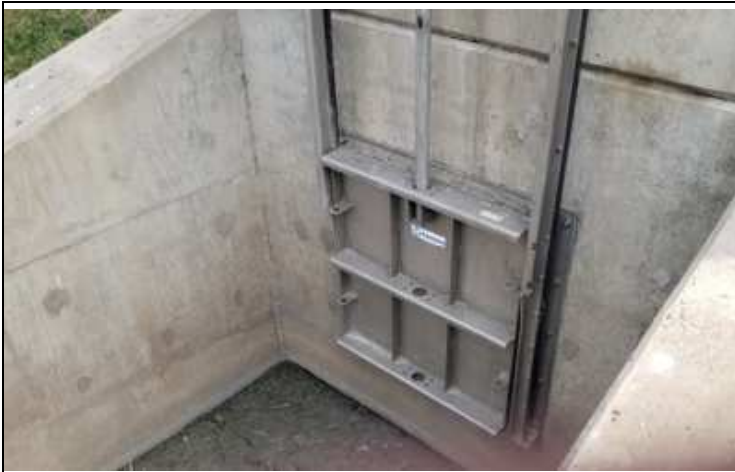
Category:	Interior Drainage System	Item:	Sluice / Slide Gates
Observation ID:	2023-0062		
Description:	HA-08: Some debris in gatewell. No issues with closing and opening		
Caption:	0062 - No User Rating (Site Visit) - HA-08: Some debris in gatewell. No issues with closing and opening		
Lat/Long:	41.57155/-87.50919

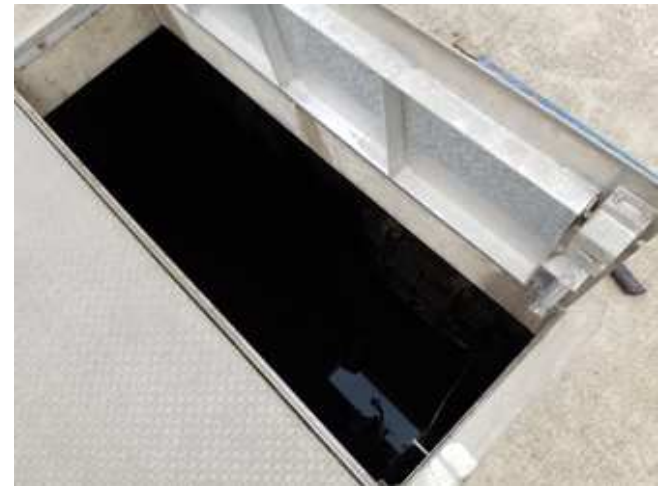
Category:	Interior Drainage System	Item:	Sluice / Slide Gates
Observation ID:	2023-0074		
Description:	HA-10: Gate wouldn't close fully because of sediment buildup		
Caption:	0074 - No User Rating (Site Visit) - HA-10: Gate wouldn't close fully because of sediment buildup.		
Lat/Long:	41.57053/-87.50514

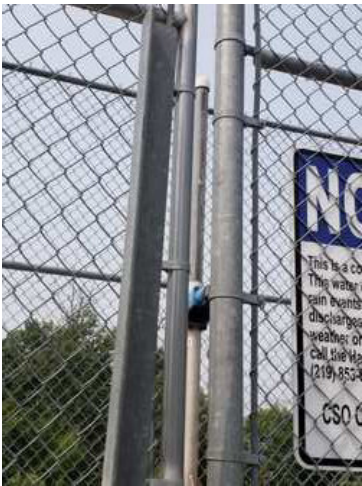
Category:	Interior Drainage System	Item:	Sluice / Slide Gates
Observation ID:	2023-0076		
Description:	HA-26A,B: Some debris in gatewell. No issues with closing and opening		
Caption:	0076 - No User Rating (Site Visit) - HA-26A,B: Some debris in gatewell. No issues with closing and opening		
Lat/Long:	41.56994/-87.46192

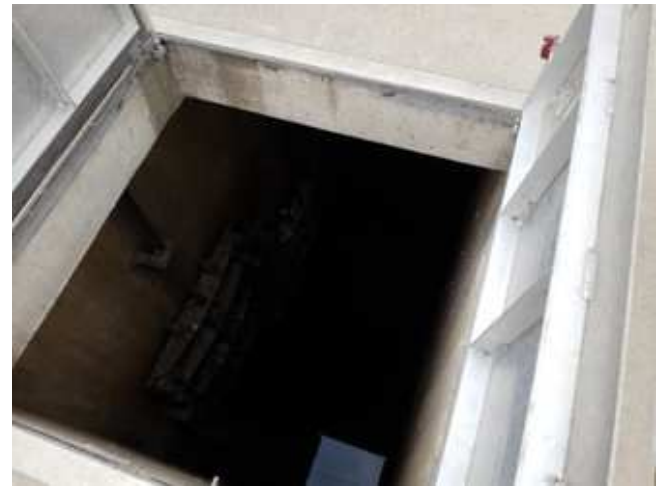
Category:	Interior Drainage System	Item:	Sluice / Slide Gates
Observation ID:	2023-0078		
Description:	HA-10: Condensation in gauge		
Caption:	0078 - No User Rating (Site Visit) - HA-10: Condensation in gauge		
Lat/Long:	41.57057/-87.50507

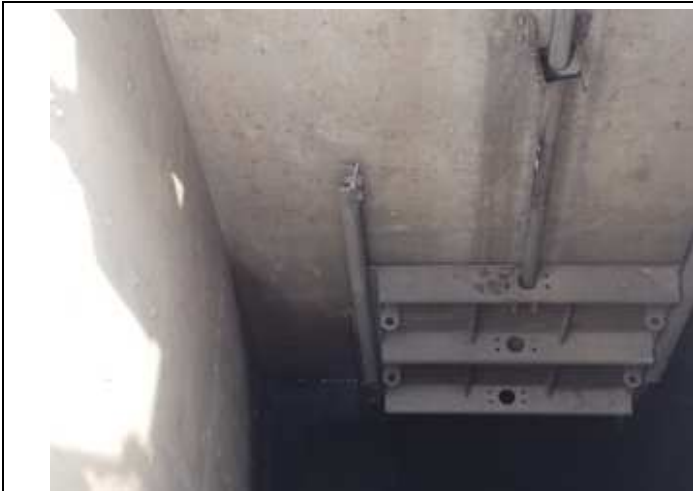
Category:	Interior Drainage System	Item:	Sluice / Slide Gates
Observation ID:	2023-0100		
Description:	HA-27B: Some debris in gateway		
Caption:	0100 - No User Rating (Site Visit) - HA-27B: Some debris in gateway		
Lat/Long:	41.56994/-87.46184

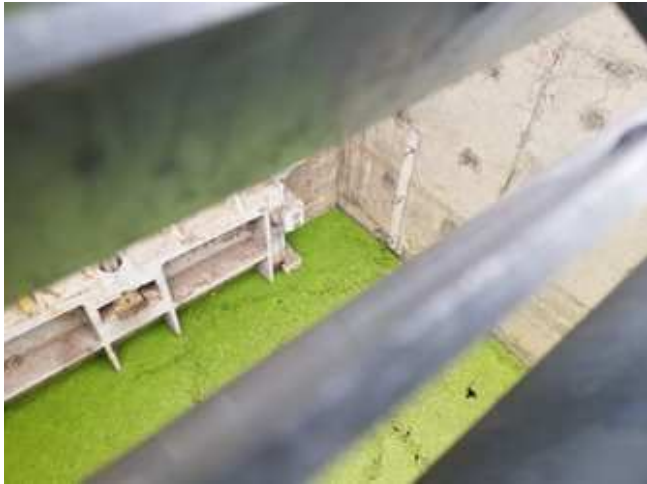
Category:	Interior Drainage System	Item:	Sluice / Slide Gates
Observation ID:	2023-0126		
Description:	HA-14: Rusting on gauge and column		
Caption:	0126 - No User Rating (Site Visit) - HA-14: Rusting on gauge and column		
Lat/Long:	41.56957/-87.50003

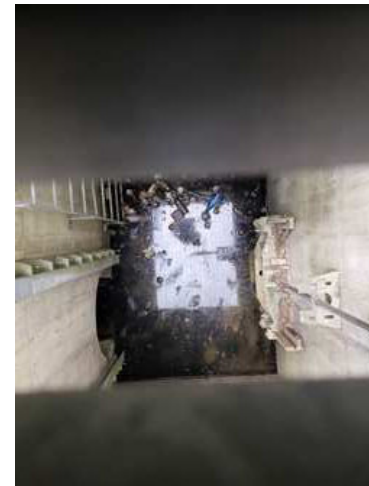
Category:	Interior Drainage System	Item:	Sluice / Slide Gates
Observation ID:	2023-0158		
Description:	HA-16: Gate to remain fully open. Some skipping while raising. Corrosion was noted on inside as well as some chipping.		
Caption:	0158 - No User Rating (Site Visit) - HA-16: Gate to remain fully open. Some skipping while raising. Corrosion was noted on inside as well as some chipping.		
Lat/Long:	41.56728/-87.48705

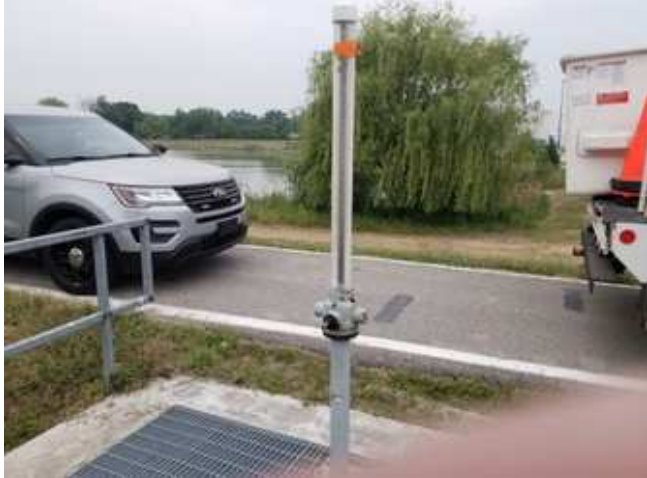
Category:	Interior Drainage System	Item:	Sluice / Slide Gates
Observation ID:	2023-0162		
Description:	HA-17: Some squeaking while closing gate. Some debris in gatewell		
Caption:	0162 - No User Rating (Site Visit) - HA-17: Some squeaking while closing gate. Some debris in gatewell		
Lat/Long:	41.56761/-87.48218

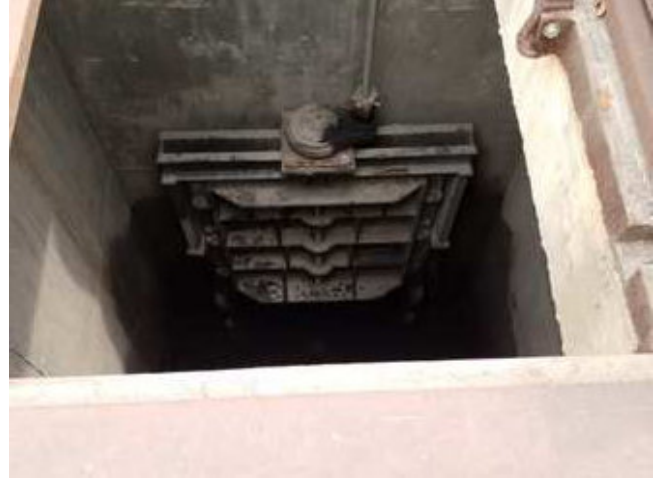
Category:	Interior Drainage System	Item:	Sluice / Slide Gates
Observation ID:	2023-0174		
Description:	HA-17: Gauge column fixed from FY22 inspection		
Caption:	0174 - No User Rating (Site Visit) - HA-17: Gauge column fixed from FY22 inspection		
Lat/Long:	41.56780/-87.48105

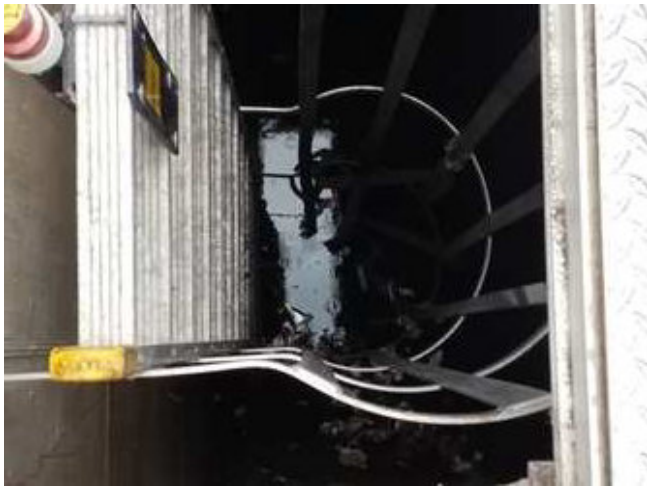
Category:	Interior Drainage System	Item:	Sluice / Slide Gates
Observation ID:	2023-0190		
Description:	HA-20: Gate partially open upon arrival, very squeaky while closing		
Caption:	0190 - No User Rating (Site Visit) - HA-20: Gate partially open upon arrival, very squeaky while closing		
Lat/Long:	41.56883/-87.47488

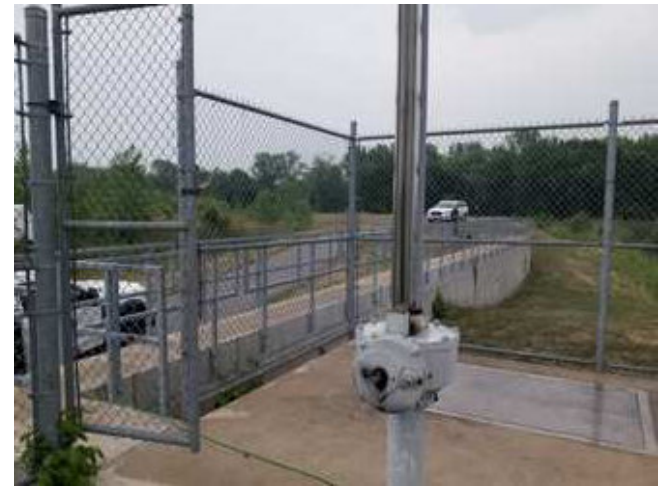
Category:	Interior Drainage System	Item:	Sluice / Slide Gates
Observation ID:	2023-0206		
Description:	HA-21A: Gate rattled while closing. Some debris in gatewell		
Caption:	0206 - No User Rating (Site Visit) - HA-21A: Gate rattled while closing. Some debris in gatewell		
Lat/Long:	41.57010/-87.47258

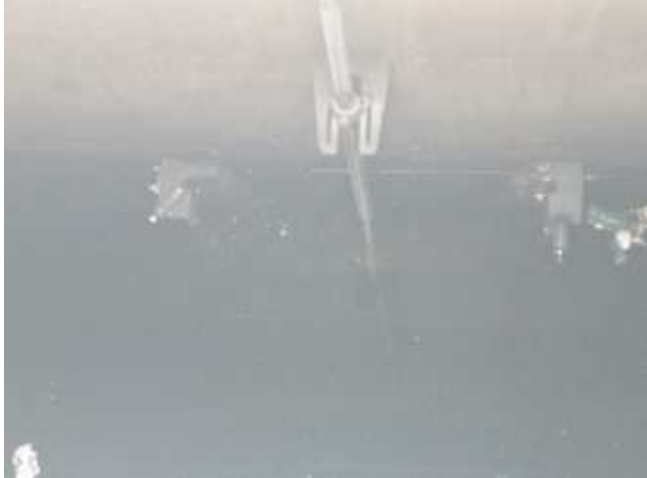
Category:	Interior Drainage System	Item:	Sluice / Slide Gates
Observation ID:	2023-0214		
Description:	HA-21A-C: All 3 gauges dirty		
Caption:	0214: No User Rating (Site Visit) - HA-21A-C: All 3 gauges dirty		
Lat/Long:	41.57010/-87.47251

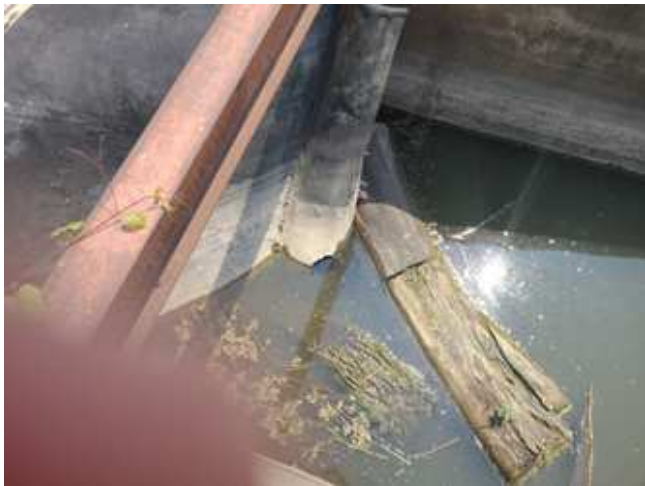
Category:	Interior Drainage System	Item:	Sluice / Slide Gates
Observation ID:	2023-0222		
Description:	HA-21C: Some debris in gatewell. Water dripping while opening during FY22 inspection - not noted during this inspection		
Caption:	0222 - No User Rating (Site Visit) - HA-21C: Some debris in gatewell. Water dripping while opening during FY22 inspection - not noted during this inspection		
Lat/Long:	41.57008/-87.47252

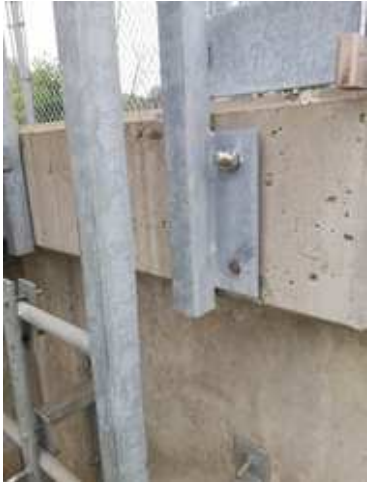
Category:	Interior Drainage System	Item:	Trash Racks (non-mec
Observation ID:		2023-0143	
Description:	HA-09: Damaged trash rack		
Caption:	0143 - No User Rating (Site Visit) - HA-09: Damaged trash rack		
Lat/Long:	41.57129/-87.50681

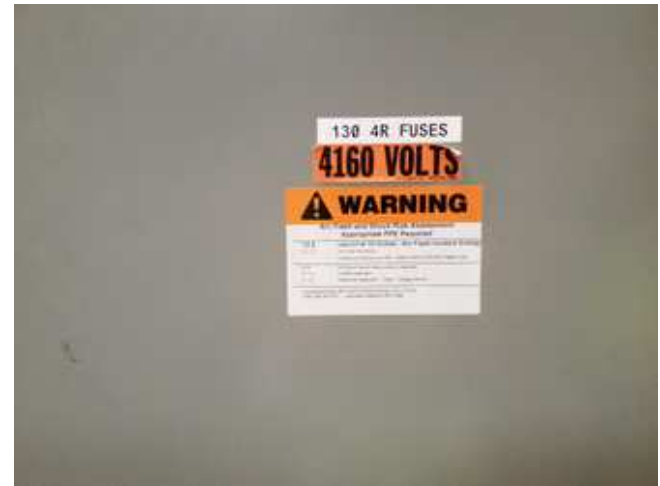
Category:	Pump Stations	Item:	Safety Compliance
Observation ID:	2023-0045		
Description:	PS-TA: Outdated arc flash labels		
Caption:	0045 - No User Rating (Site Visit) - PS-TA: Outdated arc flash labels		
Lat/Long:	41.57064/-87.50505

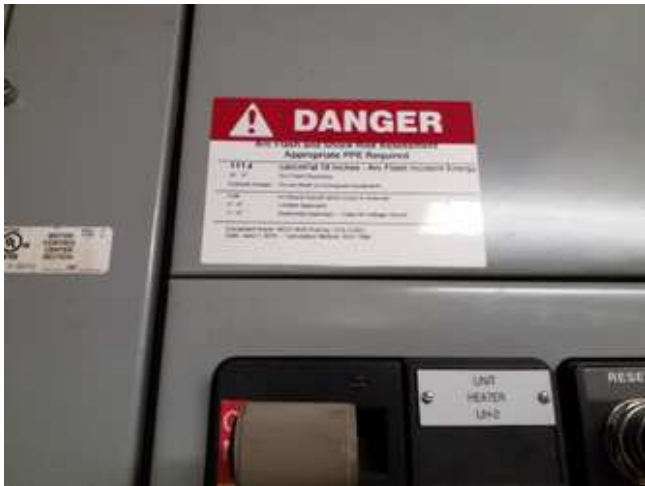
Category:	Pump Stations	Item:	Safety Compliance
Observation ID:	2023-0065		
Description:	PS-SS: Outdated arc flash labels		
Caption:	0065 - No User Rating (Site Visit) - PS-SS: Outdated arc flash labels		
Lat/Long:	41.57338/-87.50043

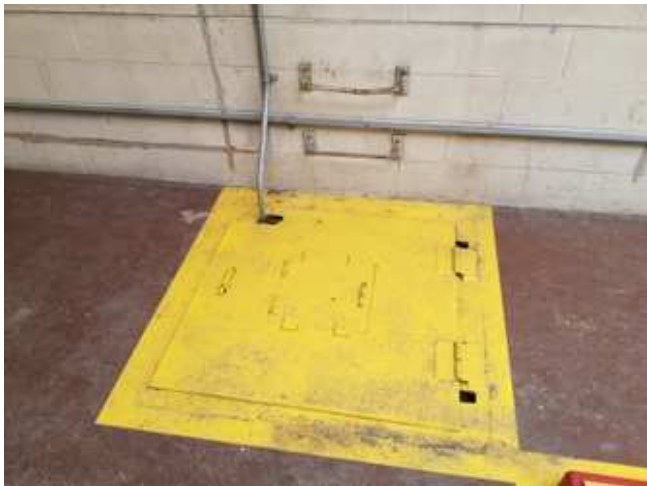
Category:	Pump Stations	Item:	Safety Compliance
Observation ID:	2023-0125		
Description:	PS-WA: No confined space label		
Caption:	0125 - No User Rating (Site Visit) - PS-WA: No confined space label		
Lat/Long:	41.56898/-87.49291

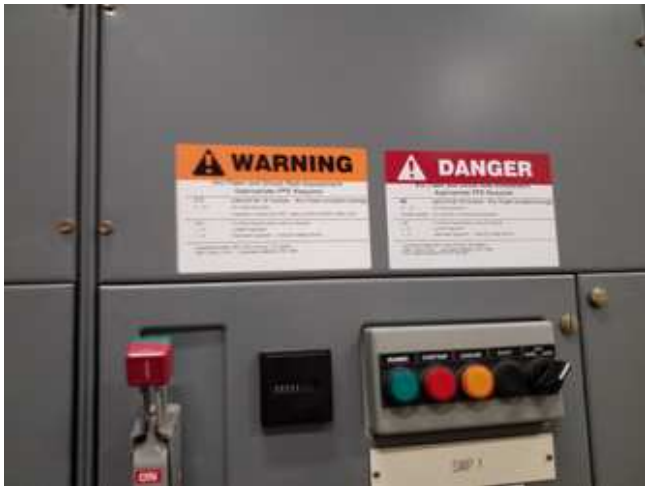
Category:	Pump Stations	Item:	Safety Compliance
Observation ID:	2023-0145		
Description:	PS-IN: Outdated arc flash labels		
Caption:	0145 - No User Rating (Site Visit) - PS-IN: Outdated arc flash labels		
Lat/Long:	41.57483/-87.47519

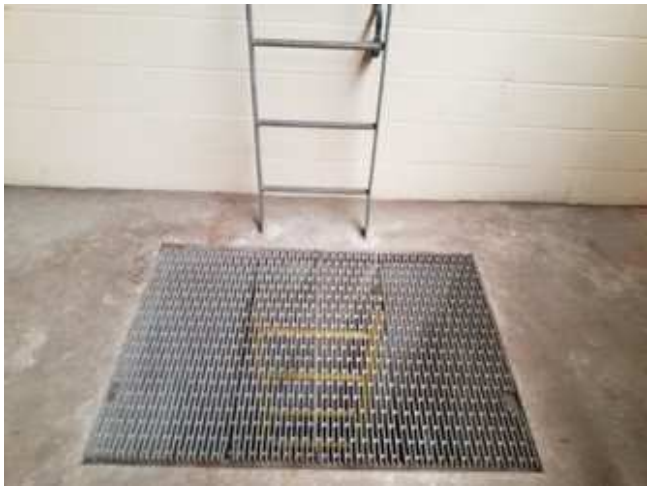
Category:	Pump Stations	Item:	Safety Compliance
Observation ID:	2023-0237		
Description:	PS-KA: No confined space label		
Caption:	0237 - No User Rating (Site Visit) - PS-KA: No confined space label		
Lat/Long:	41.57049/-87.45825

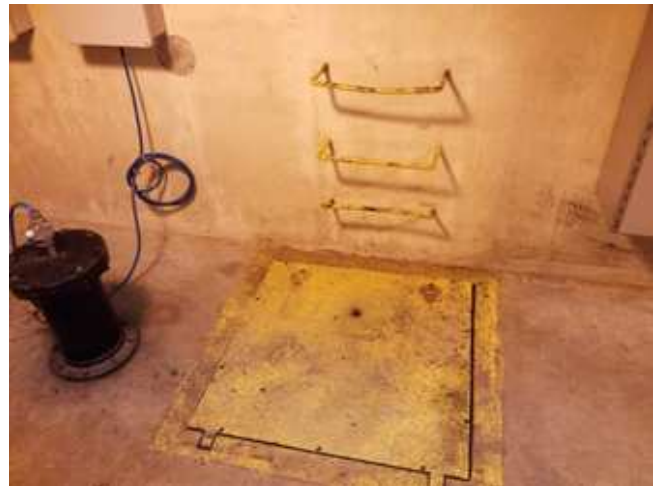
Category:	Pump Stations	Item:	Safety Compliance
Observation ID:	2023-0253		
Description:	PS-HV: No confined space label		
Caption:	No User Rating (Site Visit) - PS-HV: No confined space label		
Lat/Long:	41.57312/-87.44787

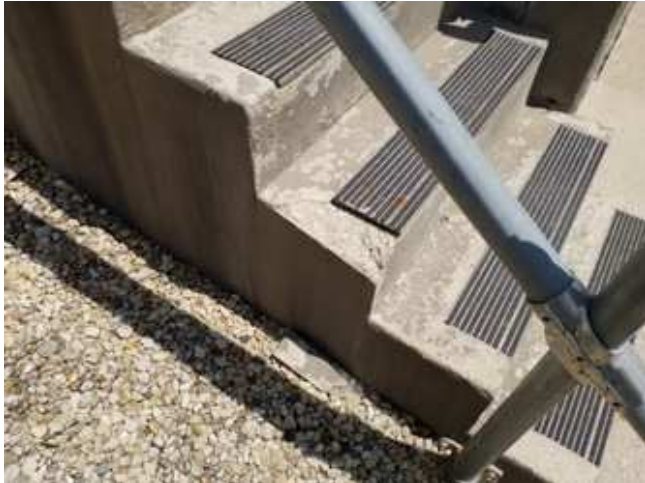
Category:	Pump Stations	Item:	Plant Building
Observation ID:	2023-0013		
Description:	PS-JA: Spalling on outside stair landing platform		
Caption:	0013 - No User Rating (Site Visit) - PS-JA: Spalling on outside stair landing platform		
Lat/Long:	41.57296/-87.51746

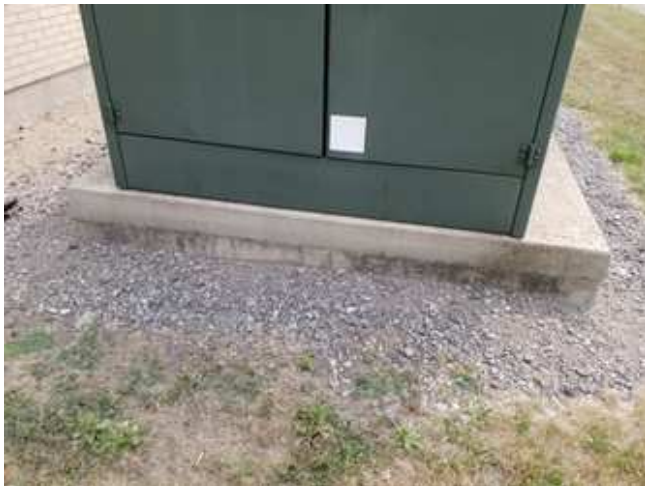
Category:	Pump Stations	Item:	Plant Building
Observation ID:	2023-0161		
Description:	PS-IN: Crack in corner of building foundation		
Caption:	0161 - No User Rating (Site Visit) - PS-IN: Crack in corner of building foundation		
Lat/Long:	41.57474/-87.47533

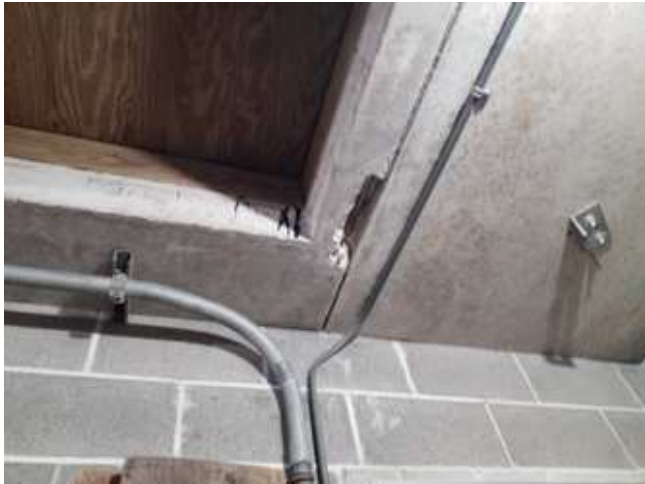
Category:	Pump Stations	Item:	Plant Building
Observation ID:	2023-0217		
Description:	PS-SK: Cracks near building foundation		
Caption:	0217 - No User Rating (Site Visit) - PS-SK: Cracks near building foundation		
Lat/Long:	41.57356/-87.46187

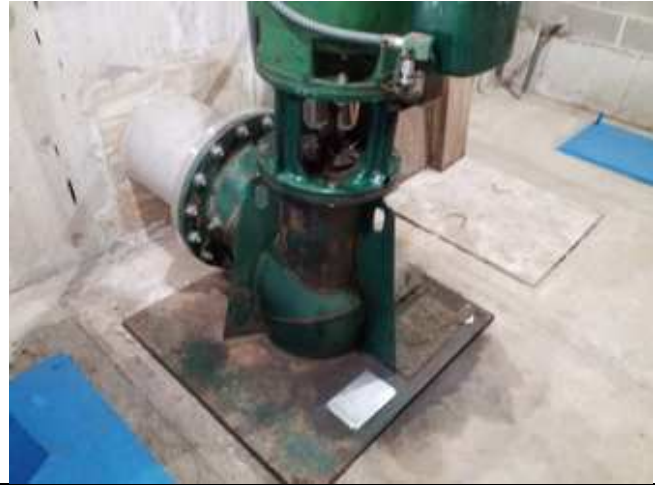
Category:	Pump Stations	Item:	Pumps
Observation ID:	2023-0225		
Description:	PS-KA: Both pumps show signs of corrosion on exposed pump shafts		
Caption:	0225 - No User Rating (Site Visit) - PS-KA: Both pumps show signs of corrosion on exposed pump shafts		
Lat/Long:	41.57048/-87.45833

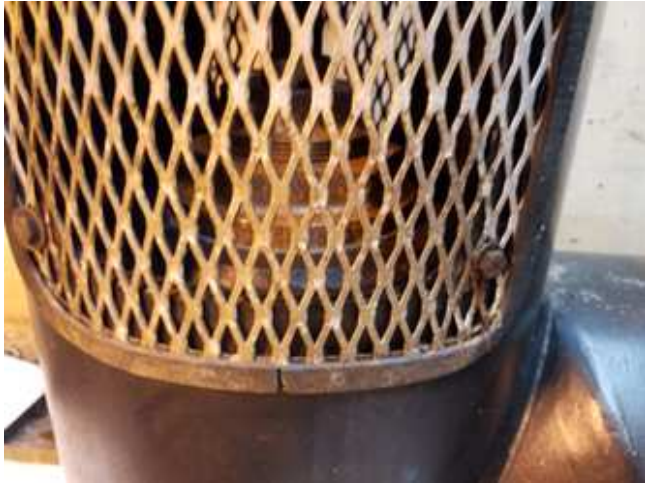
Category:	Pump Stations	Item:	Pumps
Observation ID:	2023-0229		
Description:	PS-KA: Pump 2 housing is corroded. Pump 1 recently painted, in better condition		
Caption:	0229 - No User Rating (Site Visit) - PS-KA: Pump 2 housing is corroded. Pump 1 recently painted, in better condition		
Lat/Long:	41.57048/-87.45828

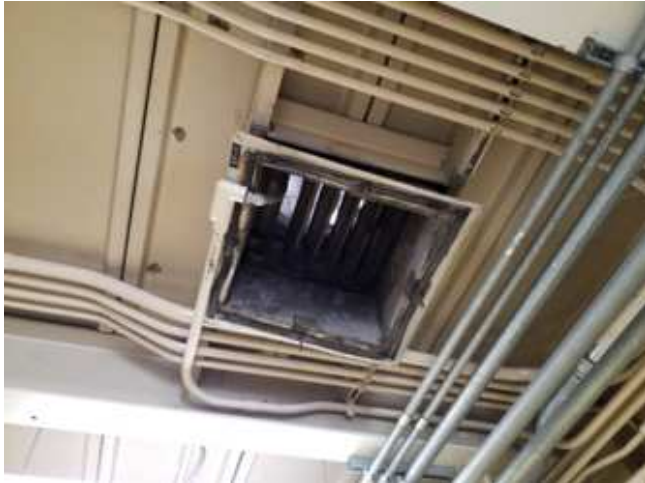
Category:	Pump Stations	Item:	Motors, Engines, Fan
Observation ID:	2023-0089		
Description:	PS-SS: Exhaust fan EF-2 in trash rake room fully operational (noted non-operational in FY22 inspection)		
Caption:	0089 - No User Rating (Site Visit) - PS-SS: Exhaust fan EF-2 in trash rake room fully operational (noted non-operational in FY22 inspection)		
Lat/Long:	41.57345/-87.50060

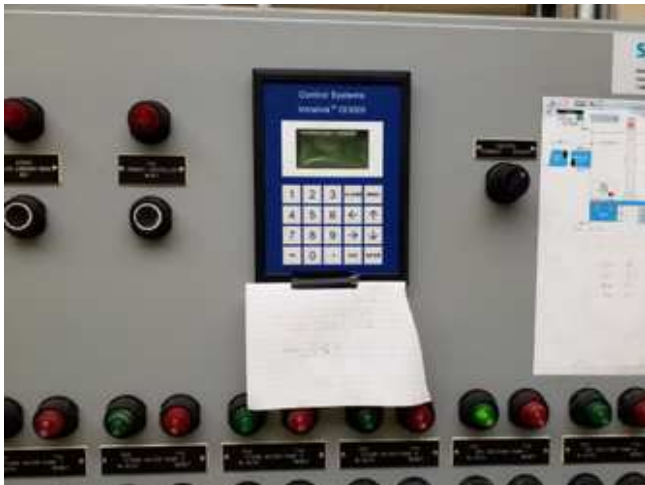
Category:	Pump Stations	Item:	Electrical Systems
Observation ID:	2023-0113		
Description:	PS-WA: Power monitor not operational		
Caption:	0113 - No User Rating (Site Visit) - PS-WA: Power monitor not operational		
Lat/Long:	41.56901/-87.49286

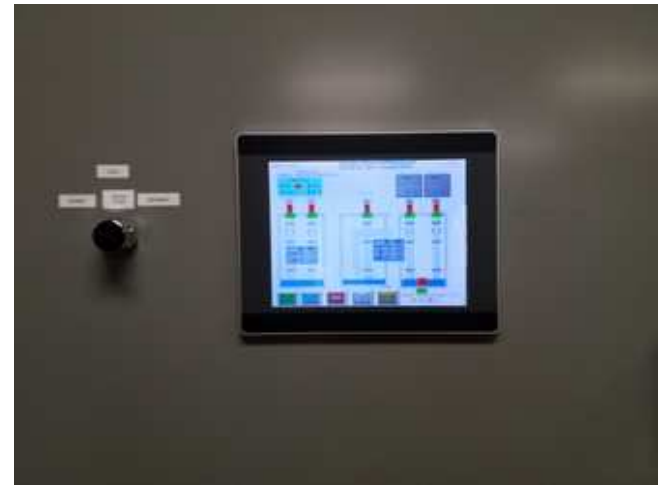
Category:	Pump Stations	Item:	Electrical Systems
Observation ID:	2023-0137		
Description:	PS-IN: PLC is not operational. HSD plans to upgrade system similar to other pump stations		
Caption:	0137 - No User Rating (Site Visit) - PS-IN: PLC is not operational. HSD plans to upgrade system similar to other pump stations		
Lat/Long:	41.57484/-87.47523

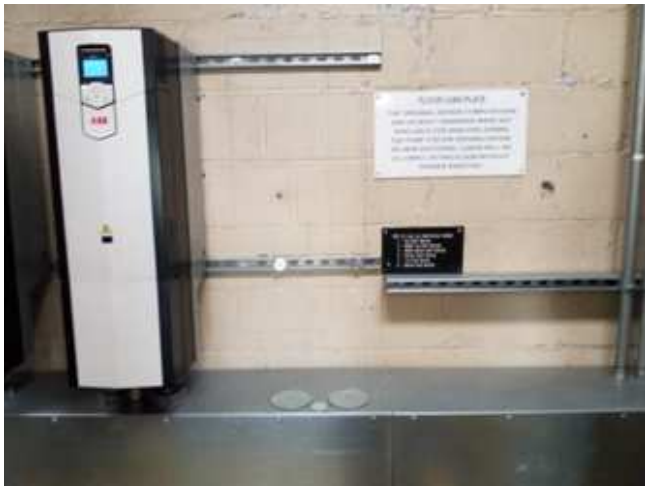
Category:	Pump Stations	Item:	Electrical Systems
Observation ID:	2023-0189		
Description:	PS-SK: New electrical control system and display installed		
Caption:	0189 - No User Rating (Site Visit) - PS-SK: New electrical control system and display installed		
Lat/Long:	41.57362/-87.46186

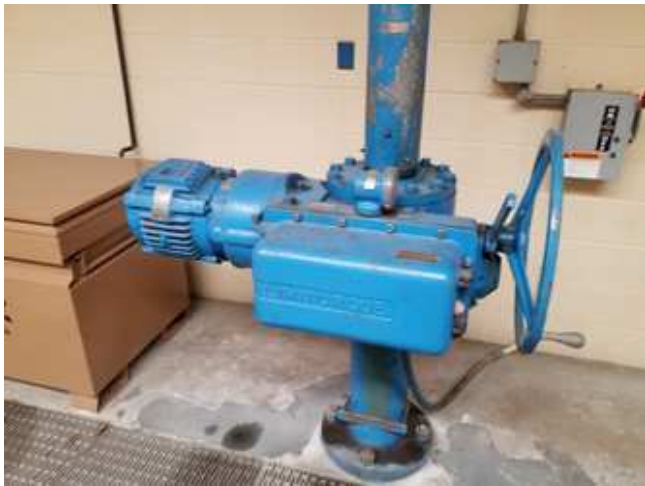
Category:	Pump Stations	Item:	Sluice/ Slide Gates
Observation ID:	2023-0097		
Description:	PS-SS: Influent sluice gate not operational		
Caption:	0097 - No User Rating (Site Visit) - PS-SS: Influent sluice gate not operational		
Lat/Long:	41.57328/-87.50072
