Name of System: Highland	Levee	Inspection Report	
US Army Corps of Engineers ® Name of Segment: Highland 2605000005		NLD Segment ID: 2604000007	
Segment Type: Locally Constructed, Locally Operated and Mainta Levee Sponsor (Name and Organization): Little Calumet River Bas Inspection Report Prepared by: Yuki Galisanao Inspection Report Prepared by: Chris Schaal	in Development Commission	Date(s) of Inspection: 06/08/2023 - 06/08/20	023
Segment Name N	Other LD Segment ID#	Segments Within This System Segment Type	Segment Inspection Rating
Contents of Levee Inspection Report: Levee Inspection Summary General Items	Type of Inspection:	Formal Inspection Special	Inspection (mark this if purpose is Initial Eligibility Inspection)
General Items Levee Embankment Floodwalls Interior Drainage System Pump Stations FRM Channels	Approval Signature:	John A Groboski	Date Approved:
Public Sponsor Pre-Inspection Form National Flood Insurance Program - 44 CFR 65.10 Subset Criteria Evaluation Levee Inspection Reference Guide Photos

No change in rating from Minimally Acceptable since the previous inspection. Minor issues with trees and tall vegetation, sod cover, debris, slope stability, bank erosion, ru

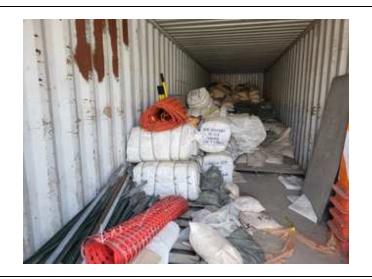
Inspect ID: 2023-0321

2604000007_2023_A_2023-0321_1_20230718T194922.jpg Rated Item: 2. Emergency Supplies and Equipment (A or M only) Caption: 0321 - Acceptable - Highland Public Works has 14 to 16 pallets of sandbags, approximately ten 1000pcs

sandbags, and 1 sand bagger machine.

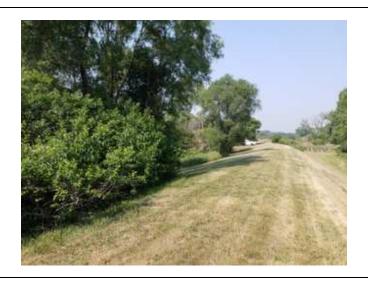
Inspect ID: 2023-0056

Rated Item: 1. Unwanted Vegetation Growth Caption: 0056 - Minimally Acceptable - Vegetation on landside slope

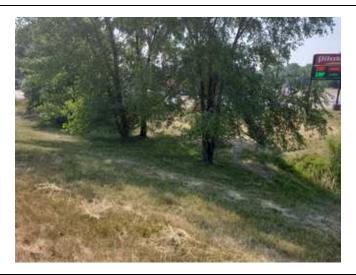
Inspect ID: 2023-0067

Rated Item: 1. Unwanted Vegetation Growth Caption: 0067 -Minimally Acceptable - Large trees (greater than 2 inches in diameter) within 15 ft of landside toe. East of Indianapolis

Blvd

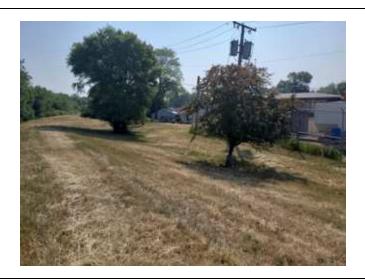
Inspect ID: 2023-0071

Rated Item: 1. Unwanted Vegetation Growth Caption: 0071 - Acceptable - Large trees (greater than 2 inches in diameter) within 15 ft of landside toe. East of Indianapolis Blvd, in

planting zone.

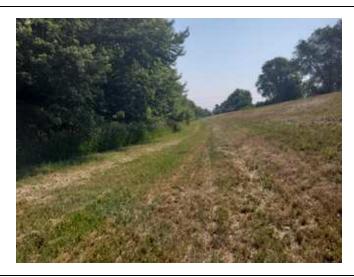
Inspect ID: 2023-0083

Rated Item: 1. Unwanted Vegetation Growth Caption: 0083 - Minimally Acceptable - Vegetation within 15 ft of riverside toe

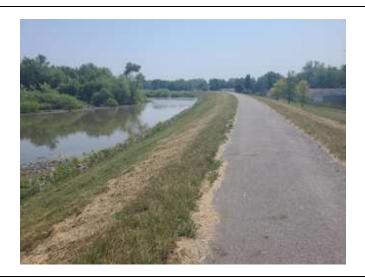
Inspect ID: 2023-0179

Rated Item: 1. Unwanted Vegetation Growth Caption: 0179 - Minimally Acceptable - Vegetation along riverside toe

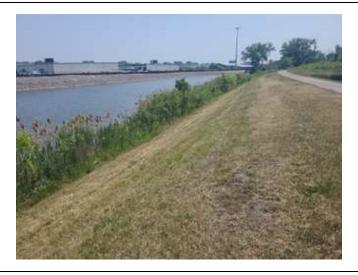
Inspect ID: 2023-0207

Rated Item: 1. Unwanted Vegetation Growth Caption: 0207 - Minimally Acceptable - Vegetation along riverside toe - typical

until HI-9

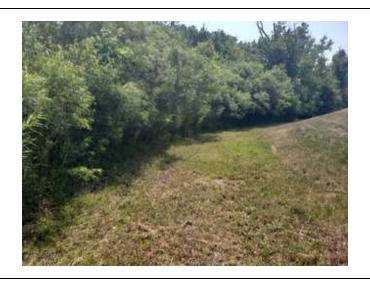
Inspect ID: 2023-0215

Rated Item: 1. Unwanted Vegetation Growth Caption: 0215 - Minimally Acceptable - Vegetation along riverside toe - typical

near HI-9.

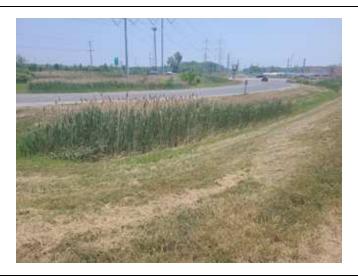
Inspect ID: 2023-0307

Rated Item: 1. Unwanted Vegetation Growth Caption: 0307 - Minimally Acceptable - Vegetation along riverside toe

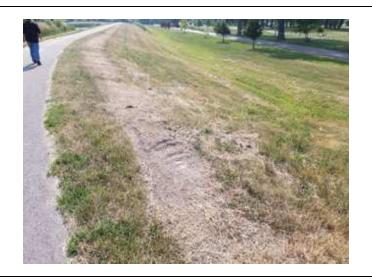
Inspect ID: 2023-0020

Rated Item: 2. Sod Cover Caption: 0020 - Minimally
Acceptable - Poor sod cover on levee crown

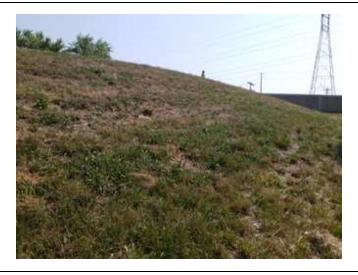
Inspect ID: 2023-0064

Rated Item: 2. Sod Cover Caption: 0064 - Minimally Acceptable - Poor sod cover on landside slope

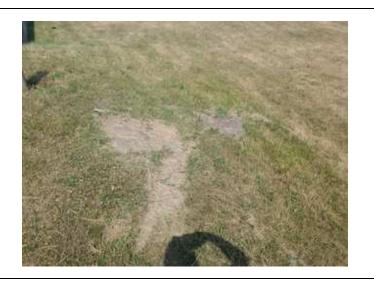
Inspect ID: 2023-0143

Rated Item: 2. Sod Cover Caption: 0143 - Minimally
Acceptable - Poor sod cover on landside slope

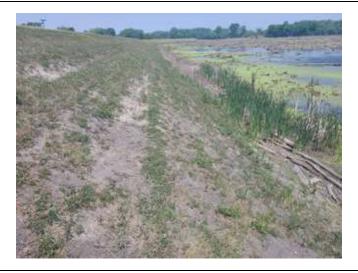
Inspect ID: 2023-0259

Rated Item: 2. Sod Cover Caption: 0259 - Minimally

Acceptable - Poor sod cover on riverside slope

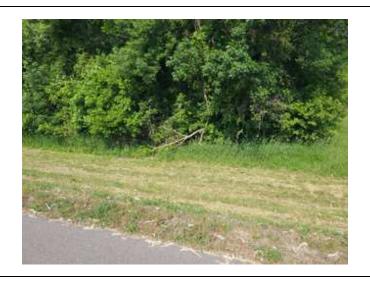
Inspect ID: 2023-0027

Rated Item: 3. Encroachments Caption: 0027 - Minimally

Acceptable - Tree debris along riverside toe

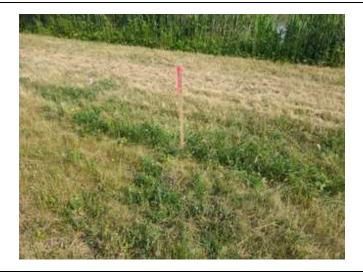
Inspect ID: 2023-0031

Rated Item: 3. Encroachments Caption: 0031 - Minimally Acceptable - Boring stake in soil riverside slope. Confirm that no unapproved borings are occuring in the levee. Label says

"patriot b-9 20 foot".

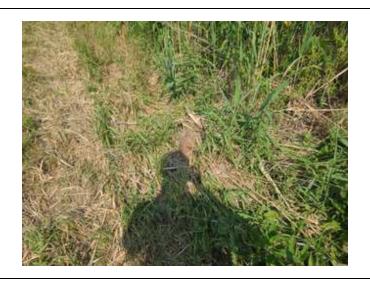
Inspect ID: 2023-0051

Rated Item: 3. Encroachments Caption: 0051 - Minimally Acceptable - Wooden beam near pedestrian bridge on the

riverside toe

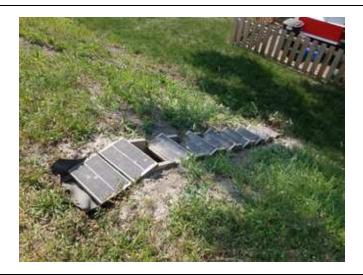
Inspect ID: 2023-0084

Rated Item: 3. Encroachments Caption: 0084 - Minimally

Acceptable - Encroachment in levee embankment

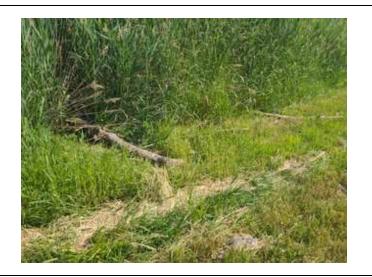
Inspect ID: 2023-0087

Rated Item: 3. Encroachments Caption: 0087 - Minimally Acceptable - Downed logs on riverside levee toe

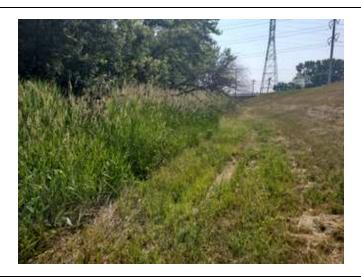
Inspect ID: 2023-0091

Rated Item: 3. Encroachments Caption: 0091 - Minimally

Acceptable - Downed tree on riverside toe

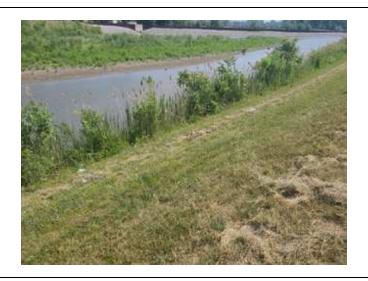
Inspect ID: 2023-0155

Rated Item: 3. Encroachments Caption: 0155 - Minimally
Acceptable - Trash on riverside levee slope

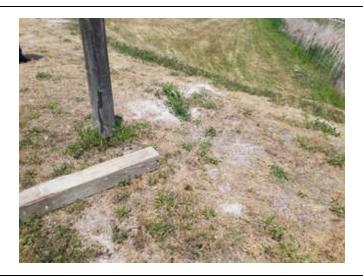
Inspect ID: 2023-0172

Rated Item: 3. Encroachments Caption: 0172 - Minimally Acceptable - Wooden bollard missing on levee crown

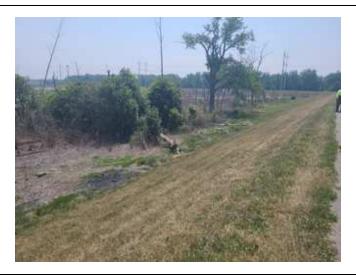
Inspect ID: 2023-0263

Rated Item: 3. Encroachments Caption: 0263 - Minimally

Acceptable - Downed trees on riverside toe

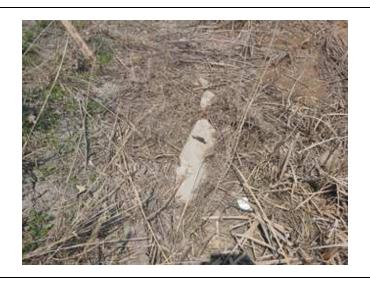
Inspect ID: 2023-0271

Rated Item: 3. Encroachments Caption: 0271 - Minimally
Acceptable - Buried concrete blocks on riverside toe

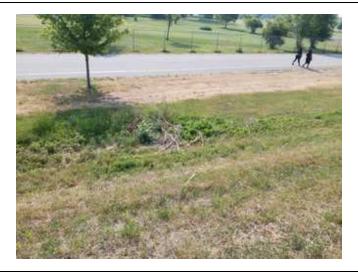
Inspect ID: 2023-0320

2604000007_2023_A_2023-0320_1_20230714T190820.jpg Rated Item: 3. Encroachments Caption: 0320 - Minimally

Acceptable - Tree debris within 15 ft of landside toe

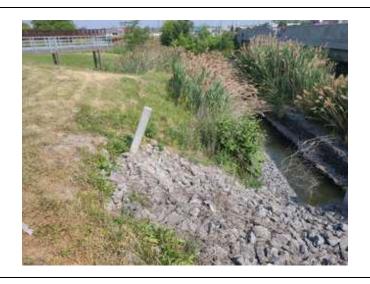
Inspect ID: 2023-0059

Rated Item: 5. Slope Stability Caption: 0059 - Minimally
Acceptable - Slope near HI-3 is slowly slipping downhill. Note

tilting stone bollards.

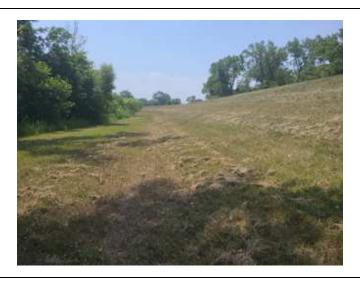
Inspect ID: 2023-0227

Rated Item: 5. Slope Stability Caption: 0227 - Acceptable -

Typical slope condition. No issues.

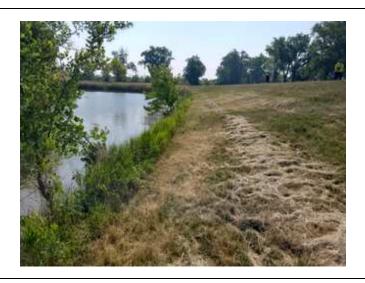
Inspect ID: 2023-0035

Rated Item: 6. Erosion/ Bank Caving Caption: 0035 Minimally Acceptable - Riverside bank erosion up to toe.

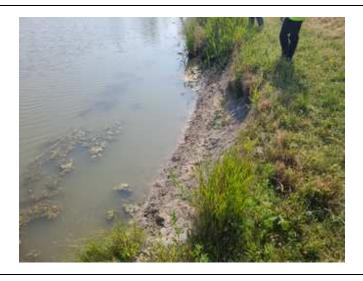
Inspect ID: 2023-0035

Rated Item: 6. Erosion/ Bank Caving Caption: 0035 - Minimally Acceptable - Riverside bank erosion up to toe.

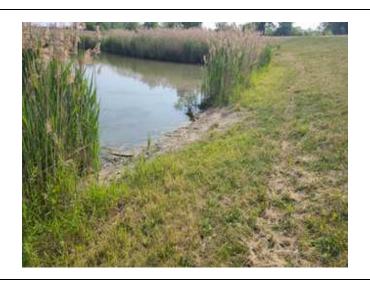
Inspect ID: 2023-0039

2604000007_CELRC_2023_A_2023-0039_1_1686234210193.jpg Rated Item: 6. Erosion/ Bank Caving Caption: 0039 -Minimally Acceptable - Bank erosion near curve on riverside

toe.

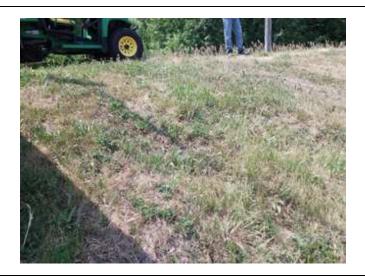
Inspect ID: 2023-0142

Rated Item: 6. Erosion/ Bank Caving Caption: 0142 - Minimally Acceptable - Near HI-11: Minor erosion

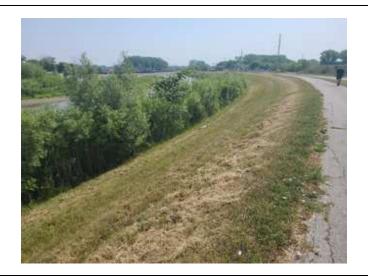
Inspect ID: 2023-0151

Rated Item: 6. Erosion/ Bank Caving Caption: 0151
Minimally Acceptable - Heavy vegetation and possible erosion

of riverside toe

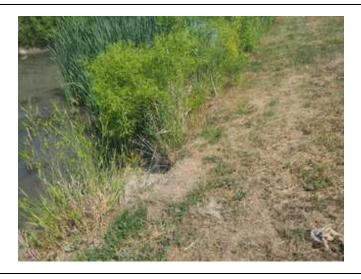
Inspect ID: 2023-0187

Rated Item: 6. Erosion/ Bank Caving Caption: 0187 Minimally Acceptable - Typical erosion and bank caving along

levee riverside toe

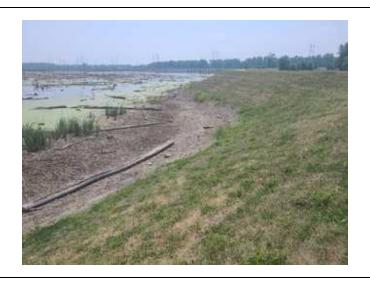
Inspect ID: 2023-0239

Rated Item: 6. Erosion/ Bank Caving Caption: 0239 Minimally Acceptable - Erosion of riverside toe at water level

in rookery

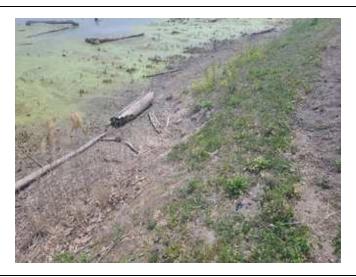
Inspect ID: 2023-0243

Minimally Acceptable - Bank caving in rookery into levee toe. Combination of bank caving and animal activity leading to

sizeable collapses into levee cross section

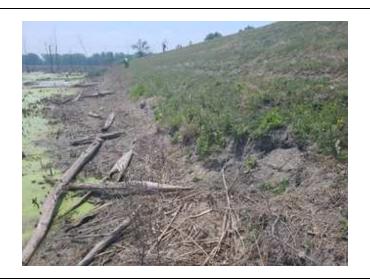
Inspect ID: 2023-0251

0251_1_1686243504943.jpg **Rated Item:** 6. Erosion/ Bank Caving **Caption:** 0251 -Minimally Acceptable - Large caving due to animal burrows

and poor vegetation.

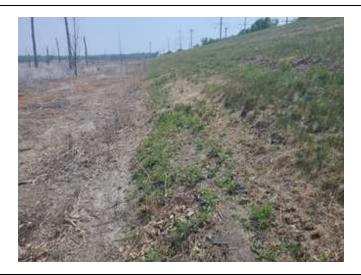
Inspect ID: 2023-0275

Rated Item: 6. Erosion/Bank Caving Caption: 0275 -Minimally Acceptable - Bank scour on riverside toe typical

throughout

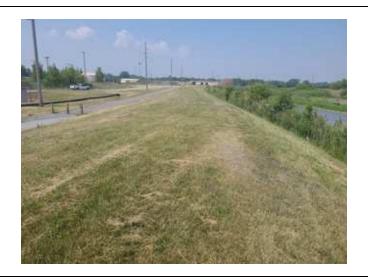
Inspect ID: 2023-0159

Rated Item: 7. Settlement Caption: 0159 - Minimally
Acceptable - Minor low spot in crest

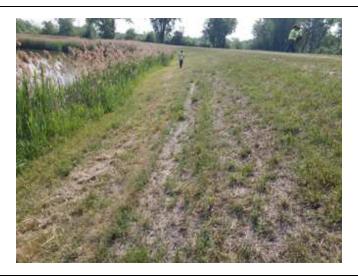
Inspect ID: 2023-0032

Rated Item: 8. Depressions/ Rutting Caption: 0032 - Minimally Acceptable - Rutting on riverside slope

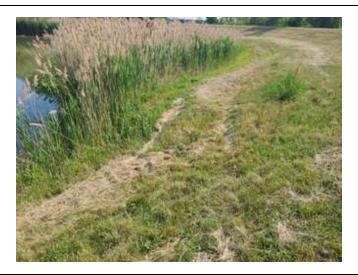
0040_1_1686234570002.jpg

Rated Item: 8. Depressions/ Rutting Caption: 0040 Minimally Acceptable - Rutting on riverside slope

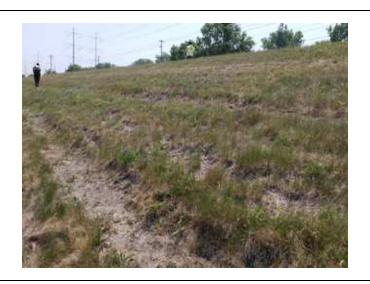
2604000007_CELRC_2023_A_2023-0047_1_1686234336080.jpg Rated Item: 8. Depressions/ Rutting Caption: 0047 -Minimally Acceptable - Depression near riverside toe

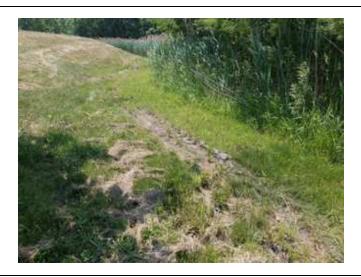
0136_1_1686244284028.jpg

Rated Item: 8. Depressions/ Rutting Caption: 0136 Minimally Acceptable - Rutting on riverside slope

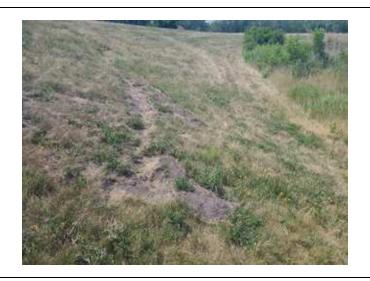
0168 1 1686245666628.jpg

Rated Item: 8. Depressions/ Rutting Caption: 0168 - Minimally Acceptable - Rutting on landside toe

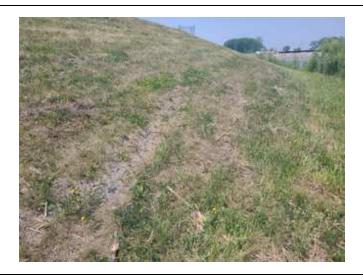
0183_1_1686240765660.jpg

Rated Item: 8. Depressions/ Rutting Caption: 0183 Minimally Acceptable - Rutting on riverside slope

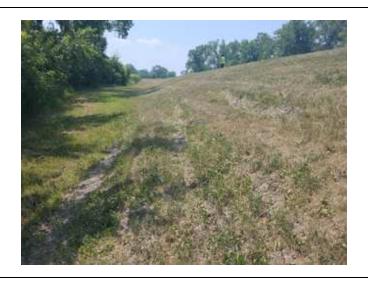
Rated Item: 8. Depressions/ Rutting Caption: 0211 -Minimally Acceptable - 3 inch ruts along outside corner on

riverside slope

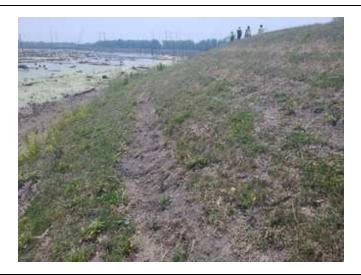
0219_1_1686242085649.jpg

Rated Item: 8. Depressions/ Rutting Caption: 0219 Minimally Acceptable - 4 inch deep ruts on riverside toe

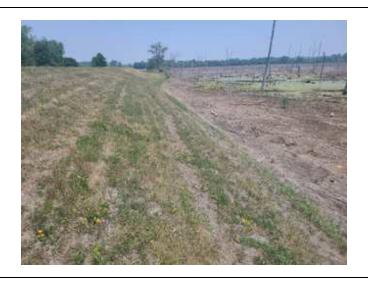
Minimally Acceptable - Poor sod cover and rutting on outside

riverside slope

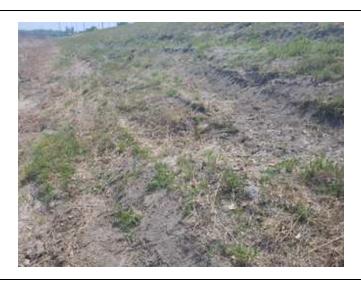
2604000007_CELRC_2023_A_2023-0267_1_1686244012699.jpg Rated Item: 8. Depressions/ Rutting Caption: 0267 -Minimally Acceptable - Rutting on riverside toe

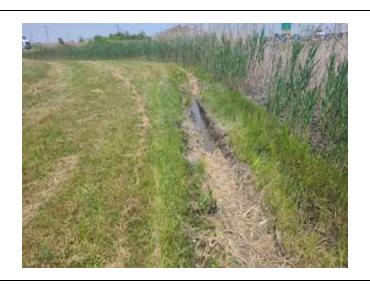
0279 1 1686244407805.jpg

Rated Item: 8. Depressions/ Rutting Caption: 0279 - Minimally Acceptable - Ruts on riverside slope

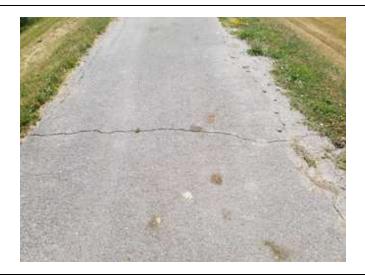
2604000007_CELRC_2023_A_2023-0311_1_1686245667976.jpg Rated Item: 8. Depressions/ Rutting Caption: 0311 -Minimally Acceptable - Very large rut in riverside toe

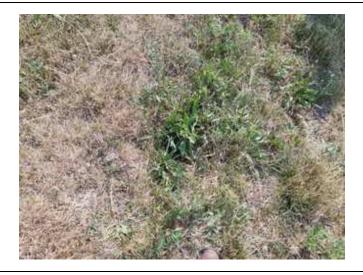
0028_1_1686234096208.jpg

Rated Item: 10. Animal Control Caption: 0028 - Minimally
Acceptable - 4 foot deep animal burrow on waterside slope

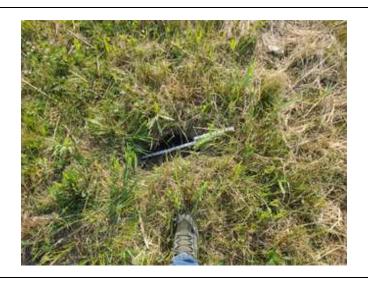
Rated Item: 10. Animal Control Caption: 0036 - Minimally

Acceptable - Burrow on landside slope

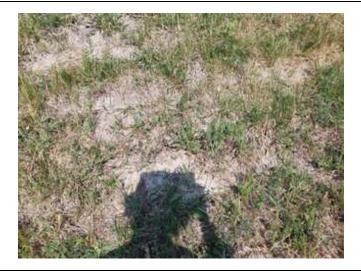
0043_1_1686234284928.jpg

Rated Item: 10. Animal Control Caption: 0043 - Minimally
Acceptable - 28 in deep animal burrow on riverside toe

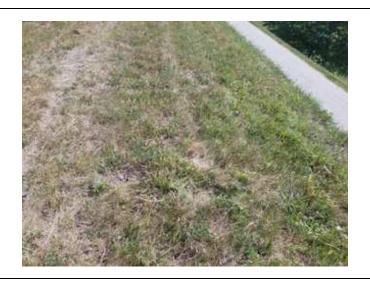
Rated Item: 10. Animal Control Caption: 0044 - Minimally

Acceptable - Burrow on riverside slope

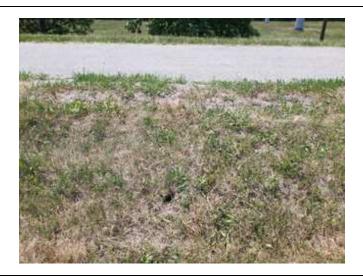
0132_1_1686244230579.jpg

Rated Item: 10. Animal Control Caption: 0132 - Minimally
Acceptable - Animal burrow on riverside slope

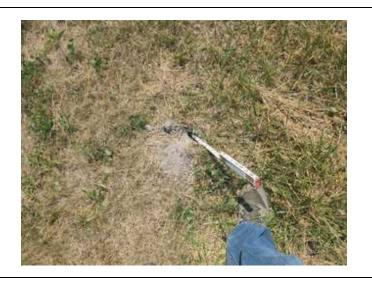
Rated Item: 10. Animal Control Caption: 0140 - Minimally Acceptable - Animal burrow near crest. Typical on south side

of Rookery

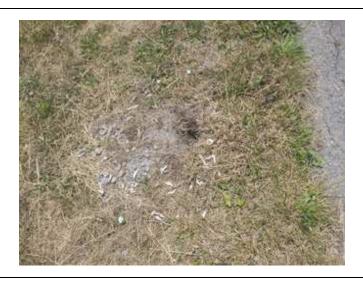
0223_1_1686242122948.jpg

Rated Item: 10. Animal Control Caption: 0223 - Minimally
Acceptable - 16 inch deep animal burrow on riverside toe

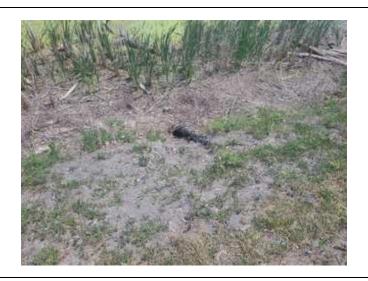
Rated Item: 10. Animal Control Caption: 0235 - Minimally

Acceptable - Animal burrow near levee crest

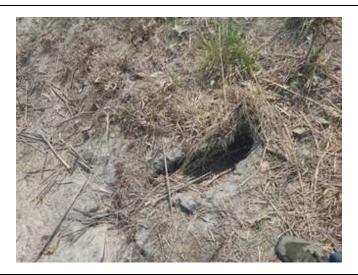
0255_1_1686243620390.jpg

Rated Item: 10. Animal Control Caption: 0255 - Minimally Acceptable - 2 foot wide collapsing burrow on riverside toe.

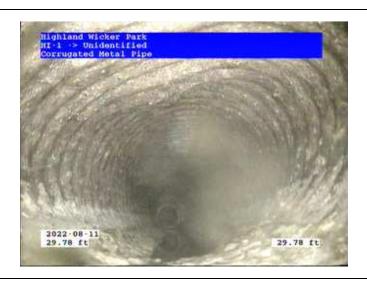
2604000007_2023_A_2023-0322_3_20230724T221333.jpg **Rated Item:** 11. Culverts/ Discharge Pipes (This item includes both concrete and corrugated metal pipes.) **Caption:** 0322 - Minimally Acceptable - Elliptical deformation in corrugated metal pipe, 23.36 feet to 29.78 feet. Creasing at the end.

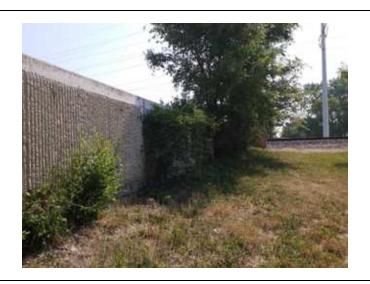
Rated Item: 1. Unwanted Vegetation Growth Caption: 0003 - Minimally Acceptable - Vegetation on floodwall, landside and

riverside

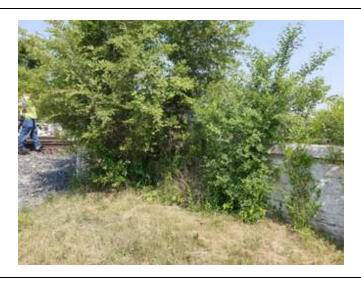
Rated Item: 1. Unwanted Vegetation Growth Caption: 0068 - Minimally Acceptable - Vegetation growing next to floodwall

landside

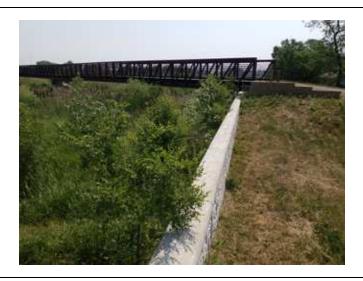
0076 1 1686237097065.jpg

Rated Item: 1. Unwanted Vegetation Growth Caption: 0076 - Minimally Acceptable - Vegetation landside of floodwall

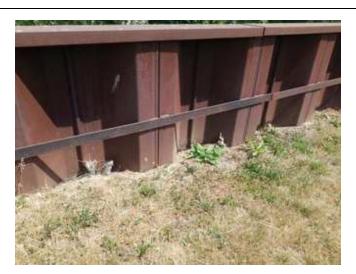
0080_1_1686237375585.jpg

Rated Item: 1. Unwanted Vegetation Growth Caption: 0080 - Minimally Acceptable - Vegetation on riverside of floodwall

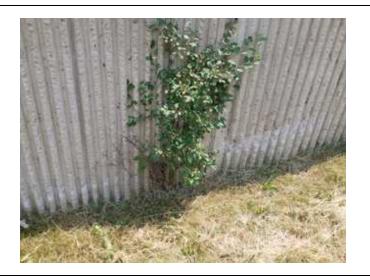
Rated Item: 1. Unwanted Vegetation Growth Caption: 0104 - Minimally Acceptable - Vegetation on landside and root balls

at the landside base

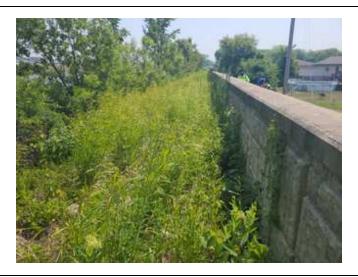
0160_1_1686245361493.jpg

Rated Item: 1. Unwanted Vegetation Growth Caption: 0160 - Minimally Acceptable - Vegetation on landside

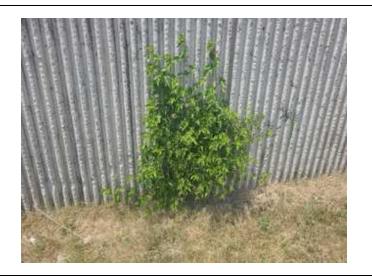
0199 1 1686241280041.jpg

Rated Item: 1. Unwanted Vegetation Growth Caption:
Minimally Acceptable - Vegetation on riverside

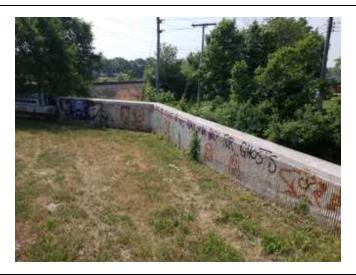
0295_1_1686245232228.jpg

Rated Item: 1. Unwanted Vegetation Growth Caption: 0295 - Minimally Acceptable - Vegetation on landside

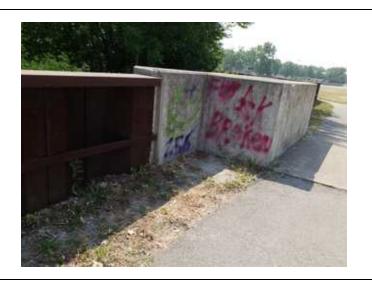
Rated Item: 2. Encroachments Caption: 0108 - Minimally

Acceptable - Graffiti on landside floodwall

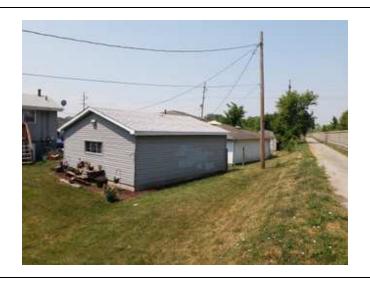
2604000007_CELRC_2023_A_2023-0128_1_1686241871946.jpg

Rated Item: 2. Encroachments Caption: 0128 - Minimally Acceptable - Garages, pole, fencing and barns

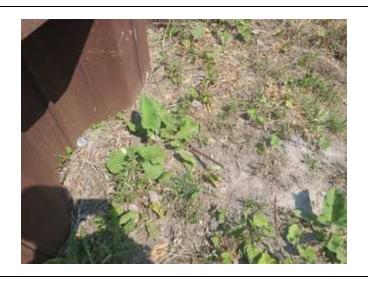
Rated Item: 2. Encroachments Caption: Minimally Acceptable - Debris on riverside face along entire floodwall

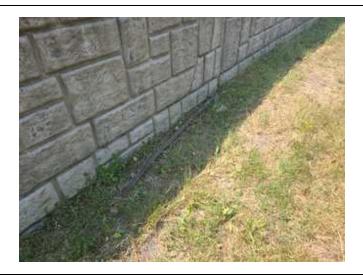
Rated Item: 2. Encroachments Caption: Minimally
Acceptable - Debris on riverside face along entire floodwall

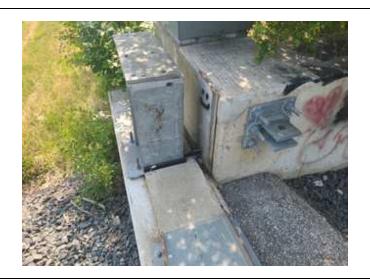
2604000007_CELRC_2023_A_2023-0203_1_1686241528598.jpg **Rated Item:** 2. Encroachments **Caption:** Minimally

Acceptable - Debris on riverside

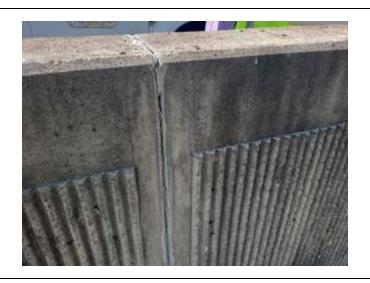
Rated Item: 3. Closure Structures (Stop Log Closures and Gates) (A or U only) Caption: Acceptable - Closure structure

in good condition in Kennedy

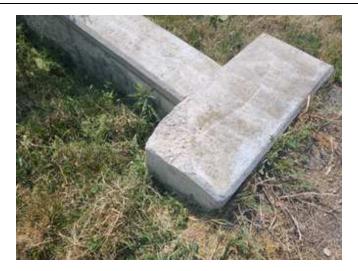
Rated Item: 4. Concrete Surfaces Caption: Minimally
Acceptable - Typical hairline surface cracking

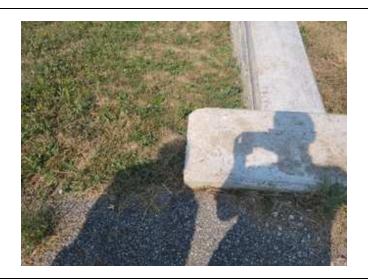
Rated Item: 4. Concrete Surfaces Caption: 0111 - Minimally Acceptable - Concrete spalling on tie in to levee embankment

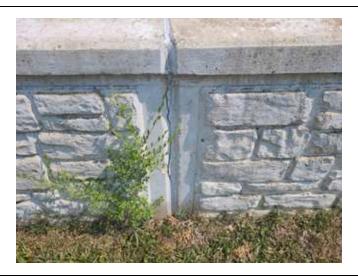
Rated Item: 4. Concrete Surfaces Caption: Minimally
Acceptable - Typical surface hairline cracks in cap

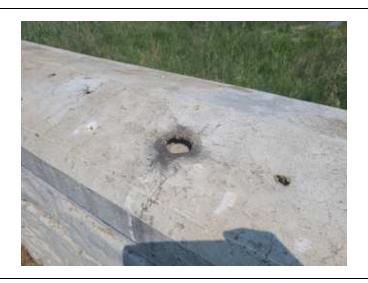
Rated Item: 4. Concrete Surfaces Caption: 0127 - Minimally

Acceptable - Typical concrete cracking near joint

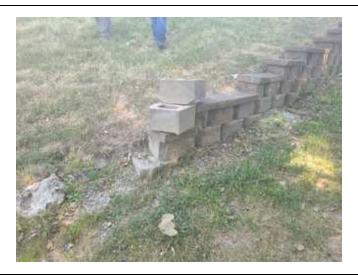
Rated Item: 4. Concrete Surfaces Caption: 0315 - Minimally Acceptable - Spalling on median floodwall. Typical

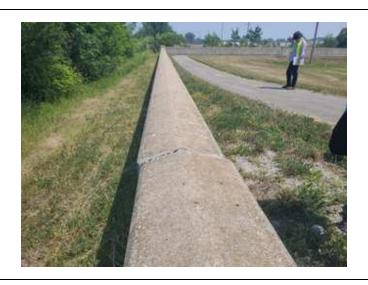
Rated Item: 5. Tilting, Sliding or Settlement of Concrete Structures Caption: 0115 - Minimally Acceptable - Blocks for

the retaining wall near pedestrian bridge are displaced

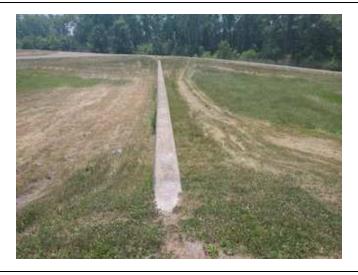
Rated Item: 5. Tilting, Sliding or Settlement of Concrete Structures Caption: Minimally Acceptable - Misaligned

floodwall tilting out towards river

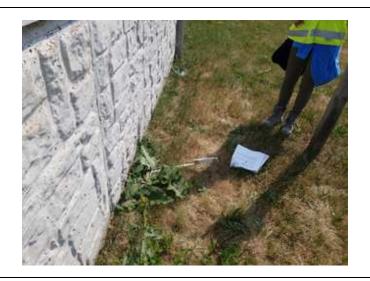
Rated Item: 5. Tilting, Sliding or Settlement of Concrete Structures Caption: Minimally Acceptable - Misalignment of

floodwall

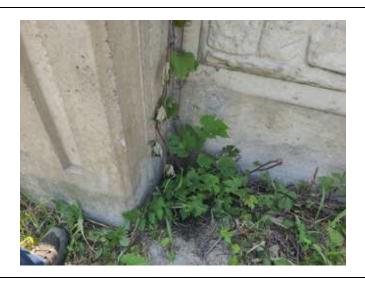
Rated Item: 6. Foundation of Concrete Structures Caption:

Minimally Acceptable - Animal burrows under closure

structure

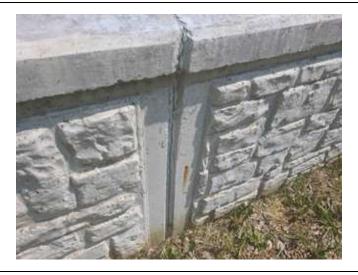
Rated Item: 7. Monolith Joints Caption: 0116 - Minimally
Acceptable - Joint sealant deteriorated

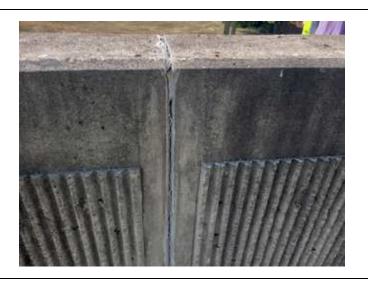
Rated Item: 7. Monolith Joints Caption: Minimally

Acceptable

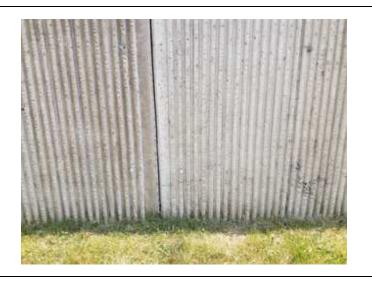
2604000007_CELRC_2023_A_2023-0139_1_1686238754709.jpg Rated Item: 7. Monolith Joints Caption: Minimally Acceptable - Typical monolith joint cracking of sealant

riverside

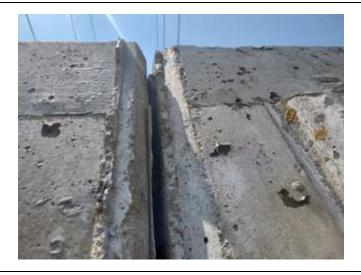
Rated Item: 7. Monolith Joints Caption: 0291 - Minimally
Acceptable - No sealant on joint

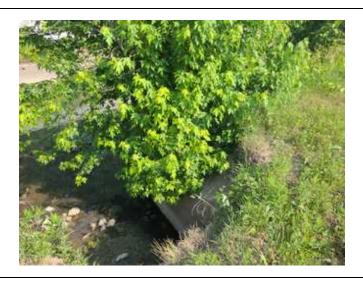
Rated Item: 1. Vegetation and Obstructions Caption: 0007 Minimally Acceptable - HI-1: Vegetation wedged in tideflex

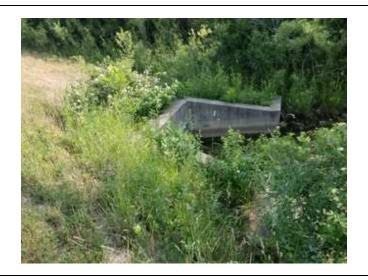
Rated Item: 1. Vegetation and Obstructions Caption: 0019 - Minimally Acceptable - HI-02: Vegetation around outlet

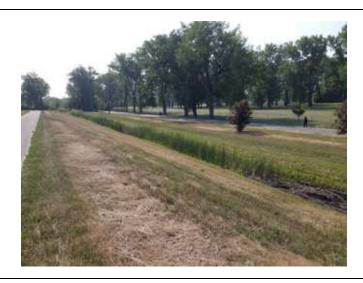
Rated Item: 1. Vegetation and Obstructions Caption: 0022 Minimally Acceptable - HI-03: Vegetation around headwall

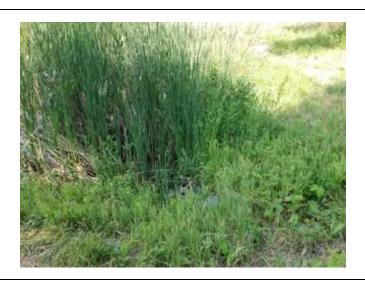
Rated Item: 1. Vegetation and Obstructions Caption: 0024 - Minimally Acceptable - Vegetation in landside ditch

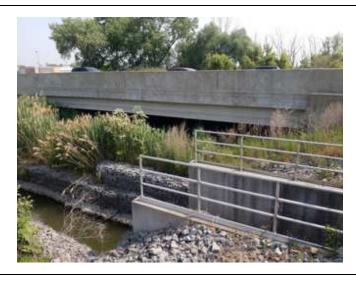
Rated Item: 1. Vegetation and Obstructions Caption: 0034 - Minimally Acceptable - HI-5: Vegetation around inlet

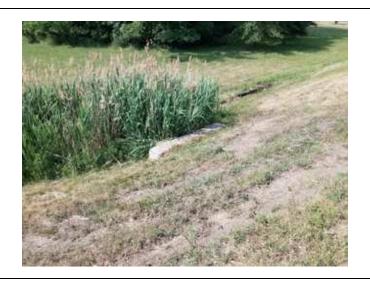
Rated Item: 1. Vegetation and Obstructions Caption: 0048 - Minimally Acceptable - HI-4: Vegetation growth along outlet

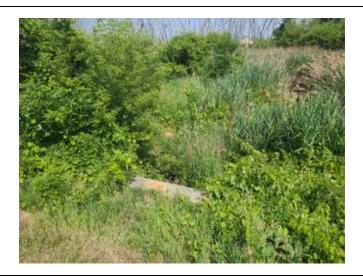
Rated Item: 1. Vegetation and Obstructions Caption:
Minimally Acceptable - HI-09: Vegetation close to inlet

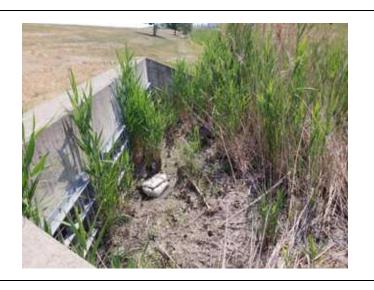
Rated Item: 1. Vegetation and Obstructions **Caption:** 0075 - Minimally Acceptable - HI-06: Heavy vegetation around outlet

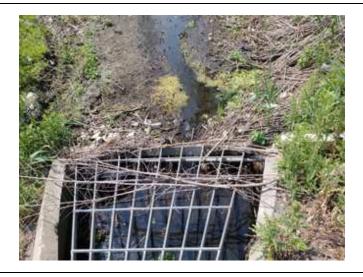
Rated Item: 1. Vegetation and Obstructions Caption: 0114 - Minimally Acceptable - HI-10A,B,C,D: Vegetation and

sediment build up around inlet structure

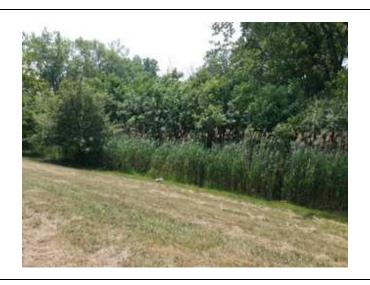
Minimally Acceptable - HI-11: Large amount of debris,

sediment, and vegetation blocking inlet

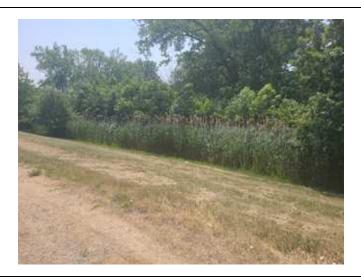
Rated Item: 1. Vegetation and Obstructions Caption:
Minimally Acceptable - Vegetation in landside ditch

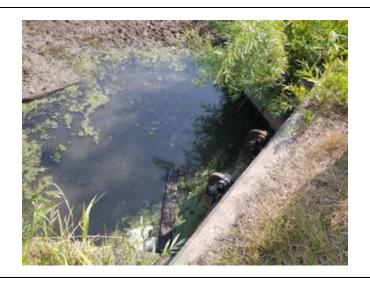
Rated Item: 1. Vegetation and Obstructions Caption: Minimally Acceptable - Vegetation in landside ditch

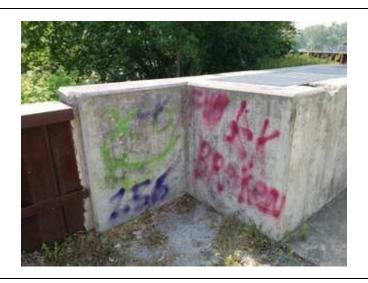
Rated Item: 2. Encroachments Caption: Minimally Acceptable - HI-7A: Graffiti on gatewell

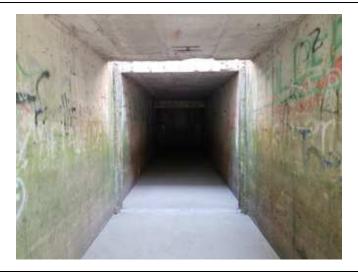
2604000007_CELRC_2023_A_2023-0042_1_1686236441787.jpg Rated Item: 2. Encroachments Caption: Minimally Acceptable - HI-7B: Graffiti on concrete surfaces

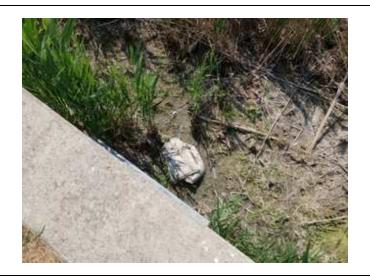
Rated Item: 2. Encroachments Caption: Minimally Acceptable - HI-7B: Encroachments in gate structure

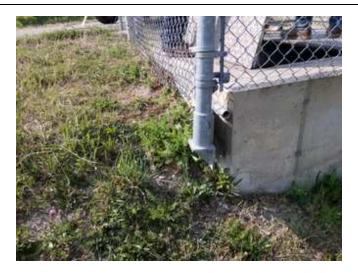
Rated Item: 2. Encroachments Caption: Minimally
Acceptable - HI-10B: Sandbag debris

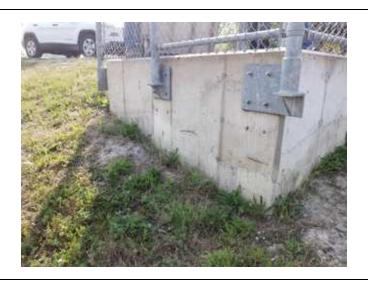
Rated Item: 4. Fencing and Gates Caption: Minimally
Acceptable - HI-03: Fencing unsecured to wall

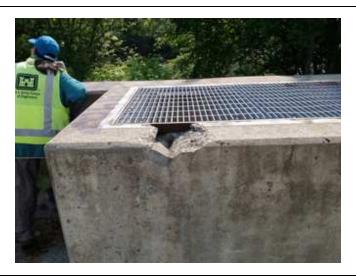
Rated Item: 5. Concrete Surfaces (Such as gatewells, outfalls, intakes, or culverts) Caption: 0006 - Minimally Acceptable -

HI-03: Wall damage from mower

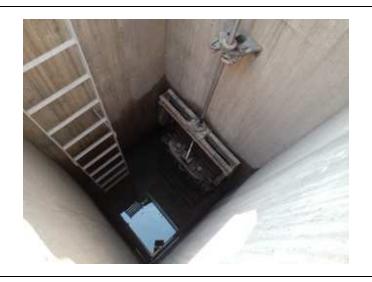
Rated Item: 10. Sluice / Slide Gates Caption: Acceptable -

HI-03: Gate closed, no issues

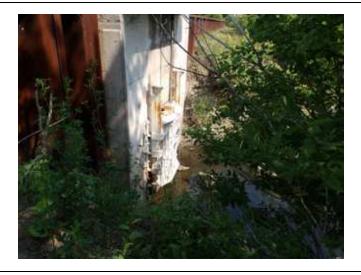
Rated Item: 10. Sluice / Slide Gates Caption: Minimally
Acceptable - HI-5: Minor squeaking during closing.

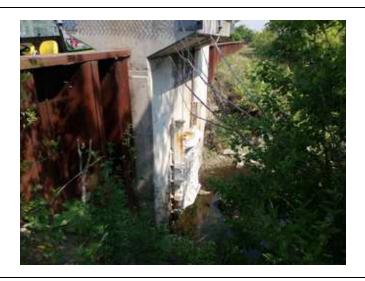
Rated Item: 10. Sluice / Slide Gates Caption: 0054 -Minimally Acceptable - HI-7A: Gate closed, no issues

observed

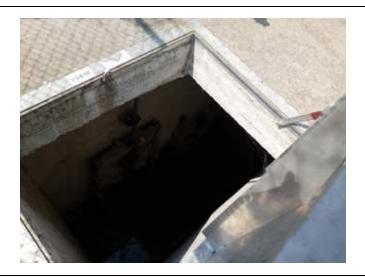
Rated Item: 10. Sluice / Slide Gates Caption: Minimally
Acceptable - HI-10D: Minor sediment in gatewell

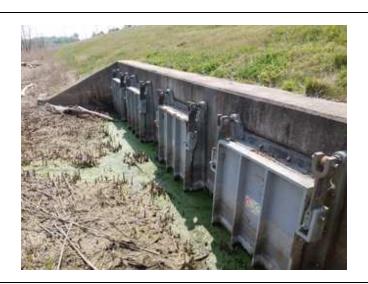
Rated Item: 10. Sluice / Slide Gates Caption: 0090 -Acceptable - HI-10C: Gate closed, no issues observed

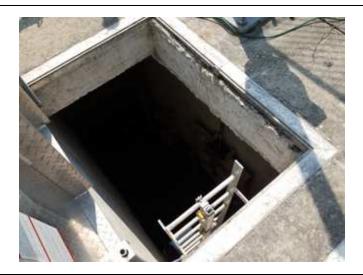
Rated Item: 10. Sluice / Slide Gates Caption: Minimally

Acceptable - HI-10B: Eroded seal

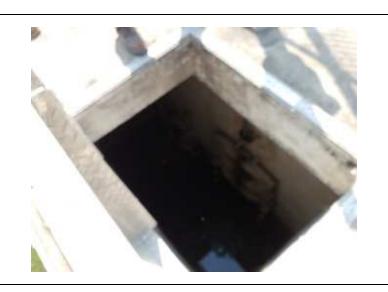
Rated Item: 10. Sluice / Slide Gates Caption: Minimally Acceptable - HI-10D:Gate closed, loud squeaking of rust

present during operation

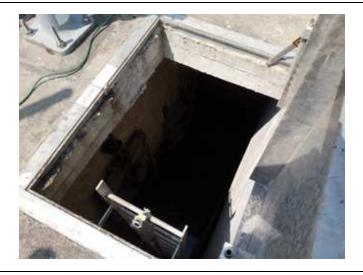
Rated Item: 10. Sluice / Slide Gates Caption: Acceptable -

HI-10B: Gate closed

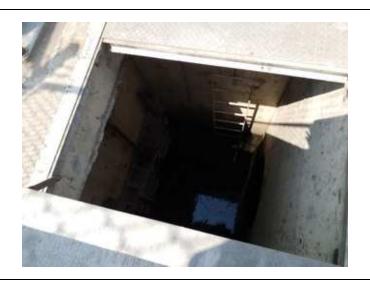
2604000007_CELRC_2023_A_2023-0118_1_1686240073974.jpg **Rated Item:** 10. Sluice / Slide Gates **Caption:** 0118 -Acceptable - HI-10A:Gate closed, no issue observed

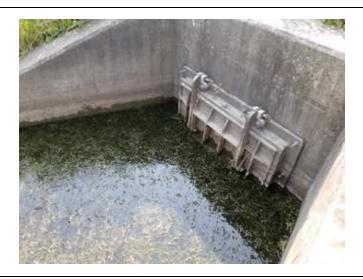
Rated Item: 10. Sluice / Slide Gates Caption: 0138 - Acceptable - HI-11: Gate closed, no issue observed

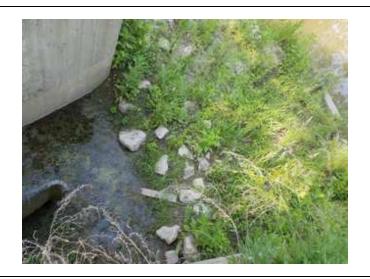
Rated Item: 11. Flap Gates/ Flap Valves/ Pinch Valves Caption: Acceptable - HI-03: Gate closed upon arrival, no

issues

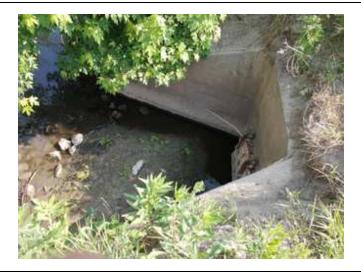
Caption: 0004 - Minimally Acceptable - HI-01: Vegetation in

outlet

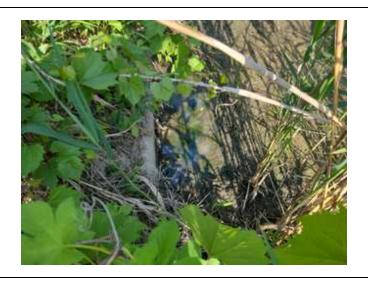
Rated Item: 11. Flap Gates/ Flap Valves/ Pinch Valves
Caption: 0012 - Minimally Acceptable - HI-02: Soil in front of

flap gate. Flap gate in good condition

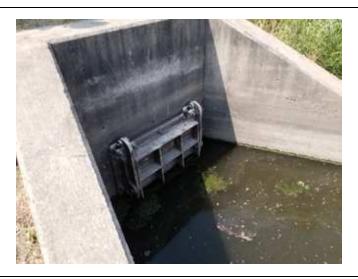
Caption: 0055 - Minimally Acceptable - HI-3 west: Flapgate

completely silted in

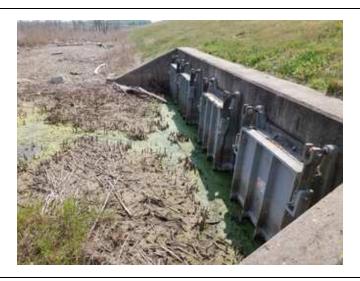
Caption: 0079 - Minimally Acceptable - HI-06: Flap gate

slightly ajar

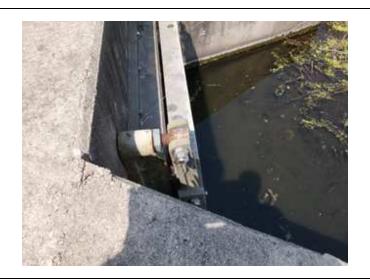
Rated Item: 11. Flap Gates/ Flap Valves/ Pinch Valves Caption: Minimally Acceptable - HI-10ABCD: Sediment

build up around outlet structure

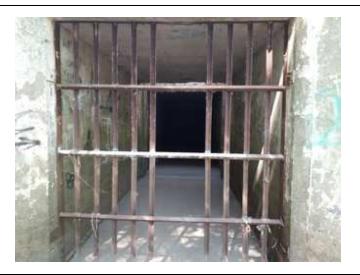
Rated Item: 11. Flap Gates/ Flap Valves/ Pinch Valves

Caption: Minimally Acceptable - HI-11: Flapgate not closed

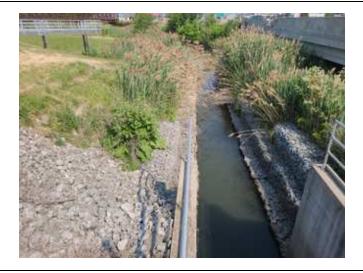
Caption: 0008 - Minimally Acceptable - Erosion on right bank

of HI-1

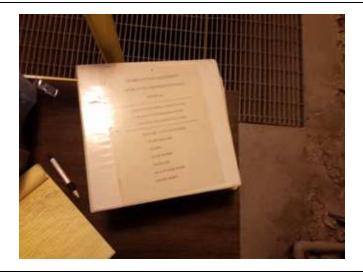
Rated Item: 2. Pump Station Operations and Maintenance
Equipment Manuals Caption: Acceptable - PS-81: Operations

manuals present on site.

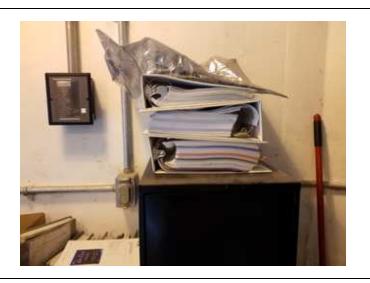
Rated Item: 2. Pump Station Operations and Maintenance Equipment Manuals **Caption:** Acceptable - PS-N5: Operations

manuals present on site.

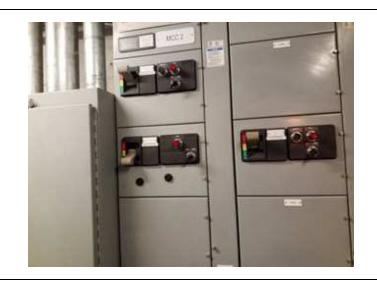
Rated Item: 3. Safety Compliance Caption: 0009 - Minimally Acceptable - PS-81: Arc flash labels need to be added to MCC

- PS-81

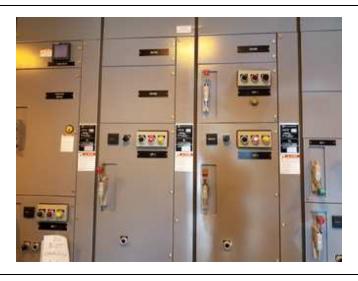
Rated Item: 3. Safety Compliance Caption: 0081 - Minimally
Acceptable - PS-N5: Arc flash labels are not present - PS-N5

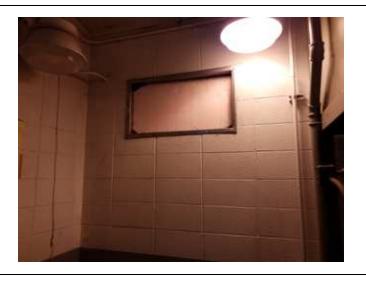
Rated Item: 5. Plant Building Caption: 0001 - Minimally Acceptable - PS-81: Bird nests in ventilation louvers. Currently have insulation on inside for bird noises. Monitor for further

activity and remove if necessary. - PS-81

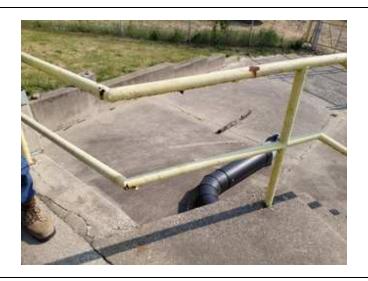
Rated Item: 5. Plant Building Caption: 0021 - Minimally Acceptable - PS-81: Gates of walkway have cracking, rusting,

and paint chipping. Recommend repairing. - PS-81

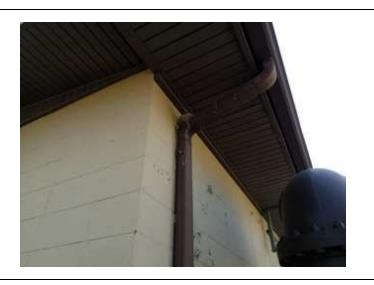
Rated Item: 5. Plant Building Caption: Minimally Acceptable - PS-81: Cracking on exterior of building. Recommend for

repair.

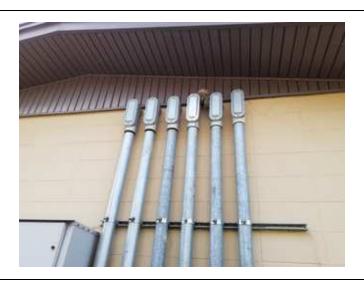
Rated Item: 5. Plant Building Caption: 0033 - Minimally Acceptable - PS-81: Birds nests also located on exterior within exhaust fans and gutters. Monitor for building and remove if

necessary. Recommend removal. - PS-81

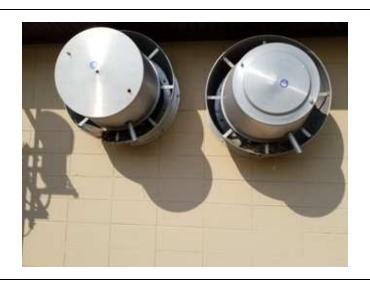
Rated Item: 5. Plant Building Caption: 0033 - Minimally Acceptable - PS-81: Birds nests also located on exterior within exhaust fans and gutters. Monitor for building and remove if

necessary. Recommend removal. - PS-81

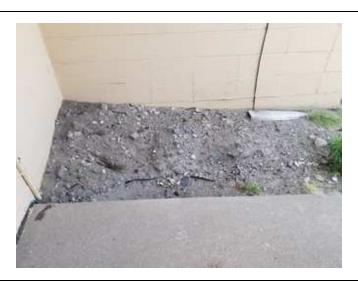
Rated Item: 5. Plant Building Caption: 0033 - Minimally Acceptable - PS-81: Birds nests also located on exterior within exhaust fans and gutters. Monitor for building and remove if

necessary. Recommend removal. - PS-81

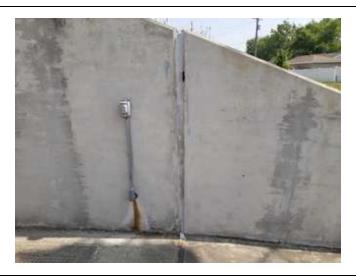
Rated Item: 5. Plant Building Caption: Minimally Acceptable - PS-ND: Weather seal and expansion joint missing on south side. 4 inch crack on top. Joint deteriorating on north side. Install survey points to monitor abutment movement.

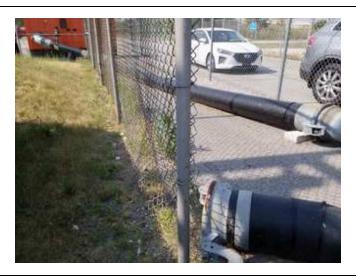
Rated Item: 6. Fencing and Gates **Caption:** 0041 - Minimally Acceptable - PS-N5: Bending and rusting of gates. Vegetation

growing on fencing as well - PS-N5

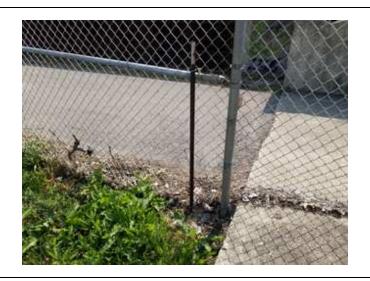
Rated Item: 6. Fencing and Gates **Caption:** 0041 - Minimally Acceptable - PS-N5: Bending and rusting of gates. Vegetation

growing on fencing as well - PS-N5

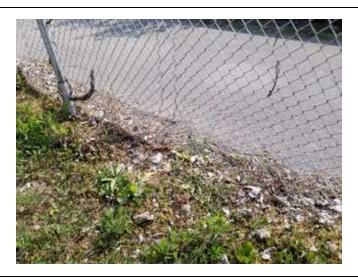
Rated Item: 6. Fencing and Gates **Caption:** 0041 - Minimally Acceptable - PS-N5: Bending and rusting of gates. Vegetation

growing on fencing as well - PS-N5

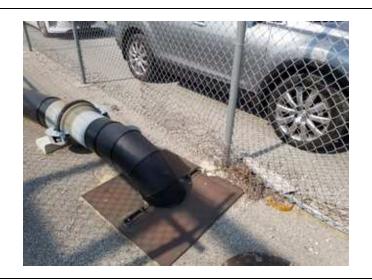
Inspect ID: 2023-0045

Rated Item: 6. Fencing and Gates Caption: Acceptable - PS-

N5: For sanitary purposes.

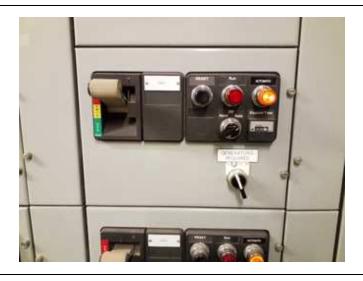
Inspect ID: 2023-0057

Rated Item: 7. Pumps Caption: Acceptable - PS-N5: DWP-1 was fixed from last inspection.

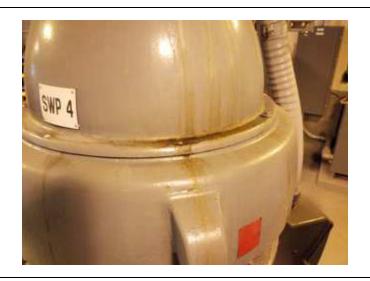
Inspect ID: 2023-0061

Rated Item: 7. Pumps Caption: Minimally Acceptable - PS-N5: Missing bolts on top of pump SWP-4. Evidence of leakage coming from the holes. Recommend replacing missing bolts.

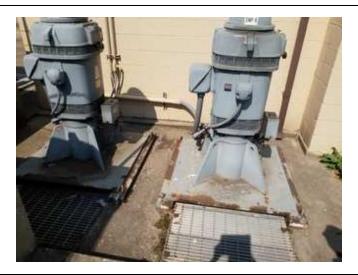
Inspect ID: 2023-0085

Rated Item: 7. Pumps **Caption:** Minimally Acceptable - PS-N5: Pumps SWP-6 and SWP-7 machinery base is corroded.

Recommend cleaning and repainting.

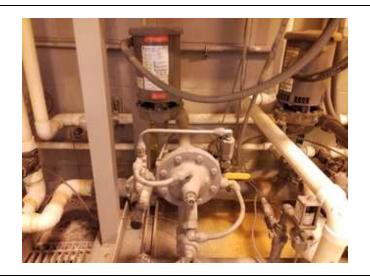
Inspect ID: 2023-0089

Rated Item: 7. Pumps Caption: Acceptable - PS-N5: Seal

water system pumps replaced and now operable.

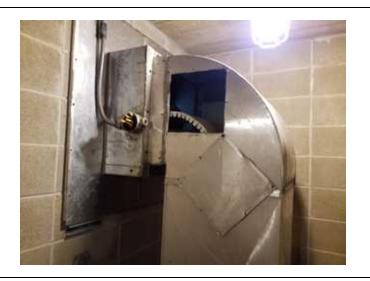
Inspect ID: 2023-0077

Rated Item: 8. Motors, Engines, Fans, Gear Reducers, Back Stop Devices, etc. Caption: 0077 - Minimally Acceptable -

PS-N5: Exhaust fan EF-3 is inoperable - PS-N5

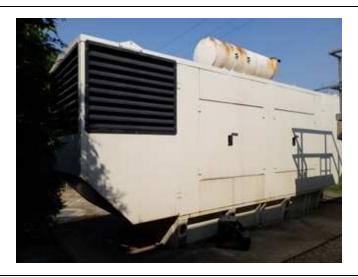
Inspect ID: 2023-0025

Rated Item: 13. Power Source Caption: 0025 - Acceptable - PS-81: Generator is in good condition and has 633.2 runtime hours. New generator is scheduled to be installed - PS-81

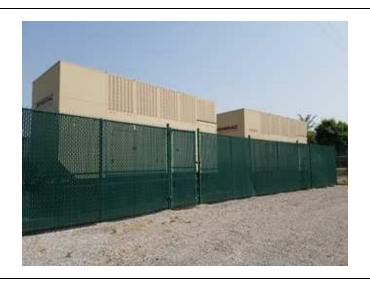
Inspect ID: 2023-0093

Rated Item: 13. Power Source Caption: 0093 - Acceptable - PS-N5: Generators are in good condition. Generator 1 has 402 hours runtime. Generator 2 has 371.2 hours runtime. Generator 3 has 380.7 hours runtime. Generator 4 has 376.1 hours

runtime - PS-N5

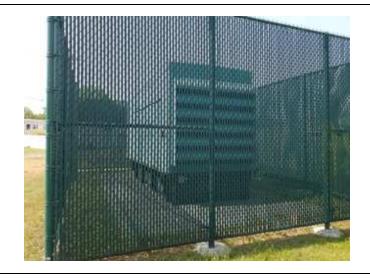
Inspect ID: 2023-0125

Rated Item: 13. Power Source Caption: 0125 - Acceptable - PS-ND: Generator is in good condition and has 551.8 hours

runtime - PS-ND

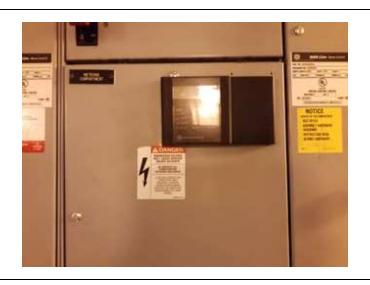
Inspect ID: 2023-0013

Rated Item: 14. Electrical Systems Caption: 0013 - Minimally Acceptable - PS-81: Power quality meter is out of

service - PS-81

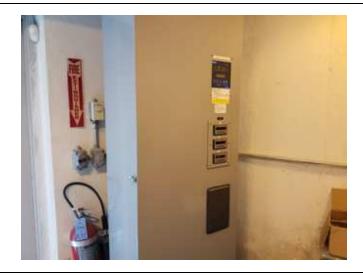
Inspect ID: 2023-0113

Acceptable - PS-ND: Transfer switch is not operational. Project

personnel indicated they have ordered a new one.
