**US Army Corps  
of Engineers ®**

## Site Visit Summary

Name of System: Munster

Date of Site Visit: 06/05/2023 - 06/05/2023

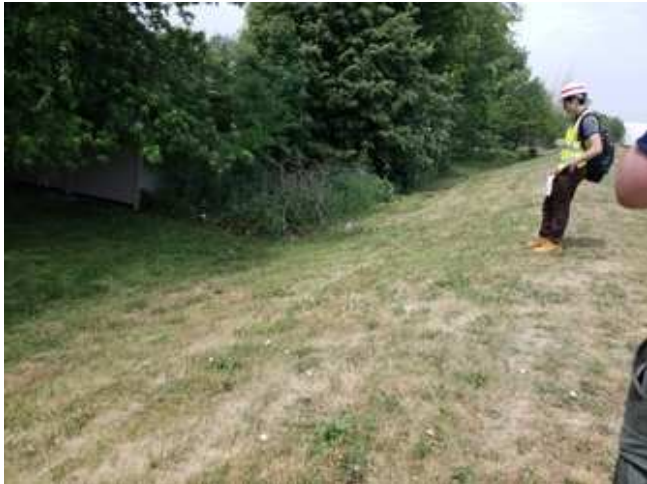
Category:	Levee Embankments	Item:	Unwanted Vegetation
Observation ID:	2023-0023		
Description:	Unwanted trees along landside toe		
Caption:	0023 - No User Rating (Site Visit) - Unwanted trees along landside toe		
Lat/Long:	41.56595/-87.48210

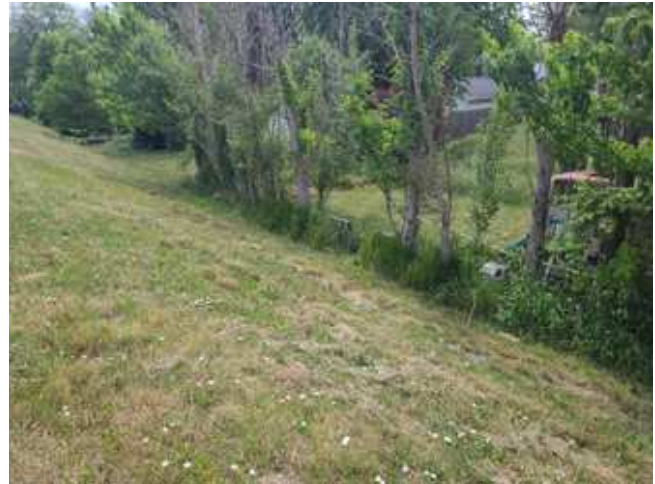
Category:	Levee Embankments	Item:	Unwanted Vegetation
Observation ID:	2023-0080		
Description:	Unwanted trees along landside toe		
Caption:	0080 - No User Rating (Site Visit) - Unwanted trees along landside toe		
Lat/Long:	41.57122/-87.51097

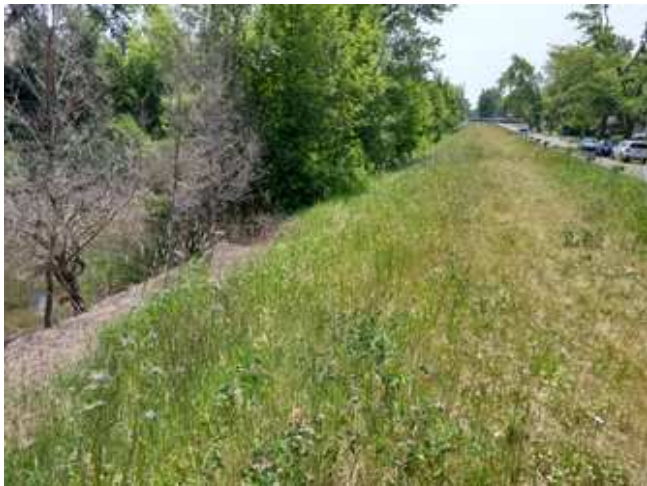
Category:	Levee Embankments	Item:	Unwanted Vegetation
Observation ID:	2023-0103		
Description:	Unwanted vegetation and debris on landside toe		
Caption:	0103 - No User Rating (Site Visit) - Unwanted vegetation and debris on landside toe		
Lat/Long:	41.57148/-87.51230

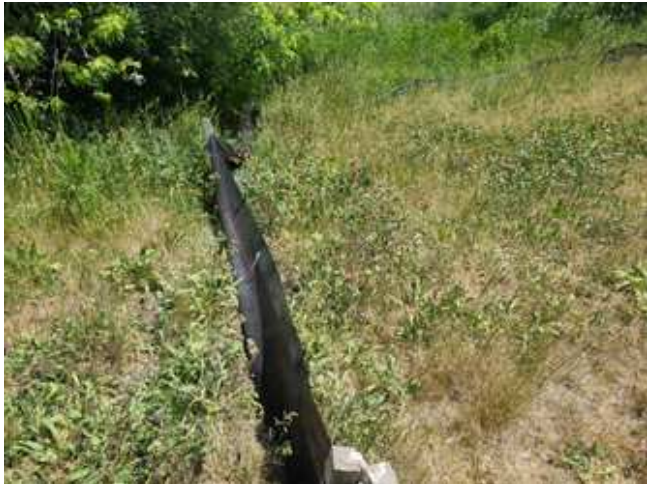
Category:	Levee Embankments	Item:	Encroachments
Observation ID:	2023-0107		
Description:	Fence encroachments on landside toe		
Caption:	0107 - No User Rating (Site Visit) - Fence encroachments on landside toe		
Lat/Long:	41.57147/-87.51260

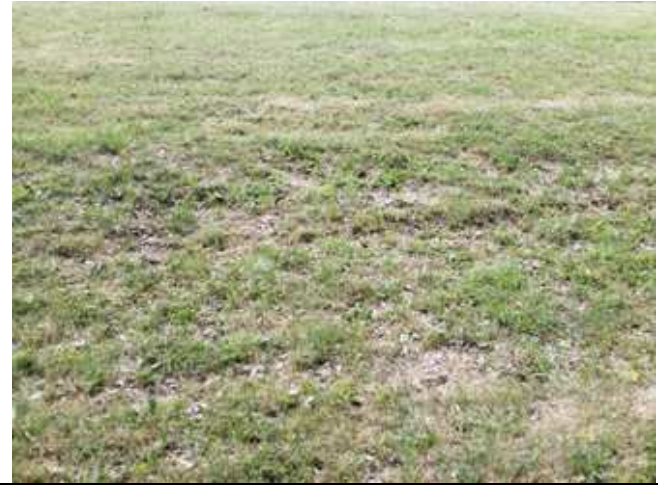
Category:	Levee Embankments	Item:	Depressions/ Rutting
Observation ID:	2023-0020		
Description:	Rutting on riverside slope		
Caption:	0020 - No User Rating (Site Visit) - Rutting on riverside slope		
Lat/Long:	41.56558/-87.48129

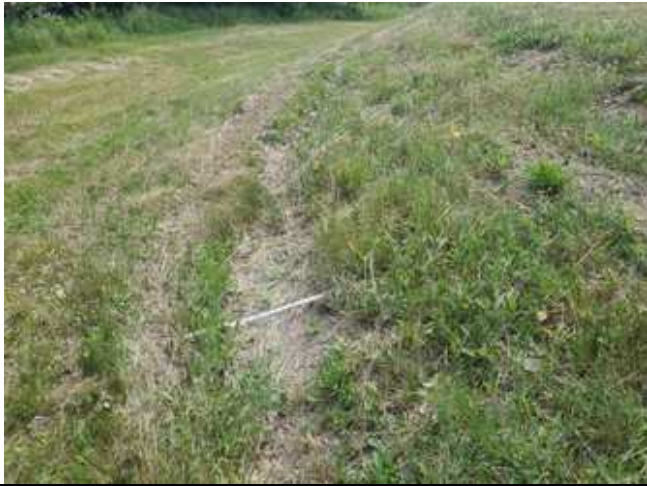
Category:	Levee Embankments	Item:	Depressions/ Rutting
Observation ID:	2023-0024		
Description:	Rutting on riverside toe		
Caption:	0024 - No User Rating (Site Visit) - Rutting on riverside toe		
Lat/Long:	41.56618/-87.48216

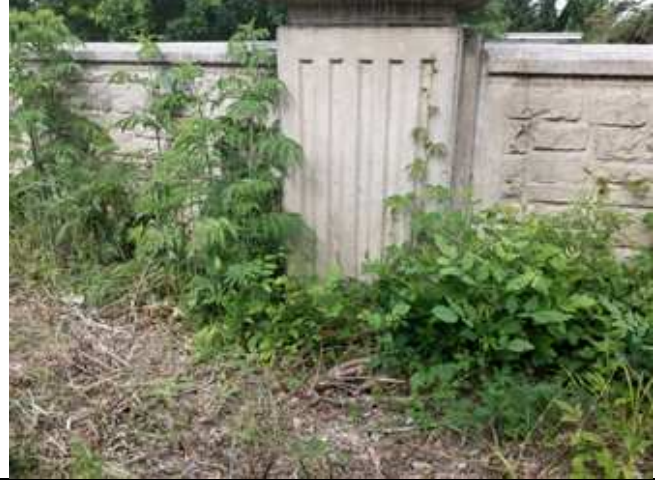
Category:	Floodwalls	Item:	Unwanted Vegetation
Observation ID:	2023-0003		
Description:	Unwanted vegetation on riverside floodwall		
Caption:	0003 - No User Rating (Site Visit) - Unwanted vegetation on riverside floodwall		
Lat/Long:	41.56012/-87.48119

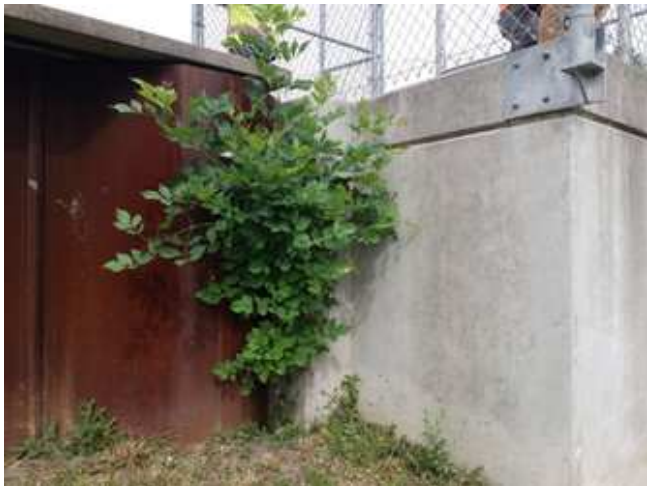
Category:	Floodwalls	Item:	Unwanted Vegetation
Observation ID:	2023-0016		
Description:	Unwanted vegetation on riverside of floodwall		
Caption:	0016 - No User Rating (Site Visit) - Unwanted vegetation on riverside of floodwall		
Lat/Long:	41.56200/-87.48112

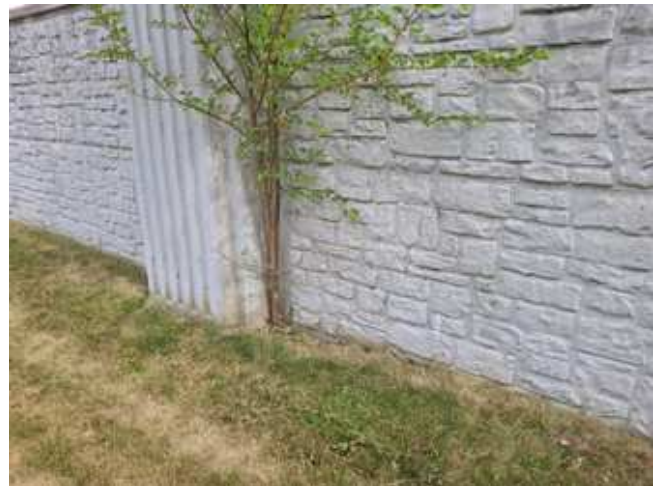
Category:	Floodwalls	Item:	Unwanted Vegetation
Observation ID:	2023-0026		
Description:	Small tree on riverside floodwall		
Caption:	0026 - No User Rating (Site Visit) - Small tree on riverside floodwall		
Lat/Long:	41.57242/-87.51409

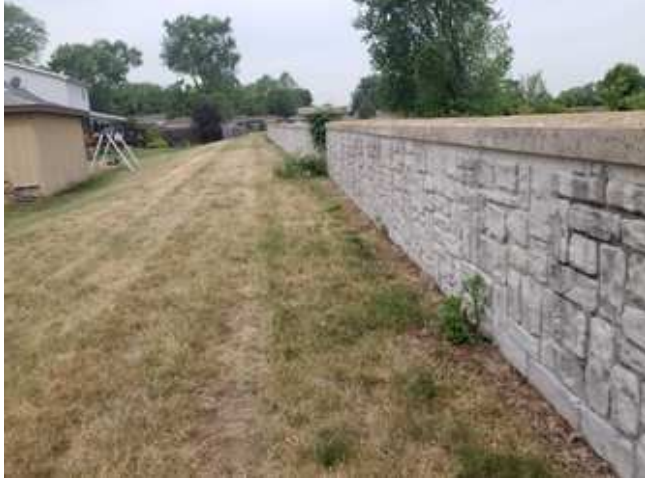
Category:	Floodwalls	Item:	Unwanted Vegetation
Observation ID:	2023-0031		
Description:	Tree on landside floodwall		
Caption:	0031 - No User Rating (Site Visit) - Tree on landside floodwall		
Lat/Long:	41.56627/-87.48414

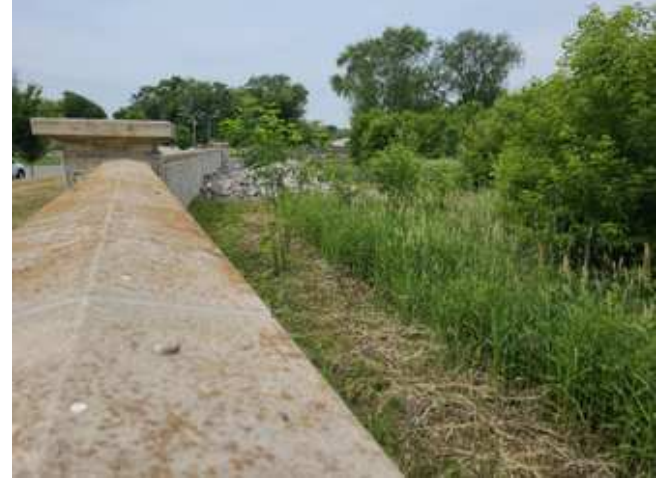
Category:	Floodwalls	Item:	Unwanted Vegetation
Observation ID:	2023-0044		
Description:	Unwanted vegetation on landside of floodwall		
Caption:	0044 - No User Rating (Site Visit) - Unwanted vegetation on landside of floodwall		
Lat/Long:	41.56902/-87.49482

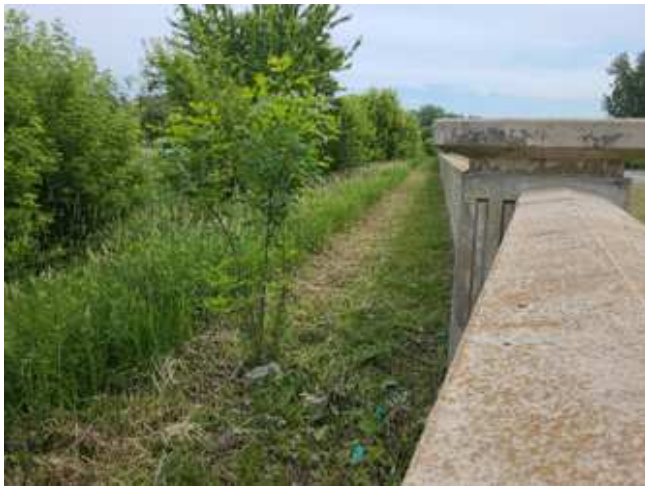
Category:	Floodwalls	Item:	Unwanted Vegetation
Observation ID:	2023-0051		
Description:	Unwanted vegetation on riverside of floodwall		
Caption:	0051 - No User Rating (Site Visit) - Unwanted vegetation on riverside of floodwall		
Lat/Long:	41.56647/-87.48967

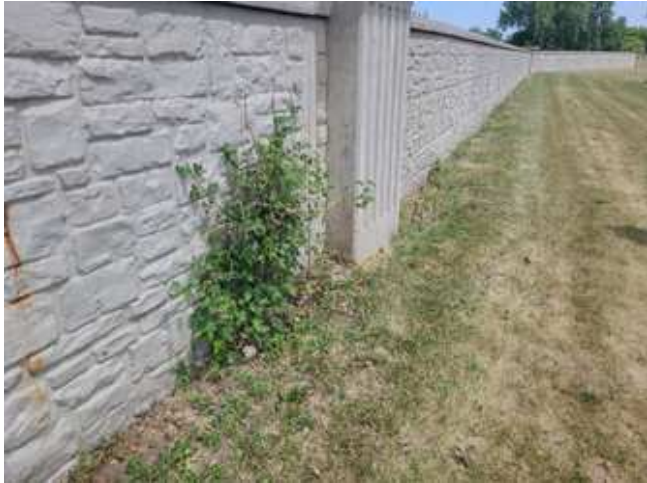
Category:	Floodwalls	Item:	Unwanted Vegetation
Observation ID:	2023-0119		
Description:	Unwanted vegetation on riverside floodwall		
Caption:	0119 - No User Rating (Site Visit) - Unwanted vegetation on riverside floodwall		
Lat/Long:	41.57174/-87.51374

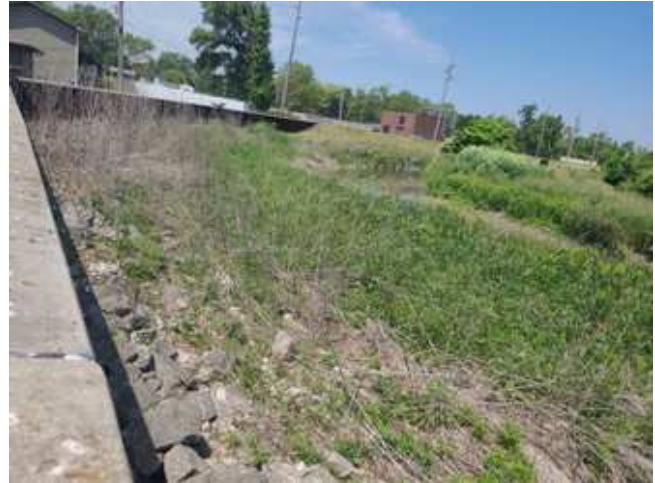
Category:	Floodwalls	Item:	Unwanted Vegetation
Observation ID:	2023-0131		
Description:	Vegetation against landside floodwall		
Caption:	0131 - No User Rating (Site Visit) - Vegetation against landside floodwall		
Lat/Long:	41.57146/-87.51622

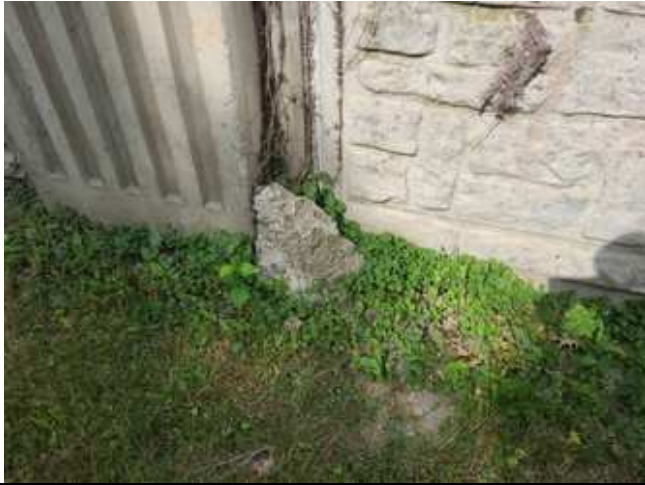
Category:	Floodwalls	Item:	Unwanted Vegetation
Observation ID:	2023-0135		
Description:	Vegetation in riprap against riverside floodwall		
Caption:	0135 - No User Rating (Site Visit) - Vegetation in riprap against riverside floodwall		
Lat/Long:	41.57115/-87.51665

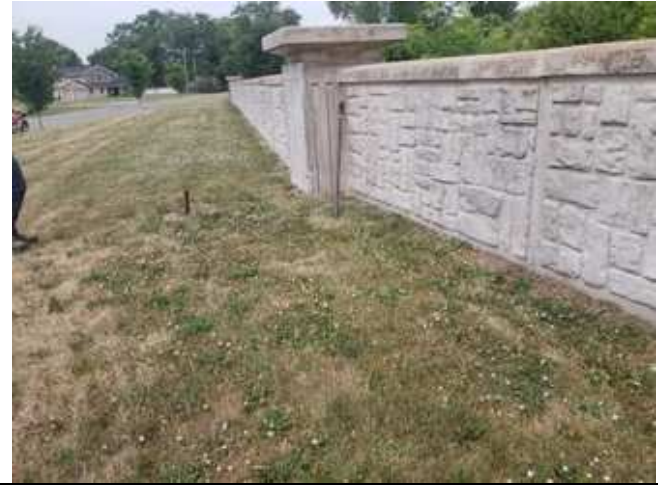
Category:	Floodwalls	Item:	Encroachments
Observation ID:	2023-0011		
Description:	Concrete against riverside floodwall		
Caption:	0011 - No User Rating (Site Visit) - Concrete against riverside floodwall		
Lat/Long:	41.56263/-87.48128

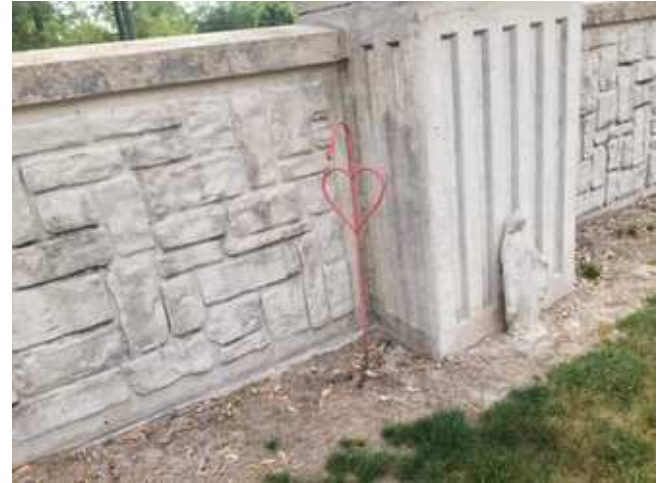
Category:	Floodwalls	Item:	Encroachments
Observation ID:	2023-0036		
Description:	Graffiti on riverside floodwall		
Caption:	0036 - No User Rating (Site Visit) - Graffiti on riverside floodwall		
Lat/Long:	41.56612/-87.49095

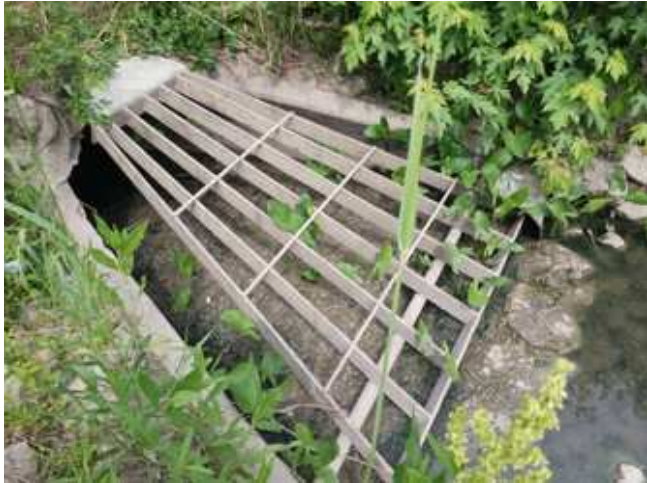
Category:	Interior Drainage System	Item:	Vegetation and Obstr
Observation ID:	2023-0022		
Description:	MU-08: Vegetation around outlet		
Caption:	0022 - No User Rating (Site Visit) - MU-08: Vegetation around outlet		
Lat/Long:	41.57243/-87.51392

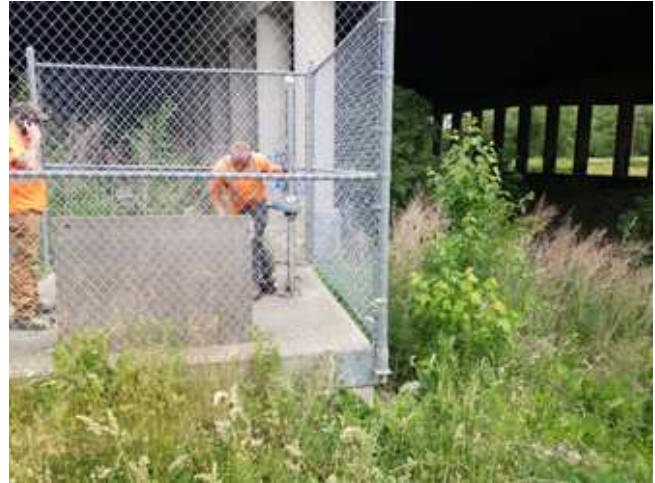
Category:	Interior Drainage System	Item:	Vegetation and Obstr
Observation ID:	2023-0038		
Description:	MU-06: Sediment in outlet		
Caption:	0038 - No User Rating (Site Visit) - MU-06: Sediment in outlet		
Lat/Long:	41.57298/-87.51815

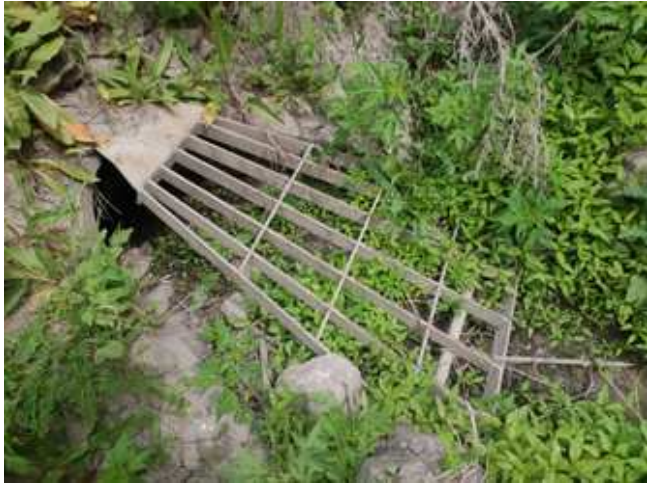
Category:	Interior Drainage System	Item:	Vegetation and Obstr
Observation ID:	2023-0058		
Description:	MU-04: Vegetation around gatewell		
Caption:	0058 - No User Rating (Site Visit) - MU-04: Vegetation around gatewell		
Lat/Long:	41.57518/-87.51973

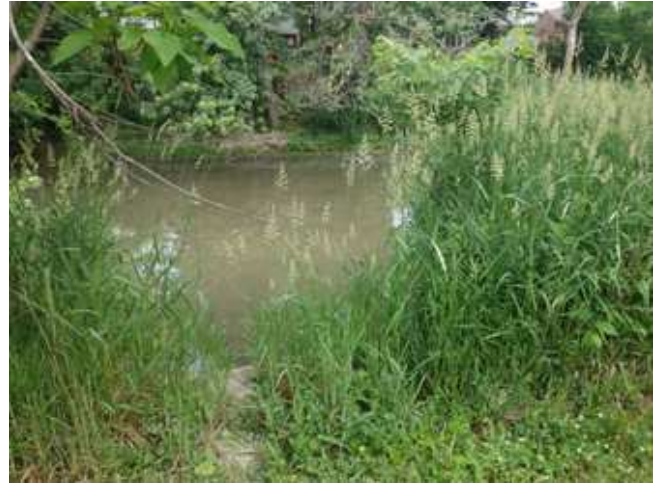
Category:	Interior Drainage System	Item:	Vegetation and Obstr
Observation ID:	2023-0066		
Description:	MU-04: Sediment and vegetation at outlet		
Caption:	0066 - No User Rating (Site Visit) - MU-04: Sediment and vegetation at outlet		
Lat/Long:	41.57522/-87.51957

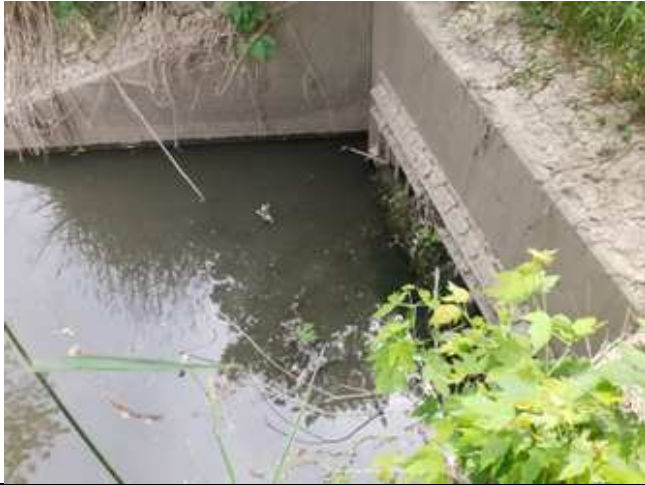
Category:	Interior Drainage System	Item:	Vegetation and Obstr
Observation ID:	2023-0082		
Description:	MU-02: Vegetation around outlet headwall		
Caption:	0082 - No User Rating (Site Visit) - MU-02: Vegetation around outlet headwall		
Lat/Long:	41.57720/-87.52171

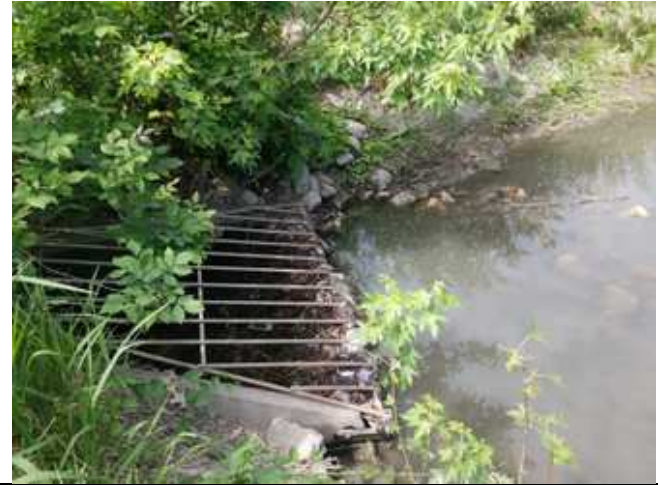
Category:	Interior Drainage System	Item:	Vegetation and Obstr
Observation ID:	2023-0086		
Description:	MU-02: Debris on outlet grate		
Caption:	0086 - No User Rating (Site Visit) - MU-02: Debris on outlet grate		
Lat/Long:	41.57727/-87.52171

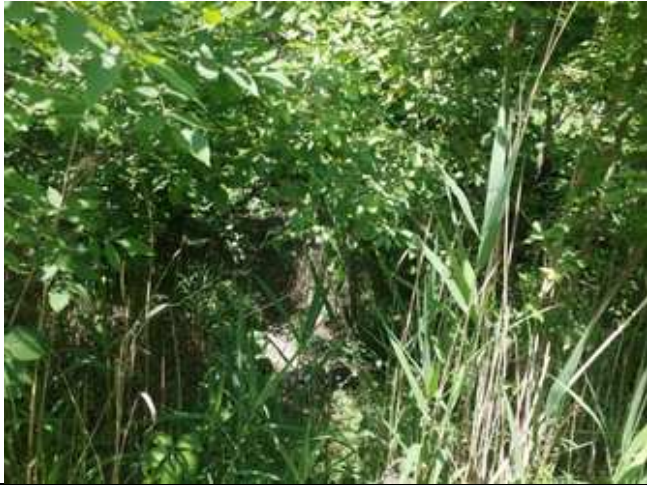
Category:	Interior Drainage System	Item:	Vegetation and Obstr
Observation ID:	2023-0090		
Description:	MU-01: Vegetation and sediment around outlet structure		
Caption:	0090 - No User Rating (Site Visit) - MU-01: Vegetation and sediment around outlet structure		
Lat/Long:	41.57745/-87.52262

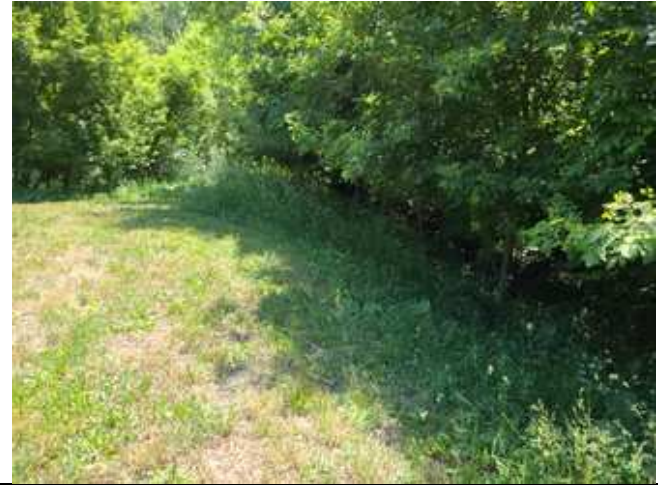
Category:	Interior Drainage System	Item:	Vegetation and Obstr
Observation ID:	2023-0106		
Description:	MU-03: Trees and vegetation around inlet		
Caption:	0106 - No User Rating (Site Visit) - MU-03: Trees and vegetation around inlet		
Lat/Long:	41.57607/-87.52022

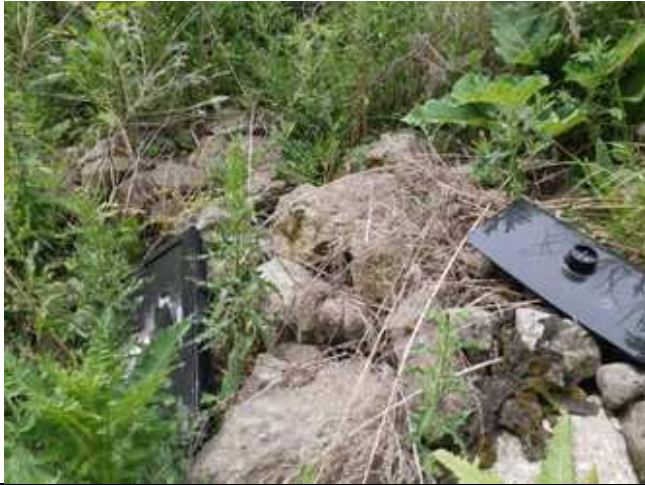
Category:	Interior Drainage System	Item:	Vegetation and Obstr
Observation ID:	2023-0159		
Description:	Vegetation in ditch - near MU-03		
Caption:	0159 - No User Rating (Site Visit) - Vegetation in ditch - near MU-03		
Lat/Long:	41.57611/-87.52008

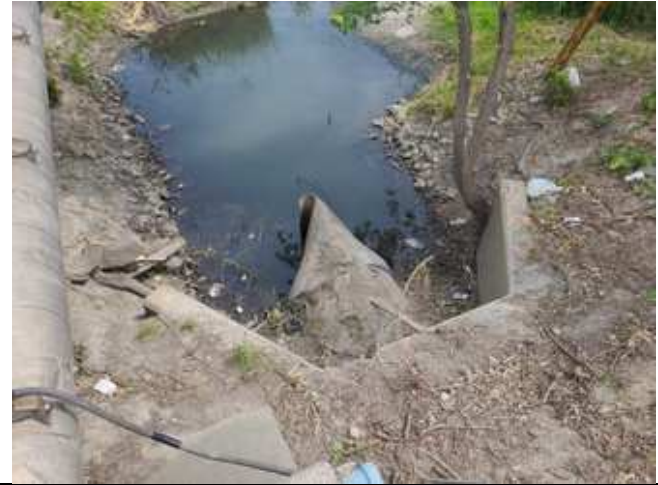
Category:	Interior Drainage System	Item:	Encroachments
Observation ID:	2023-0062		
Description:	MU-04: Debris in riprap at outlet structure		
Caption:	0062 - No User Rating (Site Visit) - MU-04: Debris in riprap at outlet structure		
Lat/Long:	41.57519/-87.51962

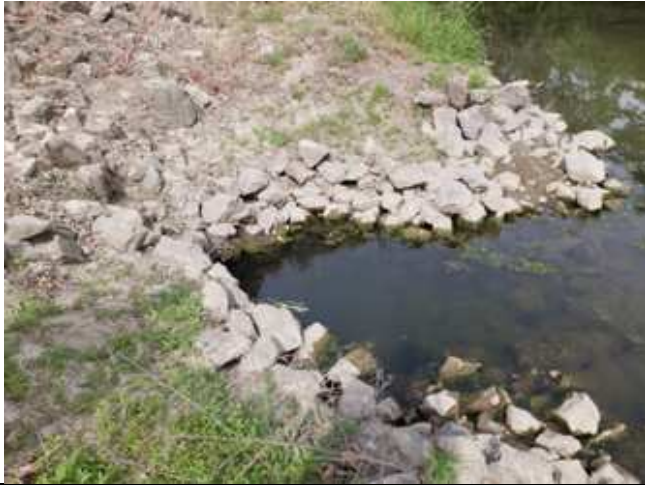
Category:	Interior Drainage System	Item:	Encroachments
Observation ID:	2023-0087		
Description:	MU-09: Debris around duckbill valve		
Caption:	0087 - No User Rating (Site Visit) - MU-09: Debris around duckbill valve		
Lat/Long:	41.57106/-87.50886

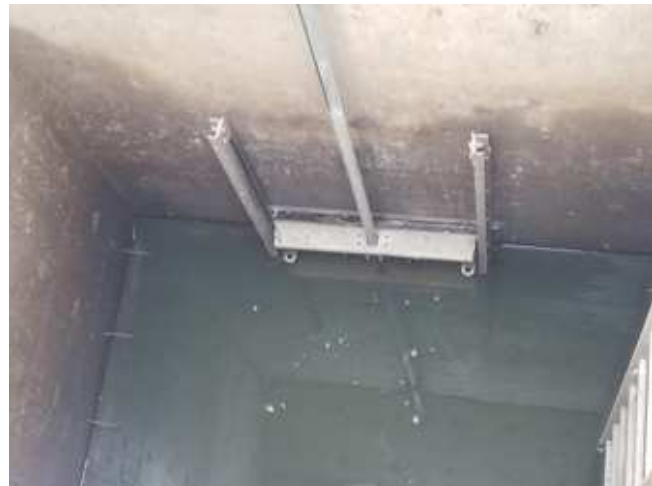
Category:	Interior Drainage System	Item:	Sluice / Slide Gates
Observation ID:	2023-0034		
Description:	MU-08: Sluice gate fully closed. Water backed up, potential blockage at outlet		
Caption:	0034 - No User Rating (Site Visit) - MU-08: Sluice gate fully closed. Water backed up, potential blockage at outlet		
Lat/Long:	41.57243/-87.51404

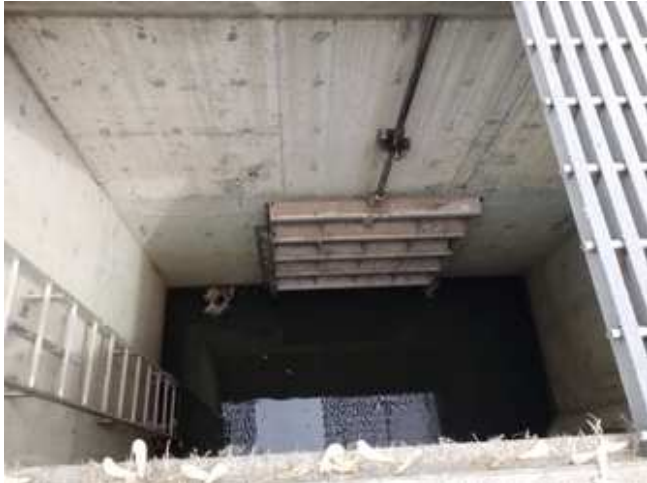
Category:	Interior Drainage System	Item:	Sluice / Slide Gates
Observation ID:		2023-0078	
Description:	MU-02: Sluice gate fully open. Some debris in the gatewell. Gate closed with no issues. Water build up could indicate outlet blockage		
Caption:	0078 - No User Rating (Site Visit) - MU-02: Sluice gate fully open. Some debris in the gatewell. Gate closed with no issues. Water build up could indicate outlet blockage		
Lat/Long:	41.57718/-87.52168

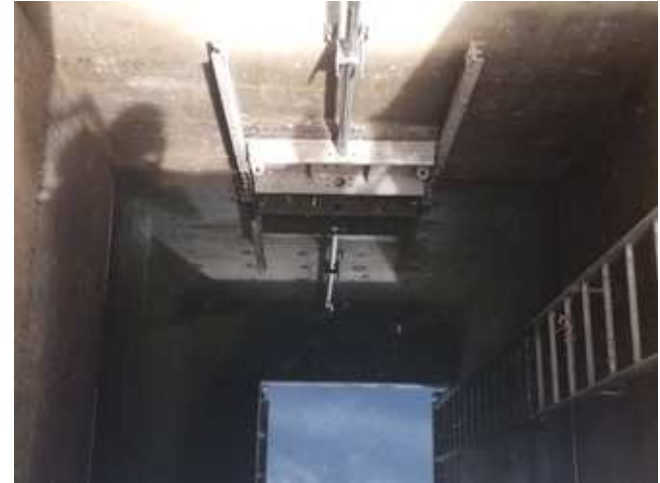
Category:	Interior Drainage System	Item:	Sluice / Slide Gates
Observation ID:		2023-0094	
Description:	MU-01: Sluice gate fully closed. No issues. Some water build up		
Caption:	0094 - No User Rating (Site Visit) - MU-01: Sluice gate fully closed. No issues. Some water build up		
Lat/Long:	41.57725/-87.52247

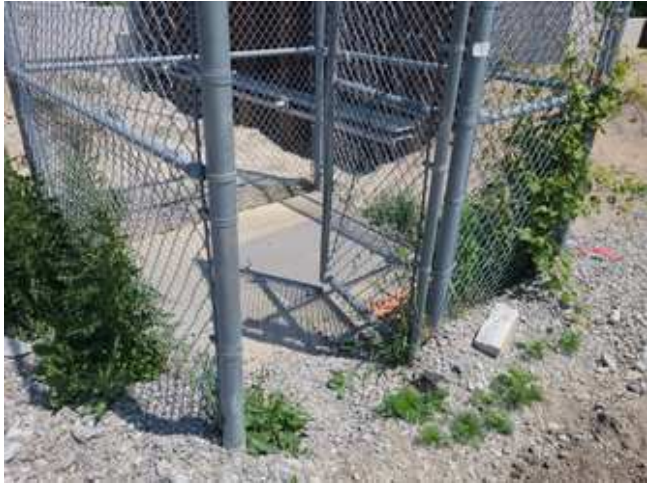
Category:	Interior Drainage System	Item:	Sluice / Slide Gates
Observation ID:	2023-0147		
Description:	MU-05: In active construction zone, could not inspect		
Caption:	0147 - No User Rating (Site Visit) - MU-05: In active construction zone, could not inspect		
Lat/Long:	41.57343/-87.51866

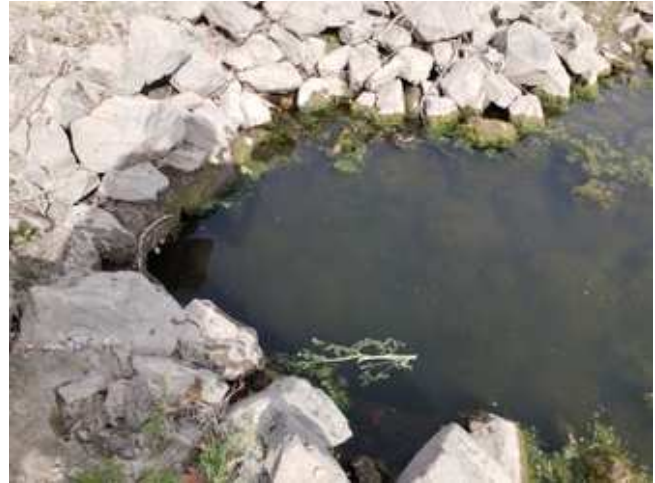
Category:	Interior Drainage System	Item:	Flap Gates/ Flap Val
Observation ID:	2023-0010		
Description:	MU-11: Flap gate underwater		
Caption:	0010 - No User Rating (Site Visit) - MU-11: Flap gate underwater		
Lat/Long:	41.56649/-87.48504

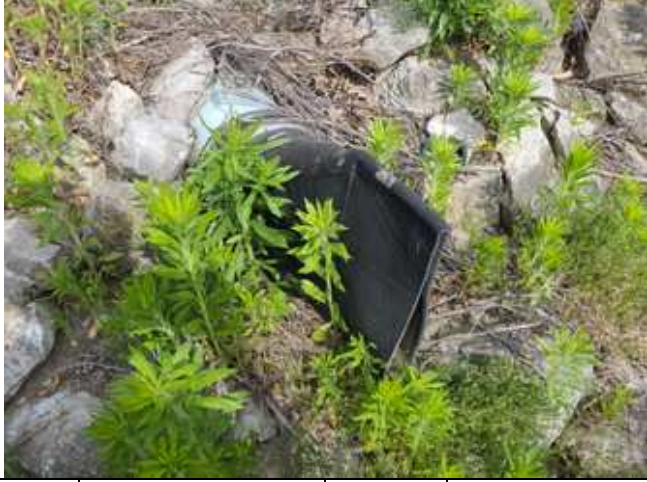
Category:	Interior Drainage System	Item:	Flap Gates/ Flap Val
Observation ID:	2023-0015		
Description:	MU-12: Duckbill valve stuck open		
Caption:	0015 - No User Rating (Site Visit) - MU-12: Duckbill valve stuck open		
Lat/Long:	41.56168/-87.48114

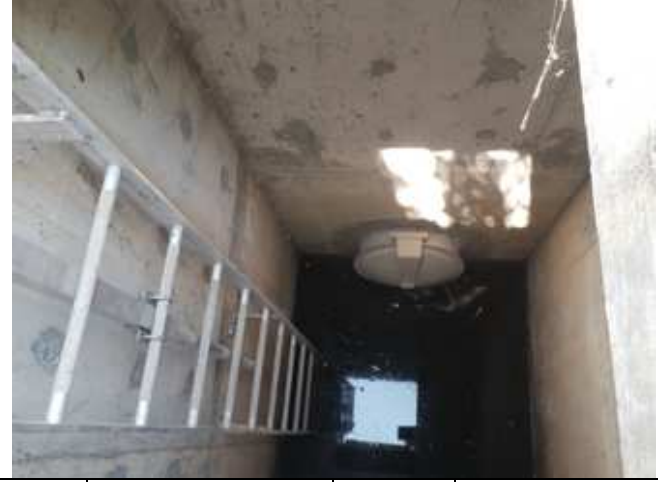
Category:	Interior Drainage System	Item:	Flap Gates/ Flap Val
Observation ID:	2023-0098		
Description:	MU-03: Flap gate, no issues		
Caption:	0098 - No User Rating (Site Visit) - MU-03: Flap gate, no issues		
Lat/Long:	41.57614/-87.52015

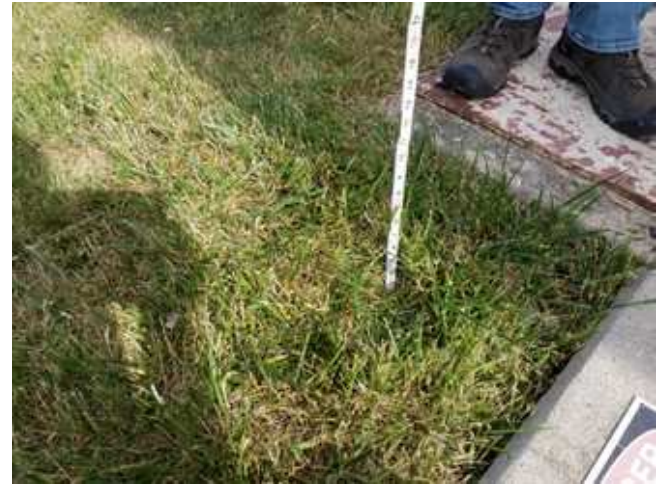
Category:	Pump Stations	Item:	Plant Building
Observation ID:	2023-0037		
Description:	PS-BA: Minor depression near EF-02		
Caption:	0037 - No User Rating (Site Visit) - PS-BA: Minor depression near EF-02		
Lat/Long:	41.56636/-87.48516

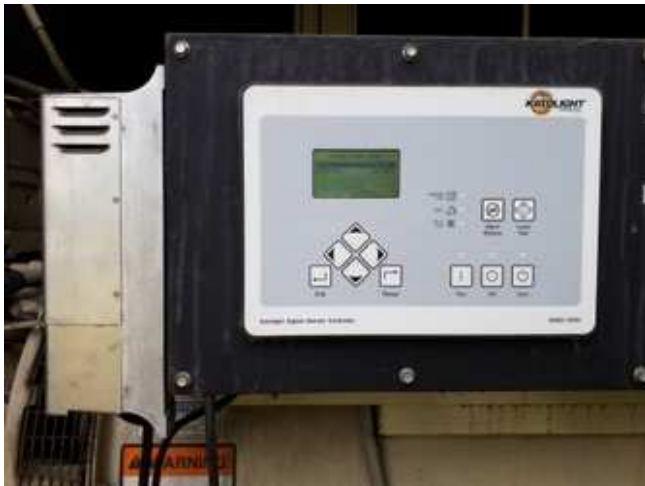
Category:	Pump Stations	Item:	Power Source
Observation ID:	2023-0017		
Description:	PS-BA: Exterior backup generator runtime (291 hrs 21 min)		
Caption:	No User Rating (Site Visit) - PS-BA: Exterior backup generator runtime (291 hrs 21 min)		
Lat/Long:	41.56641/-87.48518

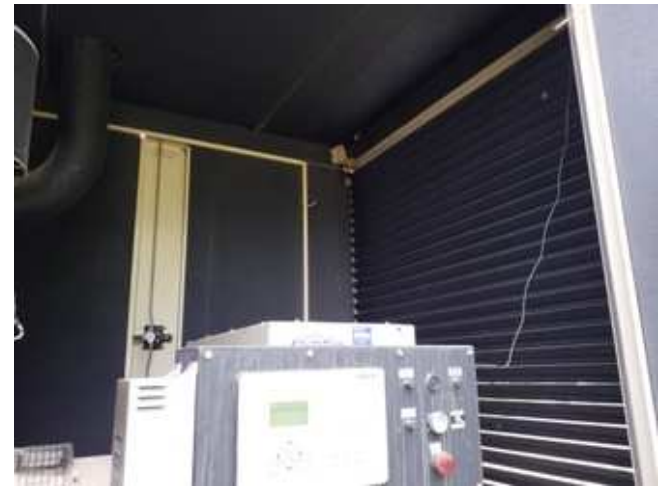
Category:	Pump Stations	Item:	Power Source
Observation ID:	2023-0021		
Description:	PS-BA: Wasp nest located inside upper corners of generator enclosure		
Caption:	0021 - No User Rating (Site Visit) - PS-BA: Wasp nest located inside upper corners of generator enclosure		
Lat/Long:	41.56641/-87.48518

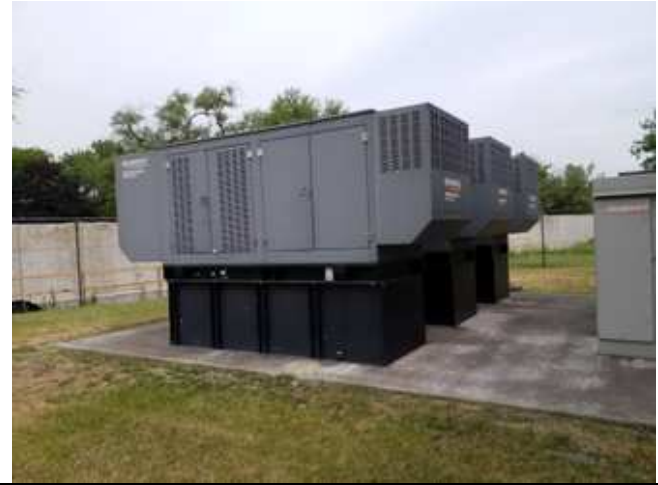
Category:	Pump Stations	Item:	Power Source
Observation ID:	2023-0149		
Description:	PS-OA: Generator 1 runtime is 141.1 hours. Generator 2 runtime is 172 hours. Generator 3 runtime is 167.4 hours		
Caption:	0149 - No User Rating (Site Visit) - PS-OA: Generator 1 runtime is 141.1 hours. Generator 2 runtime is 172 hours. Generator 3 runtime is 167.4 hours		
Lat/Long:	41.57184/-87.51824

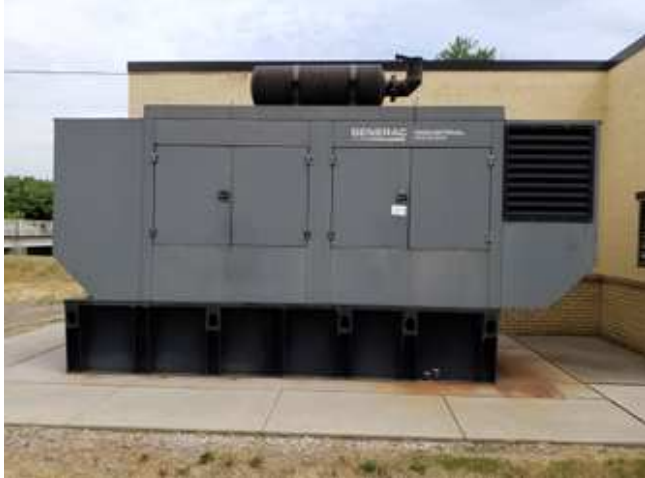
Category:	Pump Stations	Item:	Power Source
Observation ID:	2023-0173		
Description:	PS-HM: Generator runtime is 761.3 hours		
Caption:	0173 - No User Rating (Site Visit) - PS-HM: Generator runtime is 761.3 hours		
Lat/Long:	41.57701/-87.52176

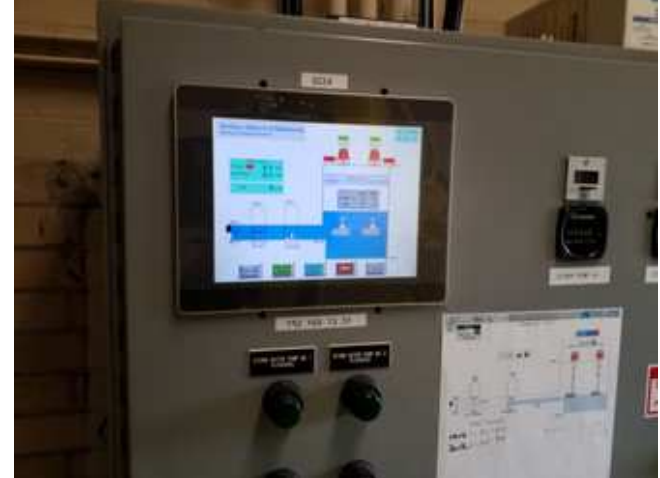
Category:	Pump Stations	Item:	Enclosures, Panels,
Observation ID:	2023-0005		
Description:	PS-BA: New control system and display monitor installed within the last year		
Caption:	0005 - No User Rating (Site Visit) - PS-BA: New control system and display monitor installed within the last year		
Lat/Long:	41.56638/-87.48508

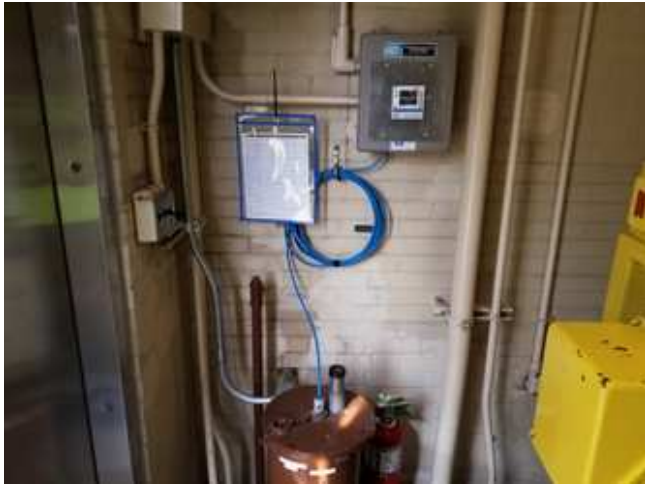
Category:	Pump Stations	Item:	Enclosures, Panels,
Observation ID:	2023-0009		
Description:	PS-BA: New wet well transducer installed within last year to monitor water level		
Caption:	0009 - No User Rating (Site Visit) - PS-BA: New wet well transducer installed within last year to monitor water level		
Lat/Long:	41.56637/-87.48511

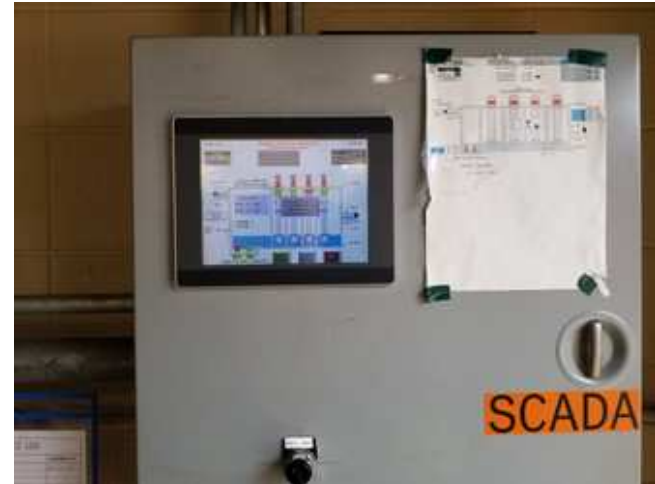
Category:	Pump Stations	Item:	Enclosures, Panels,
Observation ID:	2023-0069		
Description:	PS-CA: New levee monitoring and control system installed within the last year		
Caption:	0069 - No User Rating (Site Visit) - PS-CA: New levee monitoring and control system installed within the last year		
Lat/Long:	41.57064/-87.50789

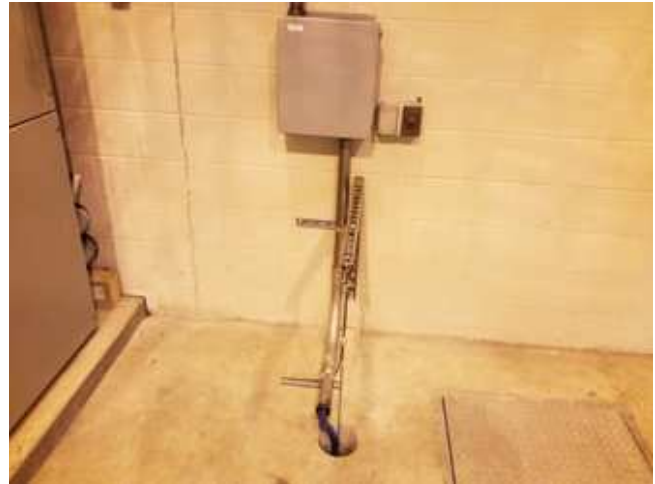
Category:	Pump Stations	Item:	Enclosures, Panels,
Observation ID:	2023-0117		
Description:	PS-OA: New float level system installed within the last year		
Caption:	0117 - No User Rating (Site Visit) - PS-OA: New float level system installed within the last year		
Lat/Long:	41.57190/-87.51812

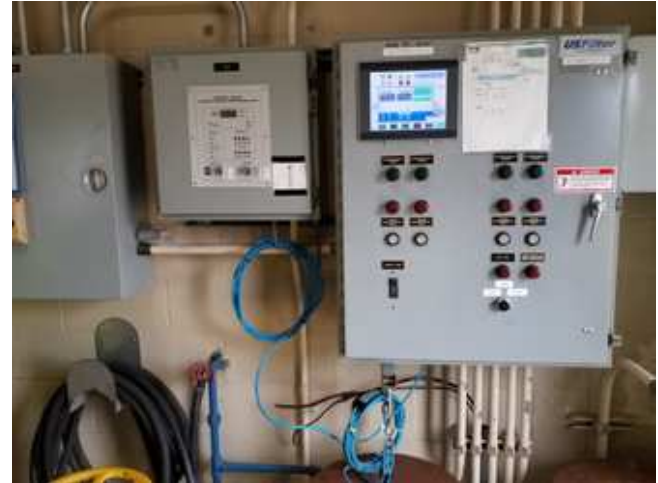
Category:	Pump Stations	Item:	Enclosures, Panels,
Observation ID:	2023-0153		
Description:	PS-HM: New level transducer and control system installed within the last year		
Caption:	0153 - No User Rating (Site Visit) - PS-HM: New level transducer and control system installed within the last year		
Lat/Long:	41.57709/-87.52178
