**US Army Corps
of Engineers ®**

Site Visit Summary

Name of System: Gary

Name of Segment: Gary North

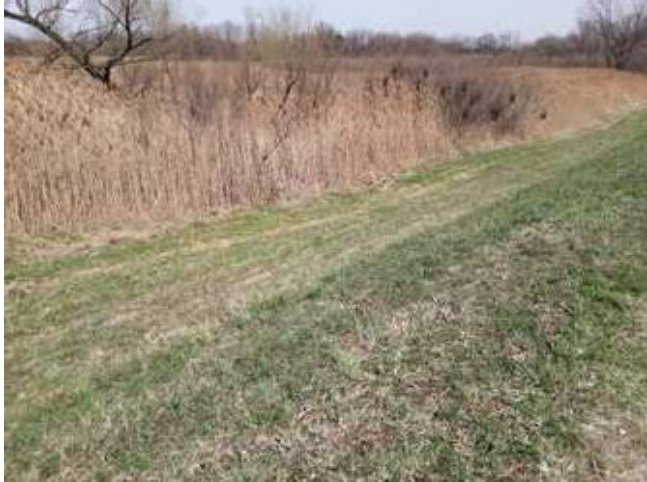
Category:	Levee Embankments	Item:	Unwanted Vegetation
Observation ID:	2023-0010		
Description:	Vegetation within 15 feet of riverside toe		
Caption:	0010 - No User Rating (Site Visit) - Vegetation within 15 feet of riverside toe		
Lat/Long:	41.56846/-87.31732

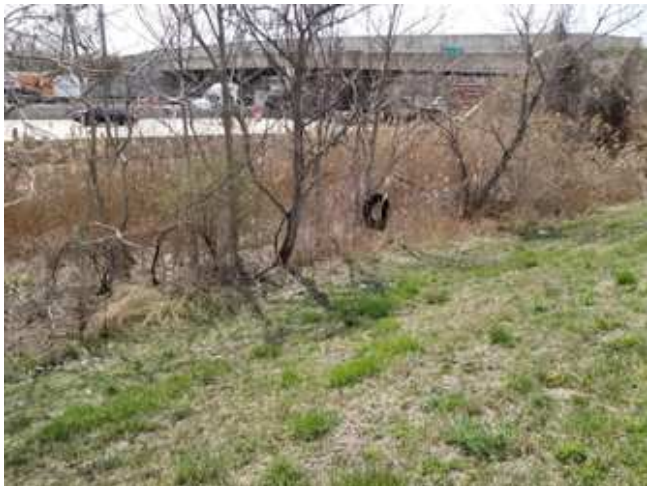
Category:	Levee Embankments	Item:	Unwanted Vegetation
Observation ID:	2023-0061		
Description:	Vegetation within 15 ft of riverside toe		
Caption:	0061 - No User Rating (Site Visit) - Vegetation within 15 ft of riverside toe		
Lat/Long:	41.56791/-87.32475

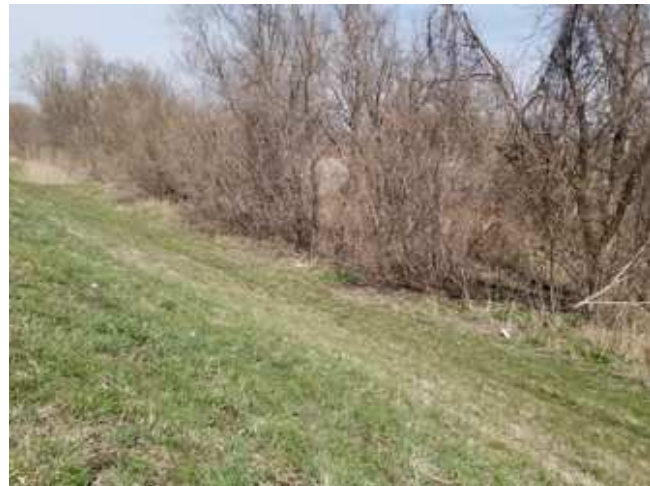
Category:	Levee Embankments	Item:	Unwanted Vegetation
Observation ID:	2023-0079		
Description:	Trees on landslide toe		
Caption:	0079 - No User Rating (Site Visit) - Trees on landslide toe		
Lat/Long:	41.56790/-87.32639

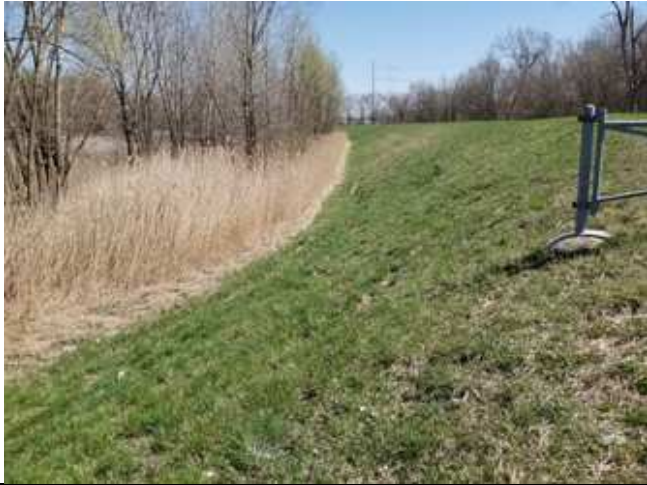
Category:	Levee Embankments	Item:	Unwanted Vegetation
Observation ID:	2023-0085		
Description:	Trees close to riverside toe		
Caption:	0085 - No User Rating (Site Visit) - Trees close to riverside toe		
Lat/Long:	41.56905/-87.32677

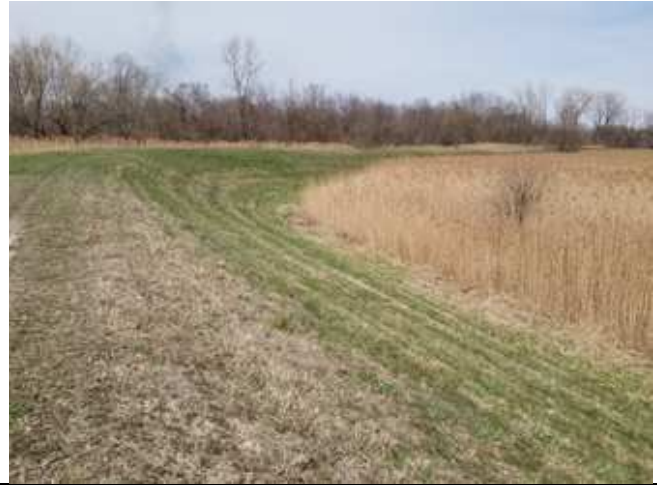
Category:	Levee Embankments	Item:	Unwanted Vegetation
Observation ID:	2023-0087		
Description:	Vegetation along landside toe		
Caption:	0087 - No User Rating (Site Visit) - Vegetation along landside toe		
Lat/Long:	41.56133/-87.40756

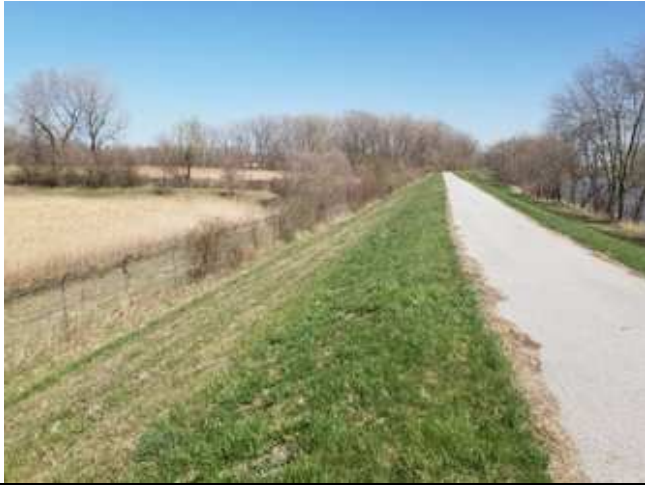
Category:	Levee Embankments	Item:	Unwanted Vegetation
Observation ID:	2023-0109		
Description:	Tall vegetation on riverside toe		
Caption:	0109 - No User Rating (Site Visit) - Tall vegetation on riverside toe		
Lat/Long:	41.57184/-87.32676

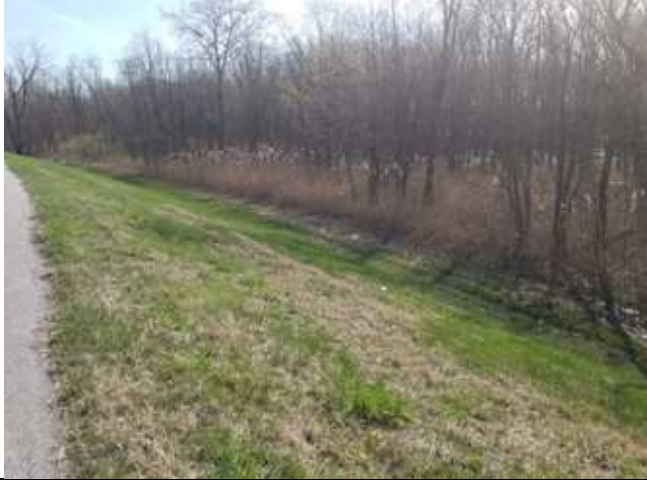
Category:	Levee Embankments	Item:	Unwanted Vegetation
Observation ID:	2023-0126		
Description:	Vegetation on riverside toe		
Caption:	0126 - No User Rating (Site Visit) - Vegetation on riverside toe		
Lat/Long:	41.56121/-87.39345

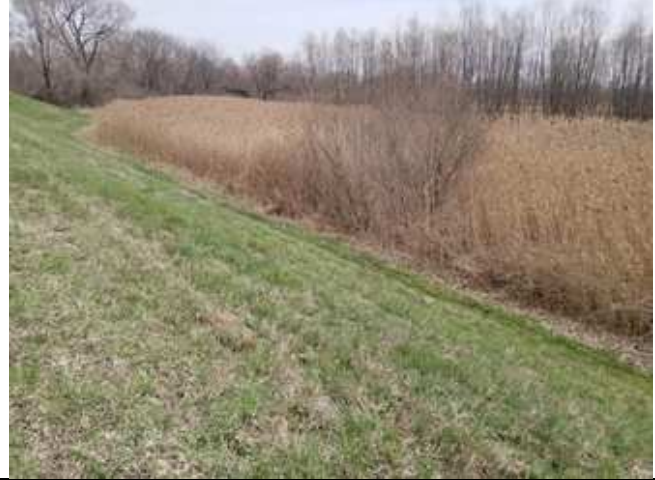
Category:	Levee Embankments	Item:	Unwanted Vegetation
Observation ID:	2023-0135		
Description:	Vegetation along corner within 15 ft of riverside toe		
Caption:	0135 - No User Rating (Site Visit) - Vegetation along corner within 15 ft of riverside toe		
Lat/Long:	41.56332/-87.38308

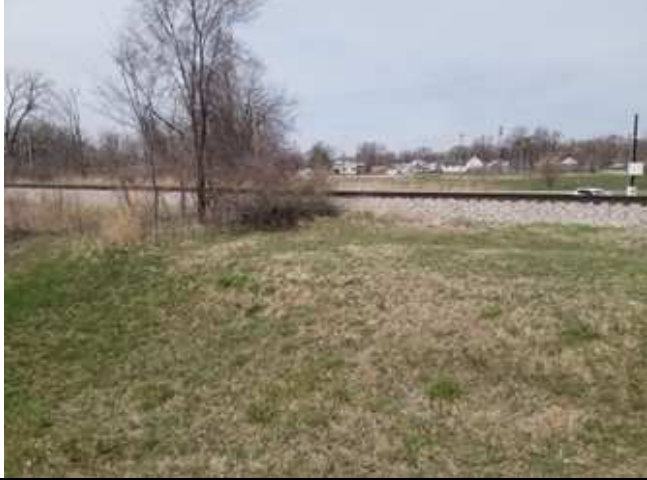
Category:	Levee Embankments	Item:	Unwanted Vegetation
Observation ID:	2023-0142		
Description:	Small trees on riverside toe		
Caption:	0142 - No User Rating (Site Visit) - Small trees on riverside toe		
Lat/Long:	41.57282/-87.32303

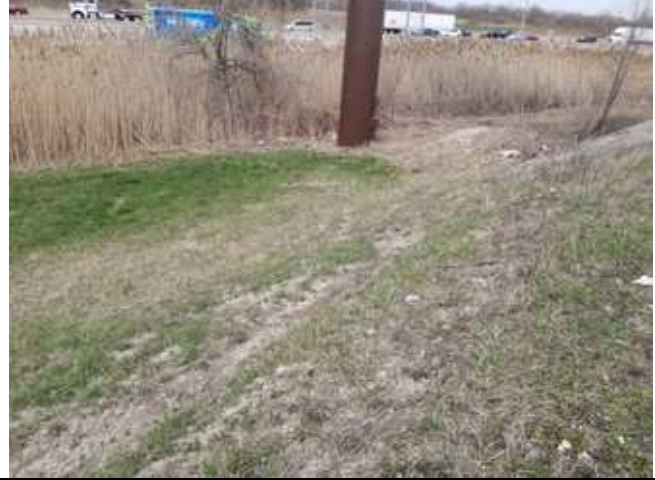
Category:	Levee Embankments	Item:	Unwanted Vegetation
Observation ID:	2023-0145		
Description:	Small trees at end of levee on crown		
Caption:	0145 - No User Rating (Site Visit) - Small trees at end of levee on crown		
Lat/Long:	41.57298/-87.32223

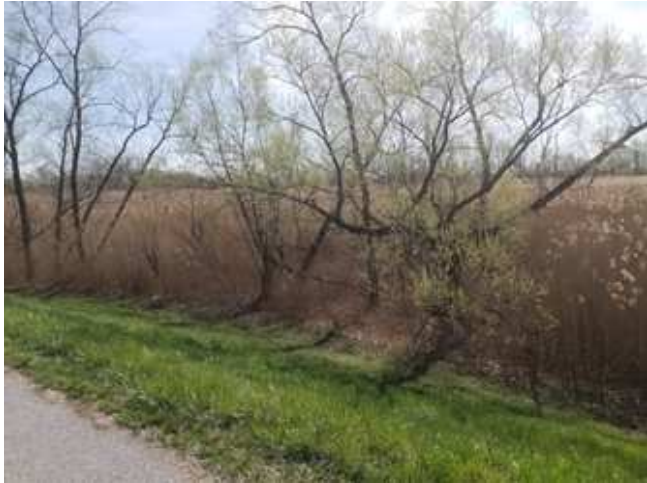
Category:	Levee Embankments	Item:	Unwanted Vegetation
Observation ID:	2023-0154		
Description:	Unwanted vegetation within 15 ft of landside toe		
Caption:	0154 - No User Rating (Site Visit) - Unwanted vegetation within 15 ft of landside toe		
Lat/Long:	41.56689/-87.32638

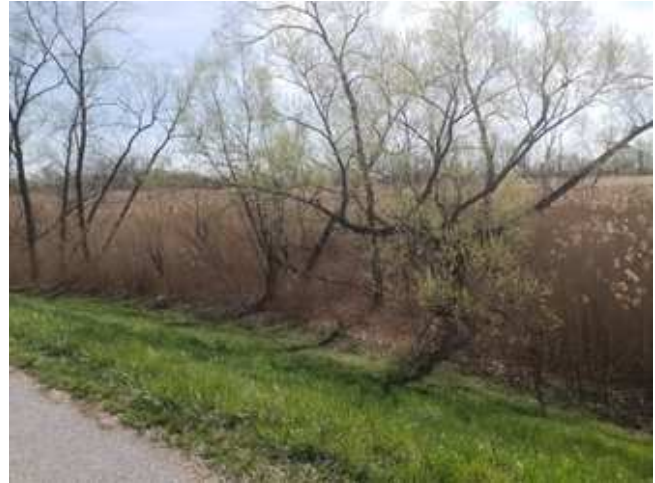
Category:	Levee Embankments	Item:	Unwanted Vegetation
Observation ID:	2023-0168		
Description:	Unwanted vegetation on riverside slope		
Caption:	0168 - No User Rating (Site Visit) - Unwanted vegetation on riverside slope		
Lat/Long:	41.56603/-87.37475

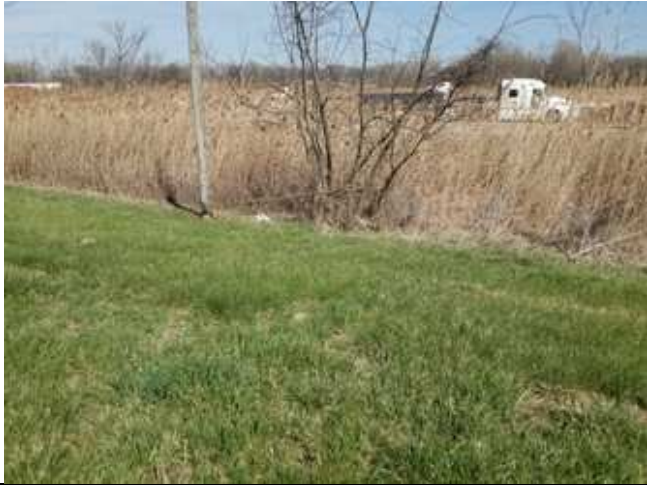
Category:	Levee Embankments	Item:	Unwanted Vegetation
Observation ID:	2023-0171		
Description:	Tree overhanging riverside slope		
Caption:	0171 - No User Rating (Site Visit) - Tree overhanging riverside slope		
Lat/Long:	41.56805/-87.37417

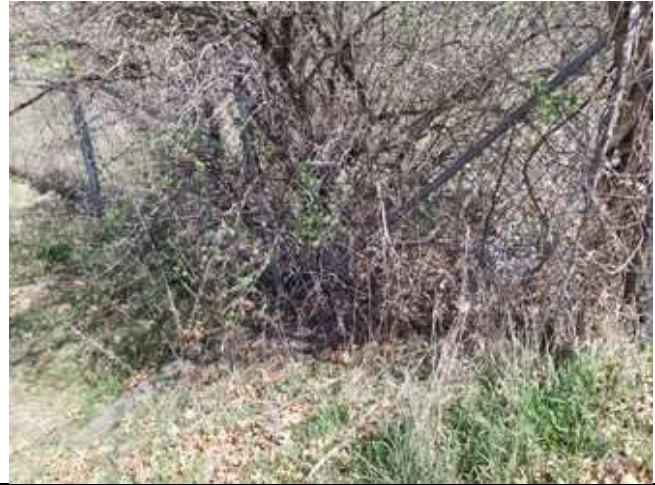
Category:	Levee Embankments	Item:	Unwanted Vegetation
Observation ID:	2023-0186		
Description:	Tree on landside slope		
Caption:	0186 - No User Rating (Site Visit) - Tree on landside slope		
Lat/Long:	41.56909/-87.36280

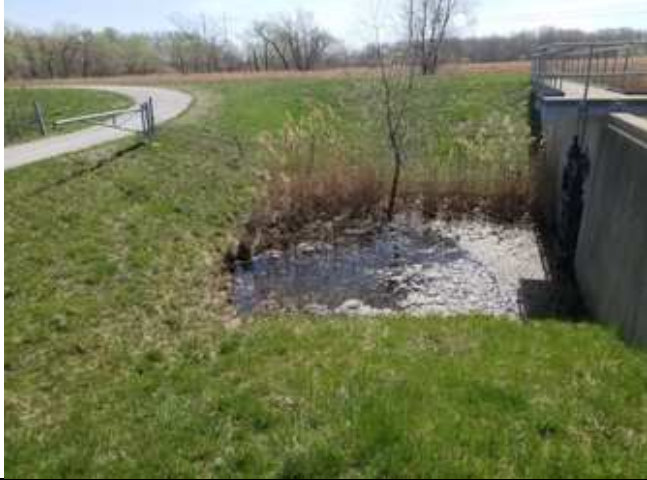
Category:	Levee Embankments	Item:	Unwanted Vegetation
Observation ID:	2023-0196		
Description:	Vegetation in fencing on landside slope		
Caption:	0196 - No User Rating (Site Visit) - Vegetation in fencing on landside slope		
Lat/Long:	41.56865/-87.42363

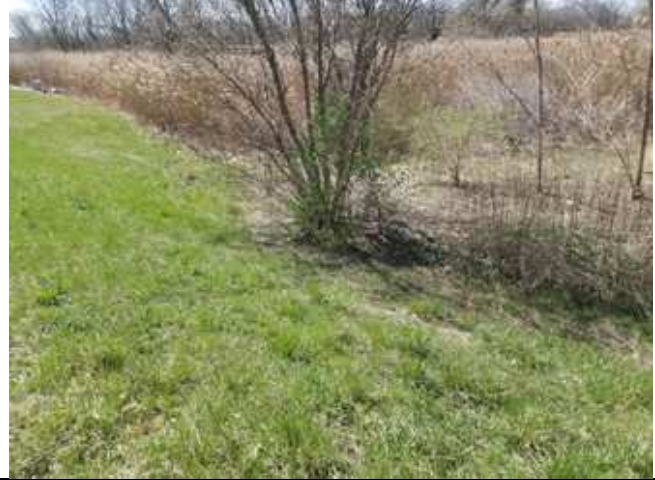
Category:	Levee Embankments	Item:	Unwanted Vegetation
Observation ID:	2023-0204		
Description:	Vegetation on landside toe near gate		
Caption:	0204 - No User Rating (Site Visit) - Vegetation on landside toe near gate		
Lat/Long:	41.56713/-87.35476

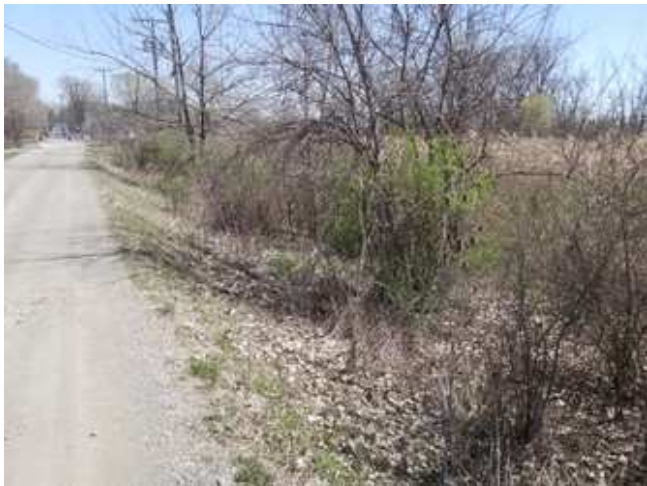
Category:	Levee Embankments	Item:	Unwanted Vegetation
Observation ID:	2023-0205		
Description:	Tree on riverside toe		
Caption:	0205 - No User Rating (Site Visit) - Tree on riverside toe		
Lat/Long:	41.56902/-87.42370

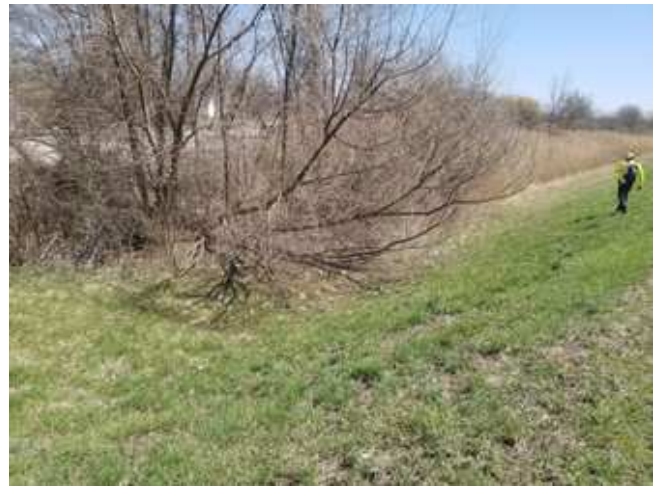
Category:	Levee Embankments	Item:	Unwanted Vegetation
Observation ID:	2023-0214		
Description:	Vegetation within 15 ft of riverside toe		
Caption:	0214 - No User Rating (Site Visit) - Vegetation within 15 ft of riverside toe		
Lat/Long:	41.56859/-87.42249

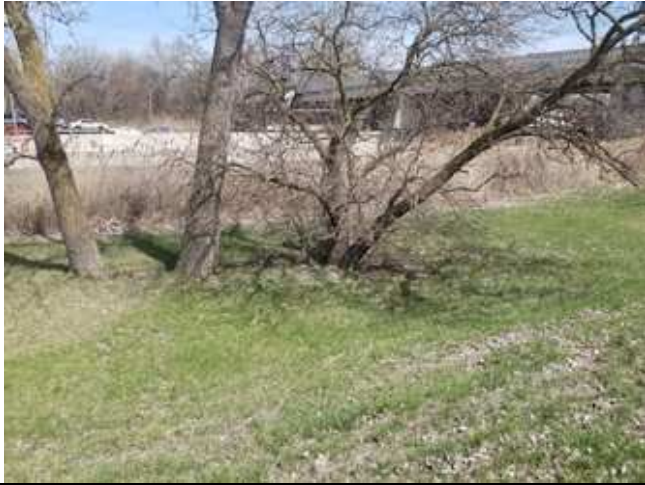
Category:	Levee Embankments	Item:	Unwanted Vegetation
Observation ID:	2023-0220		
Description:	Large tree on landside toe		
Caption:	0220 - No User Rating (Site Visit) - Large tree on landside toe		
Lat/Long:	41.56837/-87.42139

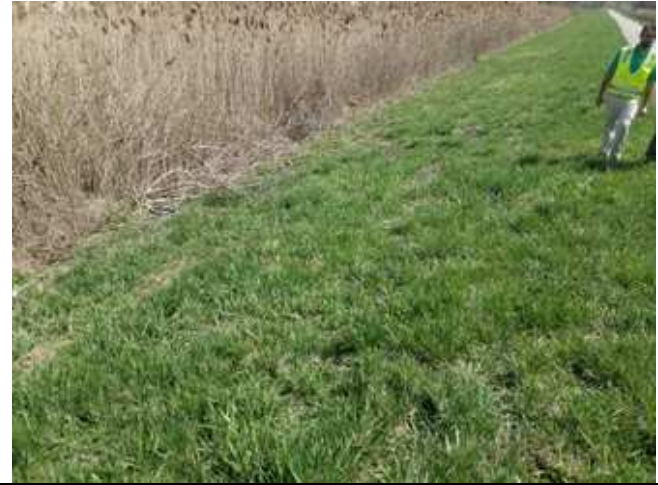
Category:	Levee Embankments	Item:	Unwanted Vegetation
Observation ID:	2023-0222		
Description:	Tree on landside toe		
Caption:	0222 - No User Rating (Site Visit) - Tree on landside toe		
Lat/Long:	41.56714/-87.34700

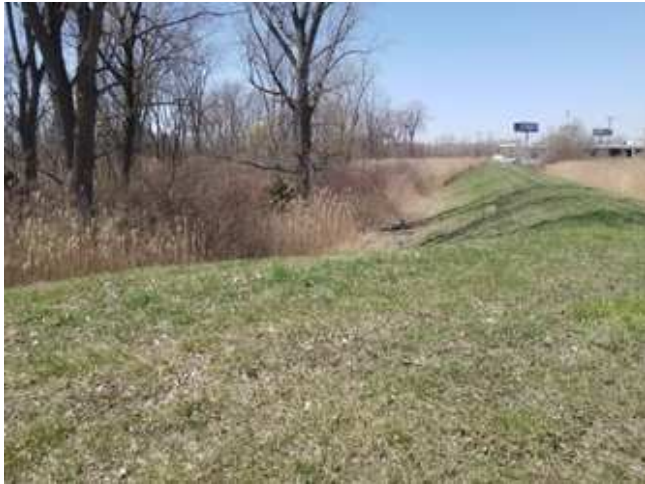
Category:	Levee Embankments	Item:	Unwanted Vegetation
Observation ID:	2023-0231		
Description:	Unwanted vegetation on landside toe		
Caption:	0231 - No User Rating (Site Visit) - Unwanted vegetation on landside toe		
Lat/Long:	41.56712/-87.34587

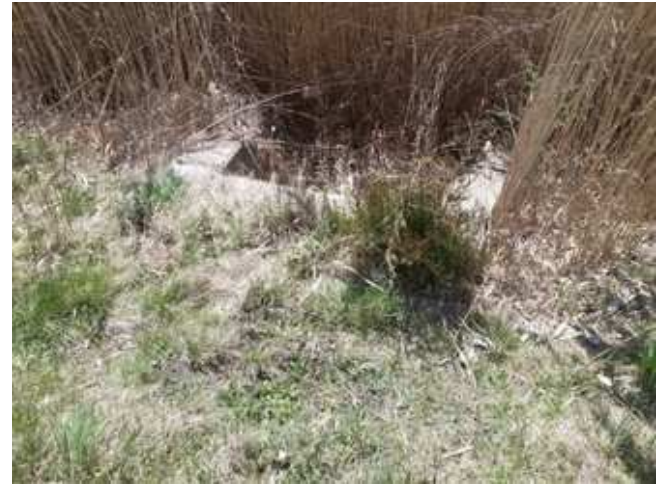
Category:	Levee Embankments	Item:	Unwanted Vegetation
Observation ID:	2023-0232		
Description:	Vegetation along riverside toe		
Caption:	0232 - No User Rating (Site Visit) - Vegetation along riverside toe		
Lat/Long:	41.56846/-87.42179

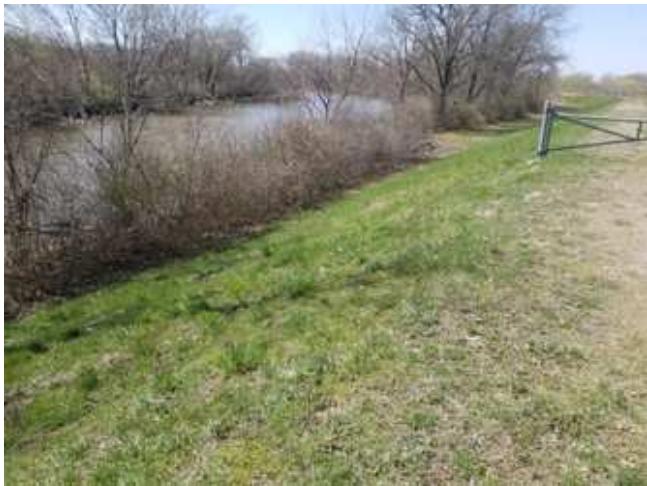
Category:	Levee Embankments	Item:	Unwanted Vegetation
Observation ID:	2023-0235		
Description:	GN-02: Trees near wingwall		
Caption:	0235 - No User Rating (Site Visit) - GN-02: Trees near wingwall		
Lat/Long:	41.56750/-87.41967

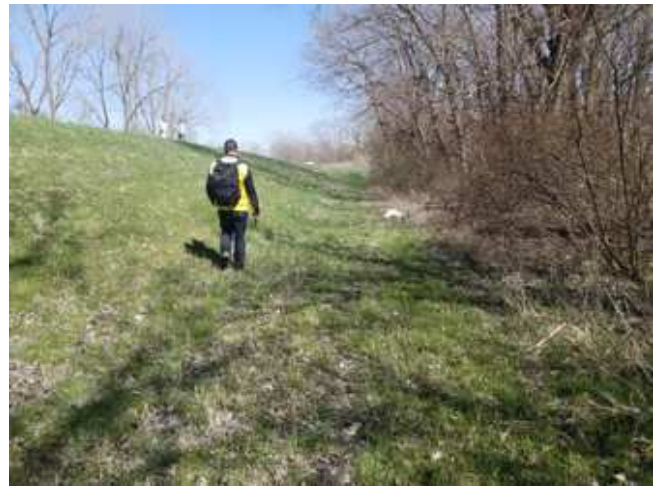
Category:	Levee Embankments	Item:	Unwanted Vegetation
Observation ID:	2023-0283		
Description:	Vegetation along riverside toe		
Caption:	0283 - No User Rating (Site Visit) - Vegetation along riverside toe		
Lat/Long:	41.56448/-87.41364

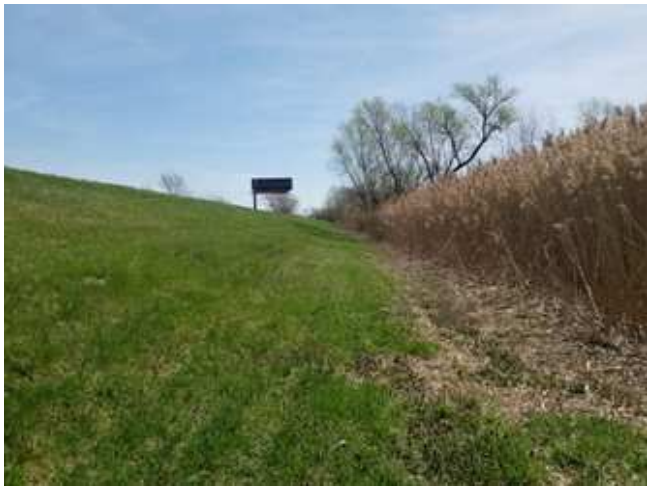
Category:	Levee Embankments	Item:	Unwanted Vegetation
Observation ID:	2023-0379		
Description:	Unwanted vegetation on riverside toe		
Caption:	0379 - No User Rating (Site Visit) - Unwanted vegetation on riverside toe		
Lat/Long:	41.56061/-87.39525

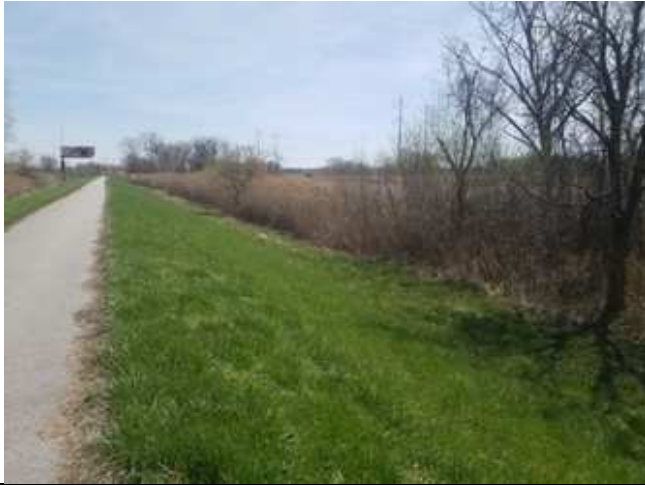
Category:	Levee Embankments	Item:	Unwanted Vegetation
Observation ID:	2023-0451		
Description:	Root extending into embankment/animal burrows on landside toe		
Caption:	0451 - No User Rating (Site Visit) - Root extending into embankment/animal burrows on landside toe		
Lat/Long:	41.56722/-87.34900

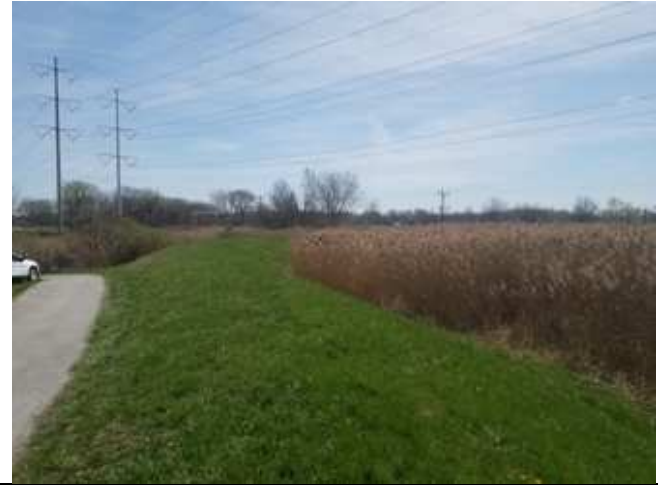
Category:	Levee Embankments	Item:	Unwanted Vegetation
Observation ID:	2023-0463		
Description:	Trees/tall vegetation within 15 ft of riverside toe		
Caption:	0463 - No User Rating (Site Visit) - Trees/tall vegetation within 15 ft of riverside toe		
Lat/Long:	41.56701/-87.34522

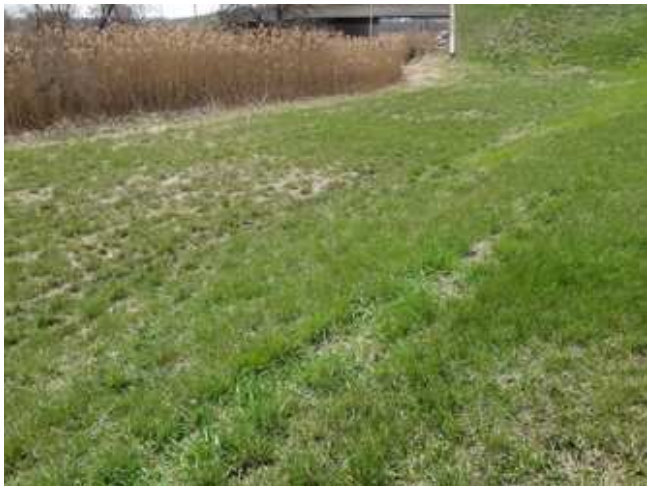
Category:	Levee Embankments	Item:	Unwanted Vegetation
Observation ID:	2023-0475		
Description:	Phragmites within 15 ft of toe (both sides)		
Caption:	0475 - No User Rating (Site Visit) - Phragmites within 15 ft of toe (both sides)		
Lat/Long:	41.56597/-87.33908

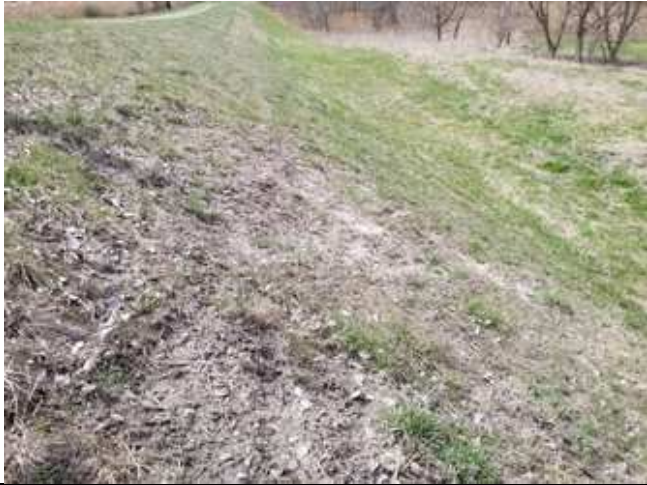
Category:	Levee Embankments	Item:	Sod Cover
Observation ID:	2023-0019		
Description:	Poor sod cover on crown		
Caption:	0019 - No User Rating (Site Visit) - Poor sod cover on crown		
Lat/Long:	41.56850/-87.31693

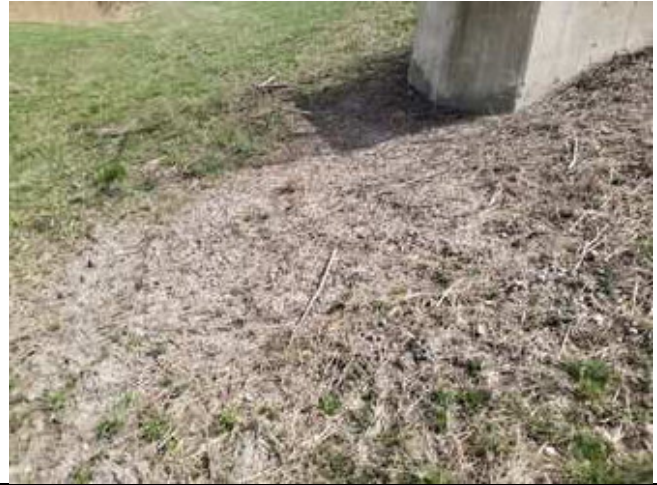
Category:	Levee Embankments	Item:	Sod Cover
Observation ID:	2023-0043		
Description:	Poor sod cover on riverside slope		
Caption:	0043 - No User Rating (Site Visit) - Poor sod cover on riverside slope		
Lat/Long:	41.56799/-87.31919

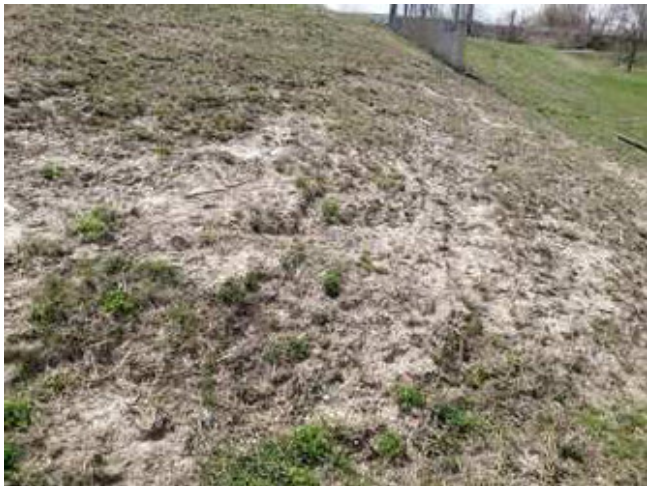
Category:	Levee Embankments	Item:	Sod Cover
Observation ID:	2023-0064		
Description:	Poor sod cover on riverside slope		
Caption:	0064 - No User Rating (Site Visit) - Poor sod cover on riverside slope		
Lat/Long:	41.56798/-87.32506

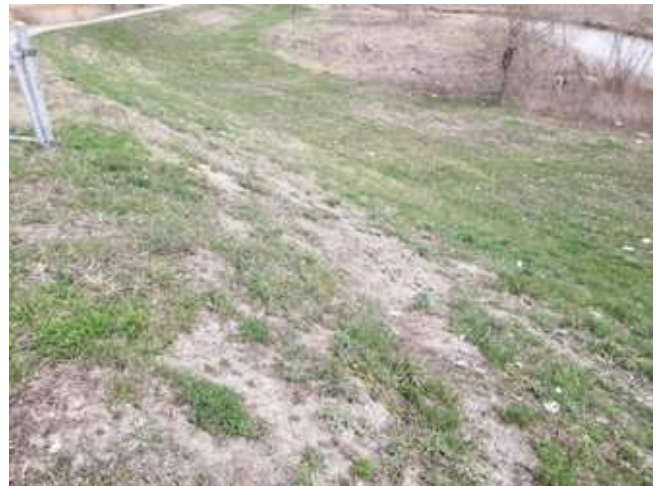
Category:	Levee Embankments	Item:	Sod Cover
Observation ID:	2023-0067		
Description:	Poor sod cover on riverside toe		
Caption:	0067 - No User Rating (Site Visit) - Poor sod cover on riverside toe		
Lat/Long:	41.56801/-87.32520

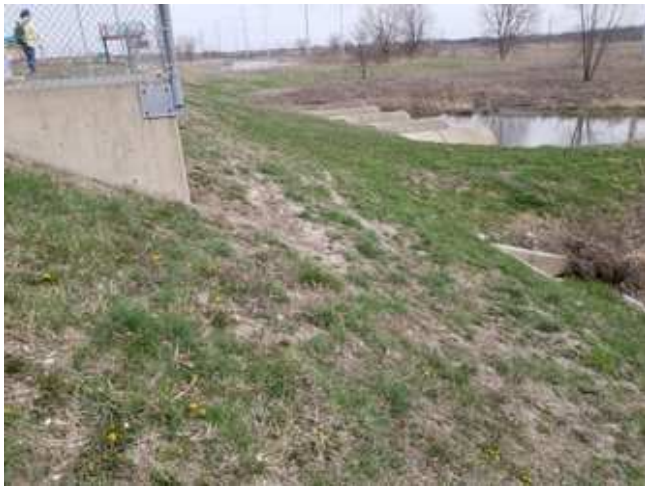
Category:	Levee Embankments	Item:	Sod Cover
Observation ID:	2023-0151		
Description:	Poor sod cover on riverside slope		
Caption:	0151 - No User Rating (Site Visit) - Poor sod cover on riverside slope		
Lat/Long:	41.56665/-87.32687

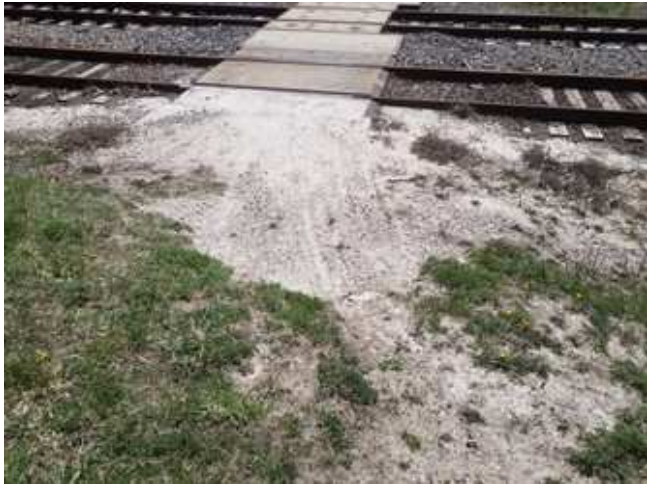
Category:	Levee Embankments	Item:	Sod Cover
Observation ID:	2023-0160		
Description:	Poor sod cover on riverside slope		
Caption:	0160 - No User Rating (Site Visit) - Poor sod cover on riverside slope		
Lat/Long:	41.56678/-87.32533

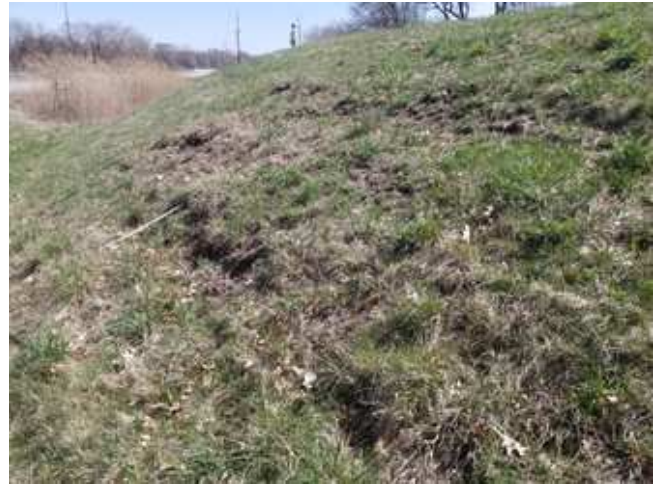
Category:	Levee Embankments	Item:	Sod Cover
Observation ID:	2023-0241		
Description:	Poor sod cover on crown near the railroad closure		
Caption:	0241 - No User Rating (Site Visit) - Poor sod cover on crown near the railroad closure		
Lat/Long:	41.56739/-87.41939

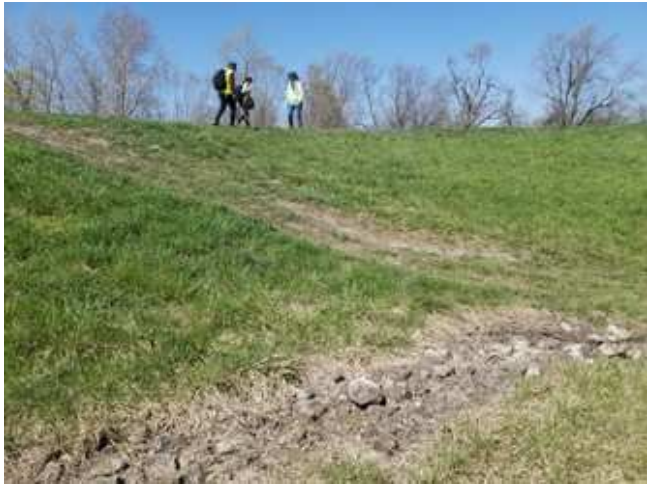
Category:	Levee Embankments	Item:	Sod Cover
Observation ID:	2023-0286		
Description:	Poor sod cover on landside slope		
Caption:	0286 - No User Rating (Site Visit) - Poor sod cover on landside slope		
Lat/Long:	41.56448/-87.41333

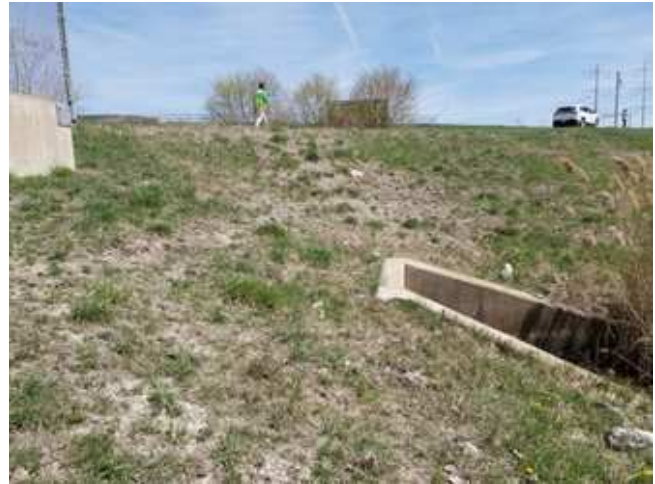
Category:	Levee Embankments	Item:	Sod Cover
Observation ID:	2023-0352		
Description:	Poor sod cover on riverside slope		
Caption:	0352 - No User Rating (Site Visit) - Poor sod cover on riverside slope		
Lat/Long:	41.56070/-87.40425

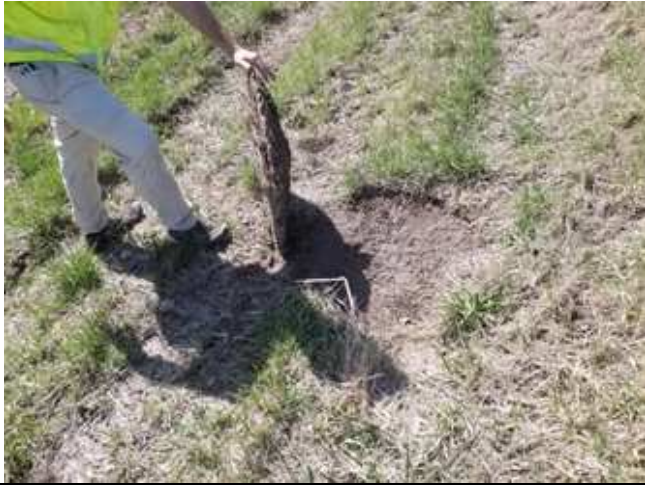
Category:	Levee Embankments	Item:	Encroachments
Observation ID:	2023-0123		
Description:	Removed wood bollard and hole in slope.		
Caption:	0123 - No User Rating (Site Visit) - Removed wooden bollard and hole on slope		
Lat/Long:	41.56083/-87.39363

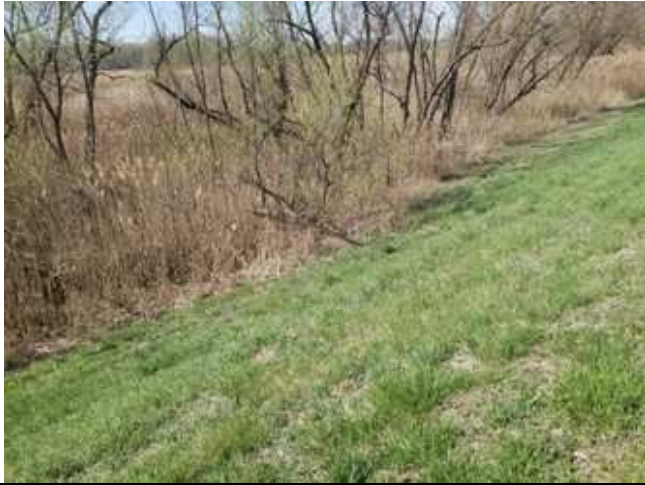
Category:	Levee Embankments	Item:	Encroachments
Observation ID:	2023-0169		
Description:	Log encroachment on riverside toe		
Caption:	0169 - No User Rating (Site Visit) - Log encroachment on riverside toe		
Lat/Long:	41.56675/-87.32208

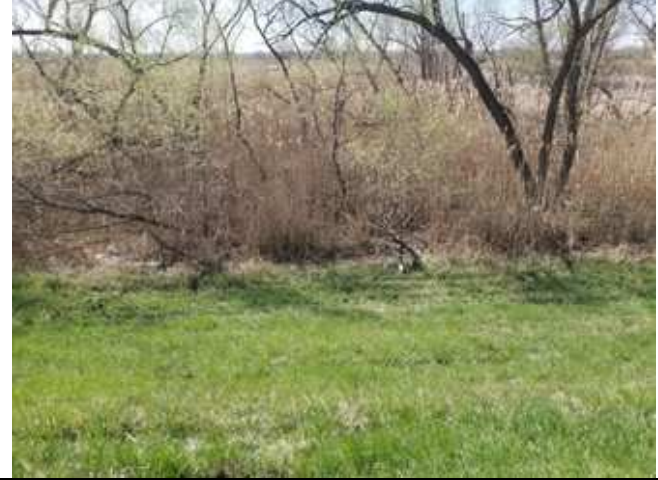
Category:	Levee Embankments	Item:	Encroachments
Observation ID:	2023-0180		
Description:	Fallen tree on riverside toe		
Caption:	0180 - No User Rating (Site Visit) - Fallen tree on riverside toe		
Lat/Long:	41.56905/-87.36588

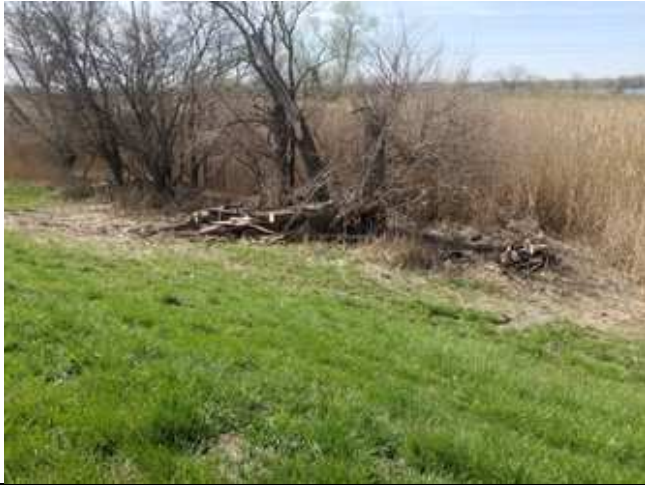
Category:	Levee Embankments	Item:	Encroachments
Observation ID:	2023-0183		
Description:	Dead trees on riverside toe		
Caption:	0183 - No User Rating (Site Visit) - Dead trees on riverside toe		
Lat/Long:	41.56903/-87.36272

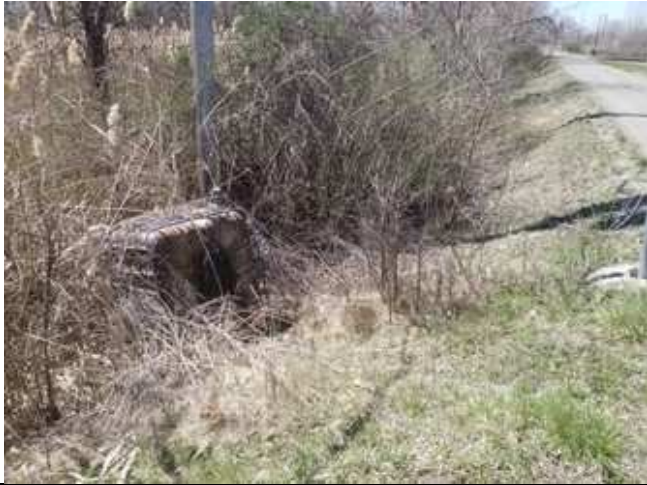
Category:	Levee Embankments	Item:	Encroachments
Observation ID:	2023-0208		
Description:	Debris on riverside toe		
Caption:	0208 - No User Rating (Site Visit) - Debris on riverside toe		
Lat/Long:	41.56874/-87.42373

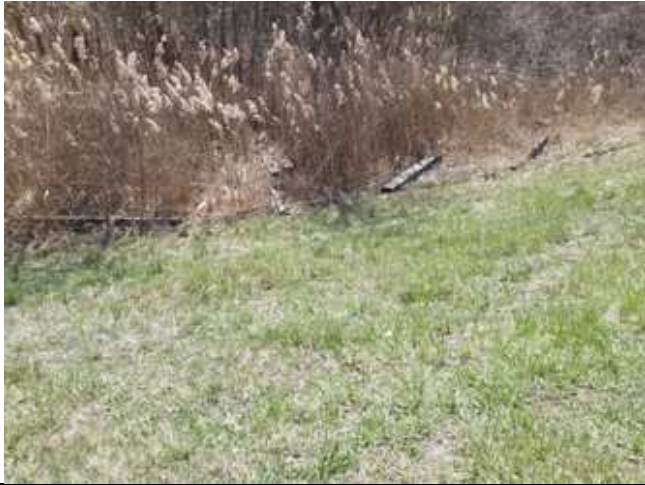
Category:	Levee Embankments	Item:	Encroachments
Observation ID:	2023-0247		
Description:	Debris on riverside slope		
Caption:	0247 - No User Rating (Site Visit) - Debris on riverside slope		
Lat/Long:	41.56707/-87.41936

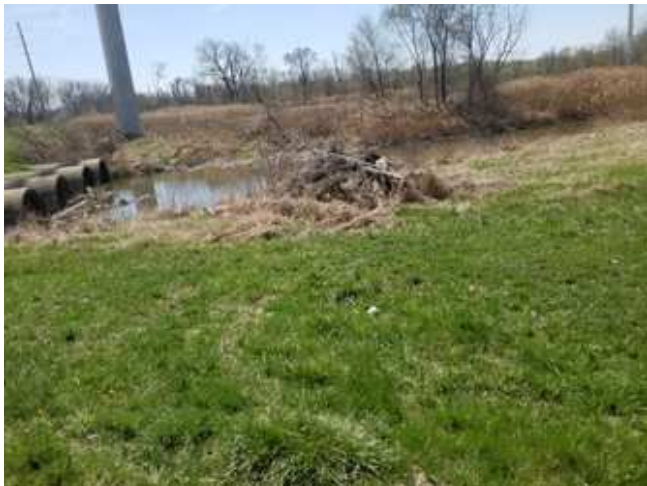
Category:	Levee Embankments	Item:	Encroachments
Observation ID:	2023-0280		
Description:	Railroad debris on landside toe		
Caption:	0280 - No User Rating (Site Visit) - Railroad debris on landside toe		
Lat/Long:	41.56461/-87.41406

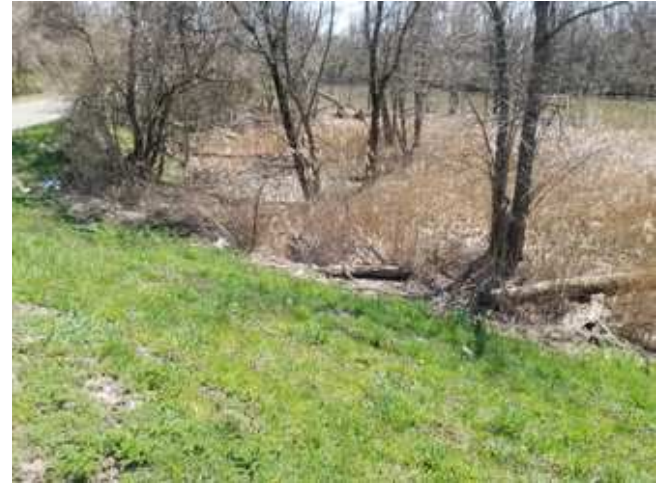
Category:	Levee Embankments	Item:	Encroachments
Observation ID:	2023-0328		
Description:	Tree encroachment on riverside slope		
Caption:	0328 - No User Rating (Site Visit) - Tree encroachment on riverside slope		
Lat/Long:	41.56216/-87.40943

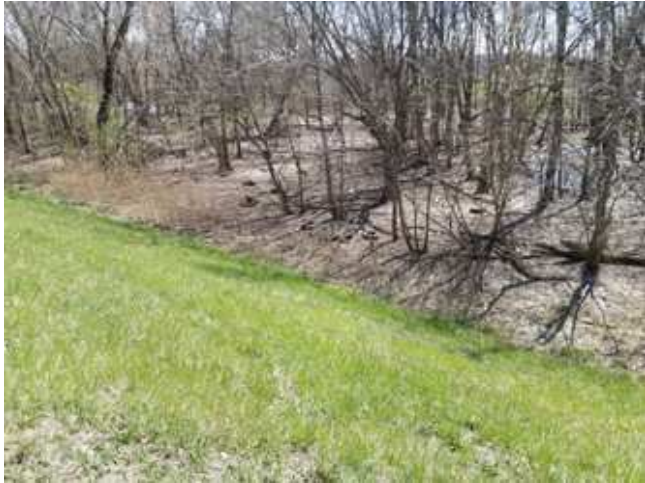
Category:	Levee Embankments	Item:	Encroachments
Observation ID:	2023-0334		
Description:	Debris on riverside toe		
Caption:	0334 - No User Rating (Site Visit) - Debris on riverside toe		
Lat/Long:	41.56173/-87.40849

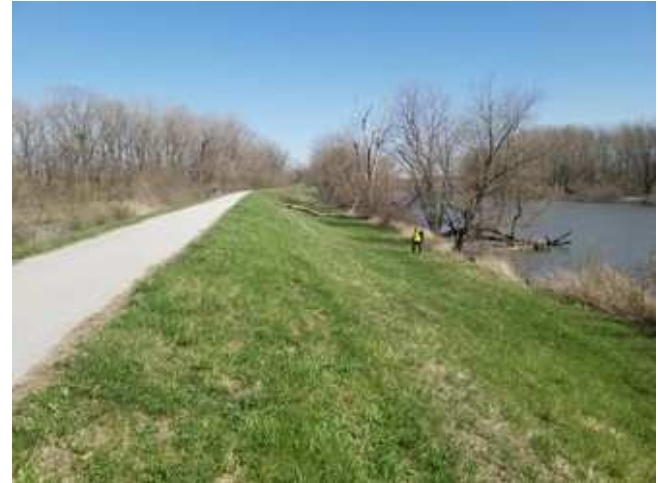
Category:	Levee Embankments	Item:	Encroachments
Observation ID:	2023-0337		
Description:	Debris on riverside toe		
Caption:	0337 - No User Rating (Site Visit) - Debris on riverside toe		
Lat/Long:	41.56117/-87.40752

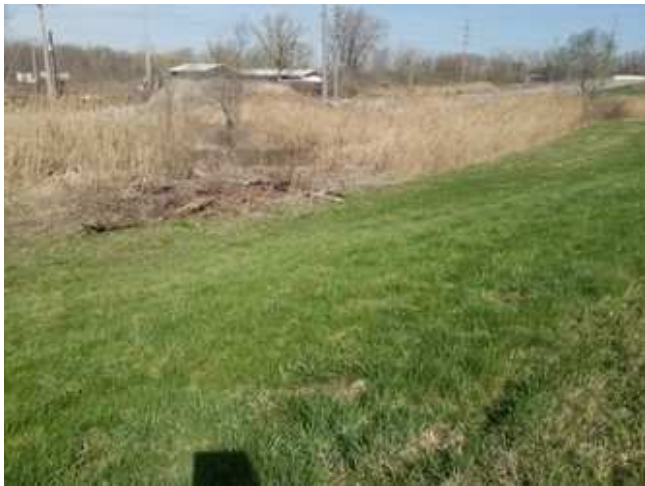
Category:	Levee Embankments	Item:	Encroachments
Observation ID:	2023-0364		
Description:	Fallen tree on riverside toe and slope		
Caption:	0364 - No User Rating (Site Visit) - Fallen tree on riverside toe and slope		
Lat/Long:	41.56091/-87.39809

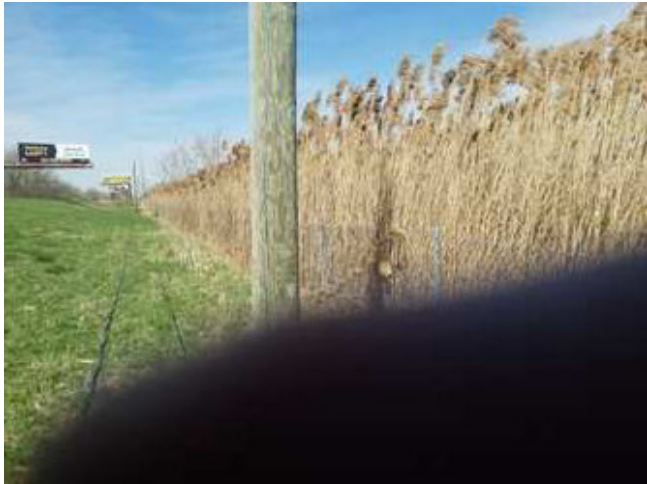
Category:	Levee Embankments	Item:	Encroachments
Observation ID:	2023-0430		
Description:	Downed tree on landside toe		
Caption:	0430 - No User Rating (Site Visit) - Downed tree on landside toe		
Lat/Long:	41.56779/-87.37471

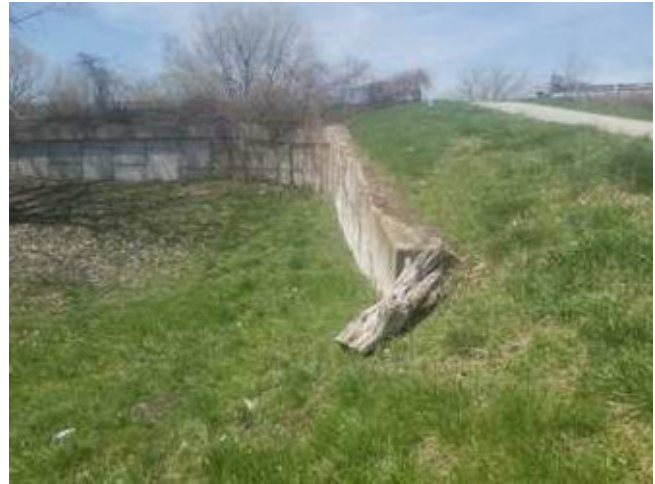
Category:	Levee Embankments	Item:	Encroachments
Observation ID:	2023-0433		
Description:	Sagging power line on landside toe		
Caption:	0433 - No User Rating (Site Visit) - Sagging power line on landside toe		
Lat/Long:	41.56918/-87.36343

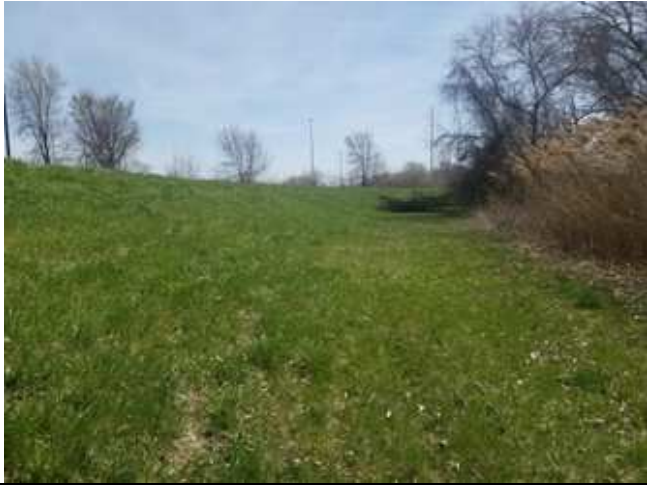
Category:	Levee Embankments	Item:	Encroachments
Observation ID:	2023-0460		
Description:	Log encroachment on riverside slope		
Caption:	0460 - No User Rating (Site Visit) - Log encroachment on riverside slope		
Lat/Long:	41.56706/-87.34590

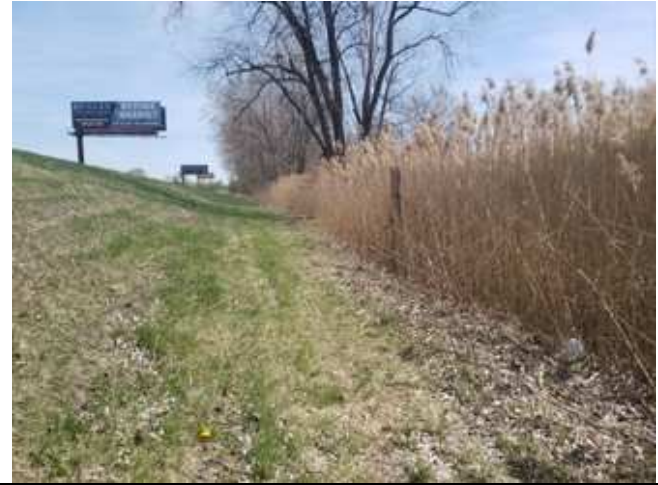
Category:	Levee Embankments	Item:	Encroachments
Observation ID:	2023-0493		
Description:	Downed tree on riverside toe		
Caption:	0493 - No User Rating (Site Visit) - Downed tree on riverside toe		
Lat/Long:	41.56677/-87.33284

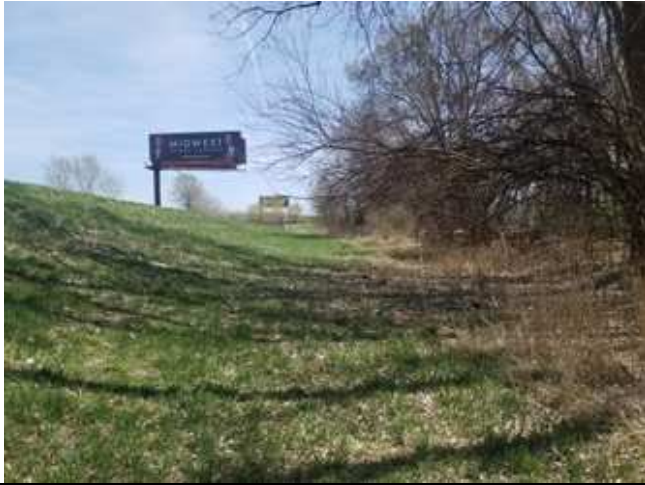
Category:	Levee Embankments	Item:	Encroachments
Observation ID:	2023-0496		
Description:	Power pole encroachment on riverside toe		
Caption:	0496 - No User Rating (Site Visit) - Power pole encroachment on riverside toe		
Lat/Long:	41.56680/-87.33207

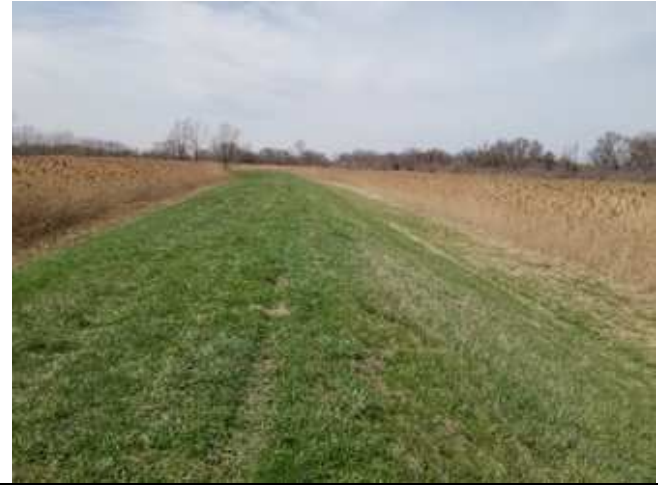
Category:	Levee Embankments	Item:	Encroachments
Observation ID:	2023-0502		
Description:	Low tree limbs on riverside toe		
Caption:	0502 - No User Rating (Site Visit) - Low tree limbs on riverside toe		
Lat/Long:	41.56670/-87.32941

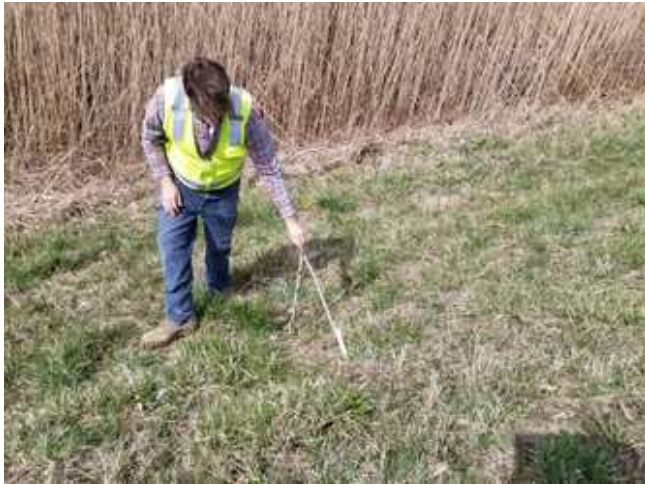
Category:	Levee Embankments	Item:	Slope Stability
Observation ID:	2023-0037		
Description:	Typical good slope stability		
Caption:	0037 - No User Rating (Site Visit) - Typical good slope stability		
Lat/Long:	41.56799/-87.31433

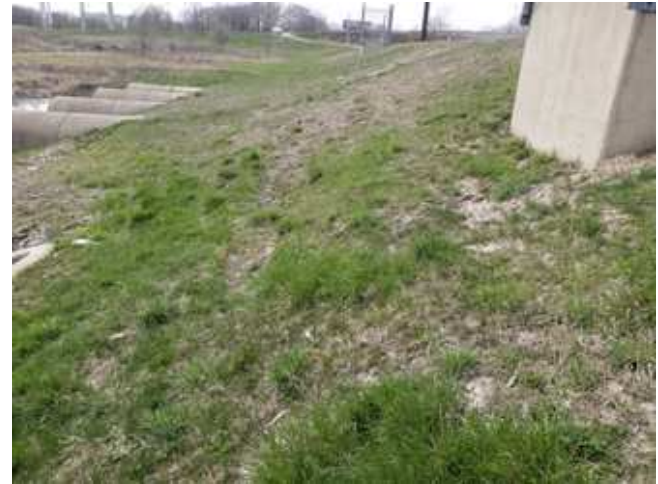
Category:	Levee Embankments	Item:	Slope Stability
Observation ID:	2023-0112		
Description:	1V:1H slope on landside		
Caption:	0112 - No User Rating (Site Visit) - 1V:1H slope on landside		
Lat/Long:	41.57228/-87.32644

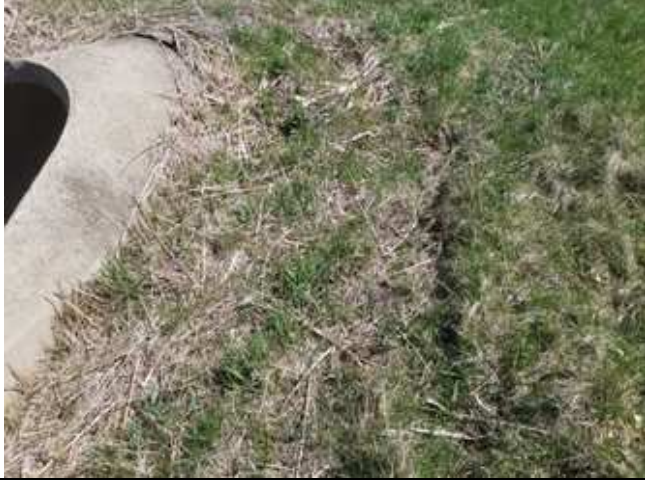
Category:	Levee Embankments	Item:	Slope Stability
Observation ID:	2023-0166		
Description:	1.5V:1H slope on riverside		
Caption:	0166 - No User Rating (Site Visit) - 1.5V:1H slope on riverside		
Lat/Long:	41.56678/-87.32494

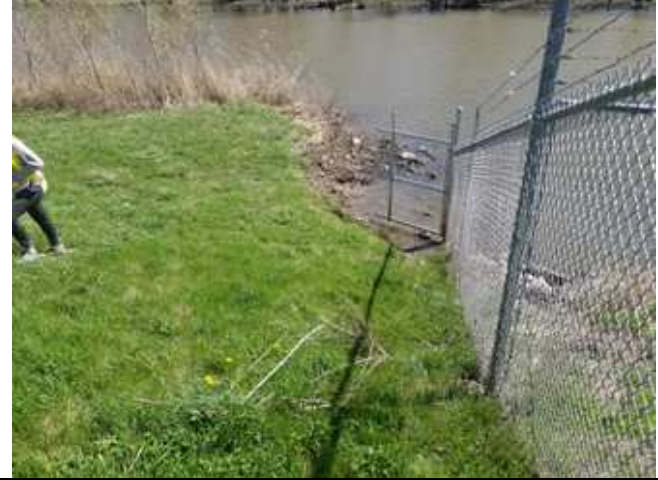
Category:	Levee Embankments	Item:	Erosion/ Bank Caving
Observation ID:	2023-0256		
Description:	Erosion around side of culvert on landside toe		
Caption:	0256 - No User Rating (Site Visit) - Erosion around side of culvert on riverside toe		
Lat/Long:	41.56664/-87.41806

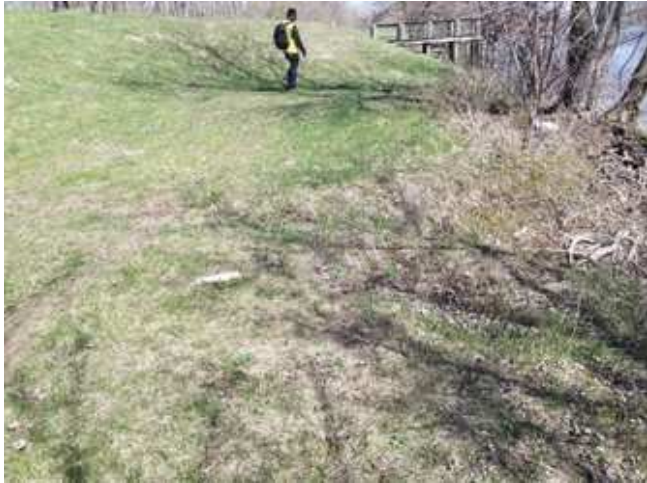
Category:	Levee Embankments	Item:	Erosion/ Bank Caving
Observation ID:	2023-0358		
Description:	Bank erosion on riverside toe		
Caption:	0358 - No User Rating (Site Visit) - Bank erosion on riverside toe		
Lat/Long:	41.56066/-87.40181

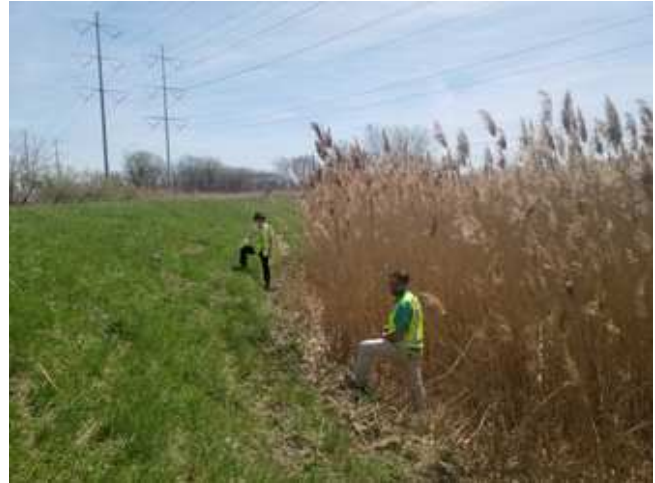
Category:	Levee Embankments	Item:	Erosion/ Bank Caving
Observation ID:	2023-0370		
Description:	Bank erosion on riverside toe		
Caption:	0370 - No User Rating (Site Visit) - Bank erosion on riverside toe		
Lat/Long:	41.56089/-87.39755
