**US Army Corps
of Engineers ®**

Site Visit Summary

Name of System: Gary

Name of Segment: Gary North

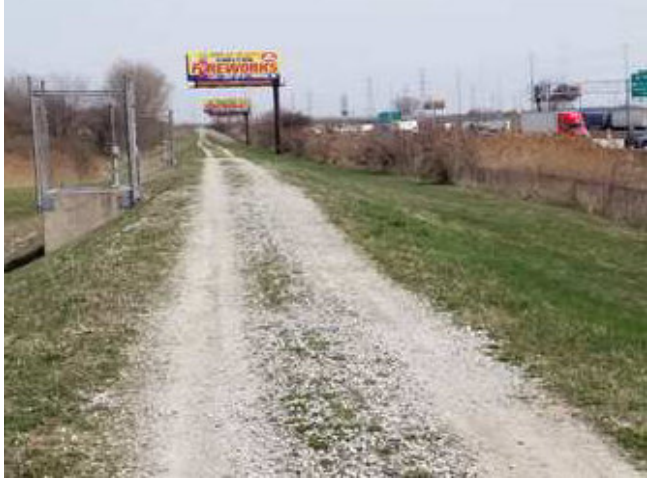
Category:	Levee Embankments	Item:	Erosion/ Bank Caving
Observation ID:	2023-0478		
Description:	Erosion on riverside slope		
Caption:	0478 - No User Rating (Site Visit) - Erosion on riverside slope		
Lat/Long:	41.56585/-87.33889

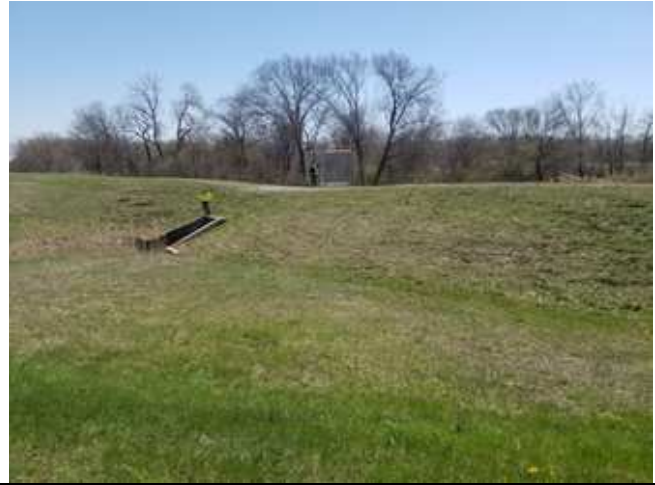
Category:	Levee Embankments	Item:	Settlement
Observation ID:	2023-0244		
Description:	Settlement of crown in road (towards left of photo)		
Caption:	0244 - No User Rating (Site Visit) - Settlement of crown in road (towards left of photo)		
Lat/Long:	41.56710/-87.41939

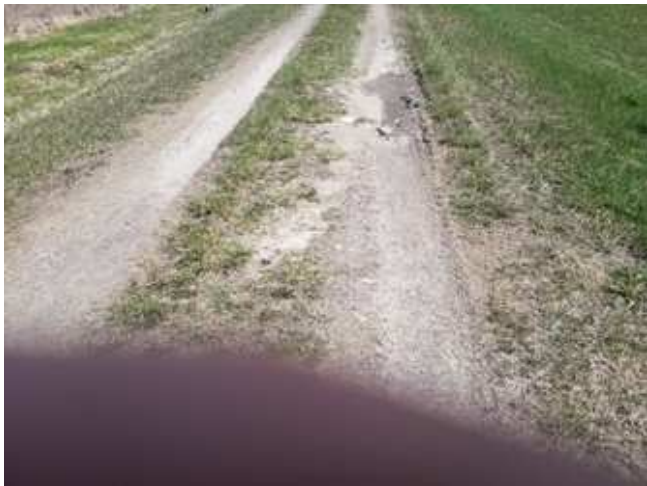
Category:	Levee Embankments	Item:	Settlement
Observation ID:	2023-0268		
Description:	Settlement above gate structure		
Caption:	0268 - No User Rating (Site Visit) - Settlement above gate structure		
Lat/Long:	41.56549/-87.41605

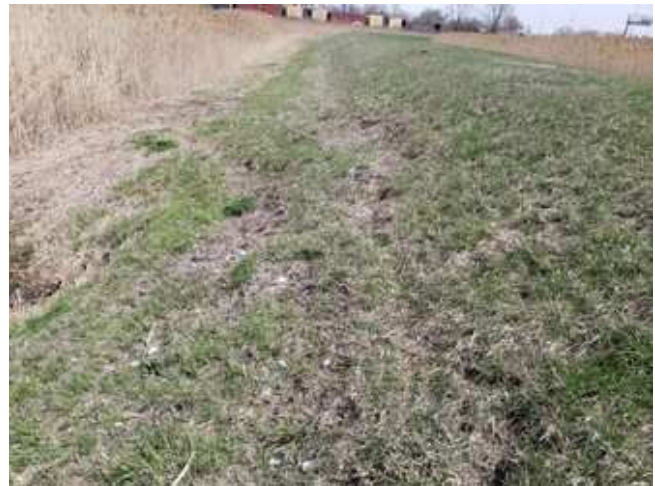
Category:	Levee Embankments	Item:	Depressions/ Rutting
Observation ID:	2023-0001		
Description:	Crown depressions		
Caption:	0001 - No User Rating (Site Visit) - Crown depressions		
Lat/Long:	41.56829/-87.31794

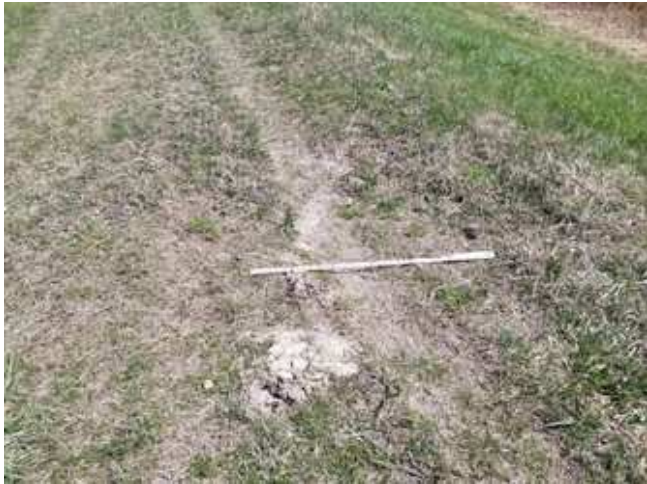
Category:	Levee Embankments	Item:	Depressions/ Rutting
Observation ID:	2023-0016		
Description:	Rutting on riverside slope		
Caption:	0016 - No User Rating (Site Visit) - Rutting on riverside slope		
Lat/Long:	41.56848/-87.31694

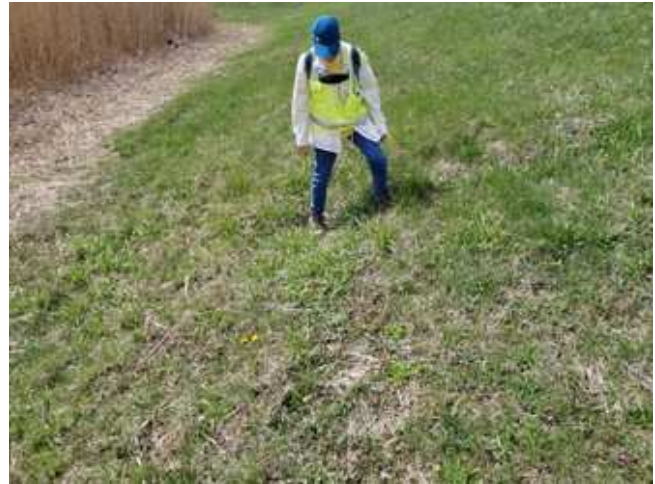
Category:	Levee Embankments	Item:	Depressions/ Rutting
Observation ID:	2023-0022		
Description:	Crown depression/ rut		
Caption:	0022 - No User Rating (Site Visit) - Crown depression/ rut		
Lat/Long:	41.56864/-87.31652

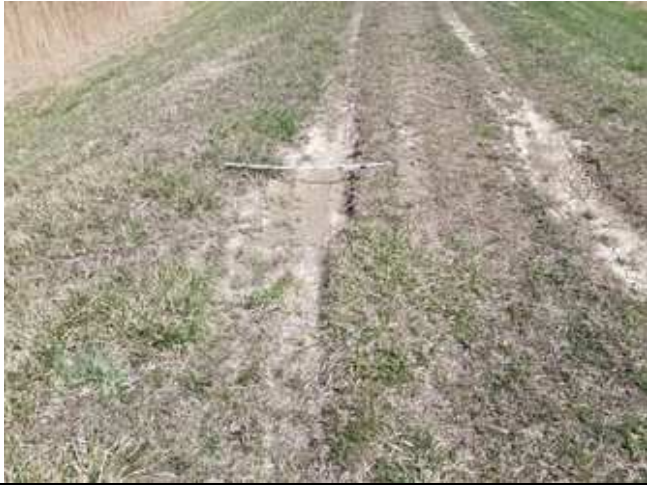
Category:	Levee Embankments	Item:	Depressions/ Rutting
Observation ID:	2023-0025		
Description:	Depression on landside slope		
Caption:	0025 - No User Rating (Site Visit) - Depression on landside slope		
Lat/Long:	41.56856/-87.31632

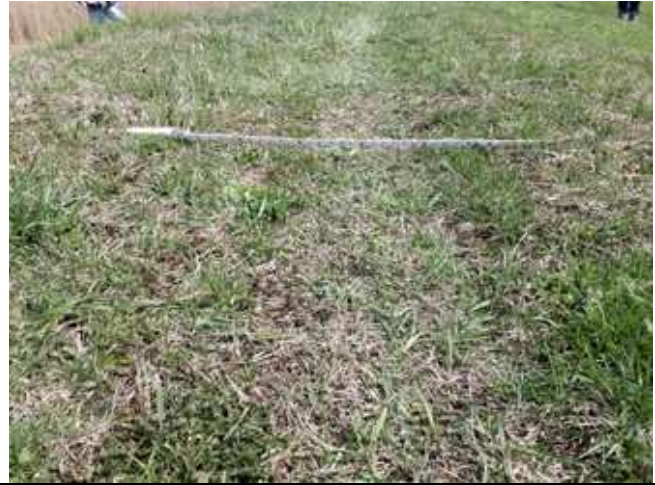
Category:	Levee Embankments	Item:	Depressions/ Rutting
Observation ID:	2023-0028		
Description:	Rutting/ depression on crown		
Caption:	0028 - No User Rating (Site Visit) - Rutting/ depression on crown		
Lat/Long:	41.56866/-87.31623

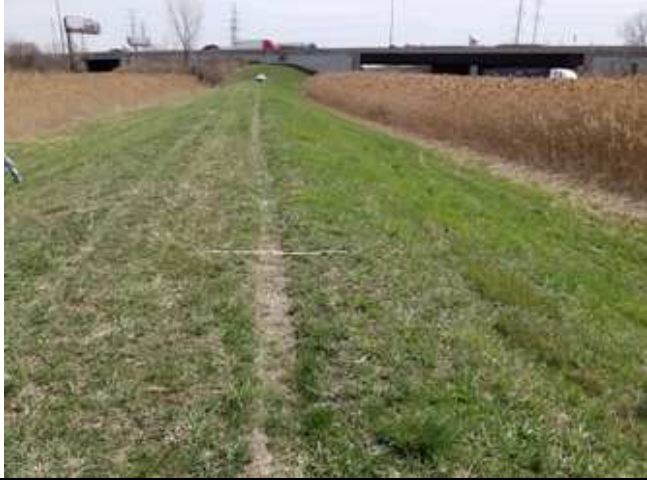
Category:	Levee Embankments	Item:	Depressions/ Rutting
Observation ID:	2023-0031		
Description:	Rutting and depression on corner of crown		
Caption:	0031 - No User Rating (Site Visit) - Rutting and depression on corner of crown		
Lat/Long:	41.56872/-87.31573

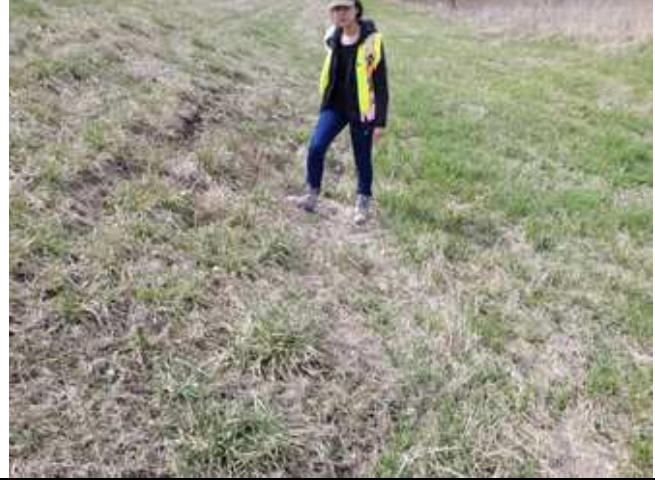
Category:	Levee Embankments	Item:	Depressions/ Rutting
Observation ID:	2023-0034		
Description:	Rutting along crown entire length to end		
Caption:	0034 - No User Rating (Site Visit) - Rutting along crown (entire length to end)		
Lat/Long:	41.56853/-87.31526

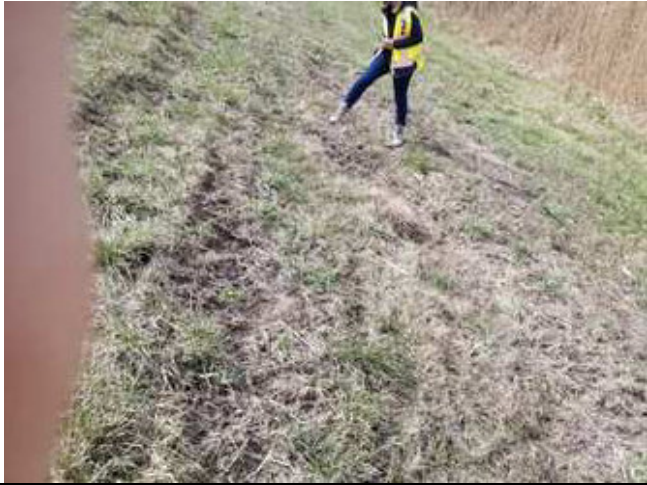
Category:	Levee Embankments	Item:	Depressions/ Rutting
Observation ID:	2023-0046		
Description:	Depression along riverside toe		
Caption:	0046 - No User Rating (Site Visit) - Depression along riverside toe		
Lat/Long:	41.56797/-87.31964

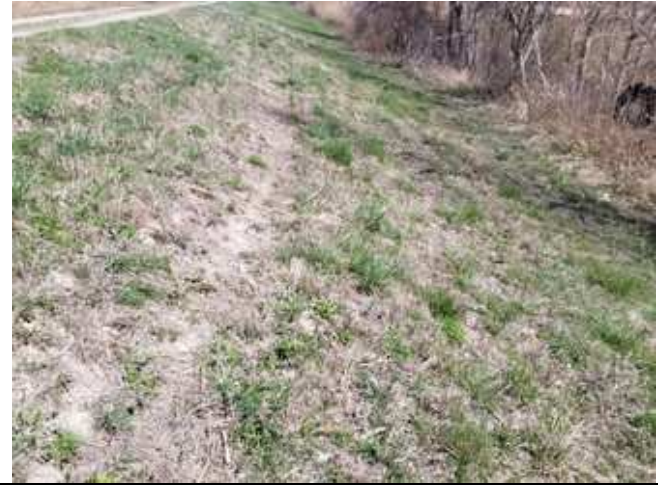
Category:	Levee Embankments	Item:	Depressions/ Rutting
Observation ID:	2023-0058		
Description:	Large ruts on riverside slope		
Caption:	0058 - No User Rating (Site Visit) - Large ruts on riverside slope		
Lat/Long:	41.56793/-87.32390

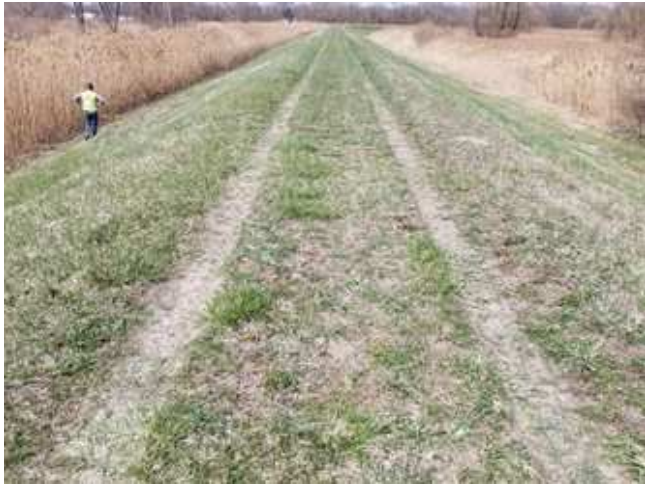
Category:	Levee Embankments	Item:	Depressions/ Rutting
Observation ID:	2023-0082		
Description:	Rutting on landside slope		
Caption:	0082 - No User Rating (Site Visit) - Rutting on landside slope		
Lat/Long:	41.56789/-87.32665

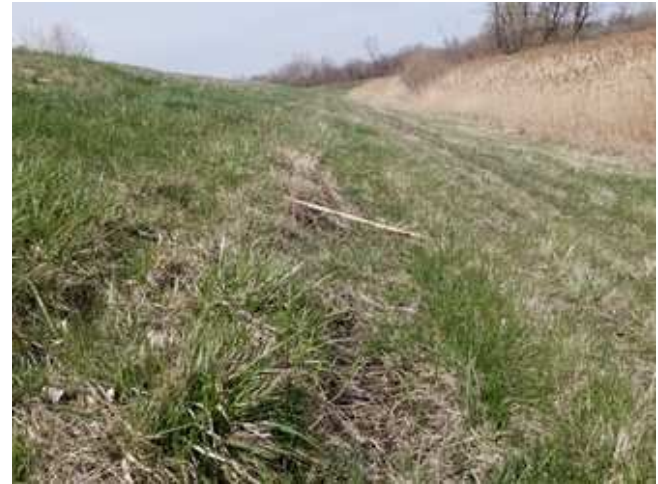
Category:	Levee Embankments	Item:	Depressions/ Rutting
Observation ID:	2023-0091		
Description:	Rutting on crest		
Caption:	0091 - No User Rating (Site Visit) - Rutting on crest		
Lat/Long:	41.57000/-87.32671

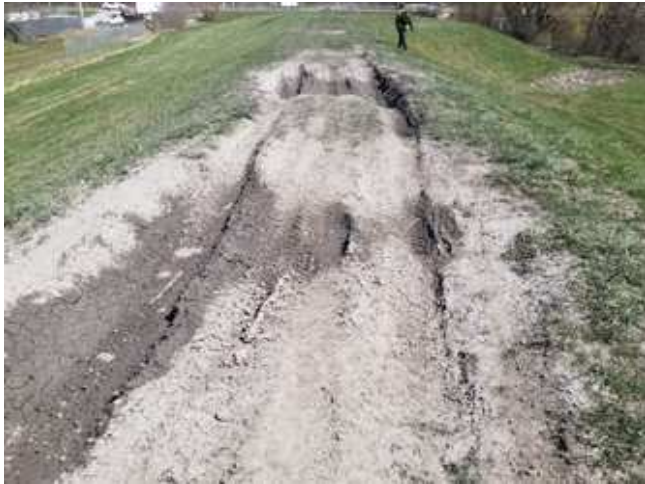
Category:	Levee Embankments	Item:	Depressions/ Rutting
Observation ID:	2023-0097		
Description:	Rutting on riverside slope		
Caption:	0097 - No User Rating (Site Visit) - Rutting on riverside slope		
Lat/Long:	41.57021/-87.32671

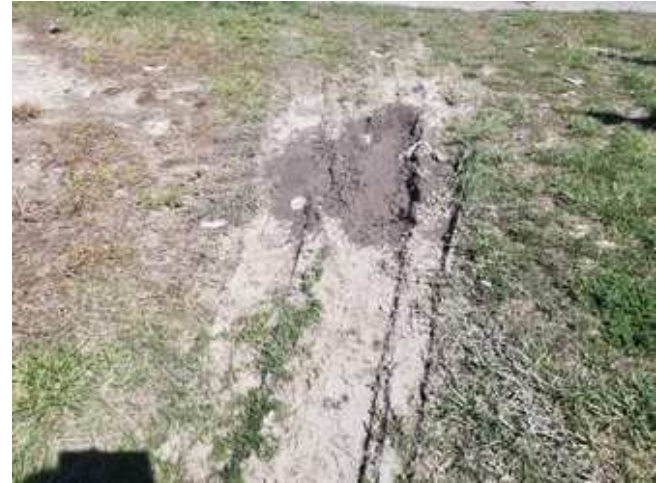
Category:	Levee Embankments	Item:	Depressions/ Rutting
Observation ID:	2023-0108		
Description:	Rutting along levee ramp		
Caption:	0108 - No User Rating (Site Visit) - Rutting along levee ramp		
Lat/Long:	41.56092/-87.40474

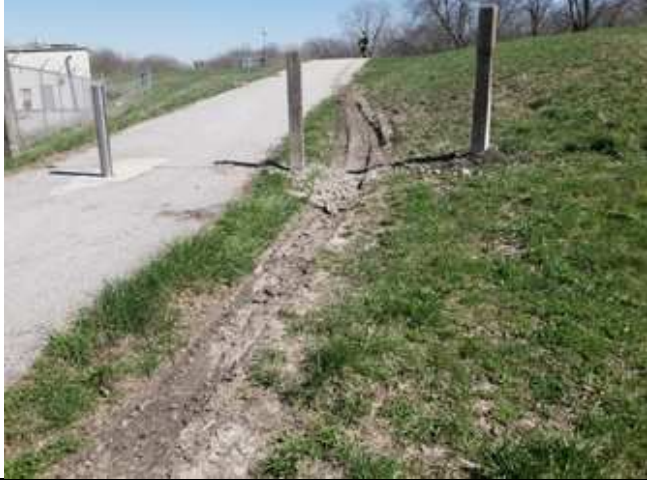
Category:	Levee Embankments	Item:	Depressions/ Rutting
Observation ID:	2023-0111		
Description:	Rutting along levee embankment to road		
Caption:	0111 - No User Rating (Site Visit) - Rutting along levee embankment to road		
Lat/Long:	41.56087/-87.40356

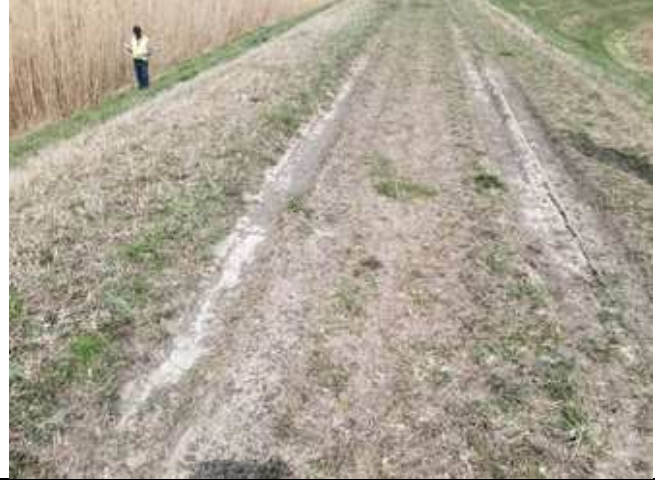
Category:	Levee Embankments	Item:	Depressions/ Rutting
Observation ID:	2023-0114		
Description:	Rutting along embankment ramp		
Caption:	0114 - No User Rating (Site Visit) - Rutting along embankment ramp		
Lat/Long:	41.56077/-87.40280

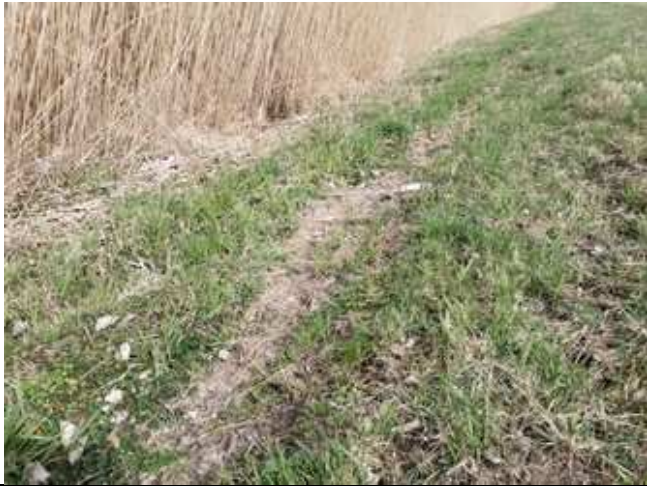
Category:	Levee Embankments	Item:	Depressions/ Rutting
Observation ID:	2023-0124		
Description:	Rutting on crest		
Caption:	0124 - No User Rating (Site Visit) - Rutting on crest		
Lat/Long:	41.57261/-87.32559

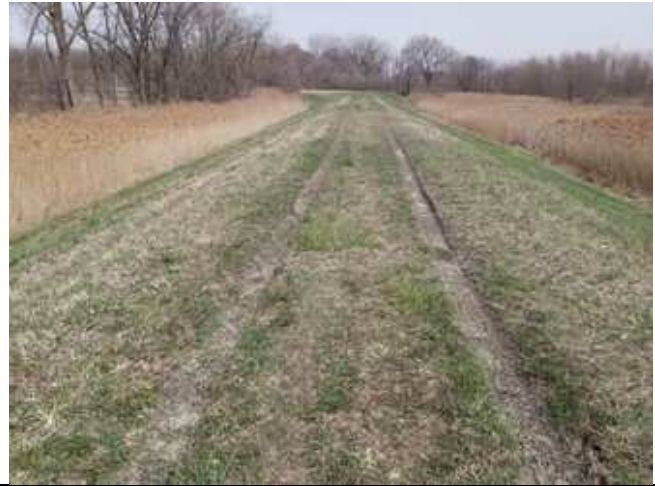
Category:	Levee Embankments	Item:	Depressions/ Rutting
Observation ID:	2023-0127		
Description:	Rutting on landside slope		
Caption:	0127 - No User Rating (Site Visit) - Rutting on landside slope		
Lat/Long:	41.57290/-87.32485

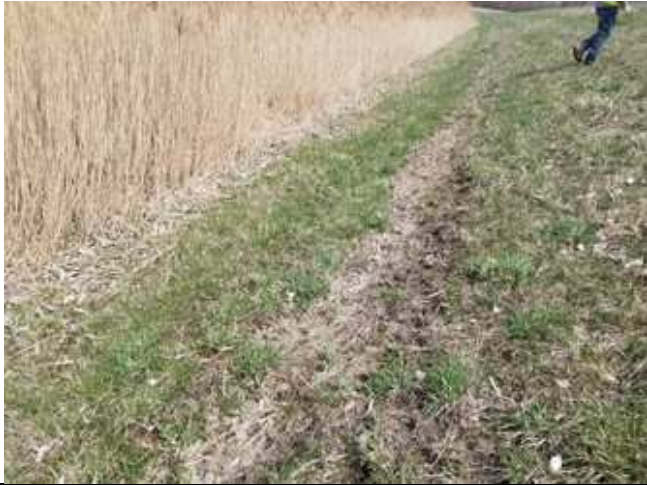
Category:	Levee Embankments	Item:	Depressions/ Rutting
Observation ID:	2023-0130		
Description:	Rutting on crest		
Caption:	0130 - No User Rating (Site Visit) - Rutting on crest		
Lat/Long:	41.57285/-87.32440

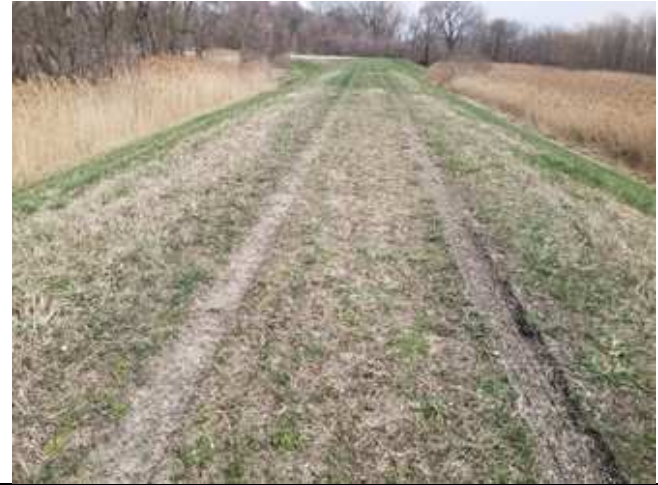
Category:	Levee Embankments	Item:	Depressions/ Rutting
Observation ID:	2023-0133		
Description:	Rutting on landside slope		
Caption:	0133 - No User Rating (Site Visit) - Rutting on landside slope		
Lat/Long:	41.57290/-87.32430

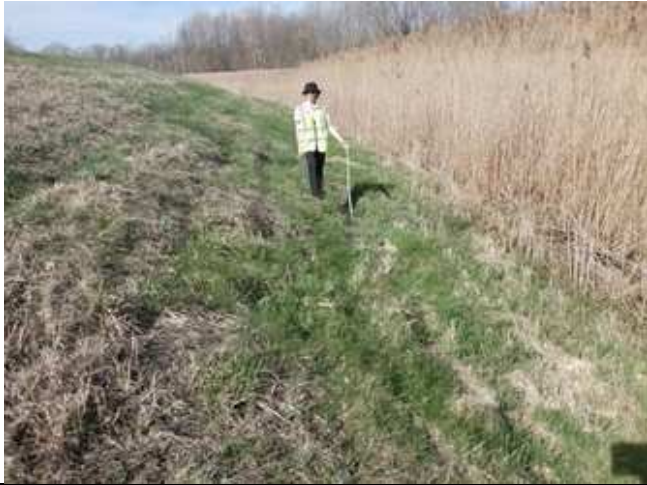
Category:	Levee Embankments	Item:	Depressions/ Rutting
Observation ID:	2023-0136		
Description:	Rutting on crest		
Caption:	0136 - No User Rating (Site Visit) - Rutting on crest		
Lat/Long:	41.57285/-87.32395

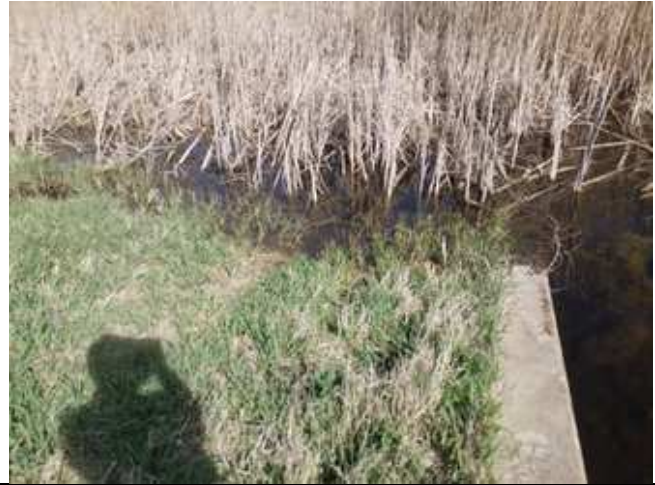
Category:	Levee Embankments	Item:	Depressions/ Rutting
Observation ID:	2023-0141		
Description:	One ft deep rut along landside toe		
Caption:	0141 - No User Rating (Site Visit) - One ft deep rut along landside toe		
Lat/Long:	41.56547/-87.38034

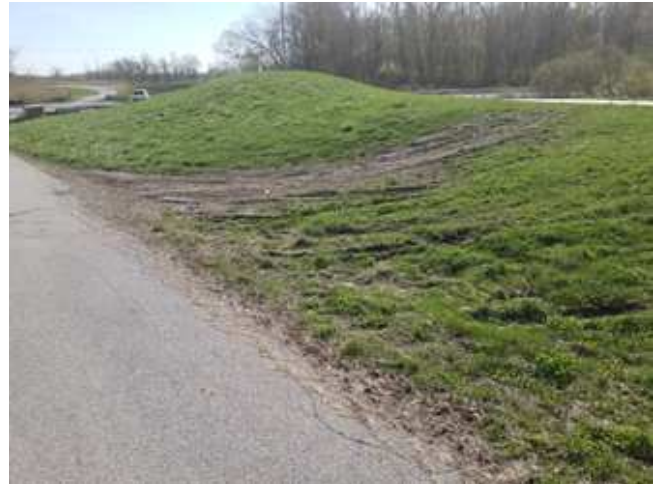
Category:	Levee Embankments	Item:	Depressions/ Rutting
Observation ID:	2023-0148		
Description:	Ruts on crest		
Caption:	0148 - No User Rating (Site Visit) - Ruts on crest		
Lat/Long:	41.57283/-87.32197

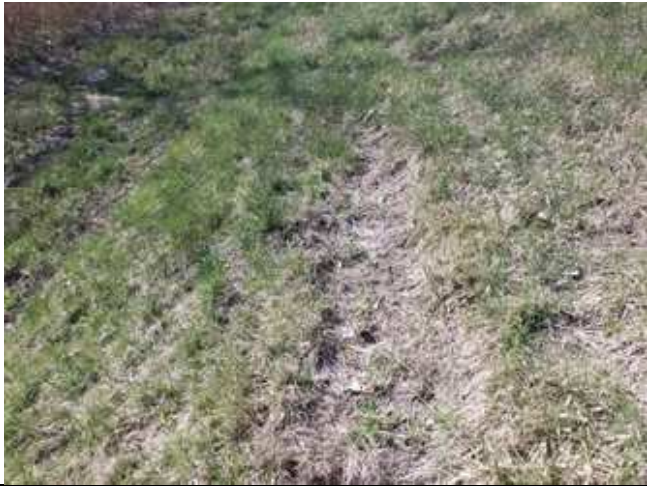
Category:	Levee Embankments	Item:	Depressions/ Rutting
Observation ID:	2023-0150		
Description:	Vehicle rutting on crest		
Caption:	0150 - No User Rating (Site Visit) - Vehicle rutting on crest		
Lat/Long:	41.56599/-87.37609

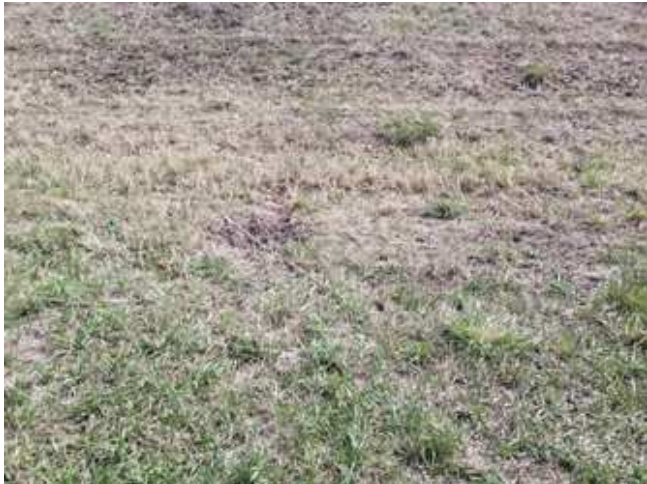
Category:	Levee Embankments	Item:	Depressions/ Rutting
Observation ID:	2023-0177		
Description:	Rutting and ponding on riverside toe		
Caption:	0177 - No User Rating (Site Visit) - Rutting and ponding on riverside toe		
Lat/Long:	41.56902/-87.36875

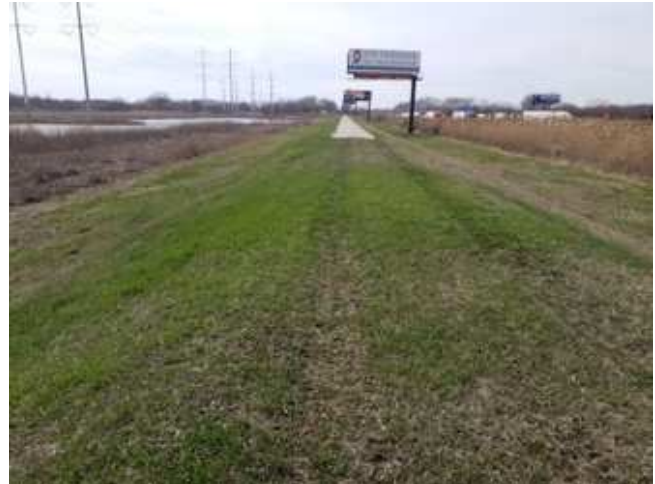
Category:	Levee Embankments	Item:	Depressions/ Rutting
Observation ID:	2023-0178		
Description:	Depression on landside toe		
Caption:	0178 - No User Rating (Site Visit) - Depression on landside toe		
Lat/Long:	41.56688/-87.31972

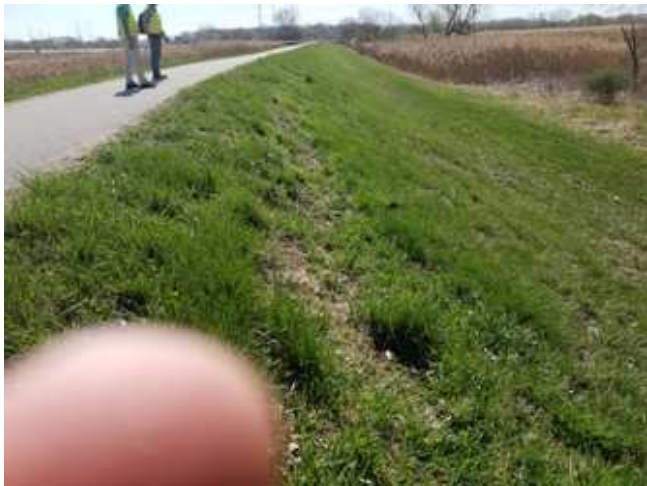
Category:	Levee Embankments	Item:	Depressions/ Rutting
Observation ID:	2023-0181		
Description:	Depression/rutting on crown		
Caption:	0181 - No User Rating (Site Visit) - Depression/rutting on crown		
Lat/Long:	41.56678/-87.31974

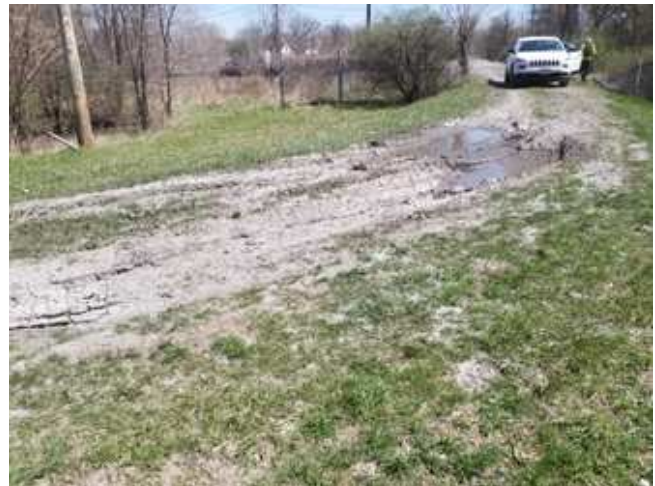
Category:	Levee Embankments	Item:	Depressions/ Rutting
Observation ID:	2023-0189		
Description:	Rutting on riverside slope		
Caption:	0189 - No User Rating (Site Visit) - Rutting on riverside slope		
Lat/Long:	41.56873/-87.36021

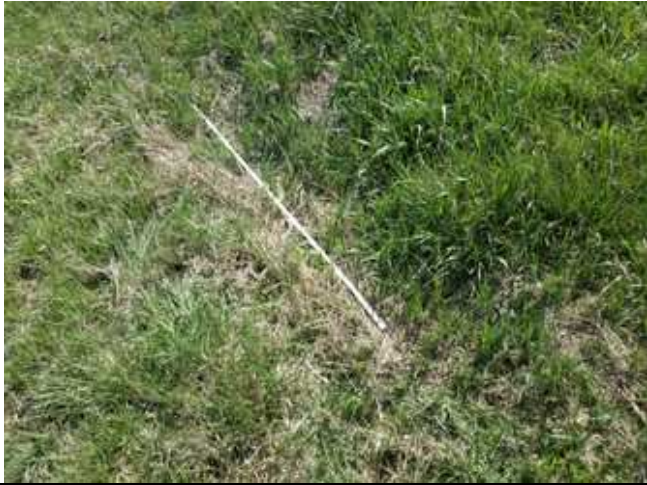
Category:	Levee Embankments	Item:	Depressions/ Rutting
Observation ID:	2023-0213		
Description:	Depression on landslide slope (12 foot wide 3 foot deep)		
Caption:	0213 - No User Rating (Site Visit) - Depression on landslide slope (12 foot wide 3 foot deep)		
Lat/Long:	41.56753/-87.35011

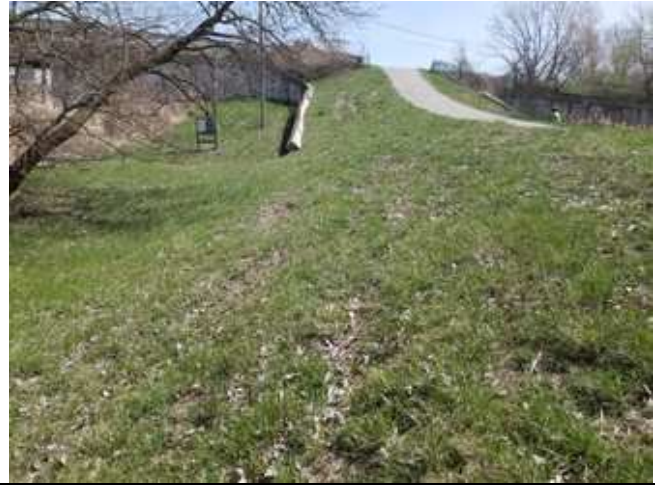
Category:	Levee Embankments	Item:	Depressions/ Rutting
Observation ID:	2023-0219		
Description:	Depression on landside slope		
Caption:	0219 - No User Rating (Site Visit) - Depression on landside slope		
Lat/Long:	41.56725/-87.34825

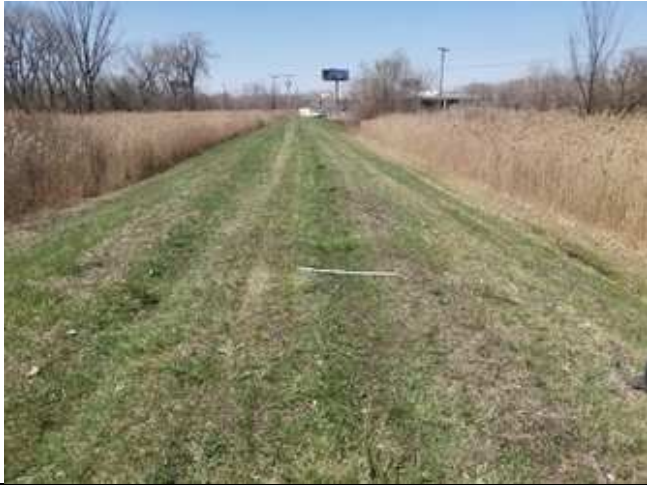
Category:	Levee Embankments	Item:	Depressions/ Rutting
Observation ID:	2023-0225		
Description:	Rutting on landside slope to road		
Caption:	0225 - No User Rating (Site Visit) - Rutting on landside slope to road		
Lat/Long:	41.56712/-87.34705

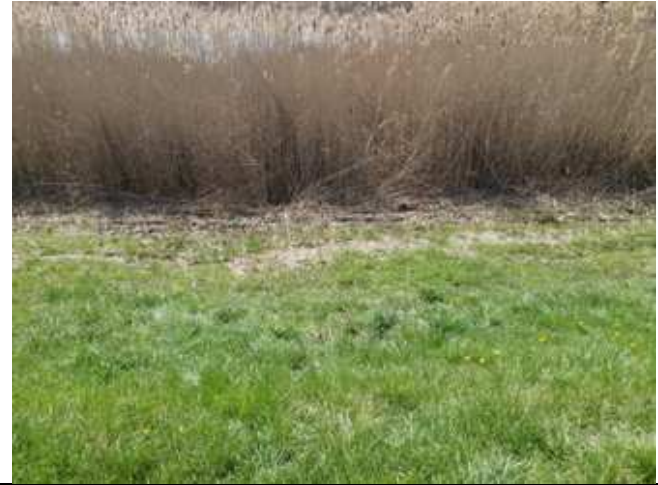
Category:	Levee Embankments	Item:	Depressions/ Rutting
Observation ID:	2023-0229		
Description:	Rutting along crown and slope		
Caption:	0229 - No User Rating (Site Visit) - Rutting along crown and slope		
Lat/Long:	41.56786/-87.42037

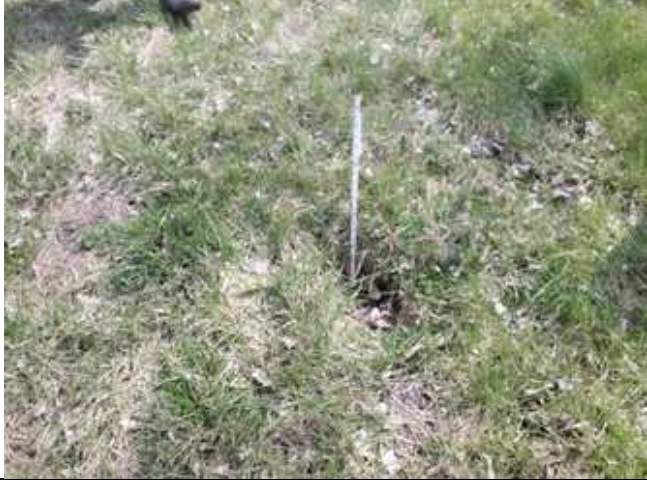
Category:	Levee Embankments	Item:	Depressions/ Rutting
Observation ID:	2023-0240		
Description:	Rut ponding water on riverside toe		
Caption:	0240 - No User Rating (Site Visit) - Rut ponding water on riverside toe		
Lat/Long:	41.56693/-87.34478

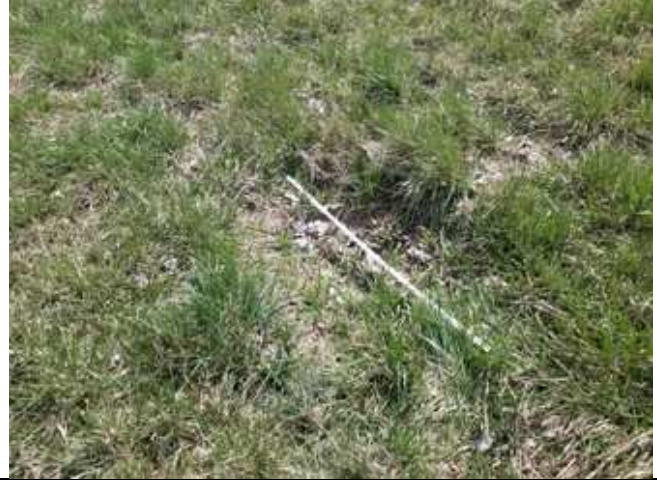
Category:	Levee Embankments	Item:	Depressions/ Rutting
Observation ID:	2023-0249		
Description:	Hole in crown where bollard was		
Caption:	0249 - No User Rating (Site Visit) - Hole in crown where bollard was		
Lat/Long:	41.56683/-87.34108

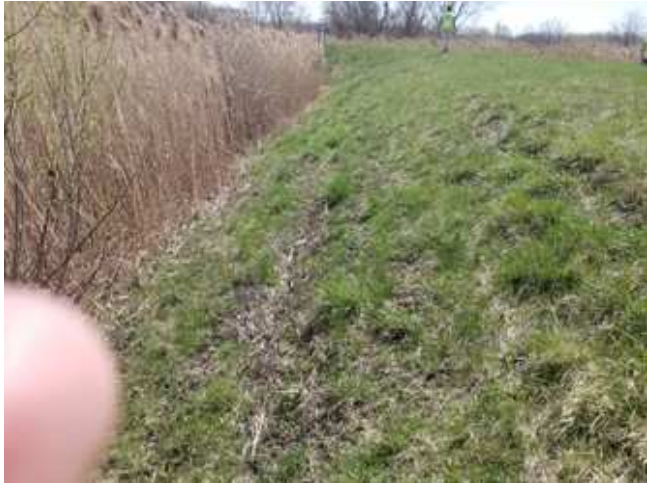
Category:	Levee Embankments	Item:	Depressions/ Rutting
Observation ID:	2023-0252		
Description:	Small depression on landside toe		
Caption:	0252 - No User Rating (Site Visit) - Small depression on landside toe		
Lat/Long:	41.56689/-87.34058

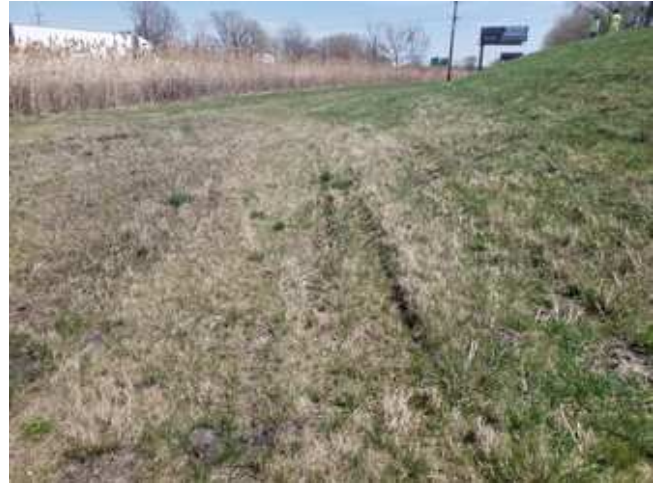
Category:	Levee Embankments	Item:	Depressions/ Rutting
Observation ID:	2023-0258		
Description:	Rut on landside slope		
Caption:	0258 - No User Rating (Site Visit) - Rut on landside slope		
Lat/Long:	41.56574/-87.33850

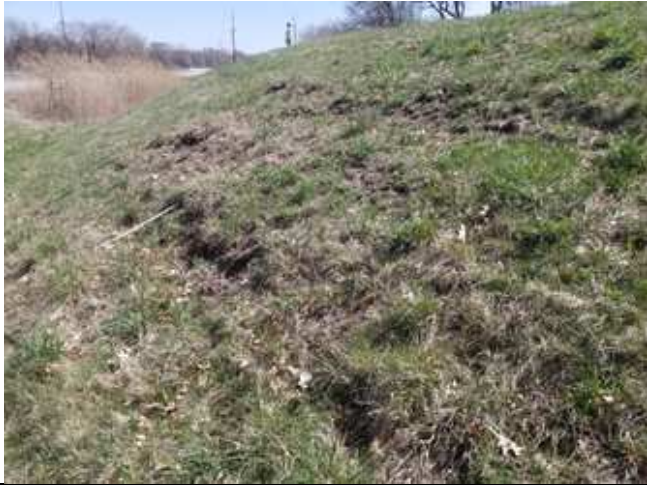
Category:	Levee Embankments	Item:	Depressions/ Rutting
Observation ID:	2023-0270		
Description:	Rutting on landside toe		
Caption:	0270 - No User Rating (Site Visit) - Rutting on landside toe		
Lat/Long:	41.56690/-87.33320

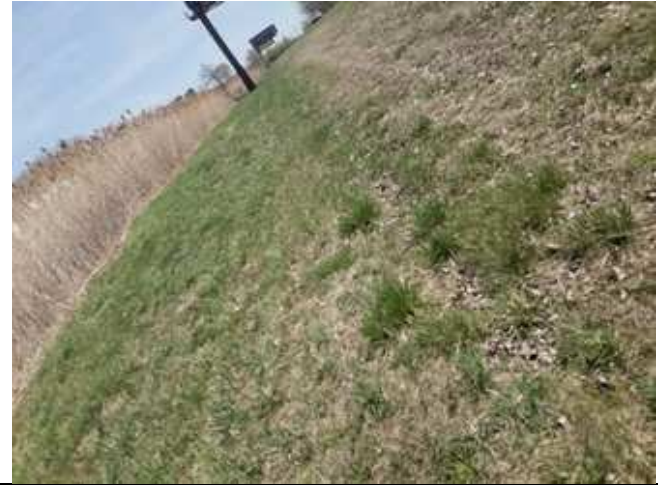
Category:	Levee Embankments	Item:	Depressions/ Rutting
Observation ID:	2023-0274		
Description:	Rutting along landside slope		
Caption:	0274 - No User Rating (Site Visit) - Rutting along landside slope		
Lat/Long:	41.56508/-87.41511

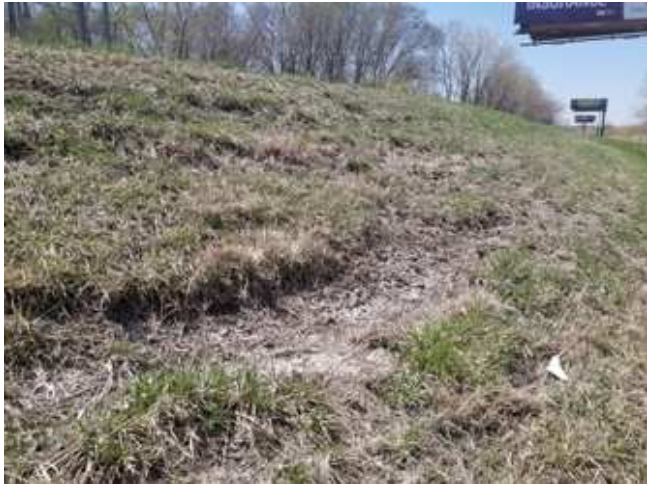
Category:	Levee Embankments	Item:	Depressions/ Rutting
Observation ID:	2023-0276		
Description:	Rutting on landside toe		
Caption:	0276 - No User Rating (Site Visit) - Rutting on landside toe		
Lat/Long:	41.56695/-87.33178

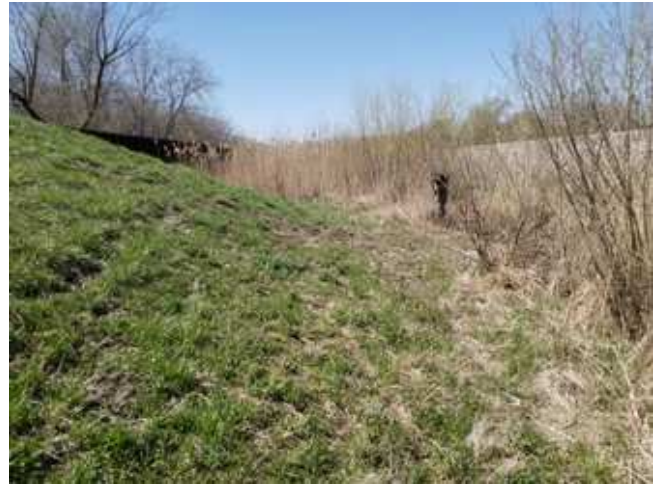
Category:	Levee Embankments	Item:	Depressions/ Rutting
Observation ID:	2023-0279		
Description:	Rutting on landside slope		
Caption:	0279 - No User Rating (Site Visit) - Rutting on landside slope		
Lat/Long:	41.56689/-87.32769

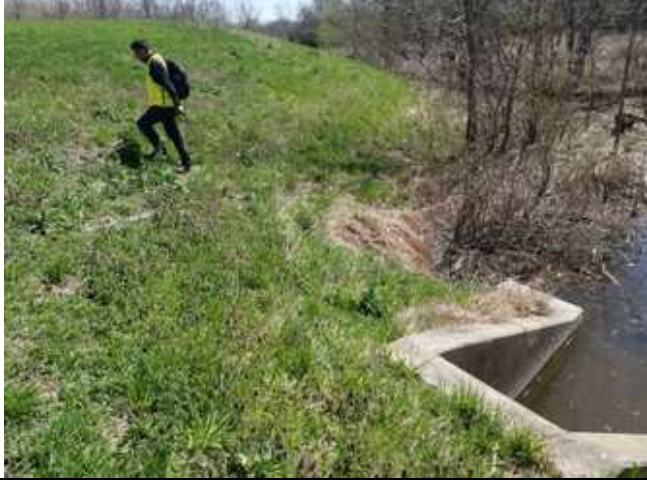
Category:	Levee Embankments	Item:	Depressions/ Rutting
Observation ID:	2023-0319		
Description:	Rutting on landside toe		
Caption:	0319 - No User Rating (Site Visit) - Rutting on landside toe		
Lat/Long:	41.56242/-87.40942

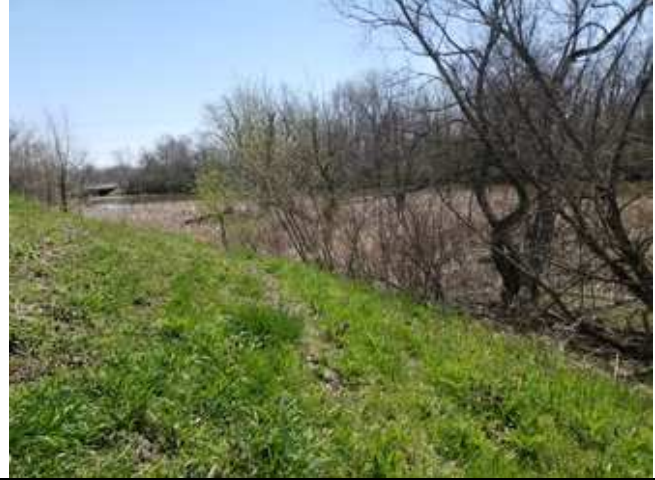
Category:	Levee Embankments	Item:	Depressions/ Rutting
Observation ID:	2023-0322		
Description:	Rutting/erosion on riverside slope		
Caption:	0322 - No User Rating (Site Visit) - Rutting/erosion on riverside slope		
Lat/Long:	41.56218/-87.40948

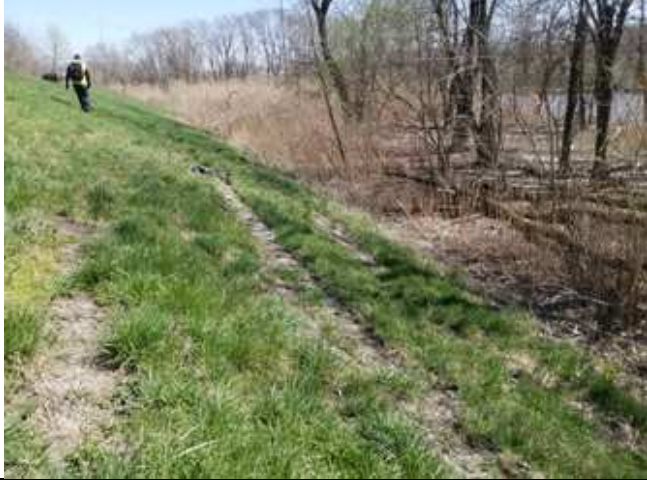
Category:	Levee Embankments	Item:	Depressions/ Rutting
Observation ID:	2023-0331		
Description:	Continued rutting on riverside slope		
Caption:	0331 - No User Rating (Site Visit) - Continued rutting on riverside slope		
Lat/Long:	41.56202/-87.40928

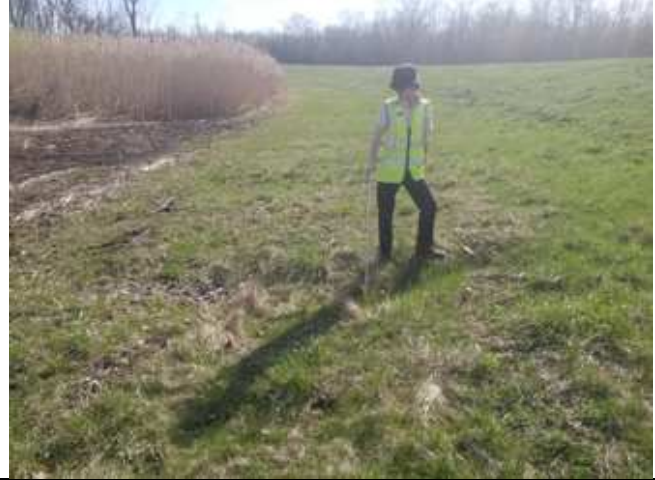
Category:	Levee Embankments	Item:	Depressions/ Rutting
Observation ID:	2023-0340		
Description:	Rutting on riverside slope		
Caption:	0340 - No User Rating (Site Visit) - Rutting on riverside slope		
Lat/Long:	41.56084/-87.40702

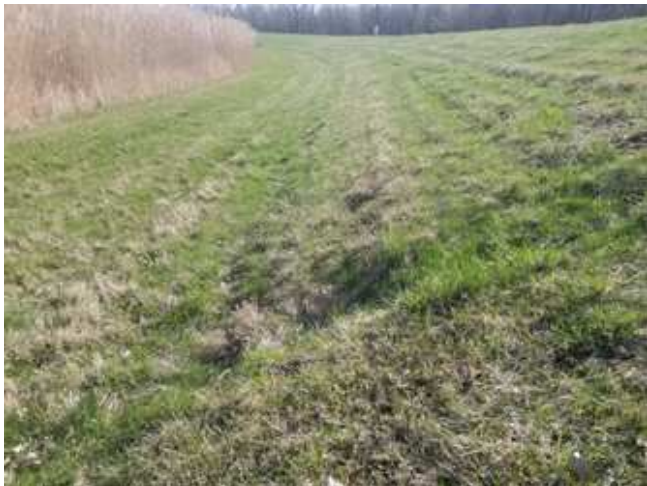
Category:	Levee Embankments	Item:	Depressions/ Rutting
Observation ID:	2023-0397		
Description:	Depression ~1 ft deep on landside toe		
Caption:	0397 - No User Rating (Site Visit) - Depression ~1' deep on landside toe		
Lat/Long:	41.56295/-87.38456

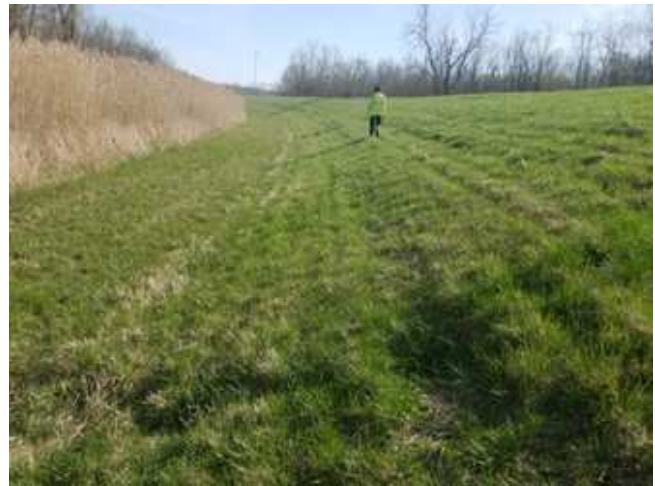
Category:	Levee Embankments	Item:	Depressions/ Rutting
Observation ID:	2023-0400		
Description:	Depression (potentially collapsed animal burrow) on landside slope		
Caption:	0400 - No User Rating (Site Visit) - Depression (potentially collapsed animal burrow) on landside slope		
Lat/Long:	41.56302/-87.38385

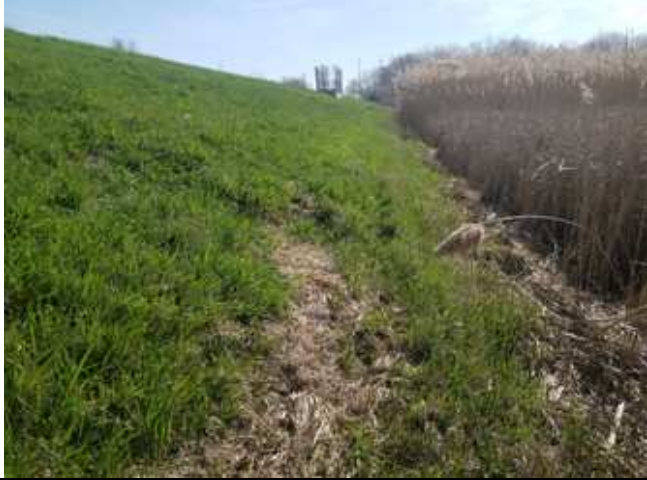
Category:	Levee Embankments	Item:	Depressions/ Rutting
Observation ID:	2023-0403		
Description:	Typical depressions on landside slope		
Caption:	0403 - No User Rating (Site Visit) - Typical depressions on landside slope		
Lat/Long:	41.56331/-87.38309

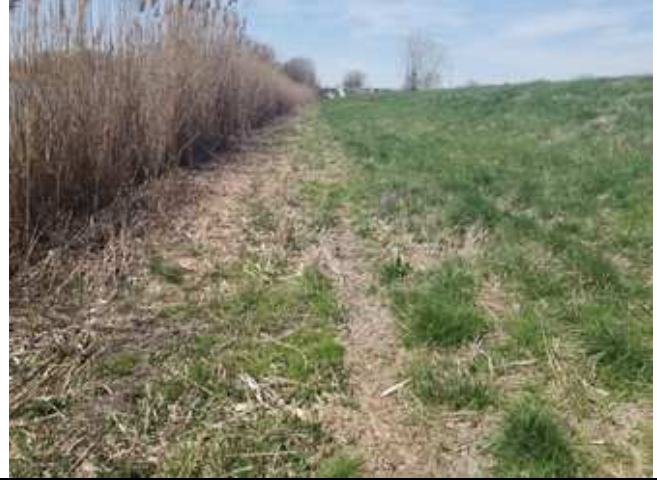
Category:	Levee Embankments	Item:	Depressions/ Rutting
Observation ID:	2023-0409		
Description:	Depression on riverside toe and slope		
Caption:	0409 - No User Rating (Site Visit) - Depression on riverside toe and slope		
Lat/Long:	41.56565/-87.37783

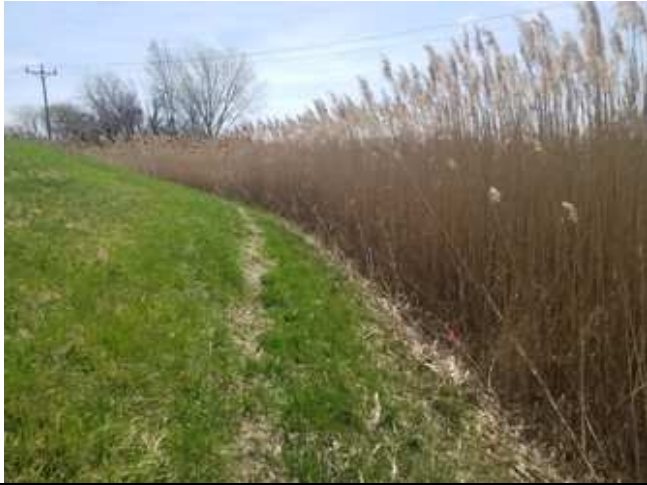
Category:	Levee Embankments	Item:	Depressions/ Rutting
Observation ID:	2023-0466		
Description:	Depression on riverside toe		
Caption:	0466 - No User Rating (Site Visit) - Depression on riverside toe		
Lat/Long:	41.56684/-87.34262

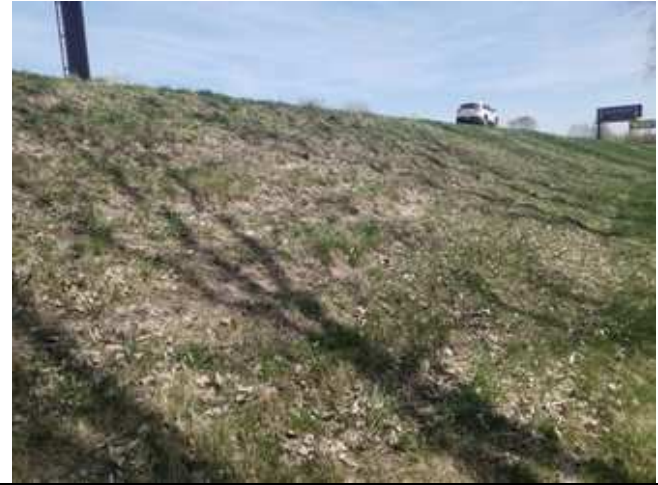
Category:	Levee Embankments	Item:	Depressions/ Rutting
Observation ID:	2023-0481		
Description:	Rutting on riverside slope		
Caption:	0481 - No User Rating (Site Visit) - Rutting on riverside slope		
Lat/Long:	41.56560/-87.33844

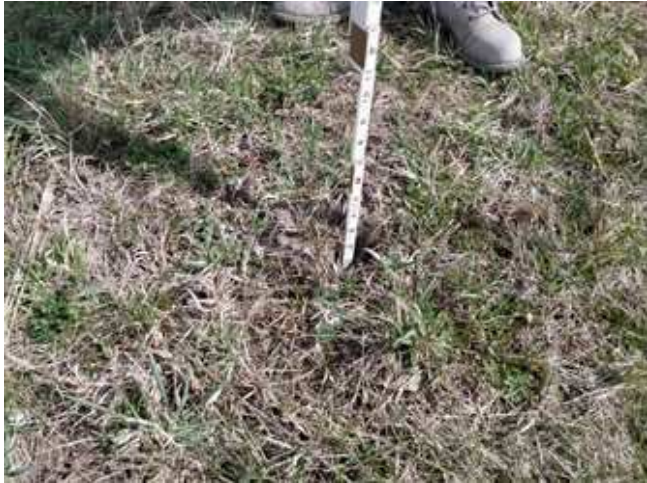
Category:	Levee Embankments	Item:	Animal Control
Observation ID:	2023-0052		
Description:	Six-inch burrow on riverside slope		
Caption:	0052 - No User Rating (Site Visit) - Six-inch burrow on riverside slope		
Lat/Long:	41.56800/-87.32187

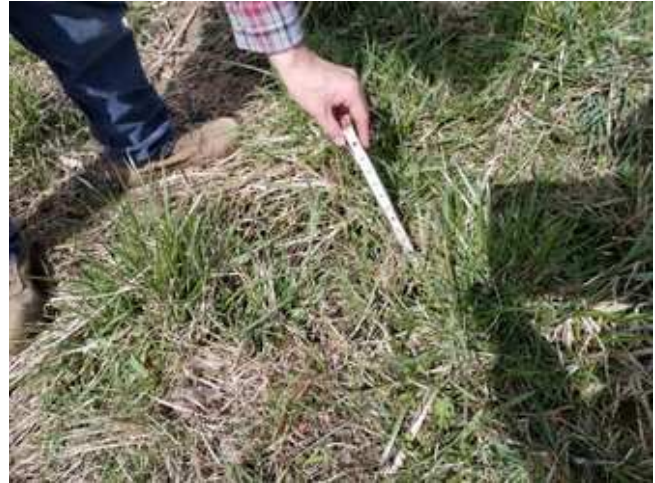
Category:	Levee Embankments	Item:	Animal Control
Observation ID:	2023-0094		
Description:	Two-inch burrow on riverside slope		
Caption:	0094 - No User Rating (Site Visit) - 2 inch burrow on riverside slope		
Lat/Long:	41.57002/-87.32672

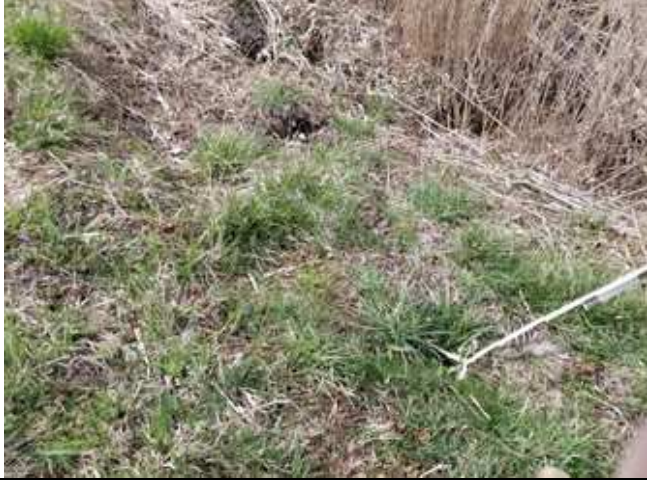
Category:	Levee Embankments	Item:	Animal Control
Observation ID:	2023-0103		
Description:	Nine-inch burrow on landside slope		
Caption:	0103 - No User Rating (Site Visit) - Nine-inch burrow on landside slope		
Lat/Long:	41.57075/-87.32684

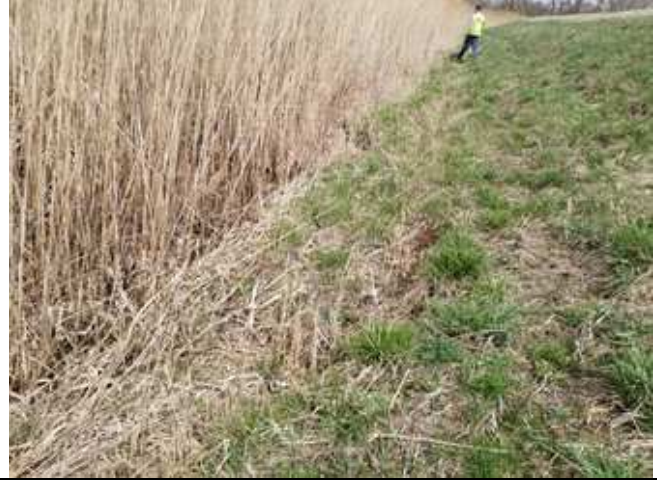
Category:	Levee Embankments	Item:	Animal Control
Observation ID:	2023-0118		
Description:	1.25 ft burrow on landside toe		
Caption:	0118 - No User Rating (Site Visit) - 1.25 ft burrow on landside toe		
Lat/Long:	41.57249/-87.32610

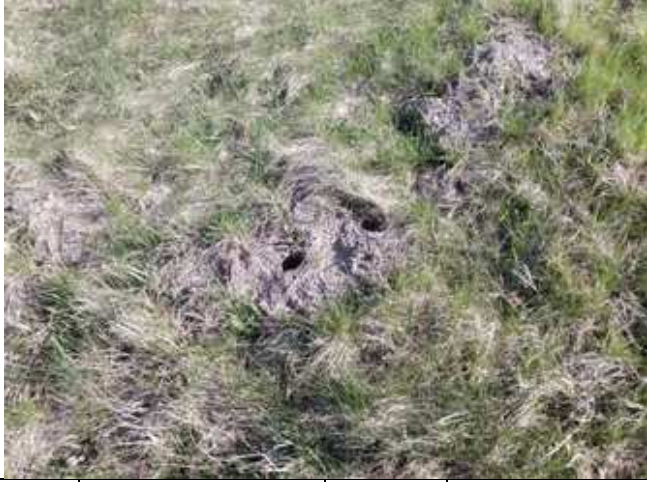
Category:	Levee Embankments	Item:	Animal Control
Observation ID:	2023-0121		
Description:	Collapsed burrows on landside toe		
Caption:	0121 - No User Rating (Site Visit) - Collapsed burrows on landside toe		
Lat/Long:	41.57252/-87.32600

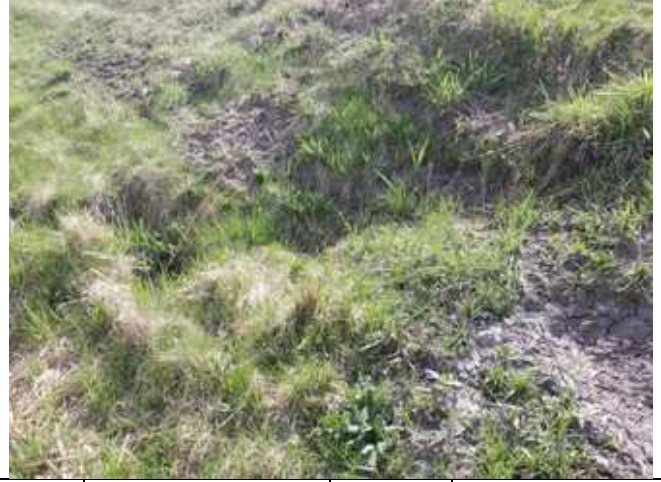
Category:	Levee Embankments	Item:	Animal Control
Observation ID:	2023-0129		
Description:	Small animal burrows on landside toe		
Caption:	0129 - No User Rating (Site Visit) - Small animal burrows on landside toe		
Lat/Long:	41.56200/-87.39354

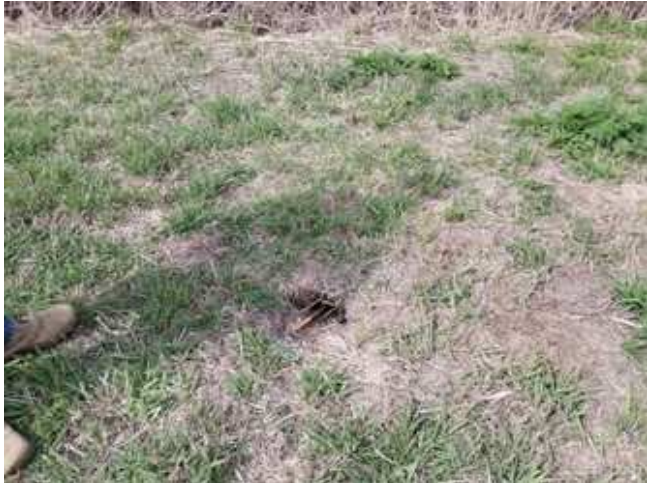
Category:	Levee Embankments	Item:	Animal Control
Observation ID:	2023-0138		
Description:	Two 2 ft deep holes and collapsed burrows halfway up landside slope		
Caption:	0138 - No User Rating (Site Visit) - Two 2 ft deep holes and collapsed burrows halfway up landside slope		
Lat/Long:	41.56523/-87.38055

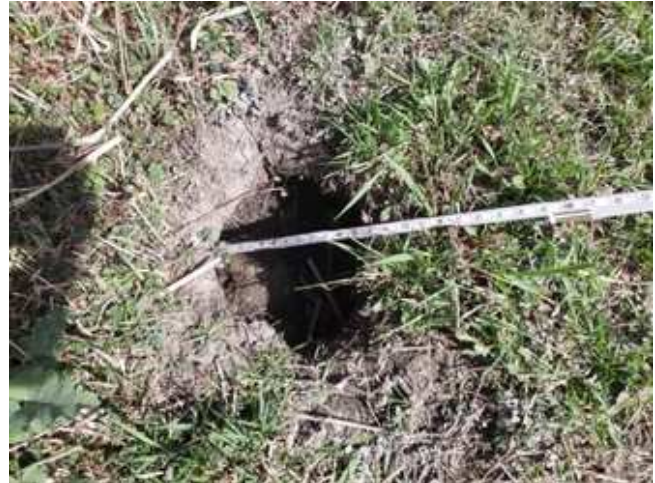
Category:	Levee Embankments	Item:	Animal Control
Observation ID:	2023-0172		
Description:	Animal burrow >4 ft deep on landside toe		
Caption:	0172 - No User Rating (Site Visit) - Animal burrow >4 ft deep on landside toe		
Lat/Long:	41.56693/-87.32191
